Historic Furnishings Report

Golden Gate National Recreation Area
San Francisco, California

Alcatraz Island: Main Prison Building

Mary Grassick
Staff Curator

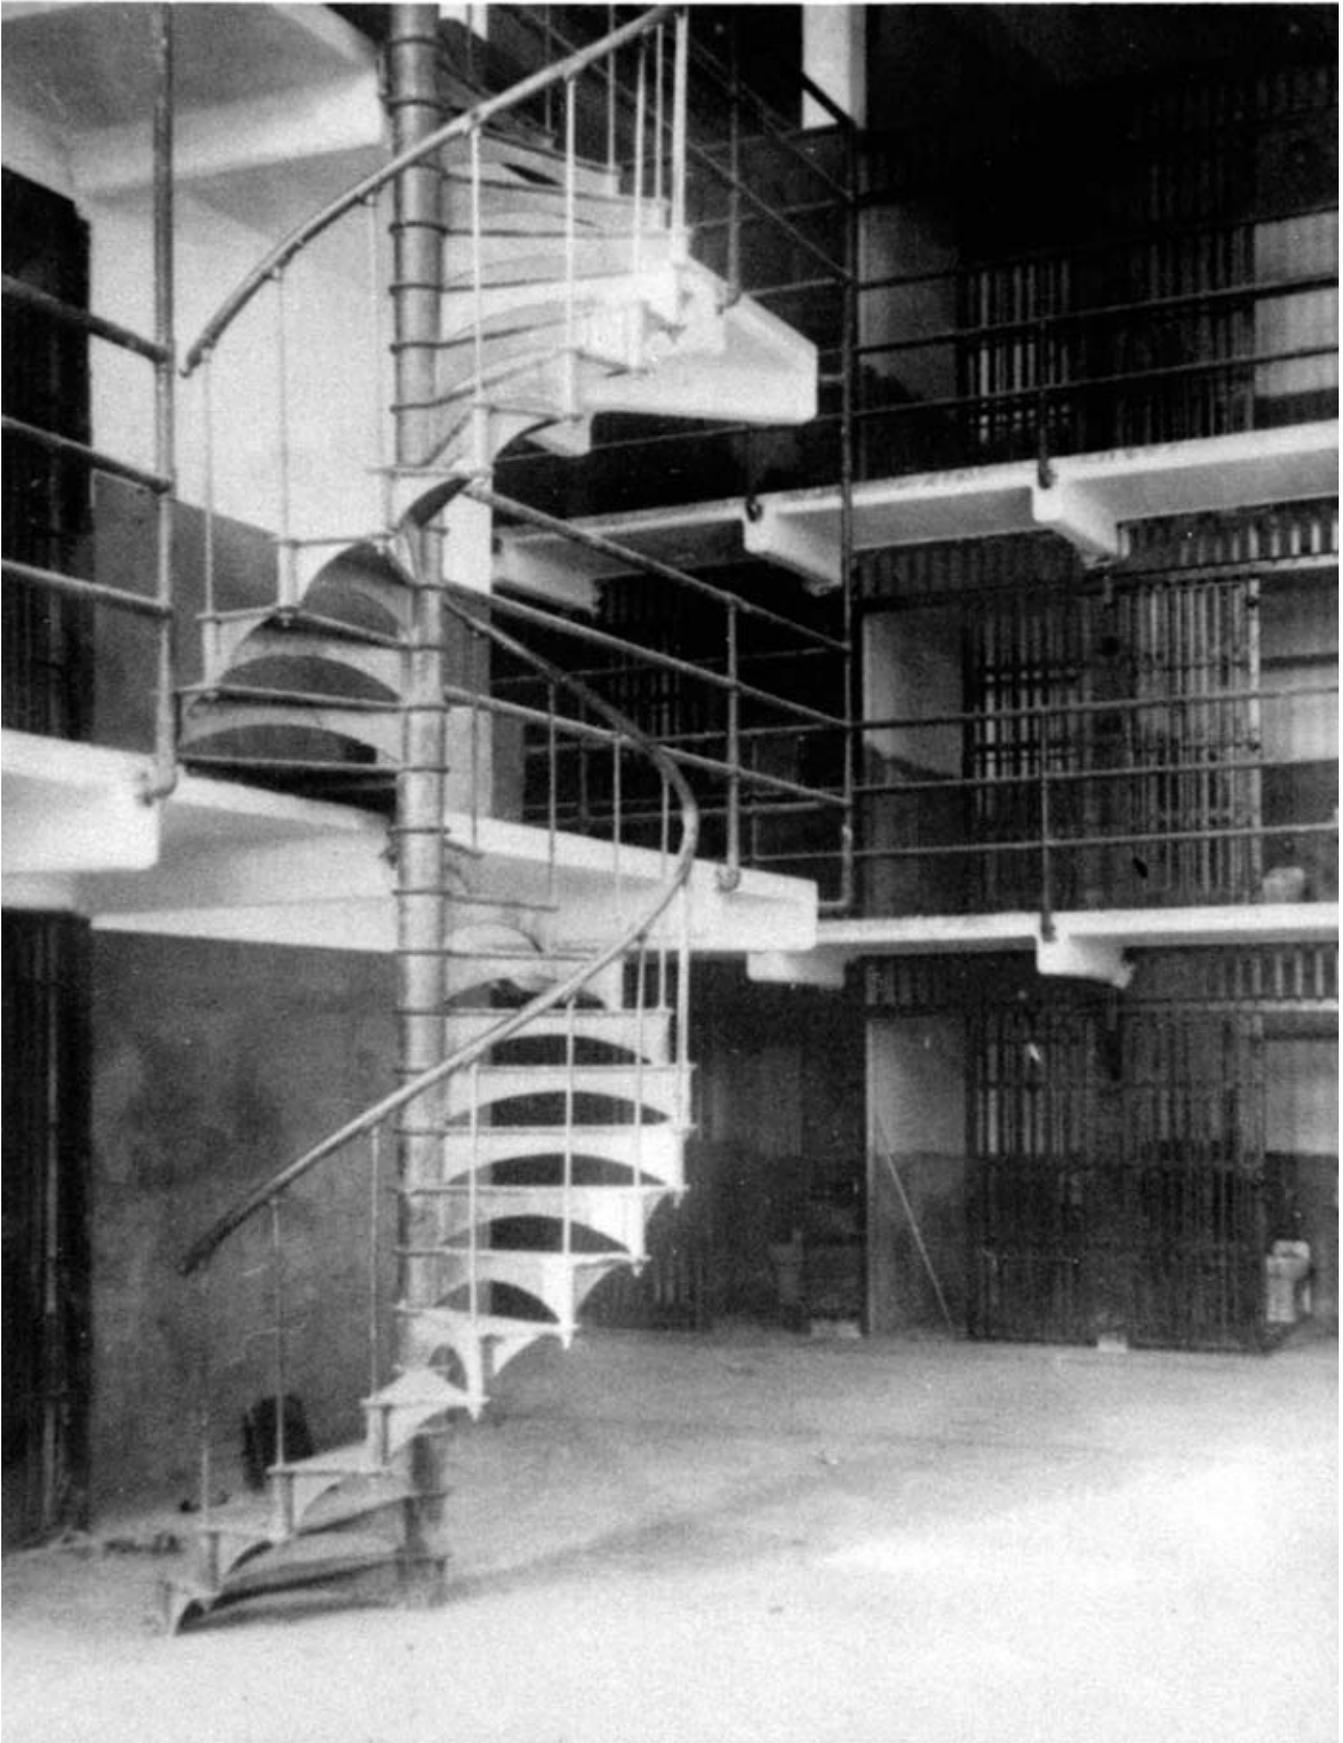
**DB3**

Interior of Cell House during construction, ca. 1911. GGNRA Park Archives Collection, GOGA 3078. Note stairway, cell paint treatment, and toilets.

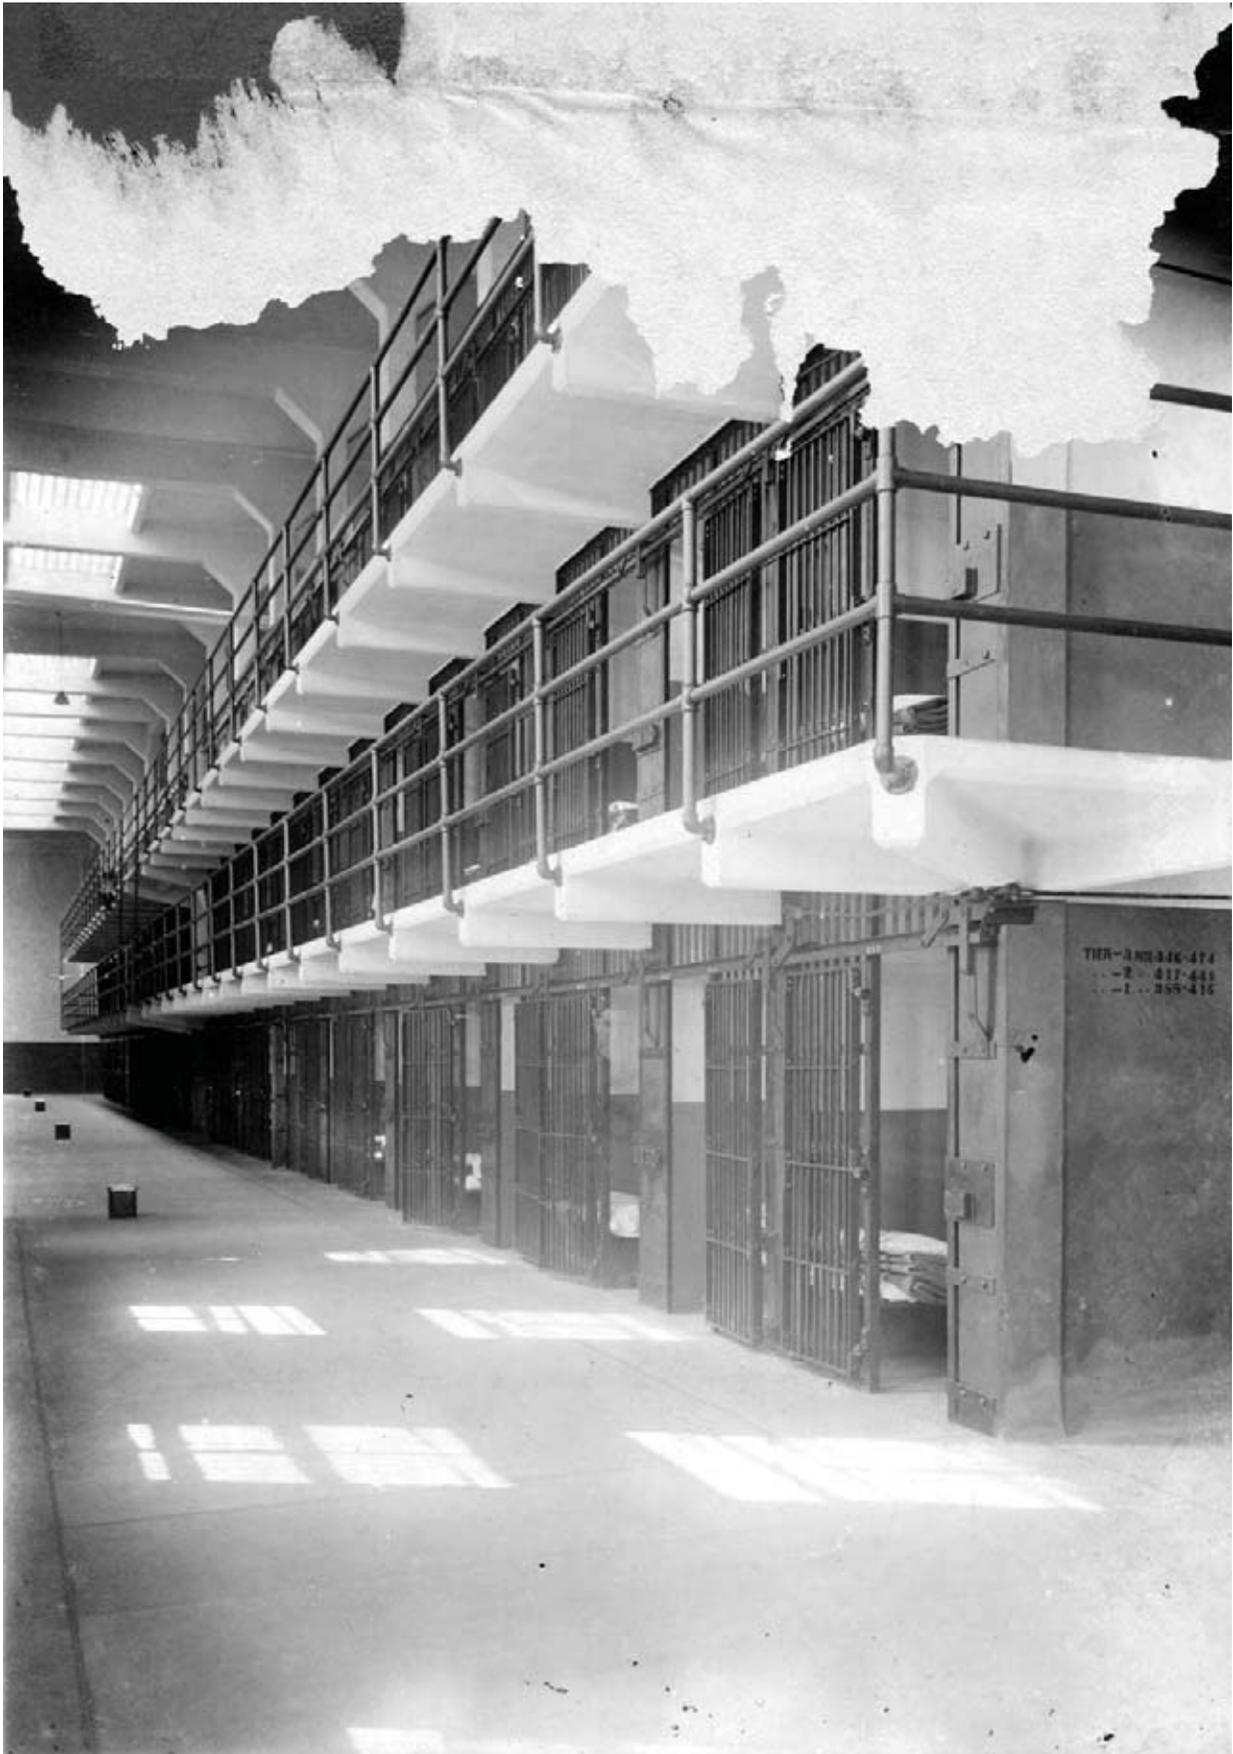
**DB5**

C-block, no date. GGNRA Park Archives Collection, GOGA 1473. Note tier numbering on wall.

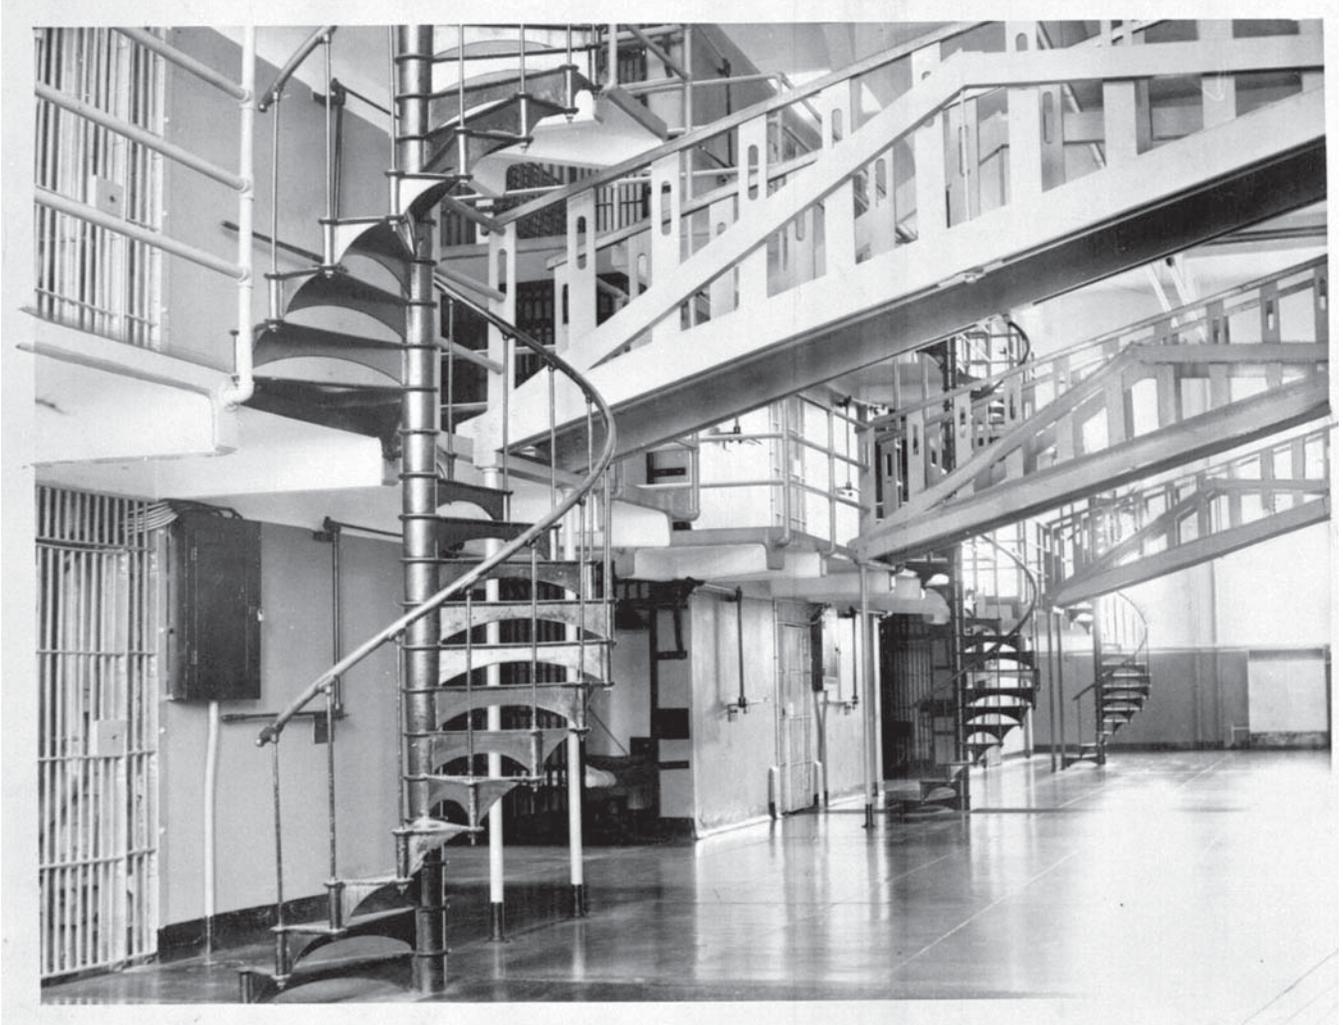
**DB6**

Bridges at south end of tiers leading to second floor of Administration Wing, ca. 1930. San Francisco History Center, SFPL.

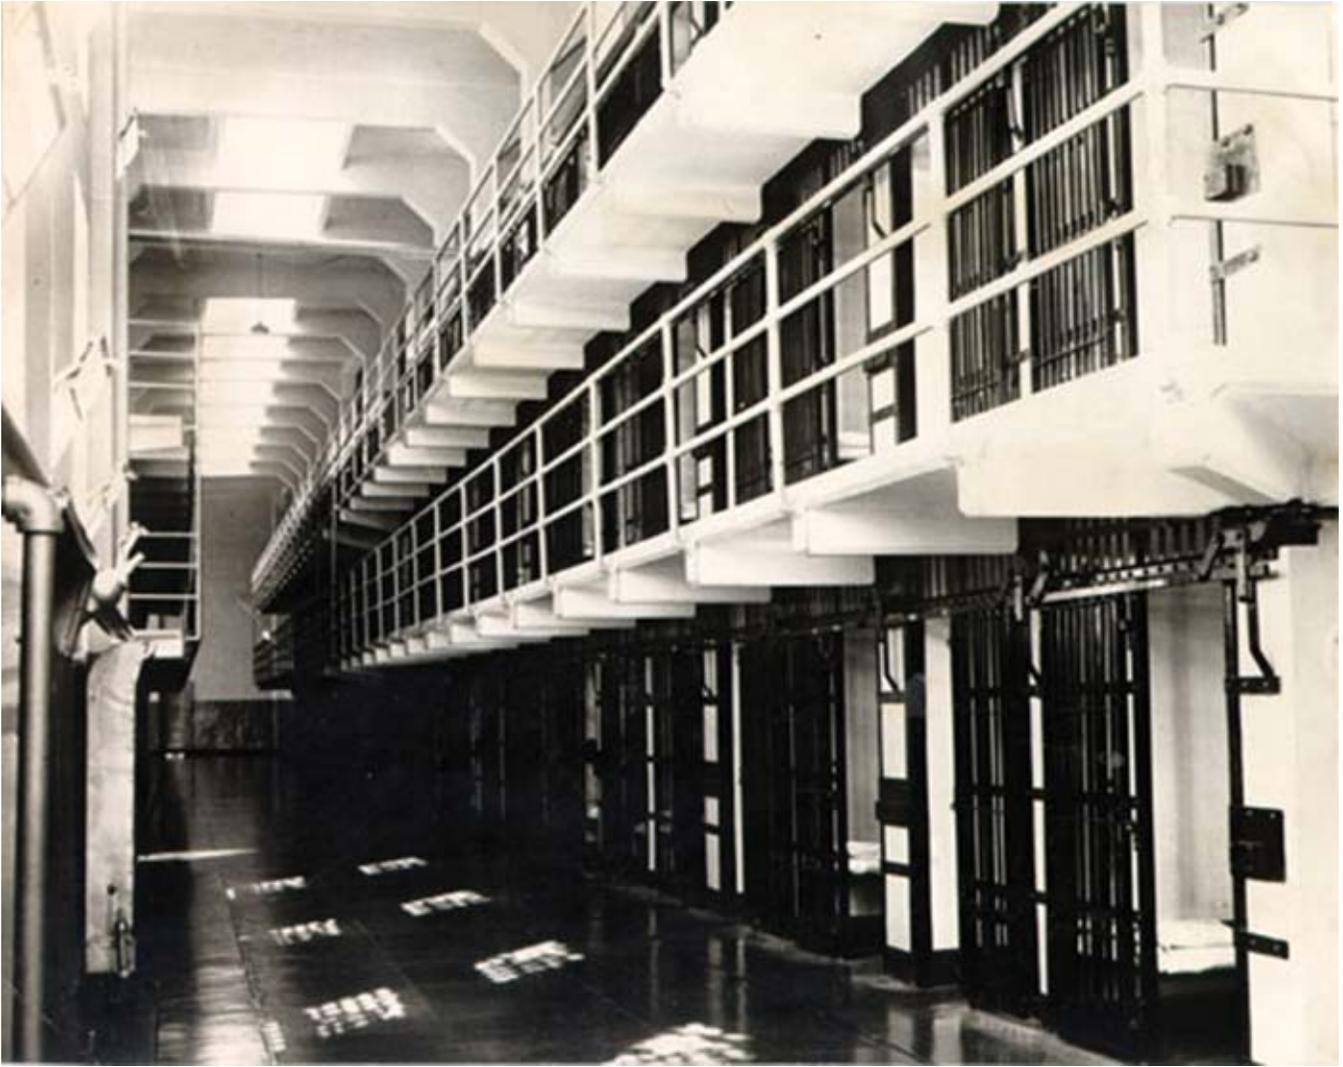
DB7

A-B aisle, looking south, ca. 1930. San Francisco History Center, SFPL. Note door in wall to Commandant's Office.

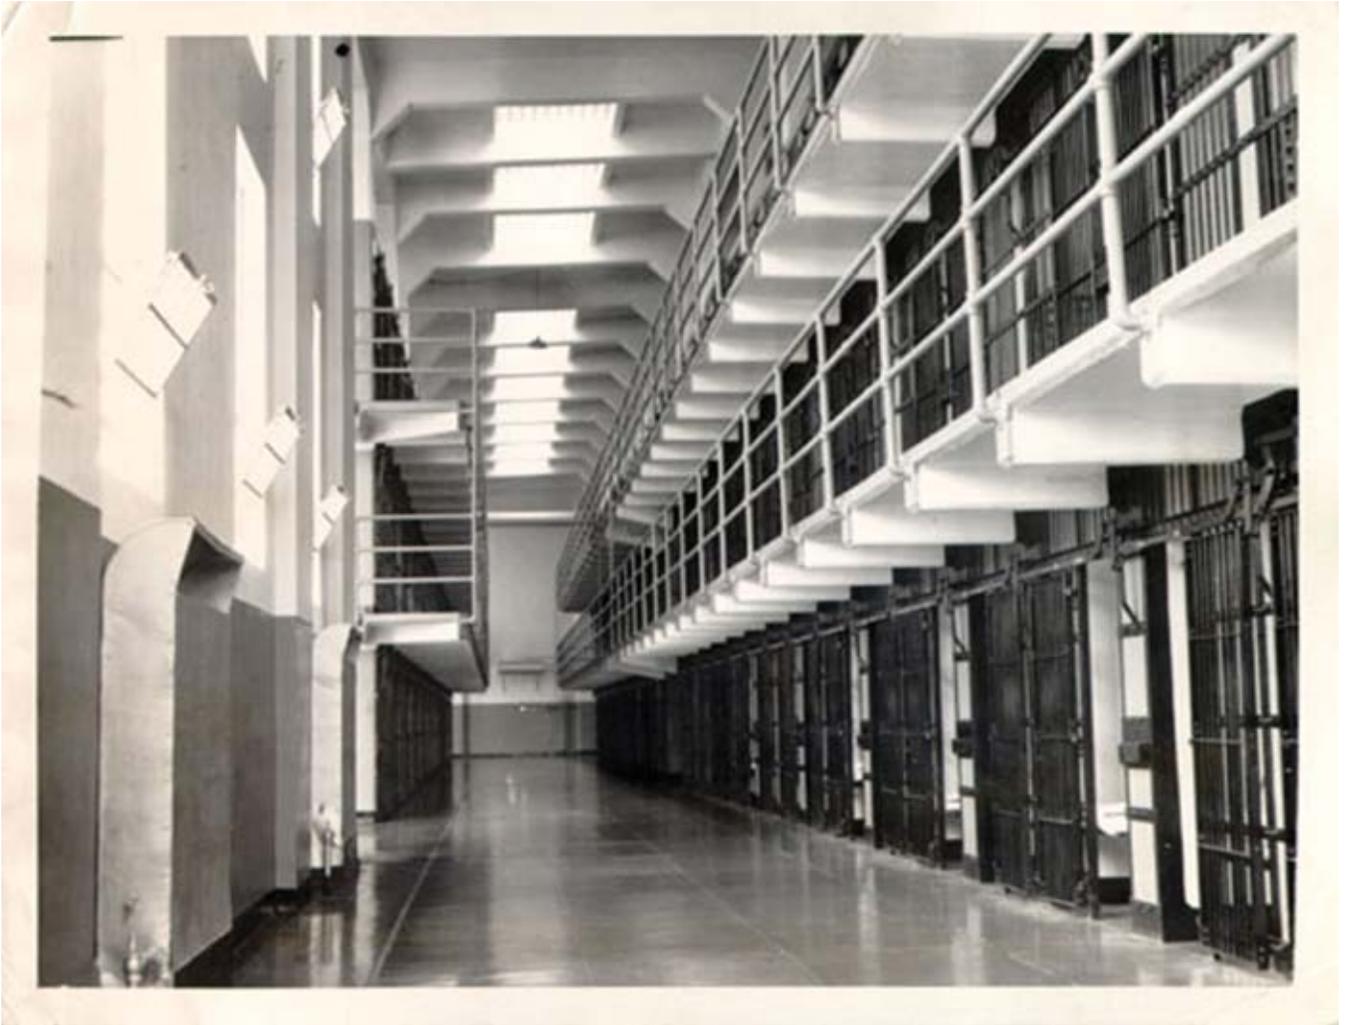
DB8

A-B aisle, looking south, ca. 1930. San Francisco History Center, SFPL. Note door in south wall has been removed.

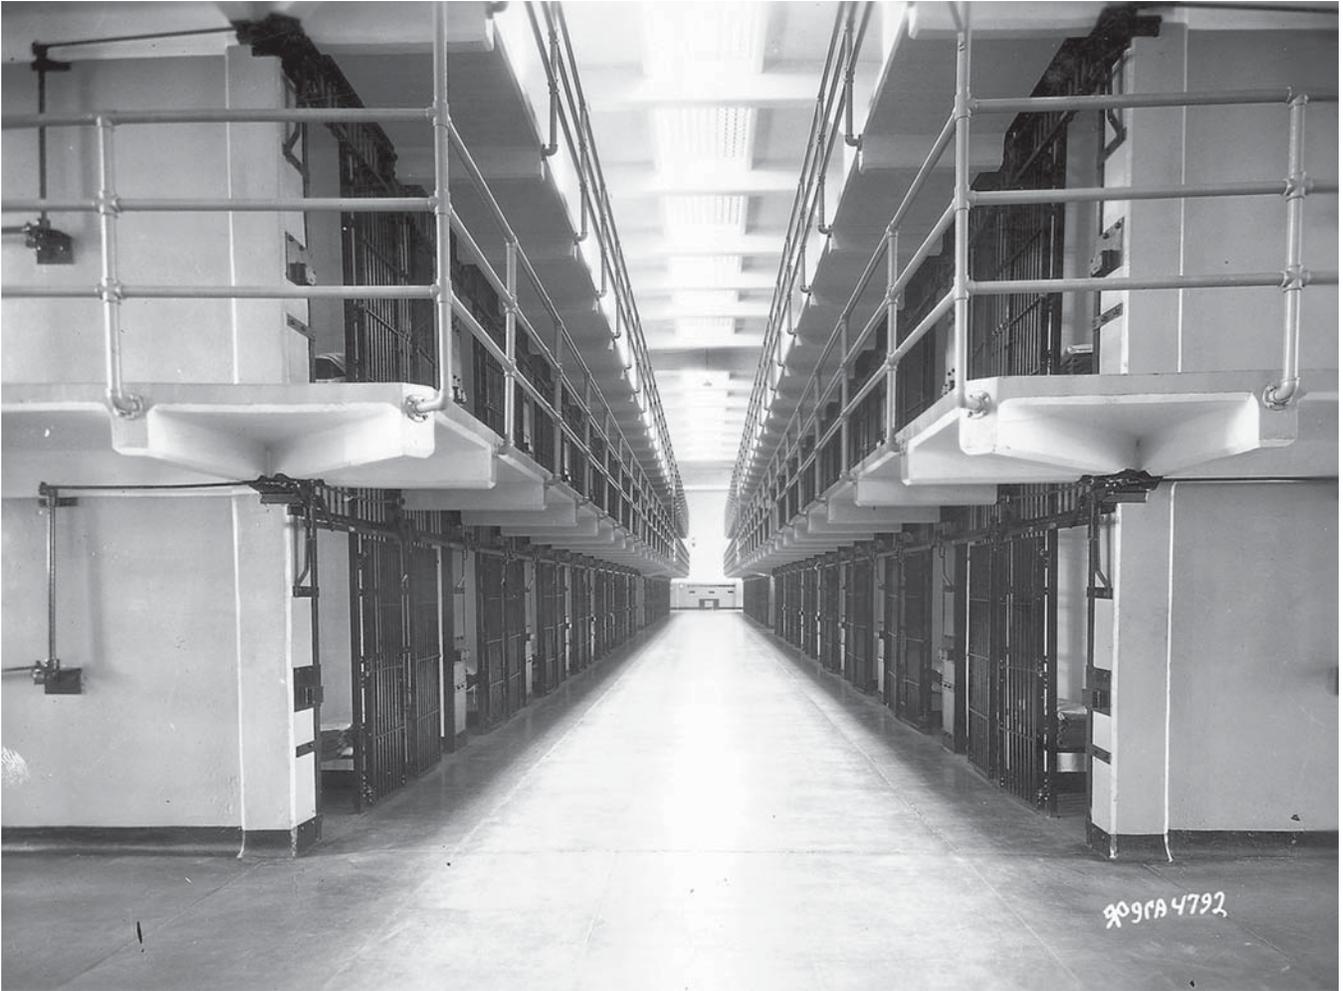
DB9

“Broadway,” B-C aisle, looking south, no date. Courtesy Chuck Stucker Collection. Note change in cell paint treatment.

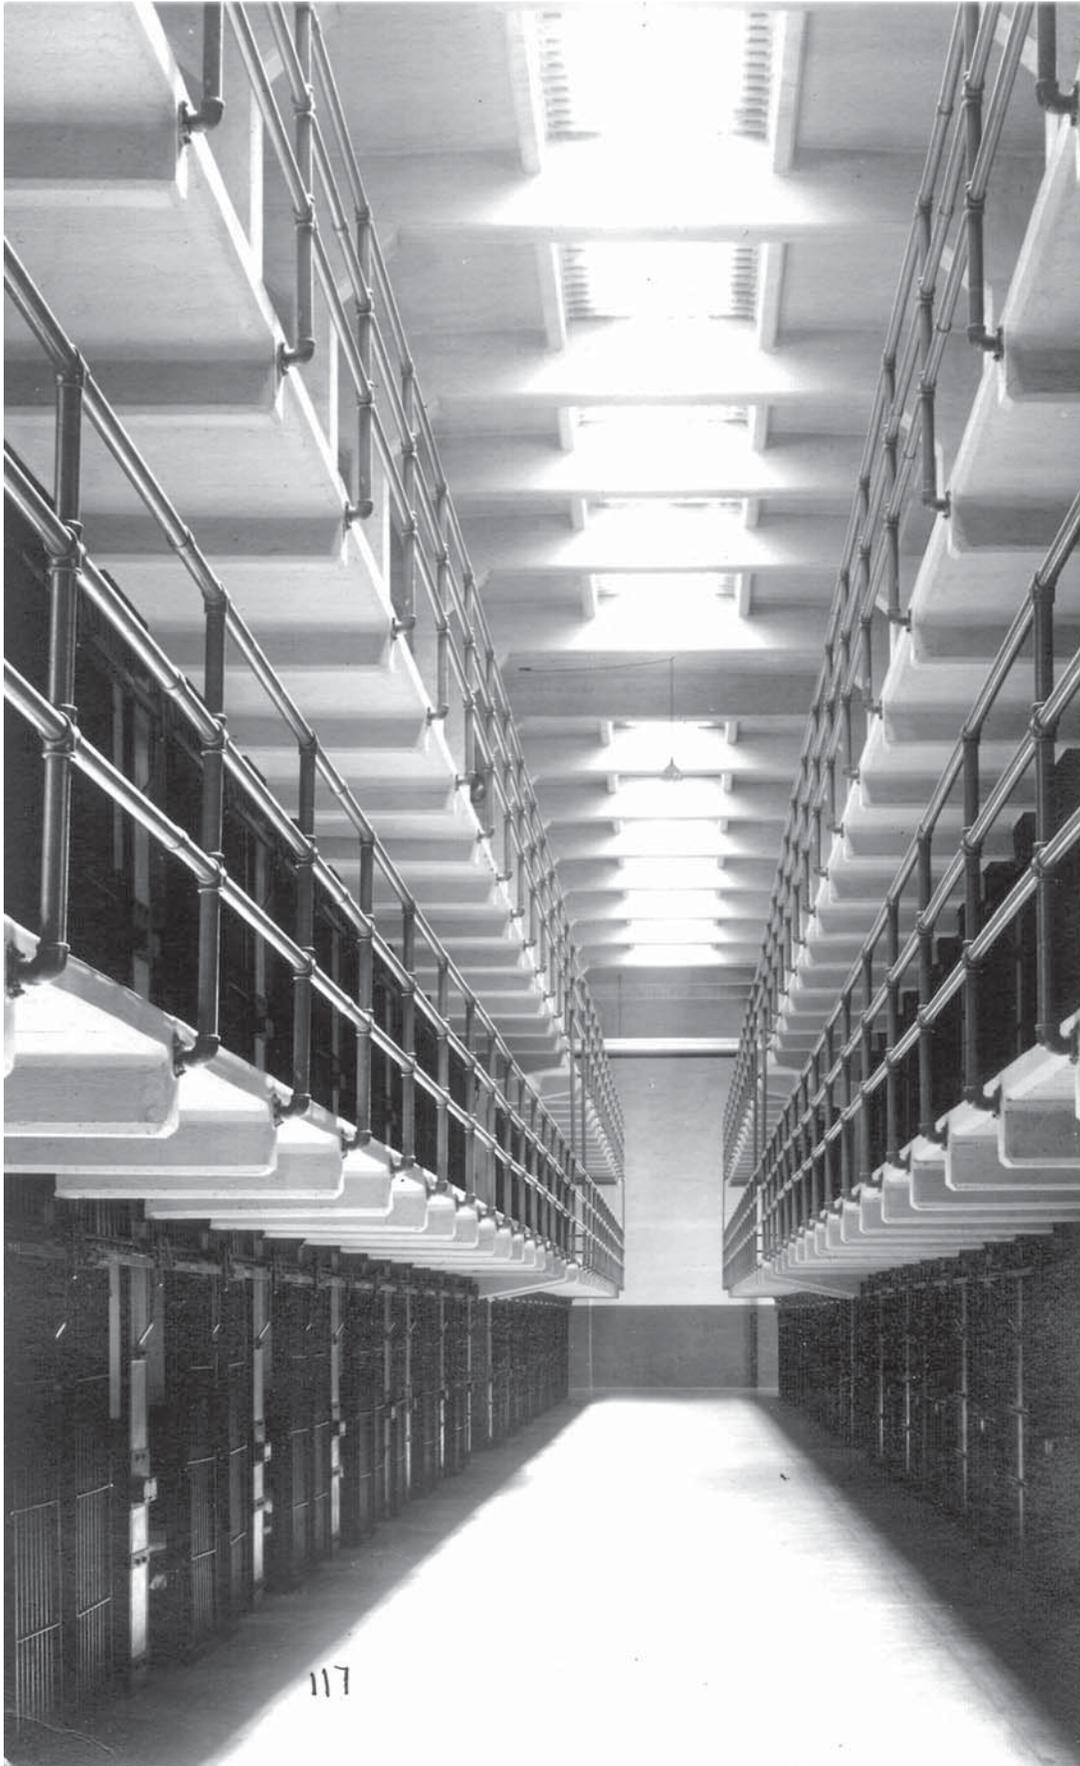
DB10

“Broadway,” B–C aisle, no date. Courtesy Chuck Stucker Collection. Note lighting fixtures.

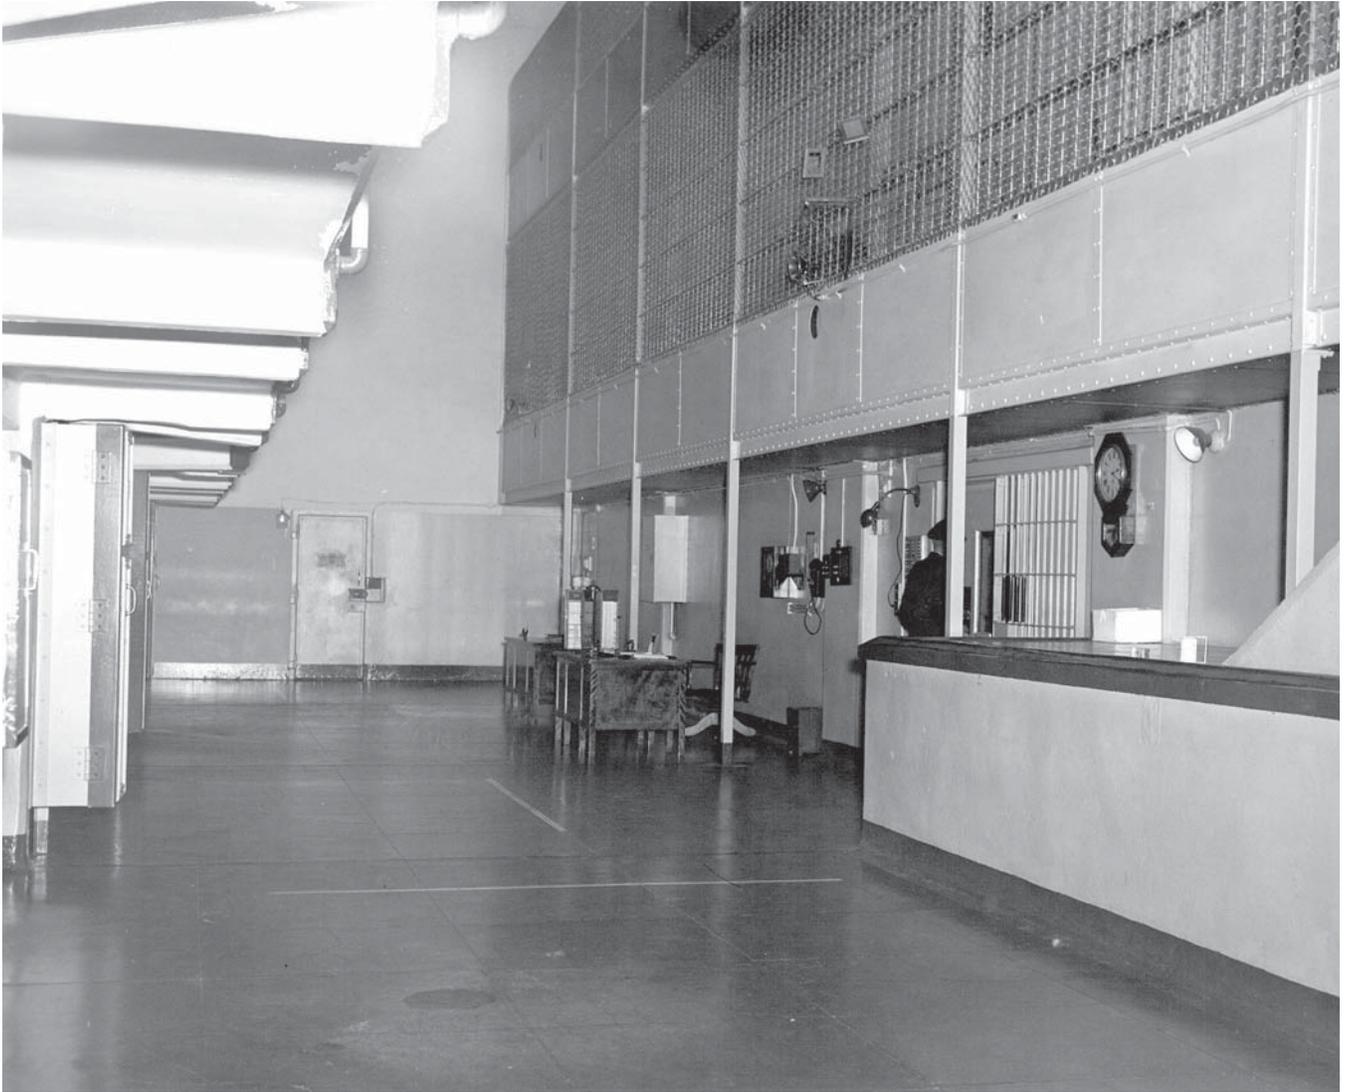
P15 Cut-off gates, center of cell blocks, no date. GGNRA Park Archives Collection, P83-144.164.

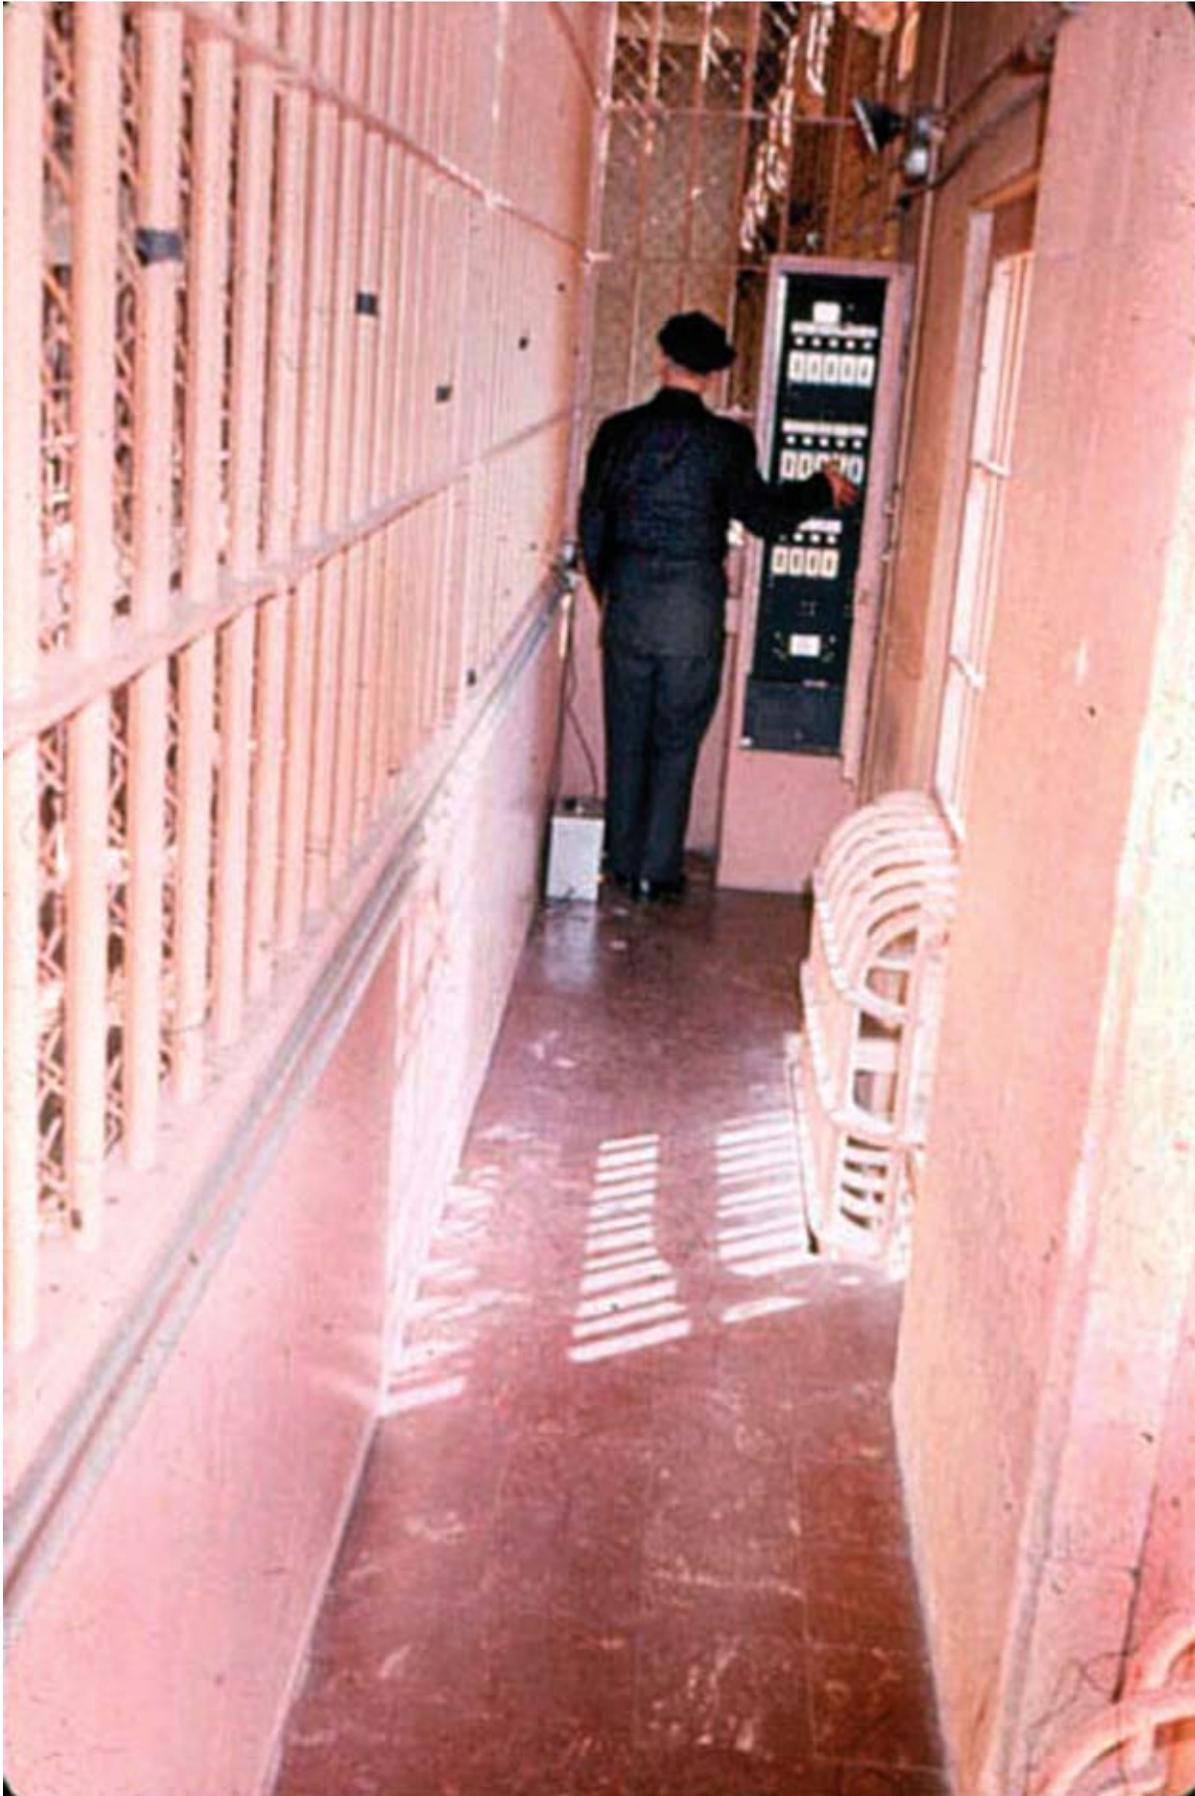
P24

Radio distribution panel in Gun Gallery, ca. 1962. GGNRA Park Archives Collection, P89-055.71.

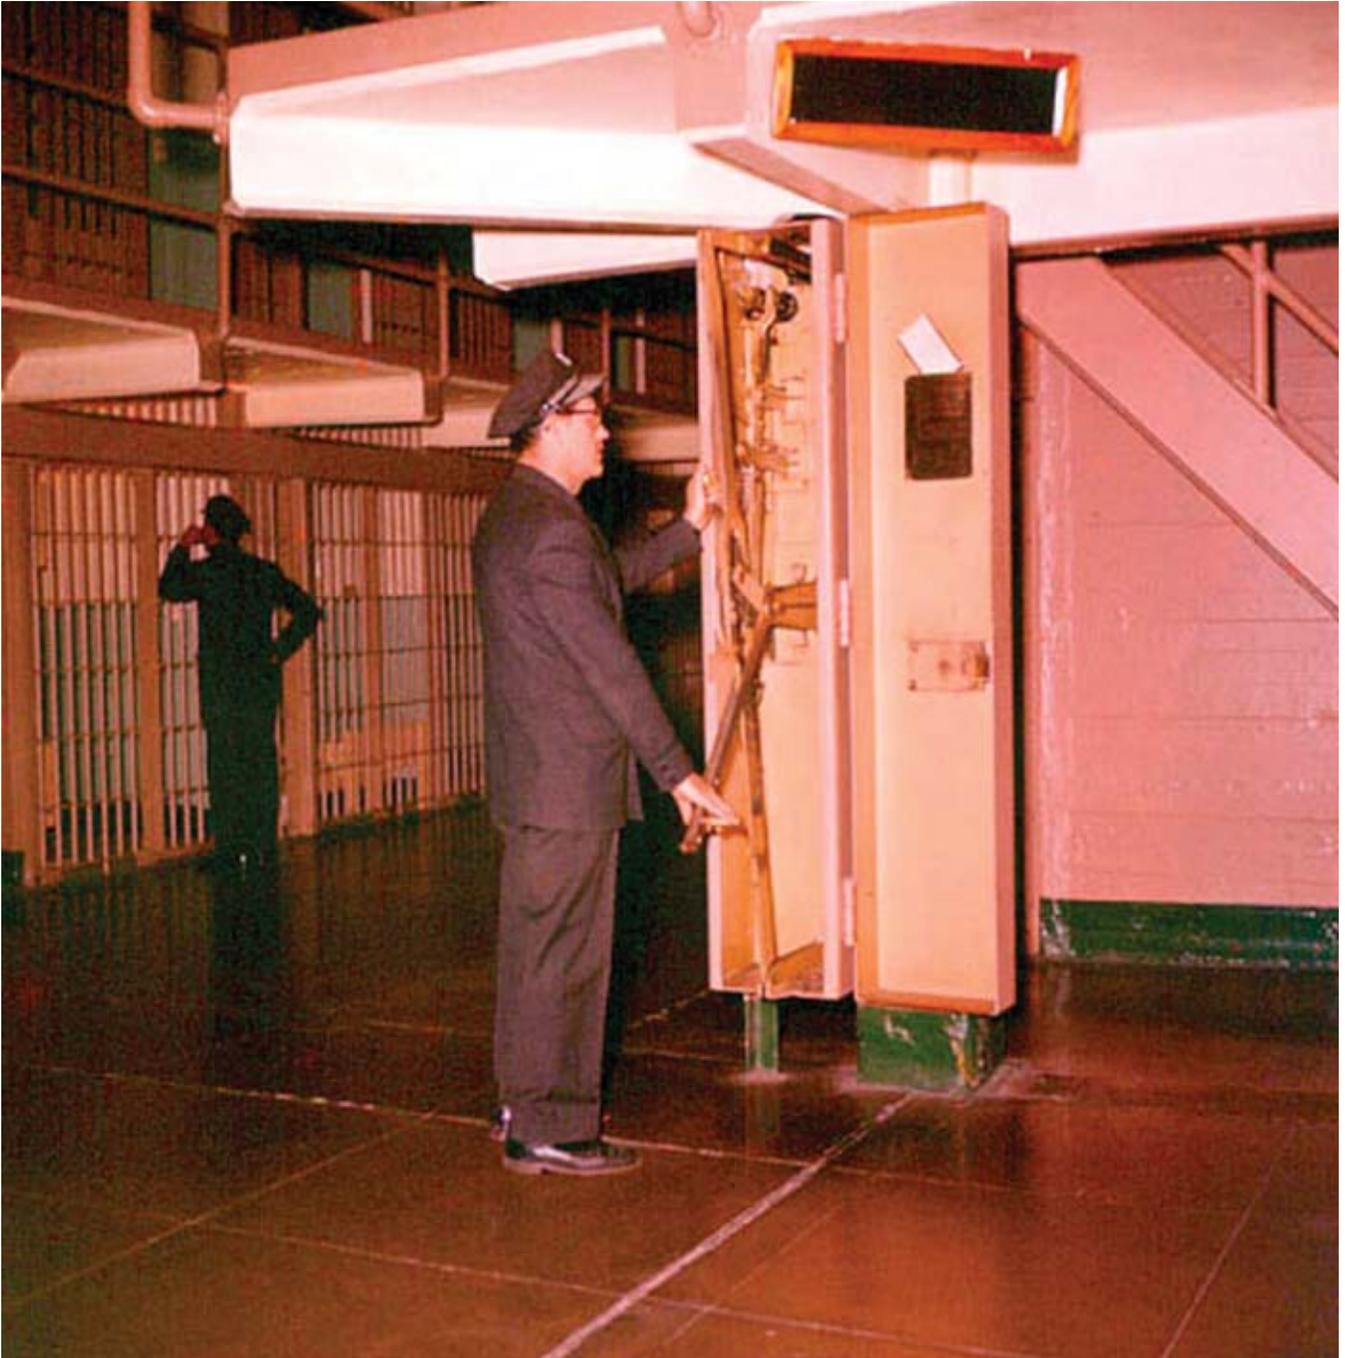
P31 Metal detector, ca. 1962. GGNRA Park Archives Collection, P89-055.84.

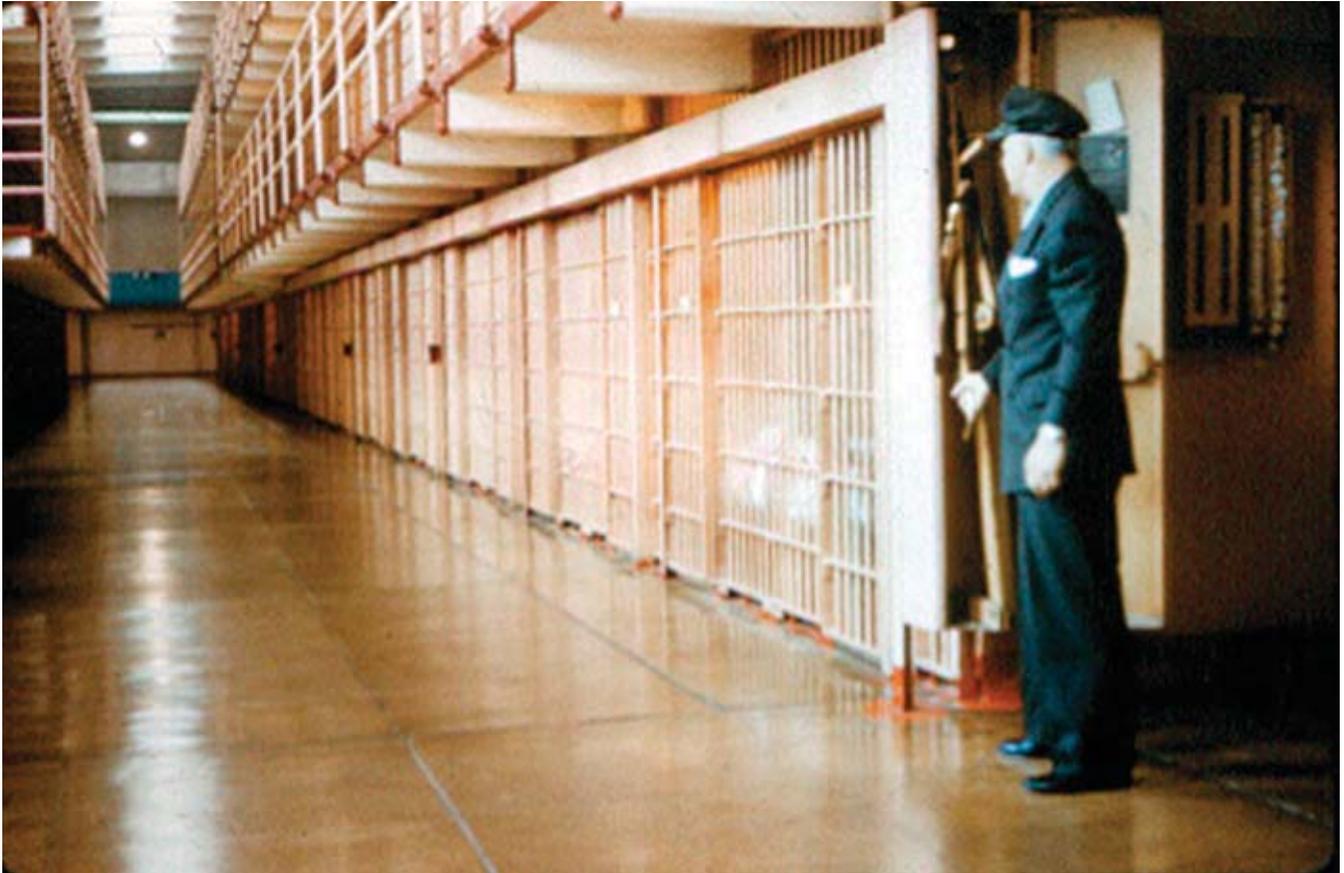
P32 Locking mechanism, cell house, ca. 1962. GGNRA Park Archives Collection, P89-057.70.

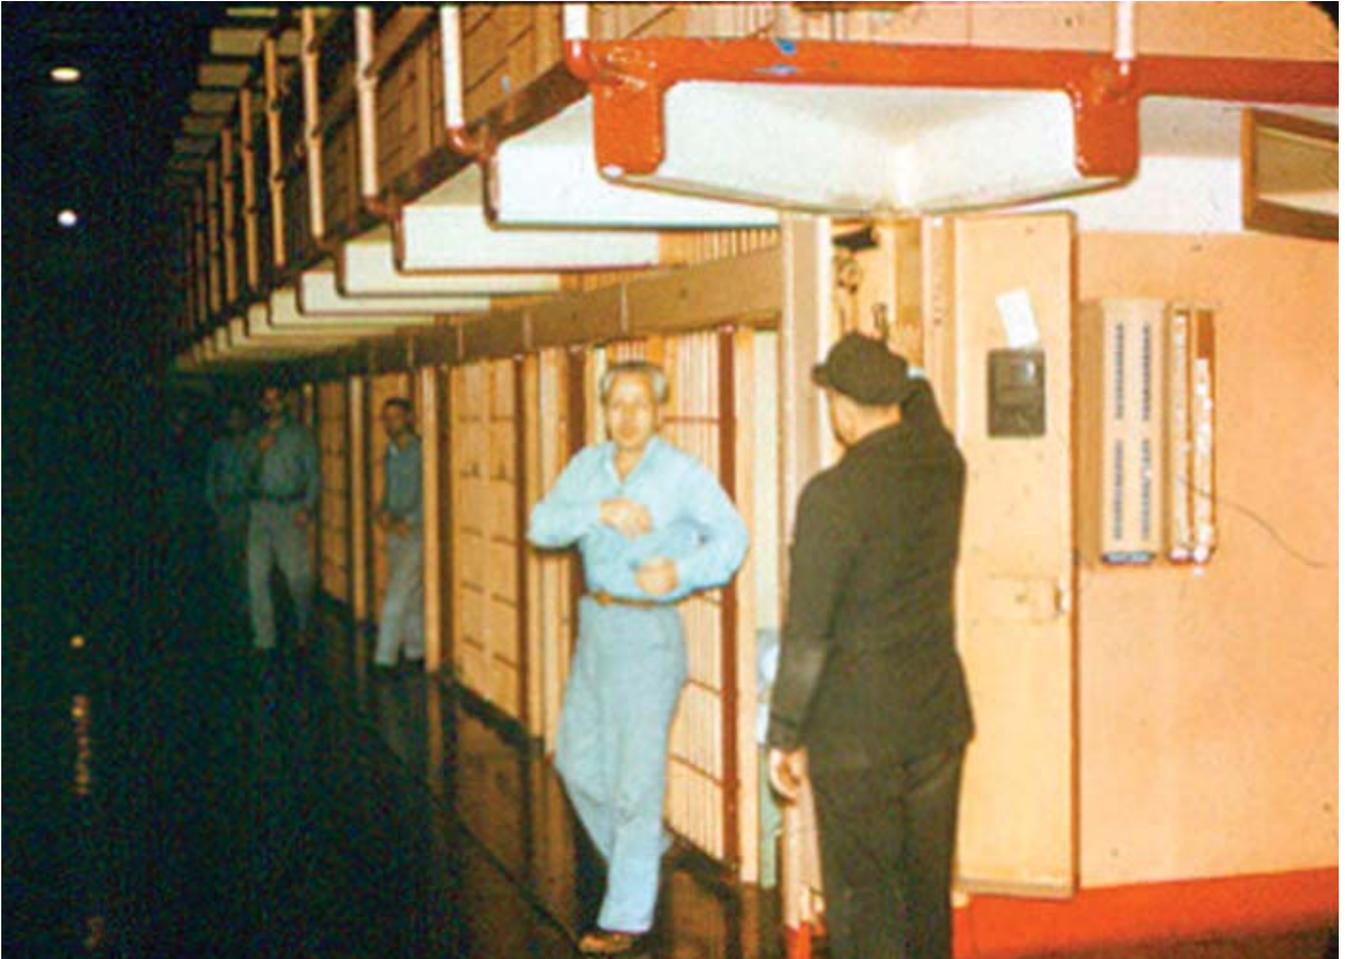
P33 Guard operating door mechanism, west end of outside B-block, ca. 1962. GGNRA Park Archives Collection, P92-007.4.

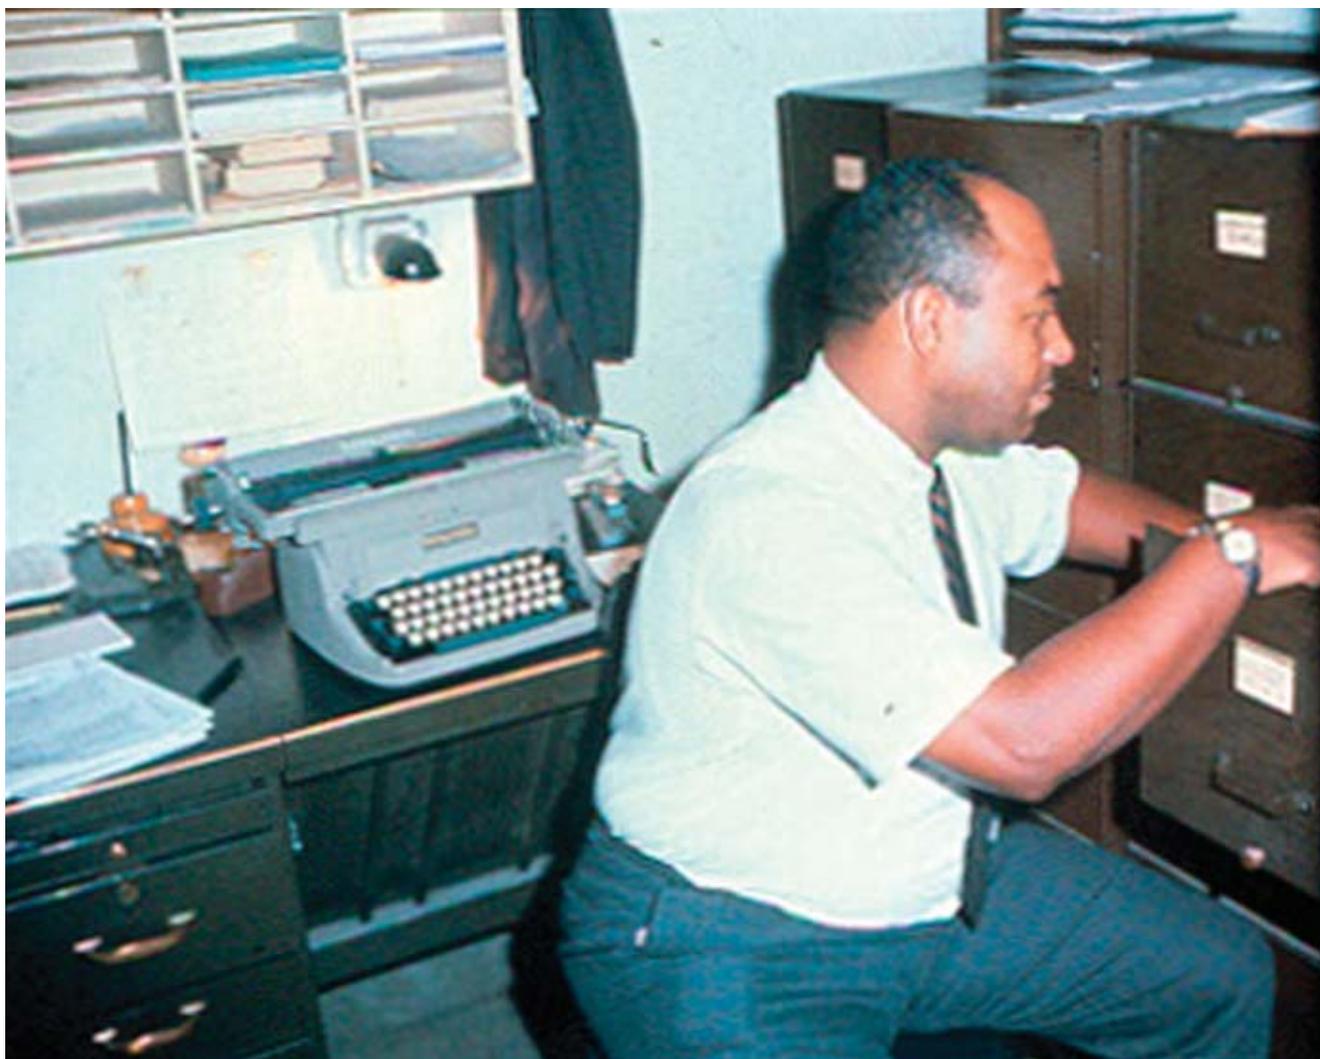
AO9

Unidentified office worker in Administration Wing, ca. 1962. GGNRA Park Archives Collection, P89-055.79. Note new office partitions.

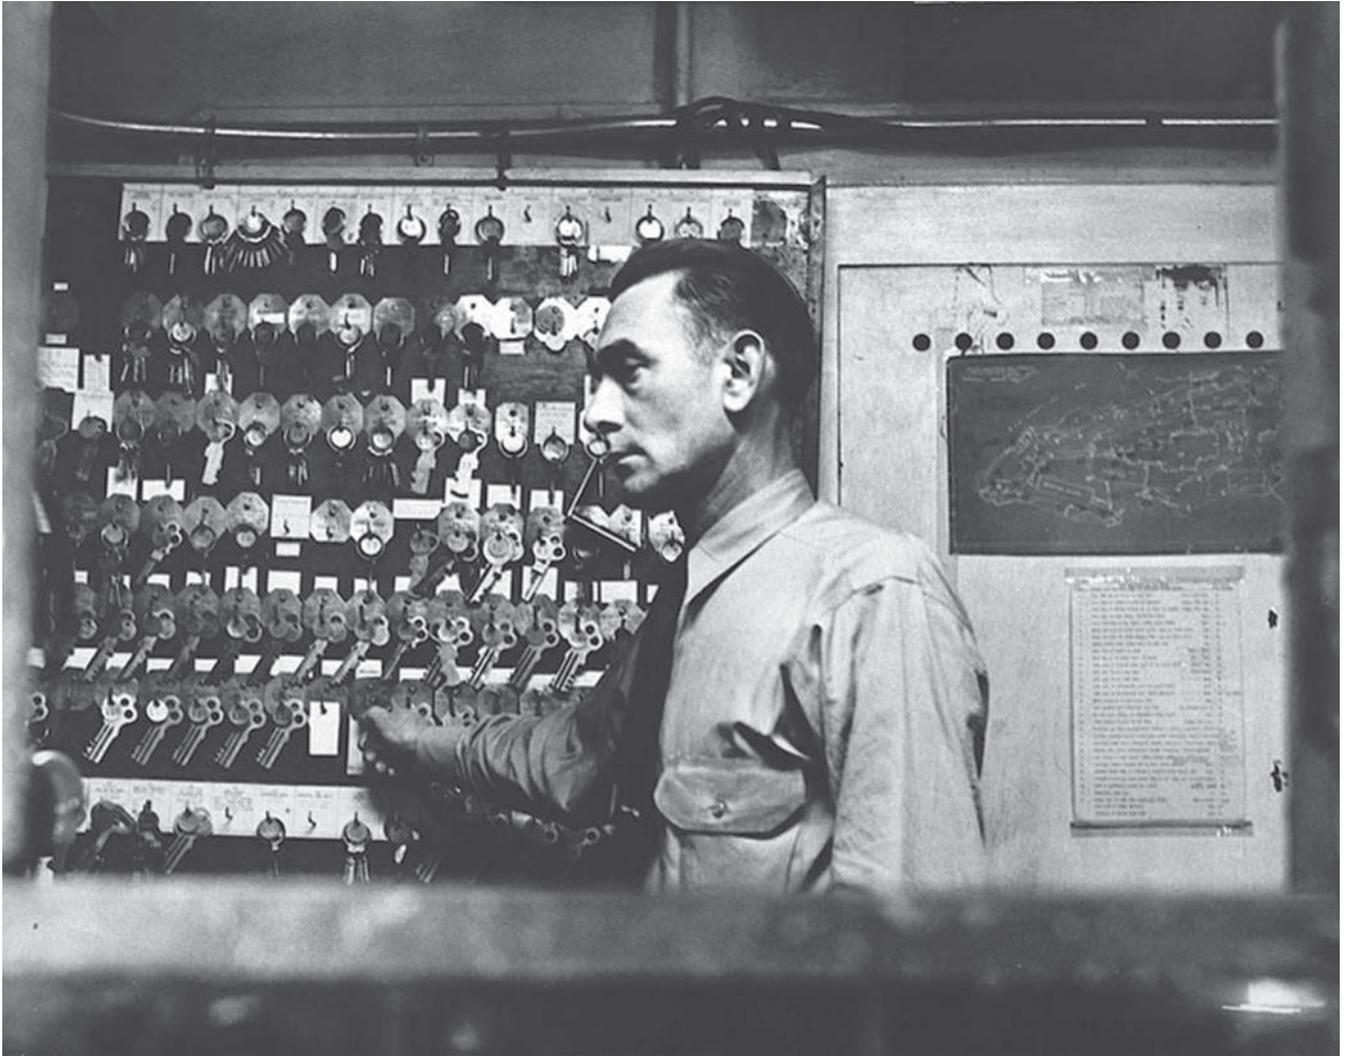
OA3 Annotated armory console, ca. 1956. Courtesy Chuck Stucker Collection.
