Historic Furnishings Report

Golden Gate National Recreation Area
San Francisco, California

Alcatraz Island: Main Prison Building

Mary Grassick
Staff Curator

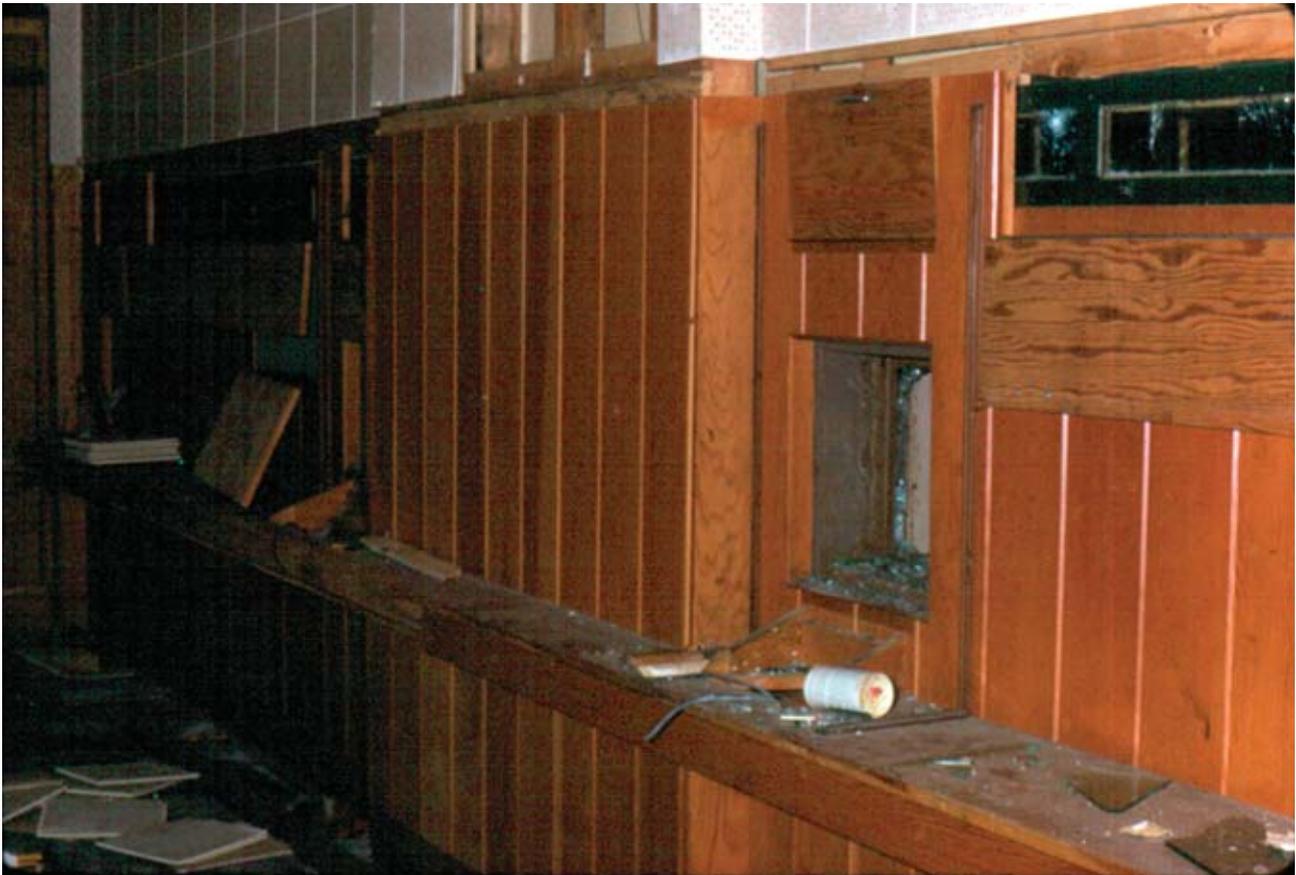
**V7**

Visitors' Room, facing east, 1963. GGNRA Interpretive Photo Collection, 77-341. The south side of the room is being used by administrative staff. The framed opening on the south wall leads to the new Control Center, and the hinged door in the paneling provides access to switch boxes and junction boxes.

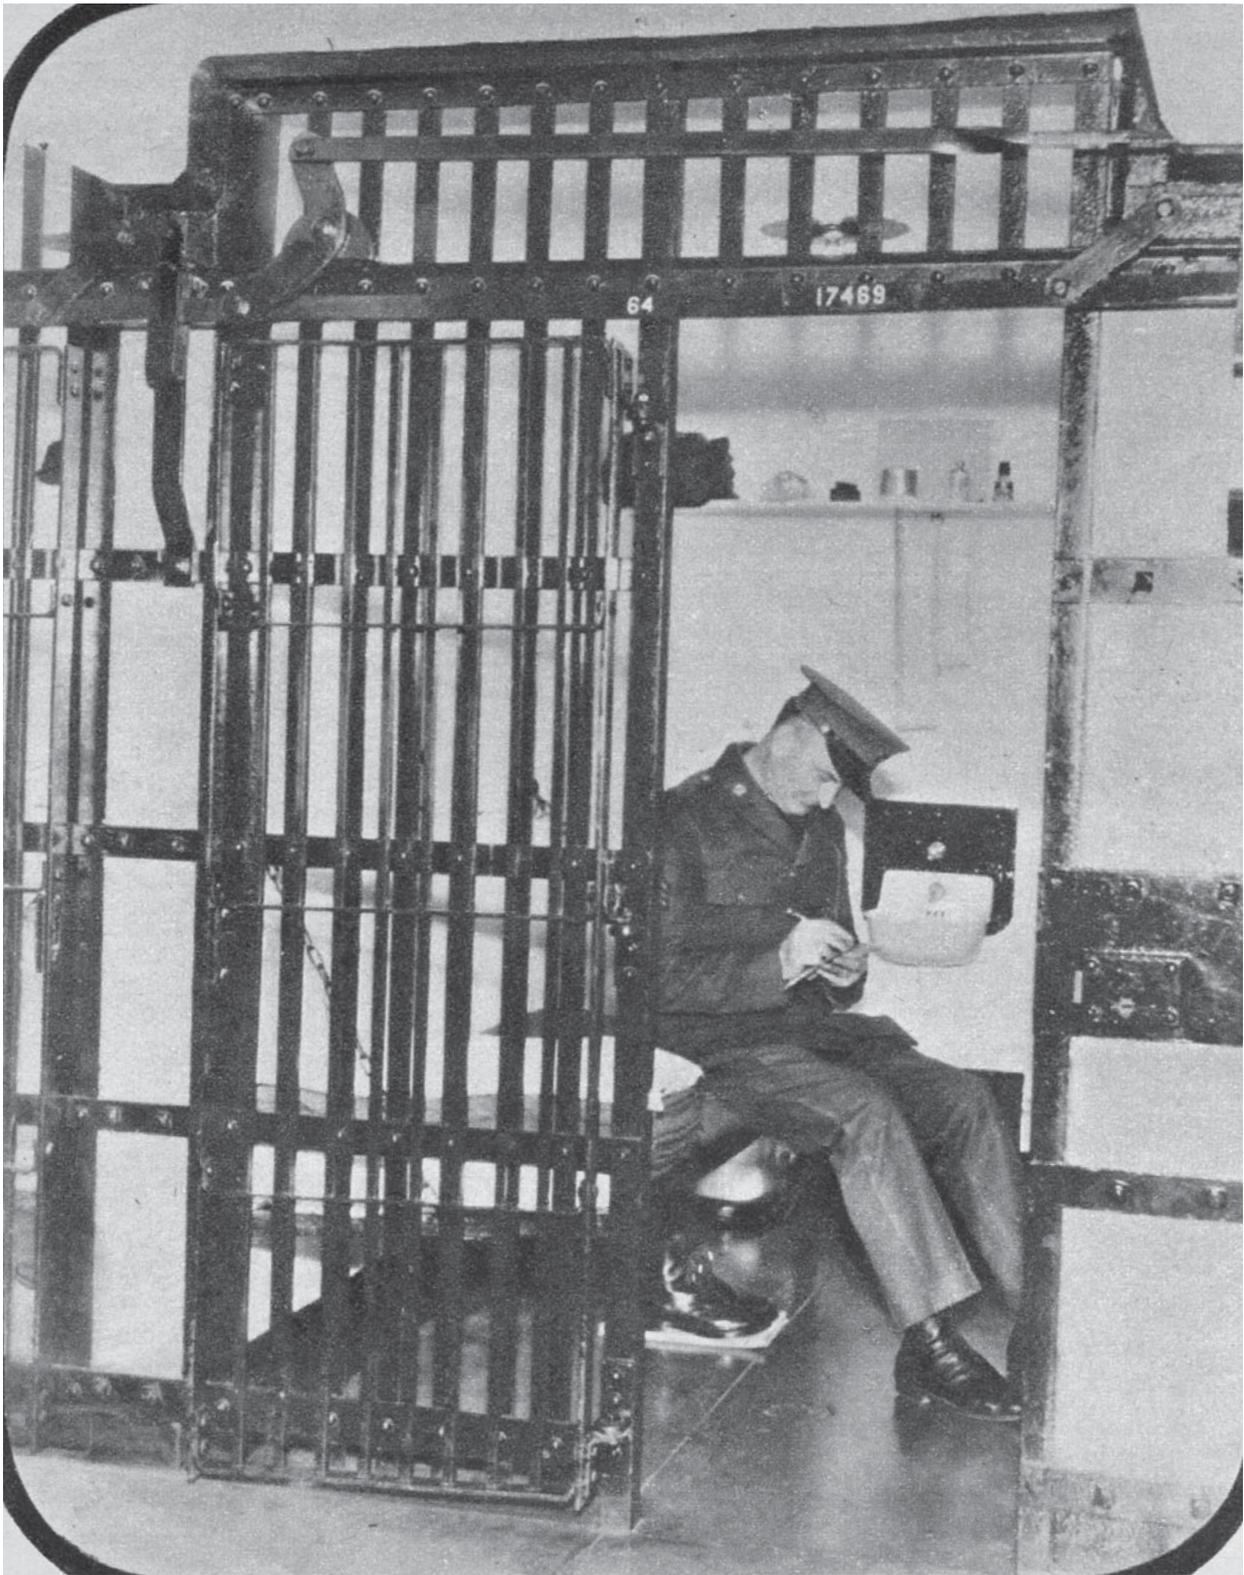
C5

Army guard in disciplinary barracks-era cell, ca. 1933. *American Detective Magazine*, ca. 1936–38. GGNRA Park Archives Collection. Note cell number and prisoner registry number painted over the cell door.

OBJECT AND LOCATION	EVIDENCE	RECOMMENDATION
Toiletries: shaving cup , tin, with soap and brush comb nail clippers toothpowder , can toothbrush drinking cup , tin	Figures C4, C5, C6. List, 1934	Acquire.
Mirror , framed, for shaving (on shelf above sink)	Figure C6	Acquire or reproduce.
Books: Bible Library books, two (on shelf)	Figure C6. List, 1934	Acquire.
Magazines , two, c. 1935 (on shelf or on fold-out table)	Figure C6. List, 1934	Acquire.
Face towel , cotton, white (hanging on nail under shelf)	Figure C6. List, 1934	Acquire.
Bath towel , cotton, white, 22 inches x 44 inches (hanging on nail under shelf)	Figure C6. List, 1934	Acquire.
Table and seat , metal, fold-out (attached to wall)	Figure C6	Use cell with intact original table or reproduce.
Ashtray (on fold-out table or on shelf)	List, 1934	Acquire.
Tobacco , cigarette, in 1-ounce cloth pouch; and Cigarette papers , package (on fold-out table or on shelf)	List, 1934	Acquire Duke Mixture, Golden Grain, Bull Durham, Stud, or Union Leader brand tobacco and papers.

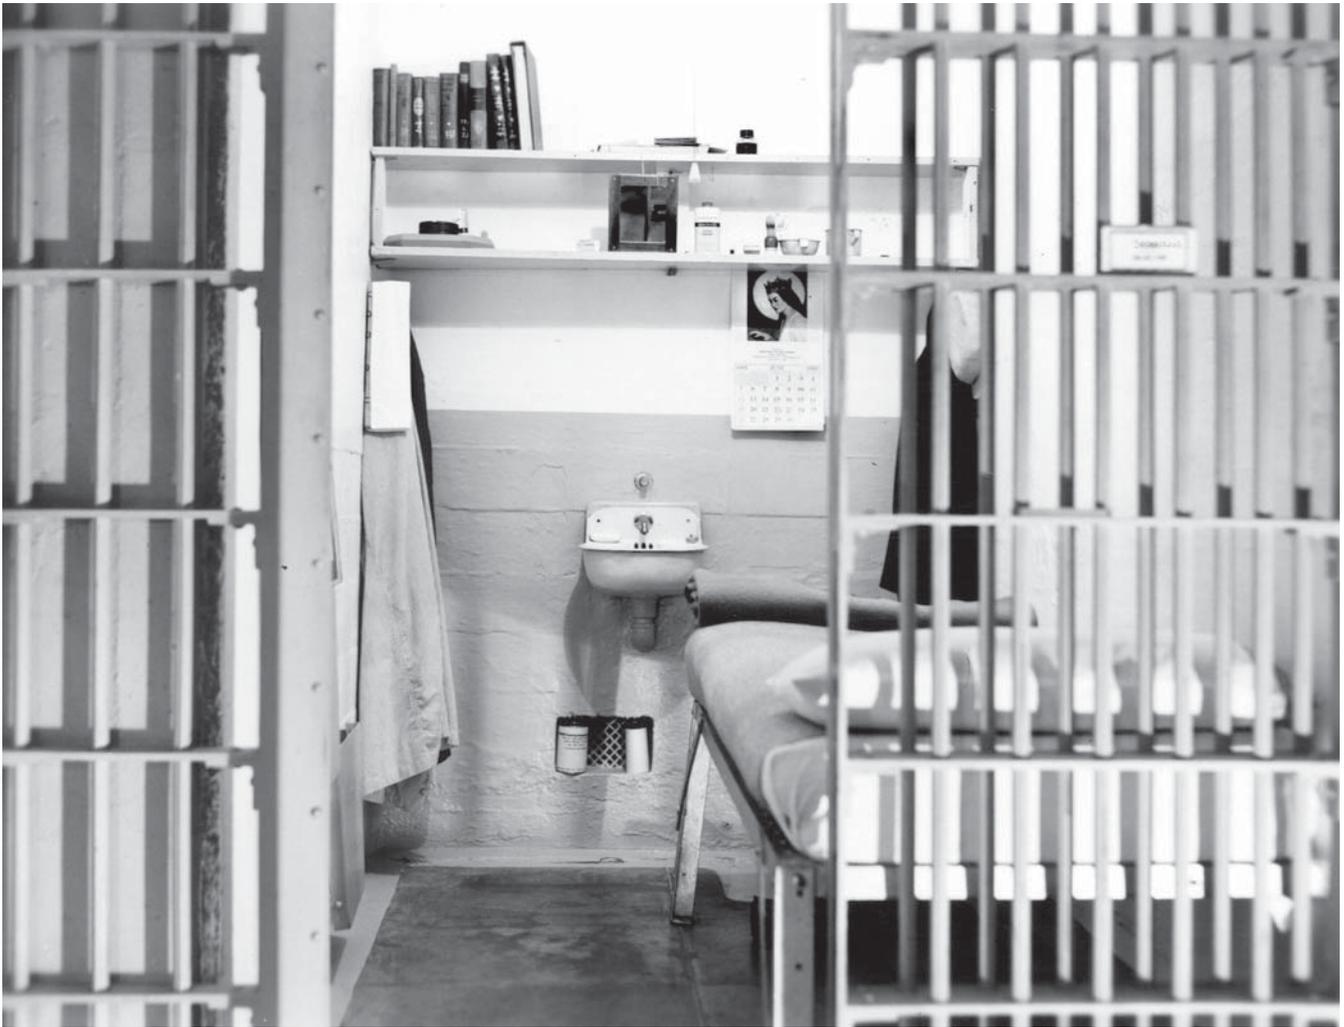
REGULATIONS FOR INMATES
 U.S.P., ALCATRAZ
 PAGE 8

- | | | |

| A - 12 Books (Maximum) | j - Shaving Brush | S - Sink Stopper |
| B - Personal Papers | K - Shaving Mug | T - Cleaning Powder |

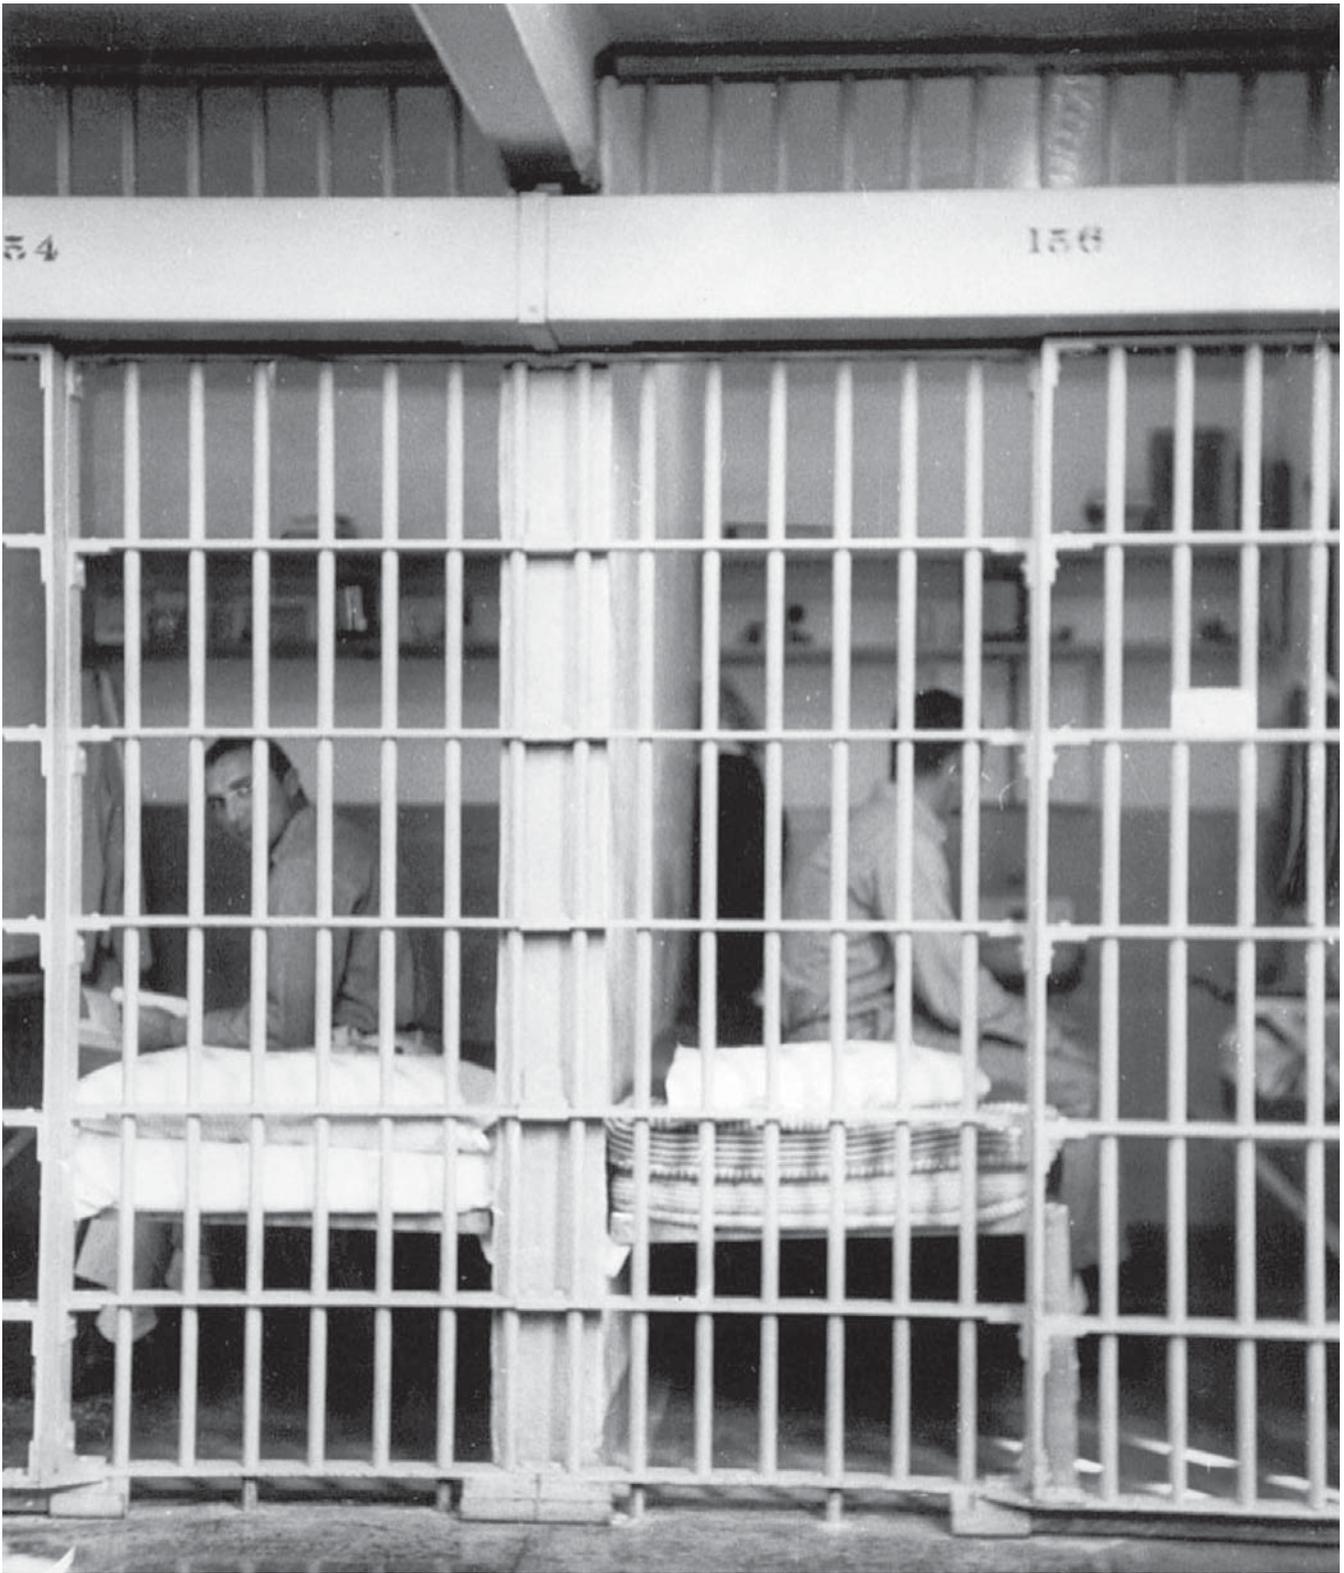
Cell plan, 1956. *Institution Rules and Regulations, United States Penitentiary, Alcatraz, California*, revised 1956 (reprint).

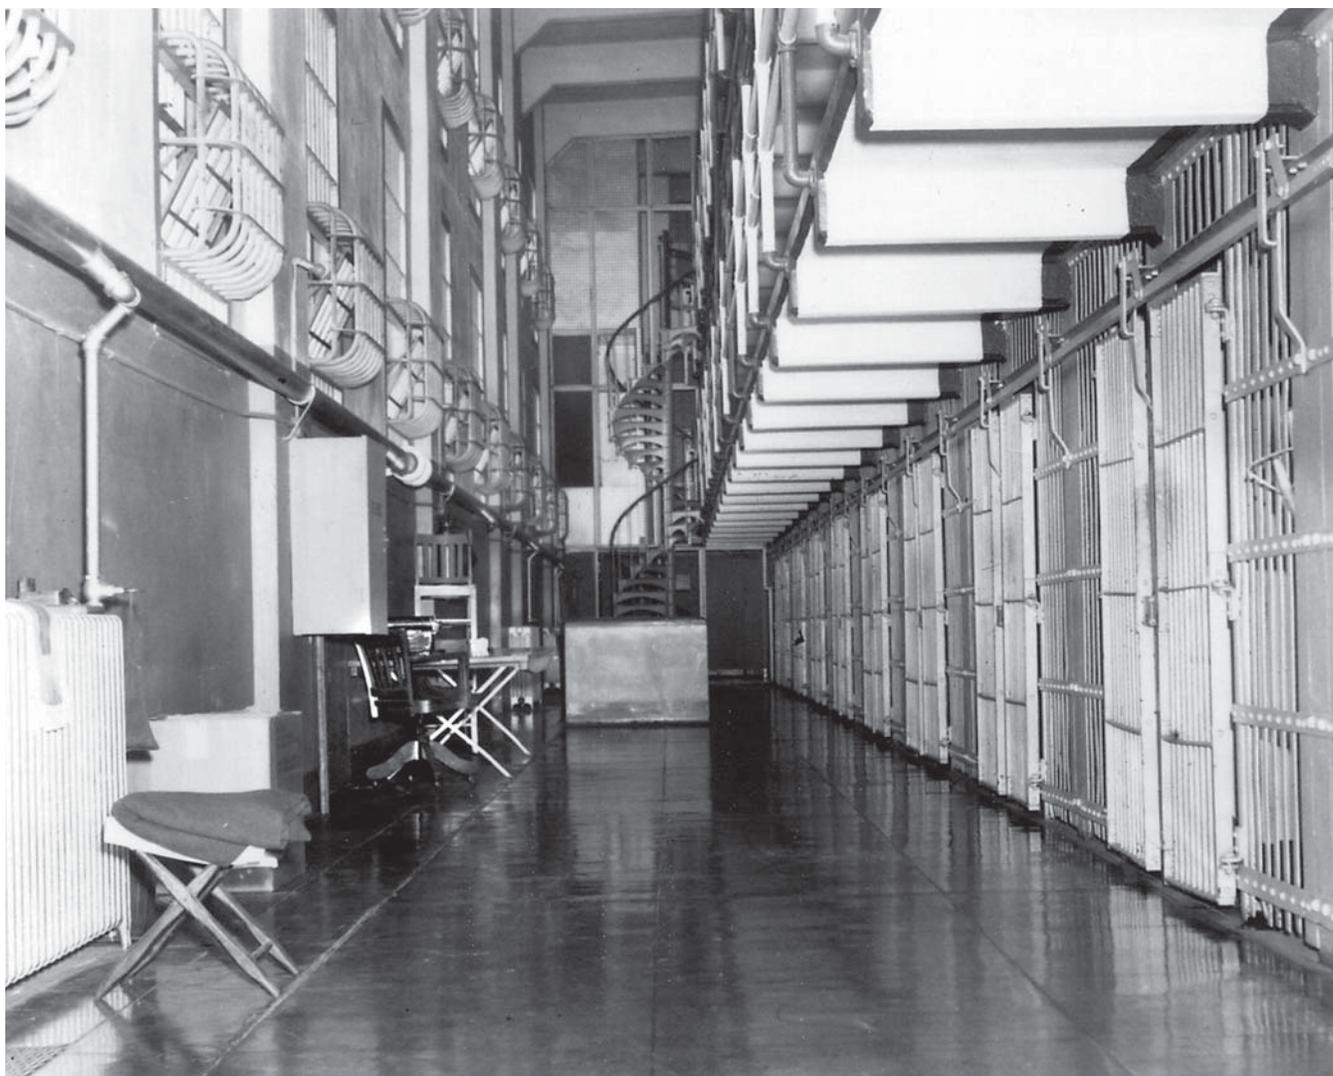
AB5

A-block, looking south, 1950. GGNRA Interpretive Photo Collection, 77-C-333. Note stools and chairs in corridor.

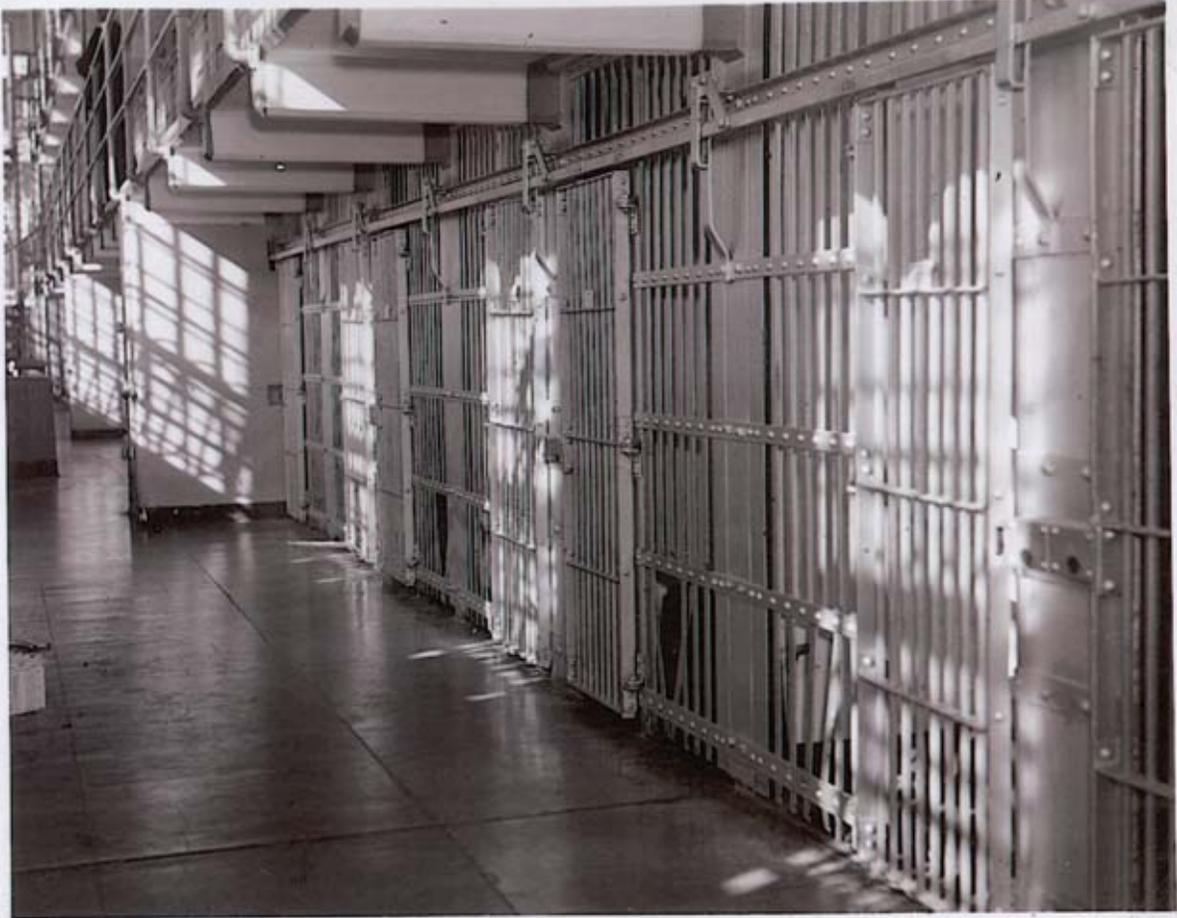
D4

1. Corridor of cell block in front of cells from which escape made. Photo taken from direction of Warden's Office.

“Corridor of cell block in front of cells from which escape made. Photograph taken from direction of Warden’s Office [north],” 1939. NARA, RG 65.

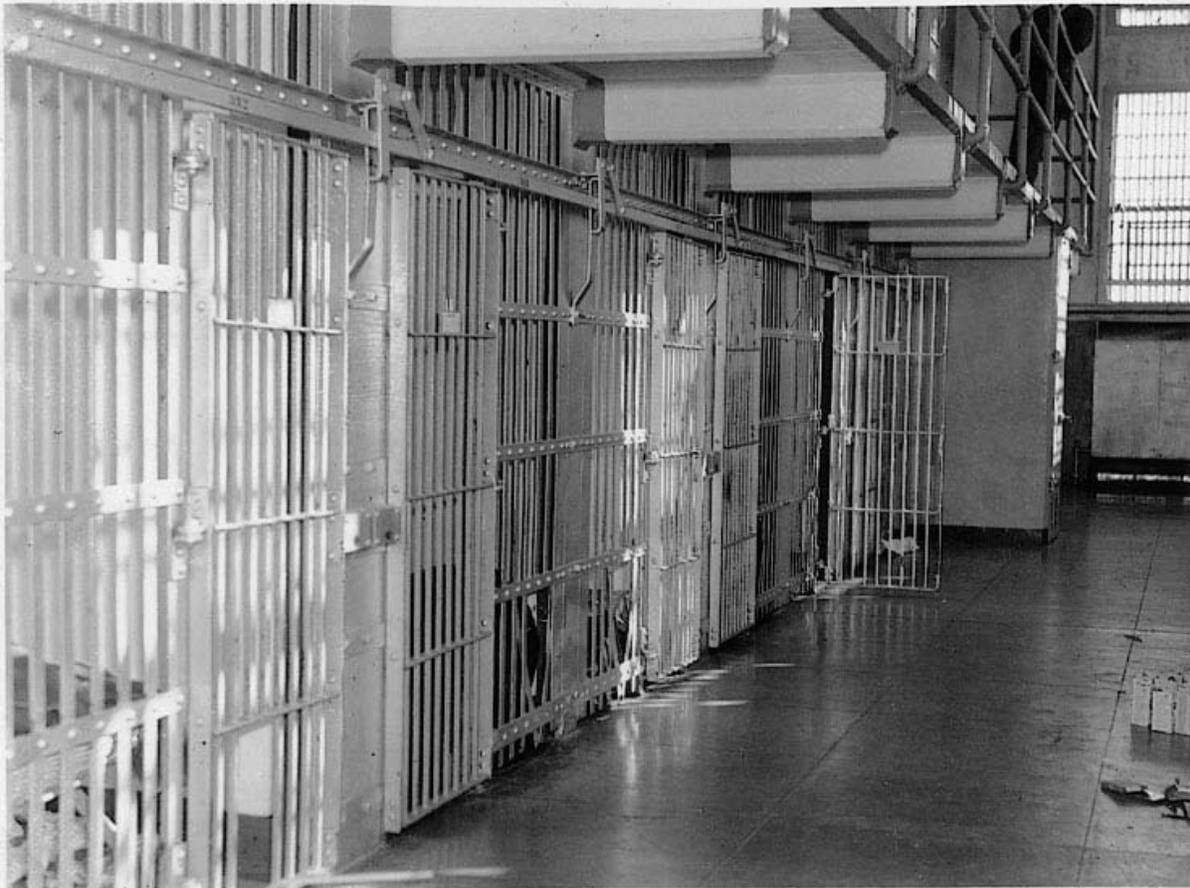
D5 "Corridor of cell block in front of cells from which escape made. Looking towards office [north]," 1939. NARA, RG 65.

2. Corridor of cell block in front of cells from which escape made. Looking towards office.

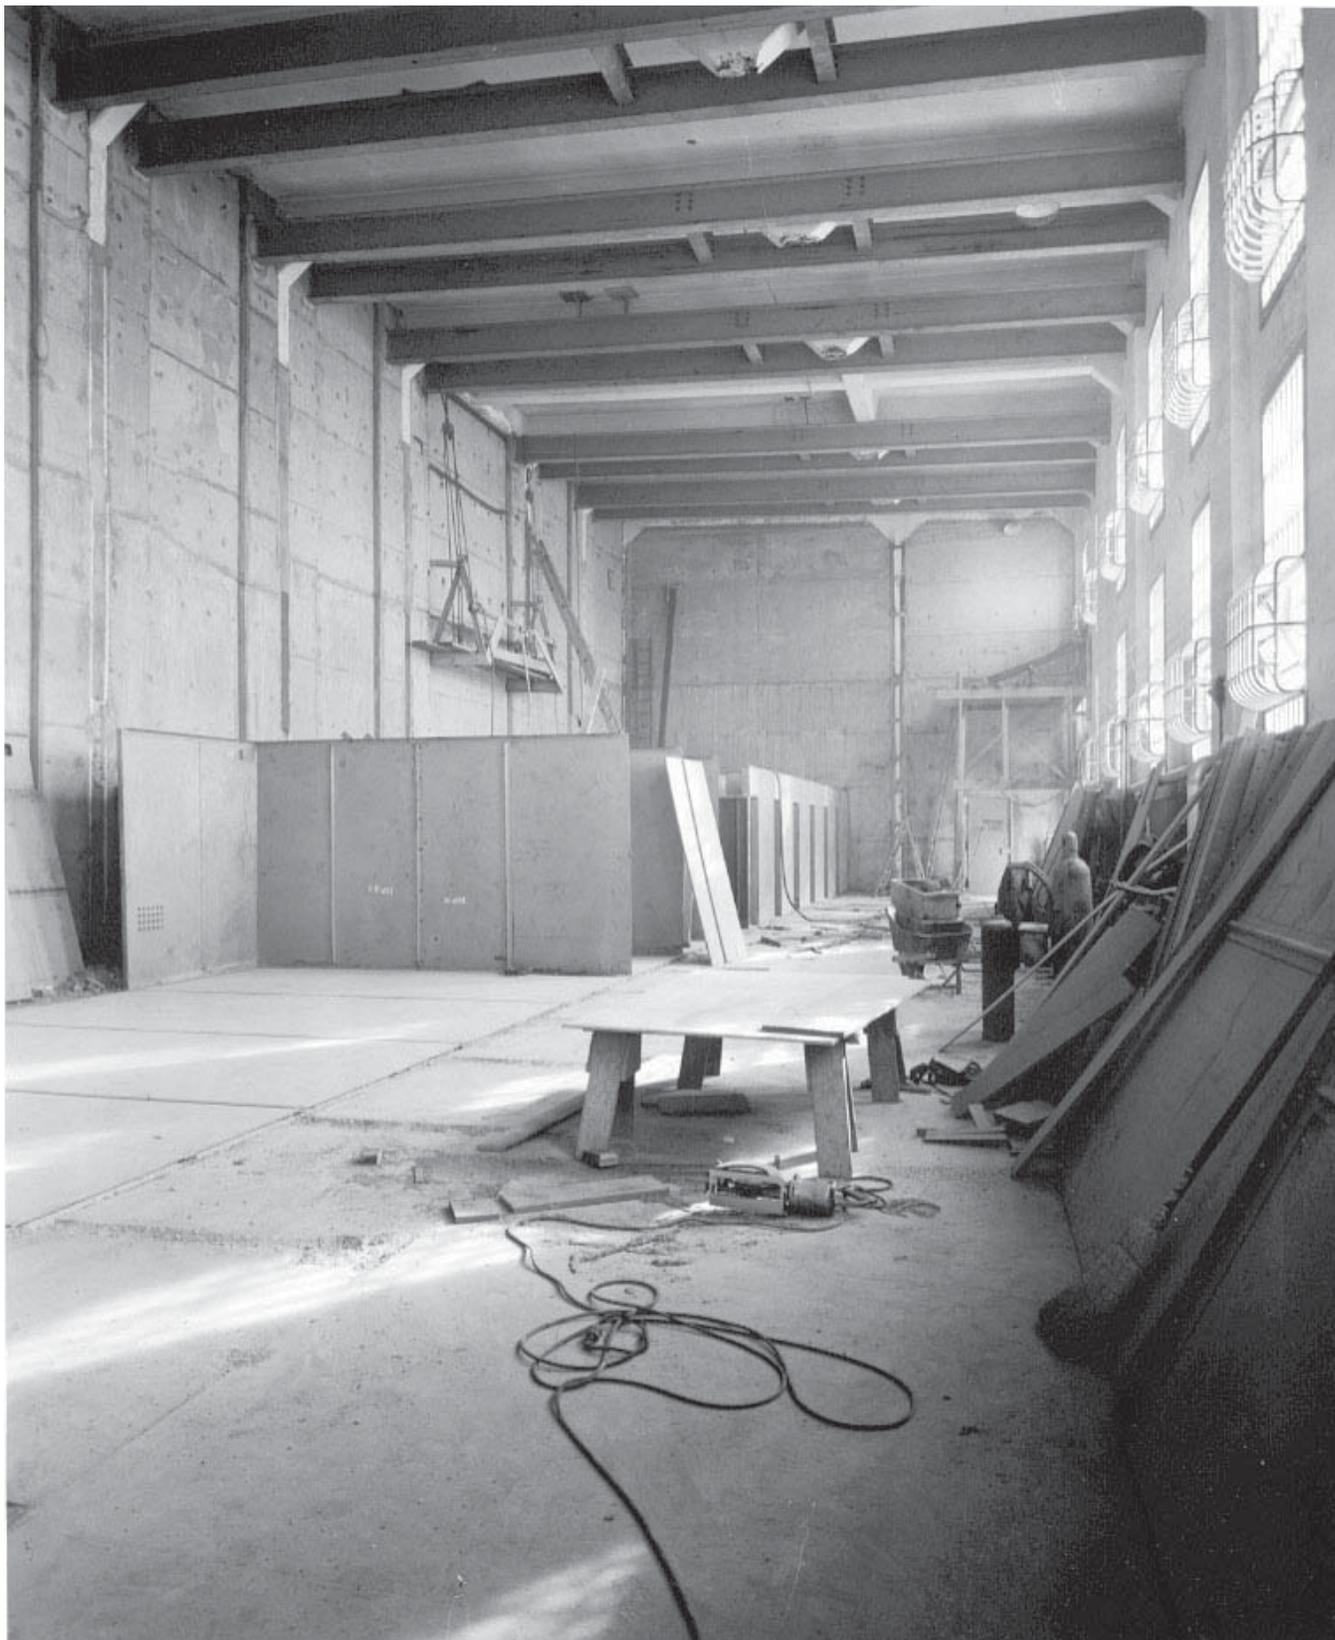
**D8**

Construction of D-block isolation cells, looking south, 1941. GGNRA Park Archives Collection, P83-170.190.

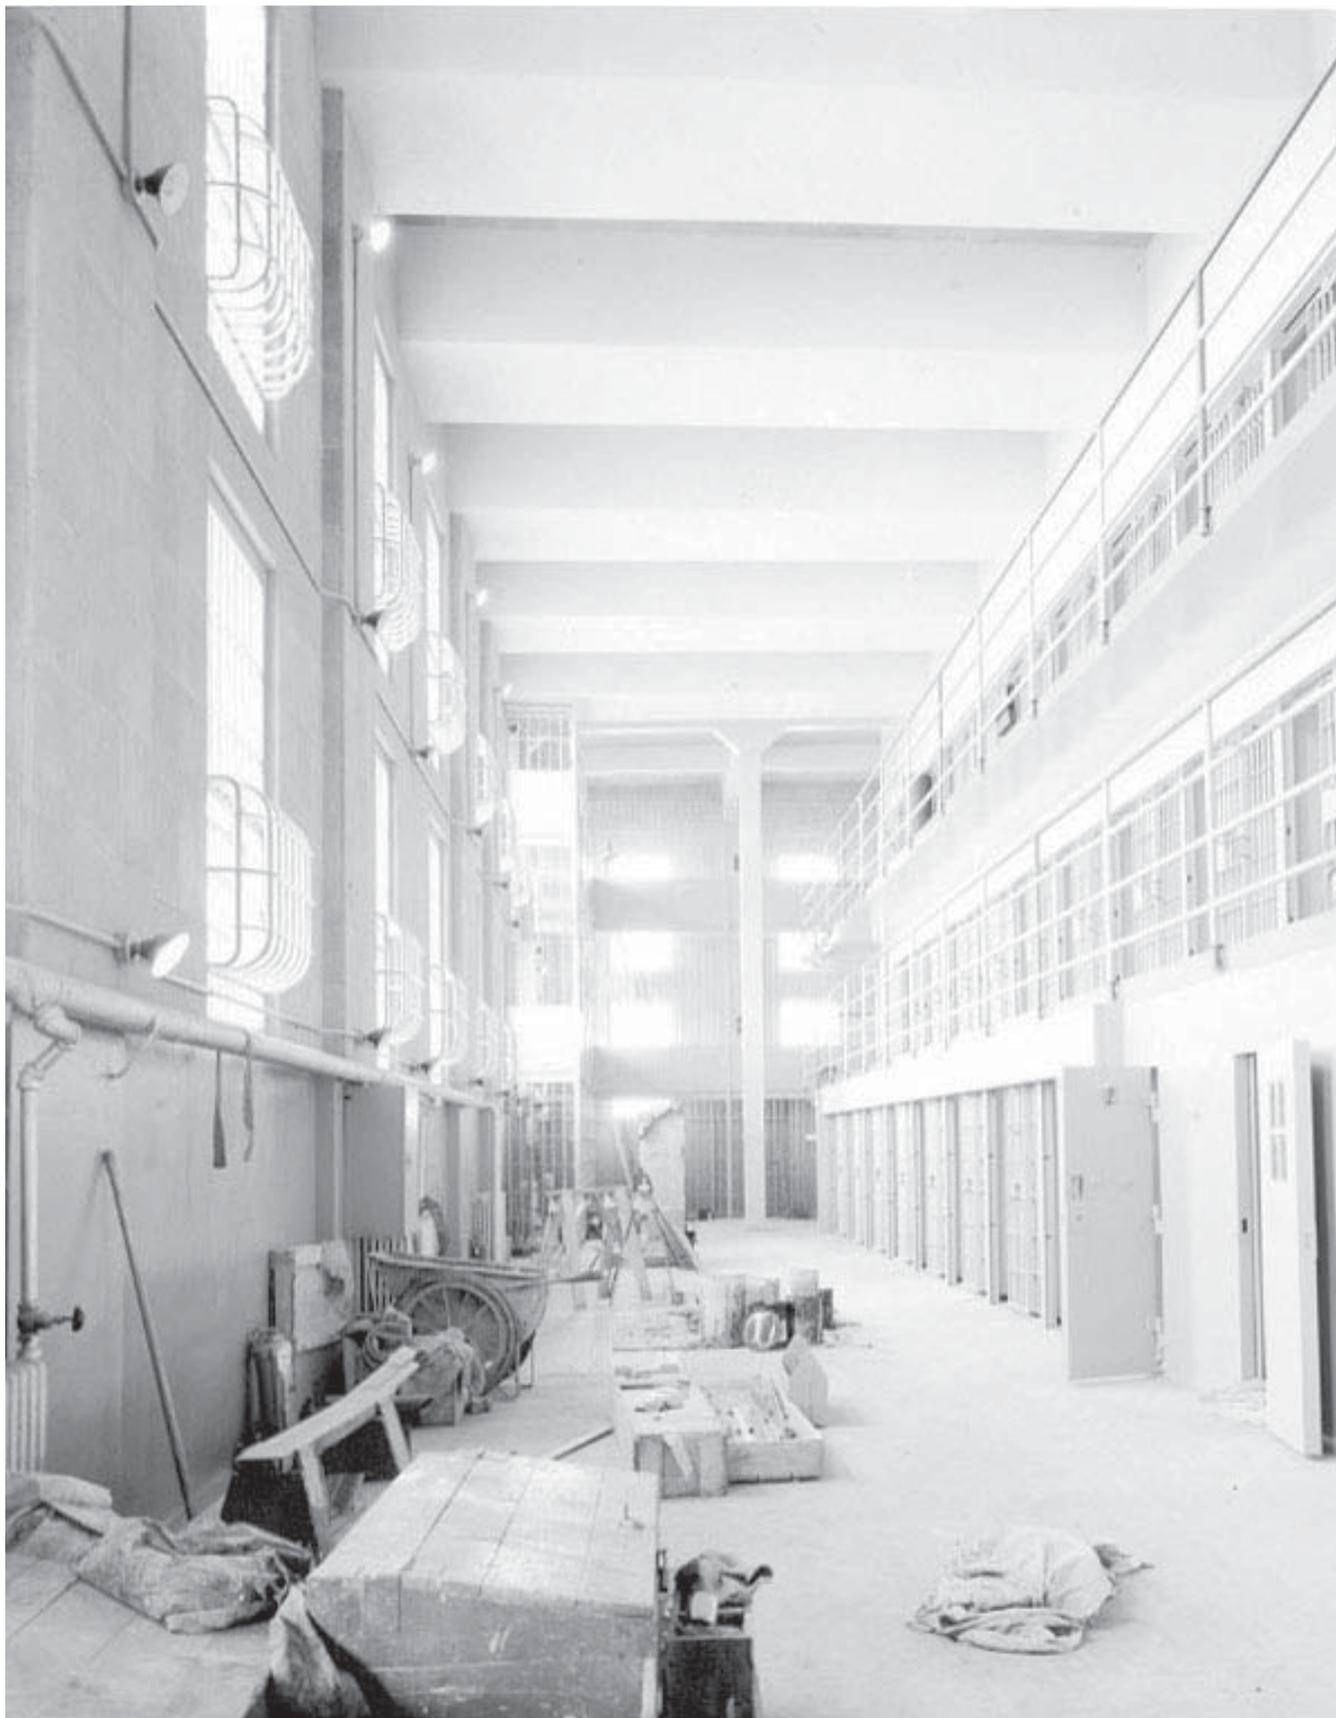
D9 Construction of D-block isolation cells, looking north, 1941. Courtesy Chuck Stucker Collection.

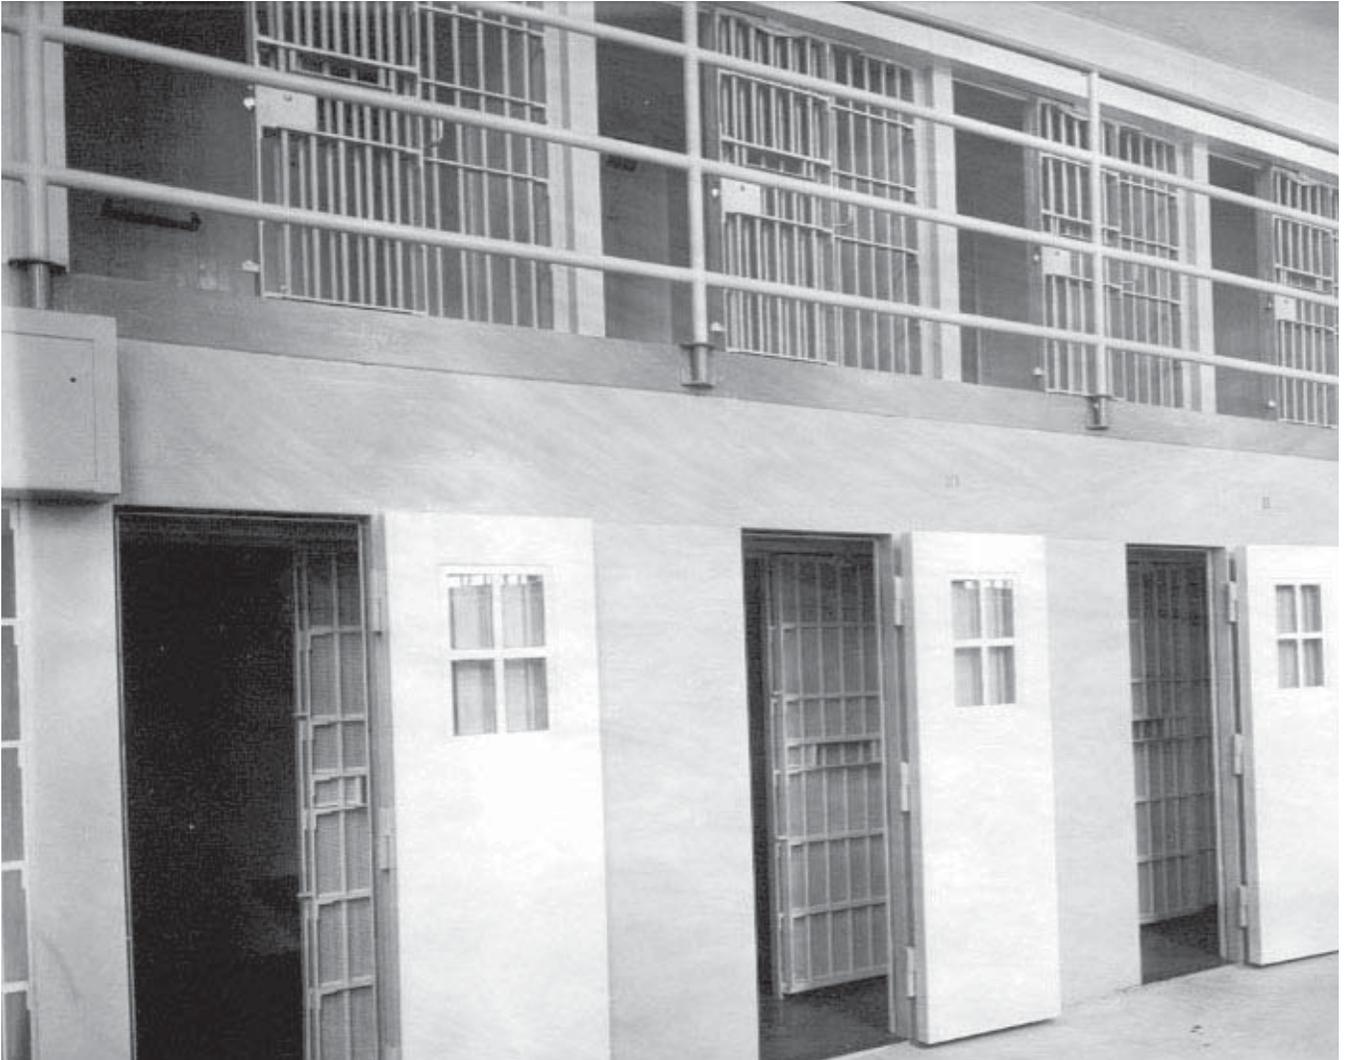
**D11**

Newly constructed D-block isolation cells, 1941. GGNRA Park Archives Collection, P83-170.167. Note bunks inside solid front cells.

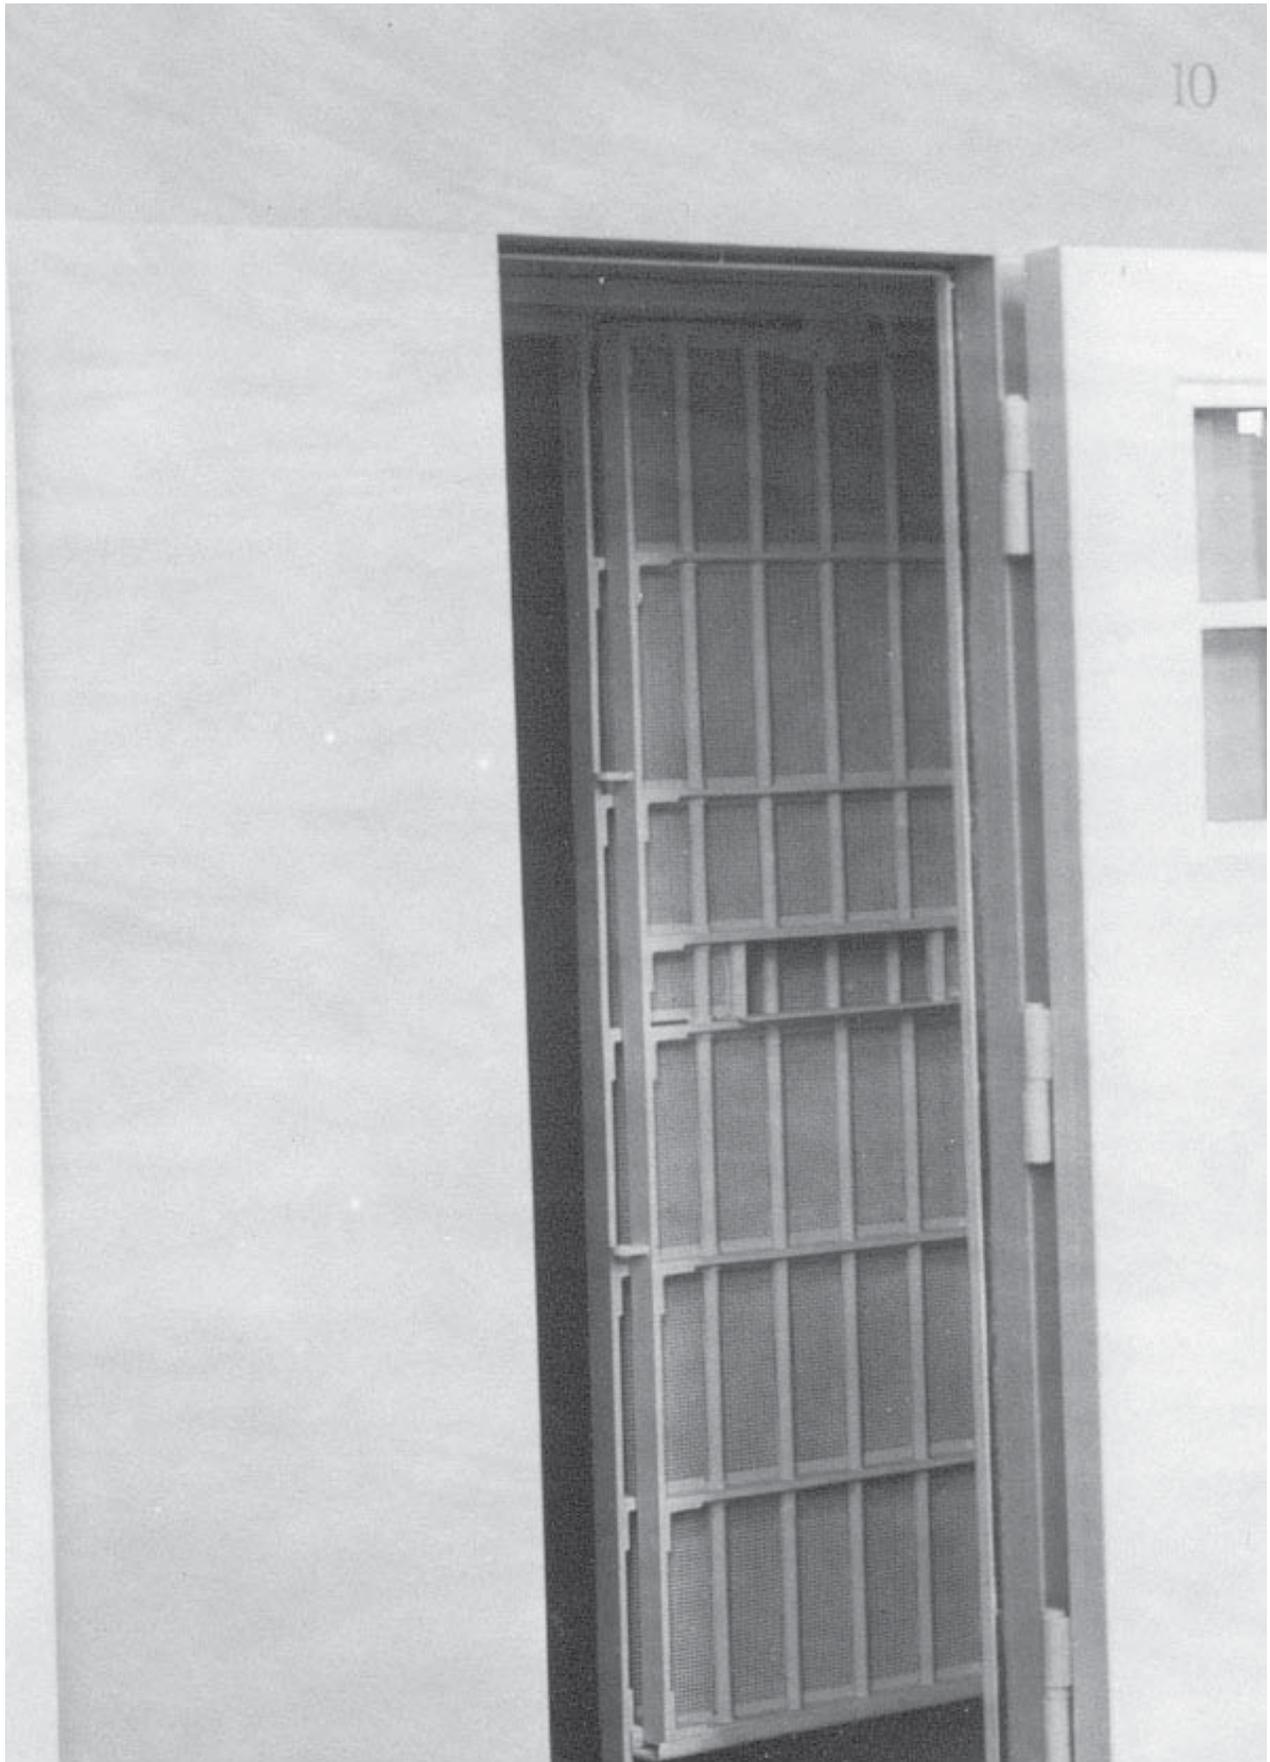
D13 D-block solid-front cell, 1941. GGNRA Park Archives Collection, Detail from P83-170.167. Mesh over interior bars was eventually removed so that guards could see inmates inside cells.

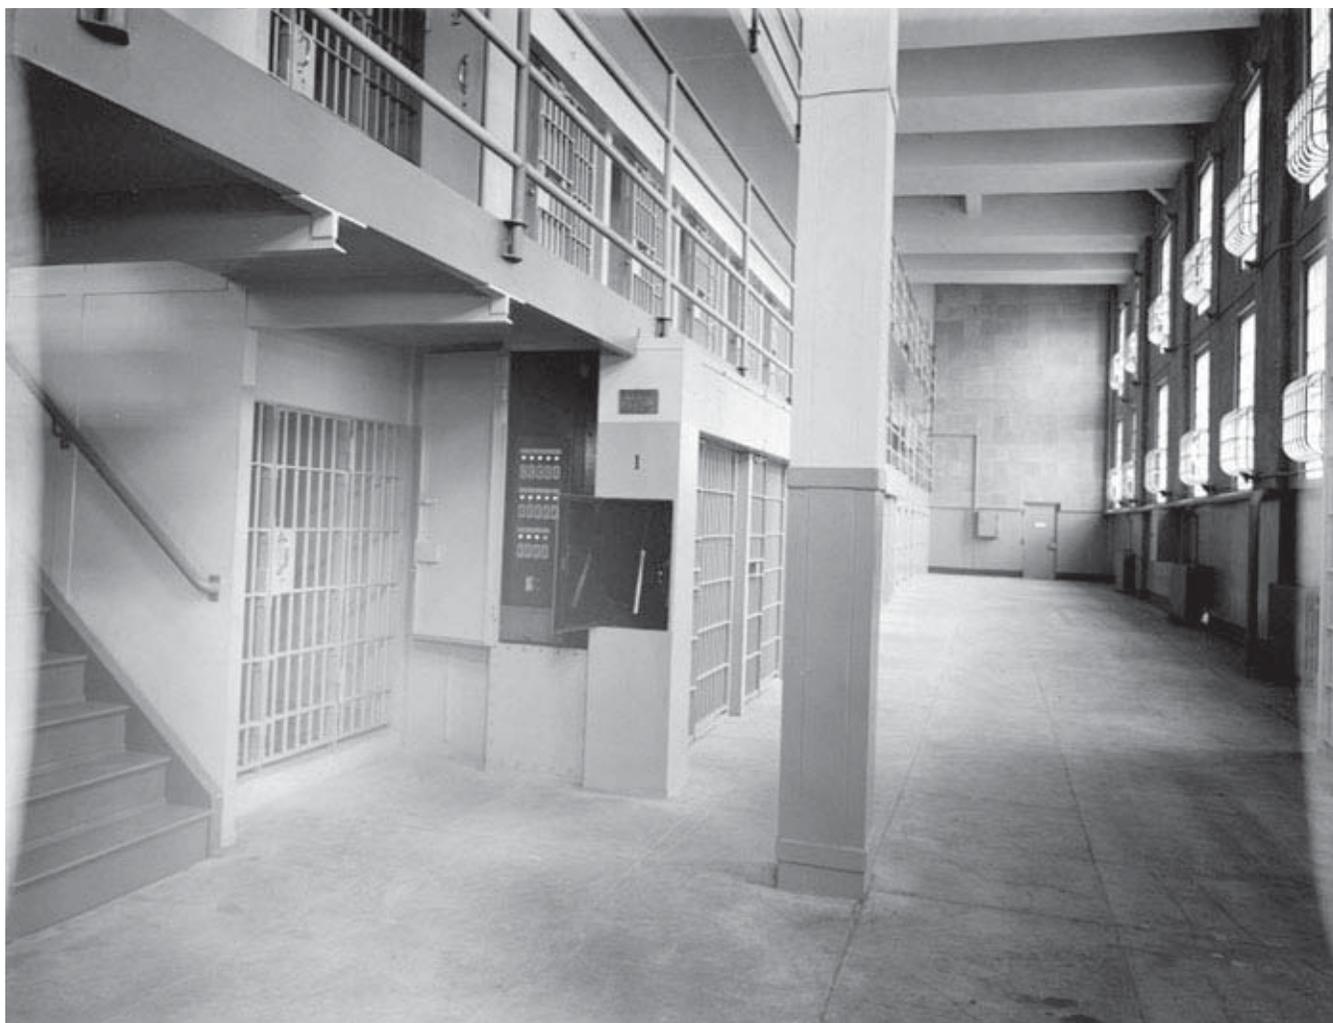
D14 Control panel for D-block locking mechanism, 1941. GGNRA Park Archives Collection, P83-144.59.

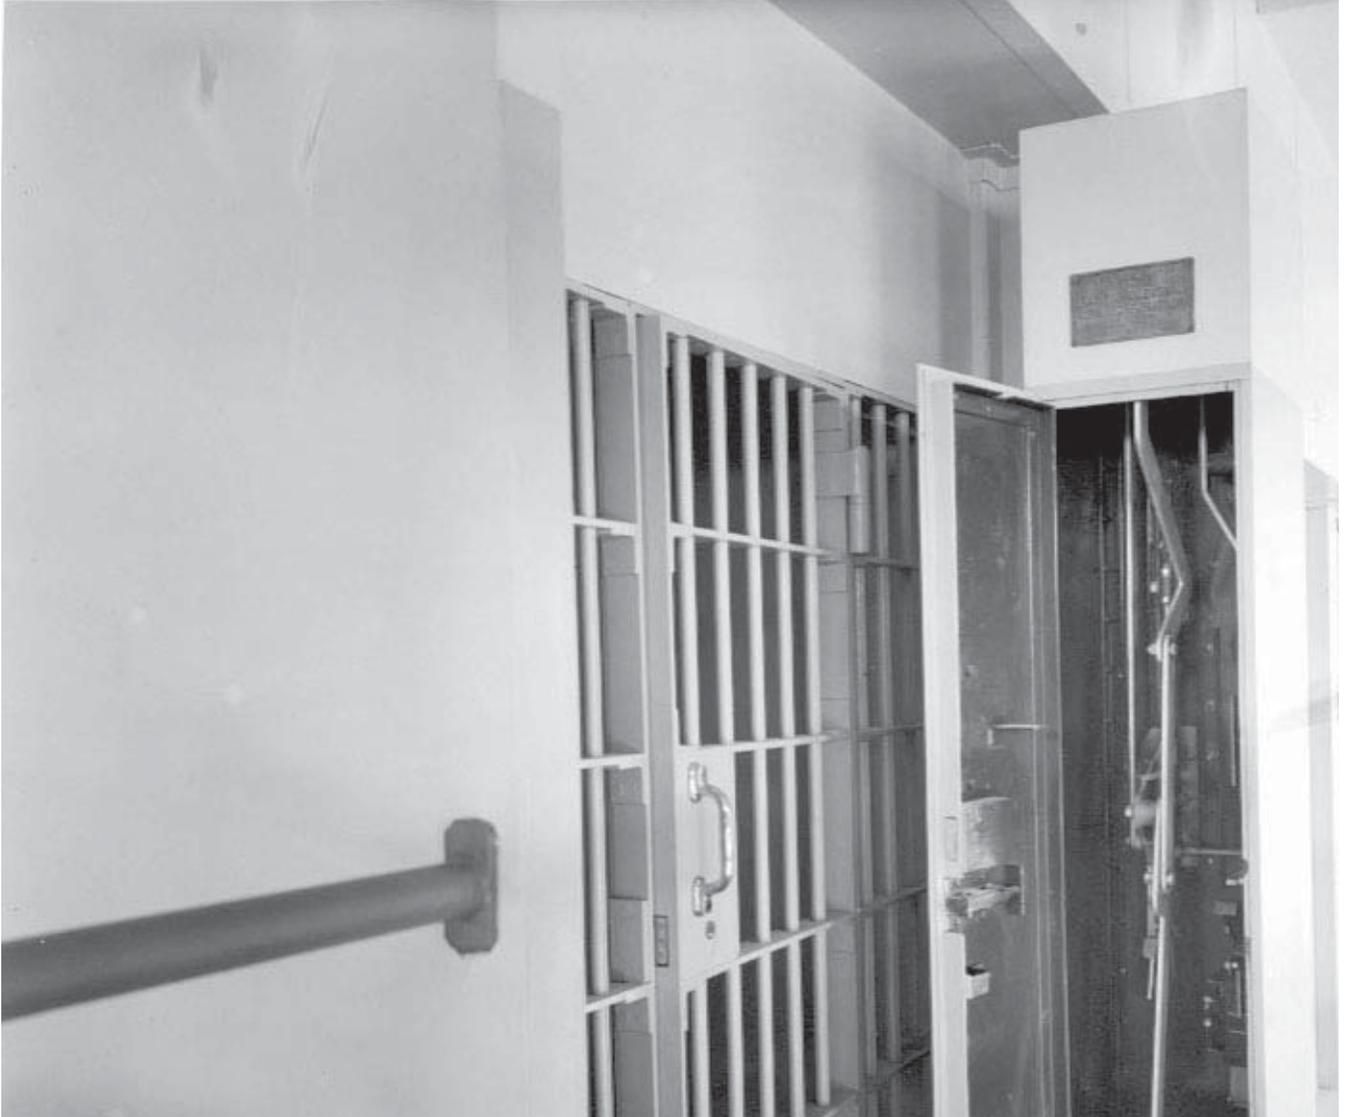
**D15**

Control panel for D-block locking mechanism, third tier, 1941. GGNRA Park Archives Collection, P83-170.153.

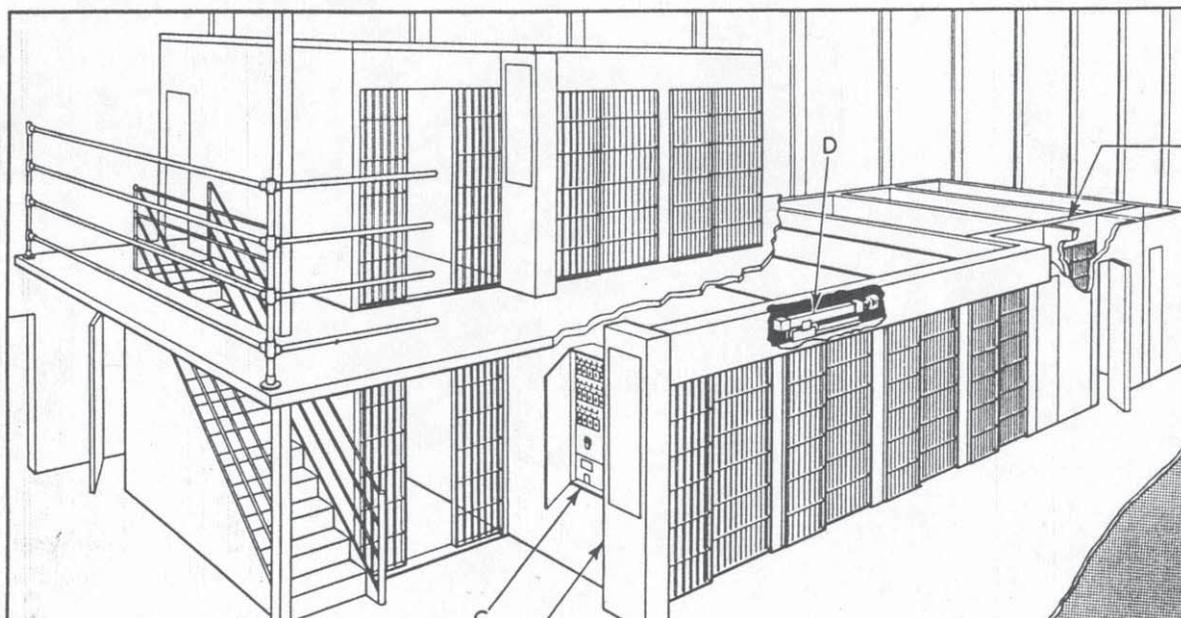
**D16**

Cell locking device, from "Control System of Locks for Prison Cell Doors," April 1941. NARA, RG 129, Alcatraz Admin. Files, 129-96-03, Box 15.
