Historic Furnishings Report

Golden Gate National Recreation Area
San Francisco, California

Alcatraz Island: Main Prison Building

Mary Grassick
Staff Curator

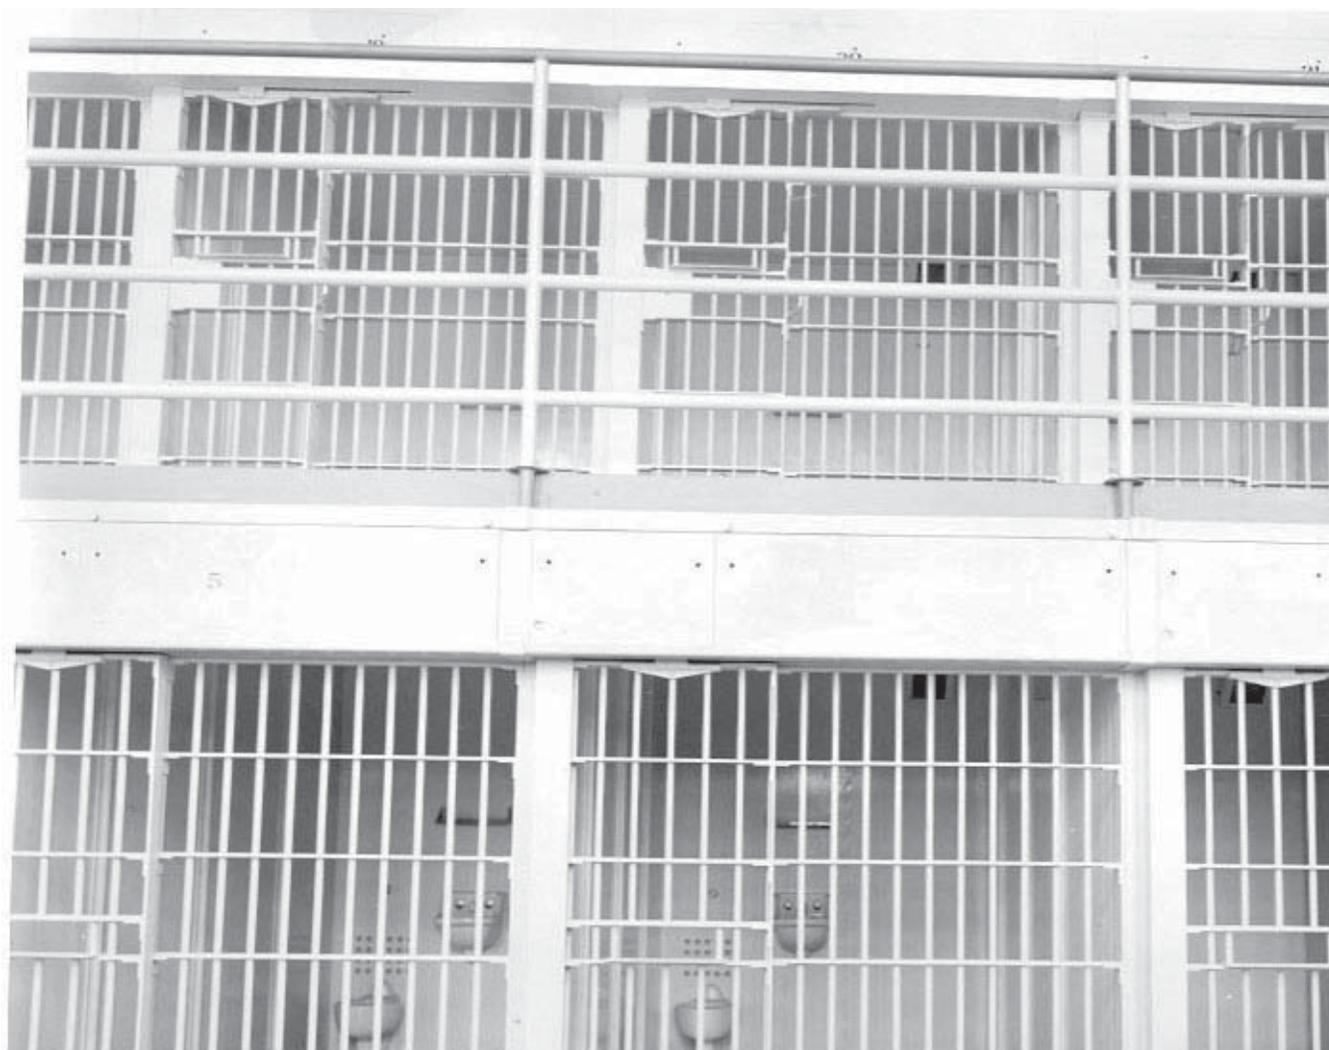
D18 D-block cells, 1941. GGNRA Park Archives Collection, P83-170.170. Note that bunks have not yet been installed.

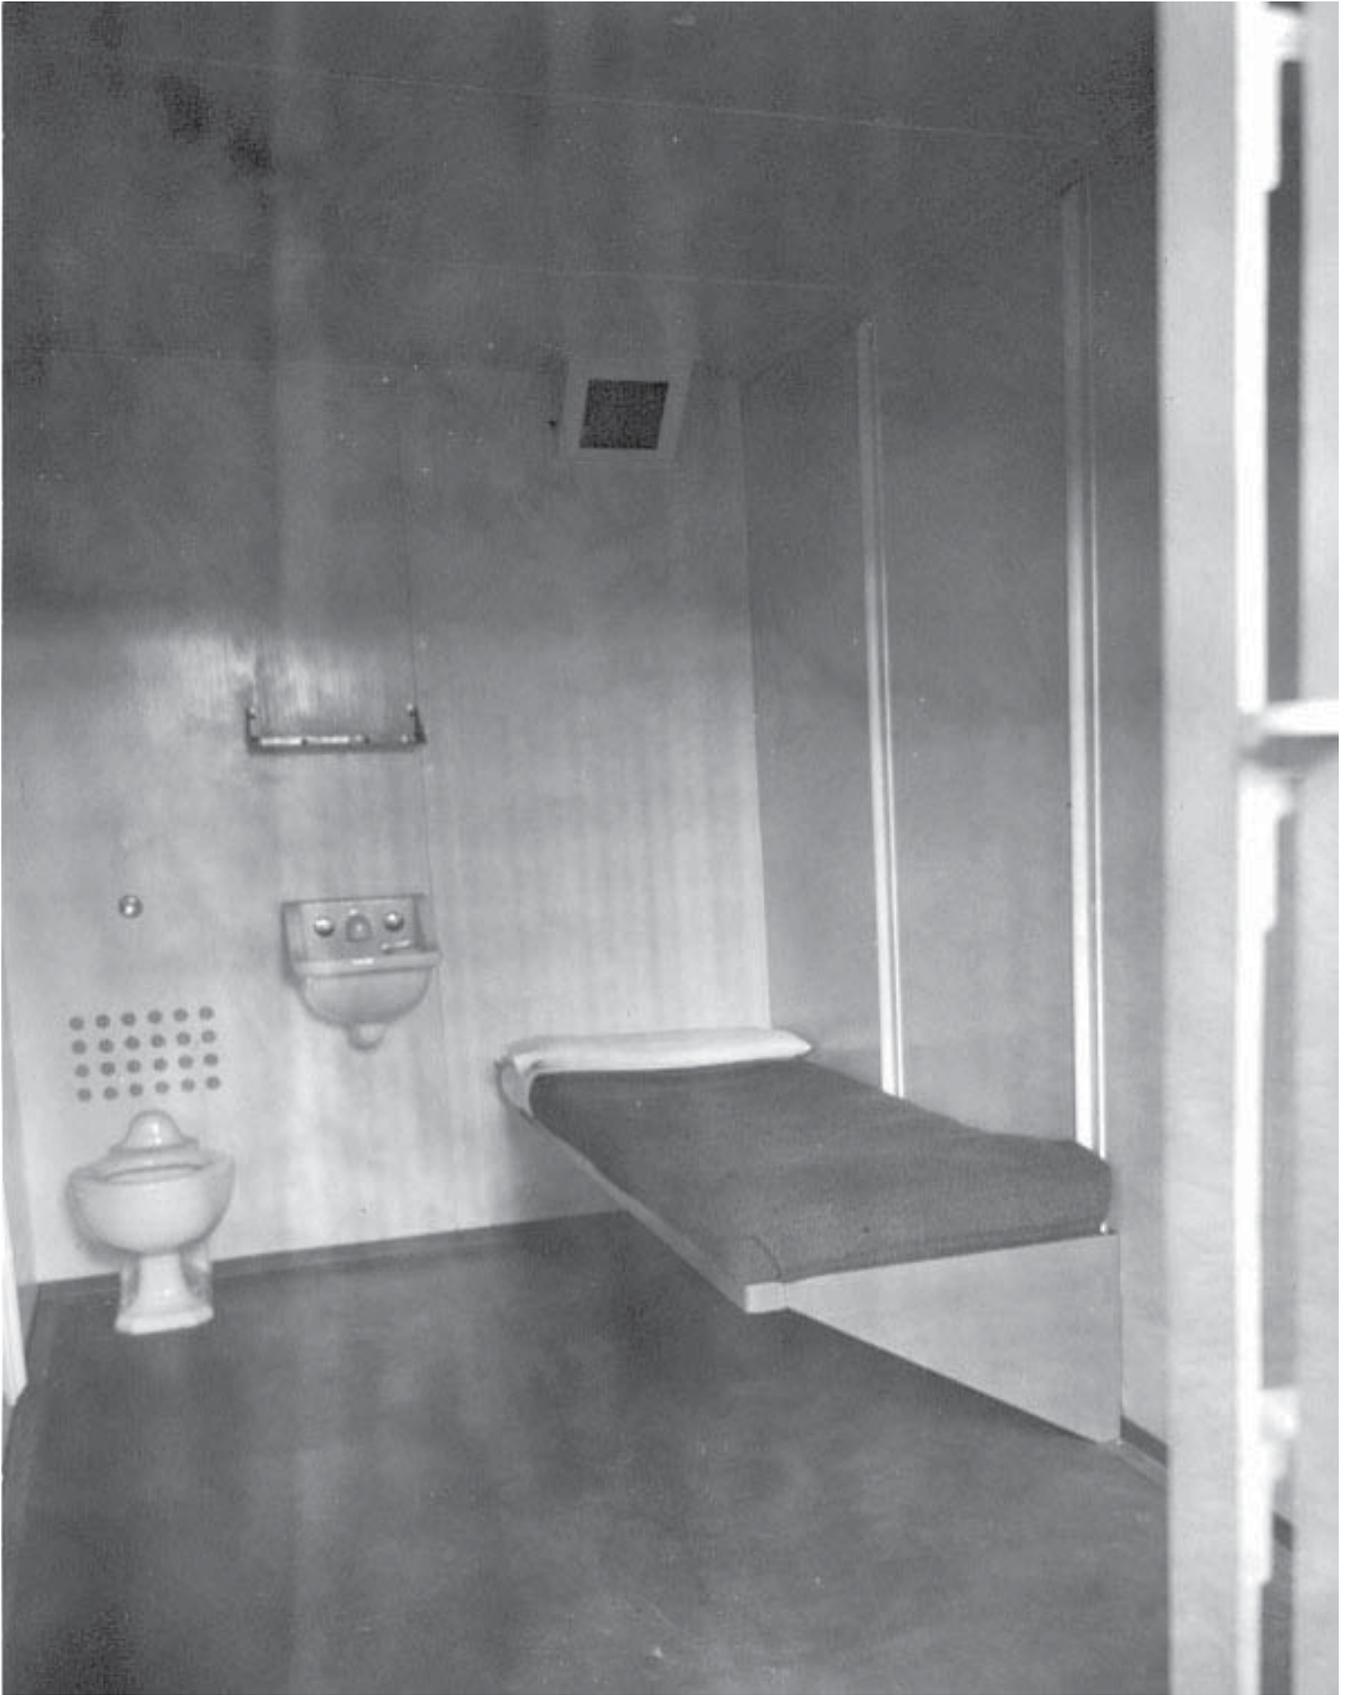
**D21**

D-block cell interior with bunk and bedding, 1941. GGNRA Park Archives Collection, P83-170.169.

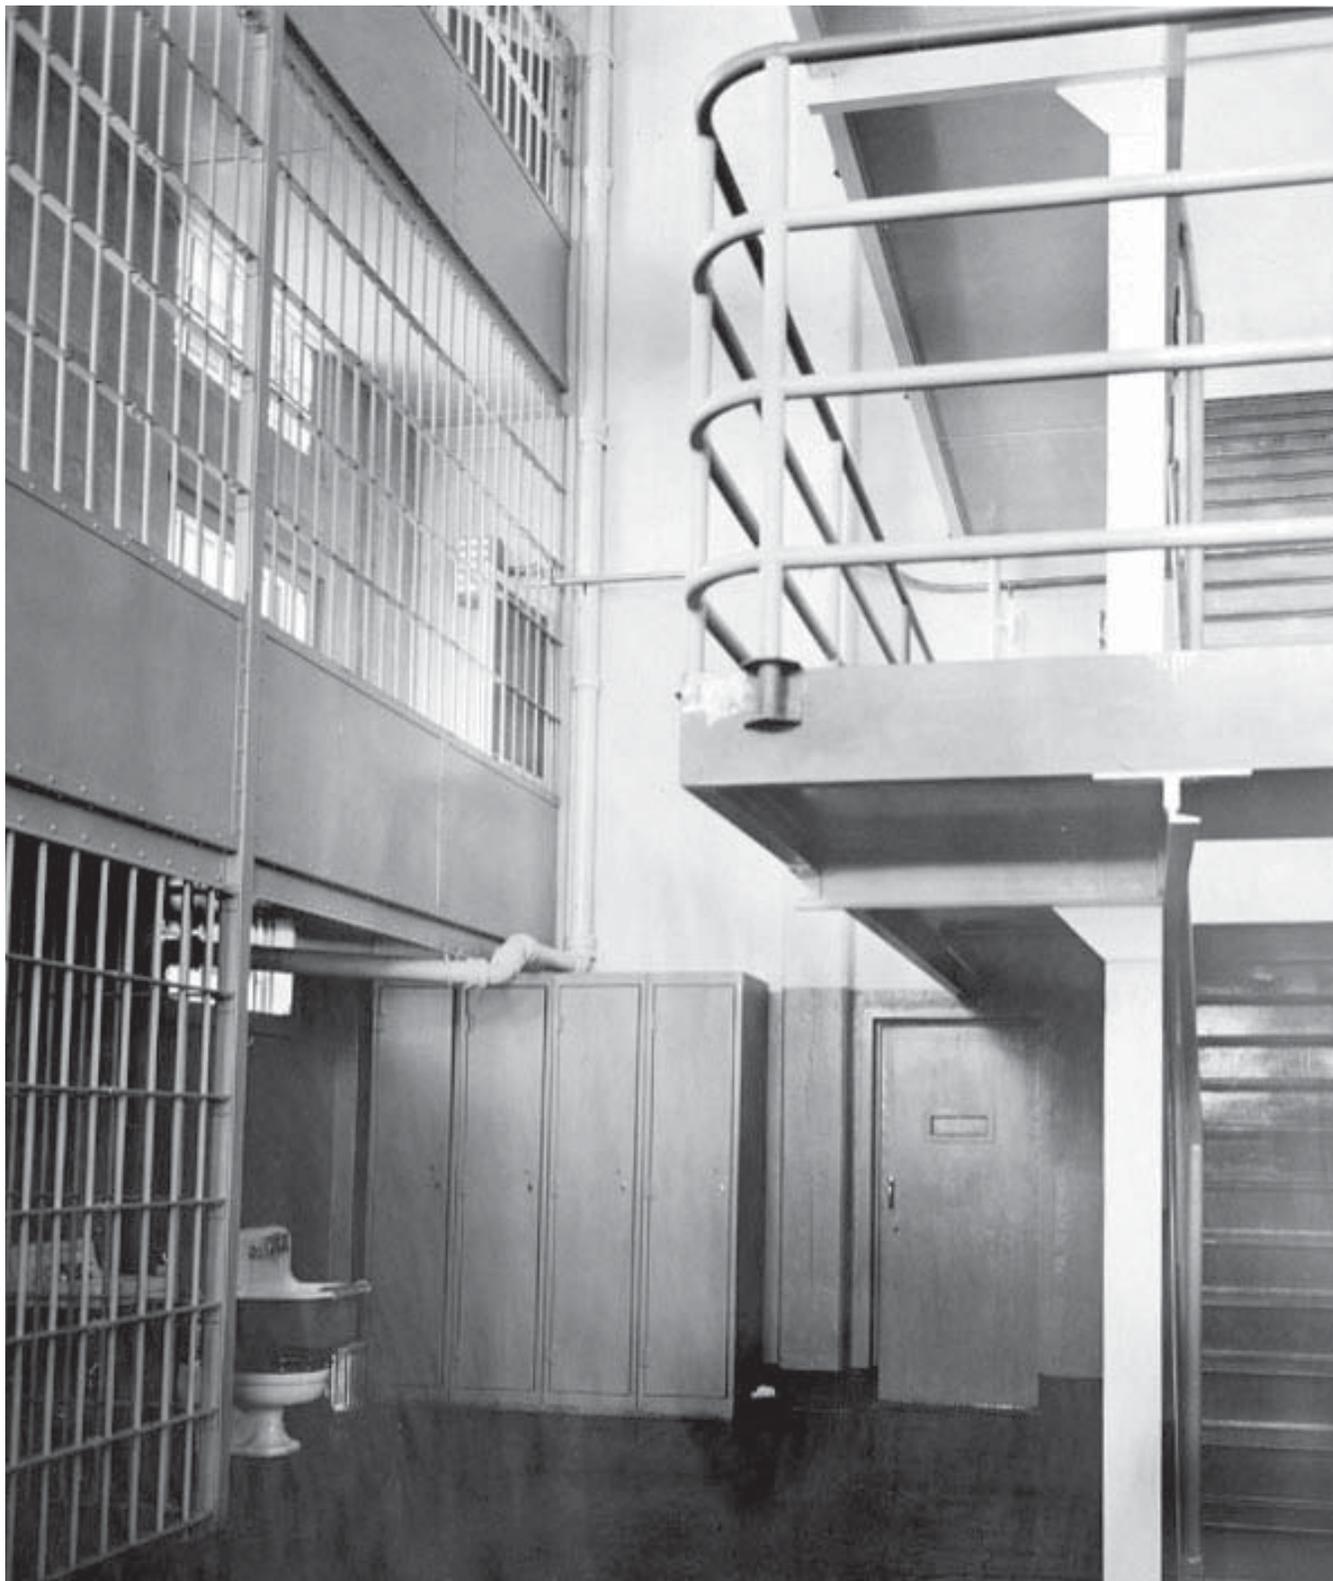
D22

Stairway, north end of D-block, no date. GGNRA Park Archives Collection, P83-170.150. Grating has not yet been installed over Gun Gallery, so photograph predates May 1946 riot.

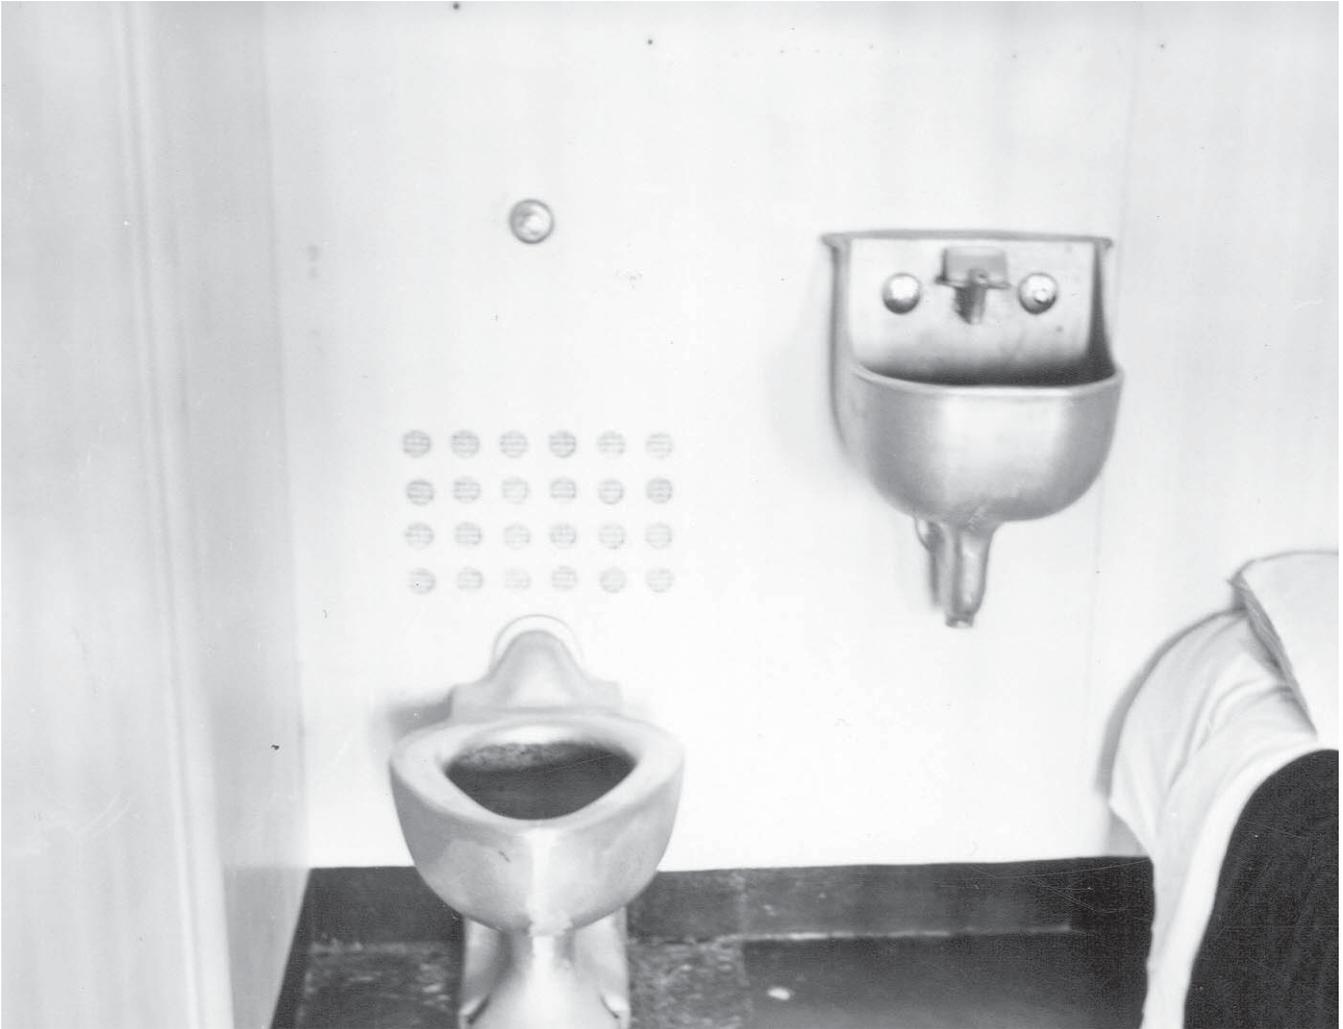
**D23**

D-block cell interior with cast aluminum sink and toilet, post-1955. Jack Fleming Alcatraz Collection, GGNRA Park Archives Collection.

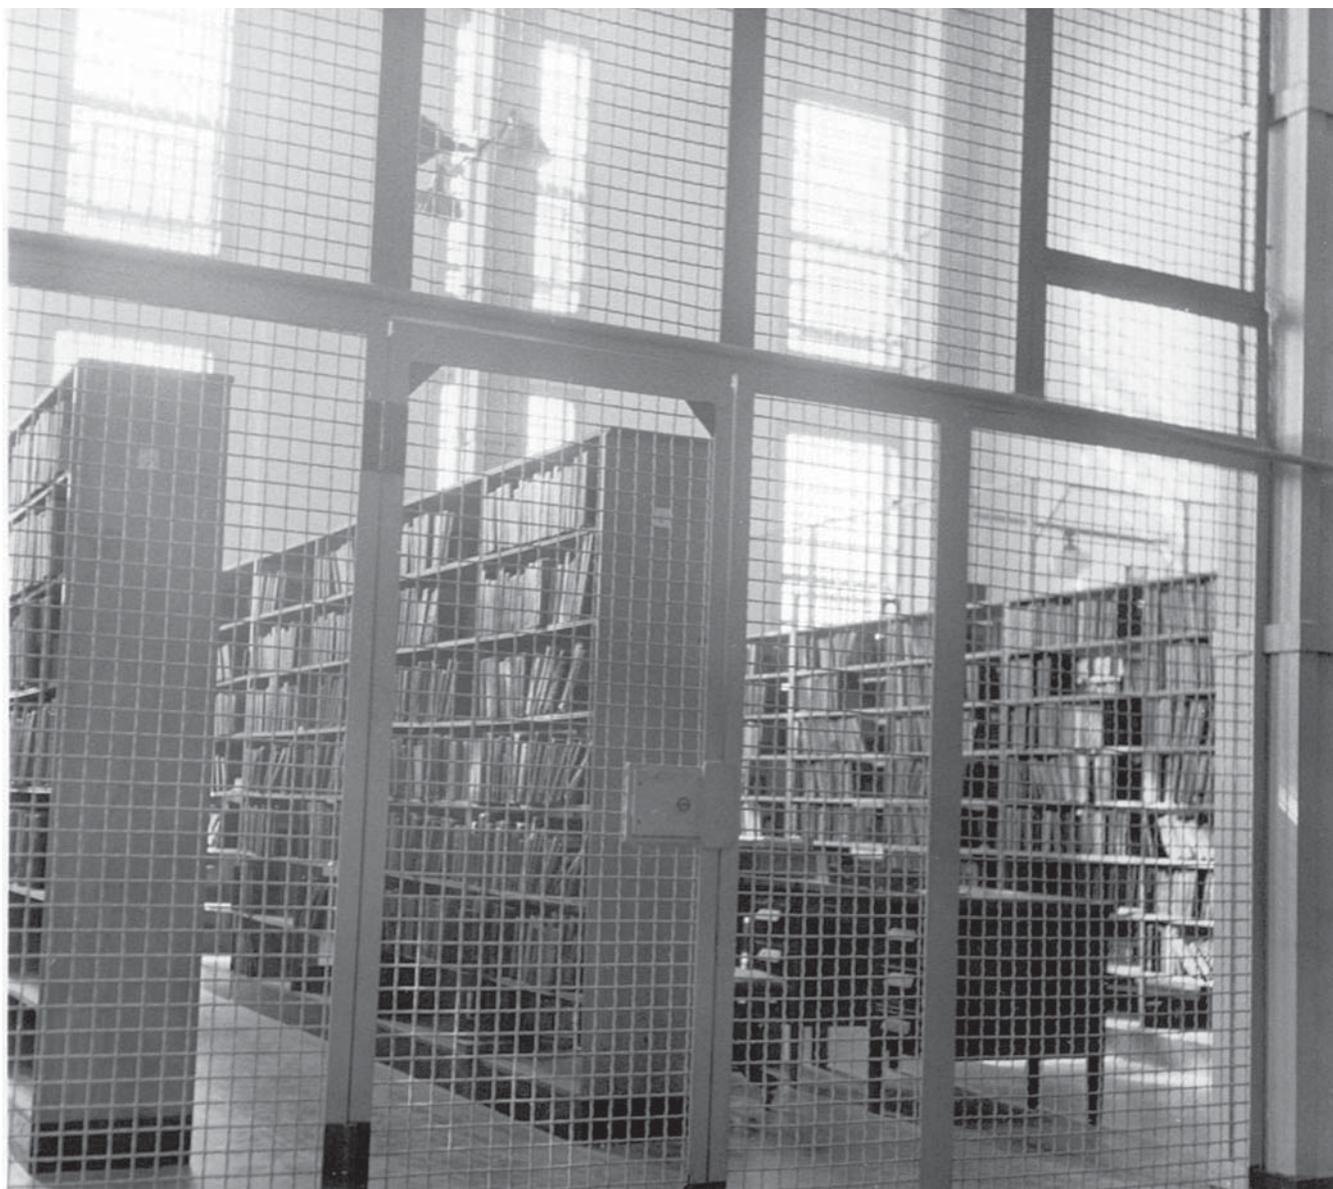
L2 Library, ca. 1954. GGNRA Park Archives Collection, P83-166.49. Note the wood office desk in the stacks.

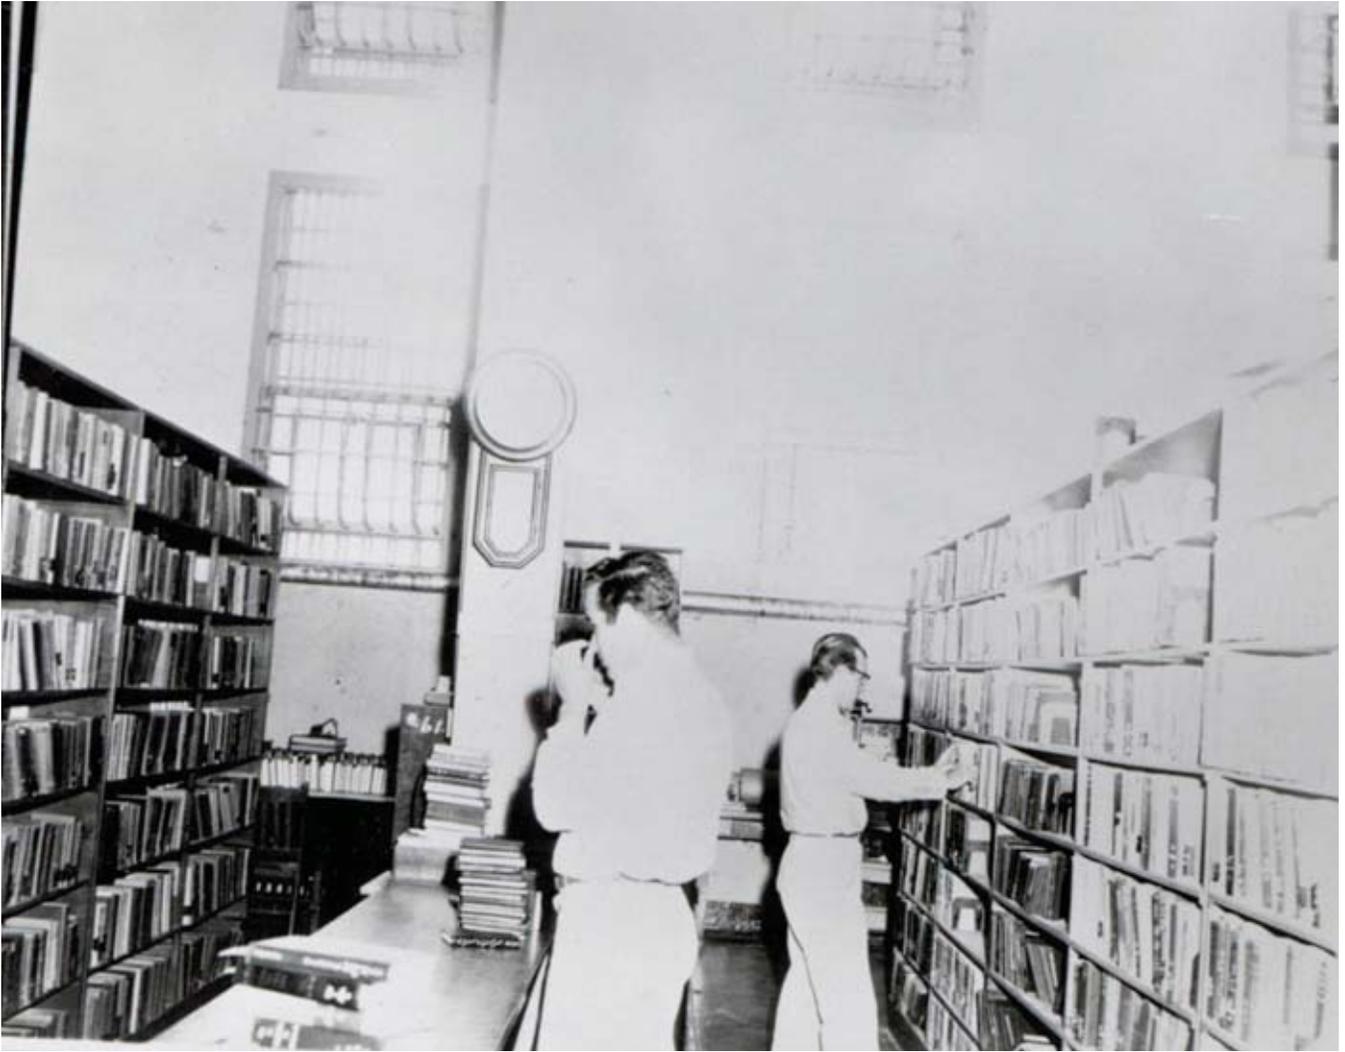
**L3**

Convict library assistants in library stacks, no date. GGNRA Interpretive Photo Collection, 77-393. Note Army-era *Ansonia* clock and wood library tables.

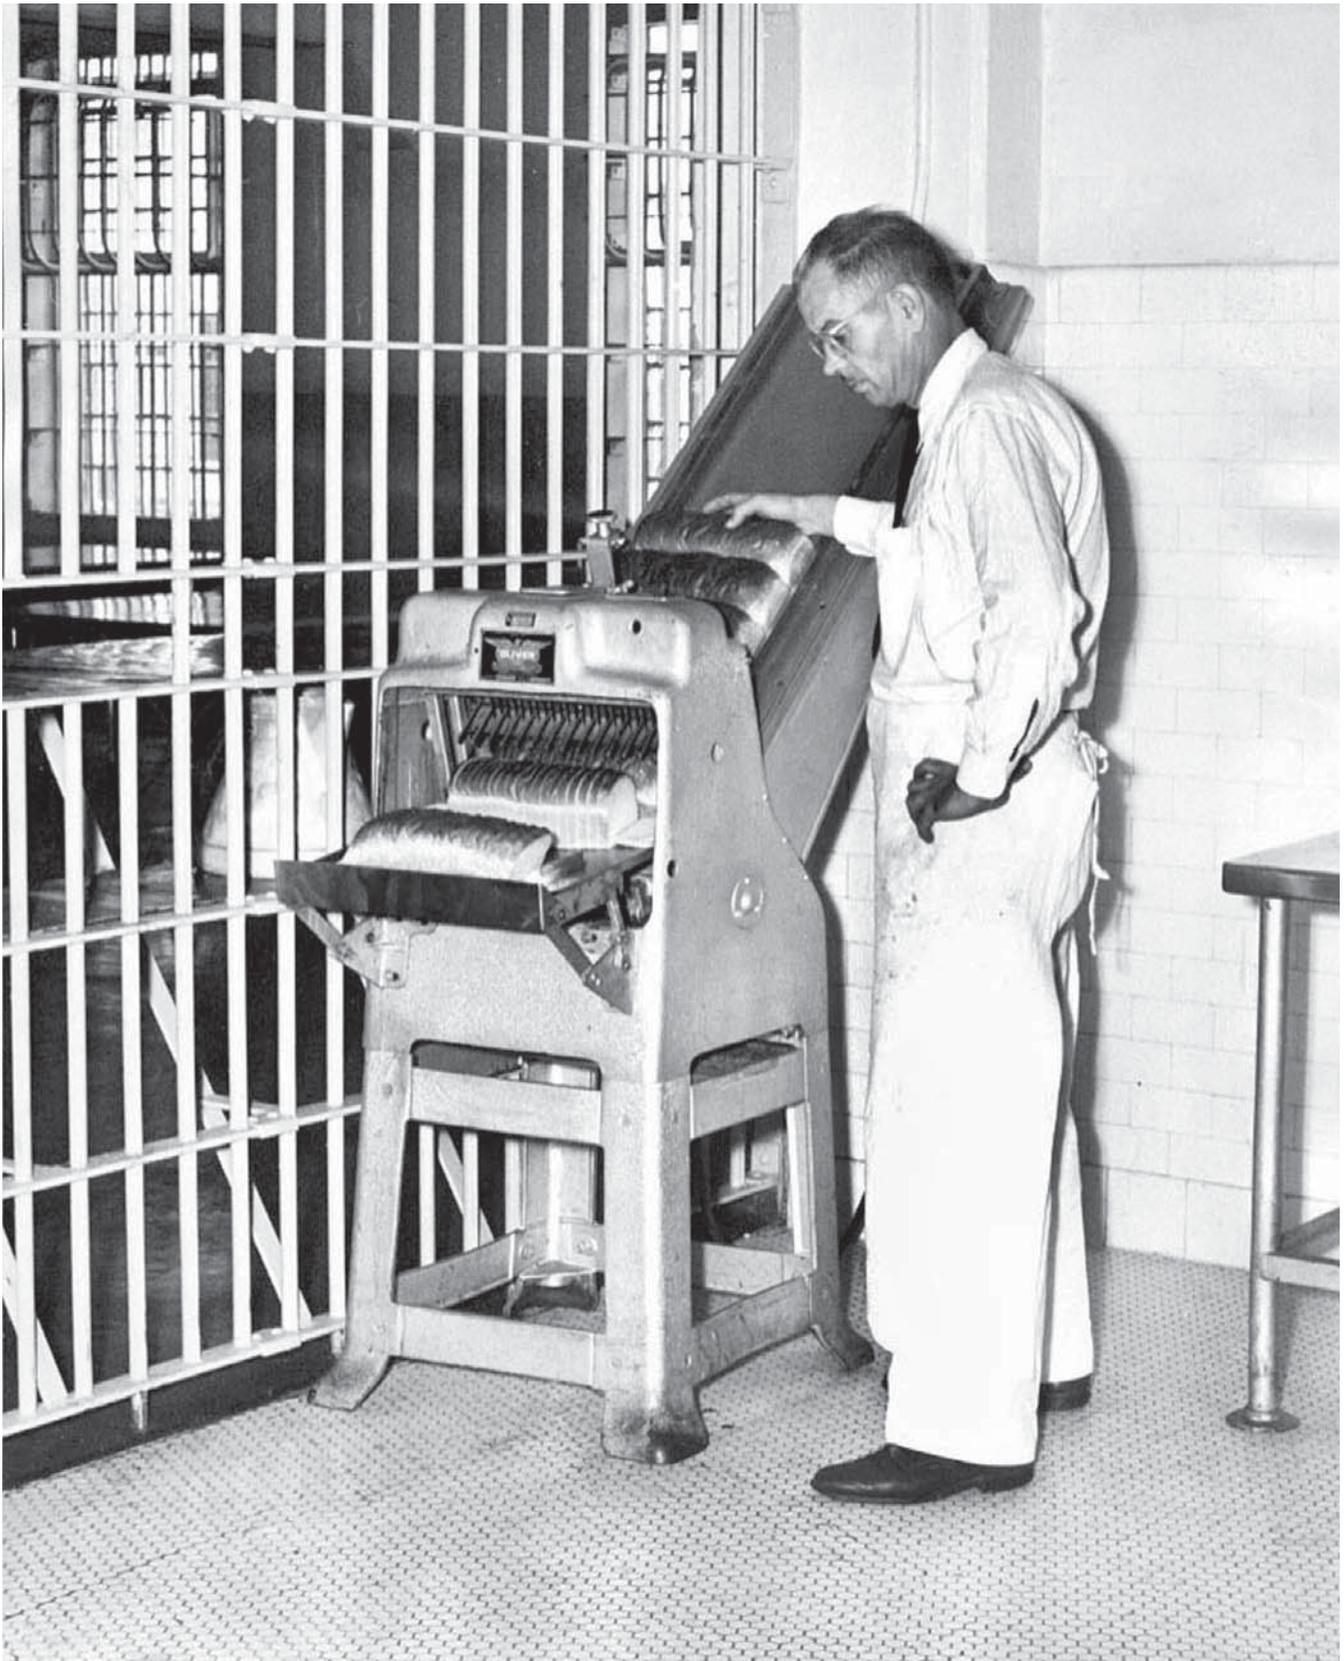
**K6**

Culinary Department staff member with Oliver-brand bread slicer, pre-1953. GGNRA Park Archives Collection, P83-170.219. The metal shelves attached to the gate on the Dining Room side serve as a back bar for the steam tables.

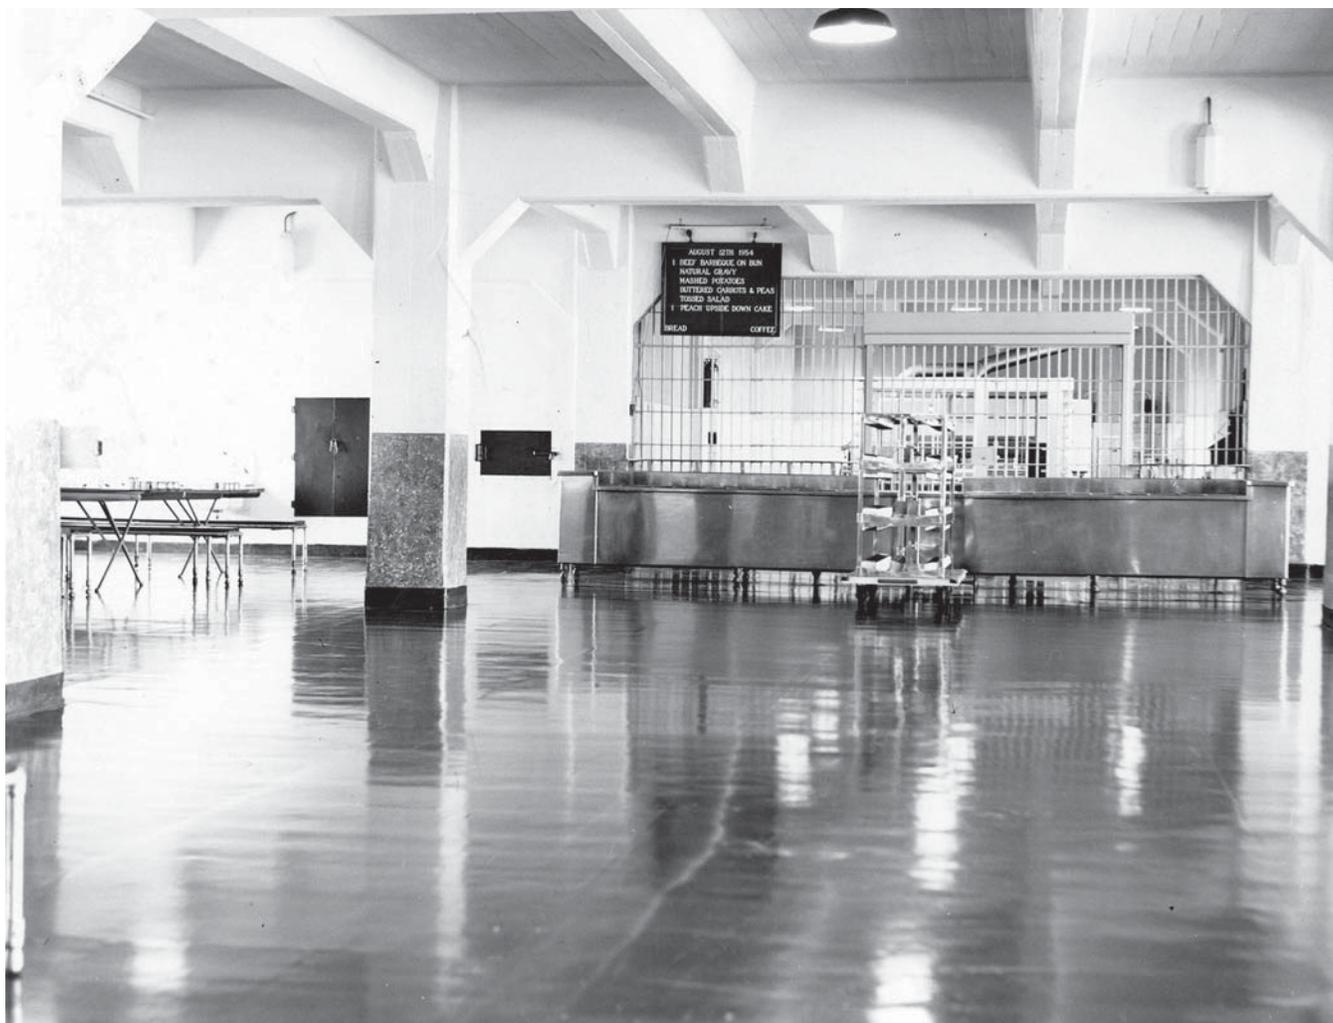
M9

Dining Room steam tables, facing north, September, 1941–53. GGNRA Park Archives Collection, P83-170.228. Note that the shelving behind the steam tables was installed around 1941–42 and the steam kettles visible in the background were moved in 1953.

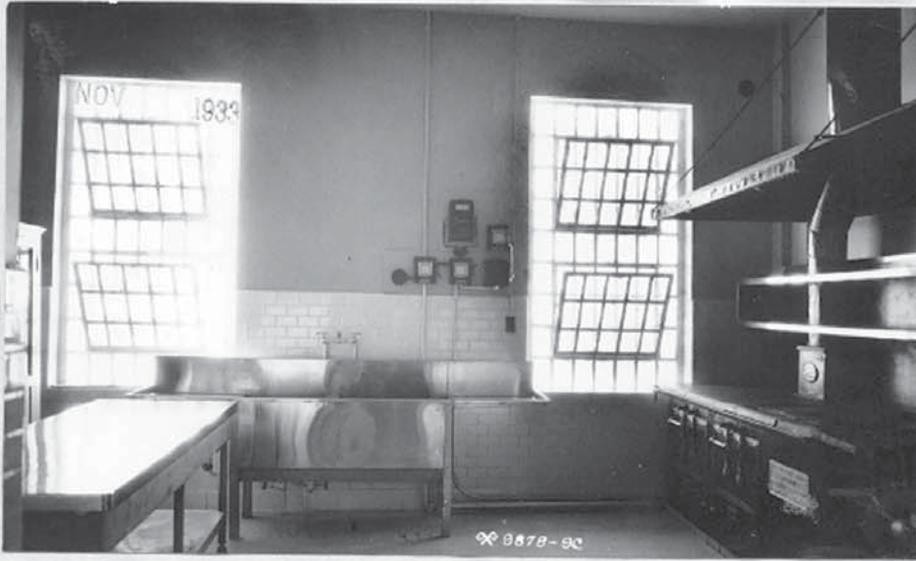
New Stainless Metal Sink--Post Hospital Kitchen
Building No. 68 (a)

“New Stainless Metal Sink, Post Hospital Kitchen, Building No. 68 (a)” and “Tiling on walls--Post Hospital Kitchen and Scullery, Building No. 68 (a),” 1933. NACP, RG 77, Building Book, Alcatraz.

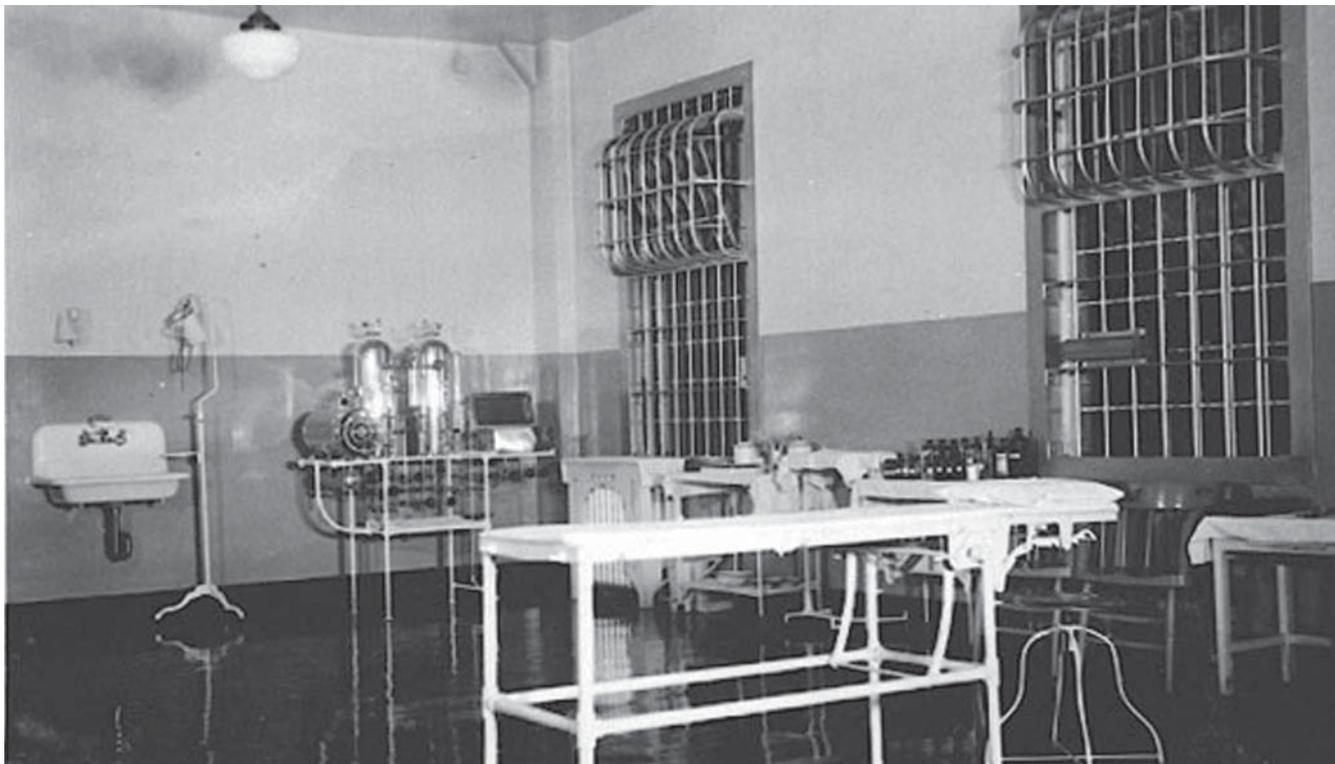
- H6** Outpatient room, ca. 1938. GGNRA Park Archives Collection, P88-020.5. The square black machine in the center is an electrocautery machine, also known as an electric “Bovie” after its inventor. The center cabinet holds bandages, and the cabinet on the right holds chemicals and pharmaceuticals. In the center of the room is a gurney or operating table.

iH7 Outpatient room, ca. 1938. GGNRA Park Archives Collection, P88-020.6. Note the autoclave in the northeast corner and the IV pole next to the sink. The photographer took this image from the opposite side of the gurney shown in figure H6.

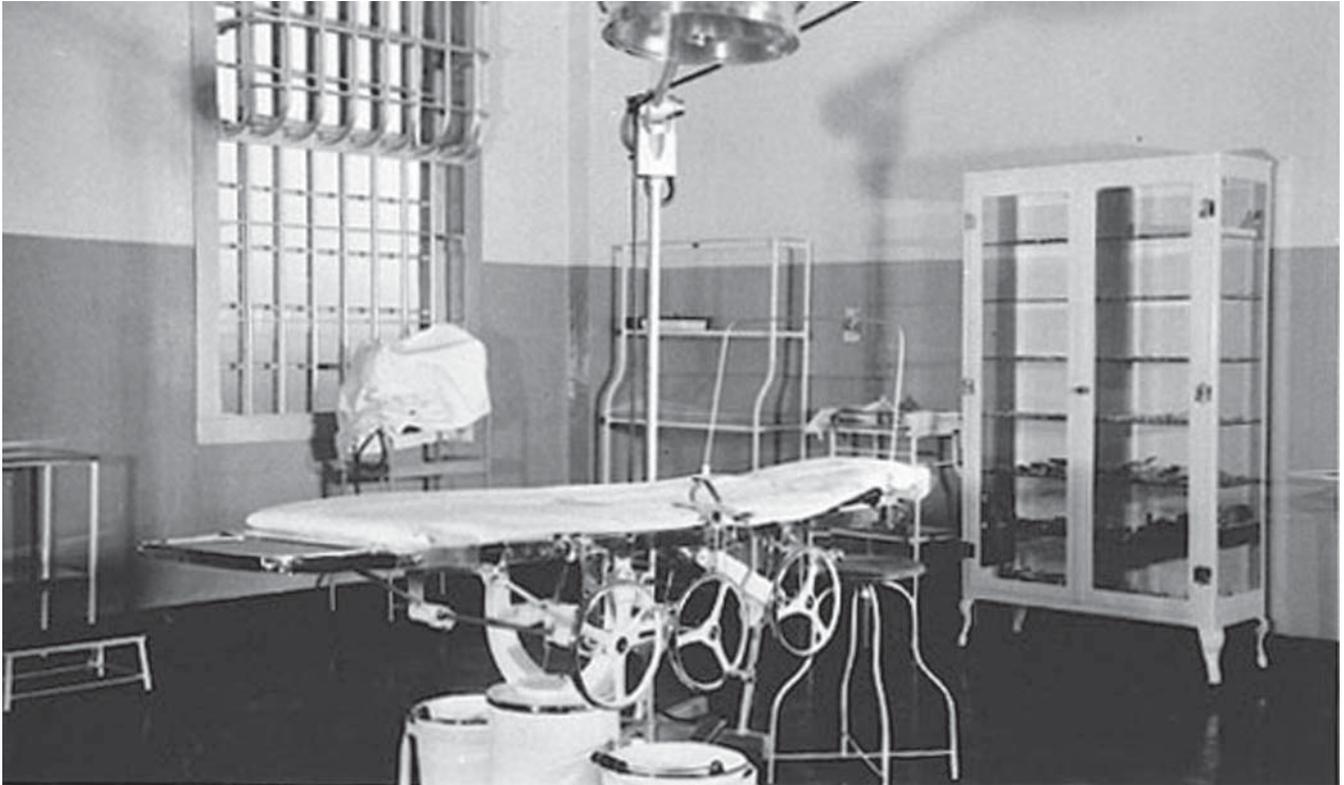
- H9** Operating room, ca. 1938. GGNRA Park Archives Collection, P88-020.4. At far left is a light pole and a stool for the anesthesiologist. The bar arching over the operating table is an ether screen. A cloth drape was put over the screen to divide anesthesia from surgery and to protect the sterile area. The table in the corner was called the “back table” and held most of the surgical instruments. The “Mayo stand” at far right held instruments used immediately in surgery. The buckets in the foreground are known as “kick buckets” and were used to keep track of used sponges during surgery.

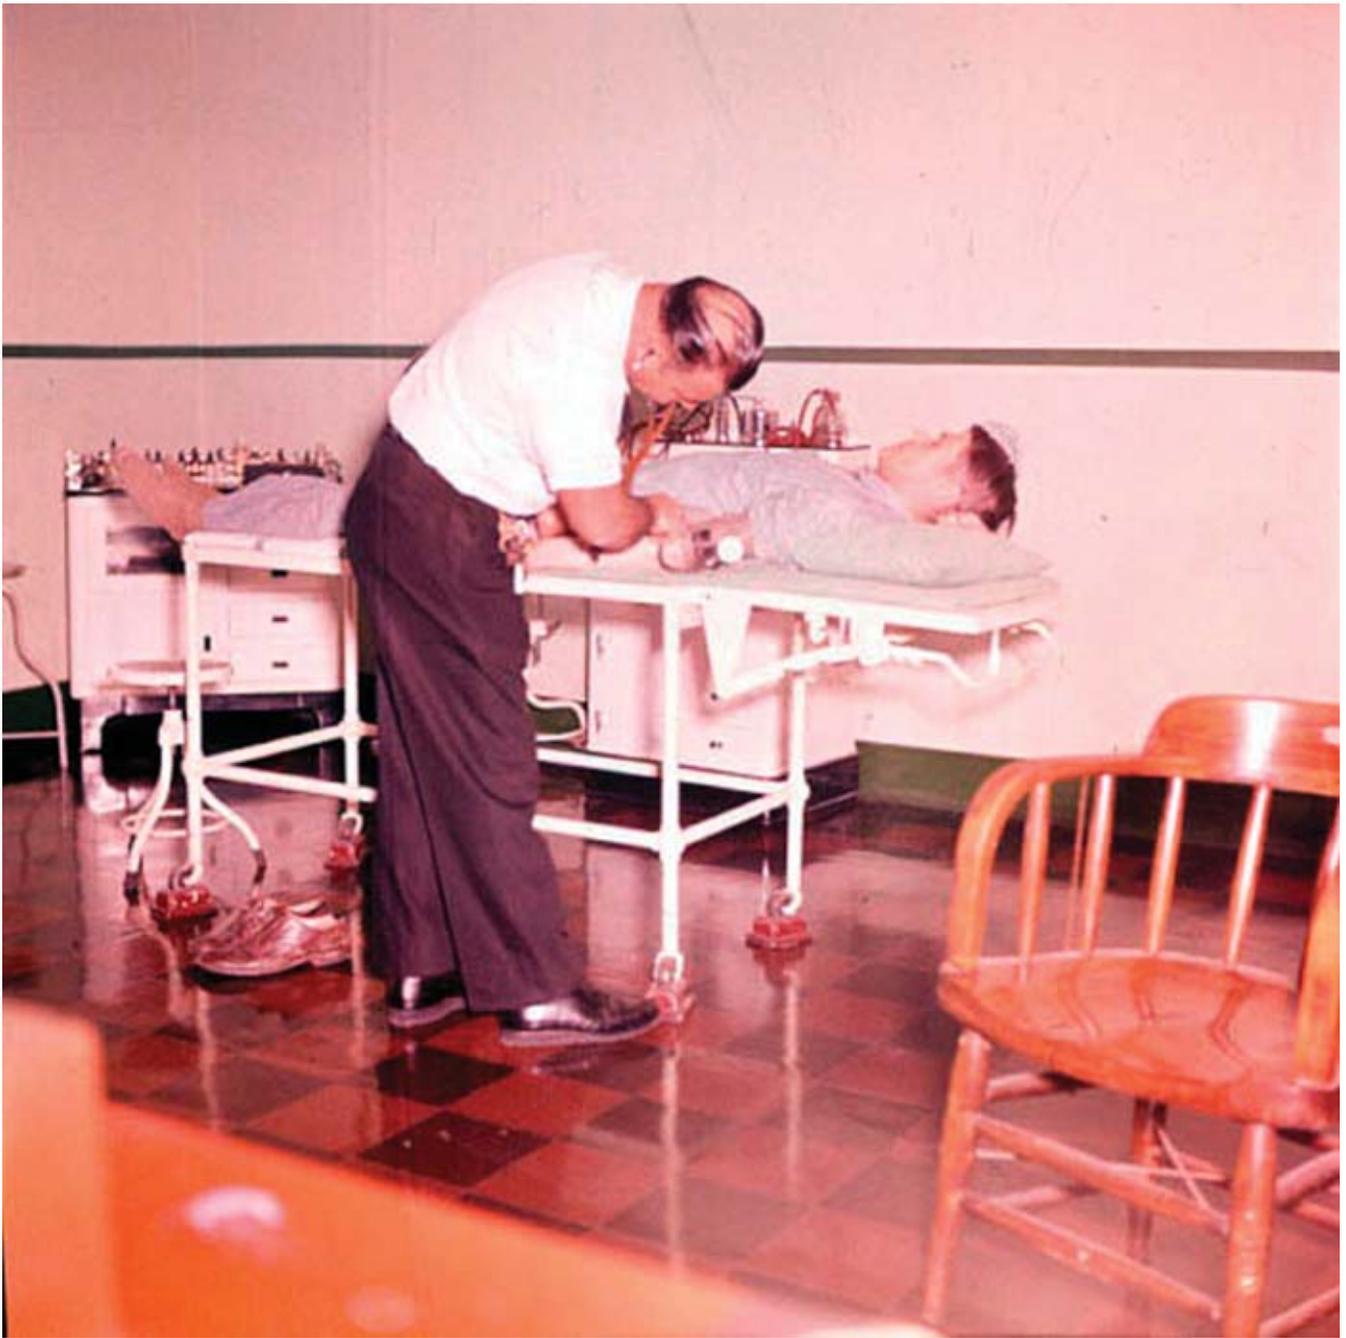
H25 Outpatient room, 1962. GGNRA Park Archives Collection, P88-050.48. Note that the gurney has no brakes, so it is stabilized by blocks. The gurney, or table, is shown in the ca. 1938 photograph, as is the supply cabinet, the stool, and the Army-era wooden chair.

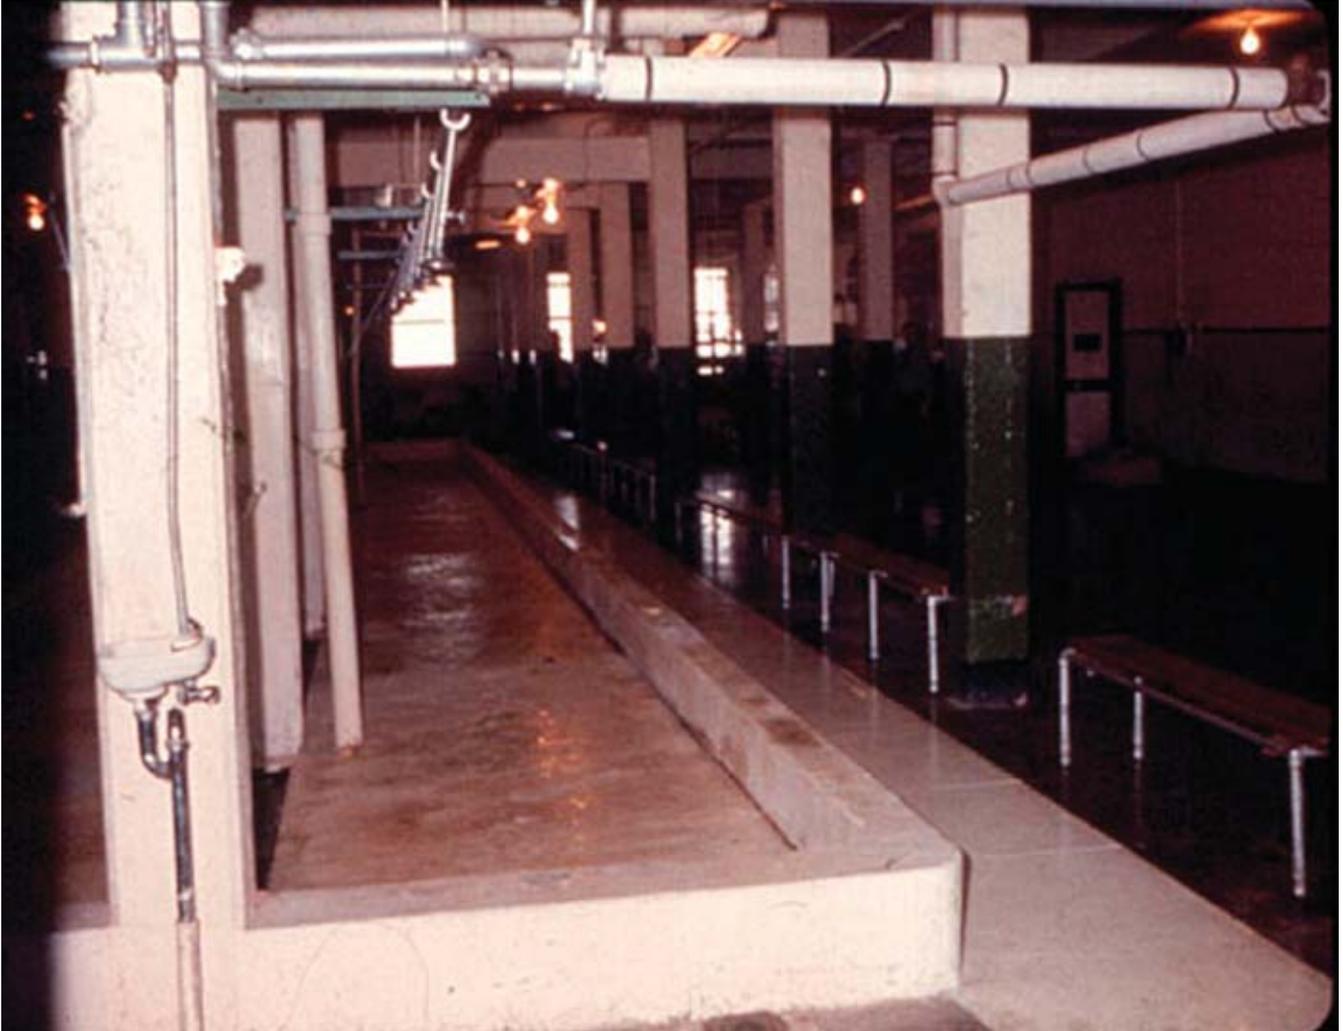
- S1** Shower Room, facing east, pre-1956. Photograph offered on eBay, 1999. The marble shower dividers were painted black sometime before 1953.
