# Indian Garden • Grand Canyon National Park

## Cultural Landscape Report

Contract No. 1443-C2000020300  
June 2005

**John Milner Associates, Inc.**  
103 West Main Street  
Charlottesville, Virginia 22902

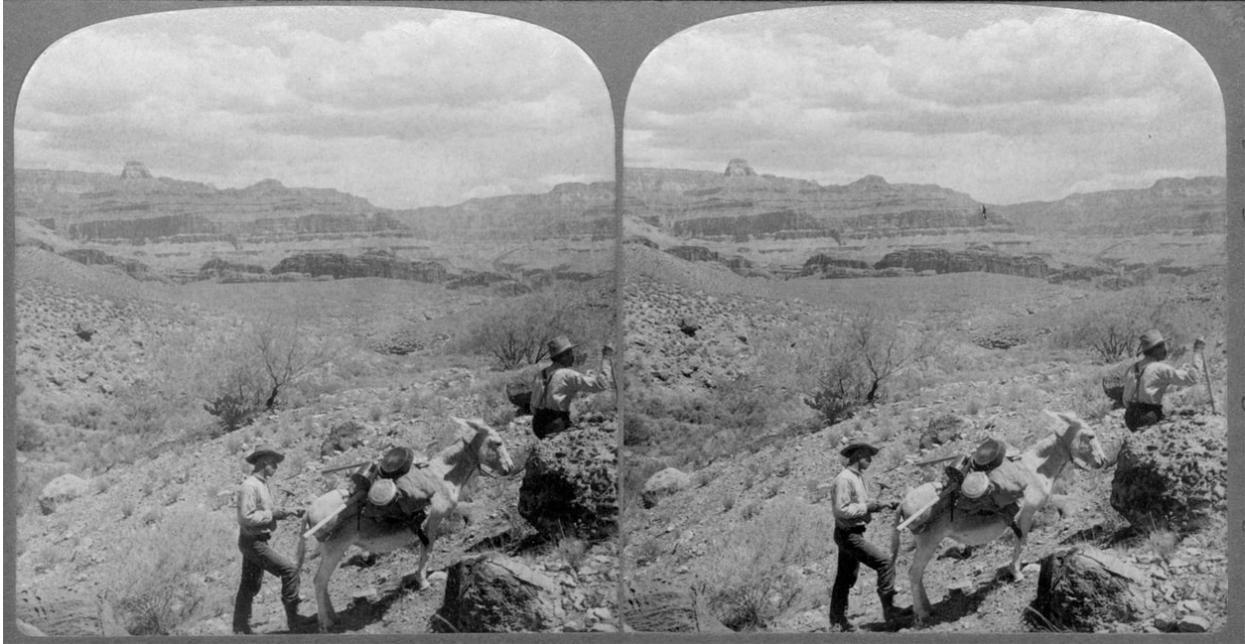
**Figure 3.** “Prospecting for Gold, Indian Gardens, Grand Canyon of Arizona,” ca.1901. (NAU-Cline Library Collection, #NAU.PH.99.48)

As a result of extensive prospecting in the Indian Garden vicinity, numerous adits and tunnels were excavated in an attempt to find valuable minerals and demonstrate proof that claims were being worked.

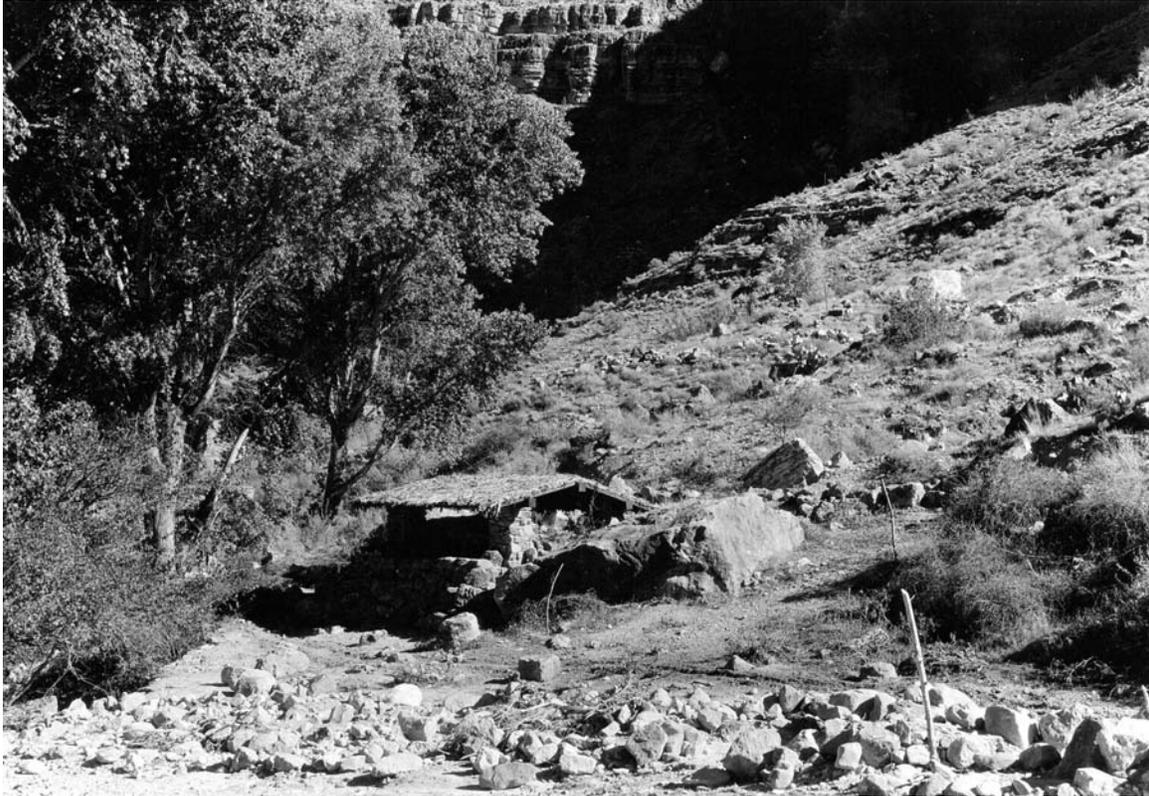
**Figure 30.** Building #143, Trail Shelter at Indian Garden, ca.1936. (Grand Canyon National Park Museum Collection #7584)

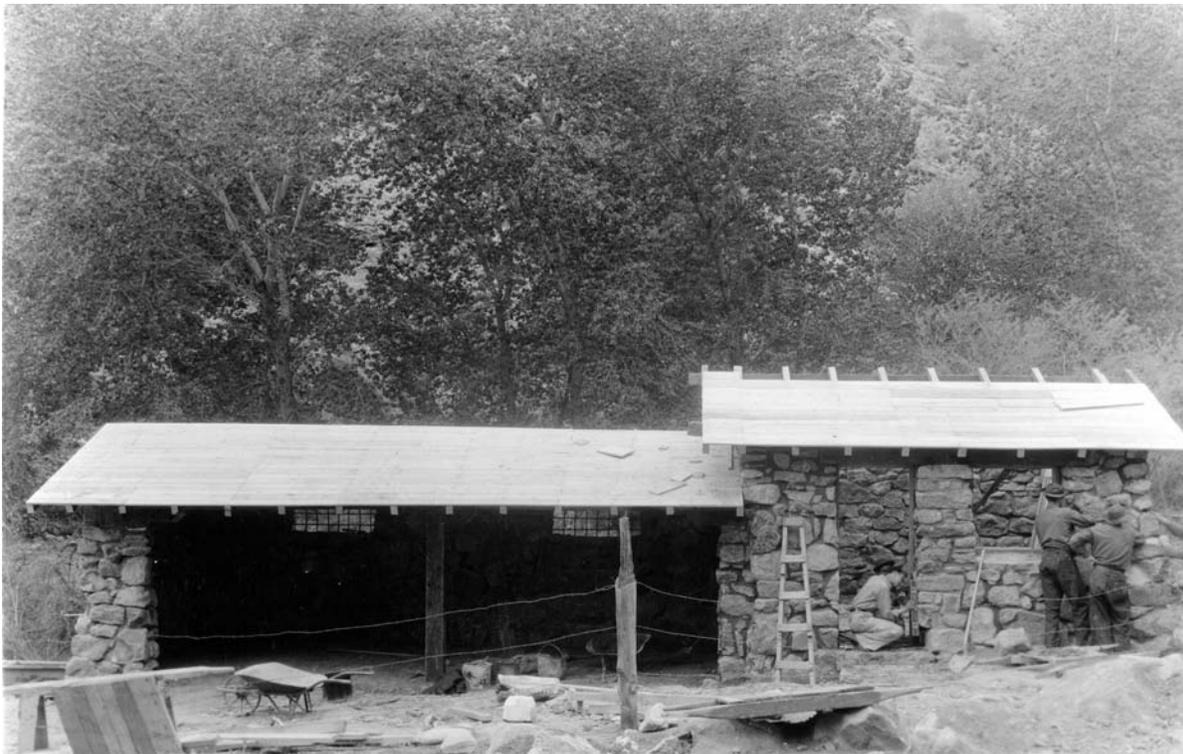
**Figure 31.** NP-4 unit of CCC constructing Indian Garden Mule Barn, March 25, 1936. (Grand Canyon National Park Museum Collection #10056)

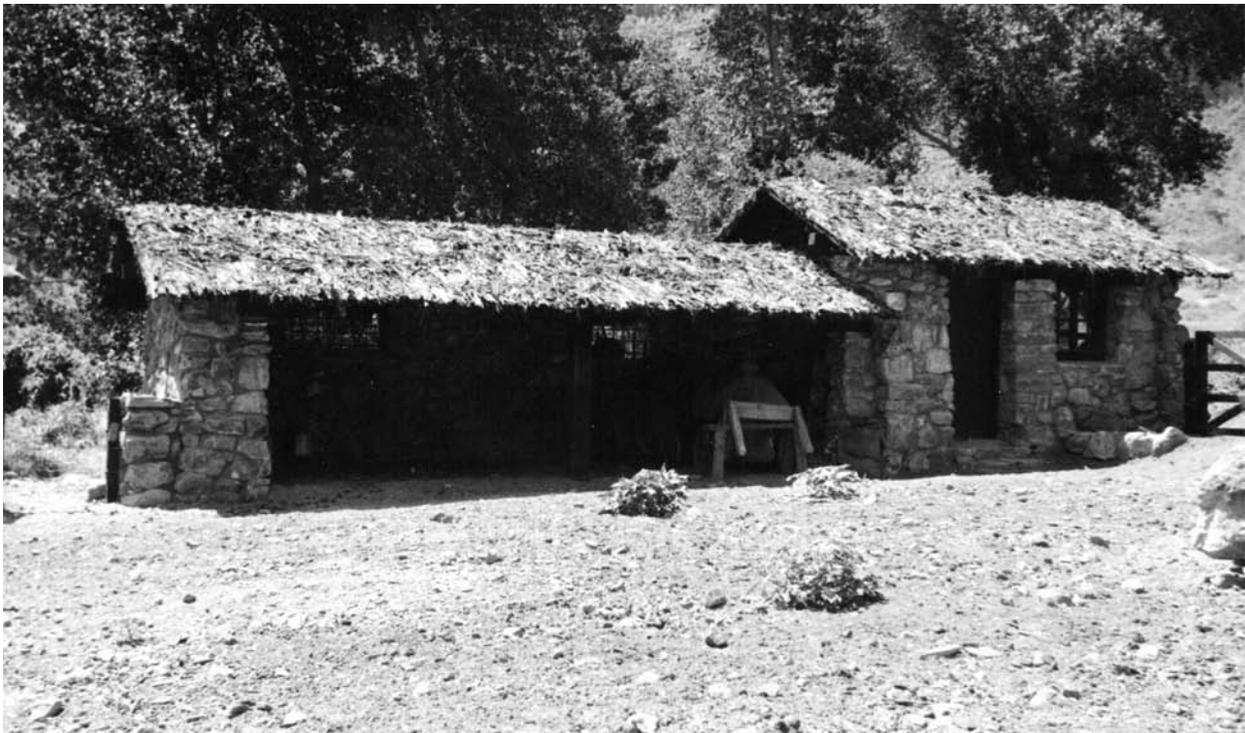
**Figure 33.** West view of Mule Barn at Indian Garden, ca.1936. (Grand Canyon National Park Museum Collection #10054)

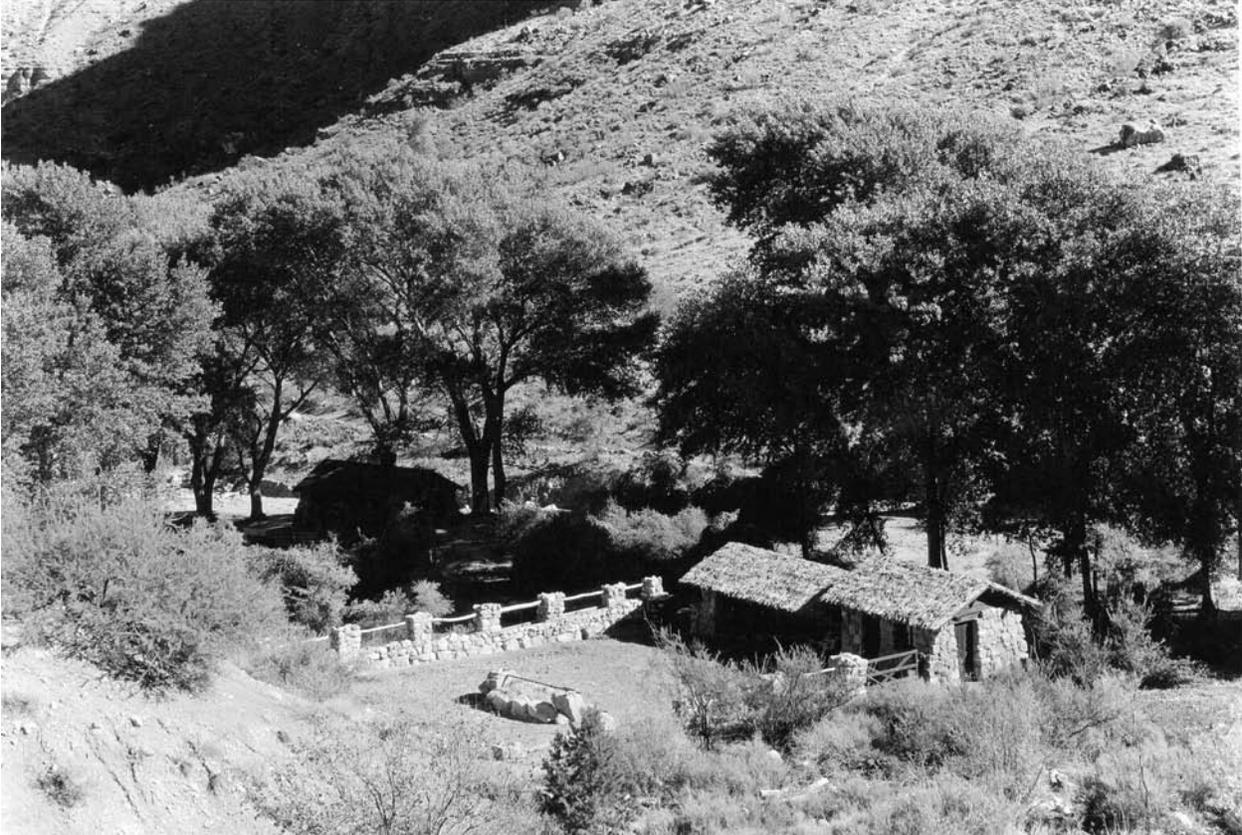
**Figure 34.** Northwest view of Indian Garden mule barn, corral fence, ranger station, ca. 1936. (Grand Canyon National Park Museum Collection #10053)

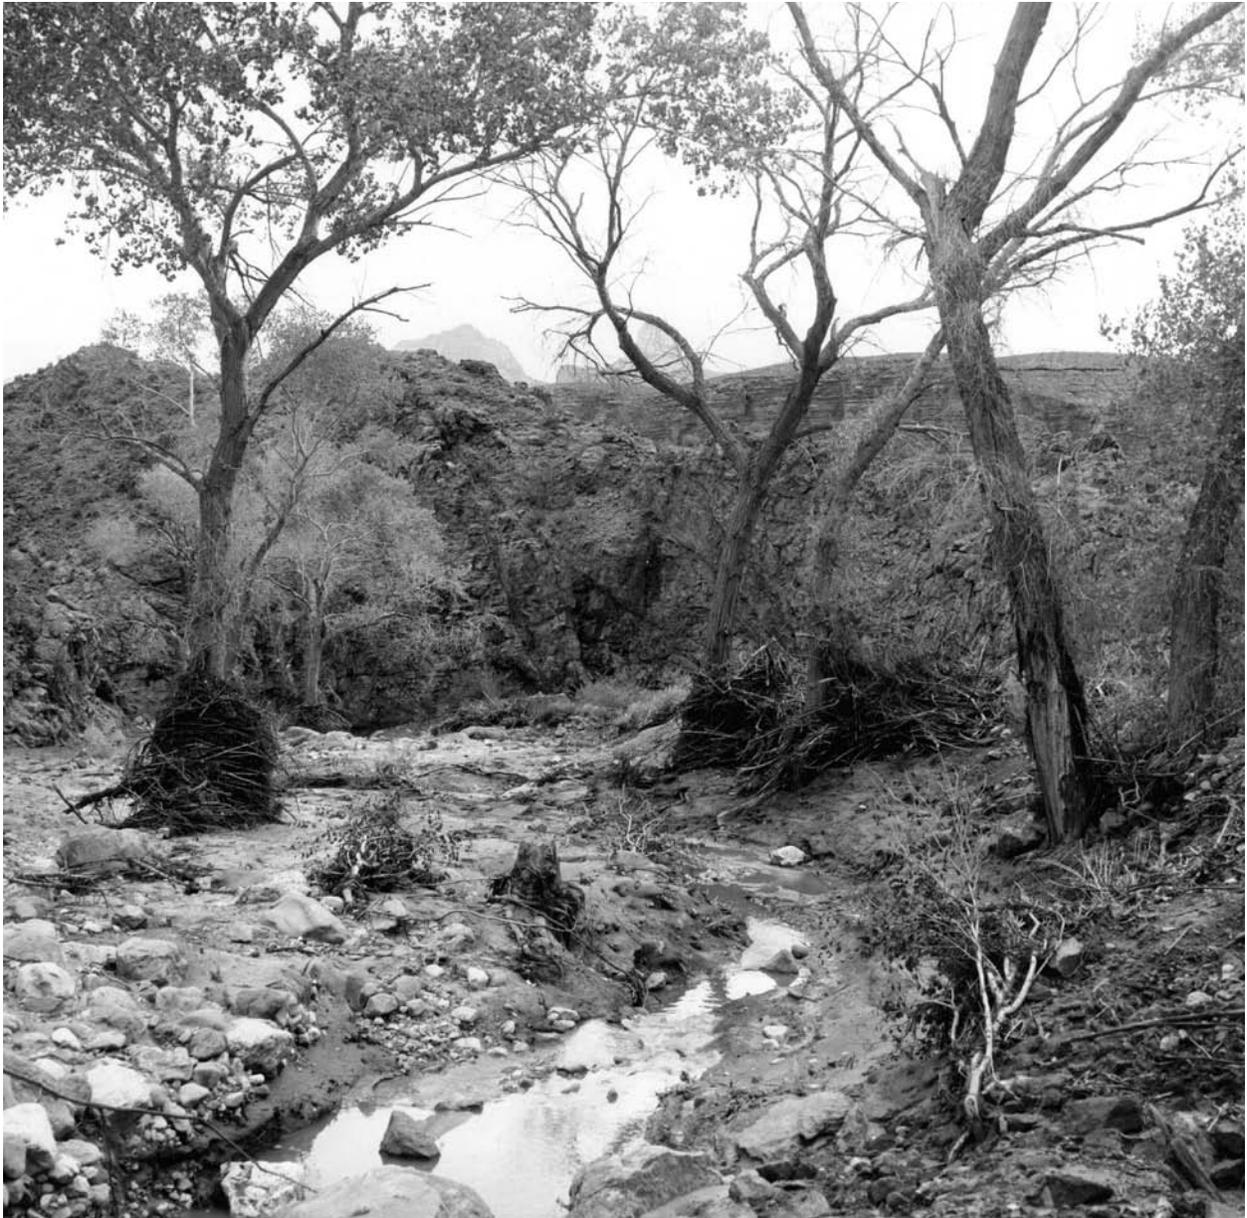
**Figure 40.** Scene after flash flood below Indian Garden, 1963. (Grand Canyon National Park Museum Collection #4477)

destroyed a number of facilities at Indian Garden (*Figure 40*). General clean-up and facilities repair, including repair of the Rehandling Pump House, the Garden Creek channel and banks, and utility lines, took place over the subsequent two years. At the Rehandling Pump House, a masonry rock wall was constructed around the upstream part of the complex to protect it. The catchment basin was dug out and reconstructed with a new reinforced concrete inlet and cover. A new ten-horsepower motor and two electrical starting units were replaced in the pump house. Elsewhere in Indian Garden, the Garden Creek channel was cleaned of debris, including 8,800 cubic yards of rock and earth. This debris was used to fill in eroded areas of the campground and to build up the creek banks. A 100-foot-long and 4-foot-wide masonry rock protection wall was also constructed to keep future flood waters within the channel and to protect the Indian Garden site. The footbridge over Garden Creek that had been washed away was replaced with a timbered structure. Additionally, 210 feet of 2-inch underground waterlines and valves were replaced and soils were re-graded to cover seventy feet of a four-inch sanitary sewer line that had been exposed by the flood.<sup>158</sup>

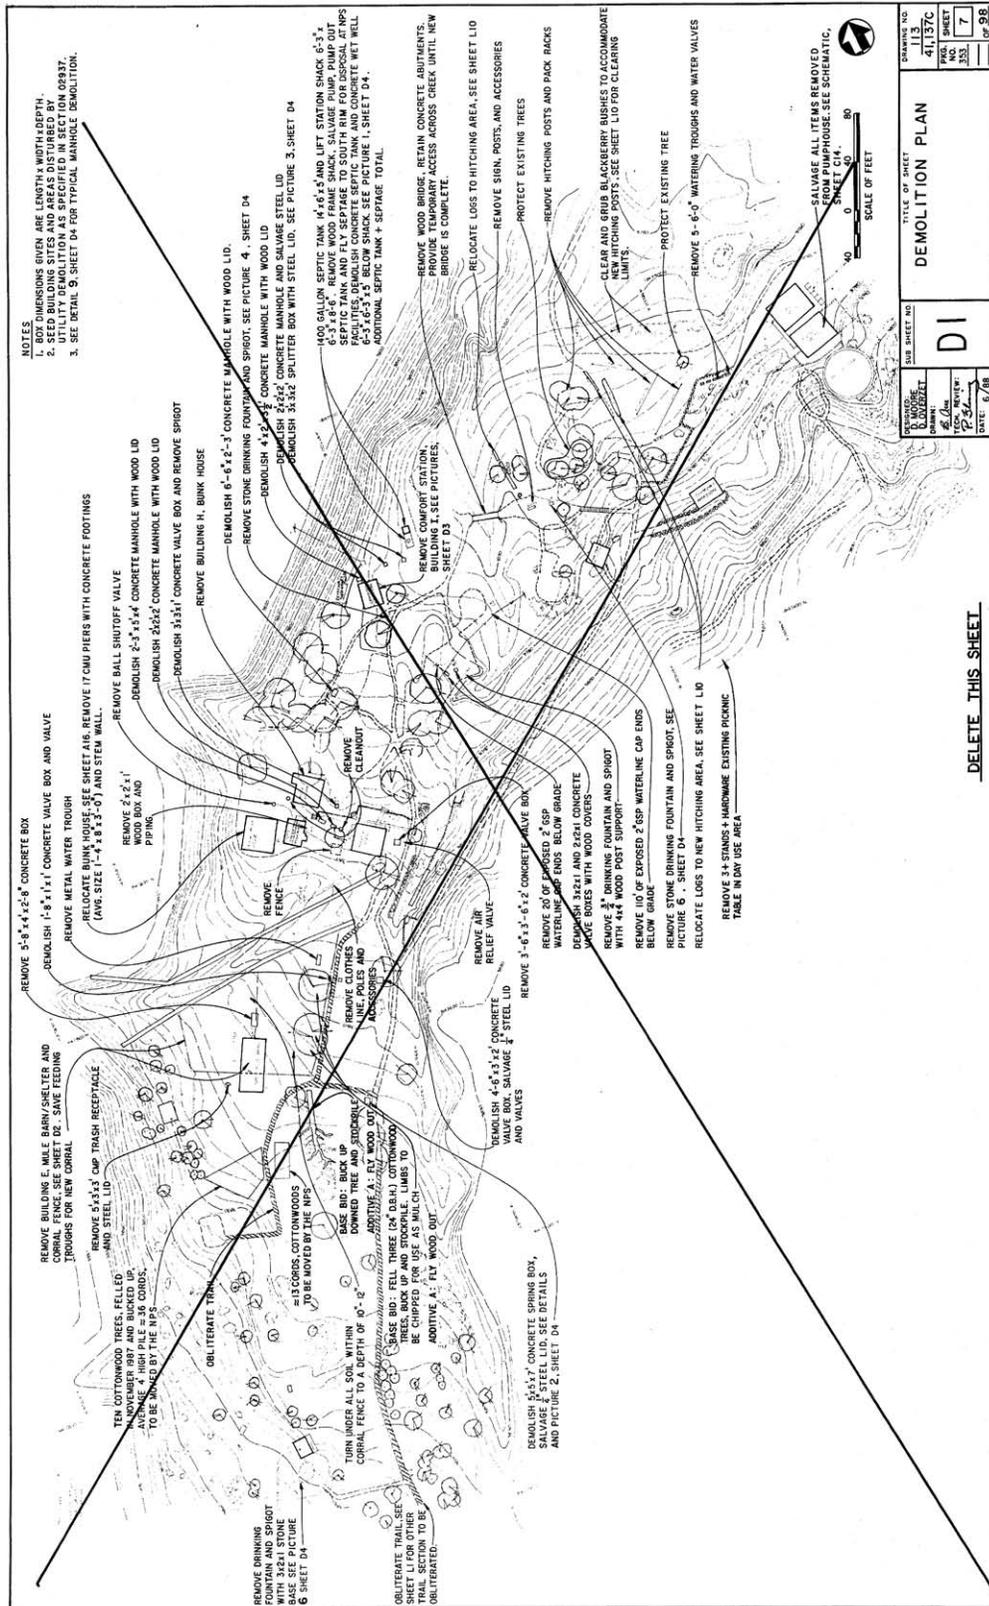
Figure 45 “Demolition Plan,” Sheet D-1 of as-constructed drawings for “Modify Wastewater Treatment Facilities” project, 1989. Demo plan shows Indian Garden existing conditions prior to 1989 rehabilitation. (Grand Canyon National Park Museum Collection #41137C)

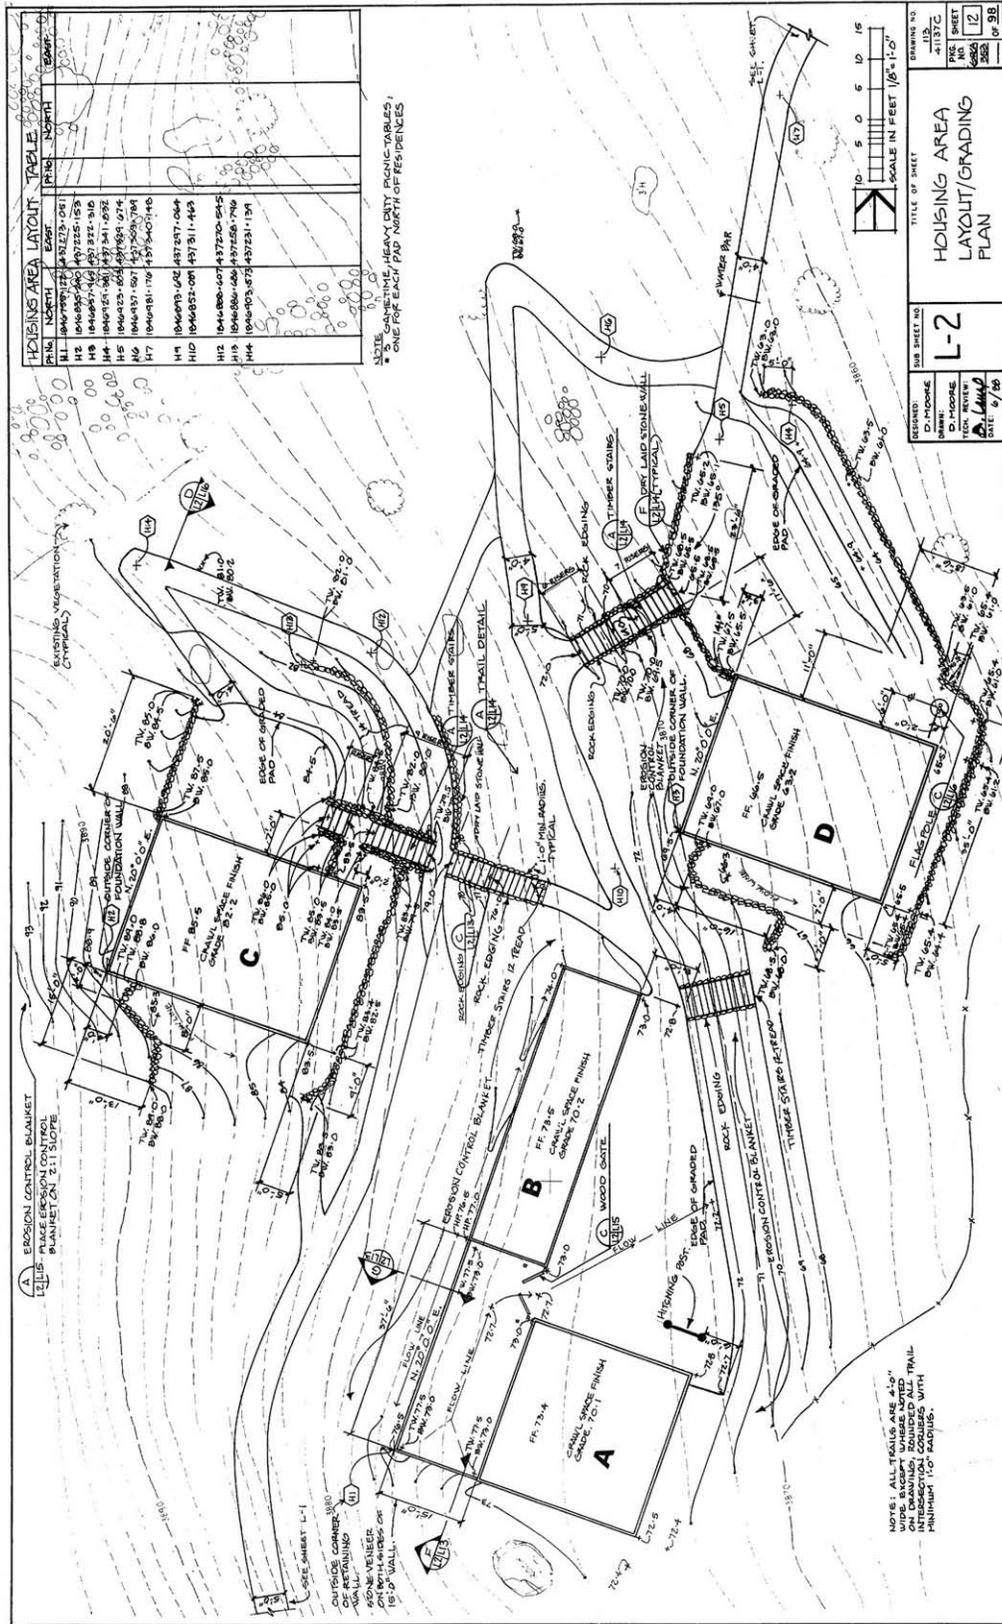
Figure 46 "Housing Area Layout/Grading Plan," Sheet L-2 of as-constructed drawings for "Modify Wastewater Treatment Facilities" project, 1989. (Grand Canyon National Park Museum Collection #41137C)

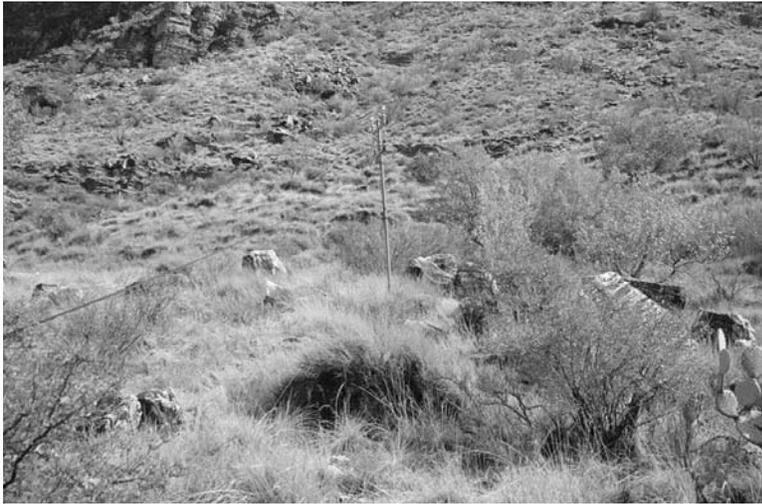
**Photograph 4.** Historic telephone pole, part of the trans-canyon telephone line.  
(JMA 2002)

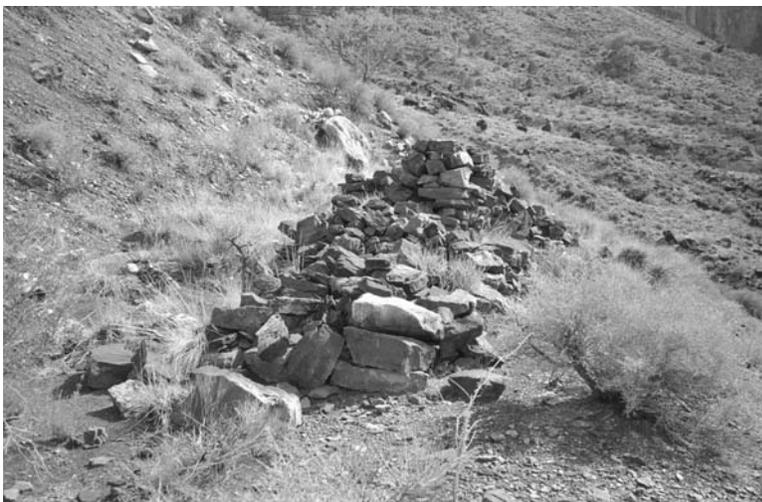
**Photograph 5.** Site No. Ariz. B:16:140, dry-laid stone masonry structures.  
(JMA 2002)

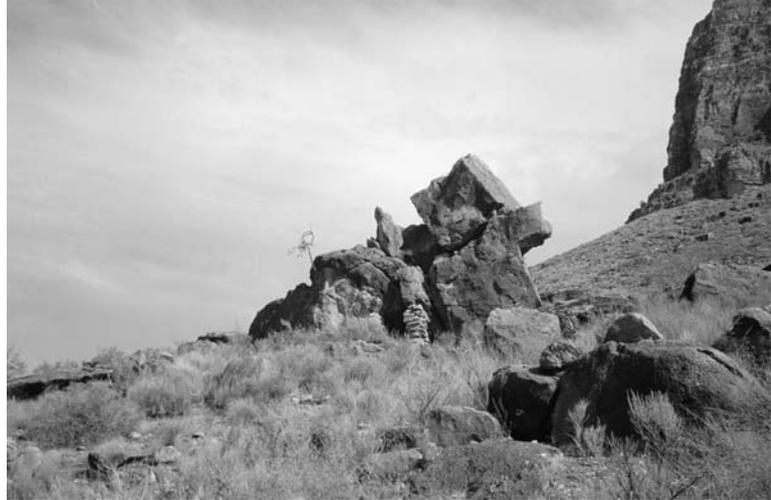
**Photograph 6.** Site No. Ariz. B:16:165, “Cooler” or latrine comprised of masonry wall between two boulders. (JMA 2002)

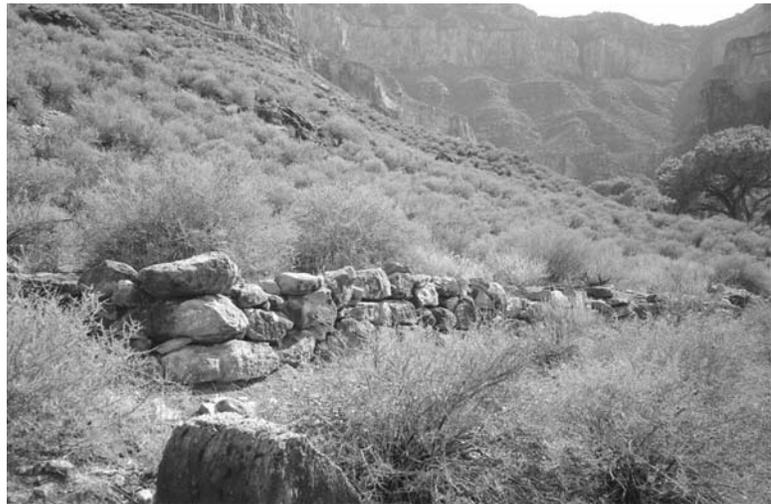
**Photograph 7.** Site. No. Ariz. B:16:165, Tent platform with stone retaining wall. (JMA 2002)

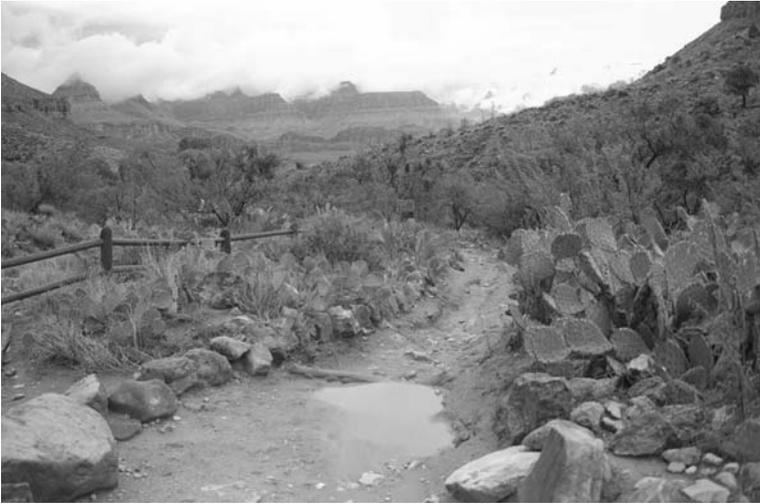
**Photograph 8.** Bright Angel Trail Corridor with fencing, vegetation, and stone edging. (JMA 2002)

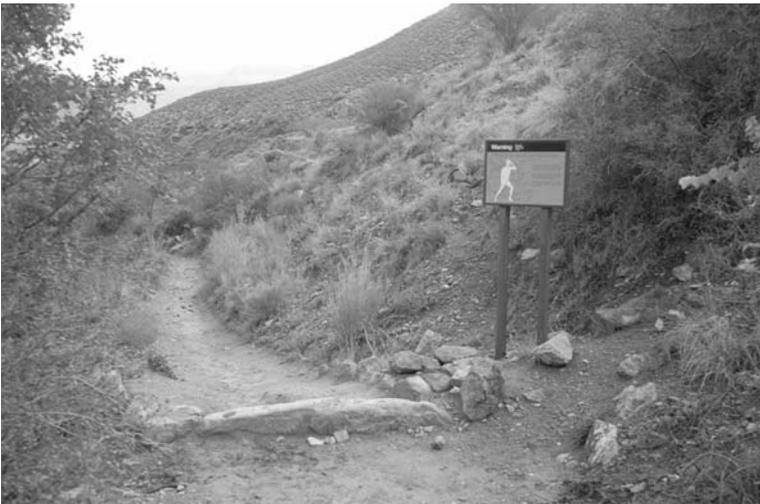
**Photograph 9.** Bright Angel Trail Corridor with stone waterbar and signage. (JMA 2002)

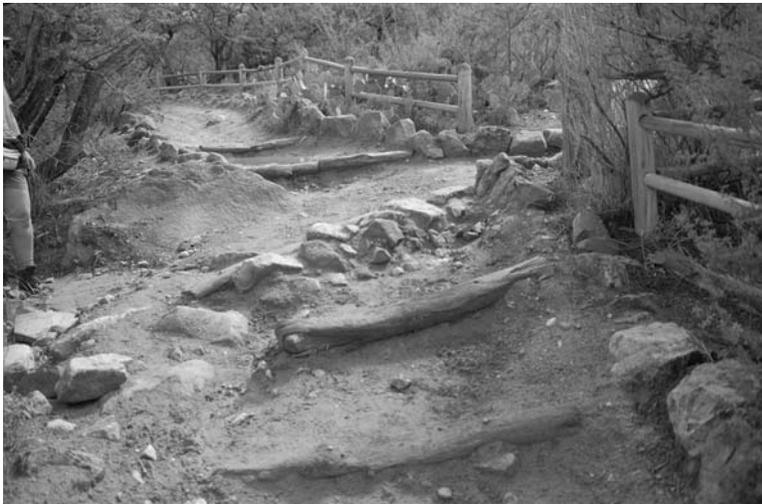
**Photograph 14.** Erosion around Bright Angel Trail log risers.  
(JMA 2002)

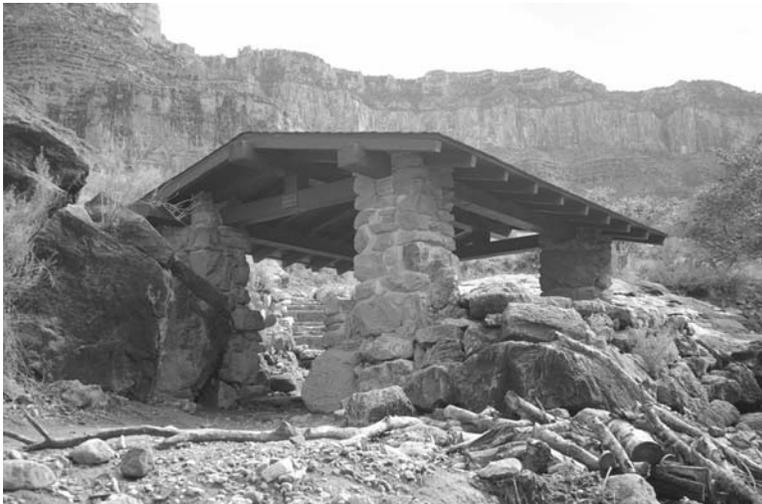
**Photograph 19.** Trailside Shelter, built in 1937.  
(JMA 2002)

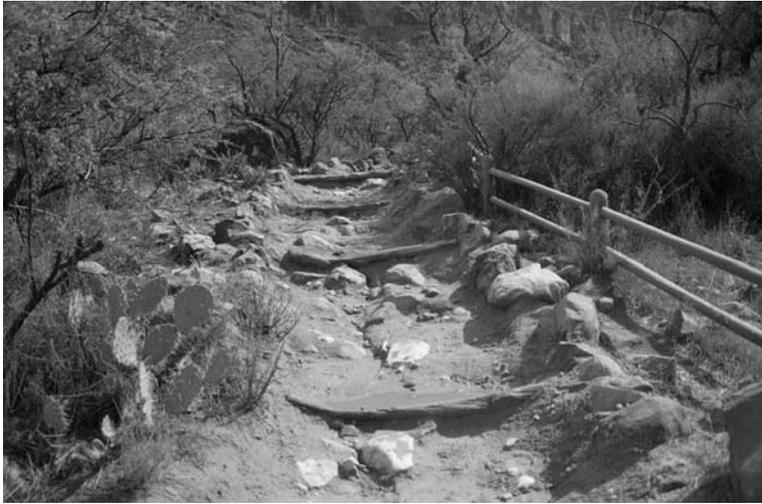
**Photograph 23.** Log risers and stone waterbars.  
(JMA 2002)

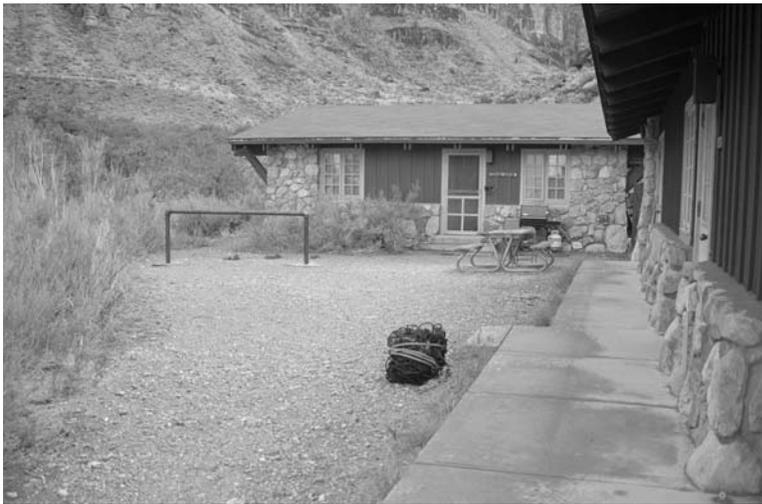
**Photograph 28.** Courtyard with concrete sidewalk, hitching bar. Relocated Bunkhouse is in background. (JMA 2002)

A **courtyard** is formed by the eastern elevation of the Storage/Laundry/First Aid Building and northern elevation of the Bunkhouse (*Photograph 28*). The courtyard has seating and a mule hitching bar. A retaining wall to the south of the Ranger Residence creates a small **backyard space** and private space for the ranger (*Photograph 29*). To the north of the Ranger Residence, an open front porch and picnic table create a **public space** where the ranger greets hikers and visitors (*Photograph 30*).

In 1989, the NPS relocated a 1986 **Bunkhouse** (Bldg. #473/1429) that stood just north of the historic Pump Operator's Residence/Rock House (*Photograph 28*). The original structure comprised a one-story, frame, gable-roofed building clad in board-and-batten siding. In 1989, the structure was dismantled and reconstructed on a new concrete block foundation and remodeled on the exterior and interior to match the three new buildings in the NPS housing cluster. The frame walls are clad in board-and-batten siding and a partial random-rubble stone veneer that accentuates the corners and the base of the building. The building features exposed rafter tails; gable-end, eave brackets; paired, eight-light, wood casement windows; and single-leaf, panel-and-light metal doors. At present, the Bunkhouse provides temporary accommodations for NPS staff.

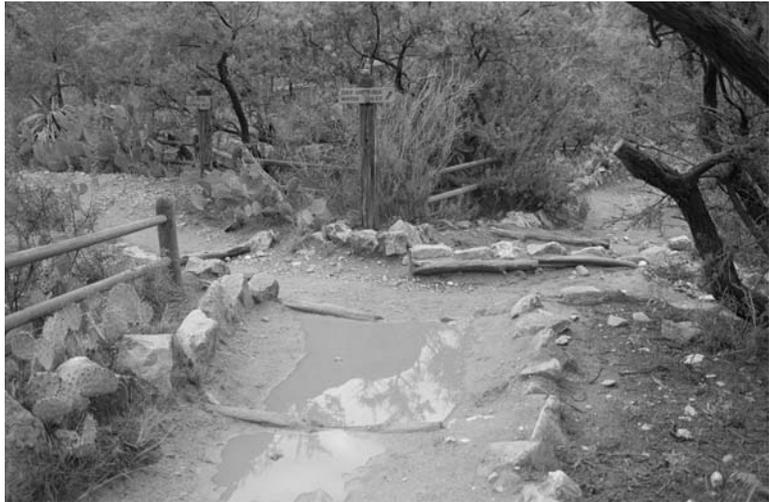
**Photograph 32.** Informal spur trail to helispot. (JMA 2002)

To expedite access to the helispot and Administration Area, an informal, loosely-defined **spur trail**, narrow in width, leads from Bright Angel Trail to the helispot (*Photograph 32*). This trail is intended for NPS personnel only and not for hikers. Another informal **spur trail**, intended only for NPS personnel, begins at Bright Angel Trail and heads up the slope to the Bunkhouse (*Photograph 22*). The trail is blocked by the length of wood fence that runs along Bright Angel Trail. A **concrete sidewalk** is located along the eastern elevation of the Storage/Laundry/First Aid Building (*Photograph 28*).

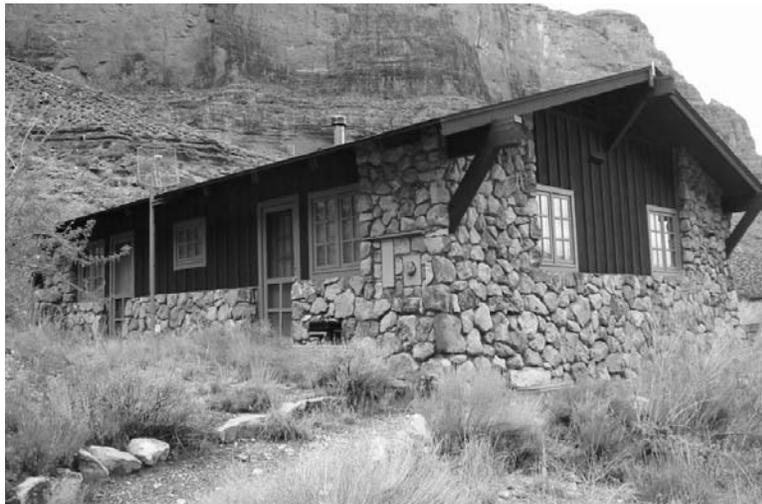
**Photograph 34.** Pump Operator's Residence.  
(History Matters 2002)

The **NPS Ranger Residence** (Bldg. #1460) (*Photograph 30*) and **Pump Operator’s Residence** (Bldg. #1459) (*Photograph 34*) are two of four buildings that comprise the central building cluster. Built in 1989, the Ranger and Pump Operator’s Residences are identical in design. Utilizing the NPS Rustic Revival style, they consist of twenty-eight-feet by thirty-six-feet, rectangular-plan structures covered by side-gable, asphalt-shingled roofs. The frame walls are clad in board-and-batten siding with partial random-rubble, stone façades accentuating the corners and base of the buildings. Other distinguishing features include the paired, exposed rafter tails; gable-end eave brackets; ganged, eight-light, wood casement windows; and single-leaf, panel-and-light metal doors.

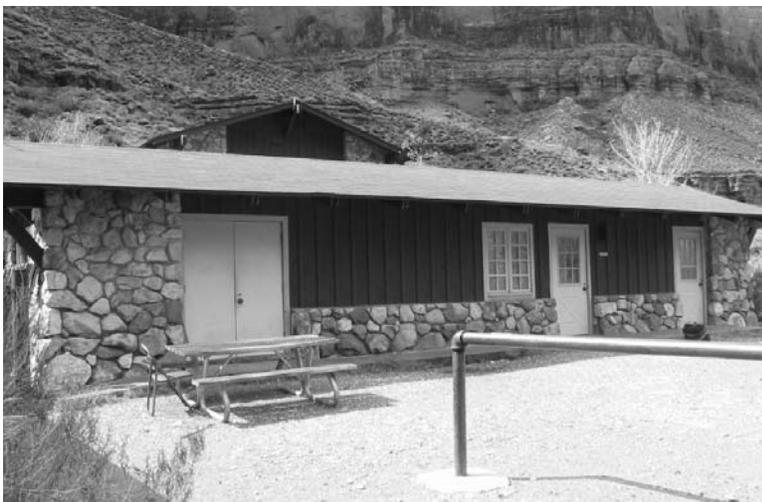
**Photograph 35.** Storage/Laundry/First Aid Building.  
(History Matters 2002)

The **NPS Storage/Laundry/First Aid Building** (Bldg. #1462) was built in 1989 and consists of a forty-eight-feet-long by fourteen-feet-deep, rectangular, frame structure that is covered by an asphalt-shingled, side-gable roof (*Photograph 35*). Like the Ranger and Pump Operator’s Residences, the Storage/Laundry/First Aid building’s frame walls are clad in board-and-batten siding and partial random-rubble, stone façades that accentuate the corners and base of the building. The building features paired, exposed rafter tails; gable-end eave brackets; paired, eight-light, wood casement windows; and two single-leaf, panel-and-light metal doors.

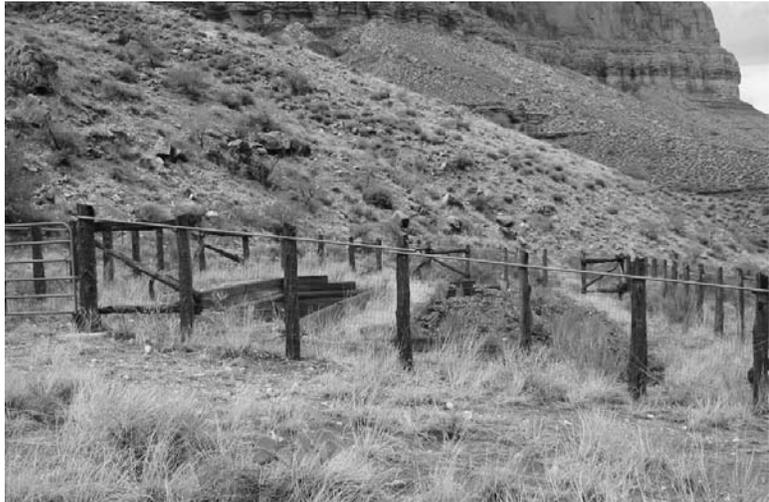
**Photograph 38.** Helispot.  
(JMA 2002)

The **helispot** is located south of the central building cluster and consists of a circular gravel clearing approximately thirty feet in diameter (*Photograph 38*).

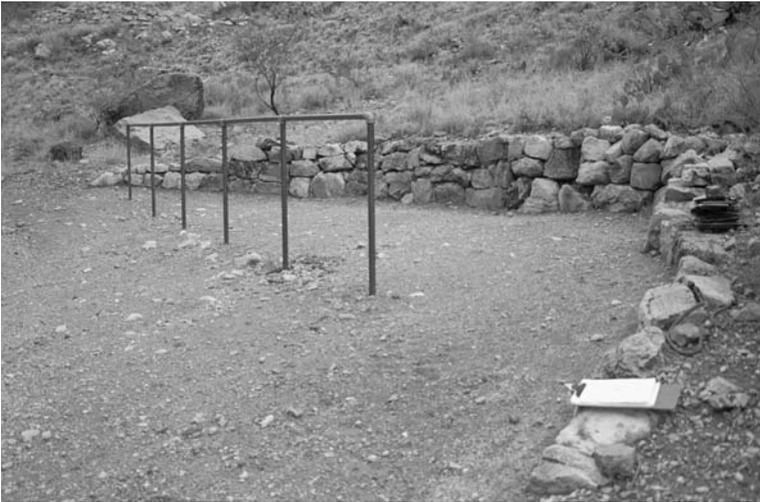
**Photograph 46.** Hitching bar and stone wall.  
(JMA 2002)

Two **hitching bars** are located within the central building complex. The first is found south of the Pump Operator's Residence and on the upper secondary trail. It consists of six narrow metal pipe posts supporting horizontal metal pipes (*Photograph 46*). The second hitching post is found in the courtyard in front of the Bunkhouse and consists of thick metal pipes and elbow joints (*Photograph 28*). A wood and metal **picnic table** is also located in this courtyard. A red **windsock**, on a metal pipe post, is attached to the stone wall adjacent to the Bunkhouse (*Photograph 47*).

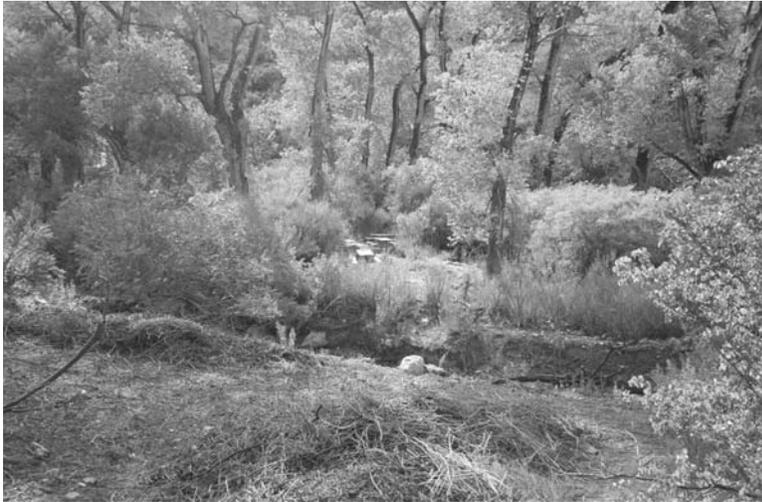
**Photograph 57.** View of picnic areas within wet area. Note cottonwood trees in background and cleared area in foreground. (JMA 2002)

The largest portion of the Day Use Area is comprised of overgrown **picnic grounds**, forming a dense and relatively uniform space that was open at one time (*Photograph 57*). A **cleared area** below the Trailside Shelter, east of Garden Creek, is one of the few open spaces in the Day Use Area. A **level terrace** of cleared, hard-packed earth, constructed between the SAR Cache and Rock House, sets these buildings apart from the picnic grounds to their north.

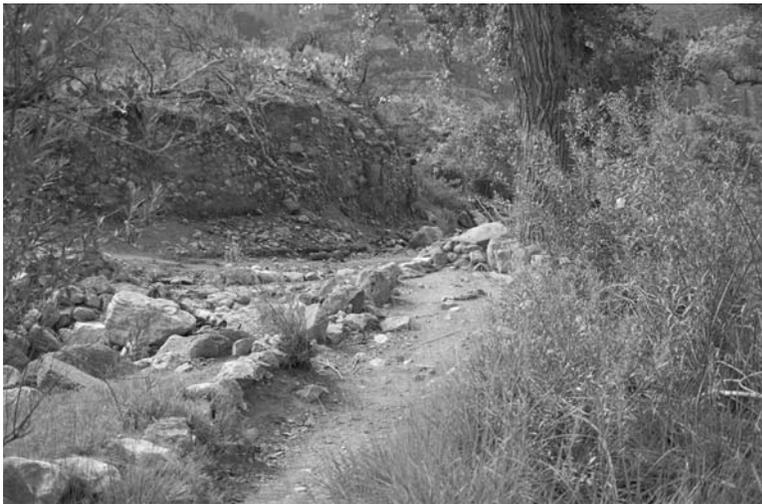
**Photograph 58.** Spur trail east of Caretaker's Residence/SAR Cache. (JMA 2002)

An informal **spur trail** forks north from the Bright Angel Trail at its junction with Garden Creek to run east of the SAR Cache (*Photograph 58*). This trail leads into the former picnic grounds. Once in the picnic grounds, this trail splits into different directions, forming a **network of trails** that weave throughout the grounds and terminate near the Mule Barn. These earthen, un-edged trails frequently pass through locations that are inundated with water in wet weather. In some places, stones and logs have been laid along the path as stepping stones. **Concrete sidewalks** access the SAR Cache entrances (*Photograph 59*).

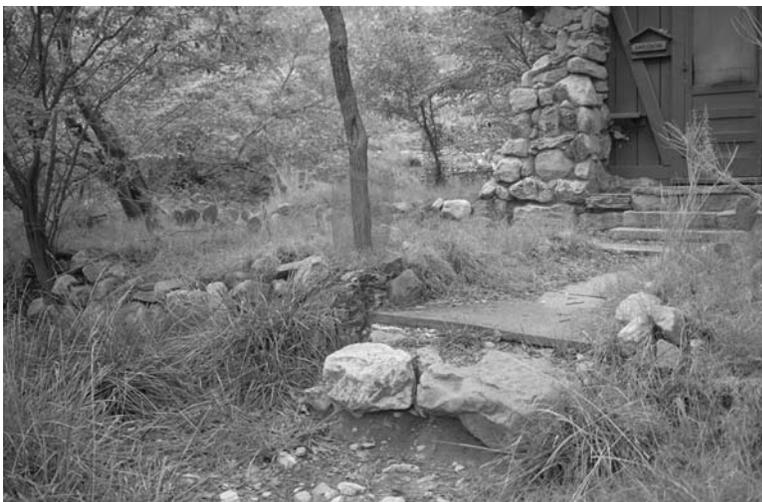
**Photograph 59.** Stone steps, concrete sidewalk at Caretaker's Residence/SAR Cache. (JMA 2002)

North of the SAR Cache/Caretaker's Residence and Pump Caretaker's Residence/Rock House is a three feet high, rubble **stone retaining wall** separating the terrace from the former picnic grounds (*Photograph 69*). **Stone steps** lead up from the picnic grounds to the buildings (*Photograph 59*). A **utility pole** is located west of the Rock House (*Photograph 70*). The pole was intended for the installation of a public pay phone, which was never installed due to the limitations of the old phone system.

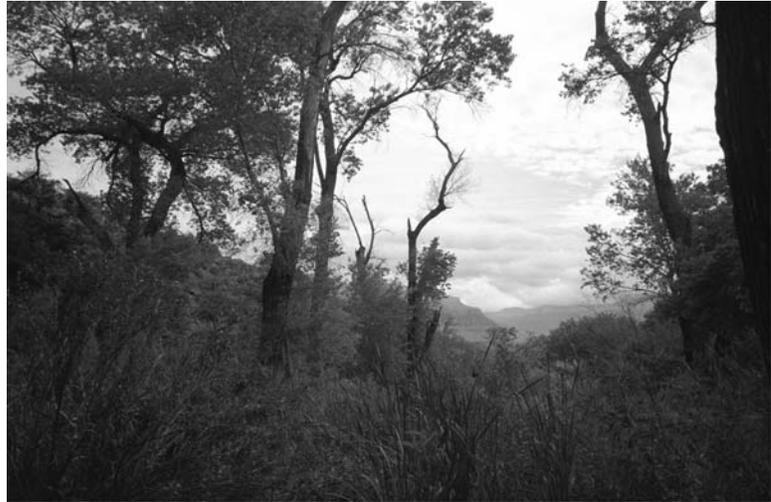
**Photograph 61.** Remains of large cottonwood near Caretaker's Residence/SAR Cache. (JMA 2002)

Rows of large **cottonwood trees** are present within the Day Use Area. Some of these are in decline—displaying dieback and missing limbs (*Photograph 61*). Stumps appear where trees have been cut down in recent years. A large cottonwood tree is growing out of the terrace between the SAR Cache and Rock House. A single **peach tree** of unknown origin grows just north of the SAR Cache.

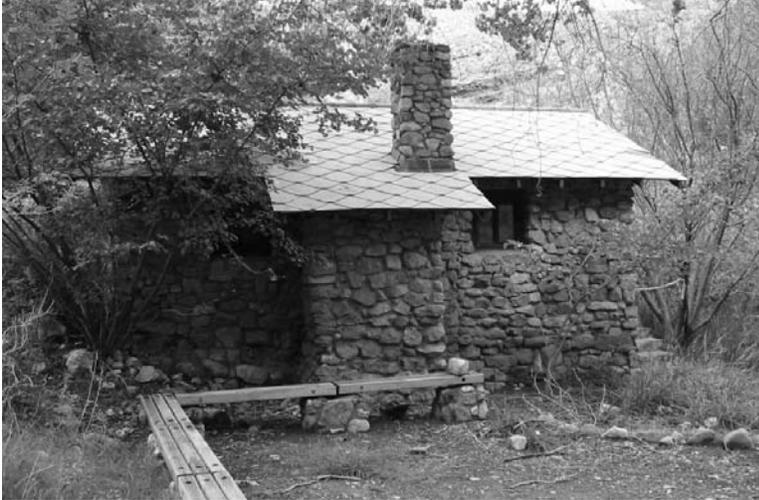
**Photograph 63.** Rock House (former Pump Caretaker's Residence), 1943, with seating bench area in foreground. (History Matters 2002)

In 1943, the Fred Harvey Company constructed the **Pump Caretaker's Residence** (Bldg. #0018), also known as the Rock House, at Indian Garden as part of their development of Garden Creek as a water source for their tourist facilities on the South Rim (*Photograph 63*). The residence replaced a 1936 residence—a one-story, external frame structure set on a raised stone foundation which burned in 1942. The next year, the current residence was built in stone at the same location. The 1943 masonry building reused portions of the original foundation and steps. The one-story, front gable residence displays a rectangular plan with a small projecting bay on its east elevation. The front gable roof features wide, overhanging eaves, exposed rafters, and

diamond-shaped, asbestos-shingle cladding. The building's entrance occupies the north gable end and consists of a single-leaf, paneled, wood door with an outer screened door. The windows have been replaced with paired, one-light metal casement windows.

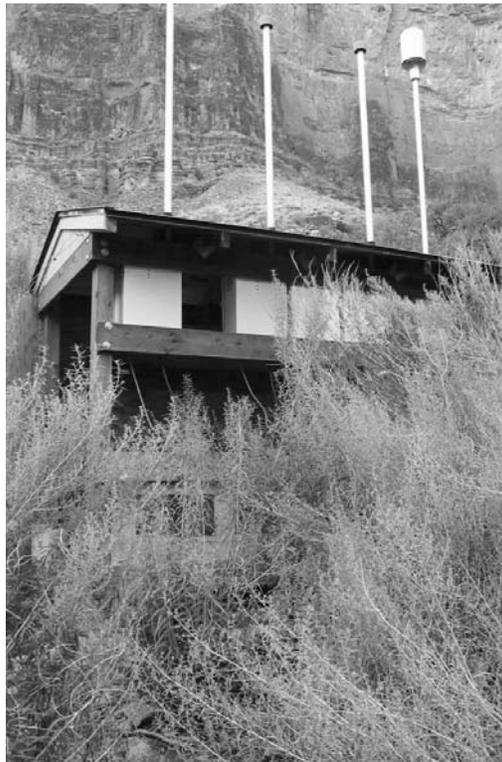
**Photograph 64.** Air Quality Monitoring Station. (History Matters 2002)

A frame shed structure, located approximately fifty feet southwest of the Rock House, contains an NPS **Air Quality Monitoring Station** (*Photograph 64*). It is a simple, post-and-beam wood frame structure covered by an asphalt-shingled, gable roof. The southern elevation of the structure is enclosed with plywood, while the northern elevation is open. Equipment boxes line the interior and four antennae extend above the roof. A hinged plywood door covers the east gable end of the structure. The construction date for the weather station is not known. However, 1988 plans indicate that the station was formerly located directly behind the Pump Caretaker's Residence. The structure was relocated and rebuilt around 1995.

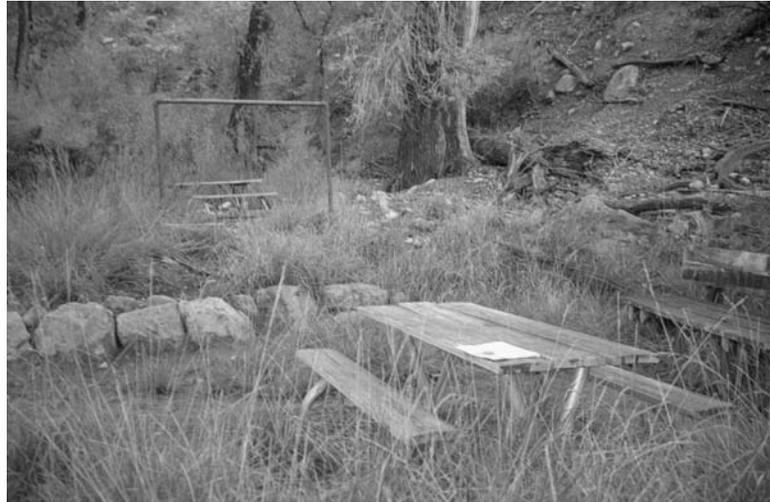
**Photograph 72.** Benches and drinking fountain on edge of picnic area, just north of Caretaker's Residence/SAR Cache. Contemporary bench is shown front left and rustic bench is shown rear left. (JMA 2002)

Many wooden benches are scattered throughout the Day Use Area (*Photograph 72*). Just below the SAR Cache/Caretaker's Residence and Pump Caretaker's Residence/Rock House are two wooden benches of varying construction. The contemporary-styled "**contemporary**" bench consists of long, square wood posts whose seat back and seat are joined by two thick metal brackets. The "**rustic**" bench, possibly of earlier construction date, is constructed of two flat, wood planks forming the seat back and seat and attached to round wood post frame. **Continuous bench seating** is located on the terrace (*Photograph 73*). It consists of one continuous bench running the length of the terrace between the SAR Cache/Caretaker's Residence and Pump Caretaker's Residence/Rock House. The wood bench is supported by at least eight short, square, stone pillars at a height of approximately eighteen inches.

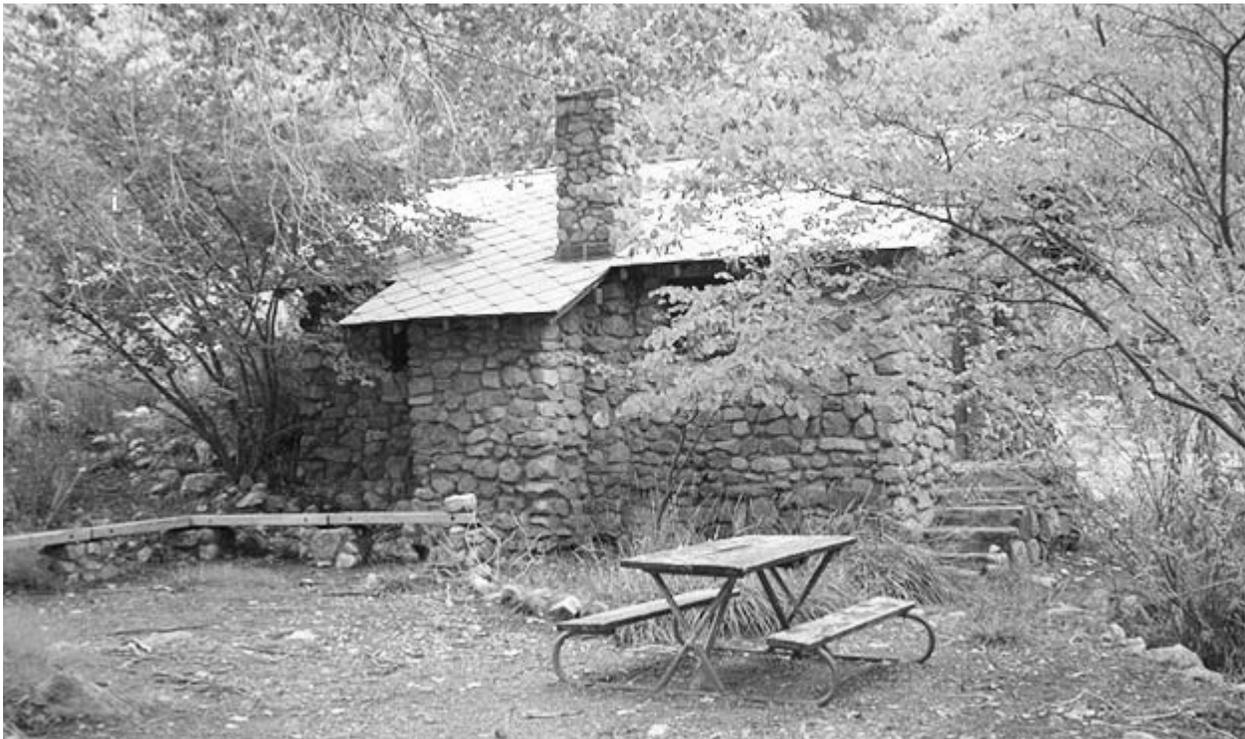
**Figure 57a.** Rock House/Pump Caretaker's Residence, note increase in vegetation and more-defined terrace space with site furnishings. (JMA 2002)
