# Indian Garden • Grand Canyon National Park

## Cultural Landscape Report

Contract No. 1443-C2000020300  
June 2005

**John Milner Associates, Inc.**  
103 West Main Street  
Charlottesville, Virginia 22902

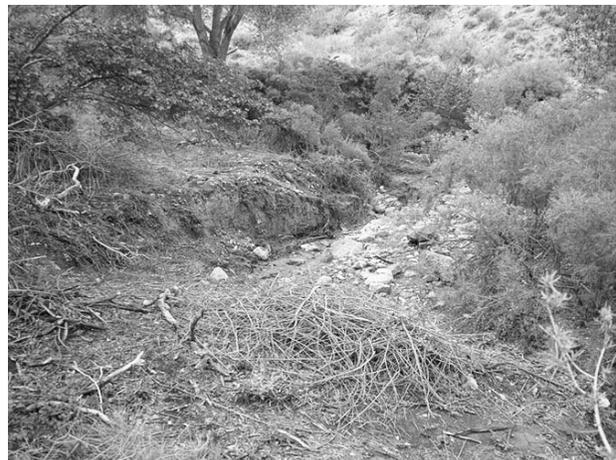
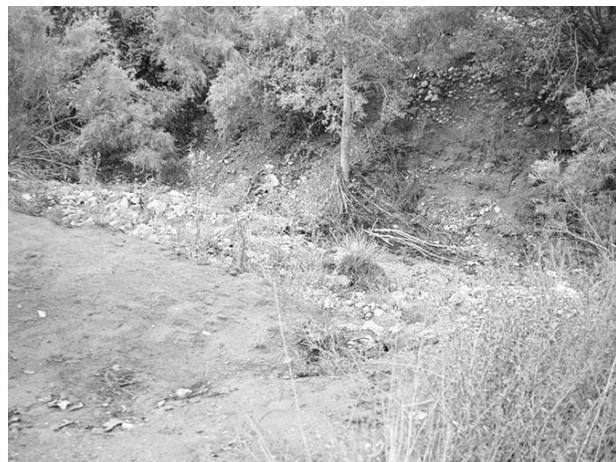
**Figure 58.** Examples of eroded banks and flood debris in Garden Creek.

Indian Garden is supplemented by surges of excess water from the trans-canyon pipeline. The surges contain a different quality of water than the springs, although the plan does not explain the variation. Although water quality issues fall outside the scope of this CLR, the impacts of the surge releases on the cultural landscape—including increased vegetation growth or possible increases in flood intensity—resulting in greater damage to the landscape—should be studied.

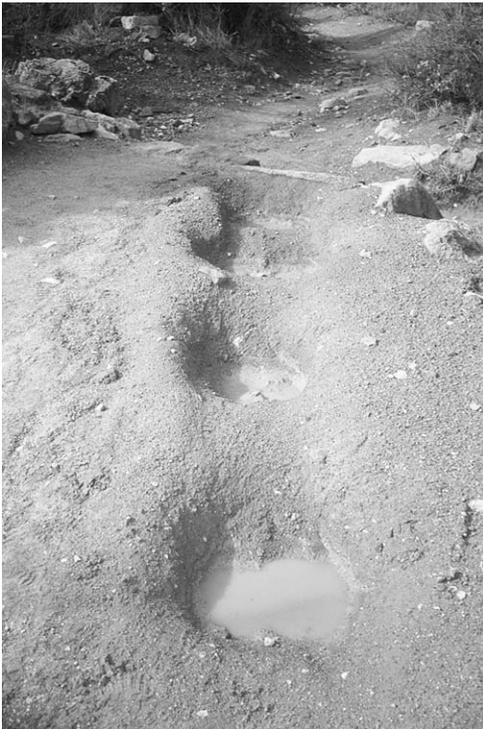
**Figure 59.** Fill holes in trails during maintenance.

- Include such tasks as filling holes, resurfacing the trail tread, repairing waterbars and risers, and pruning vegetation along trails throughout Indian Garden.

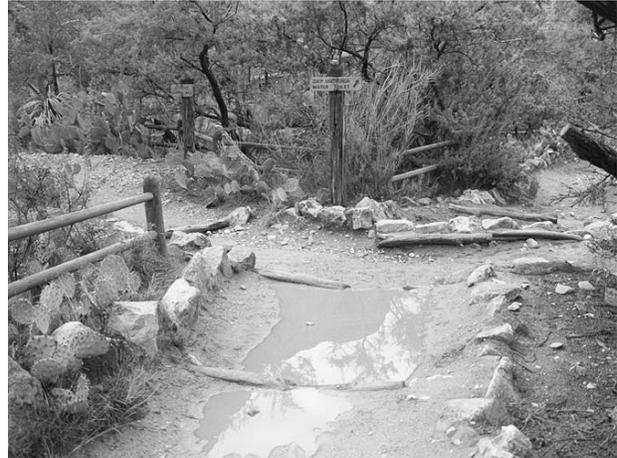
**Figure 60.** Portions of trails that puddle during wet weather should have low spots filled during trail maintenance. Assess the causes of puddling to prevent recurrence.

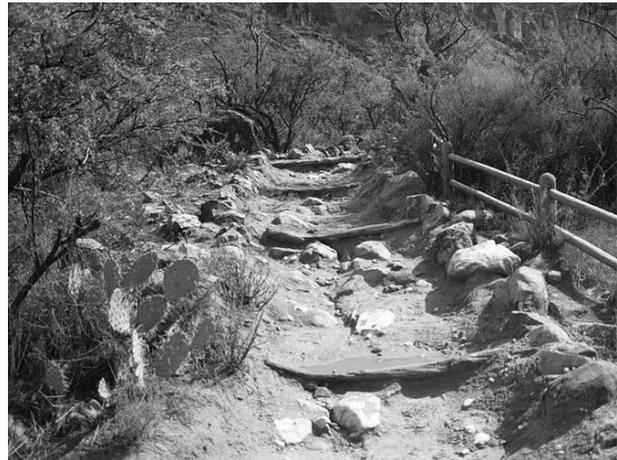
**Figure 61.** Eroded places around log risers should be backfilled and the trail tread resurfaced during trail maintenance. Repairs should be made so that water is diverted away from the trail tread, rather than trapped.

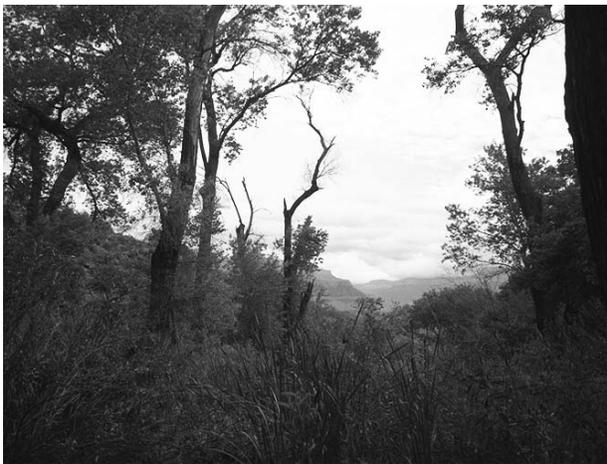
**Figure 62.** Remove vegetation that is dead, dying, or hazardous to people or resources.

- Remove any vegetation that poses a hazard to people or surrounding cultural or natural resources.

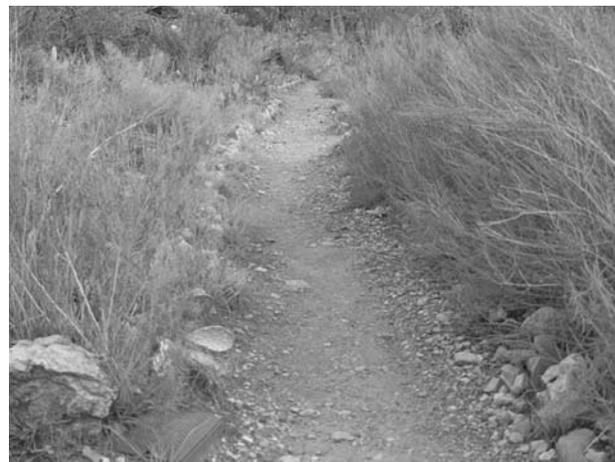
**Figure 63.** Remove vegetation that grows over and between stone edging.

- Replace stone edging with stones of a similar shape, color, and size as those existing to present a uniform appearance. If stone edging is replaced throughout a particular character area, it is acceptable to introduce new, compatible stone edging styles.

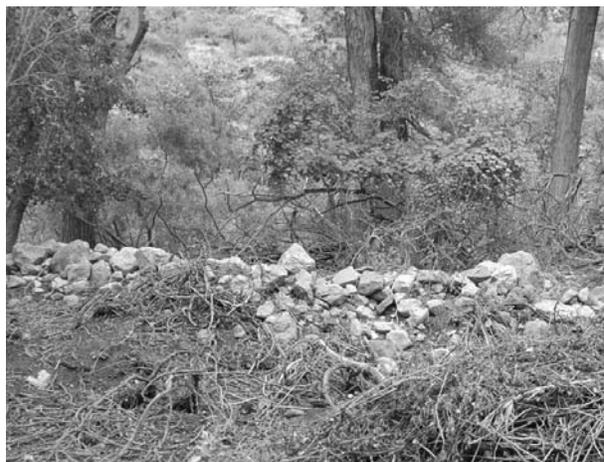
**Figure 64.** Undertake archeological surveys for sites that may contain information-yielding resources such as this site in the North Indian Garden Area.

- Protect and preserve archeological resources in place. If such resources must be disturbed, undertake mitigation measures such as documentation, recovery, and curation.
- Enlist a qualified archeologist to survey areas that may contain archeological features, such as the North Indian Garden Area.
- Retain and maintain all archeological features that have already been documented, including the Trail Maintainer's Tent Platform, the Cooler, and the dry-laid masonry room that may be associated with Ralph Cameron.

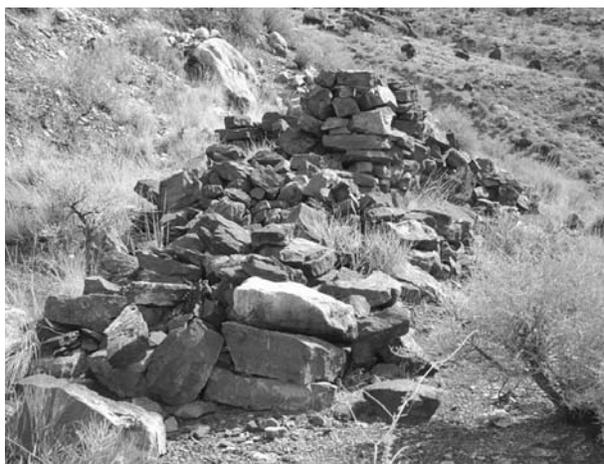
**Figure 65.** Retain and maintain all archeological features in and around Indian Garden.

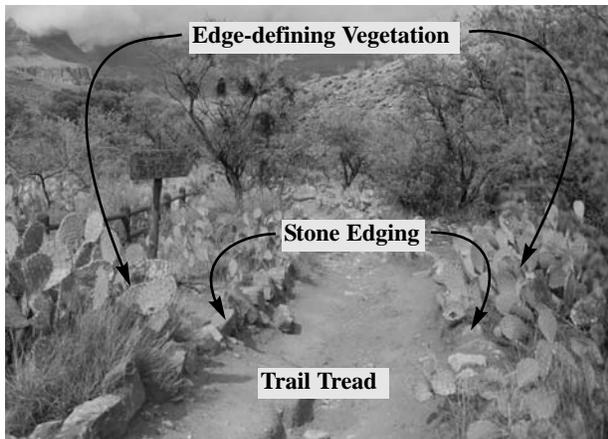
**Southern Bright Angel Trail, typical condition**

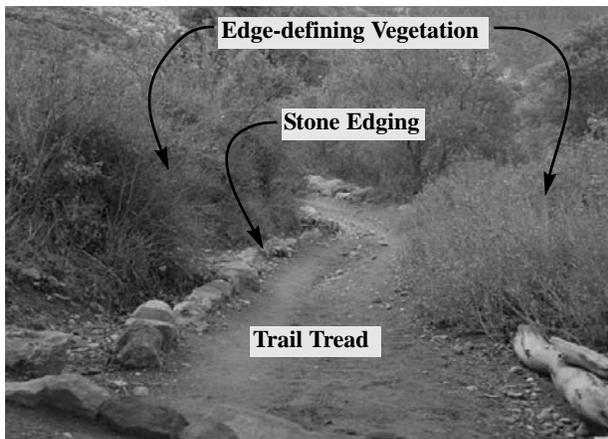
**Northern Bright Angel Trail, typical condition**

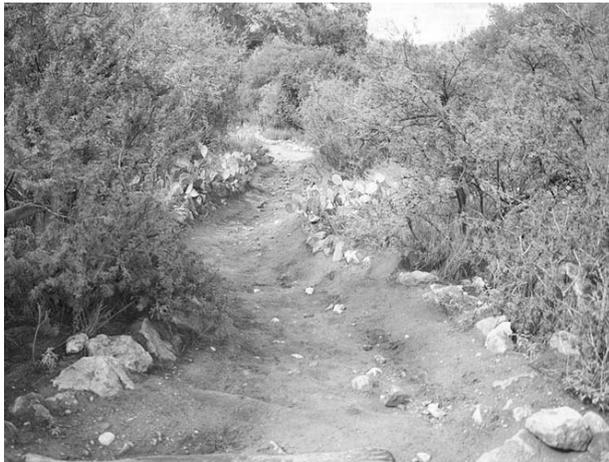
**Original, typical condition of Bright Angel Trail.**

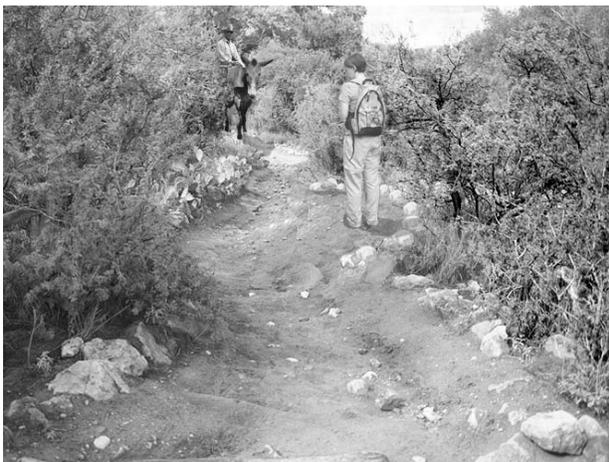
**Illustrative concept of bump-out along trail.**

° The bump-outs should be an informal widening of the trail tread, limited in size to hold two to four hikers, and demarcated by stone or log edging.

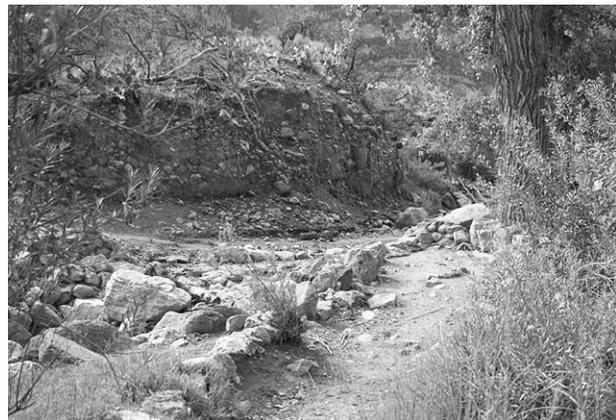
**Figure 68.** Assess the stability of the vertical slope on Bright Angel Trail.

- Enlist a qualified natural resource specialist and/or a civil engineer to assess the stability of the vertical slope at the junction of Bright Angel Trail and Garden Creek. The same personnel should prepare a stabilization and maintenance plan depending on their findings.

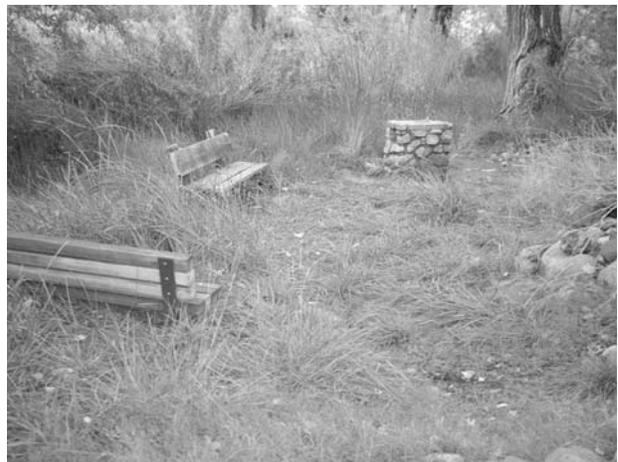
**Once overgrown, unusable seating area in Day Use Area.**

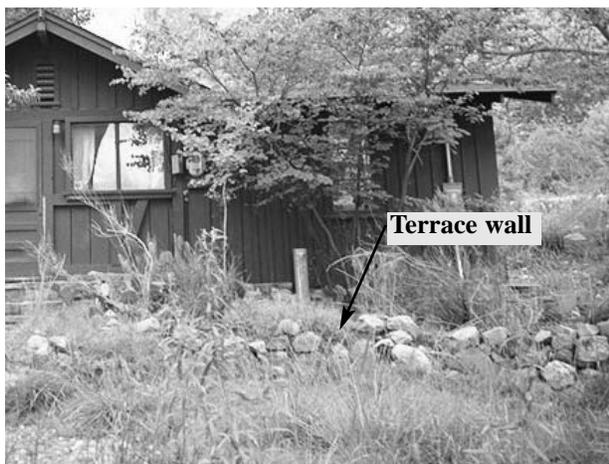
**Figure 71.** Repair the Caretaker's Residence/SAR Cache terrace by stabilizing the wall and removing unwanted vegetation growing through and over the stones. (History Matters 2002)

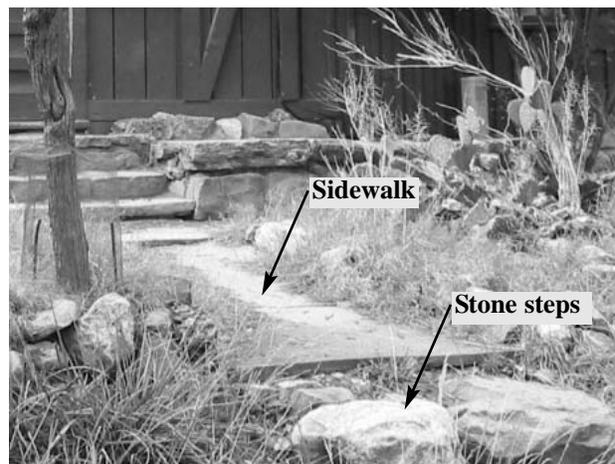
**Figure 72.** Repair and maintain the concrete sidewalk and stone steps found at the Caretaker's Residence/SAR Cache. (History Matters 2002)

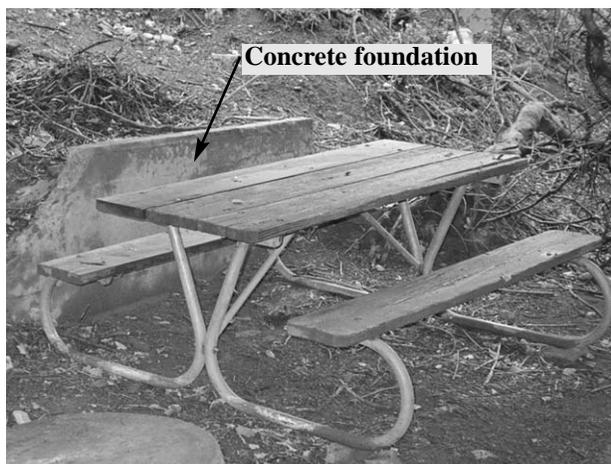
**Figure 73.** Determine the original purpose of the foundation and remove it if it is not historic, serves no purpose, and will not be re-used.

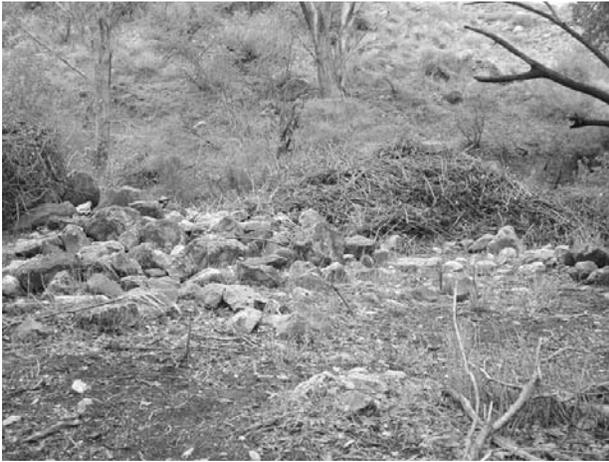
**Figure 74.** Survey potential archeological sites, such as the rock pile on the left. Continue Himalaya Blackberry eradication efforts and remove slash piles, such as the pile on the right, as soon as possible.

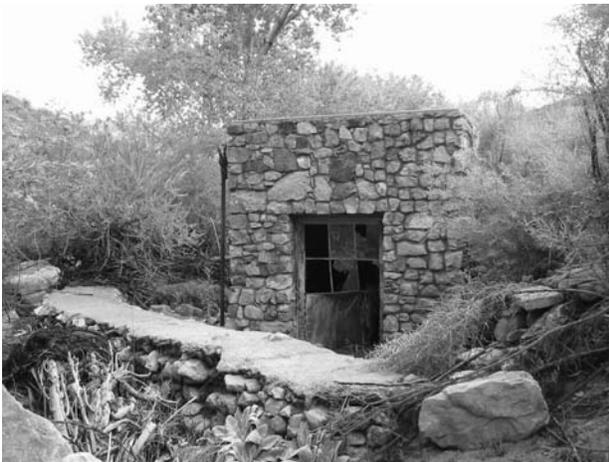
**Figure 75.** Retain and maintain the Rehandling Pump House and associated flood walls. (History Matters 2002)
