CULTURAL LANDSCAPE REPORT: Dumbarton Oaks Park, Rock Creek Park

Part I: Site History, Existing Conditions, and
Analysis and Evaluation

August 2000

U.S. Department of Interior
National Park Service
National Capital Region
Cultural Landscape Program
Washington, D.C.

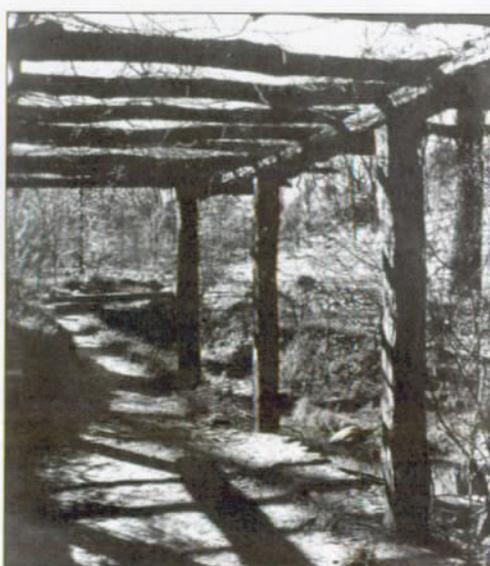
Figure 17a & b Farrand's design progression is evident in the treatment two arbors: Arbor Terrace in the upper gardens, (March 1998. NCR, Photo Archive, DOP 37-7) and the Stream Arbor in the naturalistic garden, 1932 (DOSLA, Photo Archive, #13.2).

Wooden arbors are treated in a similar fashion. Farrand adapted the arched arbor at the western end of the Arbor Terrace from a plate in a book by the 18th-century French architect Du Cerceaux. Wisteria grows in profusion over its vaulted roof. The Stream Arbor in the naturalistic garden was a rustic structure built of hewn timbers, most likely covered with wild grape (*Vitis* sp.) and wisteria (see *Chapter 4 - Analysis and Evaluation: Landscape Characteristics, Structures*).

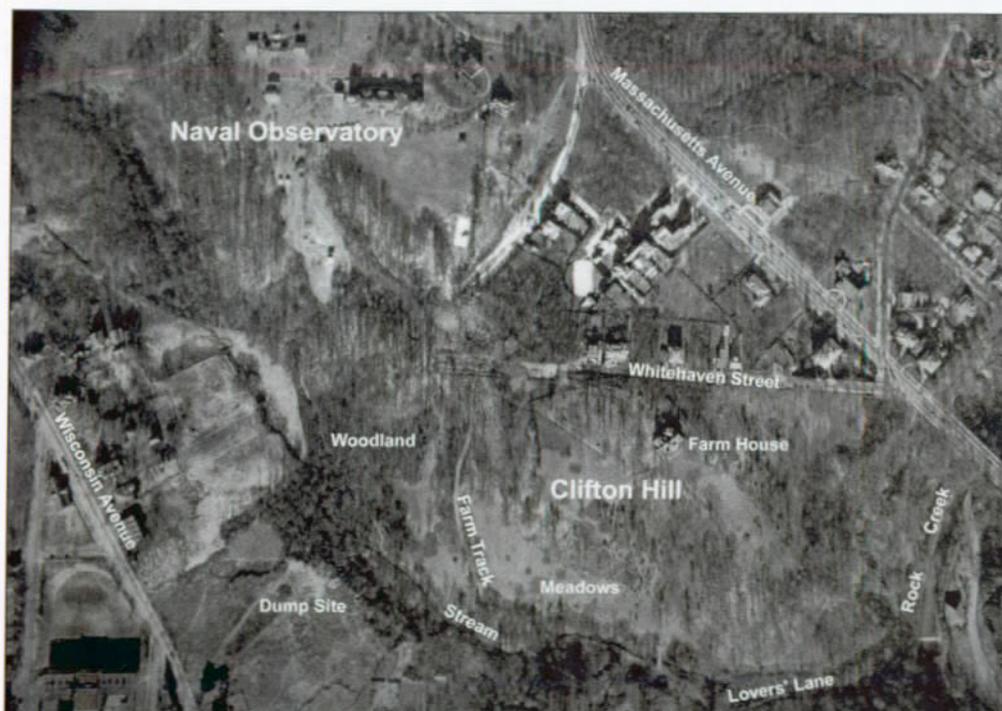
Figure 19 Aerial view of valley garden showing early development of the park-- layout of farm track, open meadows and woodland areas, 1930-1945. NCR, Photo Archive, DOP 54-1.

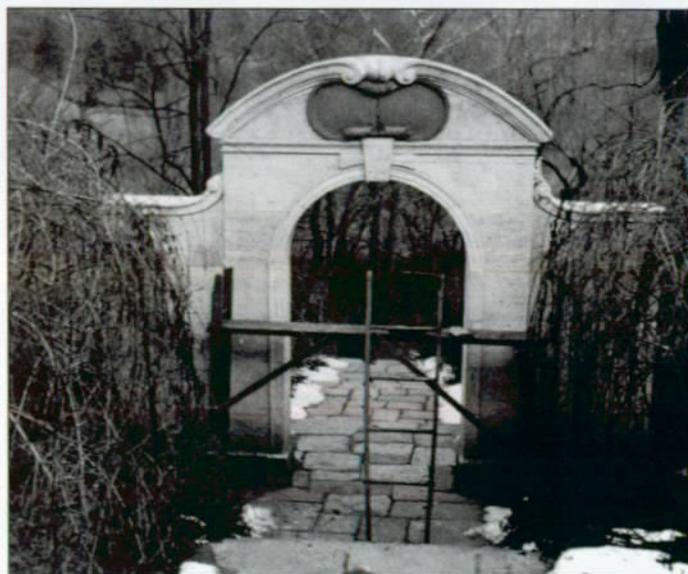
Figure 21 Construction of Forsythia Arch, ca. 1938. DOSLA, Photo Archive, #17.13.

The paved path, which wound down Forsythia Hill through the dense plantation of forsythia, led to a formal entryway dating from the late 1930s. An iron gate, known as the Forsythia Gate, was set within a masonry archway, the Forsythia Arch, constructed of limestone veneer over rubble brick. The arch had a scrolled, broken segmental pediment, ornamented with carved foliage; its tympanum (the wall surface within the pediment) was inscribed with "Dumbarton Oaks Park" on its south face and "Dumbarton Oaks" on the north. In late 1938 Mildred Bliss wrote to Farrand: "...the arch-way as the entrance to the park from Dumbarton Oaks and vice versa should carry some weight, both actual and metaphorical."⁷⁹ The design of the arch and its relation to the adjoining fence caused some concern, with Mildred Bliss telling Farrand to "please push through the Forsythia Arch so its wings minimize the unfortunate fence"⁸⁰ Though whether a wooden stockade fence was still present at this time is unknown.⁸¹ The path passed through the arch and descended in a series of limestone stairs, the Forsythia Steps, through the remainder of the forsythia plantation, terminating at the stream path, which wound along the foot of the slope.

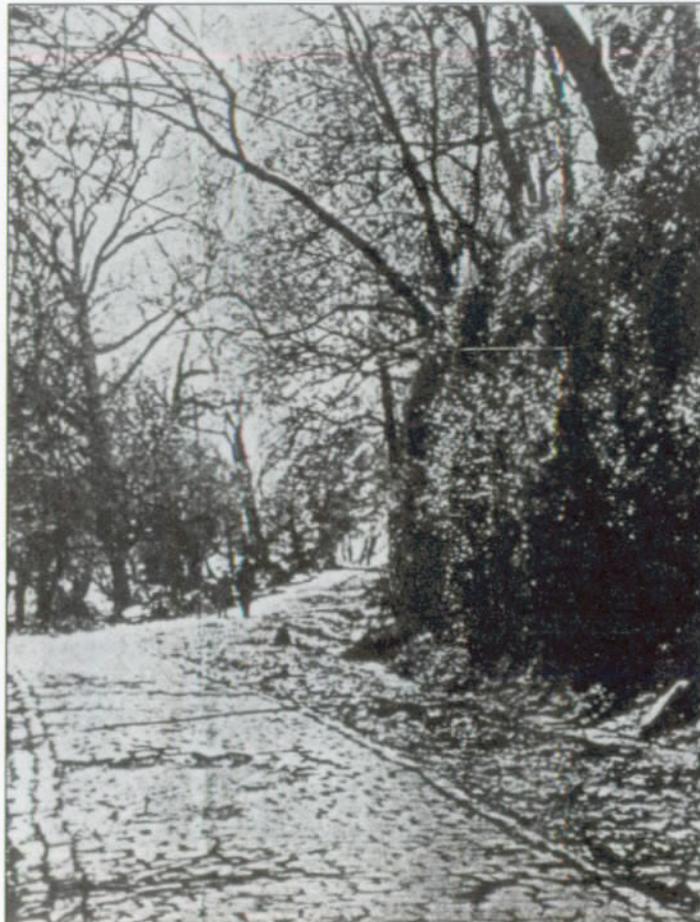
Figure 22 The cobbled road and decorative drainage channel of Lovers' Lane as it appeared on Dec. 29, 1940 in the Washington Star, Sunday edition.

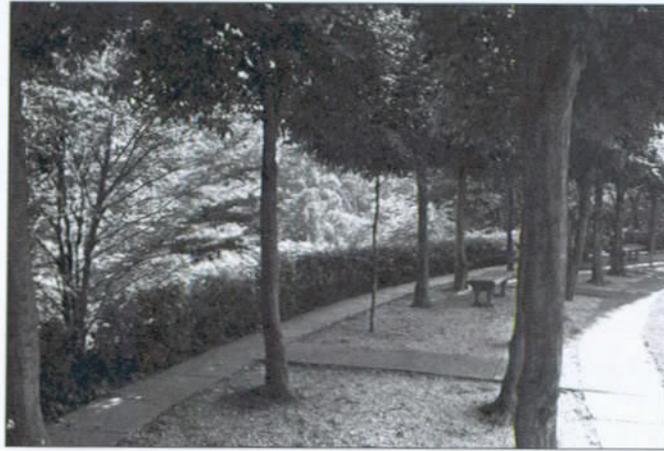
Figure 30 Aerial hornbeam hedge at the redesigned Ellipse, July 9, 1997. NCR, Photo Archive, DOP 3-24.

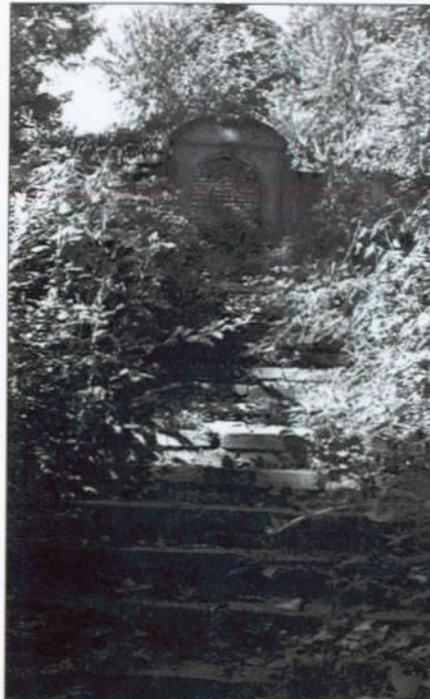
Figure 38 Forsythia Steps and sealed archway, July 11, 1997. NCR, Photo Archive, DOP 6-14.

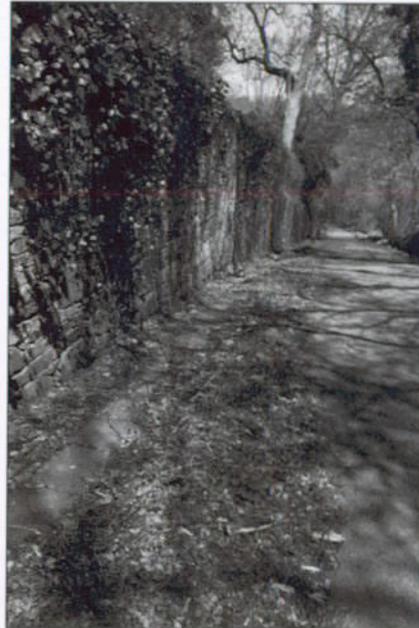
Figure 82 Dumbarton Oaks Garden retaining wall and gutter along Lovers' Lane, April 1, 1997. NCR Photo Archive, DOP 1-2.

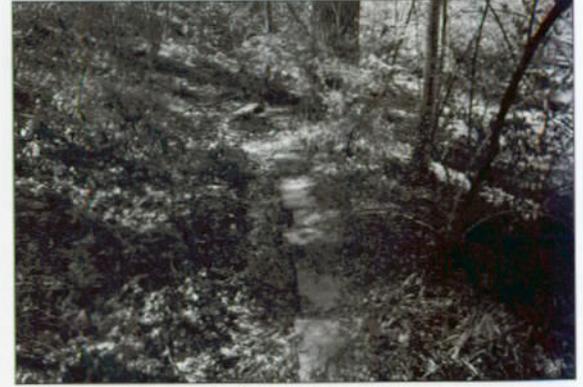
Figure 87 Remnant flagstones from the Hazel Walk covered with leaf litter, April 1, 1997. NCR, Photo Archive, DOP 1-35.

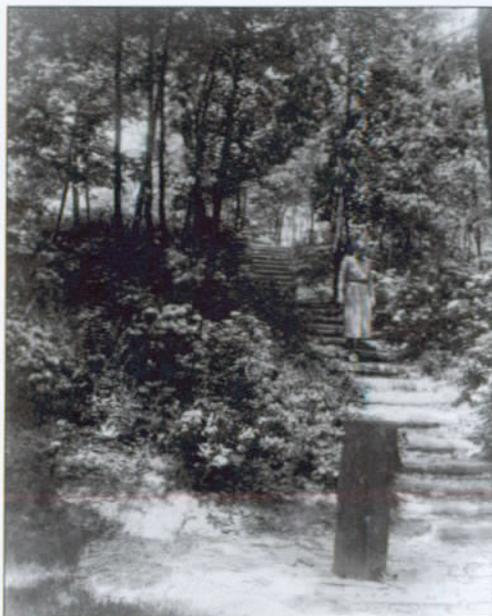
Figure 97 Character of railroad tie and stone steps going through the uppermost portion of the designed woodland, 1961. ROCR, Photo Archive, #6516-B.

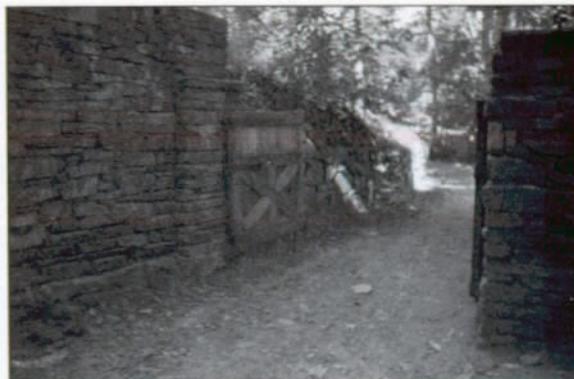
The gates consist of two heavy wood panels, with cross-members on their lower halves and three large steel strapwork hinges each. The north gate has a pull ring, probably wrought iron, with a star-shaped escutcheon on the front. The south gate has a long gate pin on the inside face. A round stone with a

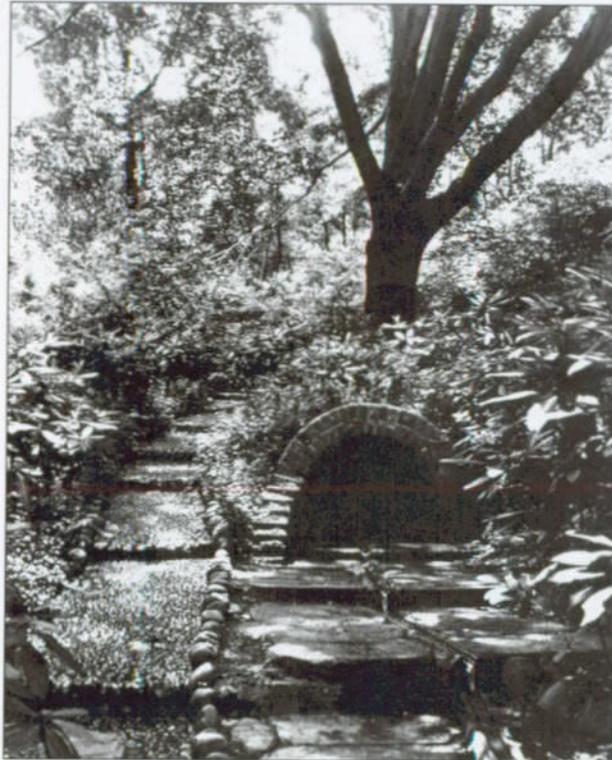
Figure 168 Spring Grotto and pebble stream with water flowing over the pebbles and through the cedar rills, c. 1935. DOSLA, #13.21.

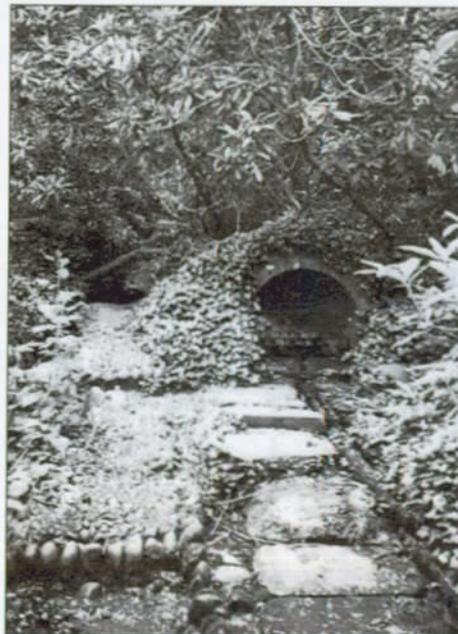
Figure 169 Condition of spring grotto and pebble stream as they appeared on June 9, 1997. NCR, Photo Archive, DOP 9-17.

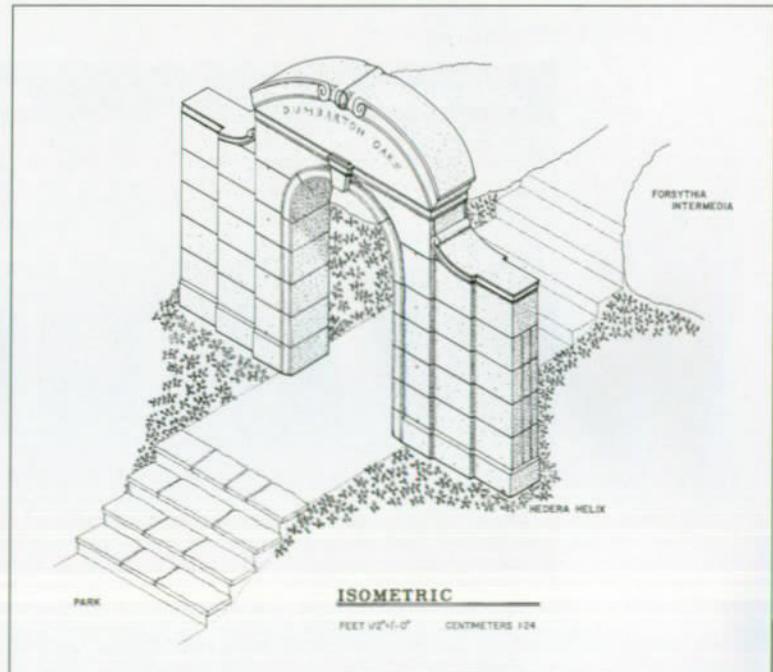
Figure 172 Detail drawing of Forsythia Arch. HABS, Summer 1989. NCR, Plans and Drawings Collection, #863/80015 (Sheet 19 of 28).

The arch remains in relatively good condition, though the gate was removed in the late 1960s or early 1970s because vandals found it easy to scale and thus enter Dumbarton Oaks Gardens from the park when the gardens were closed (see endnote 176, *Chapter 2 - Site History: 1951-1997: The Garden as a Public Park*). The opening was filled with rubble stone crudely laid in rough mortar; the stones were probably sections of sandstone paving removed from the landing in the upper gardens, which was adjacent to the gate. The gate is currently stored in the Dumbarton Oaks Gardens maintenance area.

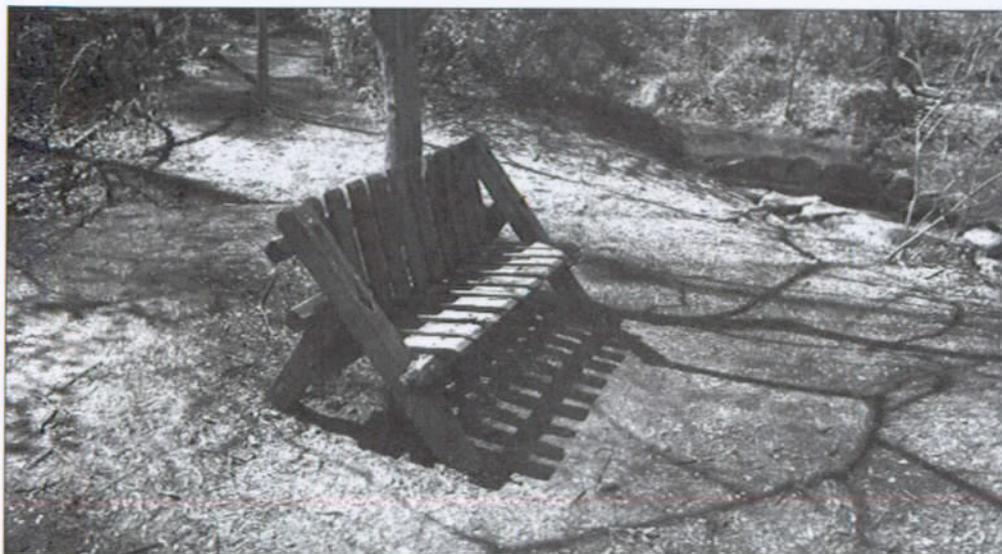
Figure 185 Existing Washington Bench located by the Laurel Pool, April 1, 1997. NCR, Photo Archive, DOP 1-33.

Bench situated beside the Laurel Pool is the only other wooden bench currently located in DOP. The remnants of an NPS bench which has rotted and decayed into a pile of scrap wood lie near the Old Pump House. All the original teak benches have either been removed or have rotted.
