National Park Service  
Cultural Landscapes Inventory  
2009

Washington Monument Grounds  
Washington Monument

## **Inventory Unit Summary & Site Plan**

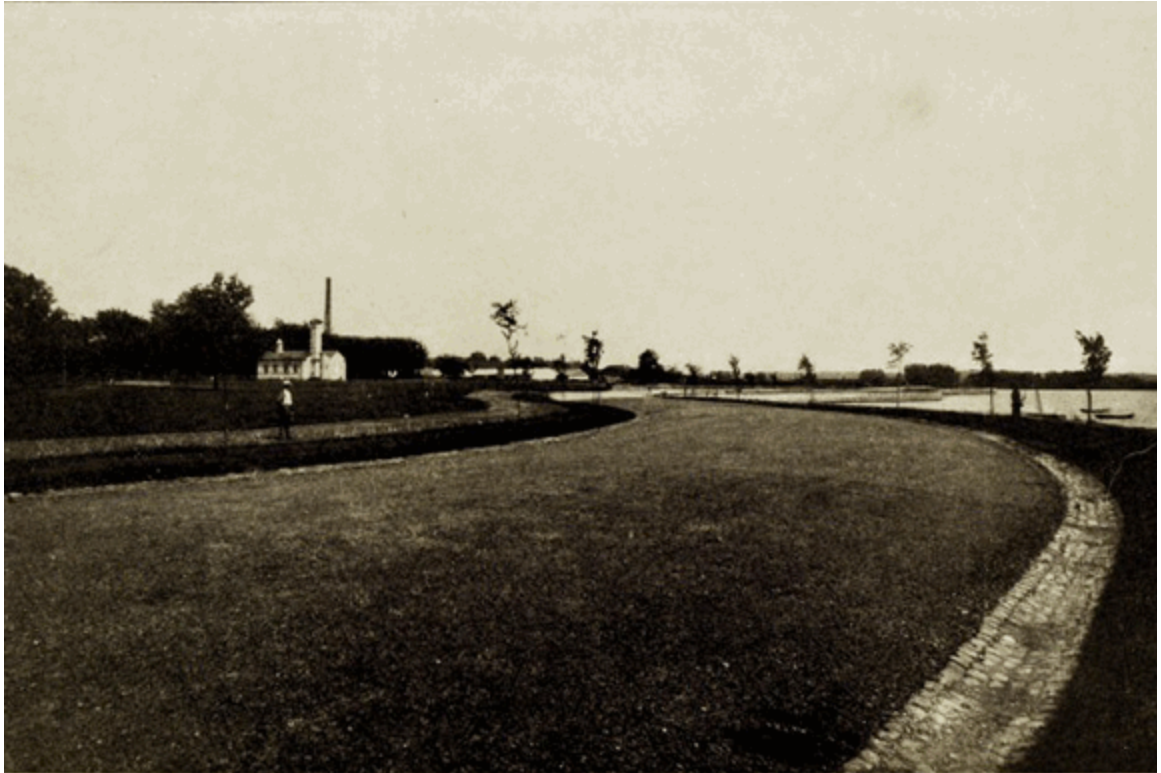
*Photograph of the Survey Lodge and the newly created River Road that connected 17th Street to 15th Street (Report of the Chief of Engineers, 1903).*

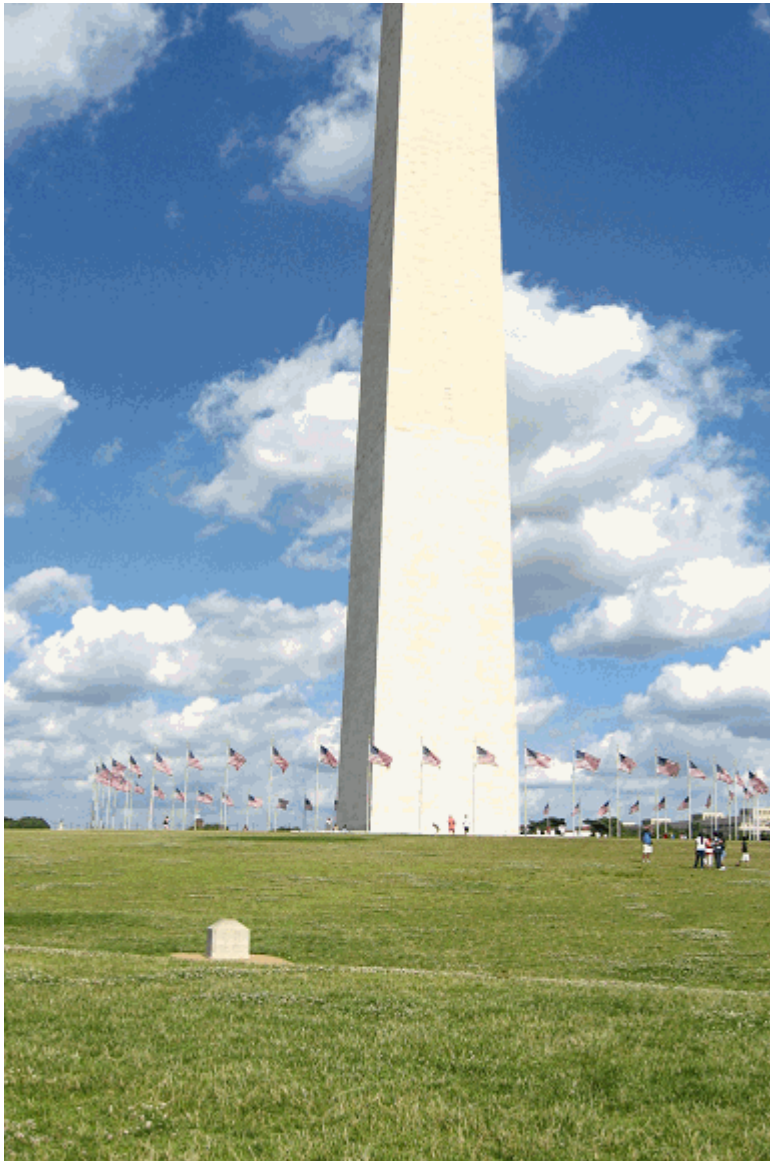
*Washington Monument and Jefferson Pier (NCR CLP 2009).*

“The location of the intersection of the two axes or meridian—one extending south from the White House, and the other west from the Capitol—was first demarcated in 1793 with a wooden post. The stone Jefferson Pier replaced the wooden posts in 1804. The present marker is a replacement for the original, which was unintentionally destroyed in 1872 (CLR 2003:4-20).” In 1889, the stone was re-erected as it stands today. The pier is a two-foot by two-foot block of granite, 3 feet, 3 inches tall. Its western face was inscribed: “Position of Jefferson / Pier Erected Dec 18, 1804. / Recovered and Re-erected / Dec 2, 1889 / District of Columbia.” It is located 371.6 feet west and 123.17 feet north of the Washington Monument.

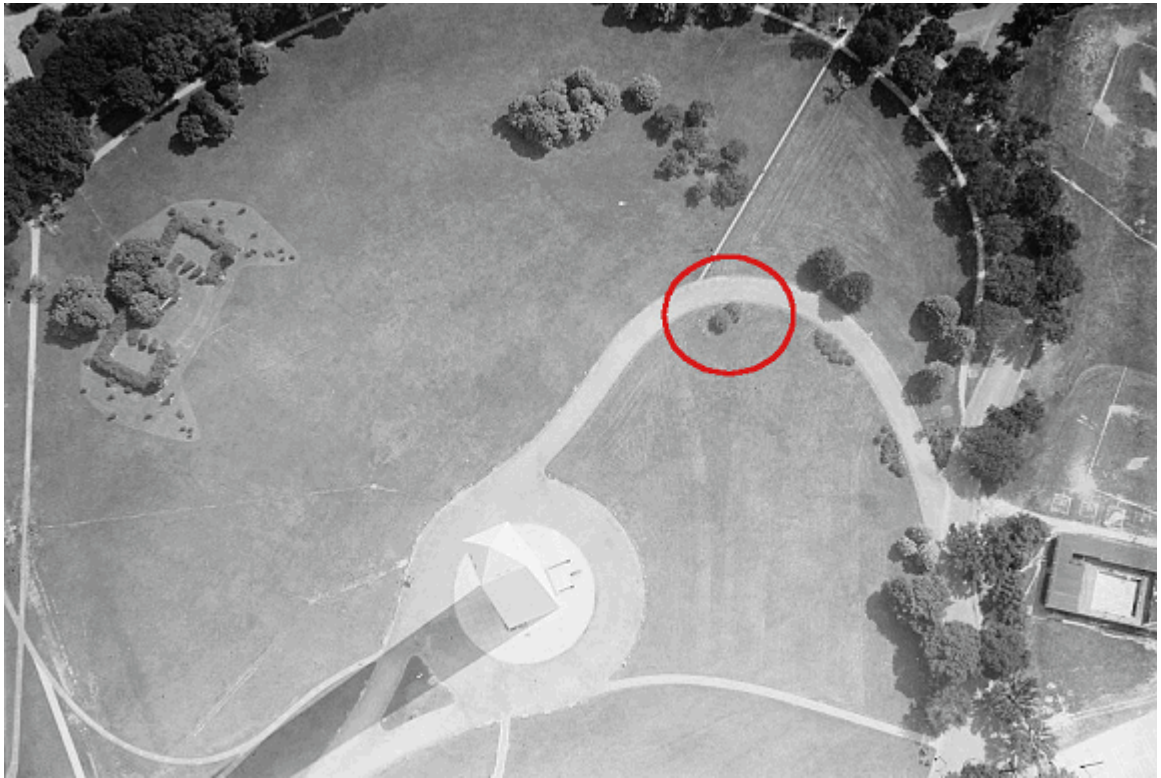
*1919 Photograph of north monument grounds, showing Sylvan Theatre plantings and tree-lined roads. The trees southwest of the monument are in a location similar to the mulberry trees extant on the site (LC-H261- 30452).*

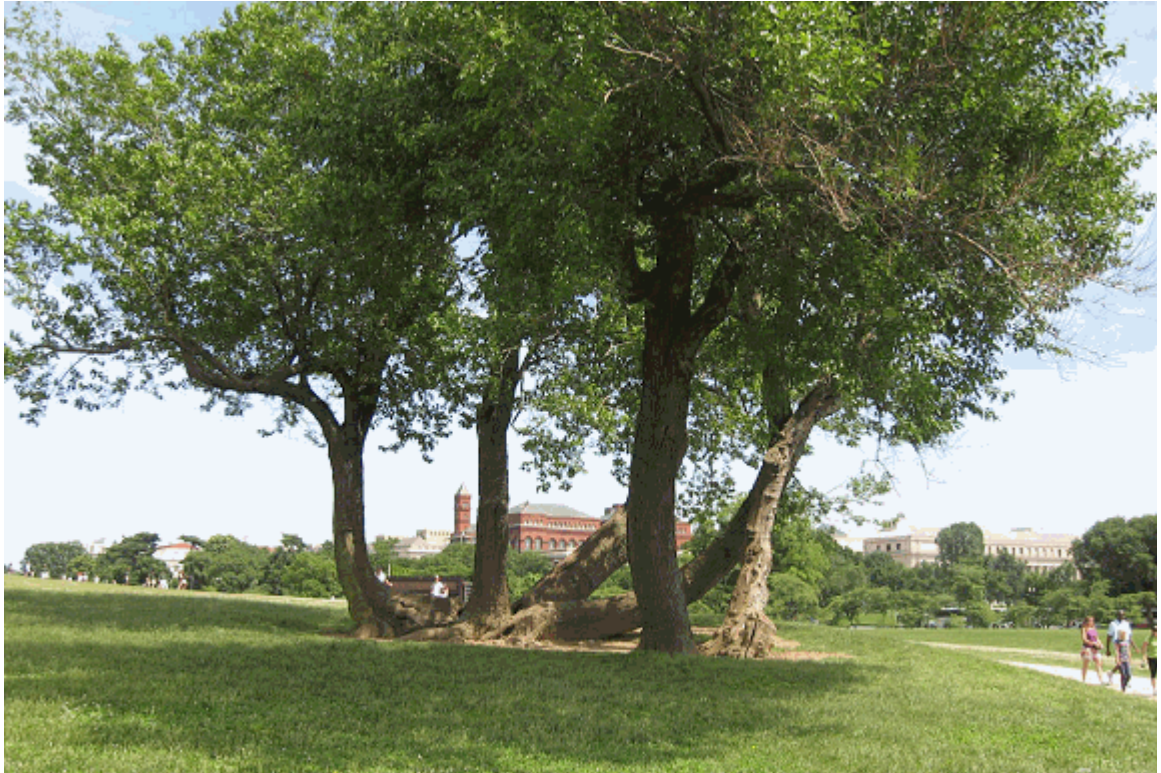
*Historic mulberry trees located southwest of the Washington Monument (NCR CLP 2009).*

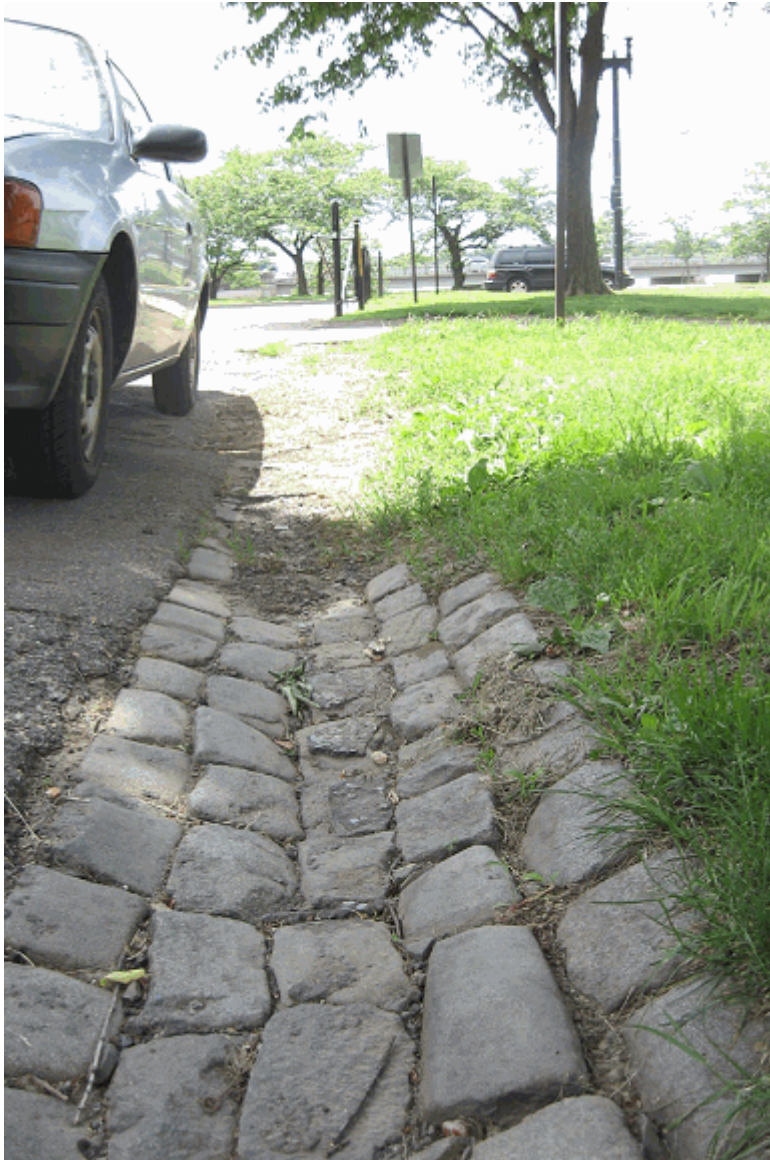
*Stone-lined drainage ditch along the Survey Lodge service drive (NCR CLP 2009).*
