Soil

Water

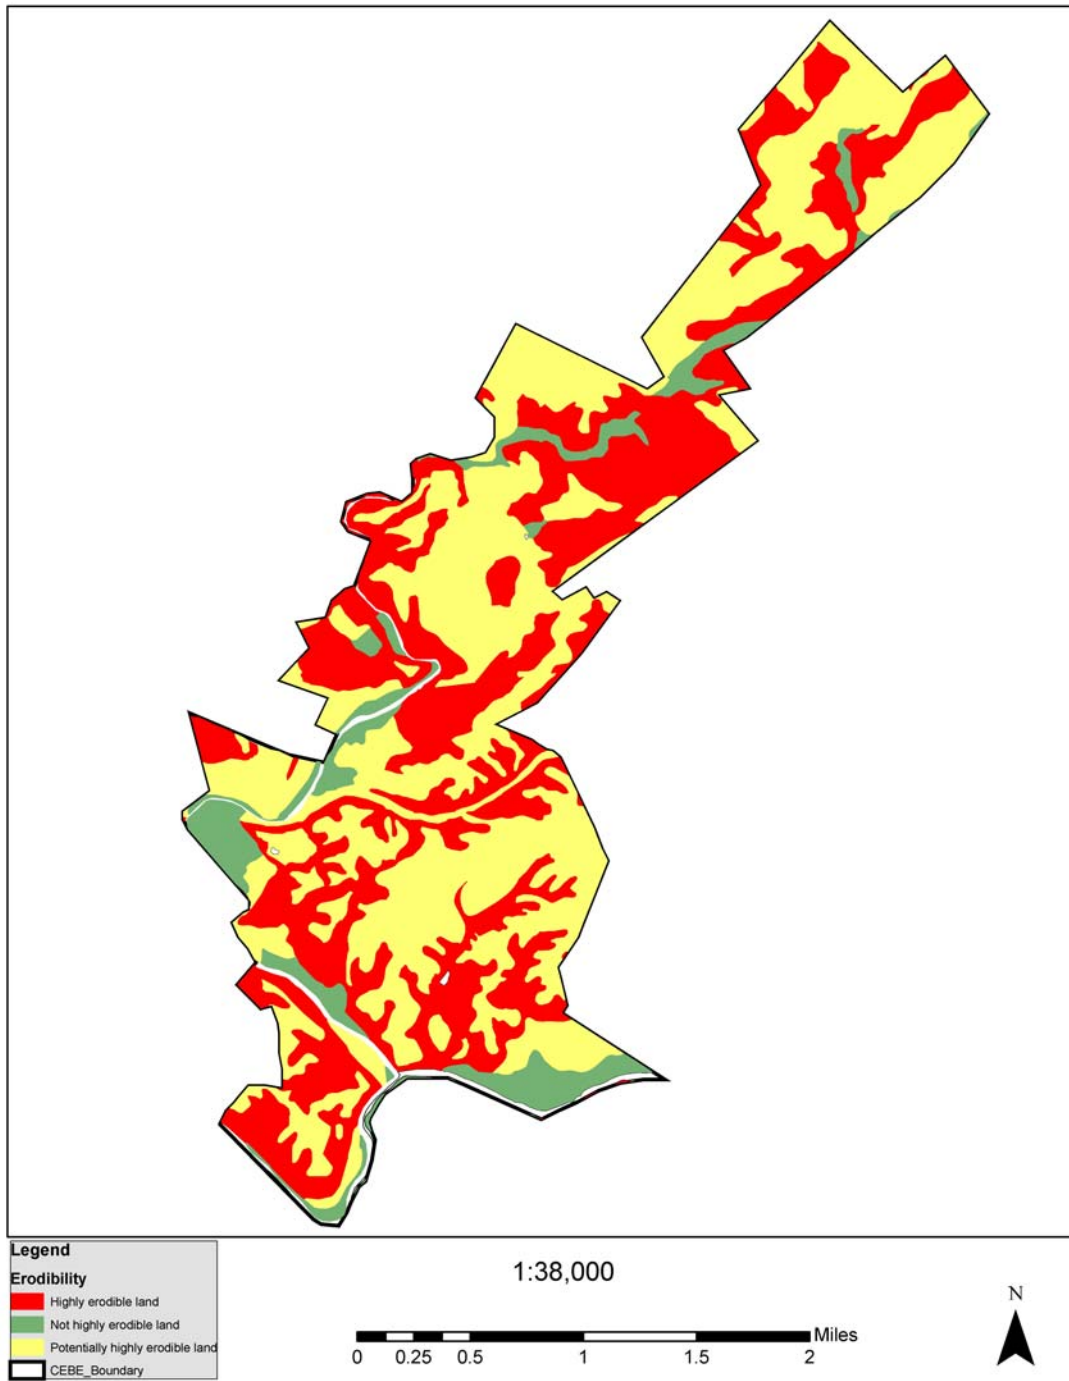
Figure 11. Erodibility of soils within the Cedar Creek and Belle Grove National Historical Park (CEBE). Data provided by NRCS 2004.

Highly erodible soils (Figure 11) as well as potentially highly erodible soils appear to be scattered throughout CEBE. Soils that are not highly erodible appear to be located along floodplains of streams and rivers where slopes are minimal (0%). Potentially highly erodible land appears to exist where slopes are between 2 and 15%, while highly erodible land exists mostly where slopes exceed 15%.

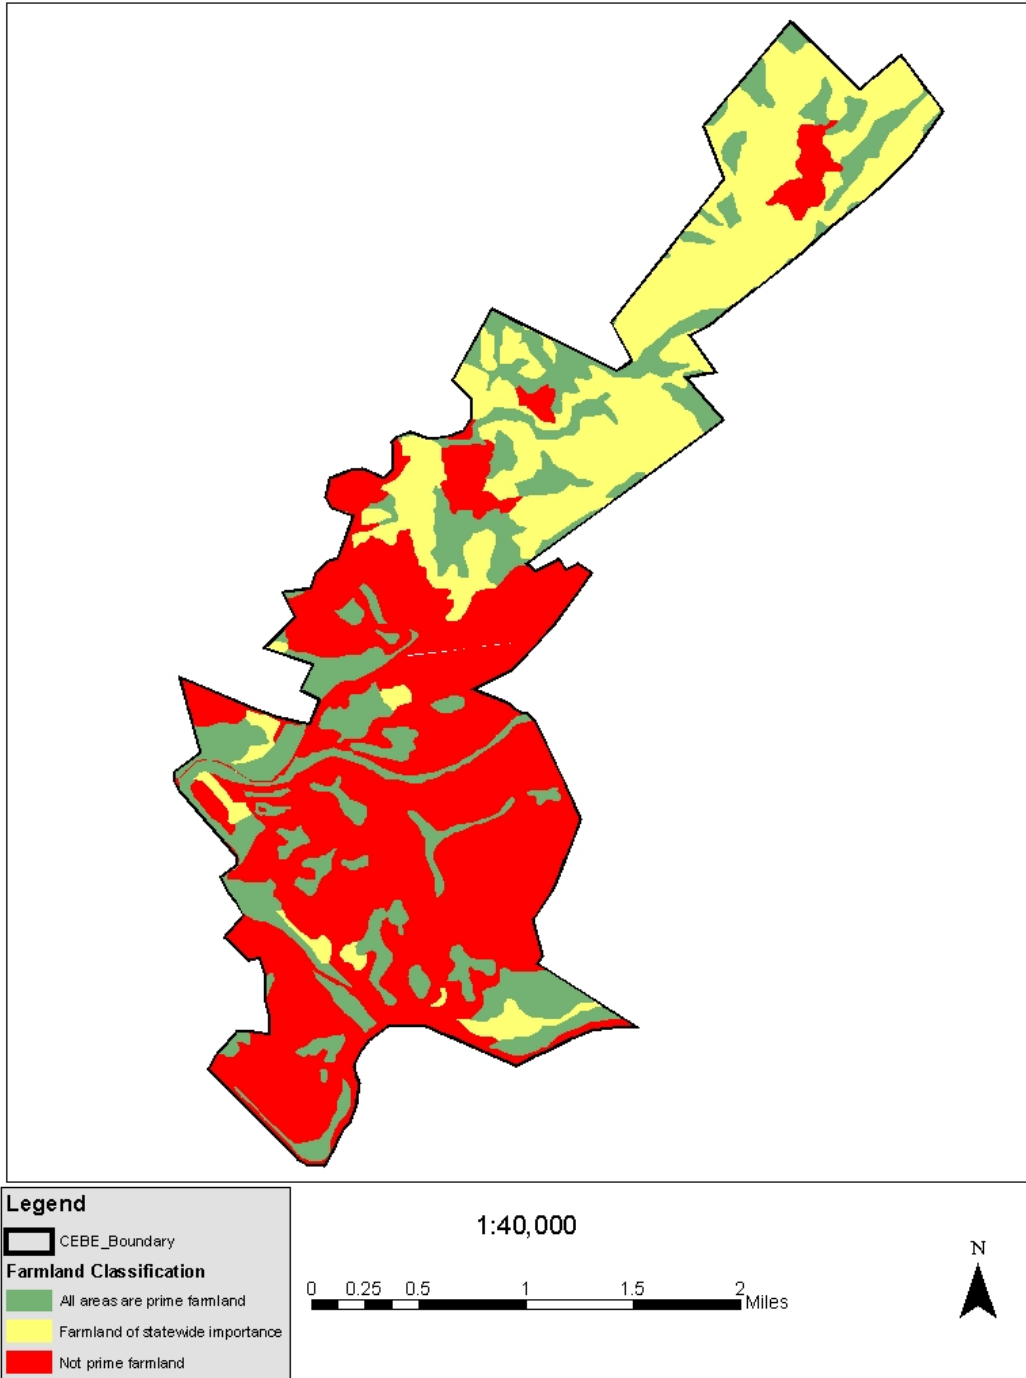
Figure 12. Prime Farmland classifications within the Cedar Creek and Belle Grove National Historical Park (CEBE). Data provided by NRCS 2004.

According to SSURGO data from the counties composing the park and 1997 aerial photographs, prime farmland (Figure 12) areas are located throughout the park primarily in floodplains. Prime farmland appears to make up approximately 15% of the park and is

scattered throughout CEBE. Farmland of statewide importance appears to make up approximately 40% of the park and is located mainly in the northern half. Non-prime farmland appears to make up approximately 45% of the park and is located in primarily the southern half. Prime farmland and farmland of statewide importance appears to exist over more alkaline soils created from Pinesburg Station Dolomite and the Rockdale Run Formation (undivided) and the Edinburg Formation, Lincolnshire Limestone, and New Market Limestone (undivided). Non-prime farmland appears to exist on soils created from the more acidic Martinsburg Formation in the southern section of the park. In addition, SSURGO data shows that soils on slopes greater than 15% are mostly in the southern section of the park. Prime farmland should not have steep slopes, which is why there is not an abundance of it in the southern section of the park.

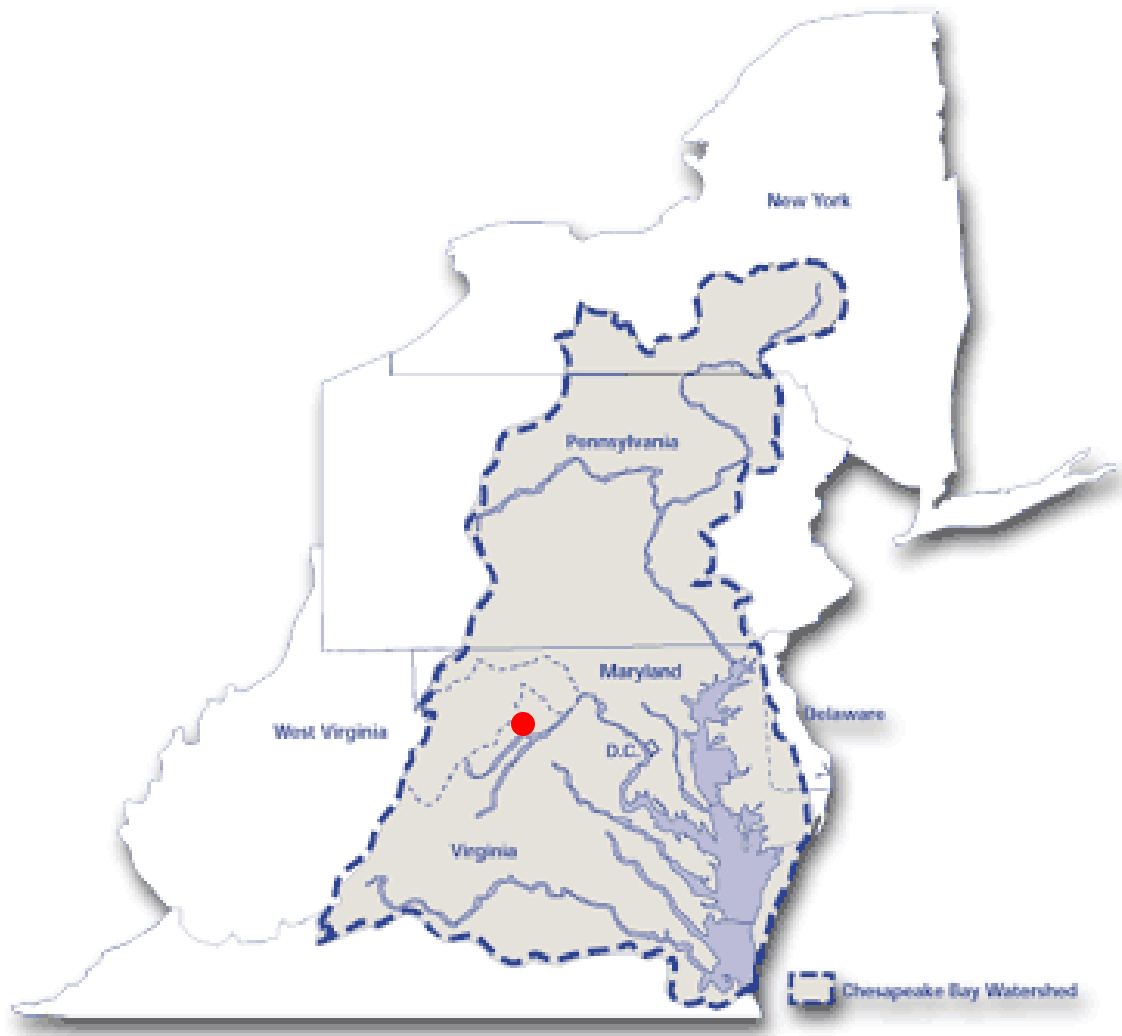
● = Location of the Cedar Creek and Belle Grove National Historical Park (CEBE).

Figure 15. The Chesapeake Bay Watershed. Provided by the Chesapeake Bay Program <http://www.chesapeakebay.net/maps.htm>.

CEBE is contained within the North Fork of the Shenandoah River Watershed with hydrologic unit code (HUC) 2070006 (Figure 14), which is part of the larger 64,000 square mile Chesapeake Bay Watershed (Figure 15). Cedar Creek flows into the North Fork of the Shenandoah River, which converges with the Potomac River on the Maryland and West Virginia border. The Potomac River is a tributary to the Chesapeake Bay. The Bay's largest problem is nutrient pollution from nitrogen and phosphorus. Other problems include toxic chemicals, air pollution, and sedimentation (Chesapeake Bay Program 2003). In 1988 the Chesapeake Bay Preservation Act was adopted by the Virginia General Assembly. The Act established a cooperative relationship between the Commonwealth of Virginia and local governments aimed at reducing and preventing

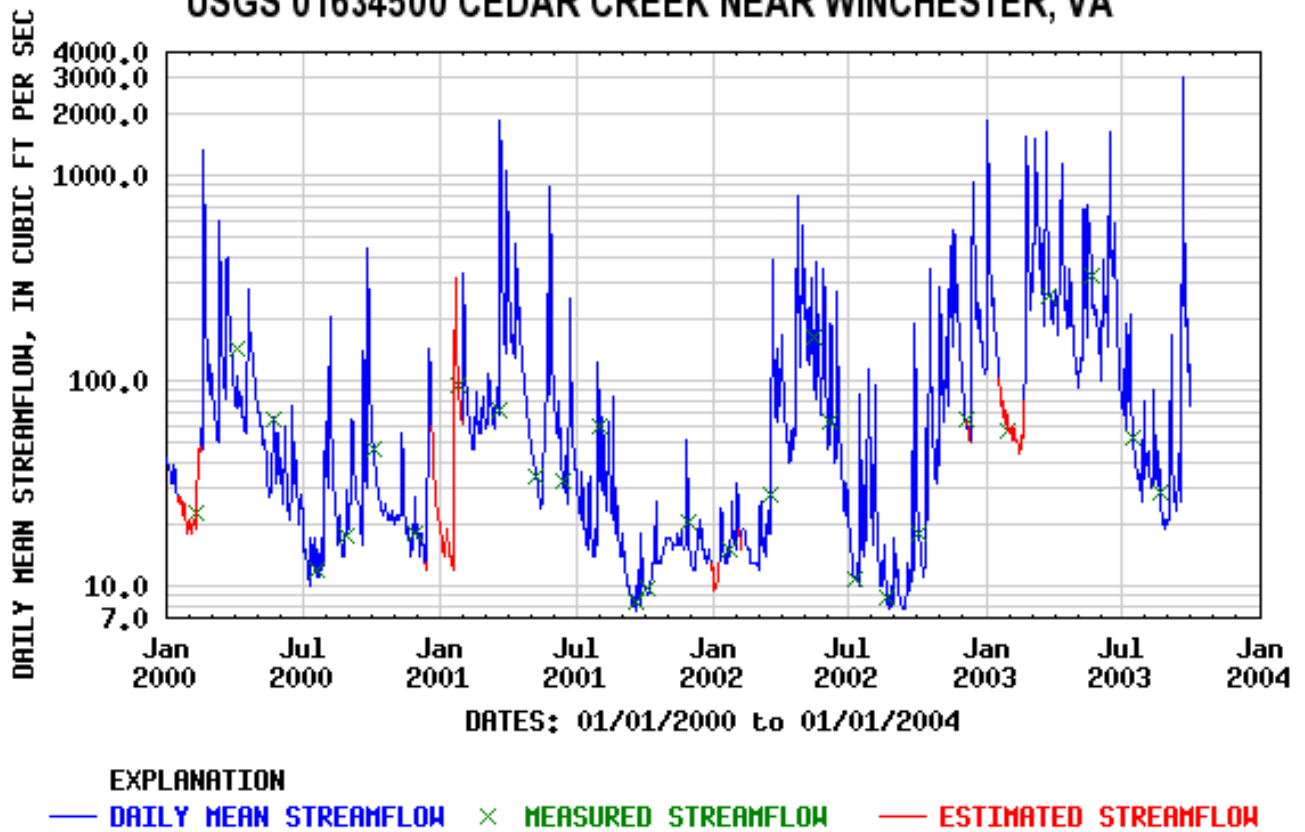
USGS 01634500 CEDAR CREEK NEAR WINCHESTER, VA

Figure 18. Daily mean streamflow between January 1, 2000 and January 1, 2004 for Cedar Creek at the USGS gaging station near Winchester, Virginia. Provided by USGS <http://va.water.usgs.gov/> 2004.

A USGS gaging station located on Cedar Creek near Winchester in Frederick county has been recording data since 1938 (Figure 17) and has an approximate 102 square mile drainage area. The gaging station is located at Latitude 39°04'52", Longitude 78°19'47" NAD27 and is 647.09 feet above sea level. The smallest mean annual discharge to date occurred in 1947 at 37.9 cubic feet per second. The largest discharge occurred in 1996 at 242 cubic feet per second. Between January 2000 and October 2003, the daily mean streamflow ranged from a low of approximately 8 cubic feet per second to a high of approximately 3000 cubic feet per second (Figure 18). According to USGS data collected since 1938, the mean daily values of discharge reveal that the highest discharges occur from February to May, when discharges exceed 100 and even 200 cubic feet per second. The lowest flows occur from July to October, when discharges do not exceed 100 cubic feet per second (Appendix 5).

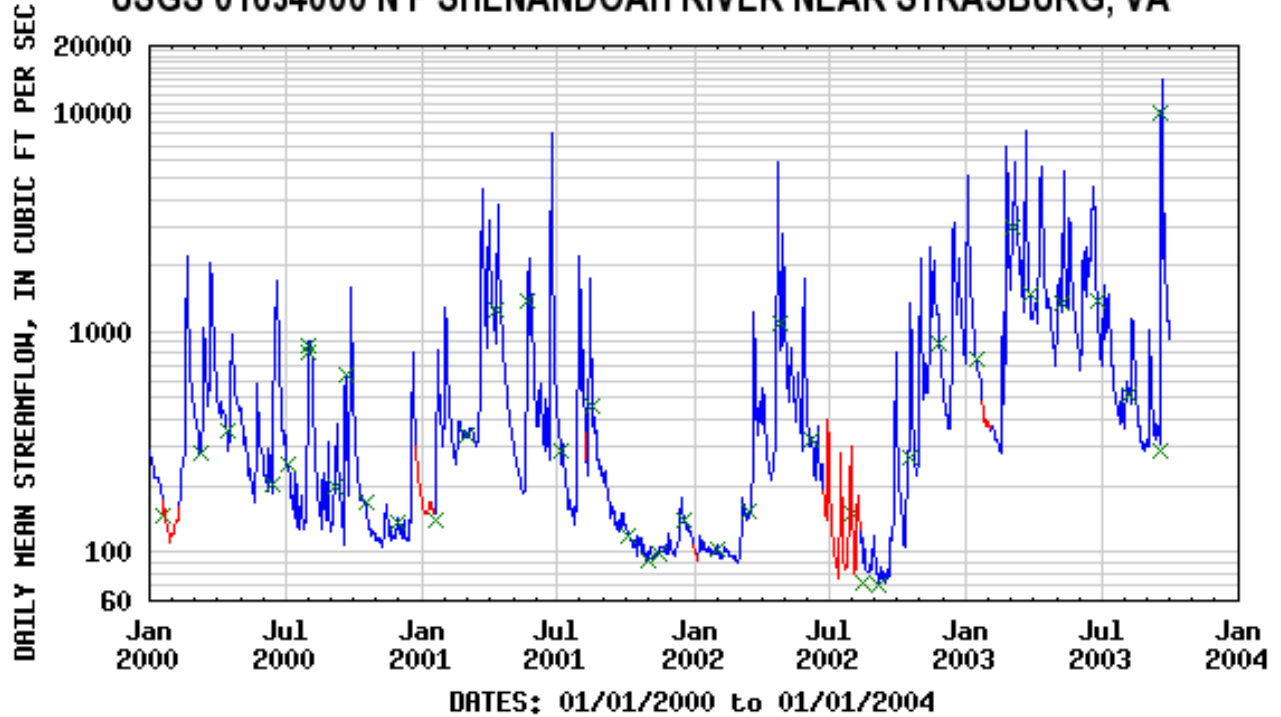
USGS 01634000 N F SHENANDOAH RIVER NEAR STRASBURG, VA

EXPLANATION
— DAILY MEAN STREAMFLOW × MEASURED STREAMFLOW — ESTIMATED STREAMFLOW

Figure 22. Daily mean streamflow between January 1, 2000 and January 1, 2004 for the North Fork of the Shenandoah River at the USGS gaging station near Strasburg, Virginia. Provided by USGS <http://va.water.usgs.gov/> 2004.

A USGS gaging station located on the North Fork of the Shenandoah River, before it flows along CEBE's border in Warren County (Figure 21), has a drainage area of approximately 768 square miles. The gaging station has been recording data since 1925 and is located at Latitude 38°58'36", Longitude 78°20'11" NAD27. The gaging station is located at 494.03 feet above sea level. The smallest mean annual discharge to date occurred in 1930 at 230 cubic feet per second. The largest mean annual discharge to date occurred in 1996 at 1,539 cubic feet per second. Between January 2000 and November 2003, the daily mean streamflow ranged from a low of approximately 70 cubic feet per second to a high of approximately 15,000 cubic feet per second (Figure 22). According to USGS data collected since 1925, the mean daily values of discharge reveal that the highest discharges occur from February (5/29 days) to April (10/29 days), when discharges exceed 1000 cubic feet per second. The lowest flows occur from July to September, when discharges rarely exceed 400 cubic feet per second (Appendix 7).
