**ORGAN PIPE CACTUS NATIONAL MONUMENT**

**Alamo and Kuakatch Wash floods of the 2012 monsoon: a short  
summary from Organ Pipe Cactus National Monument Natural  
Resources Division**

November 13, 2012

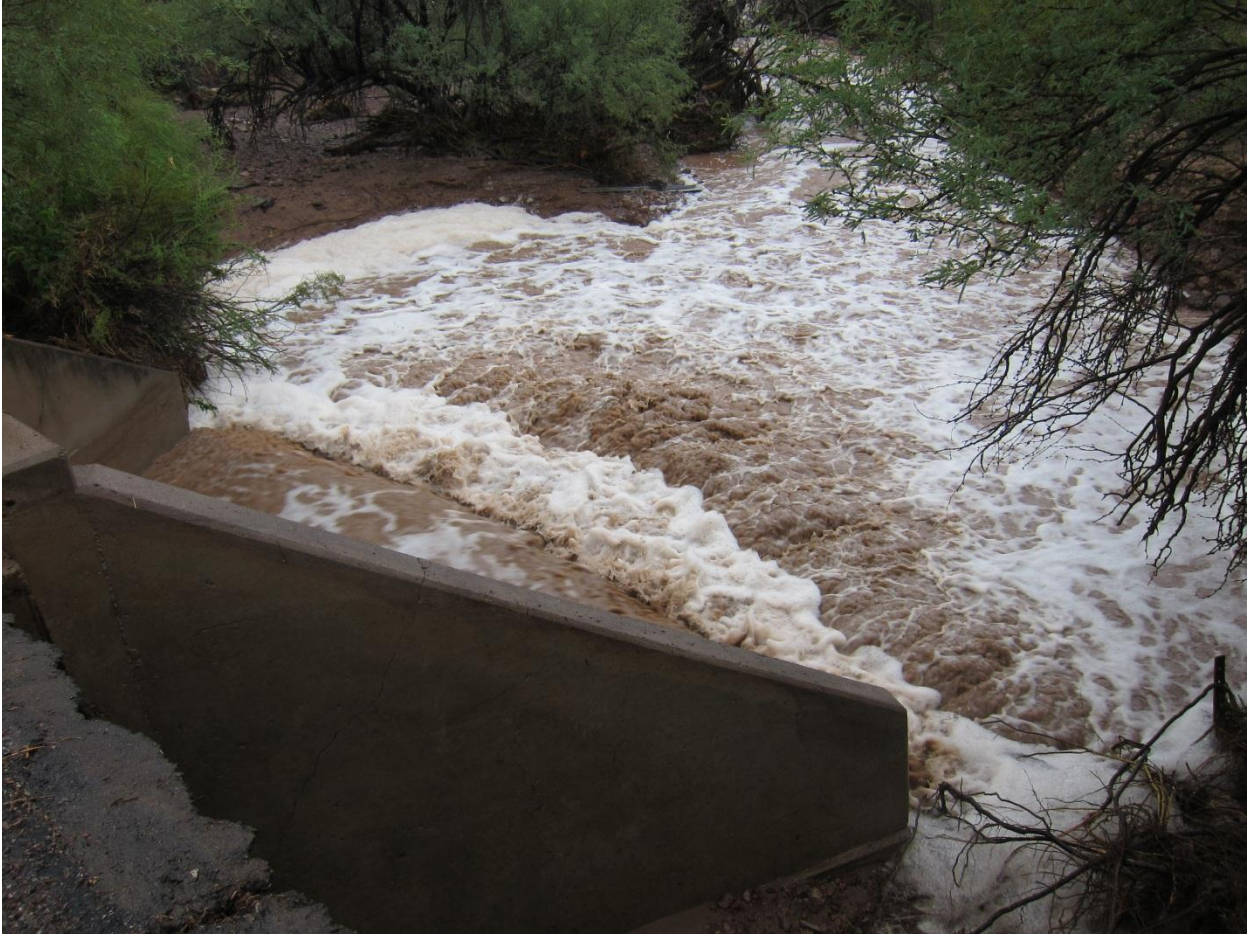
*Figure 3. The culvert crossing at mile 66.5 after floodwaters reached Highway 85, August 16, 2012.*

The combination of drainage area and the timing of rainfall, led to two major flood events in larger canyons of the Ajo Range. The first occurred on August 16 when 2.3 inches fell in early afternoon west of Tillotson Peak, joined by 2.8 inches in Alamo Canyon in mid-late afternoon. By that evening, floodwaters were rushing through the culvert located at mile 66.5 on Highway 85 (Fig. 3) and Monument employees driving home were delayed by floodwaters across the highway, especially at Kuakatch Wash further north on Highway 85 (Fig. 4). Significant rain had already fallen the previous day.

During the second and larger event that peaked on September 10, flood waters at both the culvert at mile 66.5 and bridge at Alamo Wash overtopped Highway 85 and several sections of backcountry road were left impassable. This flood was the culmination of six continuous days of rain in the Ajo Range, which began on September 6 and lasted until September 11. This was the final surge of the 2012 monsoon season.

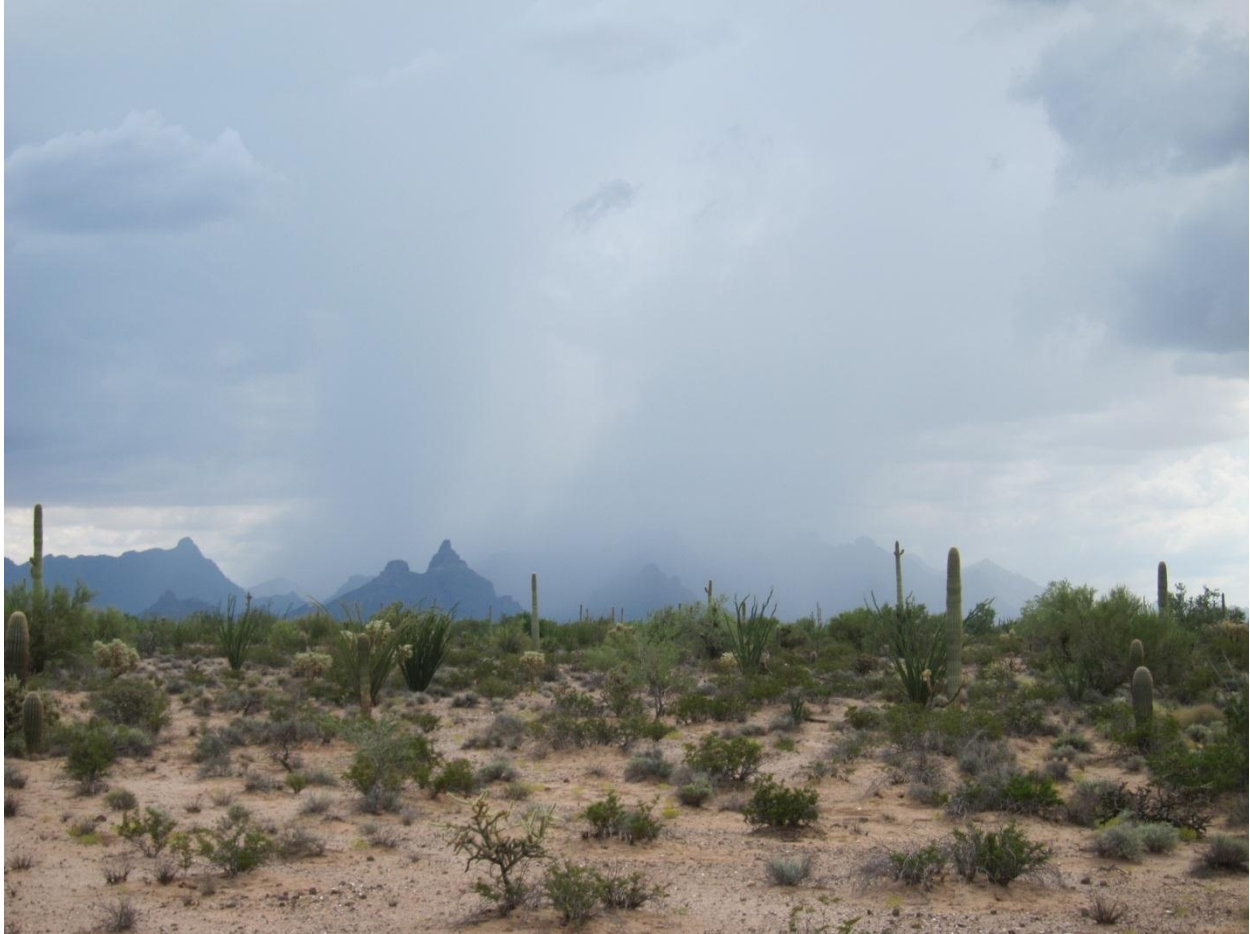
*Figure 5. The first storm to hit the Ajo Mountains during a series of early September storms, on September 6, 2012.*

On the first day, September 6, the weather station in Alamo Canyon recorded 2.0 inches of rainfall from 2:00 PM to 11:00 PM (Fig. 5). Rain began again the following morning on September 7, dropping another 0.5 inches between 7:00 AM and 10:00 AM. On the third day, September 8, 0.3 inches of rain fell 3:00 PM and 10:00 PM. On the fourth day, September 9, 0.9 inches of rain fell between 5:00 PM and 9:00 PM. The greatest daily and one-hour totals occurred on September 10 when 3.5 inches fell between 8:00 PM to 11:00 PM and 2.7 inches fell in the first hour. Although the subsequent flooding may have been caused by just the storm event of the 10<sup>th</sup>, the preceding four days of rain undoubtedly enhanced the size of the flood due to near- or already-saturated soil conditions. The rain finally came to a close on 11 September, dropping a final 0.6 inches between 8:00 AM and 2:00 PM.
