HISTORIC STRUCTURE REPORT ♦ THUNDERBIRD LODGE

CANYON DE CHELLY NATIONAL MONUMENT

HISTORIC STRUCTURE REPORT  
CHINLE TRADING POST, THUNDERBIRD RANCH,  
AND CUSTODIAN'S RESIDENCE  
CANYON DE CHELLY NATIONAL MONUMENT  
ARIZONA

NATIONAL PARK SERVICE  
SOUTHWEST REGIONAL OFFICE  
SANTA FE, NEW MEXICO  
OCTOBER 1989

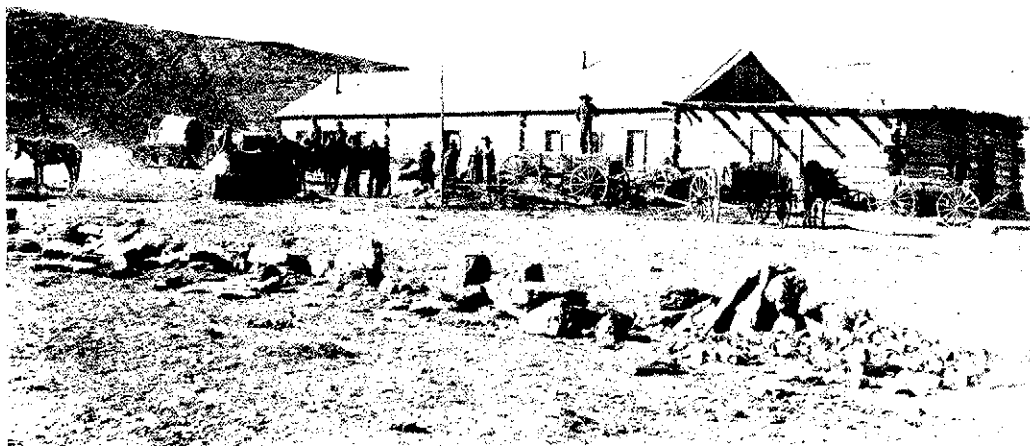
Sam Day's Chinle Trading Post shortly after construction, about 1902. The gable roof covered the trading post. Sam Day and his wife, Anna, lived in the flat-roofed extension at the north end of the building. The oven sat to the east of trading post. The pile of rocks and trash in the foreground probably helped delineate the post's activity space.

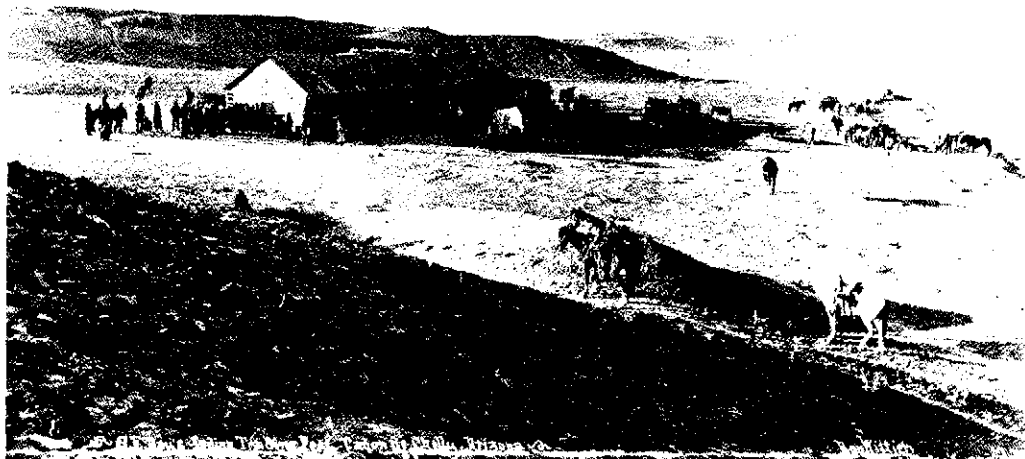
Sam Day's Chinle Trading Post shortly after construction, about 1902. Overgrazing livestock stripped the surrounding landscape bare of vegetation. The pile of dirt in the center foreground might have been the beginning of a dugout structure. A path led from it to the trading post. Some type of brush-covered structure sat at the northwest side of the post. The small depression between the oven and the south end of the rock wall might have been a watering trough.

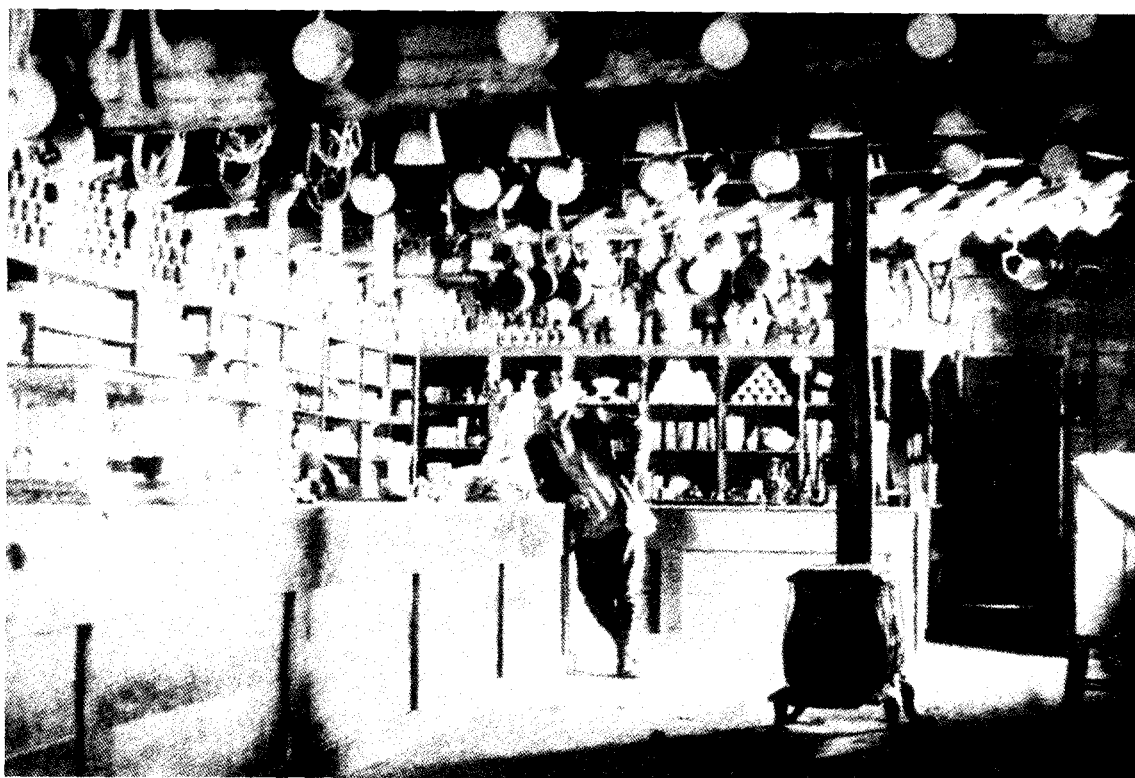
Trader George E. Kennedy inside his Chinle Trading Post in 1916. A strong sense of order pervaded the interior of the of the trading post. A wood stove warmed the main room.

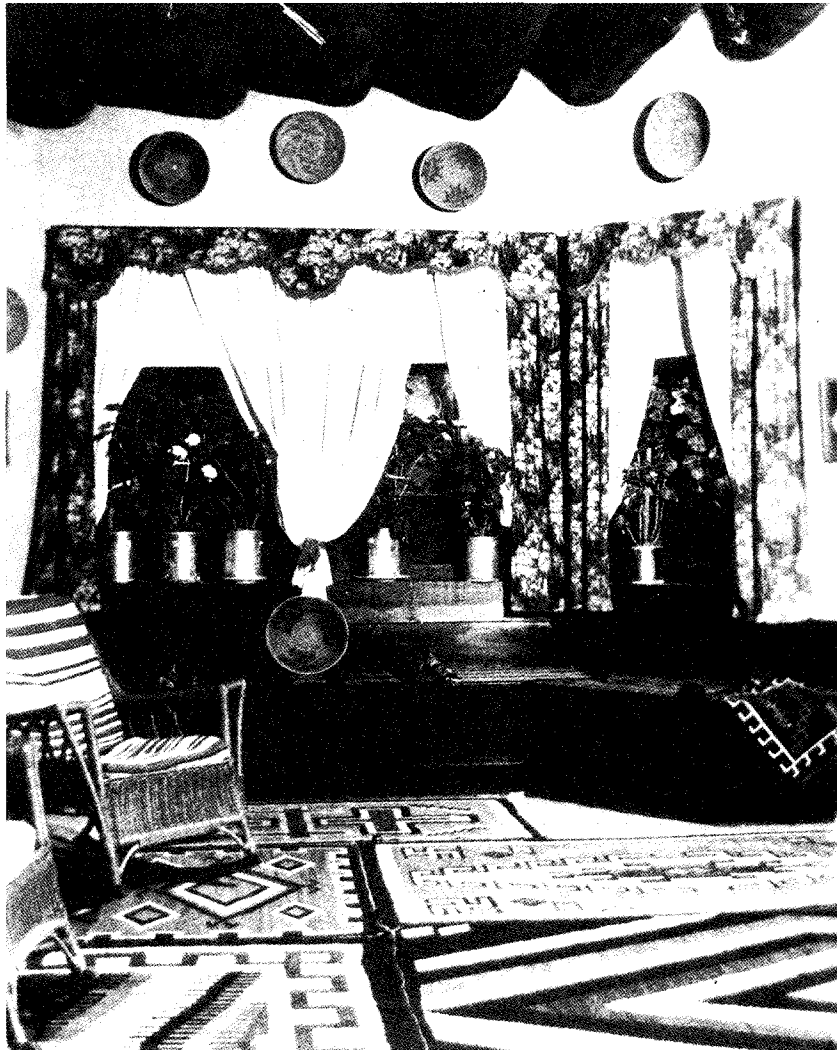
The interior of the main room of Thunderbird Ranch house was orderly and comfortable. Geraniums grew in metal buckets along the window sills of the bay. Chintz drapes in a floral pattern and sheer curtains covered the windows. Nearly wall-to-wall Navajo rugs covered the floor. Wicker easy chairs provided comfortable seating for guests. An arrow sticking out of one of the vigas (beams) undoubtedly furnished ample material for conversation.

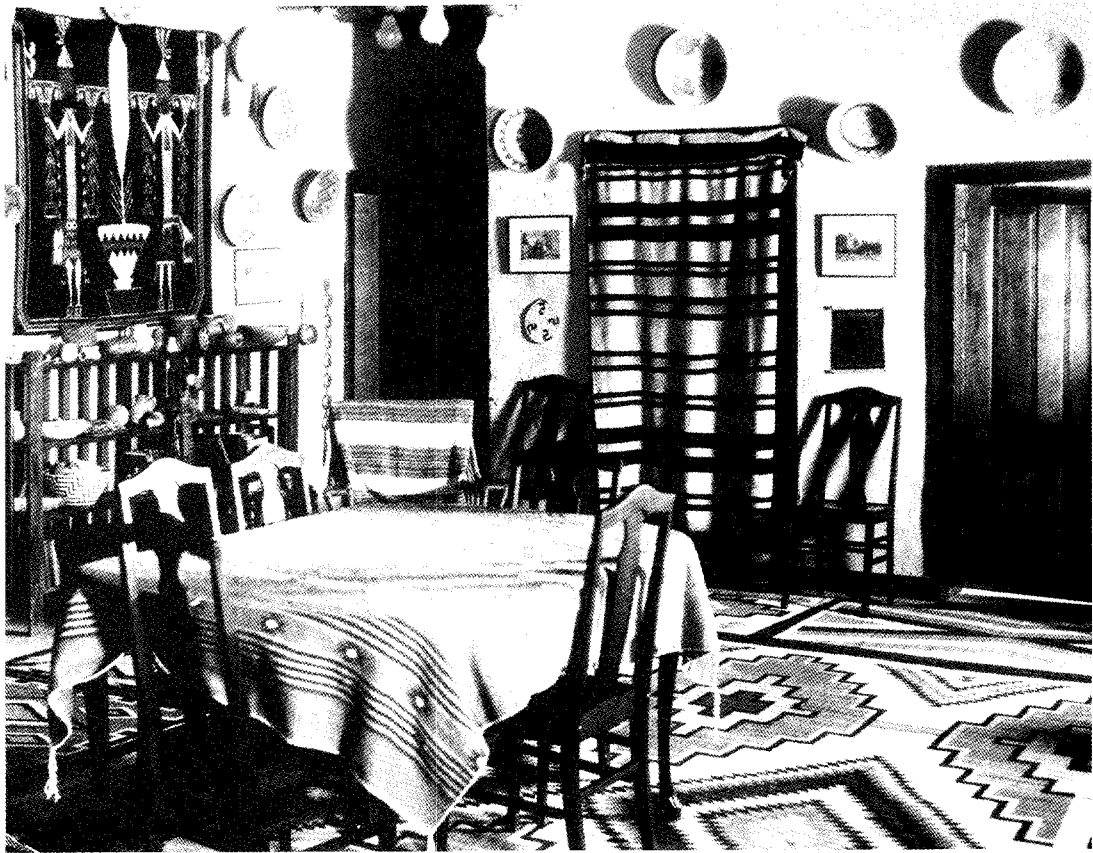
Navajo rugs covered the floor and some of the furniture in the dining room of Thunderbird Ranch. Baskets decorated the roughly plastered walls. The floorboards, exposed in only a few places, were lighter than the dark-stained moldings and doors.

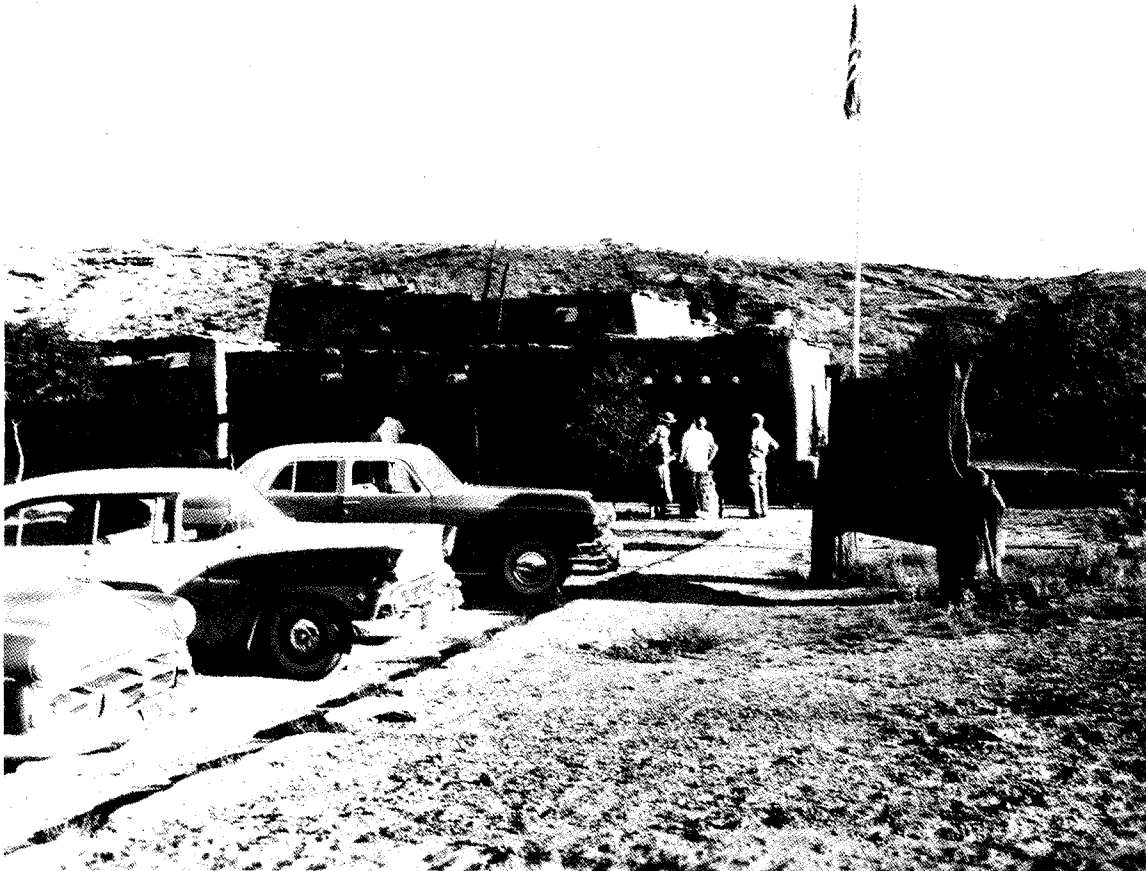
In this 1955 photograph of the custodian's residence and office, the stone coping and chimney pots remained on the building's uneven parapet. A ladder of pueblo design provided access to the building's highest roof. Projecting vigas and canales were evident. The people in the photograph stood on a flagstone walkway. Stone edged the dirt parking lot. Superintendent John Aubuchon at the left (in the hat) greeted visitors.

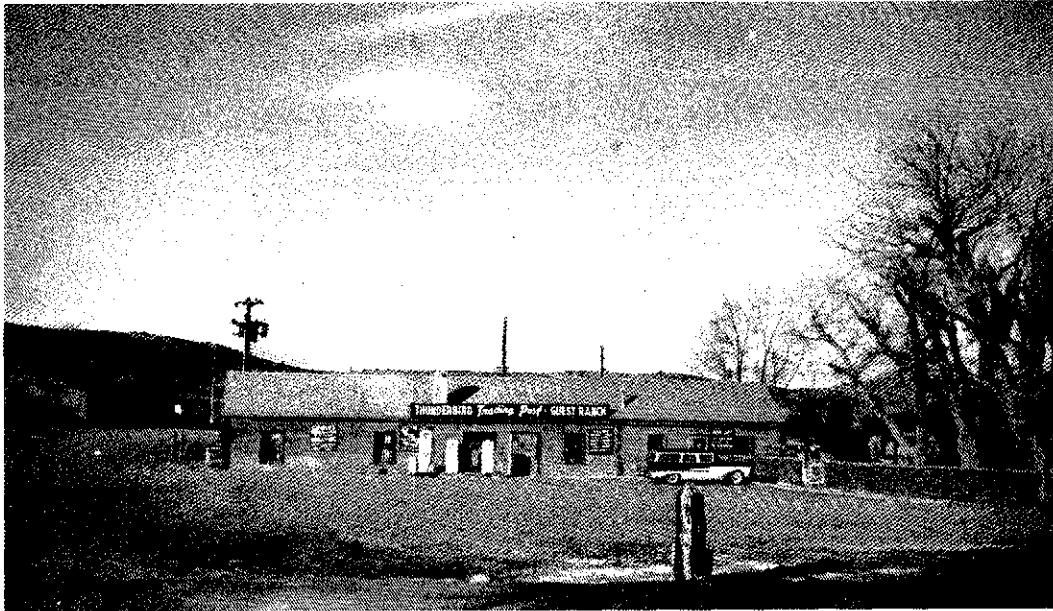
Thunderbird Trading Post and Guest Ranch looked like this in the early 1960s. Dirt surfaced the simple parking lot. The cottonwoods behind the stone wall had matured. The shade they provided in the summer gave welcome relief from the hot desert sun.

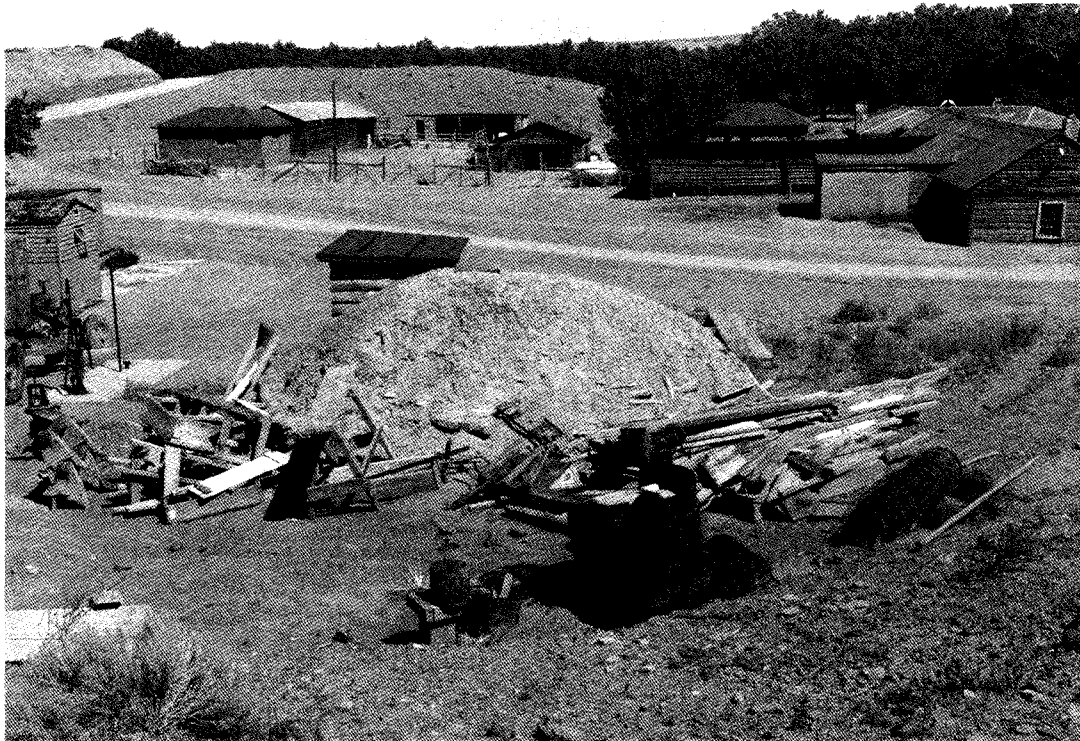
The National Park Service built a storage hogan (foreground) east of the custodian's residence and south of the ranch. A fence enclosed the ranch compound. Note the growth of vegetation in the wash in the upper part of the photograph.

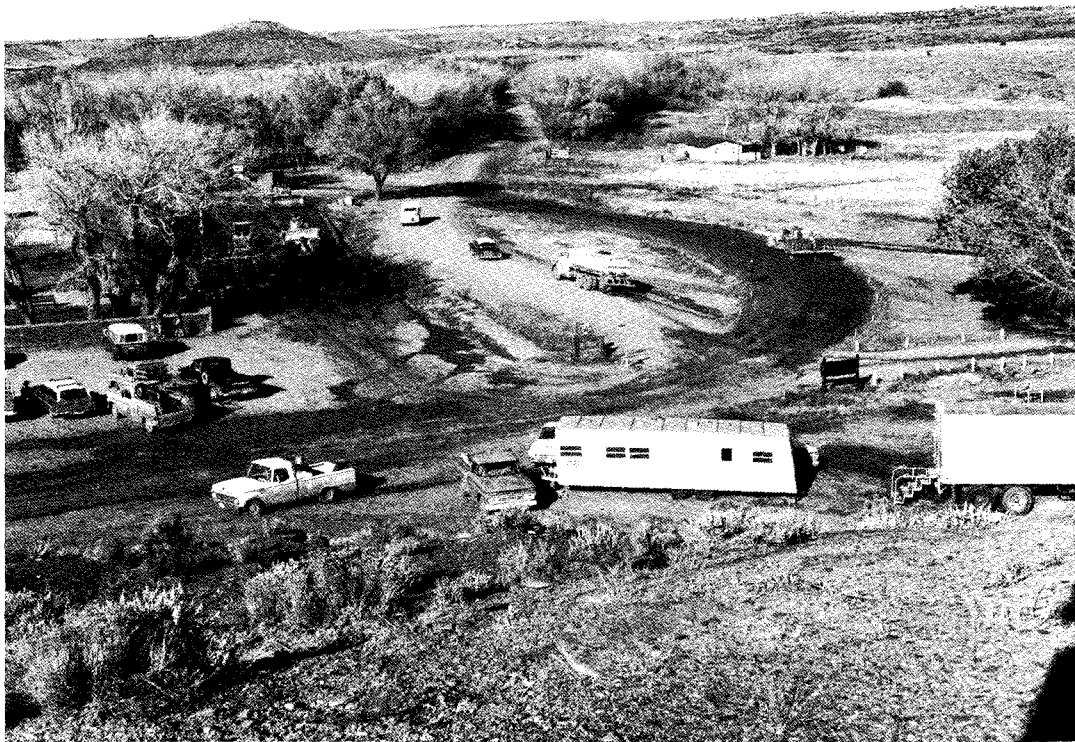
Grading for the expanded parking area entailed extensive surface disturbance. The new road to Chinle left the development to the north and east (center). Stone walls and a picket fence enclosed the grassy area in front of the ranch house.

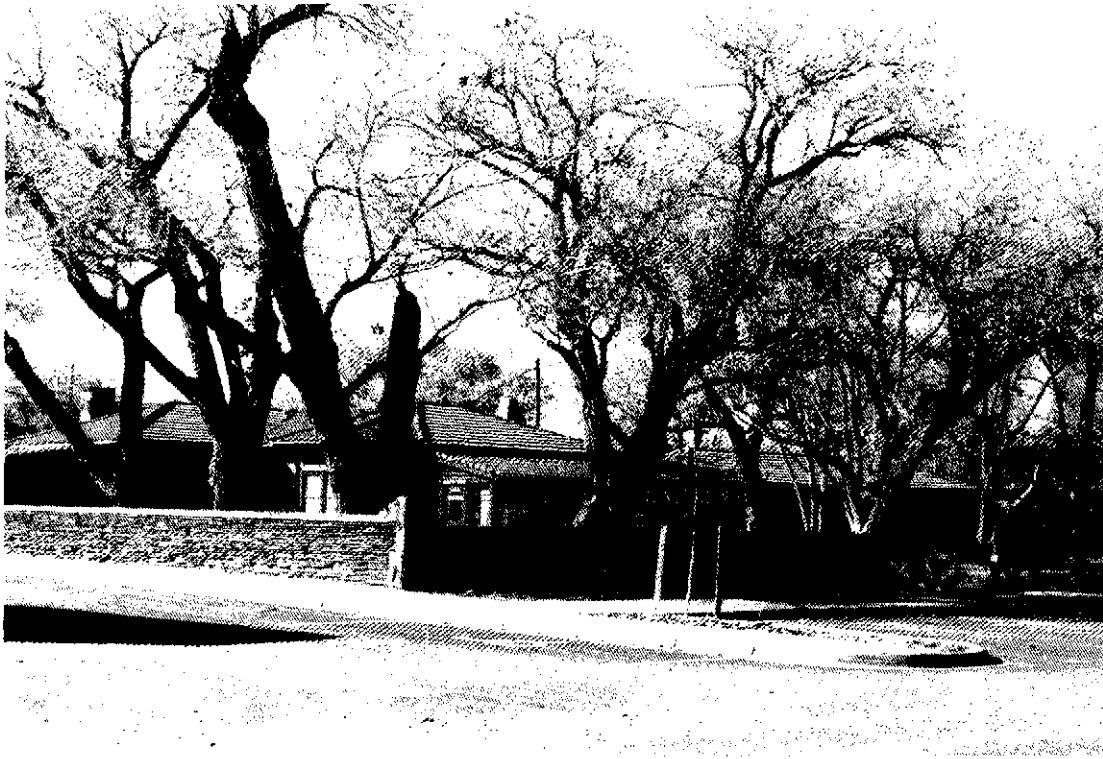
In 1986 the landscape around Thunderbird Lodge looked considerably different than it did during Cozy's time.

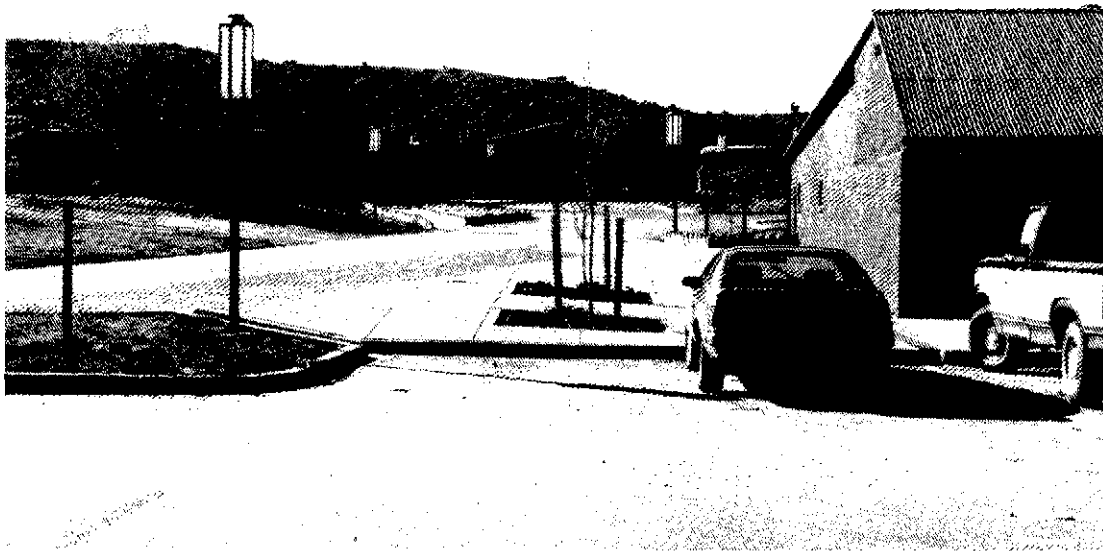
Large signs identify the office. Streetlights and concrete sidewalk give the area a more suburban character.

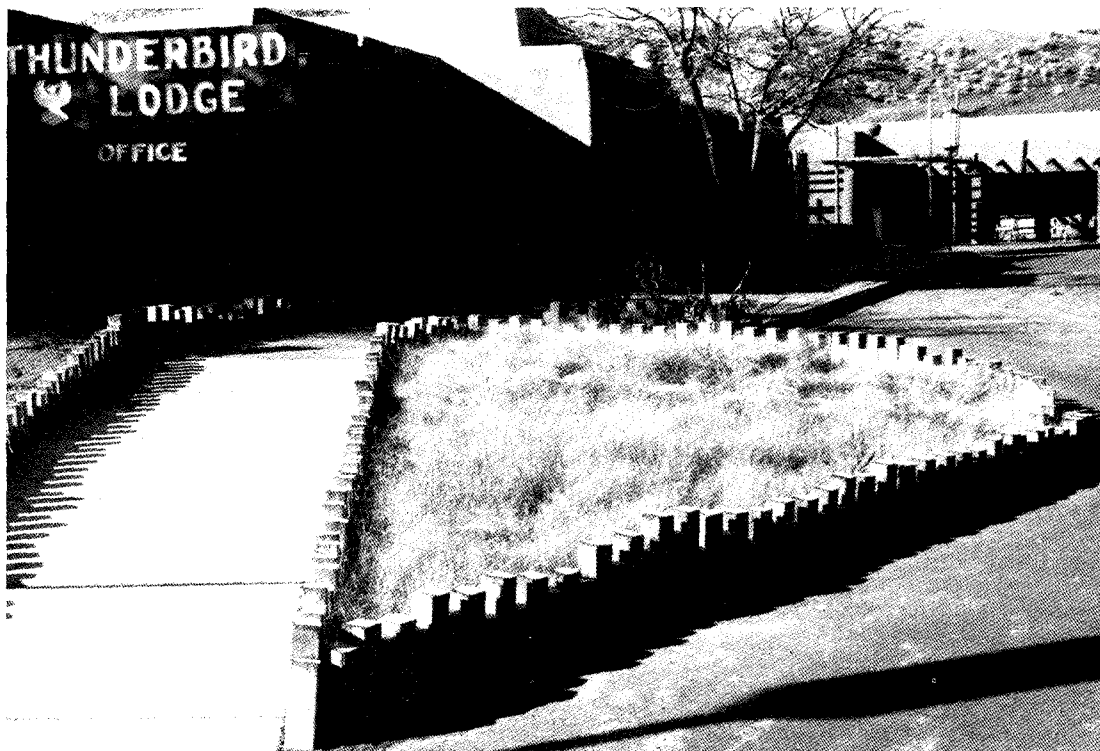
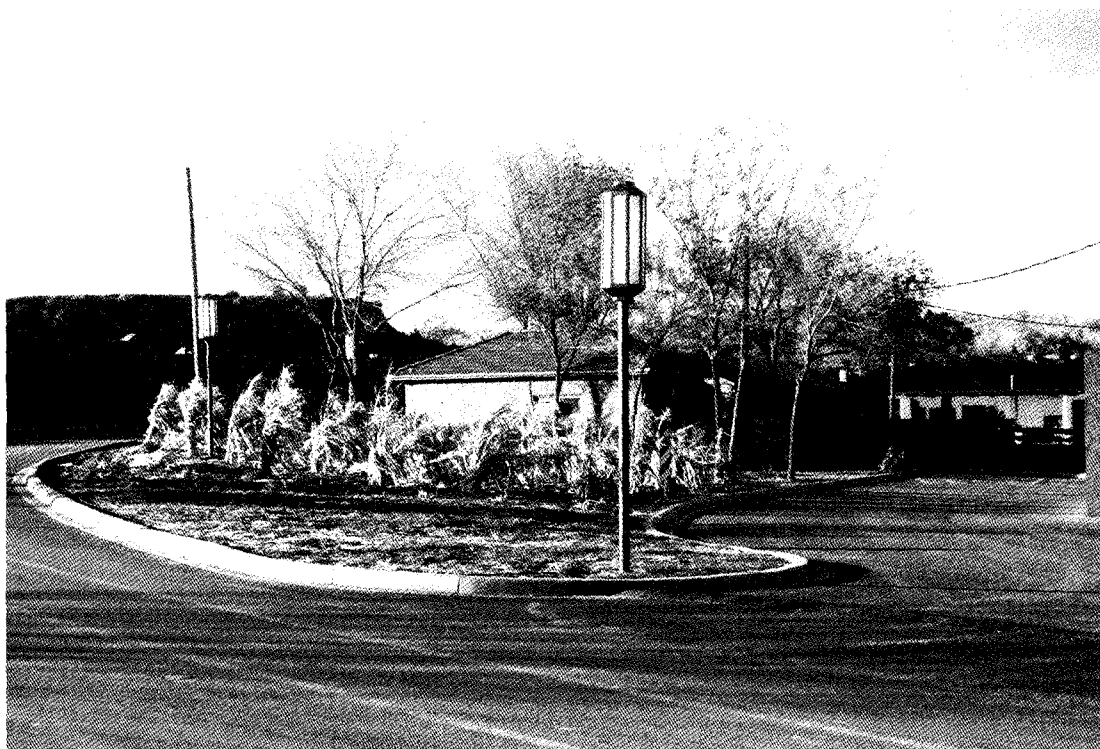
Planting beds contain materials native to the Southwest. Some of the beds have timber edges. In the future only native grasses should grow in these islands, and timber edges should be avoided. National Park Service photos by Beverley Spears.

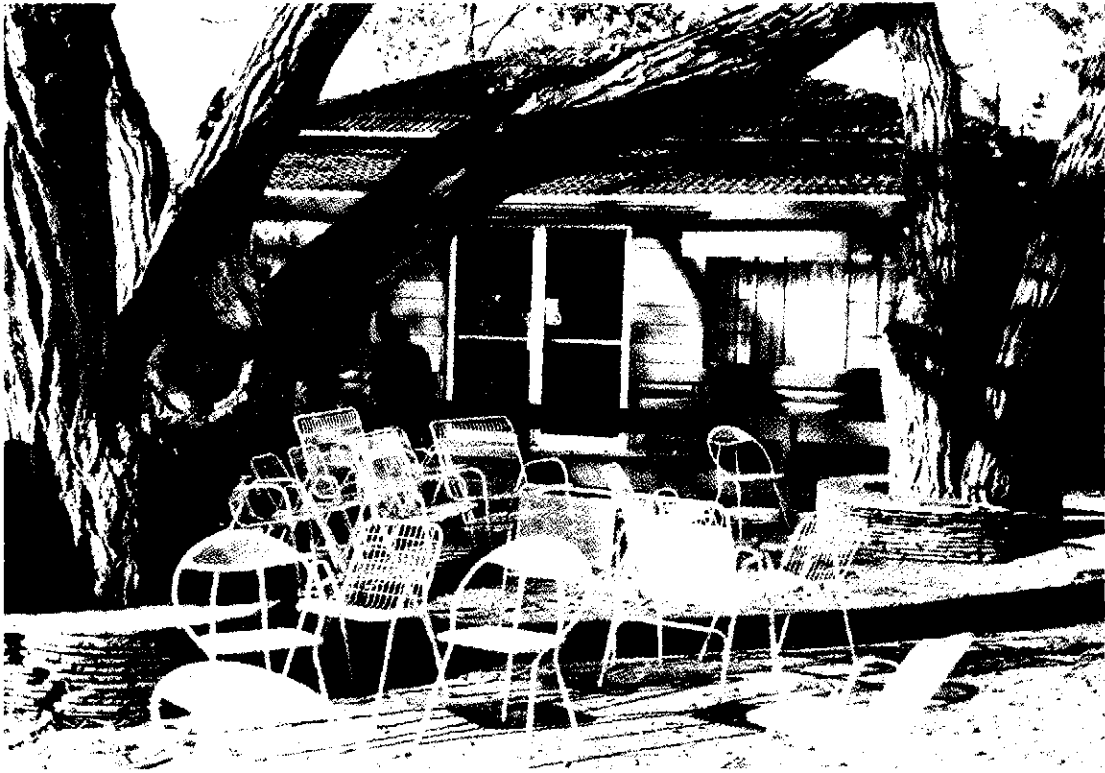
The cottonwoods in front of the gift shop outgrow the stone benches surrounding them. These were among the first trees planted at Thunderbird Ranch.

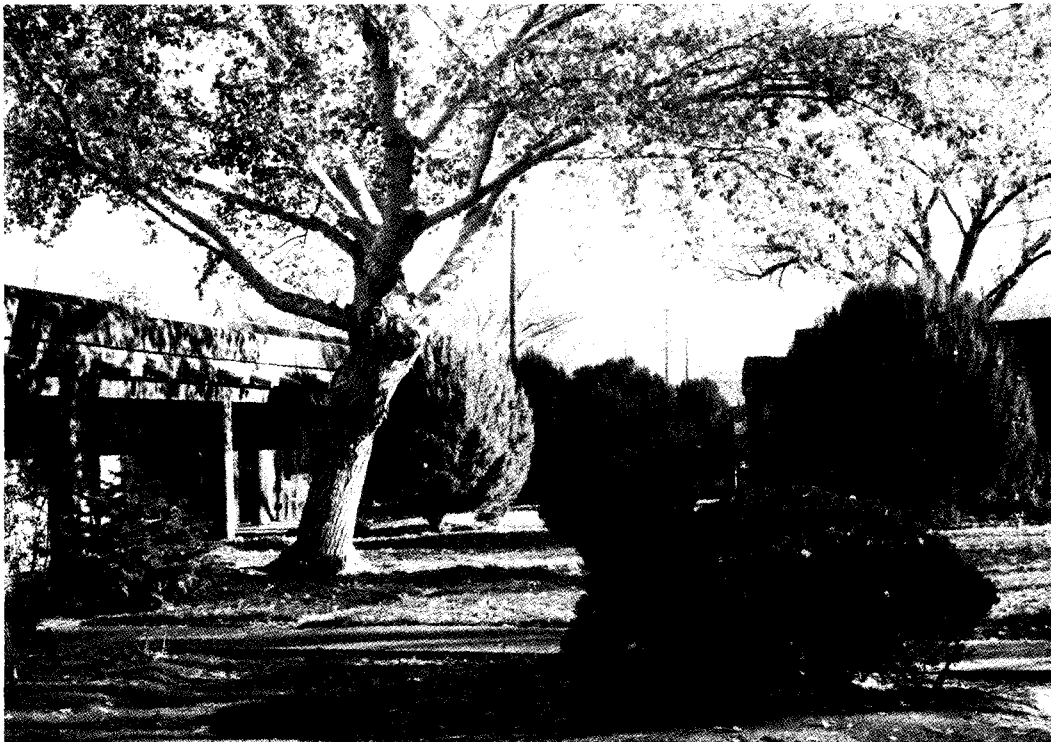
Grassy areas, such as this one, adjacent to the modern structures date from the La Fonts' time, and should be maintained.

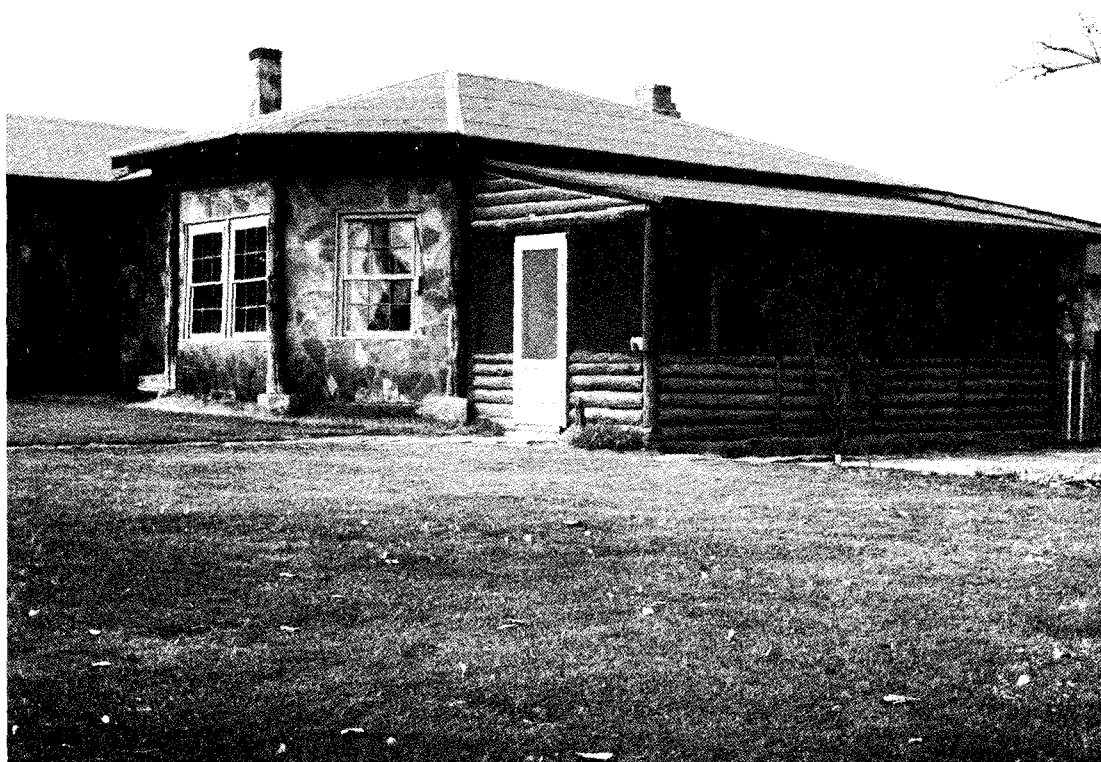
The front entrance to the main building of Thunderbird Ranch (circa 1955) had a screened-in front porch. Log-slab siding made up the lower portions of the porch walls. Flagstone covered the paths between the buildings and the small patio (right). The grassy lawn filled the spaces between the pathways on the south and east sides of the ranch house. Dark stains at the base of the building indicated moisture seeping into the base of the building.

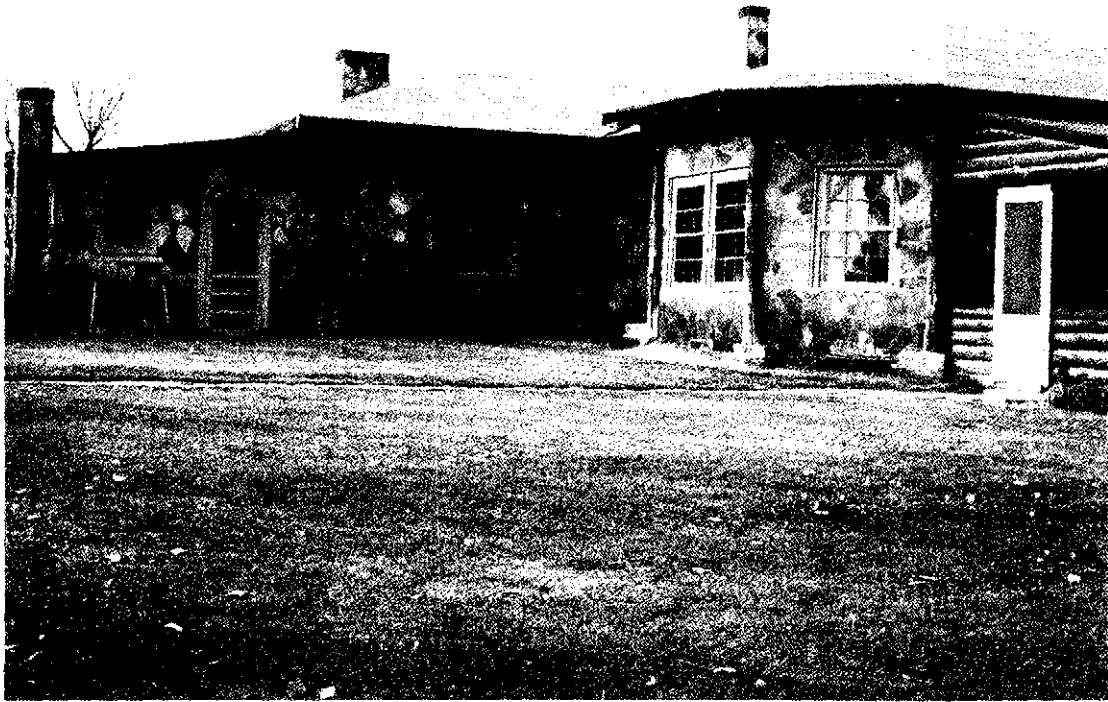
Three chimneys served the south end of the building. Most of the windows were six-over-six, and the window on the right had an alarm system. Watering this grassy expanse of lawn undoubtedly had some effect on the moisture seeping into the building.

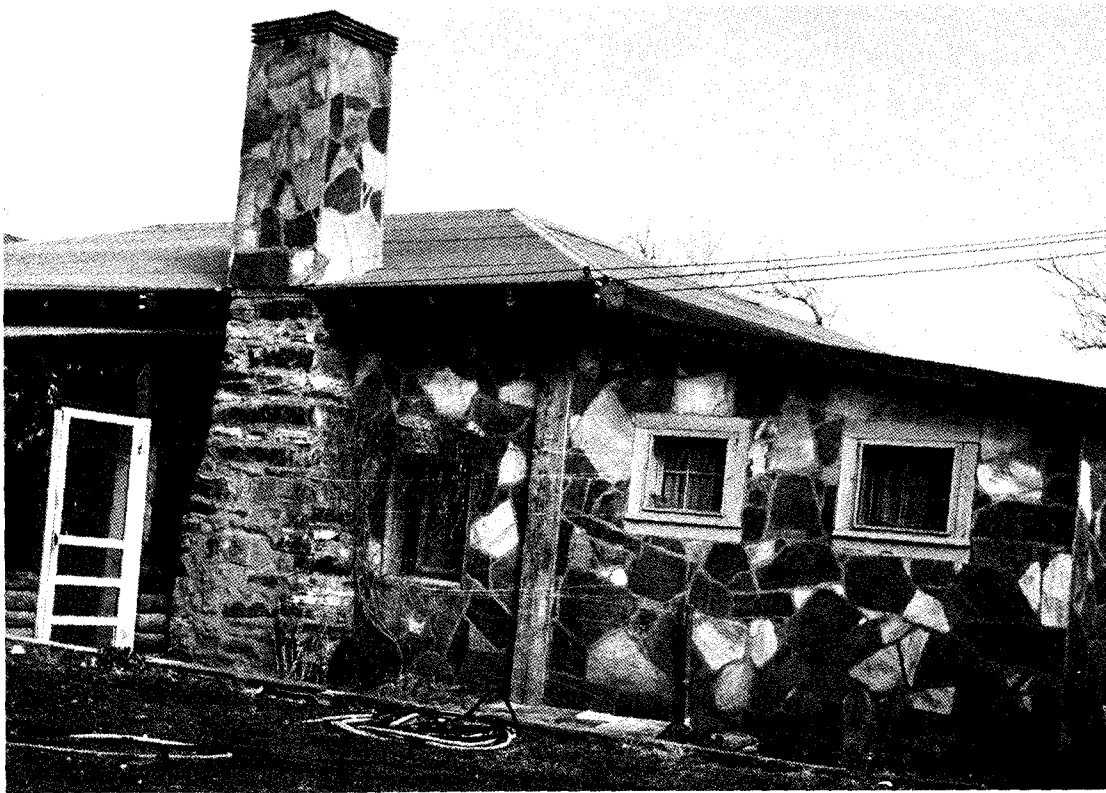
By 1955, vines grew on the south portion of the west wall. A wall and fences also protected this small patch of lawn on the west side of the ranch house. Hoses for watering the lawn are evident in the photograph.

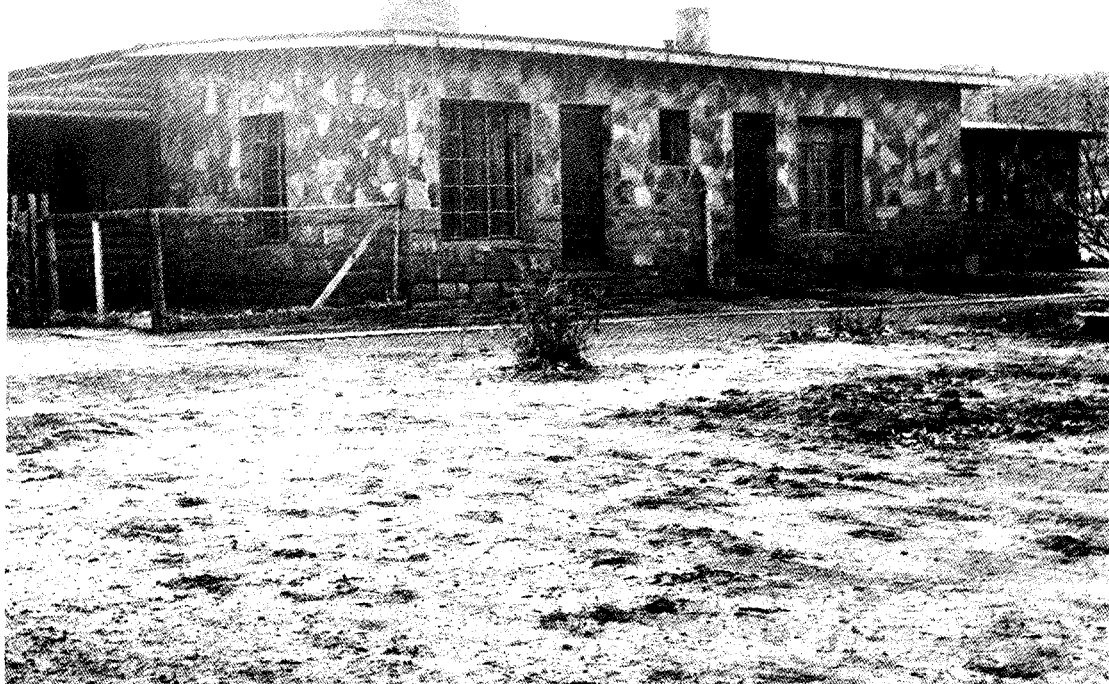
Screen doors and metal-sash windows indicated the more recent units at the north end of the ranch house. The stepped chimney on the left was original to the ranch house. The lack of groundcover was quite evident. The pathway in front of the newer units was concrete.

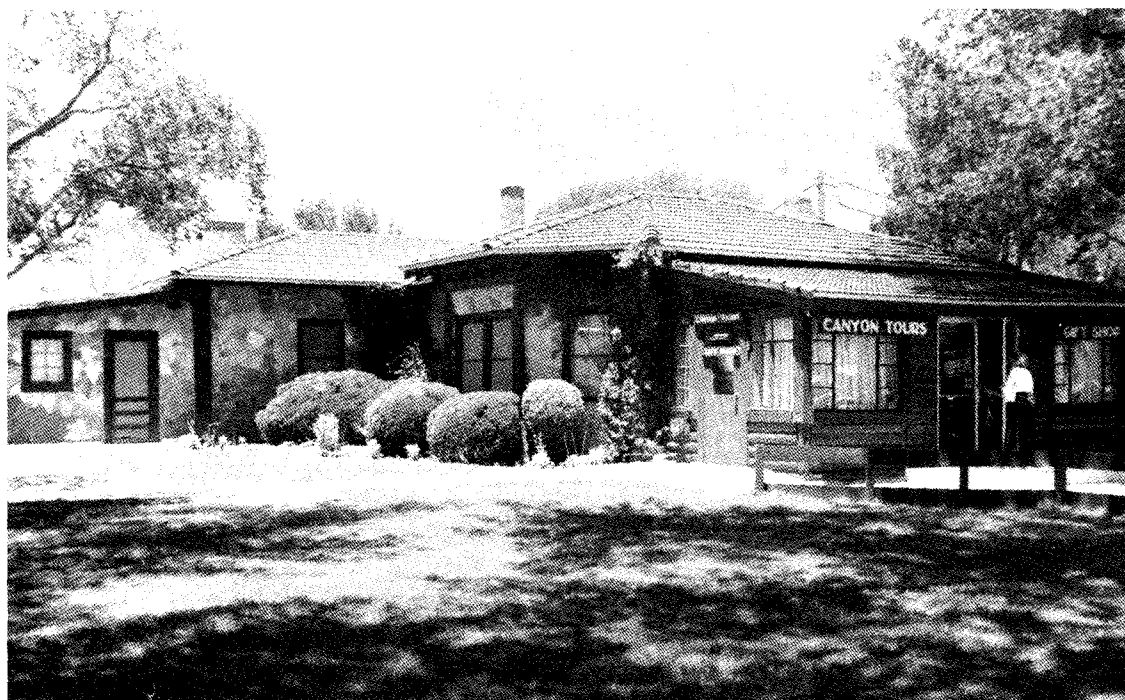
In 1986, shrubs and vines visually softened the lines of the old ranch house. Although the red tile roof improved its appearance, it detracted from the historic structure's integrity.

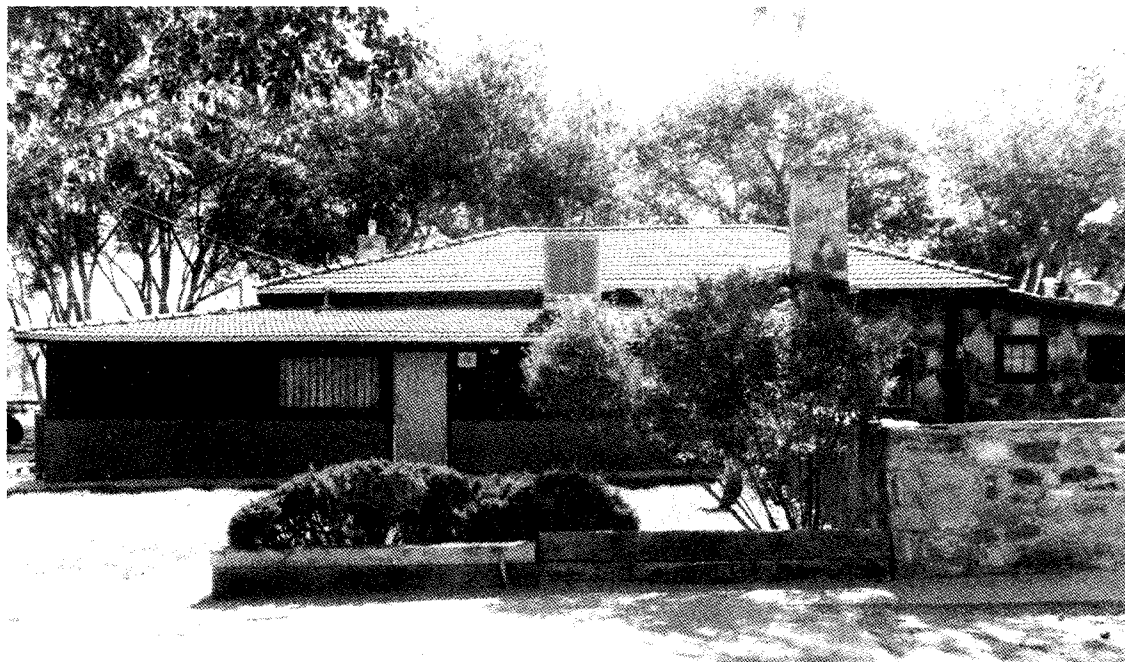
The rear porch was enclosed and swamp coolers were added. The historic bell was moved from its original location near the back door to a place approximately twelve feet southwest.

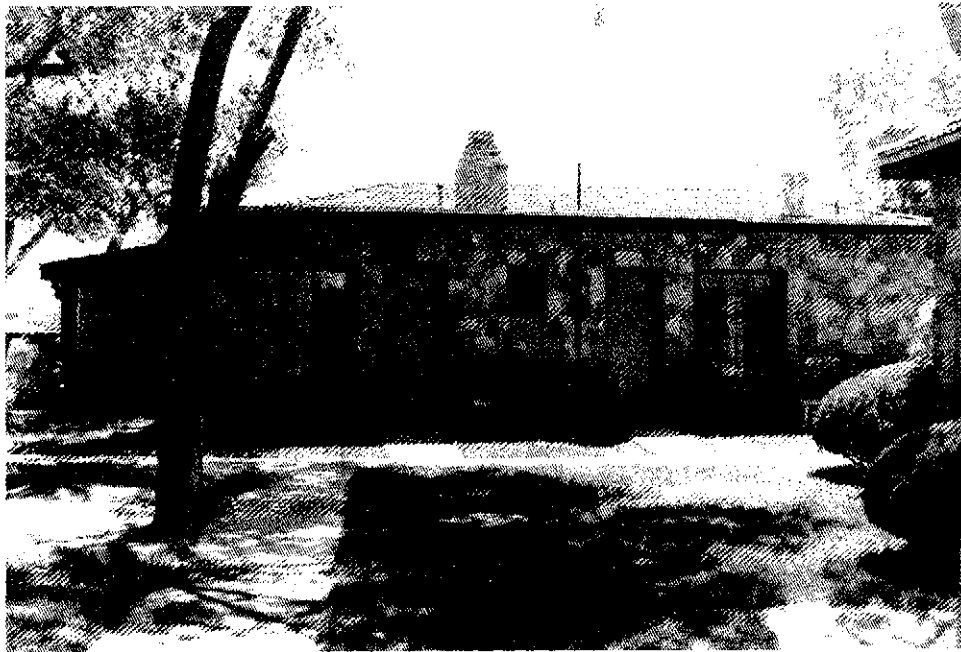
In 1986, the north end of the ranch building had new doors, and wider concrete paths provided access. Grass grew to the north of the old ranch house.

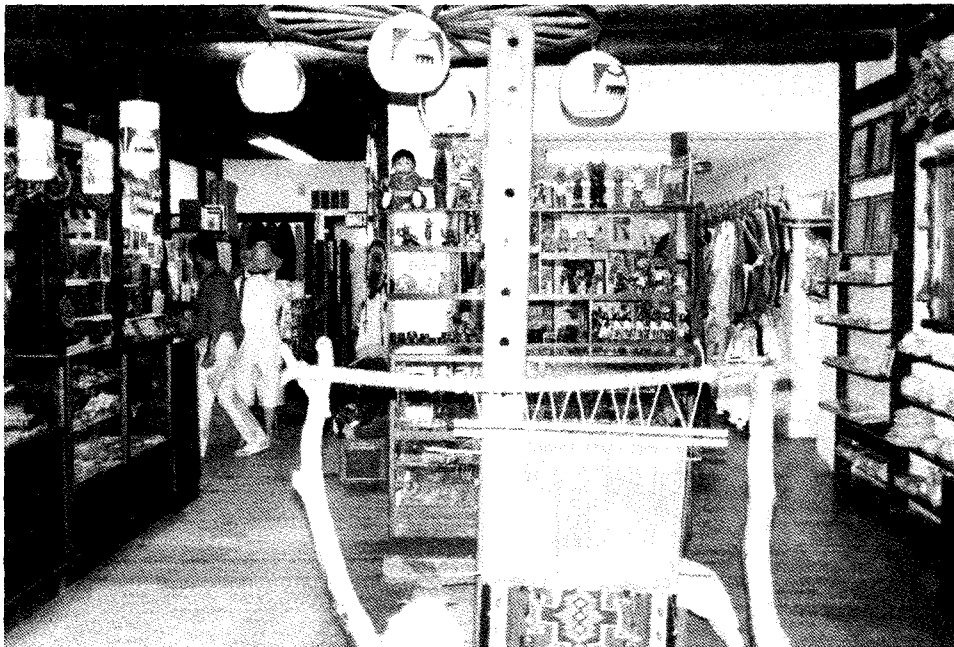
In 1986, the wagon-wheel chandelier still illuminated the former living room of the ranch house, however it had undergone some alteration. The wood floors, dark-stained vigas, and original fireplace mantle remained in tact.

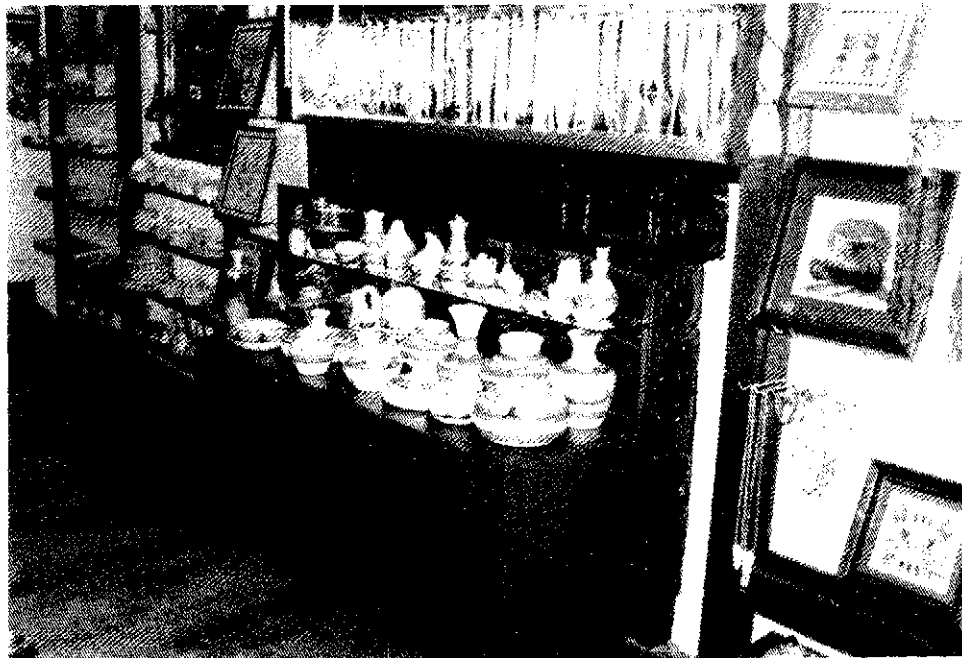
In 1986, a sales shelf obscured the original fireplace mantel.  
National Park Service photos by Laura Soullière Harrison.

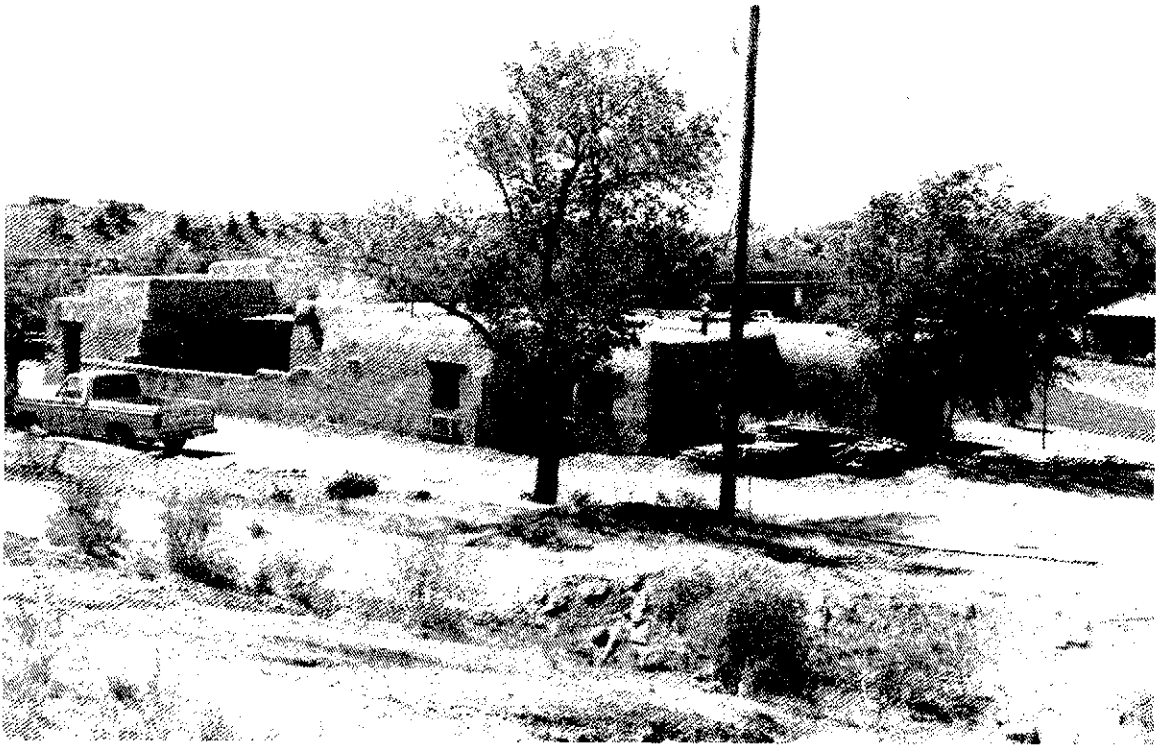
From the rear (south) the building's original massing remains. The stucco finish is too highly textured for this building.

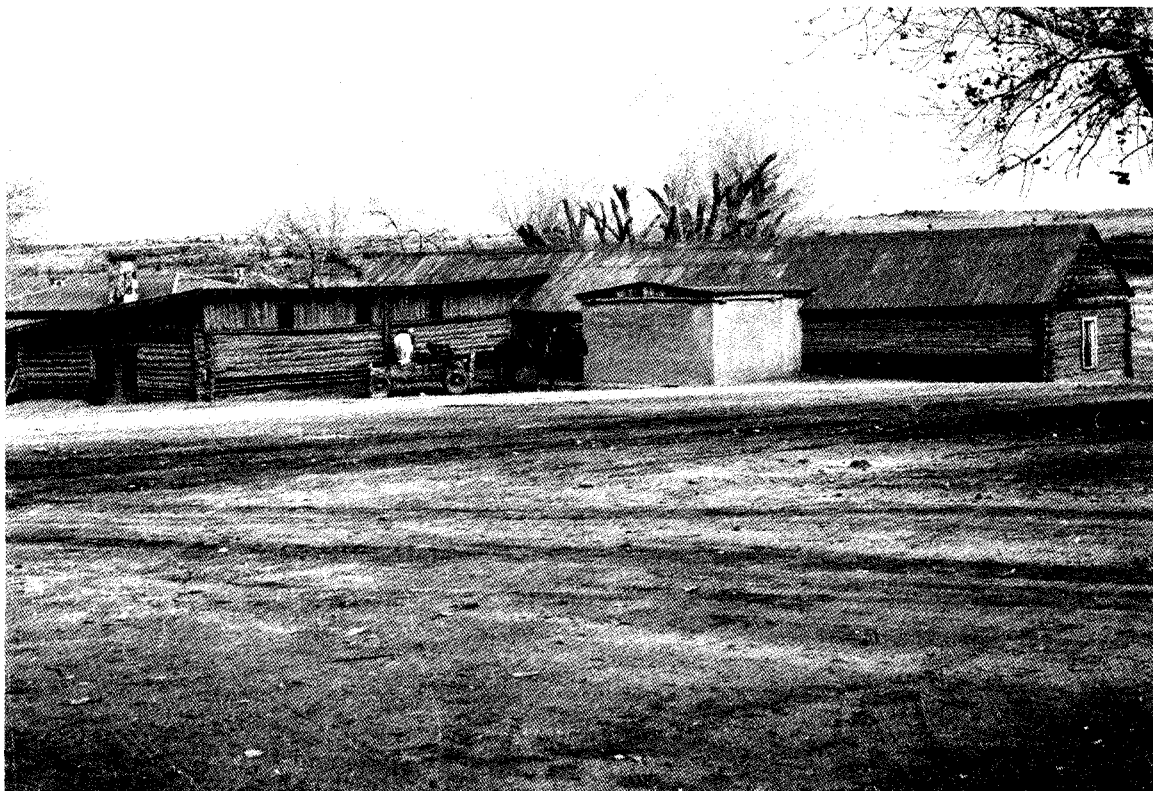
In 1902 Sam Day's Chinle trading post was a simple structure. Even then bars covered the windows. The Day's living quarters were in the flat-roofed section at the building's north end (center of photograph). The oven sat east of the trading post (right).

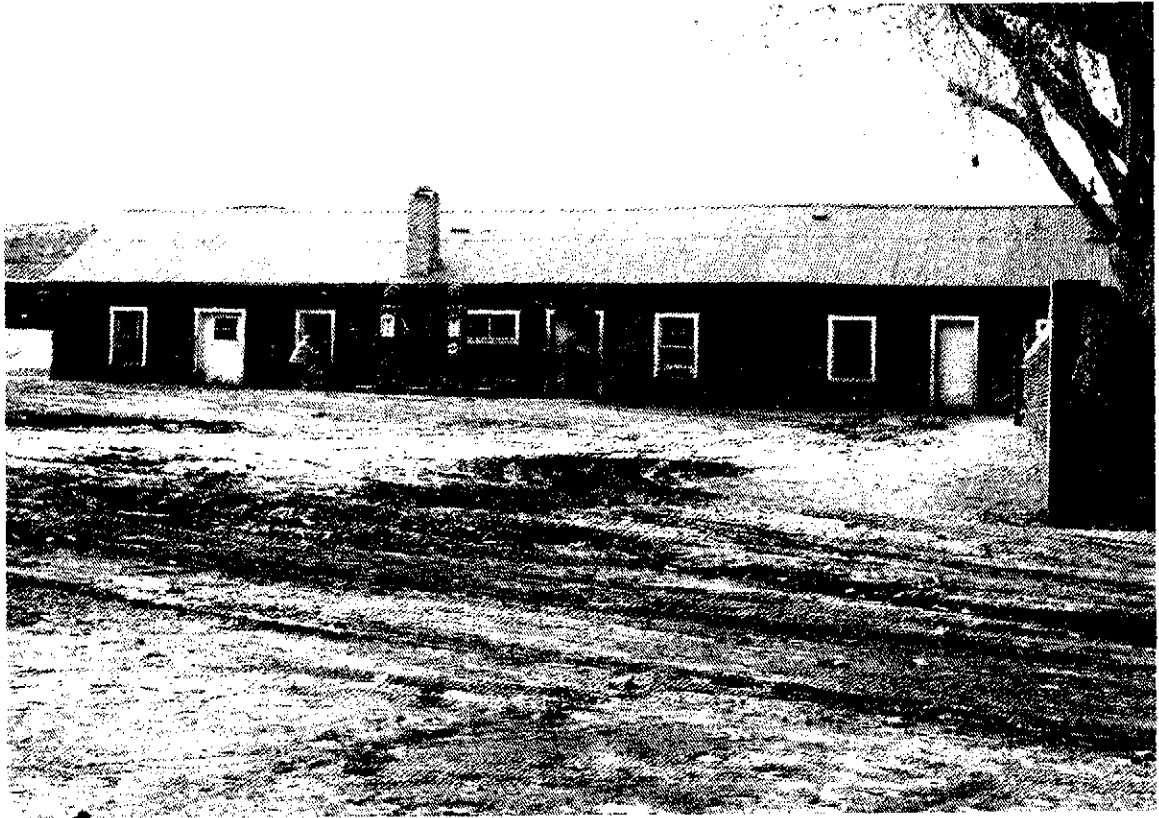
In 1953 the trading post retained most of its original fenestration. Only the stone wall on the right and the east wall of the trading post delineated the parking area. The gas pumps sat directly in front of the east wall. A small log bench was near the central front door. The sign over the door and the hand-print wear pattern on the door indicated the principal access into the trading post.
