HISTORIC STRUCTURE REPORT ♦ THUNDERBIRD LODGE

CANYON DE CHELLY NATIONAL MONUMENT

HISTORIC STRUCTURE REPORT  
CHINLE TRADING POST, THUNDERBIRD RANCH,  
AND CUSTODIAN'S RESIDENCE  
CANYON DE CHELLY NATIONAL MONUMENT  
ARIZONA

NATIONAL PARK SERVICE  
SOUTHWEST REGIONAL OFFICE  
SANTA FE, NEW MEXICO  
OCTOBER 1989

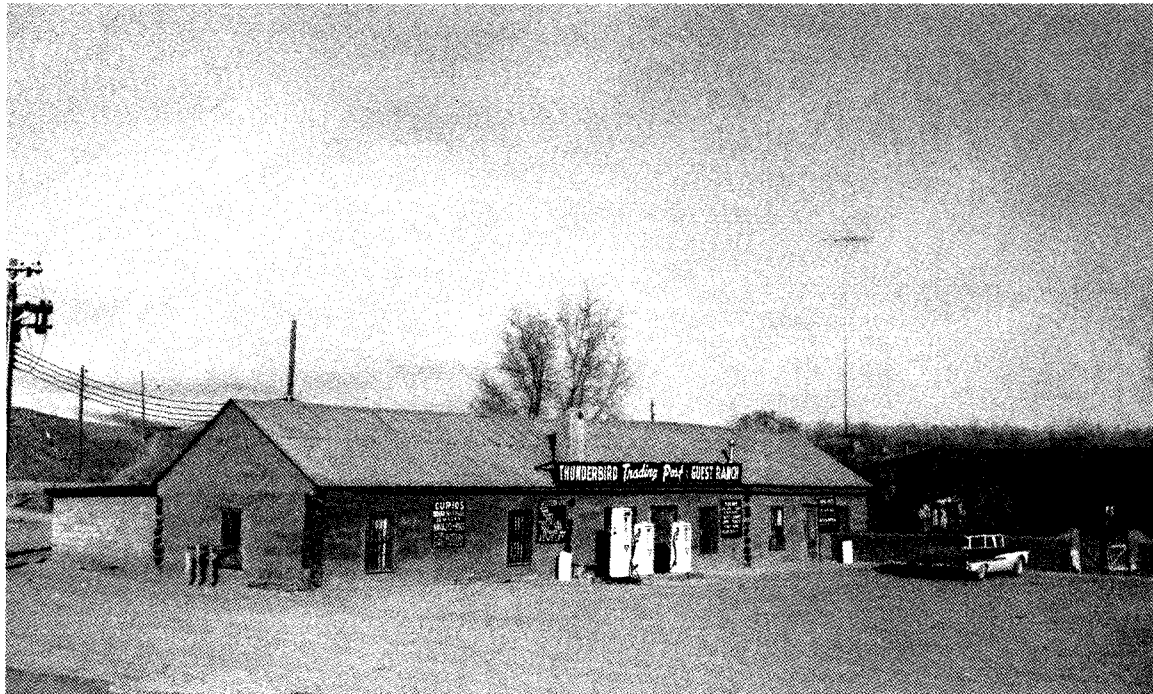
When the concessioners stuccoed the old trading post building in 1954, they left the log ends poking out of the stucco. The 1957 concrete block addition (left) made the rear wall of trading post even with the end of the vault.

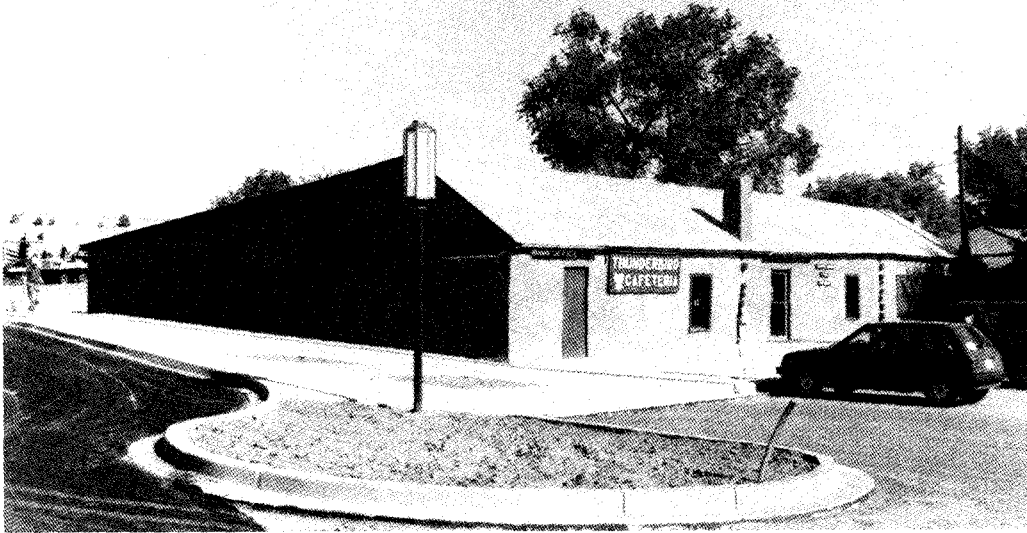
In 1986 some of the of the original fenestration remained. A scored-concrete sidewalk wrapped around the south and east sides of the building. The new parking lots and streetlights made the area's character more urban.

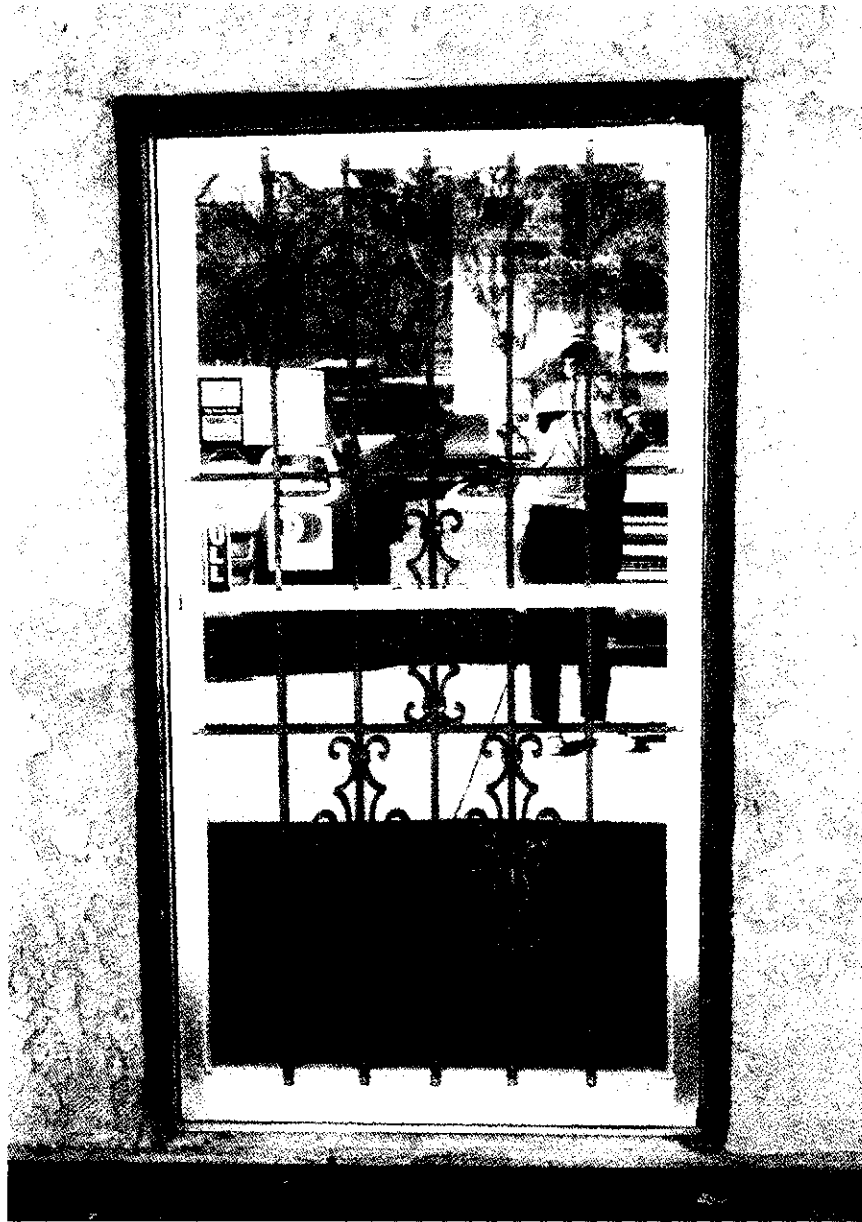
The aluminum door at the main entrance is so modern it tends to obscure the building's historic origins.

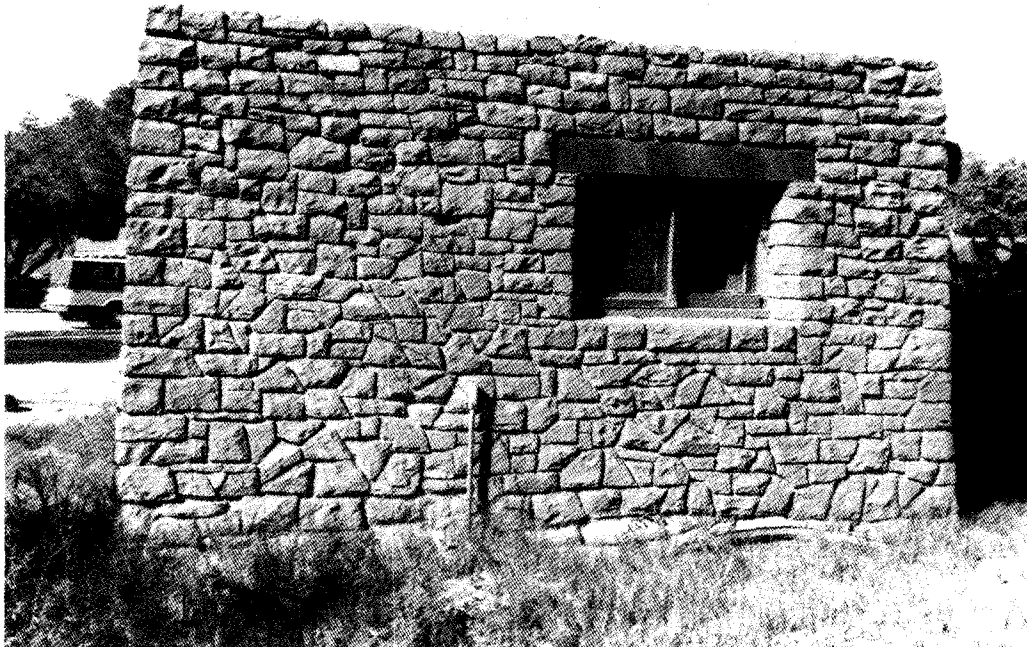
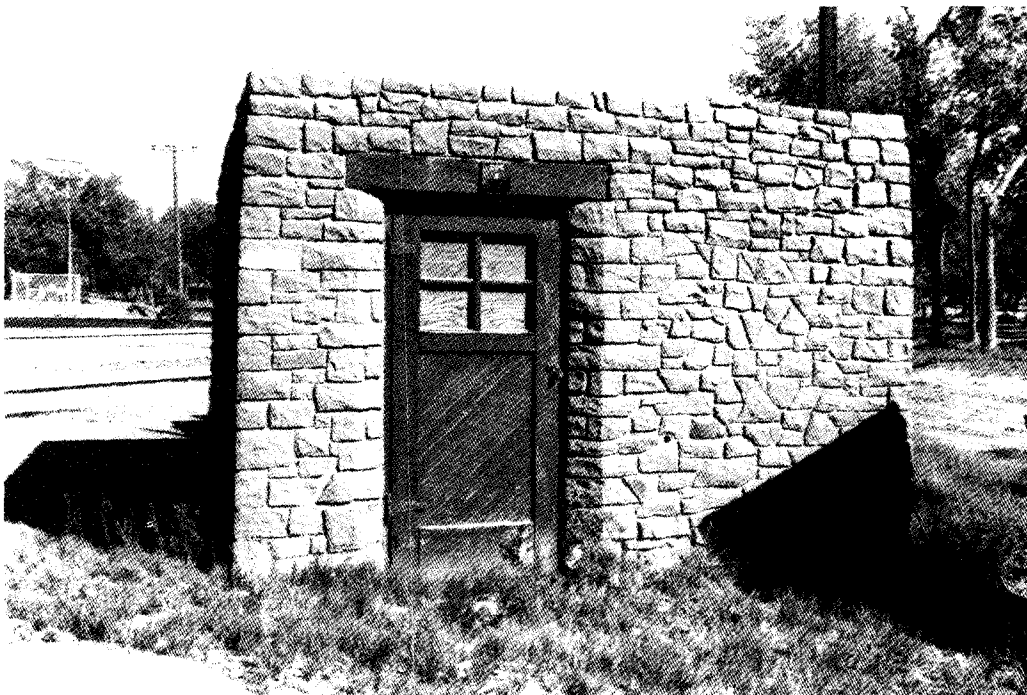
Navajo stone masons built the monument's pumphouse in 1936. The building is in excellent condition, but it is vacant.

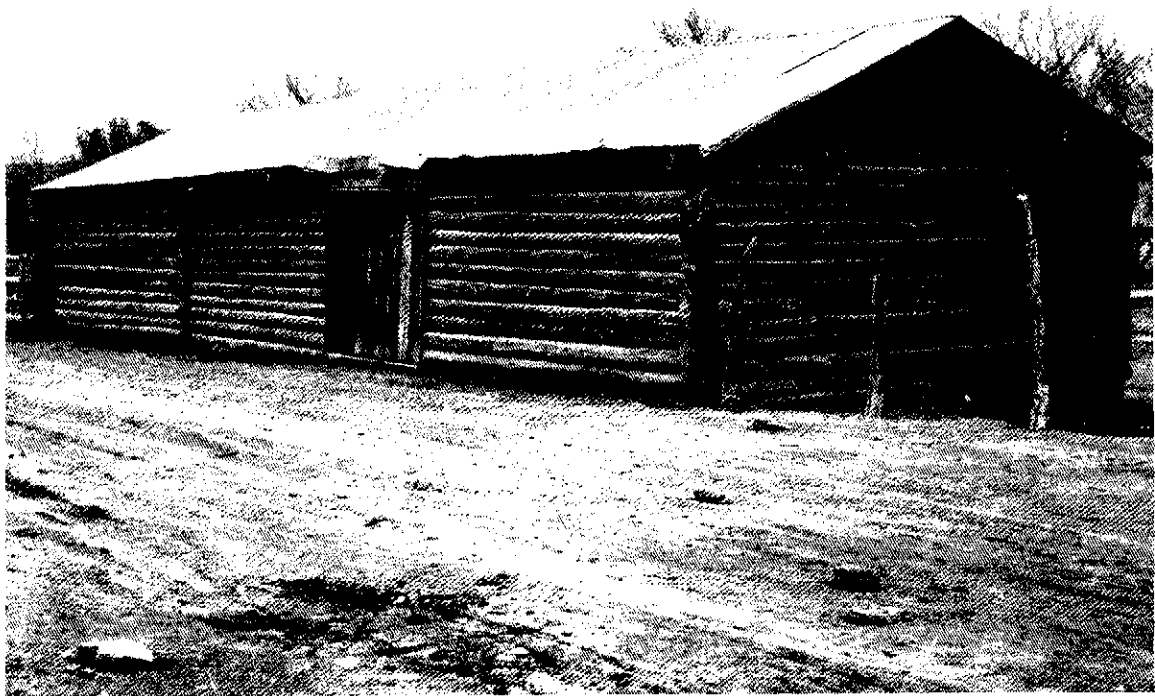
During the 1950s the log barn showed little racking. Fences at its north and south ends defined a corral (north/left) and Cozy's ranch and trading post boundary. The old road to Chinle passed along this west elevation.

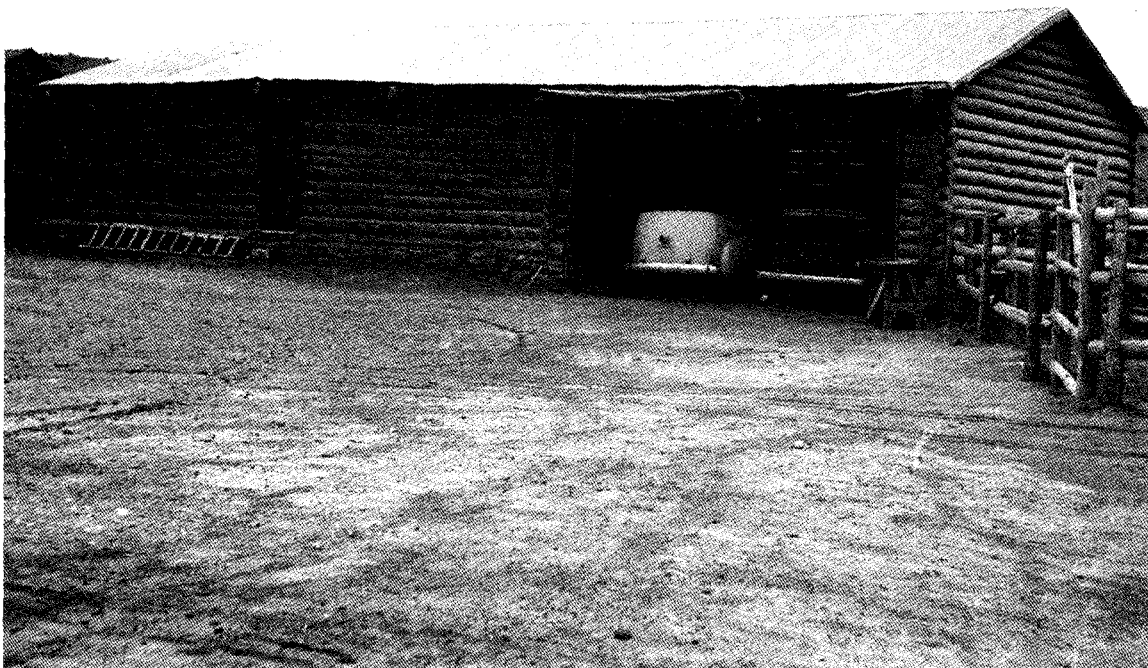
During the early 1950s the east elevation of the log barn had an opening for a two-car garage. The corral at the north (right) end of the barn served the stone shed (building 19).

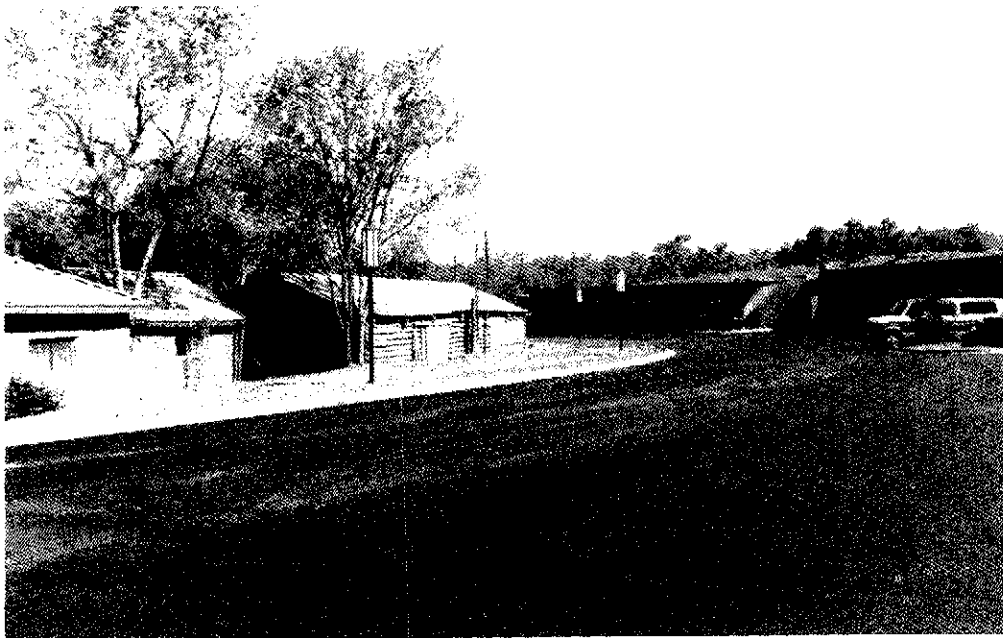
The barn's architectural context (above) was altered dramatically when in 1986 grading for the new parking lots covered up at least five of the lower logs on the barn's west elevation (below). Fill also covered the stone foundation on the south wall (below/right). The jaunty-angled board on that south wall appeared in a 1953 photograph.

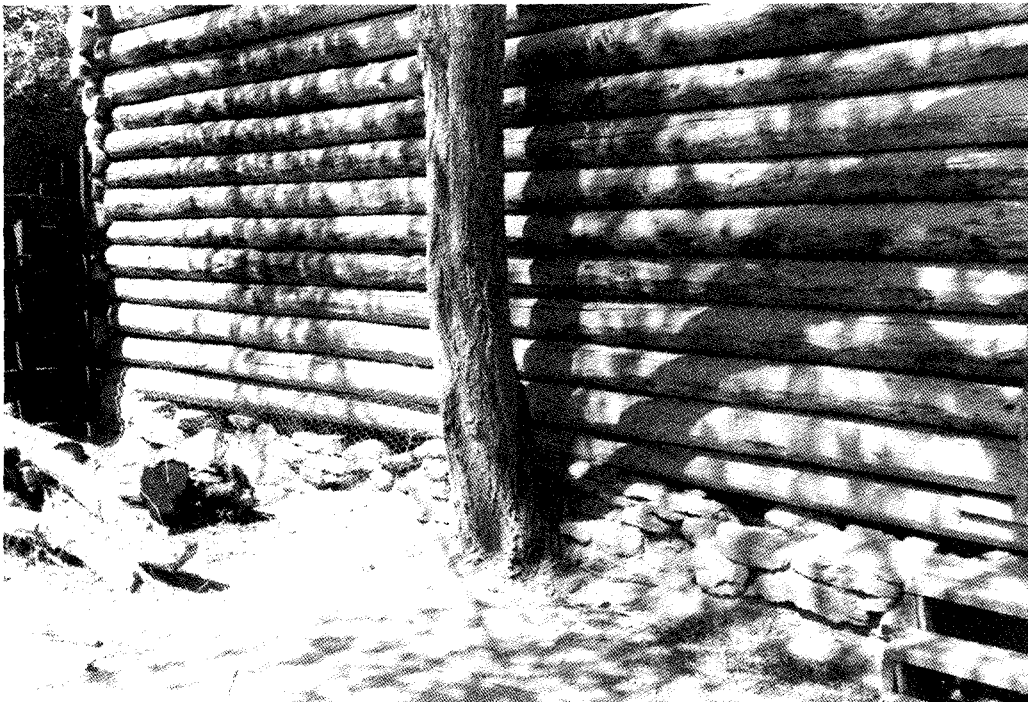
In 1986 stucco covered the east wall of the garage. A tree grew out from the stone foundation at the south end of the east wall.

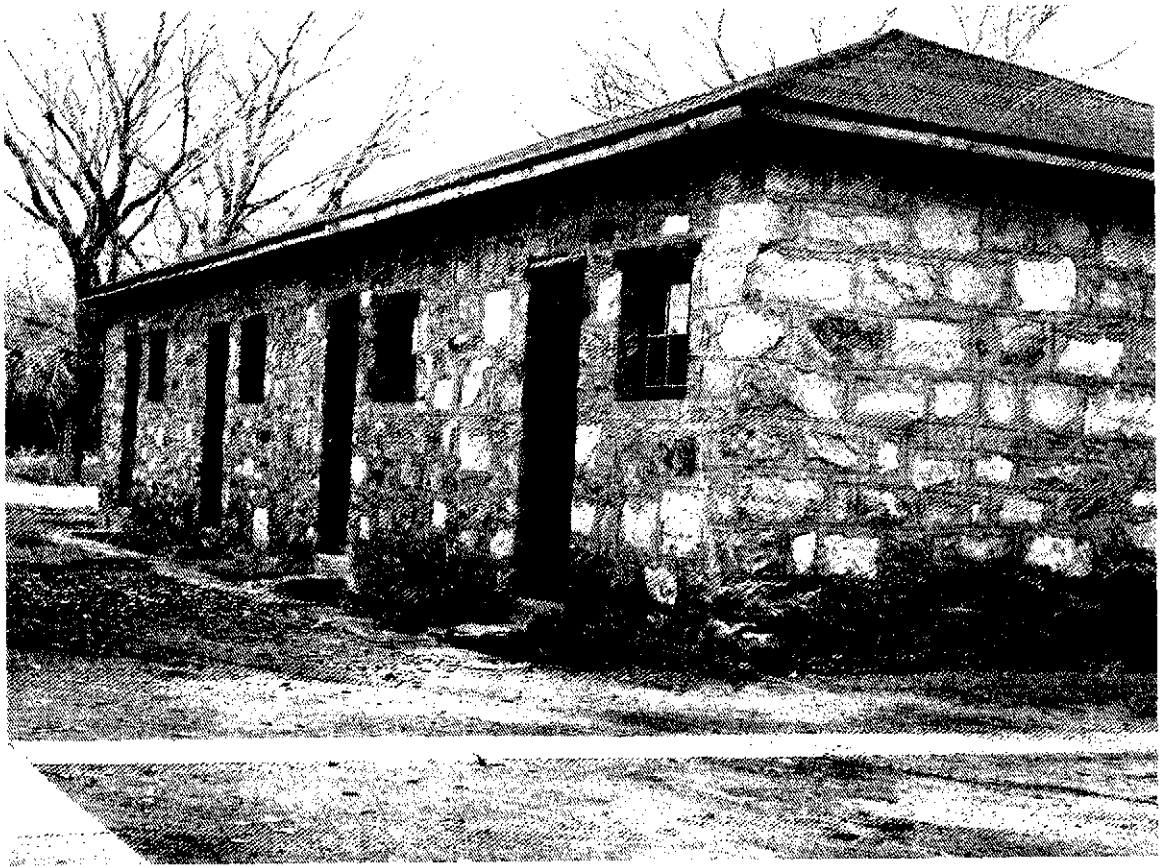
During the 1950s four doors on the west wall of building 14 (guest units 3,4,5, and 7) provided access. The concrete walkway did not extend as far as the building. Flagstone pavers led up to the steps. Moisture was evident around the bases of the walls.

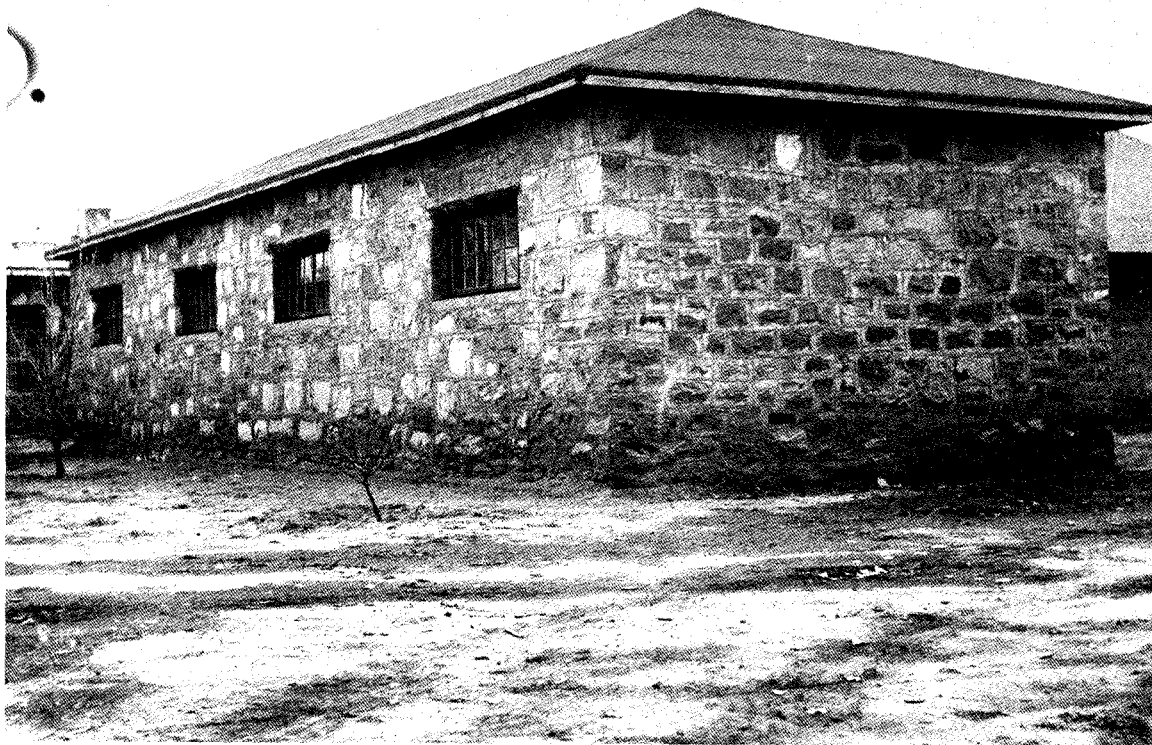
During the early 1950s the east elevation had four multi-light windows for fenestration. The north wall was solid. Small trees (left) had been planted to the east of the building, and the ground had no groundcover. Moisture was evident around the bases of the walls.

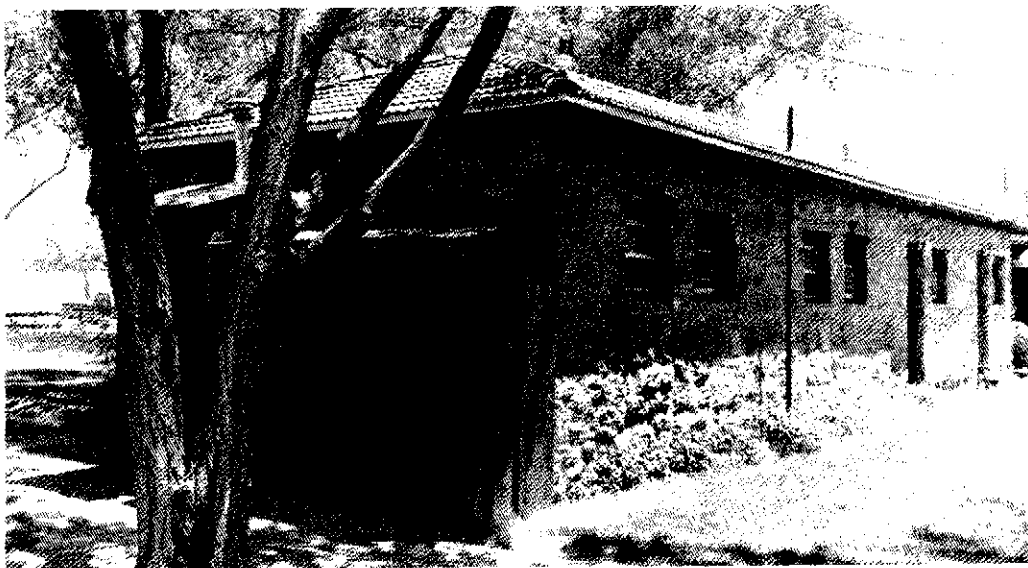
In 1986 two of the original doors remained on the west (above), and two other doors provided access on the east. A groundcover of grass and a number of shrubs surrounded the base of the building.

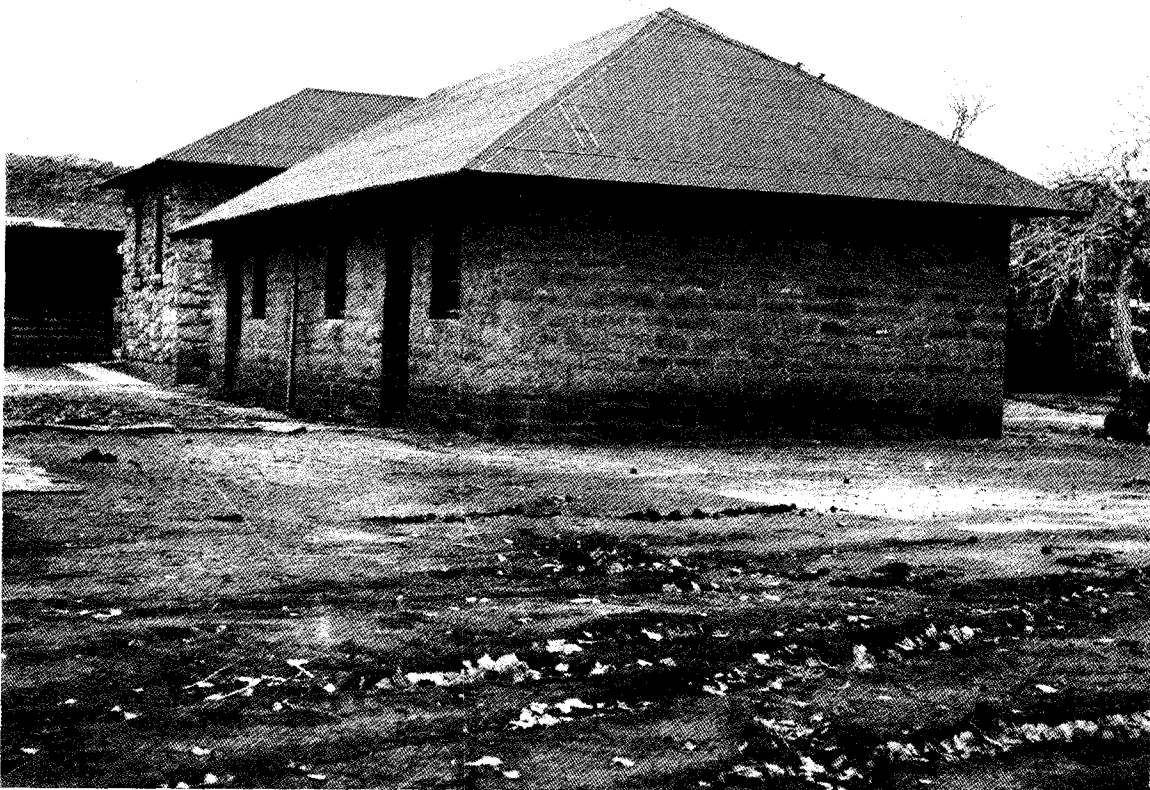
In the 1950s flagstone walkways and pavers led up to Building 15. Horses roamed the barren ground of the dude ranch. Moisture darkened the lower courses of stone.

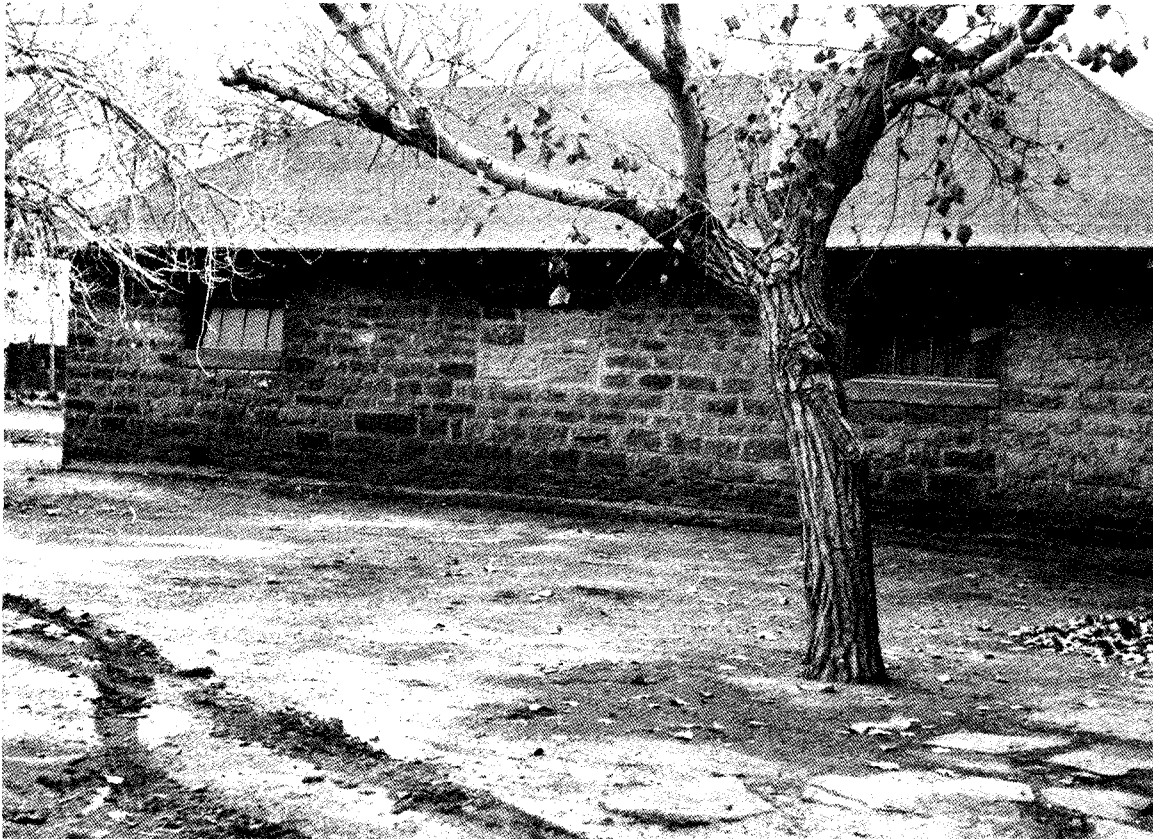
Even as early as the 1950s the concessioners had walled in one of the original windows on the west wall of Building 15. During this time huge quantities of earth sat under the hip roof and insulated the guest rooms.

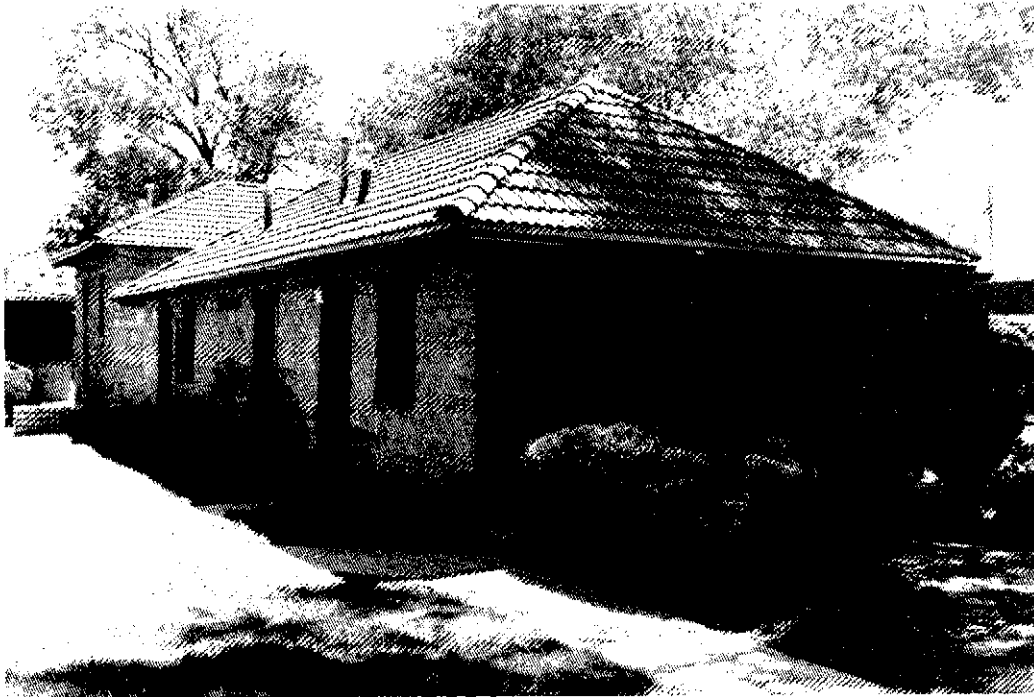
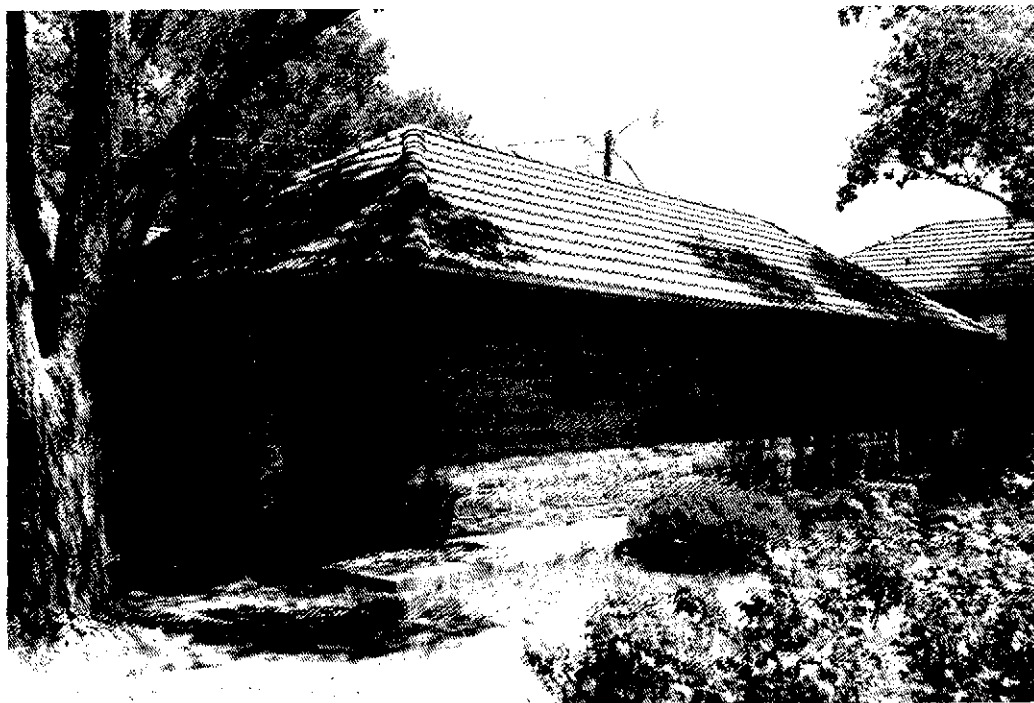
In 1986 the fenestration on the east (above) and west (below) walls was the same as it had been in the early 1950s. A concrete pad wrapping around the base of the building (below) probably dated from the La Fonts' time.

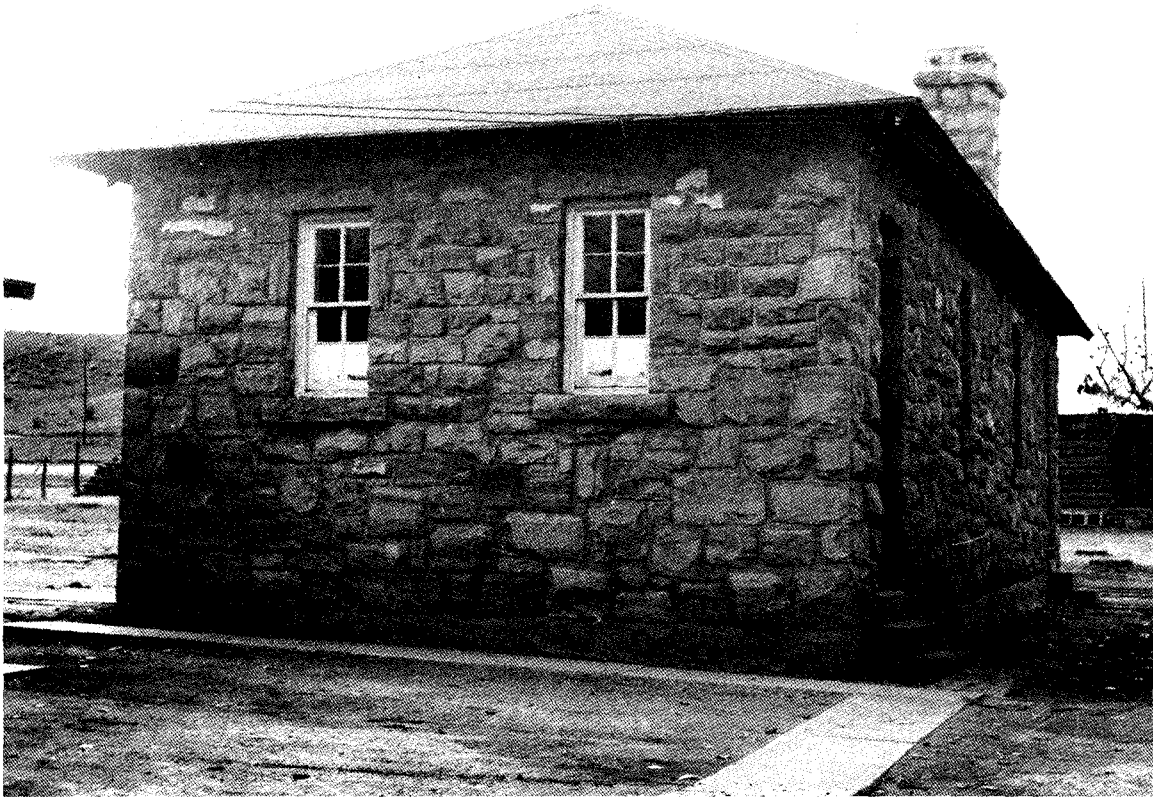
In the early 1950s this building housed the laundry room and showers. The building had a more vertical emphasis than the stone motel units. Again, the ground surrounding it had no groundcover. Some of the pathways were concrete, and some were flagstone pavers.

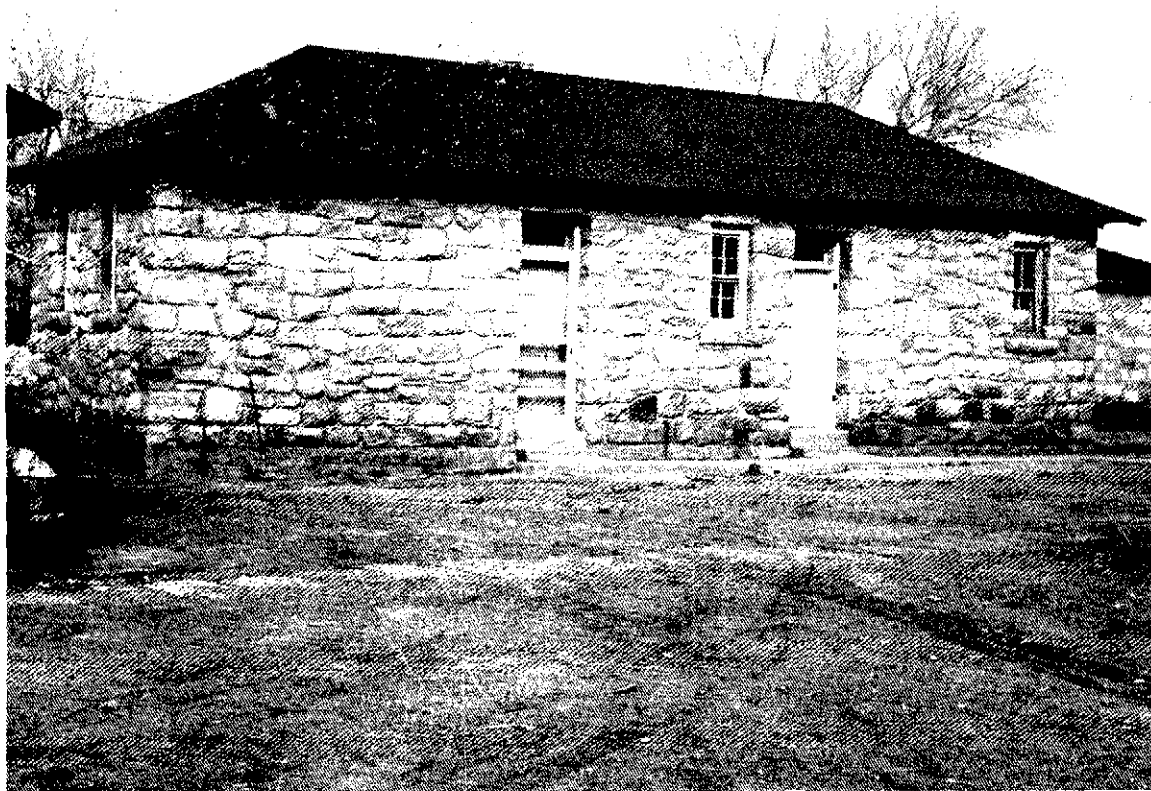
The south elevation of Building 16 had two doors and two windows. When the building became a luxury suite in 1985 the left door was partially walled in and turned in to a window.

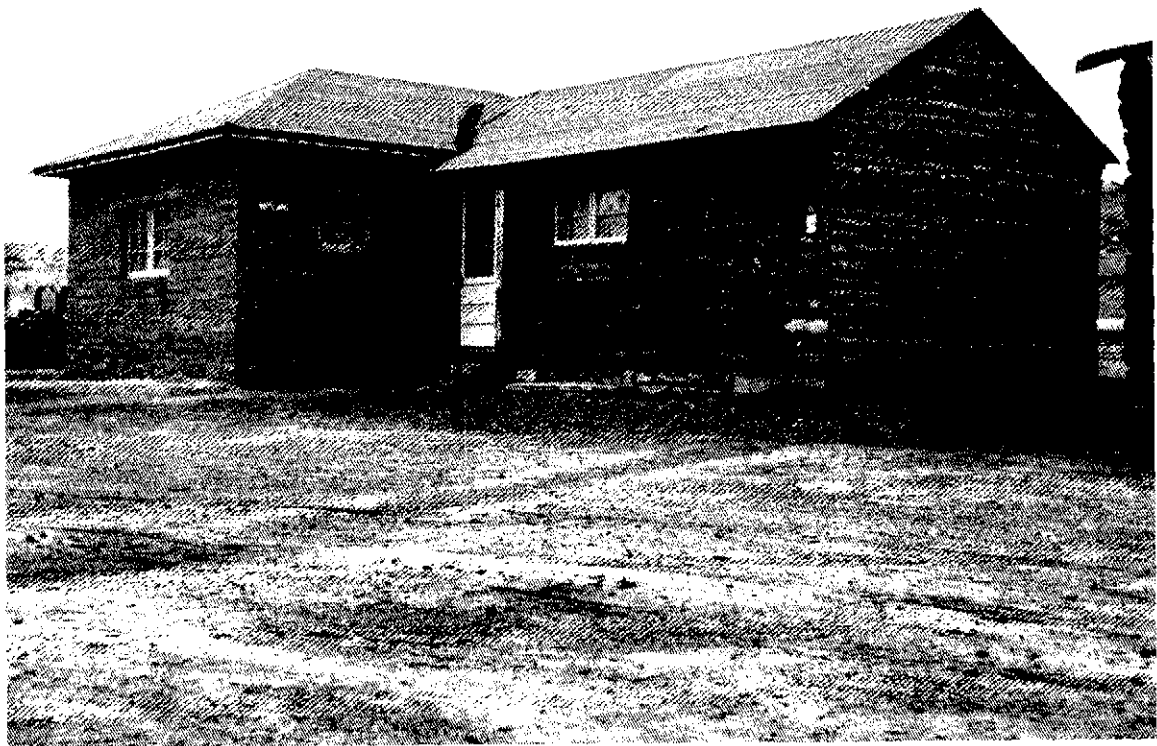
In 1946 Cozy McSparron constructed the northern wood-frame portion of this building as housing for workers. He added the adobe wing to the south five years later. The entire building had a stone foundation.

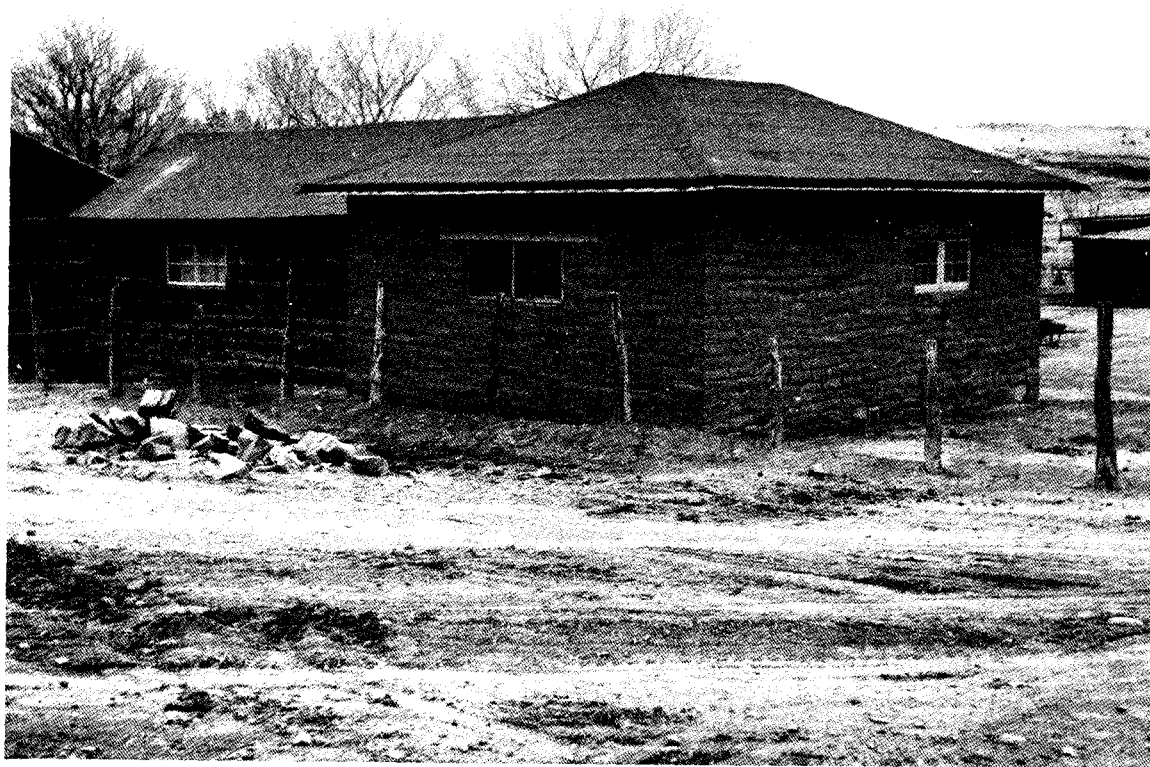
Cozy constructed the simple adobe and wood-frame building on the western edge of his small compound just south of the log barn.

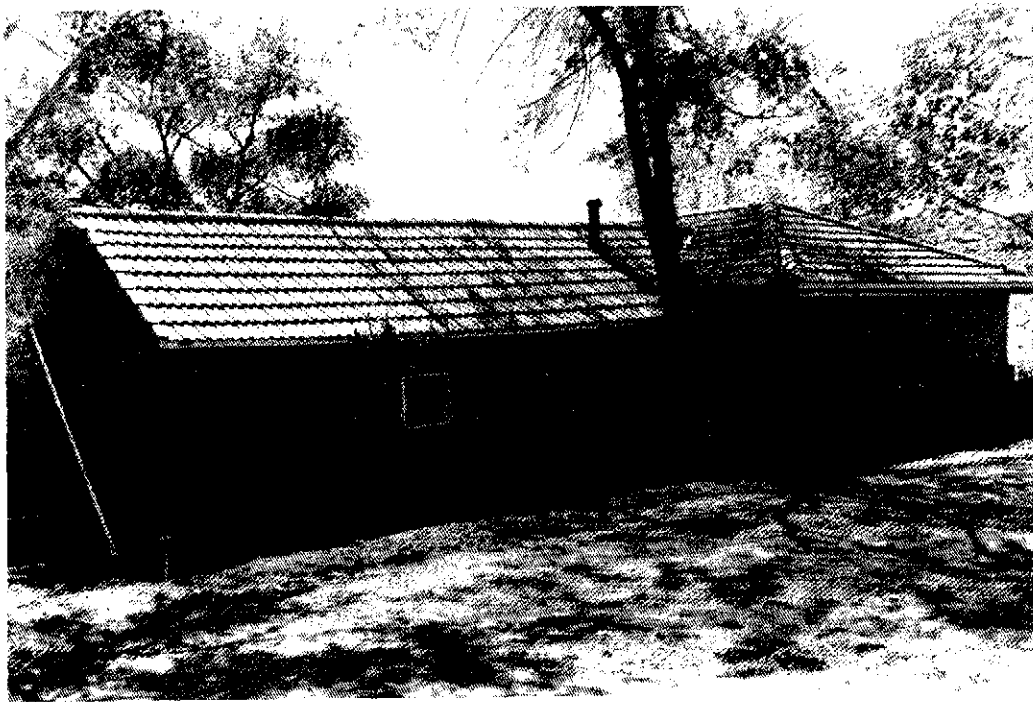
In 1986 the exterior walls had a cement stucco finish. When the motel complex expanded, this building and the log barn no longer edged the western boundary of the old compound.

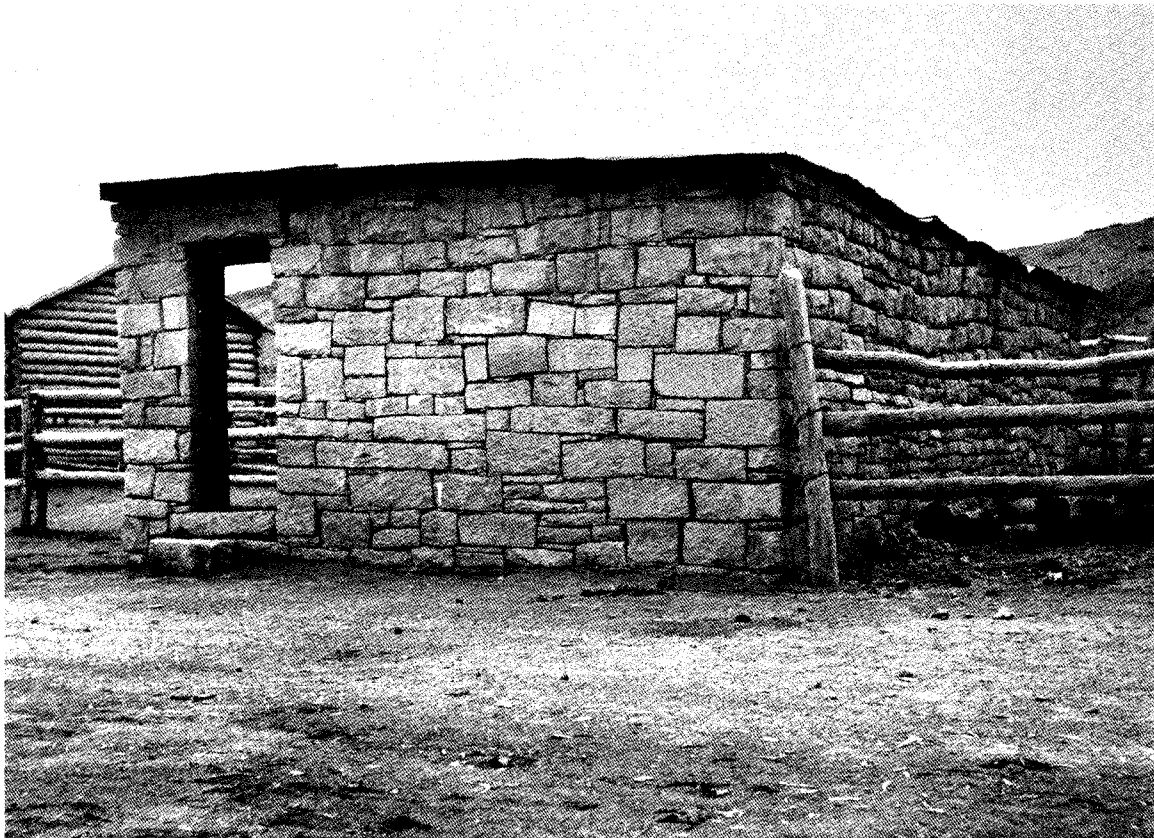
In the early 1950s small corrals bordered the north and south sides of the stone shed. A door opening was on the east wall.

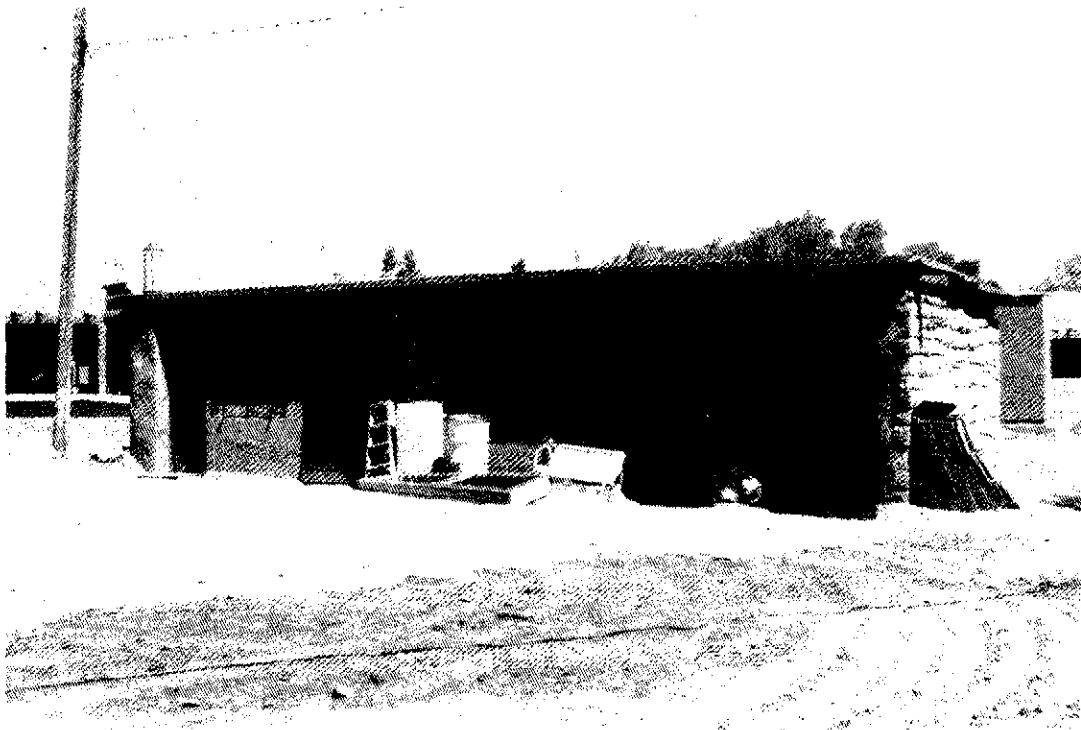
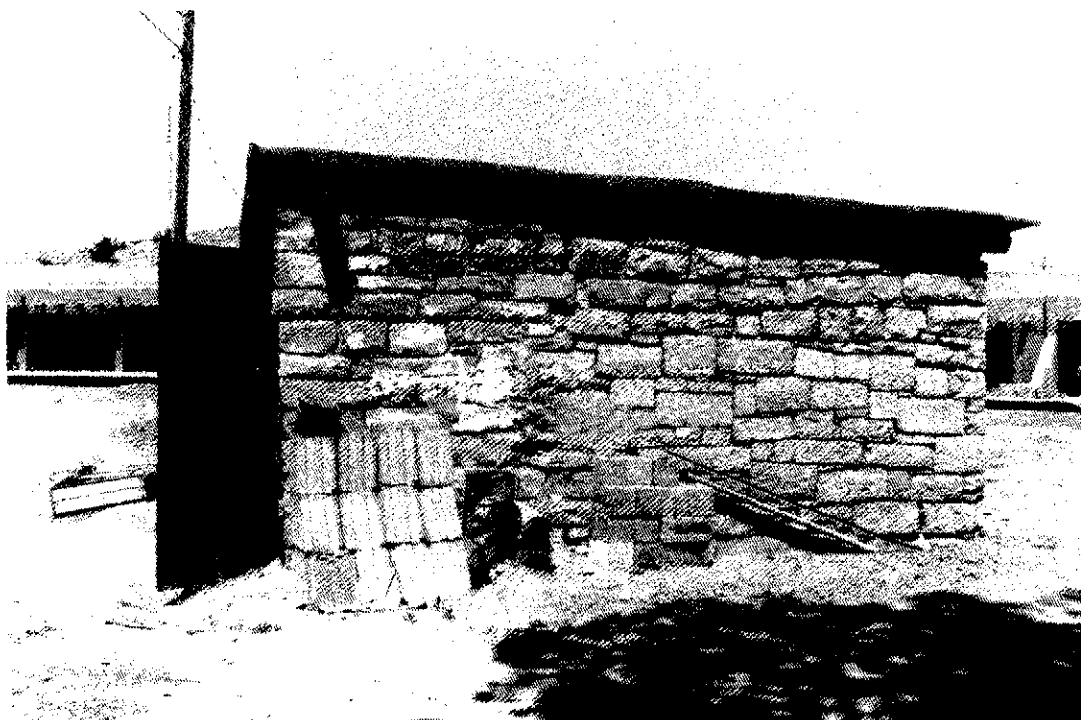
In 1986 the stone shed housed miscellaneous building materials. The front elevation had a stucco finish. The door opening in the east wall no longer existed (below).
