ARCHEOLOGICAL INVESTIGATIONS AT
THUNDERBIRD LODGE
CANYON DE CHELLY, ARIZONA

PETER J. McKENNA

SCOTT E. TRAVIS

SOUTHWEST CULTURAL RESOURCES CENTER PROFESSIONAL PAPERS
NUMBER 20

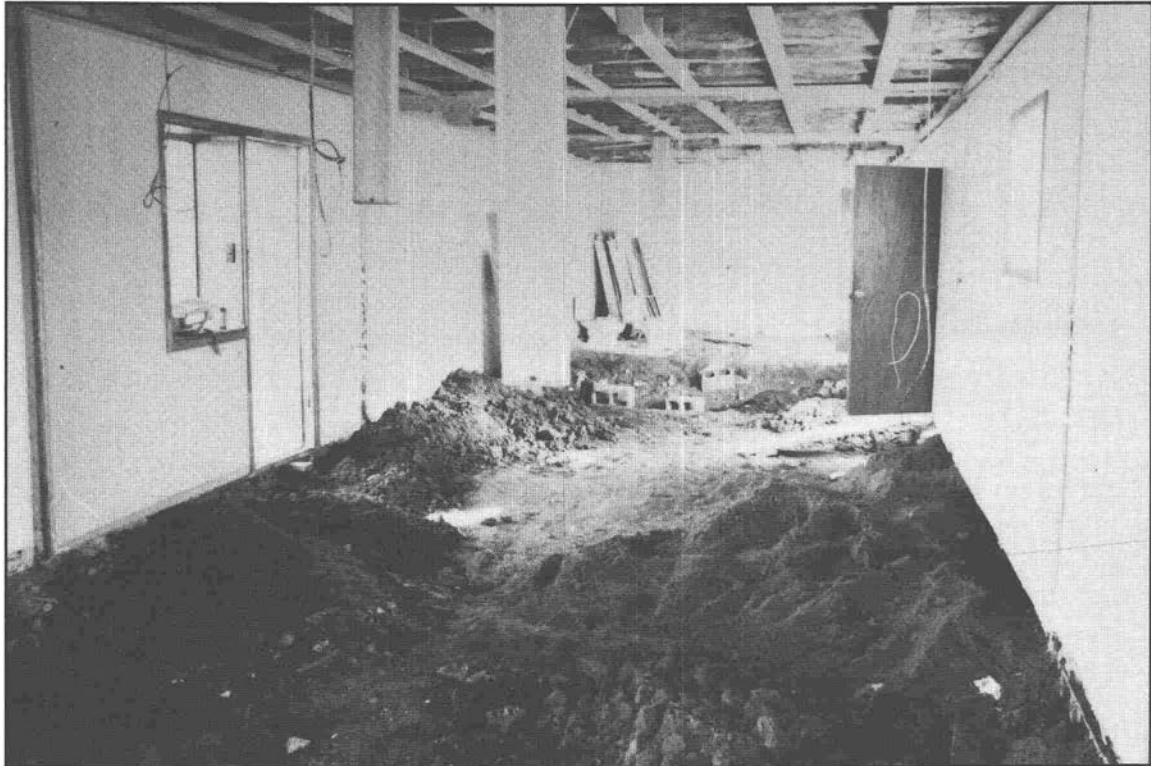
Figure 1.8 Interior of Building 14 after razing. Fill dirt is being added preparatory to pouring a concrete slab floor.

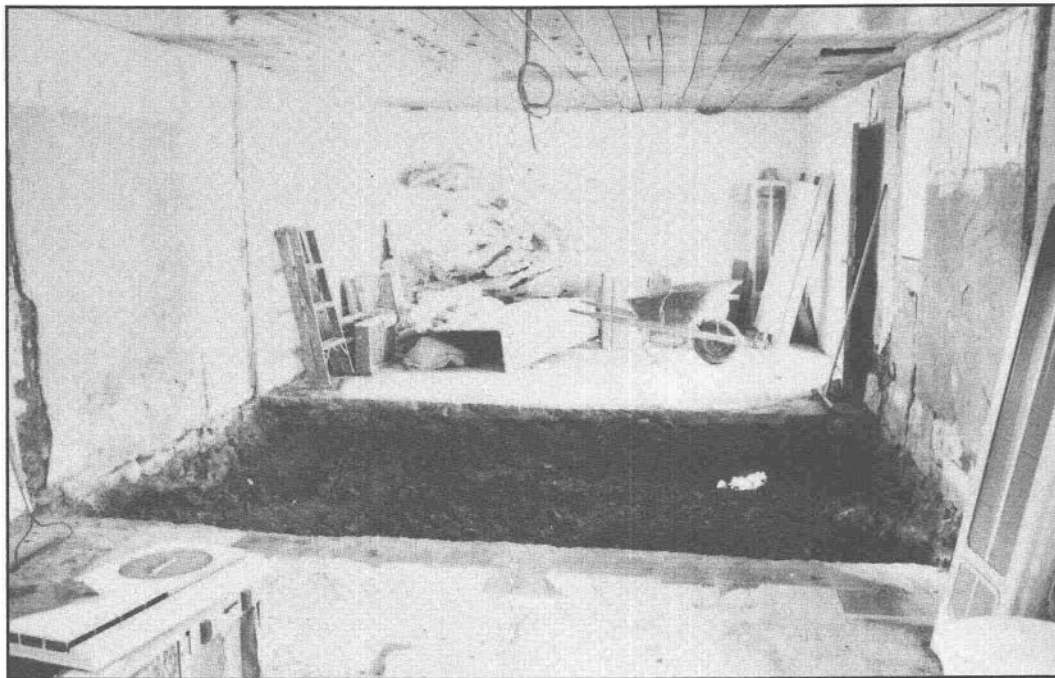
Figure 1.10 Interior of Building 15 after razing, showing removed central section of concrete floor.

The section of floor torn out, which was removed prior to any archeological examinations, measures 14 by 8.5 feet and averages just over 16 inches in depth. It revealed a segment of the structural foundations, a poorly defined foundation footing trench, and a relatively complex stratigraphy composed of construction and occupational debris (Figure 1.10).

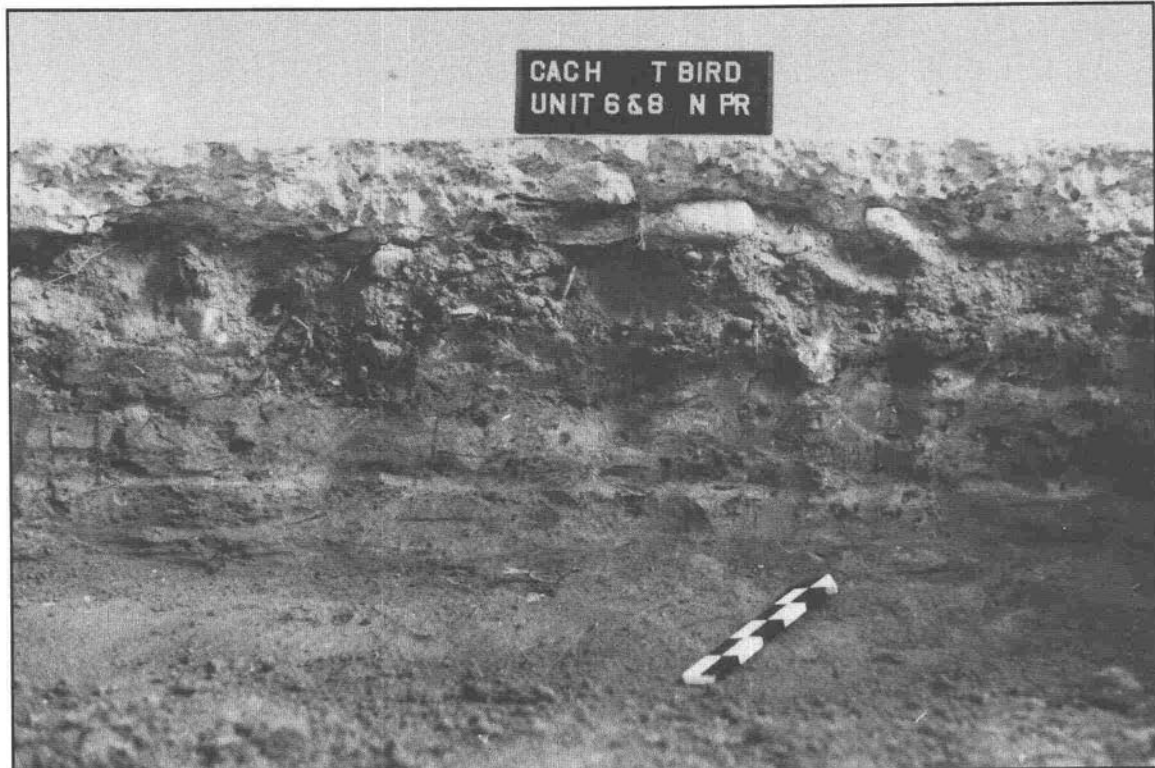
Figure 1.11 View of north profile face in Building 15.

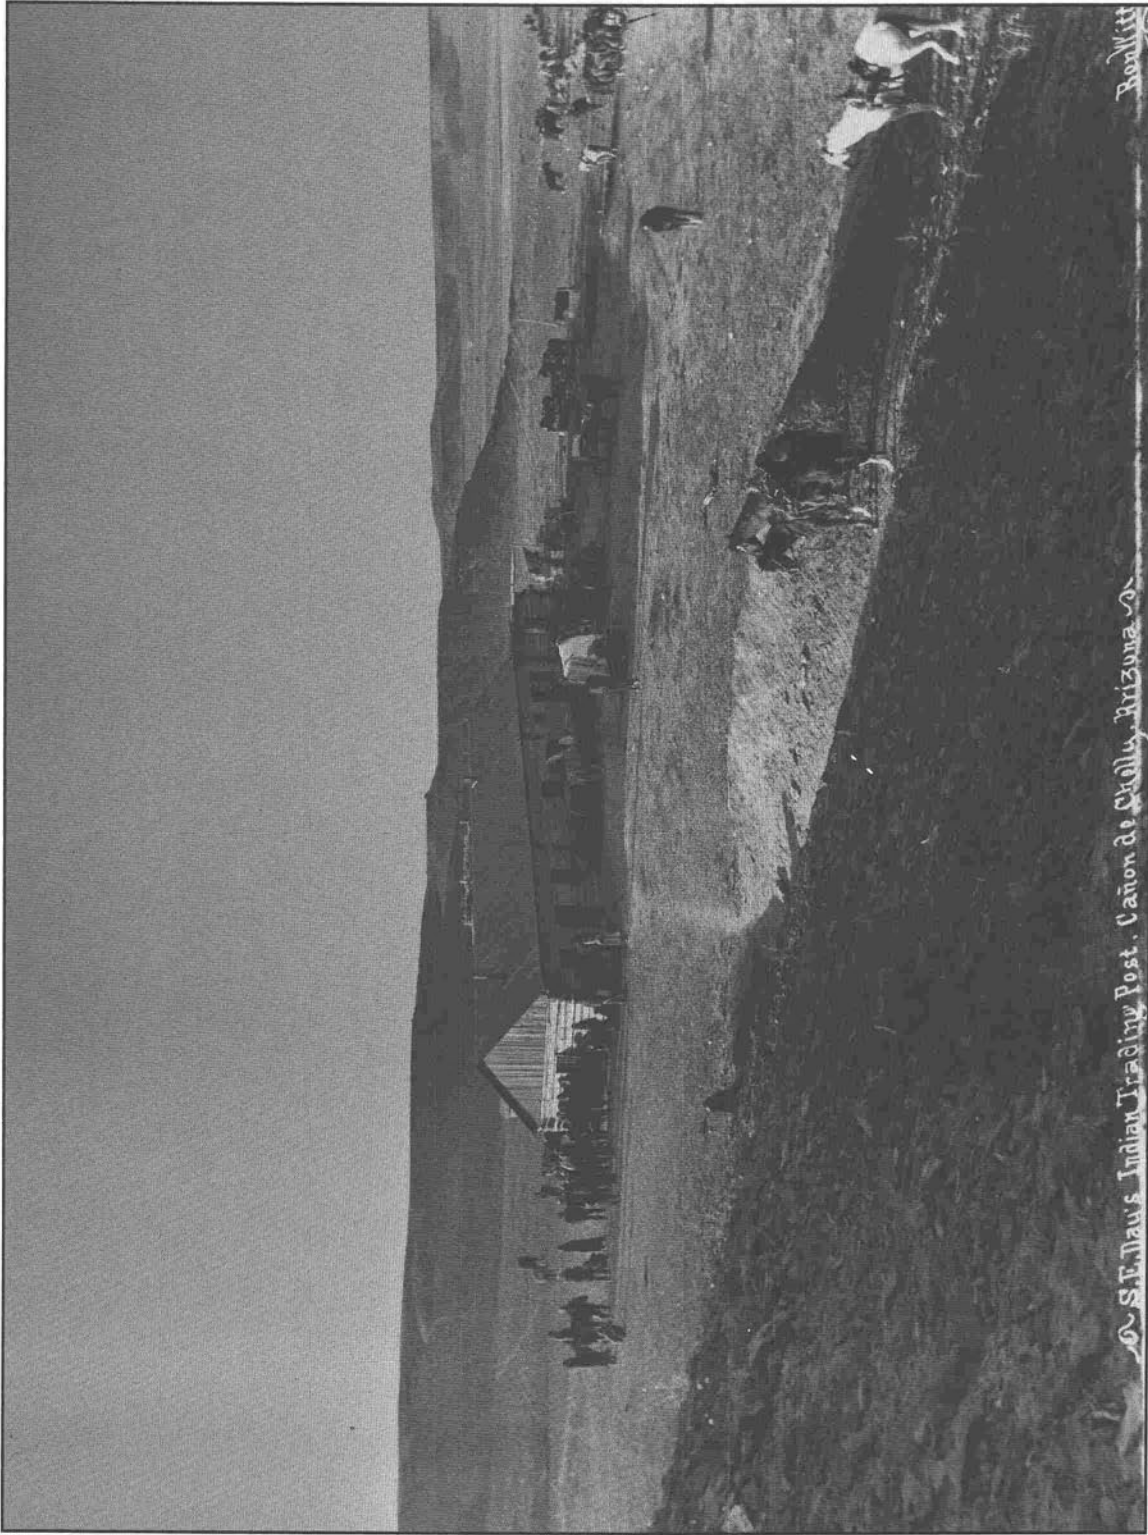
Figure 2.3. Sam Day's trading post (1902-03) with the excavation for the adobe structure in foreground. Day's flat-roofed living quarters are on the north end of the post with various activity areas and customers in front of the post. Photo by Ben Wittick, Courtesy School of American Research Collections in the Museum of New Mexico: Neg. No. 15988.

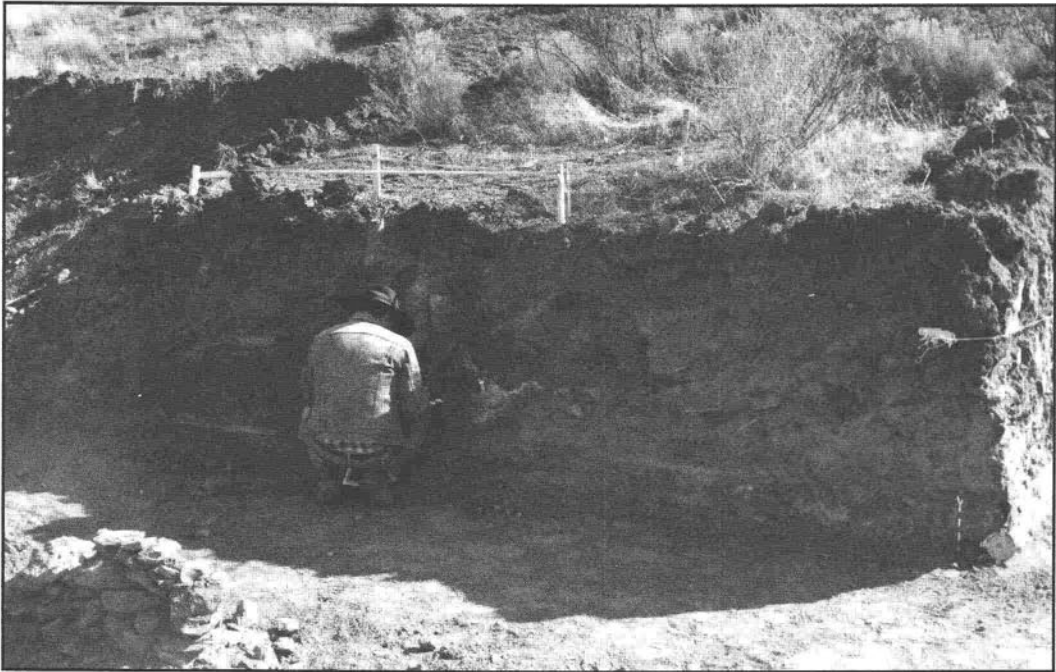
Figure 2.10. Profiling the north balk. Note wall stub and hearth ash to the right of worker.

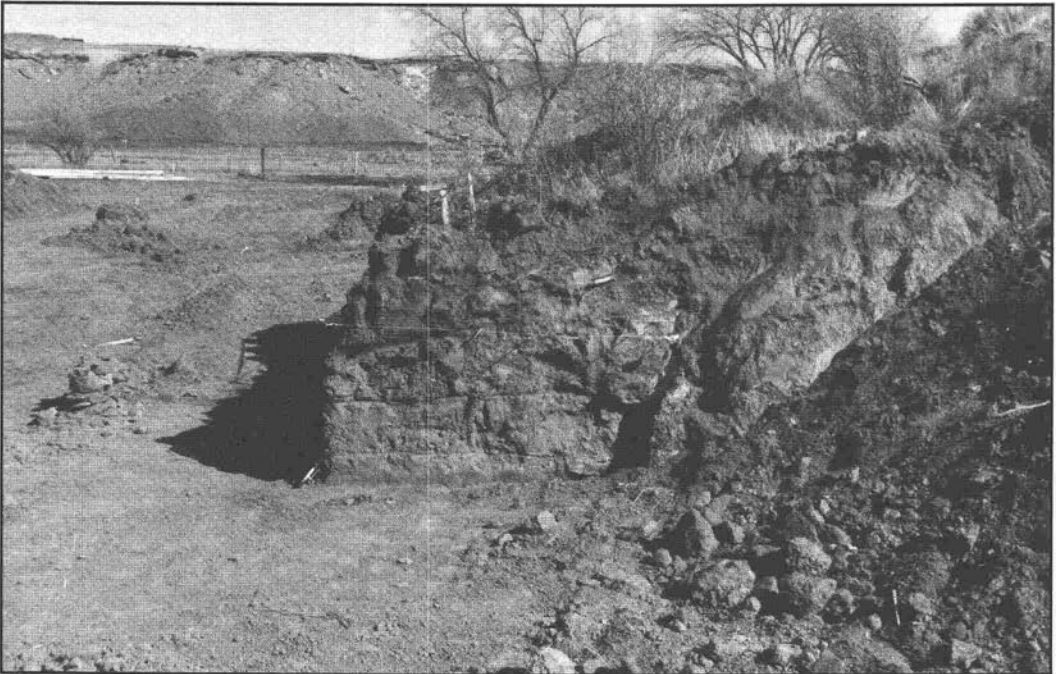
Figure 2.11. View of west profile showing stratigraphy.

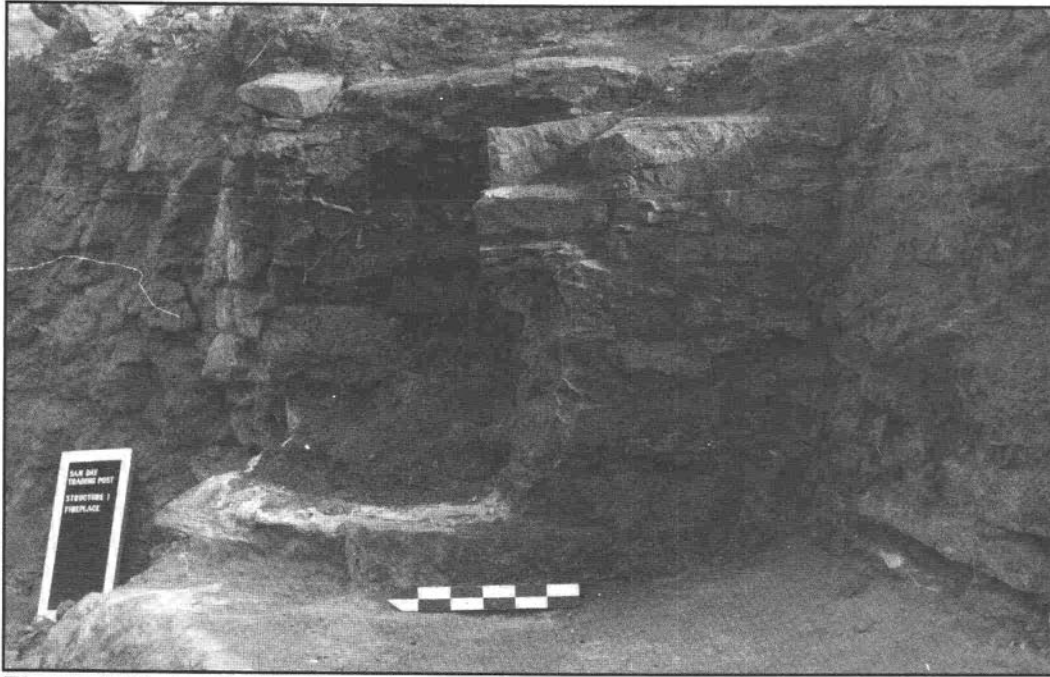
Figure 2.14 Detail of beehive-style masonry fireplace (30 cm scale to north).

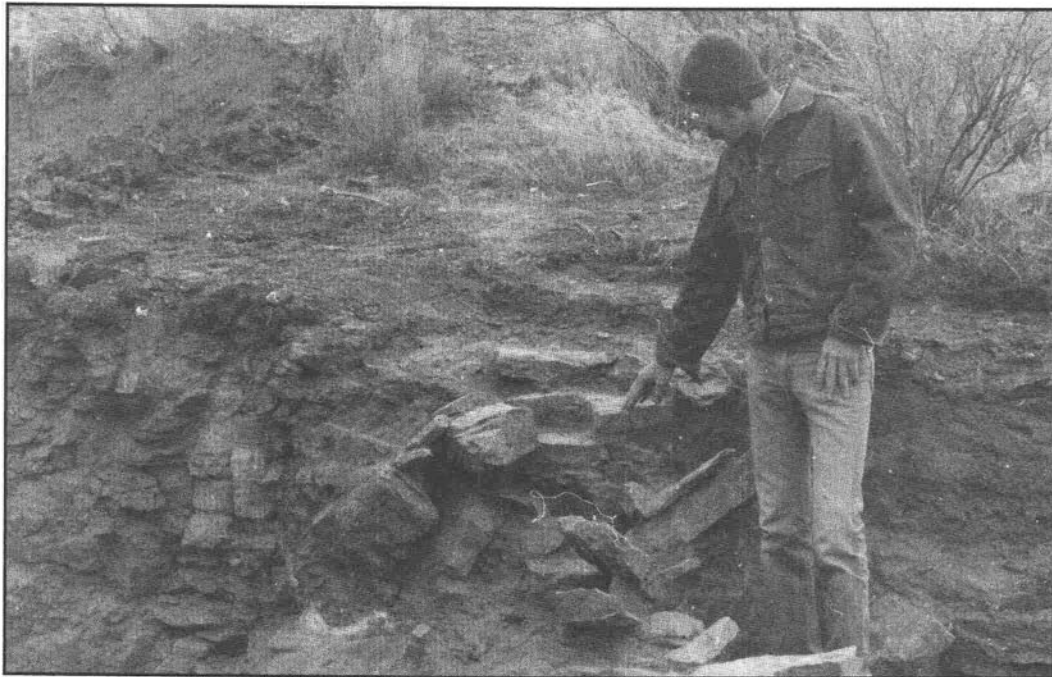
Figure 2.17 Collapsed fireplace. John Stein pointing to location of fireplace top beside mantel stone notch.

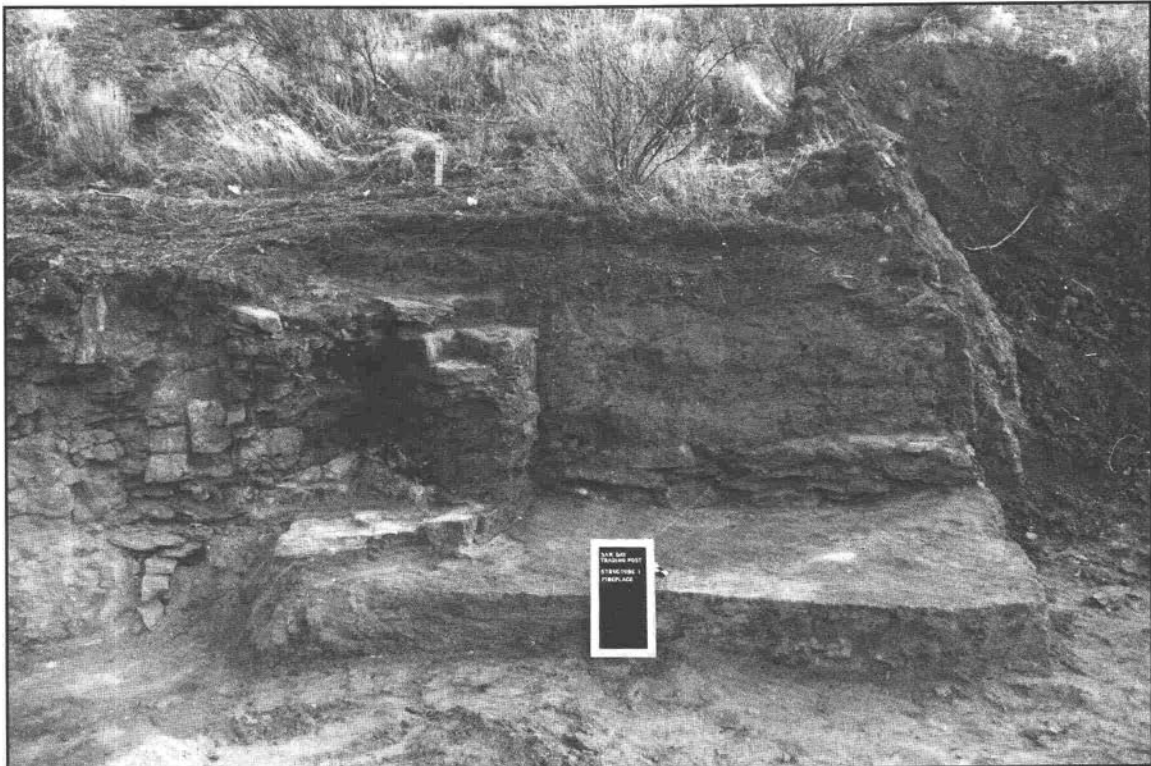
Figure 2.18 Overview of excavated room remnant: view to south.

Both floors were smooth and devoid of features other than the fireplace (Figure 2.18). No evidence of any room fenestration or other wall features was noted in the remaining walls, although one window is visible in historic photographs of the east elevation (Figure 2.4).
