CONDITION REPORT FOR FORT HILL RURAL HISTORIC DISTRICT

CAPE COD NATIONAL SEASHORE

National Park Service, Boston, Massachusetts, 2007

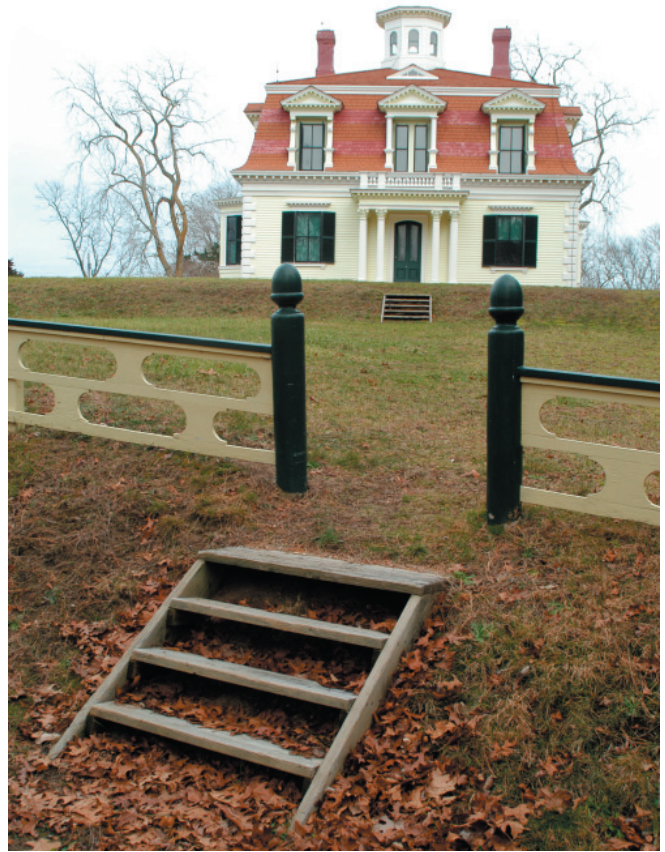
Figure 3. View looking east at west facade of Penniman house, perched on terraced lawn as seen from the south side of Fort Hill Road. A decorative fence surrounds the lawn (OCLP, January 2007).

Recommendation: Access to Penniman house via the western entrance is possible over the west lawn and two sets of wooden steps (see Figure 3). The access path to the lower set of steps from the road should be improved when clearing the woodland to the west to reinstate the view. The clearing of the woodland is discussed in more detail under the vegetation section.

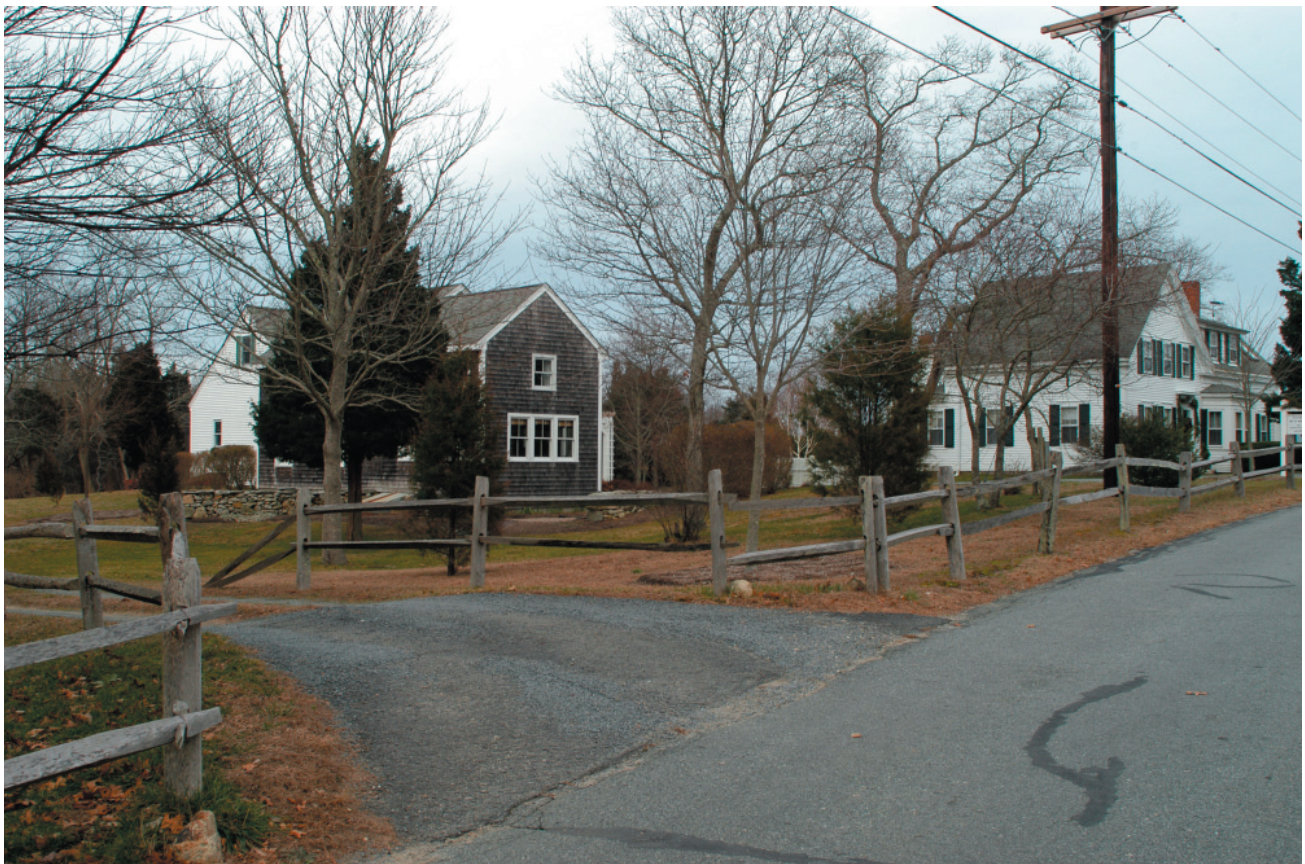
The Avery and Burrill houses are privately owned inholdings. The Avery house is on the north of Fort Hill Road, directly opposite the Penniman house. It is a white, two-story, clapboard house that now faces south (Figure 4). The earliest part of the house is a gable-roofed section that sits perpendicular to the Fort Hill Road, facing west. Another gable-roofed block was added to the rear (east) of this section, parallel to Fort Hill Road, facing south. A screened porch is appended to the east end of the house. The front of the house is planted with a variety of neatly trimmed, evergreen plants, both marking the foundation and dotted around the lawn. The front lawn is edged by a split-rail fence and buffered by additional evergreen shrubs. Two tall, conical evergreen trees mark the entrance to the property. The area to the west of the Avery driveway is heavily wooded, and a portion of a remnant stone wall, which perhaps marks the boundary of the

Figure 4. View looking northeast at west and south sides of the Avery (formerly Sylvanus Knowles) house (at right) on north side of Fort Hill Road (OCLP, January 2007).

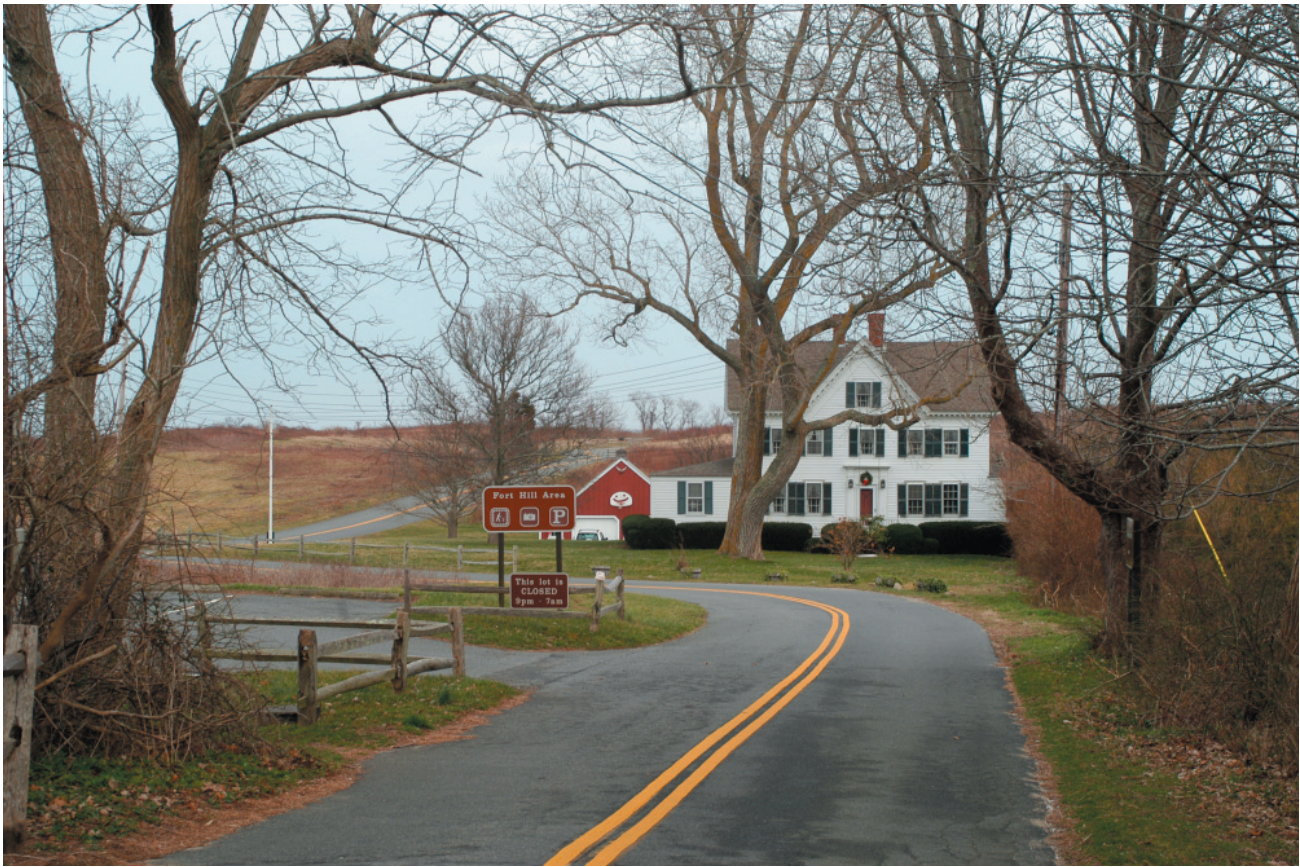
The Burrill house is located at the eastern end of the residential cluster and faces west (Figure 5). It is situated largely in line with Fort Hill Road, which curves sharply around to the north of the house. This structure is a two and one-half-story frame house with both clapboard and shingle siding. It has a gable roof with a central chimney and a large center cross-gable. Evergreen shrubs create a foundation planting around the front of the house. The front west lawn is planted with grass and contains a large cottonwood tree and a single flowering hydrangea. The rear east lawn is largely open.

Figure 5. View looking east at west facade of the Burrill (formerly Seth Knowles) house and barn on south side of Fort Hill Road. The entrance to the National Park Service lower parking lot (OCLP, January 2007)

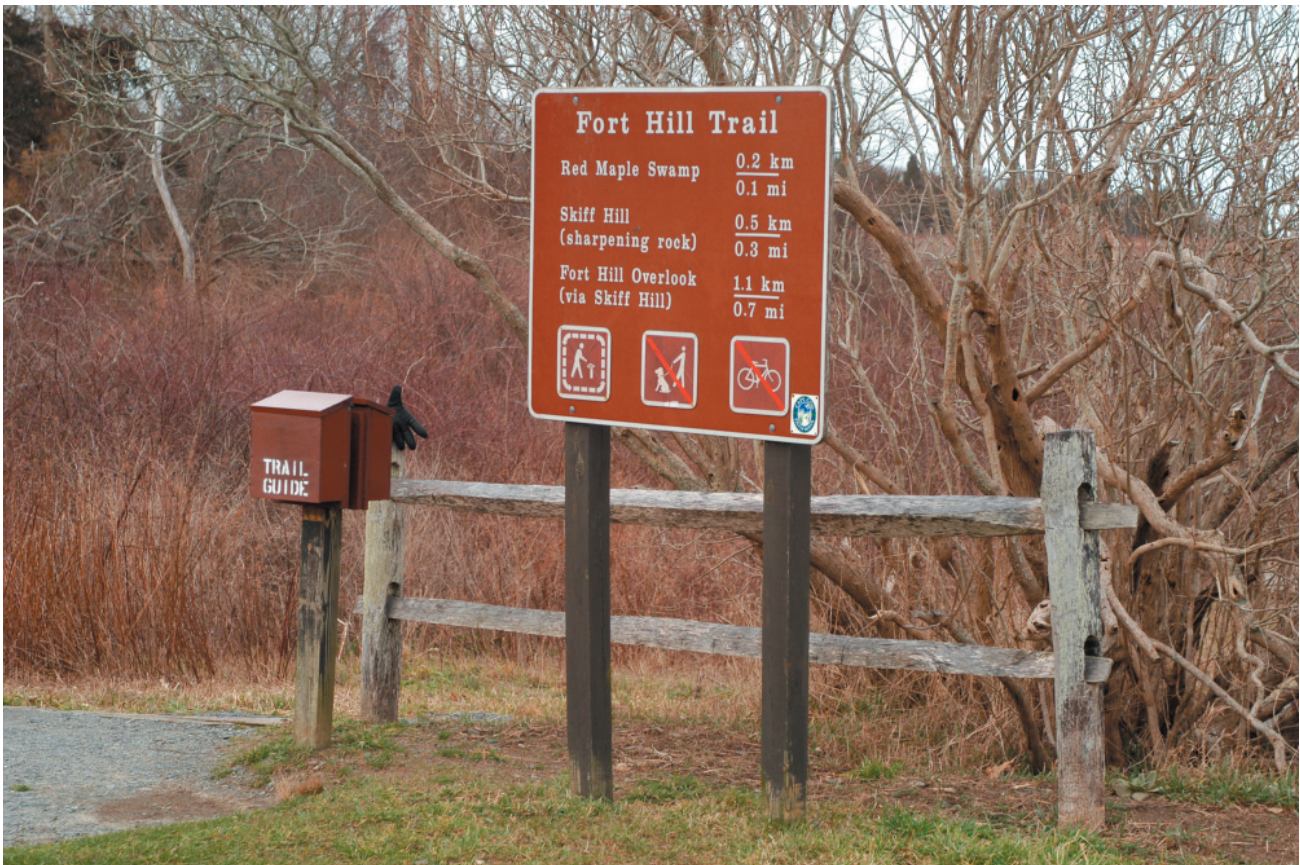
Figure 6. View looking north at trail entrance and sign near the National Park Service lower parking lot on Fort Hill Road (OCLP, January 2007).

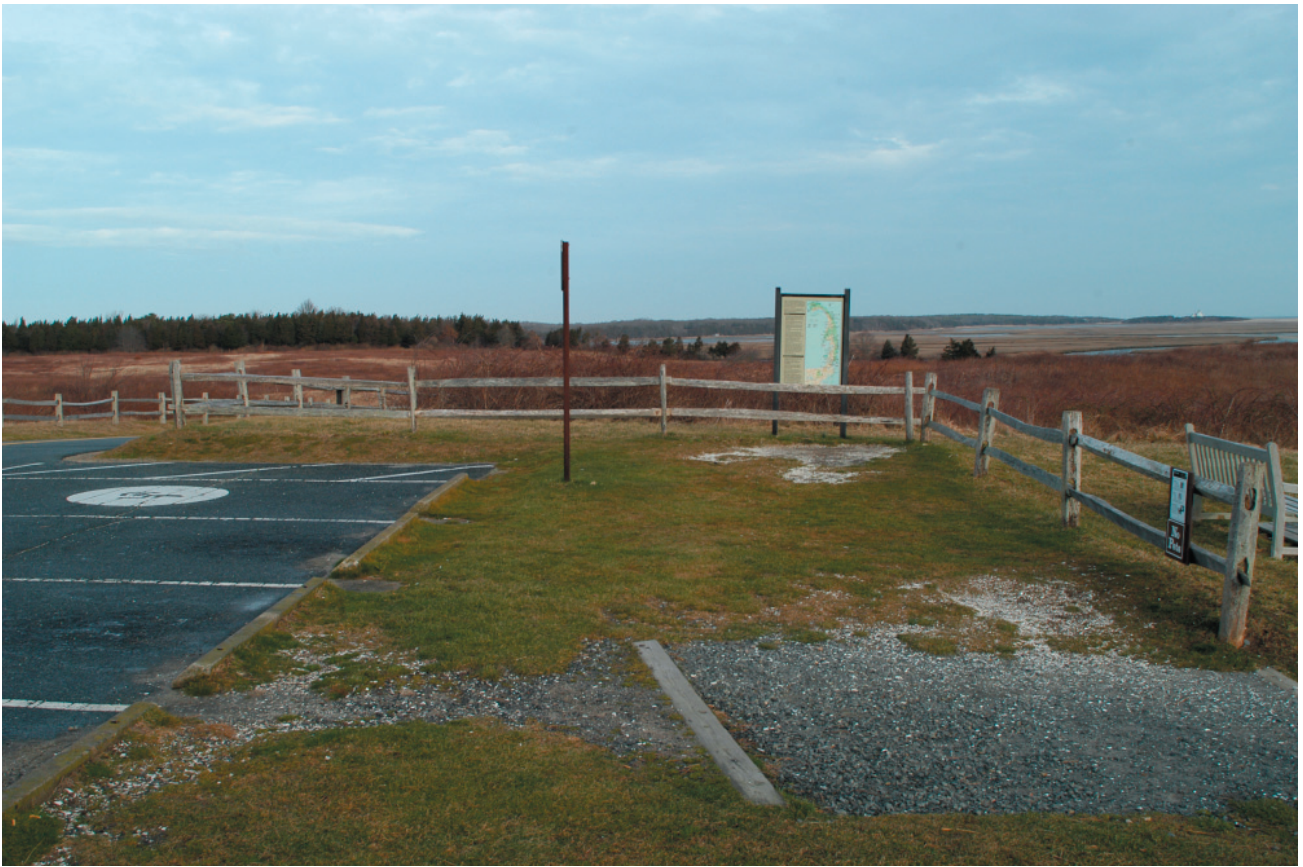
The east end of Fort Hill Road, which extends into the field area, terminates at a paved parking lot and overlook at the top of Fort Hill at an elevation of 50 feet (Figure 7). From this panoramic viewpoint, the land slopes away gently to the south, where it meets the creek and the marshy edge of Town Cove. Across the cove the residential development known as Smith Heights is visible. The view to the east looks over the Nauset Marsh to the Atlantic Ocean. To the northwest and west, the open fields extend to the woodland edge of the Red Maple Swamp, and to the wooded property lines of the three houses along Fort Hill Road. From the overlook, views north across the fields and features such as the stone walls are compromised by the overgrowth of woody plants (Figure 8).

Figure 7. View looking north from Fort Hill Overlook upper parking lot, which is bounded by split-rail fencing. The bluestone-covered walking path in the foreground leads east past a bench, visible on right, and downhill towards the Nauset Marsh, which is visible in the distance (OCLP, January 2007).

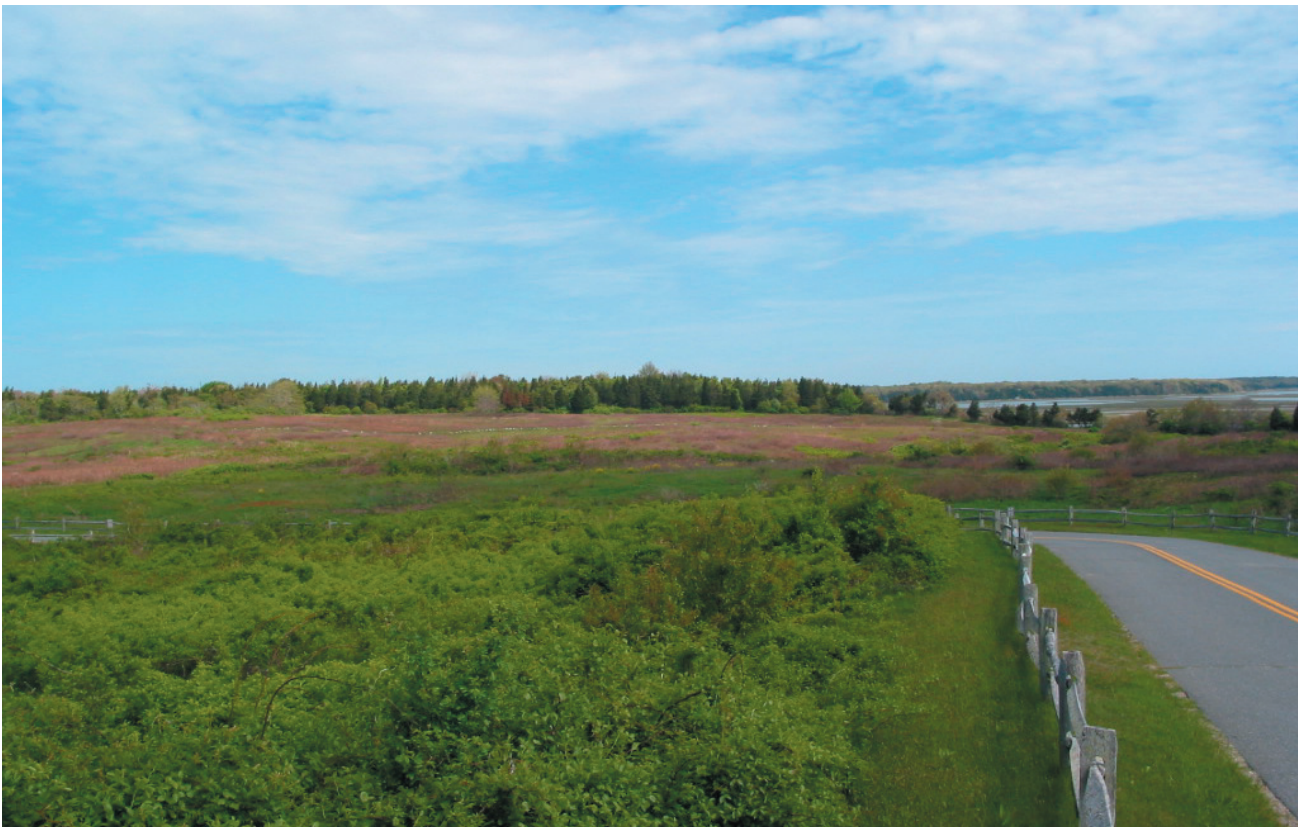
Figure 8. View looking north from the Fort Hill Overlook across the open fields toward Skiff Hill. Stone walls in the distance are partially obscured by tall vegetation. Fort Hill Road is in the foreground (OCLP, May 2007).

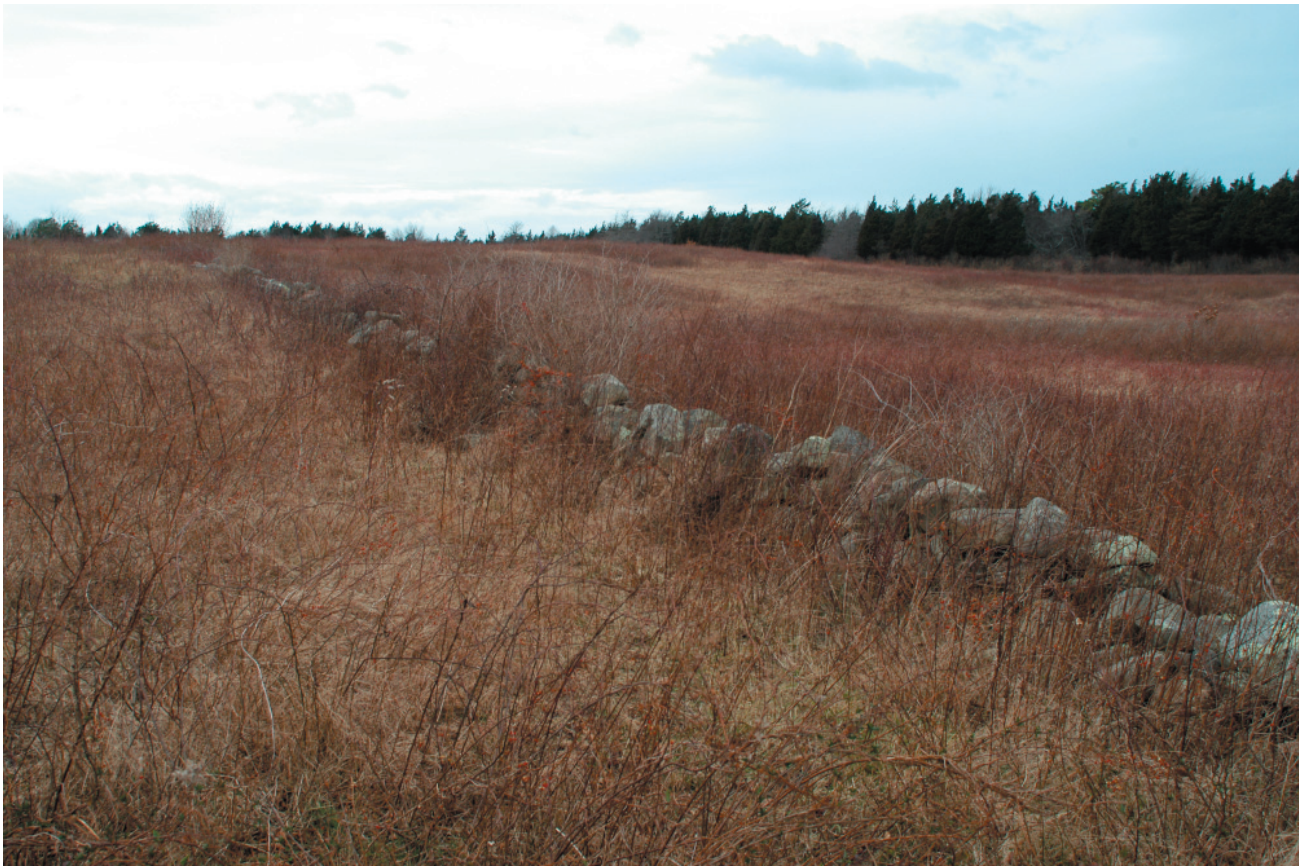
Figure 9. View looking northwest showing a stone wall obscured by multiflora rose on the north side of the open fields (OCLP, January 2007).

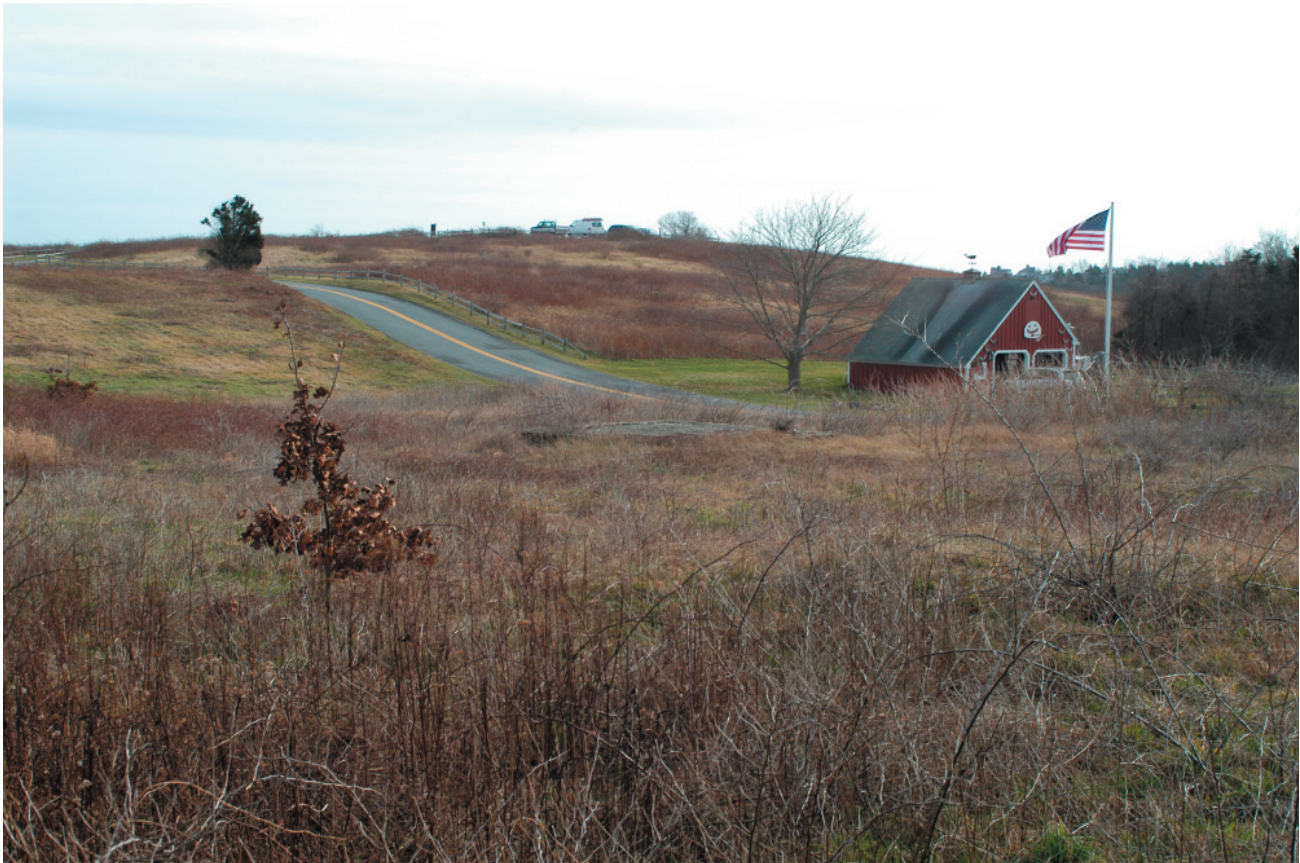
Two other features are found north of Fort Hill Road across from the Burrill house. One is a capped foundation of mortared stone, measuring 15 foot by 16.5 feet, upon which part of the large Gunn dairy barn once stood. The capped barn foundation is barely visible in the overgrown fields (Figure 10). The other is a partially buried boulder that shows drill holes, and in which a fragment of metal remains lodged.

Figure 10. View looking southeast showing the capped foundation of the Gunn dairy barn at center of photo. The Burrill barn, Fort Hill Road and Fort Hill Overlook are visible in the background (OCLP, January 2007).

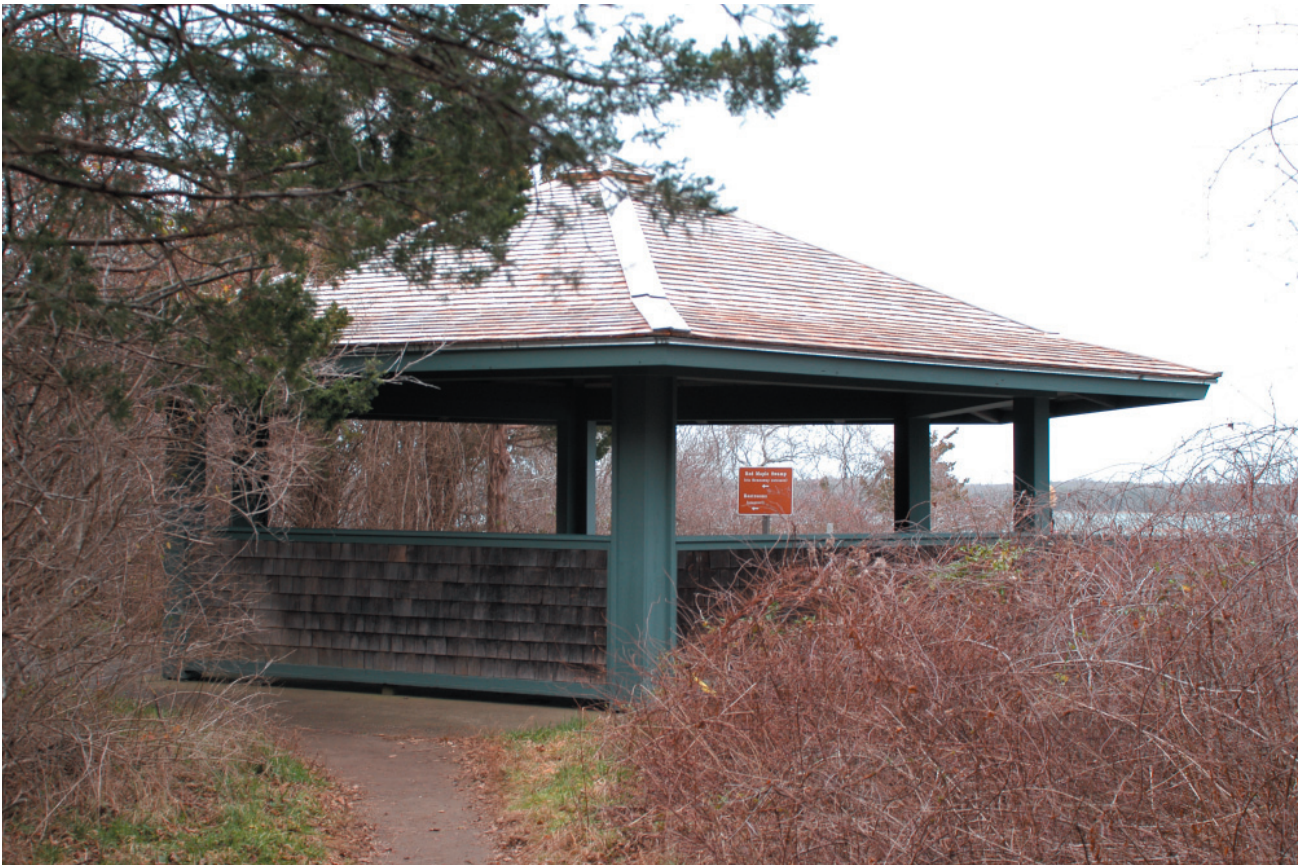
Figure 11. Skiff Hill shelter surrounded by encroaching vegetation with partial views of Nauset Marsh in the distance (OCLP, January 2007).

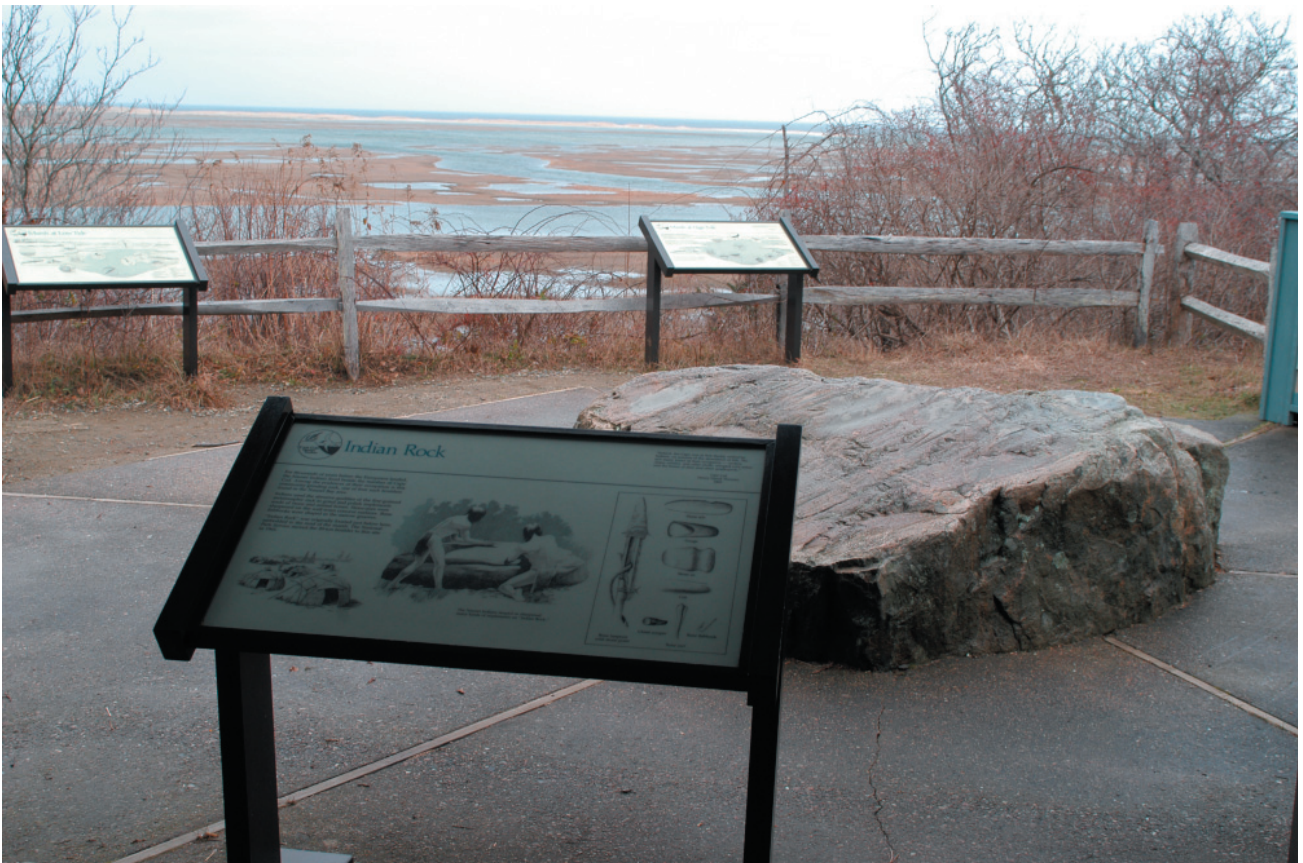
Figure 12. View looking east showing the Indian Rock used as a sharpening stone, with an interpretive sign in the foreground and Nauset Marsh in the distance (OCLP, January 2007).

Recommendation: The positioning of the four waysides at the shelter is ad-hoc and the concrete paving around the sharpening stone is aesthetically unpleasing and inappropriate given the significance of the stone (see Figures 12, 74 and 75). Interpretation should be evaluated and improved as part of the rehabilitation of the Skiff Hill shelter area.

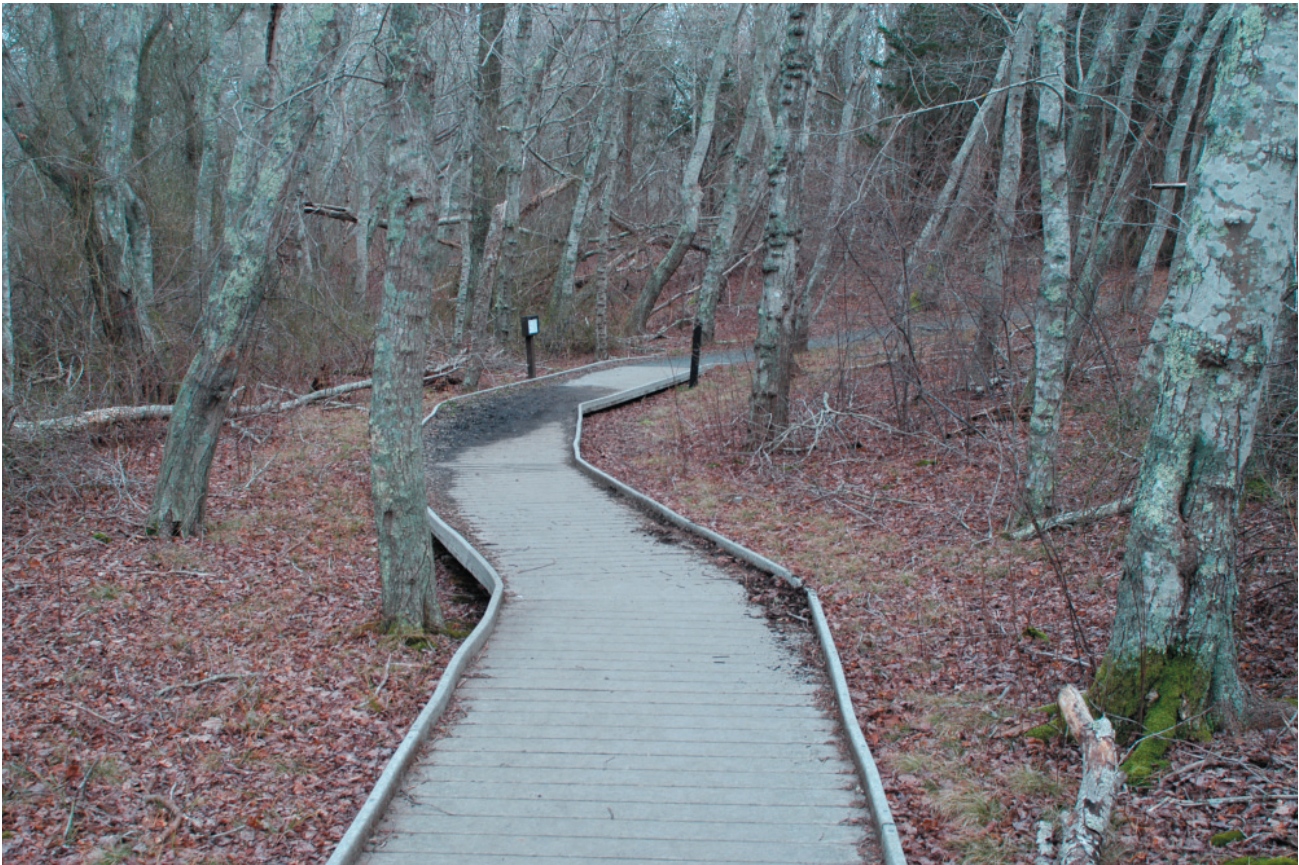
The Red Maple Swamp Trail and the Fort Hill Trail wind through the entire area. The Swamp Trail travels over a low 4-foot-wide boardwalk constructed partially of recycled material (Figure 14). It runs southwest from the Hemenway Road entrance, then serpentine eastward to join the Fort Hill Trail in the open field zone. From this main boardwalk trail another dead-end boardwalk trail diverts off east into the Red Maple Swamp as a alternative visitor route.

Figure 14. View of the Red Maple Swamp Trail boardwalk, constructed of partially recycled material, leading through the swamp (OCLP, January 2007).

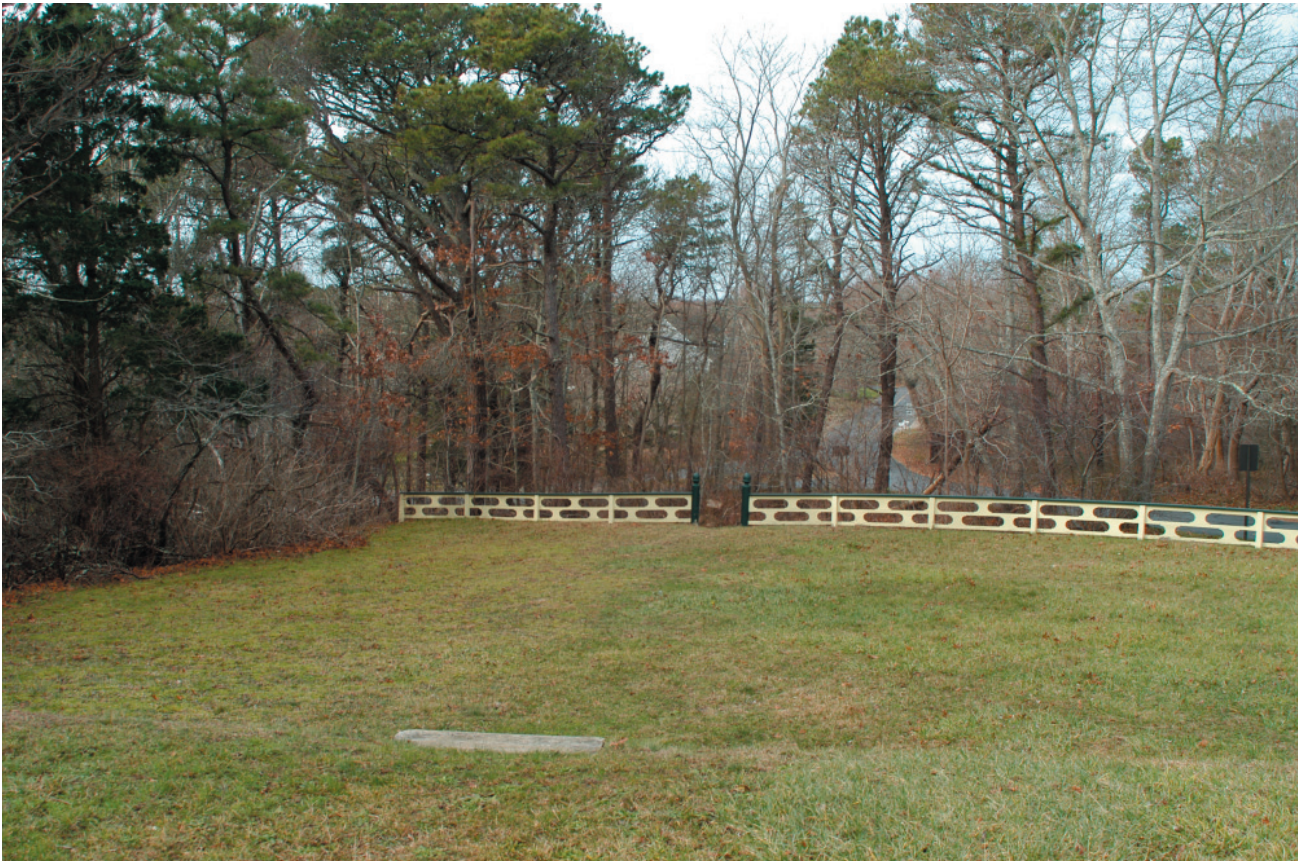
Figure 22. Recent photograph looking west across the Penniman house lawn, taken from a vantage point similar to the photograph above. Note the fence posts and the growth of vegetation which block the view (OCLP, January 2007).

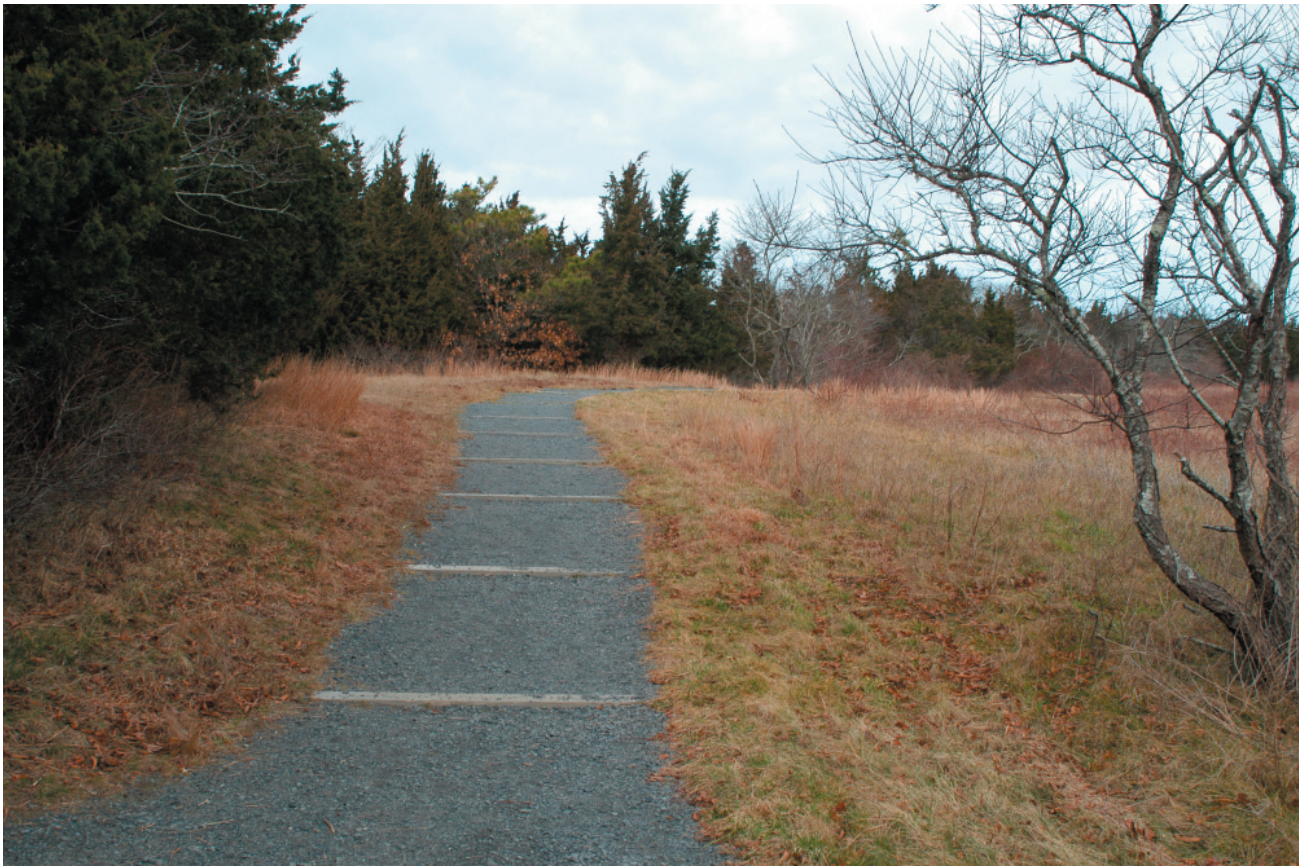
Figure 23. Photograph showing the existing bluestone gravel surface of the Fort Hill Trail. The surface material for these paths will be changed to a native colored gravel to harmonize with the natural setting (OCLP, January 2007).

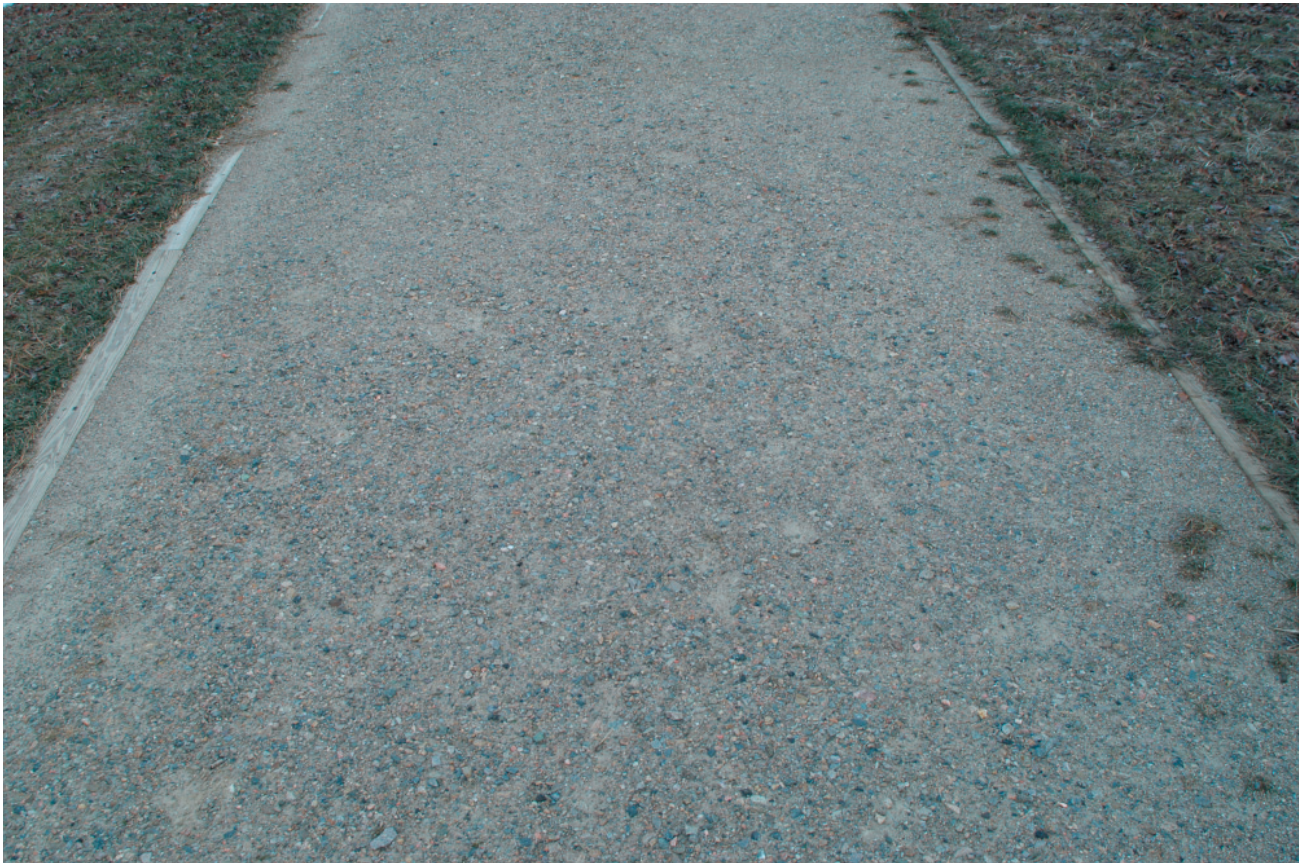
Figure 24. Example of the more natural-colored gravel surface of a path at the Salt Pond Visitor Center (OCLP, 2007).

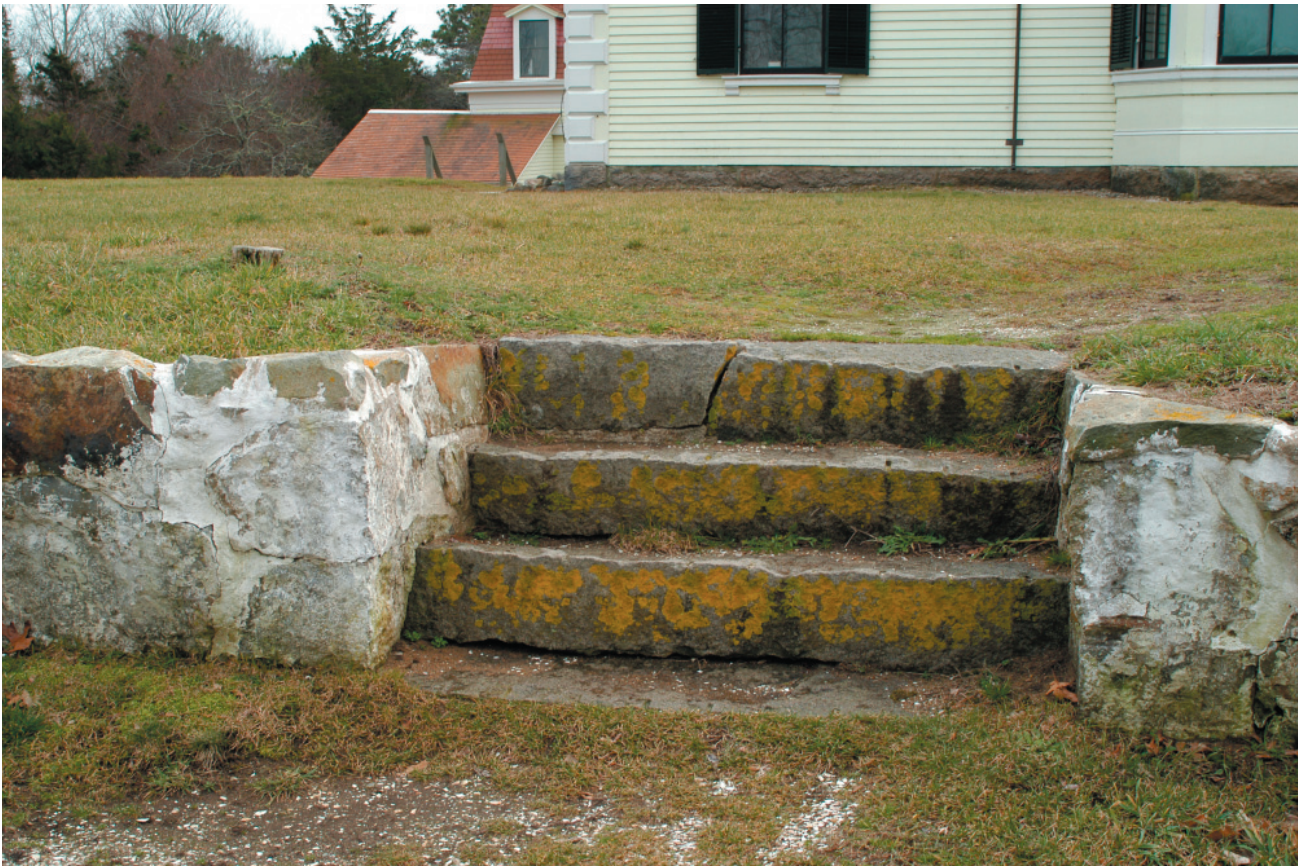
Figure 25. Granite steps on the north side of the Penniman house along Fort Hill Road. The addition of a simple, unobtrusive hand rail would aid visitors with mobility or sight impairments (OCLP, January 2007).

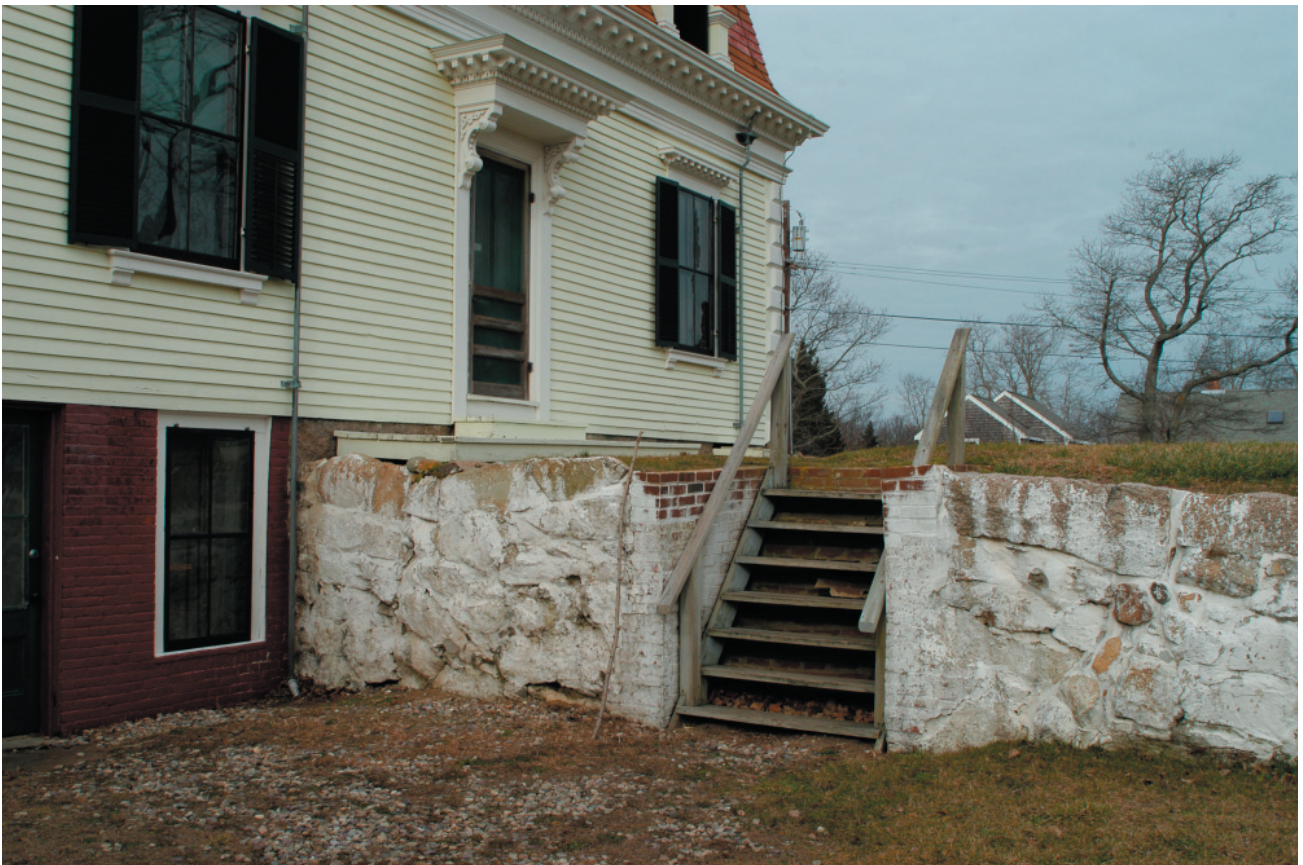
Figure 26. Steep wooden steps on the east side of the Penniman house, which connect the driveway and barn yard. The steps could be rebuilt with a gentler pitch by extending them out from the wall towards the driveway (OCLP, January 2007).

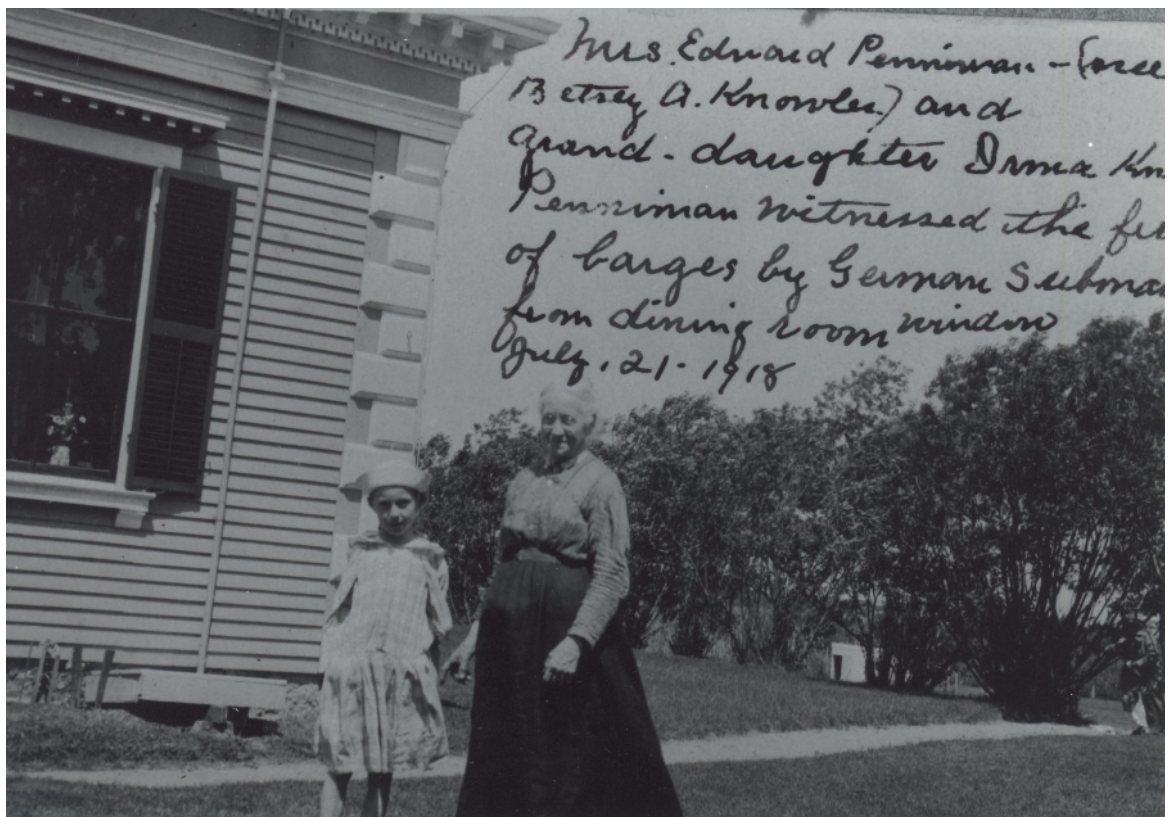
Figure 27. Photograph from 1918 of Augusta Penniman and her grand daughter Irma showing gravel walkway from Fort Hill Road on the north side of the Penniman house, as it leads to the back door on the east side of the building. Note the multi-stemmed shrubs along the roadway above the stone wall (Cape Cod NS archives, H10-359).

Historic photographs show a gravel path leading from the stone steps along Fort Hill Road to the backdoor, on the east side of the Penniman house. Photographs also show that near the backdoor there was a small brick paved area to the driveway steps and a wooden step to the door (Figures 27 through 31).

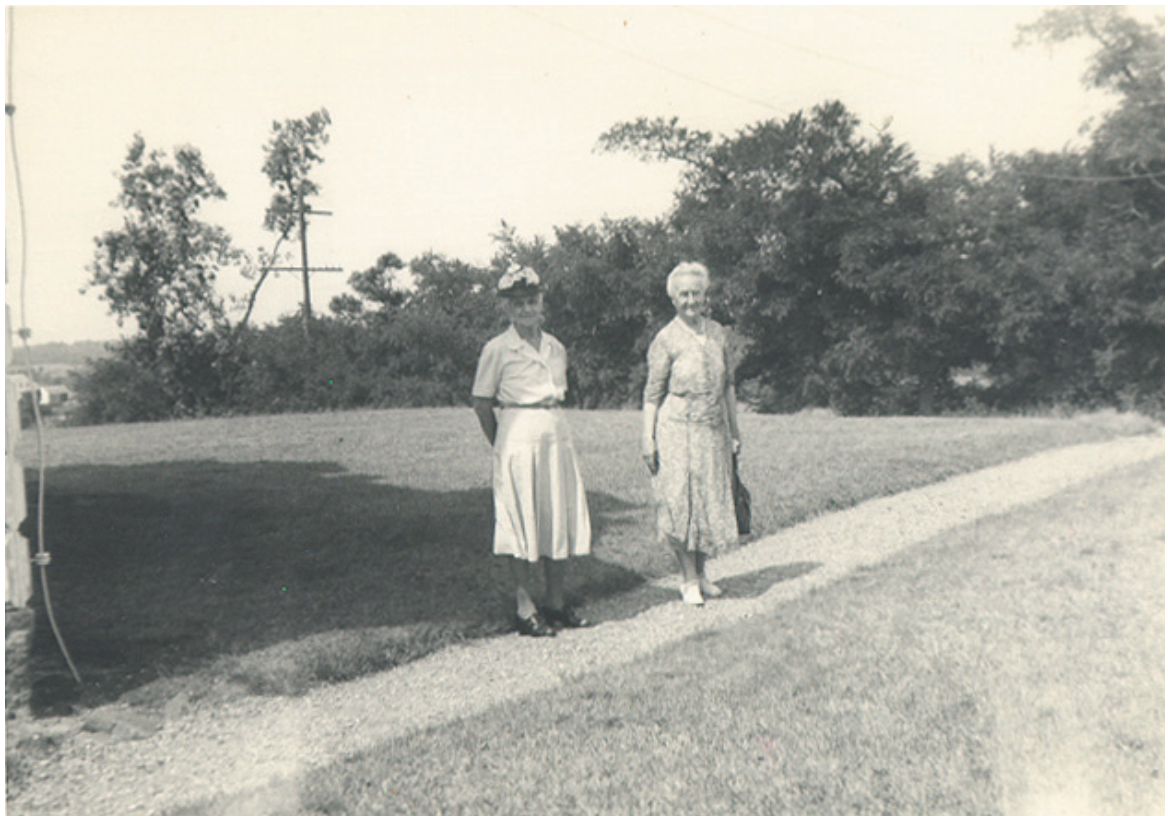
Figure 28. Photograph of Bessie Penniman and her friend on September 4, 1948 standing on the gravel walkway, which leads from Fort Hill Road on north side of Penniman house to the back door on the east side of the building. Note that the tall multi-stemmed shrubs visible along the roadway in the photograph above are gone (Cape Cod NS archives, H10-247).

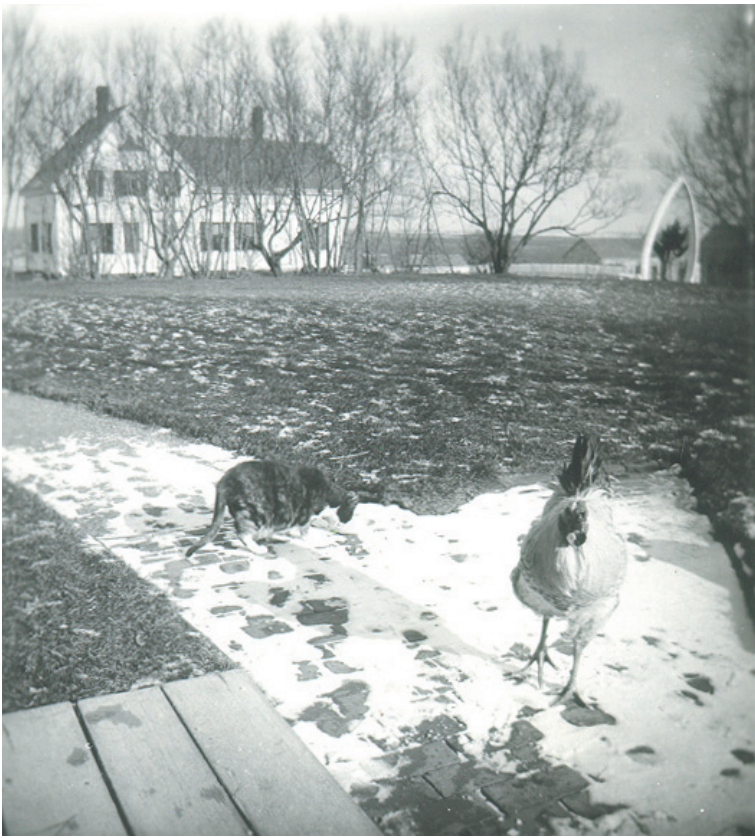
Figure 29. Historic photograph of rooster and cat by back doorstep on the east side of the Penniman house, circa 1880. The brick walkway leading to barn and the gravel walkway leading to Fort Hill Road on the north side of the Penniman house are both visible. Note the Avery (or Sylvanus Knowles) house behind the trees and the Gunn dairy barn beyond the whale bones, as well as the open winter view over the Nauset Marsh (Cape Cod NS archives, H10-094).
