CONDITION REPORT FOR FORT HILL RURAL HISTORIC DISTRICT

CAPE COD NATIONAL SEASHORE

National Park Service, Boston, Massachusetts, 2007

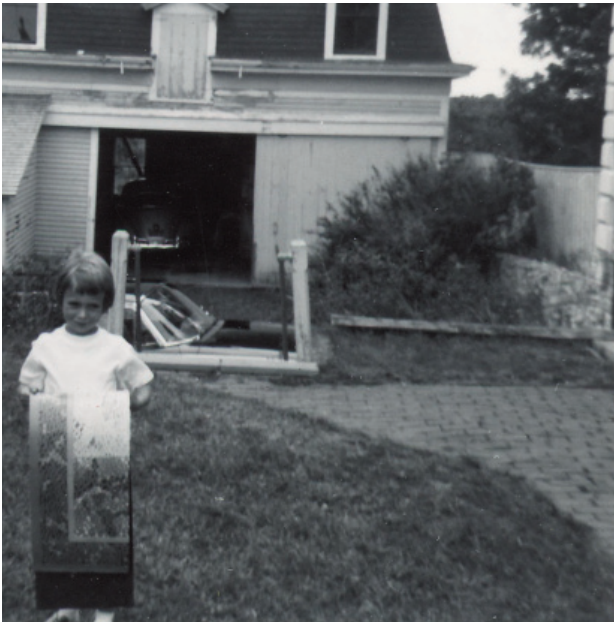
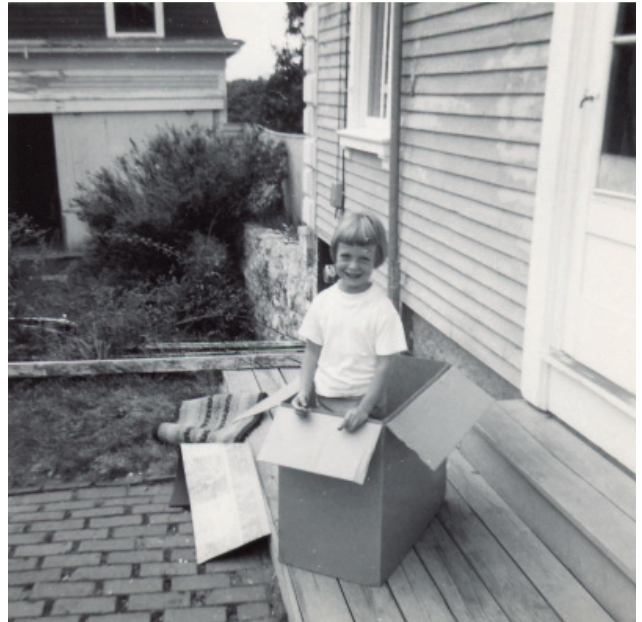
Figures 30 and 31. Photographs of a child by the back doorstep on east side of the Penniman house, 1963. The brick walkway leading to the barn is visible. (Cape Cod NS archives, H10-364 and H10-365).

Historic photographs show a gravel path leading from the stone steps along Fort Hill Road to the backdoor, on the east side of the Penniman house. Photographs also show that near the backdoor there was a small brick paved area to the driveway steps and a wooden step to the door (Figures 27 through 31).

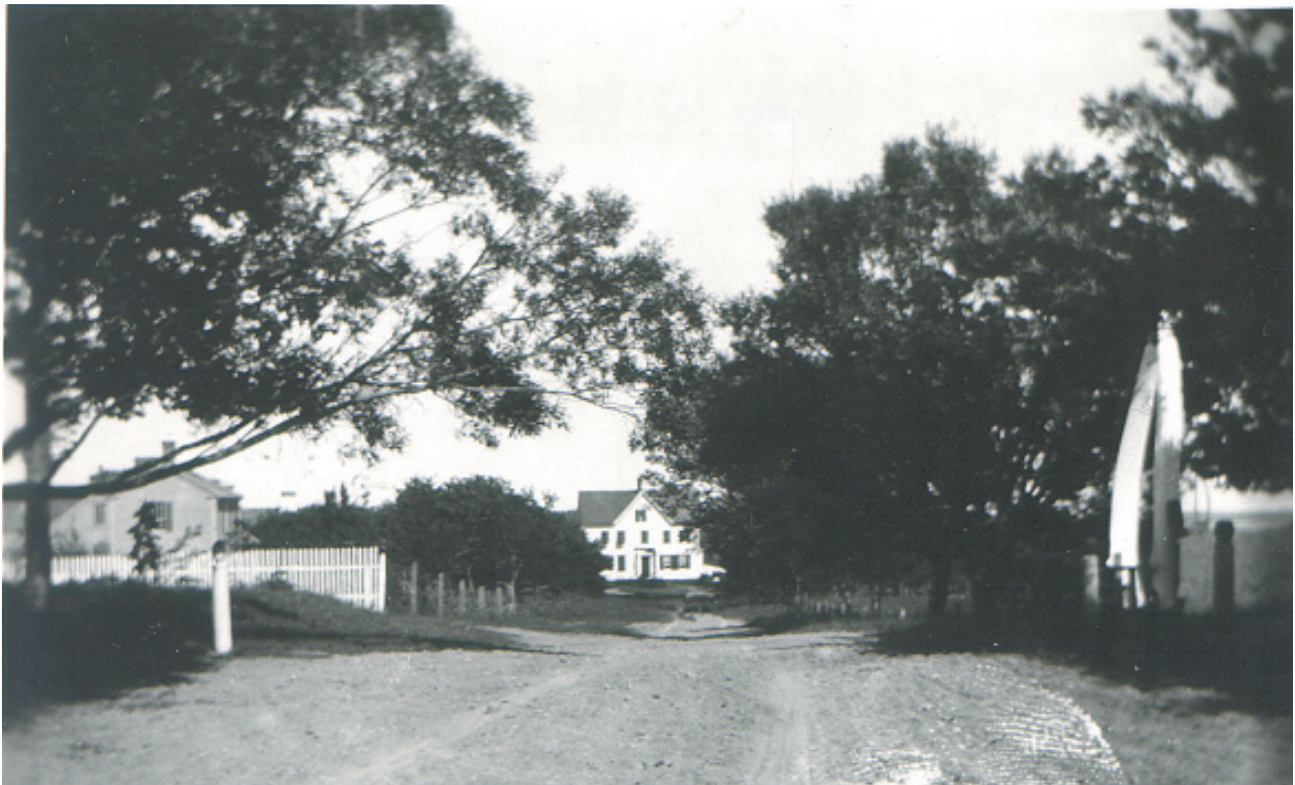
Figure 32. Photograph of the view east towards the Burrill (or Seth Knowles) house, showing the trees along Fort Hill Road, circa 1880. The trees on the right side of the road are perhaps horse chestnut trees (Cape Cod NS archives, H10-085).

Recommendation: Research has not yet confirmed that there was a line of horse chestnut trees along Fort Hill Road. A photograph of the Penniman house from ca. 1880 (see H10-157, CLR, Fig. 14, 36) shows the Fort Hill Road with a row of two or three trees on its south side, just east of the Penniman house drive. A tree(s) is visible on the north side of the drive. Another photograph from ca. 1880 of the Fort Hill Road (see CLR, Fig. 9, 24) shows trees on the south and north side of the road. Another photograph of ca. 1880 (see CLR, Fig. 44, 89) shows the Penniman house drive looking north to the whalebone gate and shows the driveway lined with cottonwood trees, but also two trees along the Fort Hill Road, east of the drive. The trees in these photographs could be horse chestnut trees. It is also believed that two horse chestnut trees were lost during Hurricane Bob in 1991, leaving only one remaining horse chestnut. Planting of a row of horse chestnut trees should happen if further evidence confirms that they were present during the historic period (Figure 32).

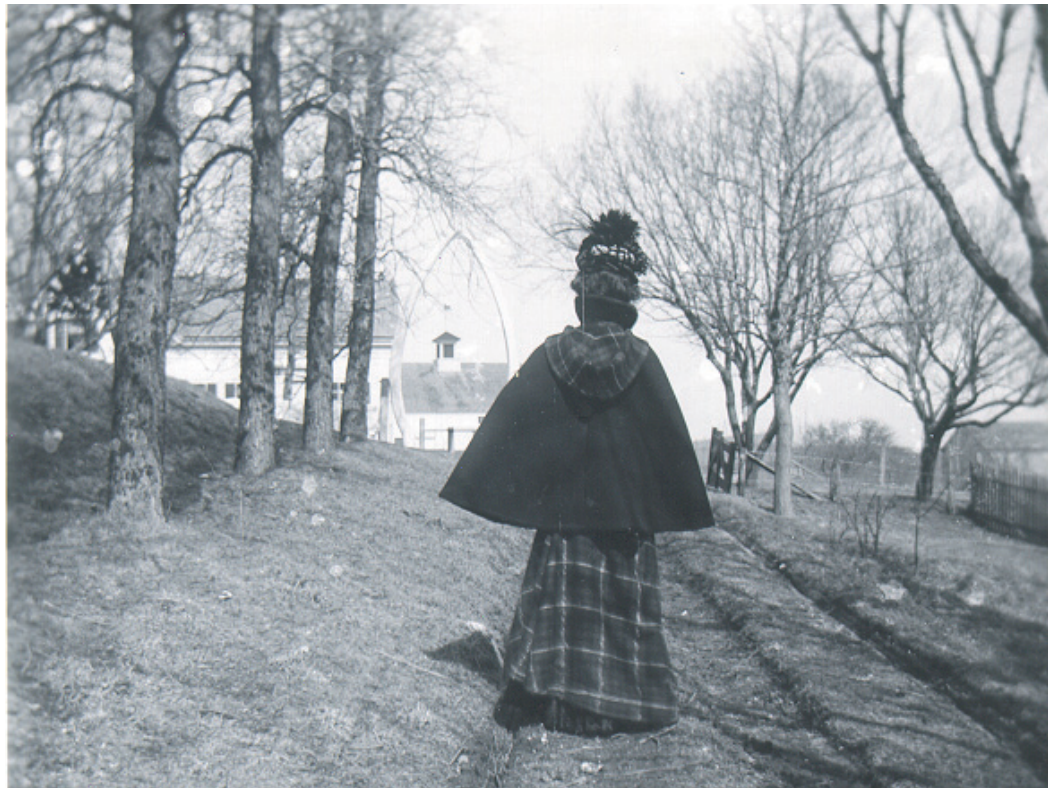
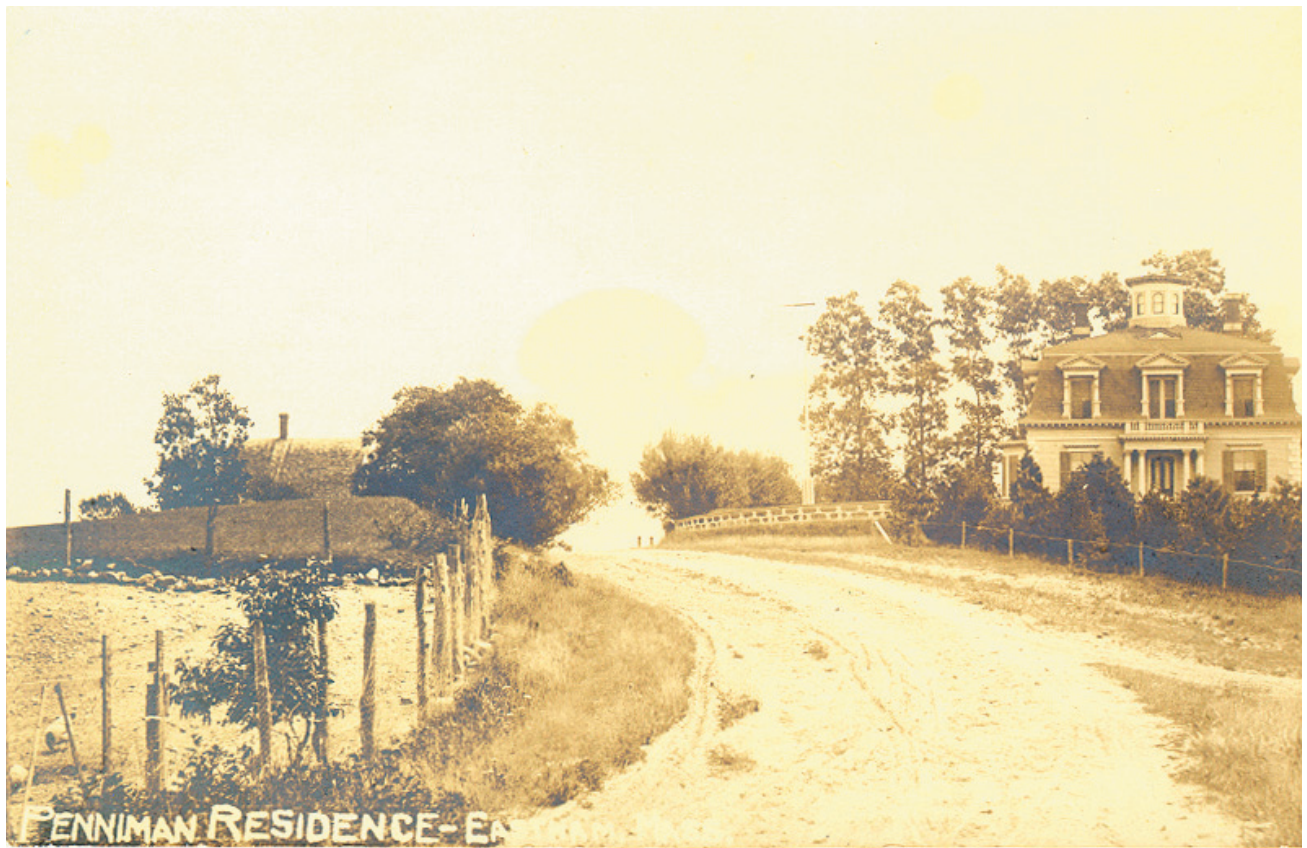
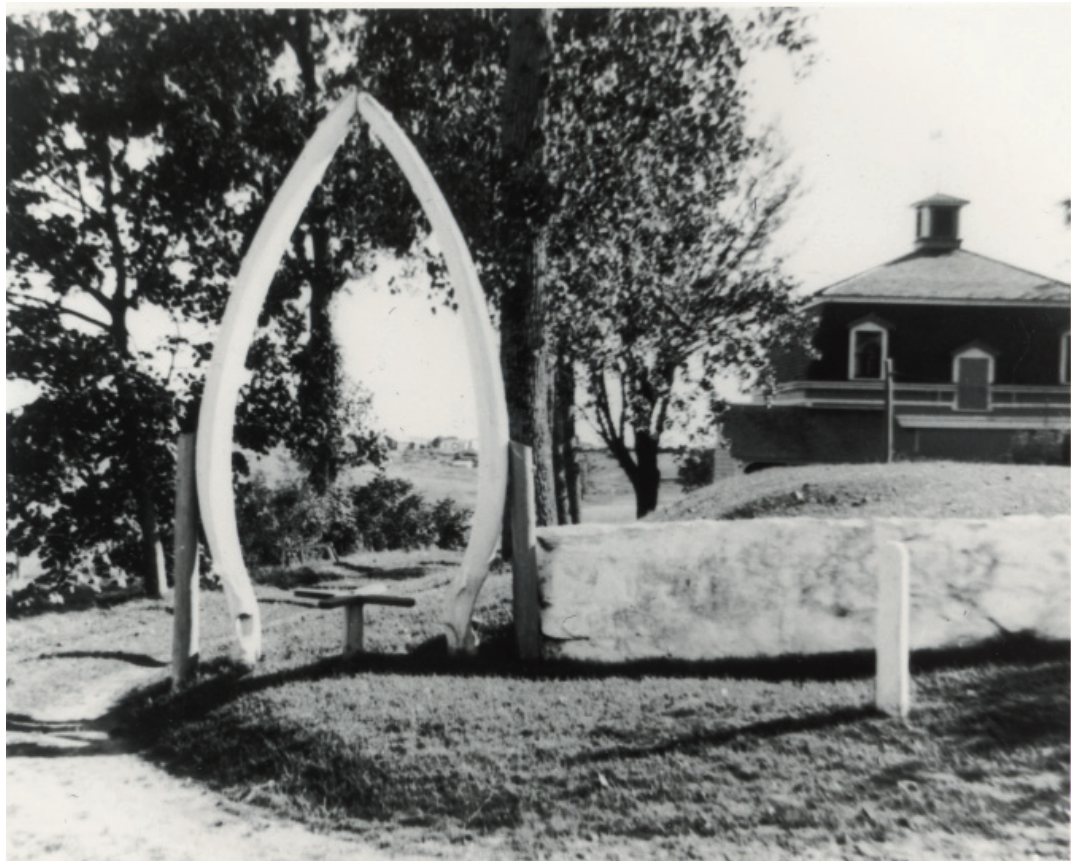
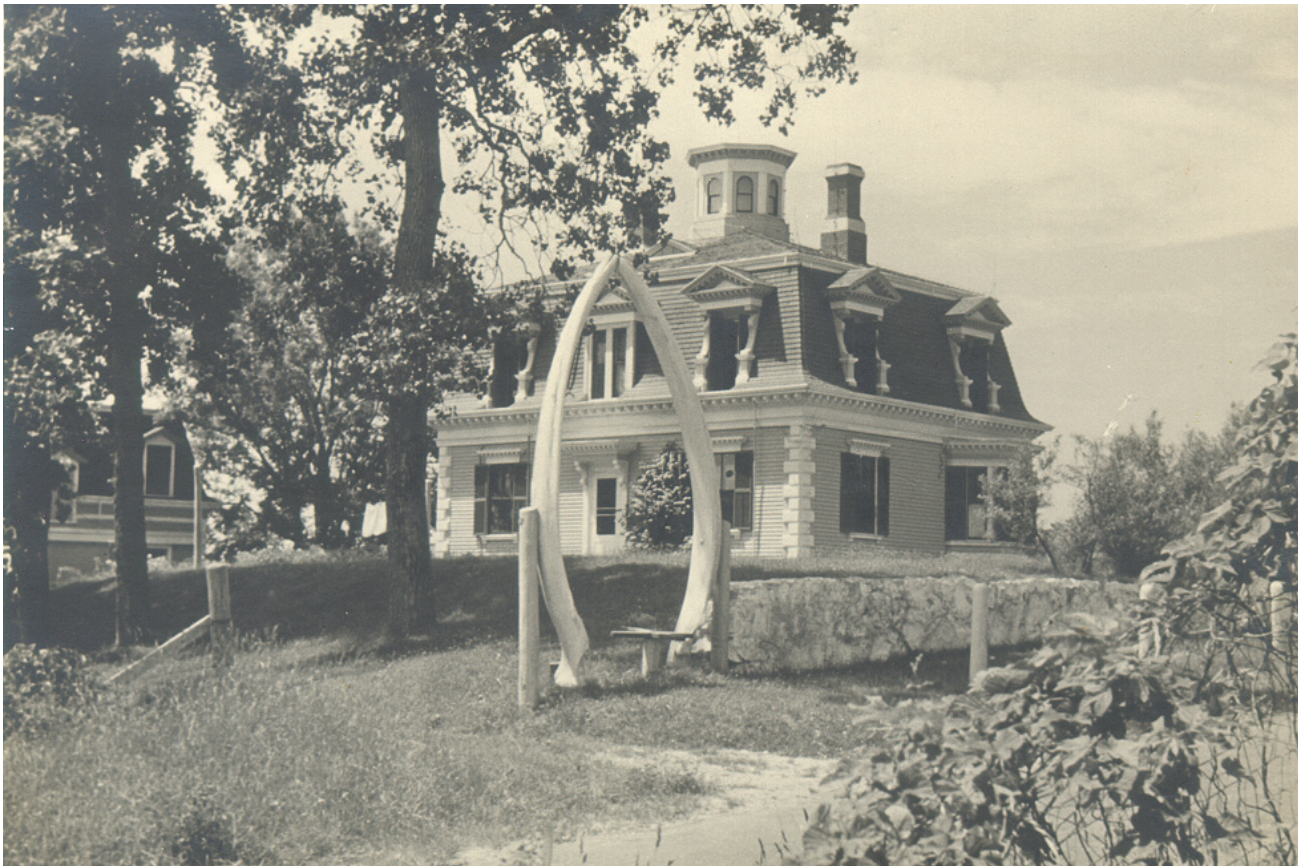
Figure 33. Photograph of Lida Brackett walking in the Penniman house driveway looking north, with cottonwood trees along its west side and unidentified species on its east side. (Cape Cod NS archives, H10-143).

Figure 34. Photograph looking east showing the cottonwood trees along the Penniman house driveway, circa 1880. Young pine trees are also visible to the west of the front entrance to the Penniman house (Cape Cod NS archives, H10-173).

Figure 35. View of the whale bones, cottonwood trees, and the Penniman barn looking south, circa 1880. (Cape Cod NS archives, H10-360).

Figure 36. View looking southwest at the cottonwood trees, whale bones, and the Penniman house and barn, circa 1880 (Cape Cod NS archives, H10-348).

Recommendation: In 2005, four cottonwood trees to the west of the drive were lost during a wind storm. Only two cottonwood trees remain to the east of the drive (Figures 33 through 37). The Olmsted Center for Landscape Preservation coordinated the propagation of cuttings of the cottonwood trees in June 2007 for propagation at the Arnold Arboretum of Harvard University. If successful, the young saplings will be grown in the historic plant nursery managed by the Olmsted Center. When the trees reach the appropriate size for planting out, a decision should be made about the timing for felling the remaining two trees and the replanting of an agreed number of trees along the driveway with an aim to restore the even-aged character. A photograph of the Penniman house from ca. 1880 (see CLR, Fig. 14, 36) shows behind the Penniman house a row of seven to eight cottonwood trees just east of the Penniman house drive. Another photograph of ca. 1880 (see CLR, Fig. 44, 89) shows the Penniman house drive looking north to the whalebone gate and shows the driveway lined with cottonwood trees.

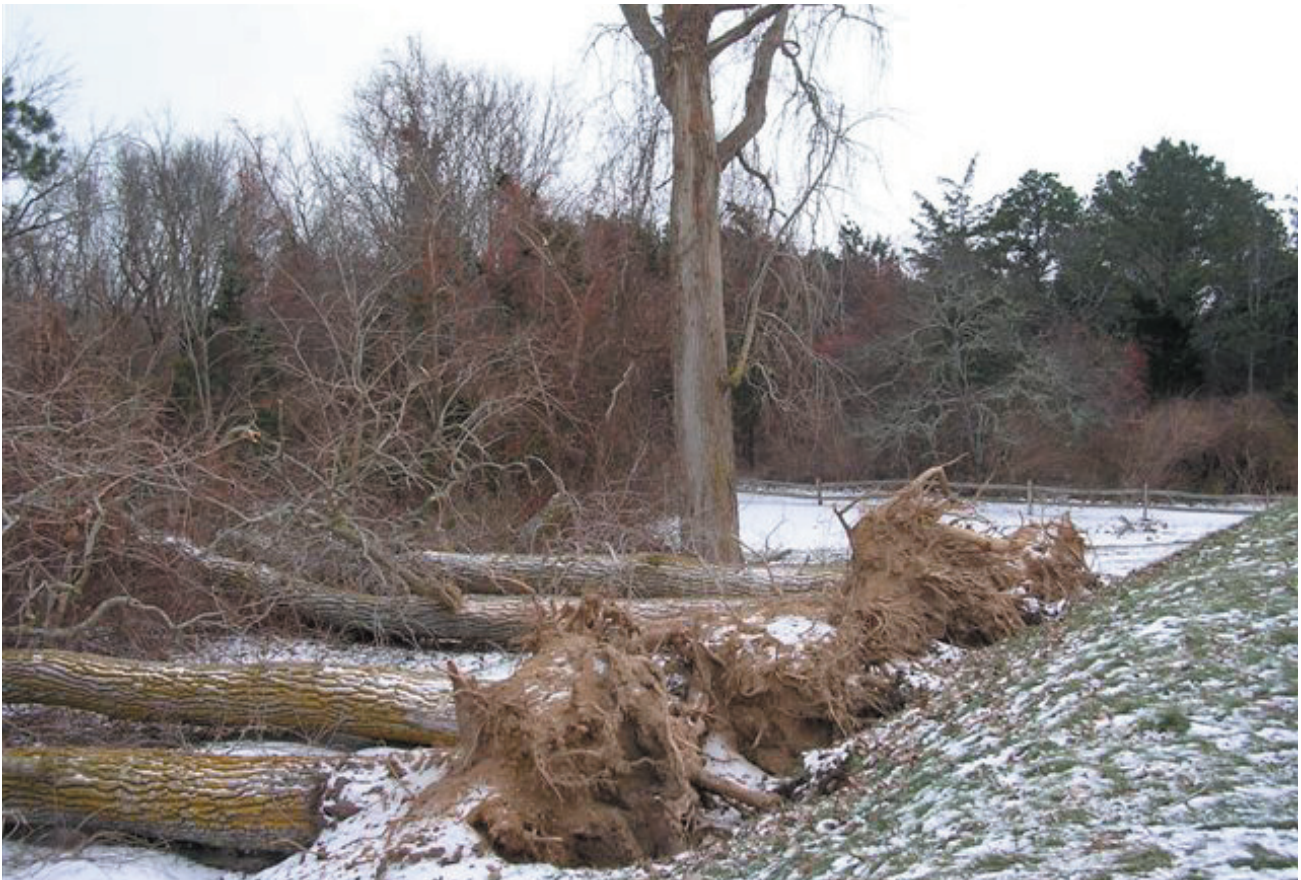
The lawn on the east side of the house slopes down to a gravel drive. The four cottonwood trees to the west of the drive were lost during a storm on 9 December 2005. Only two cottonwood trees remain to the east of the drive. Southeast of the house is a two-story barn which matches the Penniman house in style and appearance. Nearby is a small, depressed parking area that is surfaced with gravel. The parking area is bordered on the west by the exposed foundation of the Penniman house, on the north by a retaining wall, and on the south by the front of the barn. Wooden steps lead from the eastern terraced lawn down to the parking area.

Figure 37. Fallen cottonwood trees after a winter wind storm in 2005 (Cape Cod NS Cultural Resource files).

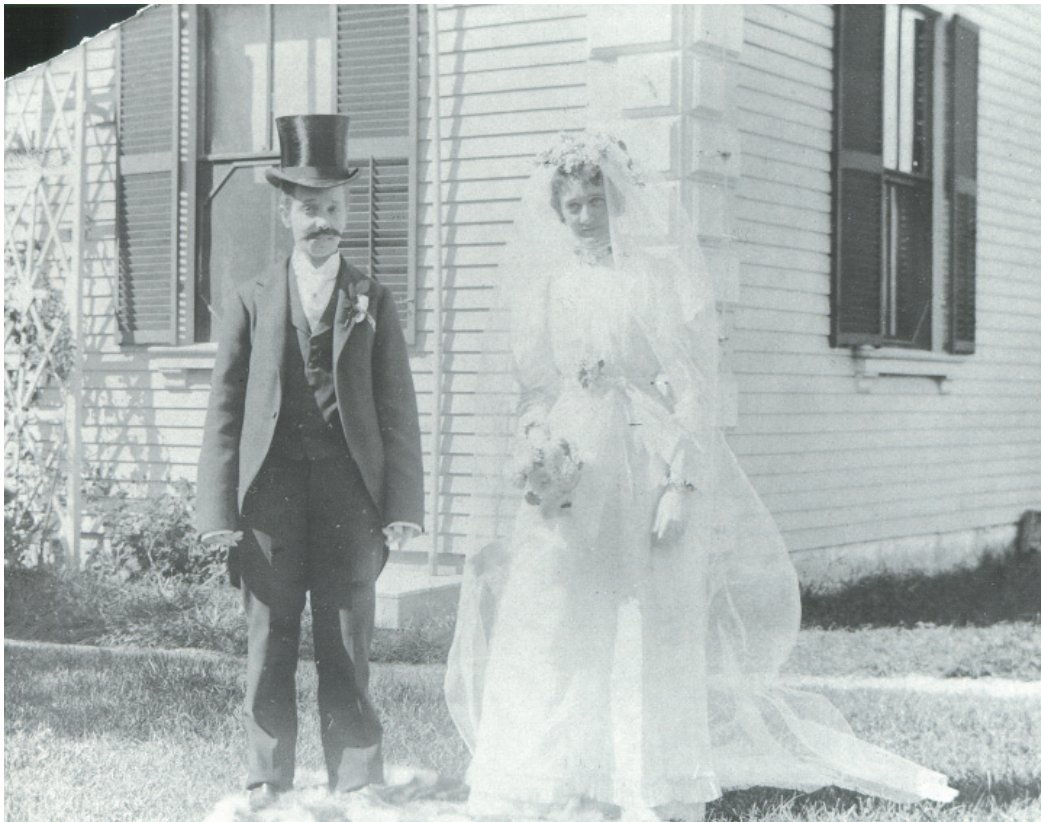
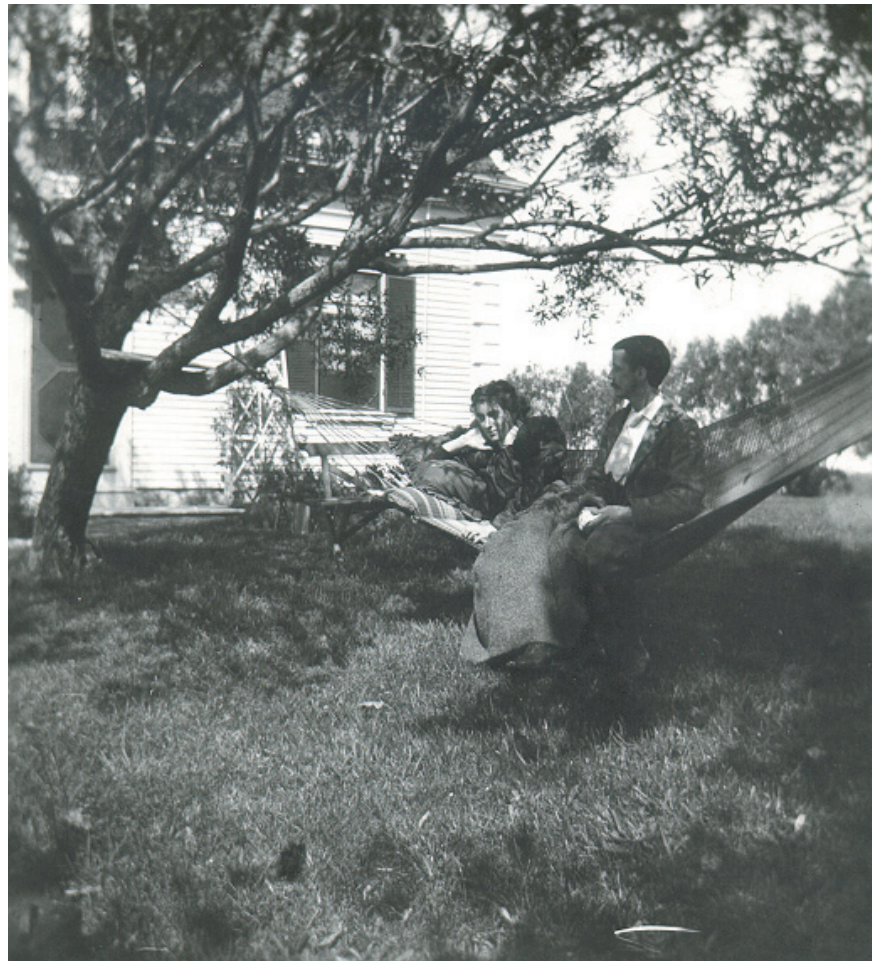
Figure 39. Photograph of a mock wedding between Bessie (left) and Olive (right) taken by the northeast corner of the Penniman house, circa 1897. Note the trellis with vine, most likely a rose, on the east side of the house, as well as the small shrub to the right of the trellis (Cape Cod NS archives, H10-237).

Figure 40. Photograph of the niece of Mrs. Penniman, Olive Brackett and her husband Sam Highley in a hammock hanging in the trees on the east lawn of the Penniman house by the back door. At least two trees existed here and added to the domestic character. The trellis and a bench are visible in the background (Cape Cod NS archives H10-038).

Historic photographs show at least two trees near the backdoor of the Penniman house. The rehabilitation of the trees, together with the rehabilitation of the flagpole, the wooden fence between Penniman house and stables, the line of cottonwood trees, the foundation planting and the gravel path to Penniman house, would all contribute towards the rehabilitation of the domestic character of the house as it appeared in 1943, at the end of the period of significance. Further research is required to establish the type of trees that should be planted (Figures 38, 39 and 40).

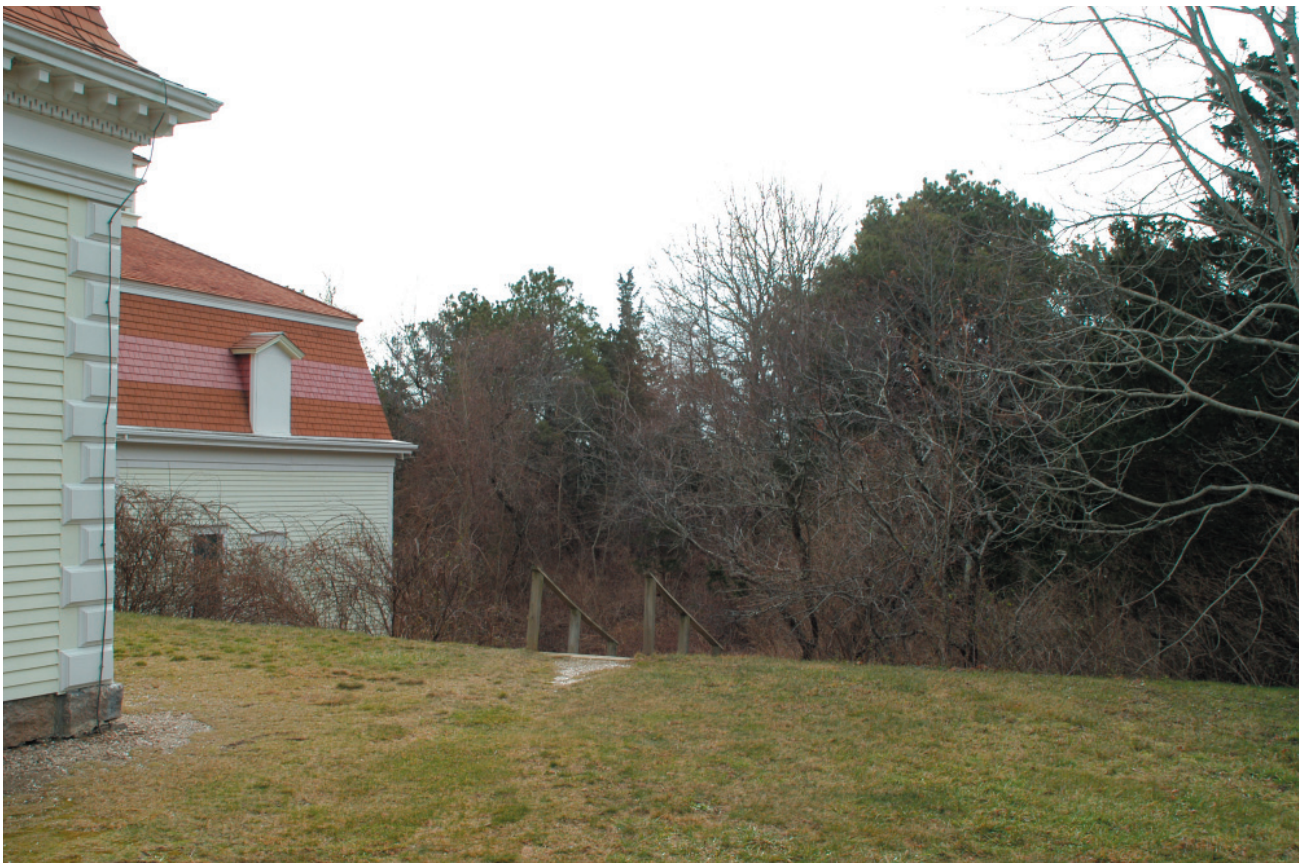
Figure 45. View south from the Penniman house front lawn, looking toward Nauset Marsh. The young pine trees shown in Figure 44 have matured and now block views to the Town Cove and Nauset Marsh (OCLP, January 2007).

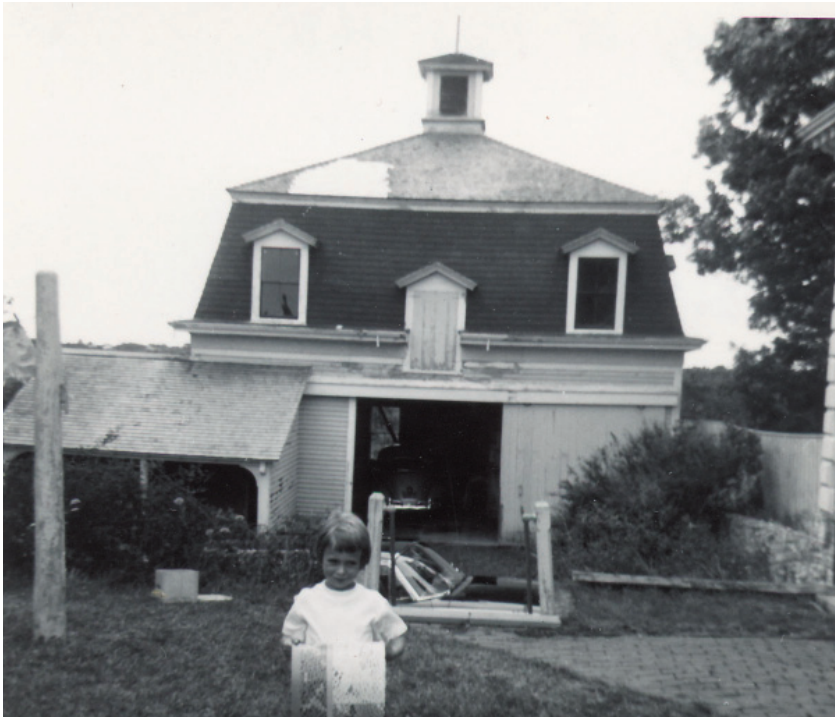
Figure 48. The wooden fence between the Penniman house and barn is visible on the right side of the photograph, 1963. Note the clothesline pole on the left side of the left photo, and the open view to the south beyond the barn (Cape Cod NS archives, H10-364).

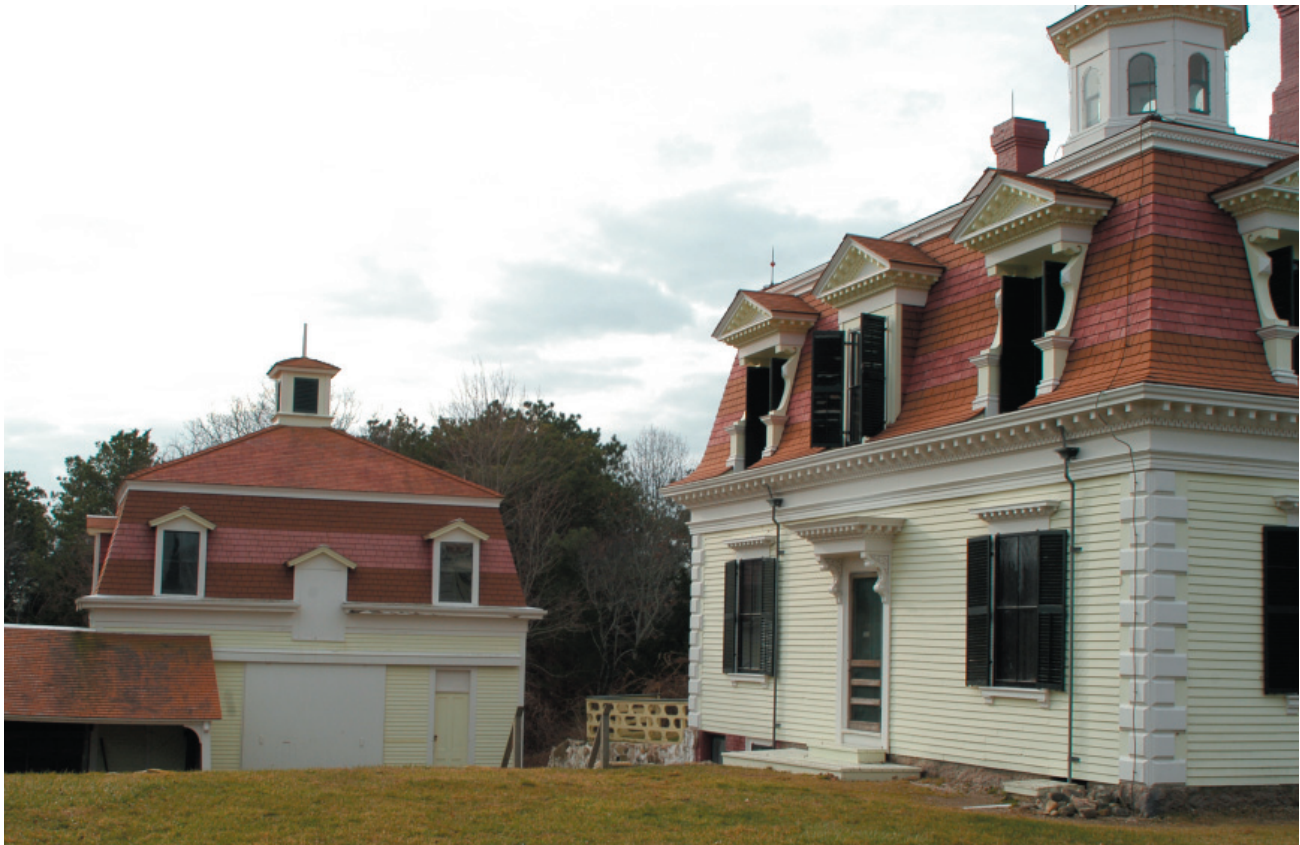
Figure 49. The wooden fence between the Penniman house and barn shown above, has now been replaced by the decorative wooden fence shown here. The courtyard is now longer enclosed (OCLP, January 2007).

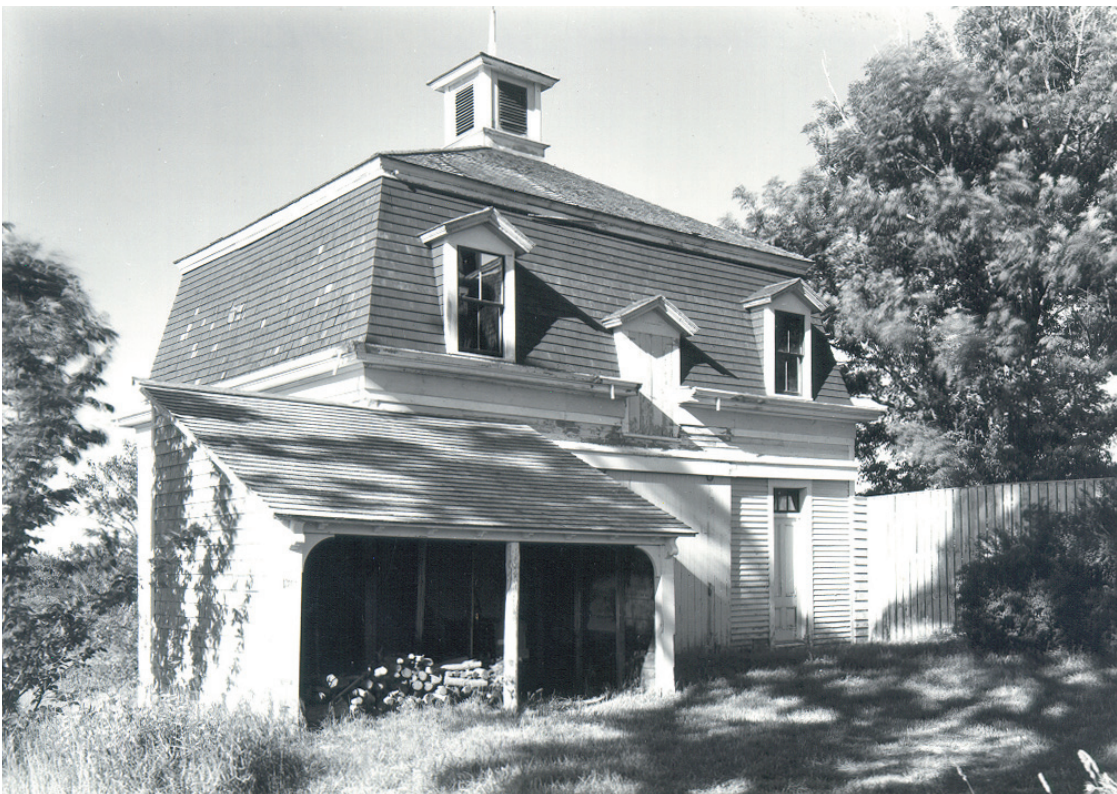
Figure 50. Photograph from the Historic American Buildings Survey (HABS) of the Penniman barn, 1962. The wooden fence between the Penniman house and barn is visible at right with a foundation planting. The courtyard is enclosed, and the passage between the building and stone wall is blocked (Cape Cod NS archives, H10-211).

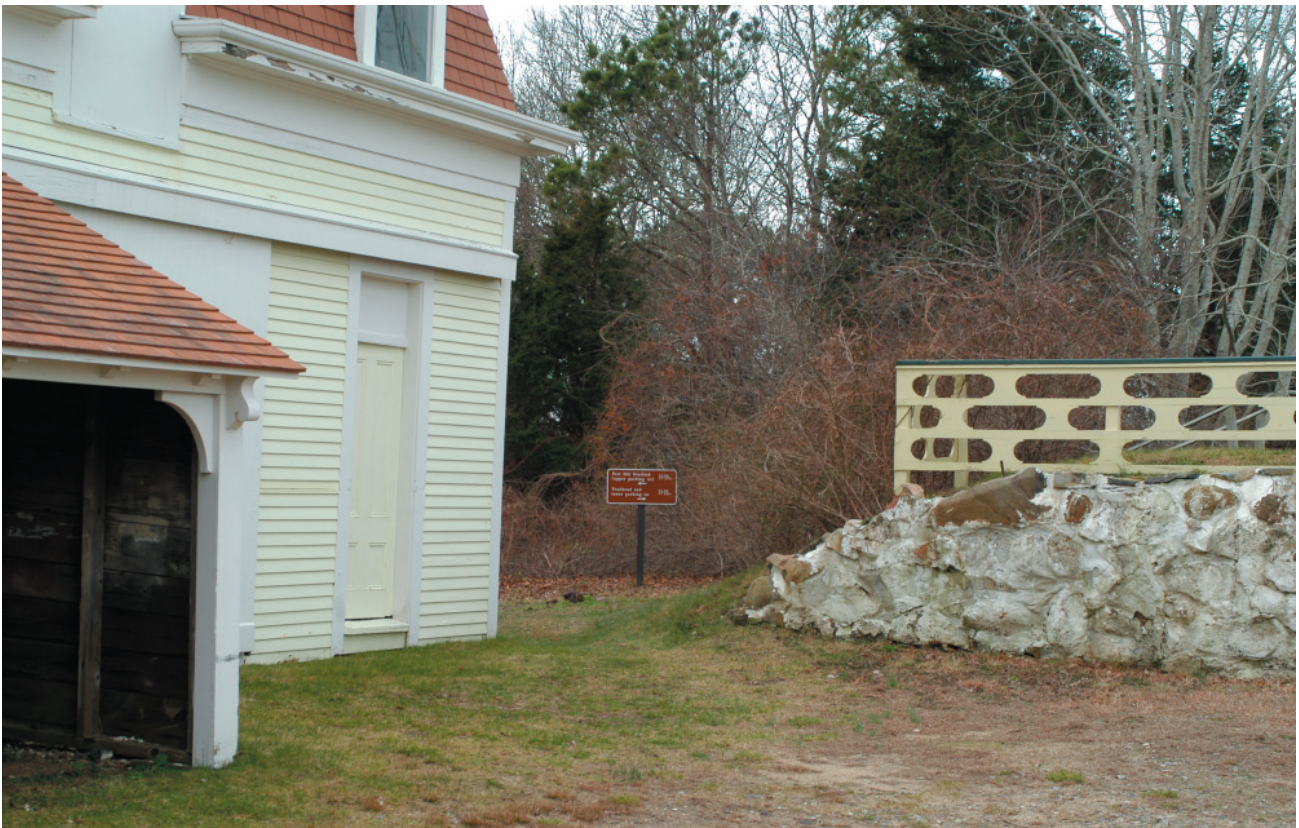
Figure 51. The wooden fence between the Penniman house and barn. The foundation plants are now gone and a decorative wooden fence has been installed above the stone wall. The courtyard is no longer enclosed and a narrow passage leads between the building and stone wall (OCLP, January 2007).

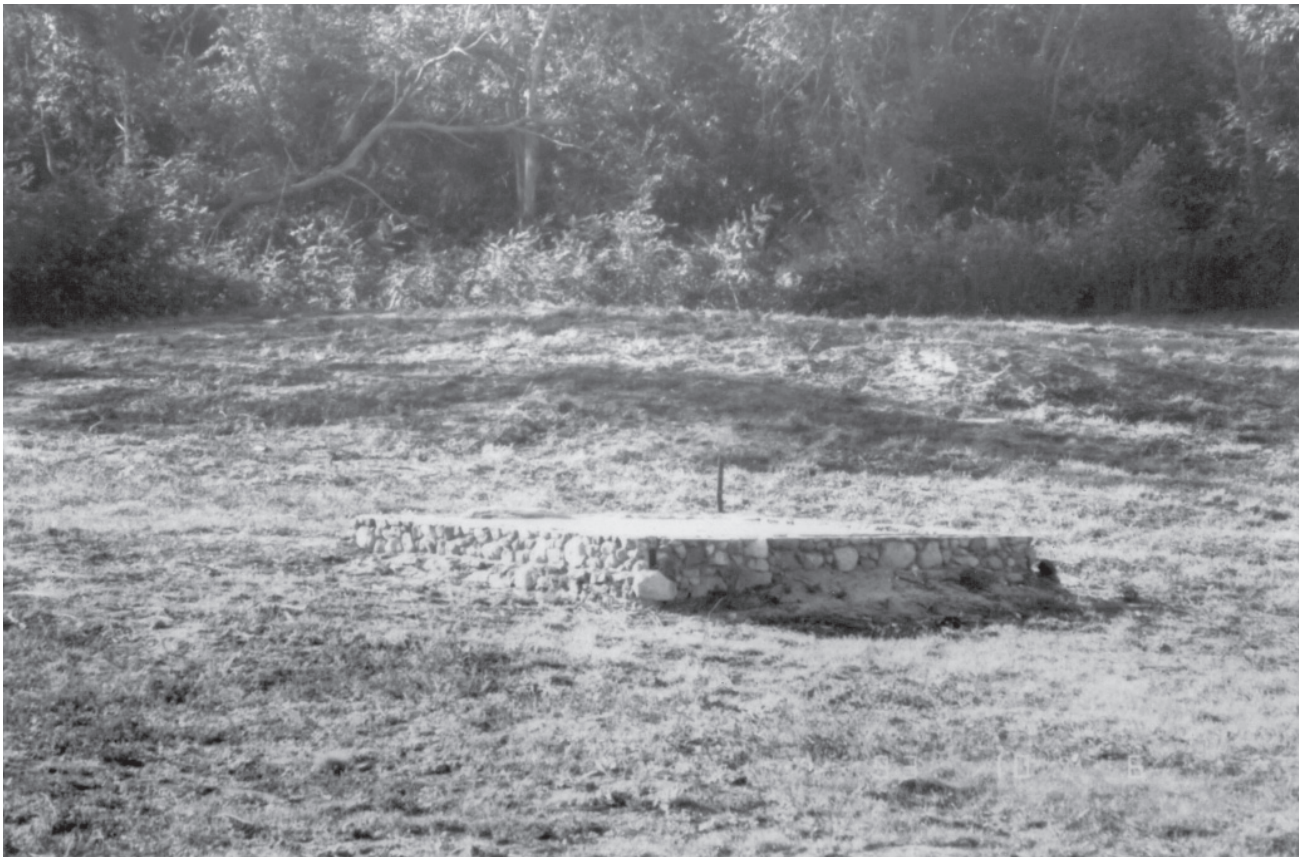
Figure 53. The capped foundation of the former Gunn dairy barn to the east of the Avery house is clearly visible in 1993. As shown, there is no encroaching vegetation and the surrounding field is cut grass (Fort Hill CLR, 1995, 70).

The capped foundation of the former Gunn dairy barn to the east of Avery house should be kept clear through regular prescribed burning in accordance with an approved prescribed burn plan (Figure 53 and see Figure 10).

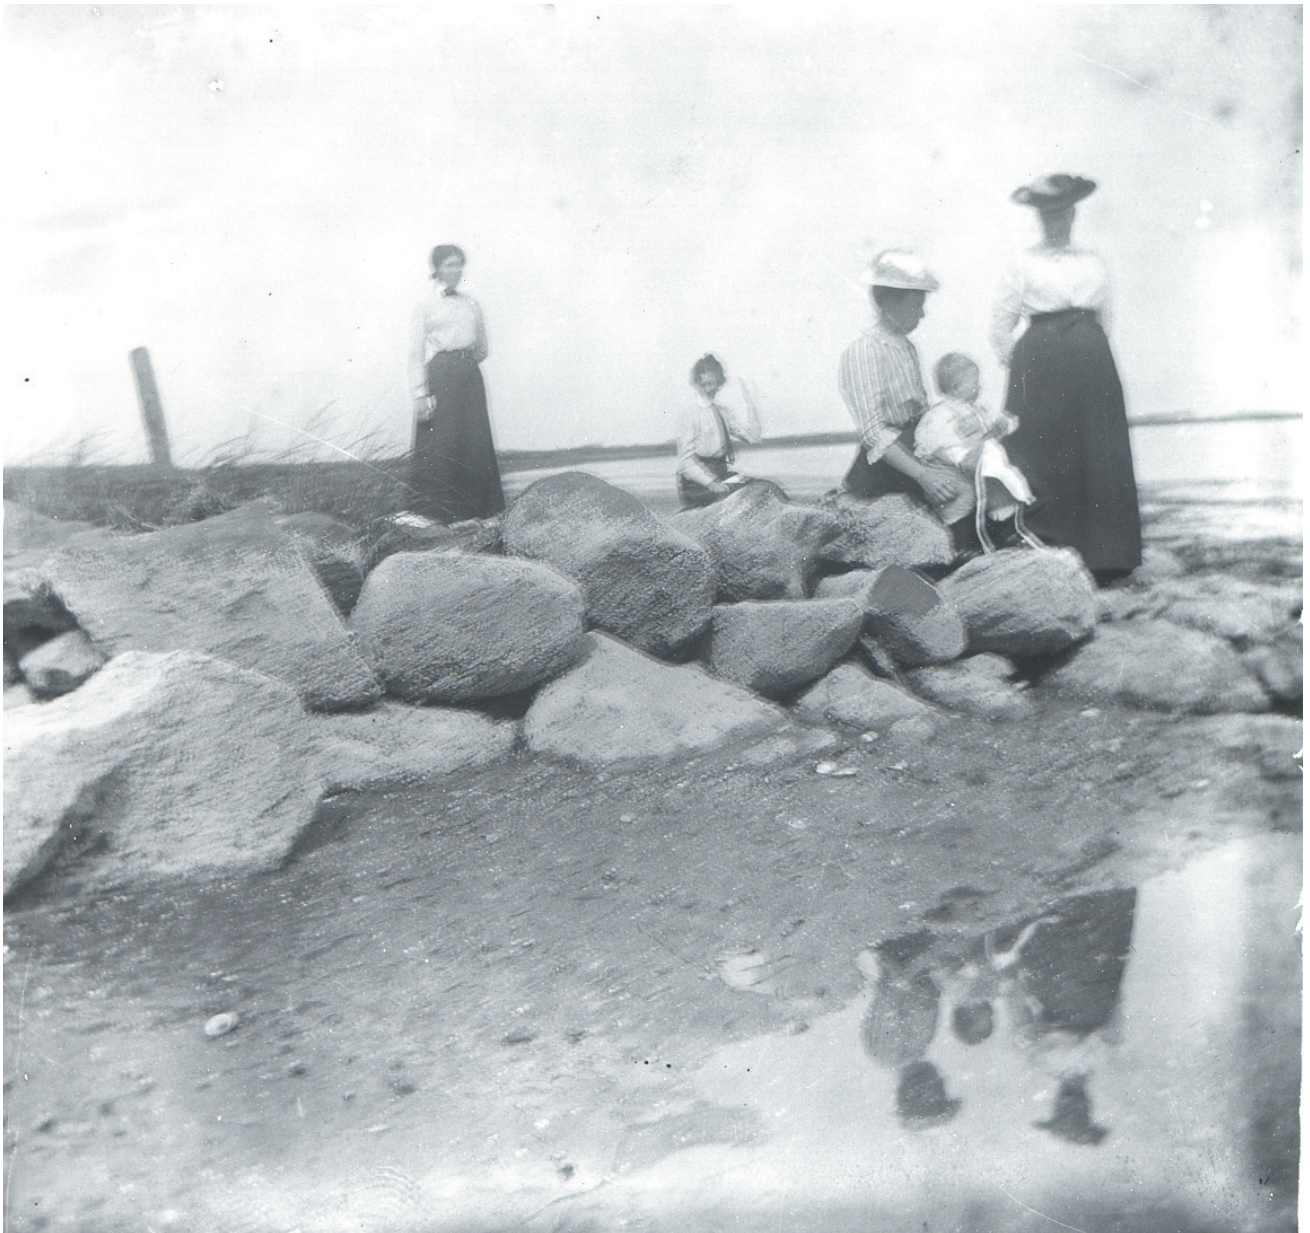
Figure 54. Photograph of four women and a child by the marsh, including Eliza Turner, the Penniman's maid (at the far left), circa 1890. A stone wall extends to the water's edge (Cape Cod NS archives, H10-097).

Historic appearance: An early photograph, circa 1890, shows a stone wall at Fort Hill (Figure 54). Four historic aerial photographs of 1938, 1960, 1974 and 1987 show how the open fields evolved (see Figures 15 through 18). The 1938 aerial shows open fields with the kettle-hole wetlands without any vegetation. Low altitude aerial photographs from the 1930s show cattle grazing in the open fields (Figures 55 and 56). On the 1960 aerial vegetation starts to appear in the fields on

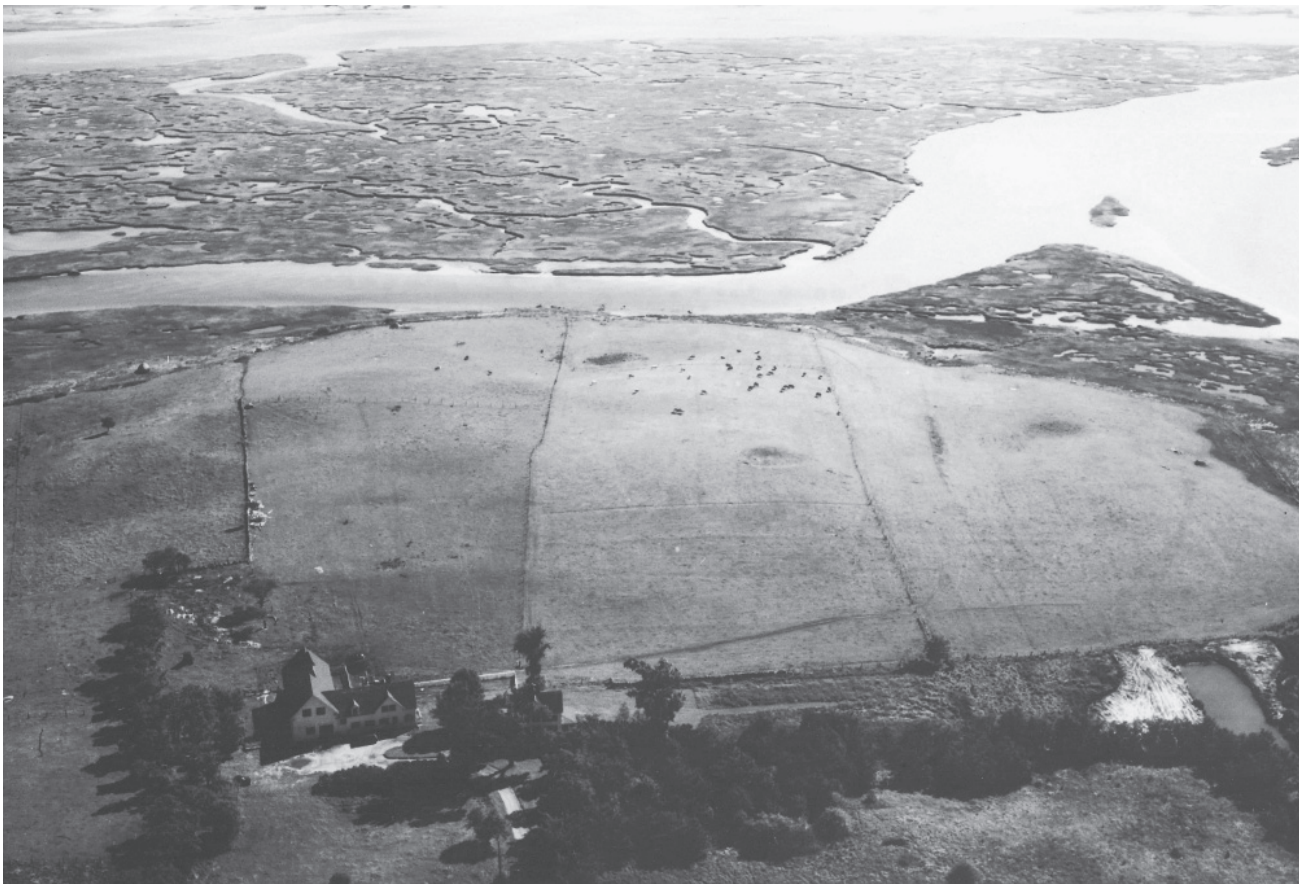
Figure 56. Aerial photograph looking east and showing cows grazing in the open fields at Fort Hill in the 1940s. The top of Fort Hill is in the center of the image (Cape Cod NS archives, courtesy of William Quinn).

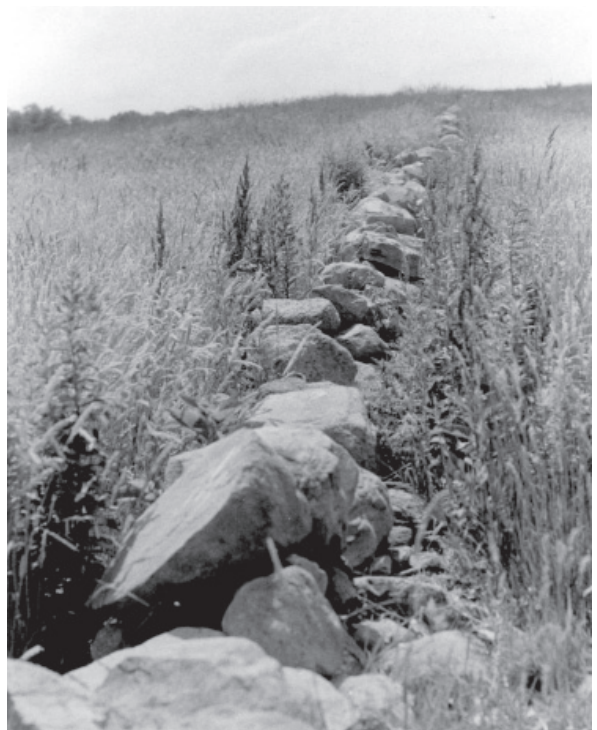
Figure 57. View of a stone wall at Fort Hill, 1993. At this time the fields were mowed twice a year (Fort Hill CLR, 1995, cover).

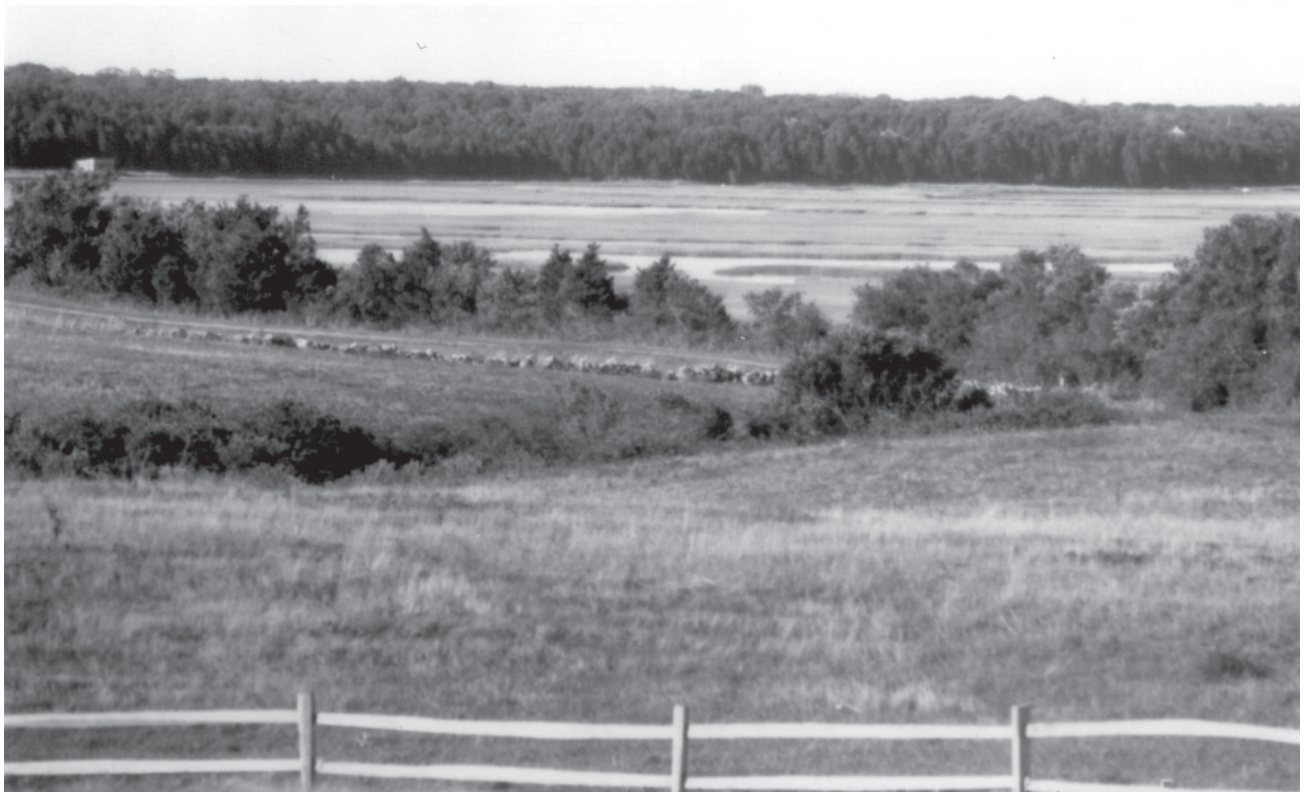
Figure 58. View from Fort Hill Road in 1993 of a stone wall, looking out over view to Nauset Marsh, 1993. At this time the fields were mowed twice a year (Fort Hill CLR, 1995, 69).

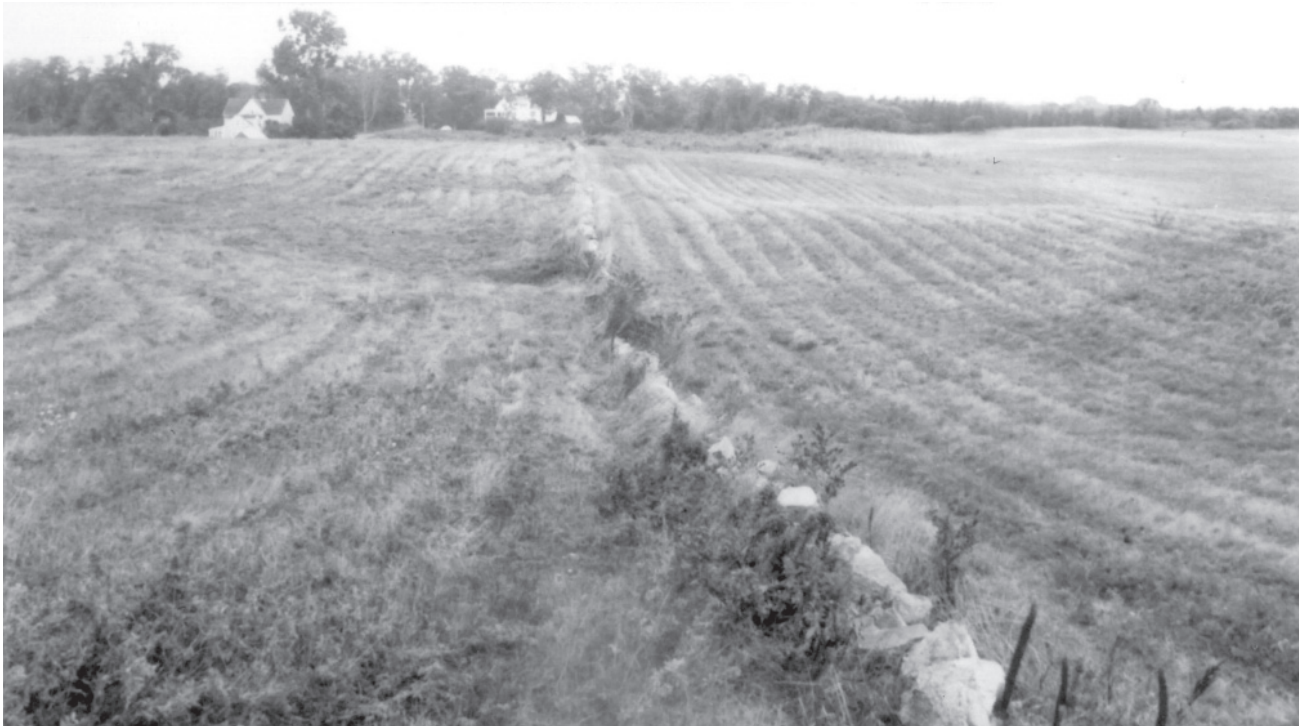
Figure 59. Photograph of a stone wall at Fort Hill, looking west toward the Burrill and Avery houses, 1993. At this time the fields were mowed twice a year (Fort Hill CLR, 1995, 69).
