CONDITION REPORT FOR FORT HILL RURAL HISTORIC DISTRICT

CAPE COD NATIONAL SEASHORE

National Park Service, Boston, Massachusetts, 2007

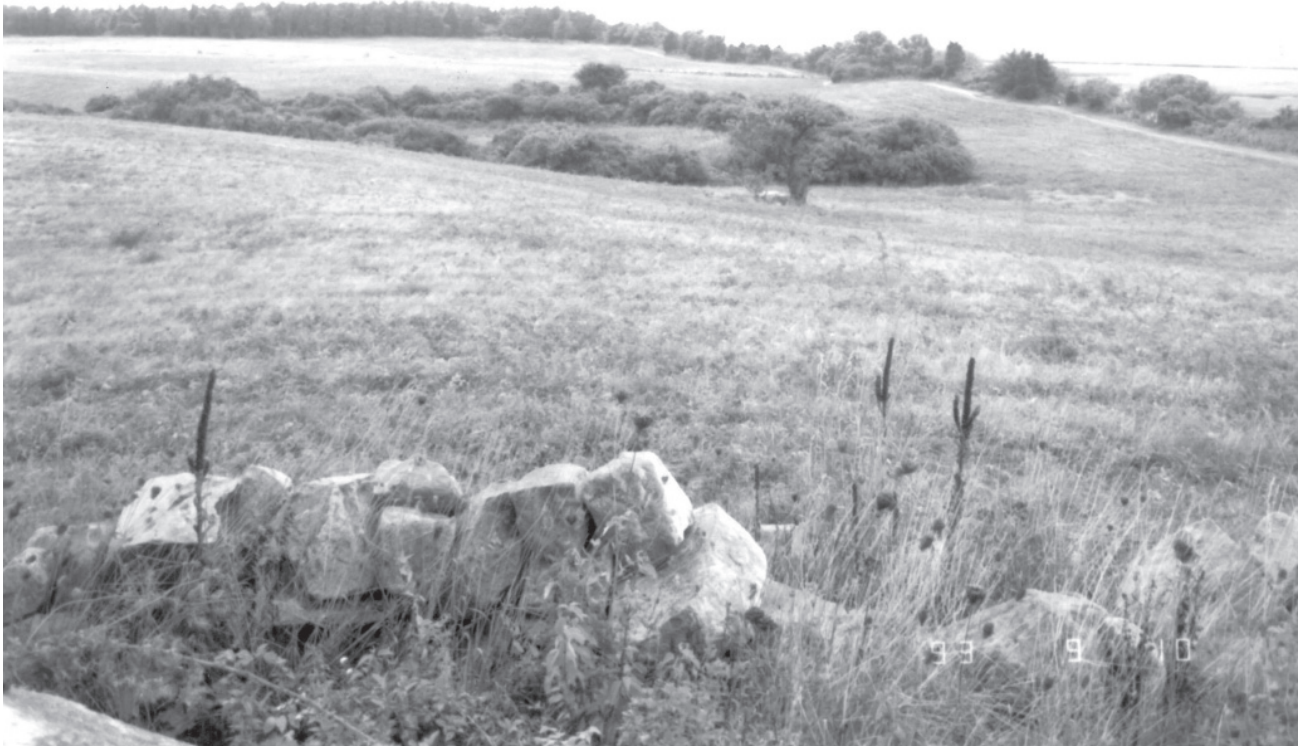
Figure 60. Photograph looking north and showing a stone wall, in the foreground, and kettle-hole wetland in the distance, which is ringed with shrubby vegetation, at Fort Hill in 1993. This is the largest of the three wetlands in the open fields at Fort Hill (Fort Hill CLR, 1995, 68).

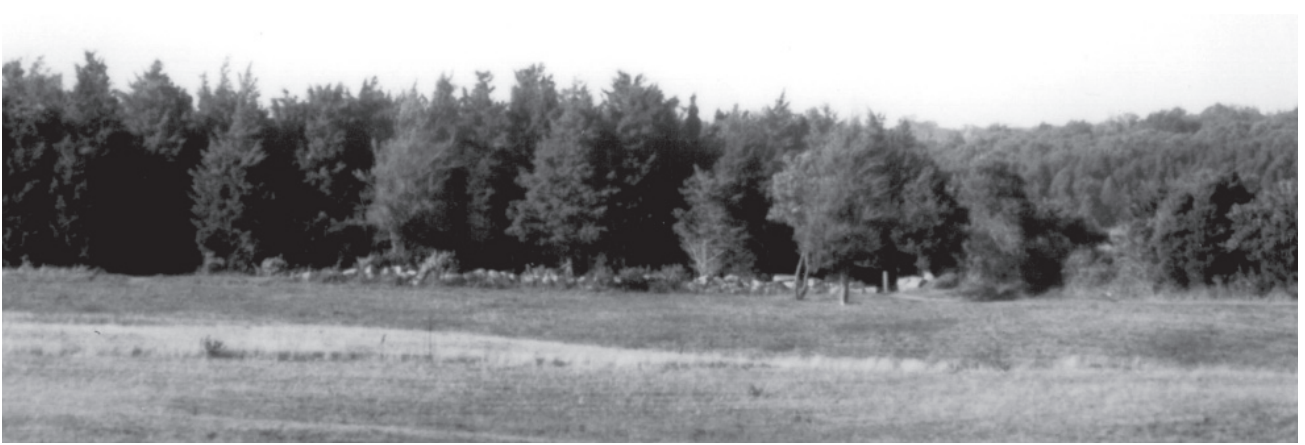
Figure 61. Photograph looking north at a stone wall on the northern edge of the open fields, also referred to as wall #1, 1993. The wall is still clearly visible as a hard edge to the field (Fort Hill CLR, 1995, 69).

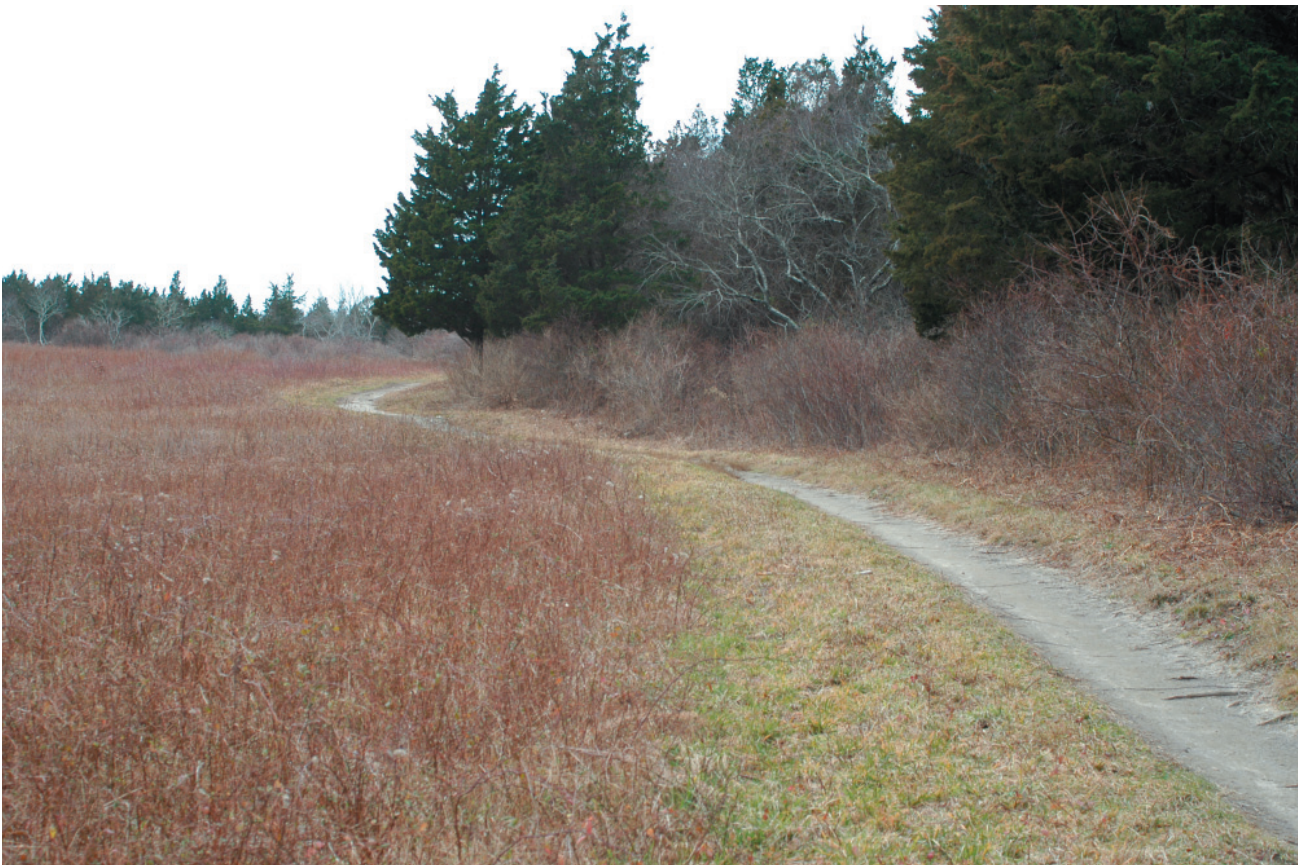
Figure 62. Photograph looking west at the stone wall referred to as wall#1, which is obscured by shrubs at northern edge of the open field. The wall is to the right of the path, below the cedar trees (OCLP, January 2007).

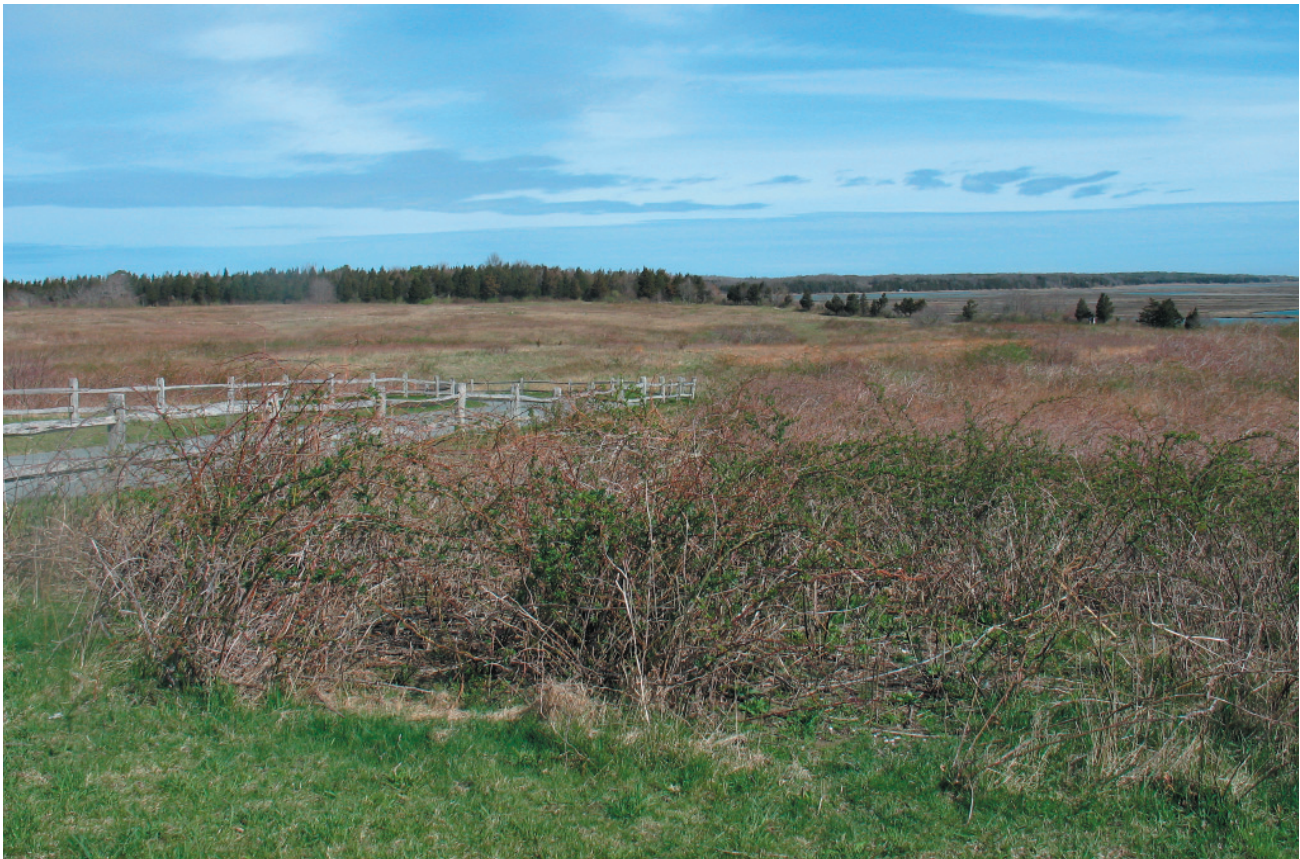
Figure 63. Photograph looking north over the open fields at Fort Hill, from the Fort Hill Overlook upper parking lot. Stone walls are obscured by multiflora rose and other woody shrubs (OCLP, April 2006).

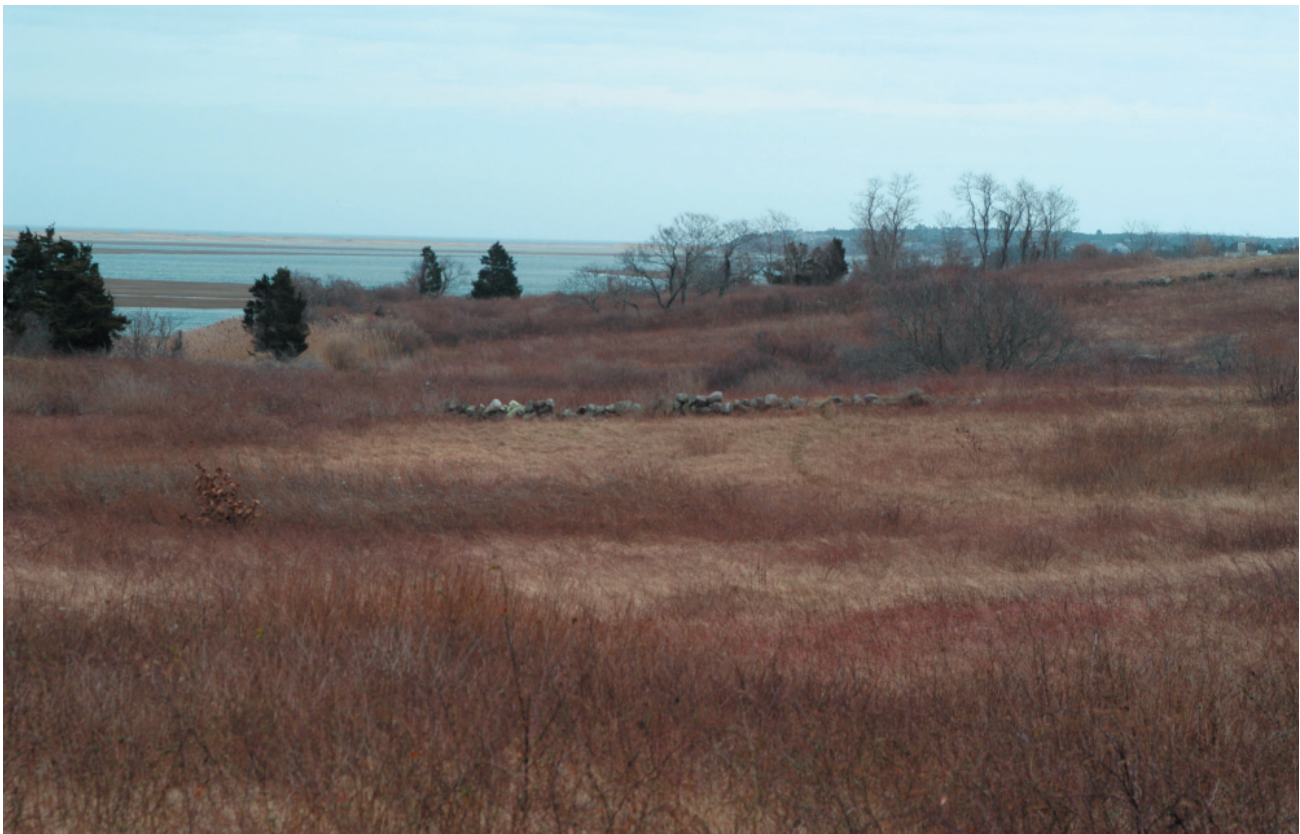
Historically, three kettle-hole wetlands stood out from the surrounding field setting, but are now hard to distinguish within the overgrown fields. Each wetland area is edged and partially filled with encroaching vegetation, which makes access and inspection difficult. However, surface water is visible within each of the three wetlands and wildlife is evident. In addition, debris such as oversized timbers can be found in the wetland areas. It is not clear whether this represents off-site dumping or storm stranding.

Figure 64. Photograph looking southeast at the largest of the three kettle-hole wetlands, in the open fields of Fort Hill. The wetland is hardly distinguishable due to shrub growth. A section of stone wall referred to as wall #2 is visible in the foreground (OCLP, January 2007).

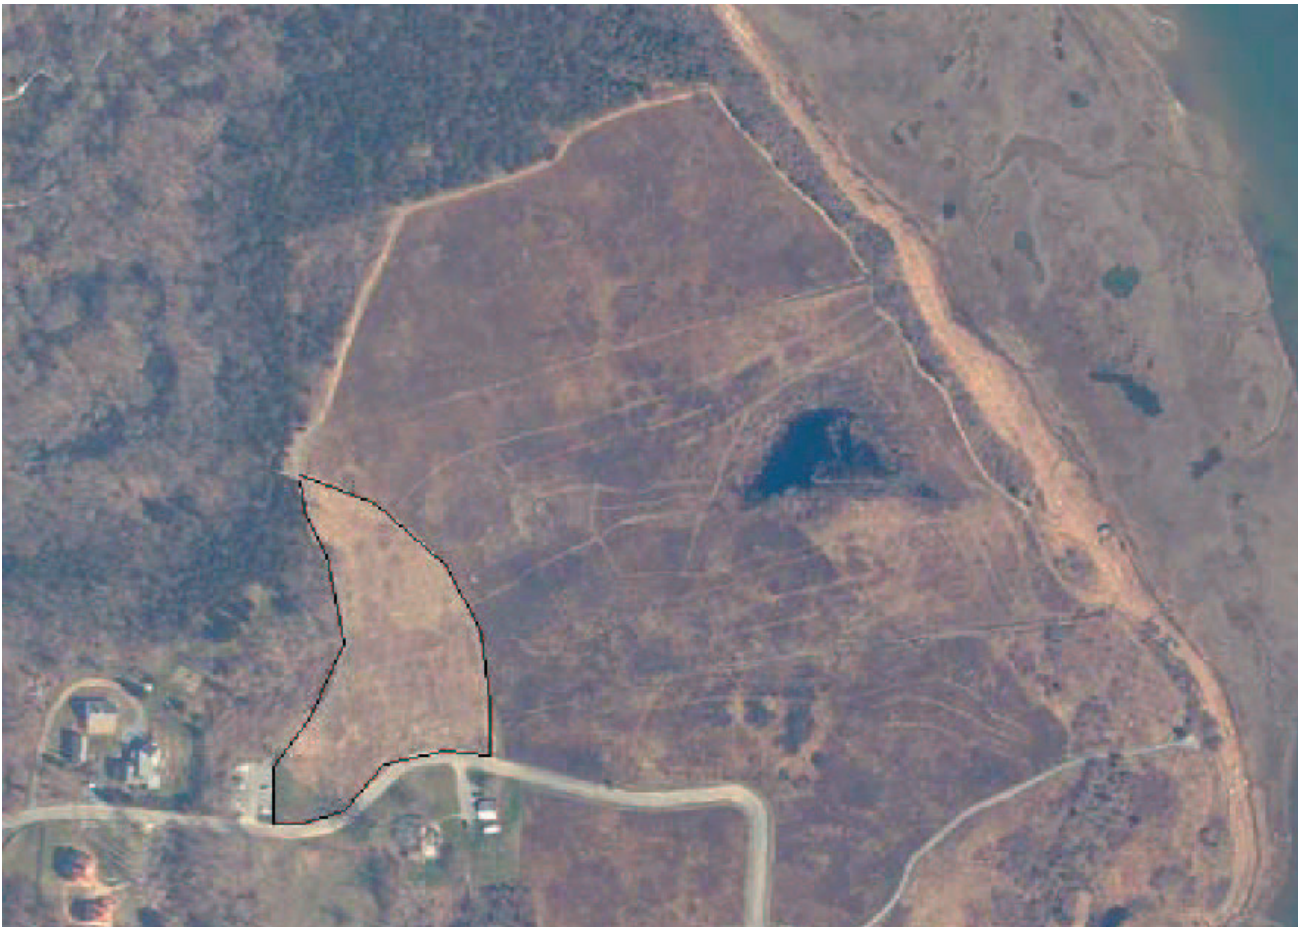
Figure 65. Aerial photograph showing area treated with foliar herbicide to eliminate exotic invasive species in 2006 (Northeast Exotic Plant Management Team, 2006).

In 2006 the National Park Service's Northeast Exotic Plant Management Team (NE EPMT) treated a subsection of Fort Hill with foliar-spraying of herbicide. This subsection included the southwest corner of Fort Hill—an area bound by the road, the footpath leading up to the Red Maple Swamp, and an old path running roughly NW to SE (Figure 65). The team focused on exotics that were present in this test area. The initial results were very encouraging in that the targeted species suffered rapid mortality, while natives flourished around them (Figures 66 and 67). In 2007 the Northeast Exotic Plant Management Team treated approximately half of the Fort Hill field area with Garlon 3A herbicide. Exotic and invasive plants were targeted, and there were very few losses of non-target species. The treatment appears to have been very effective on Oriental

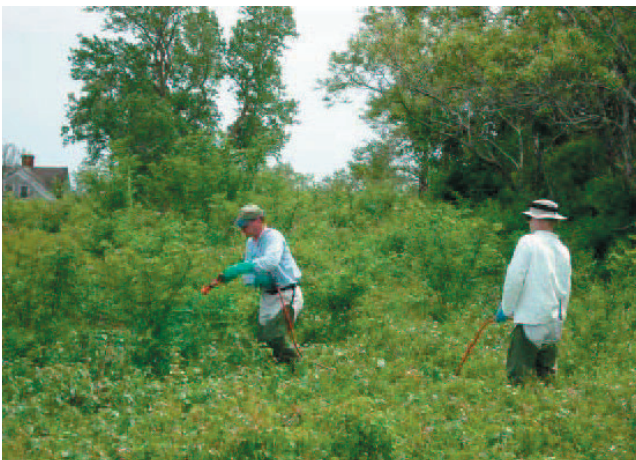
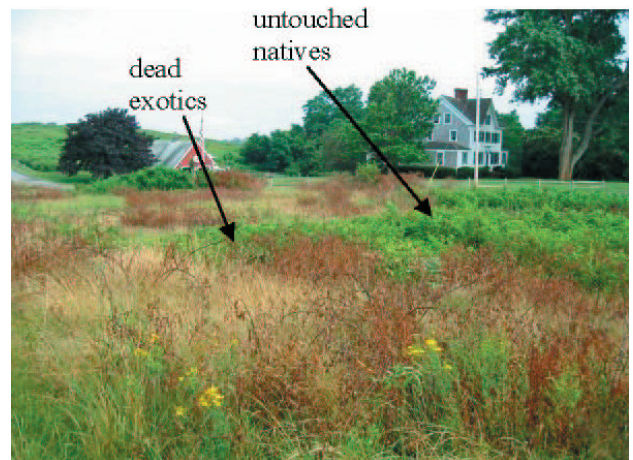
Figures 66 and 67. Photograph of the Northeast Exotic Plant Management Team treating invasive exotic plants and photograph taken after treatment showing dead exotics and untouched native plant species (Northeast Exotic Plant Management Team, 2006).

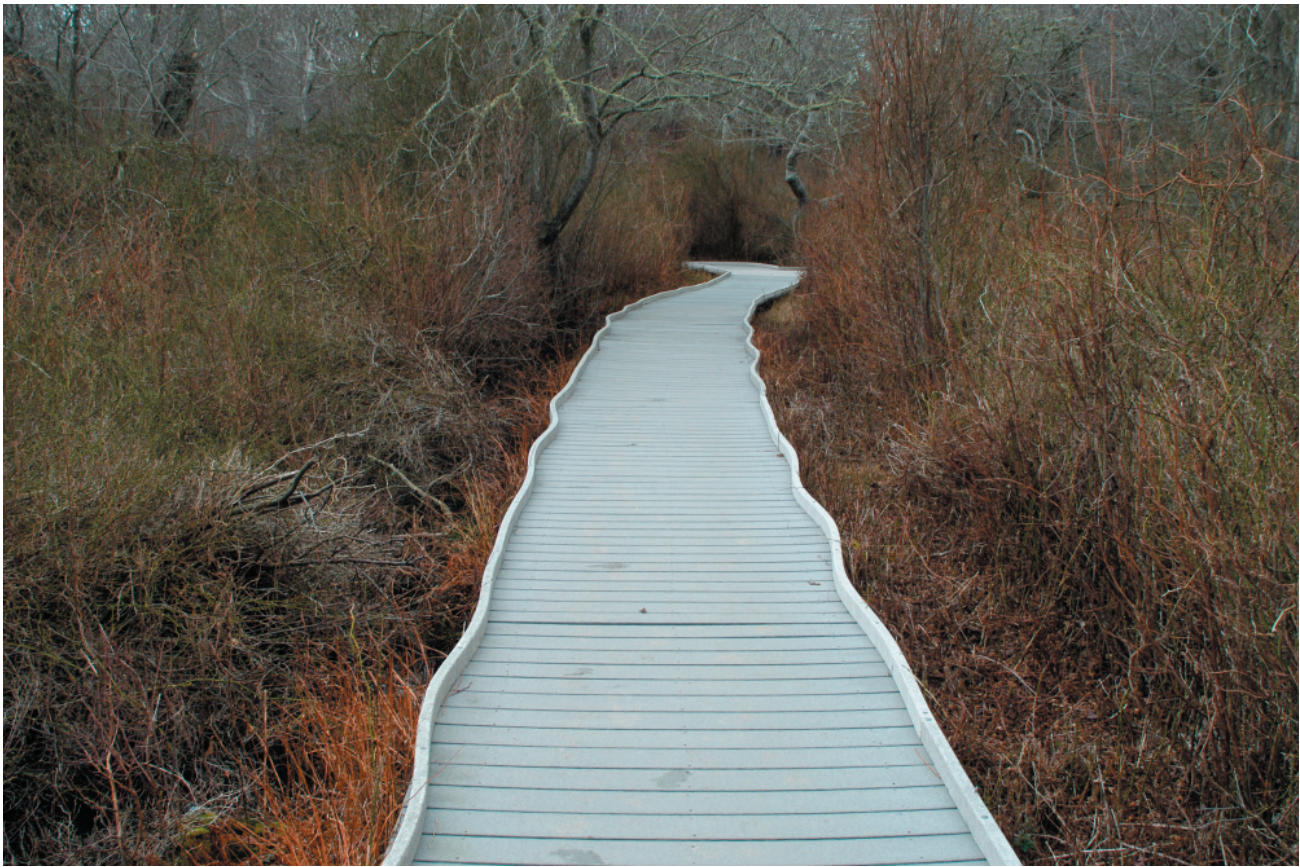
Figure 68. Photograph of the boardwalk on the Red Maple Swamp Trail. The thin pieces of recycled wood used for edging have expanded, causing the boardwalk to have a warped, wavy appearance (OCLP, January 2007).

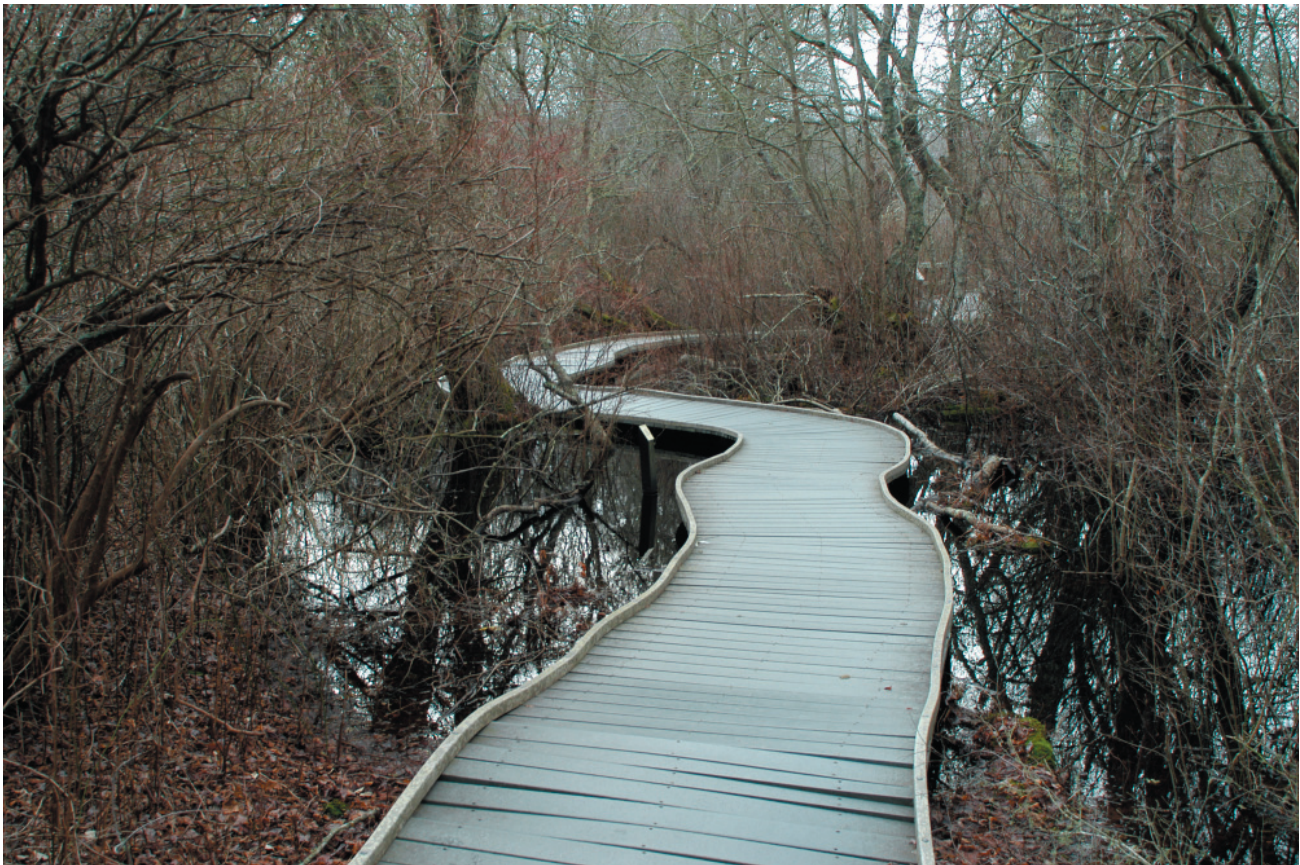
Figure 69. Photograph of the boardwalk on the Red Maple Swamp Trail, over standing water. In the foreground the old posts under the new boardwalk have rotted, causing the decking to collapse (OCLP, January 2007).

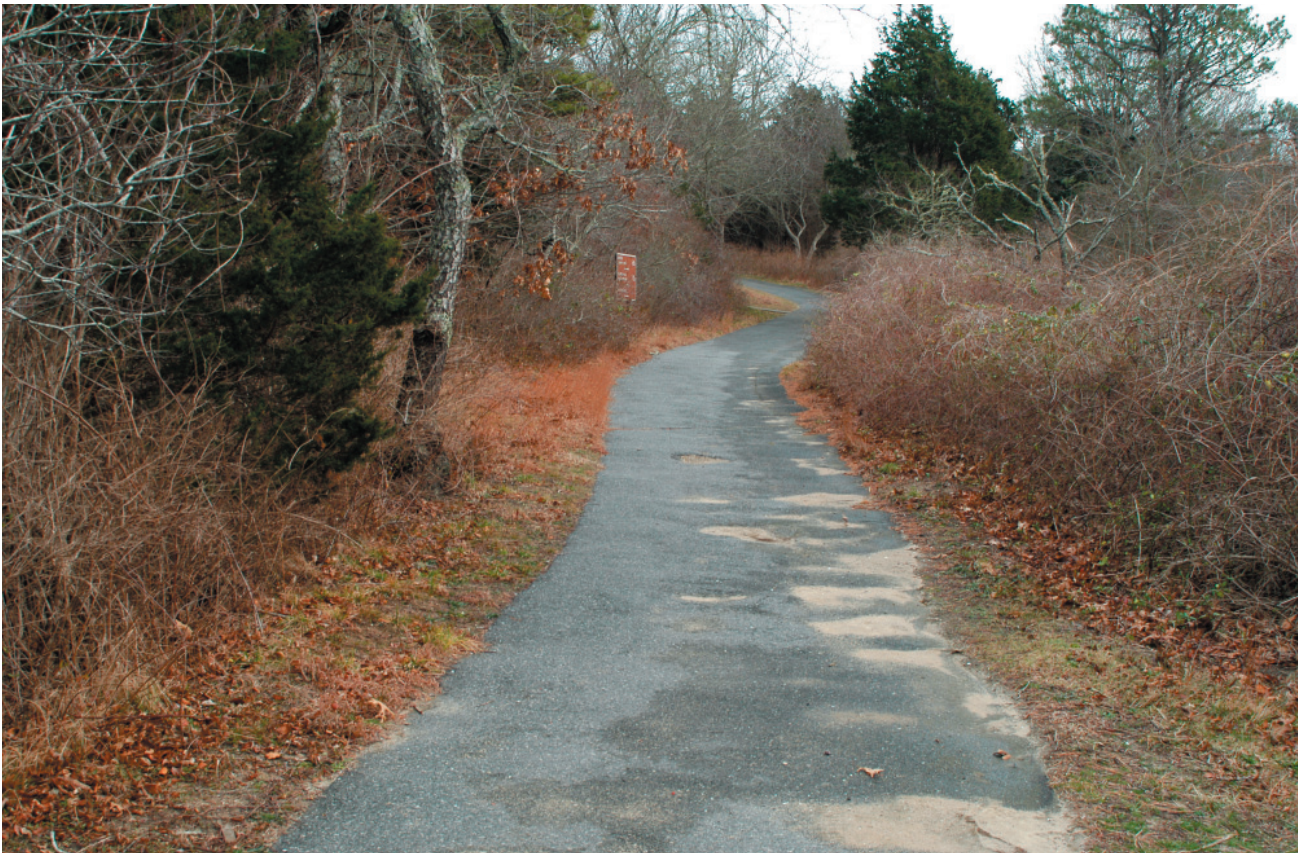
Figure 70. Photograph of the asphalt path at the Hemenway Road entrance. This surface could be replaced with gravel, narrowed, or chip-sealed and top-coated with bound gravel (OCLP, January 2007). The photograph below shows an example of a chip-sealed surface.

Black asphalt was used as a surface treatment on the path from the Hemenway Road entrance to the Skiff Hill shelter. The urban character of the asphalt surface detracts from the natural character of the site and repair and replacement of the asphalt surface will be required in the future (Figures 70 and 71).

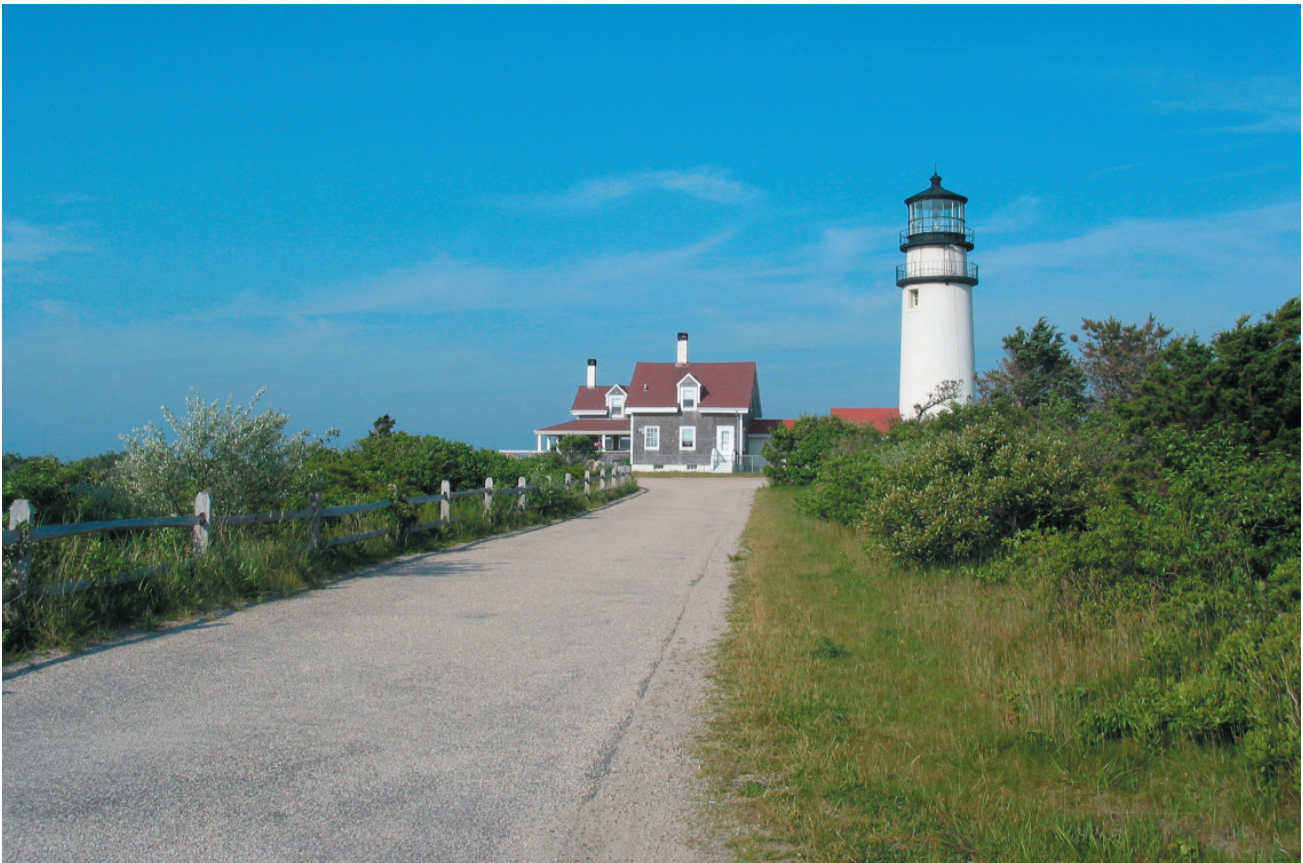
Figure 71. Photograph of the asphalt Highland Road with a chip-seal coating, an example of how asphalt paths can harmonize with the natural surroundings (OCLP, 2006).

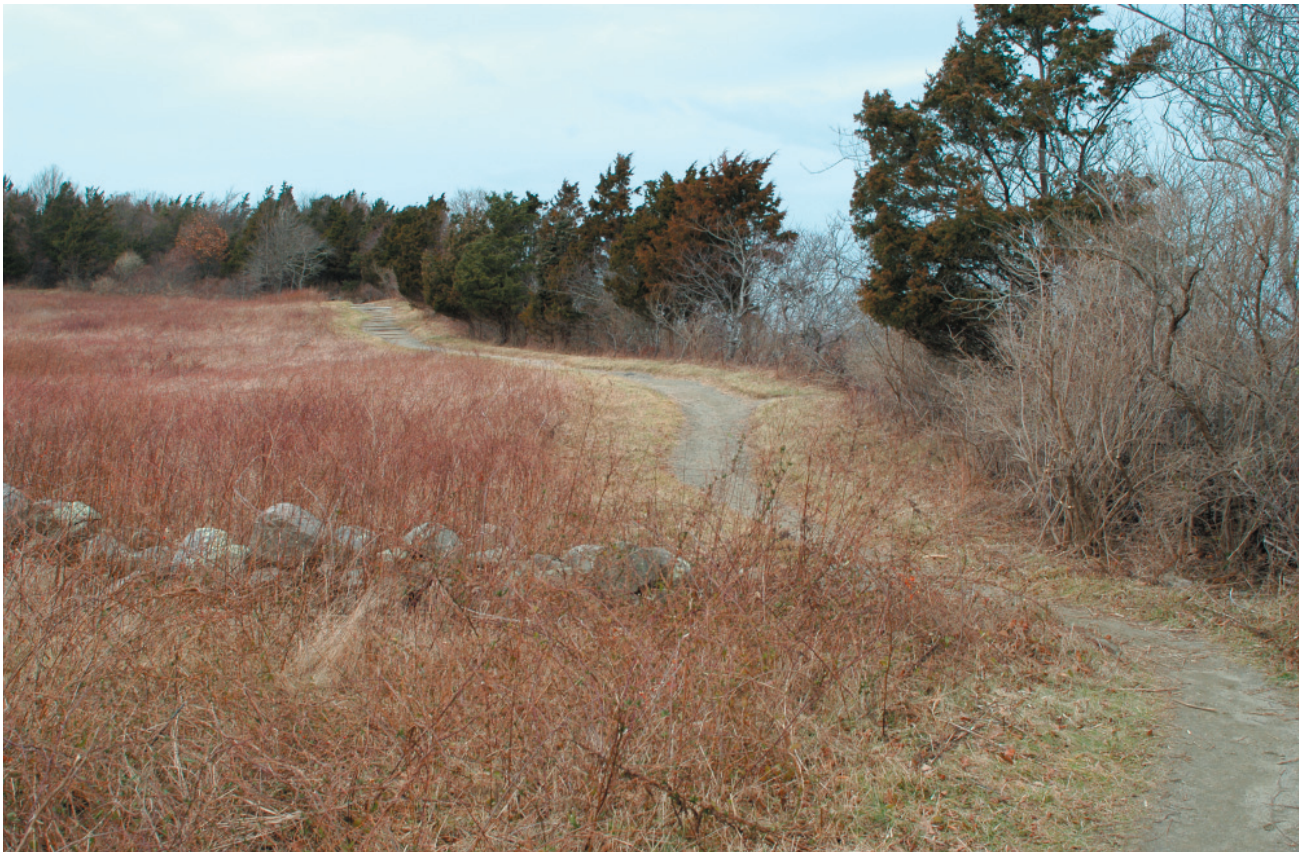
Figure 72. Photograph looking northeast along the Fort Hill Trail showing the natural color of the soil. Note how the view of Nauset Marsh is blocked by shoreline vegetation (OCLP, January 2007).

The current route and extent of the Red Maple Swamp trails should be maintained but the bluestone surface treatment should be replaced in a phased approach with a compacted natural colored gravel, similar to ongoing work to the Fort Hill trails (Figure 72). Volunteers are assisting the parks staff with this work for the Fort Hill trails and could at later stages assist with the Red Maple Swamp trails. Where the top layer is placed on trails that are eroding or where the existing bluestone top layer is replaced, care must be taken not to cut into the terrain to protect archeological features. In the long-term, all paths should have a natural colored gravel surface which harmonizes with the color of the native soil.

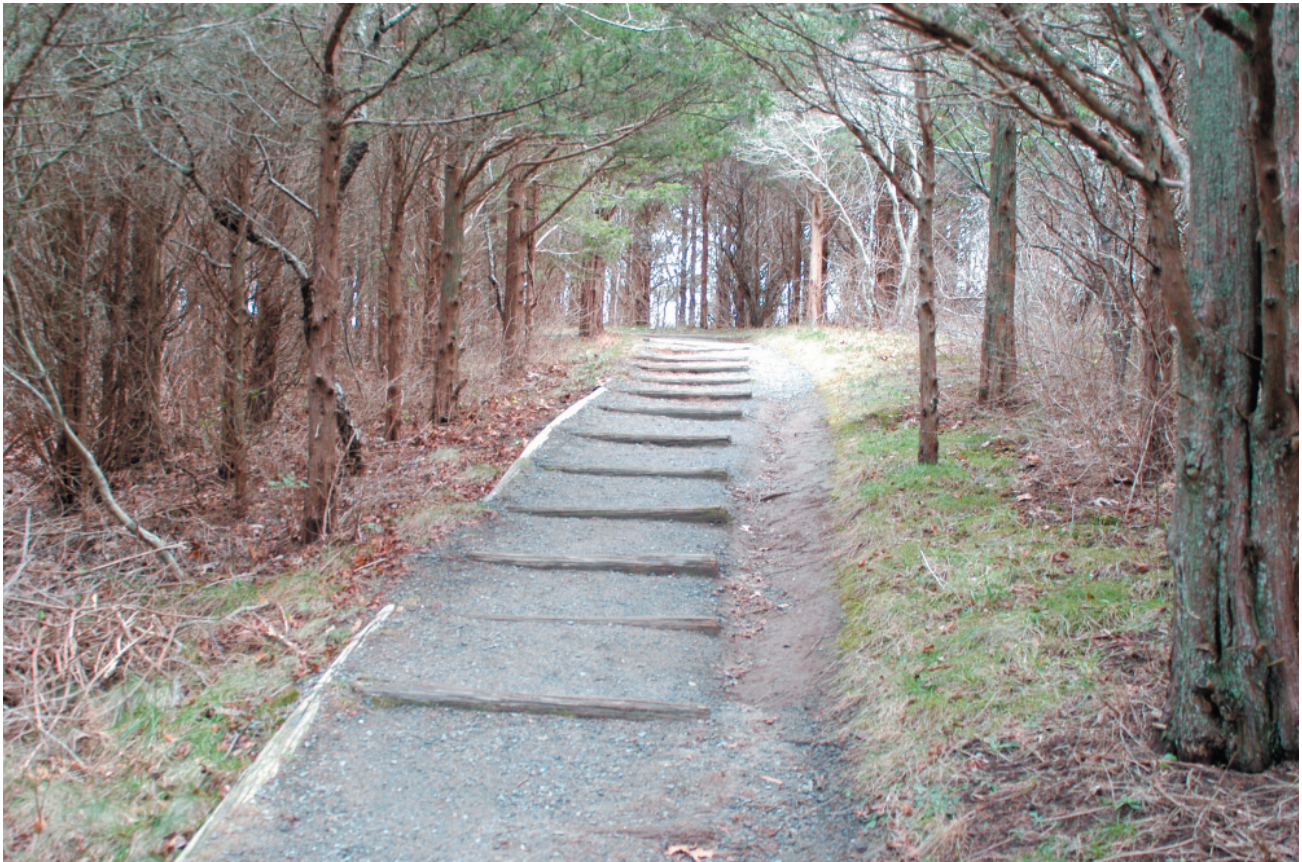
Figure 73. Photograph of the erosion along the gravel trails in the Red Maple Swamp (OCLP, January 2007).

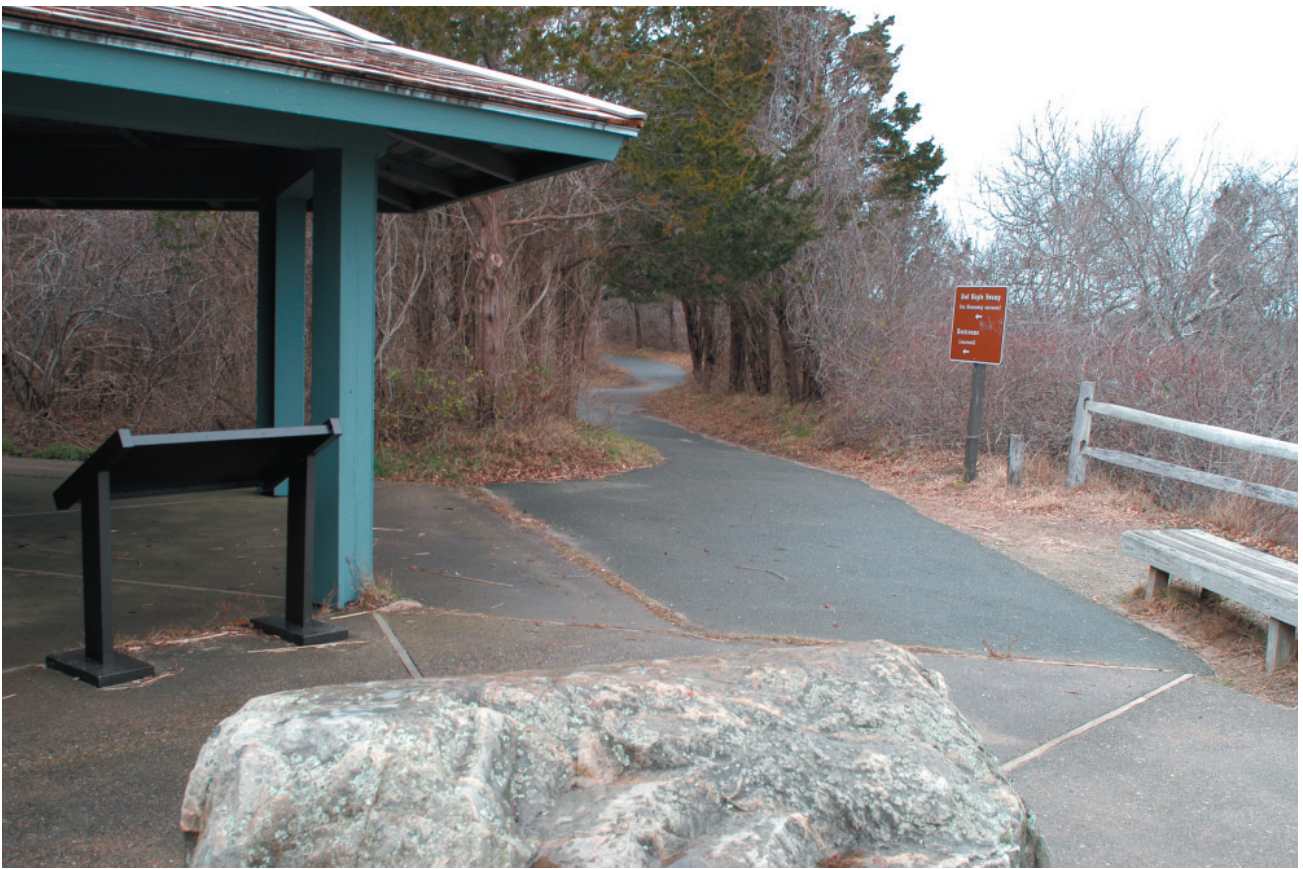
Figure 74. Photograph looking northwest showing the Skiff Hill shelter area with Indian Rock in the foreground. There are multiple surface treatments, a mixture of signs, and views are restricted by the surrounding vegetation (OCLP, January 2007).

The Skiff Hill shelter is the main viewpoint over the Nauset Marsh and was developed with interpretation of the Nauset Marsh and the Native American sharpening stone. When it was developed, the shelter sat in an open area, but at present the shelter is surrounded by trees and woody vegetation, which block views to the Nauset Marsh. The shelter area paving, signs and surrounding vegetation are in poor condition (Figures 74 and 75). The concrete paving around the sharpening stone is aesthetically unpleasing and feels inappropriate given the significance of the stone. The positioning of the four waysides is ad-hoc and does not enhance the area. The asphalt path connects to the concrete paving in an awkward way, which creates a patchwork appearance of paving surfaces. The hexagonal shapes of the Mission 66 era shelter and concrete surfaces are interesting architectural shapes but given the present condition of the shelter area they do not harmonize with the setting.

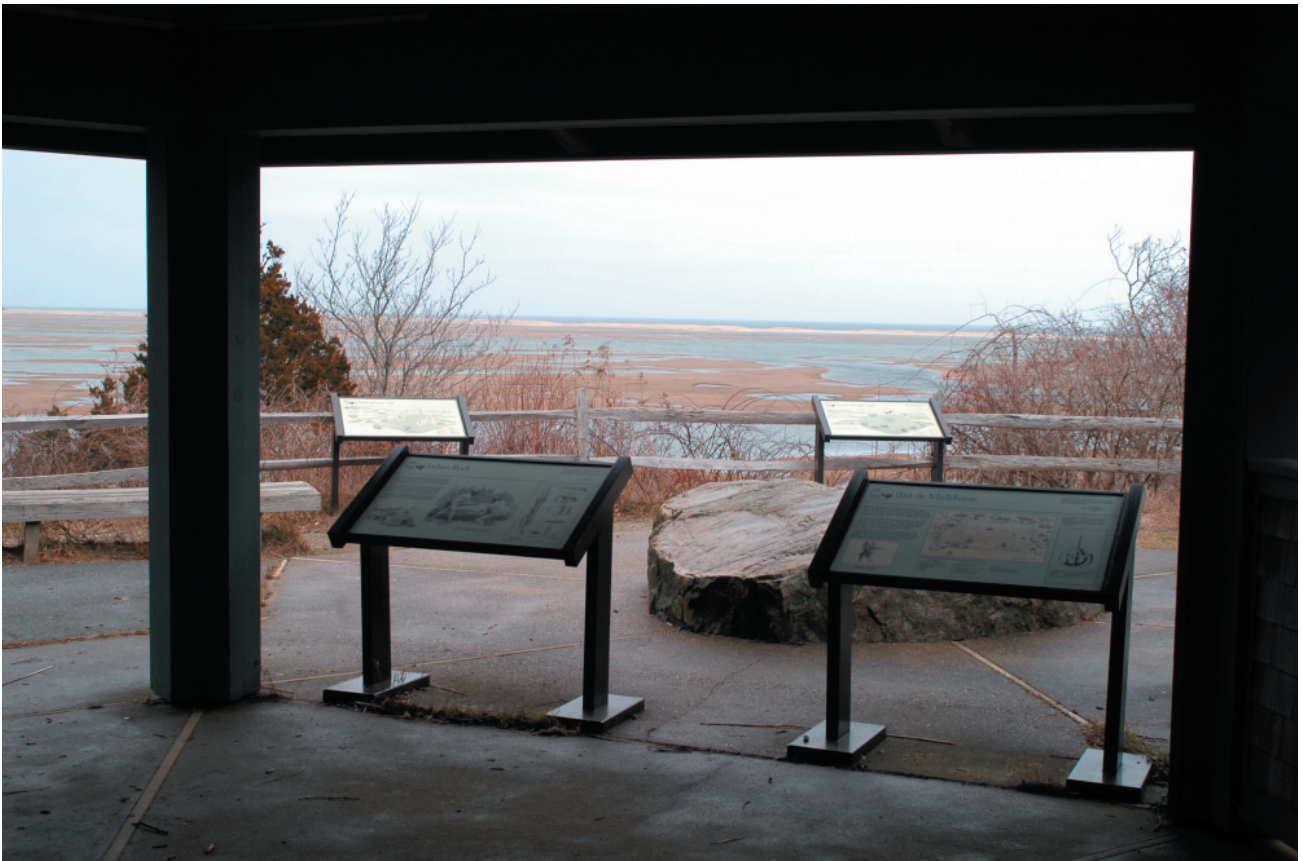
Figure 75. Photograph looking east from the Skiff Hill shelter. Signs dominate the viewshed, which is also partially obscured by surrounding vegetation (OCLP, January 2007).

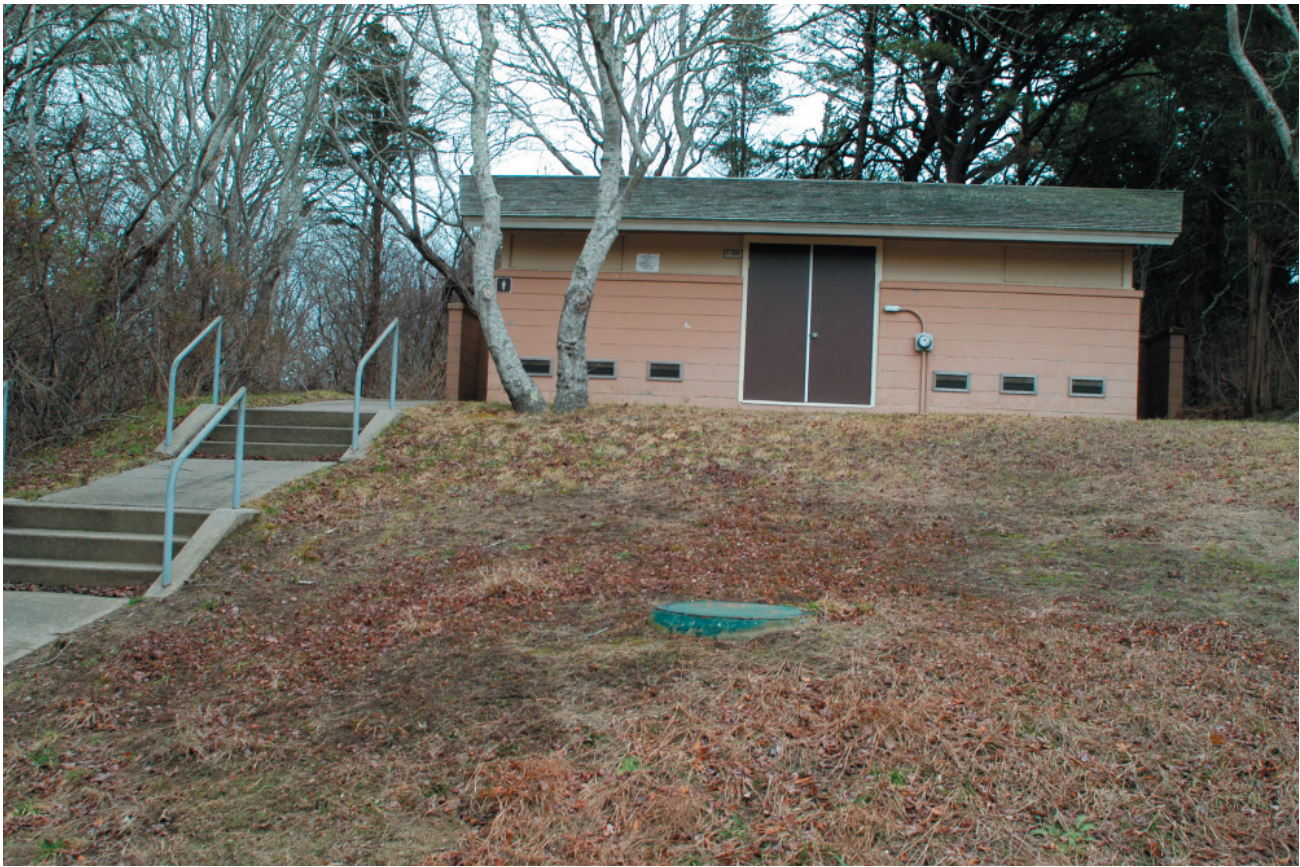
Figure 76. Photograph showing the comfort station at Skiff Hill, near the Hemenway Road entrance (OCLP, January 2007).

When the National Park Service constructed the public comfort station near Skiff Hill, the intention was that the parking at the town landing would be acquired (Figure 76). When this plan was not realized, the Fort Hill Road became the main entrance point to Fort Hill. As a result, the restrooms are located in a remote and inconvenient area of the park near the Hemenway Road entrance. Disabled access up the steps is also not ideal, but their proximity near the events area is useful.

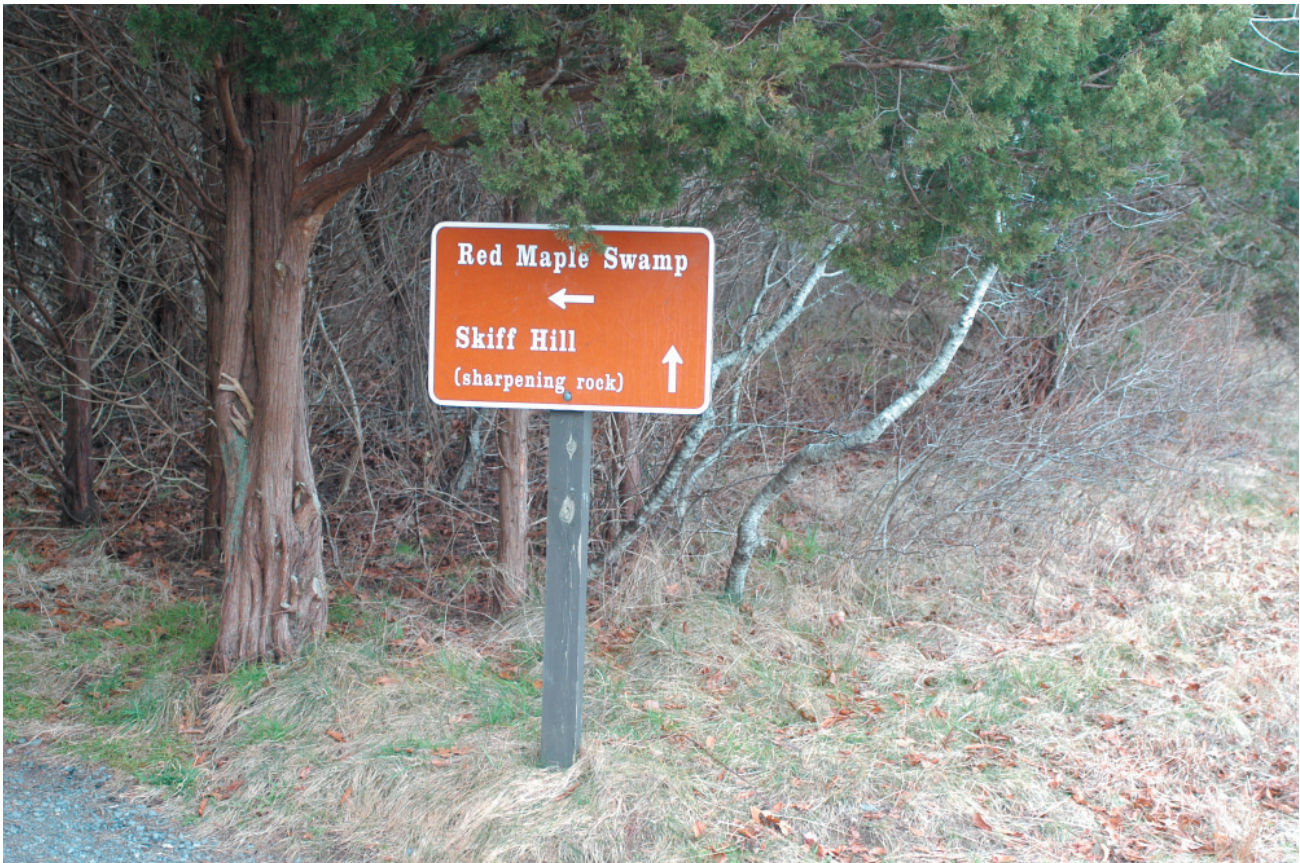
Figure 77. Photograph of a brown National Park Service directional sign, at the edge of the open field at Fort Hill (OCLP, January 2007).

Recommendation: Trail information and interpretation signs and waysides should be smaller and different in style than road signs (Figures 76 through 79). Recommendations for signage and waysides were described under signage in the Fort Hill Road zone of this treatment chapter. More information about the new style signs can be found on the website of the Harpers Ferry Center under the Uniguide sign standards at <http://www.hfc.nps.gov/uniguide>.

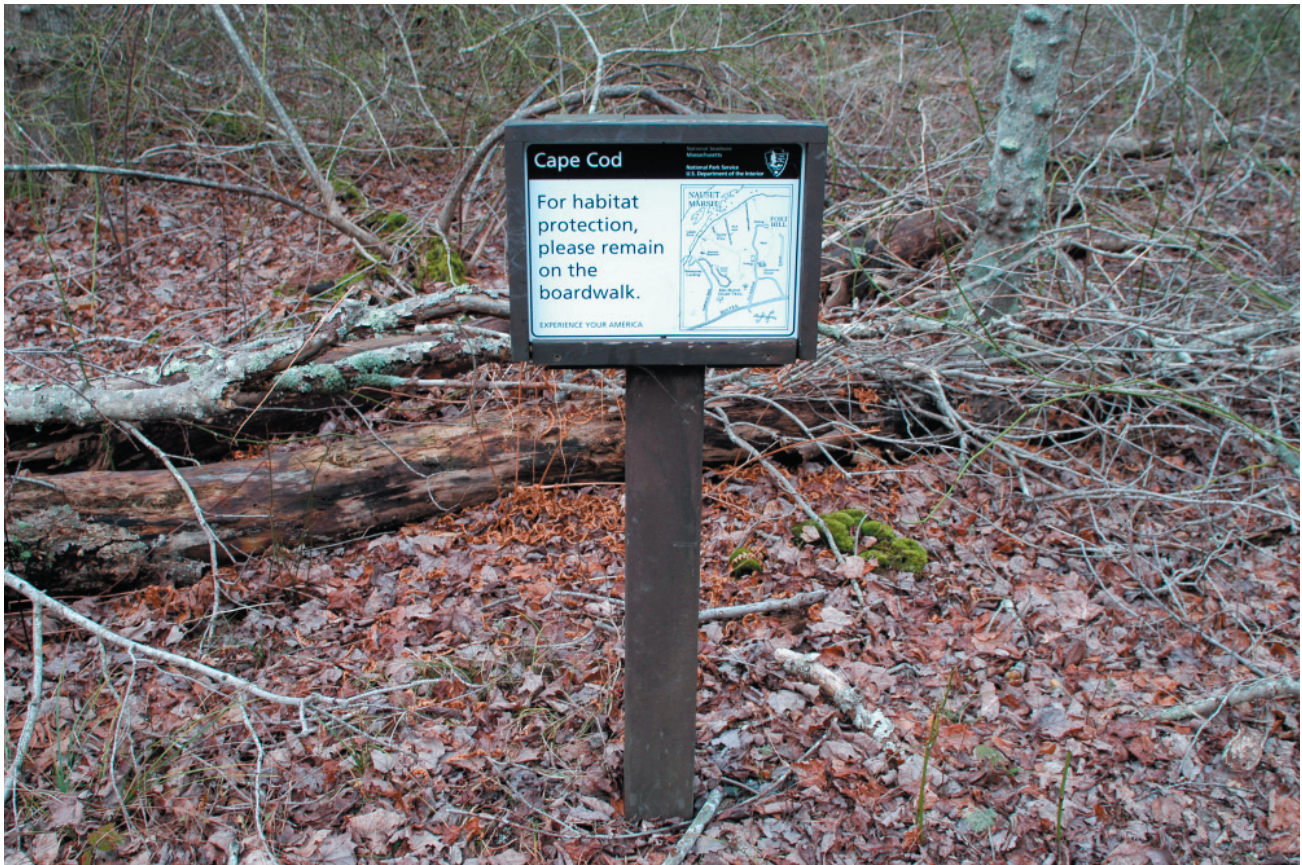
Figure 78. Photograph of an informational sign along the Red Maple Swamp Trail, which is in character with, and in proper scale for the surrounding natural environment (OCLP, January 2007).

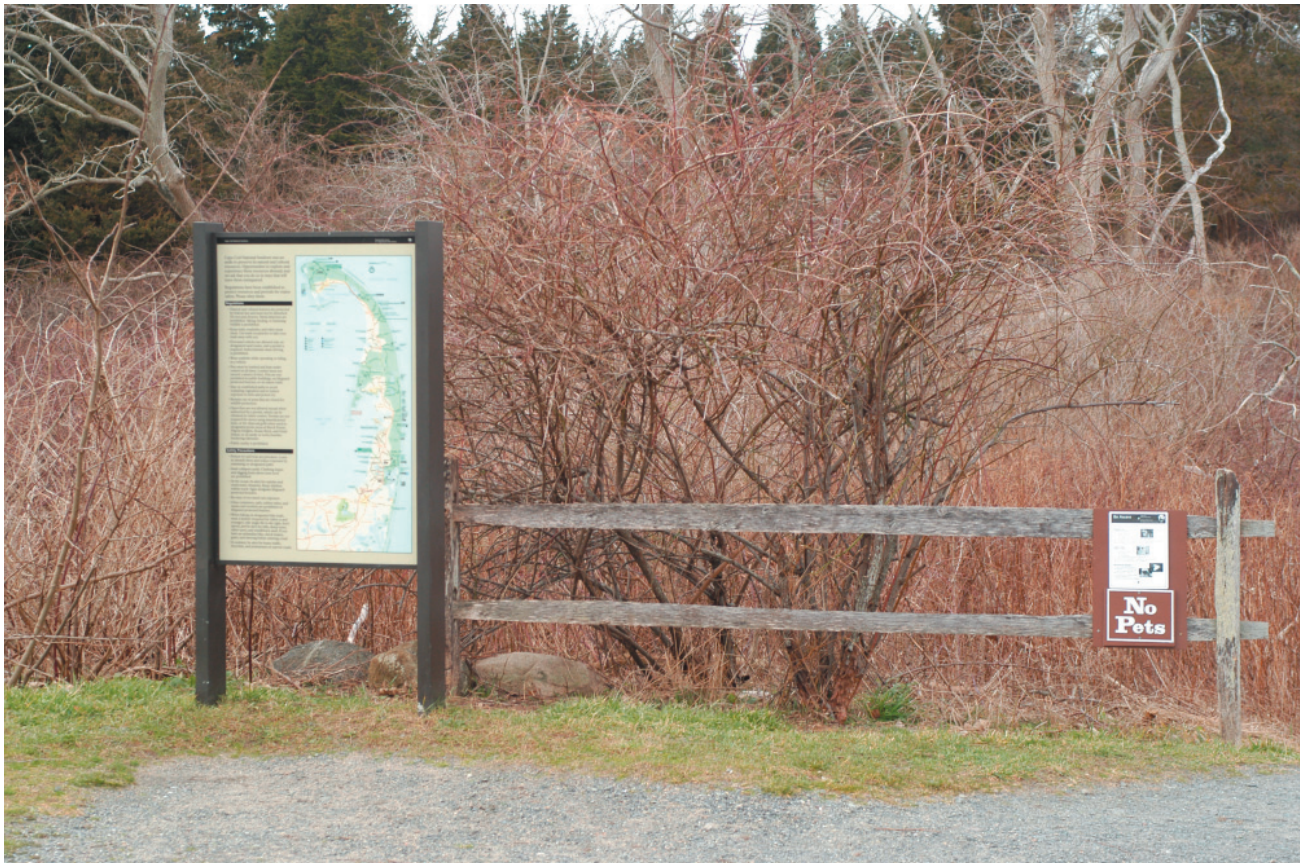
Figure 79. Photograph of multiple sign types at a Fort Hill trailhead (OCLP, January 2007).
