Chattahoochee River National Recreation Area  
Allenbrook  
**Historic Structure Report**

2004

Hartrampf, Inc.

Office of Jack Pyburn, Architect, Inc.

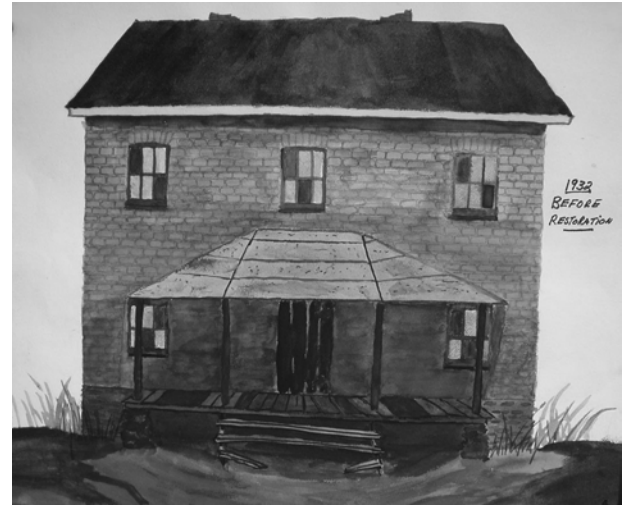
FIGURE 6. Watercolor of Allenbrook by Barnett A. Bell, Front Elevation. Courtesy of Roswell Historical Society Archives.

These two watercolors were likely painted by Bell from memory some time after the renovations. The strongest evidence of this is the depiction of the windows. Amateur artists drawing houses from

memory often depict six over six windows as three over three. They recall that the window frame has six panes; they often forget that a double-hung window has two frames. Bell also had difficulty depicting the hipped roof of the porch properly, most likely because he was not viewing it at the time he painted it. Because this painting was probably

not painted until after the changes were made, using these watercolors to recreate the exterior appearance of the building should be with extreme caution.

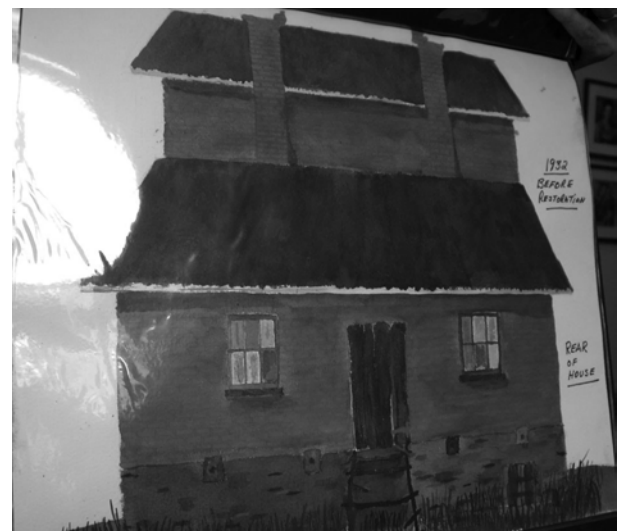
FIGURE 7. Watercolor of Allenbrook by Barnett A. Bell, Courtesy of Roswell Historical Society Archives.

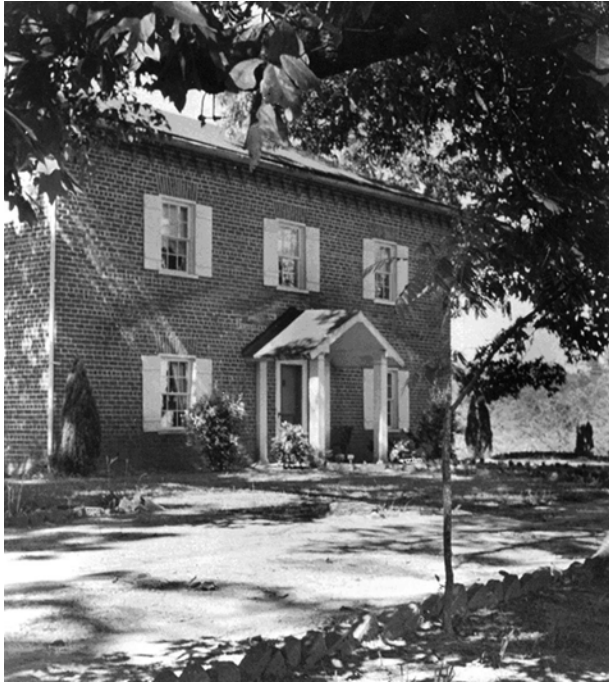
FIGURE 10. South elevation, 1940. Source: Roswell Historical Society.

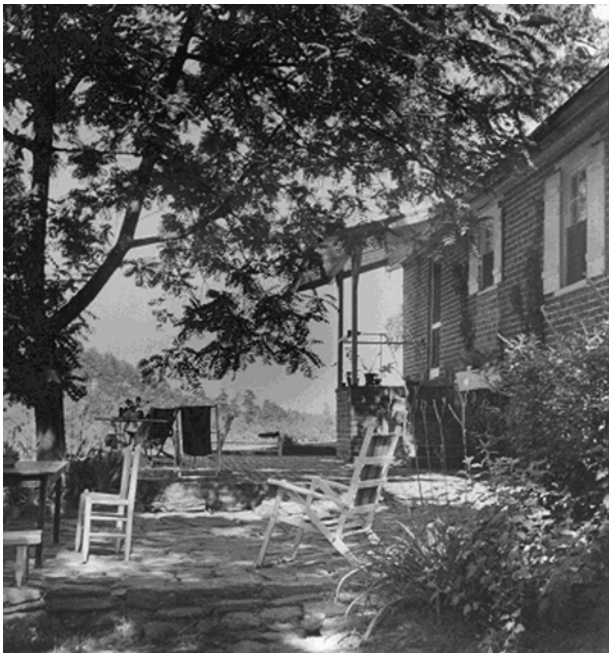
FIGURE 11. North elevation and rear yard, 1940. Source: Roswell Historical Society.

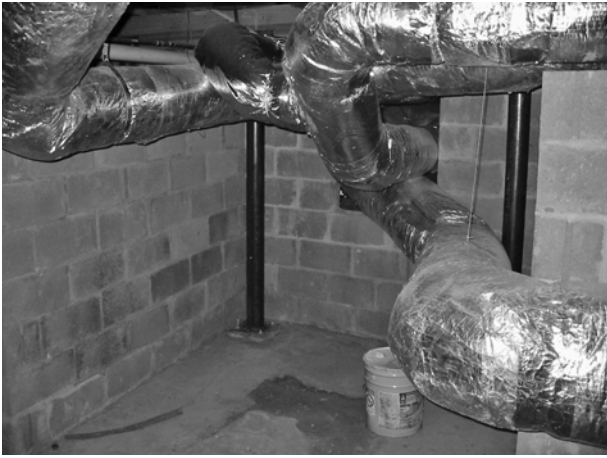
FIGURE 17. Concrete block retaining wall along south side of excavated basement.

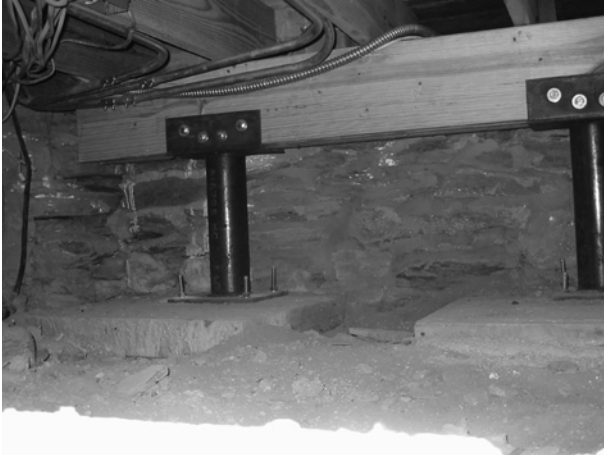
FIGURE 18. New 2" by 10" supplementary support beams at north, two-story wall.

support beams beneath the north two-story wall. A new 2" by 6" sill plate is bolted to the top of the concrete block walls along the north, east, and west elevations. A new 2" by 4" sill plate is joined to the 2" by 10" supplementary support beams at the rubble, load-bearing wall. Rolled batt insulation has been installed between the joists. This floor framing and insulation dates to the 2000-2002 National Park Service stabilization work. Beyond the concrete block retaining wall installed between 2000 and 2002, a very shallow crawl space exists. The limited height of this space and the presence of the concrete block wall prevented access to the southern half of the first floor framing. The only historic materials observed from this vantage were the granite rubble stone foundations of the chimneys and the north wall of the two-story portion of the building. All of the floor framing observed in this area appeared new but could not be reached for measurement.

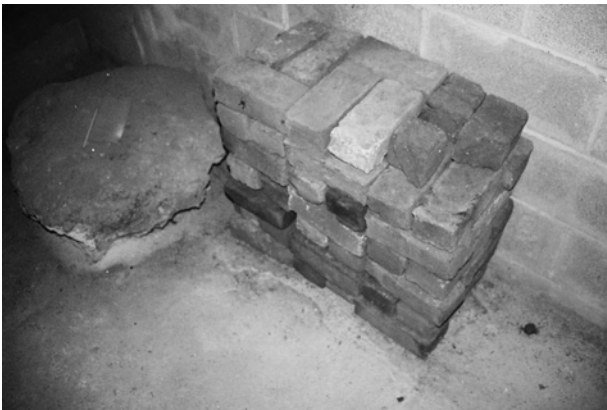
FIGURE 19. Bricks stacked in basement.

Access to the building foundation and basement is through Door 10 and down a small set of frame steps constructed by the National Park Service. Of particular note is a stack of bricks located adjacent to the stairs in the basement. It is presumed that these bricks are some of those salvaged from the site work on the front and rear yards during the stabilization and rehabilitation treatments undertaken by the National Park Service between 1998 and 2002.

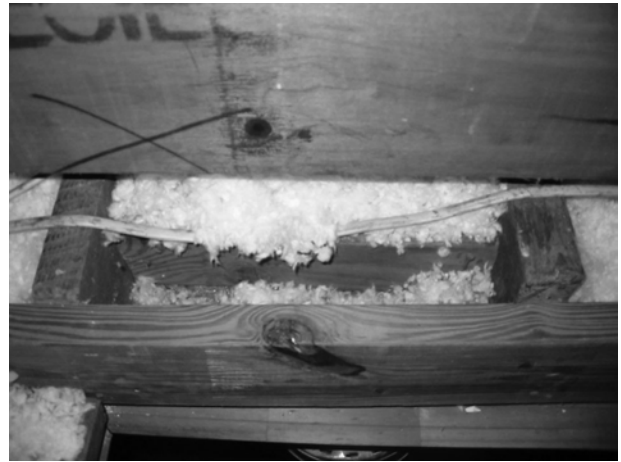
FIGURE 20. Floor joists in attic.

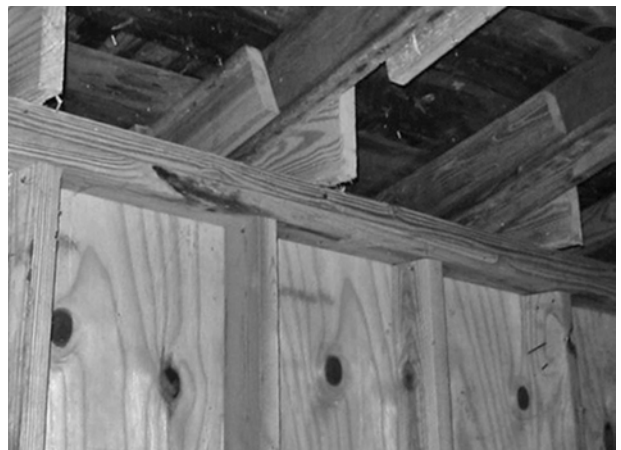
FIGURE 21. New north wall framing in Room 104.

At the perimeter of the house and at the two-story interior masonry wall, the walls are load-bearing masonry. The structural integrity of the solid masonry exterior walls is enhanced by a header course every three courses of running bond. The interior wall structure is only revealed in a few places throughout the house. A portion of the east wall in Room 102, along the stairway, has been removed to reveal the wall structure and interior plumbing. The studs at this location are circular sawn, measure 2" by 4", nominal, and are spaced approximately 16" on center. The Bell family opened this wall during renovations to accommodate plumbing. The finish material at this location is gypsum board that was installed as a patch to the wall. Also, where the truncated walls exist in Room 105, the top plate is exposed. These historic members measure 2" by 4", and date to the renovation work done by the Bell family. The framing of the north wall in Room 104 is exposed

and measures 2" by 4", nominal, spaced 16" on center. This wall was entirely rebuilt by the National Park Service contractor between 2000 and 2004.

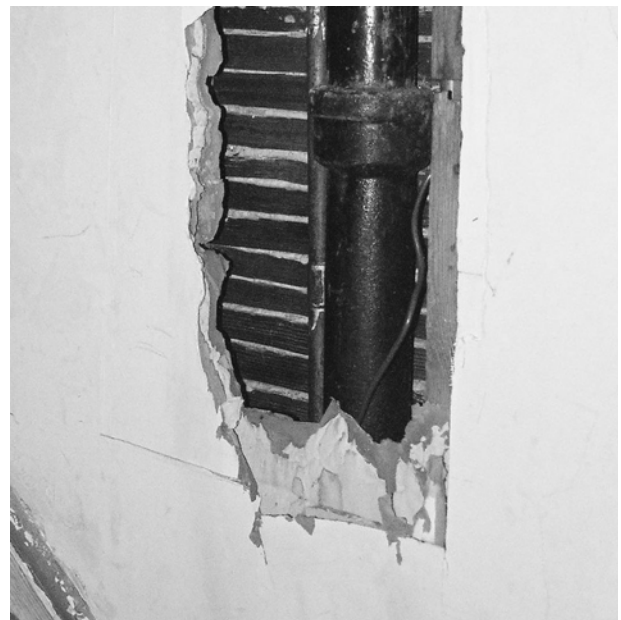
FIGURE 22. East wall of stairwell in Room 102. Note gypsum board wall finish.

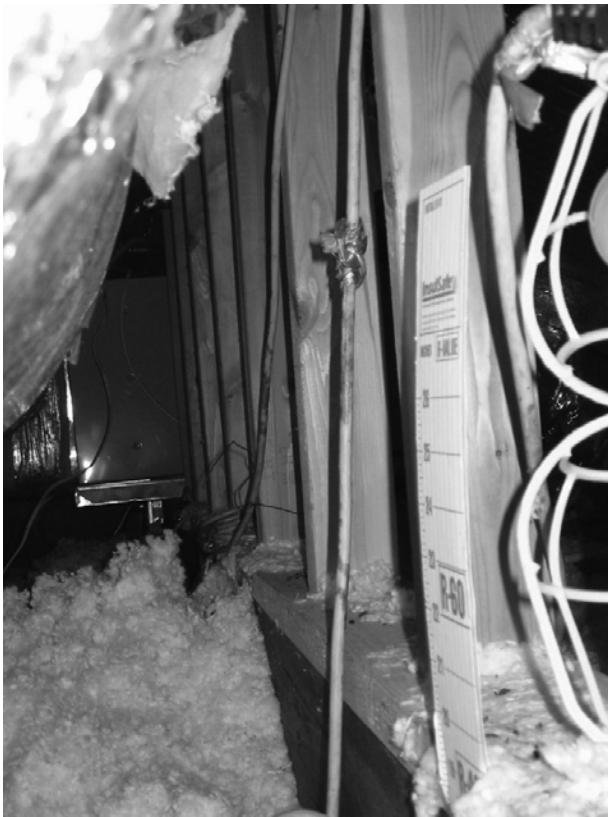
FIGURE 23. Posts and beam providing central support to hipped roof.

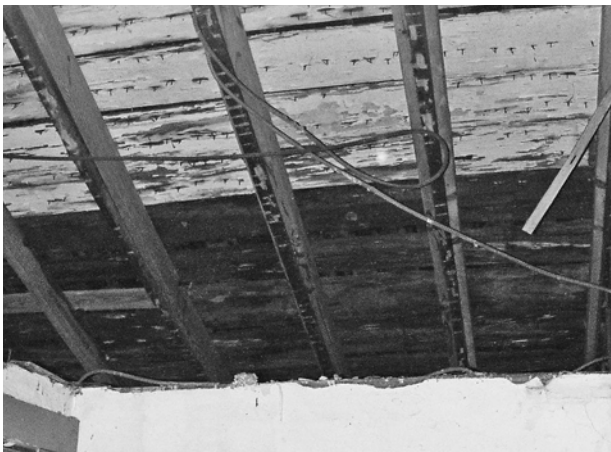
FIGURE 24. Shed roof framing as seen from Room 106.

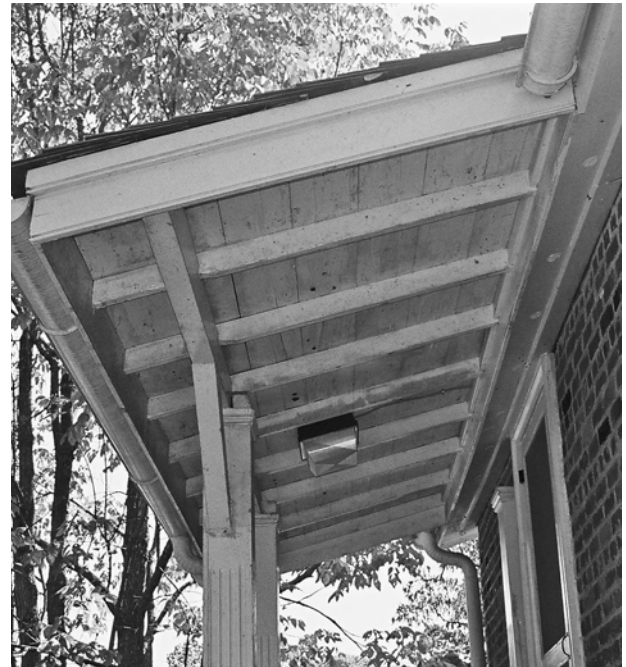
FIGURE 25. Framing for shed roof at rear stoop.

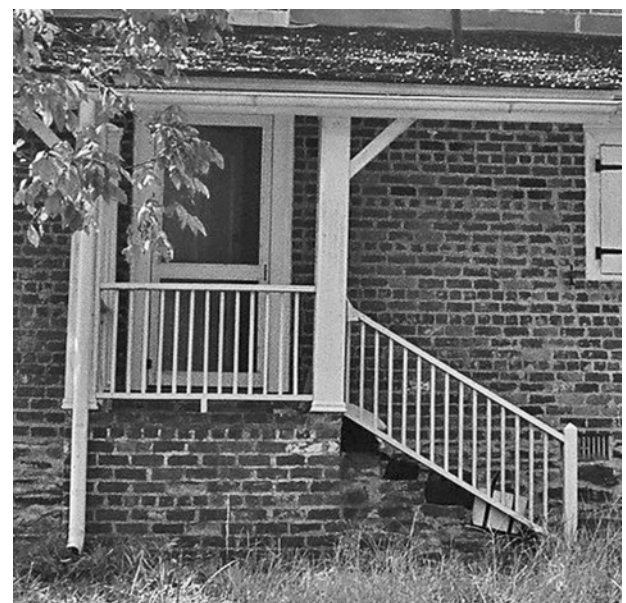
FIGURE 26. Stoop at rear entrance to house.

height of the stairs is 2'- 7½", and there are five stairs to the stoop. The stairs are comprised of five 6½" risers and five 11" treads. A balustrade extends up the north side of the stairs. The balusters measure 1" square and are spaced at 4" on center. The rails measure 4" by 2" by 5'- 9" long. Located at the top and bottom of the balustrade is a newel post, measuring 3½" square and 3'- 7" tall. The top 2" sections of the newel posts are a pyramidal shape. It

is known that the stoop was constructed sometime after 1932 by the Bell family. The stoop was dismantled when the National Park Service contractor reconstructed the north wall between 2000 and 2002. All of the materials on the stoop are historic with the exception of the balustrade, which

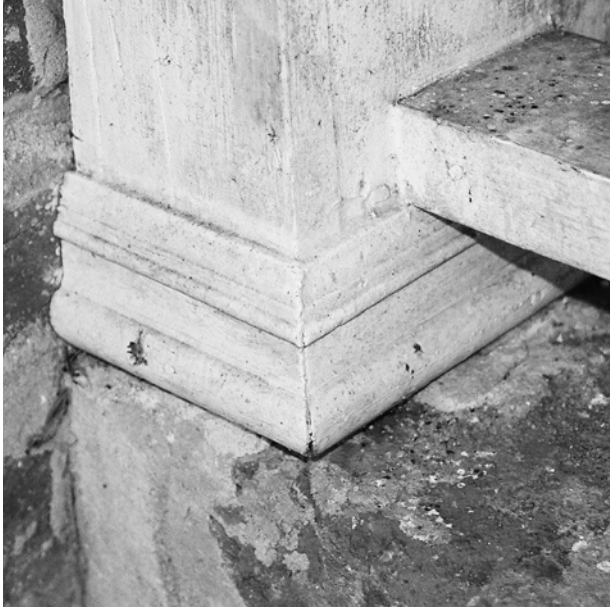
FIGURE 27. Detail of column base.

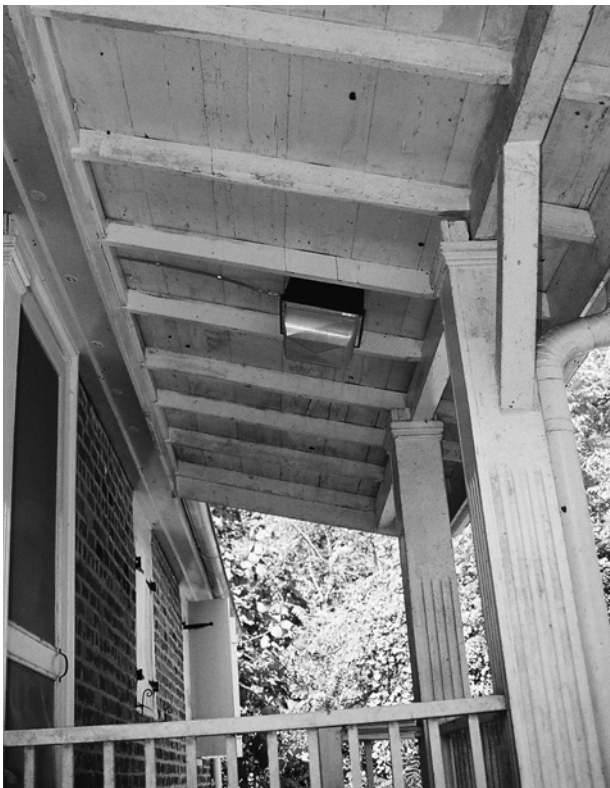
FIGURE 28. Stoop located at rear entrance to house.

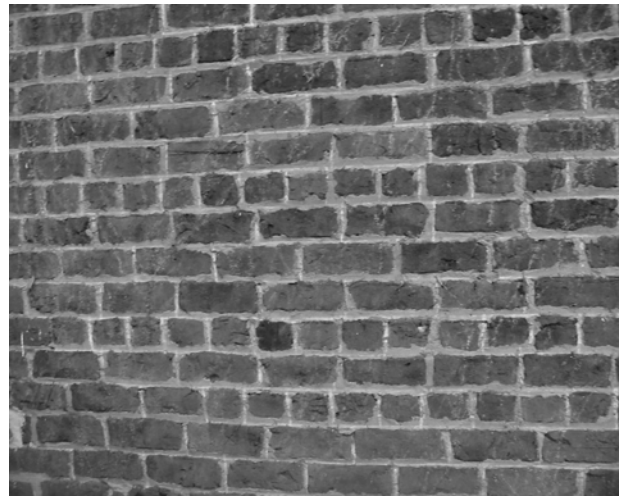
FIGURE 29. View of exterior walls. Note penciling of the mortar joints.

On the south elevation, just below the second story windows, are shadow lines of two of the former porch roofs. The National Park Service contractor repointed and reconstructed some of the exterior brick and granite walls between 2000 and 2002. Specifically, the entire north wall was reconstructed using both historic and new brick as well as granite to match the historic. Additionally, foundation vents were installed at the top of the granite section of the north wall. As directed in the National Park Service contracting documents, all new bricks were specified to match the historic in size, shape, texture, and color and were to be molded with the year of firing, 1998, on the face of each brick. This last directive was apparently to avoid any future confusion as to which materials were original and which were the result of later modifications. Ali Miri’s 1994 report illustrates that the section of the north wall beneath the bathroom window (Window 5) was filled with brick lighter in color than the surrounding materials when this area was modified and the window created between 1930- 1940. When the north wall was reconstructed between 2000 and 2002, the National Park Service contractor did not match the brick to that which existed historically in the area under Window 5, but instead matched the

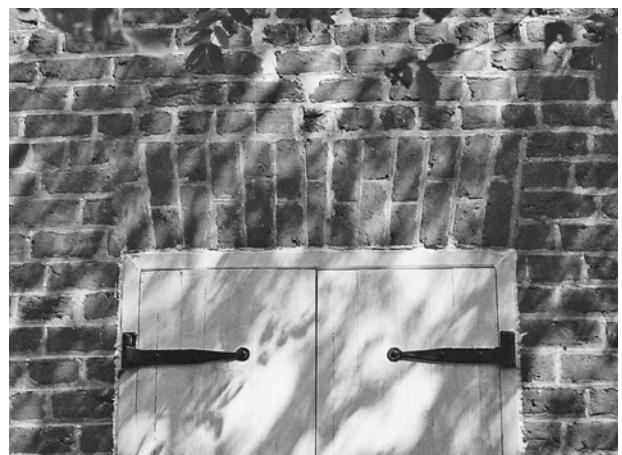
FIGURE 31. Flat arches typical of windows on south, east, and west elevations of main block of house.

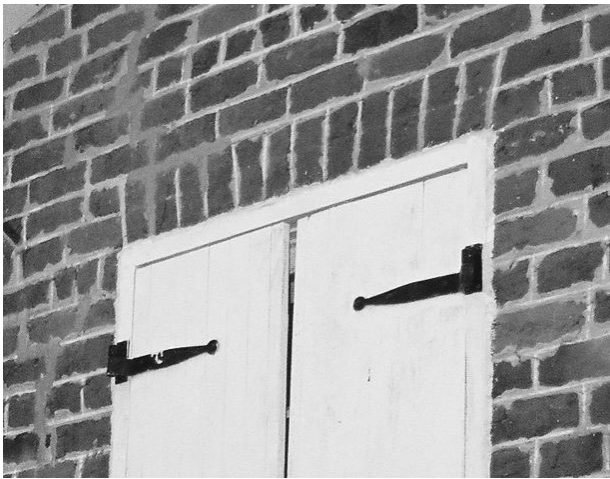
FIGURE 32. Typical flat arch at windows on east and west ends of addition.

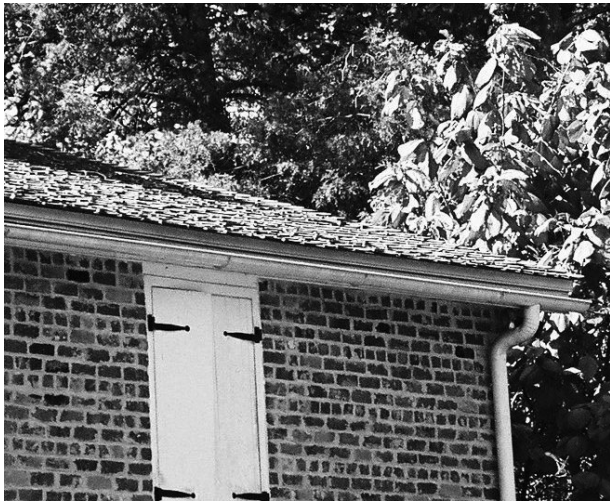
FIGURE 33. Cedar shingle roofing on shed-roofed addition.

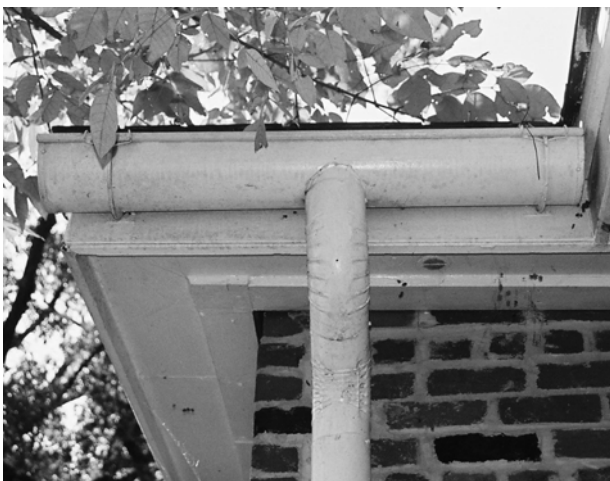
FIGURE 34. Gutter and downspout at northeast corner.

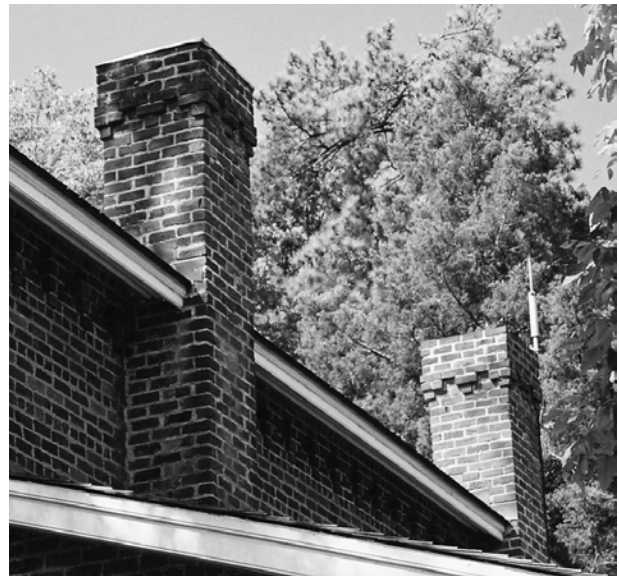
FIGURE 35. Chimneys on north elevation of second story. Note that the left chimney has a galvanized metal cap.

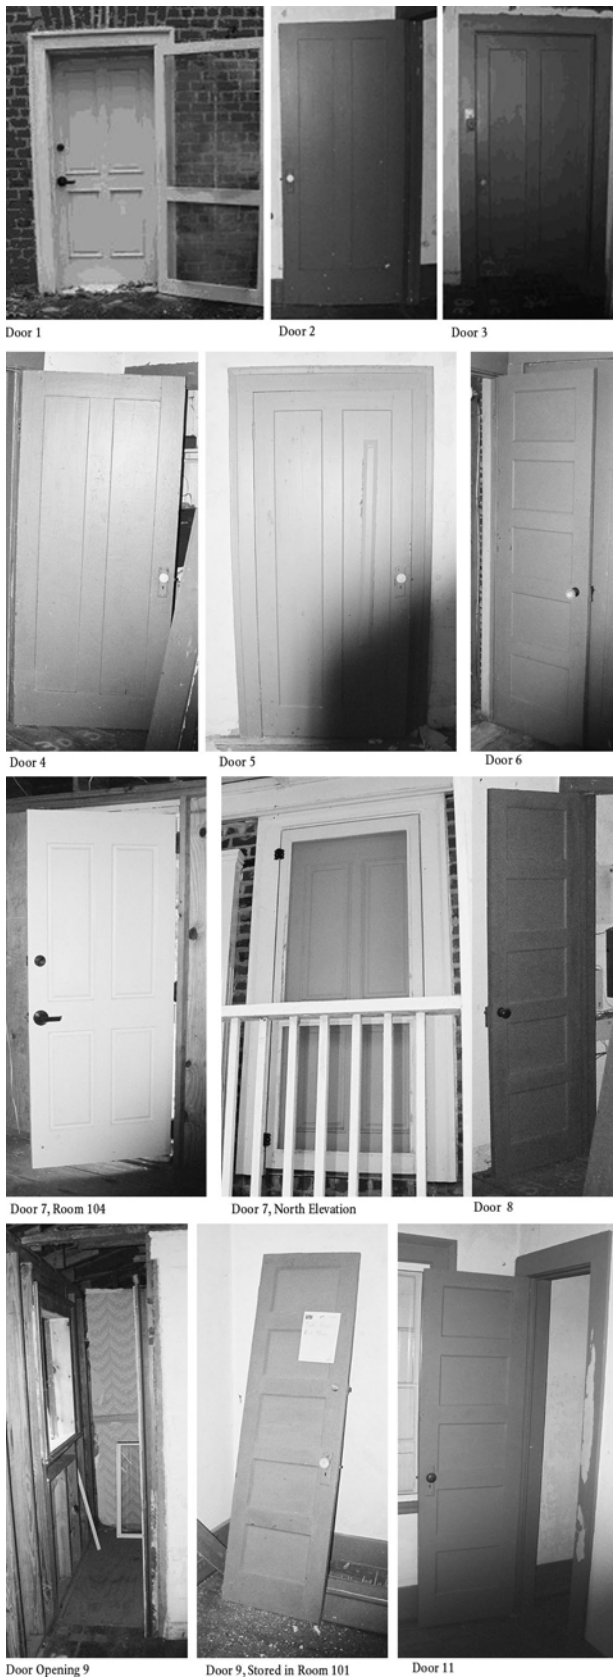
FIGURE 37. Doors 1-11.

There are three types of stile- and- rail doors in the house. Type 1 has two, long, vertical, side- by- side panels. The panels on these doors are flat and have no molding. Doors 2, 3, 4 and 5 are Type I and are believed to be original to the house. Type 2 has five equally- spaced panels running horizontally from the top to the bottom, with machine- molded stiles and rails. Doors 6, 8, 9, 11, 12, 13, 14, 15 and 16 are Type 2 and were likely installed by the Bell family sometime after 1930. Type 3 has four vertical panels arranged in a Latin cross configuration. The panels

*Door 1:* Two doors are in this opening: a four- panel door (Type 3) and a screened door on the exterior, both of which were installed by the National Park Service contractor between 2000 and 2002. The opening is original to the building. The Type 3 door in this opening measures  $2'-11\frac{3}{4}"$  by  $6'-11\frac{1}{2}"$  by  $1\frac{3}{4}"$ . Applied to each of the panels is  $\frac{1}{2}"$  molding. See details included at the end of the door descriptions. The screened door measures  $3'-0\frac{1}{4}"$  by  $6'-10\frac{3}{4}"$  and is comprised of two panels of wire screen framed between stiles and rails. A metal door handle is affixed to the exterior elevation of the door on the left stile. Both of the doors and the frame have been painted white. The threshold measures approximately  $1'-7"$  wide by  $\frac{1}{2}"$  thick. The hardware for this door consists of a lever- type door handle and core lock, a deadbolt, and butt hinges. The lever- type handle measures approximately  $4\frac{3}{4}"$  and is mounted on  $\frac{3}{4}"$  base. The deadbolt lock is

*Door 3:* Door 3 is Type 1 and measures 3’- 3” by 6’- 10”. The opening is original to the building. Both the door and the frame are painted blue. This door opening does not have a threshold. The hardware

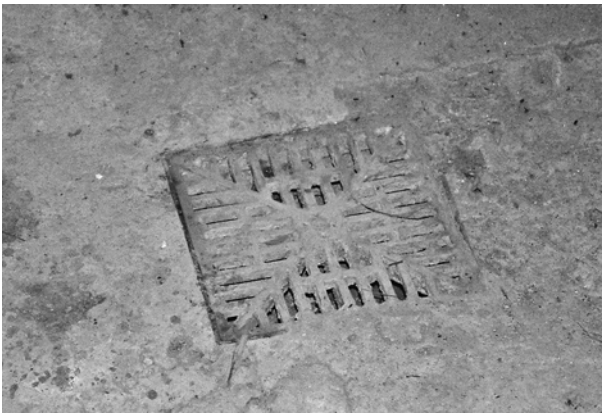
FIGURE 48. Grate in basement floor.

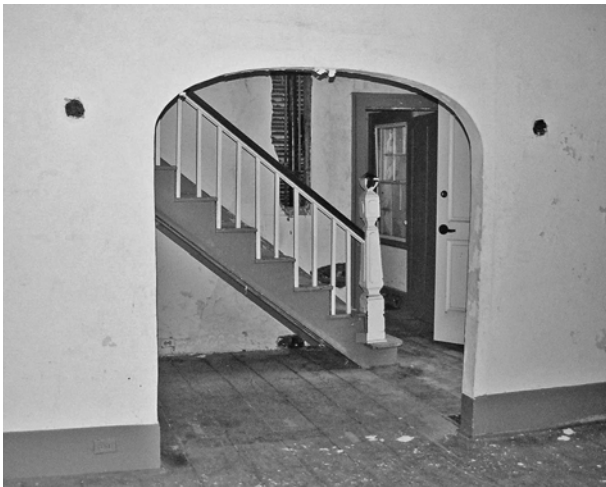
FIGURE 49. Arched opening in east wall of Room 101.

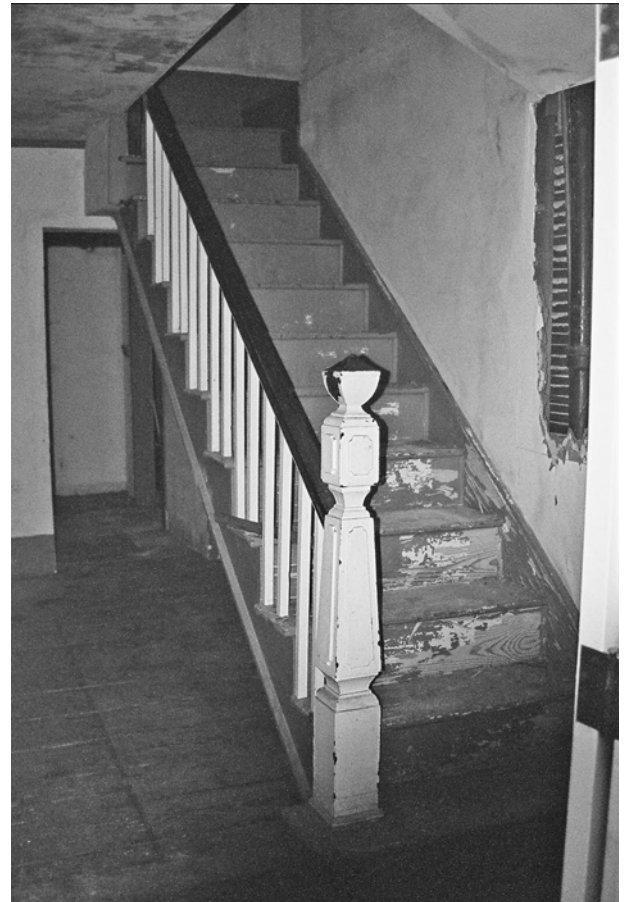
FIGURE 52. View of staircase in Room 102.

**Staircase.** A staircase leading to the second floor is located along the east wall of the hall. The height of the staircase from the finished floor of Room 102 to the underside of the top landing is 7'-5". The stairs are comprised of nine 12" by 3'-3" by ¼" treads and eleven 8" risers. At the base of the stairs is a shallow tread measuring 12" by 3'-9" by ¼" and, at the top of the stairs, immediately before the landing, is a 10½" by 3'-3" by ¼" tread. A balustrade comprised of fifteen 1" square balusters, a 2½" by 3" hand rail, a 4'-4¼" tall, ornamental newel post at the base and a 4'-1½" tall simple newel post at the top encloses the stairs to the west. The risers and treads of the staircase are painted blue. The balusters and the

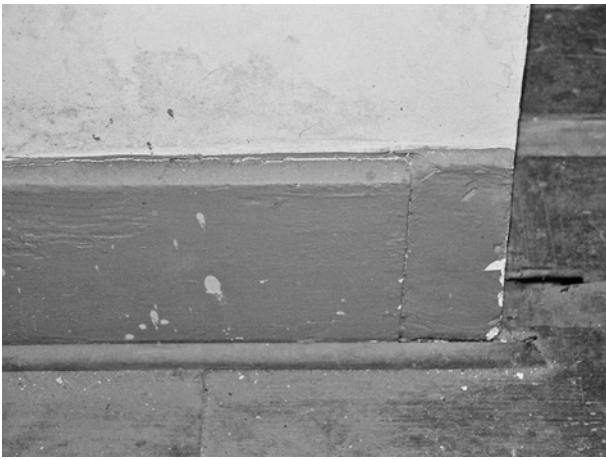
FIGURE 53. Baseboard on north wall of Room 102. Note that right end is plaster.

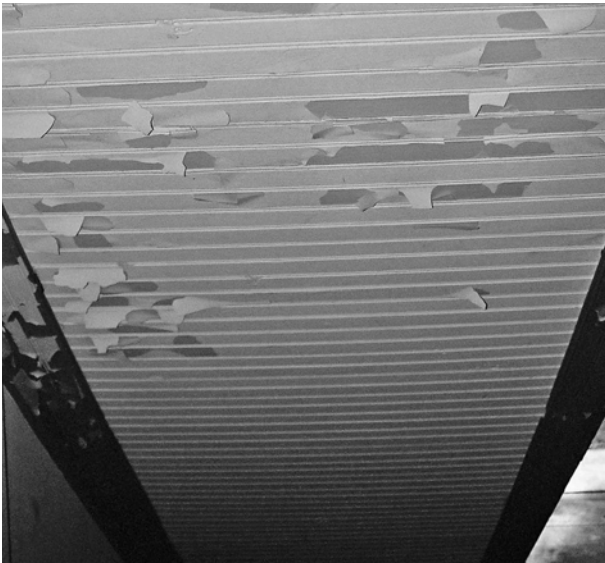
FIGURE 54. Beaded-board paneling on underside of staircase.

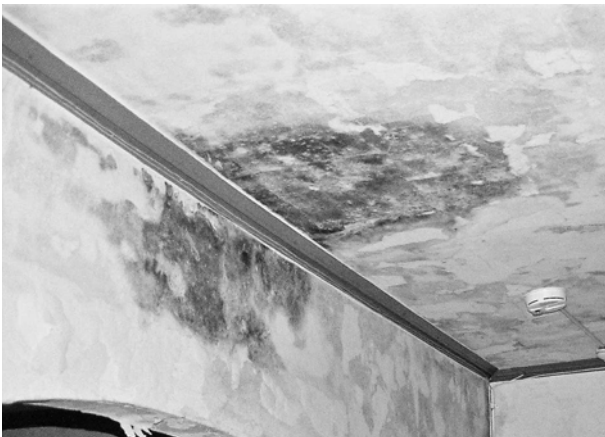
FIGURE 55. Water-damaged ceiling in Room 102.

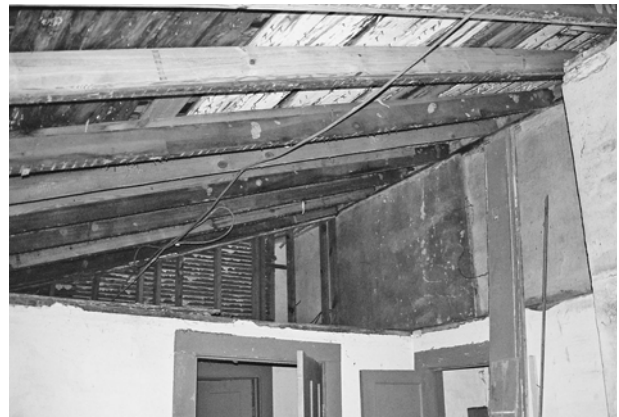
FIGURE 62. View of upper portion of east and south walls in Room 105 and exposed roof framing above.

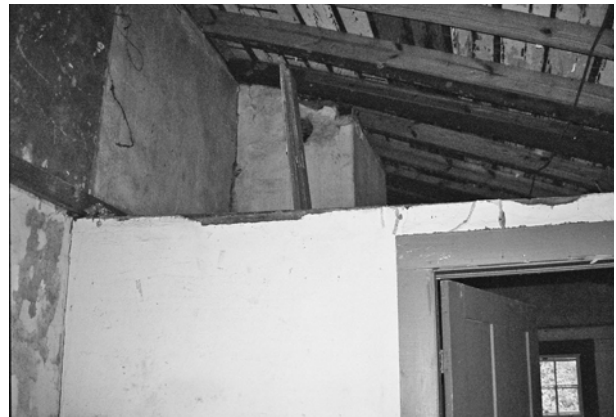
FIGURE 63. Detail of truncated west wall in Room 105, looking towards Room 107.

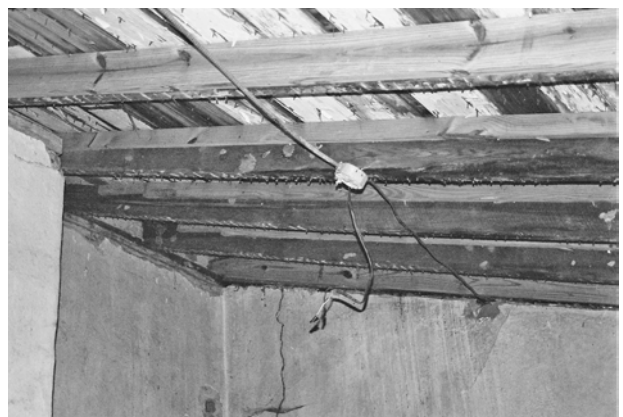
FIGURE 68. View of exposed roof framing in Room 107.
