Restoration of Historic Features Cumberland Gap National Historical Park

Wilderness Road
1780-1810

Research methodology for the
"Rediscovery" of historically significant
resources: Procedures developed to
determine their original topography of the
historic saddle of Cumberland Gap and
identify the vertical and horizontal
alignment of the historic road.

Prepared by Harland D. Unrau, Cultural Resource Specialist,
Denver Service Center, Planning and Site Design; Planning

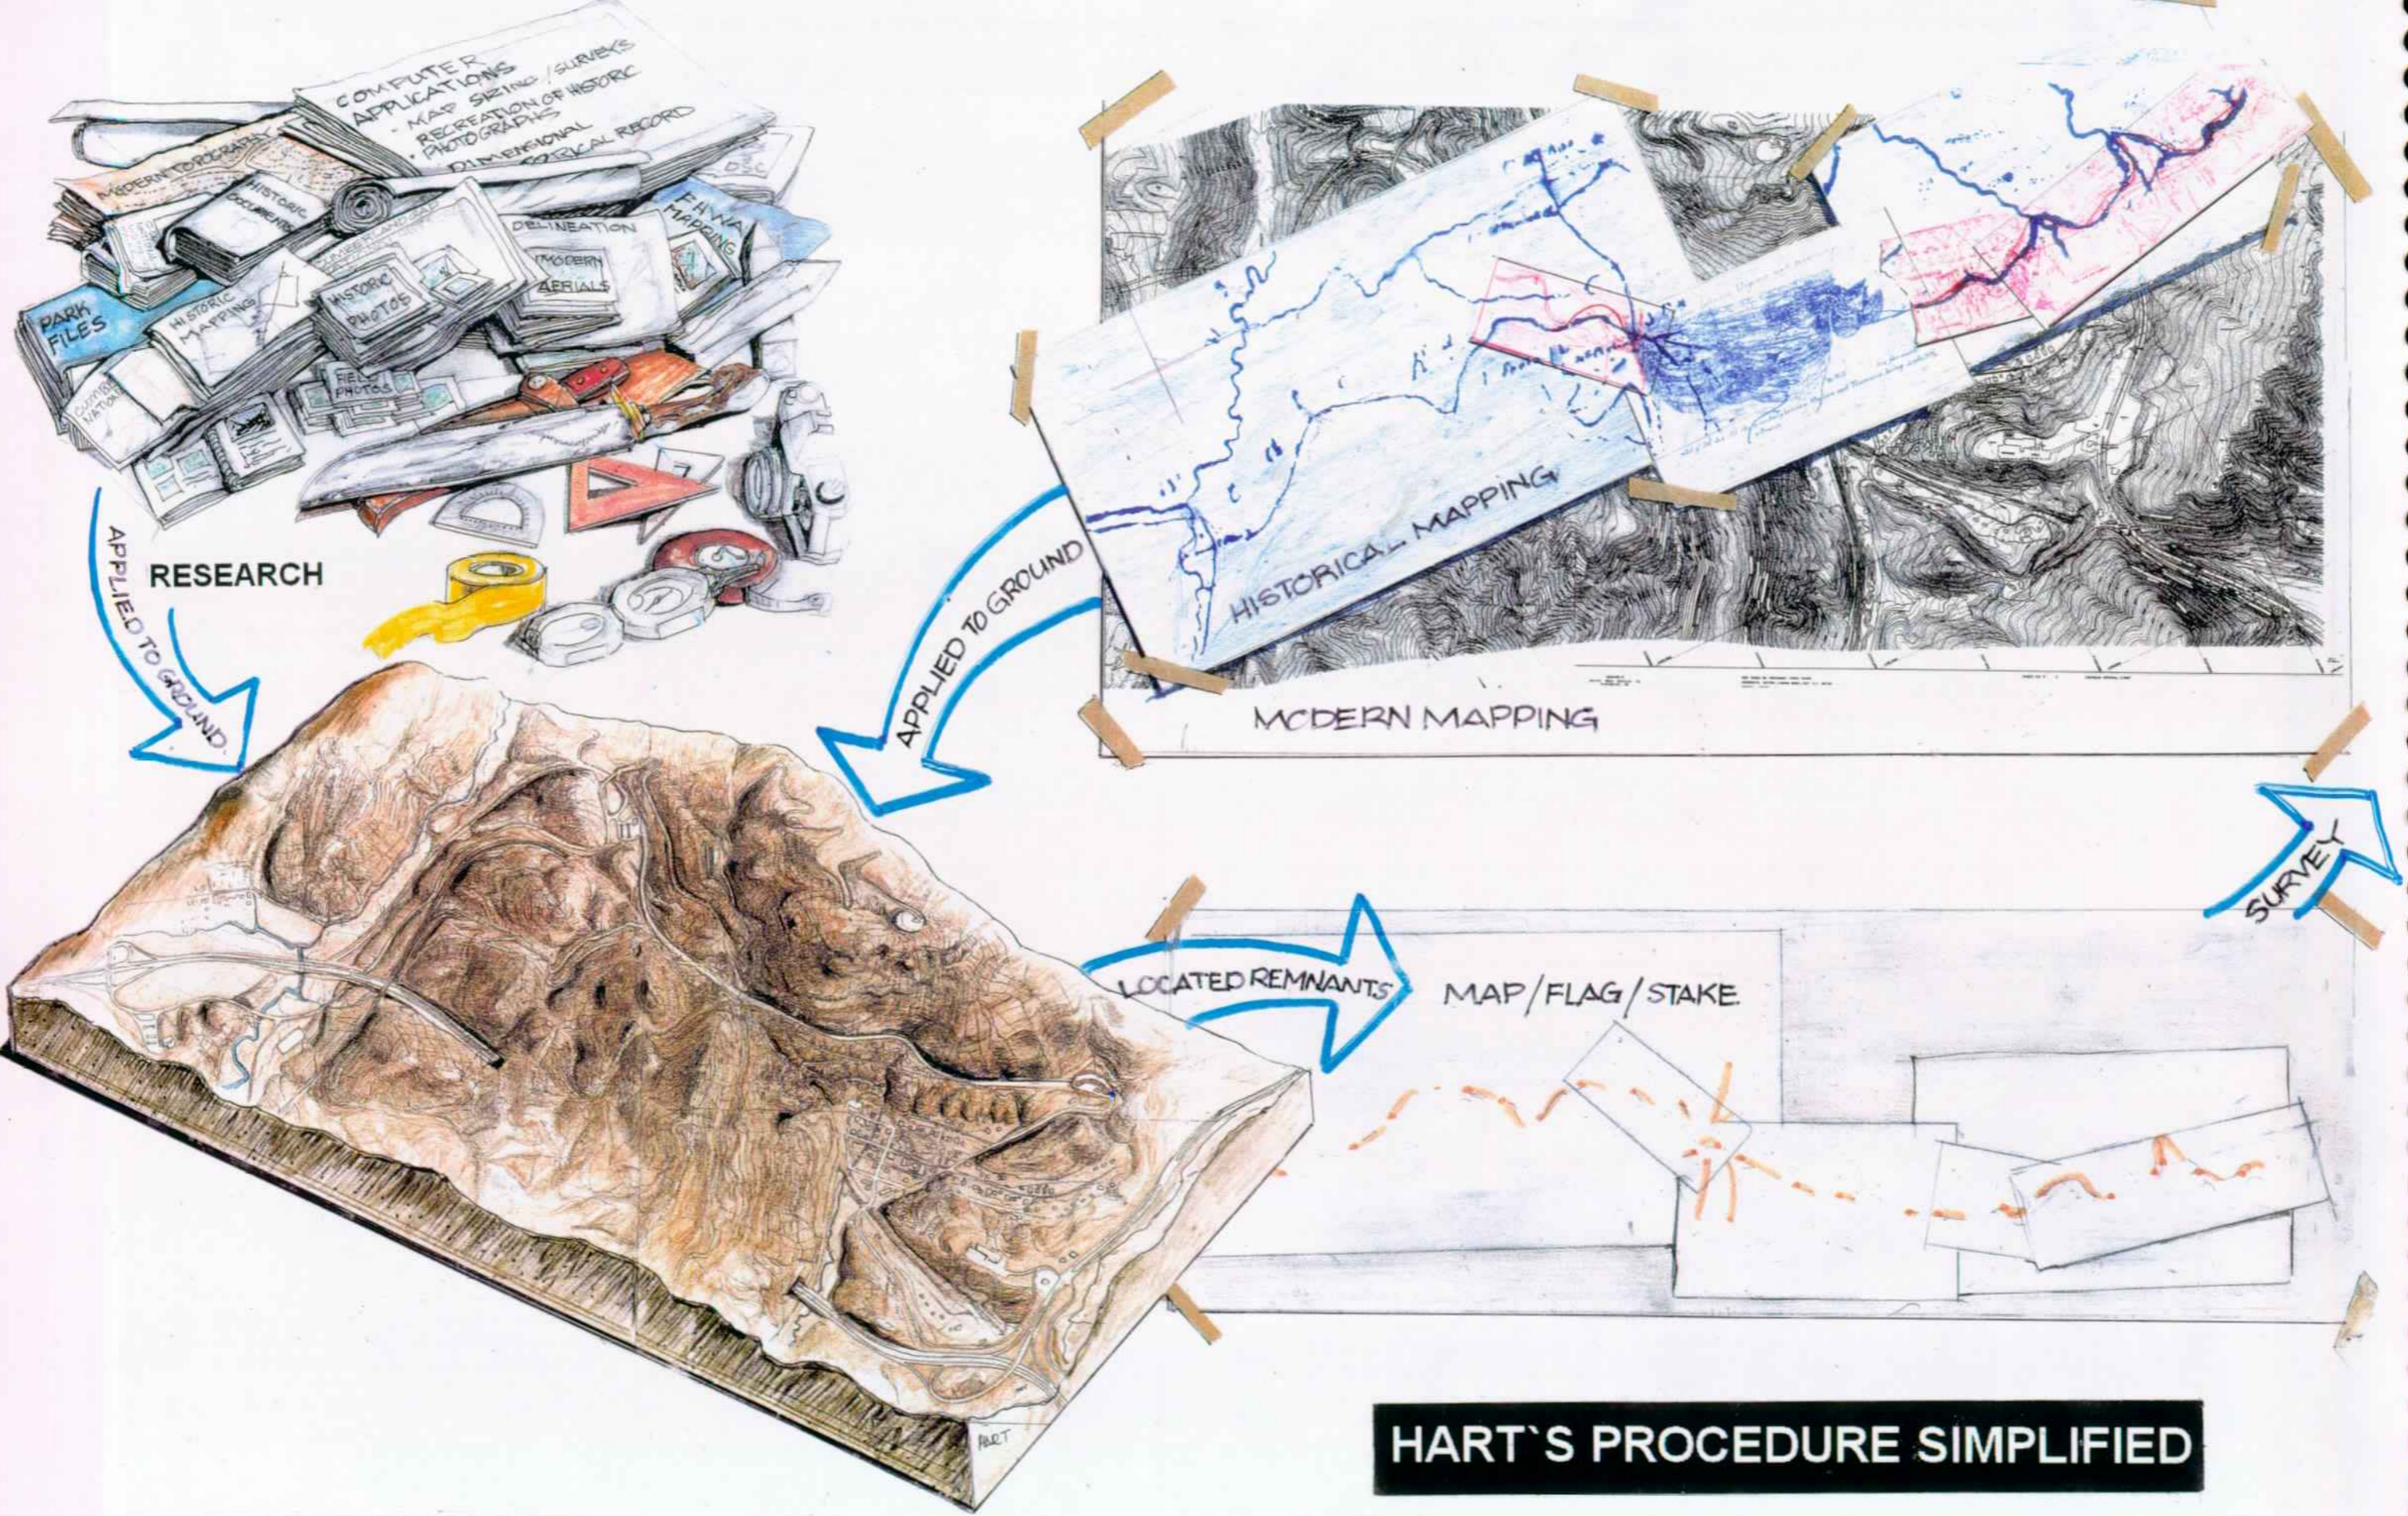
HART'S PROCEDURE SIMPLIFIED

RECOVERED REMNANTS ARE THEN RECORDED BY MODERN SURVEY AND COMPUTER

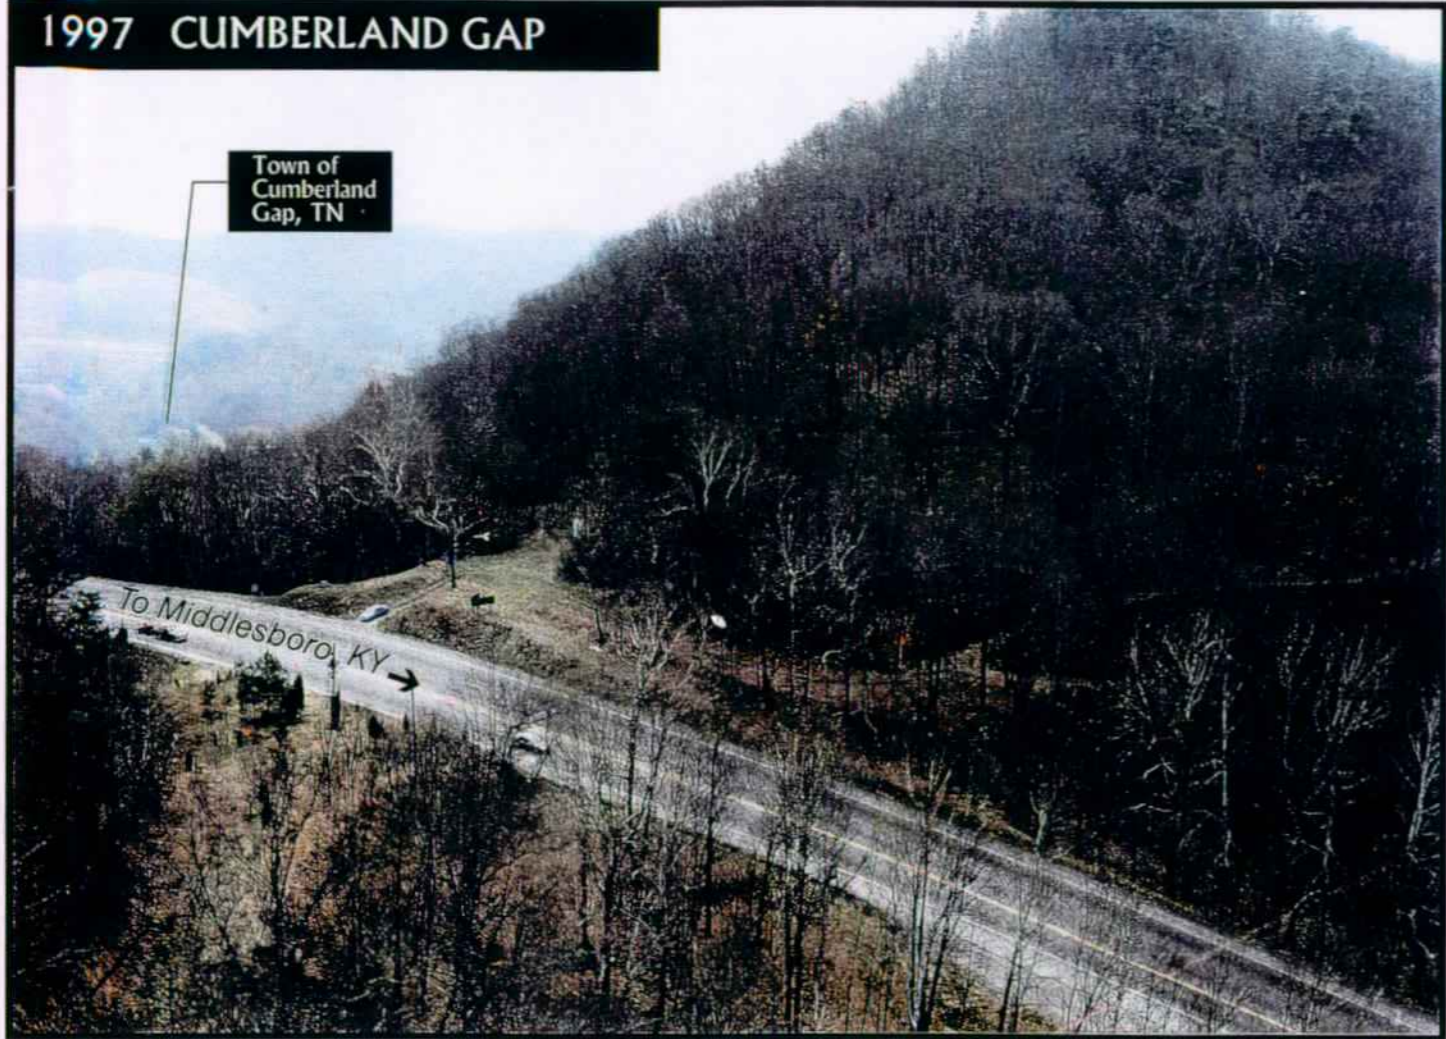
1997 CUMBERLAND GAP

OLD US 25E (NOW CLOSED)

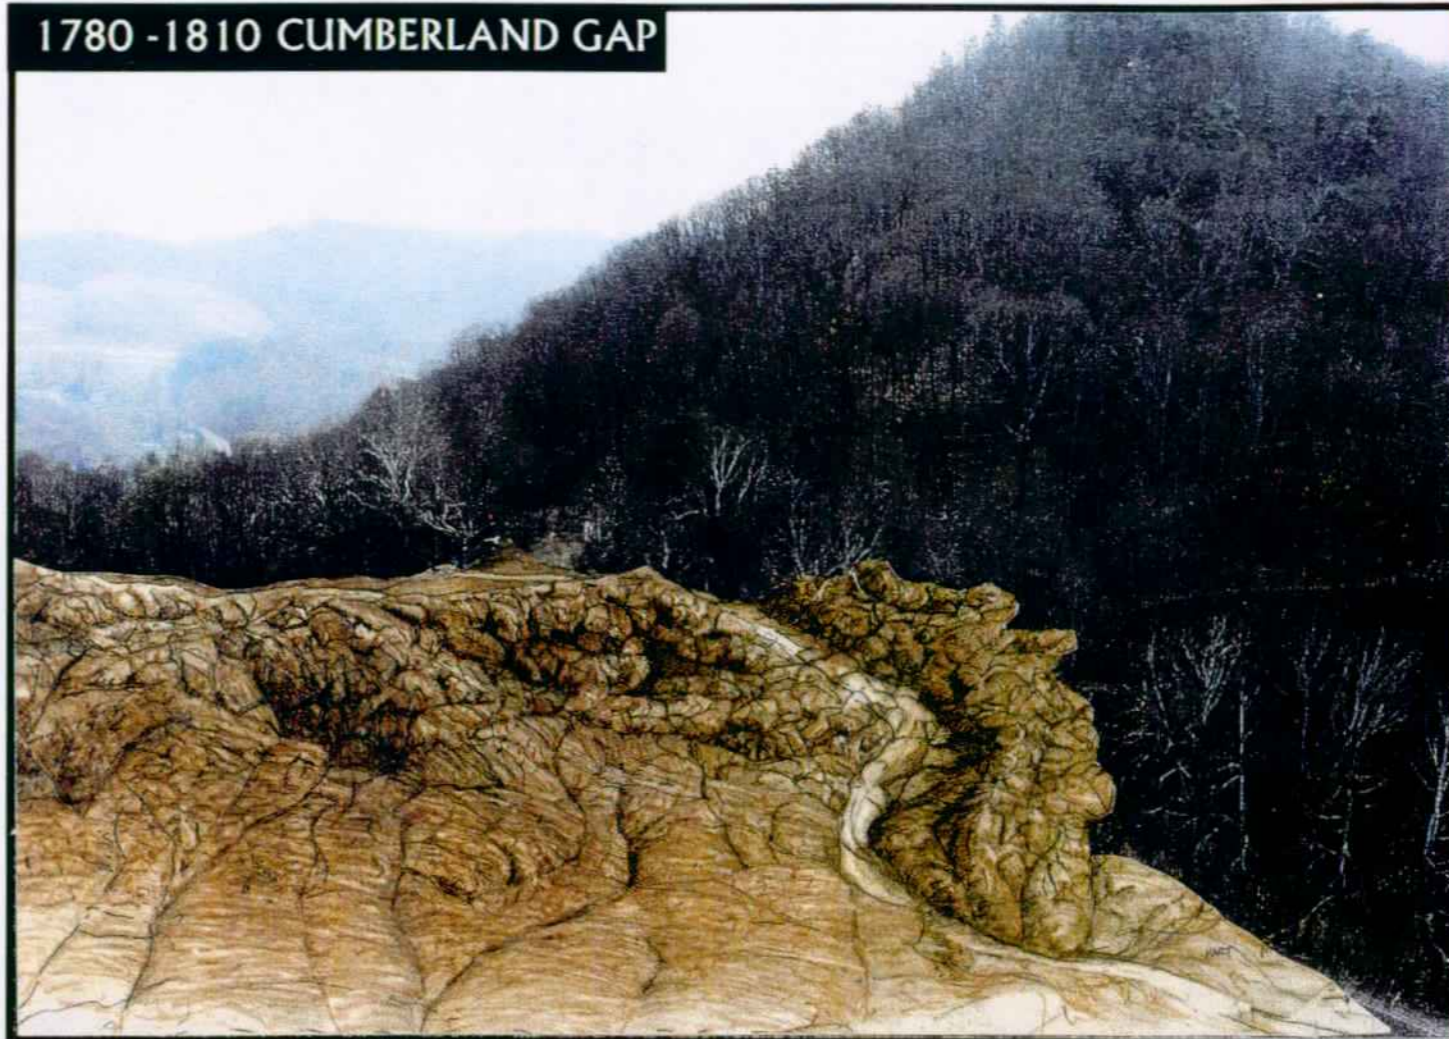
1780 - 1810 CUMBERLAND GAP

REHABILITATION (VIEWING SOUTH)

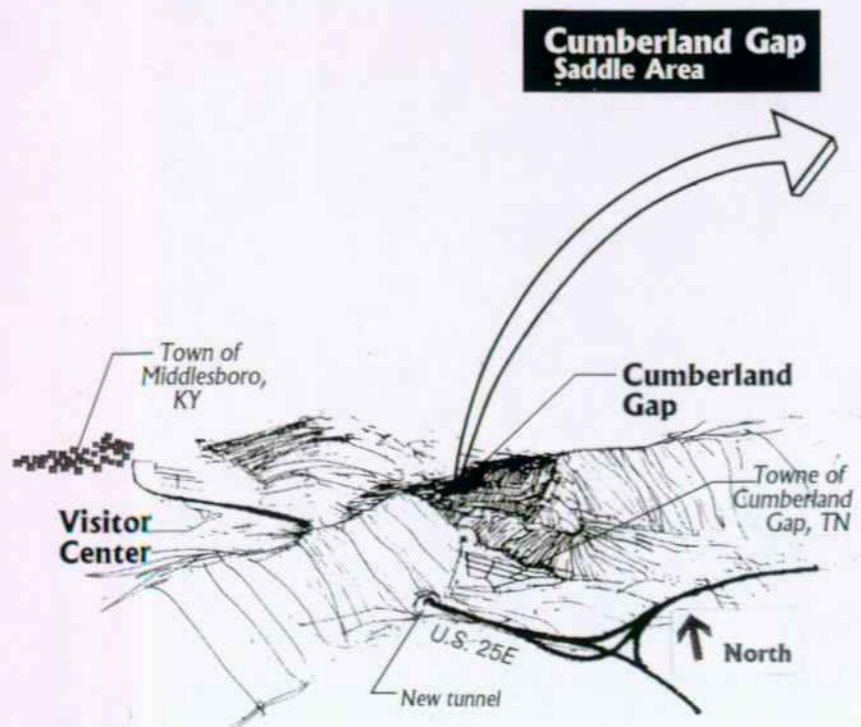
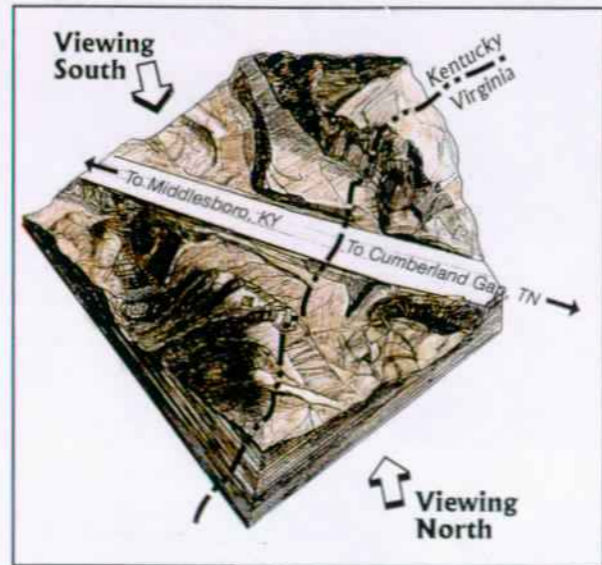
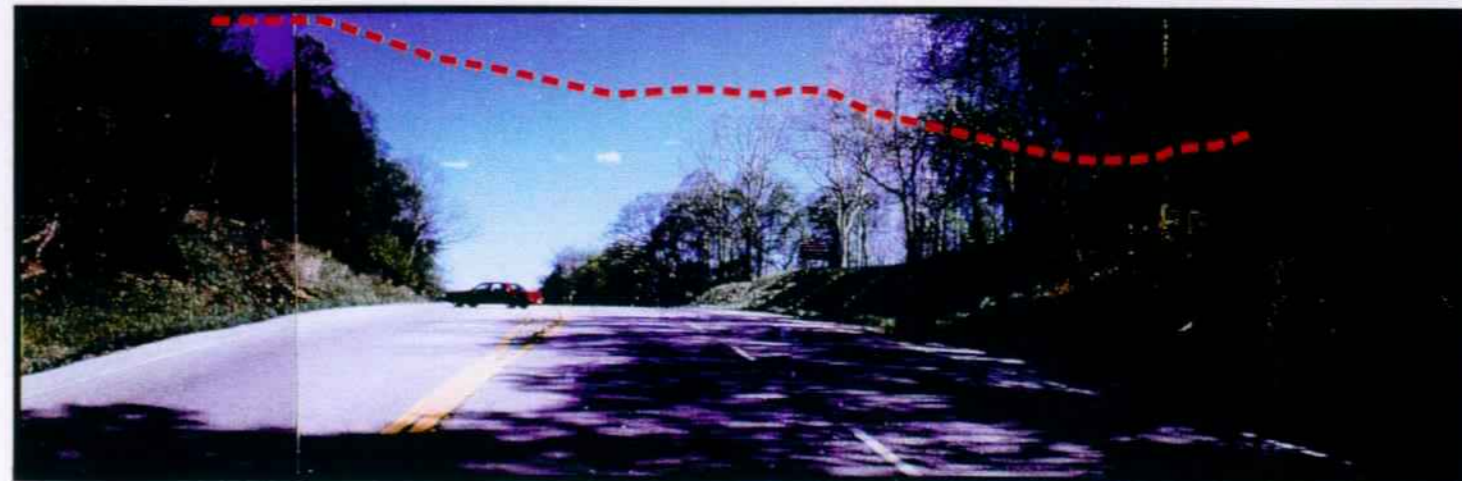
SADDLE REHABILITATION

FINISH GRADE AFTER REHABILITATION

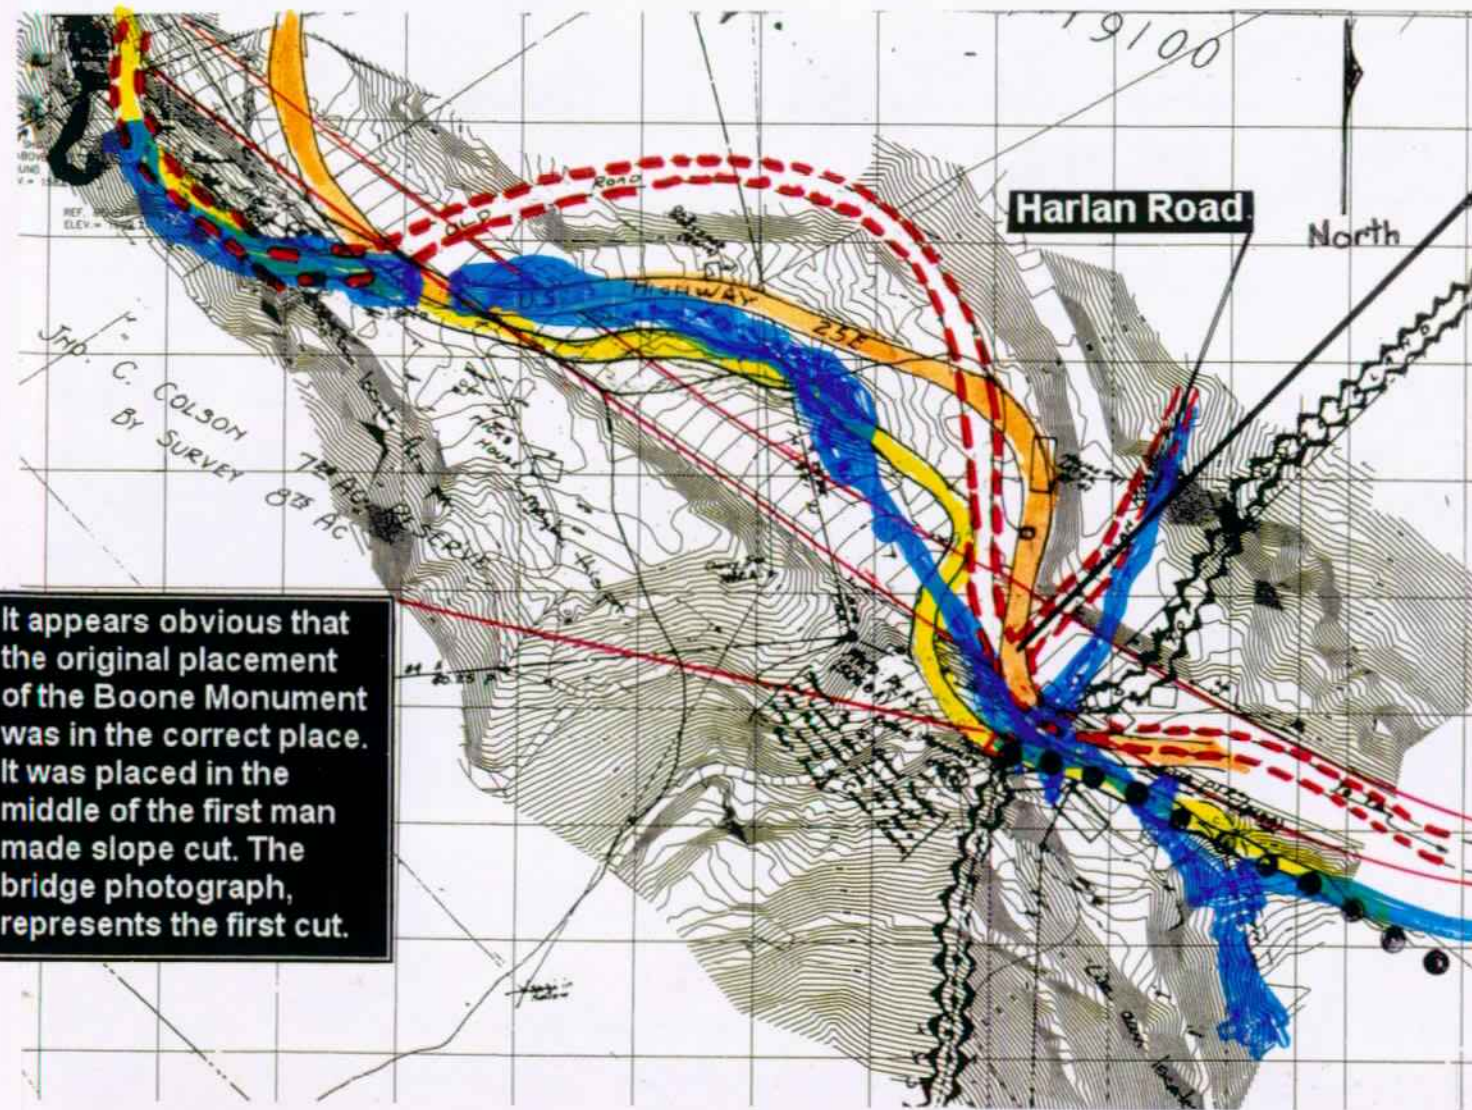
Harlan Road alignment does not match because this interchange was formed after the second slope cut.

It appears obvious that the original placement of the Boone Monument was in the correct place. It was placed in the middle of the first man made slope cut. The bridge photograph, represents the first cut.

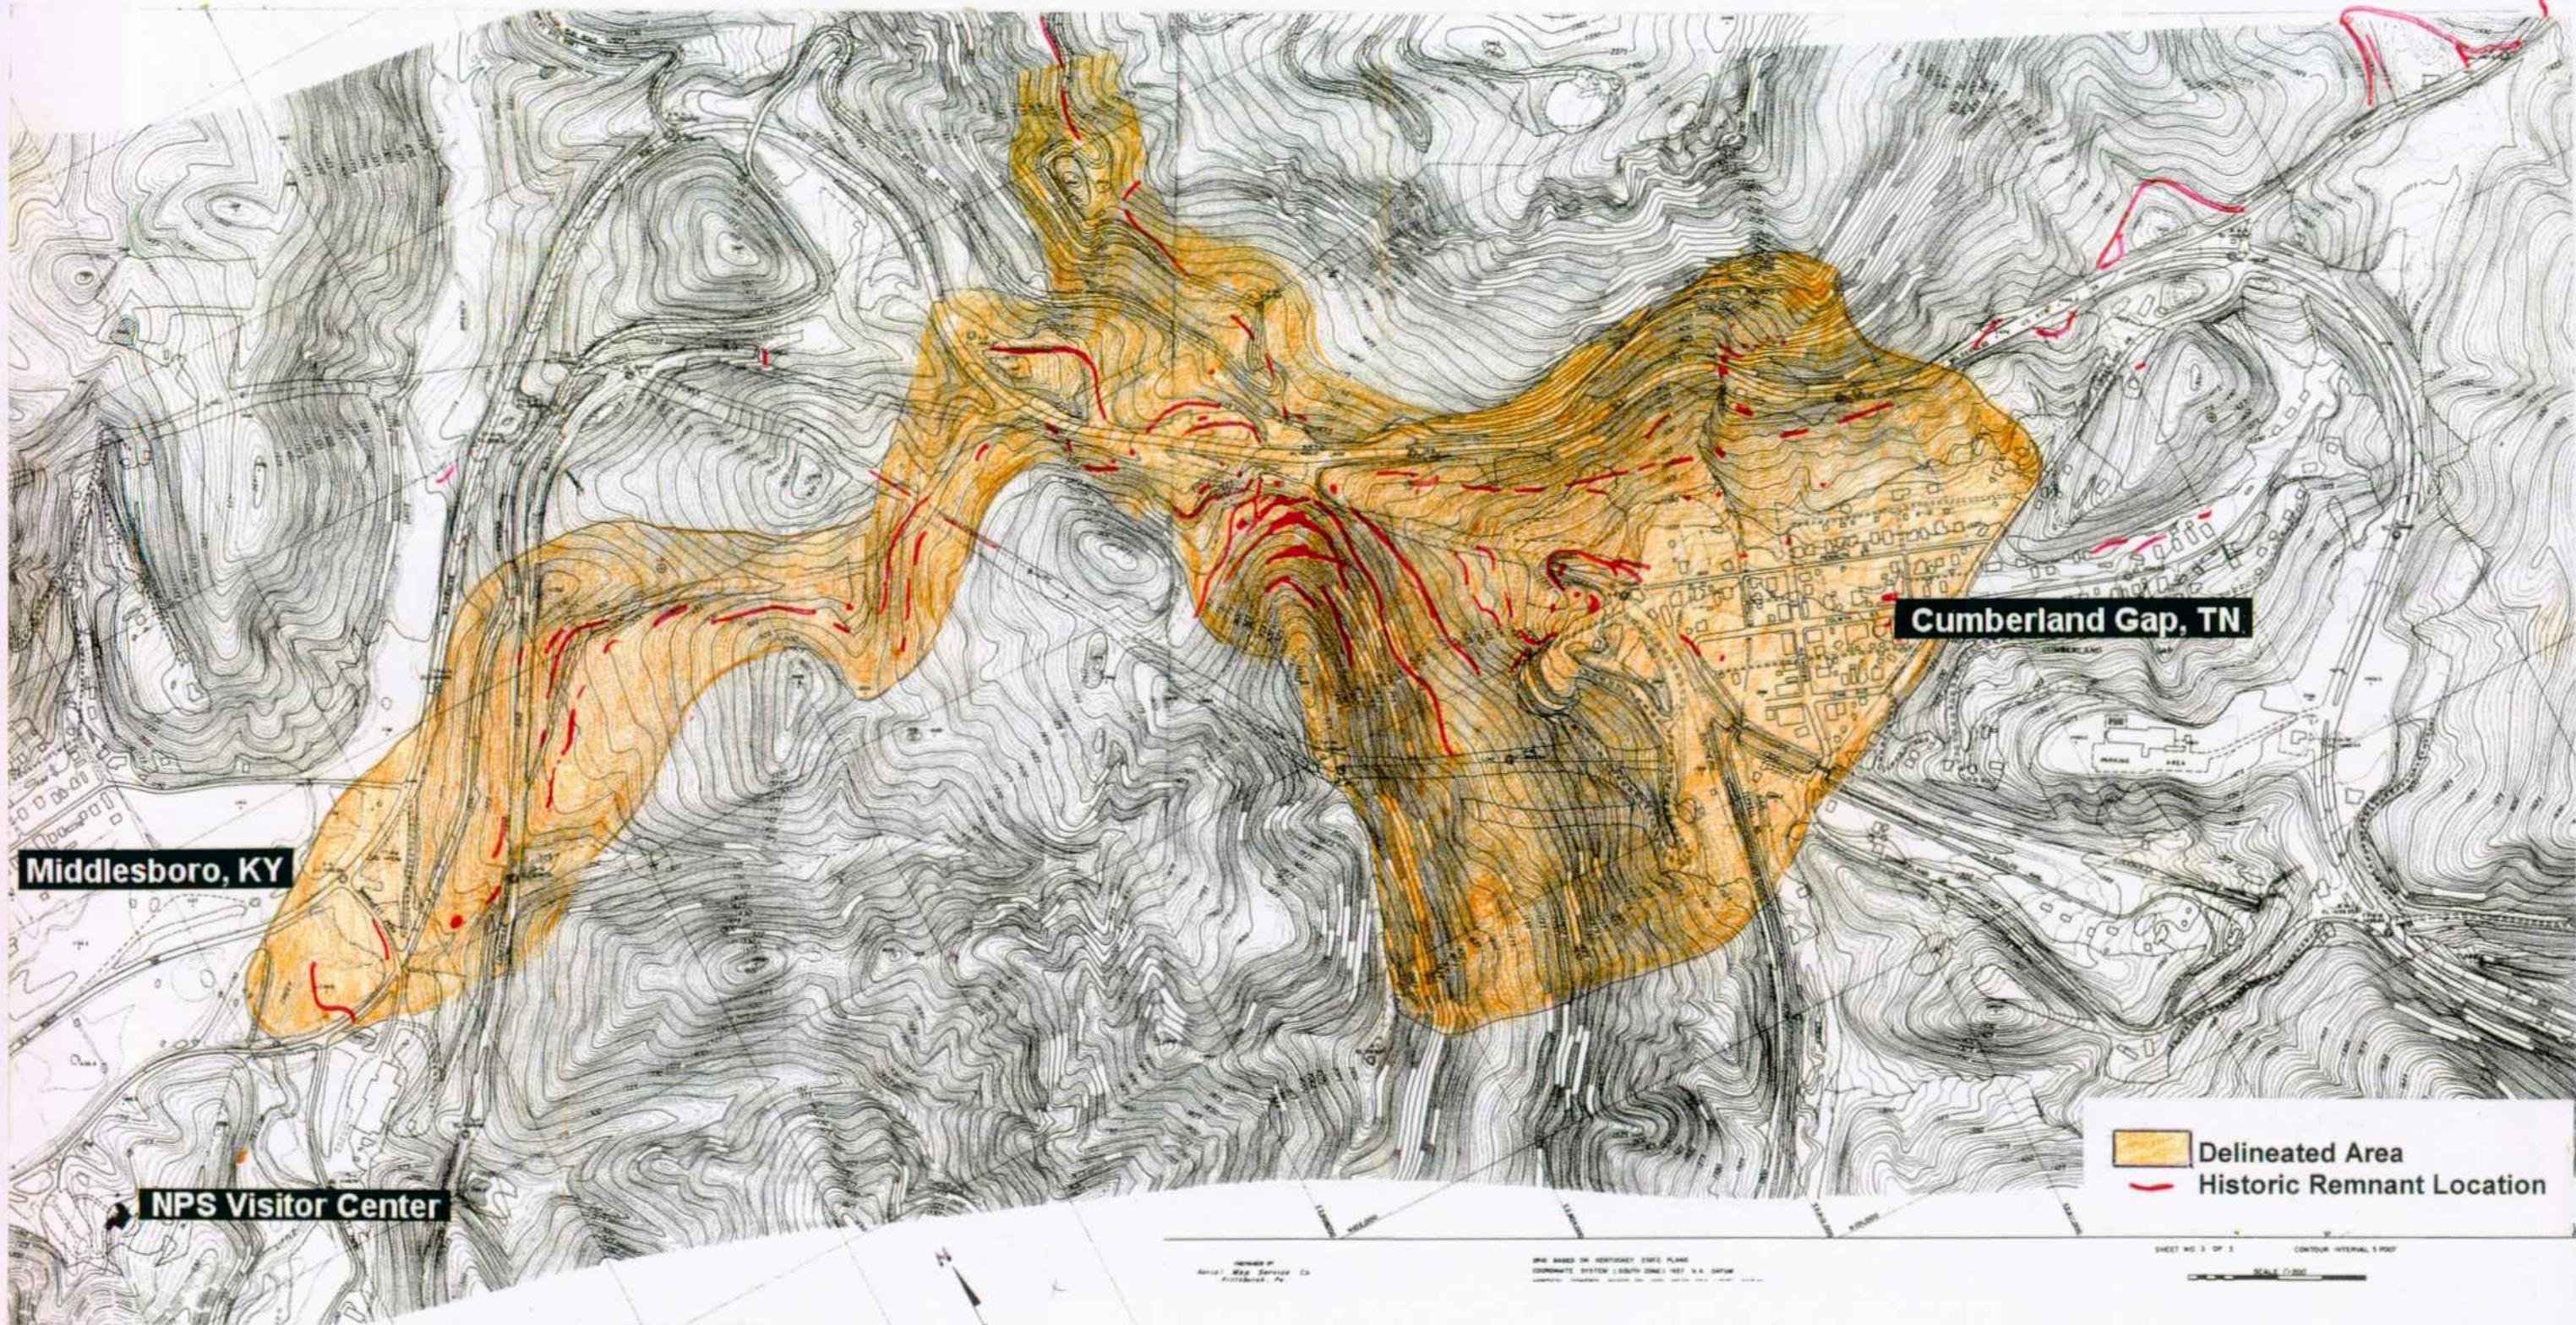
HISTORIC REMNANT LOCATIONS

This sheet shows the total area hand-delineated, plus the physical locations of historic road remnants still on the ground today. These remnants were used to find and crosscheck the Wilderness Road location, and were instrumental in the rehabilitation of the topography at the Gap. Using the remnants facilitated the determination as to whether or not topography and the Wilderness Road had been disturbed from their original configurations.

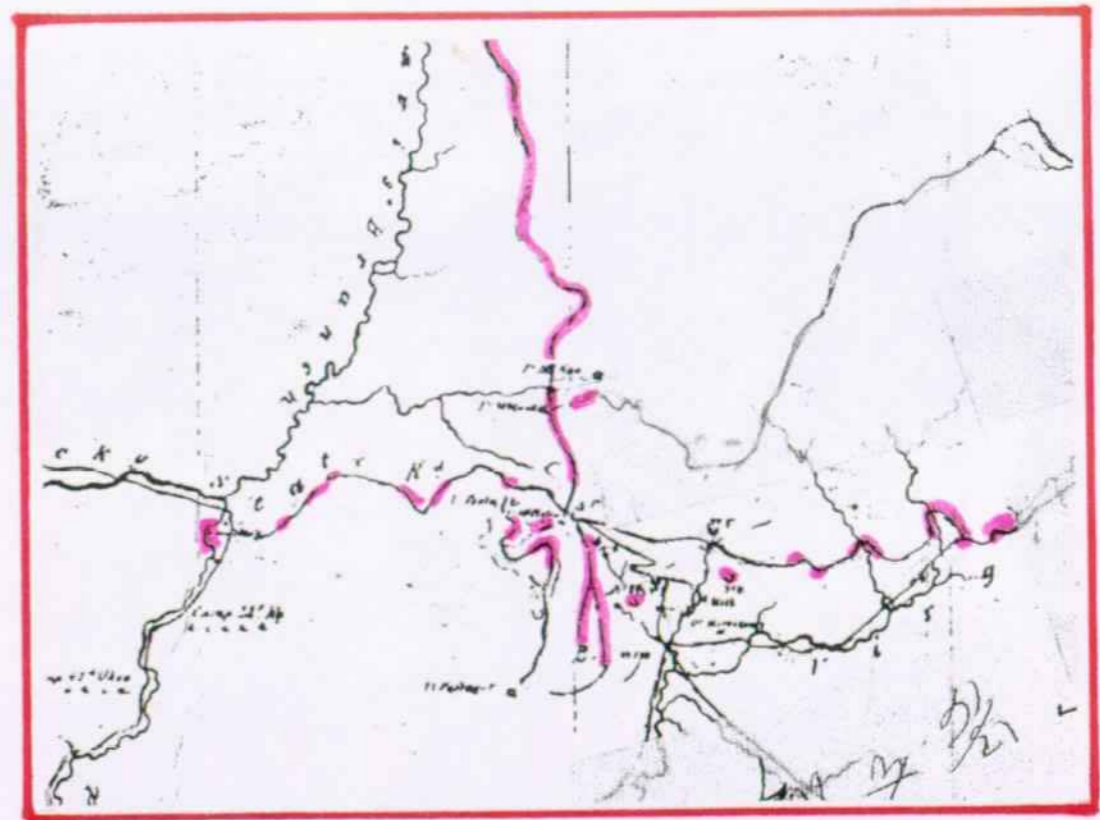
1903 map of saddle

Existing road remnants shown above in red were physically located in the field, and incorporated into the Wilderness Road discovery procedure.

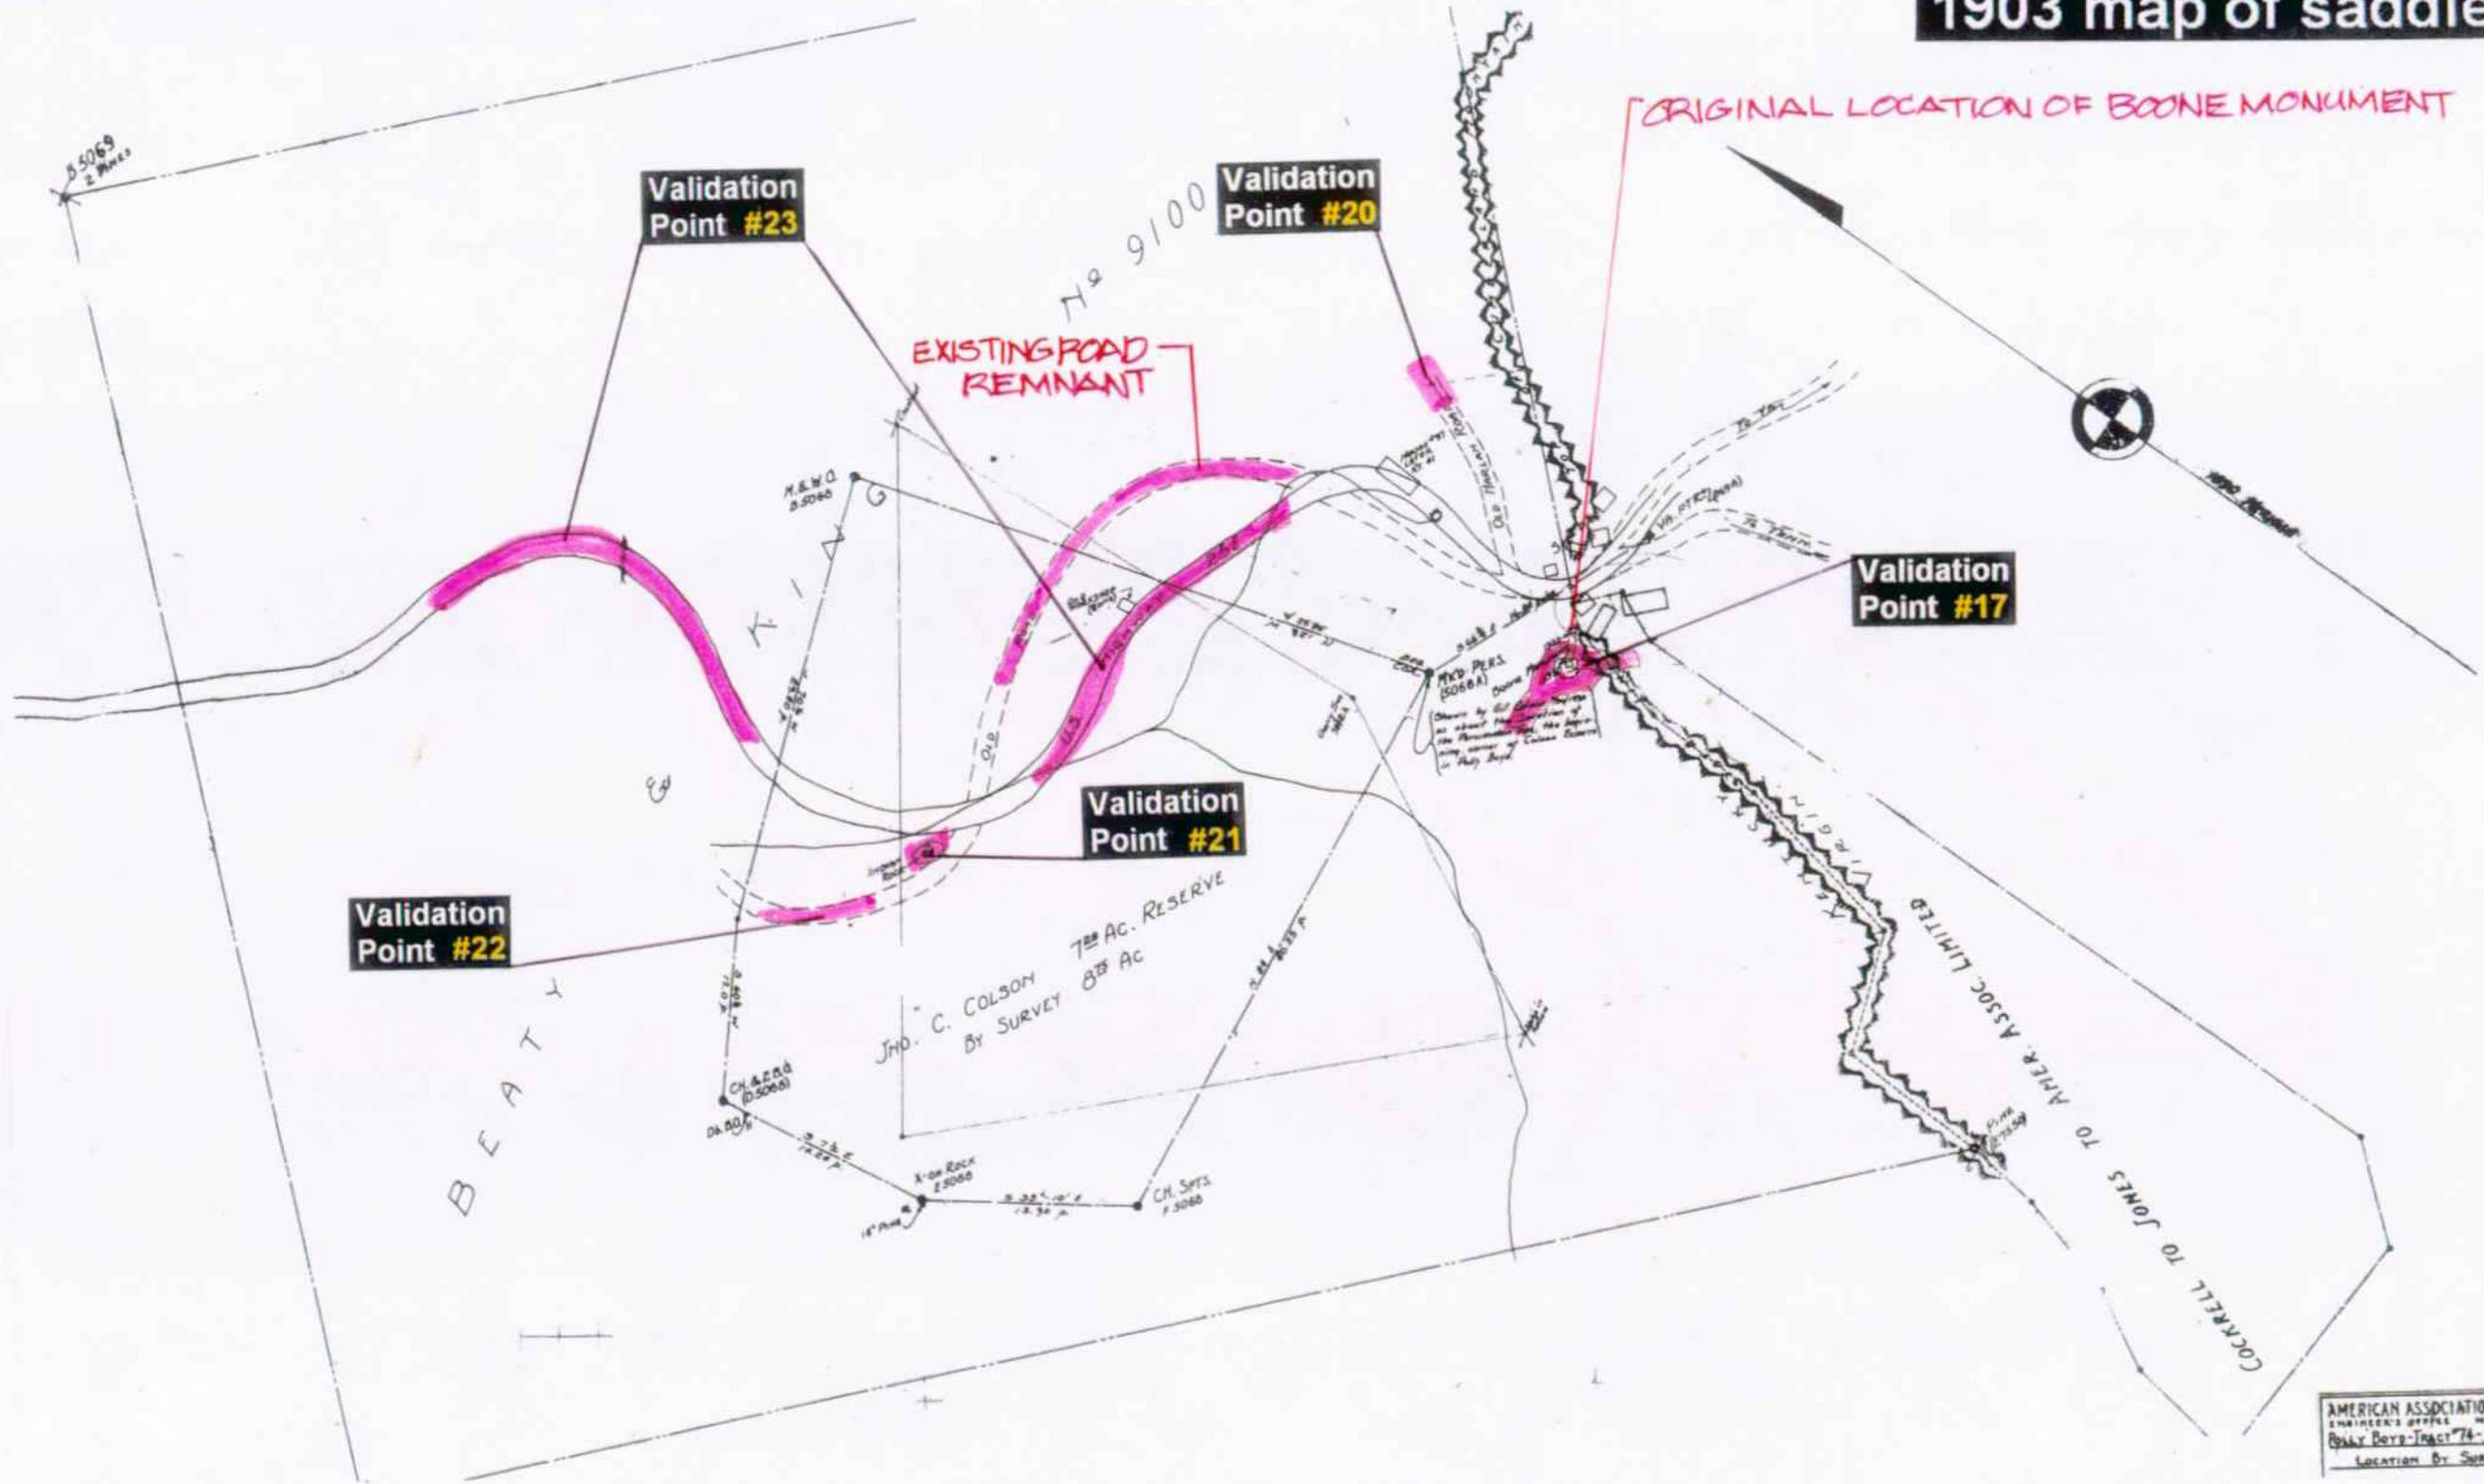
AMERICAN ASSOCIATION INCORPORATED
ENGINEERS OFFICE HUNTSVILLE, ALA.
Billy Boy's Tract 74
Location by Survey 1903 & 1911

3. During the research, a survey map was found, which showed the Polly Boyd Tract No. 74 prepared by the Engineer's Office of American Association Incorporated, a firm located in Middlesboro, Kentucky. This map was based on surveys conducted in 1903 and 1921. The map (hereinafter referred to as the Association Lands Map) showed information that related to 19th-century developments in the Gap area. The survey measurements on this map were noted in poles (one pole equals 16-1/2 feet in linear measure).

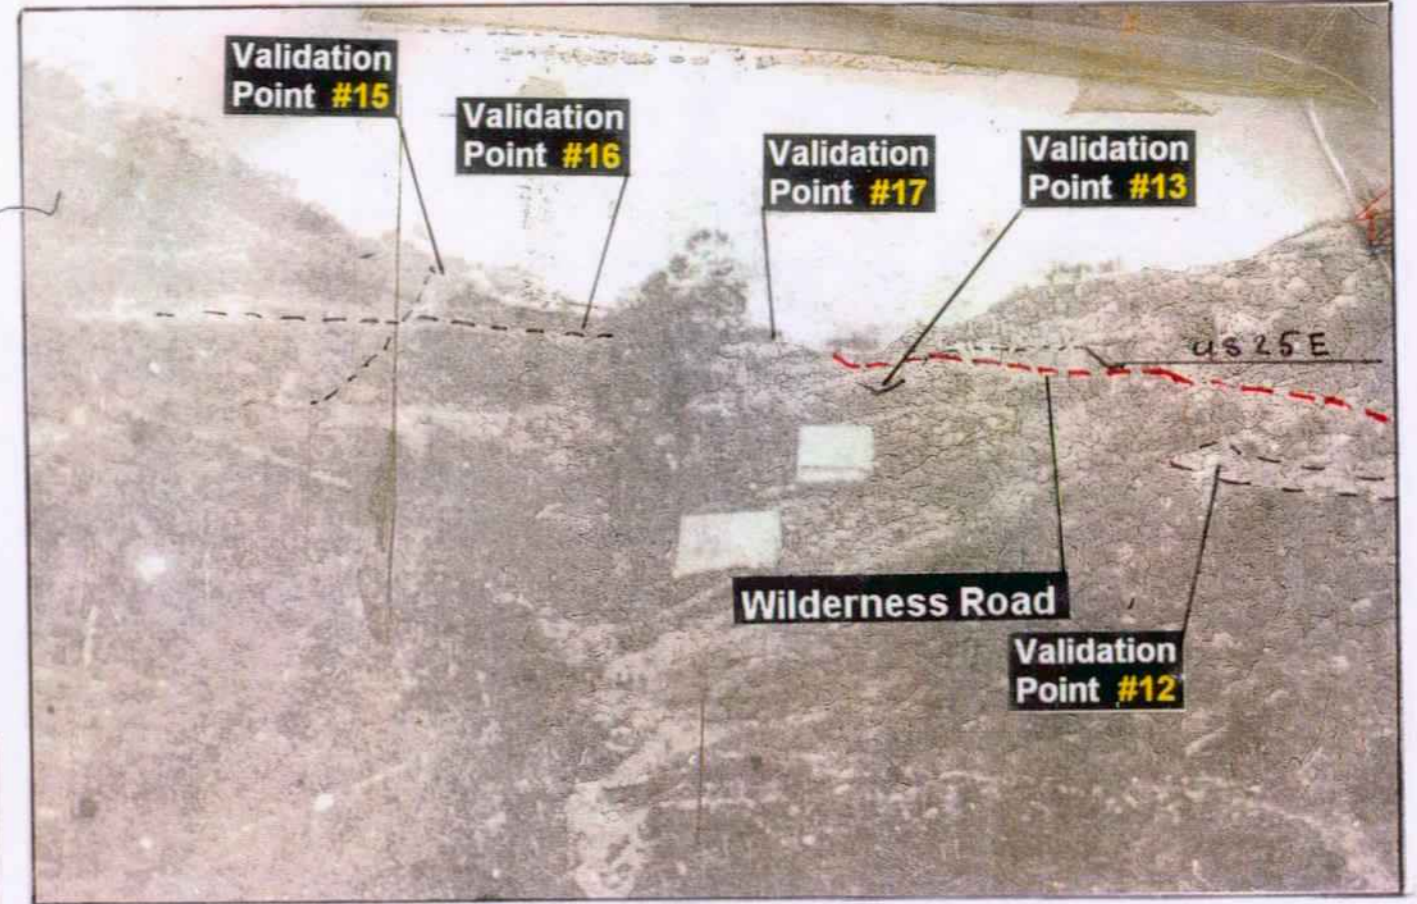
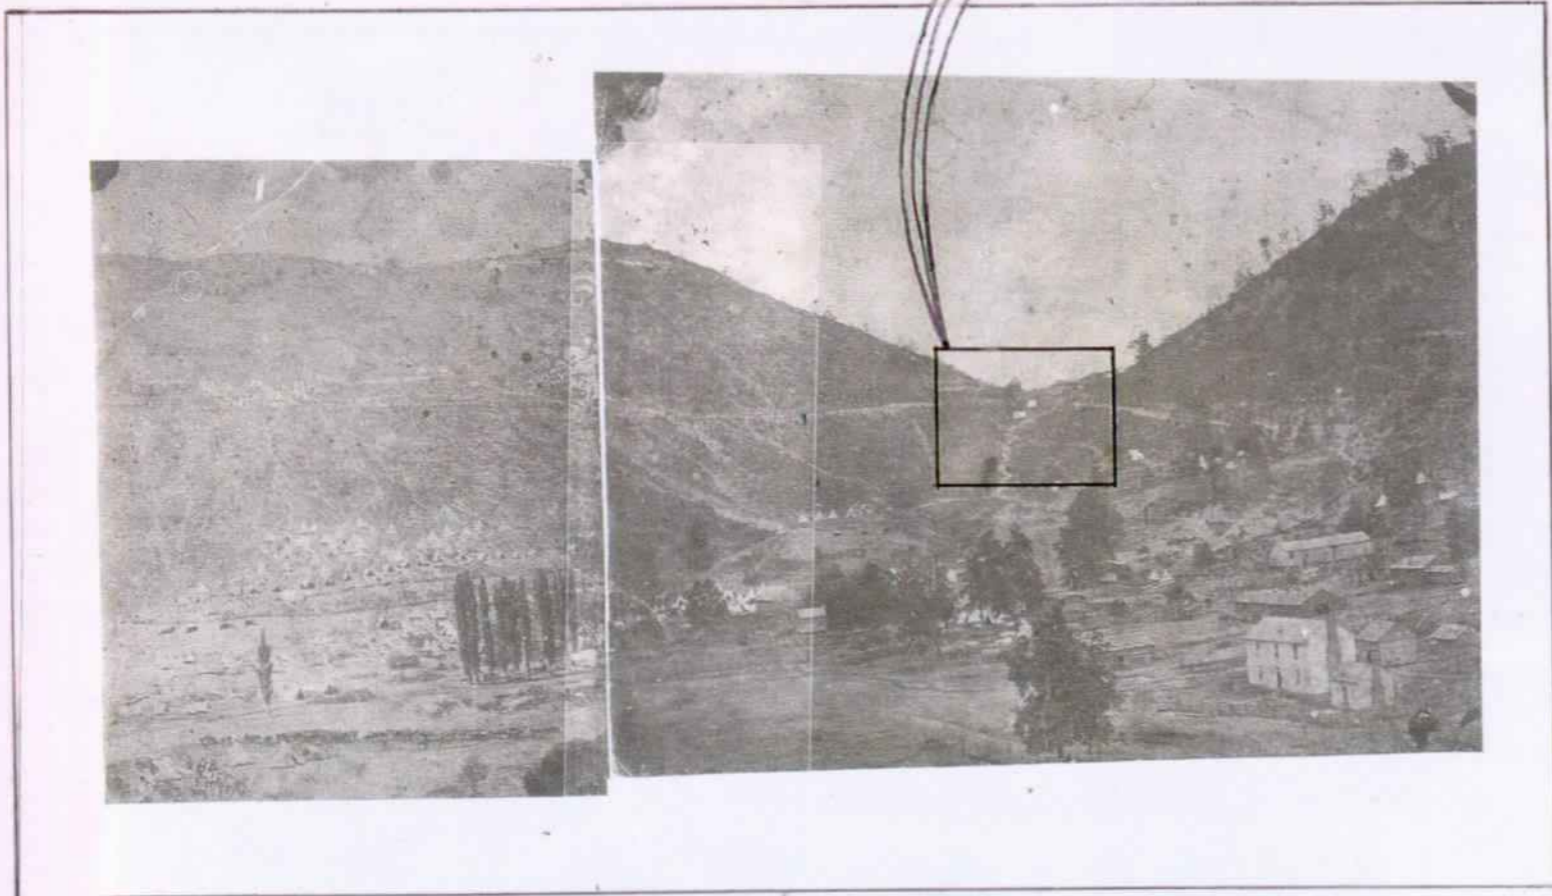
This photograph was taken during the Civil War about 1862. The view is looking Northwest, from what is now the town of Cumberland Gap, Tennessee.

4. A handwritten notation on the 1862 photograph indicated that another photograph existed. A second photograph presumably would provide an image that would give intersecting points that one could locate on the ground today. In pursuit of the matter, however, it was found that the "second" photograph was instead a side-by-side addition to the first photograph, which did demonstrate a relationship between the two sides of the saddle.
