Restoration of Historic Features Cumberland Gap National Historical Park

Wilderness Road
1780-1810

Research methodology for the
"Rediscovery" of historically significant
resources: Procedures developed to
determine their original topography of the
historic saddle of Cumberland Gap and
identify the vertical and horizontal
alignment of the historic road.

Prepared by Harland D. Unrau, Cultural Resource Specialist,
Denver Service Center, Planning and Site Design; Planning

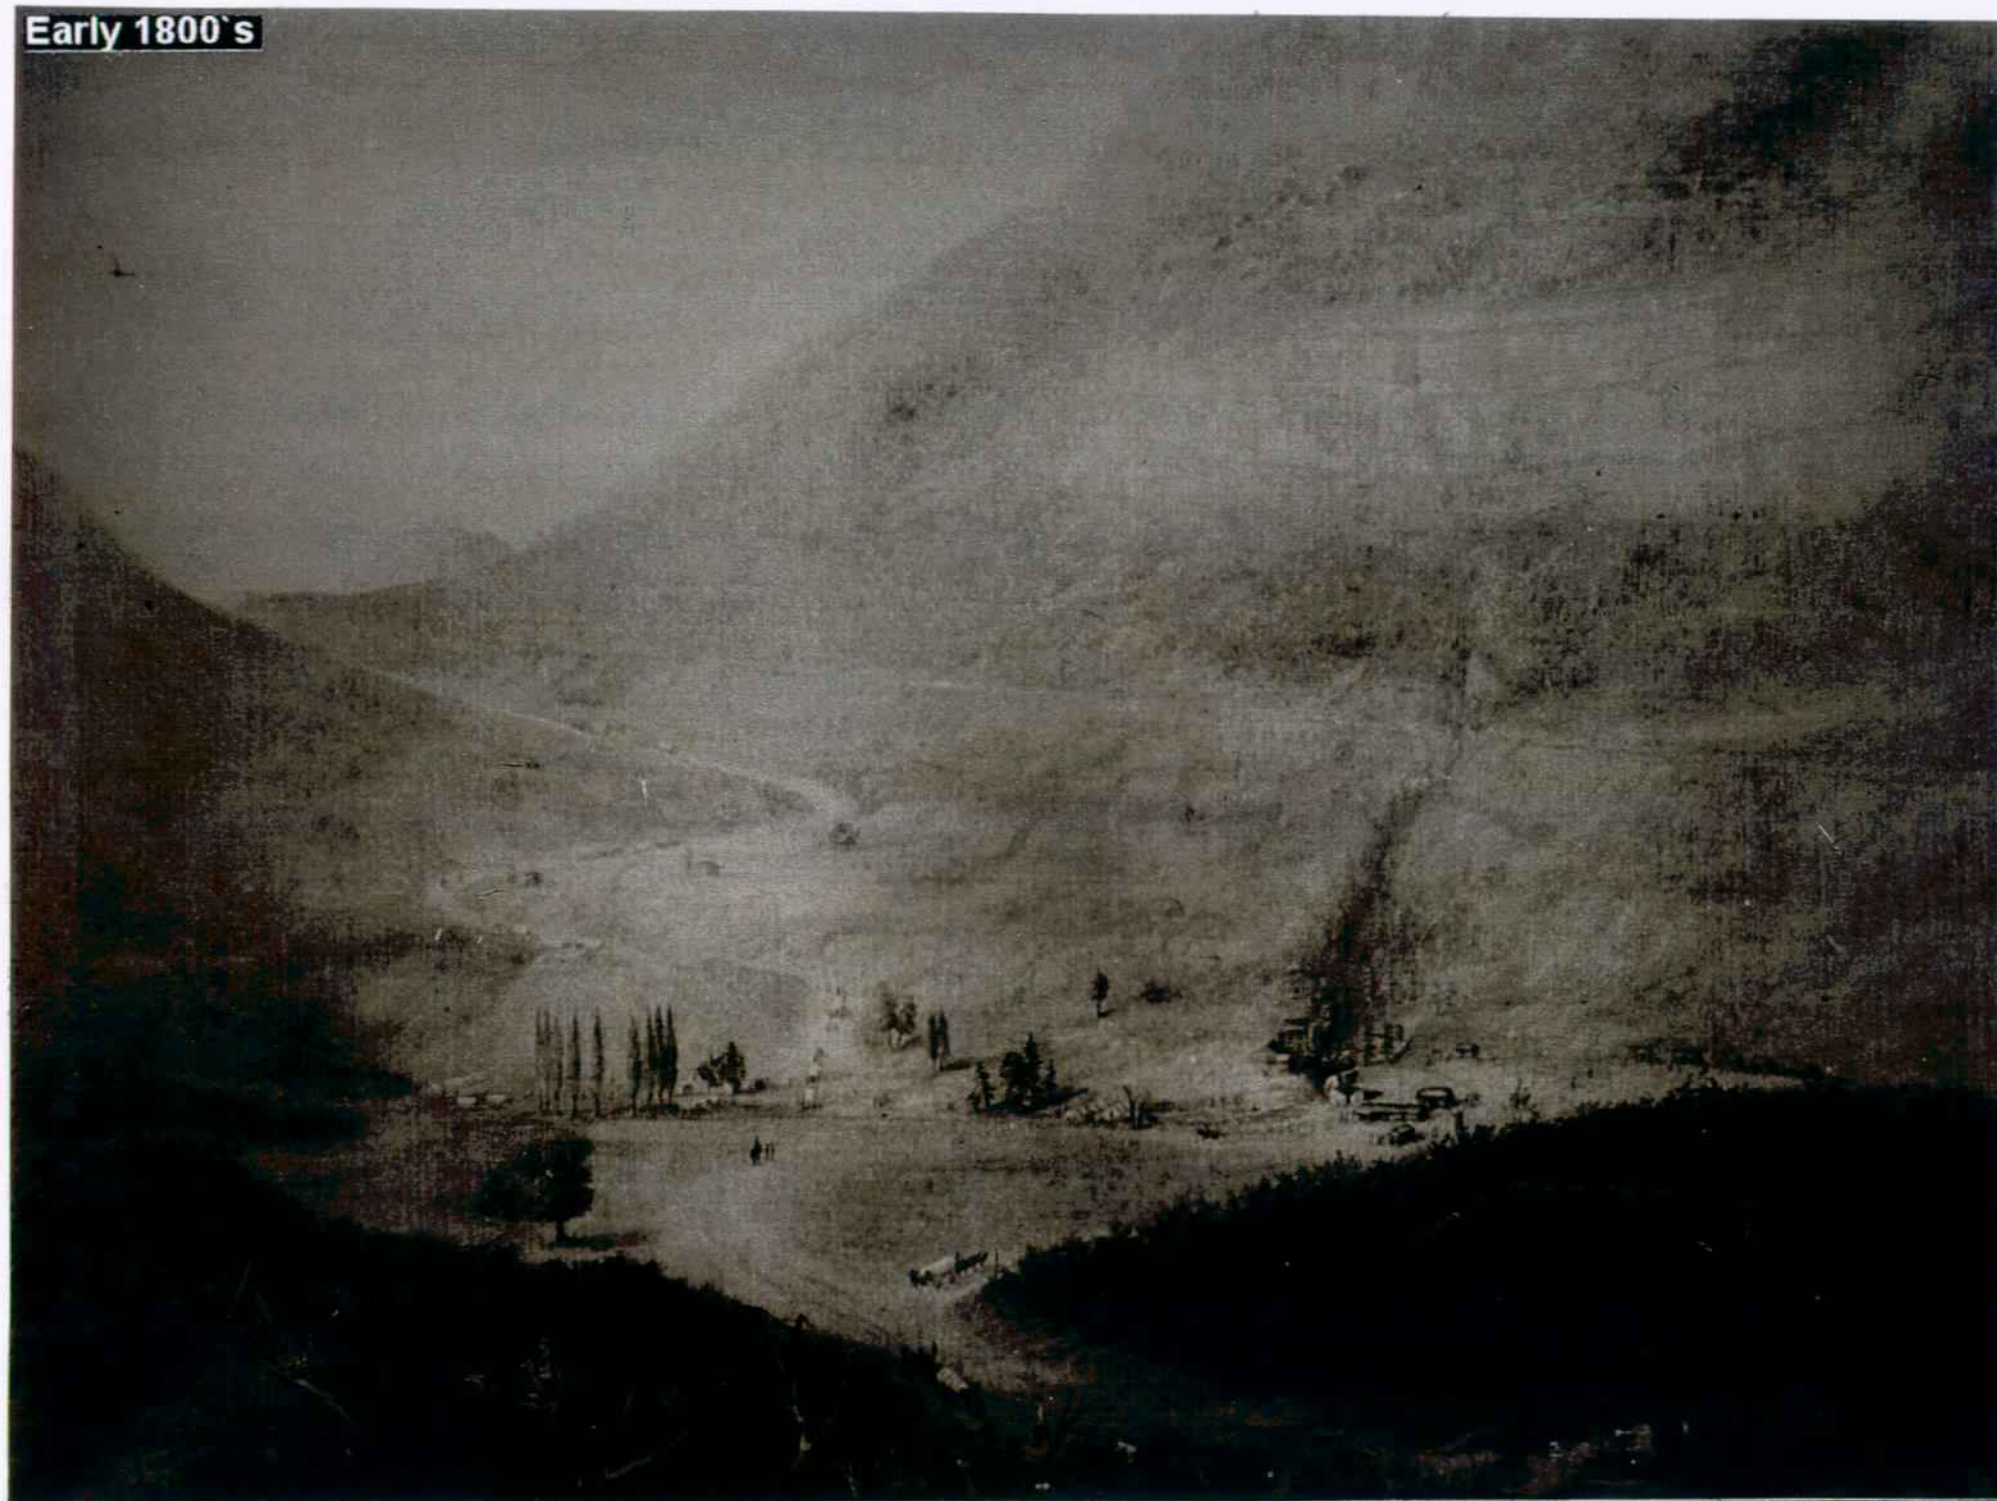
This photograph is believed to be taken from an obscura print.
(estimated to be from 1775 to 1860) Courtesy Of Cumberland Gap
National Historical Park.

9. Overlaying the delineation of the modern-day photograph on that of the obscura print allowed a determination of which topographic remnants from the obscura print were still extant and which had been removed. The delineations were very close. Discolored areas on the photograph show the topographical shapes that have broken away.

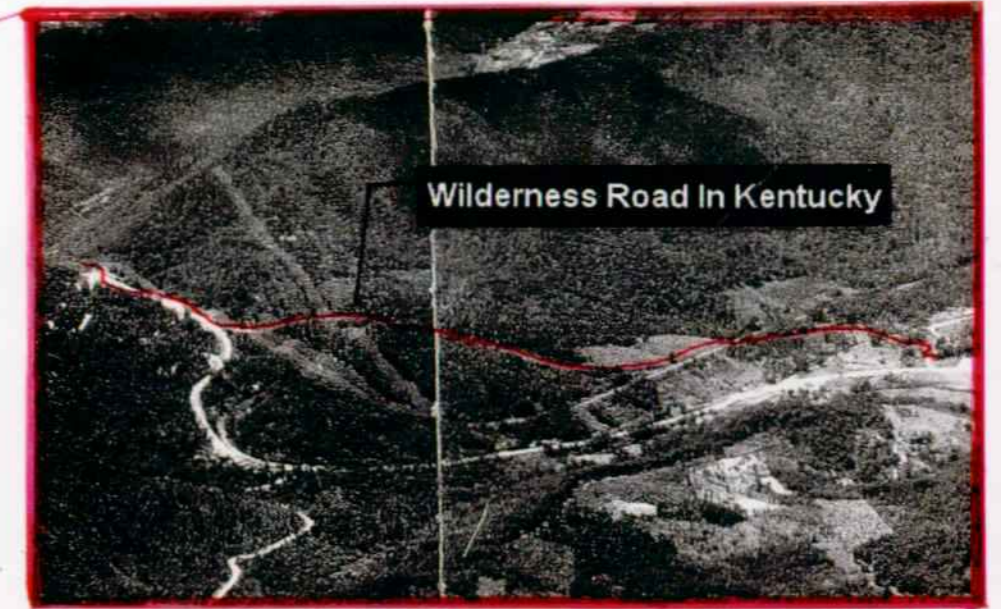
Aerial photograph of Cumberland Mountain and surrounding area.
Courtesy of Cumberland Gap National Historical Park.

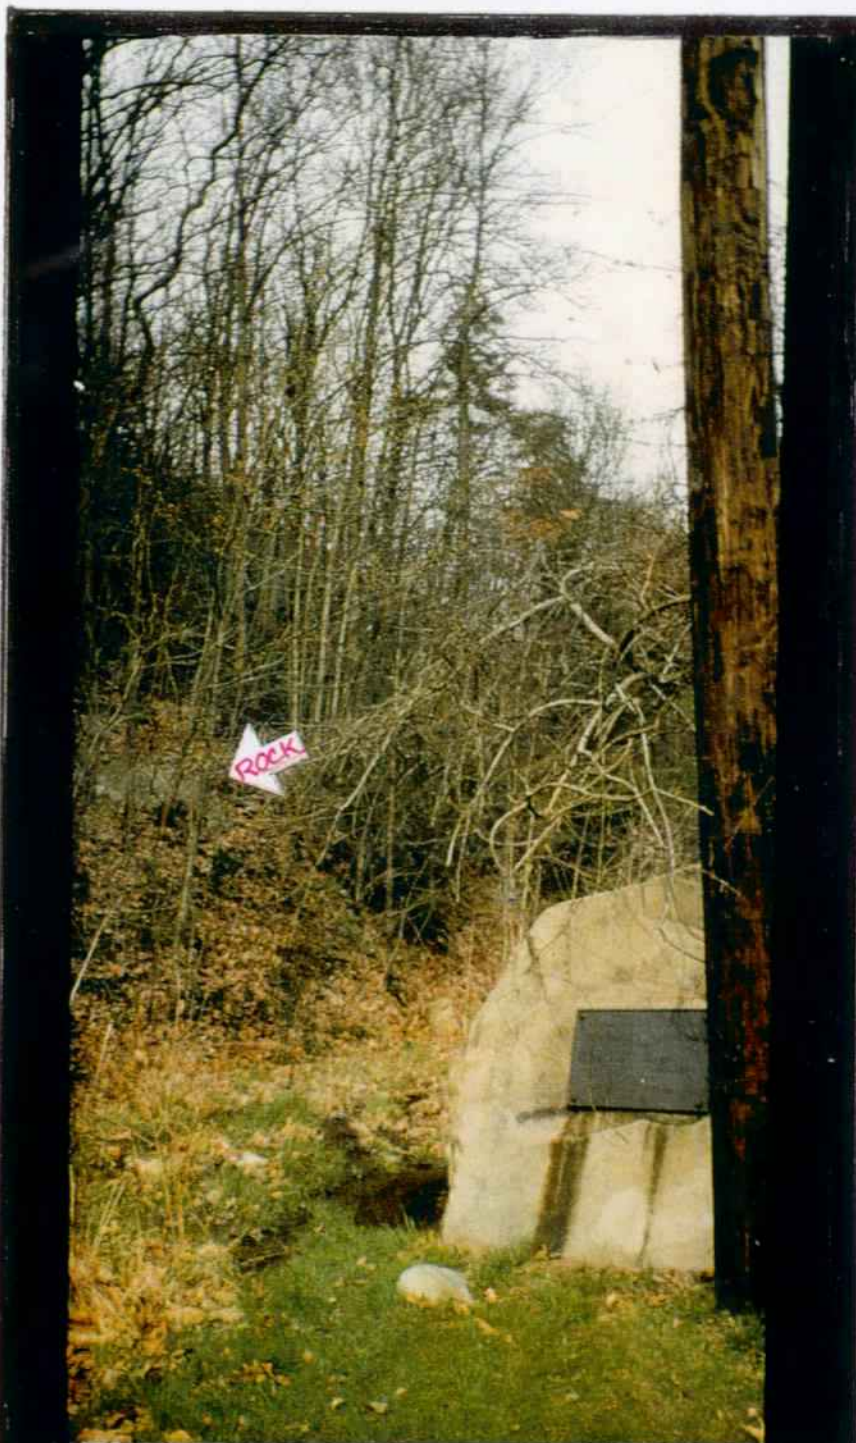
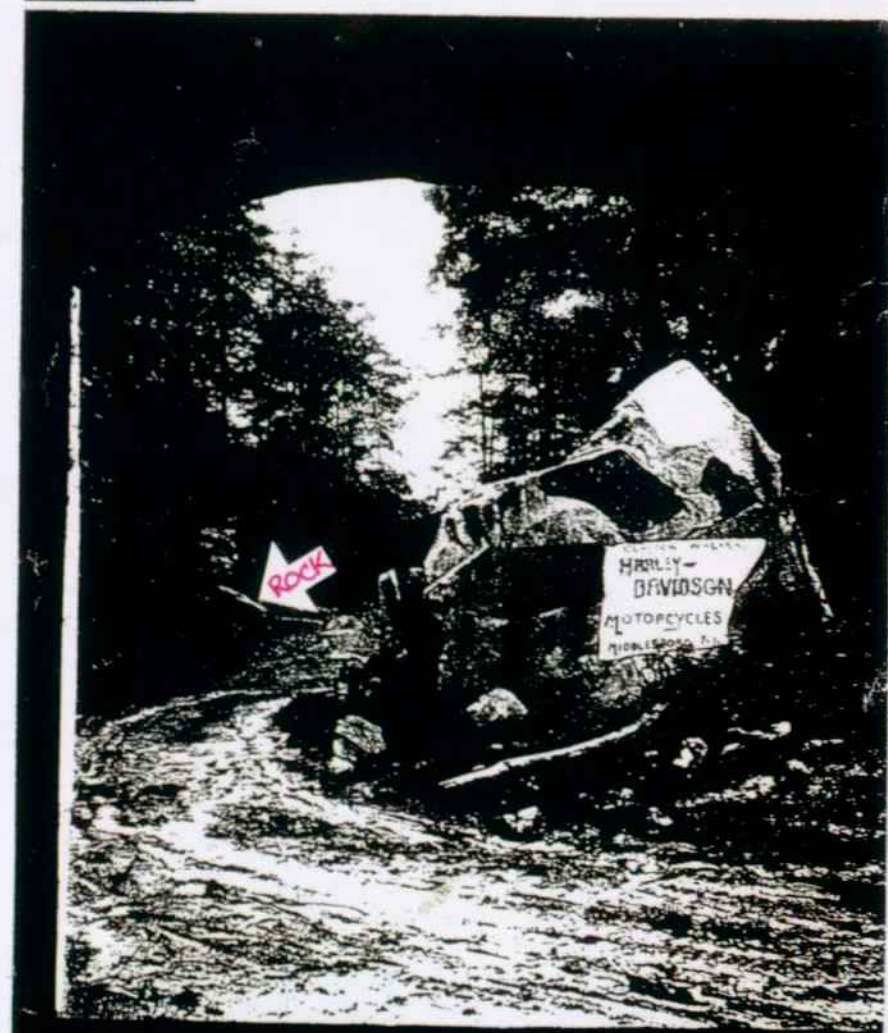
Validation Point #21

In today's photograph the Wilderness Road is also behind Indian Rock and to the left. Notice how the approach to this curve in the Wilderness Road has been removed. This portion of earth was removed in the early 1900's to allow access for a gravel pit. The arrows show the very same rock in the same position in both photographs.

This historic photograph shows the Wilderness Road behind Indian Rock and to the left.

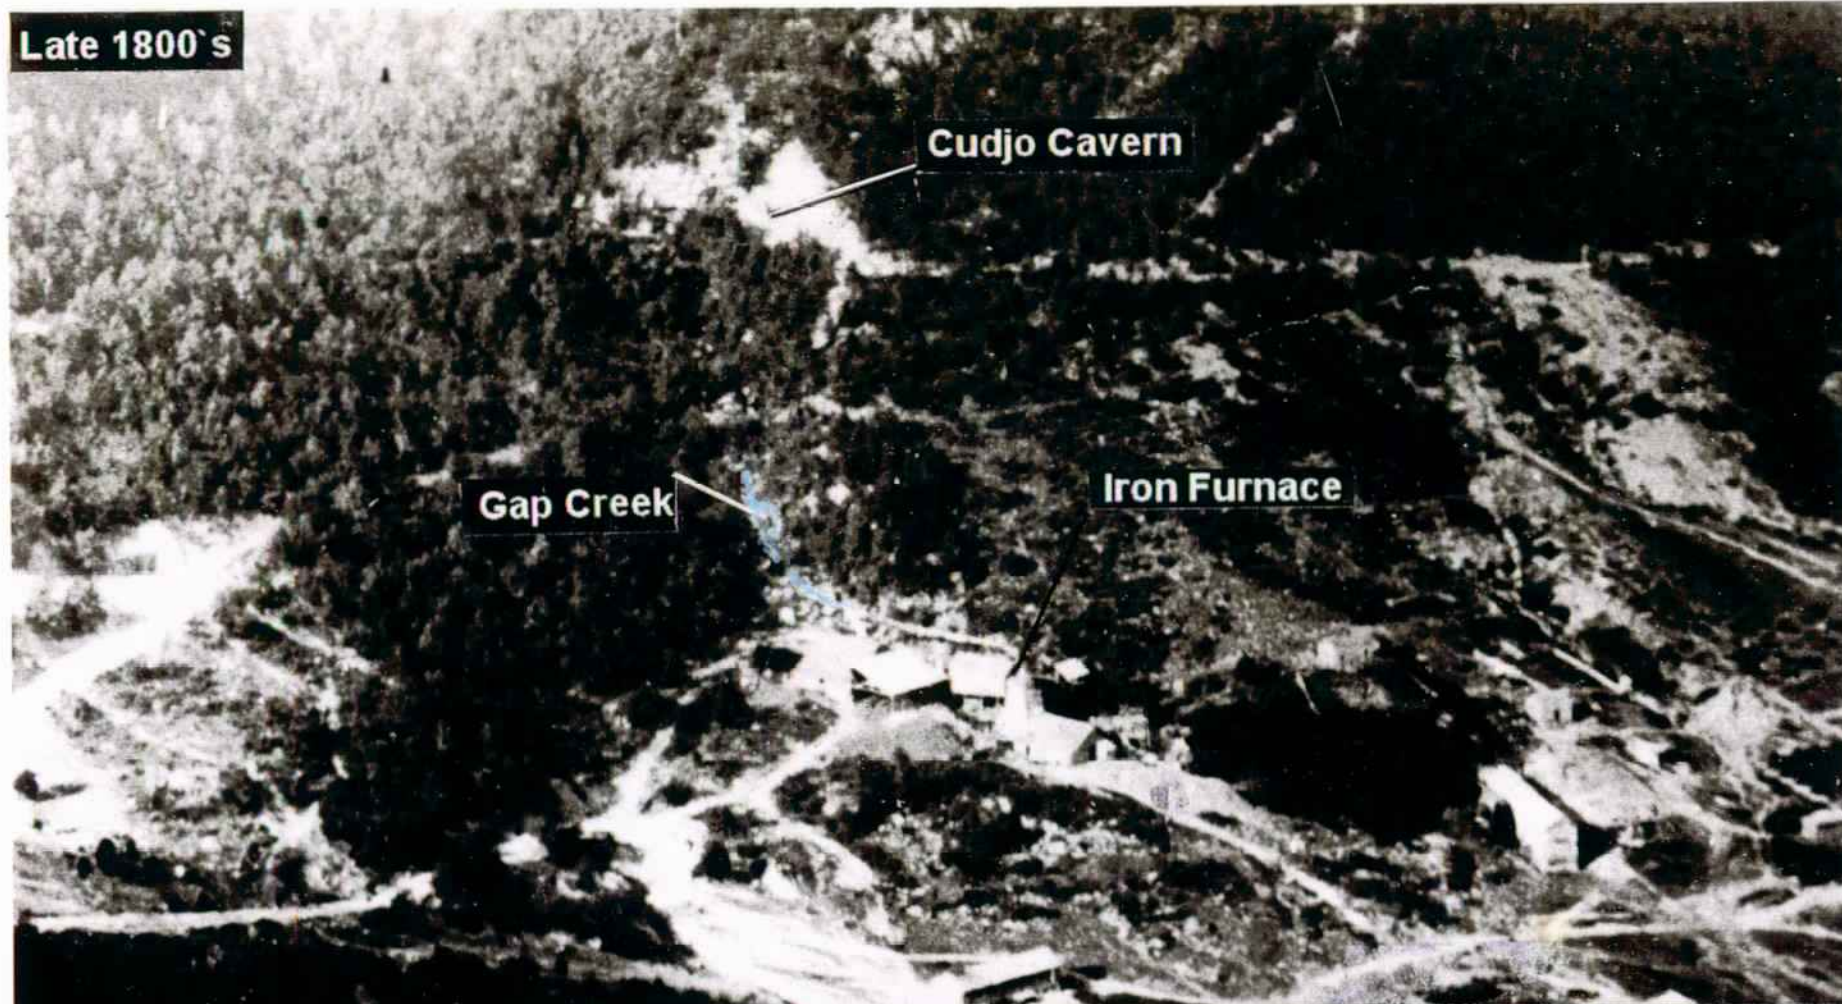
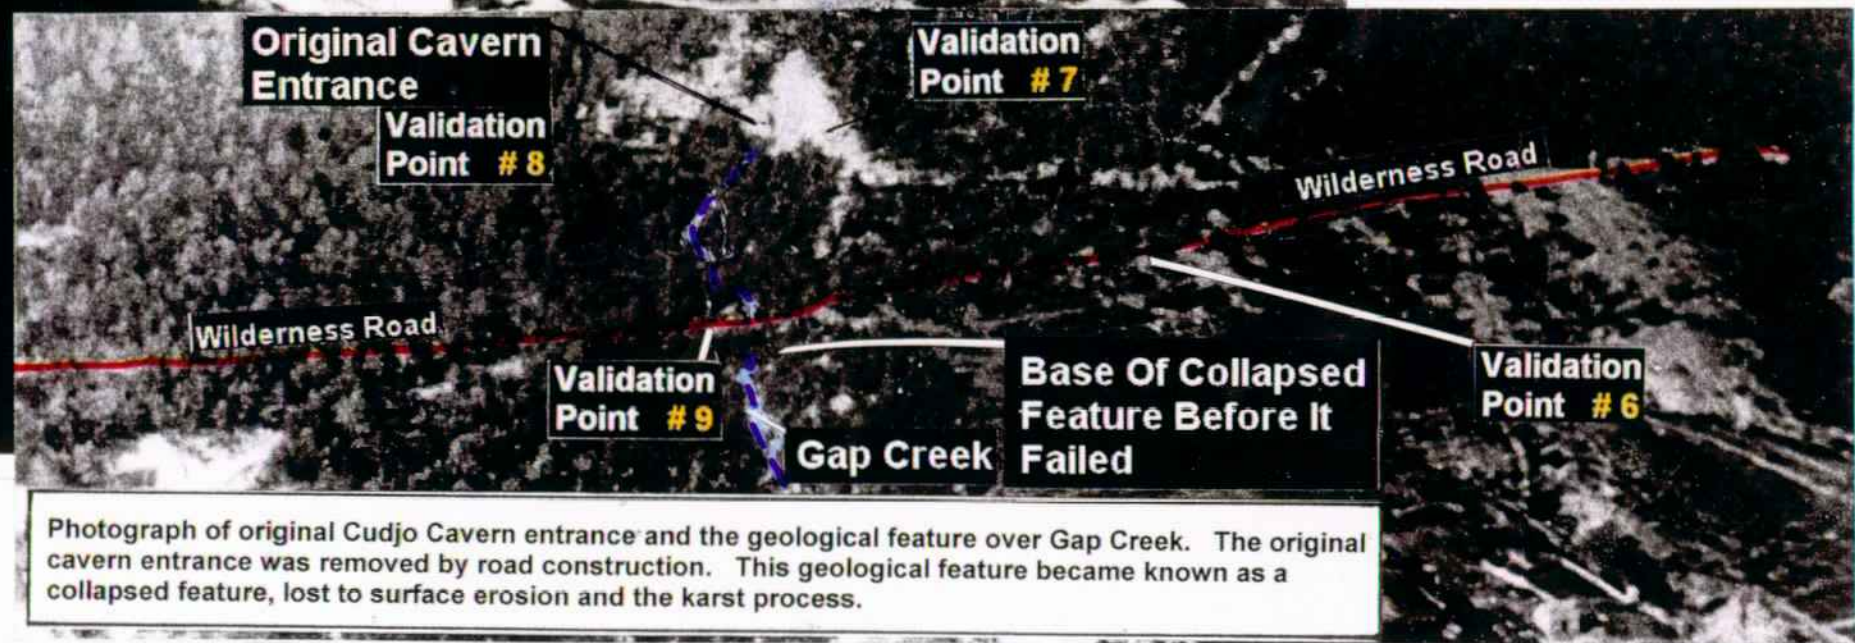
Photograph of original Cudjo Cavern entrance and the geological feature over Gap Creek. The original cavern entrance was removed by road construction. This geological feature became known as a collapsed feature, lost to surface erosion and the karst process.

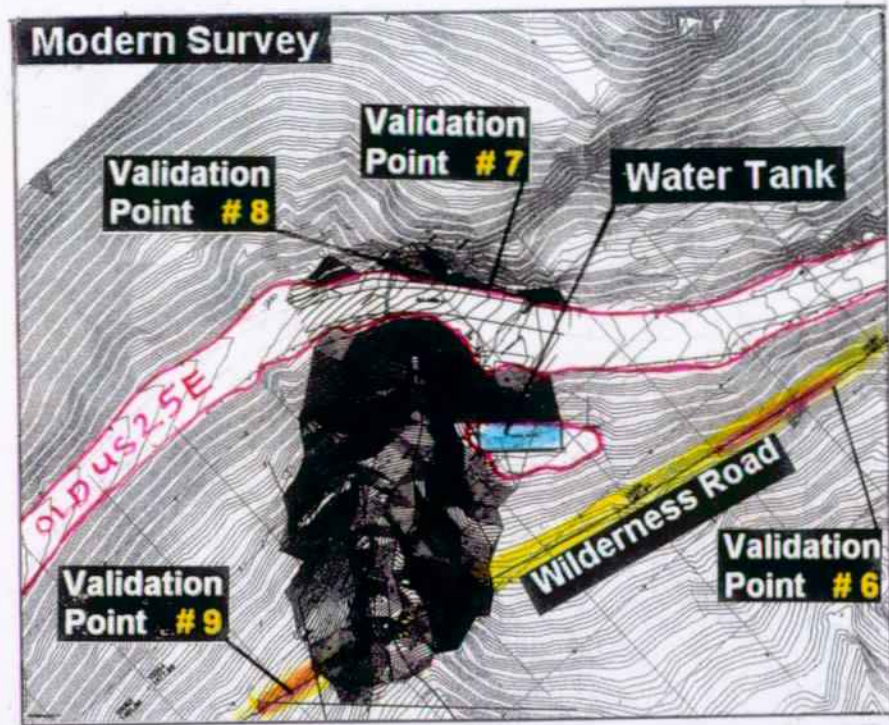
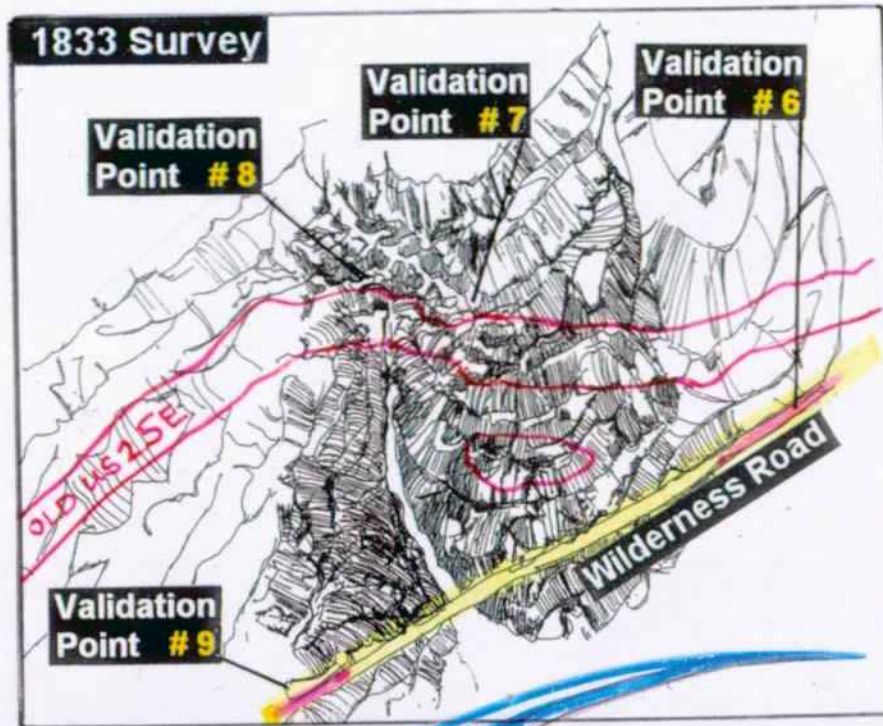
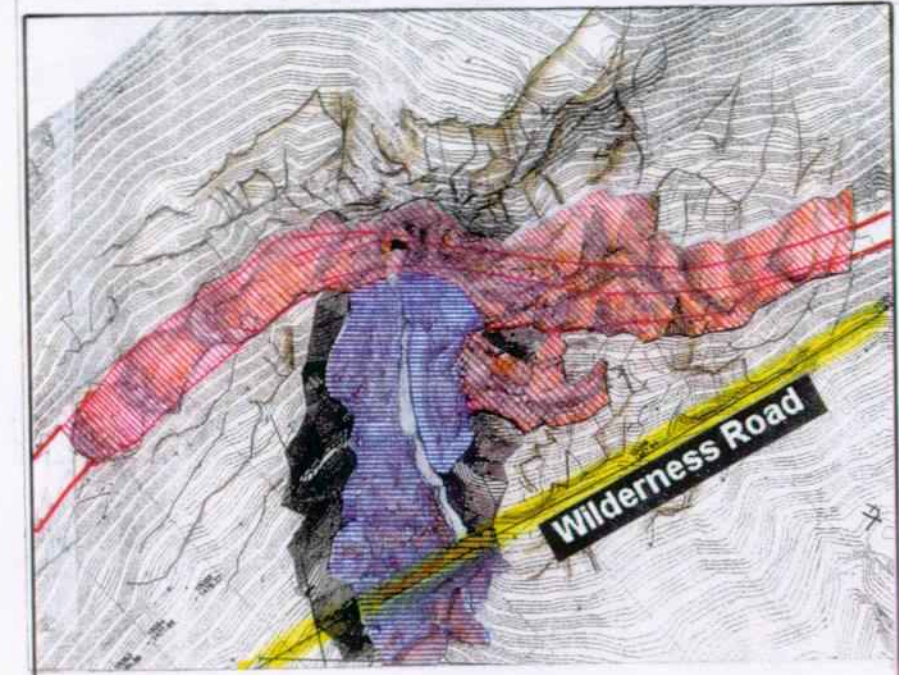
cavern area / geologic feature over gap creek

Earth Removed By Modern Construction

This Geological Feature Collapsed From Surface Erosion And The Karst Process

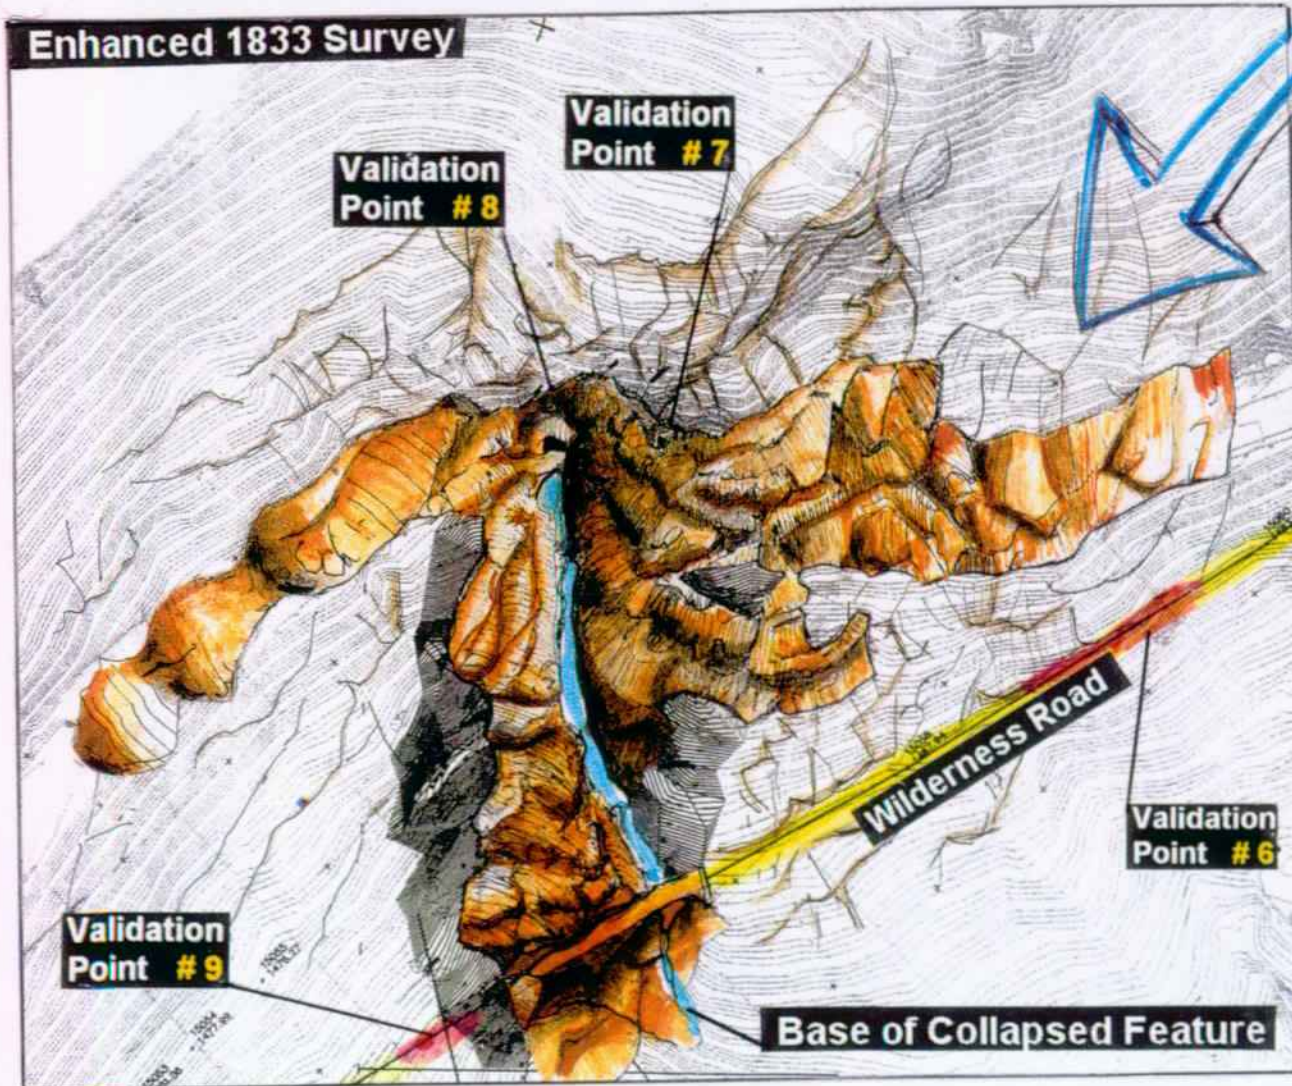
Enhanced 1833 Survey – This sheet shows a hand-enhanced version of the 1833 survey, overlaid on modern topography. The shape and position of the original cavern entrance, and the geological feature over Gap Creek, meshes perfectly with modern survey work.

The 1833 survey is believed to be the base map used for the later construction of the initial alignment of U.S. Route 25E. The first road on the higher alignment was built sometime after 1833, but before 1862. The original cave entrance was not removed by road building until the late 1800's, the same approximate time frame as when the geological feature over Gap Creek failed.

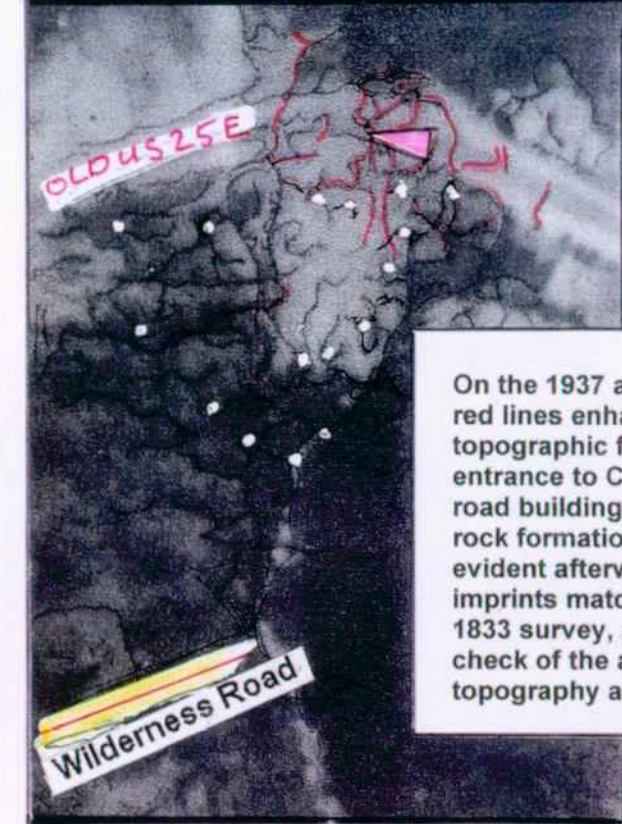
On the 1937 aerial photograph to the left, red lines enhance the delineation of topographic features around the original entrance to Cudjo Cavern. Even though road building on U.S. Route 25E removed rock formations, their "imprint" remains evident afterwards. These delineated imprints match the same features from the 1833 survey, providing yet another cross-check of the accuracy of the missing topography and cavern entrance.

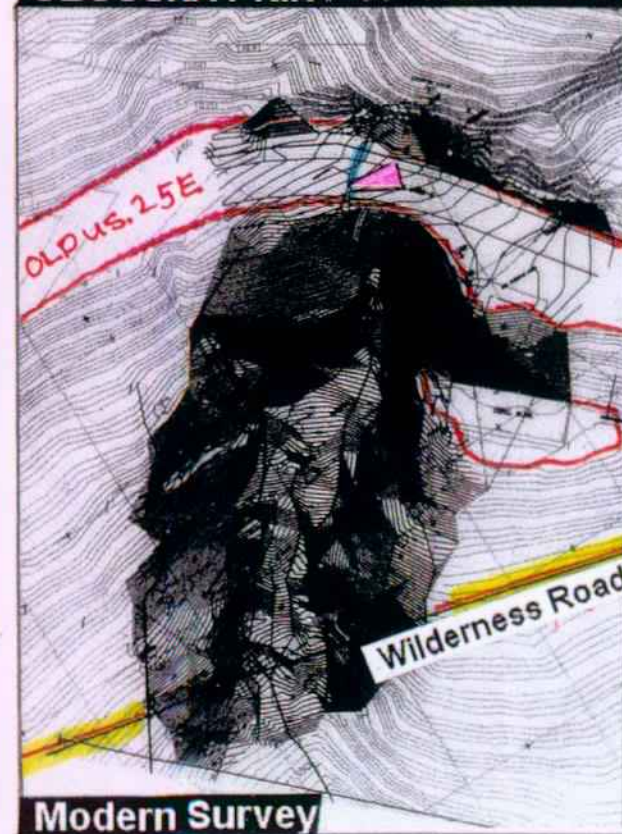
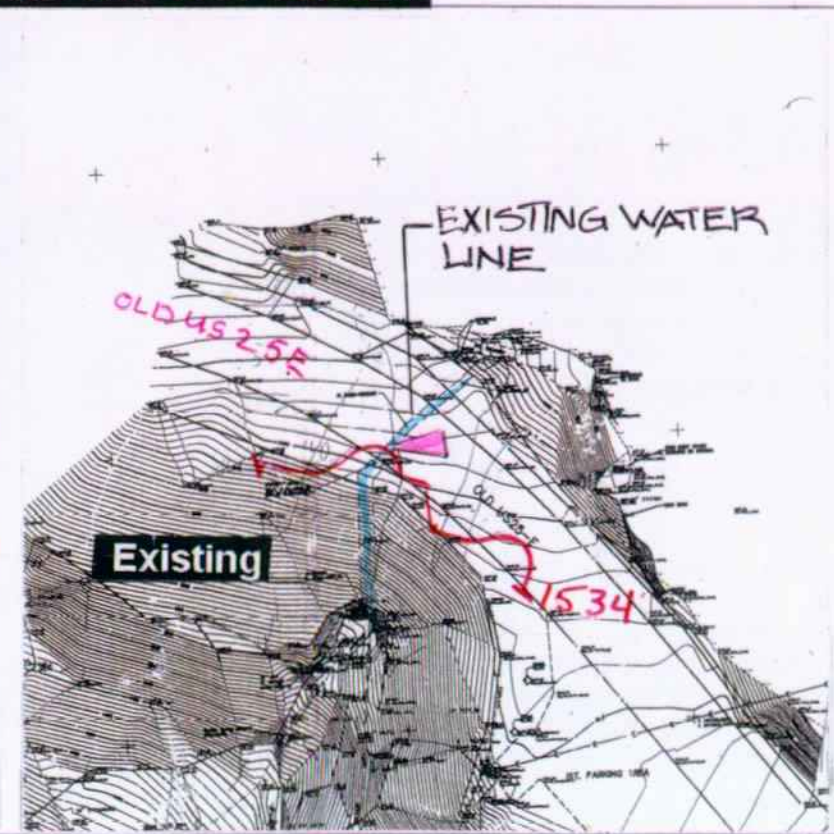
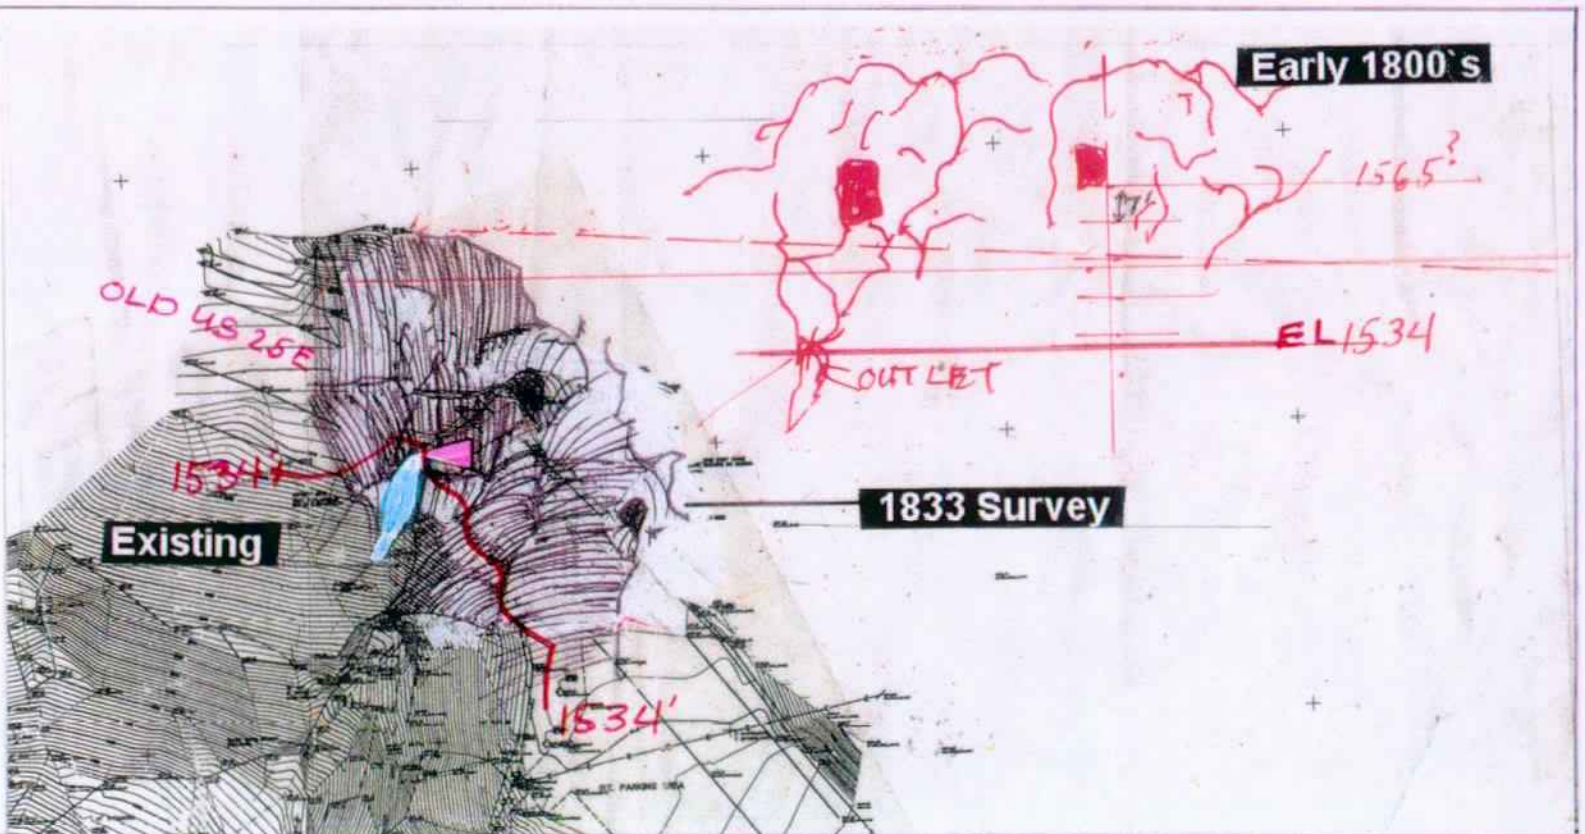
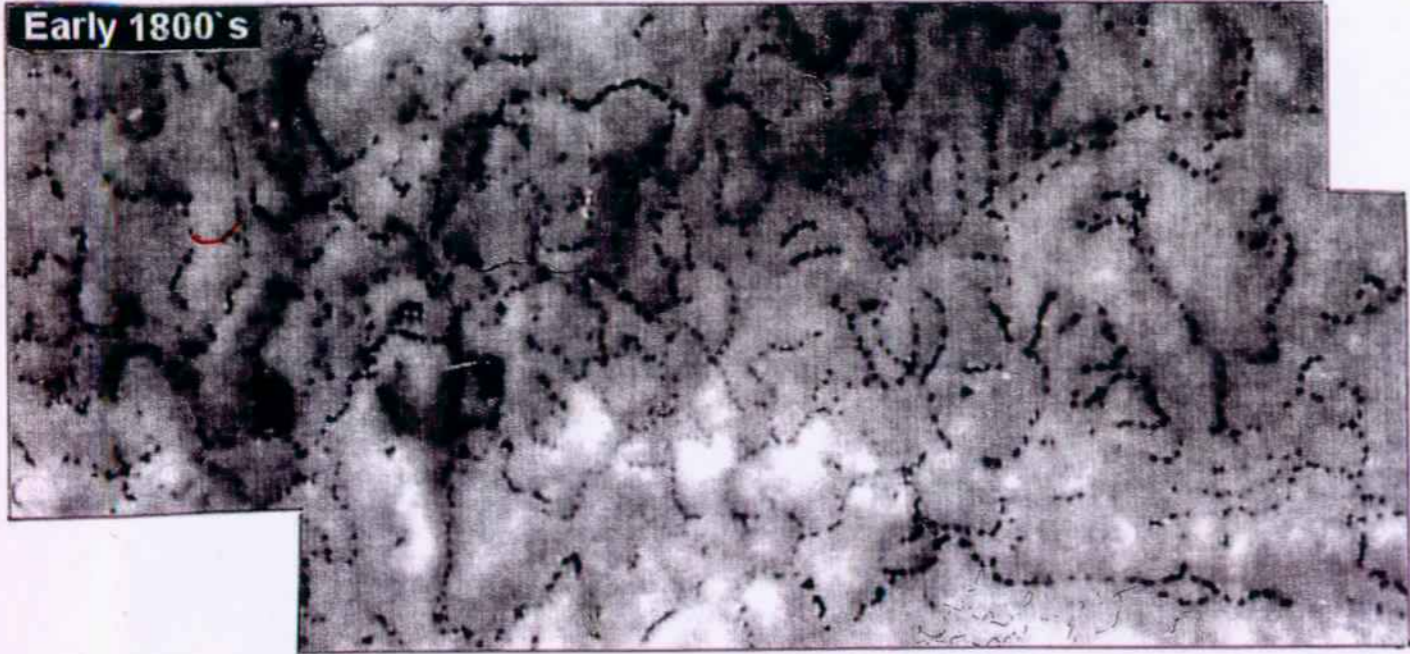
original entrance to cudjo cavern

These views of the face of Cudjo Cavern show not only the delineated precision of the missing topography, but also the original location of the cave entrance. The highlighted rock formations are interchangeable from image to image, from a current photograph on the right, to the early 1800's obscura view on the left.

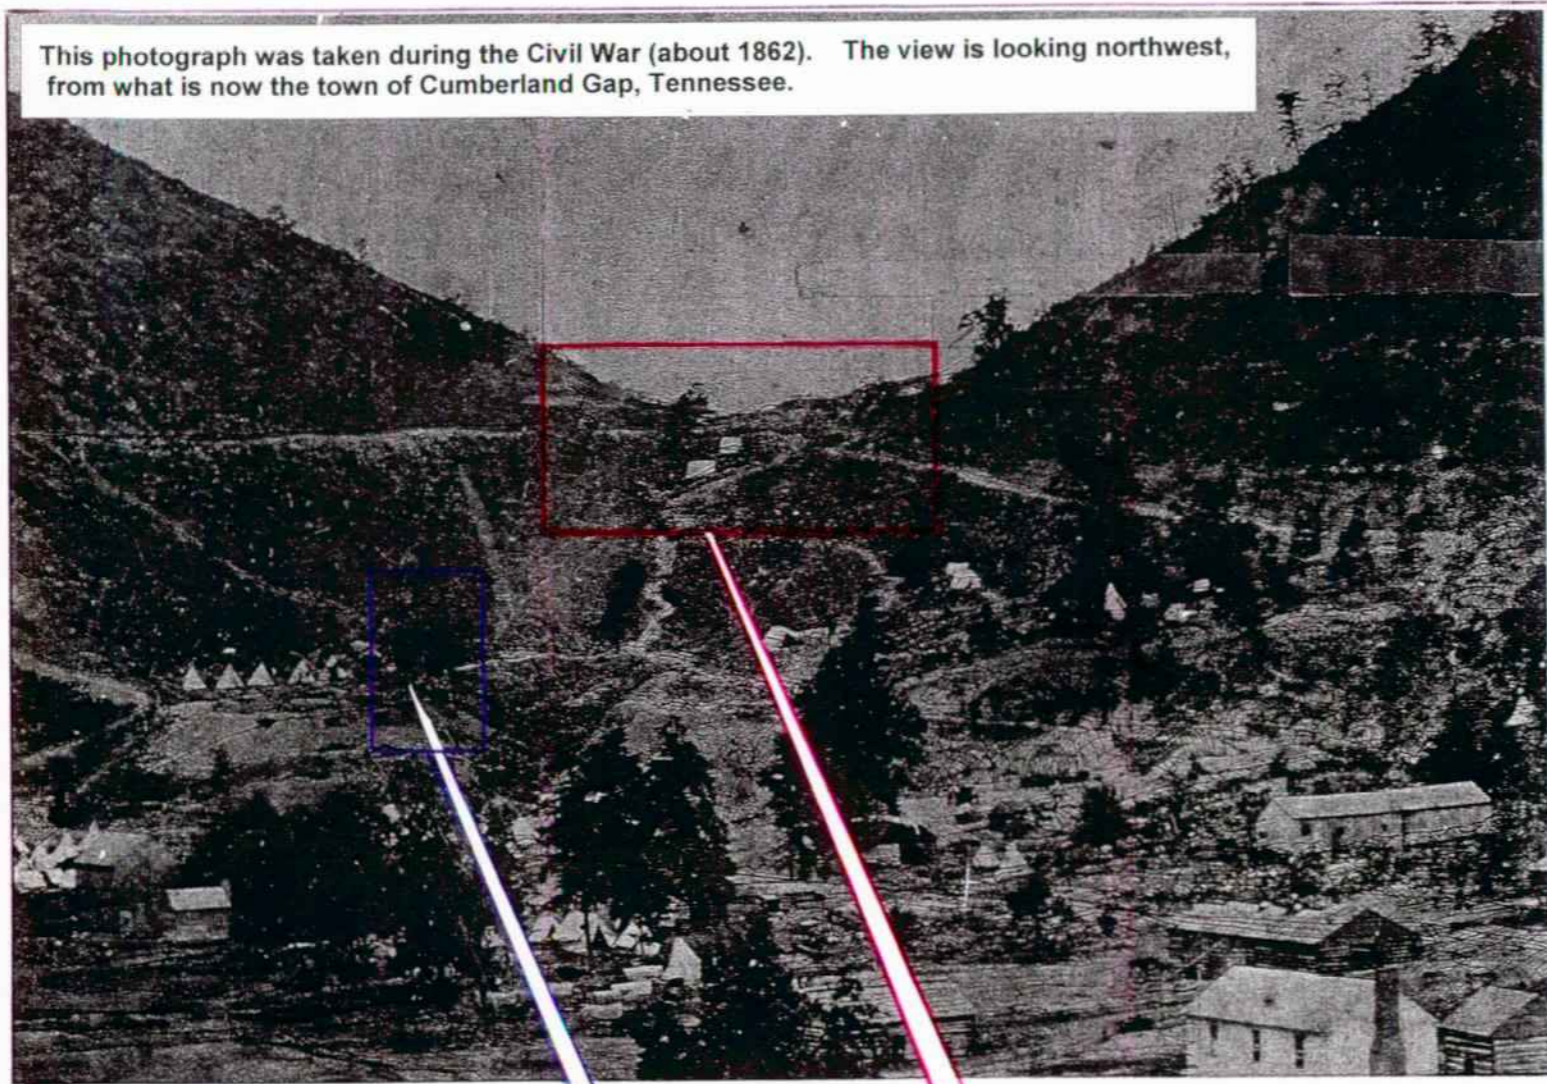
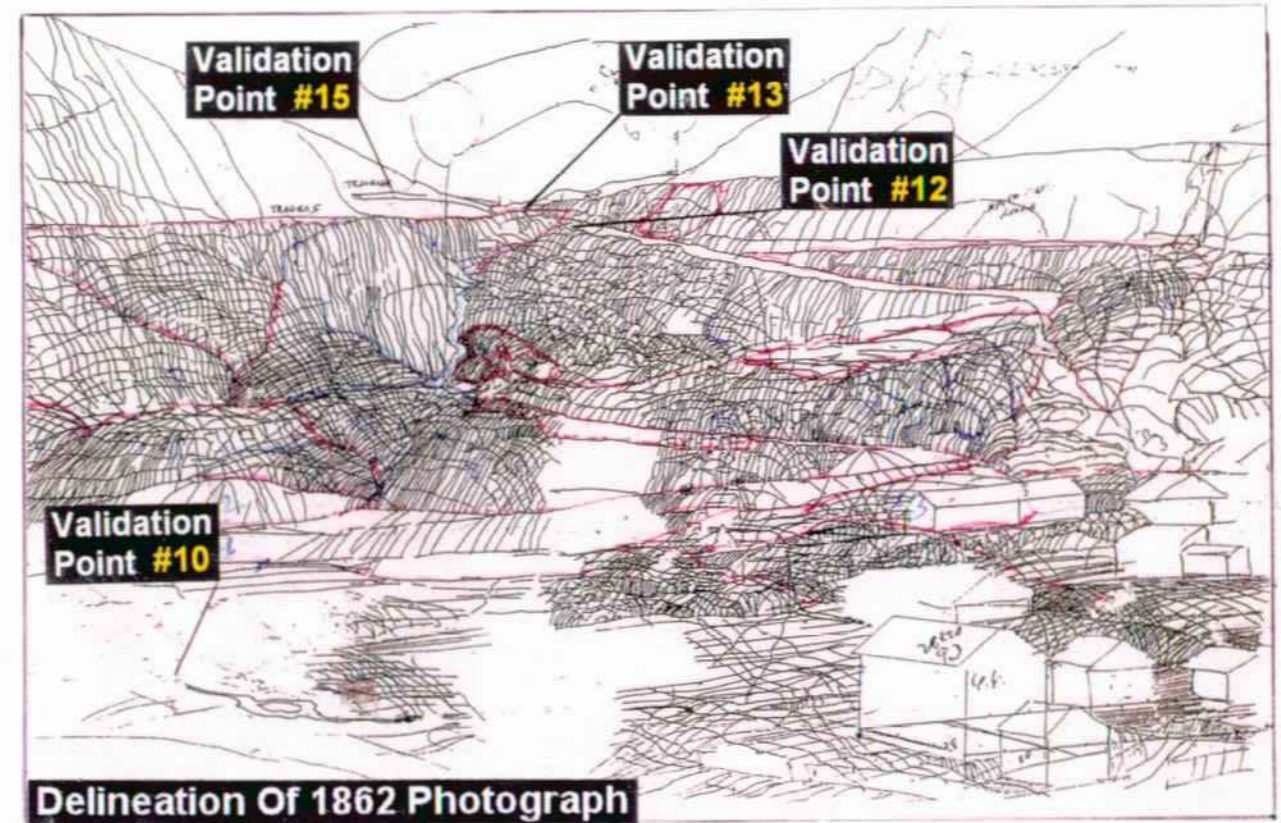
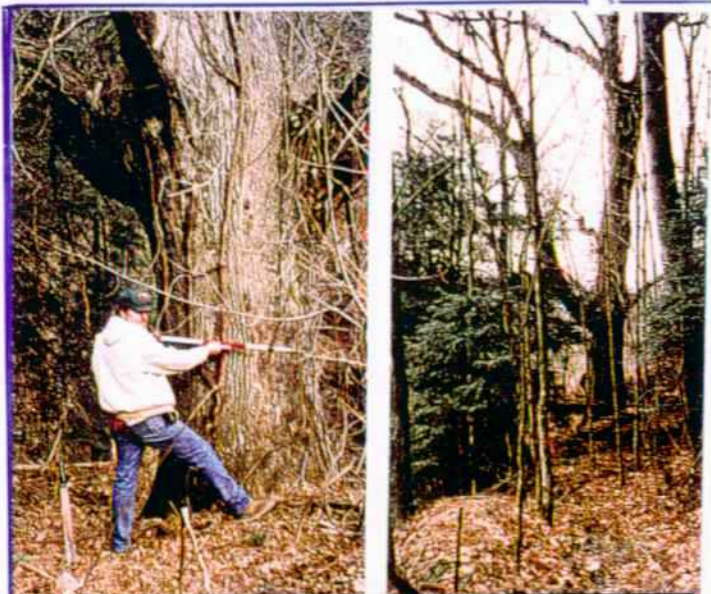
Validation Point #11

Existing tree, visible in photograph above is a Red Oak (about 12.5 ft. in circumference) and gives another location cross check.

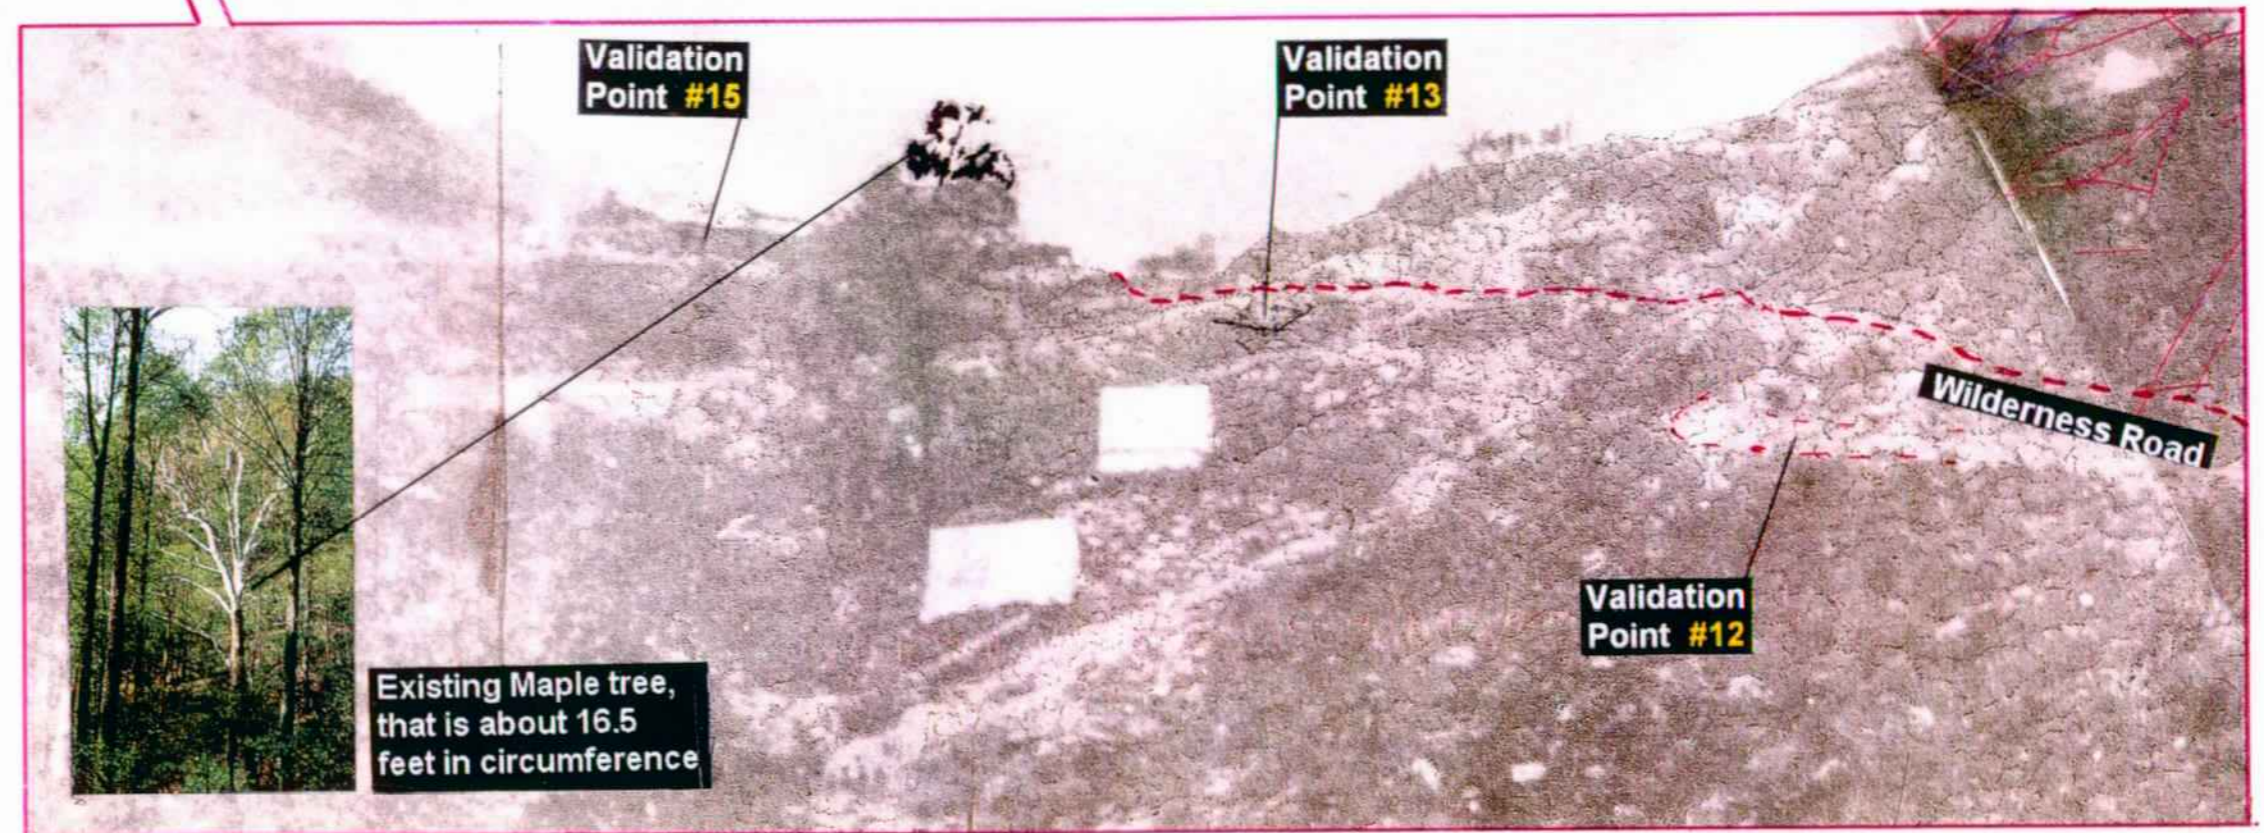
Existing Maple tree, that is about 16.5 feet in circumference
