Restoration of Historic Features Cumberland Gap National Historical Park

Wilderness Road
1780-1810

Research methodology for the
"Rediscovery" of historically significant
resources: Procedures developed to
determine their original topography of the
historic saddle of Cumberland Gap and
identify the vertical and horizontal
alignment of the historic road.

Prepared by Harland D. Unrau, Cultural Resource Specialist,
Denver Service Center, Planning and Site Design; Planning

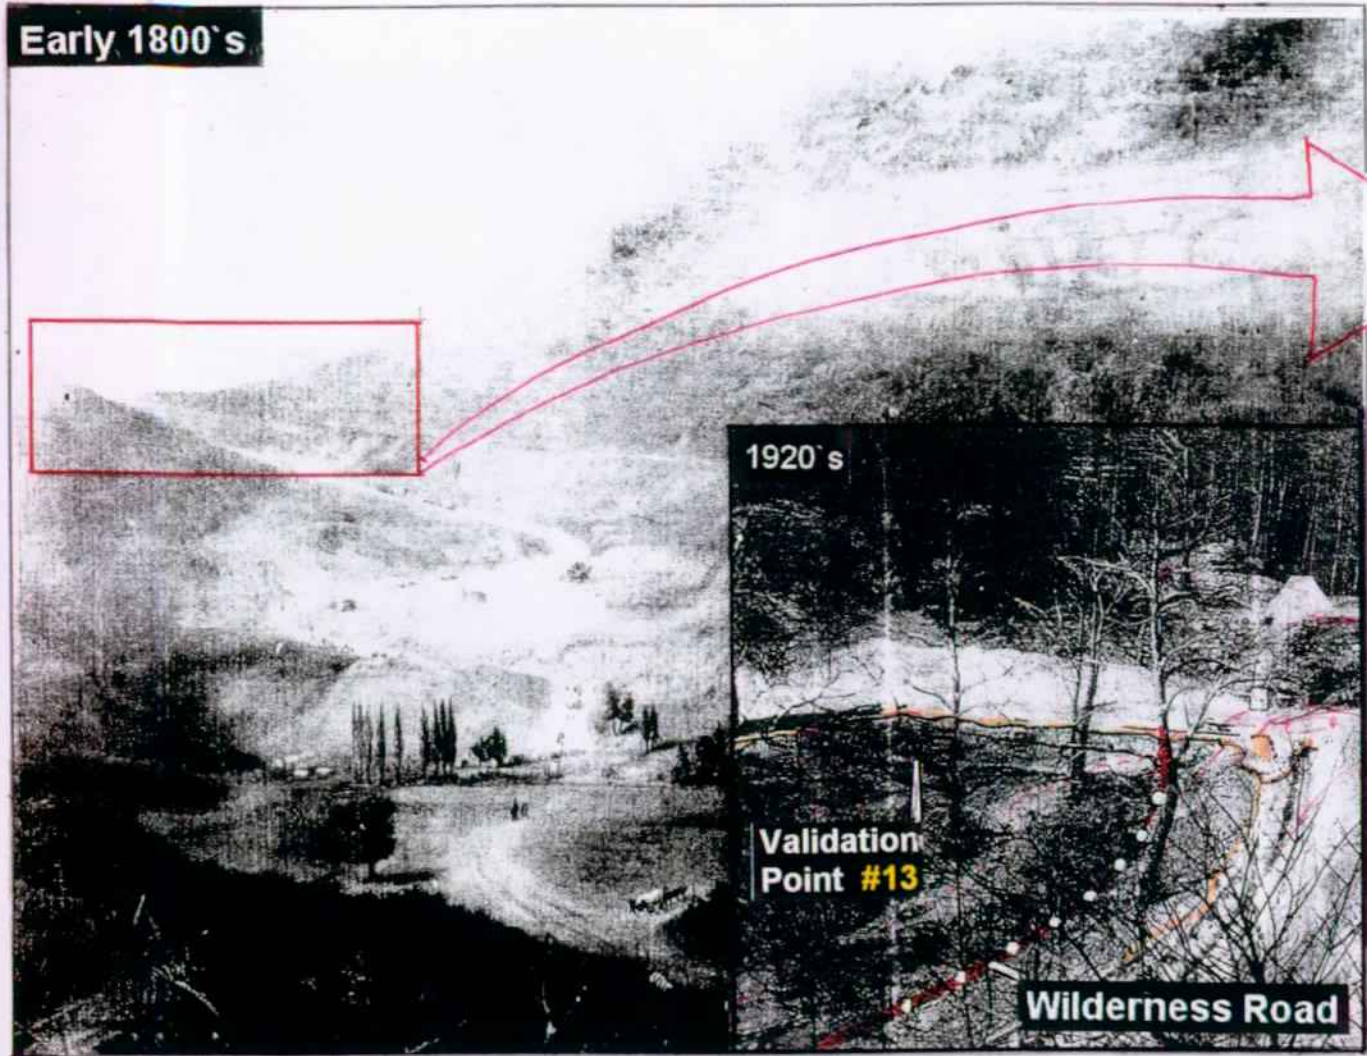
Early 1800's

This page illustrates how delineation was used to identify the shape of the missing topography, to the approach of the saddle. The delineation was cross checked with historic survey, historic photographs, aerals, and modern field photographs. These shapes are applied to a mechanical drawing technique, then added to the grading plan.

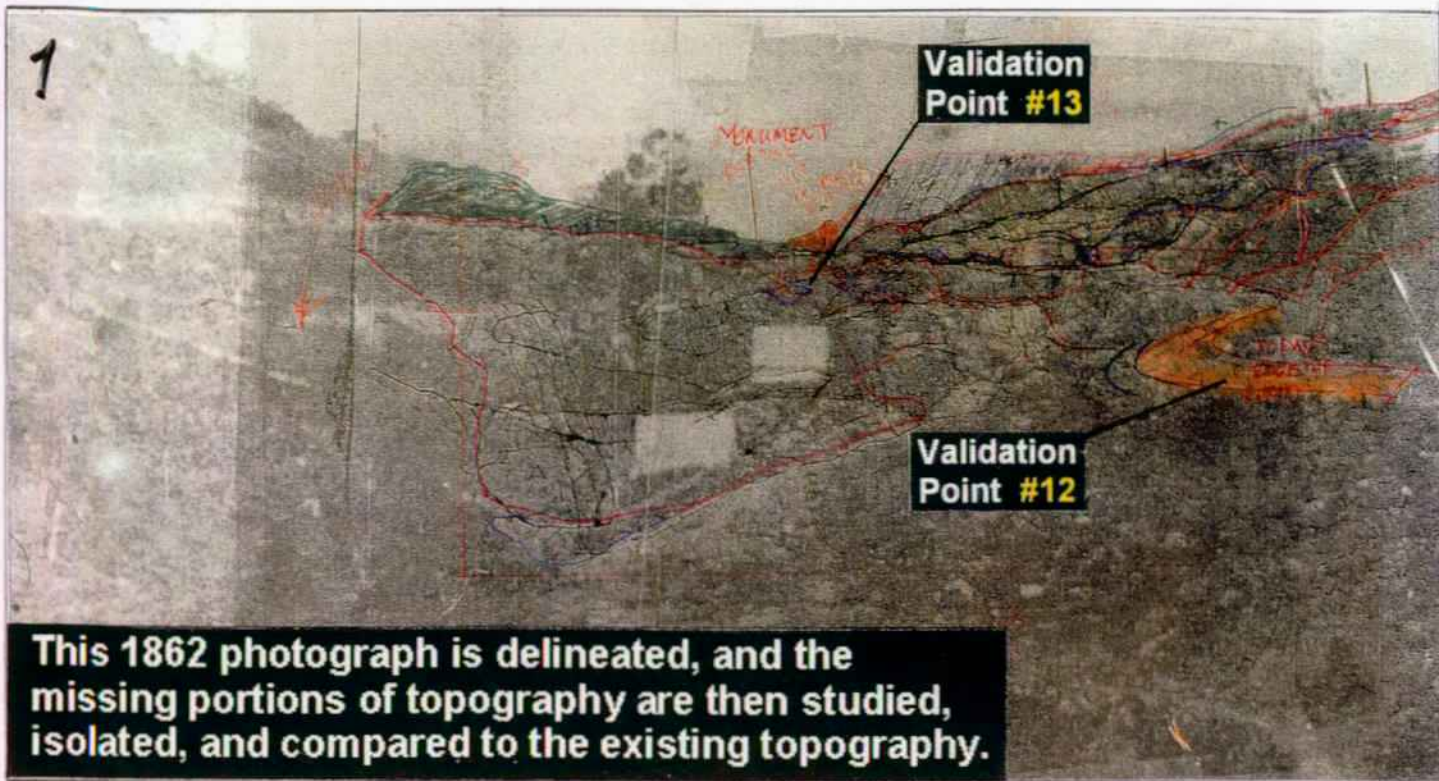
This 1862 photograph is delineated, and the missing portions of topography are then studied, isolated, and compared to the existing topography.

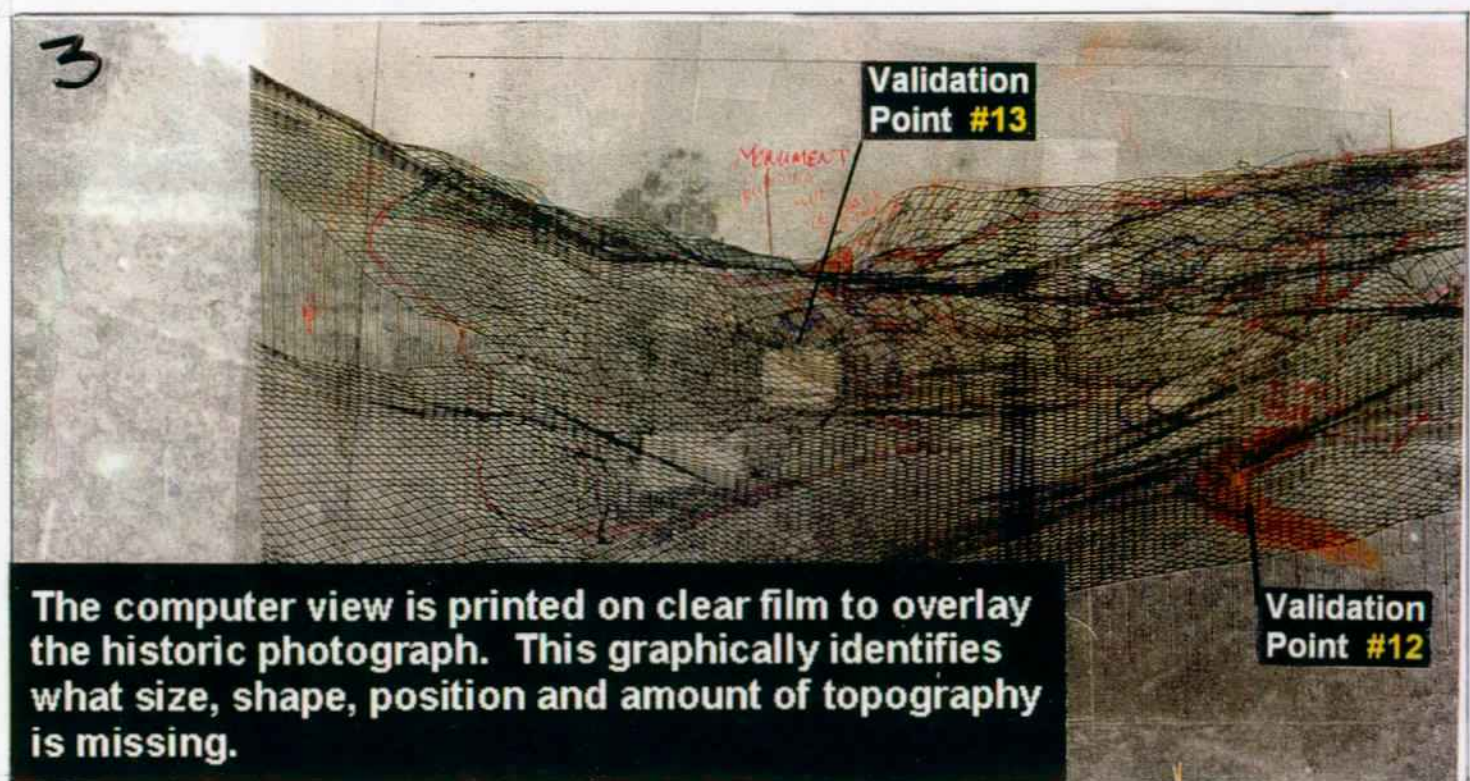
The computer view is printed on clear film to overlay the historic photograph. This graphically identifies what size, shape, position and amount of topography is missing.

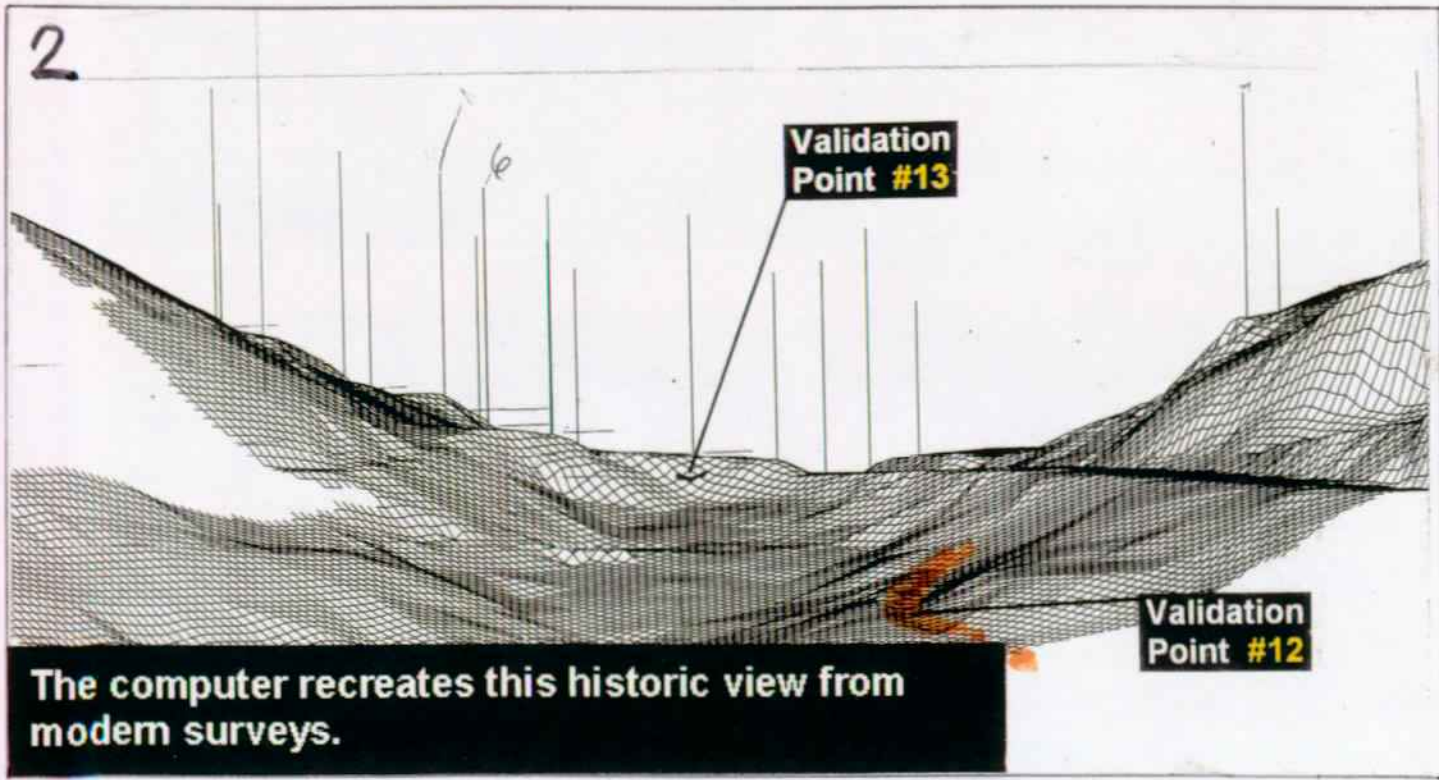
The computer recreates this historic view from modern surveys.

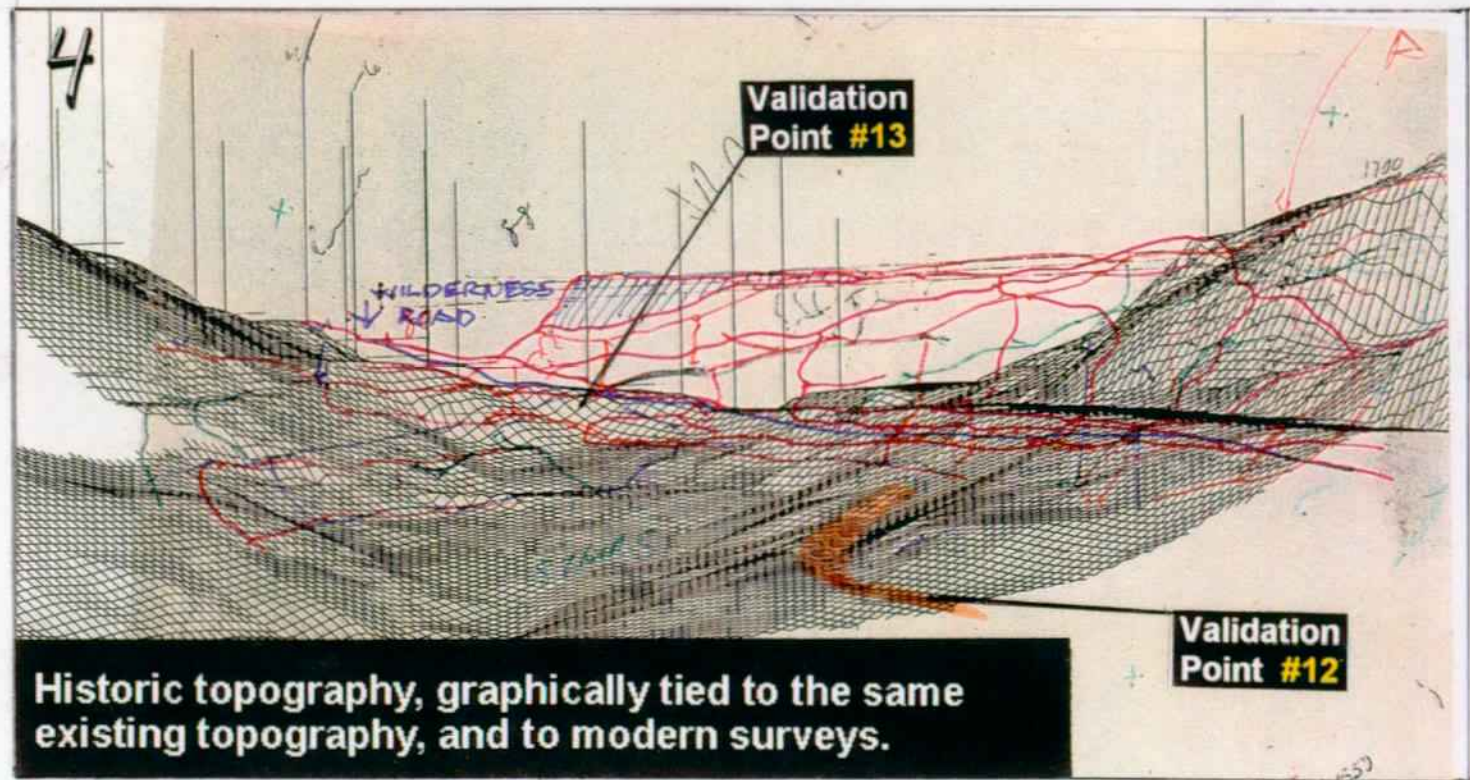
Historic topography, graphically tied to the same existing topography, and to modern surveys.

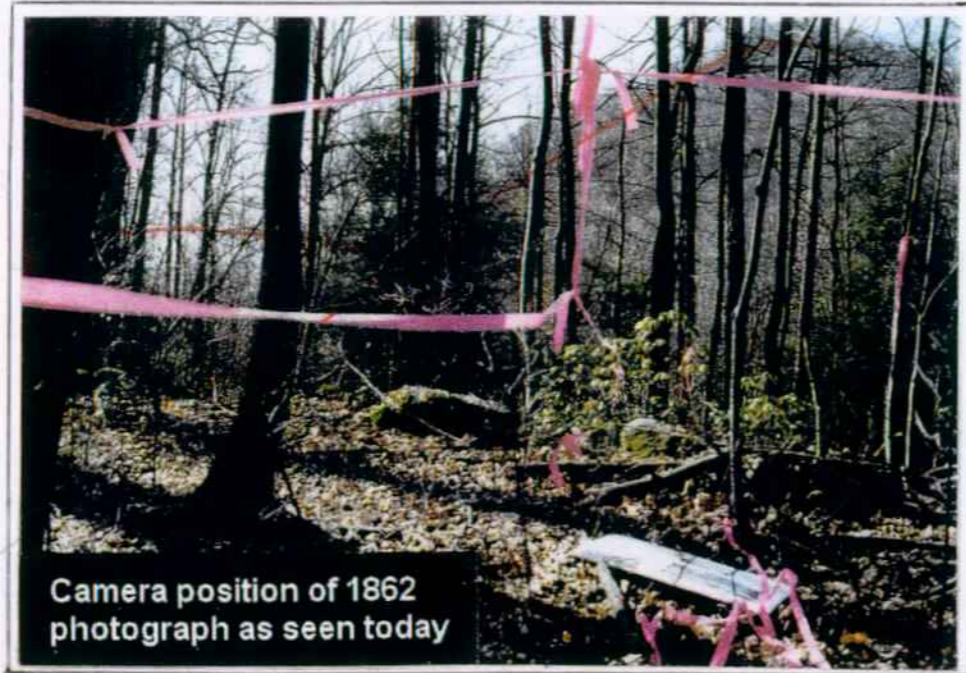
Camera position of 1862 photograph as seen today

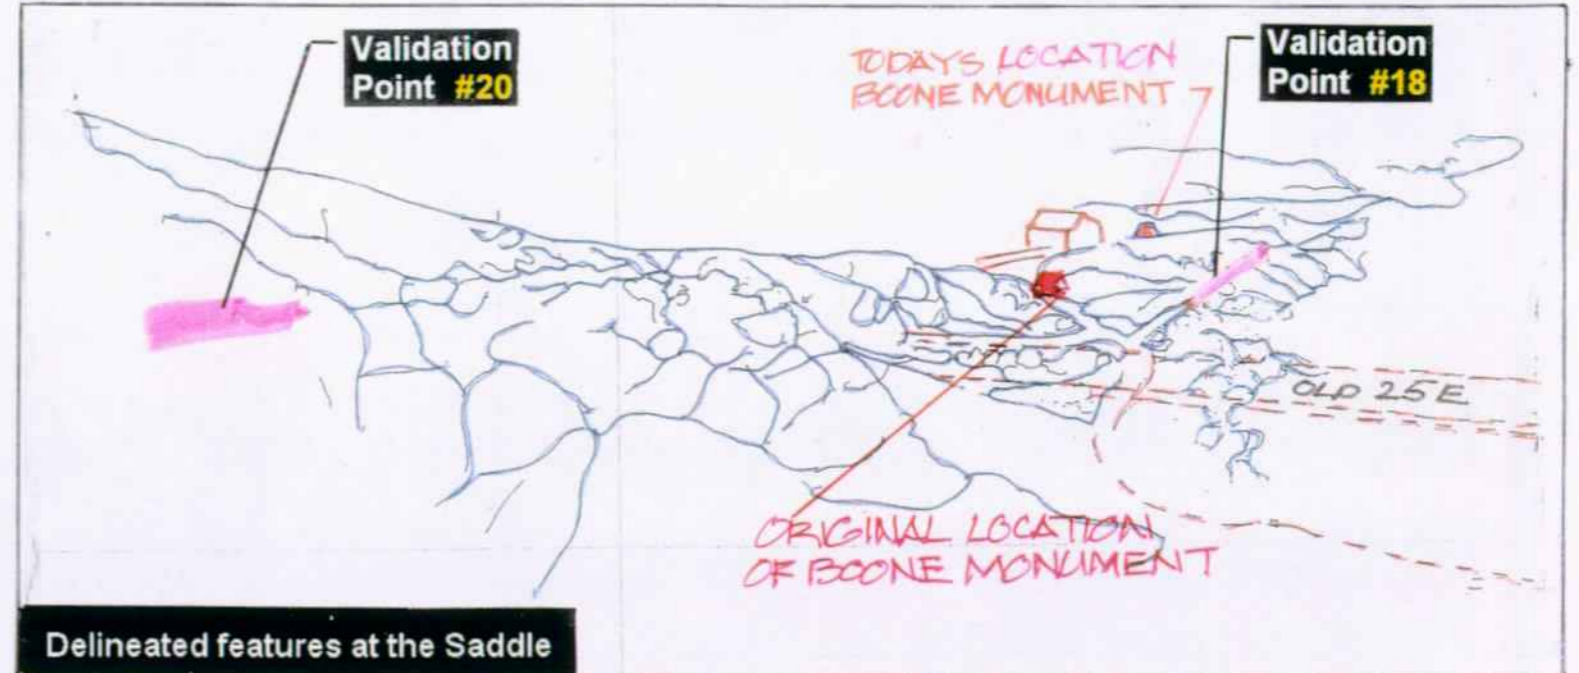
Delineated features at the Saddle

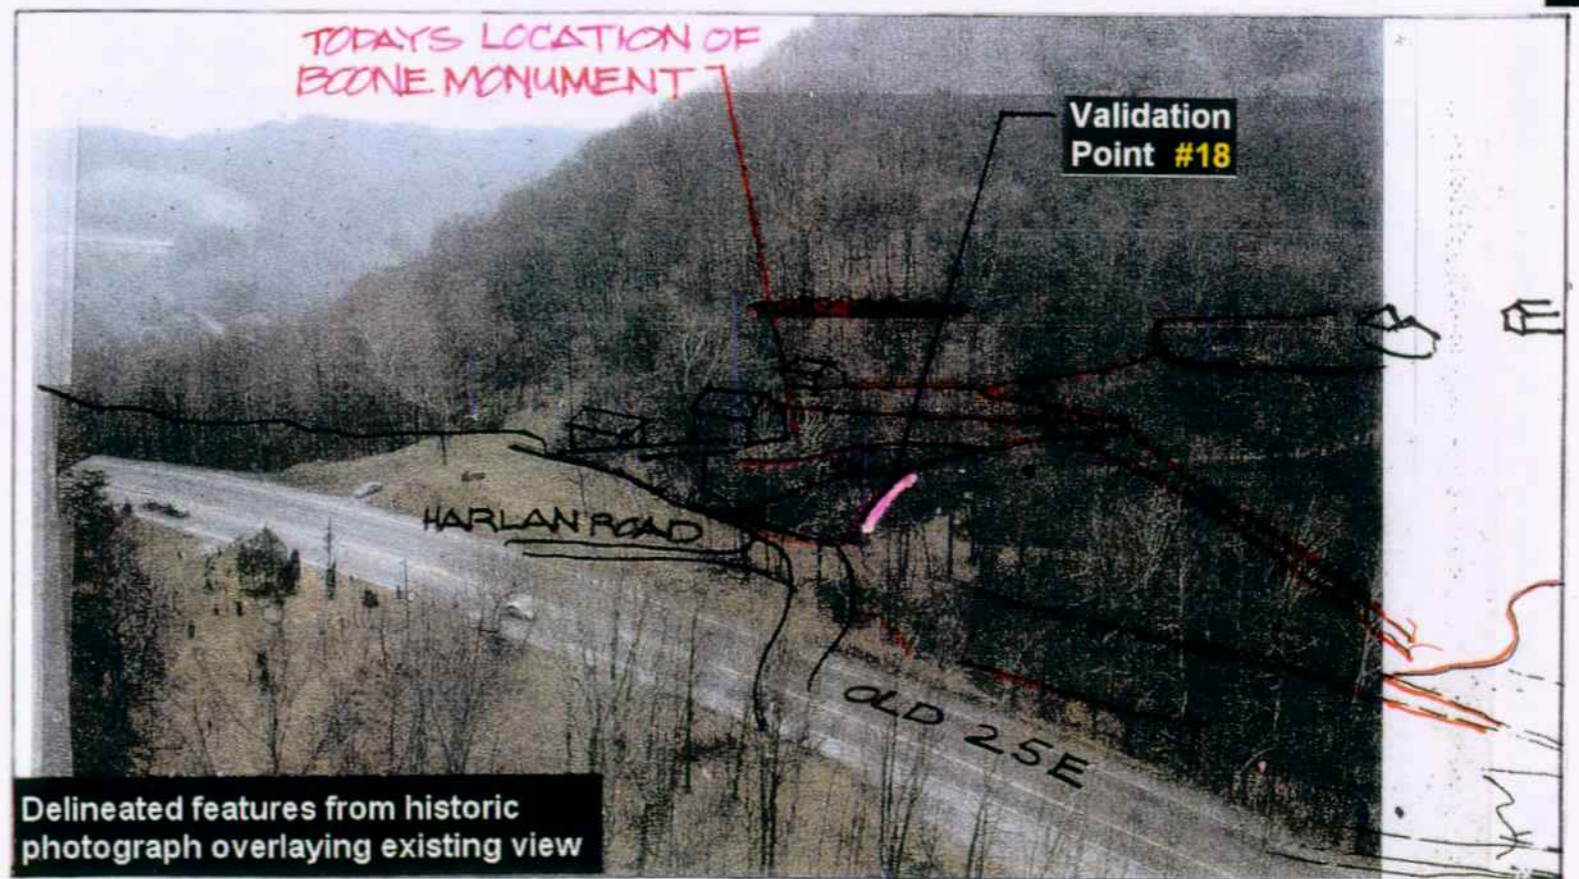
Delineated features from historic photograph overlaying existing view

— Remnants of the late 1800's as they overlay their same location today

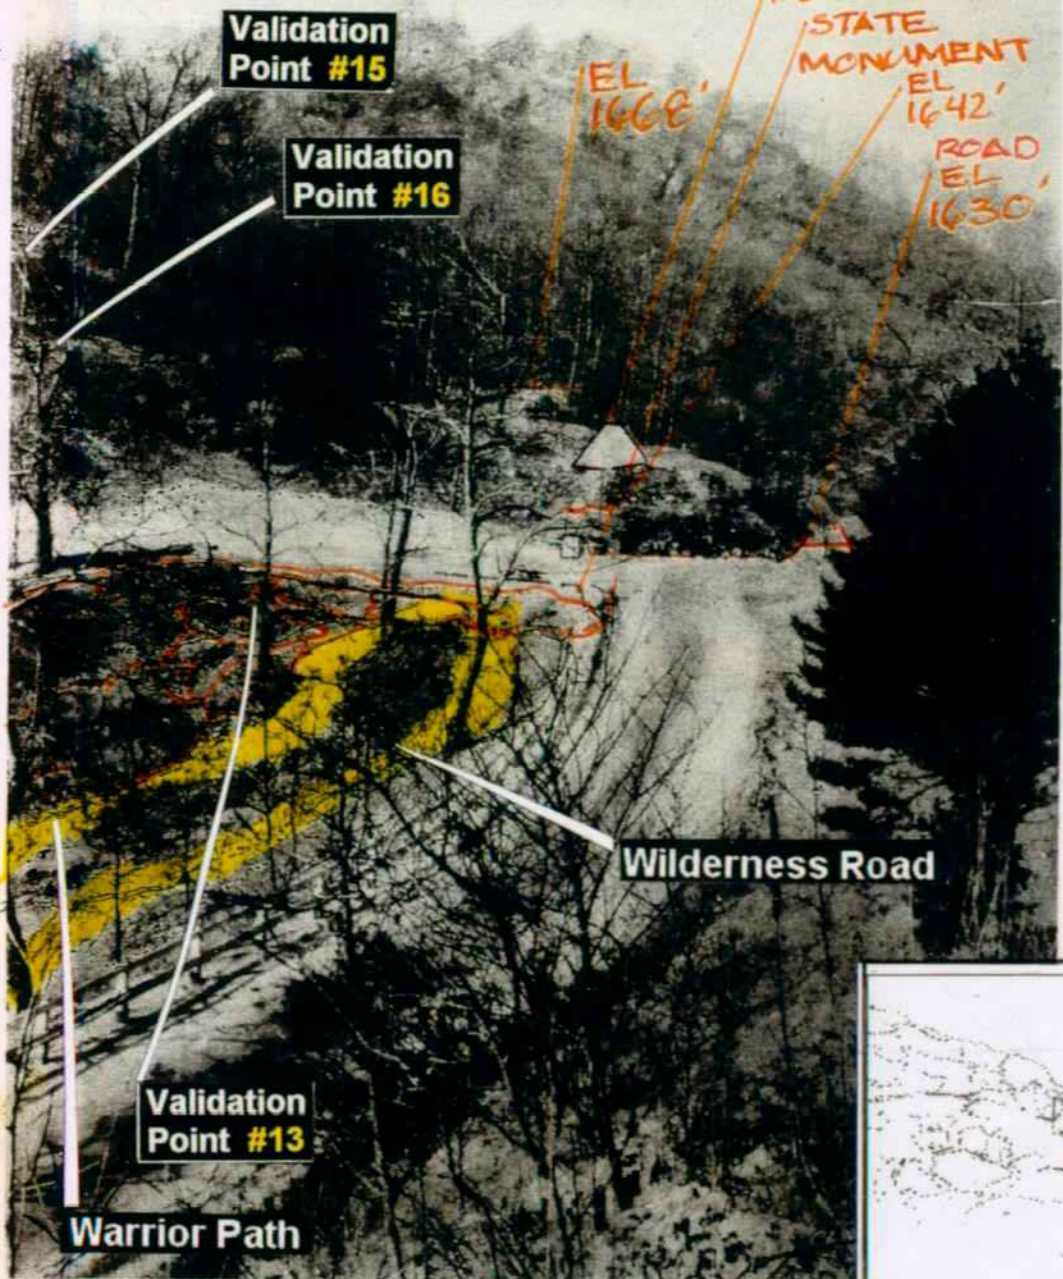
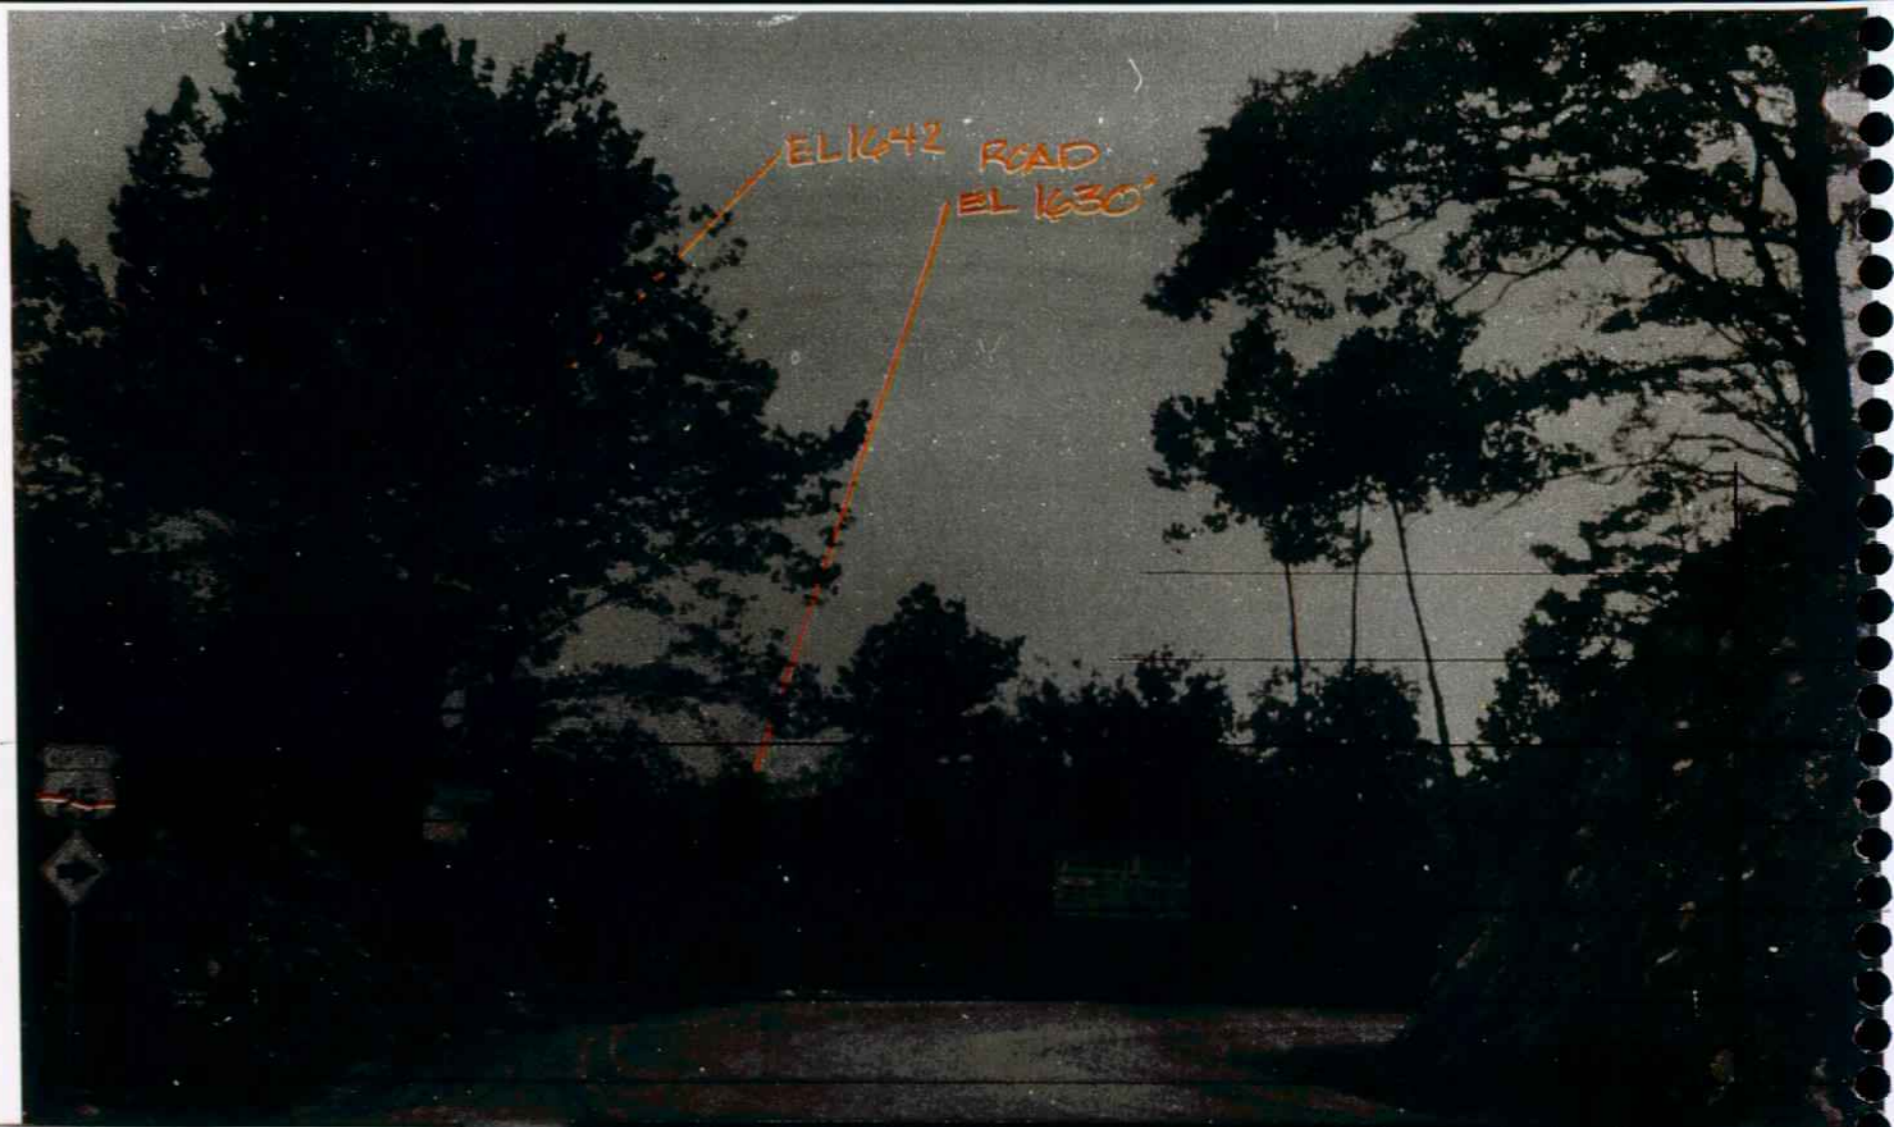
Two 1920s era photographs viewing west through the Cumberland Gap road cut. Courtesy of Cumberland Gap National Historical Park.

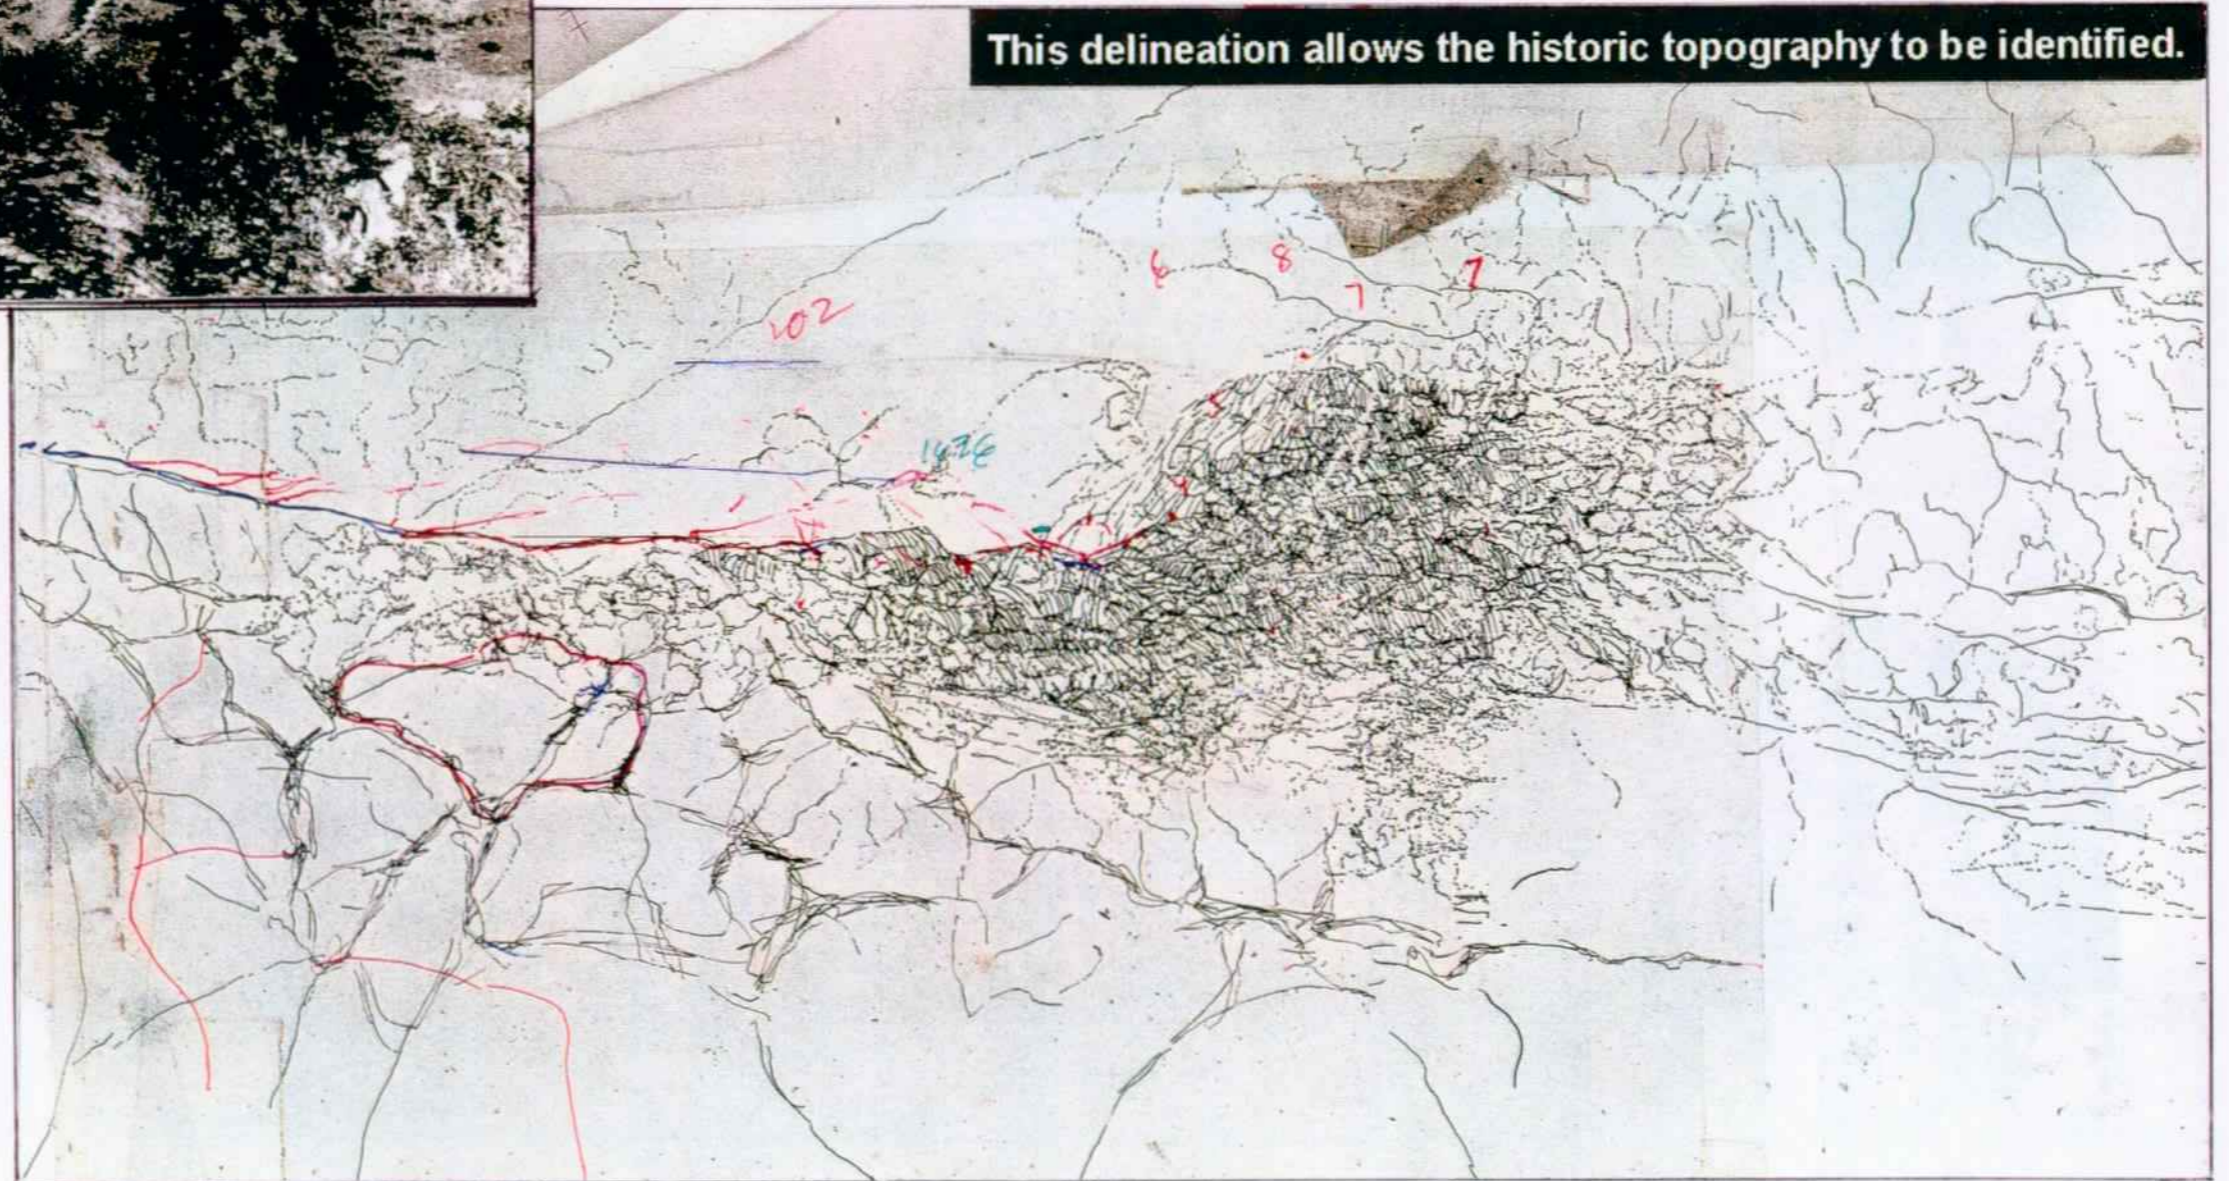
The missing portions of topography are studied, isolated and compared to the existing topography.

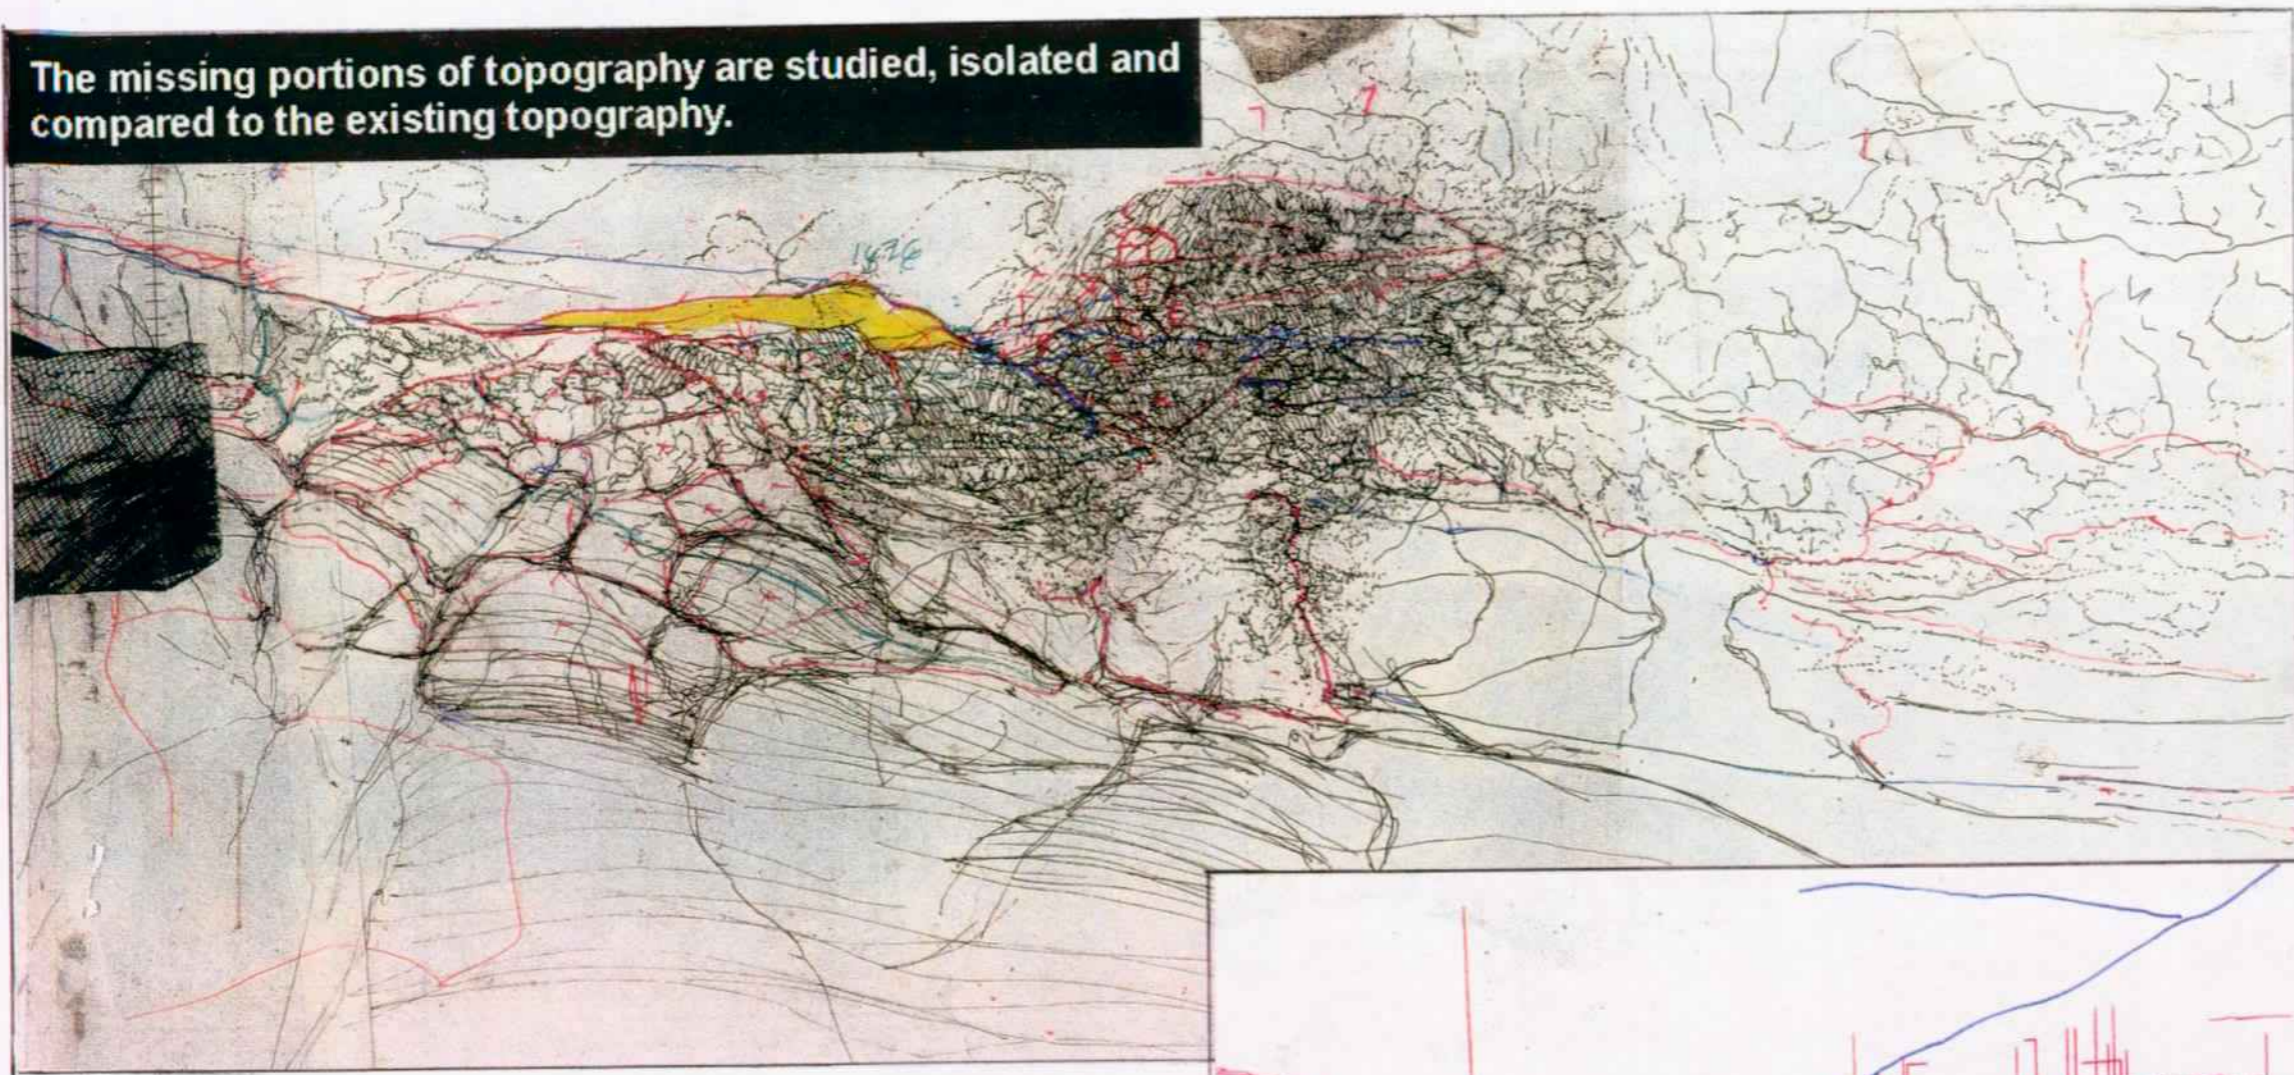
The computer recreates this historic view from modern surveys. The verticle pole-like red lines are the surveyed positions of actual remnants found on the ground today and in this historic photograph.

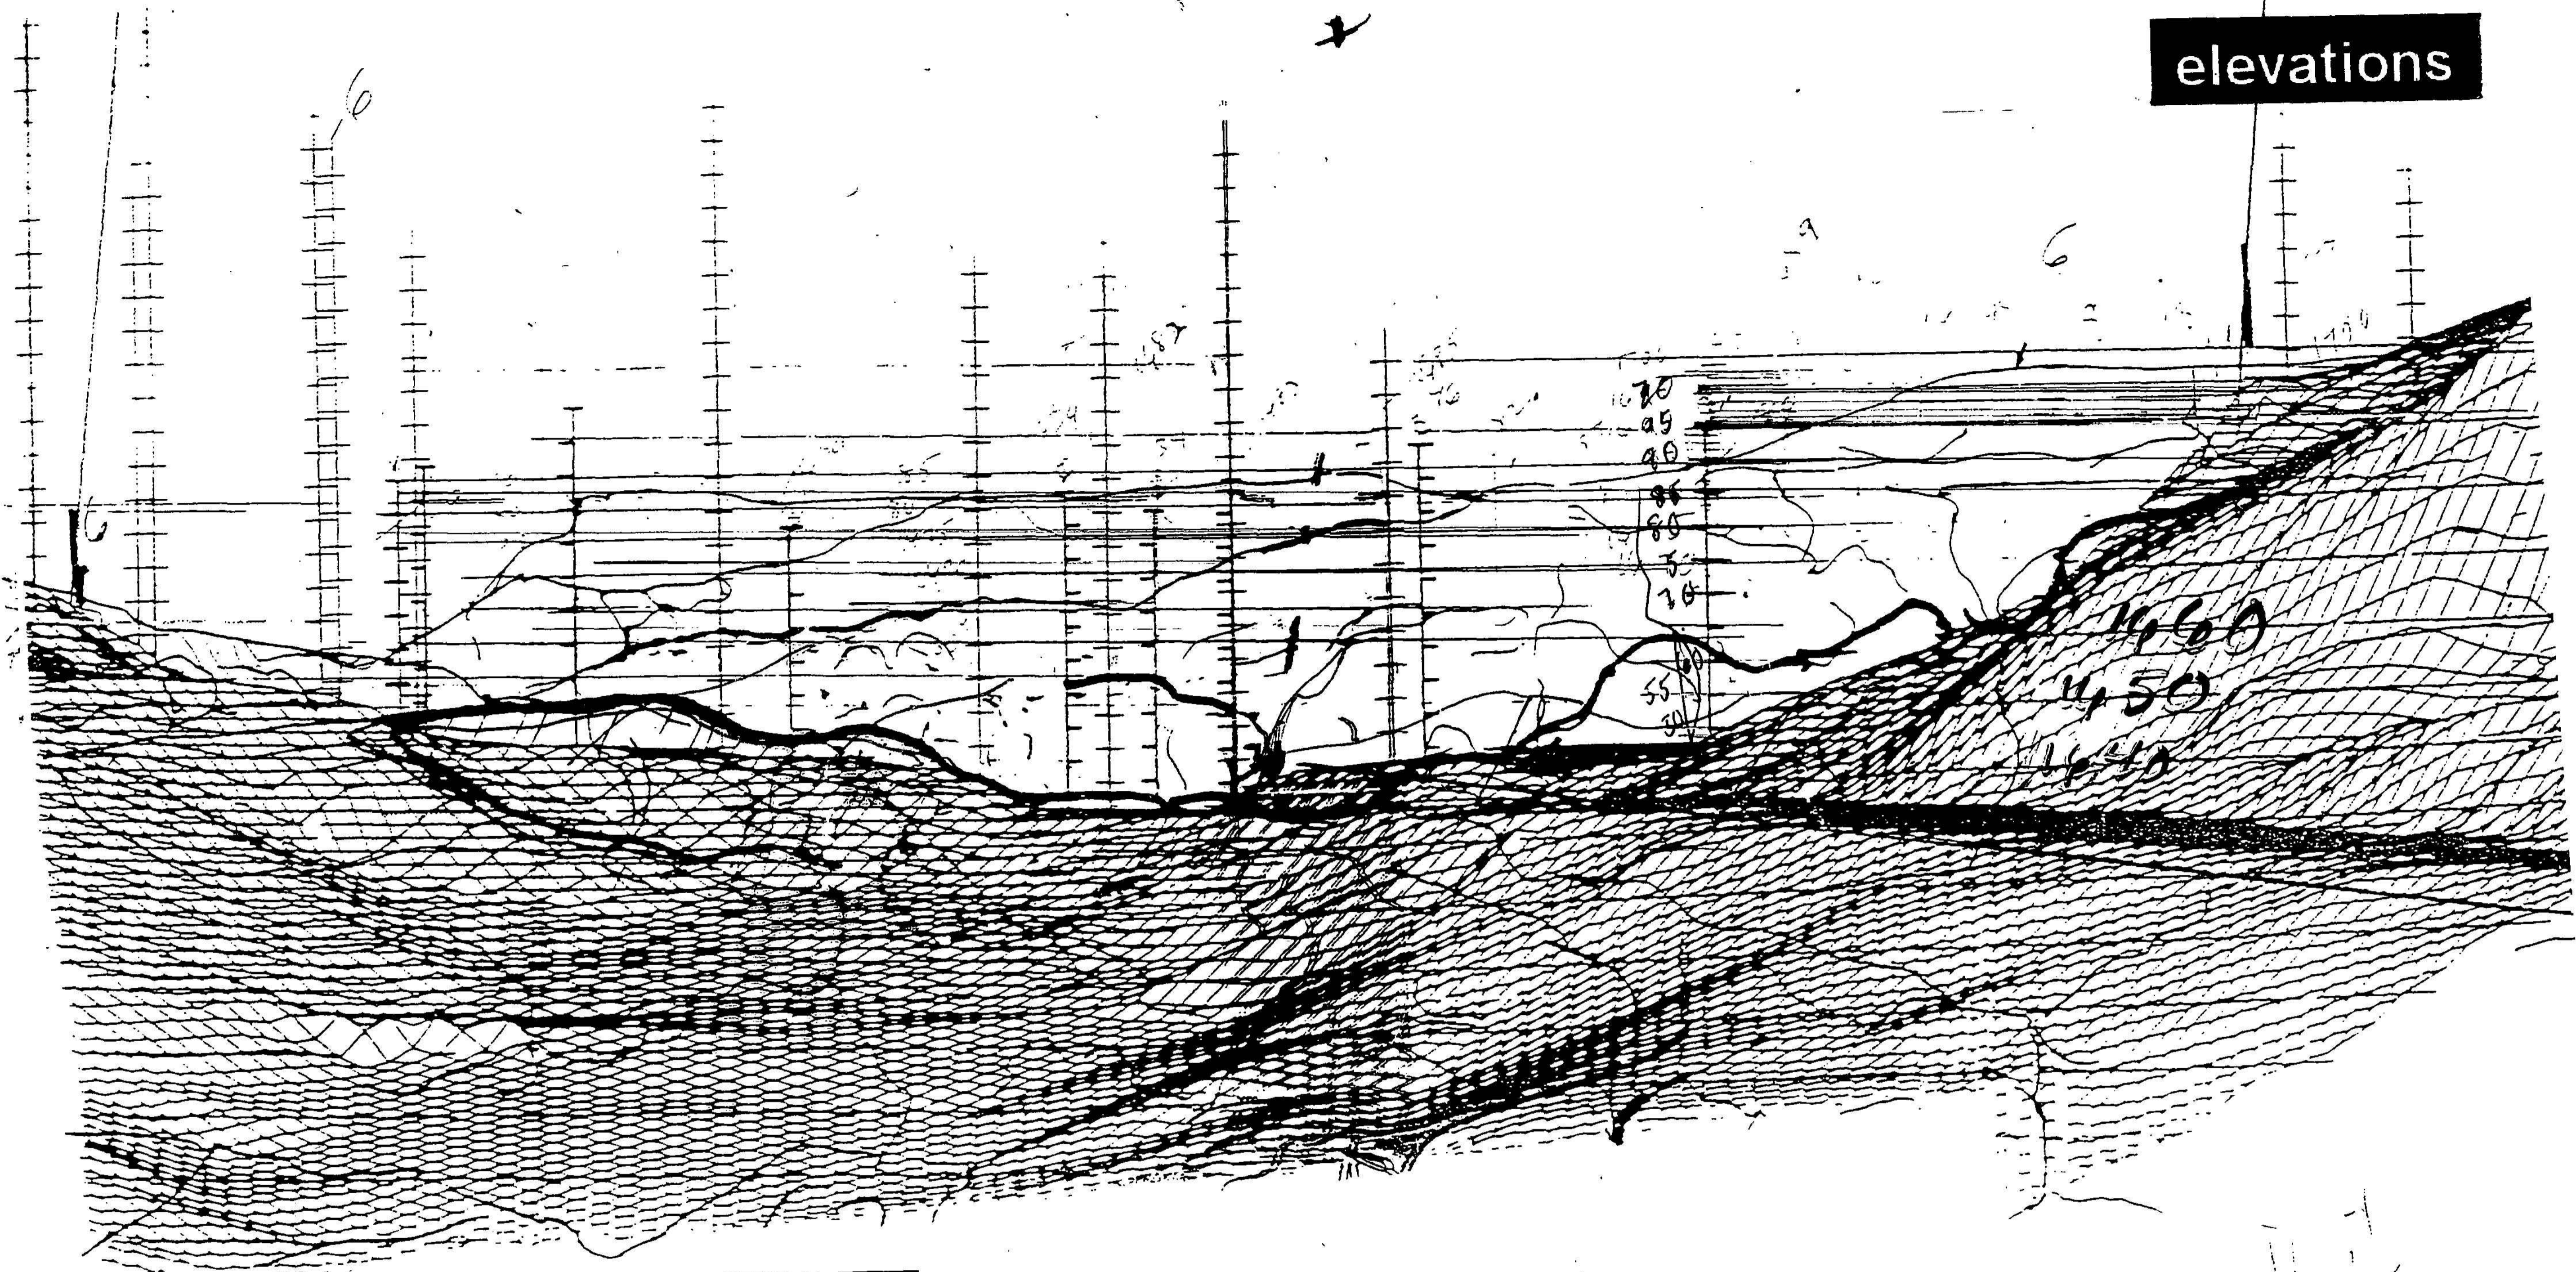
Historic elevations were determined by mechanically drawing intersecting points from a composite of the computer wireframe and major landforms delineated from the 1862 Civil War photograph.
