Restoration of Historic Features Cumberland Gap National Historical Park

Wilderness Road
1780-1810

Research methodology for the
"Rediscovery" of historically significant
resources: Procedures developed to
determine their original topography of the
historic saddle of Cumberland Gap and
identify the vertical and horizontal
alignment of the historic road.

Prepared by Harland D. Unrau, Cultural Resource Specialist,
Denver Service Center, Planning and Site Design; Planning

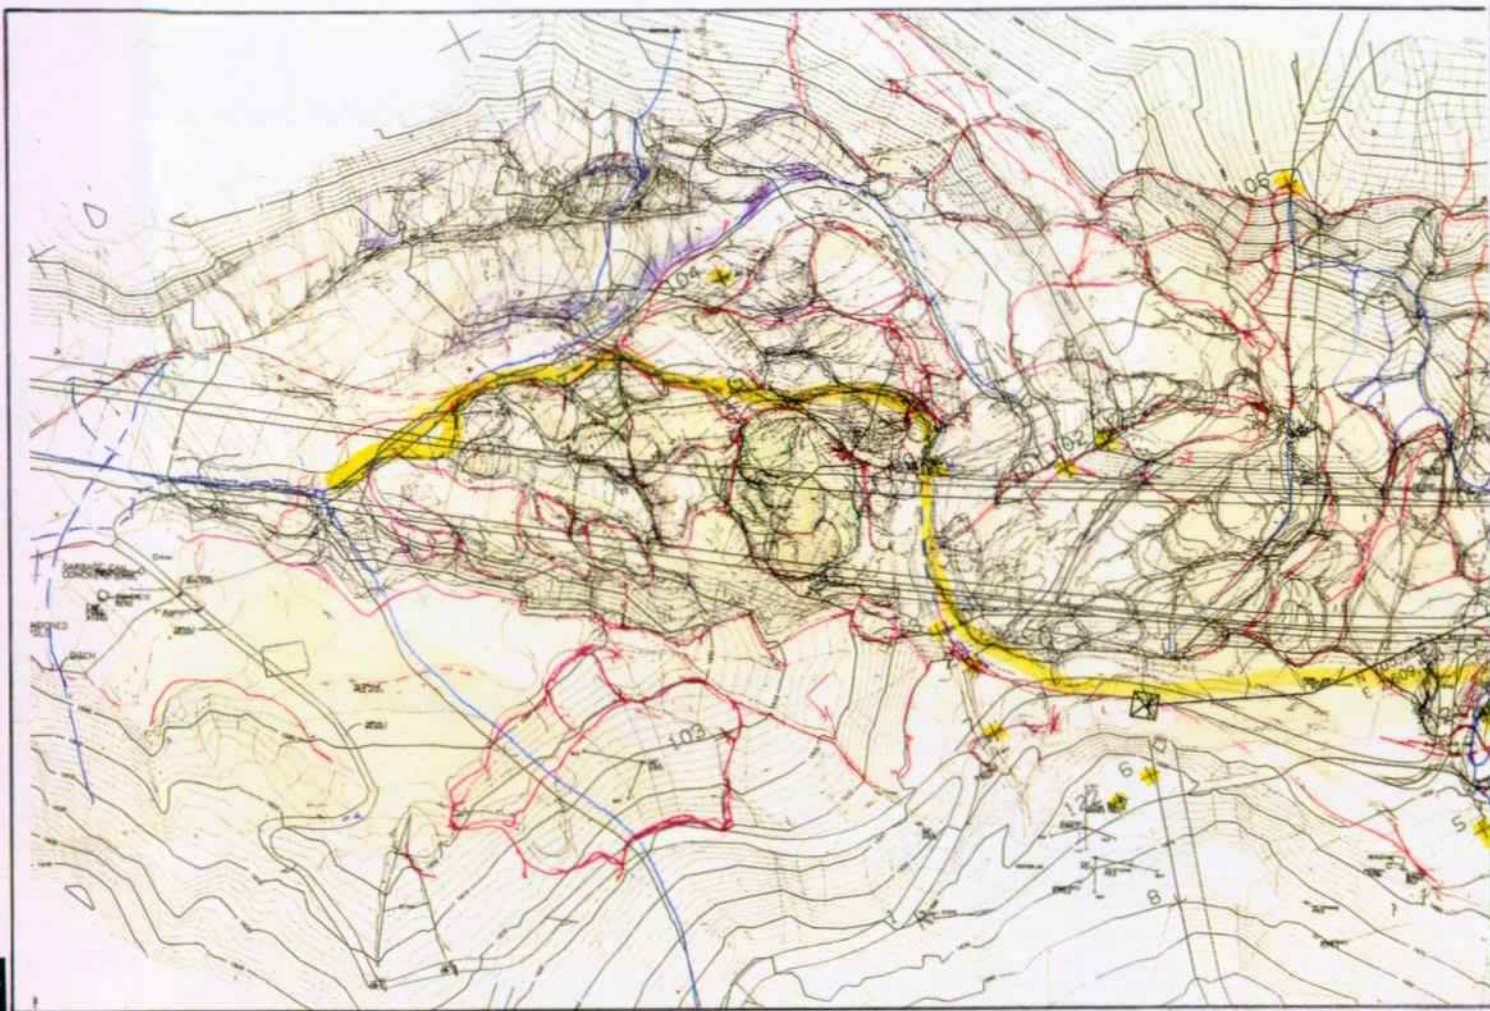
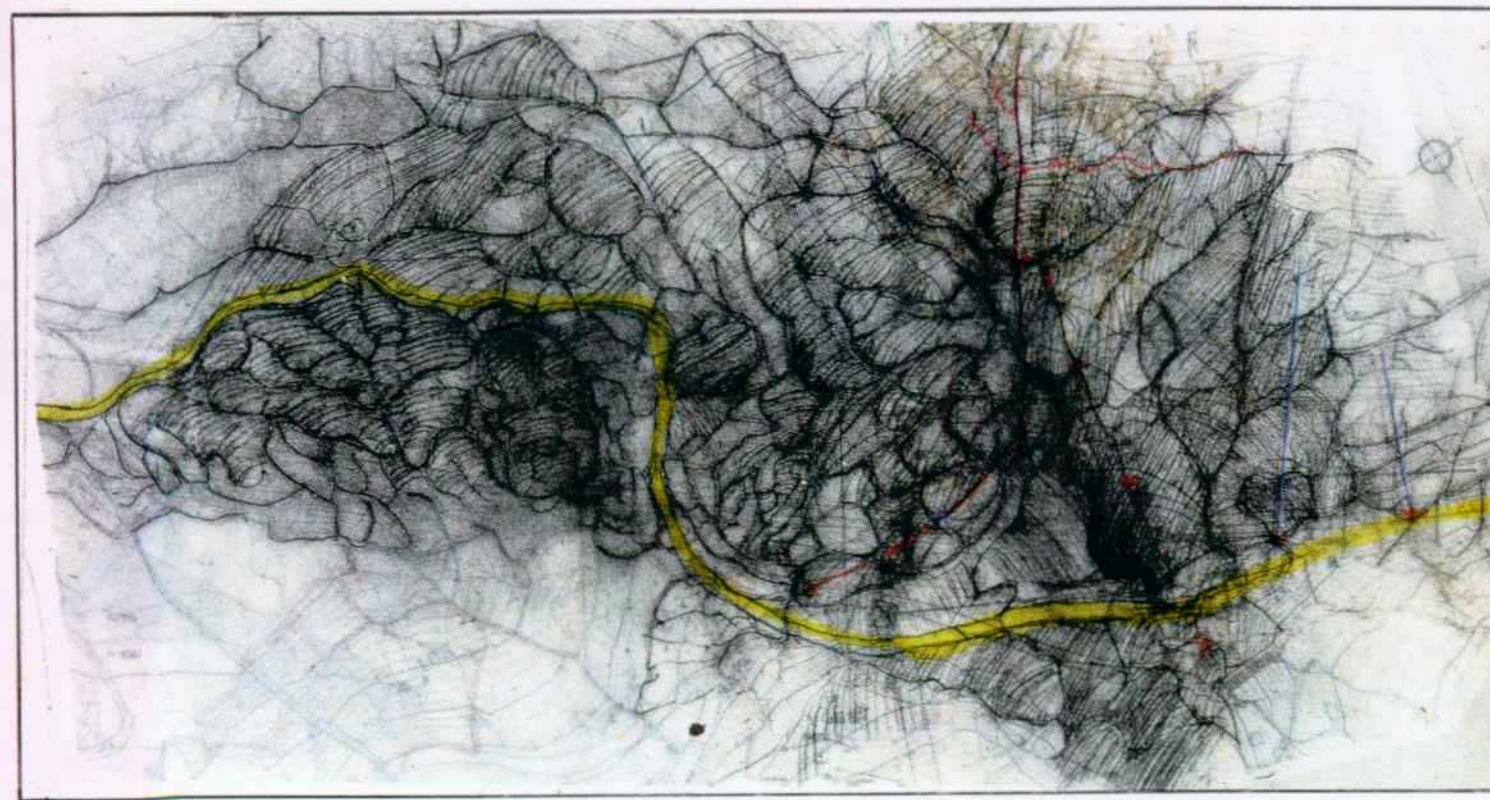
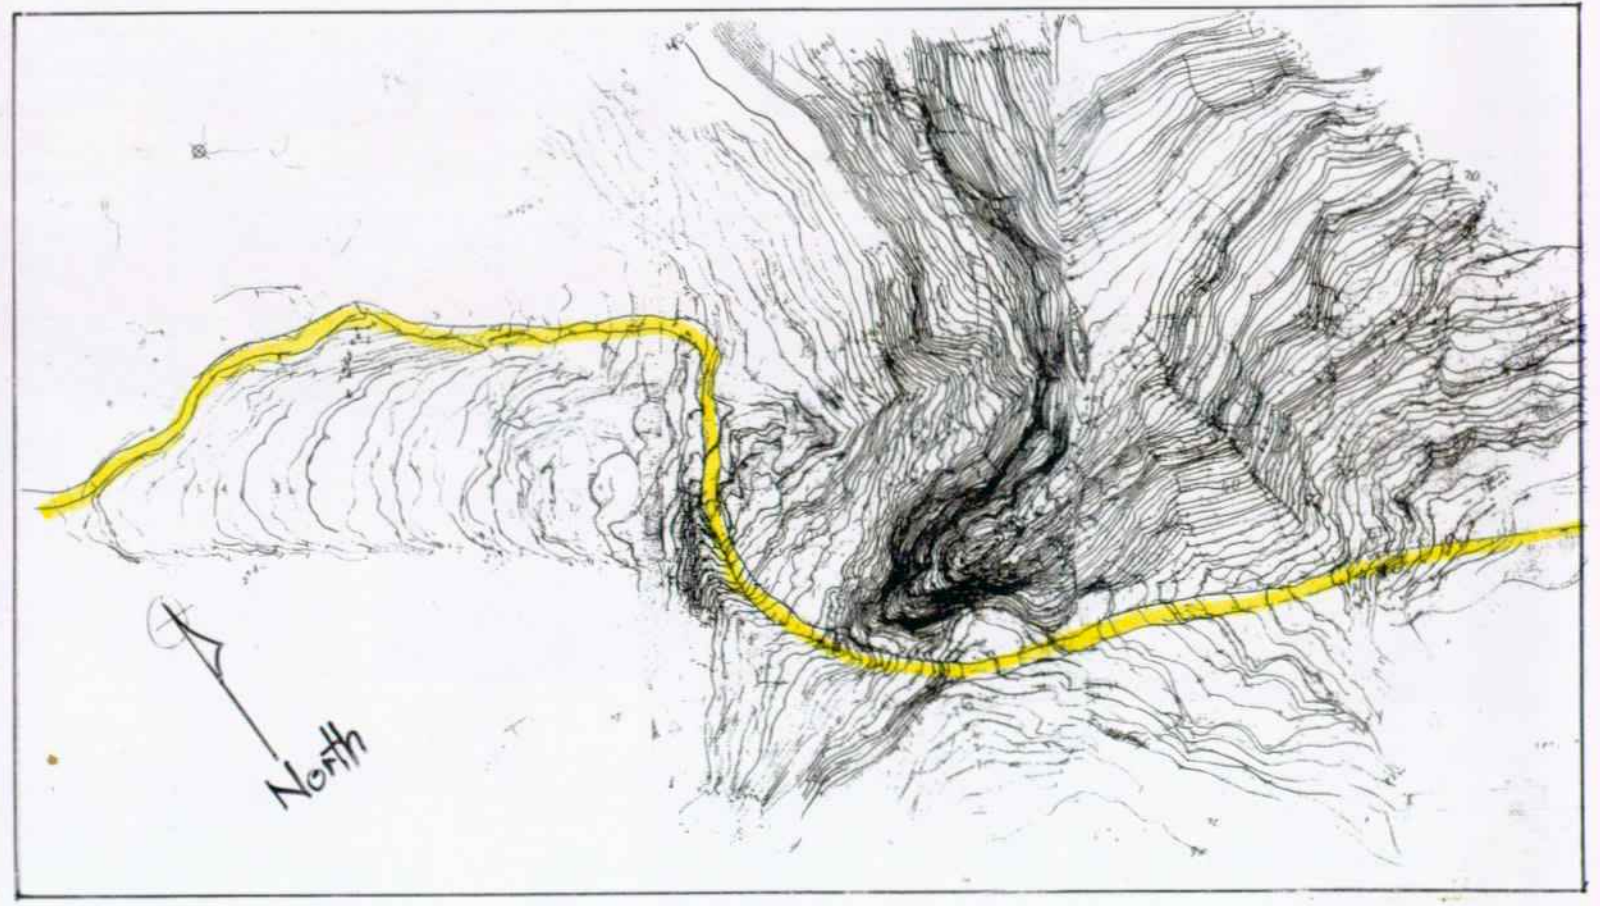
saddle plan view

All three plan view images on this sheet are oriented with Virginia/Tennessee to the right side, Kentucky to the left, and north at the top. The shapes in the left hand images evolved into the contour map on the right hand side. Determining what topography was missing resulted from intense cross checking and melding of all the different sources of information - historic and recent surveys, photographs, and maps; field discovery; graphic enhancement and delineation in the studio. This sheet shows three stages of refinement overlaying modern surveys, which were eventually put into a format that could be computerized. Once the information was in the computer, the three-dimensional wireframe output was then cross checked against the historic photographs for accuracy. The final result was a grading plan in 1790 contours which were added into Federal Highway Administration contract drawings.

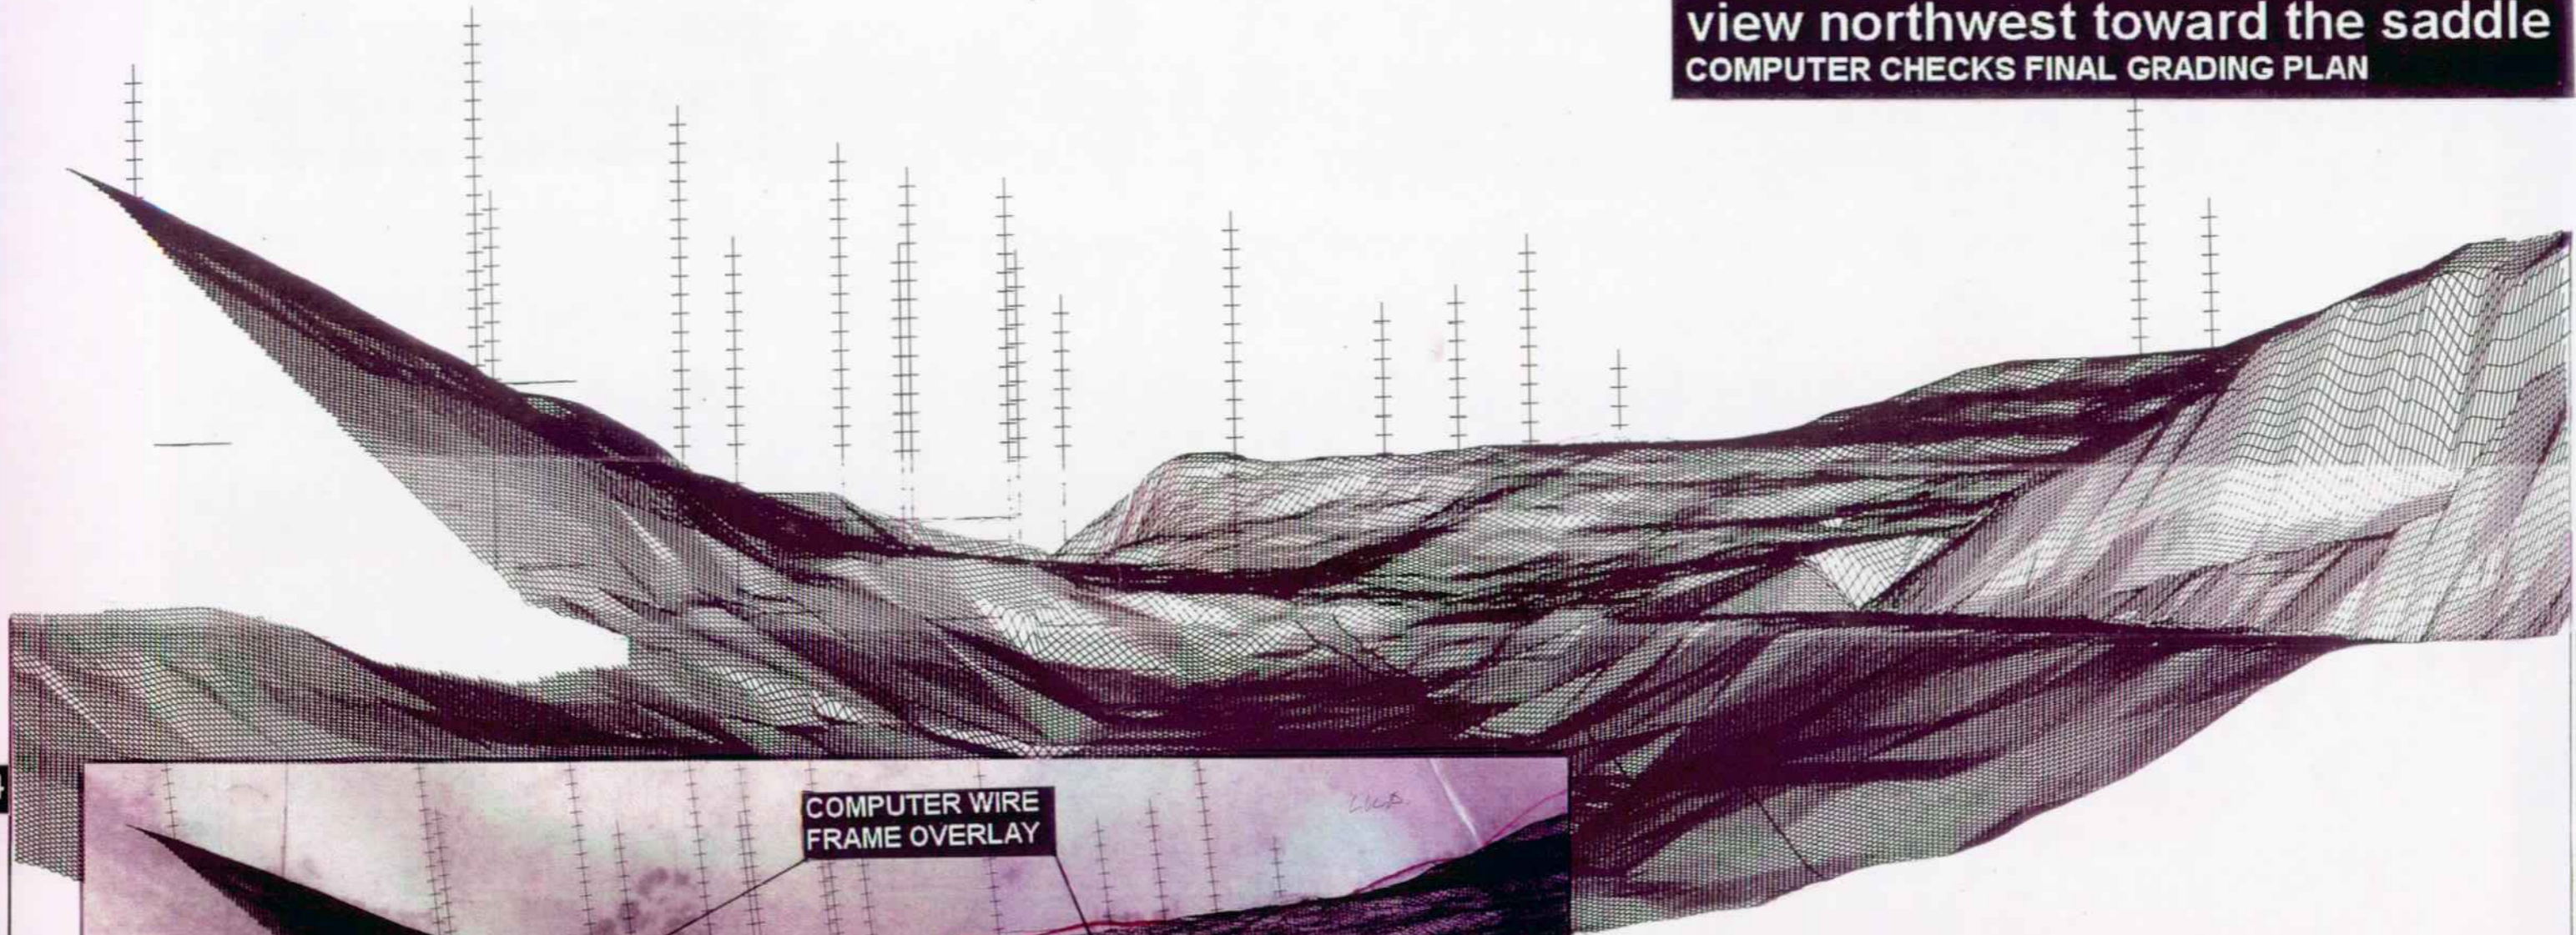
view northwest toward the saddle
COMPUTER CHECKS FINAL GRADING PLAN

This final step of refinement shows how accurate the (graphic) rehabilitation of the Gap is. The grading plan from the previous sheet has been transformed into a computerized wireframe image. The image is shown from the same viewpoint as the 1862 Civil War photograph, from Tennessee, looking northwest to the Gap and toward Kentucky. This view nearly matches the red horizon line taken from the 1862 photograph. Considering the age and quality of the source materials, tempered by 200 years of erosion and man-caused landscape modifications, this slight deviation, caused by the computer's skewed viewpoint, is as accurate as anyone will ever achieve.

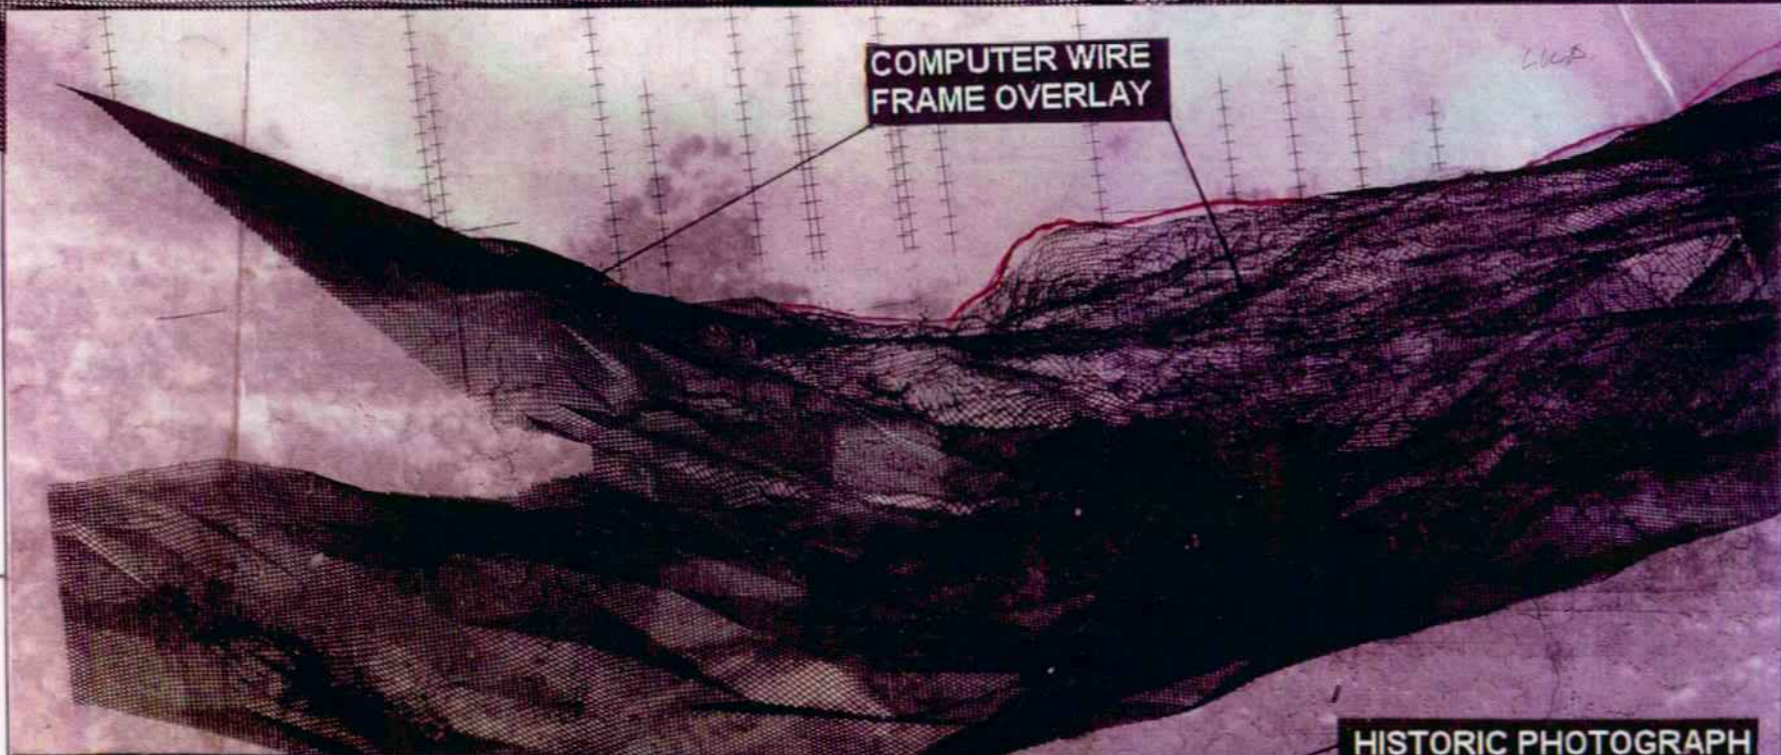
**COMPUTER WIRE
FRAME OVERLAY**

This historic photograph is also important because it shows the original topography as the trees have been clear cut. This photograph was taken before the Industrial Revolution and mans machinery had a chance to alter the land from its original shape.

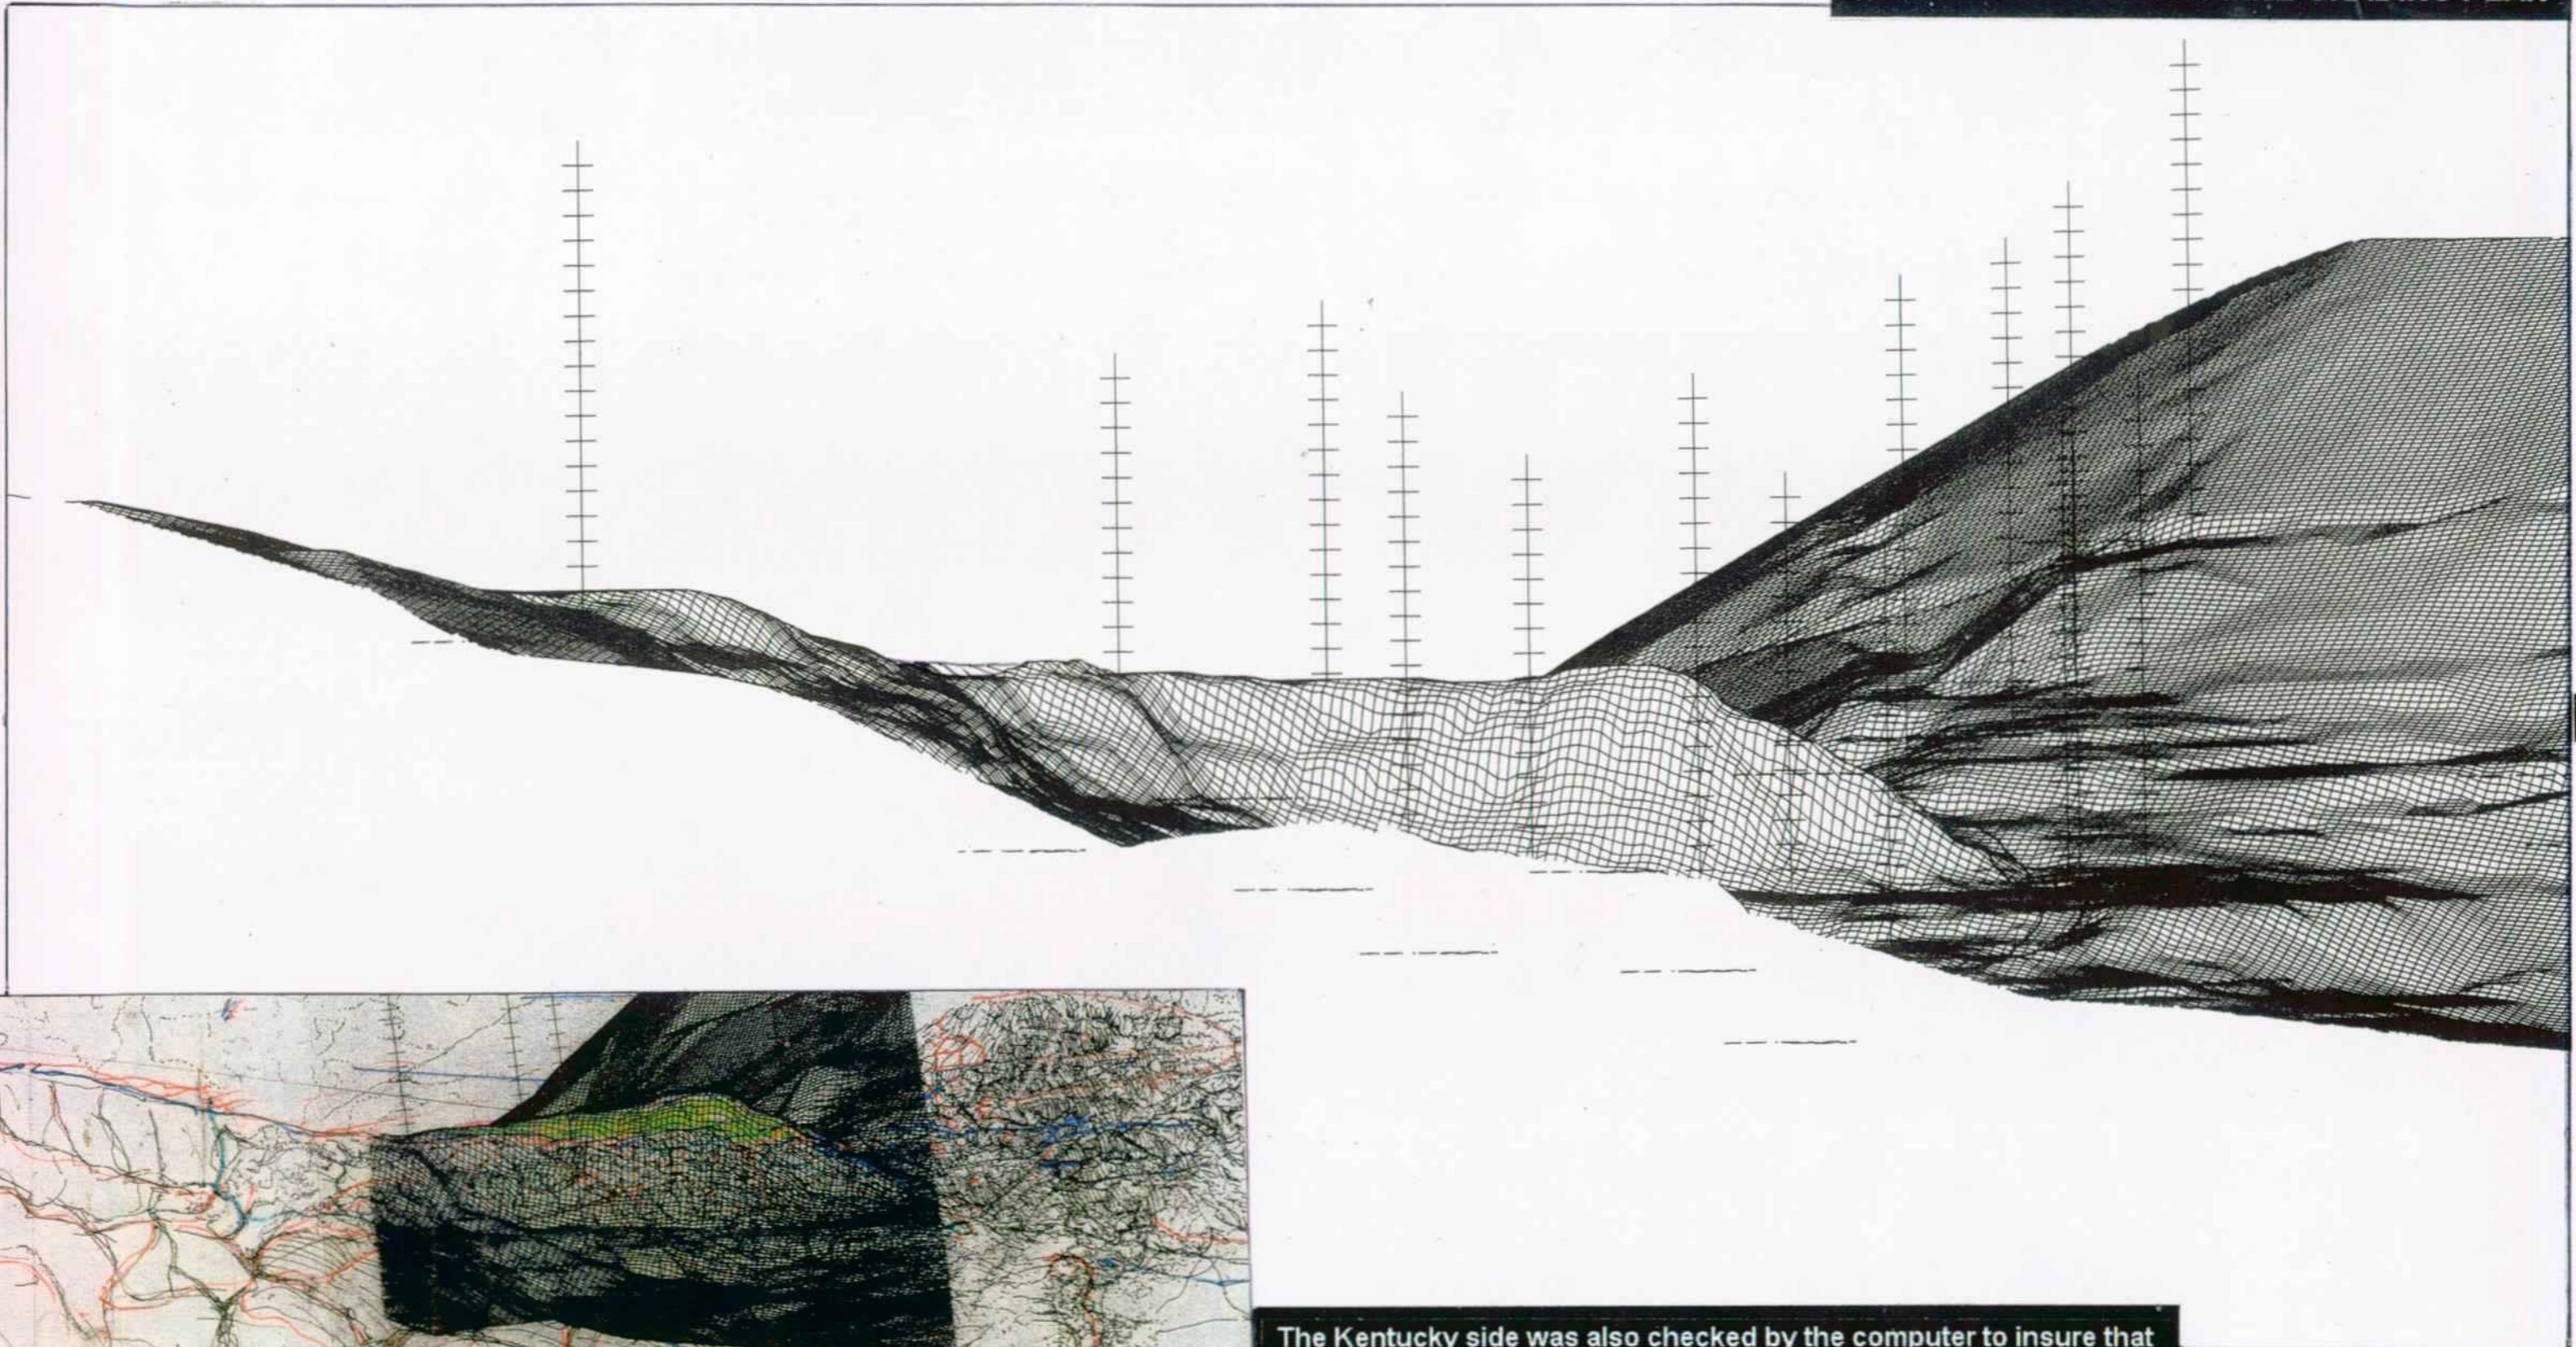
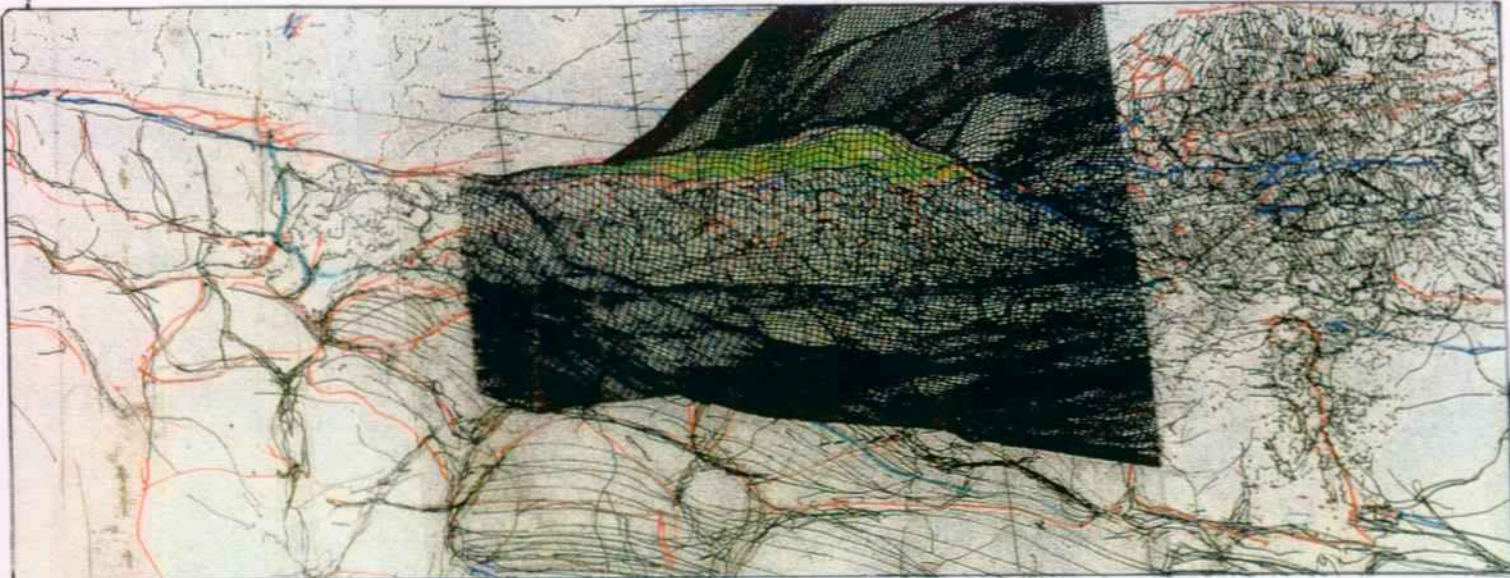
view south to the saddle
COMPUTER CHECKS FINAL GRADING PLAN

The Kentucky side was also checked by the computer to insure that the grading plan was not only historically correct from the Virginia/Tennessee side of the Gap but that it also matched the Kentucky side of the mountain.

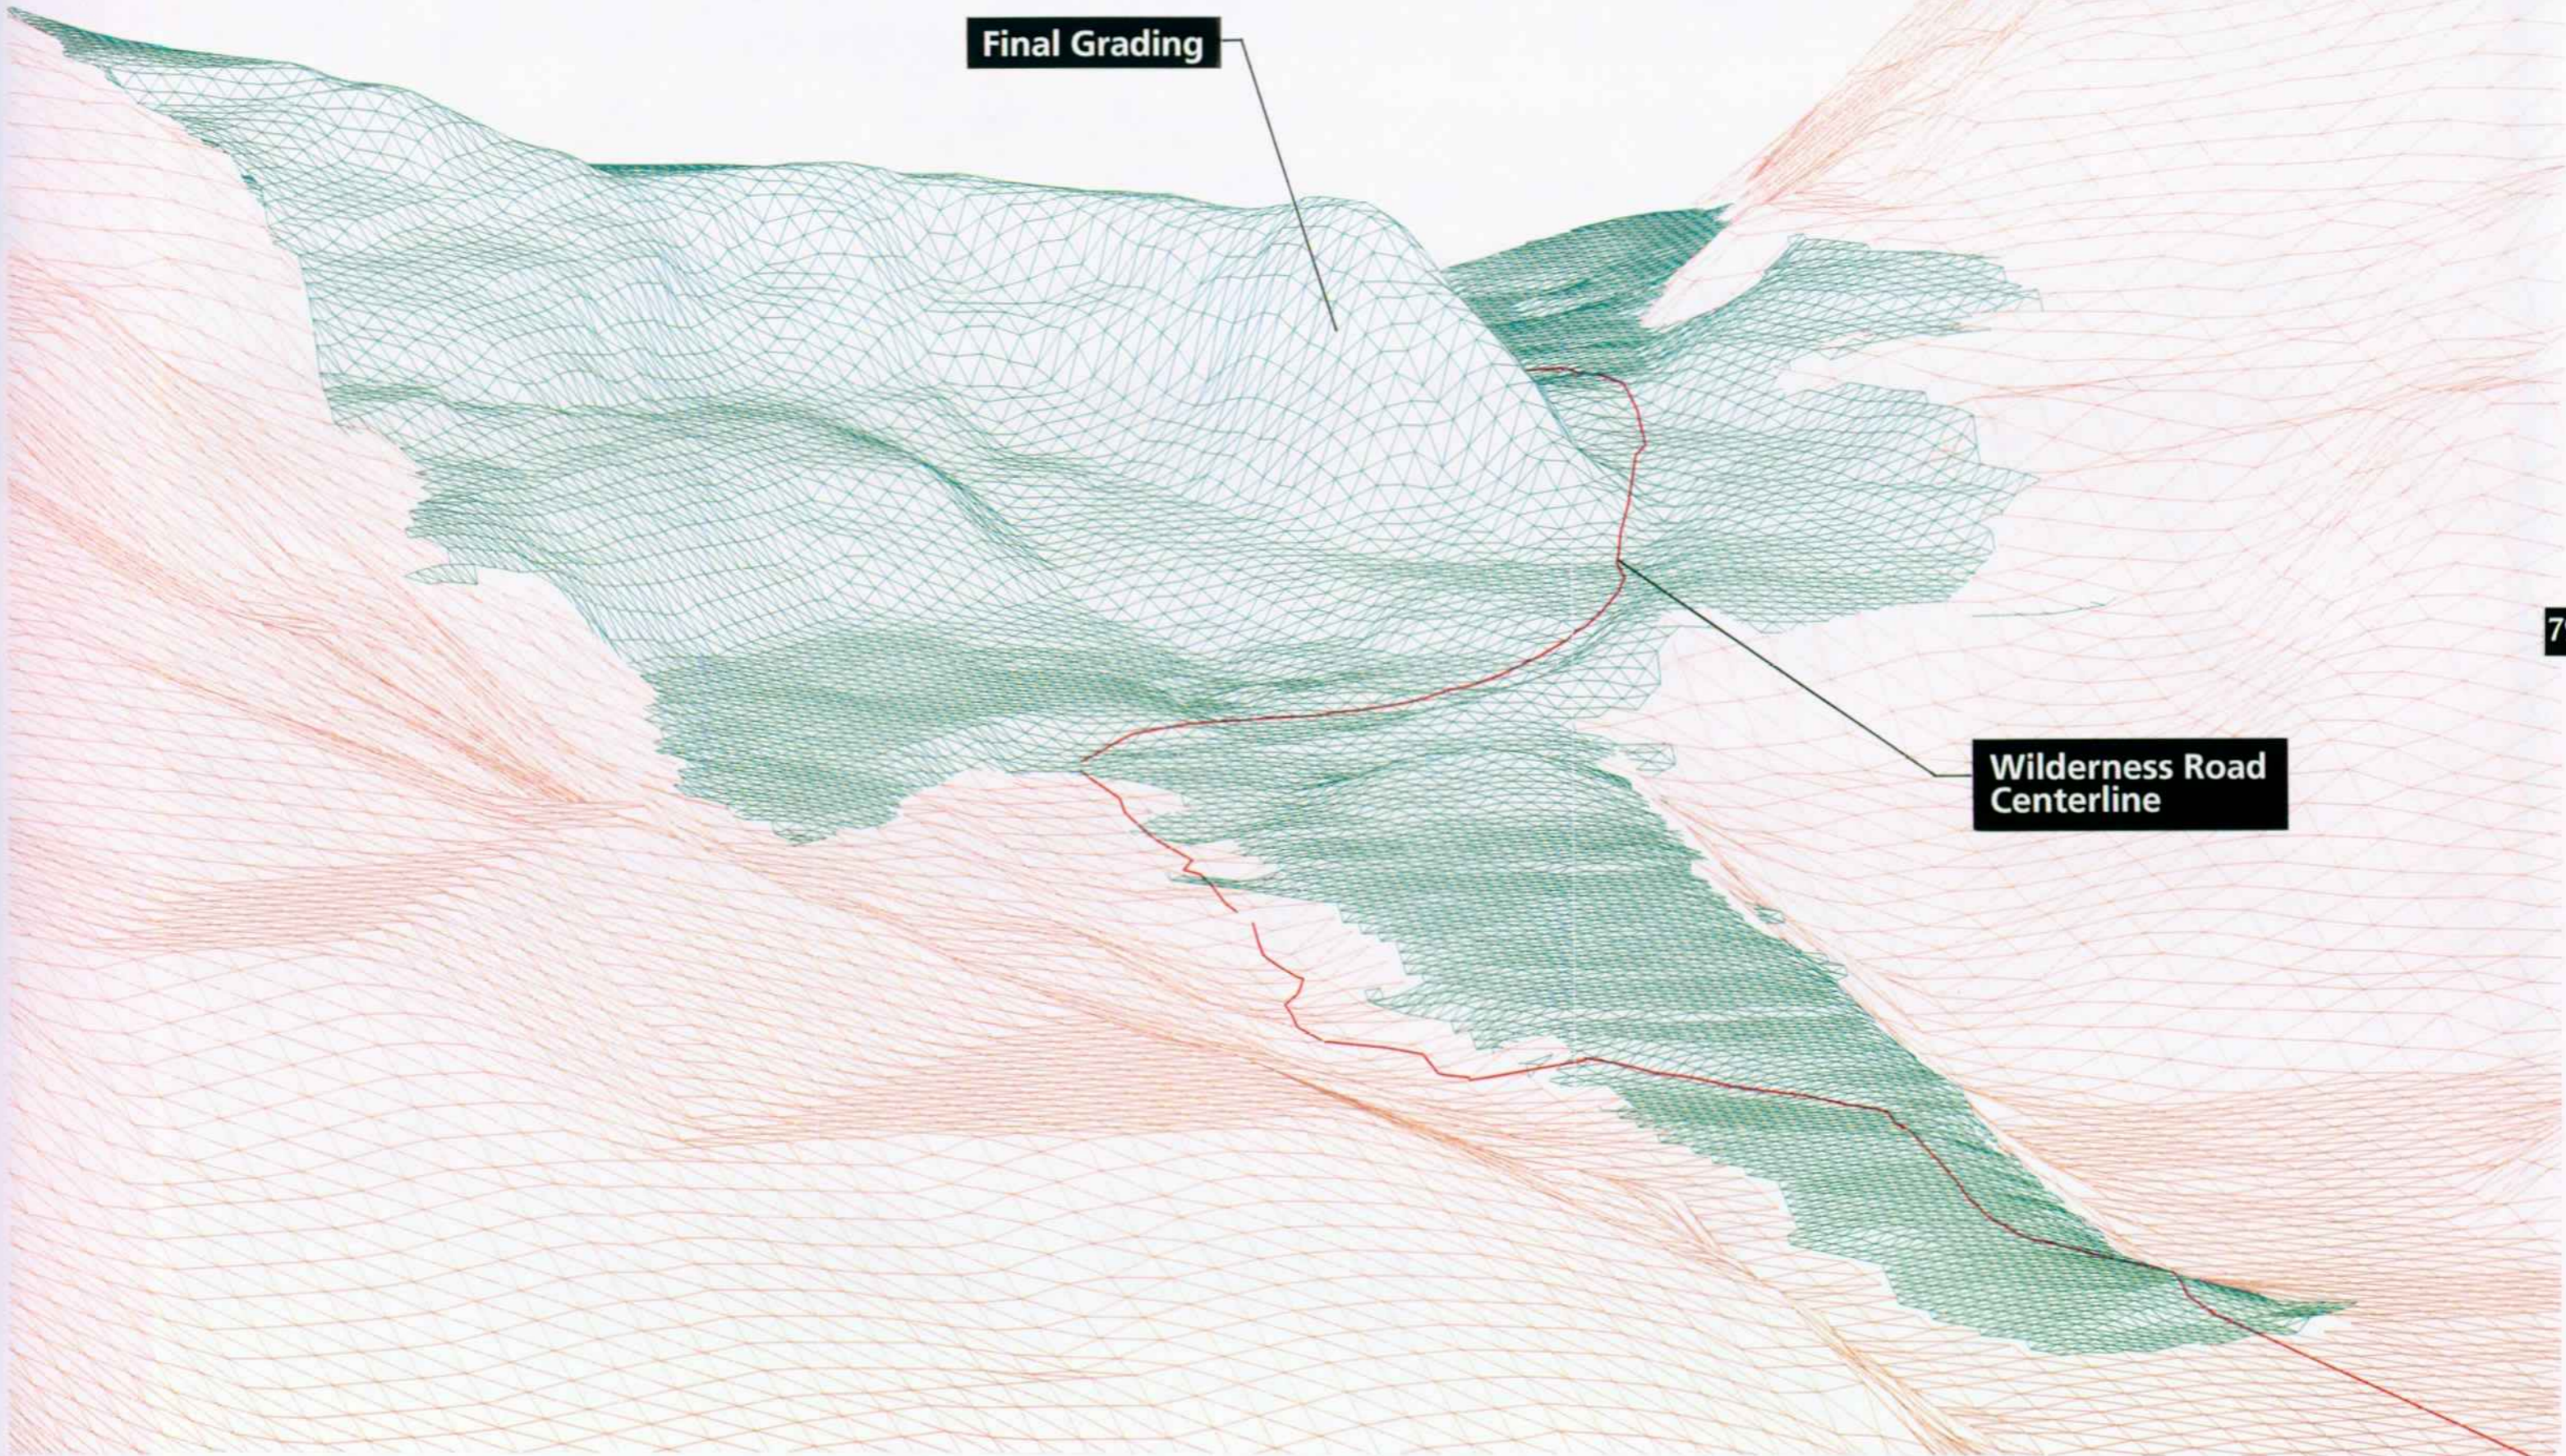
view northeast at the saddle
Final Grading Plan

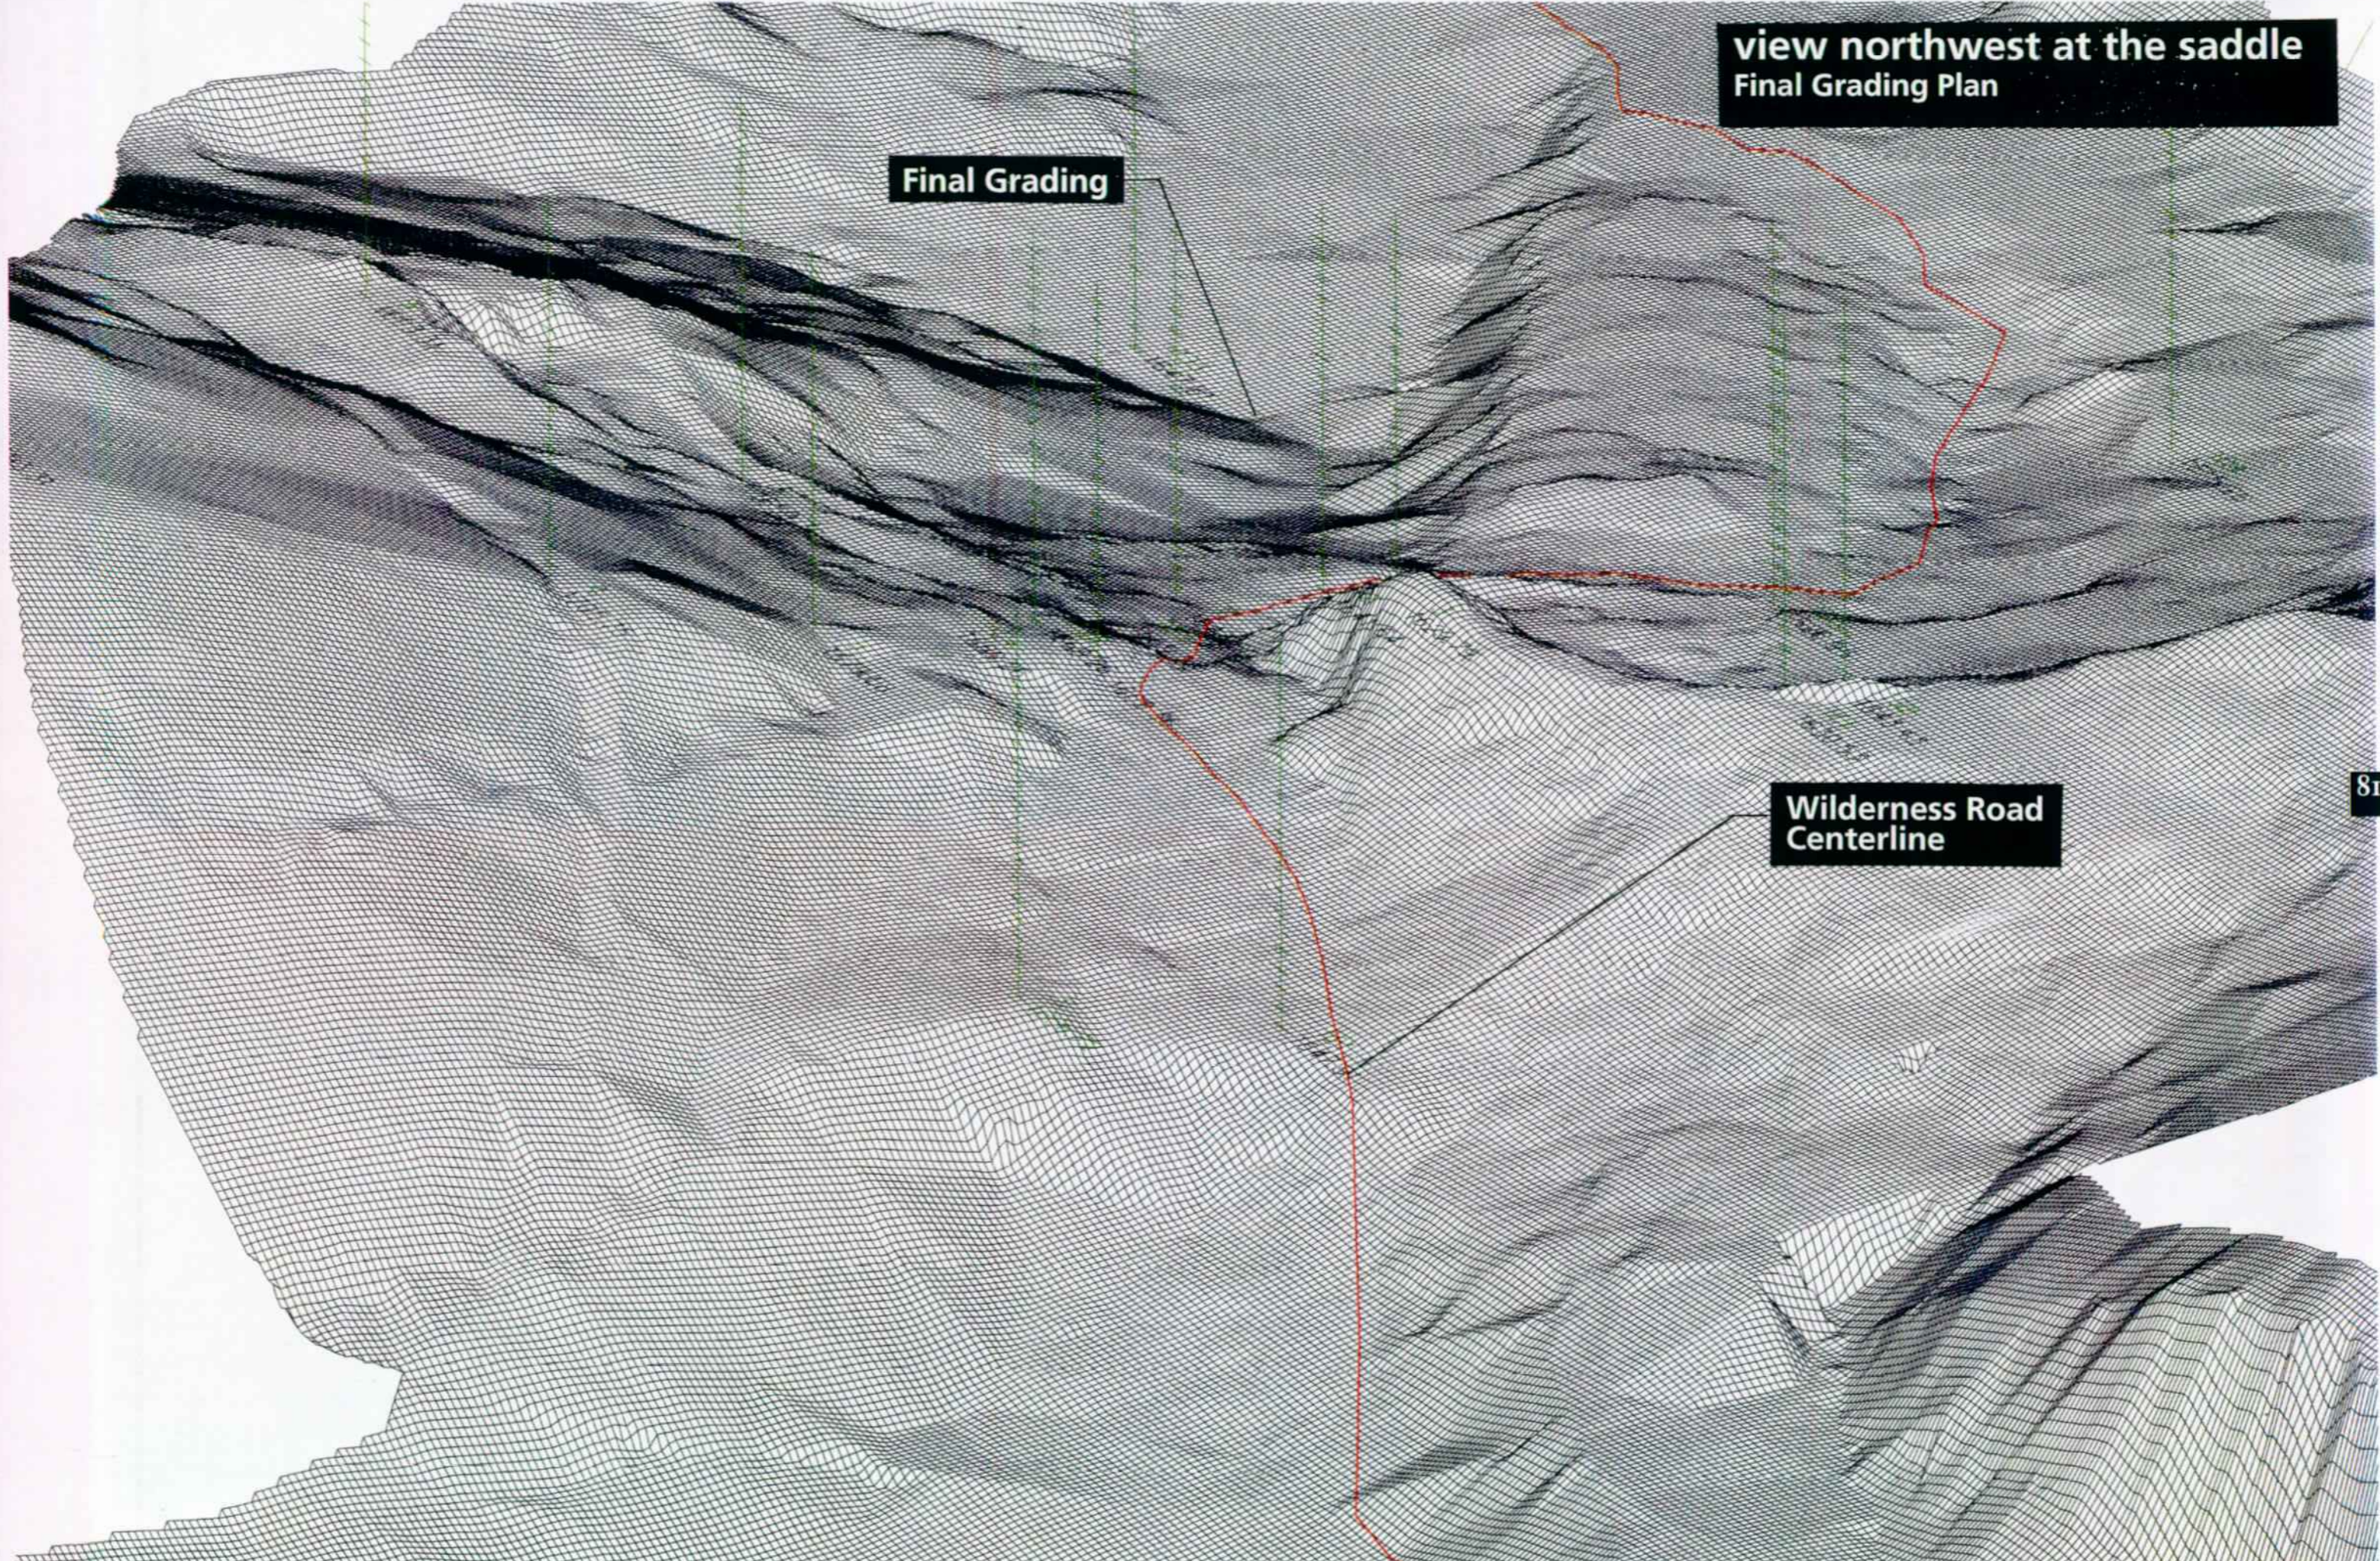
view northwest at the saddle
Final Grading Plan

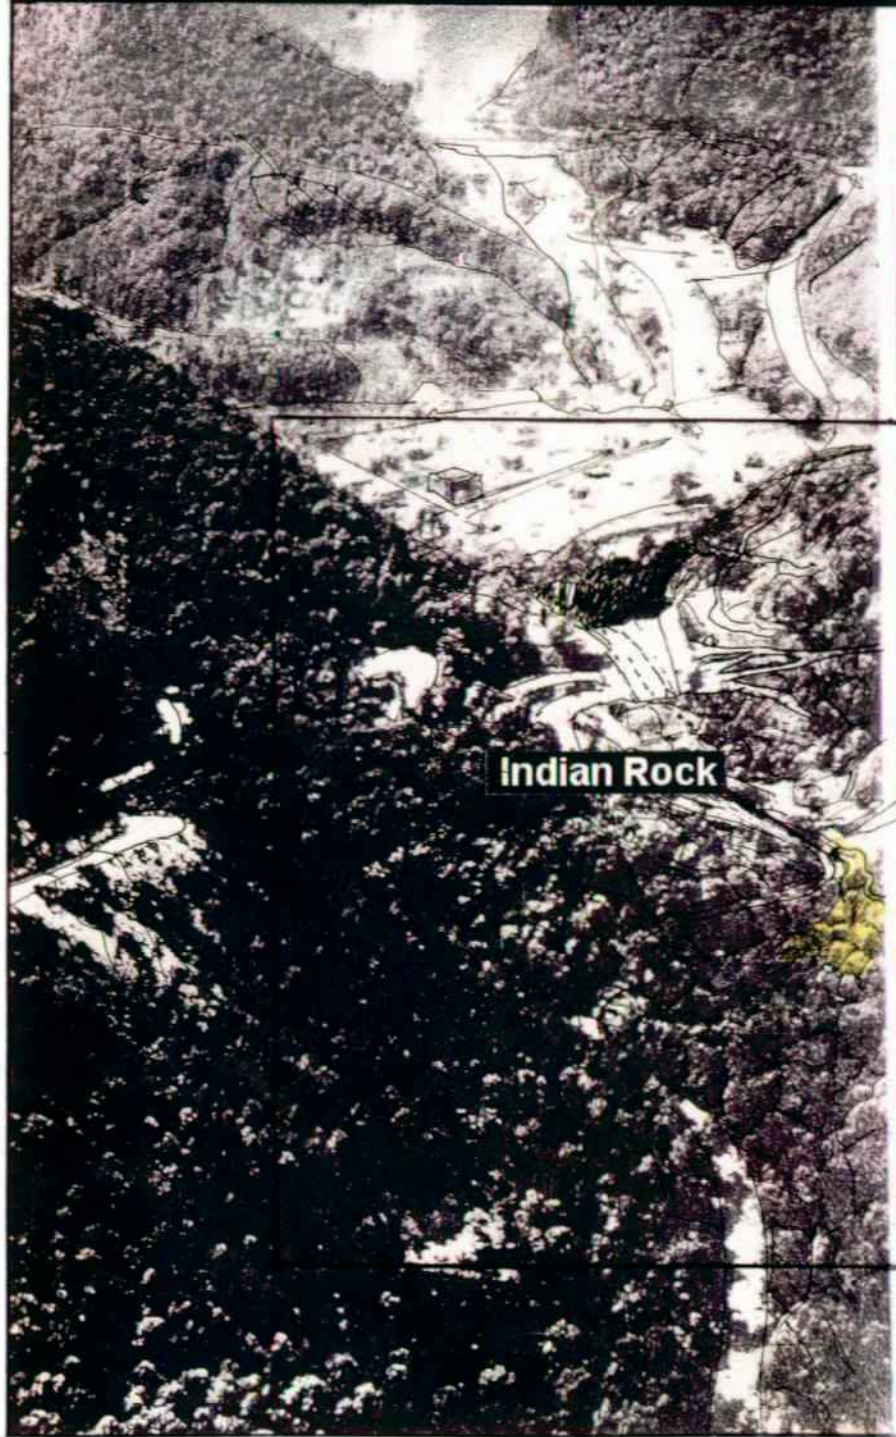
Photograph of the ridge before the earth was removed to construct what is now old US. 25 E.
