Restoration of Historic Features Cumberland Gap National Historical Park

Wilderness Road
1780-1810

Research methodology for the
"Rediscovery" of historically significant
resources: Procedures developed to
determine their original topography of the
historic saddle of Cumberland Gap and
identify the vertical and horizontal
alignment of the historic road.

Prepared by Harland D. Unrau, Cultural Resource Specialist,
Denver Service Center, Planning and Site Design; Planning

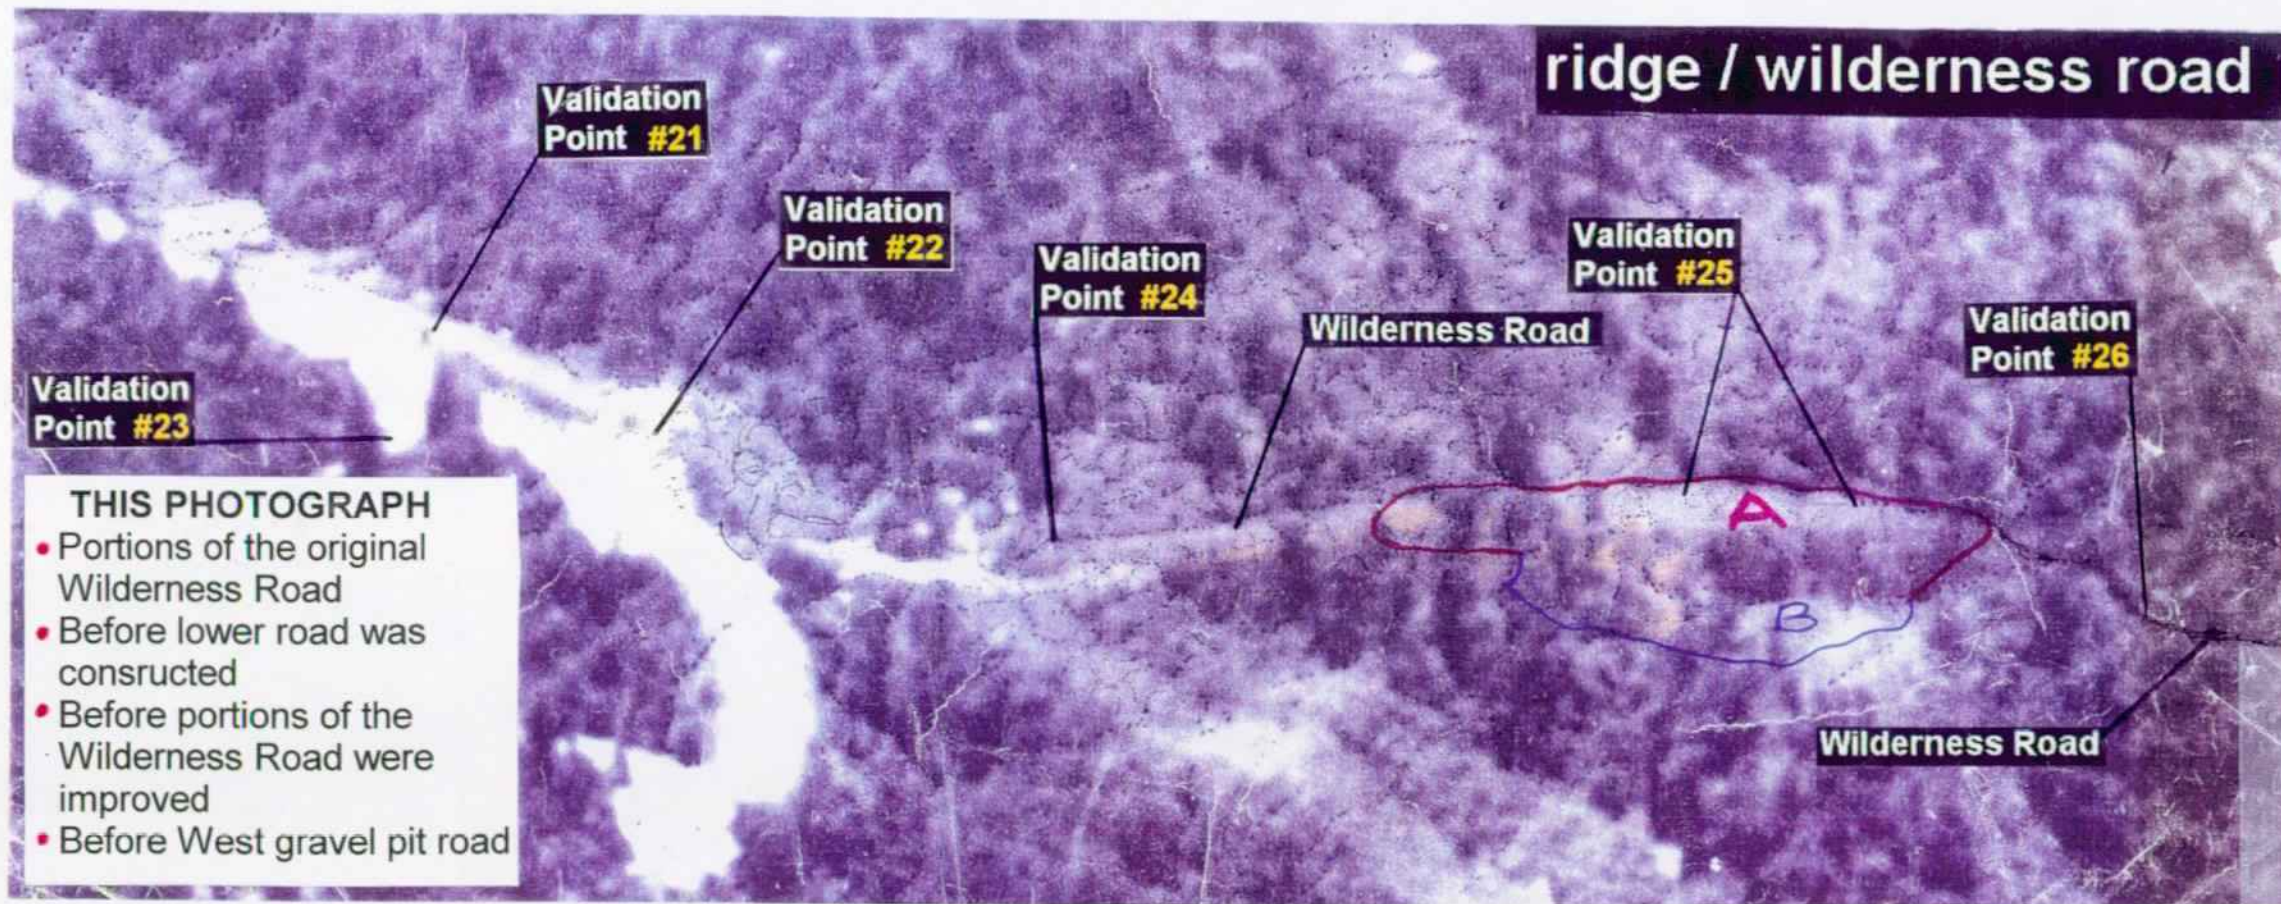
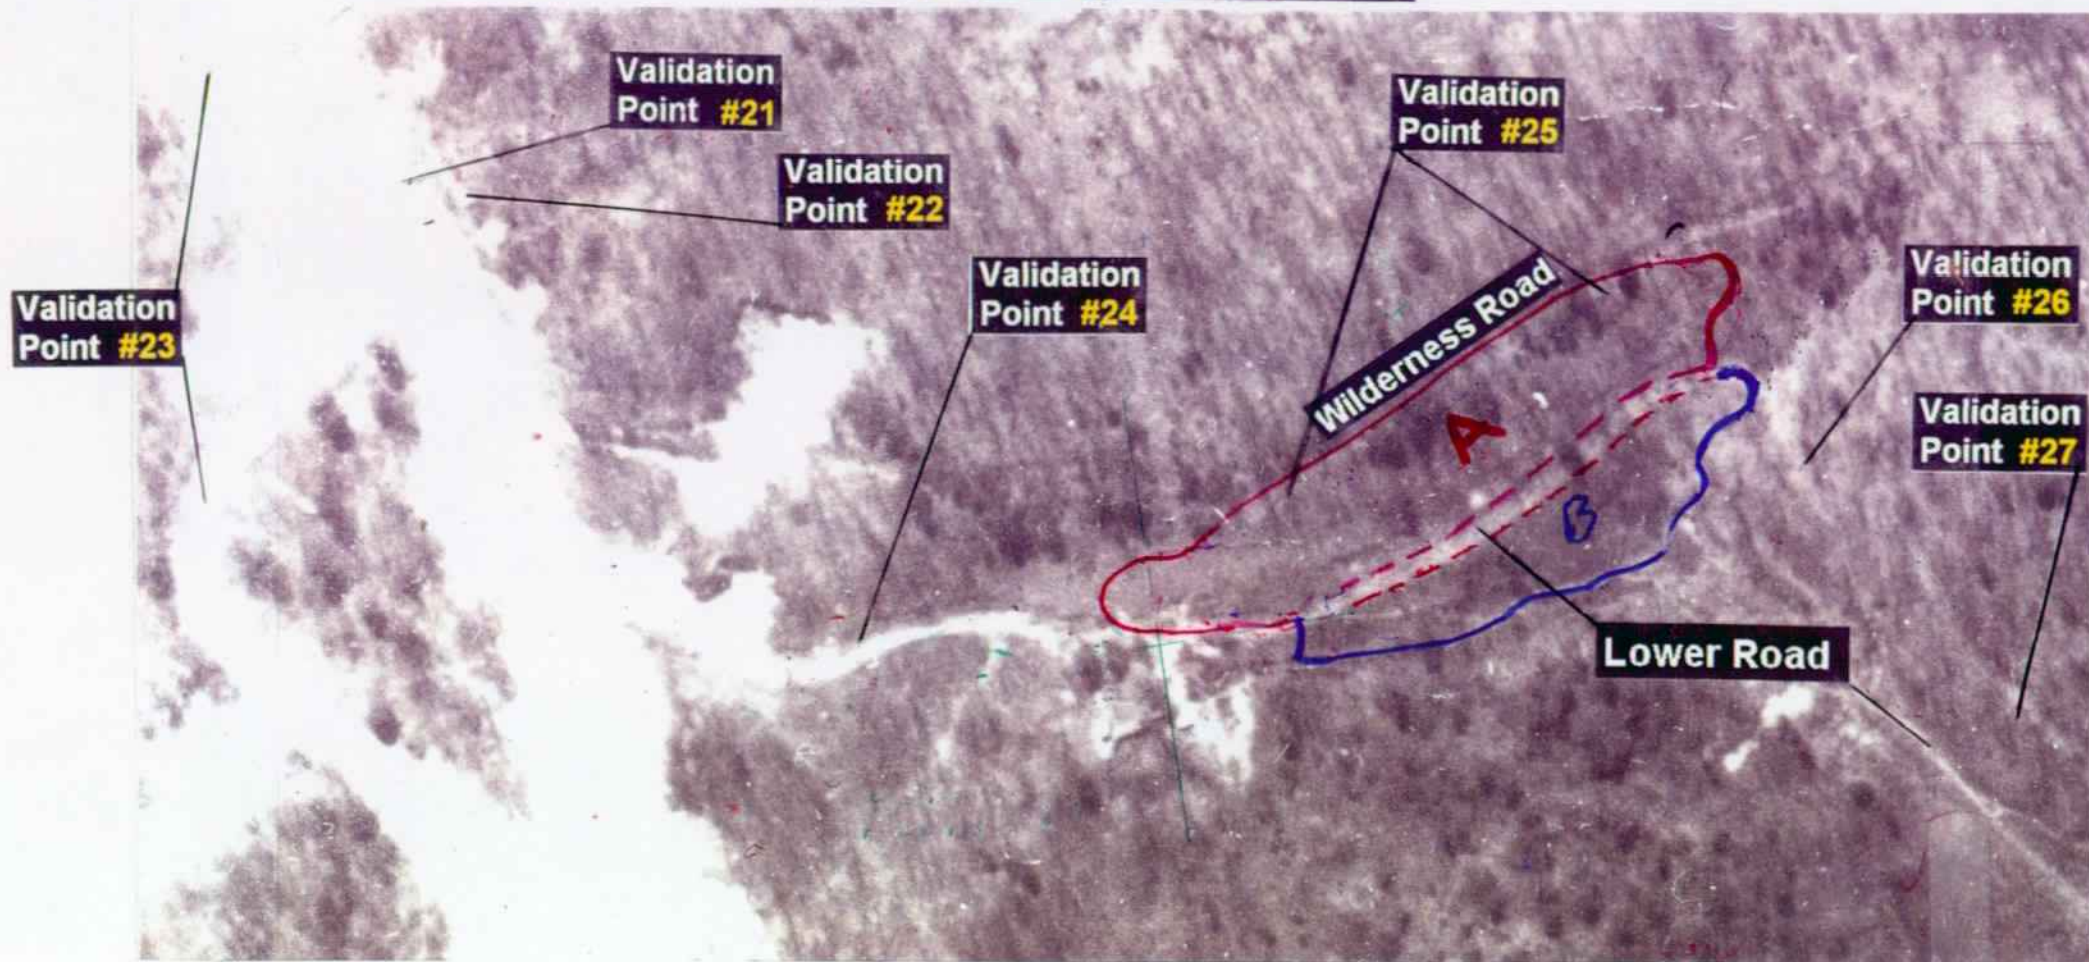
Validation Point #23

THIS PHOTOGRAPH

- Portions of the original Wilderness Road
- Before lower road was constructed
- Before portions of the Wilderness Road were improved
- Before West gravel pit road

Compare Corresponding Areas Of Topography (A and B)

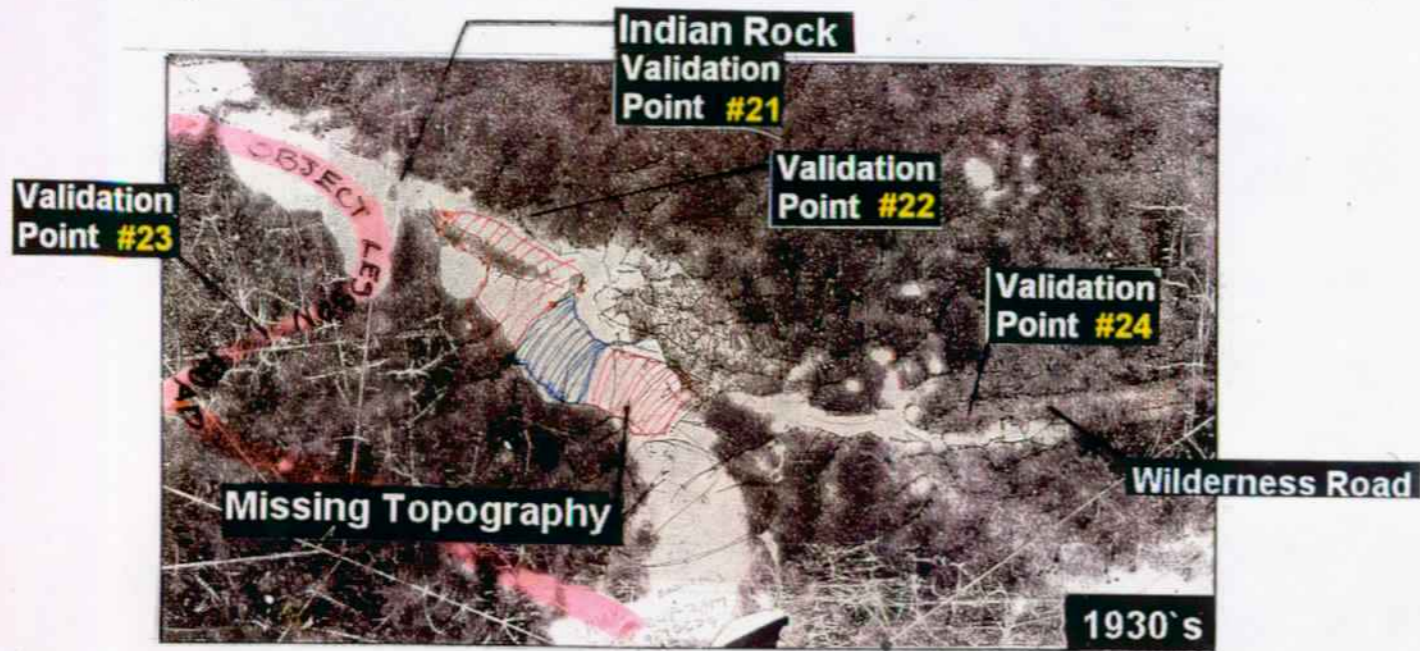
ridge / wilderness road

Lower road access was not possible for wagons without the removal of a large amount of earth, which permitted entry to the lower drainage. Even more restrictive was the steepness of the descent from the lower road. Railroad construction probably cut off the slow natural descent around 1880. By this time, more modern road building methods had been developed, and the lower road was built. Another basic reason is that no historic mapping matching any ground evidence has been found. The alignment, without more modern construction to compensate for the steepness, would have resulted in many curves in the configuration.

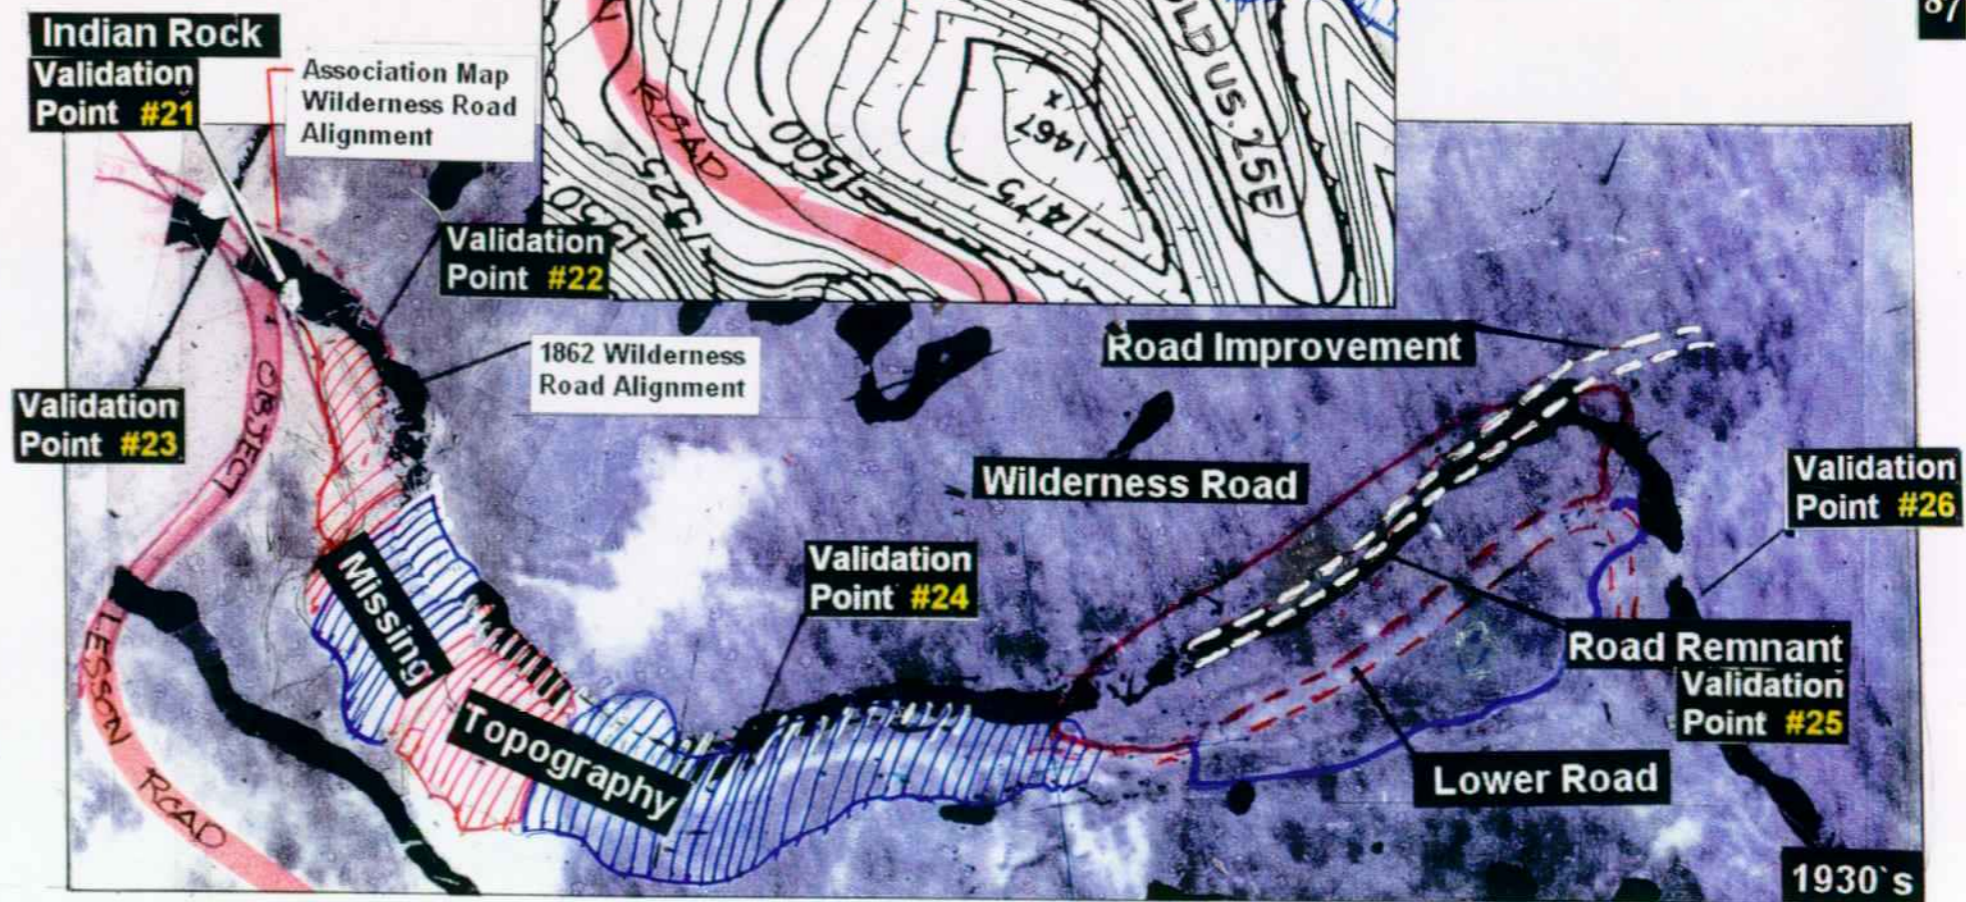
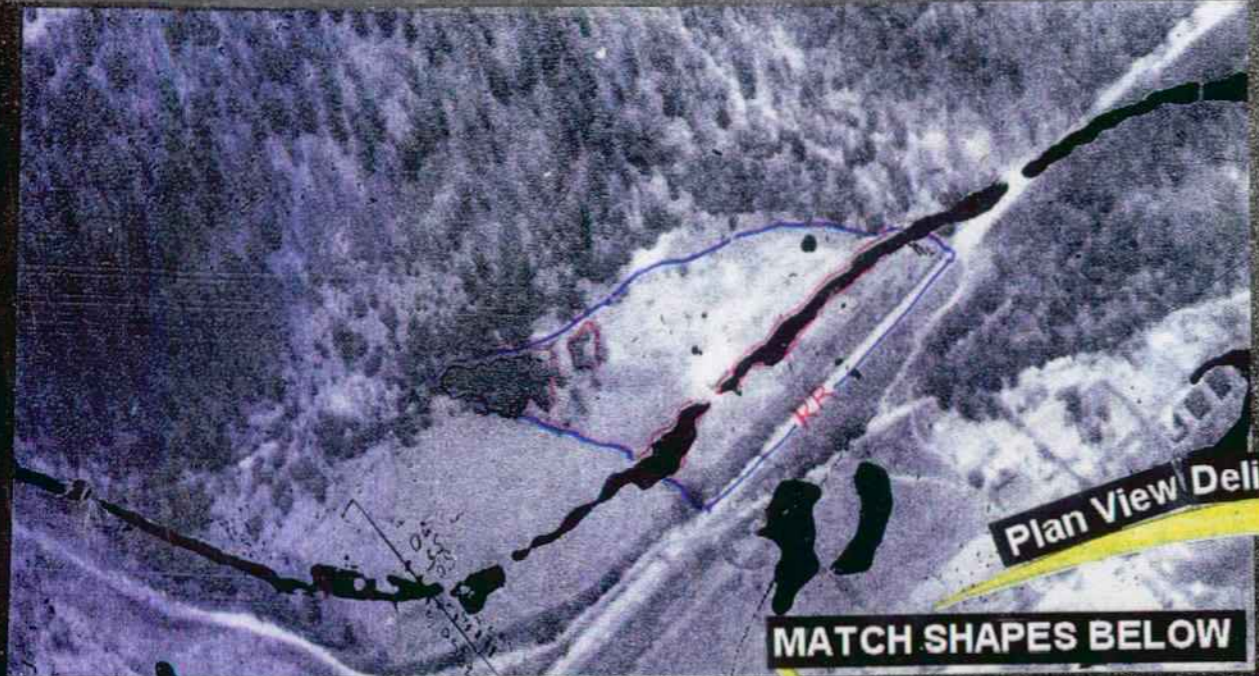
wilderness road's descent into kentucky

MATCH SHAPES BELOW

Plan View Delineation

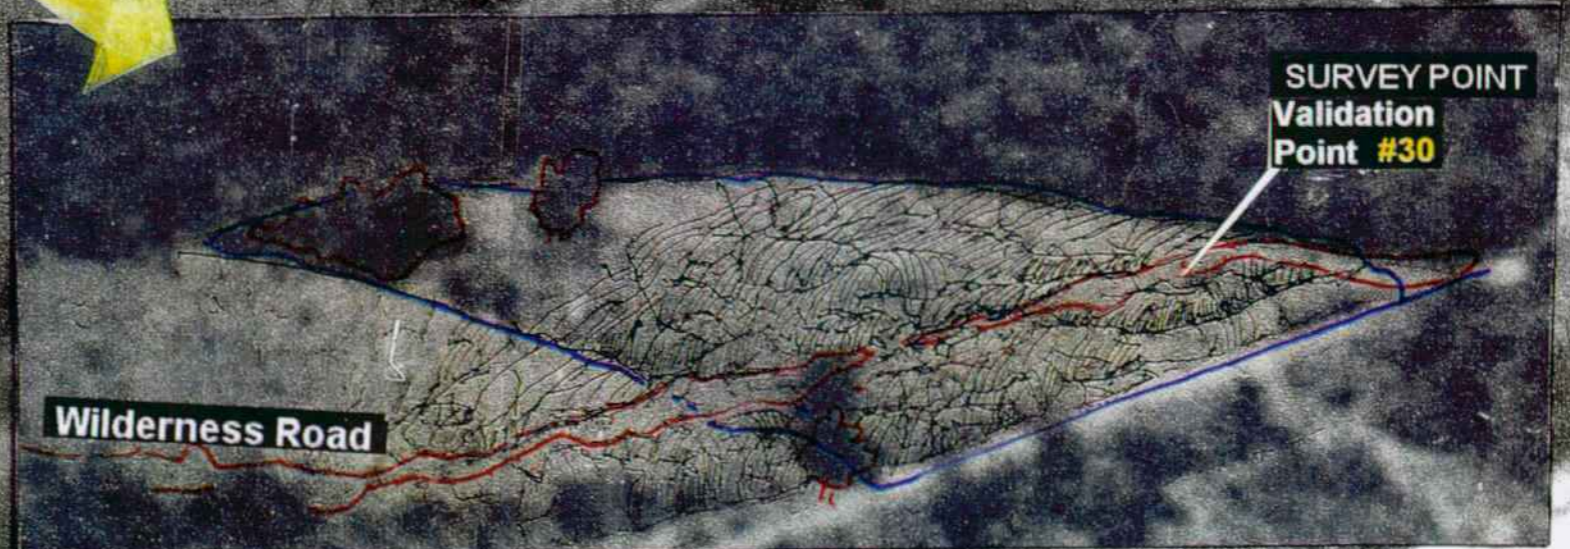
wilderness road's descent
into kentucky

The original upper road alignment used a slight climb in elevation to allow a gradual descent into Kentucky. This area of descent (shown here) was not only level enough for farming in the 1920s, but provided a gradual descent suitable for wagons and horseback without earth removal. The historical mapping not only graphically matches modern mapping, but also matches the topographical remnants on the ground. After the delineation of these two historical photographs, it is evident that the shapes (shown on the 1862 survey) are themselves surveyed. Most of them exist on the ground today. The last cross-check is that the aforementioned research is applied to modern survey points on each end of this alignment.
