SCOTTYS CASTLE COOK HOUSE

Historic Structure Report

SCOTTYS CASTLE COOK HOUSE
HISTORIC STRUCTURE REPORT

prepared by Susan Buchel, Museum Curator
and Robert Haile, Maintenance Mechanic
Death Valley National Monument

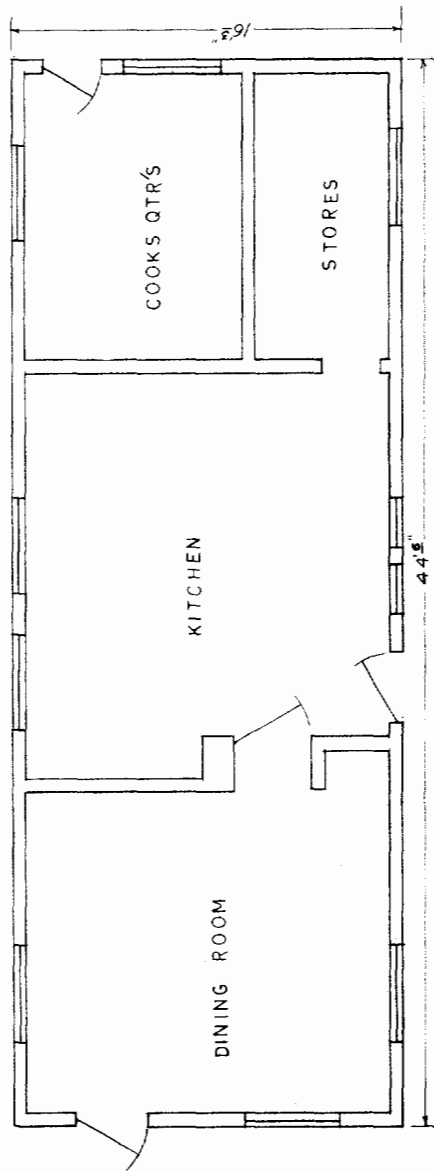
COOK HOUSE
1924 ORIGINAL
SCALE: 1/4" = 1'

Figure 2. Floor plan of Cook House as built in 1924.
(reduced) Robert Haile, 1985.

As finished in 1924, the Cook House was a rectangular structure with outside dimensions of 44'3" by 16'3" for a total of 723 sq. ft. It was divided into four rooms consisting of a dining room, kitchen, storage room and cook's quarters. The exterior of the building was given a stucco finish of one scratch and one brown coat, and the roof was covered with approximately three inches of portland cement mortar with a coating of asphalt.³ (Chapter 4 contains a more detailed description of this structure's architectural features. See also figures 2, 3, and 4).

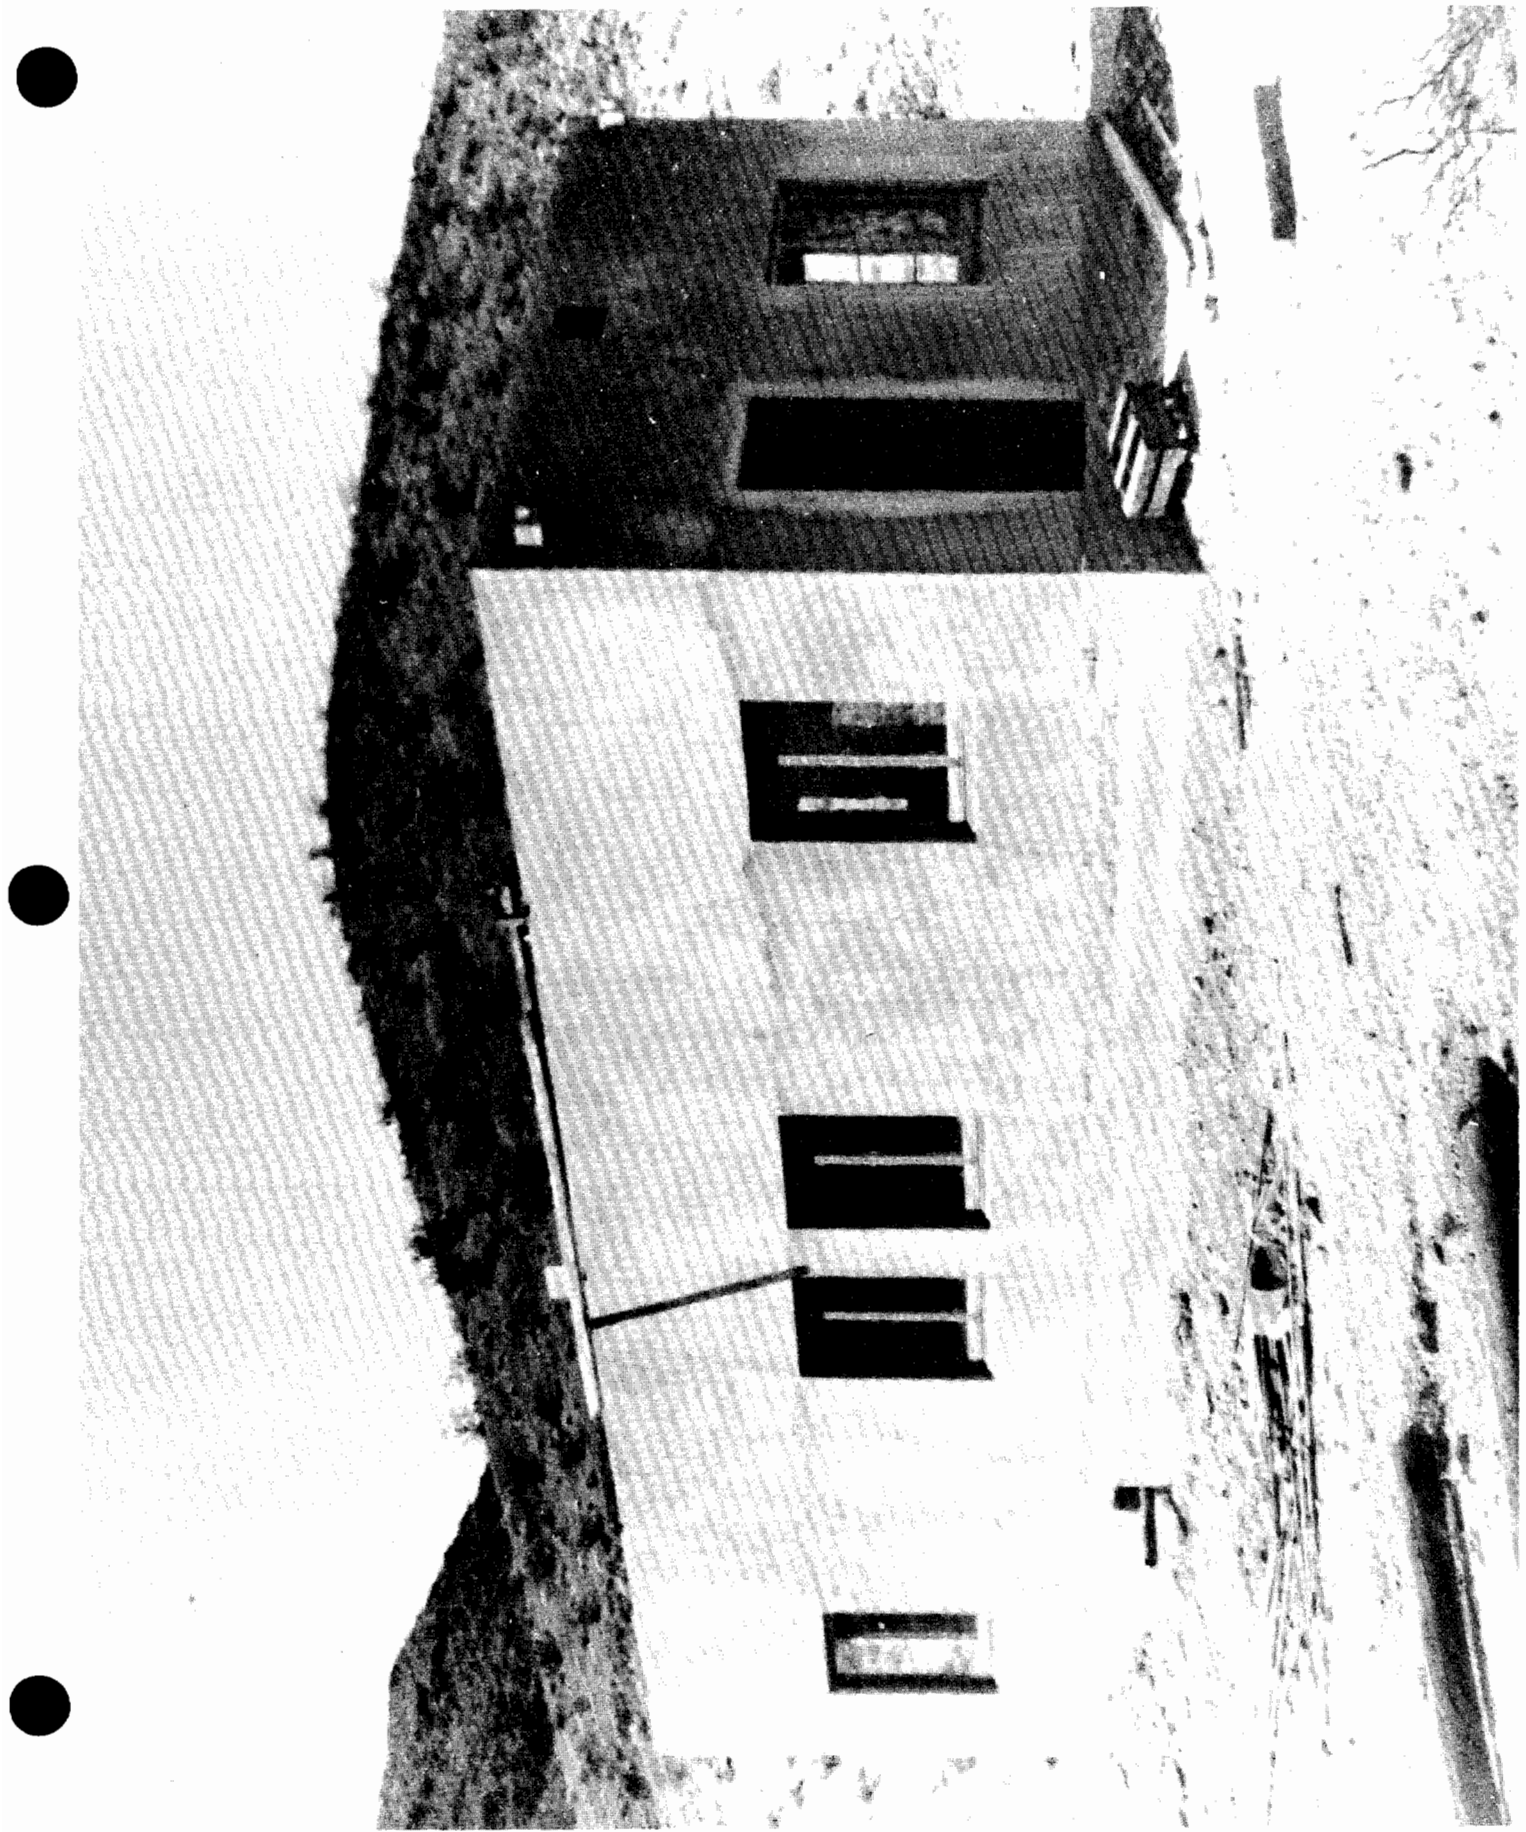
Figure 3

Figure 3. Cook House nearing completion, ca. 1924.
Photographer unknown.

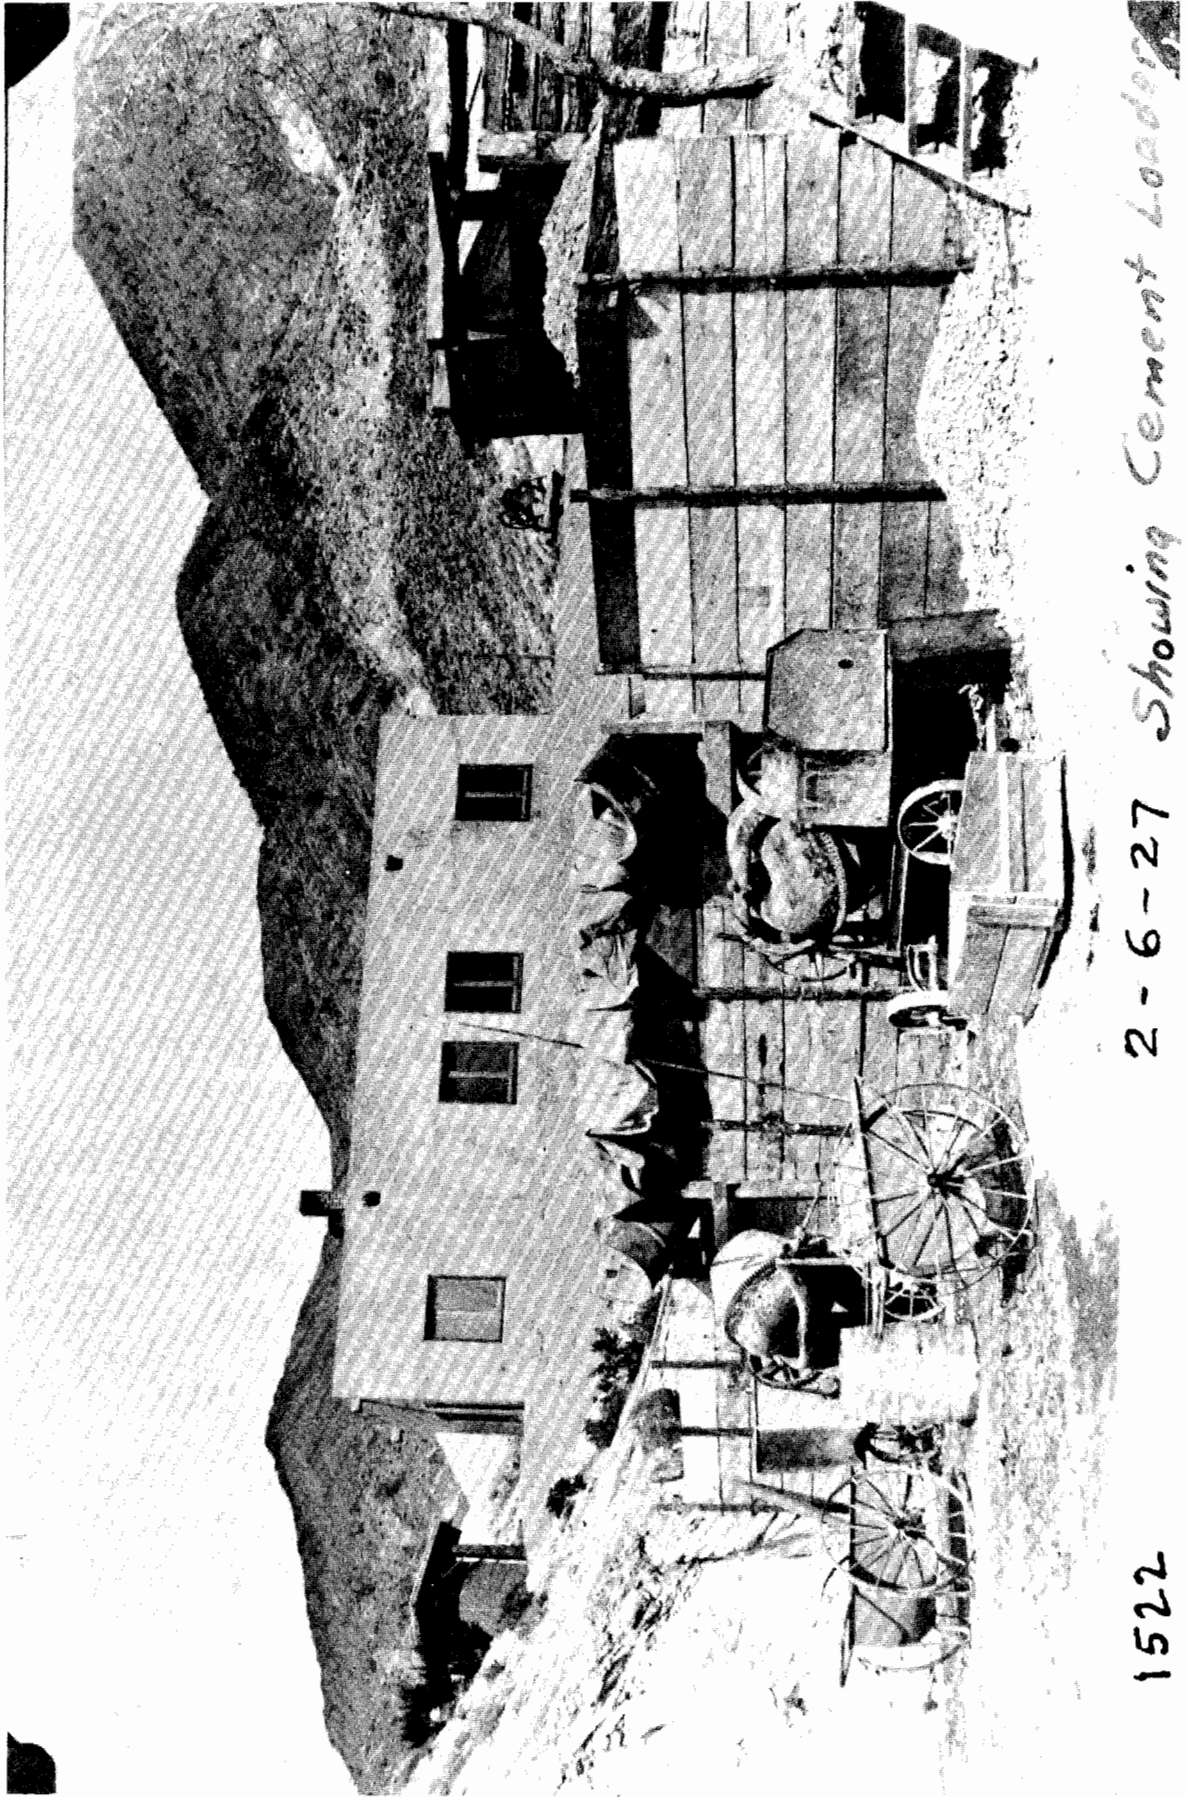
Figure 4

Figure 4. Cook House during Castle construction, 6 Feb
1927. M. Roy Thompson photo.

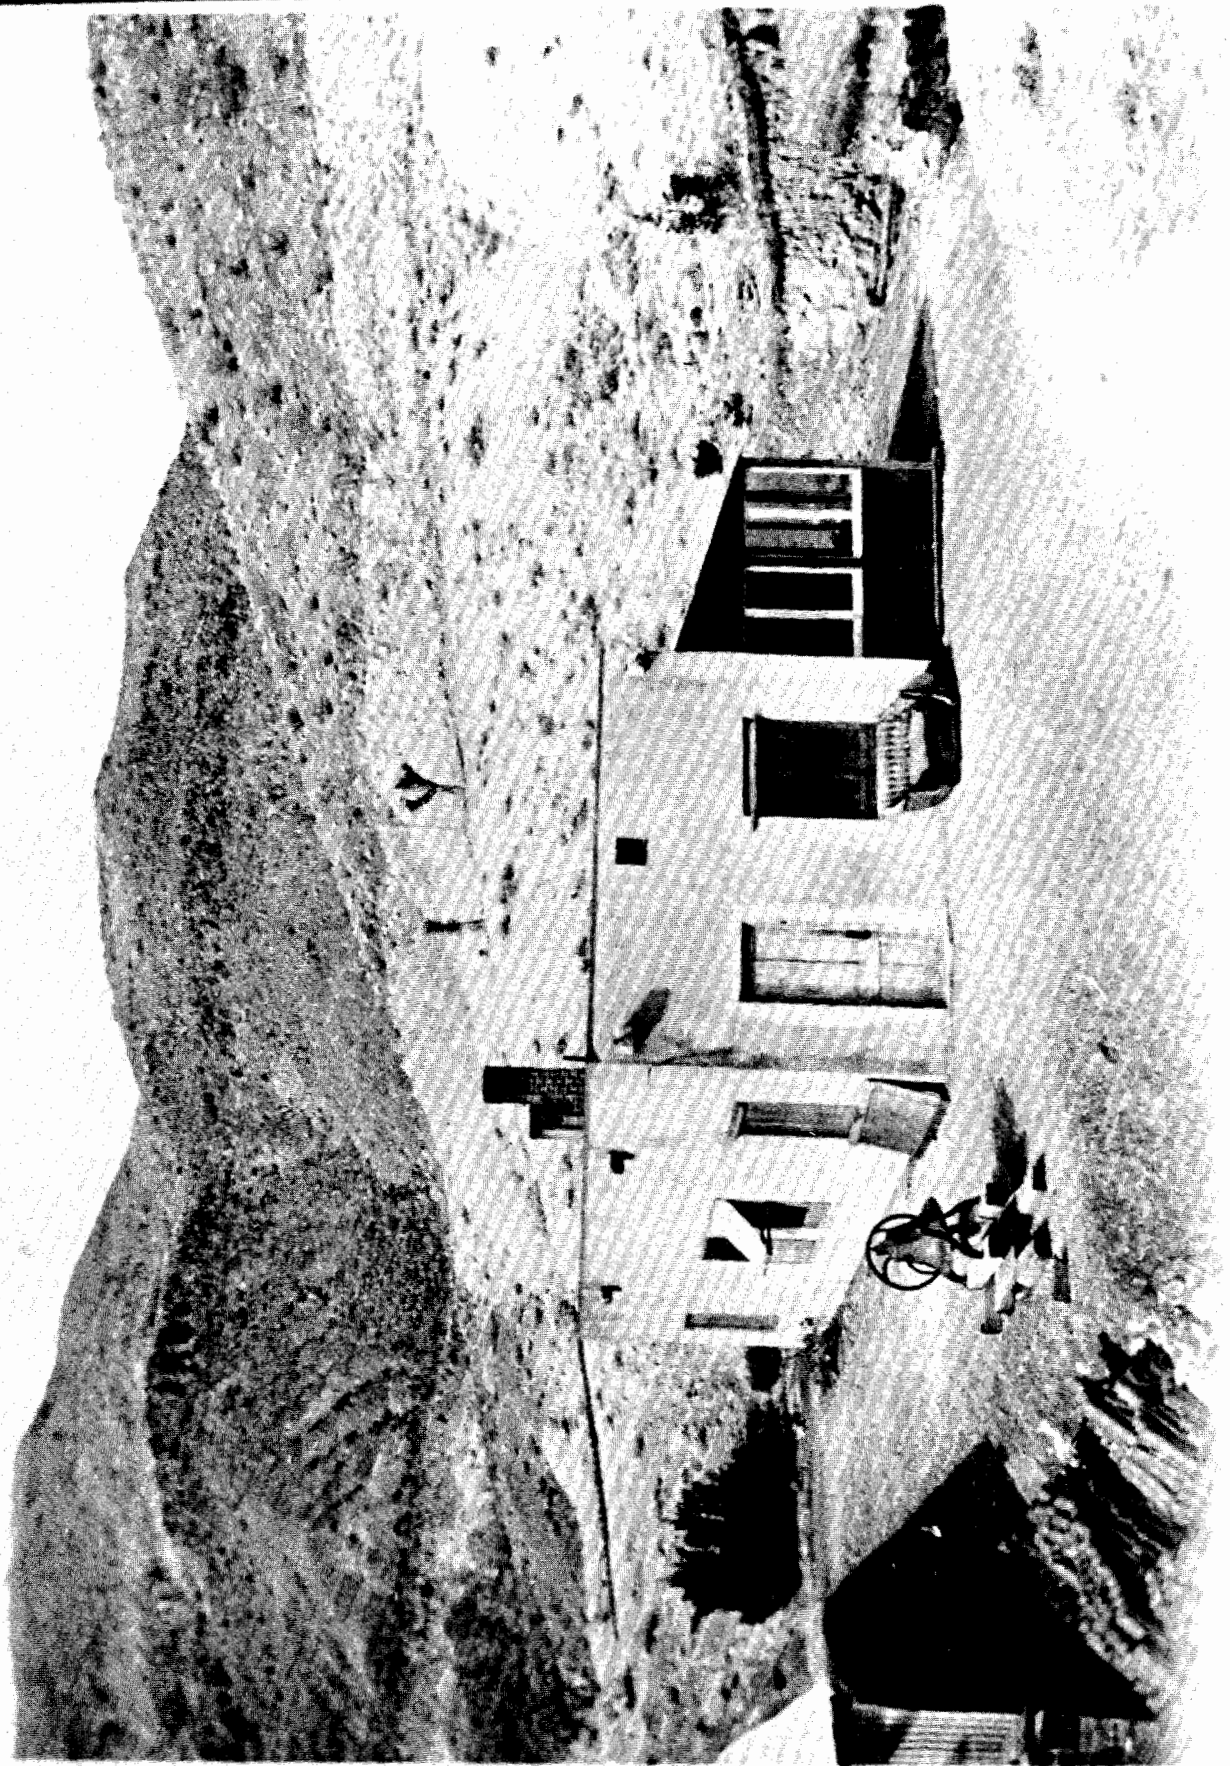
Figure 5

Figure 5. Cook House with dining room extension of sheetmetal, ca. 1928. Rhyolite school bell in foreground. Daggett photo.

extended the east wall of the Cook House approximately eight feet and featured rows of windows. The exterior walls and roof were covered with corrugated sheet metal.⁷ (see figures 5 and 6, and Chapter 4).

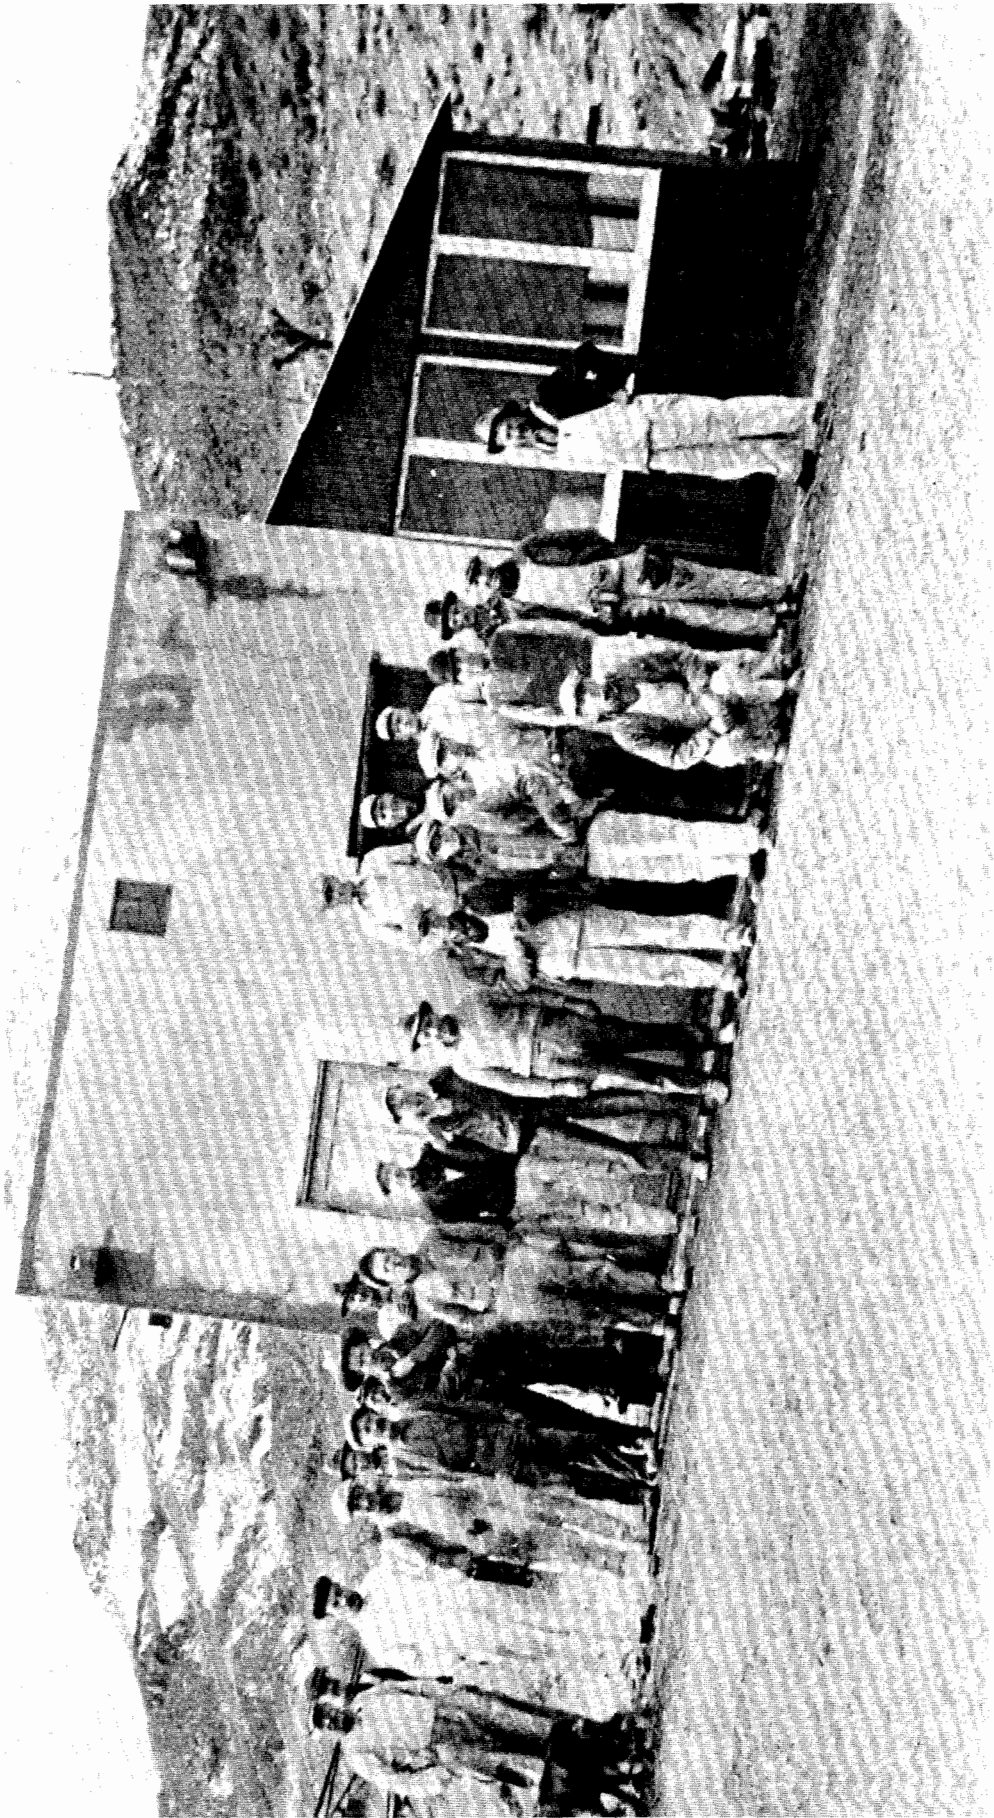
Figure 6

Figure 6. Castle construction workers in front of east wall
of Cook House, ca. 1928. Daggett photo.

A 1928 photograph (fig. 6) of the workers standing beside the Cook House shows that the building retained the original stucco finish that did not match the new finish of the Spanish-style buildings on the site, which by now had come to be known as "Scottys Castle." Mr. Johnson wrote Thompson that he eventually wanted the outside of the Garage and the Cook House stuccoed in the pattern of the Castle.⁸

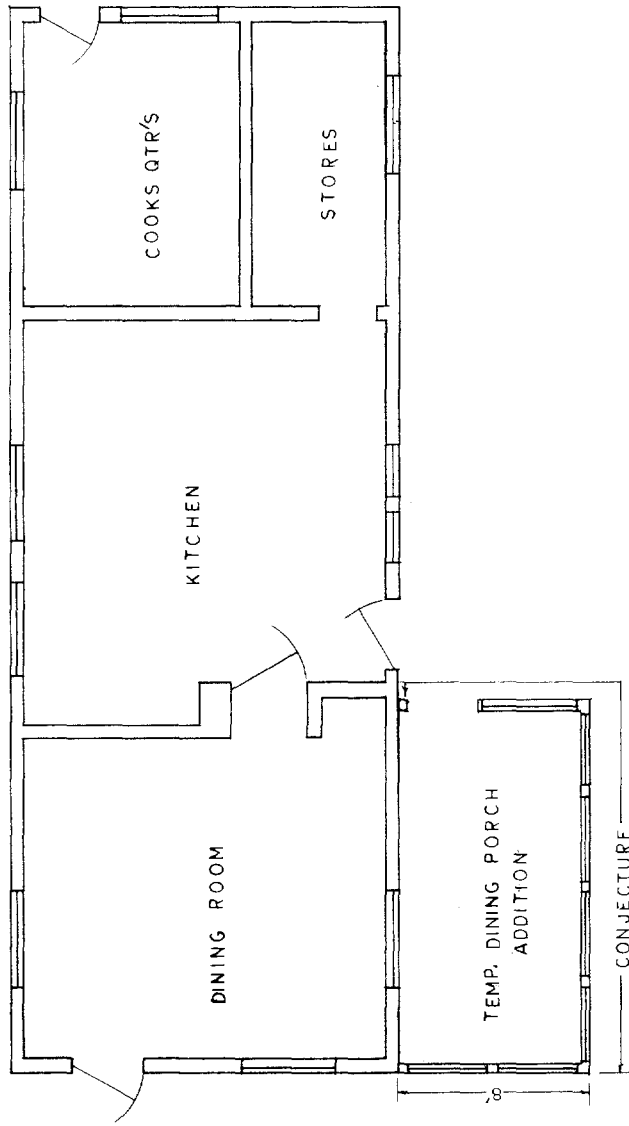
COOK HOUSE
1927 ADDITION
SCALE: 1/4"=1'

Figure 7. Floor plan of the Cook House with the temporary eating porch addition (reduced). Robert Haile, 1985.

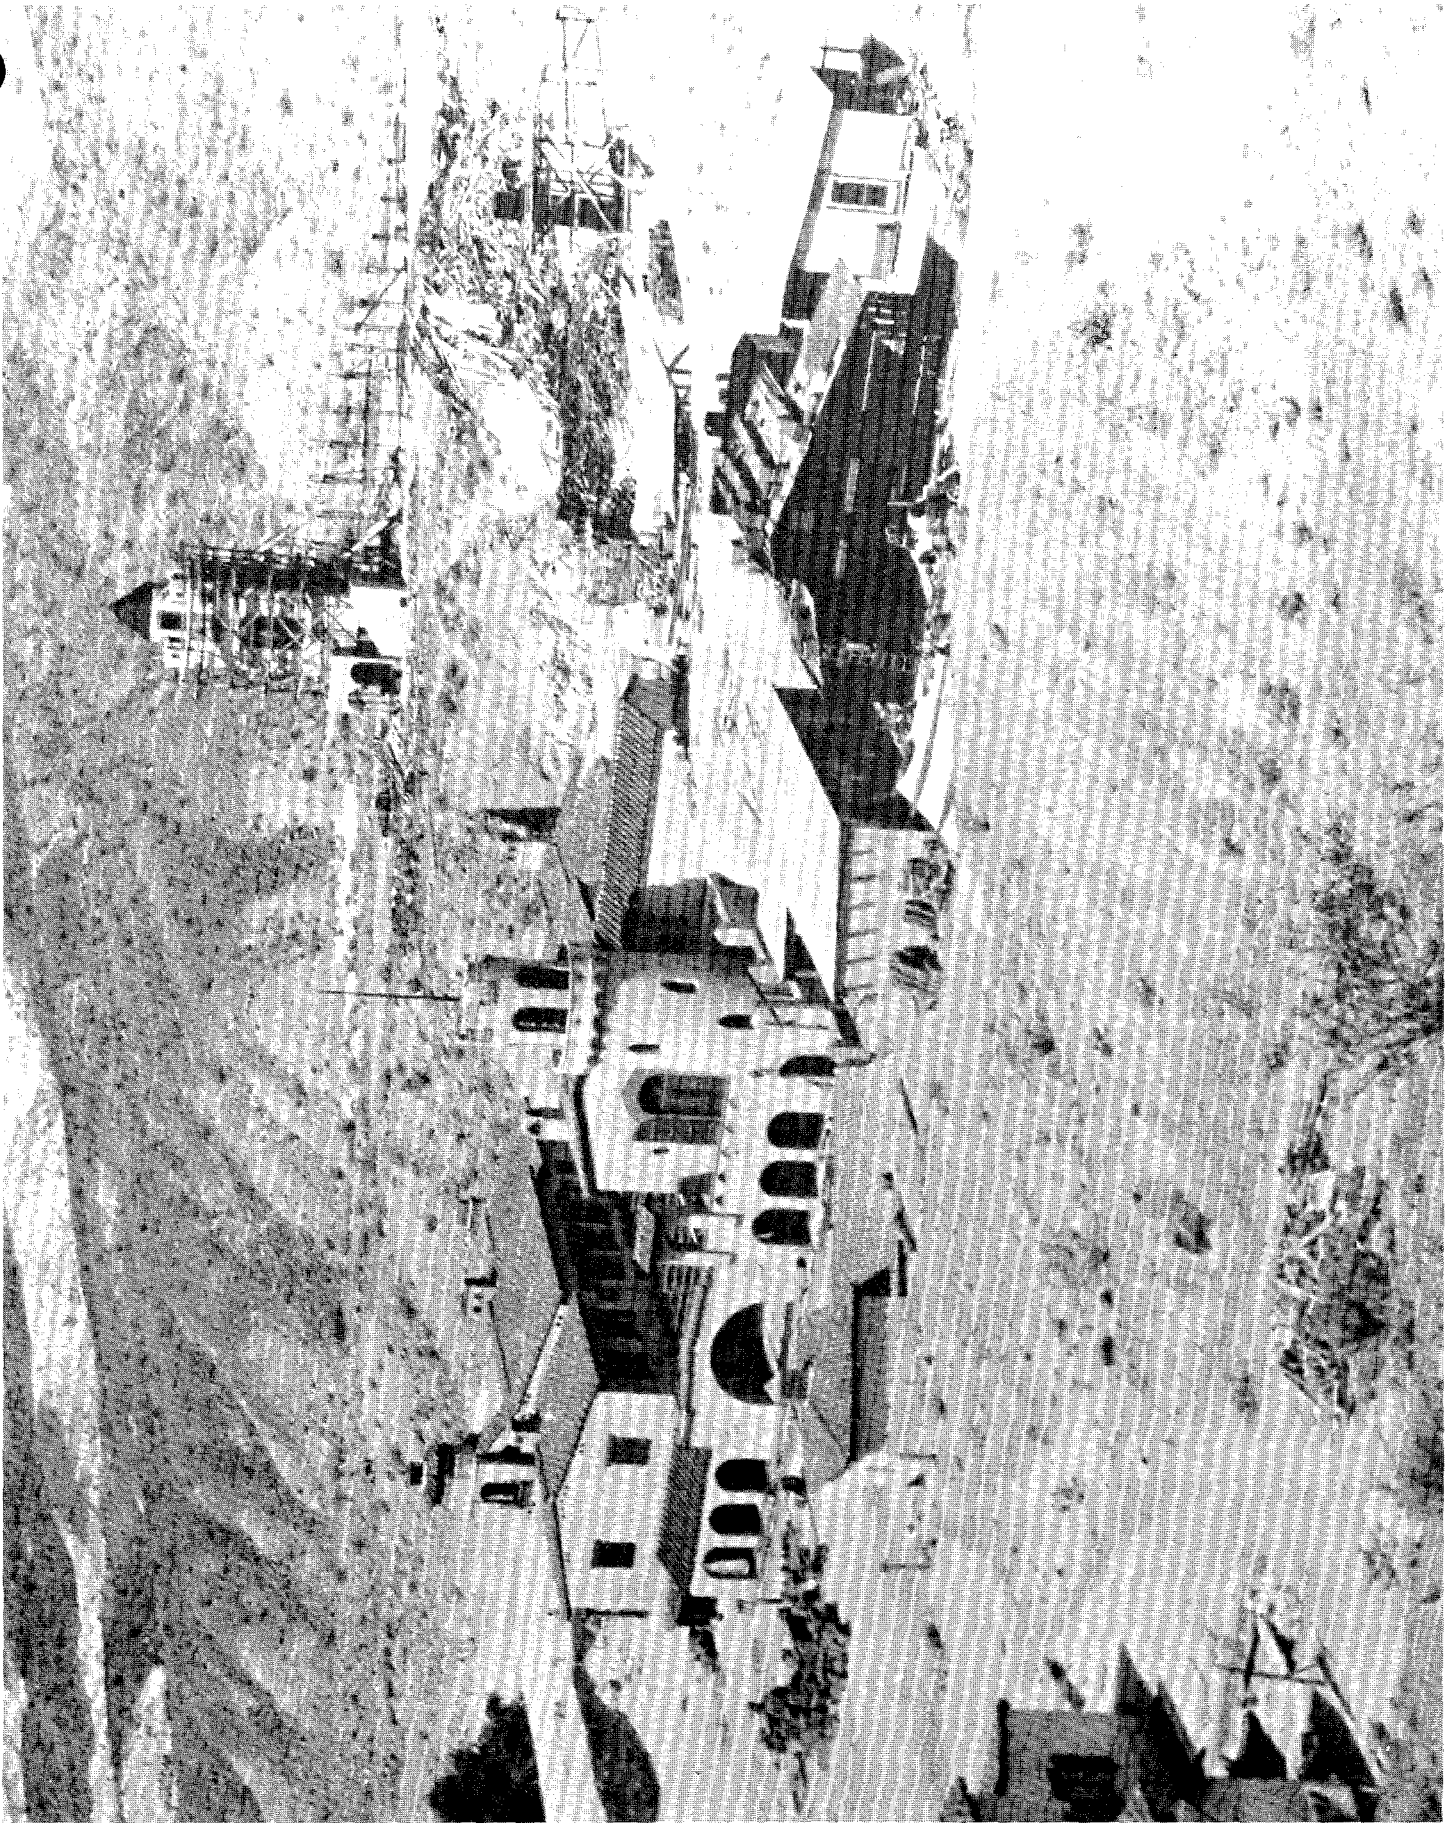
Figure 9

Figure 9. Cook House remodeling project showing temporary eating shed at far right. M. Roy Thompson photo.

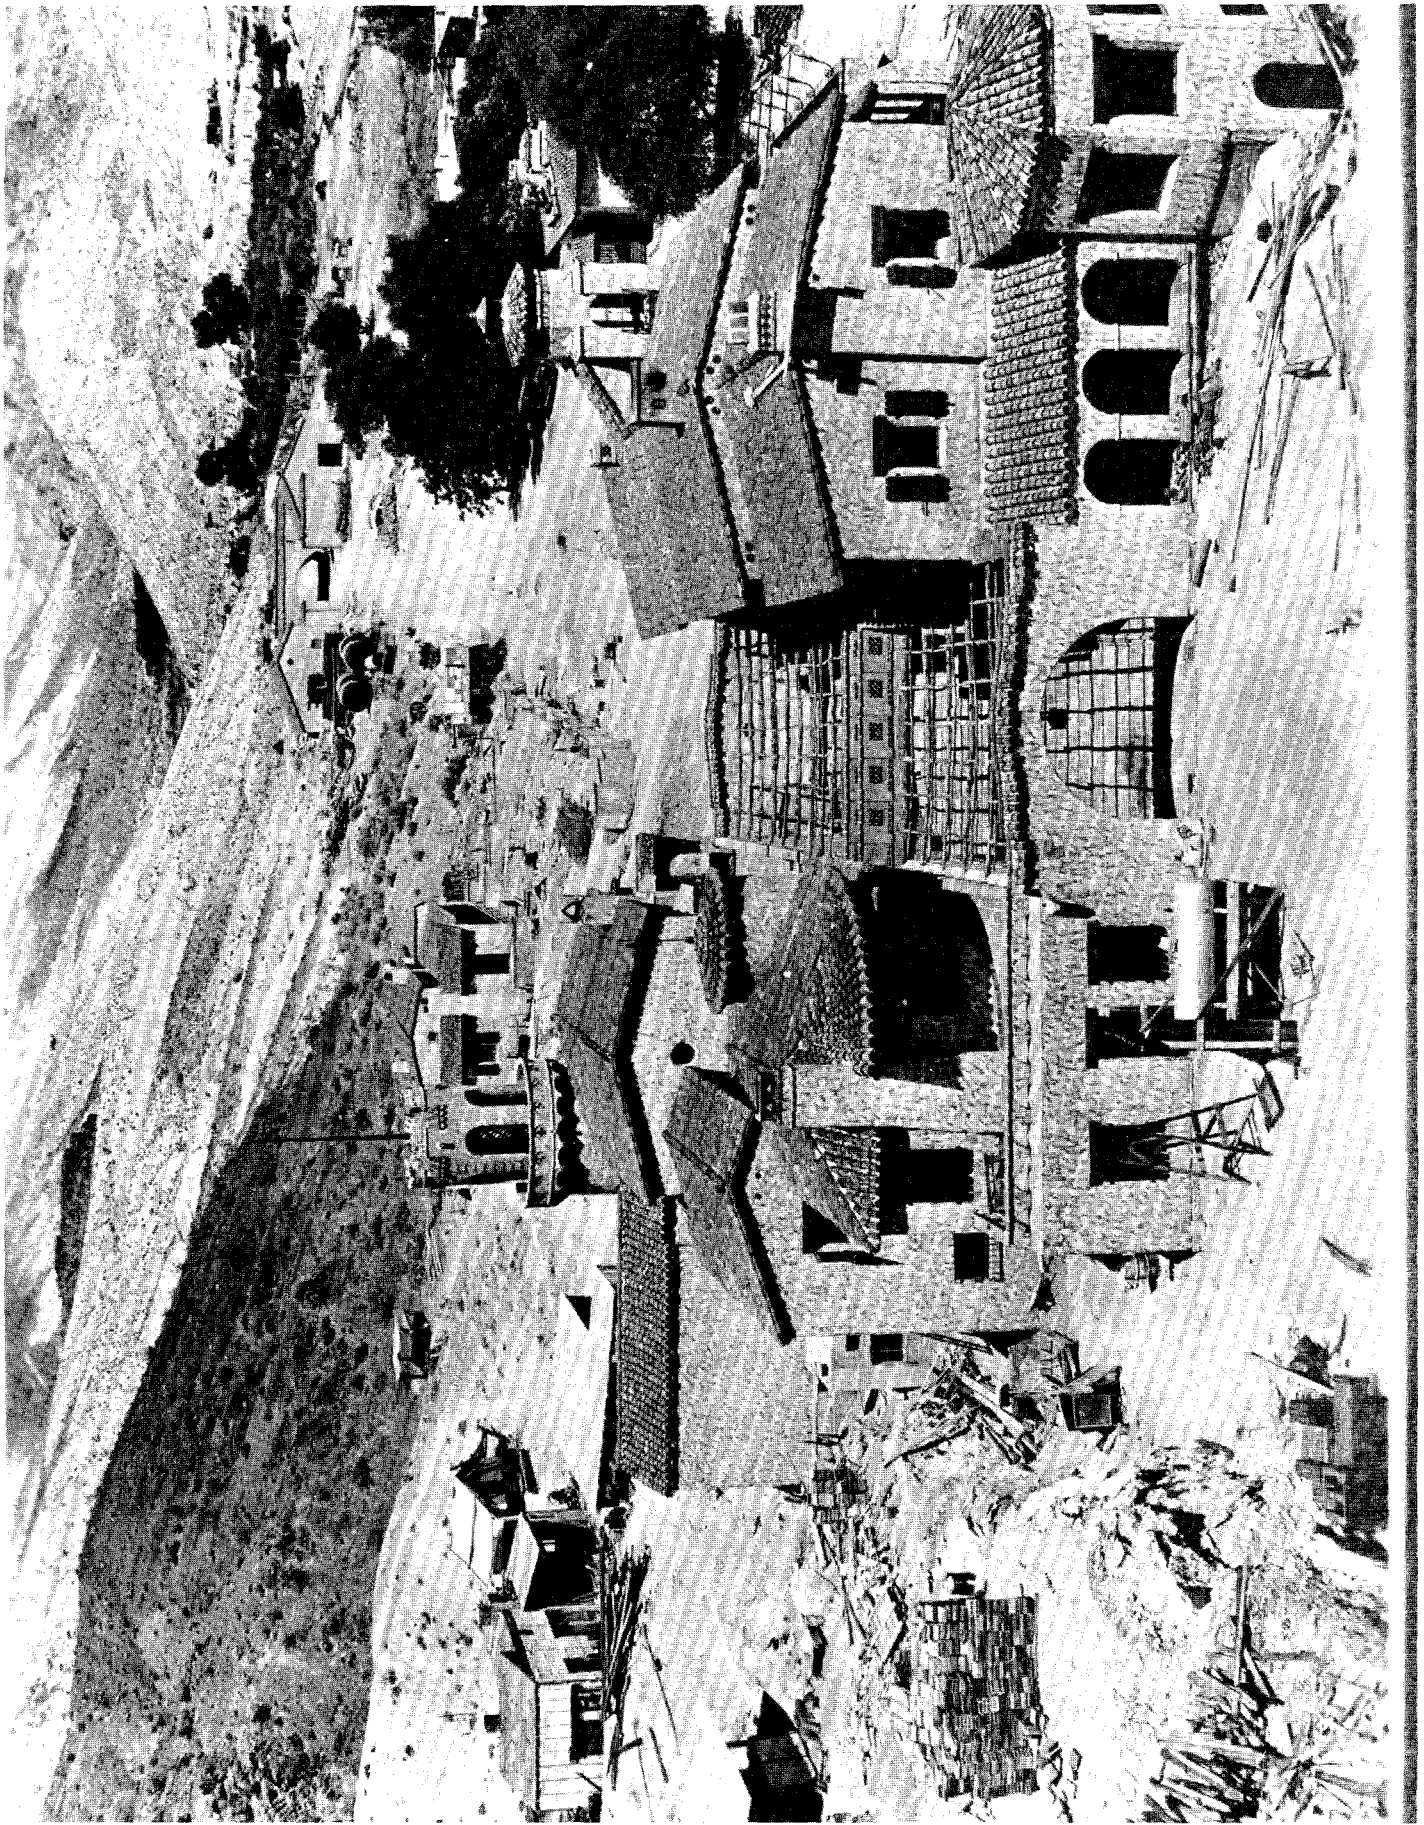
Figure 10

Figure 10. Cook House remodeling, at left. Showing insulex
in walls. M. Roy Thompson photo.

All exterior stucco was removed to facilitate the pouring of "insulex," a water-activated insulating foam, in the walls. The stucco removal also accommodated the tying in of new additions. The new foundations and wall framing was similar to the original, except in the dining porch where the walls consisted of sliding and fixed wood sash windows behind vertical spindles on 7" centers, resting on a 12" thick by 30" high framed wall.

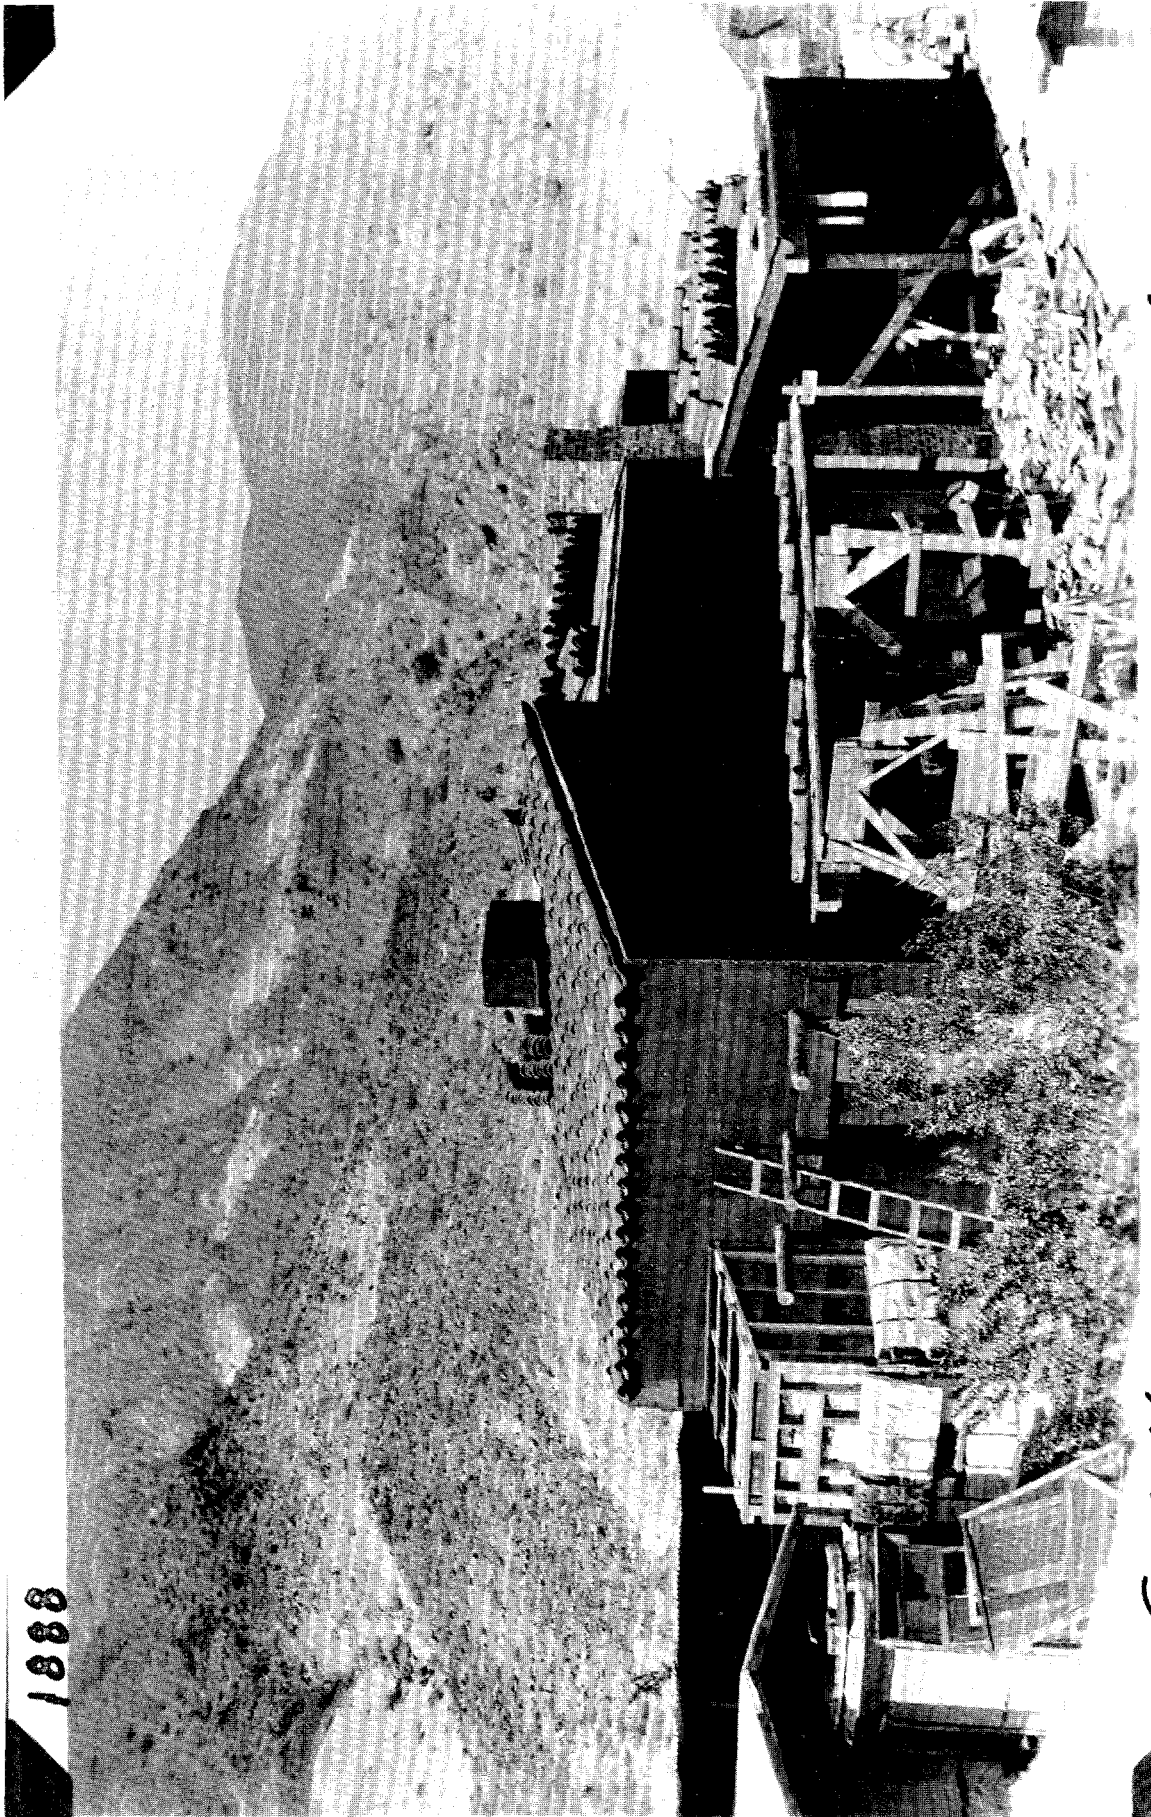
Figure 11

Figure 11. Cook House remodeling, 14 Jun 1929. M. Roy
Thompson photo.

By mid-May, Thompson could report to Johnson that the "Cook House is being rebuilt rapidly."¹¹ By June it was the only major structure on the grounds remaining to be plastered, but its walls had been insulated with a material called "insulex" and lathed in preparation for finishing. Crews laid the roof tile at this time.¹² (fig. 11)

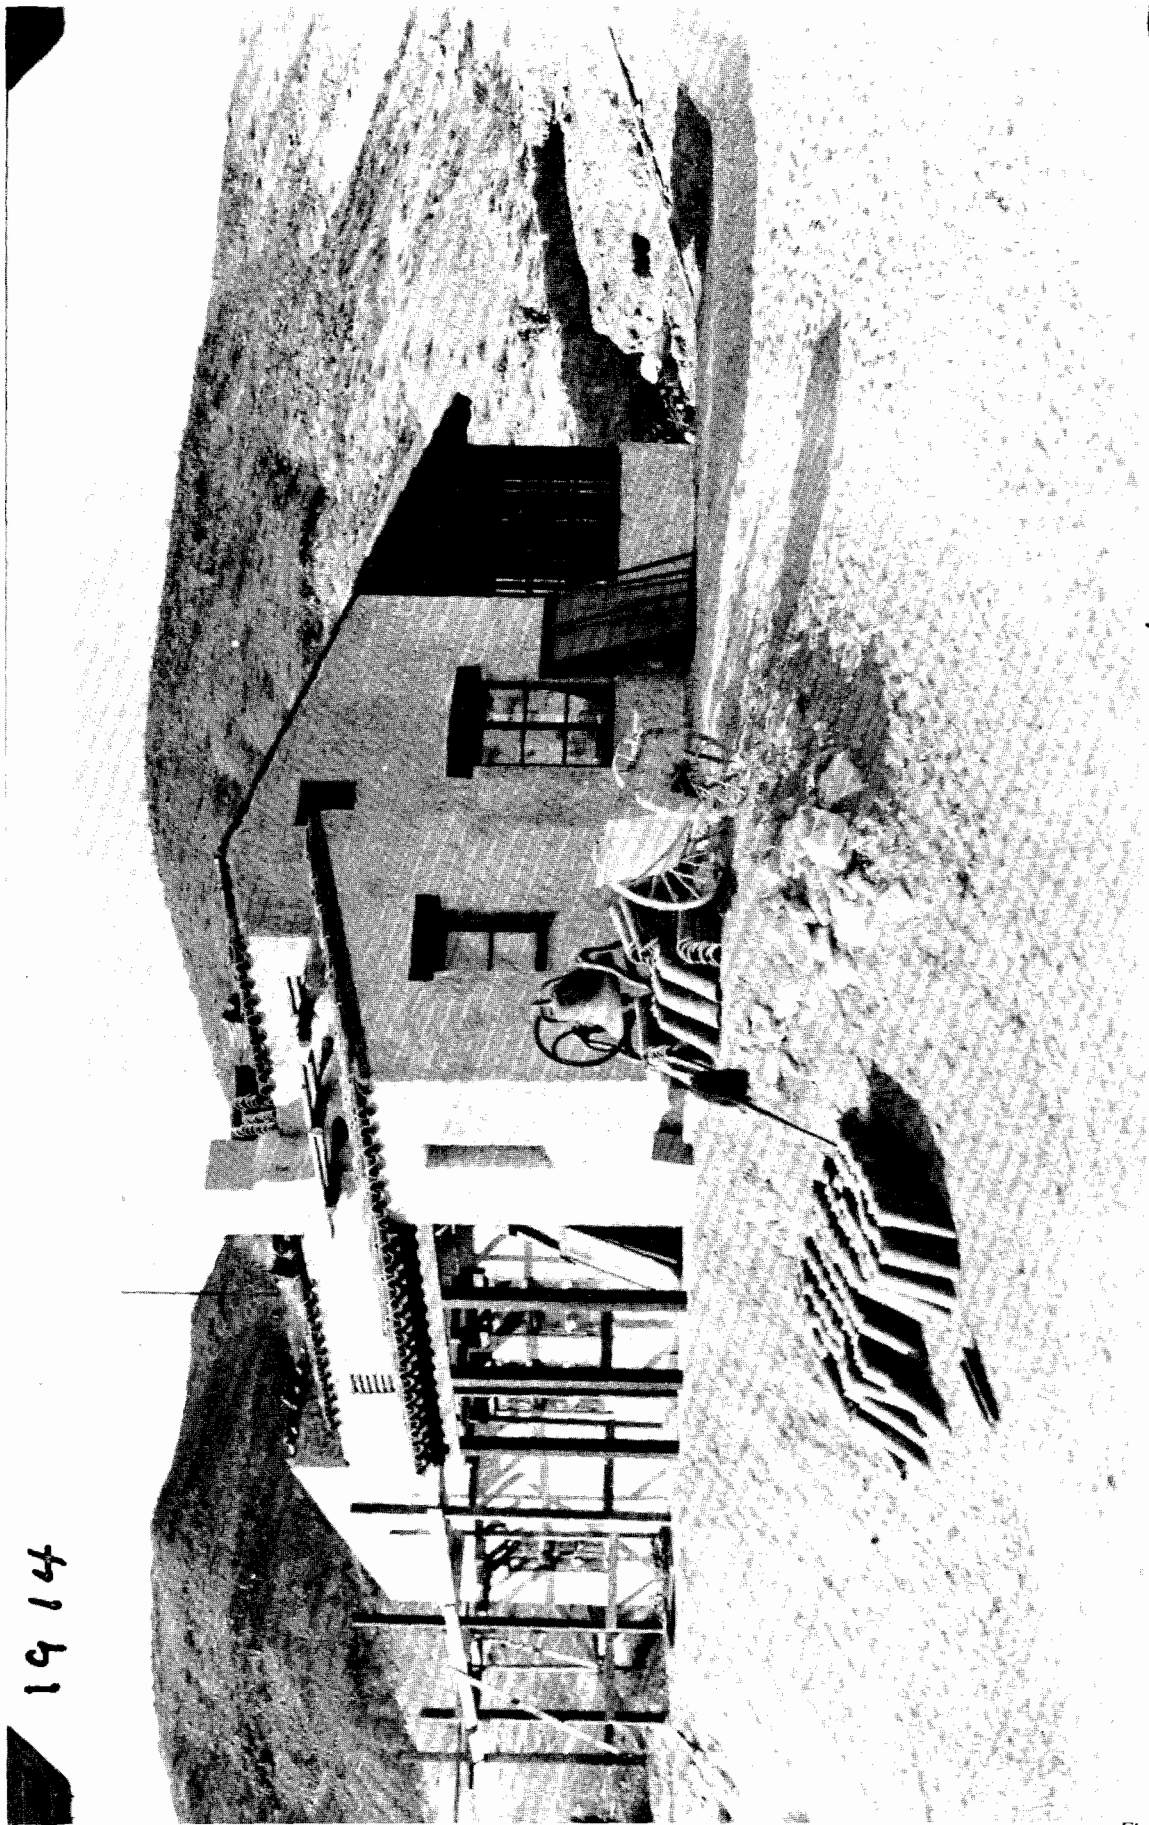
Figure 12

Figure 12. Cook House, remodeling project nearing completion. M. Roy Thompson photo.

By October the men were taking meals in the newly-remodeled and expanded Cook House, and the cook had returned to the west bedroom. They found the "temporary shed" useful for storage and quarters so they left it standing upon completion of the Cook House project (fig. 12).¹³

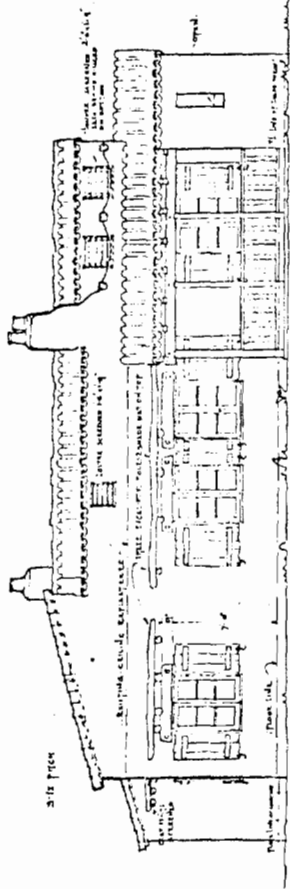
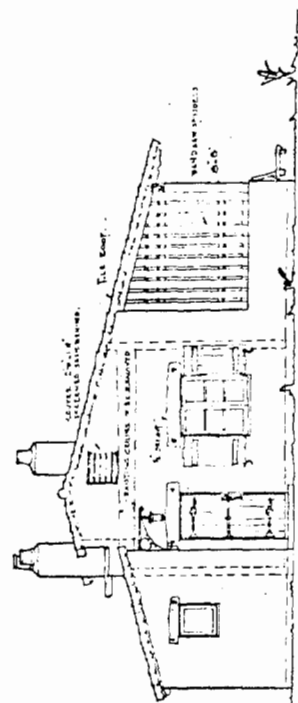
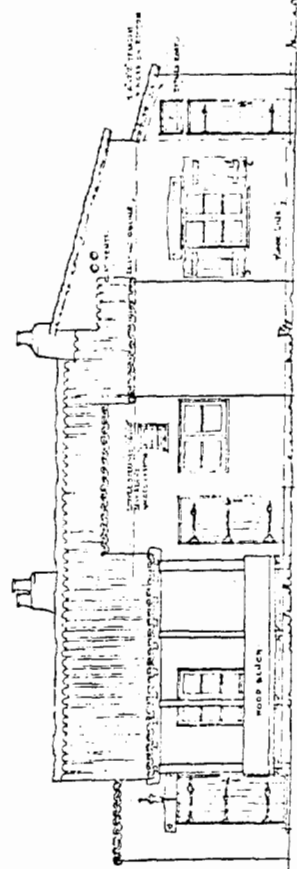
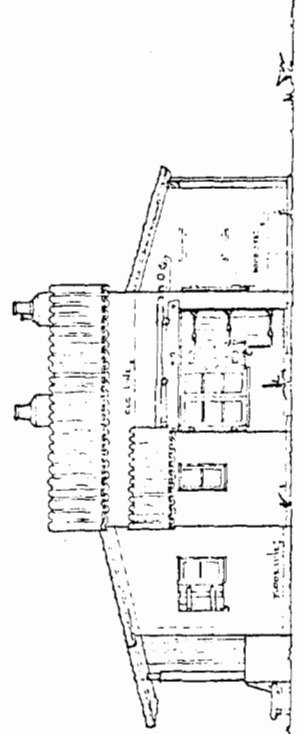
Figure 13

Figure 13. Architectural Drawing by C. A. MacNeilledge,
"Alteration to the Cook House, Death Valley Ranch, Johnson
and Scott, California." 1929. Two pages. (reduced)
