SCOTTYS CASTLE COOK HOUSE

Historic Structure Report

SCOTTYS CASTLE COOK HOUSE
HISTORIC STRUCTURE REPORT

prepared by Susan Buchel, Museum Curator
and Robert Haile, Maintenance Mechanic
Death Valley National Monument

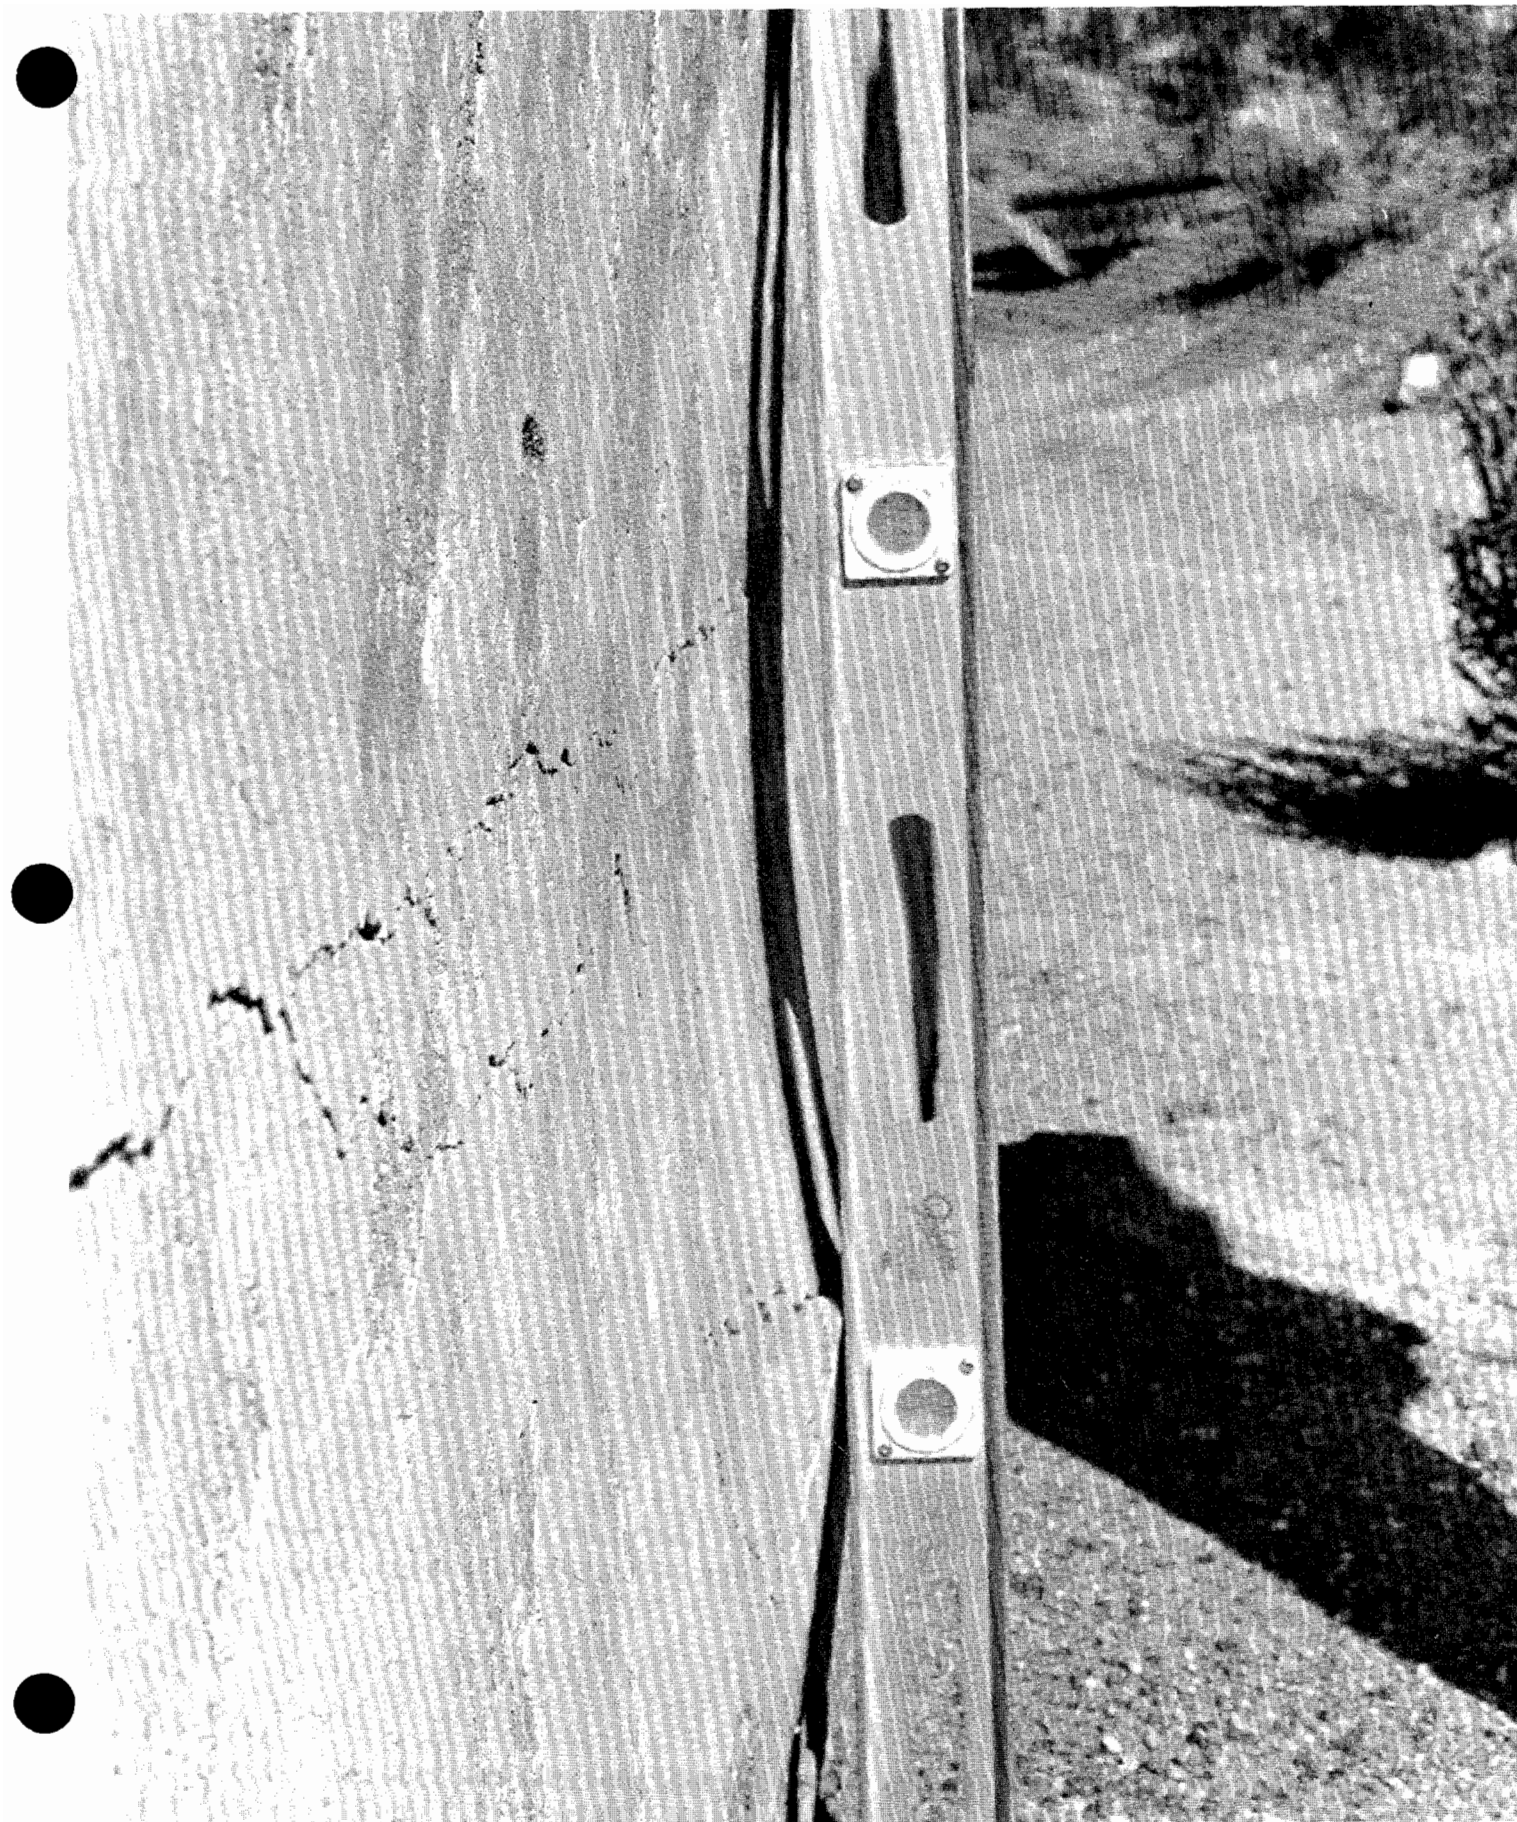
Figure 16

Main Cook House Structure: The stucco is in generally poor condition with the exception of the south wall, fronting the kitchen and chill box rooms. The stucco on the remaining walls has suffered damage due to several factors: (1) excessive moisture in the walls (due to improper placement of evaporative coolers, the improper watering of adjacent plants, and accumulation of water-retaining erosional debris against the building), (2) physical contact with equipment, (3) possible building movement. (see figures 16 through 19)

Figure 16. Southeast corner of Cook House, showing separation of stucco from metal lath. M. Lawrence photo, 1985.

Stucco surfaces: The south wall, fronting the kitchen and chill box rooms, can be retained with minor repairs, providing an excellent example of the original historic fabric. The remaining surfaces of the main structure, having sustained major deterioration (figures 16 - 19) will have to be removed, including the expanded metal lath. New lath will be applied, and the surfaces will be restuccoed, using the techniques described in appendix C. The annex stucco can be left intact with the exception of the east wall and the south wall between the west corner and window (figures 20 - 22). The material covering these two areas will also need to be removed and restuccoed.

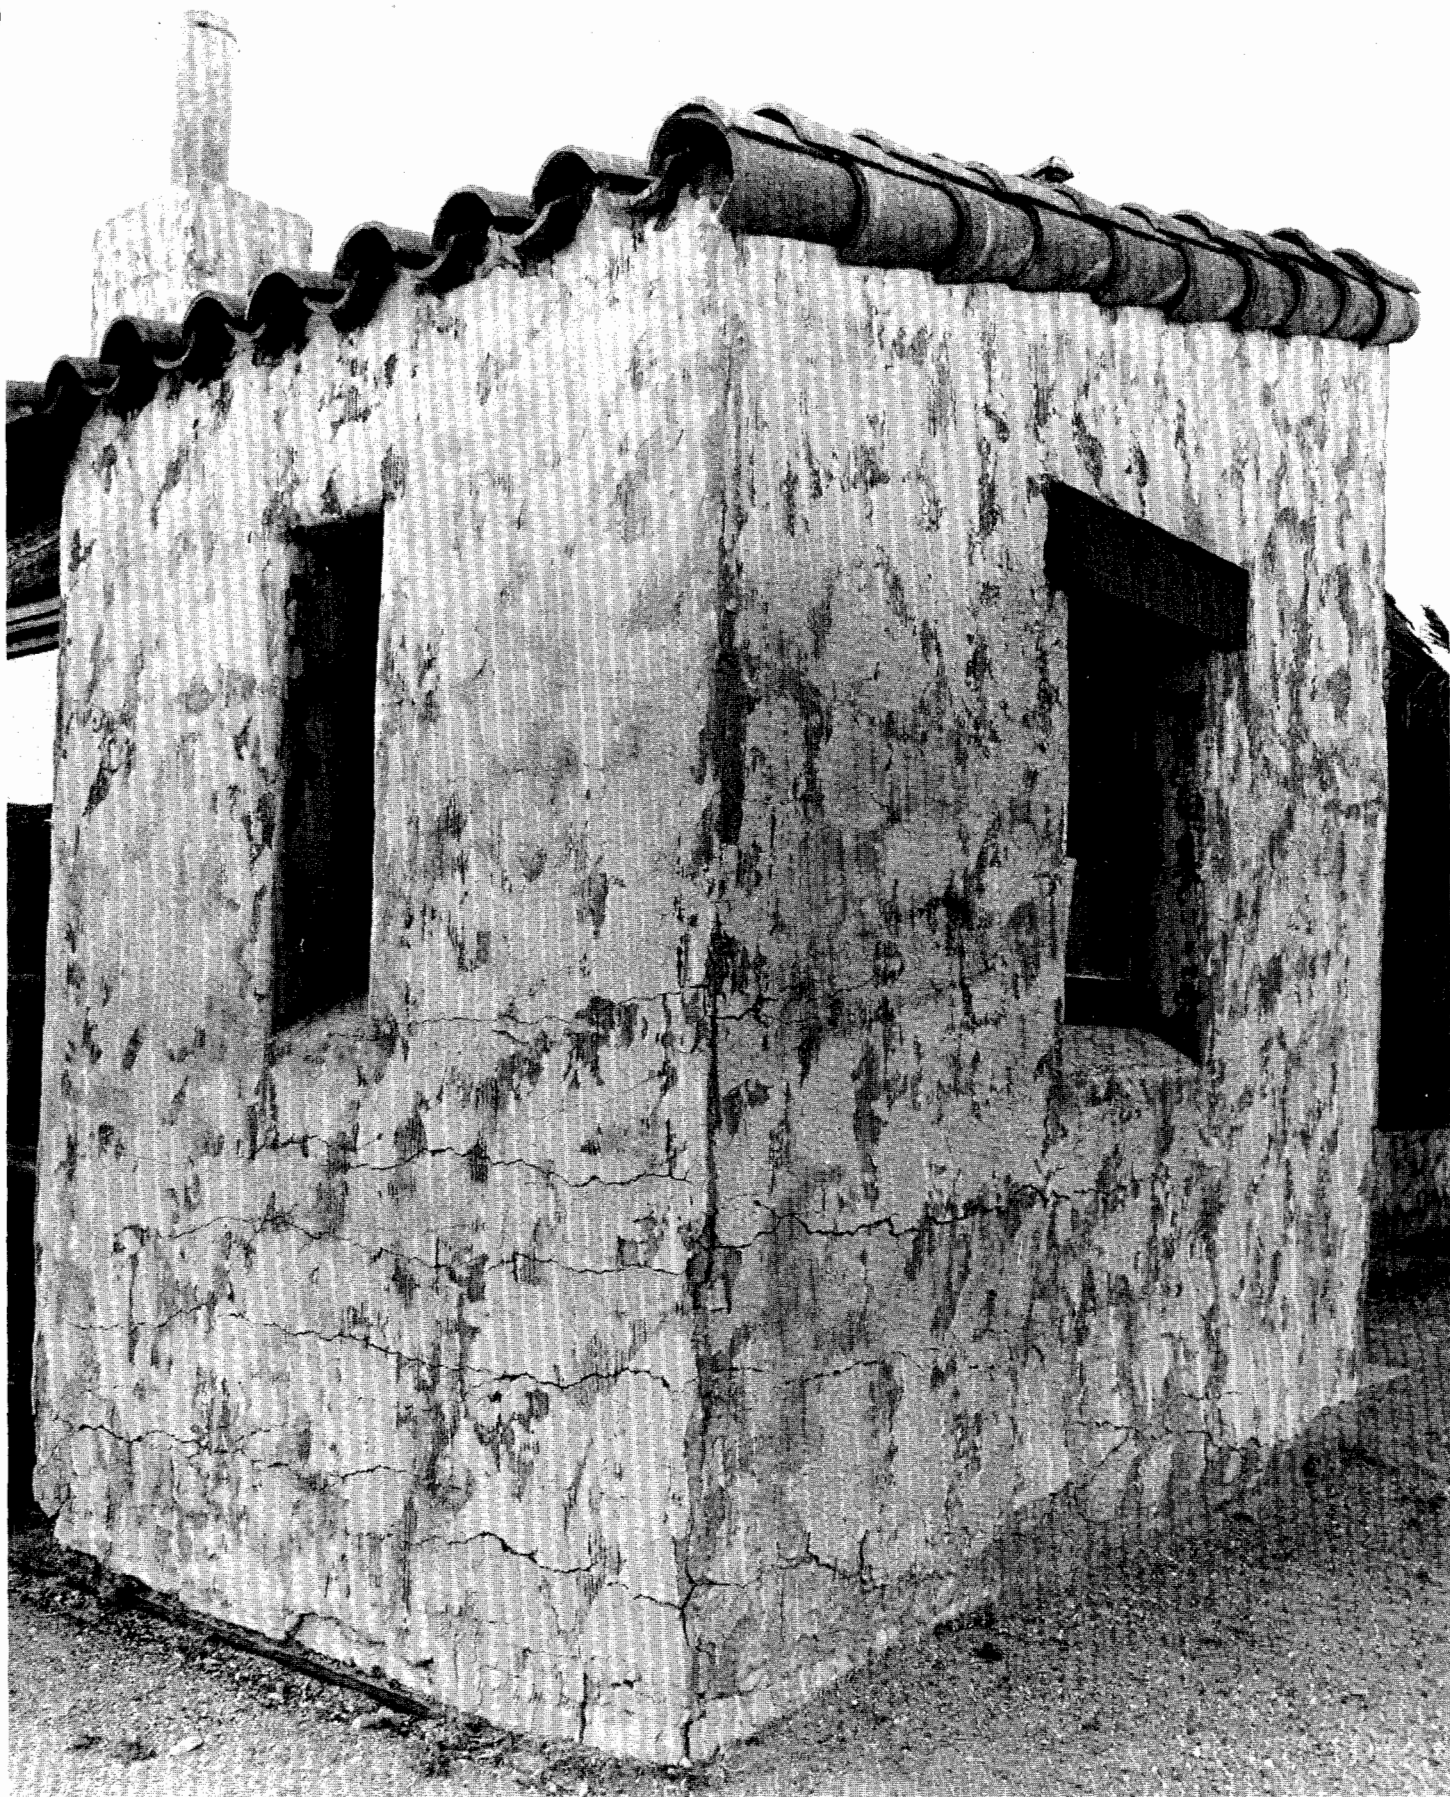
Figure 17

Figure 17. Southeast corner of Cook House, horizontal failure. M. Lawrence photo, 1985.

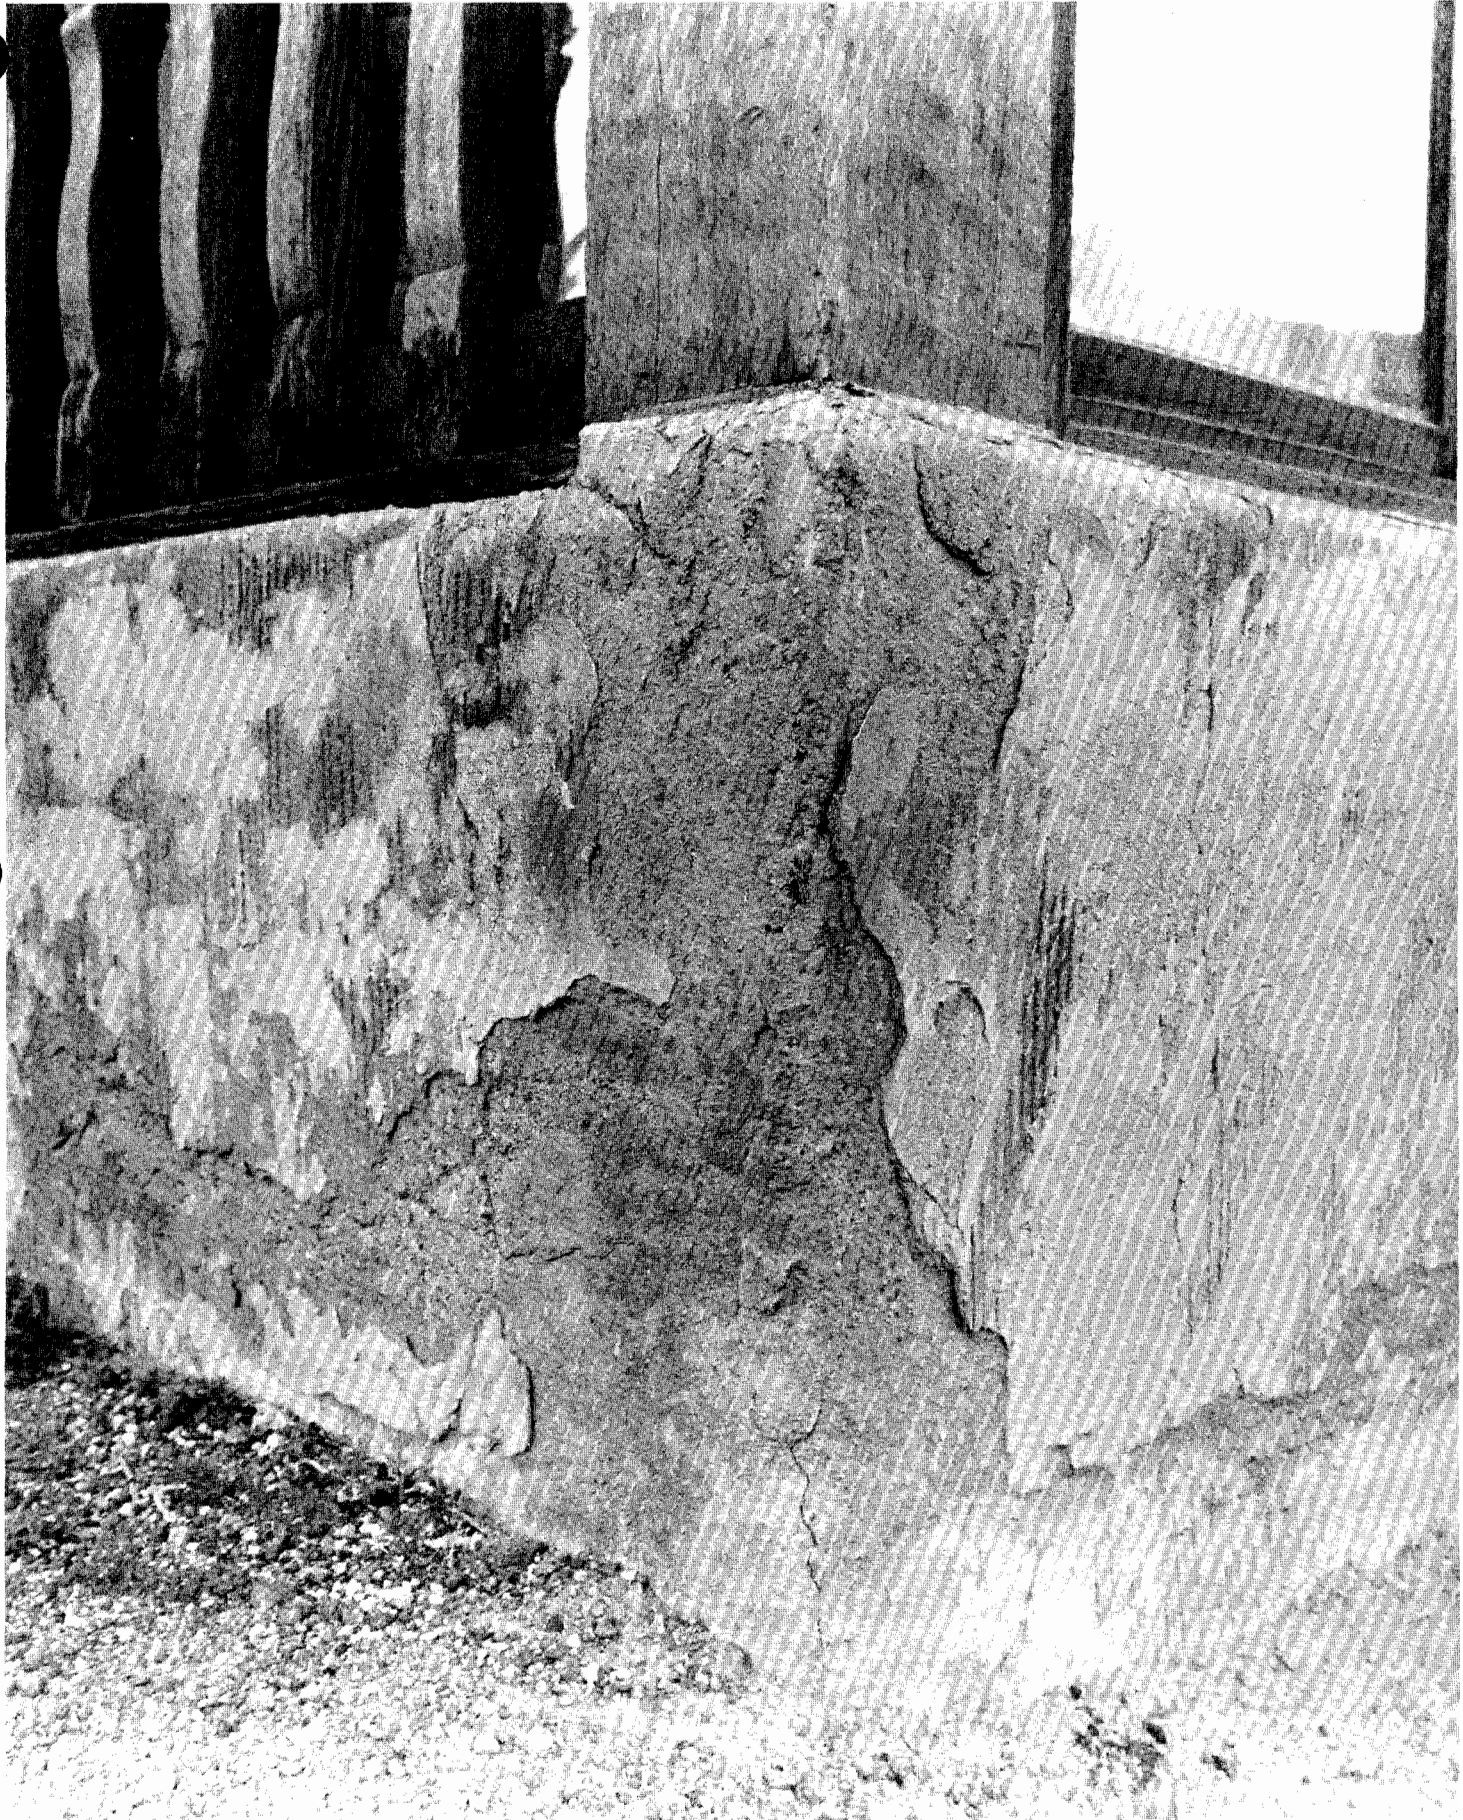
Figure 18

Figure 18. Stucco failure on northeast corner of Cook House. M. Lawrence photo, 1985.

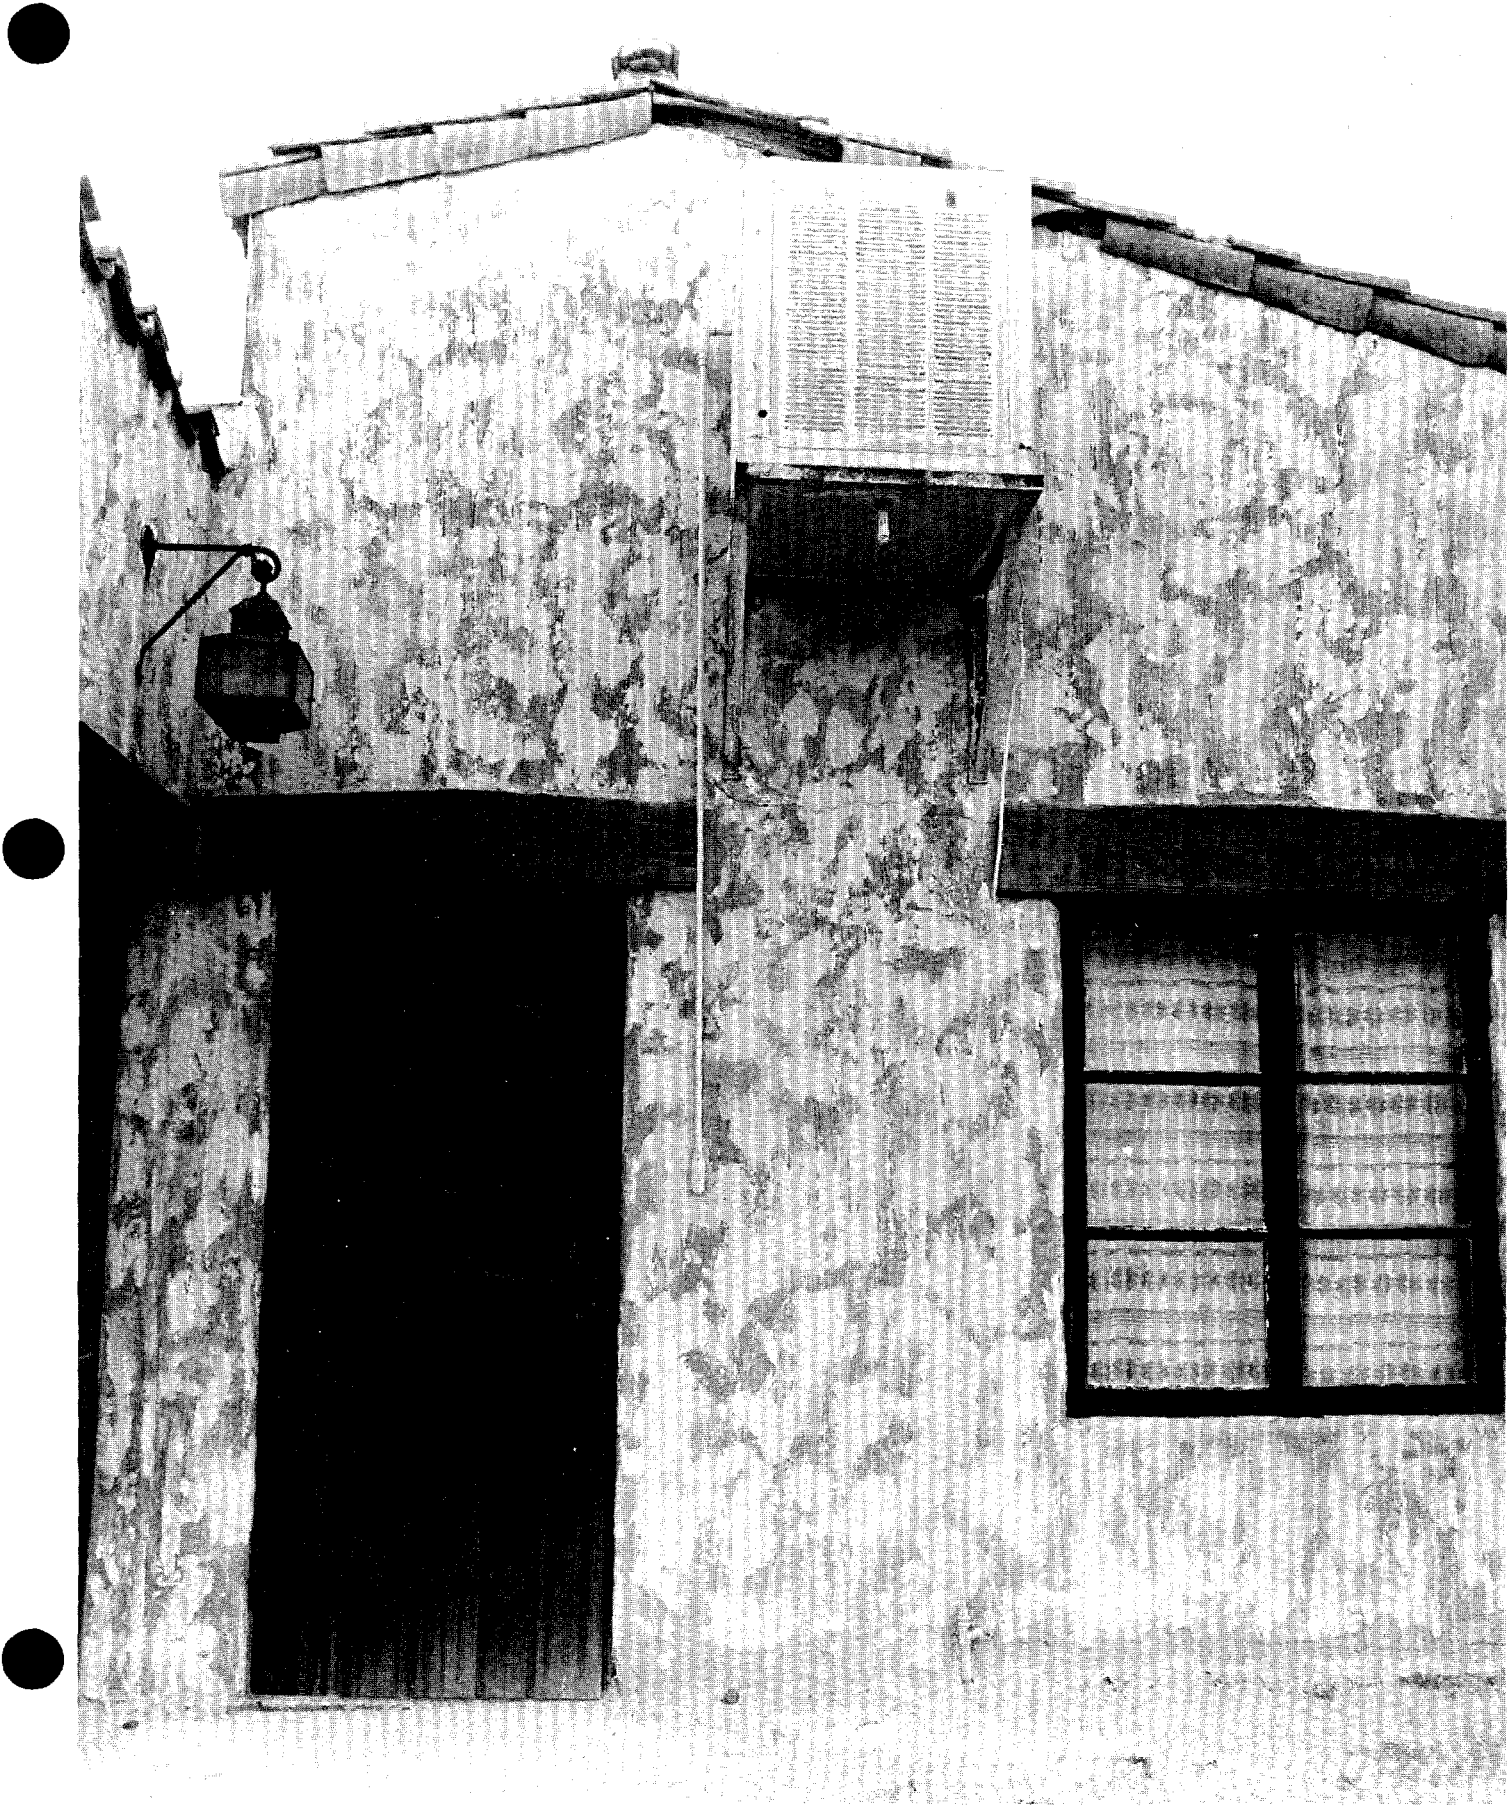
Figure 19

Figure 19. East wall of Cook House showing stucco damage below swamp cooler. M. Lawrence photo.

Swamp coolers: Lack of proper maintenance has allowed water to leak from the coolers and permeate the adjacent stucco surfaces. Castle staff will carry out a preventive maintenance program to eliminate this cause of deterioration. At the current time, the swamp coolers will continue

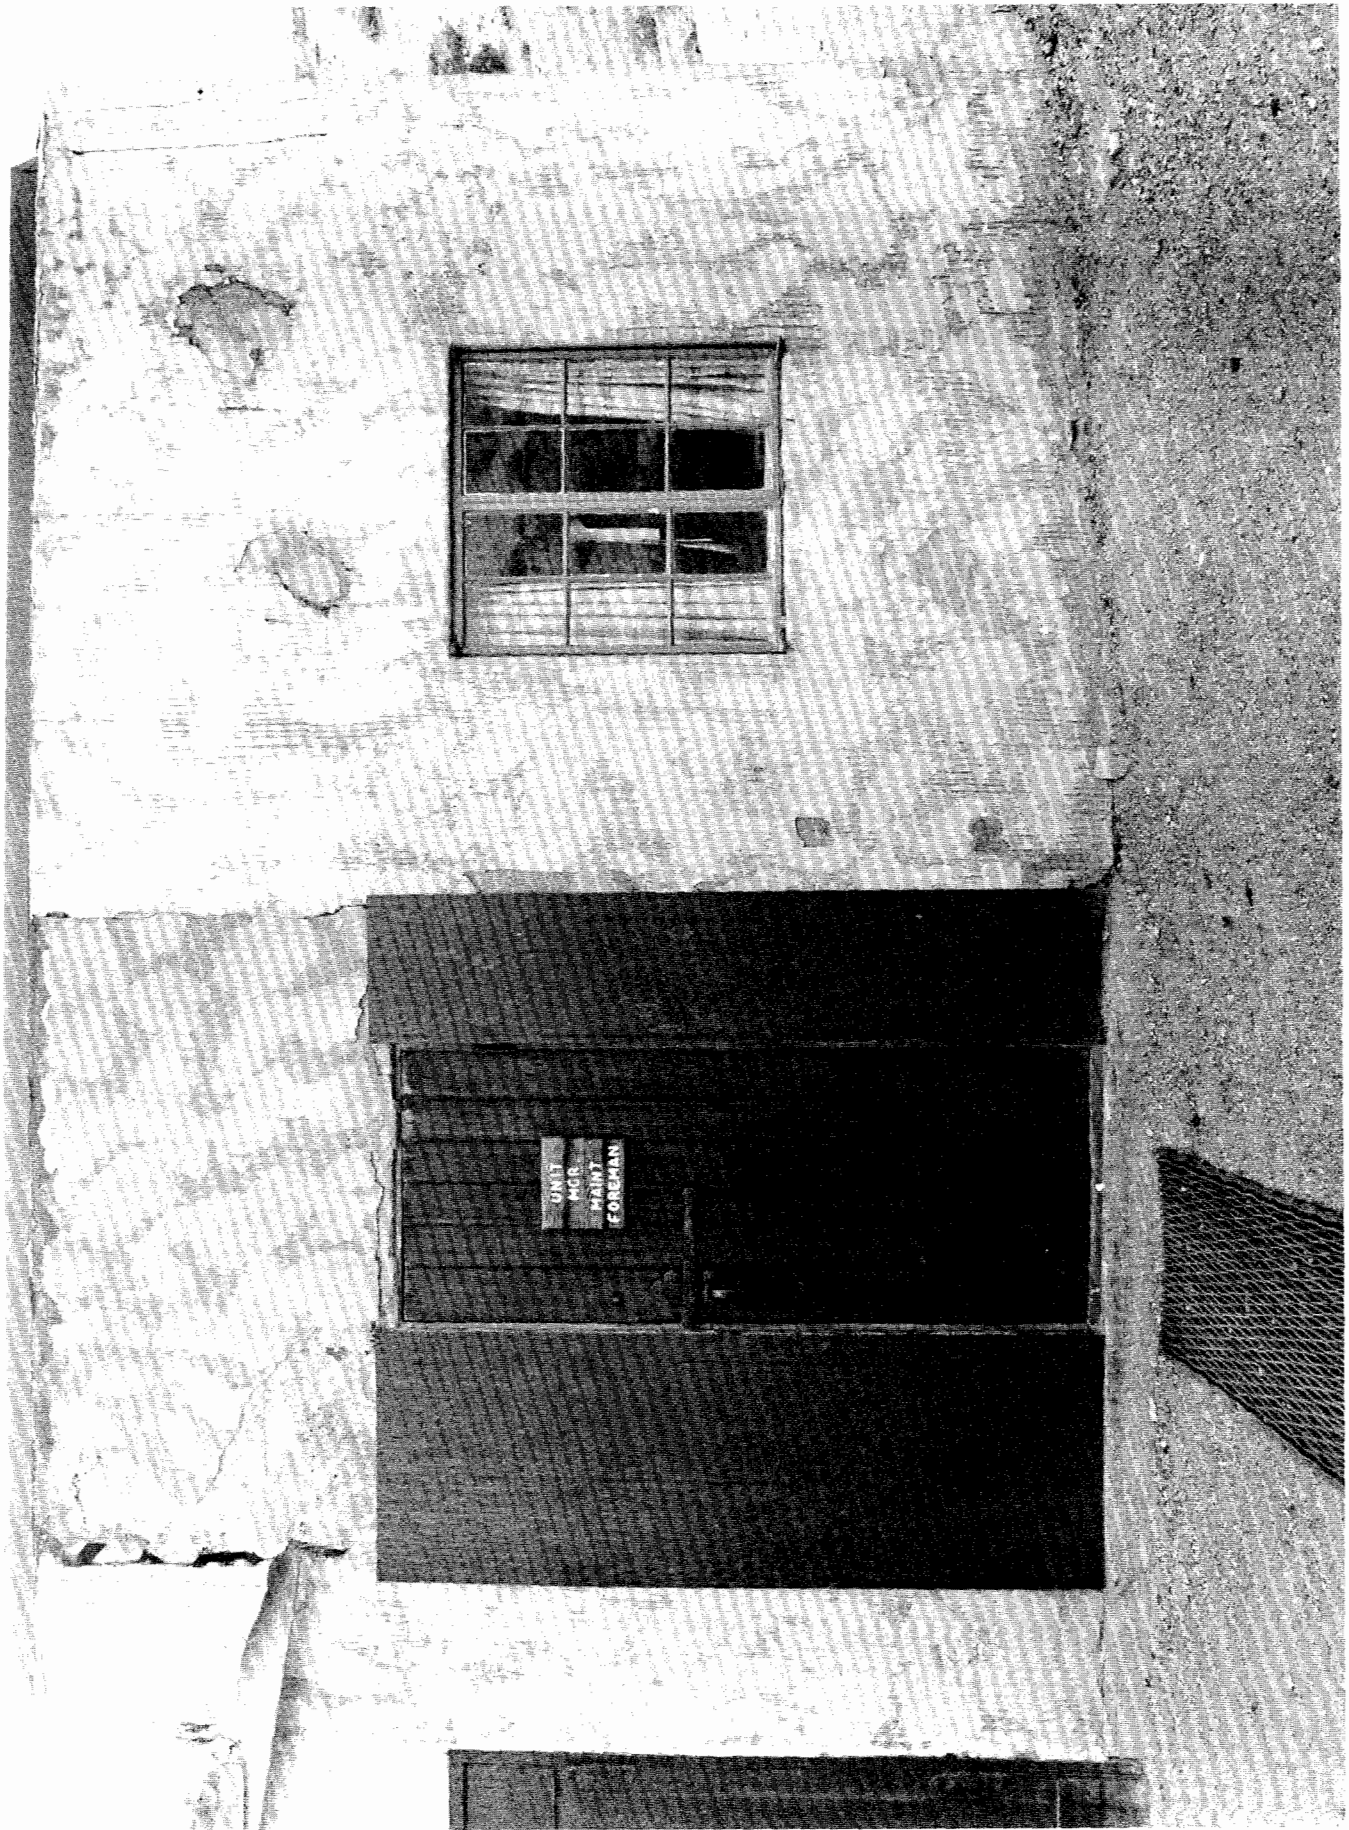
Figure 20

Cook House Annex: The stucco on this building is of a very poor quality but remains basically intact other than the east wall which sustained fire damage sometime during the Gospel Foundation period (figure 22). This wall was repaired with extremely poor-quality materials and workmanship. The stucco colors and technique on this building remain to be duplicated before any treatment can be made.

Figure 20. East wall of Cook House Annex, showing repair patches (ca. 1955) and plywood placed over areas of stucco loss (1983). M. Lawrence, 1985.

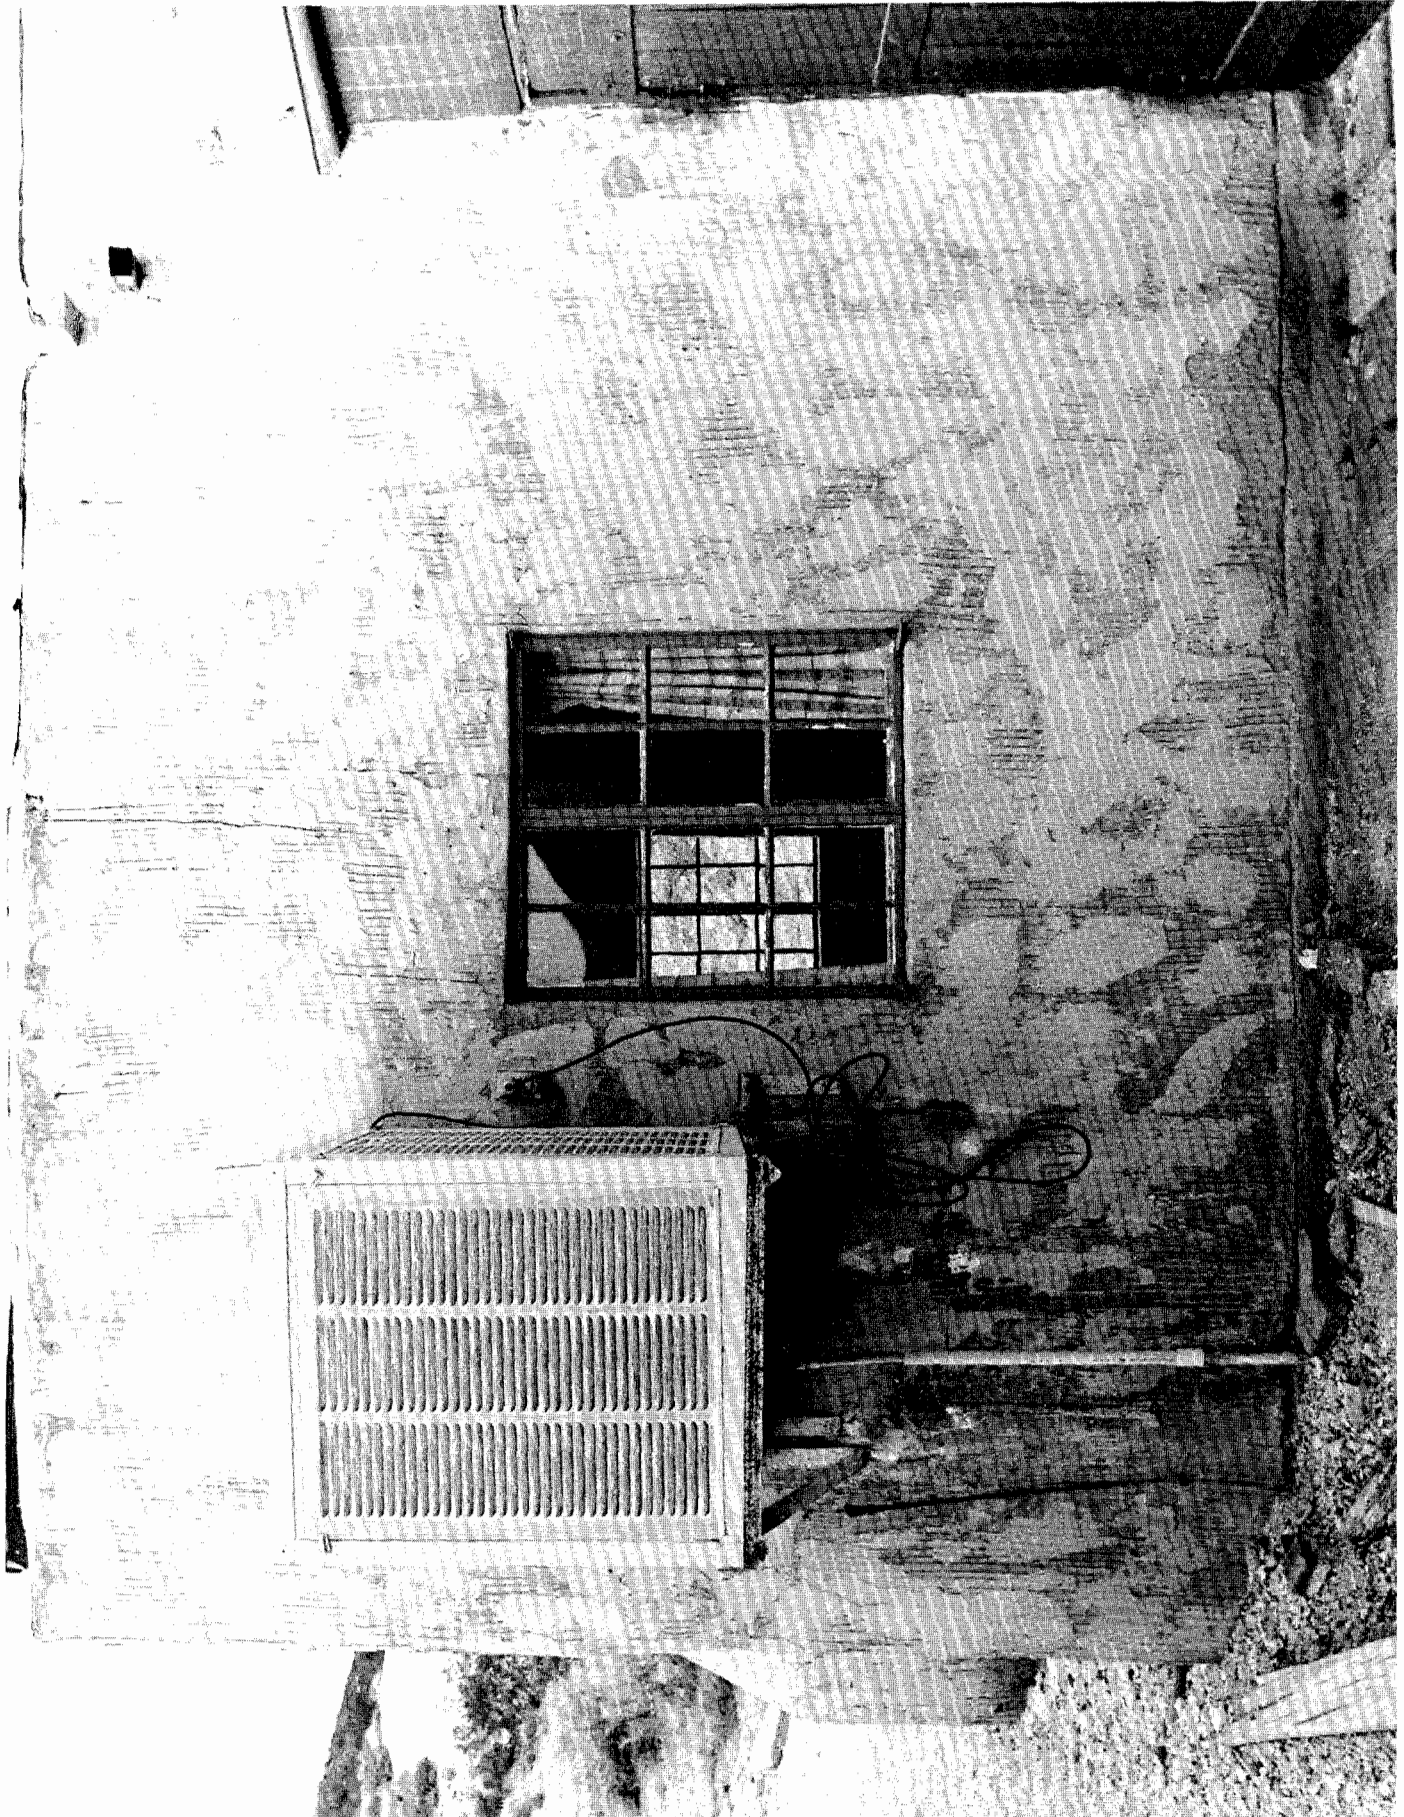
Figure 21

Figure 21. South Wall of Annex to Cook House. M. Lawrence
photo, 1985.

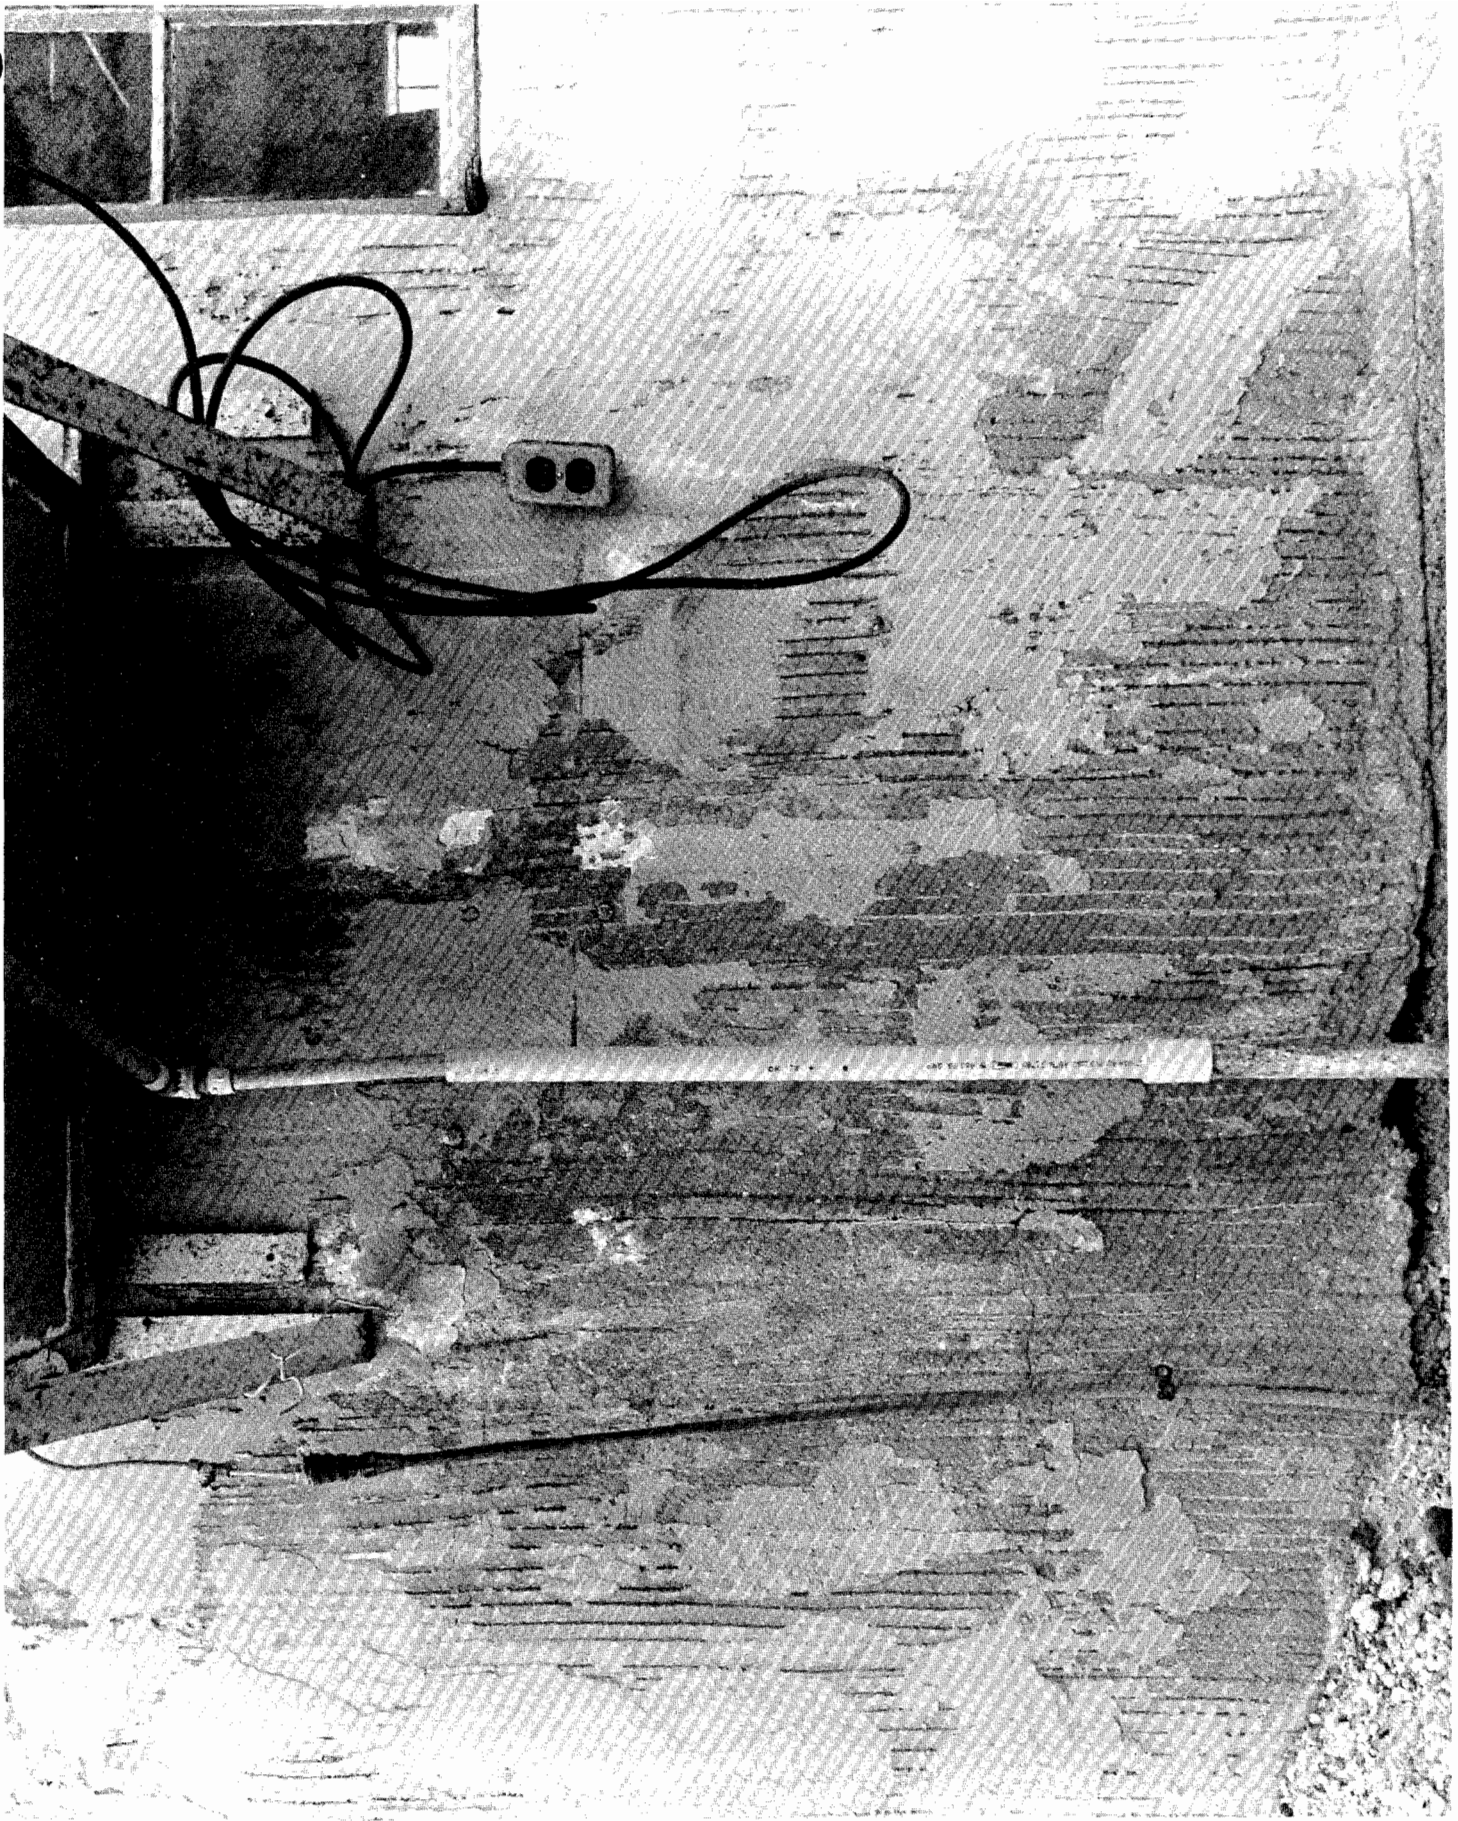
Figure 22

Figure 22. Close up of Figure 21, showing failed stucco under swamp cooler, south wall of Cook House Annex. M. Lawrence photo, 1985.
