HISTORIC GROUNDS REPORT AND MANAGEMENT PLAN

FREDERICK LAW OLMSTED
NATIONAL HISTORIC SITE
BROOKLINE, MASSACHUSETTS

By Lucinda Adele Whitehill

1982

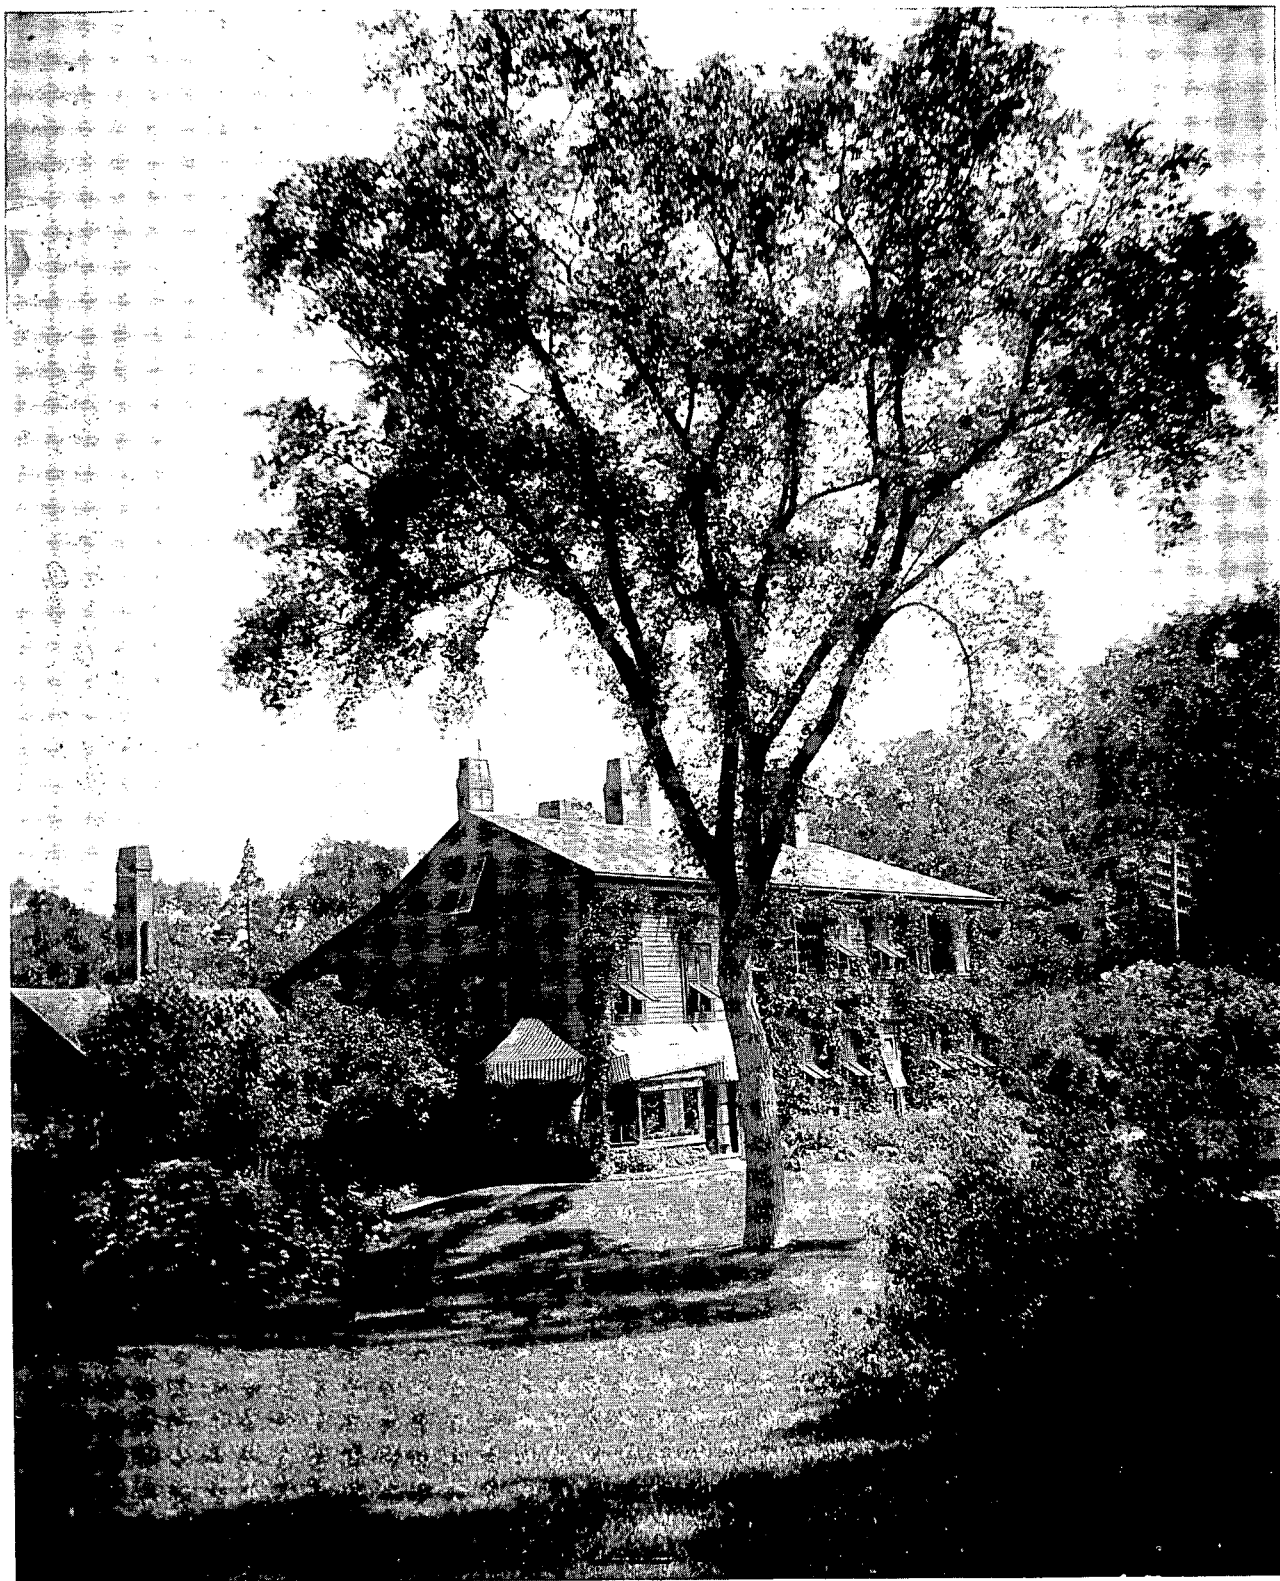
No Date. South Lawn. View Northeast. Note path pattern and plantings where pool and terrace currently stand.

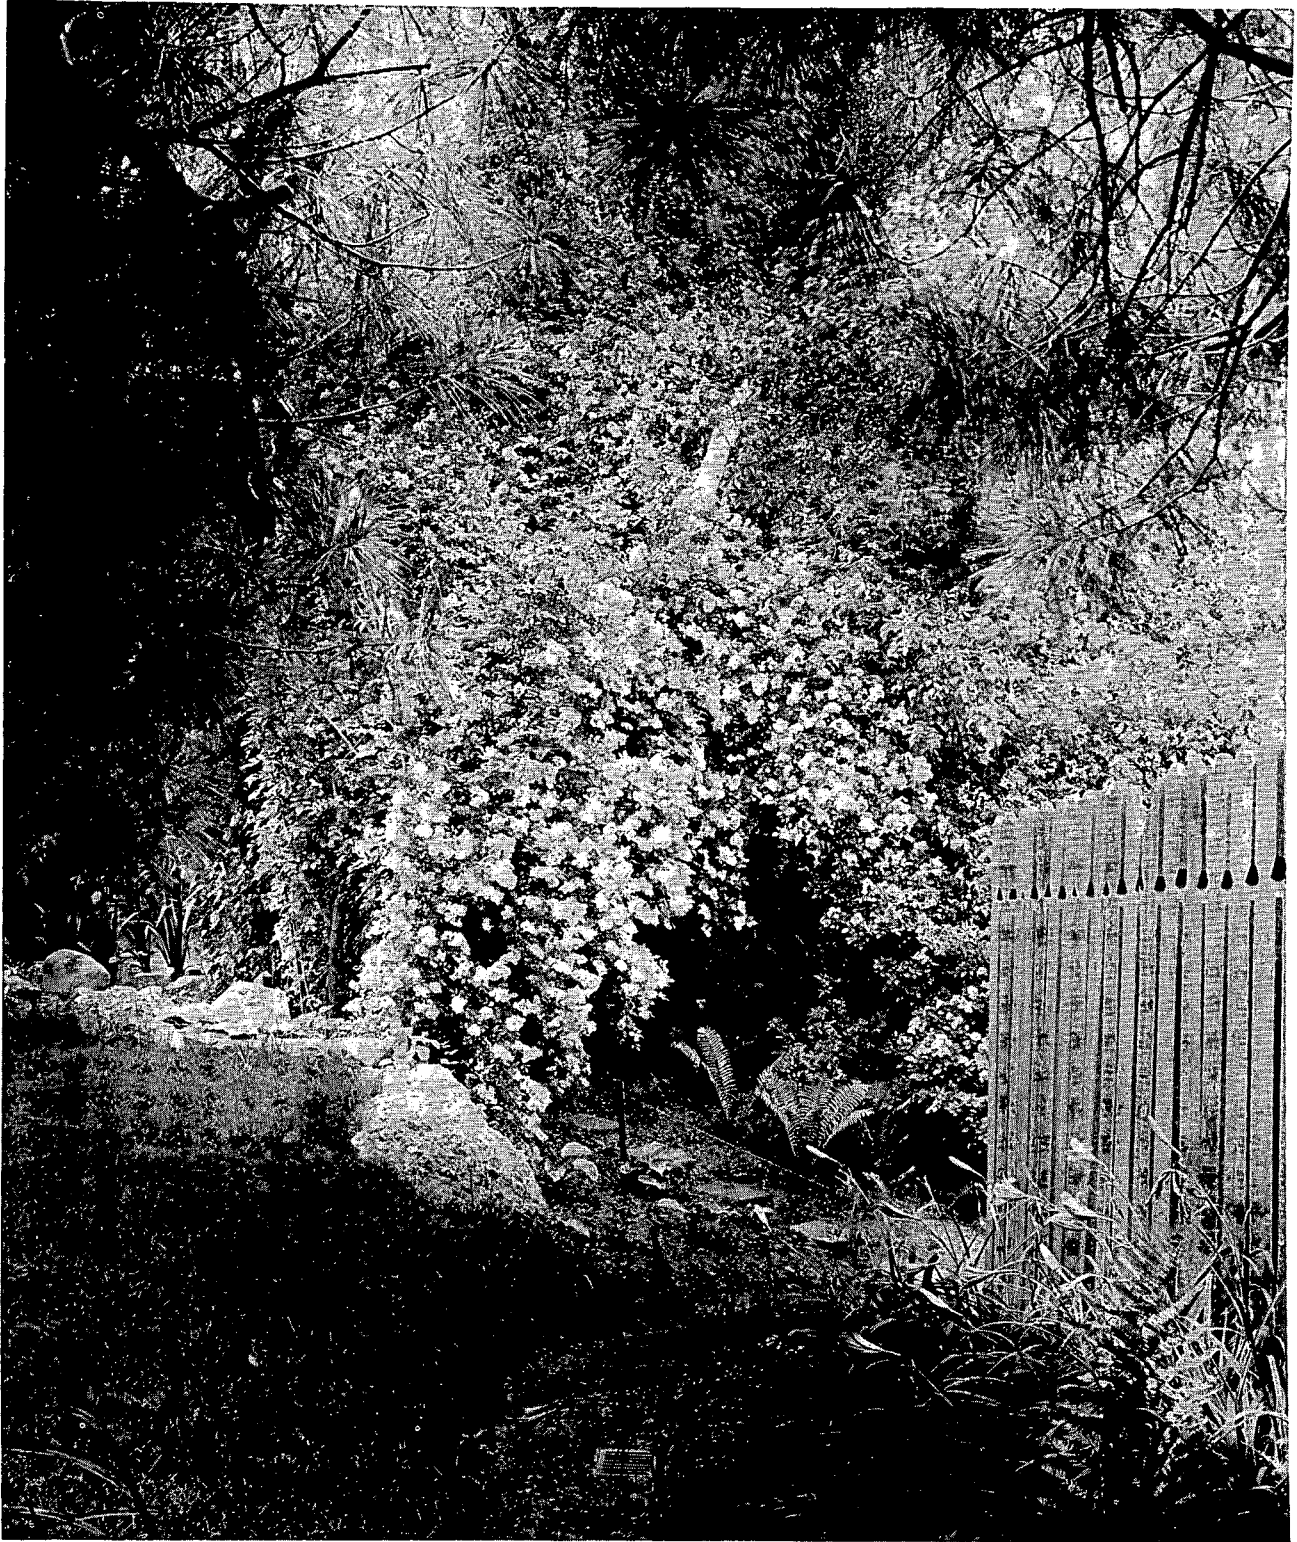
No Date. Rear Lawn. View North area just south of storage shed. This photo shows the variety of plant material and naturalists design which once dominated the site. None of the plants shown in this photo remain.

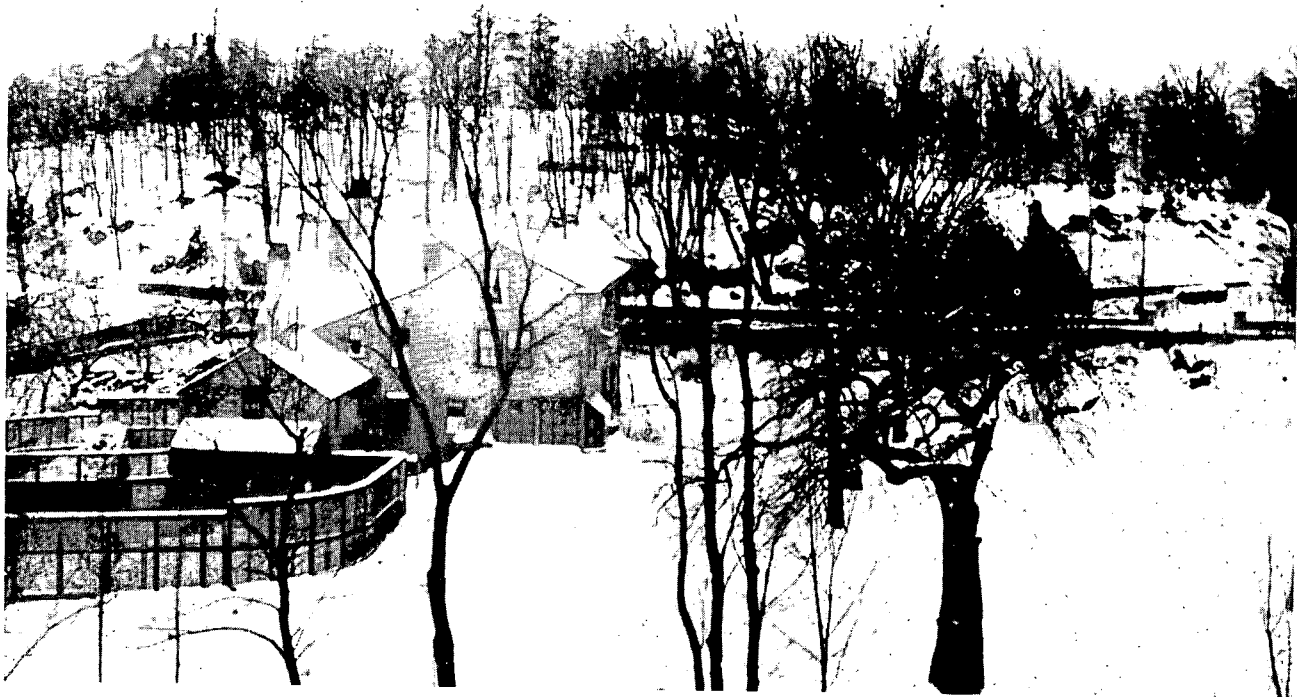
c. 1883. Fairsted. View East, taken prior to the barn being moved from the hill. Note open, farmlike appearance of the estate. Photo courtesy Frances Loeb Library, Harvard University.

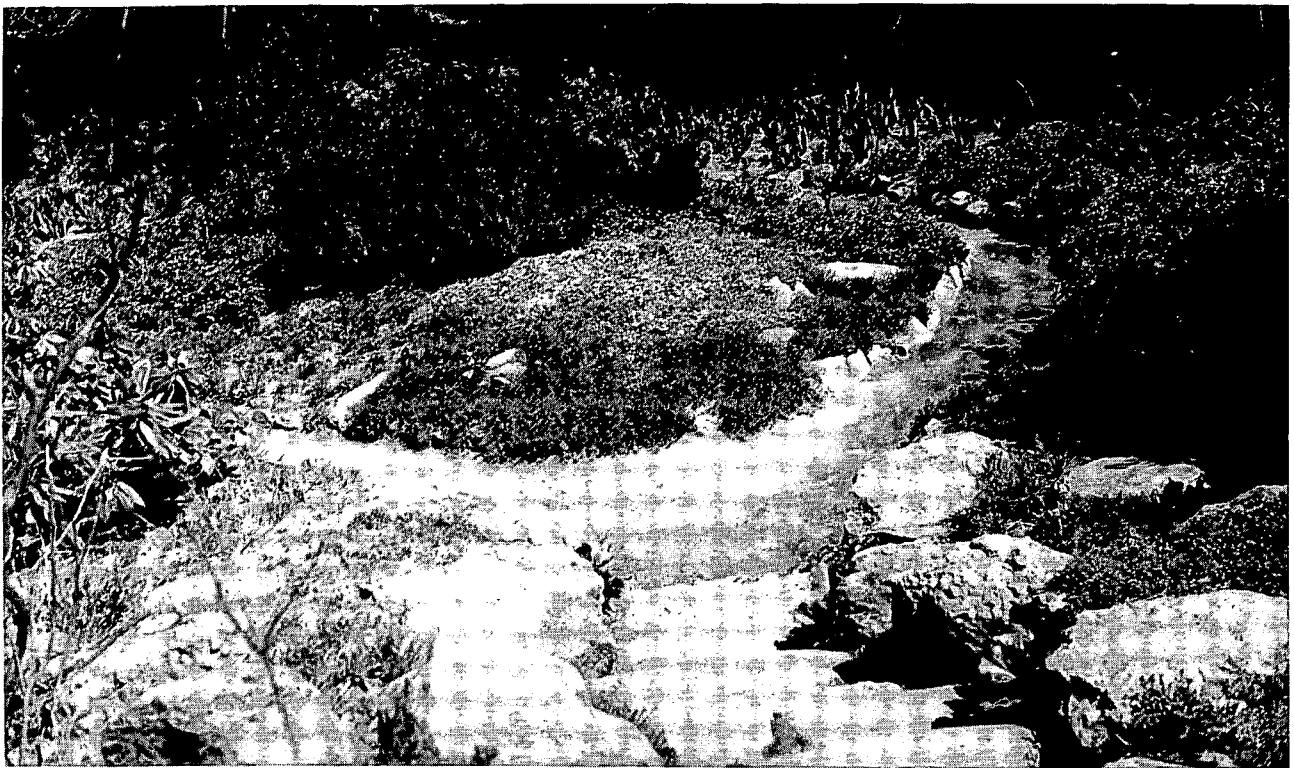
Spring 1926. The Hollow. Center Bed. View Northeast. Taken shortly after the new plantings were installed.

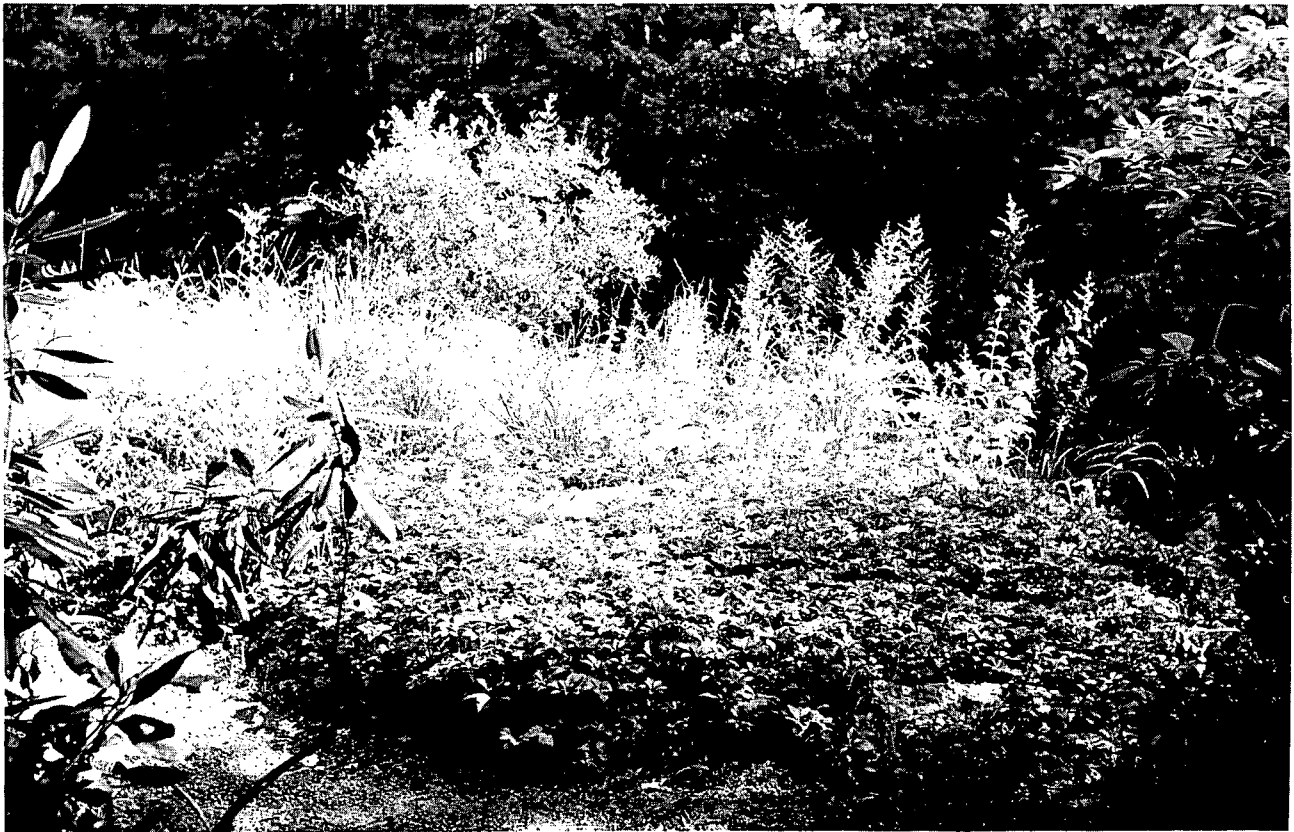
The hollow has serious overgrowth problems. The yews on the north bank have become out of scale with their surroundings, as have the azaleas and rhododendrons. Serious efforts have been made during this study period to rejuvenate these species, but more work will be necessary over the next few years to bring them back to their proper size. The boxwood behind the flowering dogwood is severely overgrown. Rejuvenation efforts are questionable for this species, therefore cuttings of the plant should be taken before any pruning begins. Many seedlings have taken hold at the base of the Canadian hemlocks in the northeast corner. These should be removed as soon as possible. They have no historic value and are robbing the hemlocks of nutrients and water, both of which are scarce to begin with. Woodbine, blackberries, black raspberries and goutweed are other weedy species which must be dealt with. If let go, these weeds will smother the other plant material.

1981. The Hollow. Center Bed. View Northeast. Today much of the area is overrun with weeds. The plant materials have been changed over time. Little remains of the 1926 plan.

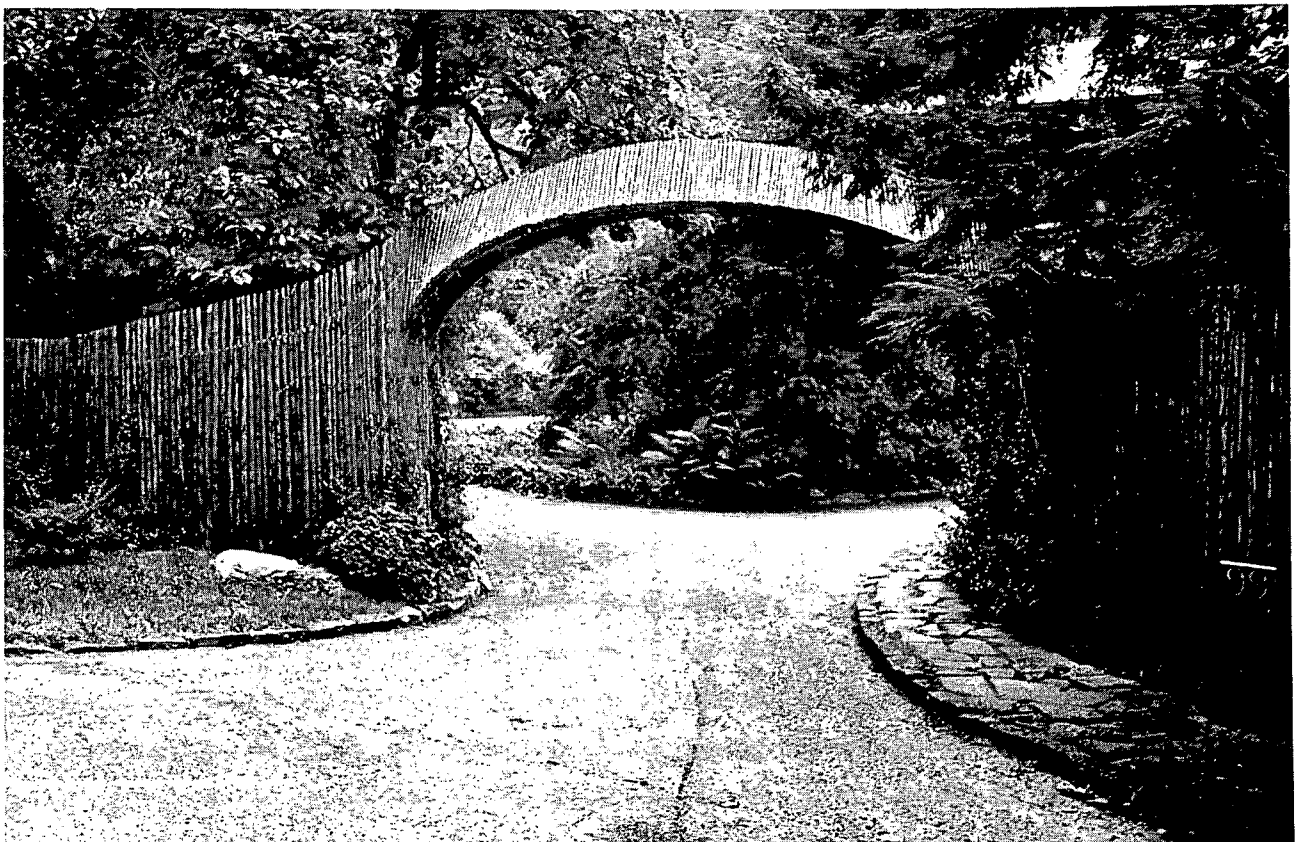
c. 1935. The Front Arch. View Southwest. The Euonymus just beginning in this photo eventually covered the arch.

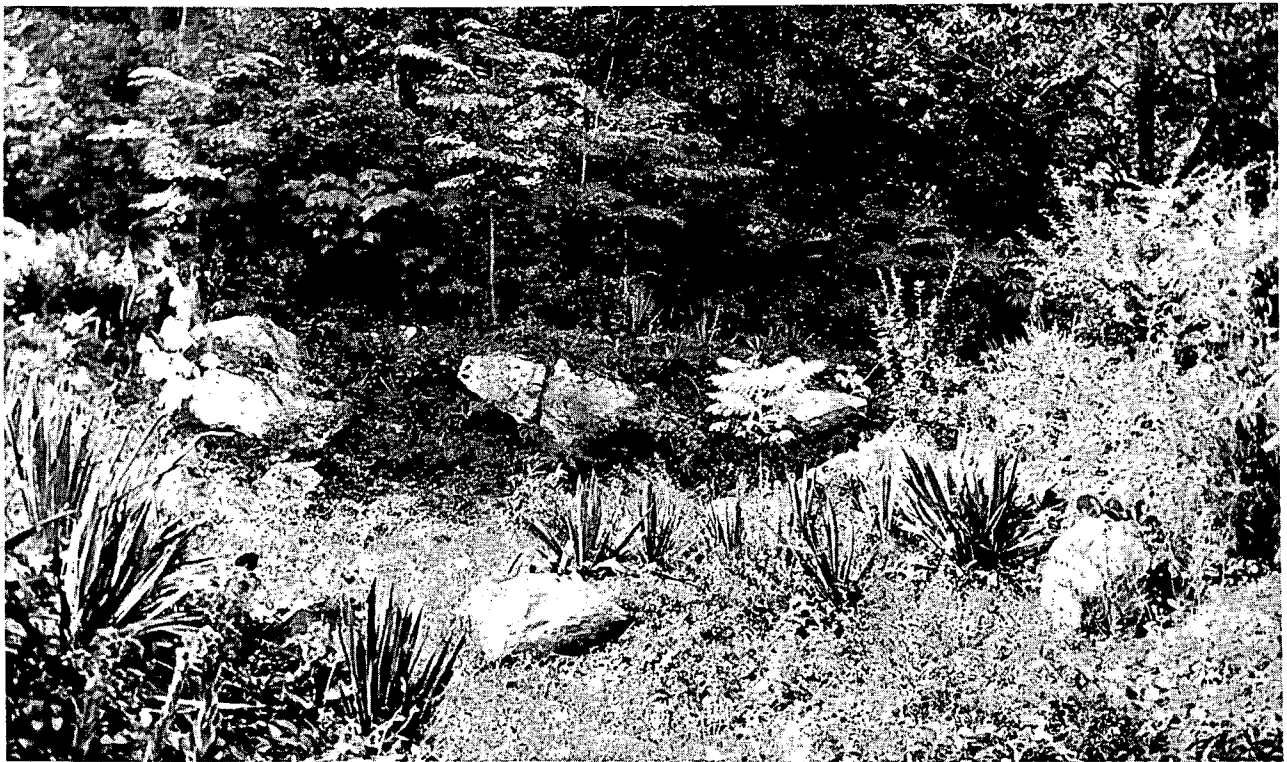
c. 1885. The Rock Garden. View South. This early design
included little shrubbery. It was replaced by the present design
in 1926. Photo courtesy Frances Loeb Library, Harvard University.

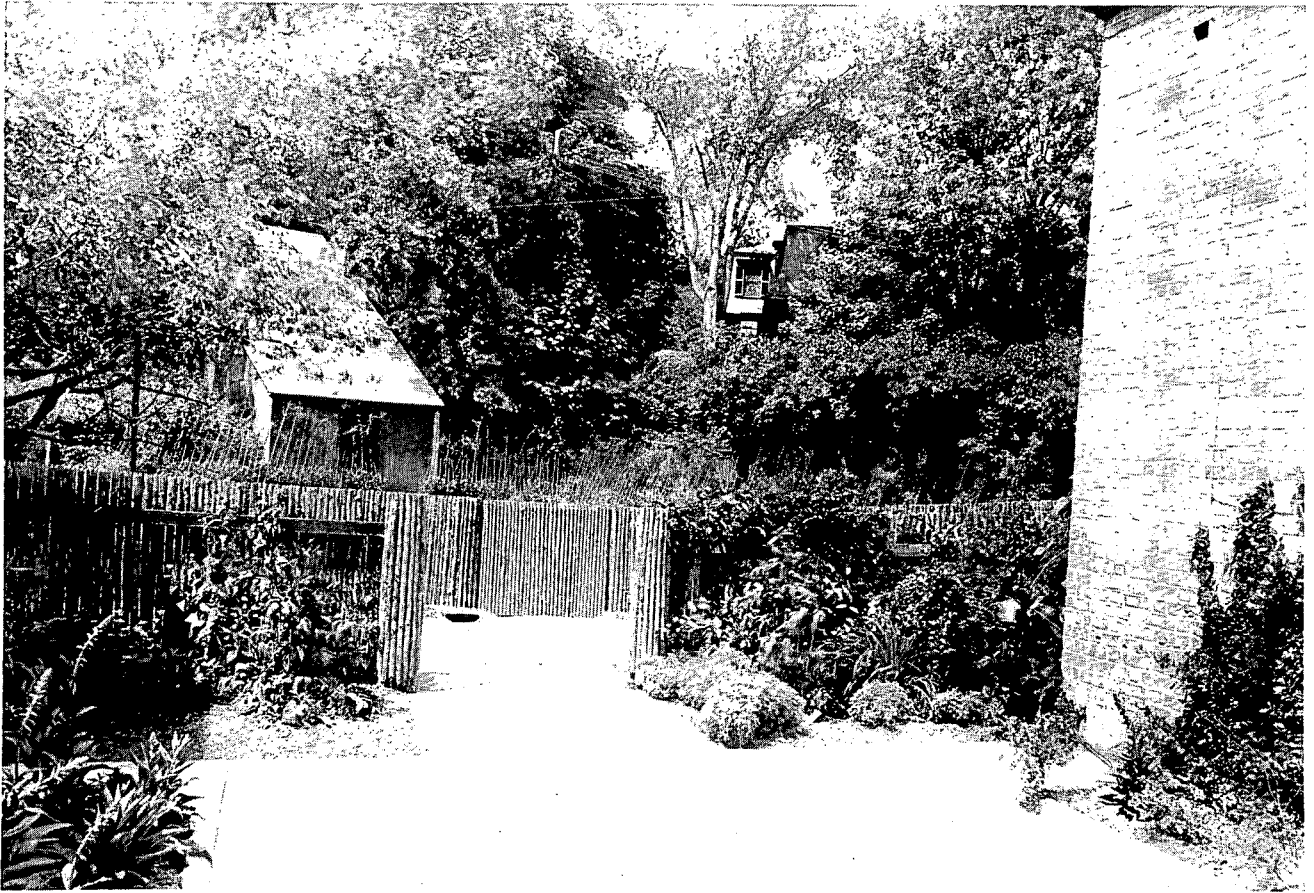
No Date (1901-1926) - Rear Office Entry Courtyard. View West to Annual Garden. Note the informal plantings and the intimacy which once characterized this area.

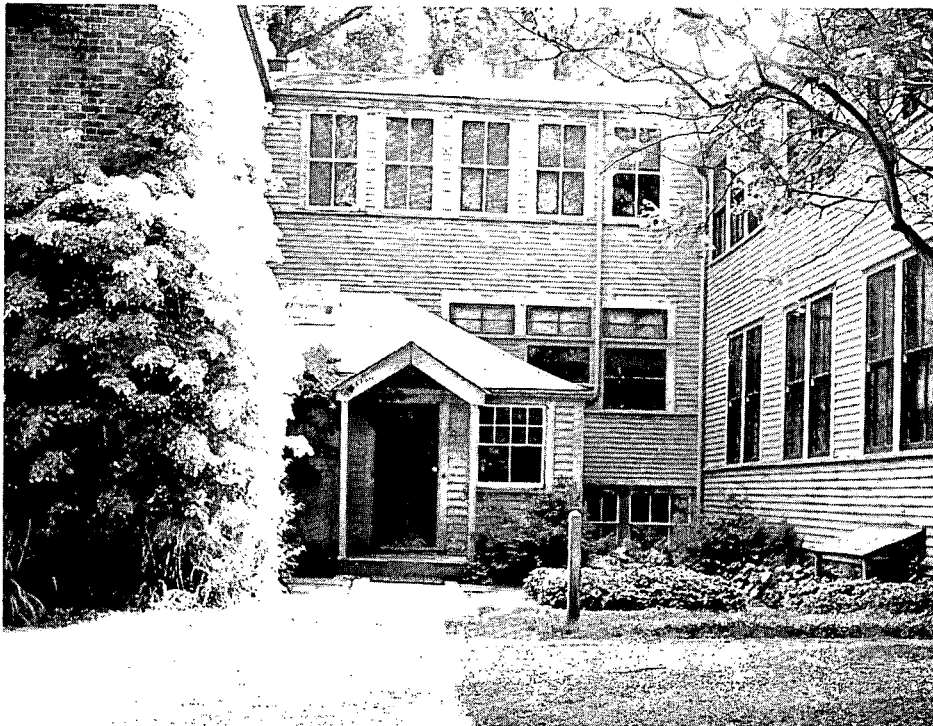
Today, little remains in this area. Two large goatsbeard, a few ostrich ferns and remnants of daylilies line the border beds. The rectangular center bed is half filled with pachysandra. The remaining half contains goutweed which is a major problem in this area. The climbing hydrangea adorns more than half of the vault wall and is truly spectacular. This area will need to be replanted almost entirely to restore its former glory. The hydrangea, pachysandra and goatsbeard may possibly remain unless an exact restoration is desired. The plans that do exist are very detailed and the plant material used would not be difficult to obtain today. Serious consideration of these plans should be part of the landscape management plan. The area could be colorful and spectacular once it is restored.

1981 - Rear Office Entry Courtyard. View East from Parking Lot.
