**Grand Canyon Village
National Historic Landmark District
Cultural Landscape Report**

**Grand Canyon National Park
Arizona**

January 2004

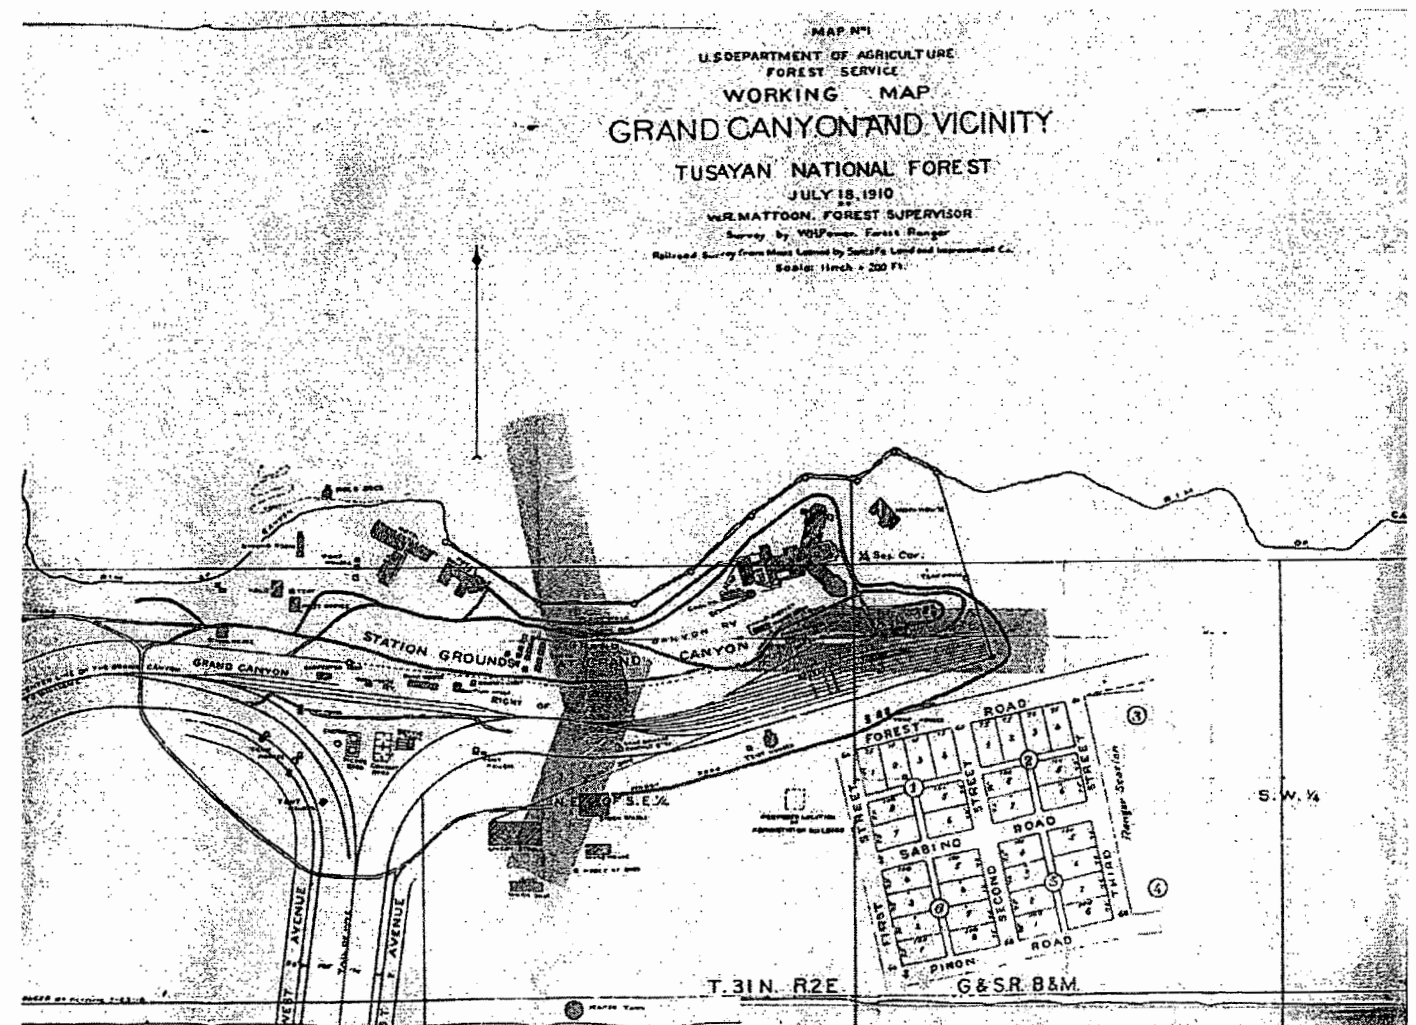
Figure 12. 1909 Guide Map of Grand Canyon National Monument. (Grand Canyon Museum Collection Catalog #27764)

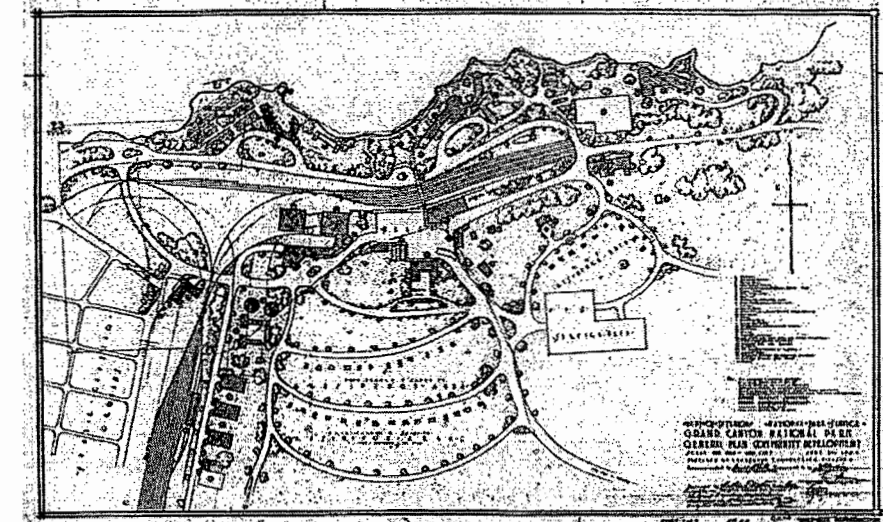
Figure 18. "Grand Canyon National Park General Plan [for] Community Development," 1924. (Grand Canyon Museum Collection Catalog #71367)

In 1920, NPS landscape architects Daniel Hull and Paul P. Kiesege undertook a thorough study of the landscape at the Grand Canyon Village. In 1921, Hull began developing plans for the layout of the Village. In 1924, his Community Development Plan was adopted for Grand Canyon Village (Figure 18). This comprehensive plan was the result of a public-private collaboration between Hull, the Santa Fe Railroad, and the latter's consultants, the Chicago architecture and planning firm of Graham, Anderson, Probst and White.³⁵

Hull's 1924 plans reiterated Waugh's proposal for a plaza or "Village Square" near the terminus of the railroad track, with the proposed administration building to be located on the north side. Hull left the vacant areas on the rim undeveloped and instead attempted to locate services and residential areas away from the rim. His design applied Johnston's and Leopold's zoning ideas and emphasized the use of existing vegetation and the area's topography for aesthetic effect. Ethan Carr maintains that Hull's 1924 plan for Grand Canyon Village "would become the essential blueprint for construction in the Village over the next twenty years."³⁶

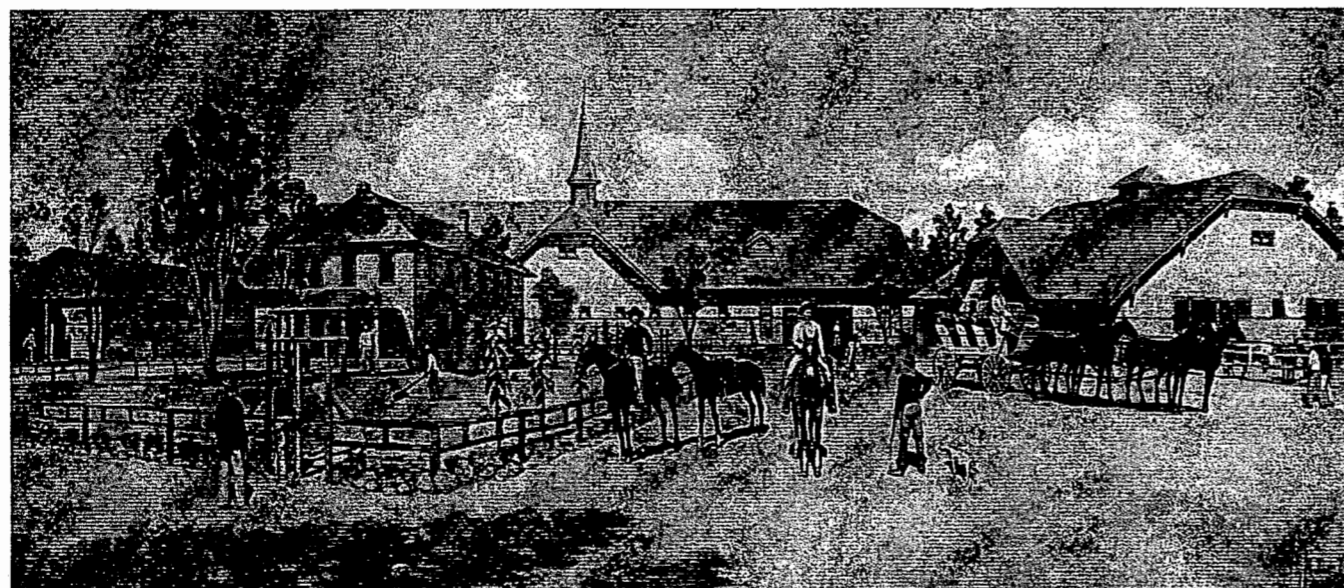
Figure 21. 1905 artist's rendering of the planned El Tovar stables complex, including (from left to right) the Blacksmith Shop, Wranglers' Dormitory, Livery Stable, and Mule Barn, drawn from an imaginary perspective before the buildings were constructed. (from Michael F. Anderson's *Along the Rim*, 32)

Between 1901 and 1914, nearly fifty permanent and temporary structures were erected near the terminus of the Grand Canyon Railway. Most of these structures were related to the developing tourist industry and associated service and residential needs. They included stables, a railroad depot, a power house, and numerous modest residences for railroad and Fred Harvey employees (*Figures 20, 21, and 22*).⁶⁹

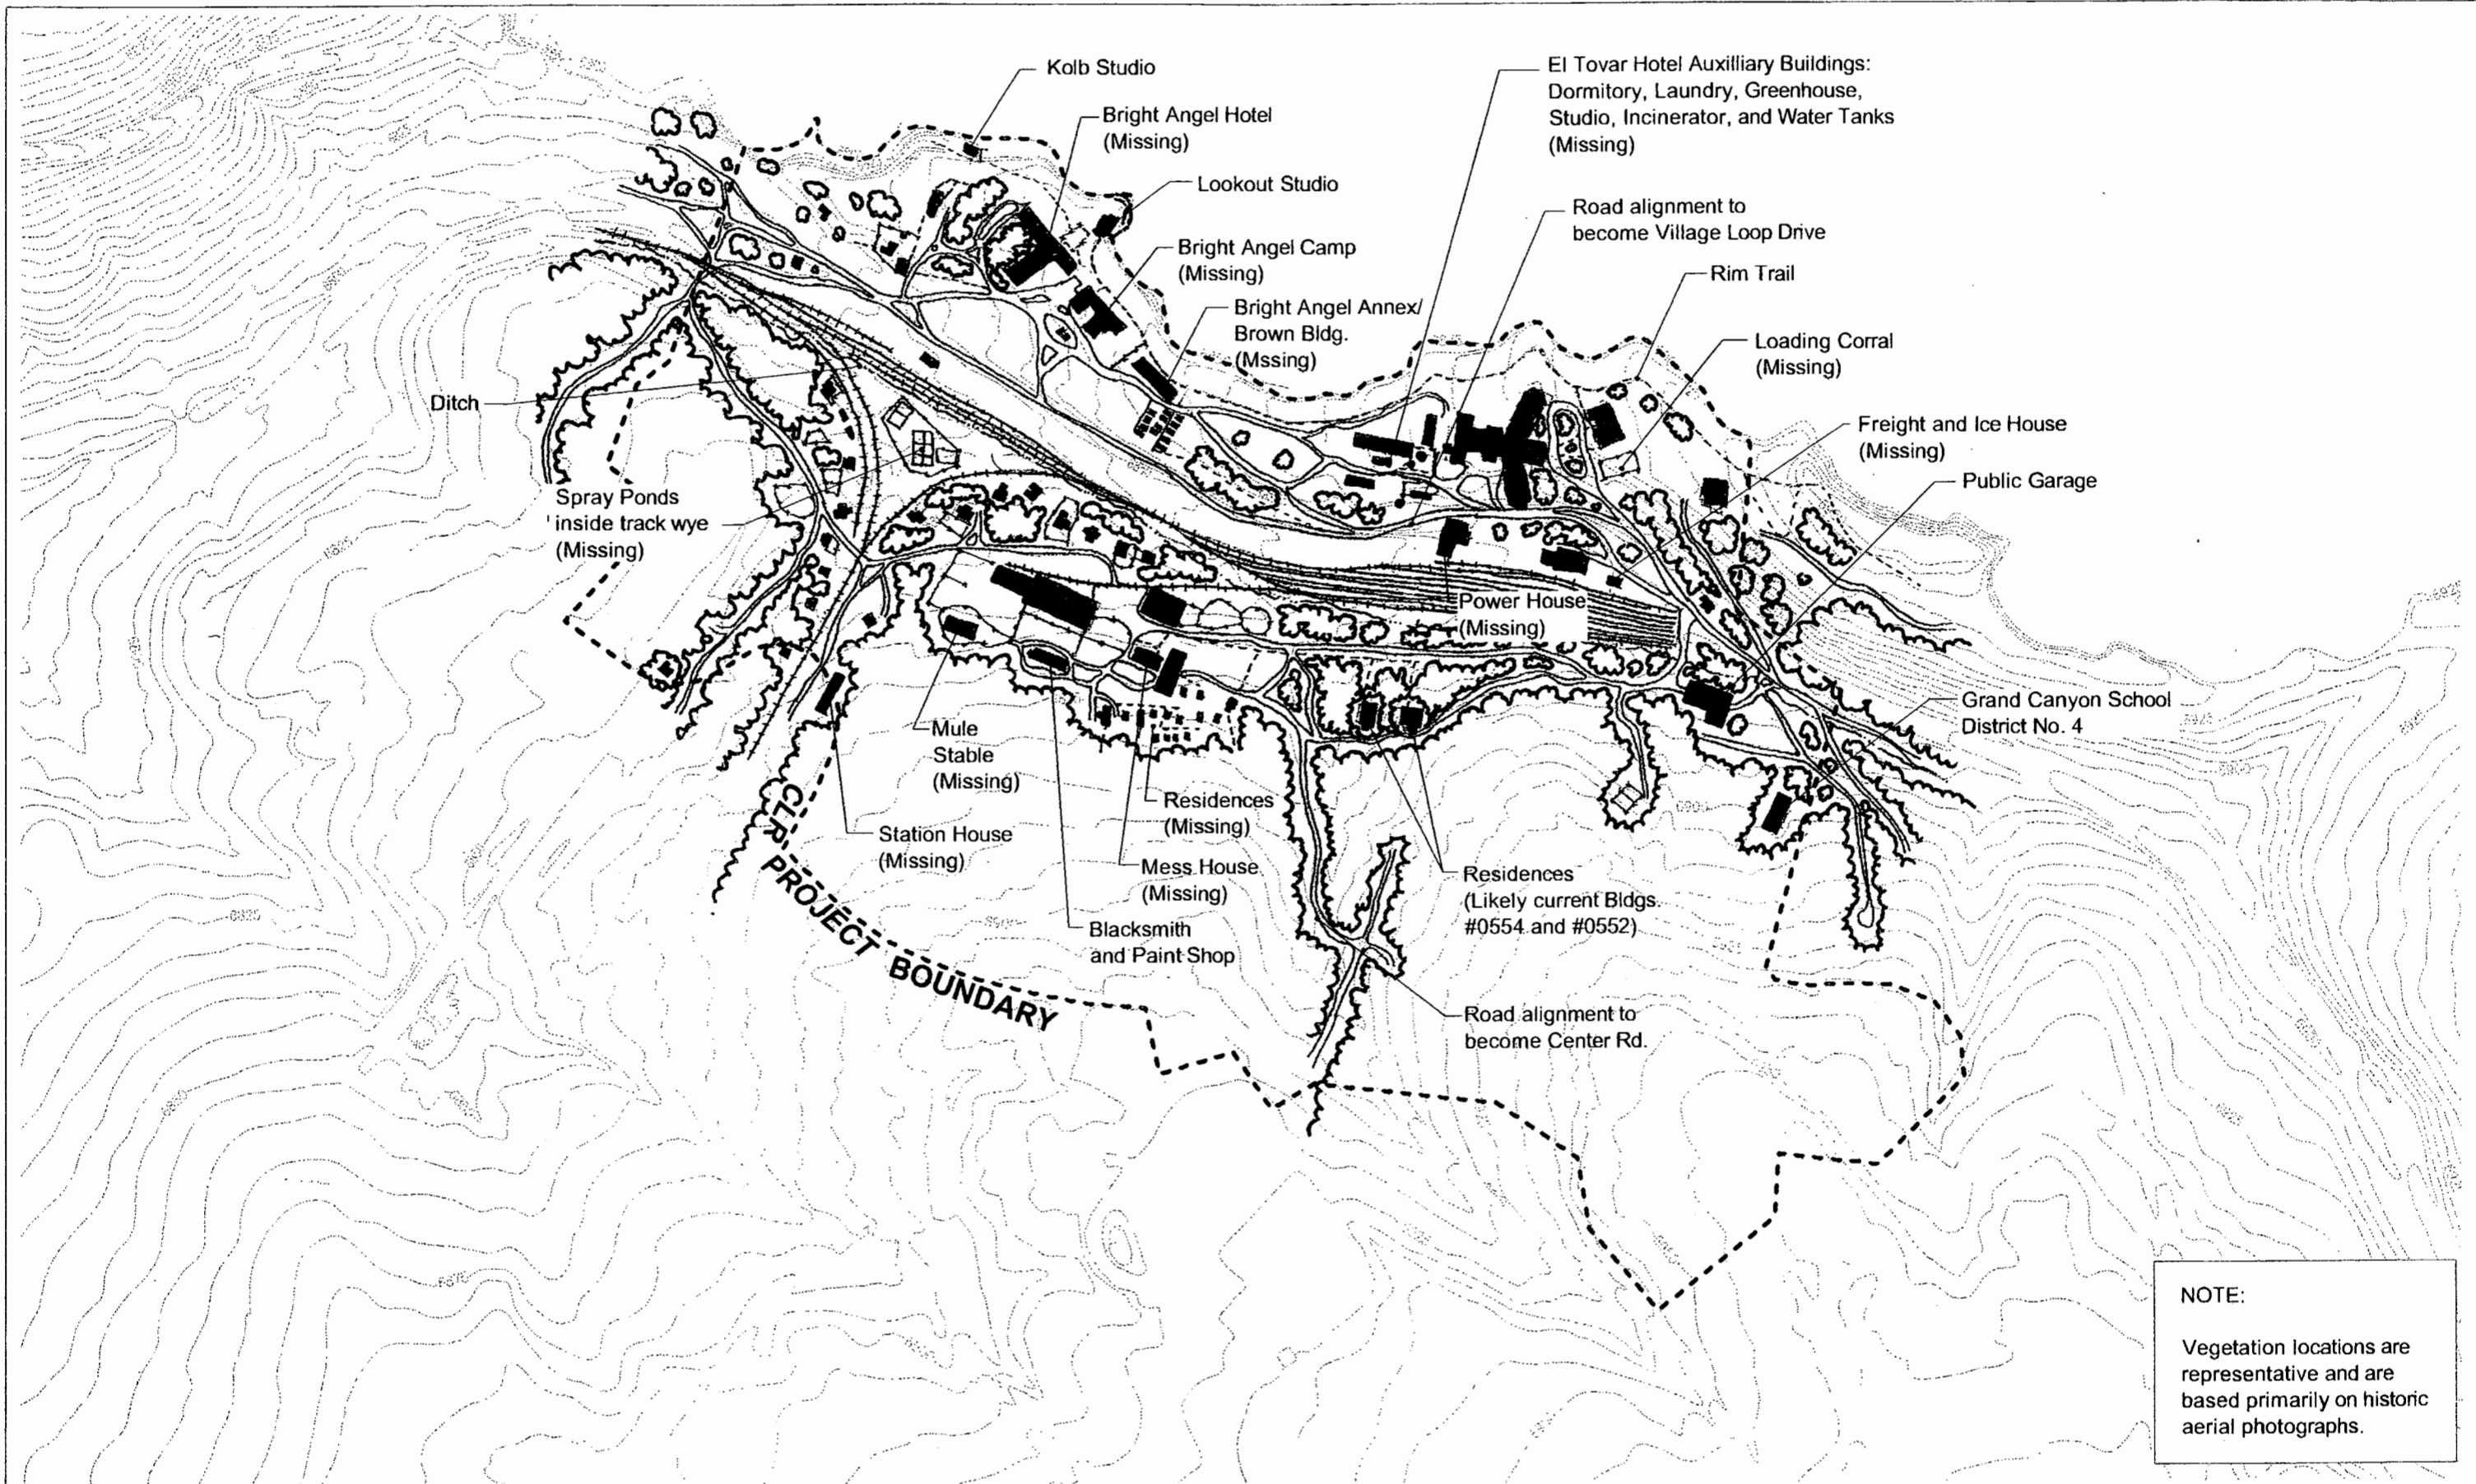
DRAWING NO.	113
	20223
PKG. NO.	
SHEET	1
OF	67

Map Sources: Working Plan Grand Canyon Tusayan Nat. For. Rim Area, Aug. 1917; Water Development Project at Grand Canyon, Arizona, February 1920/Revised 1931; National Historic Landmark nomination, 1997; and historic aerials and photographs.

NOTE:
 Vegetation locations are representative and are based primarily on historic aerial photographs.

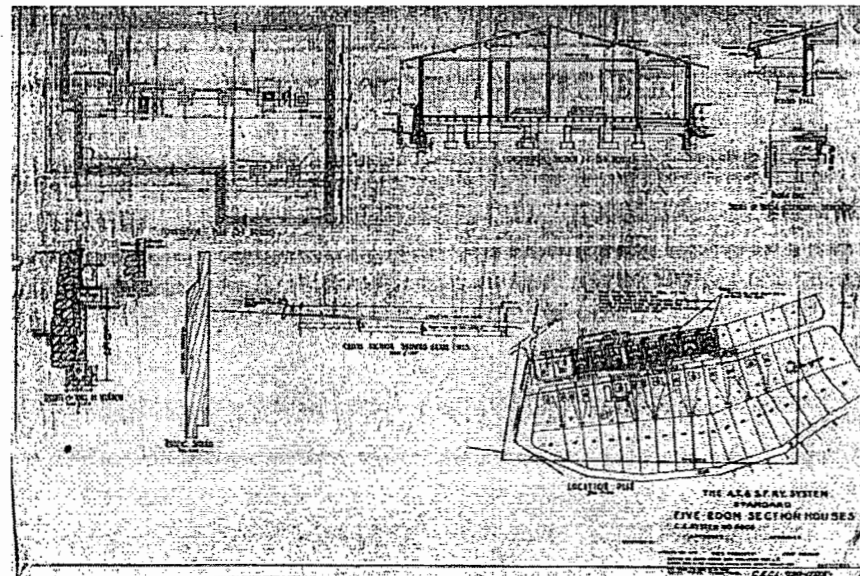
Figure 27 1929 Plan: "A.T.&S.F. Ry. System Standard Five Room Section Houses."(Grand Canyon Museum Collection Catalog #68100)

Despite this, the Fred Harvey Company, the primary concessionaire at Grand Canyon Village, constructed or upgraded several projects on the South Rim. In Grand Canyon Village, the company constructed several "utility buildings" such as a new auto paint shop and garages for the employee residences (*Figures 27, 28, and 29*).

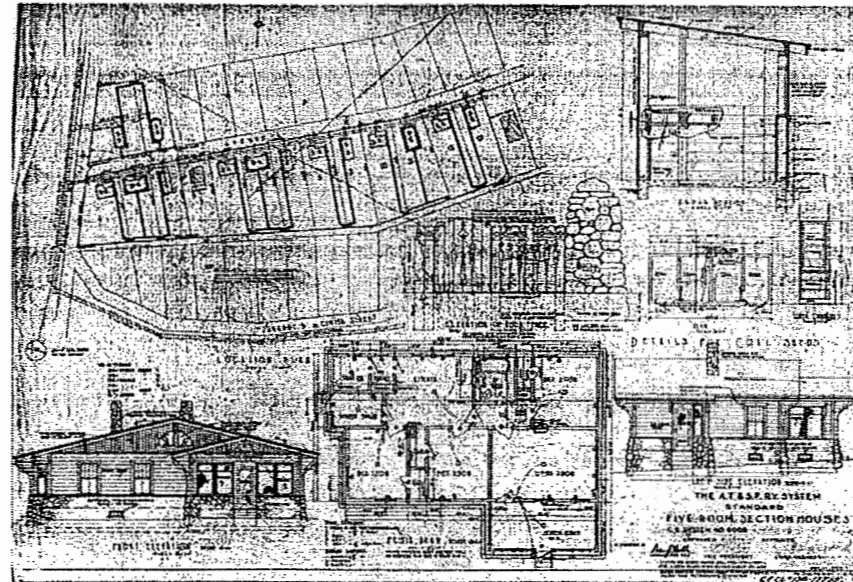
Figure 28. 1929 Plan: "A.T.&S.F. Ry. System Standard Five Room Section Houses." Note stone fence pier near center of plan. (Grand Canyon Museum Collection Catalog #68100)

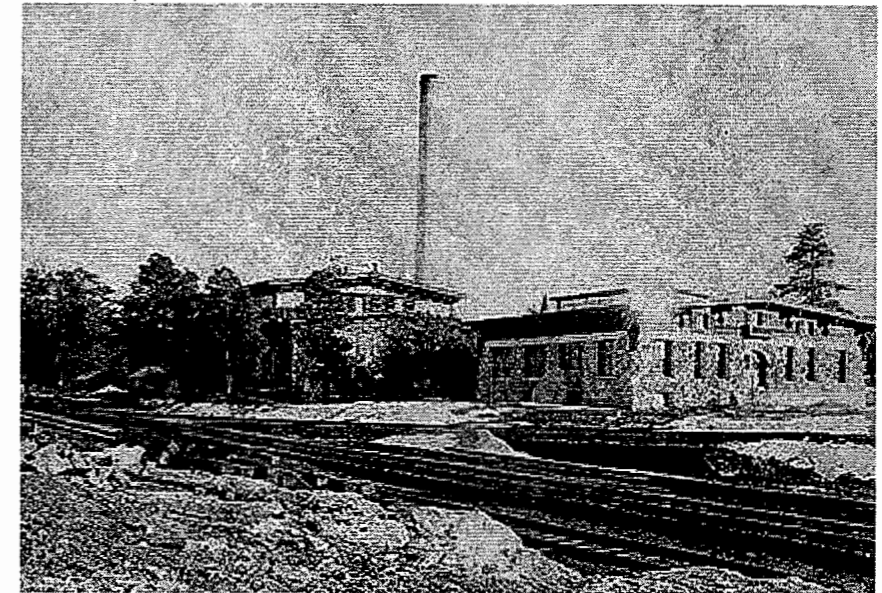
Figure 29. Laundry and Power House, photo undated. (Cline Library, NAU)

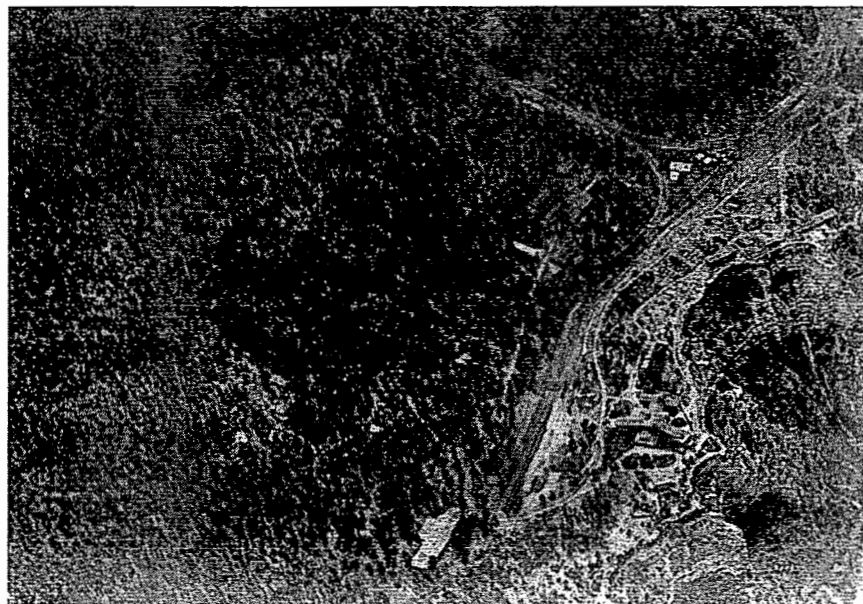
Figure 30. Pre-1925 aerial photo of the Village. Note the absence of Center Road and concessionaire utility buildings. (Grand Canyon Museum Collection Catalog #13639-13644)

In 1925, at the eighth National Parks Conference that was held at Mesa Verde National Park, then assistant and associate NPS directors Horace Albright and Arno Cammerer advocated the creation of "general development plans" for all national parks. The impetus for such plans derived from the massive road building program initiated after the 1924 roads and trails appropriations bill, and from the subsequent establishment of a cooperative agreement with the BPR.⁸² (Refer to *Figure 30* for an aerial view of the Village during this era.)

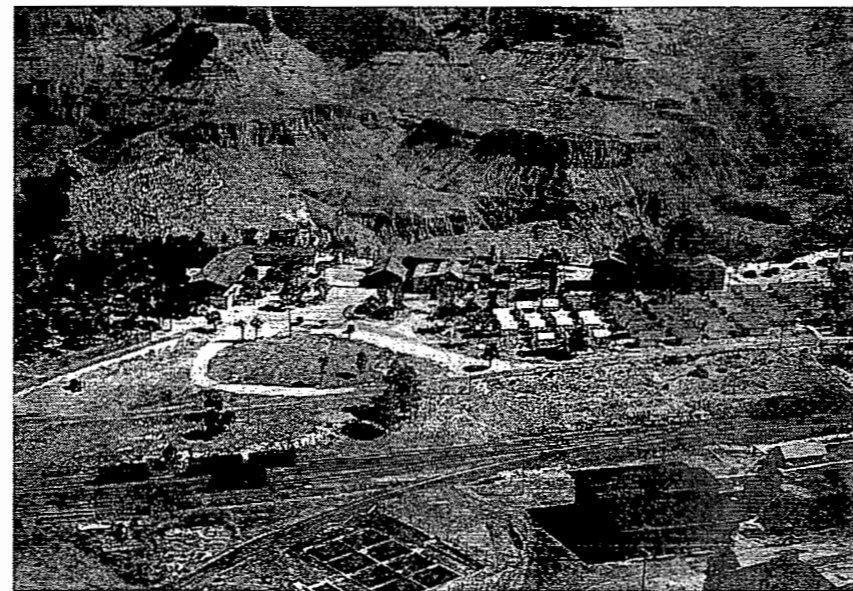
Figure 31. Photograph ca. 1930s showing spray ponds and Bright Angel Camp. (from Michael F. Anderson, *Along the Rim*, page 11).

Between 1930 and 1933, visitor numbers at the Grand Canyon dropped over 60 percent, with attendance numbers falling to pre-1925 levels. In addition, park operators sustained significant revenue losses as large as 48 percent below their 1929 peak.⁸⁴ (Refer to *Figures 31* and *32* for aerial views of the Village during this era.)

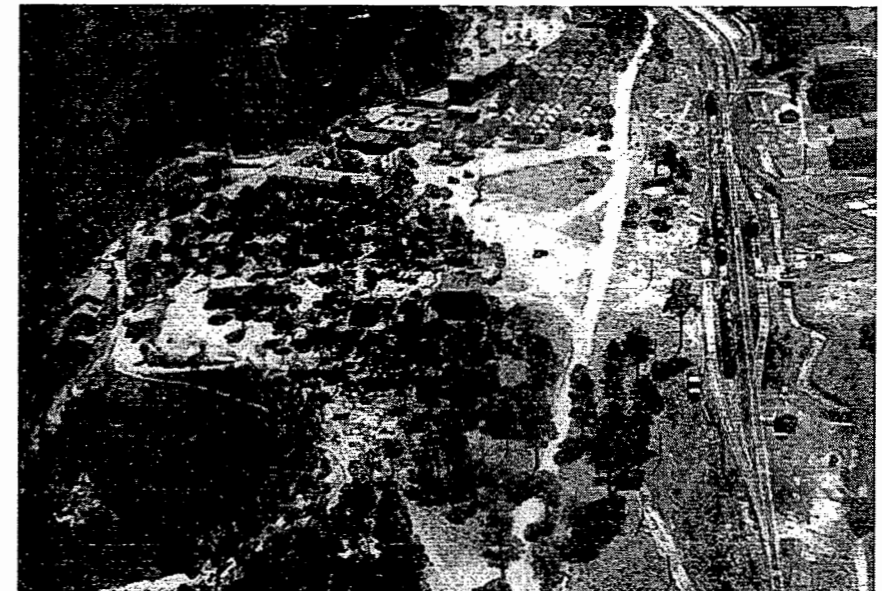
Figure 32. 1932 aerial photo of Bright Angel Hotel complex taken prior to development of Mary E.J. Colter's Bright Angel Lodge. (Grand Canyon Museum Collection Catalog #9543)

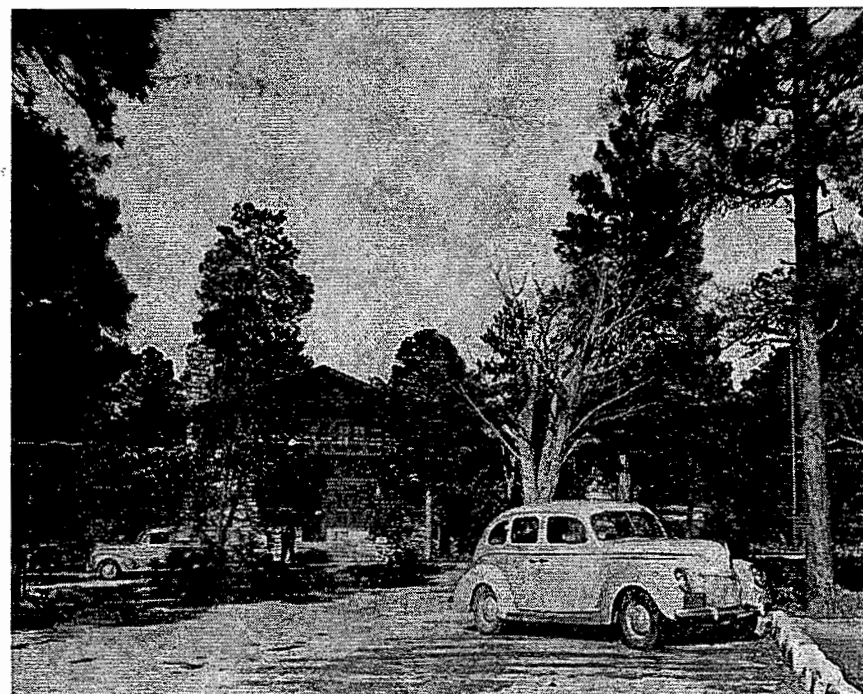
Figure 33. Circa 1930 photo of the west façade of the second NPS Administration Building (built 1929) taken from the parking area in the "public plaza." The plaza, designated as such on the 1924 Master Plan, was used as a parking area from the time it was completed. (Grand Canyon Museum Collection #9504)

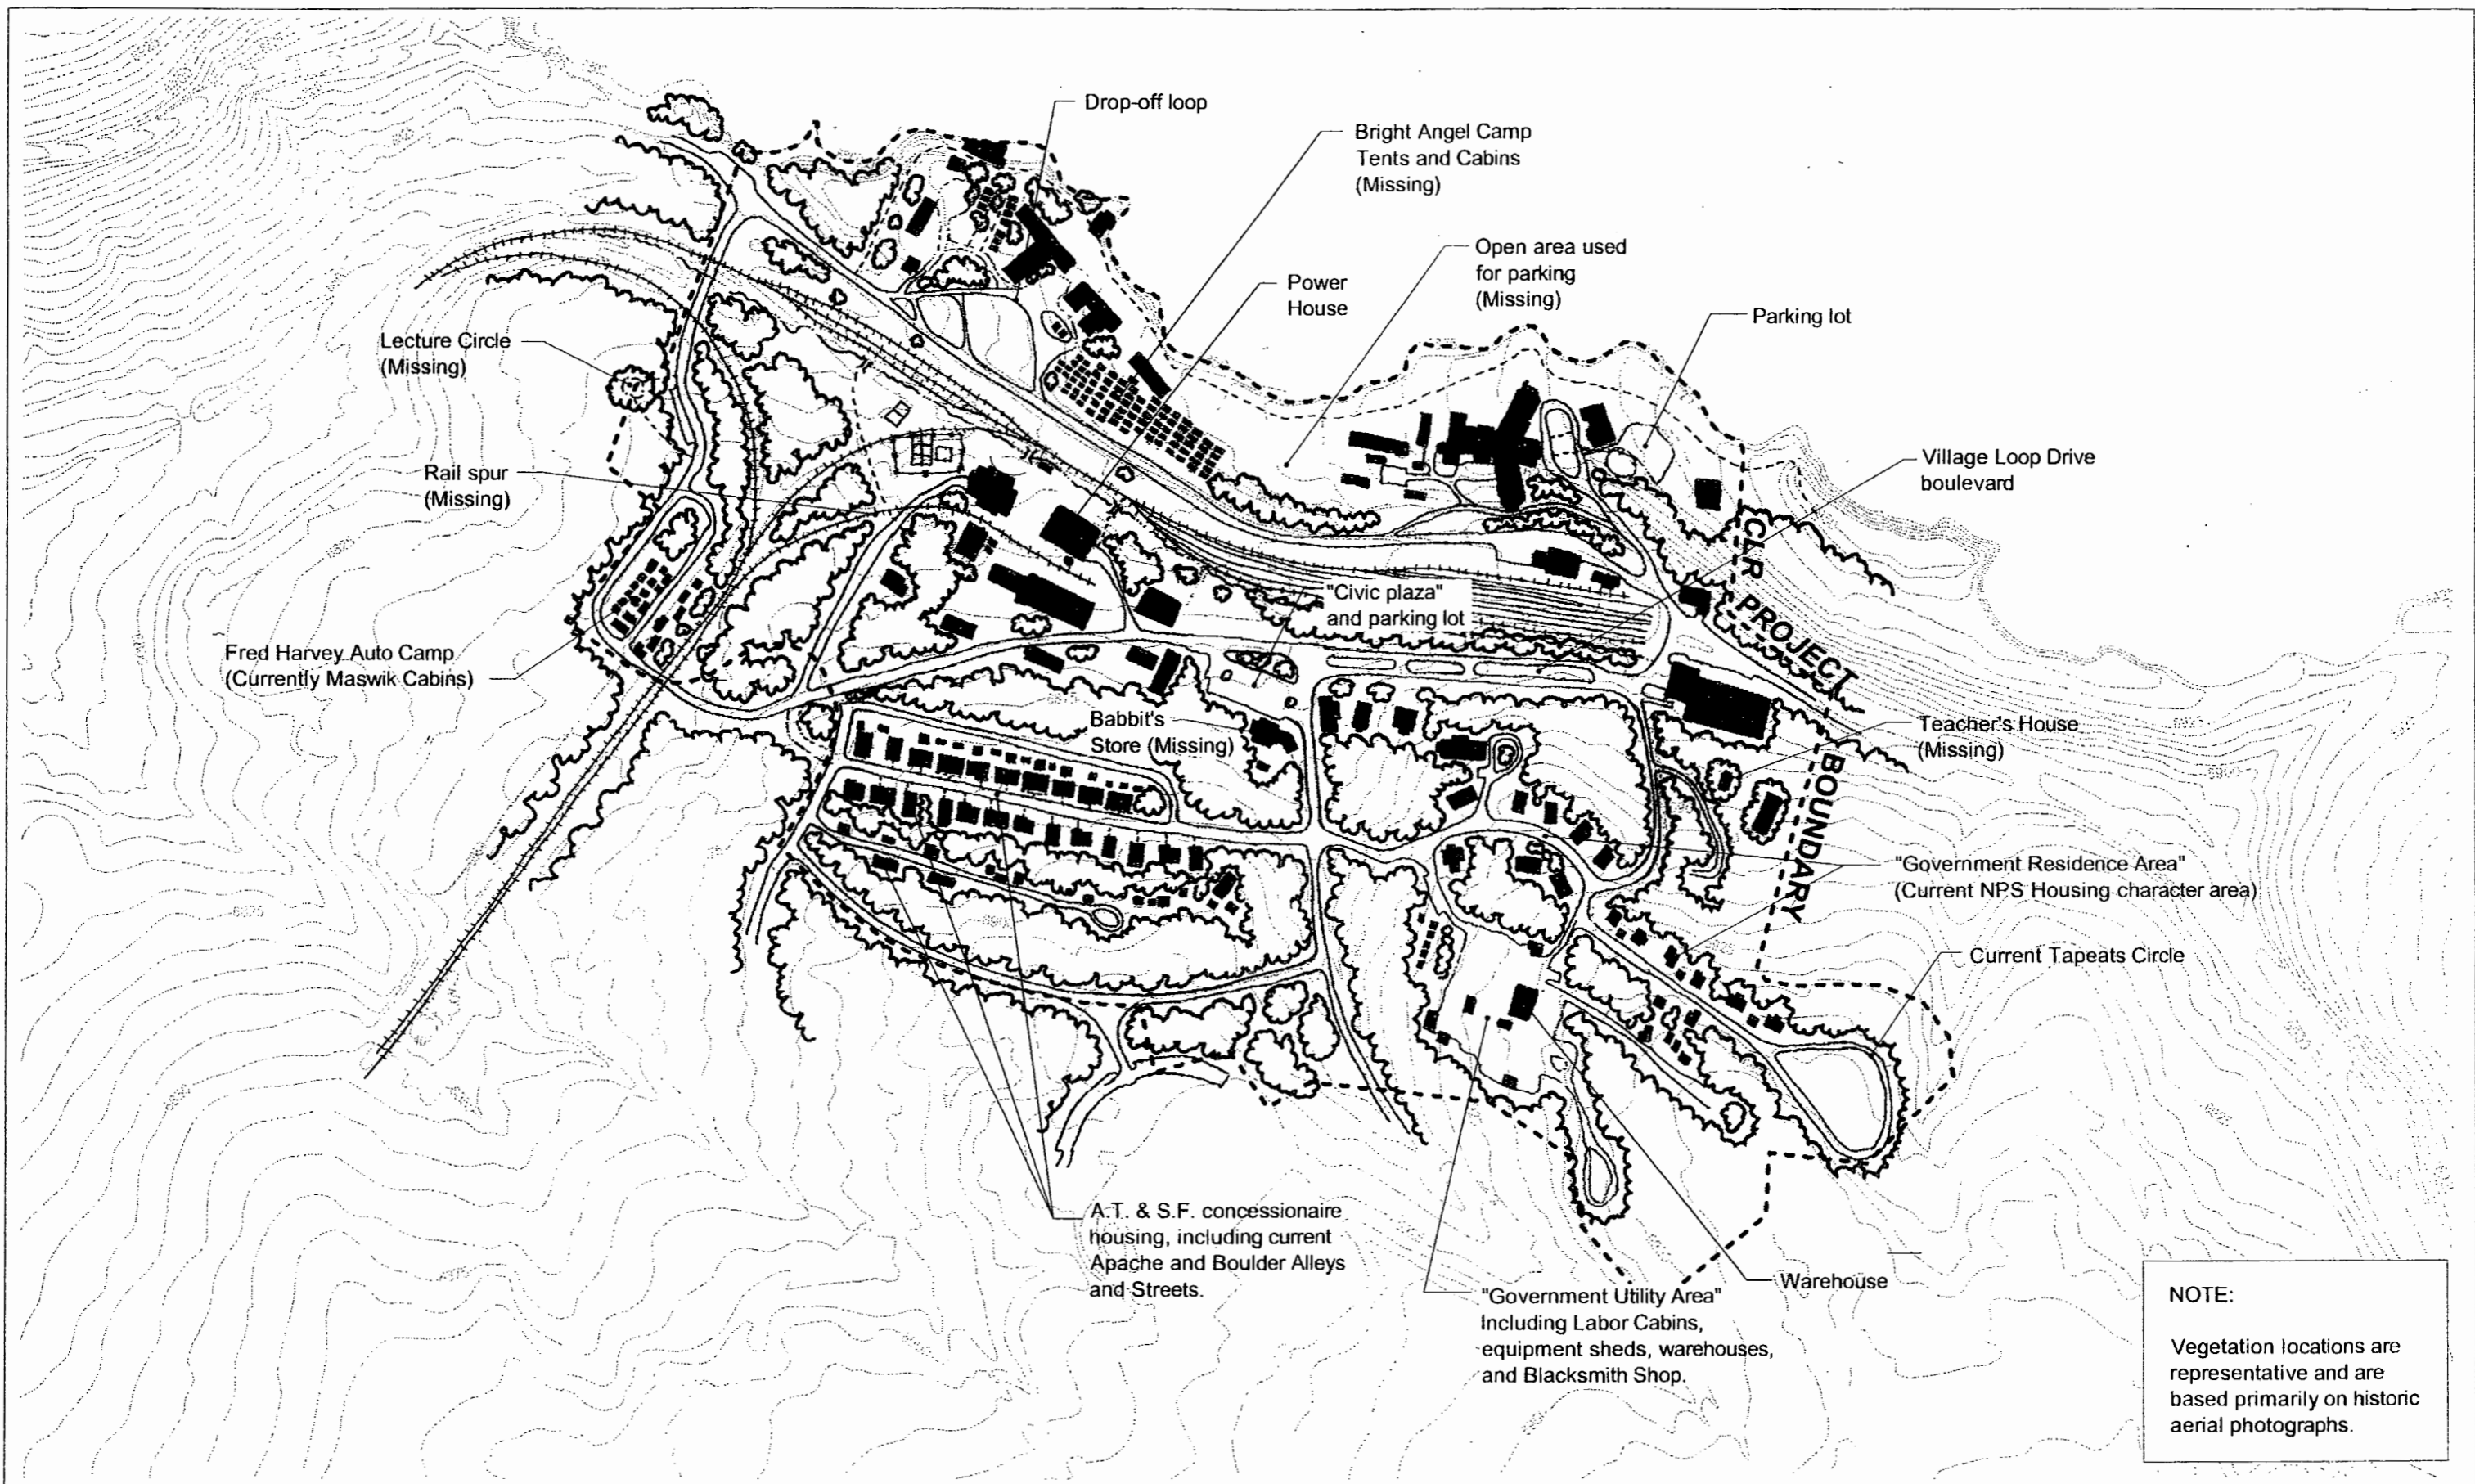
NOTE:
Vegetation locations are representative and are based primarily on historic aerial photographs.

Map Sources: Water Development Project at Grand Canyon, Arizona, February 1920/Revised 1931; A.T. & S.F. RY. System Standard Five Room Section Houses, 1927/1929; National Historic Landmark nomination, 1997; and historic aerials and photographs.

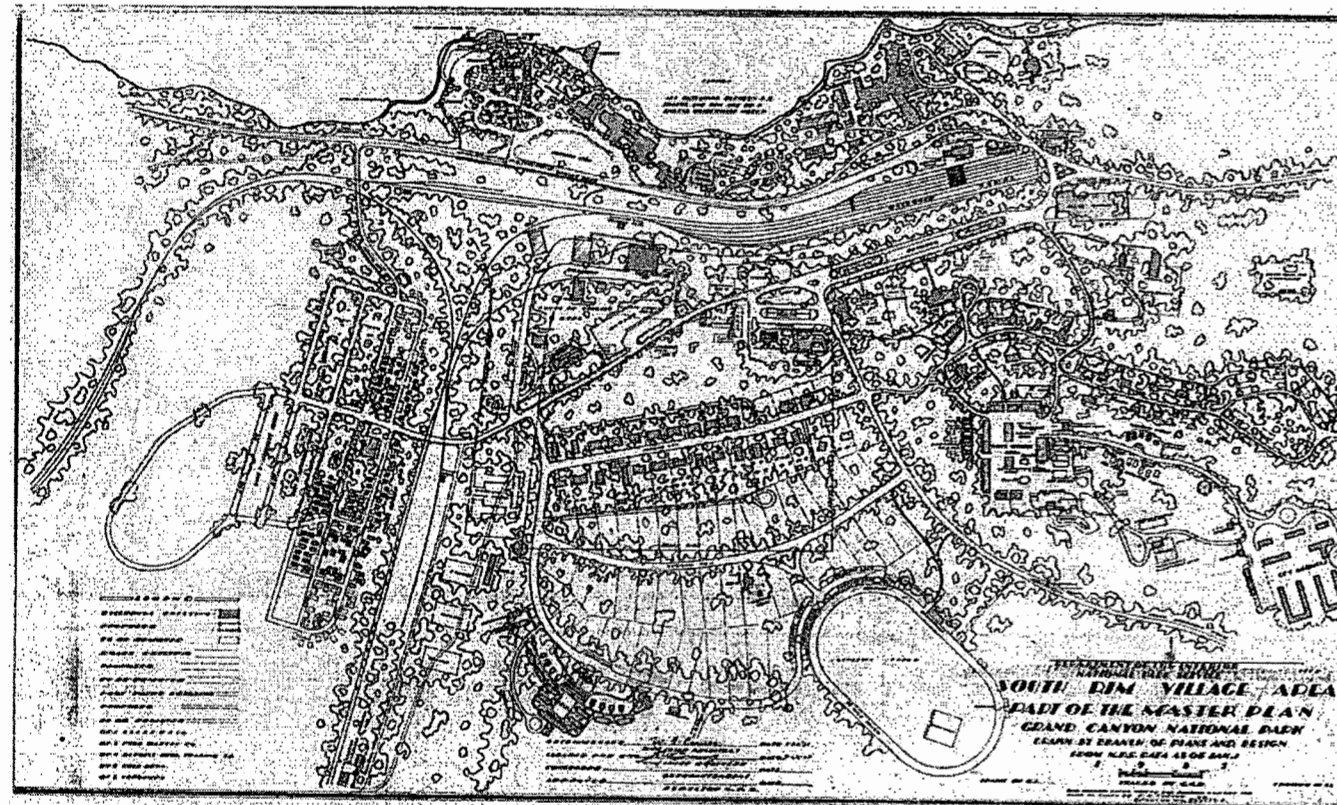
Figure 34. 1935 "South Rim Village Area, Part of the Master Plan." (Grand Canyon Museum Collection Catalog #28342)

By July 1933, nearly 200 men arrived at the South Rim and established CCC camps in Grand Canyon Village. Company #819 immediately began work. In 1933 and 1934 alone, CCC workers on the South Rim constructed sixteen miles of telephone line, built seventeen miles of boundary fencing, created water reservoirs for game, eliminated fire hazards by removing dead timber, and instituted insect and pest control over 300 acres. During their stay at the GRCA, CCC workers helped clean ditches, maintain roads, and survey and mark park boundaries. They built tennis courts, campgrounds, a new firehouse, and the Grand Canyon Village School.¹¹⁶ Just three years after Congress initiated funding for the CCC, senior executives at NPS declared that "the CCC had advanced forestry and park development by 10 to 20 years."¹¹⁷ Tillotson's vision of the future had come to pass (*Figures 34, 35, and 36*).

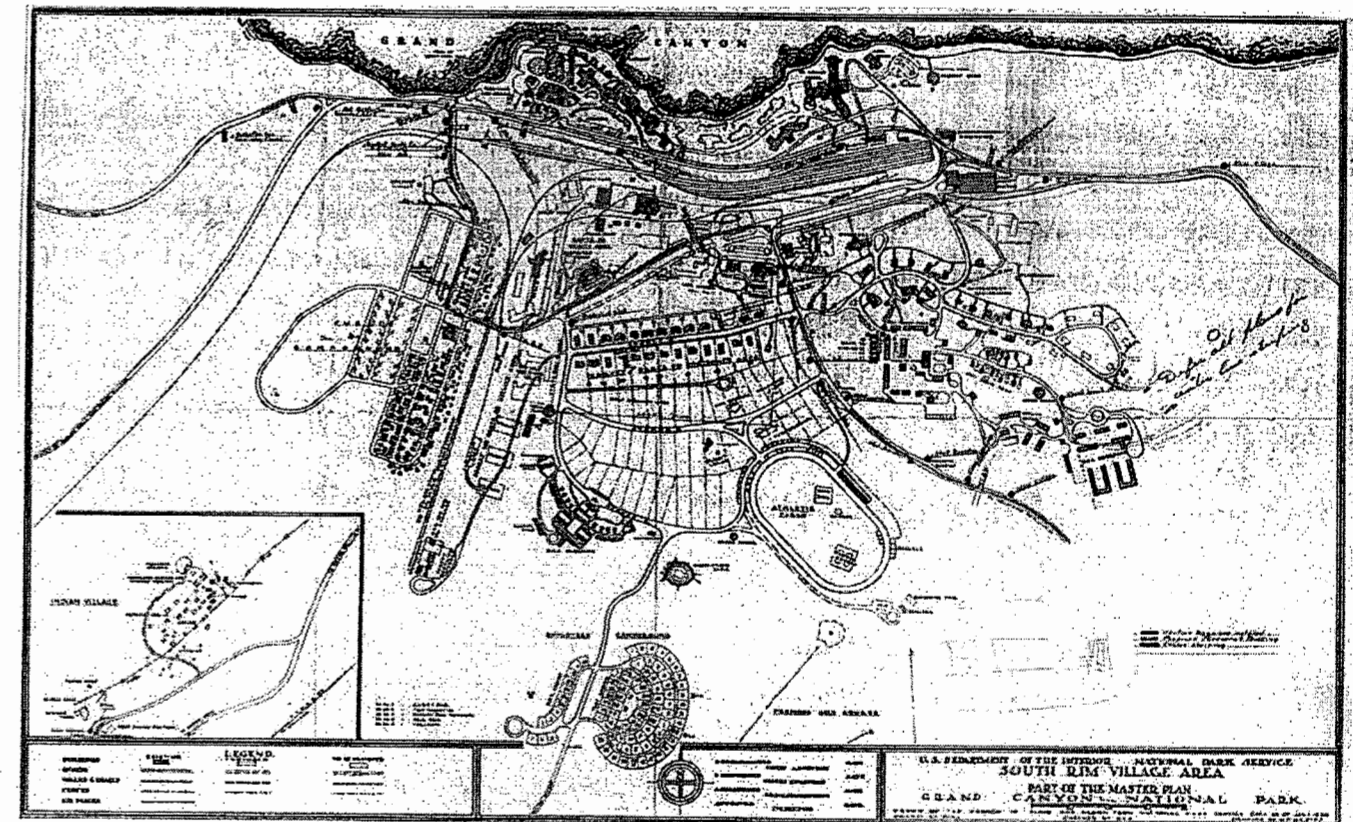
Figure 35. 1938 Master Plan for South Rim Village Area. (Grand Canyon Museum Collection Catalog #26769)

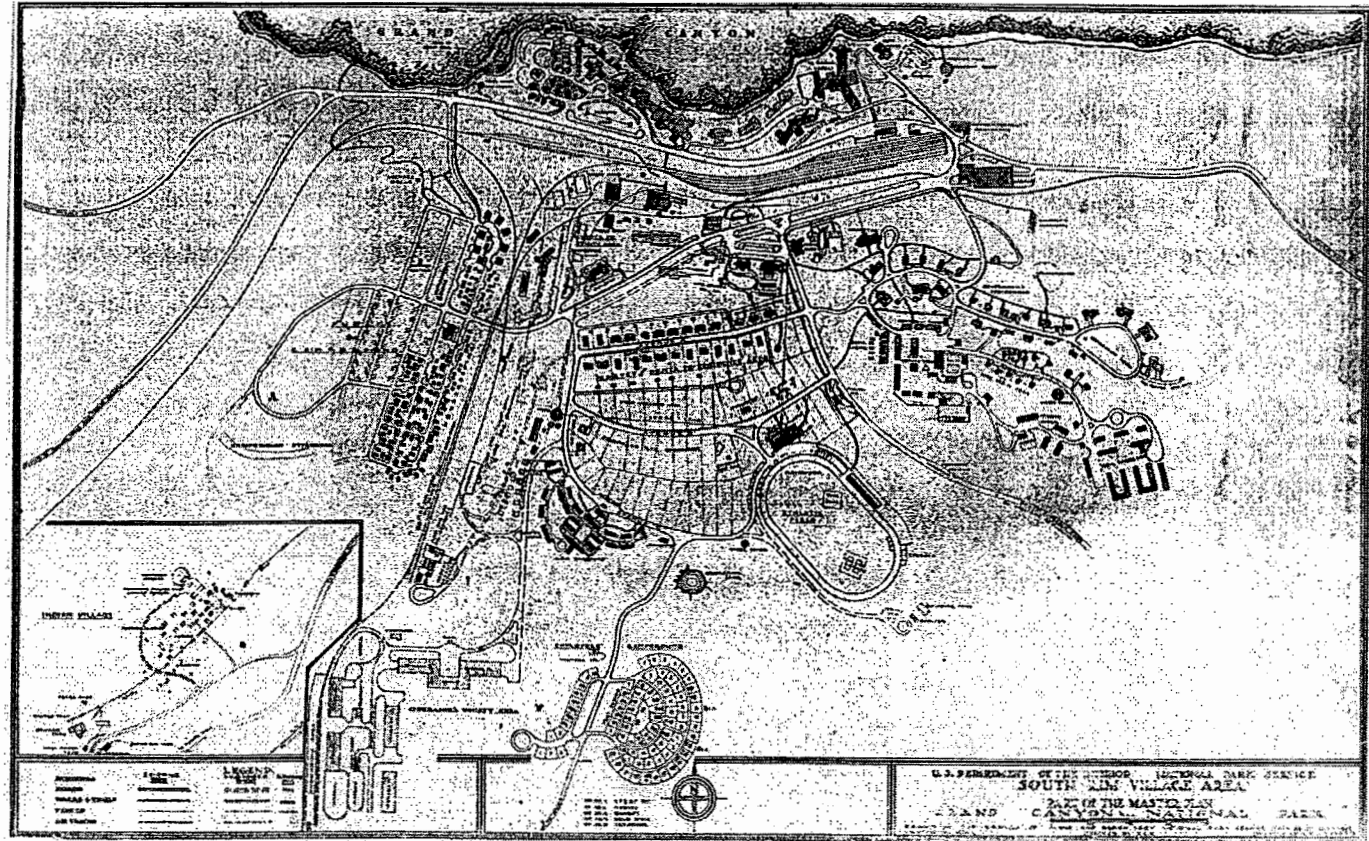
Figure 36. 1941 Master Plan for South Rim Village Area. (Grand Canyon Museum Collection Catalog #74826)

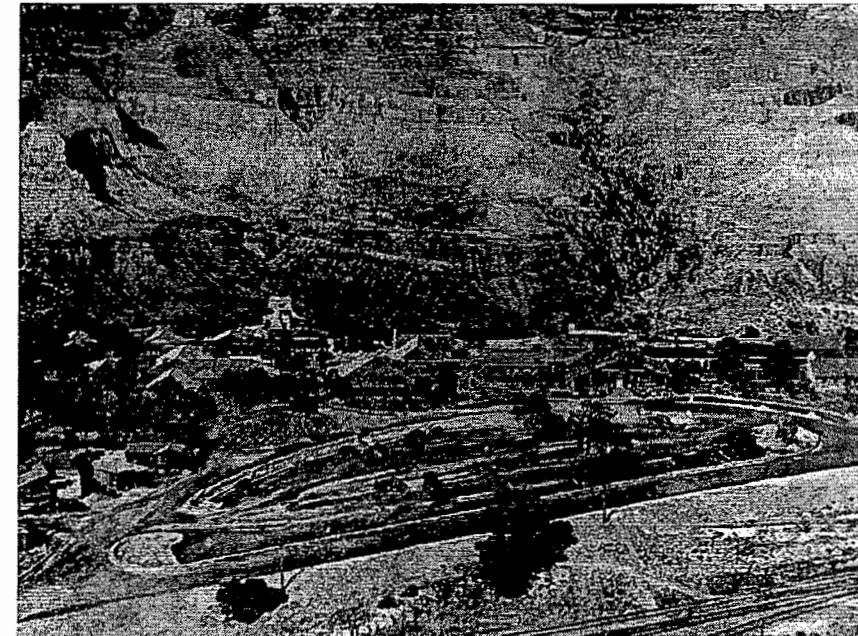
Figure 37. Aerial photo of Mary E.J. Colter's Bright Angel Lodge complex taken shortly after the building's completion in 1935. (Grand Canyon Museum Collection Catalog #9538)

During this same period, the Fred Harvey Company built another Colter-designed building in the Village, the Bright Angel Lodge, and redeveloped the Bright Angel Camp area (*Figures 37 and 38*). By 1937, there were two CCC camps at the South Rim headquarters; Company 819 had been joined by Company 847, which built a second camp near the Santa Fe housing area. Together, the CCC crews at the South Rim built storage tanks and a pump house, helped to revise and rebuild the head of the Bright Angel Trail, laid power line, built drainage systems, and helped to maintain the South Rim's roads, and foot and horse trails.¹¹⁸ By 1942, the combination of concessionaire and Federally-funded construction had completely transformed Grand Canyon Village.

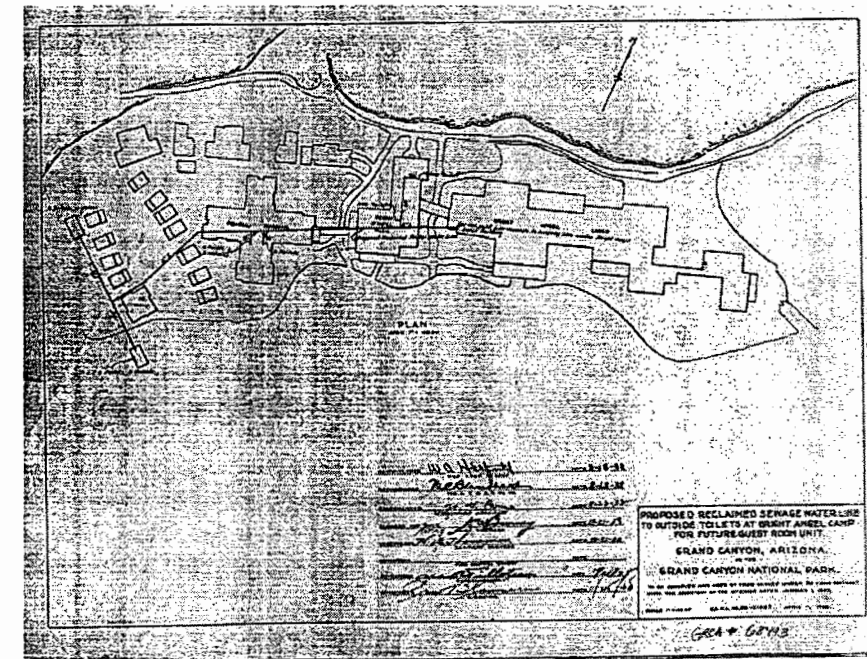
Figure 38. 1938 plan: "Proposed Reclaimed Sewage Water Line to Outside Toilets at Bright Angel Camp for Future Guest Room Unit." (Grand Canyon Museum Collection Catalog #68493)

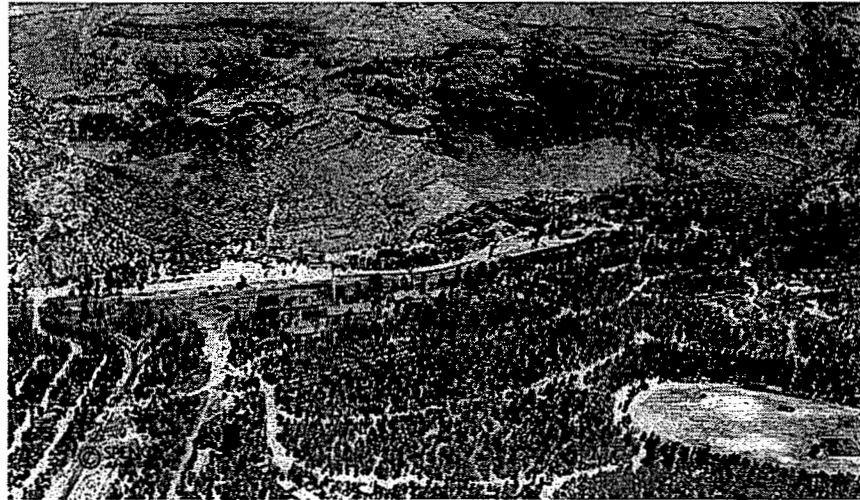
Figure 39. 1935 aerial photo of Grand Canyon Village. By this date, the 1924 Master Plan layout has been realized in the circulation system, and in the general separation of uses. (Grand Canyon Museum Collection Catalog #9539)

Village Development Activities	1933-1942	"The development of the Grand Canyon Village after the comprehensive plan was approved occurred in two distinct phases. The second phase was tied directly to the Emergency Conservation Works (ECW) programs initiated in the National Parks from 1933 through 1942. This phase witnessed substantial development of NPS facilities and Village infrastructure including footpaths, roads and utilities. Park concessionaires' development activities focused primarily on expanded visitor and tourist accommodations. Development during the second phase generally adhered to the 1924 comprehensive plan, however, the NPS made some modifications in order to accommodate new facilities or as a 'refinement of Park Service philosophy concerning aesthetically sensitive development within national parks." ¹¹⁹ (Refer to <i>Figure 39</i> for an aerial view of the Village during this era.)

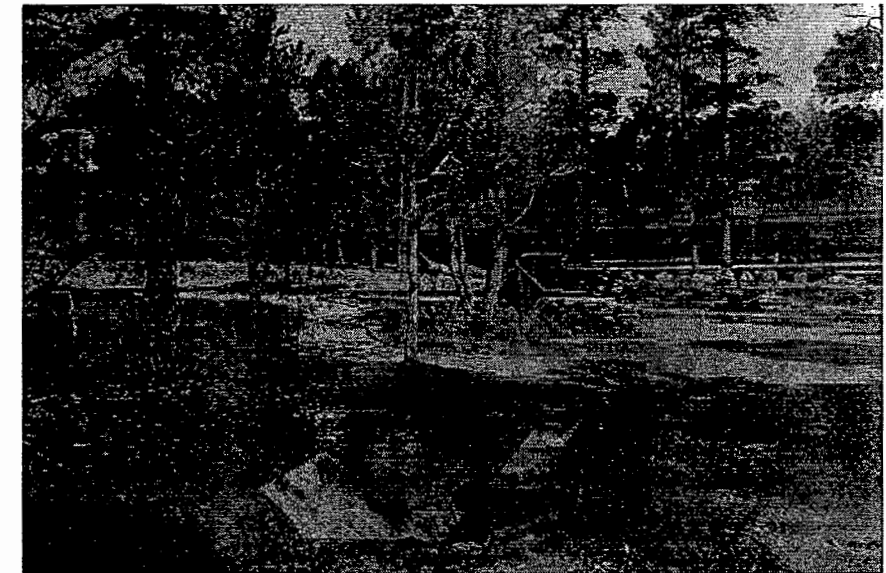
Figure 40. View of CCC-built stone culvert at Navajo Street and Village Loop Drive (looking north), circa 1935. (Grand Canyon Museum Collection Catalog #9540)

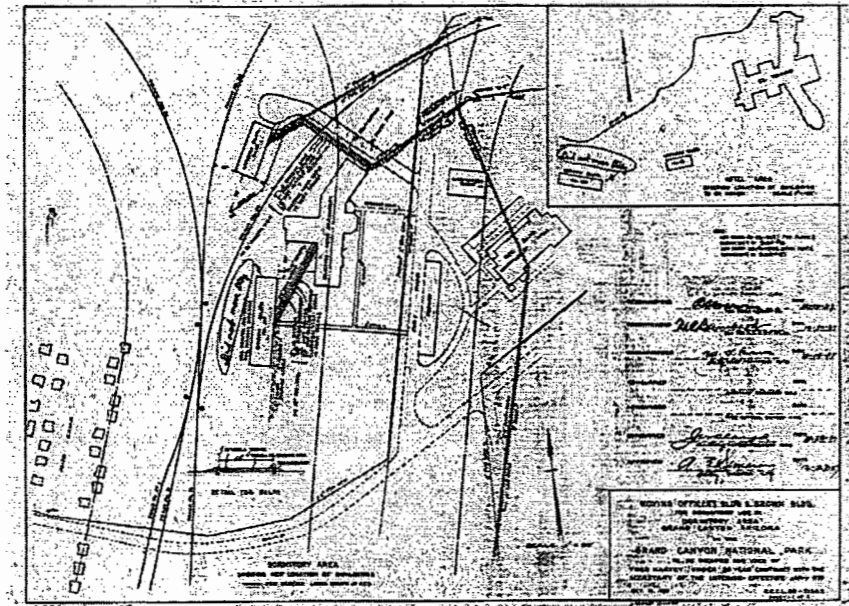
Figure 43. 1937 plan: "Moving Officer's Bldg. & Brown Bldg. for Dormitory Use in Dormitory Area, Grand Canyon, Arizona." (Grand Canyon Museum Collection Catalog #68095)
