**Grand Canyon Village
National Historic Landmark District
Cultural Landscape Report**

**Grand Canyon National Park
Arizona**

January 2004

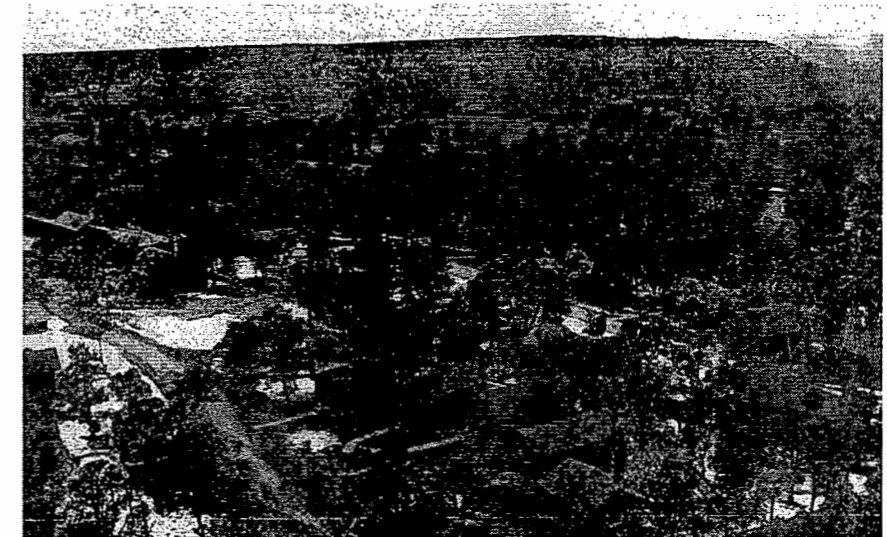
Figure 44. Aerial photo of NPS residential area, looking northwest, February 23, 1938. (Grand Canyon Museum Collection Catalog #8036)

NPS Utility Buildings Erected	1935-1936	During 1935 and 1936, the CCC erected a plumbing shop (Bldg. #SRB0080), an ECW warehouse (Bldg. #SRB0090), a jail and watchman's office (Bldg. #SRB0087), and four multi-bay garages in the NPS residential area (Bldgs. #SRB0099, #SRB0183 through #SRB0185) (Figure 44). ¹⁶⁴
Employee Cabins Built	1936	The CCC erected ten NPS employee residences and a four-car garage (Bldg. #SRB0043) on Juniper Hill in 1936. ¹⁶⁵
Wading Pool Built	1936	CCC crews built a wading pool at the school's playground area, along with steps and a walkway from the school building to the play area. ¹⁶⁶
Telephone Building Constructed	1936-1937	The Mountain States Telephone Building (Bldg. #0500) was erected behind the post office in 1936. ¹⁶⁷
Men's and Women's Dormitories Built	1937	In 1937, the Santa Fe Railway erected the Fred Harvey men's dormitory (Bldg. #0576, later known as Victor Hall) west of the community building near the railroad wye. The same year, the company erected a women's dormitory (Bldg. #0539, later known as Colter Hall) just southwest of the El Tovar Hotel. At the same time, the "Brown Building" or Fred Harvey Officer's Dormitory (Bldg. #0578) building was moved from its original location behind the El Tovar Hotel to a site just west of the Fred Harvey Men's Dormitory. The building was remodeled to house Mexican employees, who were segregated from white employees. The building was renamed "Victor Hall Annex." ¹⁶⁸

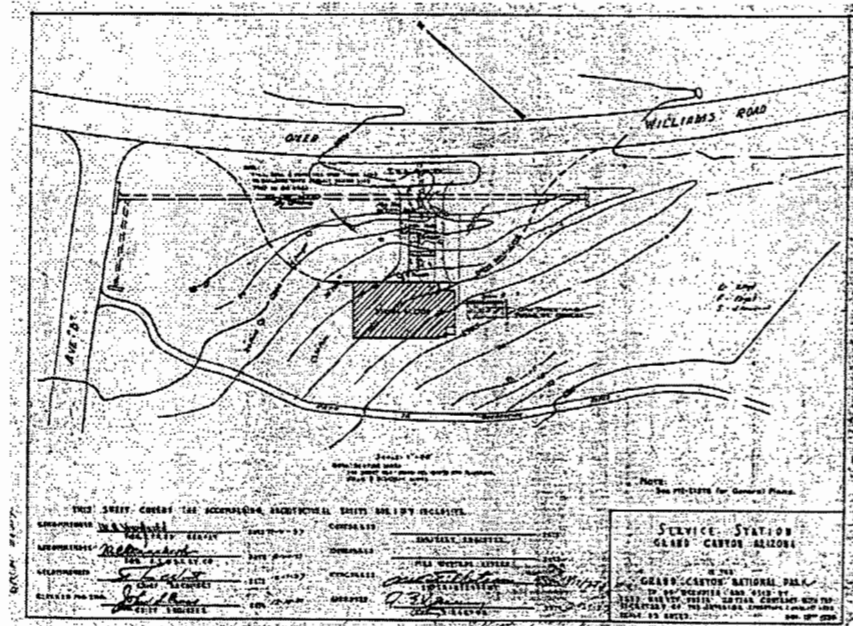
Figure 45. 1936 plan for Fred Harvey Service Station at Grand Canyon. (Grand Canyon Museum Collection Catalog #68517)

Service Station Built	1937	The Fred Harvey Service Station (Bldg. #0862), located on Center Road, just south of Avenue B, was erected in 1937 (Figure 45). ¹⁶⁹
Lookout Studio Remodeled	1937	In 1937, the Santa Fe Railway remodeled the Lookout building to serve as the Fred Harvey photo studio. ¹⁷⁰
Freight Platform Built	1938	CCC crews erected a freight platform at the railroad depot and a truck route that connected the depot and the platform. ¹⁷¹

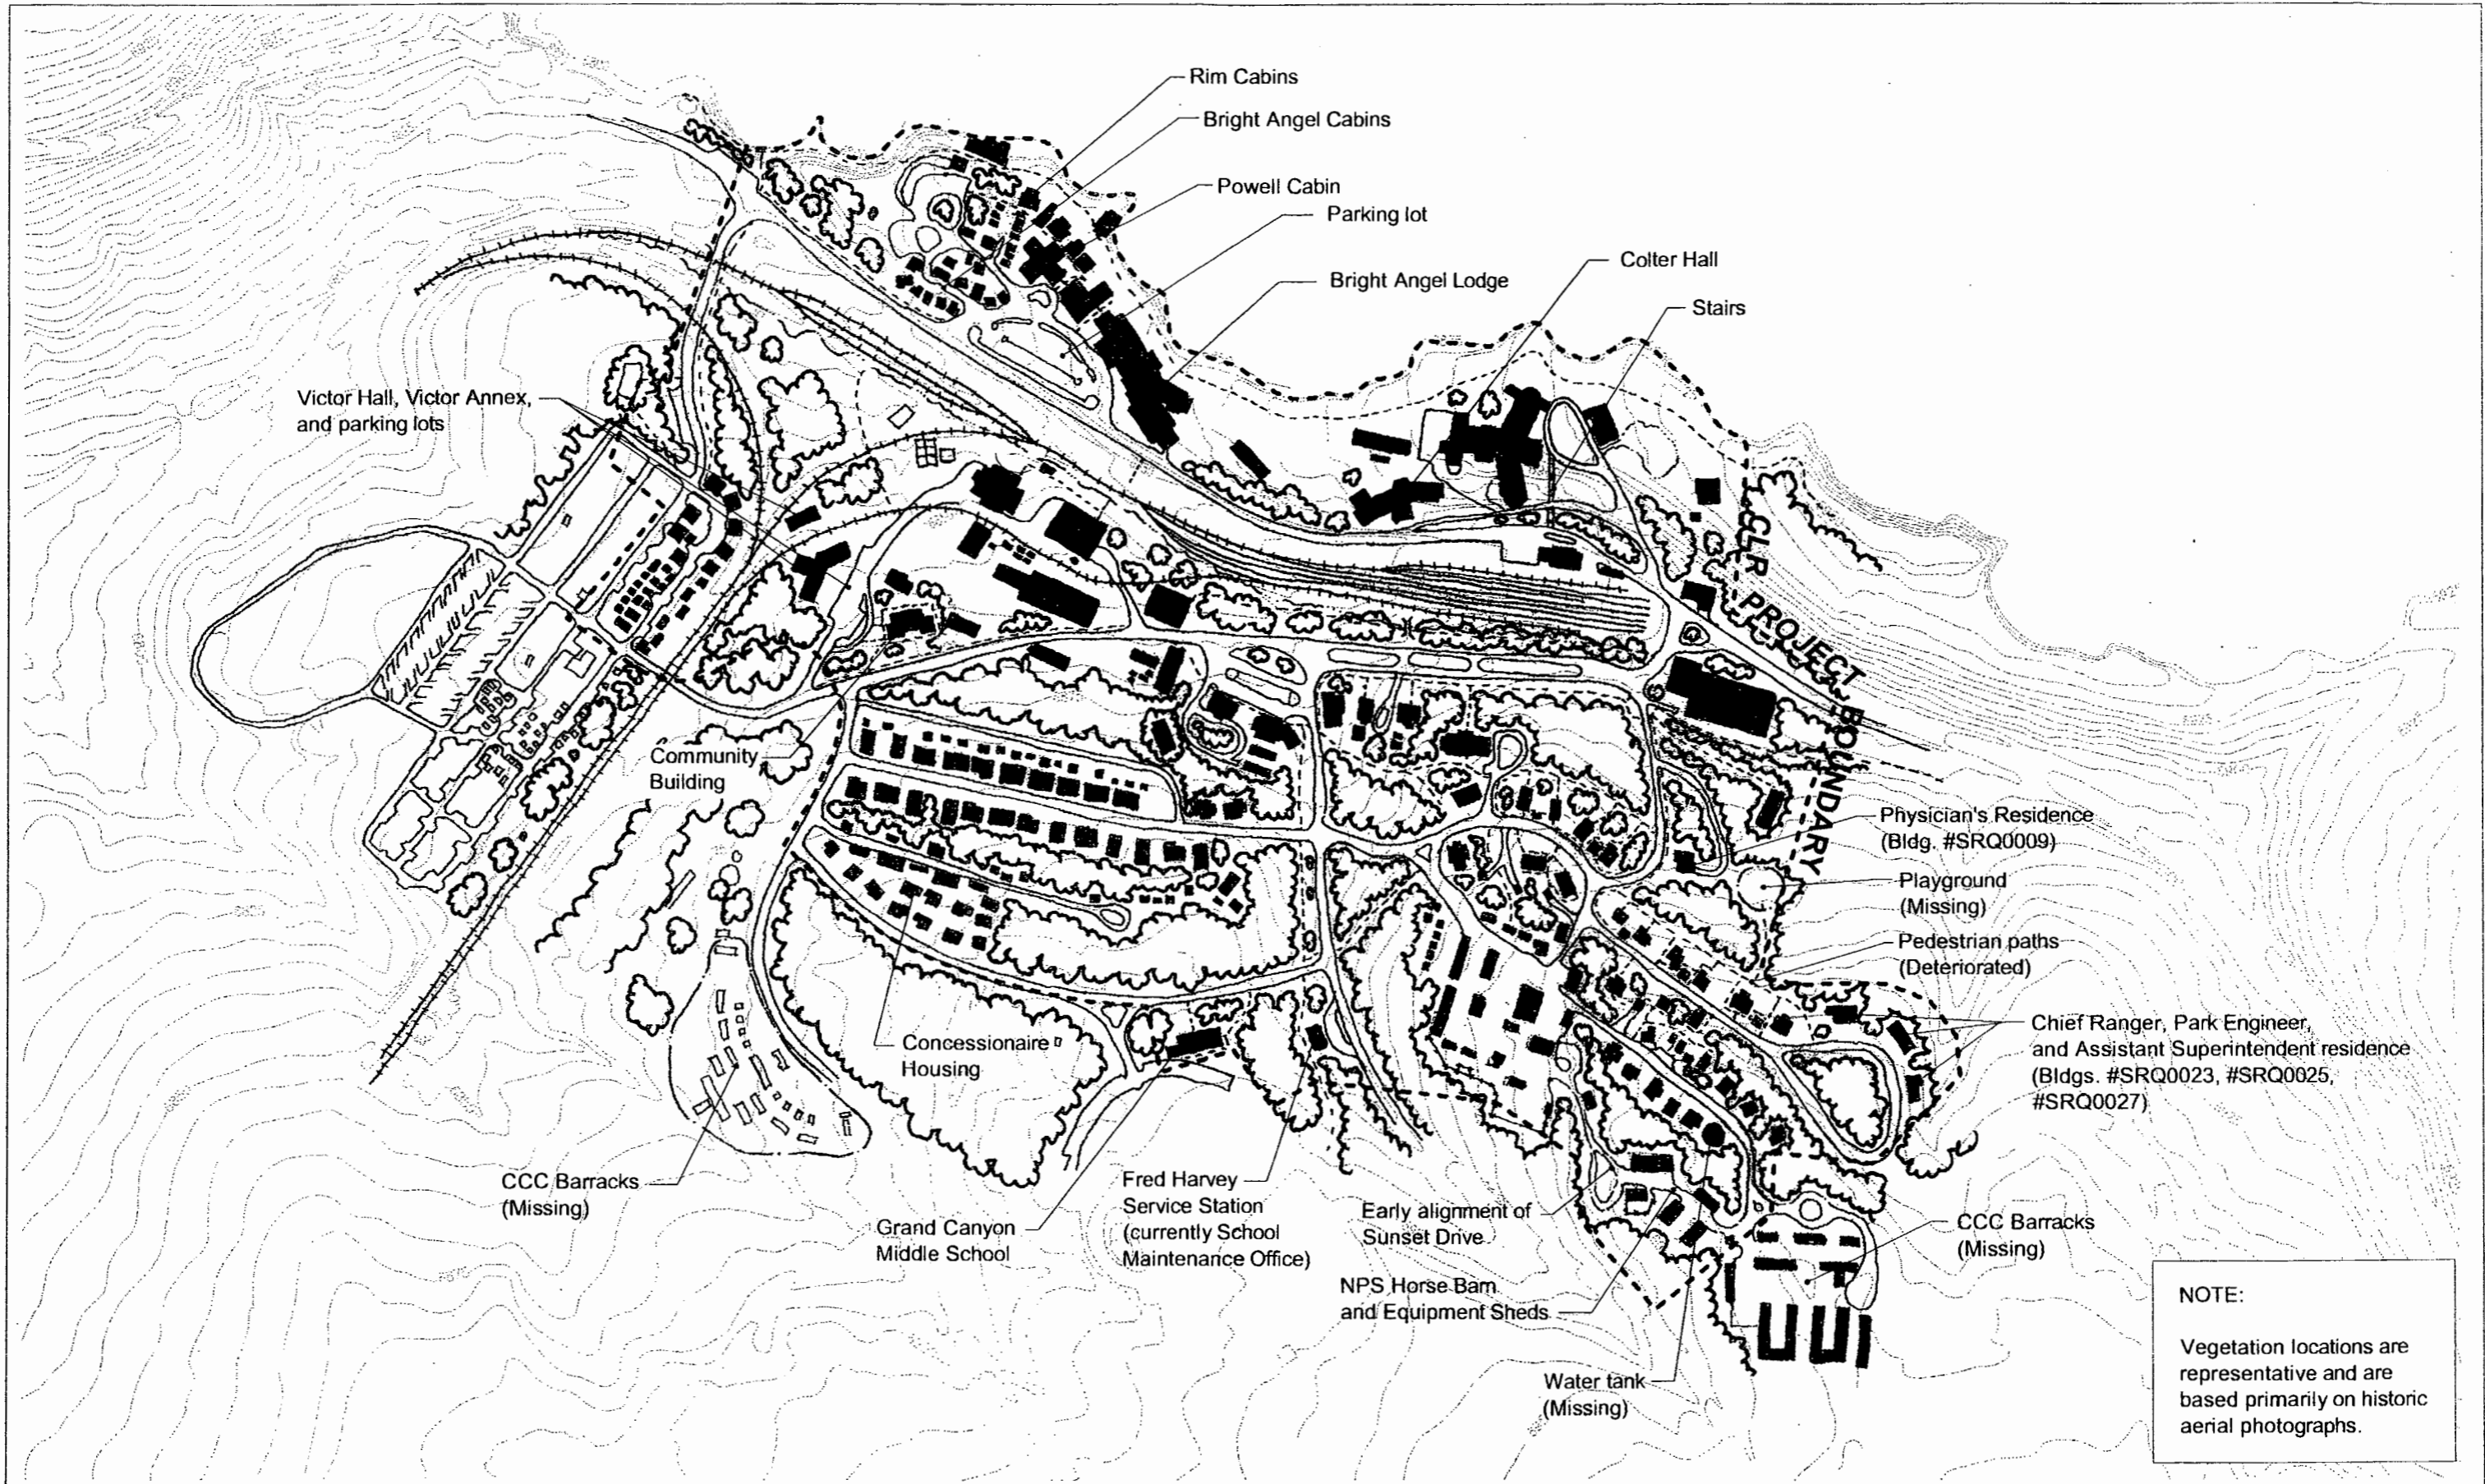
LANDSCAPE FEATURES
circa 1942
GRAND CANYON VILLAGE NATIONAL HISTORIC LANDMARK DISTRICT

NOTE:
Vegetation locations are representative and are based primarily on historic aerial photographs.

Map Sources: South Rim Village Master Plans for 1935, 1938, and 1941; Moving Officers Bld'g & Brown Bld'g, 1937; National Historic Landmark nomination, 1997; and historic aeriels and photographs.

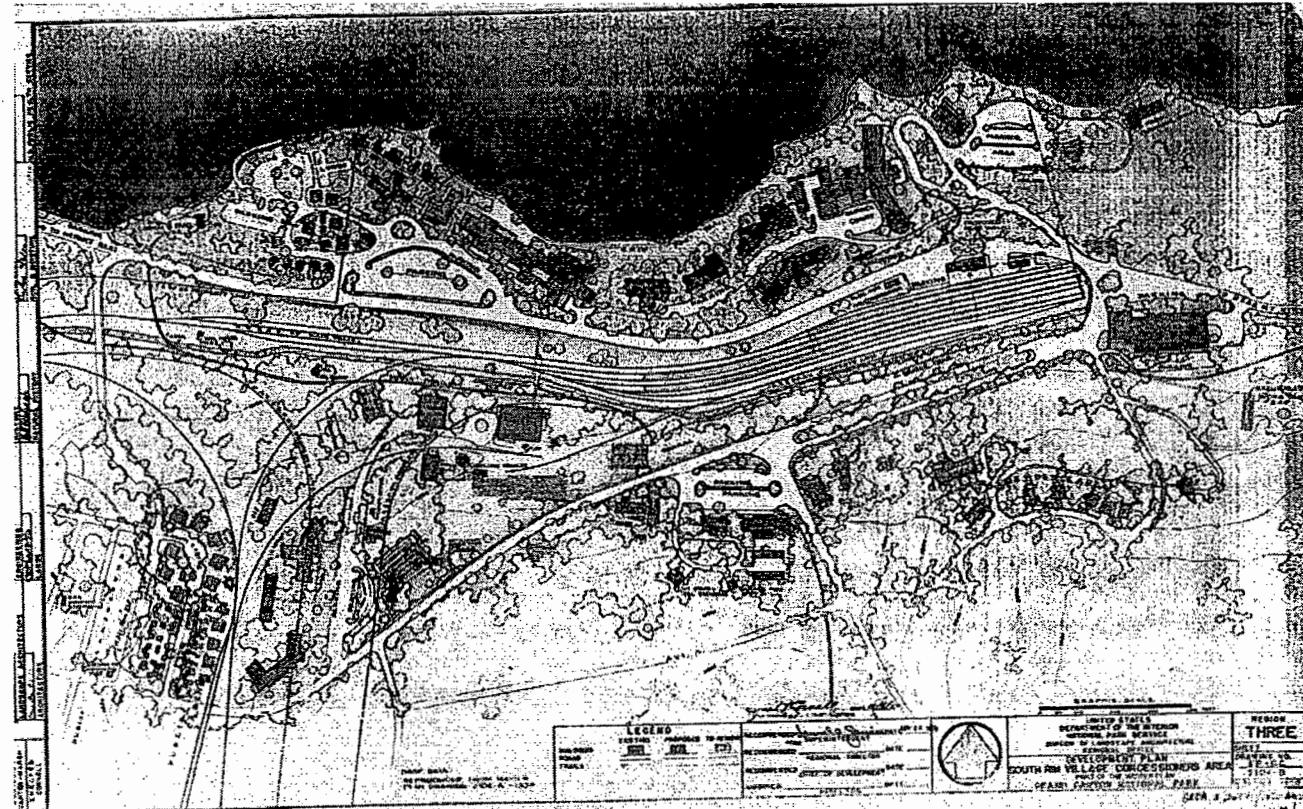
Figure 46. 1950 Master Plan for South Rim Village Area. (Grand Canyon Museum Collection Catalog #26771)

In 1950s, GRCA planners completed comprehensive master plans for the park that called for substantial development of new tourist facilities on the South Rim (*Figures 46 through 49*). In addition to proposing that three new lodges be built, the plans proposed construction of two additions to the Bright Angel Lodge complex, although the planners called for little redevelopment within the original Grand Canyon Village. Instead, they proposed a new alignment for South Entrance Road that would create an expansive loop road east of Grand Canyon Village, touch the rim near Mather Point, and continue east and south to the Village where it would intersect with Village Loop Drive at the Fred Harvey Garage. It was hoped that this new entrance road would divert traffic from Grand Canyon Village’s congested roads and provide visitors with a new approach to the rim. In 1954, when the new South Entrance Road was built, the former entrance road was redesignated as “Center Road,” or the Grand Canyon Village Commercial Access Road.¹⁸⁴

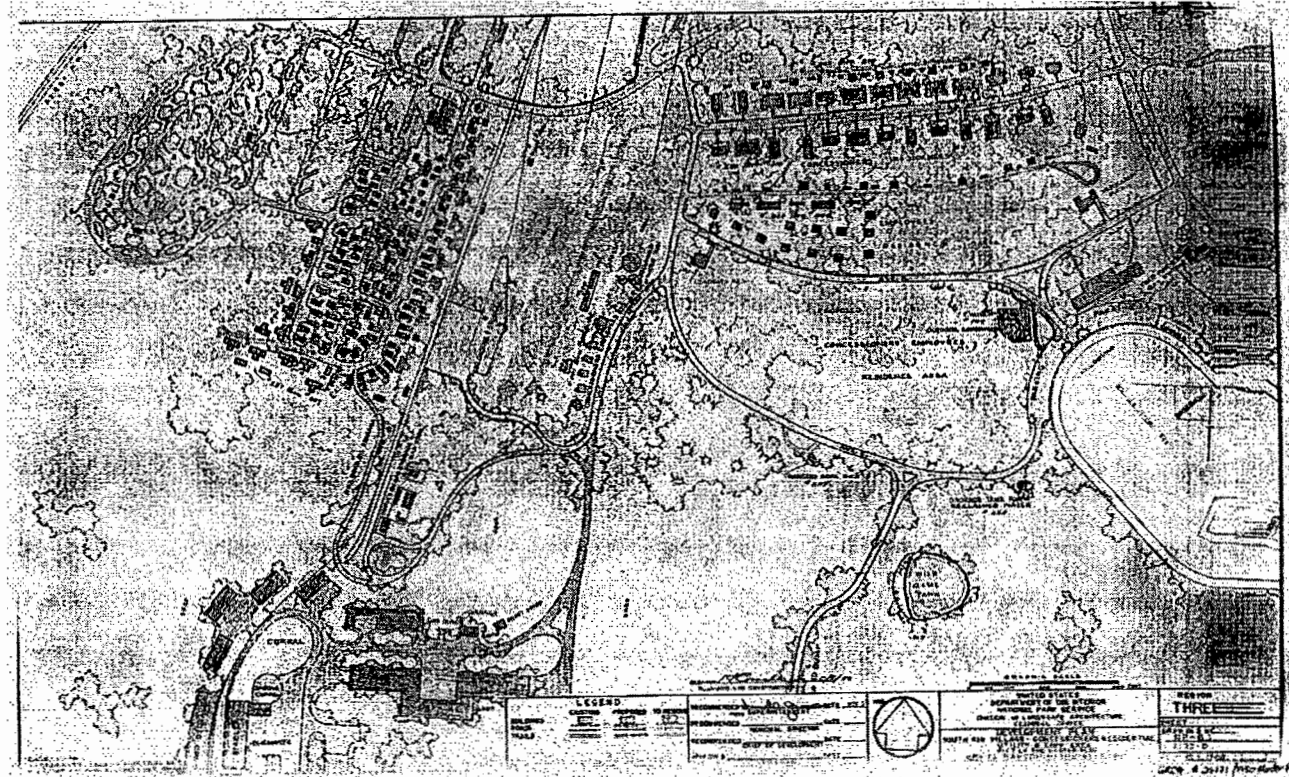
Figure 47. 1950 plan for concessionaire housing area. (Grand Canyon Museum Collection Catalog #26771)

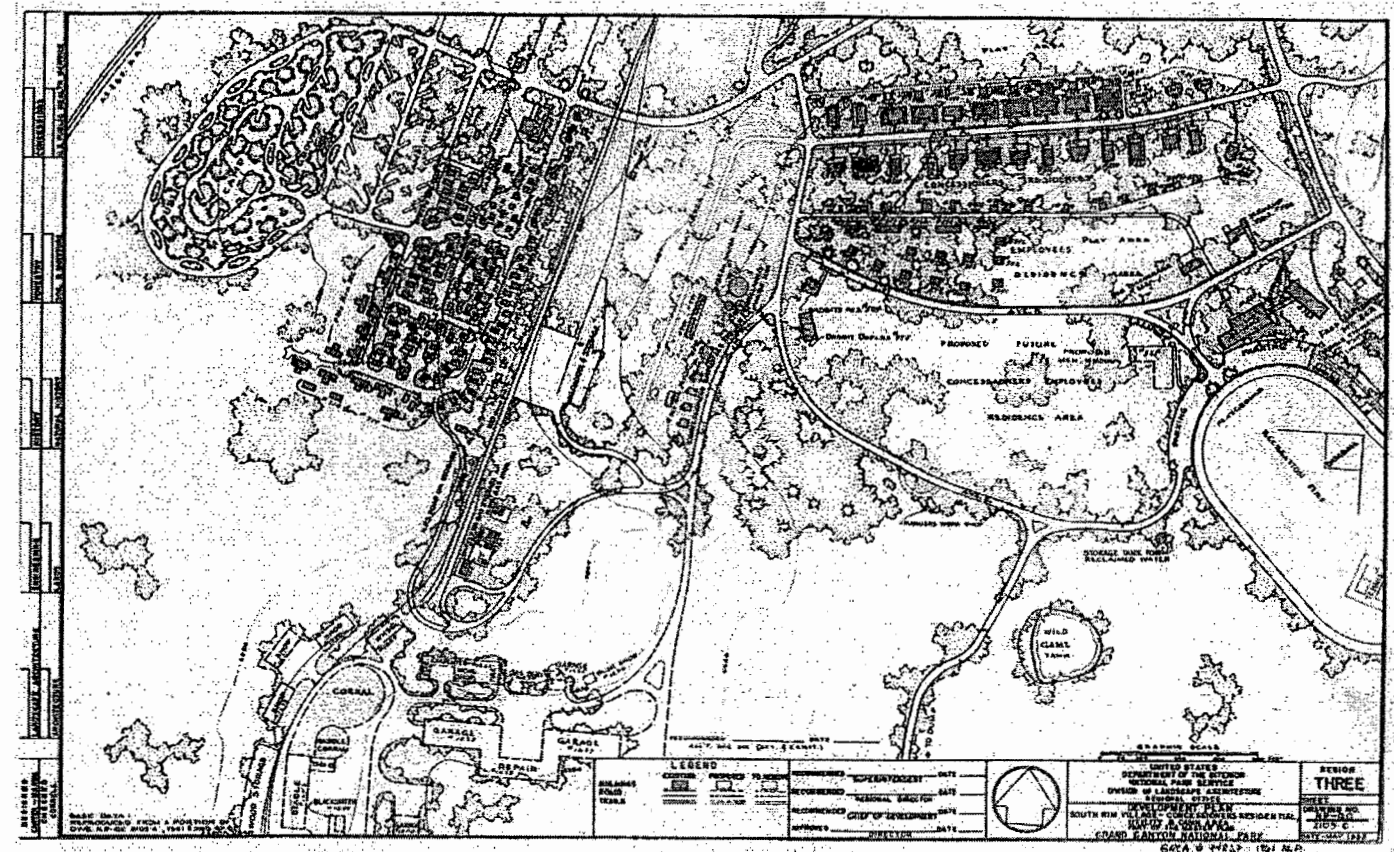
Figure 48. 1952 Development Plan for South Rim Village. (Denver Service Center TIC Drawing # GRCA 113-2105C)

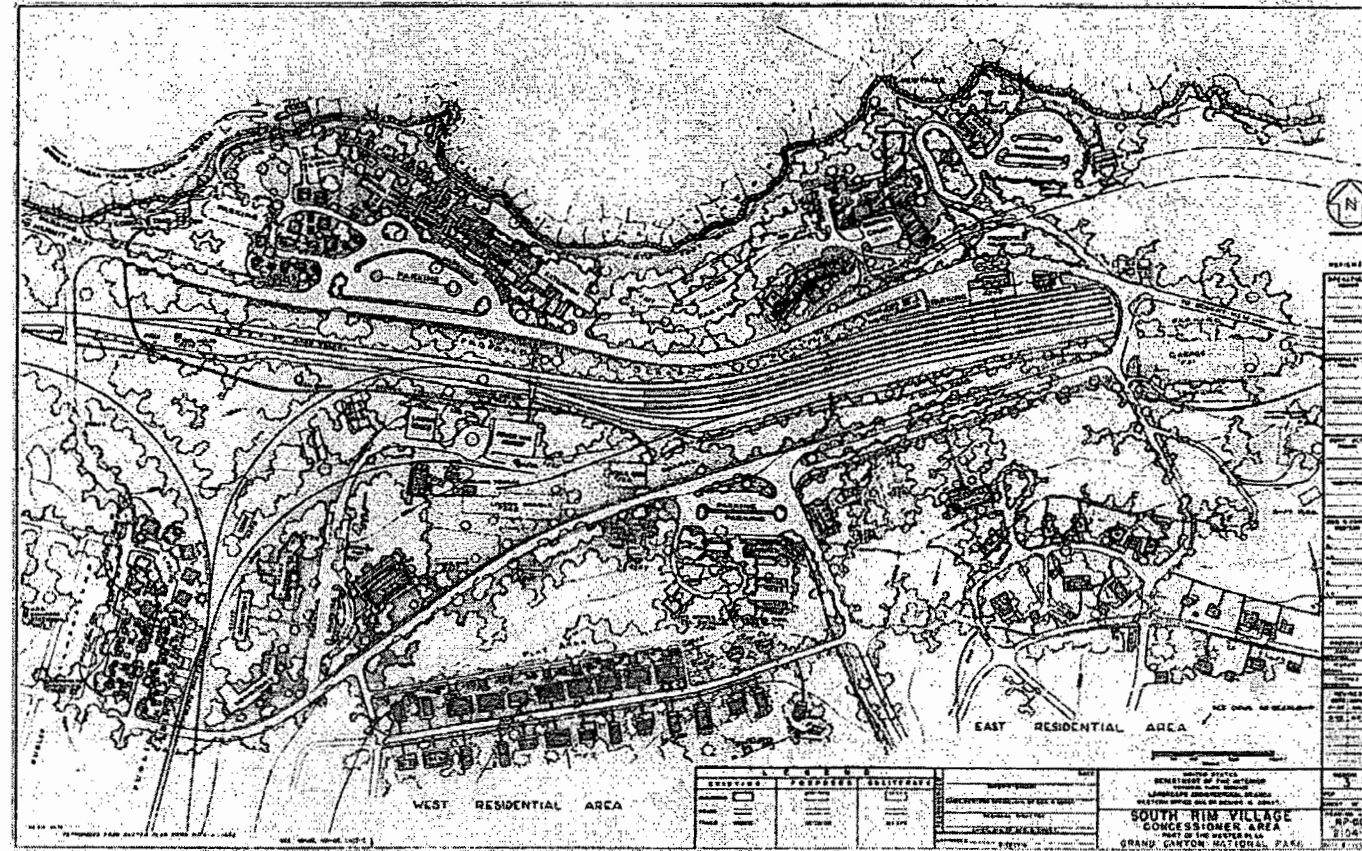
Figure 49. 1955 Development Plan for South Rim Village, Concessionaire Area.(Grand Canyon Museum Collection Catalog #74227)

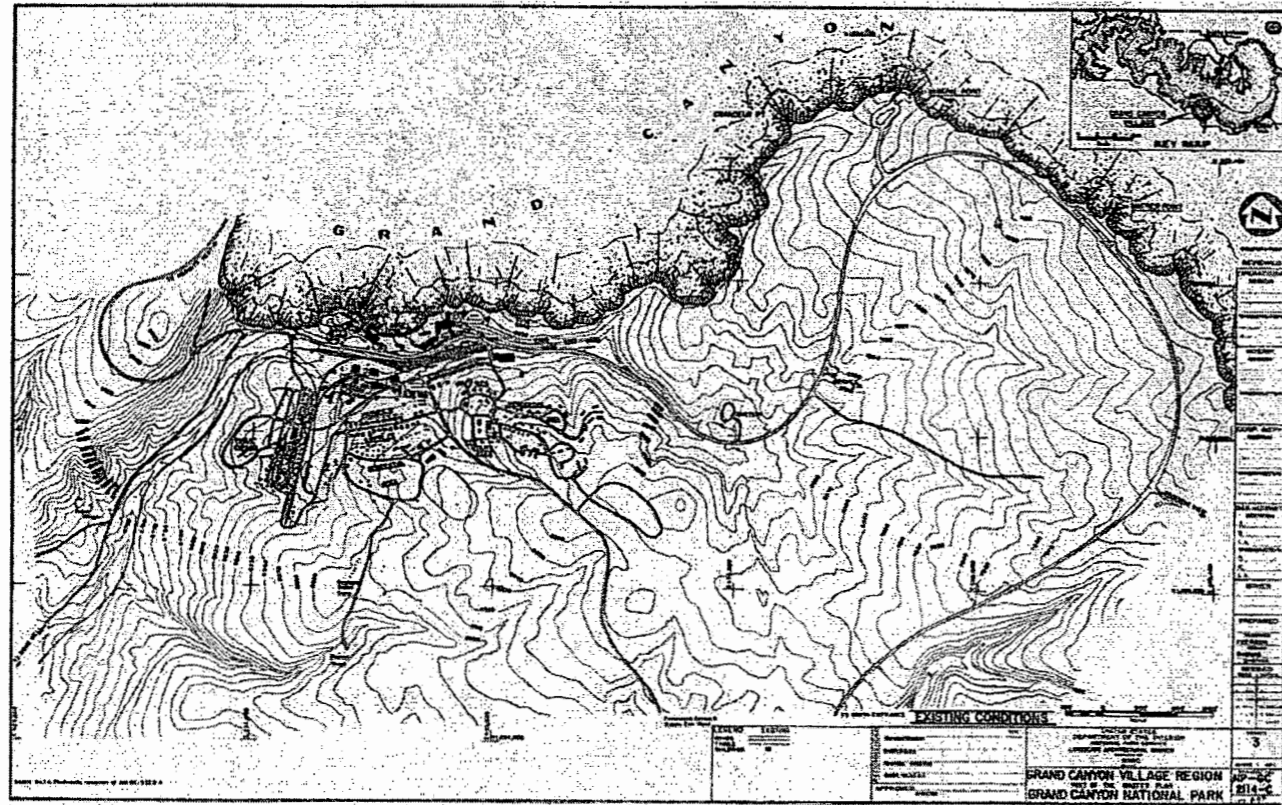
Figure 51. 1957 Existing Conditions, Grand Canyon Village Region.(Grand Canyon Museum Collection Catalog #74827)

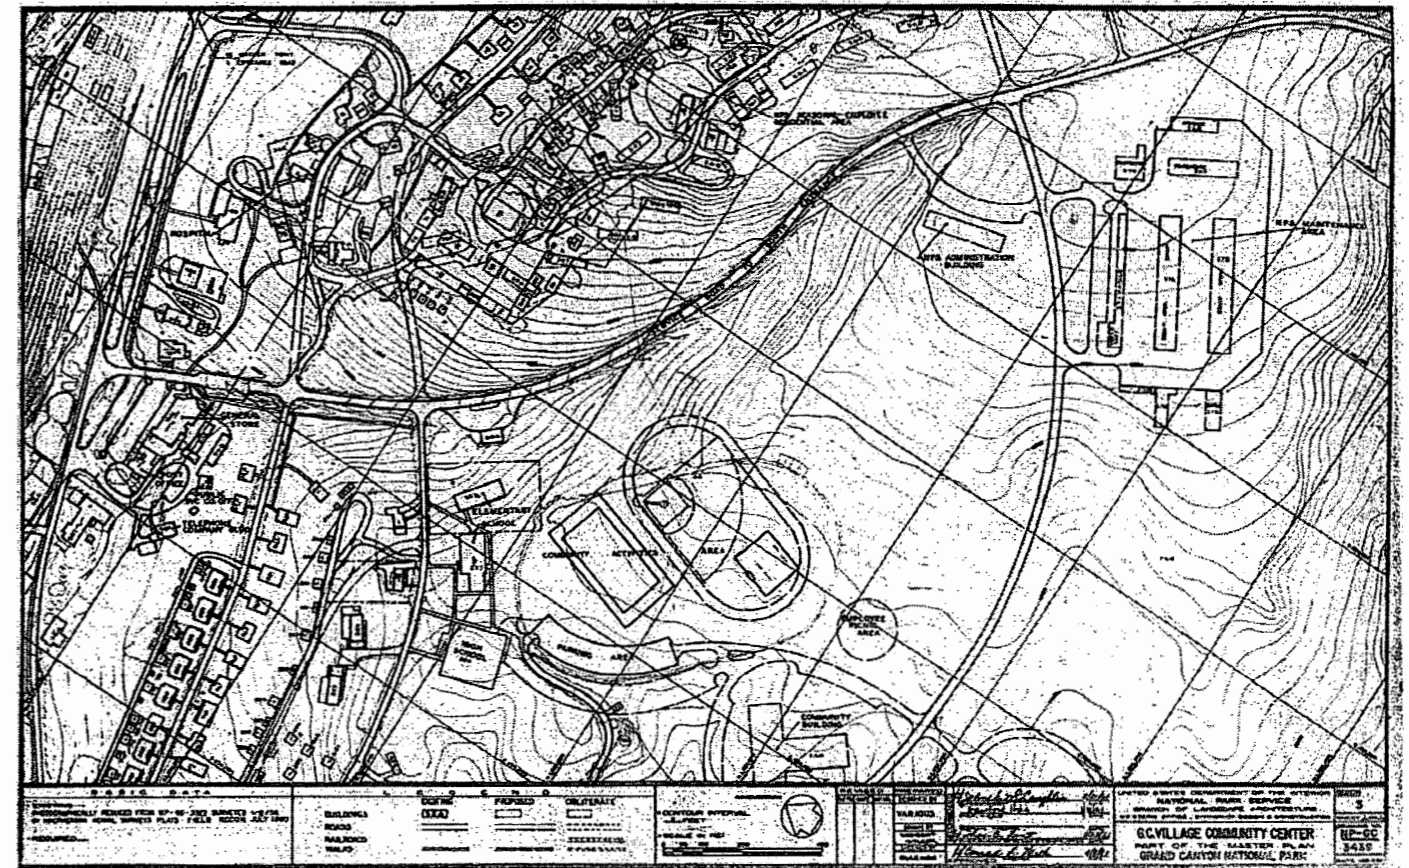
Figure 52. 1961 plan: "G.C. Village Community Center." (Grand Canyon Museum Collection Catalog #74827)

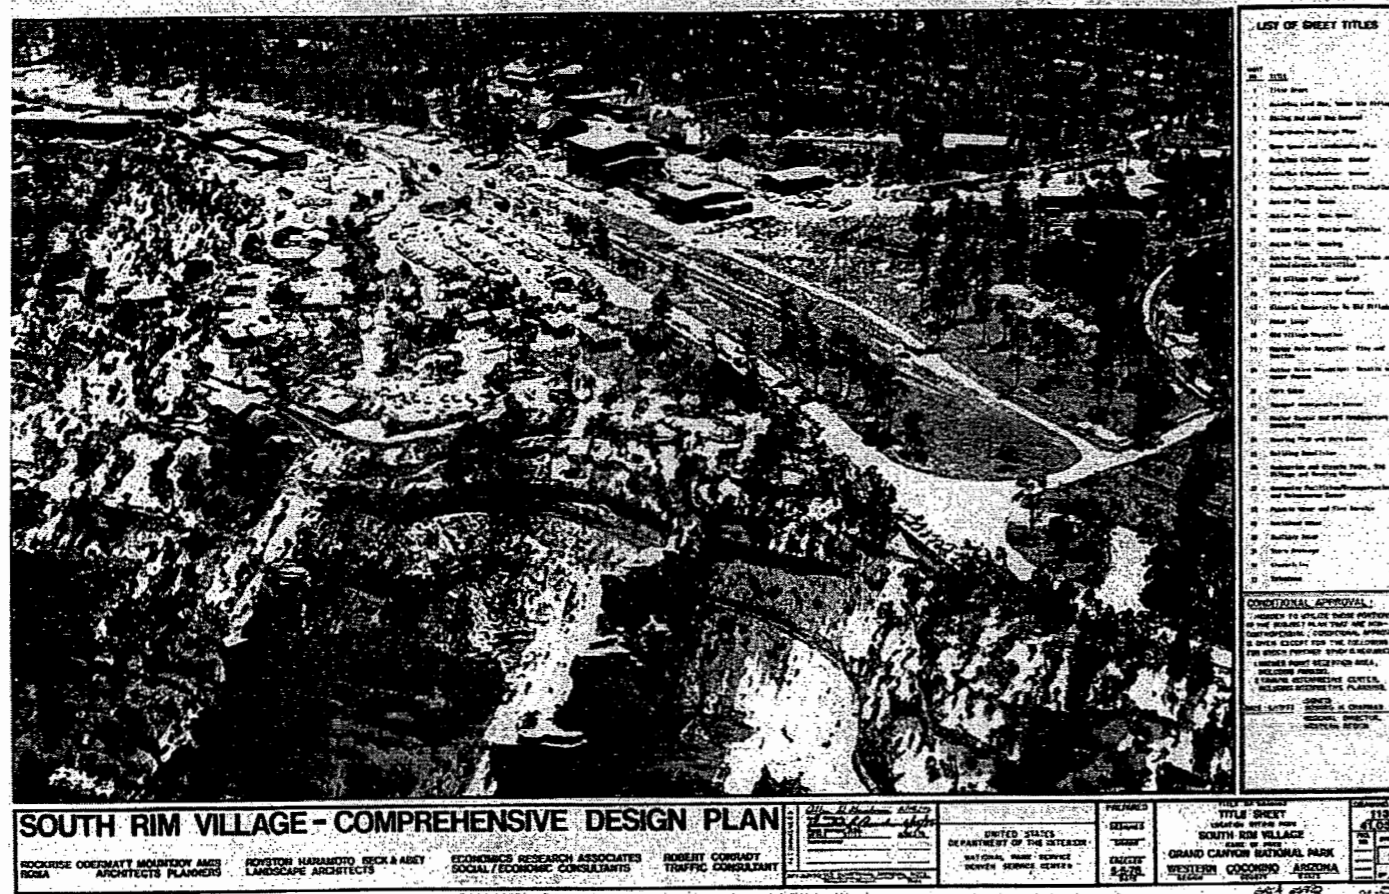
Figure 55. 1976 South Rim Village - Comprehensive Design Plan. (Grand Canyon Museum Collection Catalog #26782)

Another major planning effort was undertaken in the mid-1970s as the NPS continued to struggle with overcrowding and ever-increasing automobile traffic (*Figures 55 and 56*). This new development was facilitated by the construction of a more consistent and sustainable water supply system in the late 1960s. By the early 1950s, the water provided from Garden Creek at Indian Garden was insufficient to meet the needs of the South Rim developed area and the Santa Fe Company concessionaire had to pay to have supplemental water shipped in by train from Flagstaff. Planning for a new water source began as early as the 1940s, but did not become a NPS priority until 1965 when the Union Pacific Railroad, and its subsidiary the Utah Parks Company, donated the North Rim water system to the NPS. Construction on the cross-canyon water line commenced in 1965, was delayed by a massive flood in December 1966, and was finally completed in 1970.

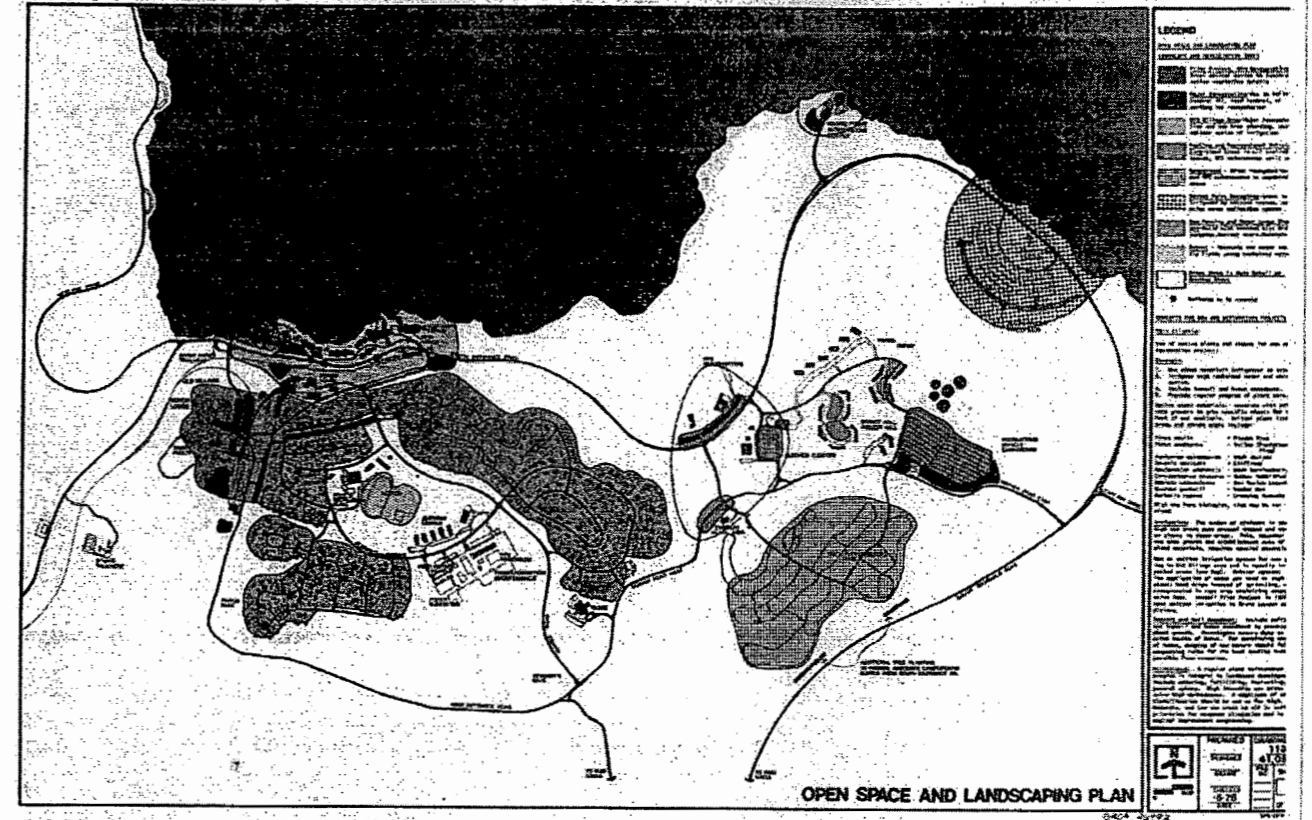
Figure 56. 1976 Open Space and Landscaping Plan for Grand Canyon Village. (Grand Canyon Museum Collection Catalog #26982)

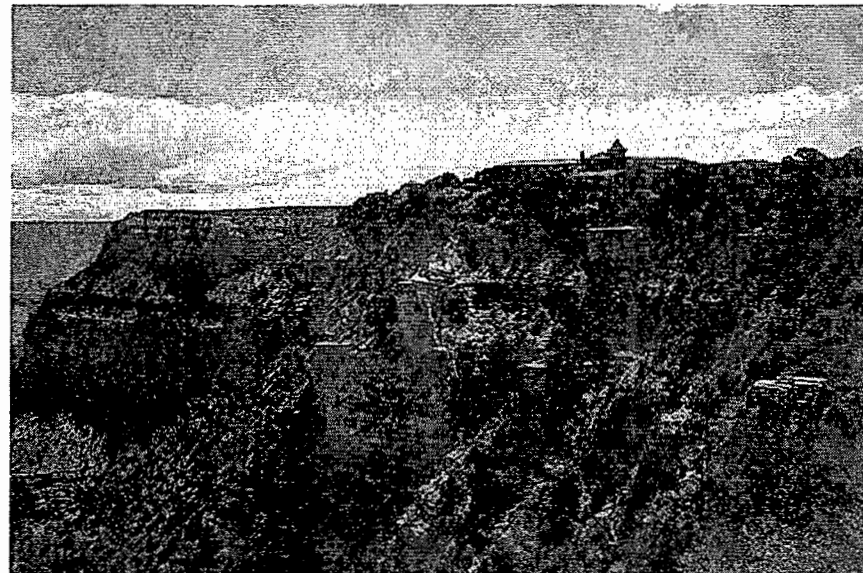
Photograph 1. Canyon edge viewed to east from near Bright Angel Lodge. El Tovar Hotel is visible in center. (JMA, 2001)

Geologic features and landforms constitute the natural systems and features in the Rim Area. The **canyon edge** drops steeply from the developed area into the inner canyon (*Photograph 1*). The Rim Area occupies a limestone and sandstone plateau upon which buildings, structures, and other features are built. The southern edge of the plateau slopes steeply into the Bright Angel Wash toward the Railroad Area.

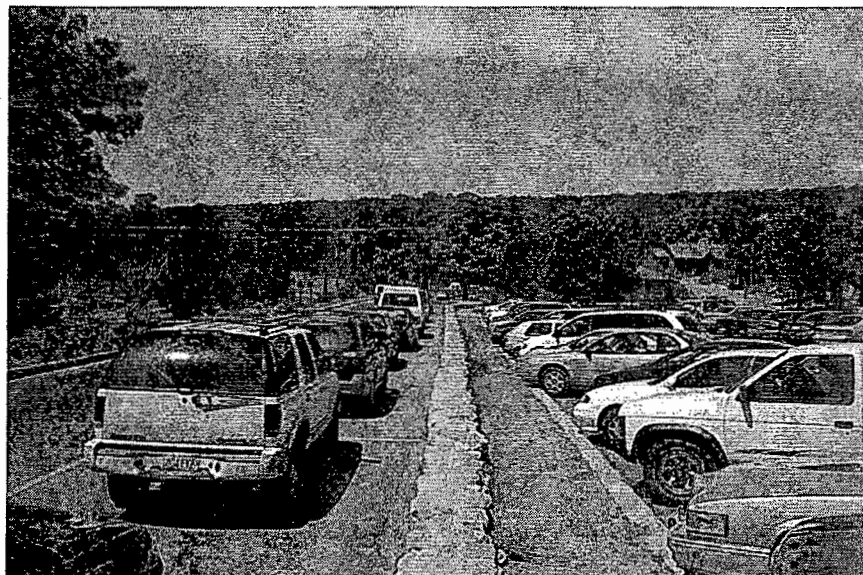
Photograph 2. Village Loop Drive along its northern stretch. (JMA, 2001)

The northern section of **Village Loop Drive**, which runs through the Rim Area, is a one-way asphalt road with parallel parking along the north edge (*Photograph 2*). Curb cuts along the Drive lead north into parking lots and access drives.

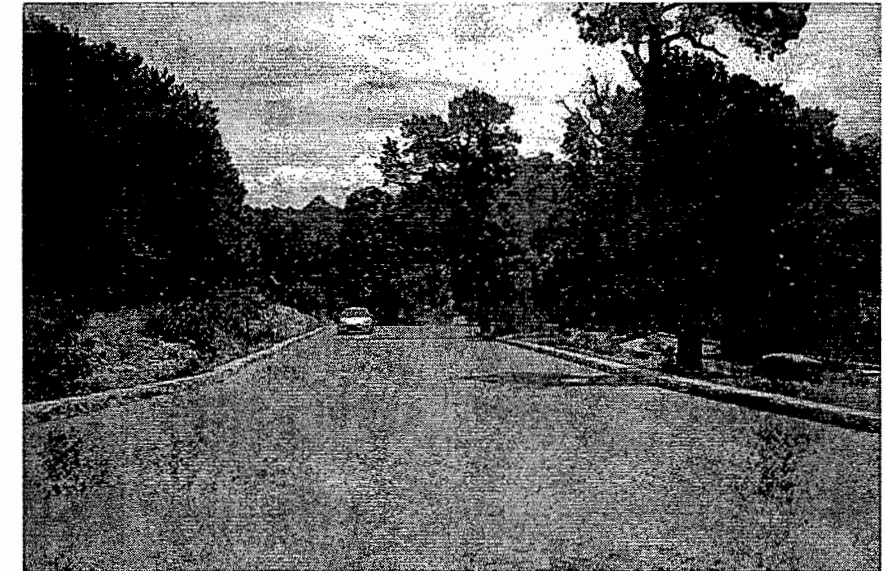
Photograph 3. Access drive to El Tovar Hotel. (JMA, 2001)

At the eastern edge of the Rim Area, an **access drive** leads north and west from Village Loop Drive (*Photograph 3*). The asphalt access drive splits into two drives. The first drive heads north to the circular, asphalt **El Tovar Hotel turn-around** (*Photograph 4*). A large, **six-bay asphalt parking lot** with two parking islands is accessed from the eastern edge of the turn-around and extends to the Verkamp's Store (*Photograph 5*). The **Verkamp's service area** consists of an asphalt parking lot south of the store. The second access drive (*Photograph 6*) leads west toward the **Kachina Lodge and Colter Hall parking lots**. These double-bay asphalt parking lots are edged in low, rectangular masonry curbing. The **El Tovar Hotel asphalt parking**, west of the hotel, and **El Tovar gravel parking and service area**, south of the hotel, are also located along this drive. The access drive dead-ends into the **Thunderbird Lodge access loop** (*Photographs 7, 8*). The asphalt loop is entered from Village Loop Drive toward the eastern end of Thunderbird Lodge, heads west, and then returns to Village Loop Drive at the western edge of Thunderbird Lodge. Vehicles parallel-park along the north edge of the road.

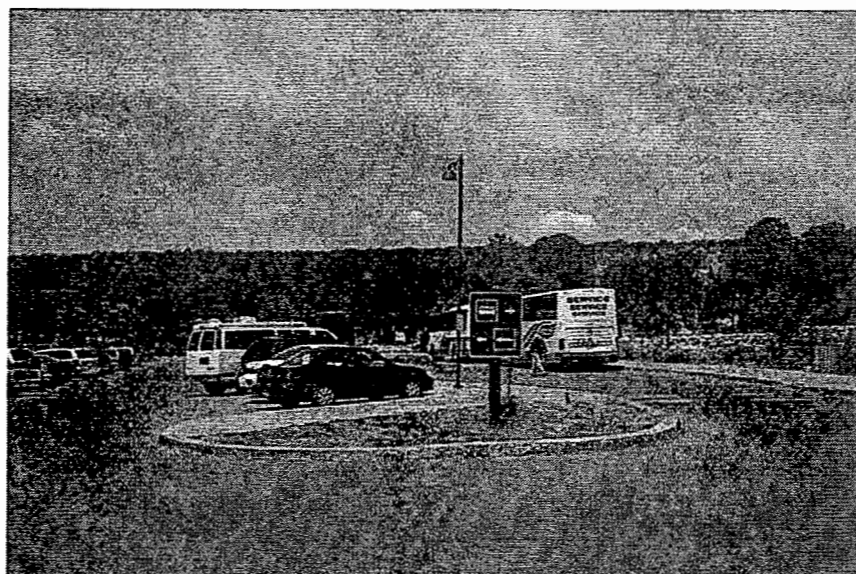
Photograph 9. Bright Angel Lodge parking, with ca. 1920 light fixture, curbing, brown and white NPS sign. (JMA, 2001)

The **Bright Angel Lodge parking and service area** is located east of the Lodge and consists of a rectangular asphalt area, edged in rectangular masonry curbing, and ringed with concrete sidewalks. The **Bright Angel Lodge parking lot** is located south of Bright Angel Lodge (*Photograph 9*). Accessed from Village Loop Drive, the asphalt parking lot consists of two bays of angled parking with a **bus drop-off lane** to the north of the parking spaces. A curb cut from Village Loop Drive leads into an entry drive which accesses the western edge of the Bright Angel Lodge parking lot and the **circular road within the Bright Angel Cabins** (*Photograph 10*). The circular asphalt road with rough stone edging encompasses most of the Rim Cabins, while several cabins are located outside the southern edge. **Rim Cabin parking** is accessed from the western edge of the circular drive (*Photograph 11*). These gravel parking lots are very loose in form. A **circular drop-off** accesses the west wing of the Bright Angel Lodge.

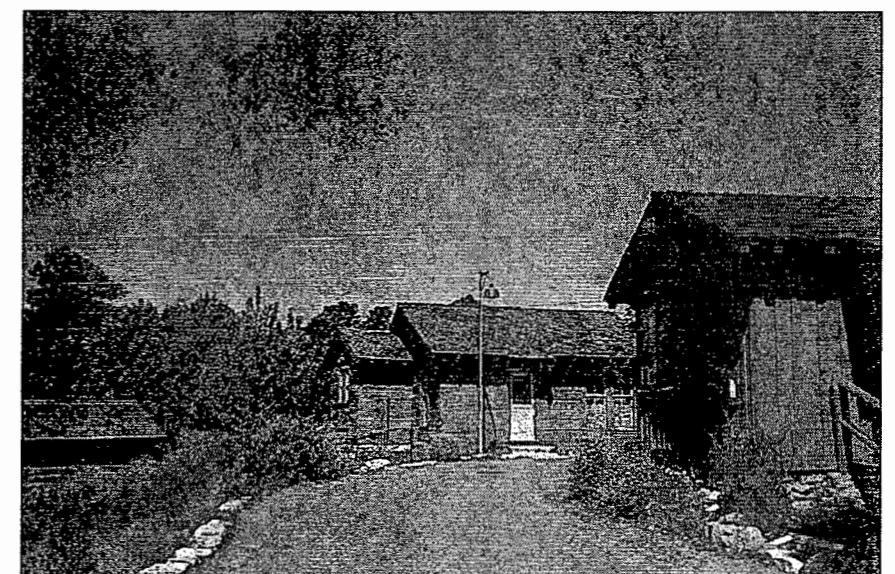
Photograph 10. Circular road within Bright Angel Cabins, with ca. 1920 light fixture, stone edging. (JMA, 2001)

Residential **Bright Angel Cabins** (Bldg. #'s 0517-0525, 0527-0531) serve as visitor accommodations and are similar in construction and design (*Photographs 10, 18, 25*). All cabins are of terra-cotta colored wood construction, either board-and-batten siding, clapboard, or chinked log, with wood-shingled gabled roofs. The gable ends are typically shingled with wood shakes and painted terra-cotta to match the cabins. The multi-light square and rectangular windows have brightly-colored blue or green trim. The cabins rest on uncoursed stone foundations.

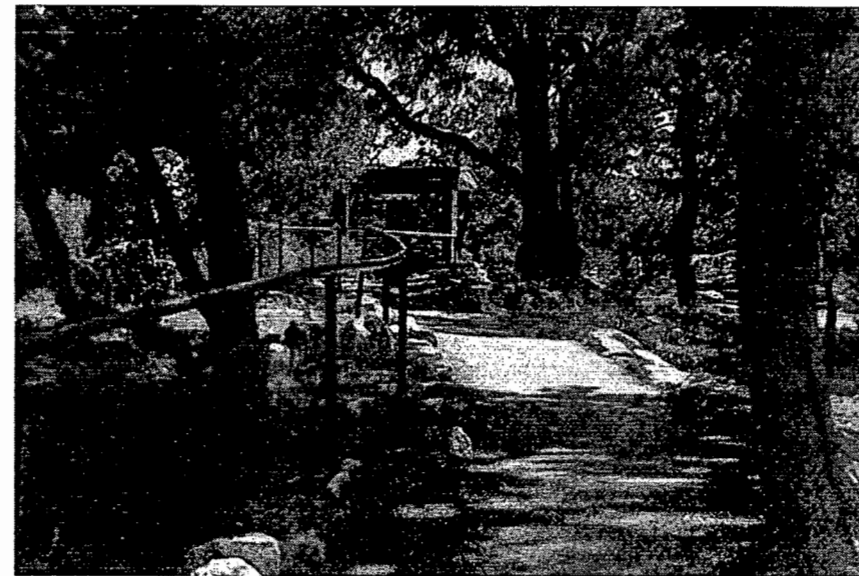
Photograph 12. Western section of Rim Trail with stone edging, metal pipe railing. (JMA, 2001)

Pedestrian trails and paths weave through the Rim Area. The **Rim Trail** is a stone-edged asphalt path that hugs the canyon edge, leading from Mather Point, west through the Rim Area, and ending at Hermit's Rest (*Photographs 12, 13*). The **Bright Angel Trailhead** is located at the western edge of the Rim Area, just beyond the mule corral (*Photograph 14*). The trailhead is a gravel area with a wayside that marks the entrance and exit of Bright Angel Trail.

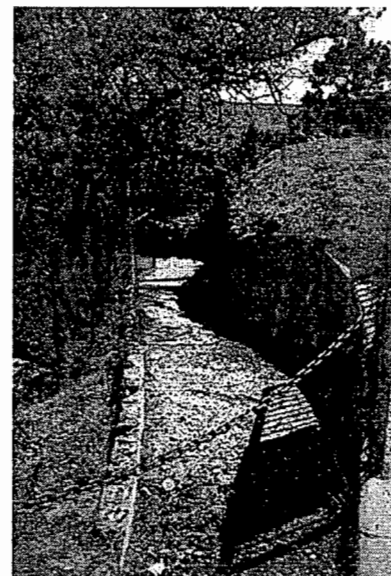
Photograph 15. Asphalt path at Kolb Studio with stone retaining walls, stone and concrete arch, and metal gate. (JMA, 2001)

An **asphalt path** leads from the Rim Trail to the Kolb Studio terrace, east of the Kolb Studio (*Photograph 15*). Currently, the path is chained off, prohibiting visitor access.

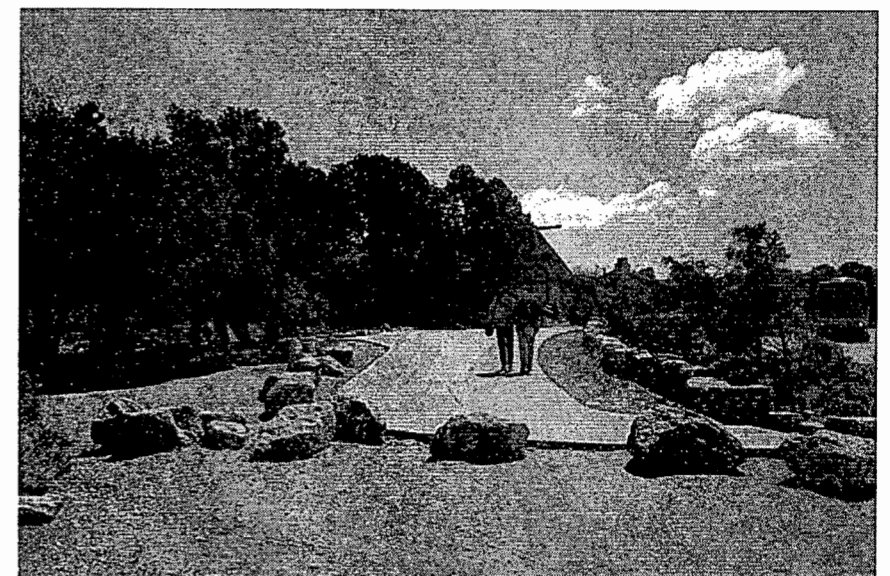
Photograph 16. Concrete sidewalk with boulder edging along Bright Angel Lodge parking. (JMA, 2001)

A **concrete sidewalk** follows the curve of the Bright Angel Lodge bus drop-off, south of Bright Angel Lodge (*Photograph 16*). The sidewalk runs along the edge of Bright Angel Lodge, ending at its eastern edge. Concrete sidewalks are also located along the north edge of the Thunderbird Lodge access loop, between the Thunderbird Lodge, Kachina Lodge, and Colter Hall, and around the El Tovar Hotel circular drive.

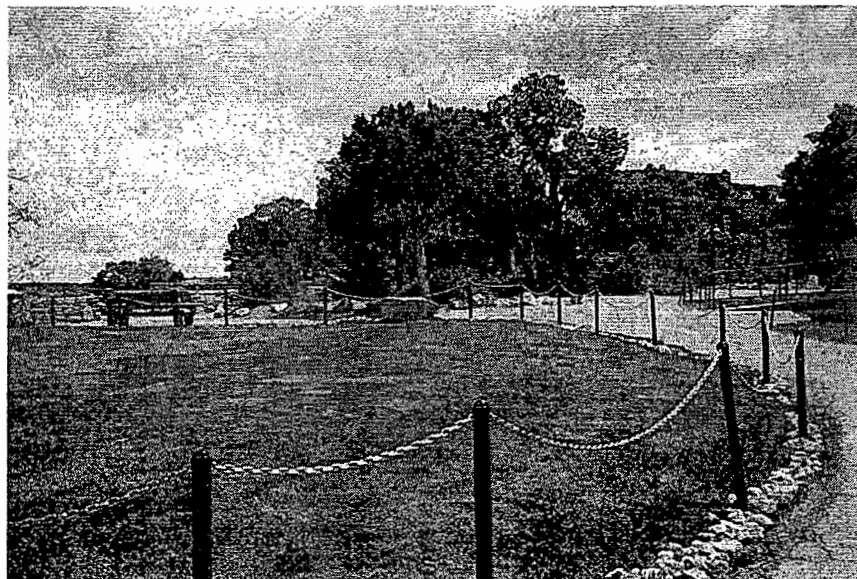
Photograph 19. Lawn at El Tovar Hotel, with stone edging, bollard-and-chain fence. (JMA, 2001)

Irrigated **turf grass lawn** is maintained around the El Tovar Hotel and Kachina and Thunderbird Lodges (*Photograph 19*). The grass draws wildlife, such as mule deer, which enjoy grazing on the lawn.

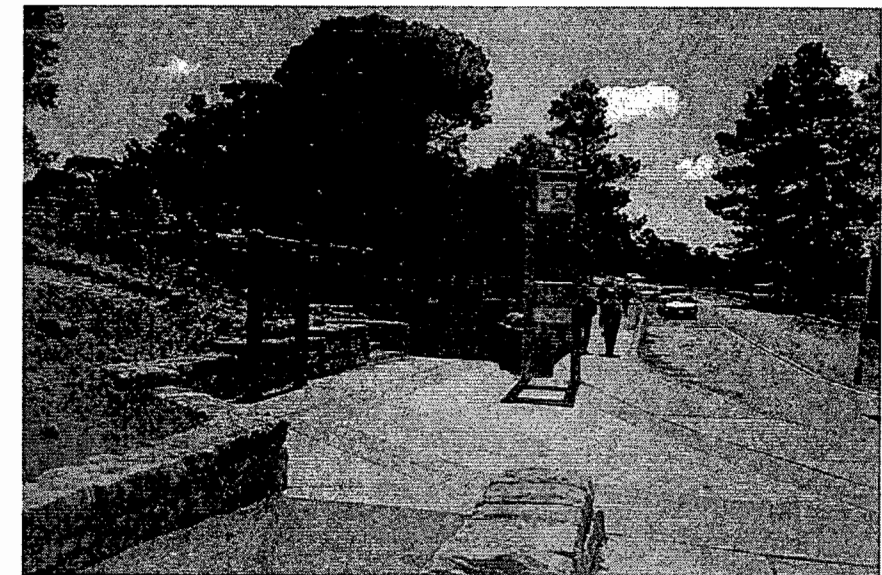
Photograph 22. Bus shelter. (JMA, 2001)

The four **bus shelters** in the Rim Area are constructed in a similar fashion. The shelters have long, rectangular, wood-shingled gabled roofs with log rafters. The roofs are supported by round, peeled-log framing and six peeled-log posts on either side of the shelters. The posts rest on flat-topped benches while one flat wood board runs between each set of posts, creating a seat back. The logs are painted brown. The bench seating is constructed of sandstone. The four shelters are located as follows: Bldg. #445 is found at a bus pull-off at the western edge of the Village Historic District; Bldg. #446 sits approximately 200 feet east of the first shelter (*Photograph 22*); Bldg. #0507 is located east of Bright Angel Lodge (*Photograph 7*); and Bldg. #0542 is found south of El Tovar Hotel.

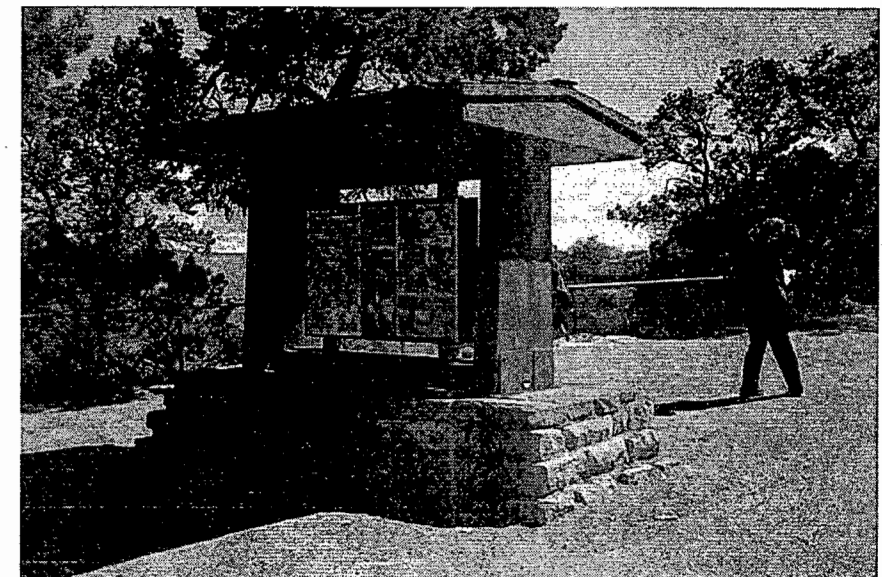
Photograph 23. Wayside exhibit structure. (JMA, 2001)

A **wayside exhibit structure** is located near the Bright Angel Trailhead (*Photograph 23*). The exhibit has a coursed, rectangular stone foundation with square wood posts supporting a gabled roof structure with wood shingles. An NPS exhibit describing the Bright Angel Trail and mule concessions is located between the posts.
