**Grand Canyon Village
National Historic Landmark District
Cultural Landscape Report**

**Grand Canyon National Park
Arizona**

January 2004

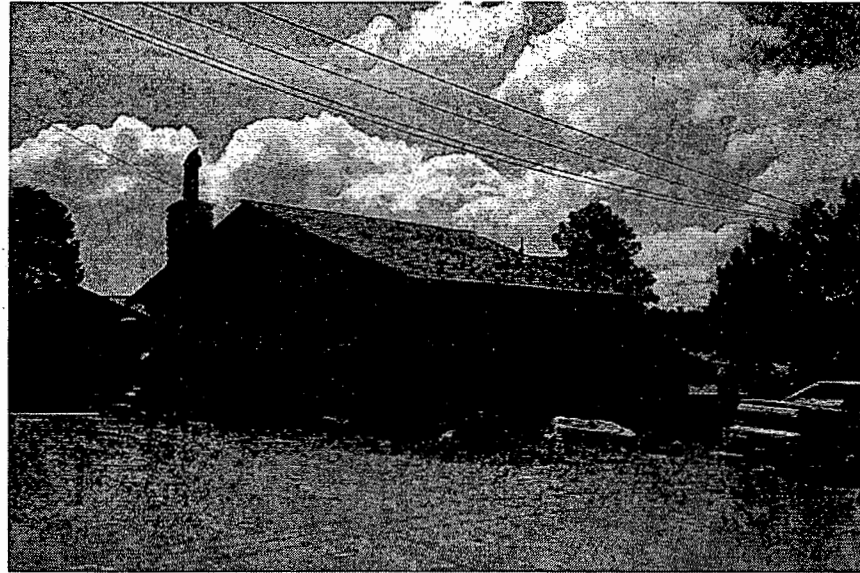
Photograph 24. Red Horse Cabin. (JMA, 2001)

The **Red Horse Cabin** (Bldg. #0526) was originally built in 1890 as a Ralph Cameron-era cabin (*Photograph 24*). In 1907, it was used as a post office and currently is used for visitor lodging. The terra-cotta colored building is constructed of square logs and chinking atop an uncoursed rubble foundation. The gabled roof has wood shingles and exposed rafter tails and most of the windows are two-over-two double hung. A coursed, rough-cut exterior stone chimney is located on the west façade, as is the main entrance.

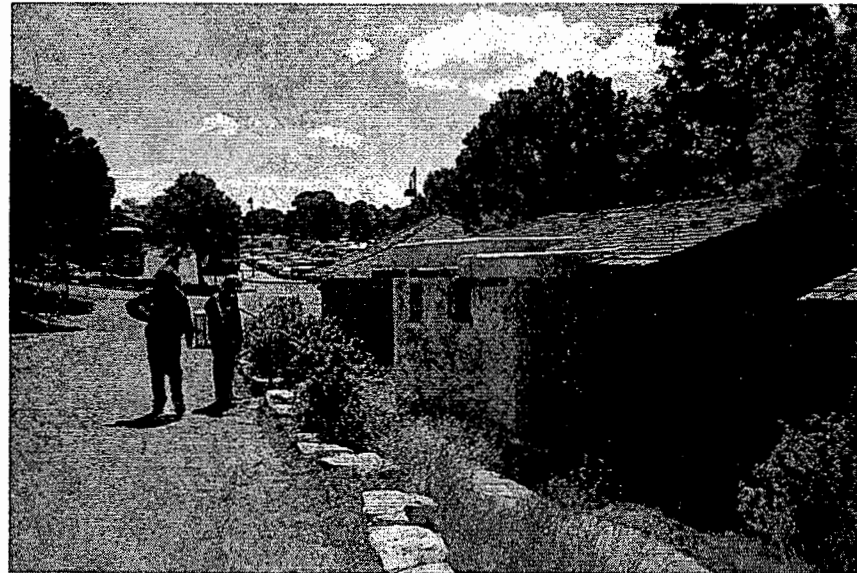
Residential **Bright Angel Cabins** (Bldg. #'s 0517-0525, 0527-0531) serve as visitor accommodations and are similar in construction and design (*Photographs 10, 18, 25*). All cabins are of terra-cotta colored wood construction, either board-and-batten siding, clapboard, or chinked log, with wood-shingled gabled roofs. The gable ends are typically shingled with wood shakes and painted terra-cotta to match the cabins. The multi-light square and rectangular windows have brightly-colored blue or green trim. The cabins rest on uncoursed stone foundations.

Photograph 25. Bright Angel Cabins. Note stone edging along road. (JMA, 2001)

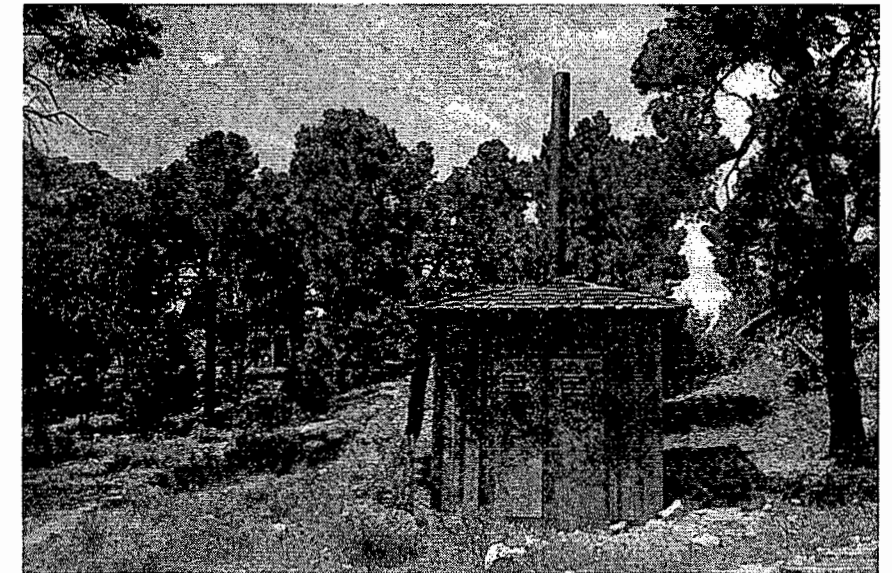
The **Utility Shed** (Bldg. #0541) is a small, square, terra-cotta-color painted wood building with board-and-batten siding, a wood-shingled hipped roof and blue-painted wood double doors on the southern elevation (*Photograph 26*). A tall, round, rusted metal pipe, secured by wires, rises out of the roof.

Photograph 26. Utility shed. (JMA, 2001)

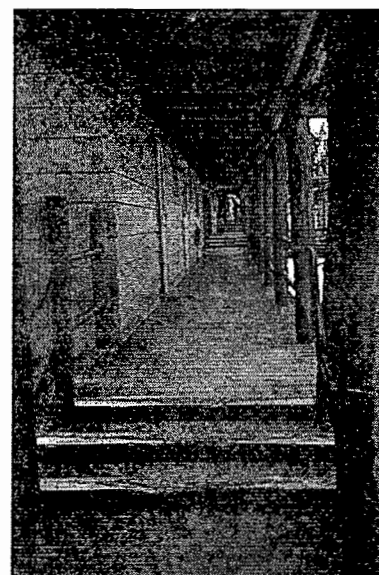
Photograph 28. Covered walkway along Rim Cabins with painted log railing on left. (JMA, 2001)

The **Rim Cabins** (Bldg. #'s 0510-0514) are of similar construction and connected through a series of adjoining porches and walkways (*Photograph 28*). Located north of Powell Lodge, the cabins are painted the same terra-cotta color as the Bright Angel Cabins and have similar siding types of log, clapboard, and board-and batten siding. Window trim, doors, and door trim are painted bright blues and greens. The interconnected porches and walkways consist of wood plank flooring and wood plank and log-beam roofs supported by log posts. Wood railings extend between each post and a contemporary metal handrail, attached to the inside of the posts, as an extra safety measure.

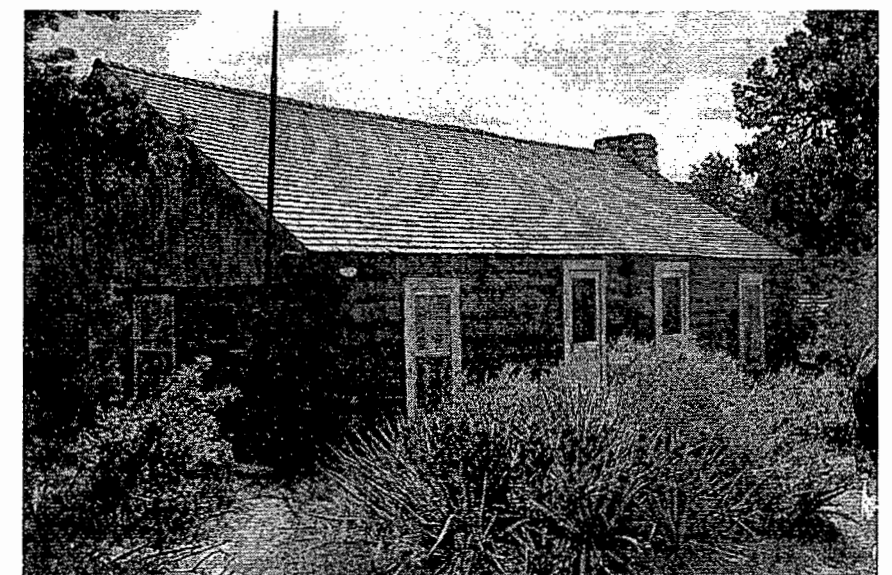
Photograph 29. Buckey O'Neill Cabin. (JMA, 2001)

The **Buckey O'Neill Cabin** (Bldg. #0508) was originally built in the 1890s and remodeled over time to become part of the Bright Angel Lodge complex (*Photograph 29*). The cabin is made of round logs that are saddle-notched at the ends. The roof is complex in design, consisting of hipped sections, shed overhangs, and gables. Gable ends have board-and-batten siding. A stone chimney is located on the cabin's west elevation. Most of the multi-light window trim and doors are painted bright green while the remaining wood elements are blue. The cabin measures approximately thirty-five feet by twenty feet.

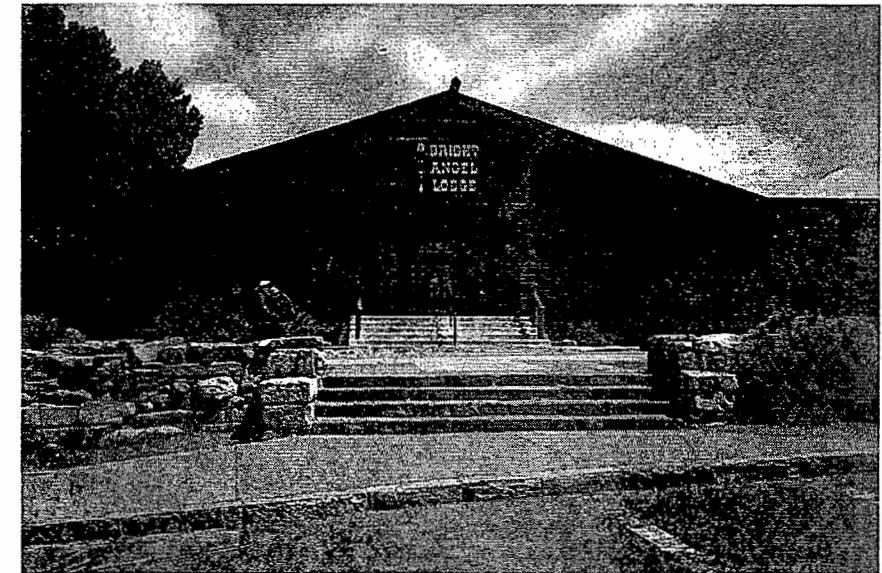
Bright Angel Lodge (Bldg. #0507), designed by Mary Colter, was completed in 1936 and has become a complex of visitor accommodations, gift shops, museums, and a restaurant (*Photograph 30*). Bright Angel Lodge exhibits numerous types, styles, and dates of construction. The building façades are constructed of multiple materials including coursed stone, vertical wood siding, adobe, and log. Because so many additions and alterations have occurred, the roof is very complex with gabled, flat, and hipped sections, all clad with a variety of shingles. The main entrance faces Village Loop Drive and is located beneath a long, gabled overhang supported by log posts and beams. A secondary entrance faces the canyon rim and is located near the gift shop portion of the lodge beneath a flat roof overhang, also supported by log beams and posts.

Photograph 30. Bright Angel Lodge south entrance. (JMA, 2001)

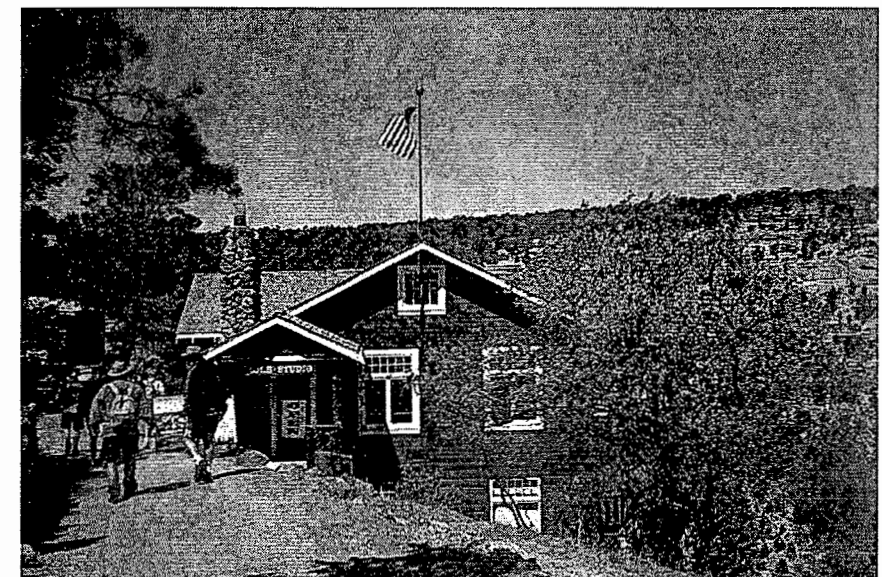
Northwest of the Bright Angel Lodge complex, the **Kolb Studio** (Bldg. #SRB0533) overlooks the canyon edge (*Photograph 31*). The Kolb Studio, completed in 1914, currently houses a gift shop and art gallery. The building is of wood frame and log construction designed in the

Craftsman architectural style. The upper-story exterior walls are covered in brown-painted wood shingles. The roof has multiple gables with exposed rafter tails and is covered in wood shingles. The windows are Craftsman-style, with smaller multi-light windows over large panes of glass. The window trim is painted white. A rough stone chimney is located on the front, or southern, façade. The **Kolb Studio Garage** (Bldg. # SRB0617) is located south of, and across the sidewalk from, the Kolb Studio (*Photograph 32*). Built in 1927, the garage is a small, rectangular building with a shed roof and brown clapboard siding. Small, square windows are located on the northern elevation.

Photograph 31. Kolb Studio. (JMA, 2001)

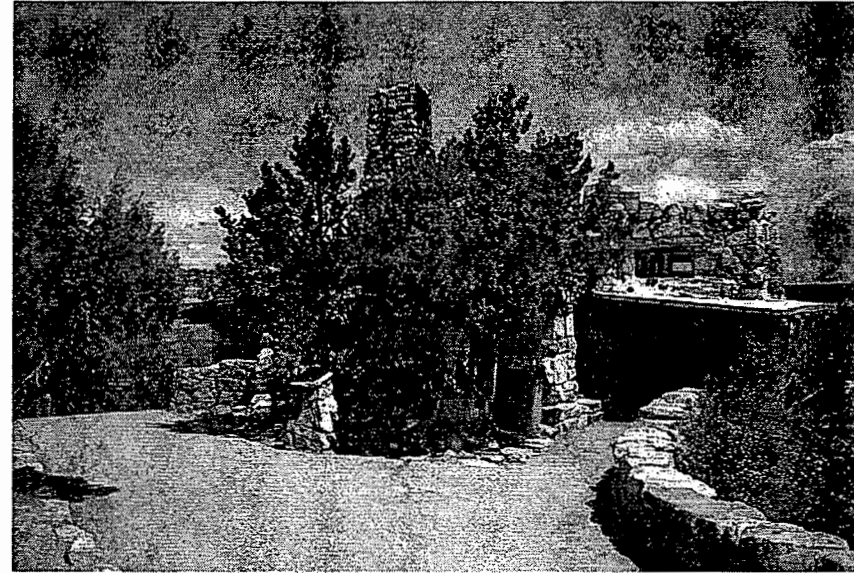
Mary Jane Colter's 1914 **Lookout Studio** (Bldg. #0532) is located directly on the canyon rim and north of the Rim Cabins (*Photograph 33*). The Lookout Studio is constructed of coursed rubble native stone and is generally rectangular in plan. Parapet rooflines and stone chimneys mimic the irregular shapes of surrounding bedrock. An uneven parapet on the roof steps up to incorporate the chimney and a small observation room. The observation room has a small balcony with a jigsaw-pattern railing. Low stone walls lead up to the building thereby protecting visitors from the precipice. Multi-light, Craftsman-style windows are located throughout the building. Although originally constructed for viewing the canyon, the building now houses a gift shop.

Photograph 33. Lookout Studio. (JMA, 2001)

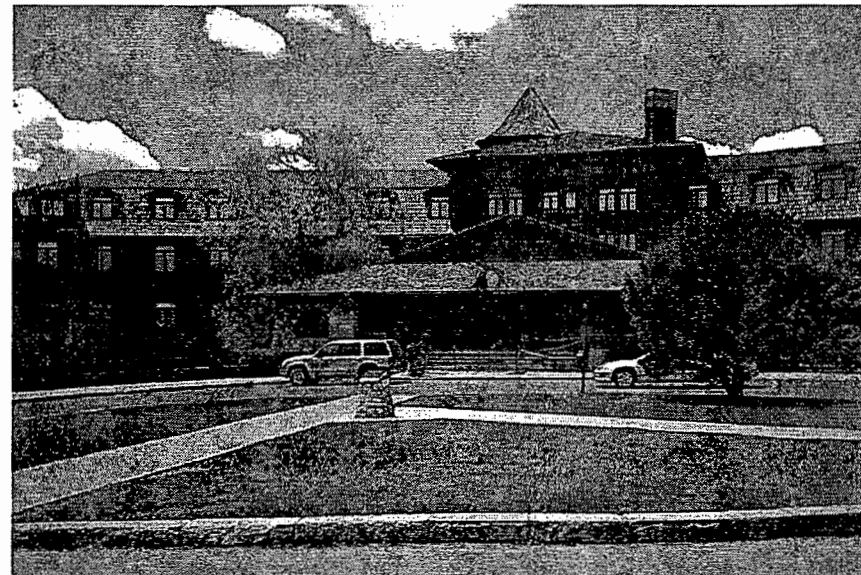
Built in 1905, the **El Tovar Hotel** (Bldg. #0542) is a large hotel built in close proximity to the edge of the Grand Canyon (*Photograph 34*). According to the 1985 El Tovar Hotel National Register Nomination, the building's foundation is rubble masonry and concrete. The superstructure is of wood frame construction. The first floor is sheathed with log slab siding complete with finely-honed corner notching that gives the appearance of log construction. The upper stories have rough

Photograph 34. El Tovar Hotel front entrance, with historical marker in foreground. (JMA, 2001)

weatherboards. Log-slab moldings surround the windows on the first floor while those on the upper stories have heavy, milled moldings. The building has multiple roofs at several different levels. The uppermost level is the wood turret which is wrapped in shingles and serves as the most important element of the El Tovar silhouette. Directly below the turret is a hip roof with bracketed eaves that shelters the central portion of the building. The three-story wings to the north and south, flanking the central portion, have mansard roofs pierced by dormers. On the north and south ends, the roofs step down to second- and first-floor terraces. The main entrance is located on the east side of the building and has a gabled roof with hipped ends covering the large entrance porch. Porches facing the canyon have peeled log posts. The railings along all terraces and porches have jigsaw balusters cut in patterns reminiscent of Swiss-Rustic detailing. The large porch on the north end of the building has two attached gazebos to the east and west (Photograph 35). An access ramp for wheelchairs was added to this north end of the building. At the southernmost end of the building, the surrounding grade drops down to the hotel's basement level. Here, the coursed rubble masonry walls contain arched openings similar to those in the stone corner wall of the entrance porch.

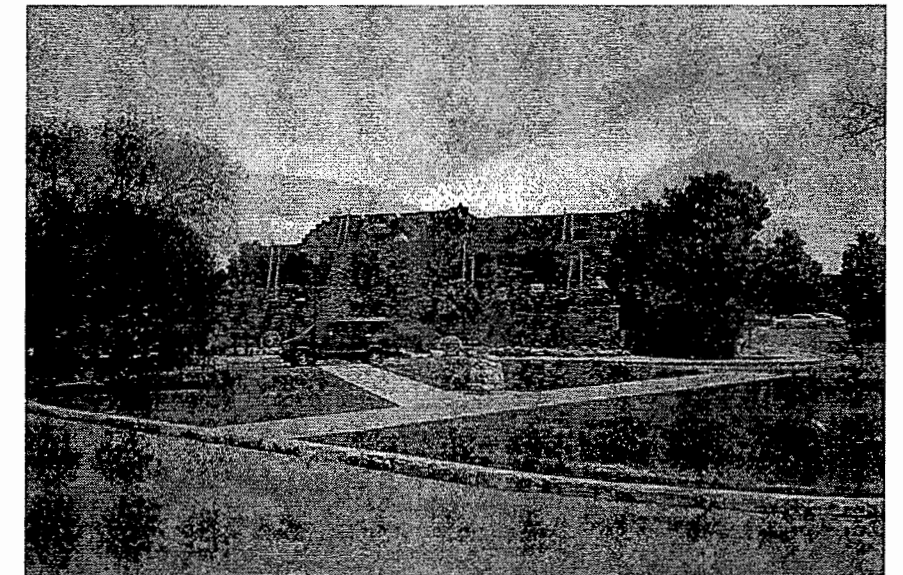
The **Hopi House** (Bldg. # 0545) was built in 1905 and designed by Mary Jane Colter (Photograph 36). The Hopi House is a large multi-story structure of stone masonry, shaped and built like a Hopi pueblo building. The building is rectangular in plan. The multiple roofs are stepped at various levels giving the impression of pueblo architecture. The sandstone walls are reddish in color. Tiny windows, like those of true Hopi structures, allow a small amount of light into the building.

Photograph 36. Hopi House. (JMA, 2001)

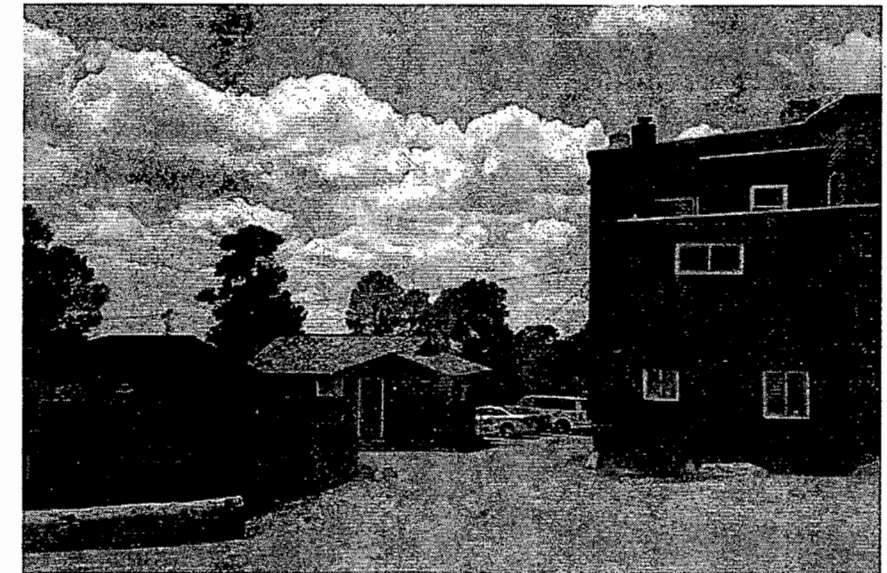
A small residential building, the **Verkamp's Residence** (Bldg. #0547) is located south of the Gift Shop (*Photograph 37*). Built in 1906, the residence consists of a rectangular core with perpendicular ell attached to the northern elevation. The roofs are gabled with wood shingles while the walls are sheathed in brown wood shingle siding. Windows are one-by-one rectangles with white trim. An entrance is located on the eastern end of the ell.

Photograph 37. Verkamp's Residence in center (small building). (JMA, 2001)

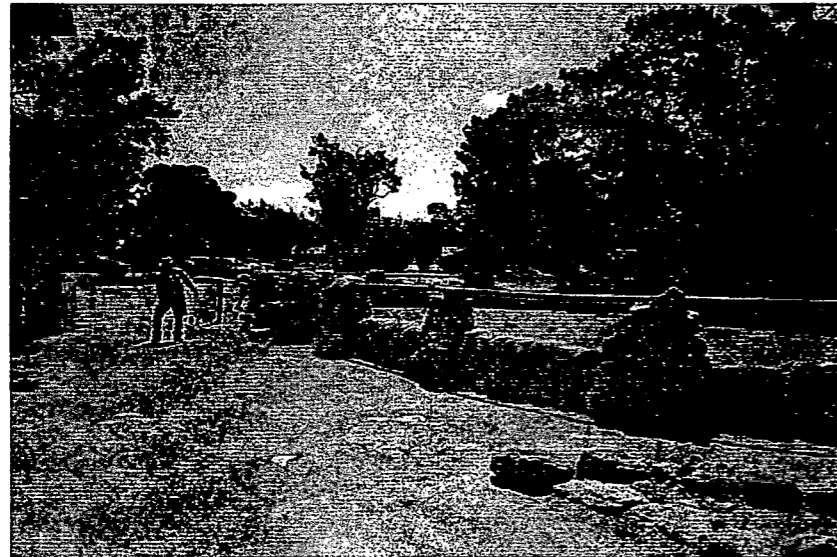
In addition to buildings and sheltering structures, the Rim Area contains various types of steps and walls. Stone walls are found throughout the area. These stone walls are of varied height, serving as seating and/or to retain earth along a grade. A low **stone wall** defines the bus shelter areas in the Rim Area. The **Mule Corral wall** consists of an oval rubble stone wall with rubble piers supporting a metal pipe rail (*Photograph 39*). The corral is located west of the Bright Angel Cabins.

Photograph 39. Mule Corral wall. (JMA, 2001)

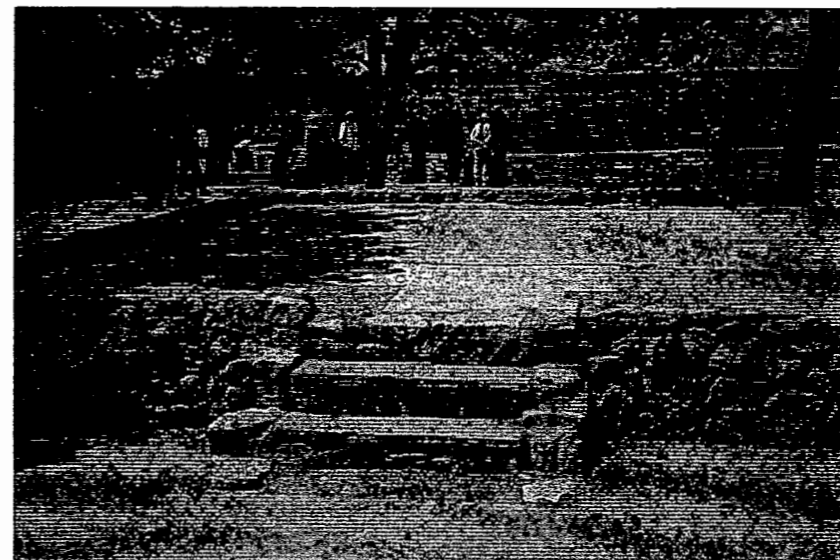
The **Hopi House Dance Platform** is located northwest of the Hopi House (*Photograph 45*). The square platform consists of a mortared stone retaining wall, approximately two feet in height, that supports a concrete and gravel floor. Three stone treads lead up to the platform.

Photograph 45. Hopi House Dance Platform. (JMA, 2001)

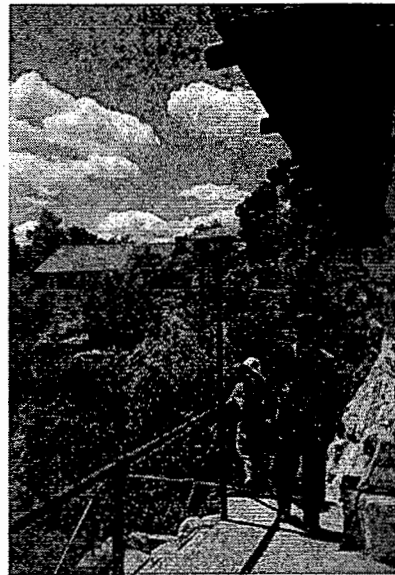
Railings are found along stairs and ramps as well as at some points along the Rim Trail. Rustic-style **painted log railings** are located around the Bright Angel Rim Cabins and Lodge. **Metal railings** in the Rim Area are painted green, brown, or black (*Photograph 12*). An extensive black metal railing runs along the concrete stair leading from the El Tovar Hotel down to the Railroad Depot (*Photograph 44*); another is found at the Lookout Studio—along the stairs down to the adjacent overlook (*Photograph 53*).

Photograph 53. Metal railing at Lookout Studio steps. (JMA, 2001)

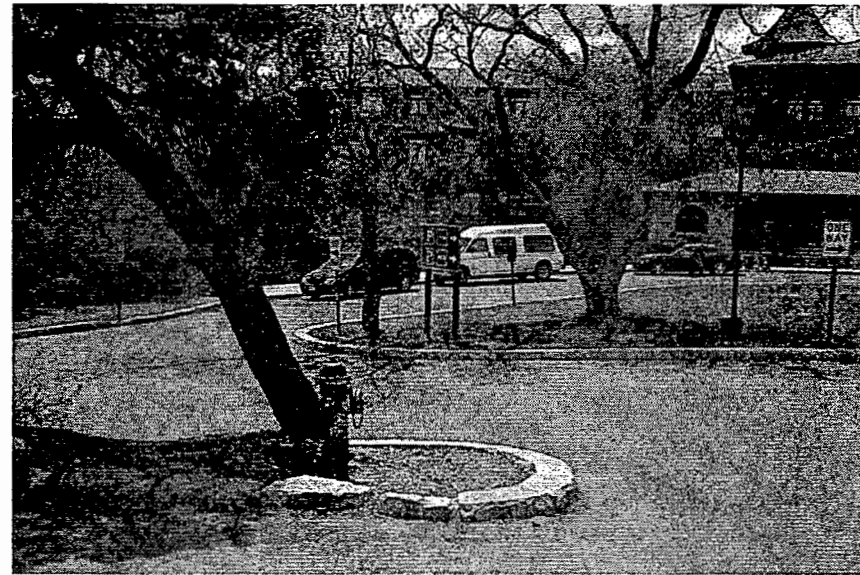
Wood plank steps are located across paths, as with the steps in the western portion of the Rim Trail, and allow the trail to make a slight grade change. **Cut stone curbs**—of similar material to the steps at the south entrance to Bright Angel Lodge—are generally found along contemporary asphalt sidewalks, along Village Loop Drive, the El Tovar Hotel drop-off loop (*Photograph 54*), and Bright Angel Lodge parking lot (*Photograph 9*).

Photograph 54. Small-scale features near El Tovar: stone curbing, fire hydrant, light, and signage. (JMA, 2001)

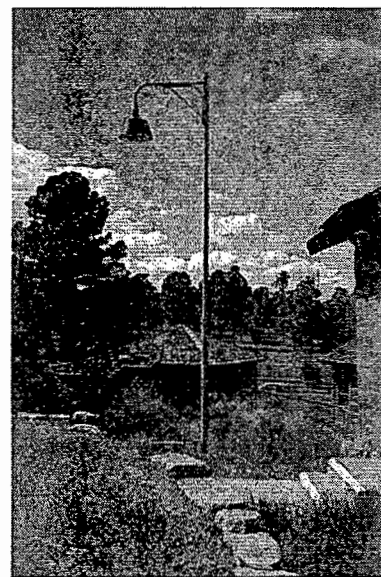
Photograph 57. Green-painted metal streetlight. (JMA, 2001)

In the Bright Angel Cabin cluster are several **green-painted metal street lights**, approximately eighteen feet tall, featuring a curving lamp arm and ornamental metal bracket with curled ends (*Photograph 57*). These may be the circa 1920 light standards described in the National Historic Landmark nomination for the Village Historic District. The luminaires and lamp arms of some lights have been replaced by contemporary “acorn” lights (*Photograph 58*).

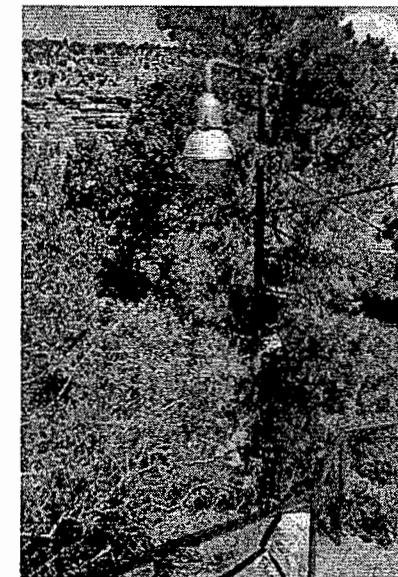
Photograph 58. Light with acorn luminaire. (JMA, 2001)

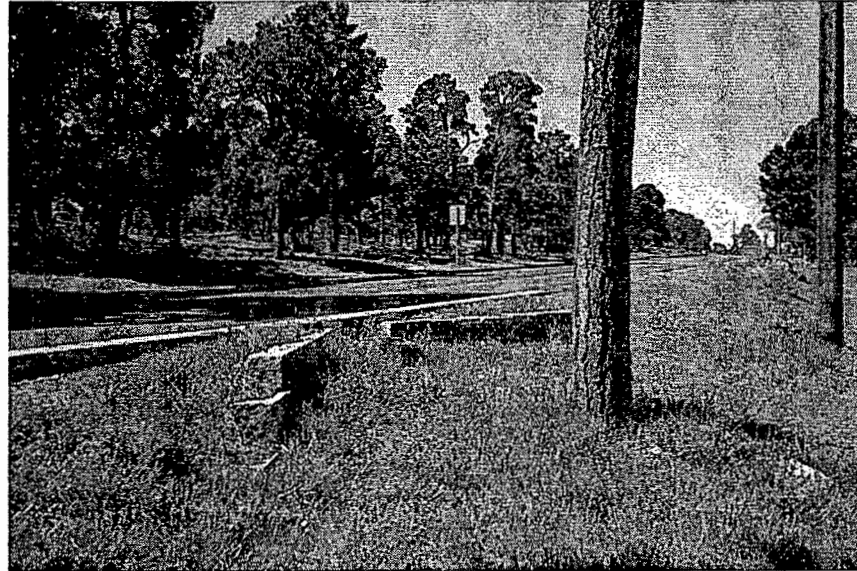
Small-scale features related to circulation include **cut sandstone curbs** found along Village Loop Drive and the asphalt sidewalks that accompany the roadway. These contemporary curbs are of evenly-cut sandstone. Similar curbing is used to protect trees and reinforce slopes along the road edge (*Photograph 97*). In a few places **boulder edging** is used along the road margin. Boulders are used in the Utility Area to control vehicular access, as wheel stops, and to protect small features, such as fire hydrants in the utility yard, from vehicles (*Photograph 98*).

Photograph 97. Cut stone curb blocks used as tree guards along Village Loop Drive bank. (JMA, 2001)

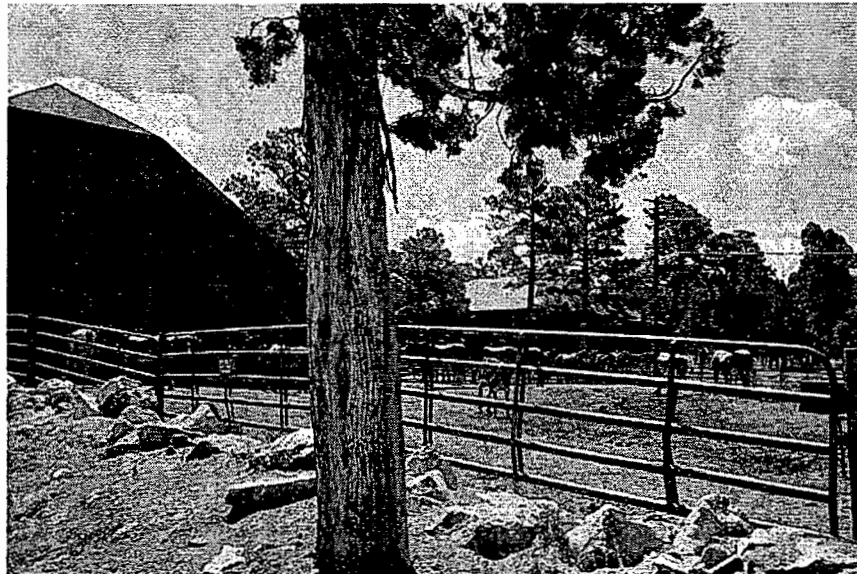
Fencing in the Utility Area is functional and contemporary. **Chain-link fencing** surrounds the radio antenna tower, is found along the south side of the Blacksmith Shop, and encloses the substation west of the Power House (*Photograph 68*). **Painted wood board privacy fence** surrounds other utility functions between the substation and the Purchasing and Receiving building (*Photograph 84*). Green or brown painted **metal corral fencing** surrounds the mule corral to the west of the Livery Stable (*Photograph 99*).

Photograph 99. Stone edging, corral fence. (JMA, 2002)

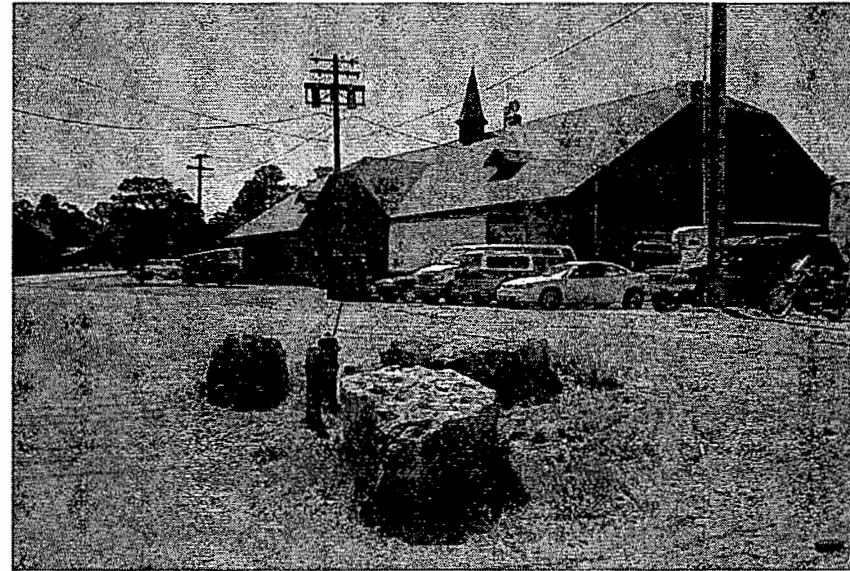
Photograph 98. Fire hydrant and protective boulders. (JMA, 2001)

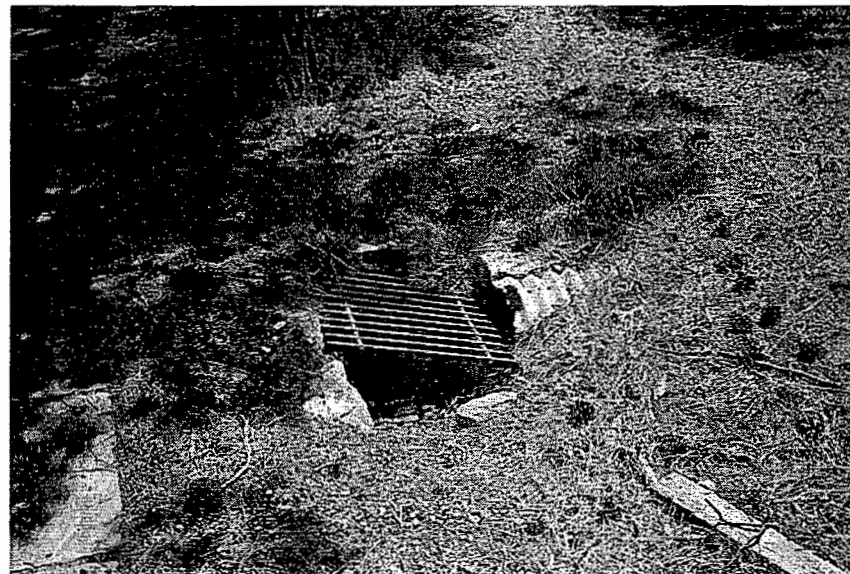
Metal **drainage grates** cover drop inlets along the margins of Village Loop Drive, both within the roadway and off to its sides. An example of this feature is the metal grate found just south of the Community Building (*Photograph 100*).

Photograph 100. Drainage grate near Community Building. (JMA, 2002)

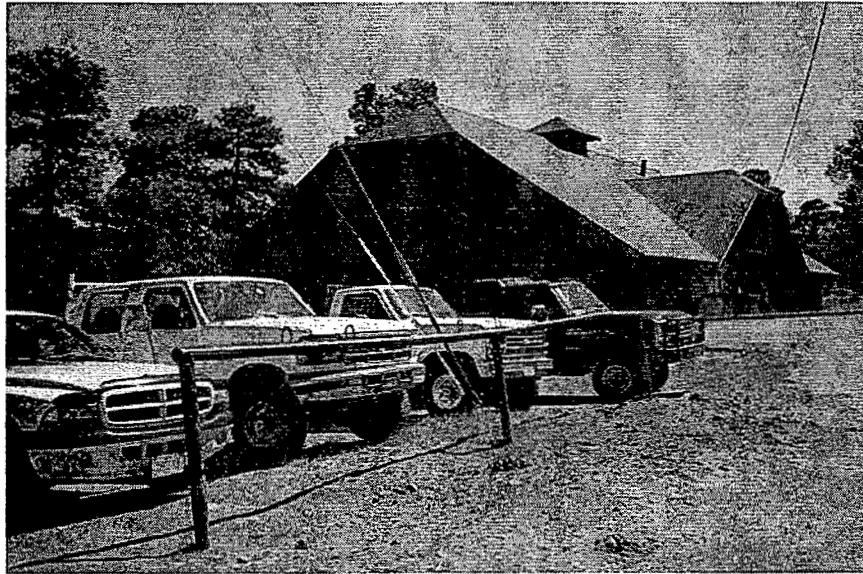
Other features related to livestock uses include a **hitching post** comprised of a metal pipe bar east of the Livery Stable (*Photograph 101*) and **corral features** including a water tank, hay racks, and water troughs, all made of green-painted metal (*Photograph 102*).

Photograph 101. Hitching post at Livery Stable. (JMA, 2001)

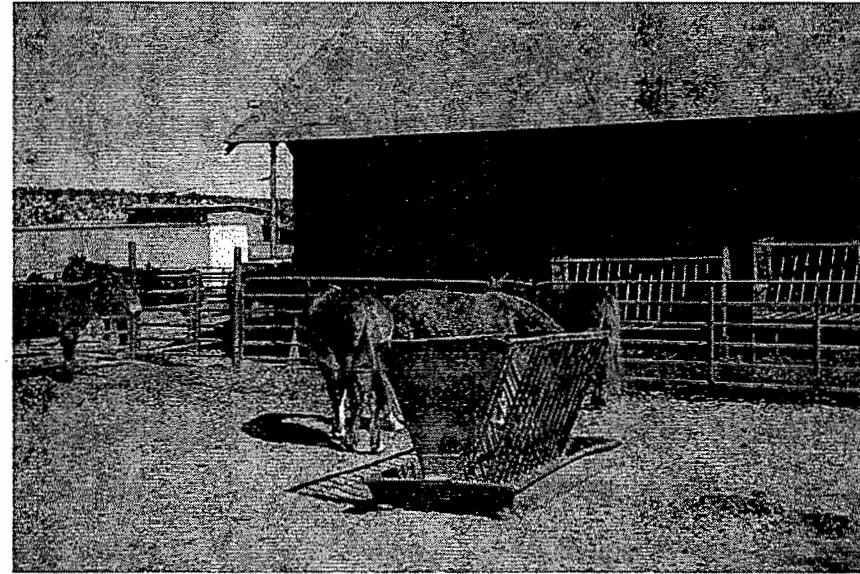
Photograph 102. Corral features. (JMA, 2001)

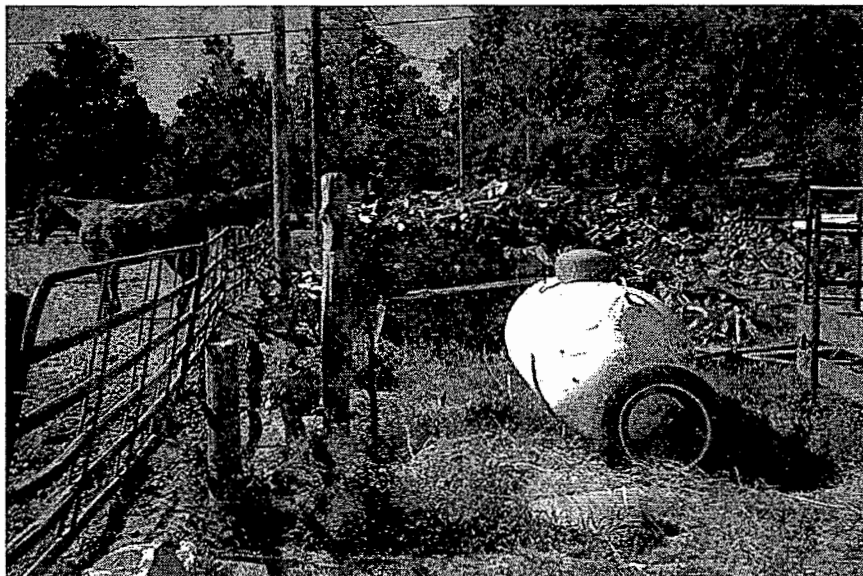
Piles of materials, including building materials, sand, and firewood are located in the Utility Area in the vicinity of the Storage Building (*Photograph 103*).

Photograph 103. Propane tank and wood pile (JMA, 2001)

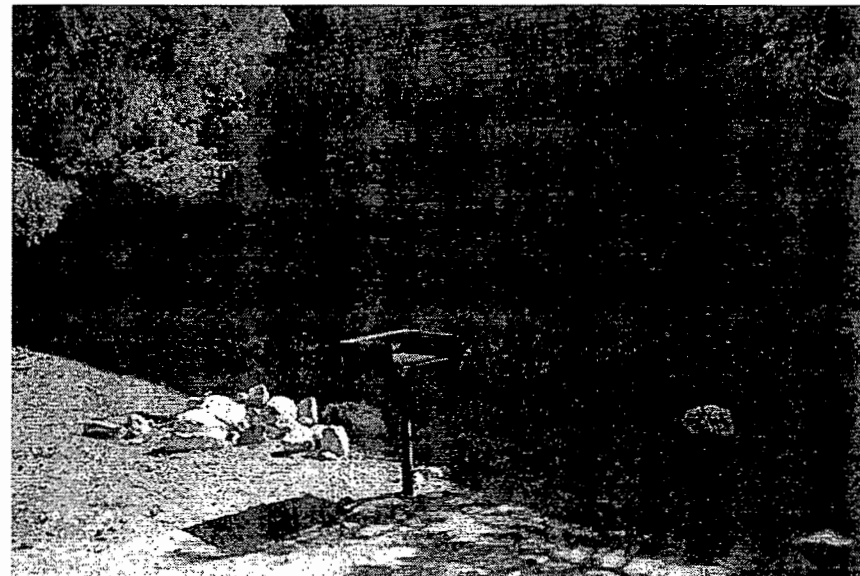
Recreational features include an **outdoor grill** (*Photograph 104*) near the basketball court and **picnic tables** on the terrace on the north side of the Community Building.

Photograph 104. Outdoor grill near Victor Hall. (JMA, 2001)

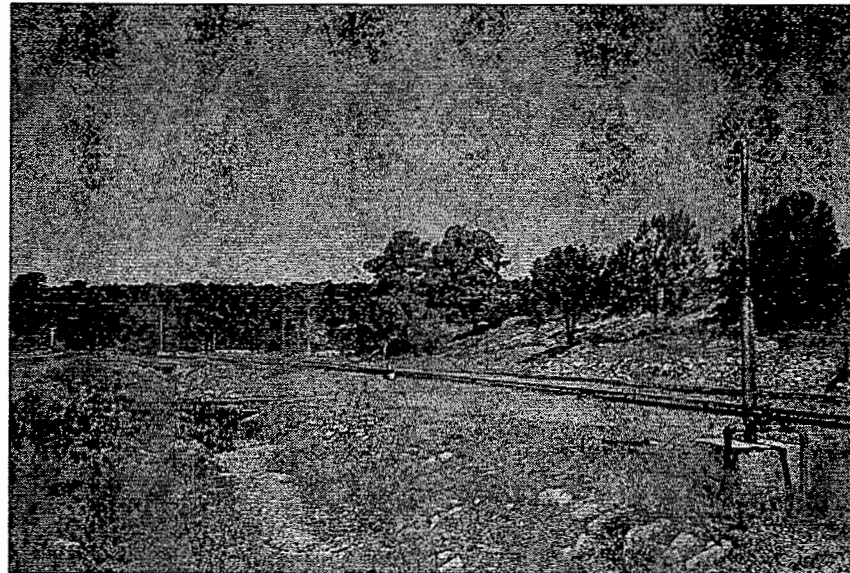
The Railroad Area is located largely within the **Bright Angel Wash**. From the north, steep slopes descend from Village Loop Drive and the rim plateau to the railroad tracks (*Photograph 105*). The tracks are aligned along the gentle grade that runs from east to west across the bottom of the drainage. Water flows west down the drainage in a **ditch** that is located generally to the south of the railroad tracks (*Photograph 106*).

Photograph 105. Bright Angel Wash. Note metal pipe feature on right. (JMA, 2001)

Most of the **trash receptacles** and recycling bins near the Depot are aggregate-covered cylinders. A **metal standpipe** is located in the central portion of the Railroad Area and consists of a tall, metal pipe set into a square concrete base. Its purpose and date of construction are unknown (*Photograph 105*).

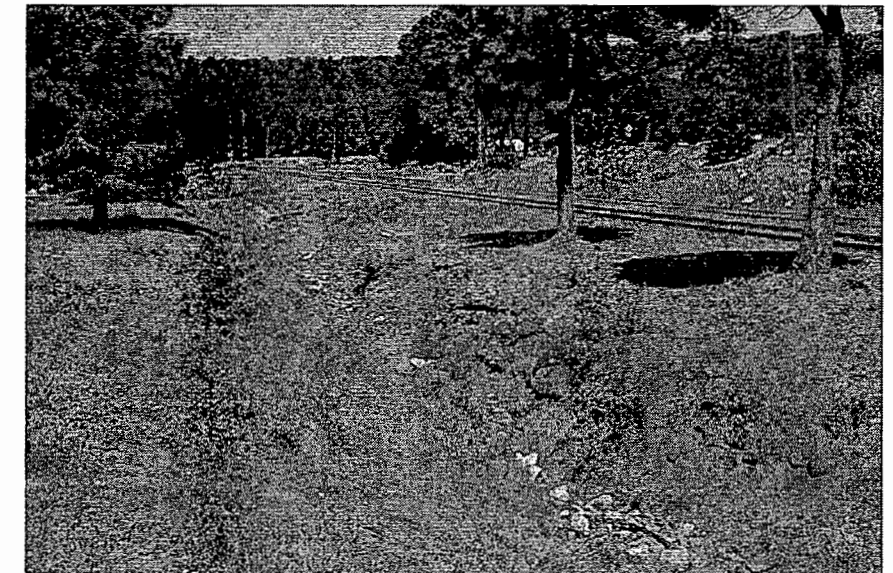
Photograph 106. Drainage ditch along tracks. (JMA, 2001)

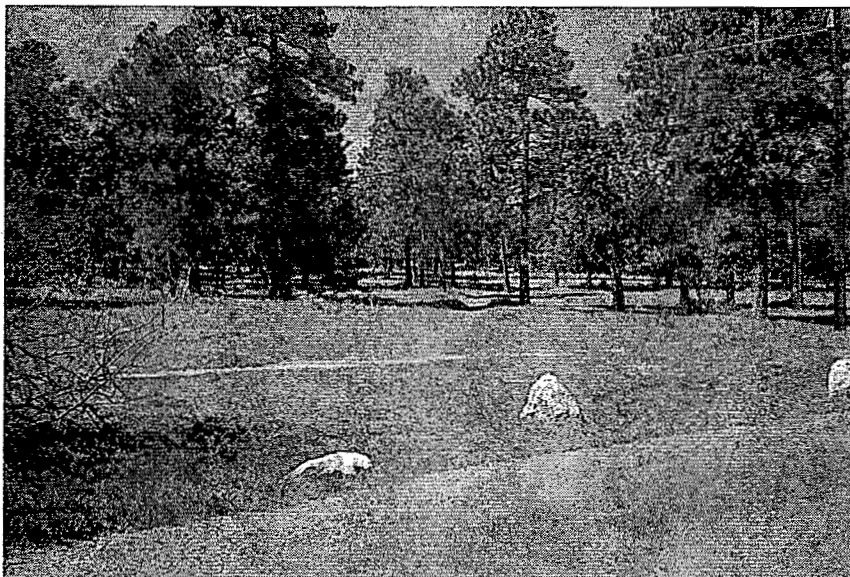
In the western portion of the area, a triangular space is created by the **wye intersection** of the railroad tracks (*Photograph 107*). This space contains ponderosa pine woods and a portion of the Old Village Bypass Road. A **node** at the eastern terminus of the railroad tracks consists of the Railroad Depot, gathering spaces for arriving or departing passengers, and spaces for loading or unloading cargo (*Photograph 108*). The node's low-lying location and the adjacent stands of tall ponderosa pines give the Depot cluster an enclosed feeling.

Photograph 107. Area inside wye intersection of railroad tracks. (JMA, 2001)

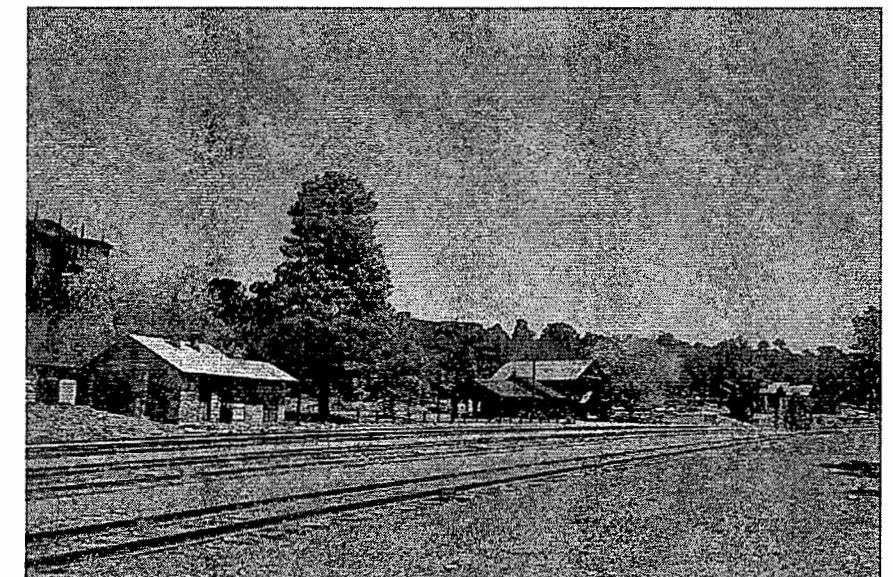
Photograph 108. Railroad Depot node and tracks. (JMA, 2001)

The views and vistas within the Railroad Area are oriented around the rail tracks and the sequence of arrival to the Grand Canyon by rail. The linear, unobstructed railroad corridor provides **long views of the railroad tracks** from points along the tracks (*Photograph 108*).

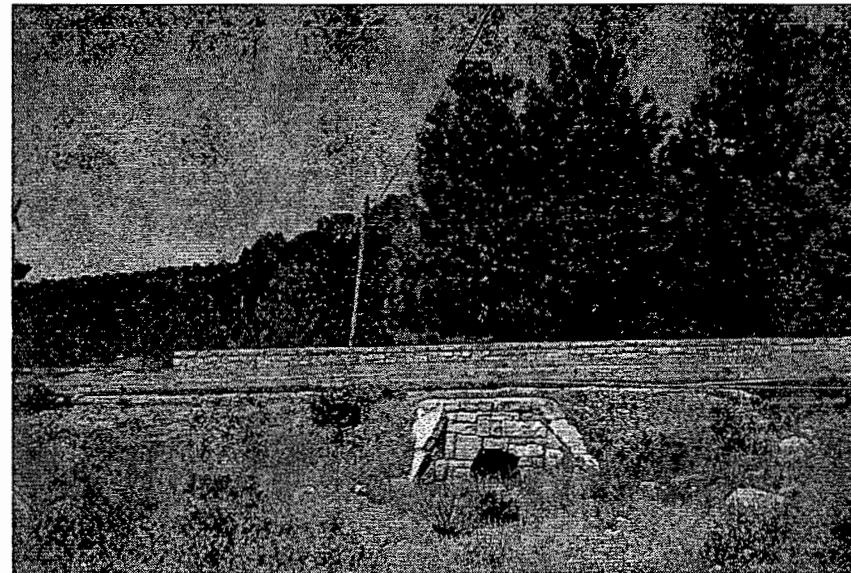
Vehicular circulation has a limited presence in the Railroad Area. A short section of **Village Loop Drive** bounds the western edge of the area (*Photograph 109*). The **Old Village Bypass Road** terminates into Village Loop Drive, also at the area’s western edge (*Photograph 110*). A short **asphalt access drive** terminates at the Railroad Depot fence, east of the building.

Photograph 109. Village Loop Drive on western edge of Railroad Area, with stone-faced culvert. (JMA, 2001)

Rubble stone headwalls, connecting four large corrugated metal pipes, form a U-shaped structure adjacent to the Old Village Bypass Road, closer to the western end of the Railroad Area boundary. A **stone-faced culvert** is at the western edge of the area along Village Loop Drive (*Photograph 109*). A second **stone-faced culvert**, with one pipe opening, is located in the wooded southeastern portion of the area, north of Village Loop Drive.

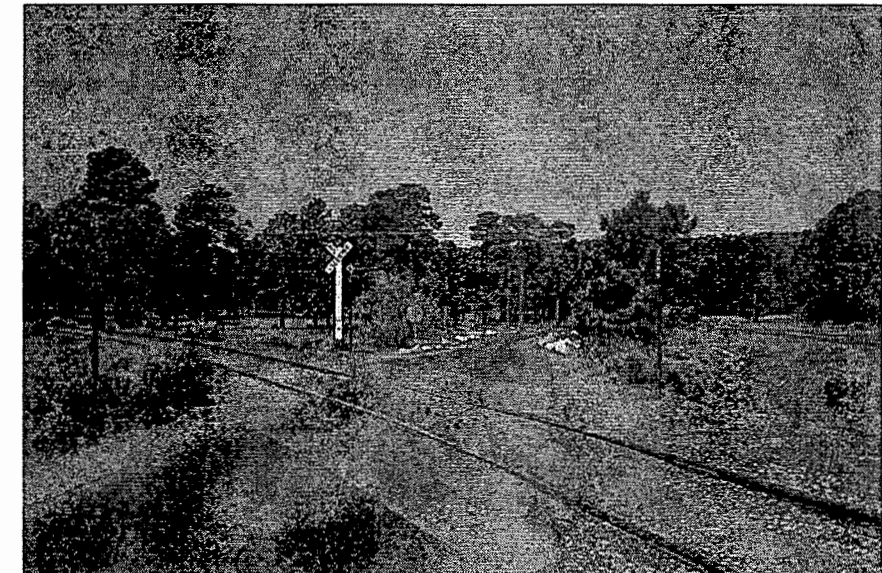
Photograph 110. Old Village Bypass Road at crossing of tracks. (JMA, 2001)

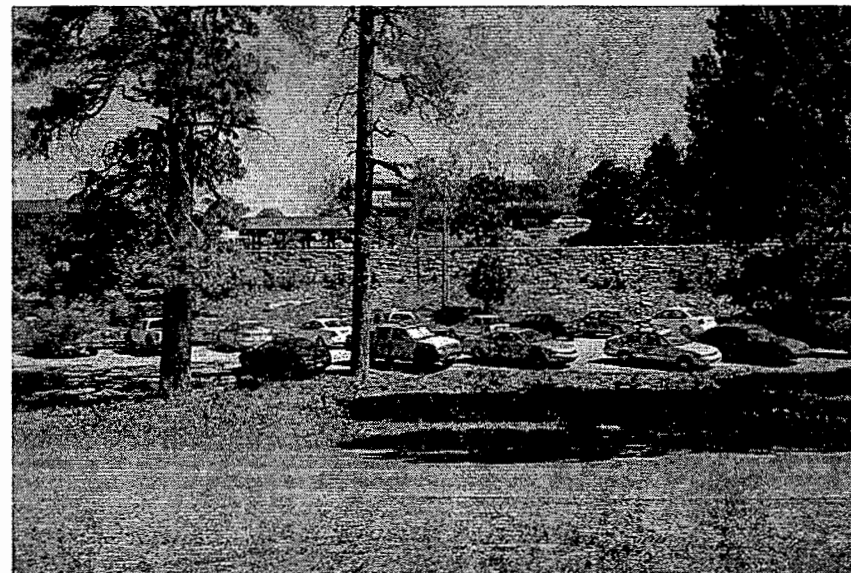
Two parking lots exist in the Railroad Area. A **gravel parking lot** is located on the south side of the railroad tracks, northeast of the Power House and Mule Barn (*Photograph 111*). An **asphalt parking lot** is located adjacent to, and west of, the Railroad Depot. North of the Depot, a **small median** divides traffic and creates a bus drop-off lane (*Photograph 112*).

Photograph 111. Old Village Bypass Road in foreground, gravel parking along tracks in background. (JMA, 2001)

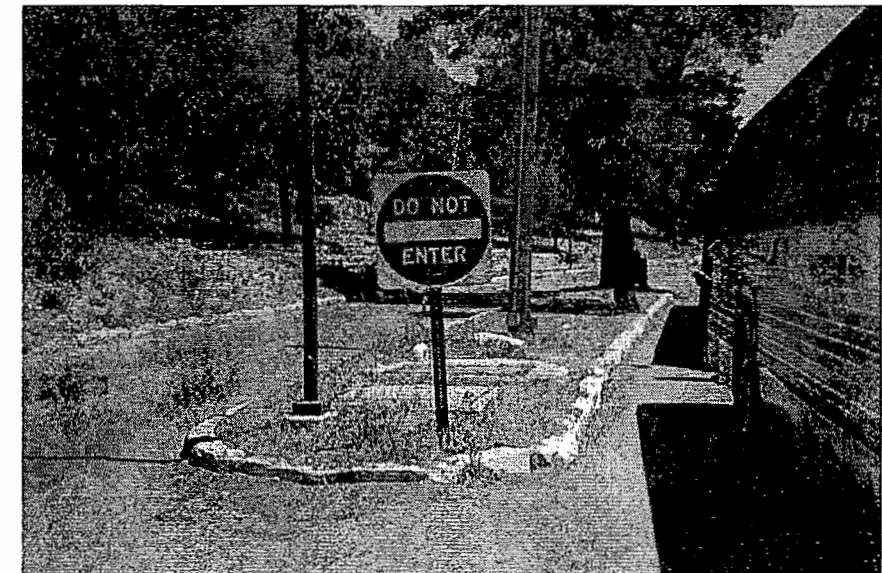
Photograph 112. Small median north of Depot, with typical vehicular traffic signage, stone curbing. (JMA, 2001)

Signage in the Railroad Area includes several contemporary **wayside exhibits** at the Depot. A contemporary **railroad crossing sign** is located at the intersection of the rail tracks and Village Loop Drive along the western edge of the Railroad Area (*Photograph 126*), while another is located at the intersection of the railroad wye and Old Village Bypass Road (*Photograph 110*). **Vehicular traffic signs**, typical of those found throughout the Village, are located where Village Loop Drive intersects or borders the railroad (*Photograph 112*).

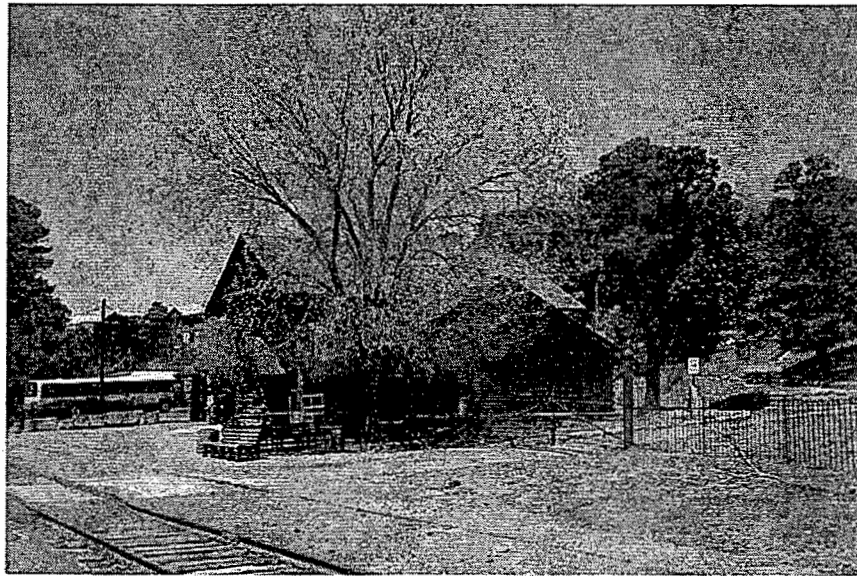
A large **maple tree** provides shade on the Depot platform area (*Photograph 113*). A **peach tree** grows behind the Depot’s associated storage structure. It is not known whether these trees were planted or were volunteers.

Photograph 113. Large maple tree at Depot. (JMA, 2001)

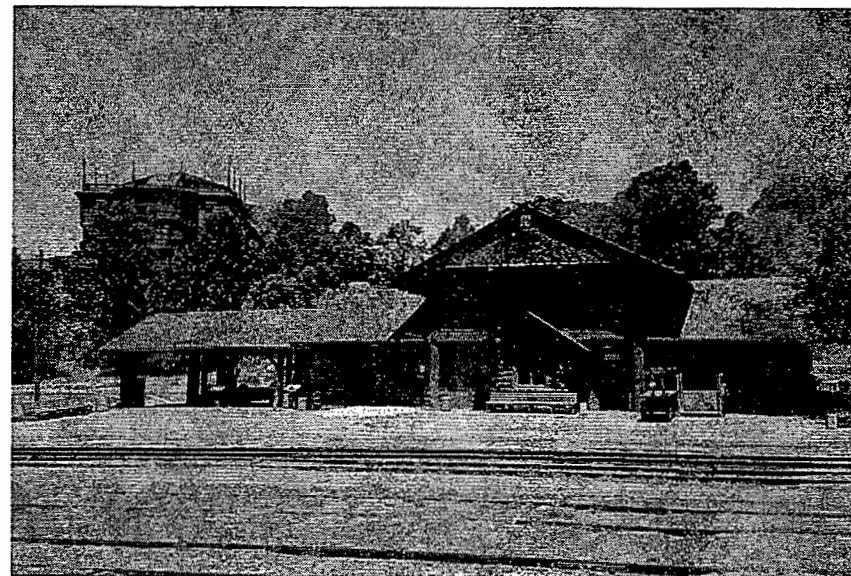
The **Grand Canyon Railroad Depot** (Bldg. #SRB0549) was built in 1910 and is a National Historic Landmark (*Photograph 114*). The depot is located at the eastern end of the Railroad Area and southeast of El Tovar Hotel. The building consists of a two-story log and wood-frame core with gabled roof. The first floor is of log construction while the second floor is sheathed in wood clapboard siding. Two one-story, gable-roof wings project out from the west and east sides of the core, both with log siding. A gable-roof open-air porch extends west from the western wing. The roof is supported by thick, peeled-log posts with diagonal log bracing. Windows are either multi-light or multi-light-over-single-pane. Metal letters on the south gable end spell out "Grand Canyon."

Photograph 114. Railroad Depot from south. (JMA, 2001)

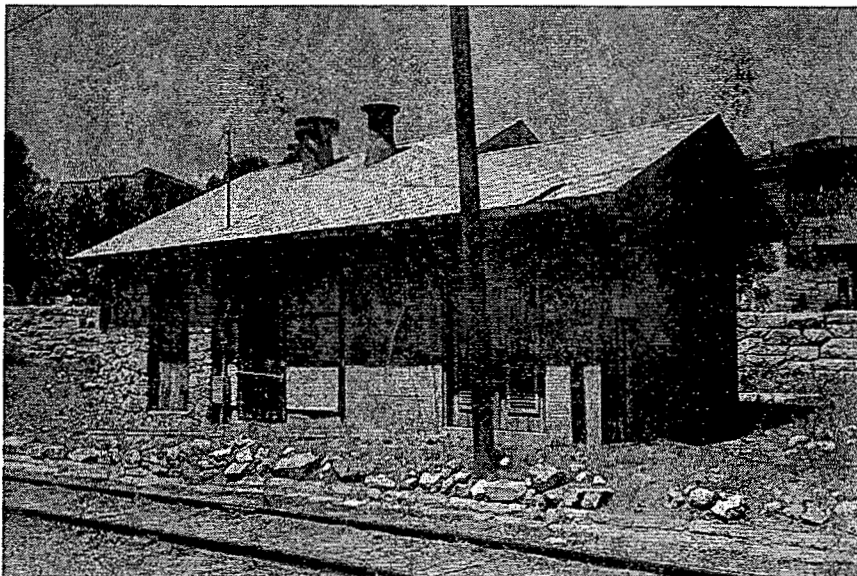
The **Air Conditioning Building** (Bldg. #548), also known as the Railroad Utility Building, was built circa 1950 (*Photograph 115*). It is located west of the Railroad Depot. The narrow, rectangular building appears to have been added onto over time, possibly in the 1980s, according to the 1995 National Register nomination. The western, and likely original, section is constructed of mortared rubble stone; the central portion has exceptionally wide clapboard siding while the third section is built of concrete masonry units. A gable roof covers all three sections.

Photograph 115. Air Conditioning Building. (JMA, 2001)
