**Grand Canyon Village
National Historic Landmark District
Cultural Landscape Report**

**Grand Canyon National Park
Arizona**

January 2004

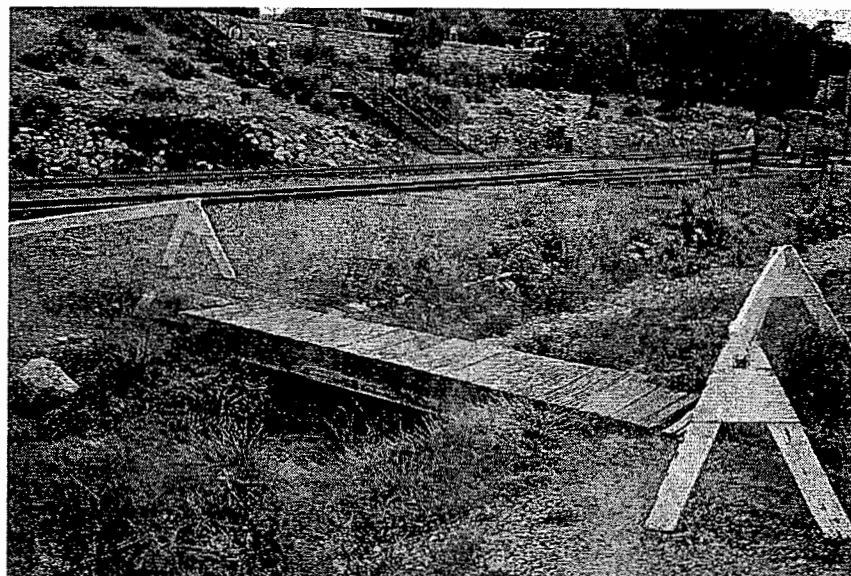
Throughout the Railroad Area, bridges are used to aid pedestrian circulation. A **wood plank bridge** is located north of the Power House (*Photograph 116*). The bridge is approximately eighteen to twenty-four inches wide and consists of short planks placed perpendicular to long, wood stringers. Several feet east of this bridge is a **wood and asphalt bridge**. The bridge consists of six-foot to eight-foot-wide planks that overhang wood supports and are attached to metal abutments (*Photograph 117*). The wood planks have been covered with a narrow asphalt path. Metal pipe railings are attached to the east and west edges of the bridge. The bridge is currently closed to pedestrian traffic due to its poor condition.

Photograph 116. Wood plank bridge north of Power House. (JMA, 2001)

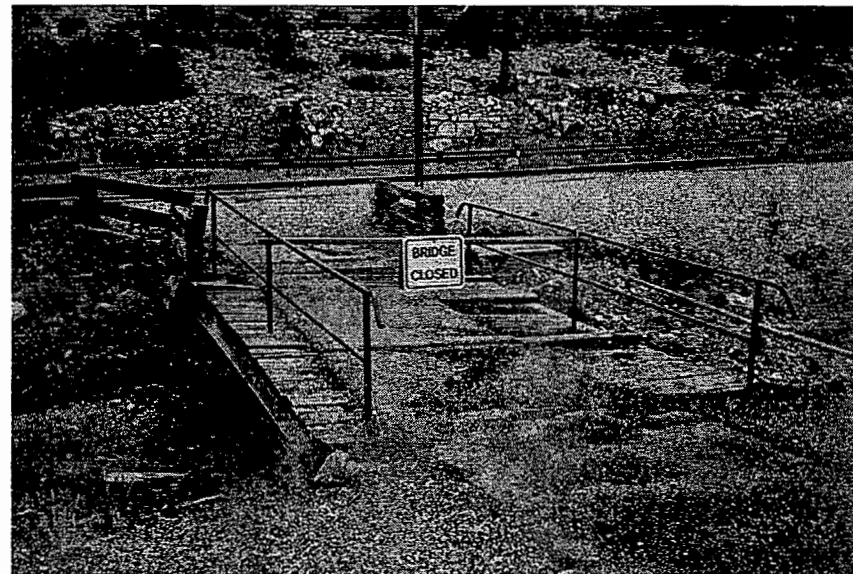
Photograph 117. Wood and asphalt bridge. (JMA, 2001)

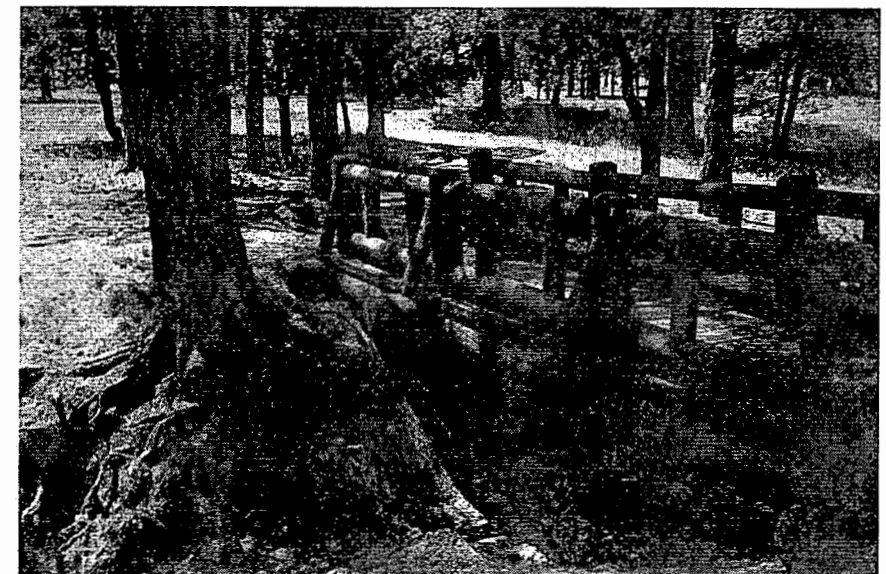
A **peeled-log bridge** is located in the wooded, eastern portion of the area, south of the tracks and Air Conditioning Building (*Photograph 118*). The bridge consists of wood planks, approximately five feet in width, atop long, log stringers. The log post and rail railing has diagonal braces attached to short log beams jutting out from the stringers.

Photograph 118. Peeled-log bridge. (JMA, 2001)

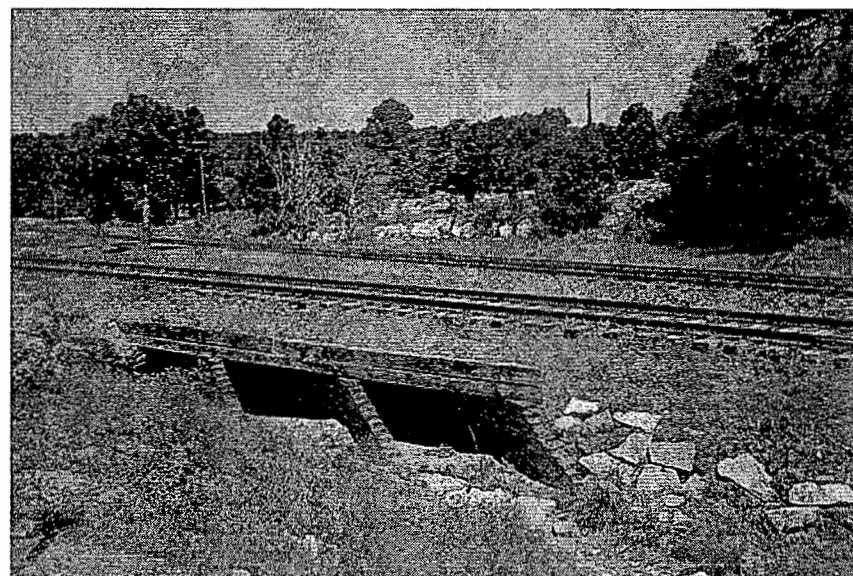
Bridges also carry the railroad tracks over culverts and drainageways. A wood **box-culvert bridge** is located north of the Purchasing and Receiving Building. The bridge consists of a wood platform—supporting earth and railroad tracks—that is braced by three stacked-wood piers placed at an angle to the platform (*Photograph 119*). A vehicular **stone-faced bridge** is located at the intersection of Village Loop Drive, Old Village Bypass Road, and the railroad tracks (*Photograph 120*). The bridge has four pipe culverts and short wing walls.

Photograph 119. Box culvert bridge. (JMA, 2001)

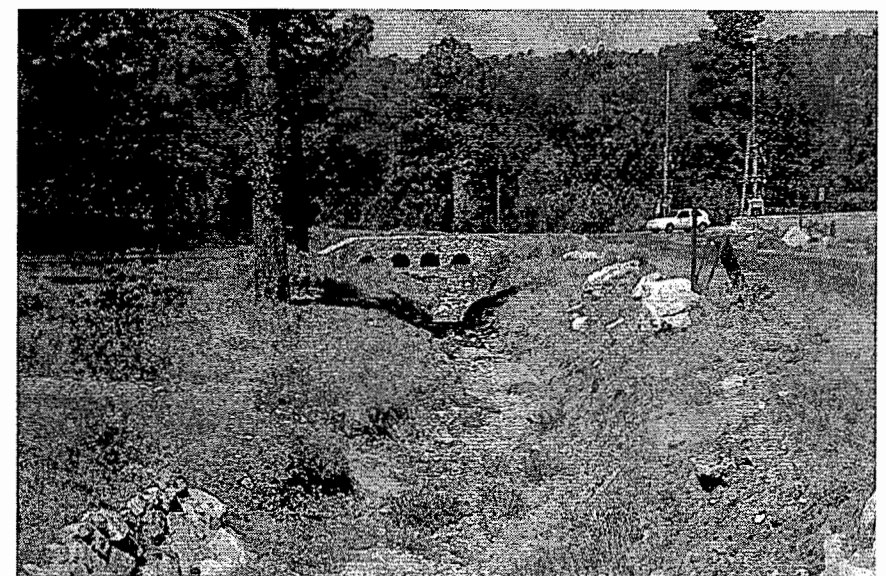
Photograph 120. Stone-faced bridge at intersection of Village Loop Drive, Old Village Bypass Road, and the railroad tracks. (JMA, 2001)

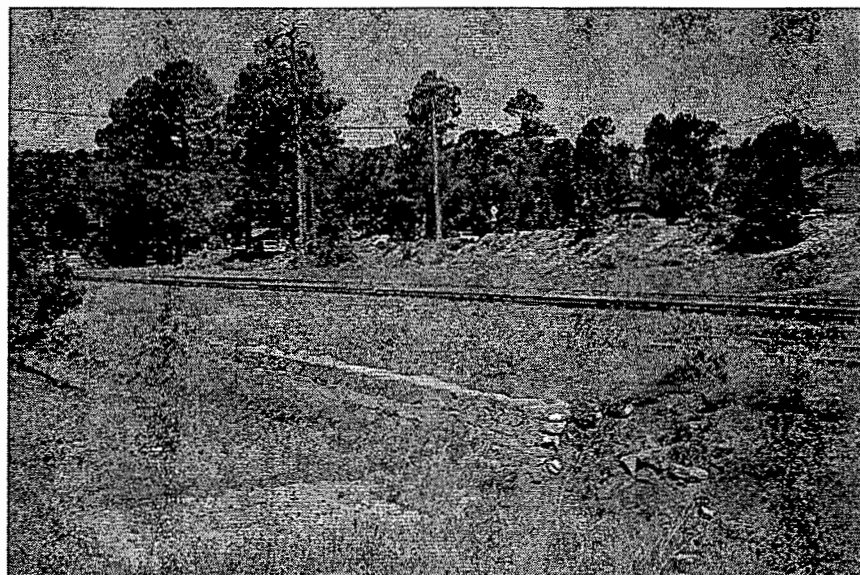
A **stone foundation** located south of the Bright Angel Cabins may be a former building or bridge location (*Photograph 121*).

Photograph 121. Stone foundation. (JMA, 2001)

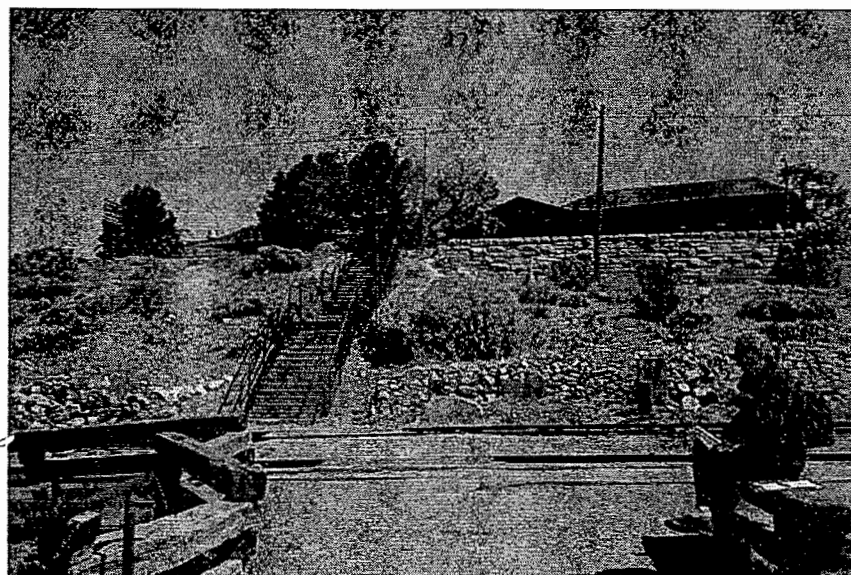
Rough-faced, cut-stone **retaining walls** are located along the northern and eastern edges of the character area. The walls retain the Bright Angel Wash slopes and support the Village Loop Drive pavement (*Photograph 122*). A lower, **rubble retaining wall**, built in 1928 by stonemason Jesus Morales, follows the same alignment as the upper wall but is heavily deteriorated.

Photograph 122. Metal stair, stone walls, and lights on slope to north of railroad tracks. Note two sets of stone walls. (JMA, 2001)

A **metal staircase**, dated circa 1980, is located on the north slope of Bright Angel Wash (*Photograph 122*). The stairs lead from the Bright Angel Lodge parking lot and Village Loop Drive to the railroad tracks.

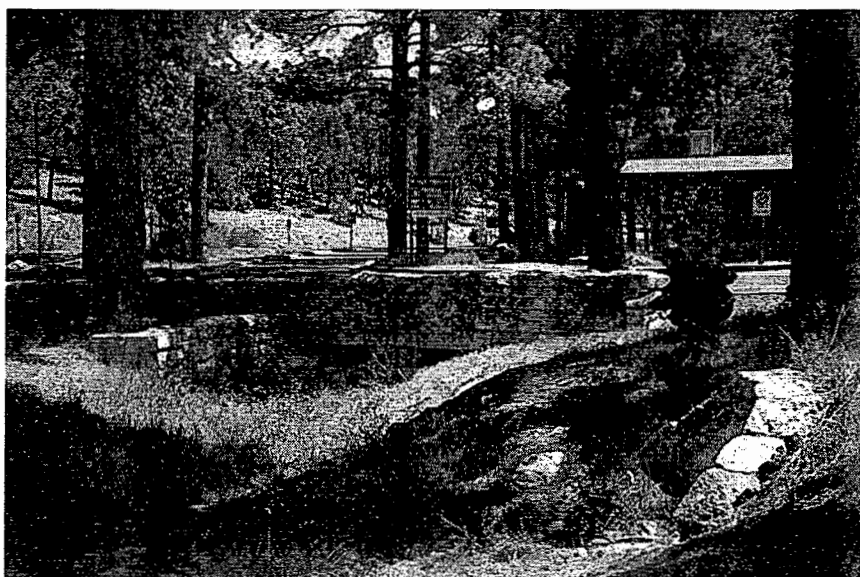
Photograph 123. Stone-faced bridge over grassy swale. (JMA, 2001)

The eastern portion of the cut-stone retaining wall extends south and becomes a **stone bridge** carrying Village Loop Drive over a grassy swale, west of the Public Garage (*Photograph 123*). The northern portion of this wall also has a set of **stone steps**, with a stepped cheek wall, that lead from the easternmost edge of the character area to Village Loop Drive (*Photograph 124*).

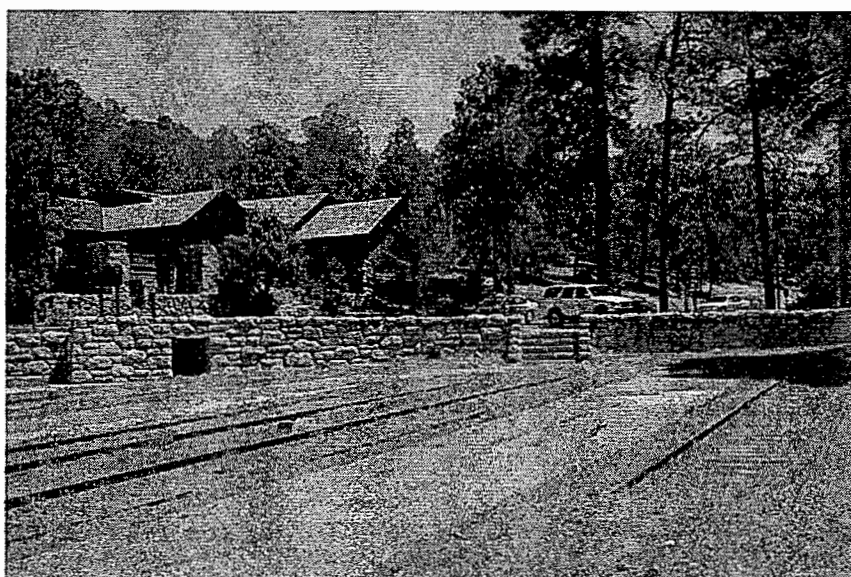
Photograph 124. Stone wall with steps at eastern end of Railroad Area. (JMA, 2001)

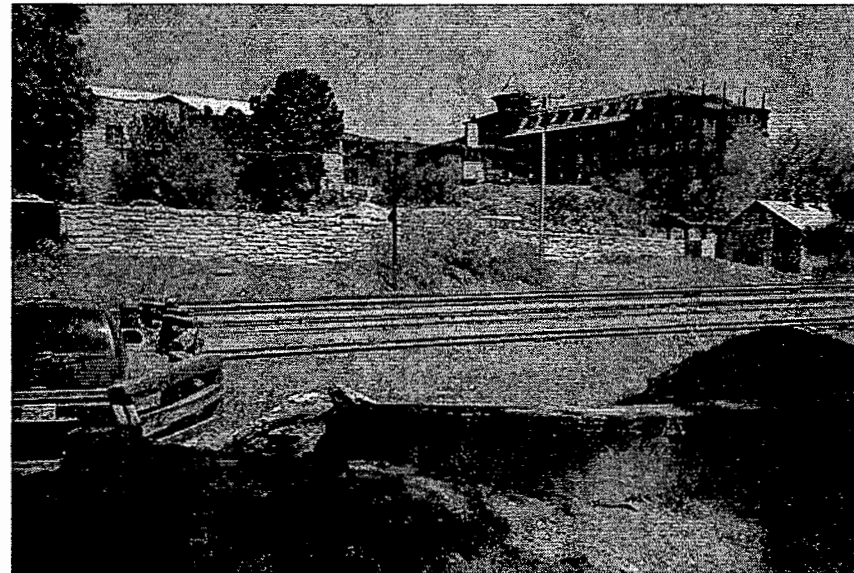
Views of the Railroad Depot from the tracks provide a signal of arrival to visitors. Additionally, partially-screened views of the **El Tovar Hotel** are afforded to the north from the Depot and tracks, providing a sense of orientation as visitors disembark from the train (*Photograph 125*).

Photograph 125. View of El Tovar from Railroad Area. Note zig-zag railroad tie fence on left. (JMA, 2001)

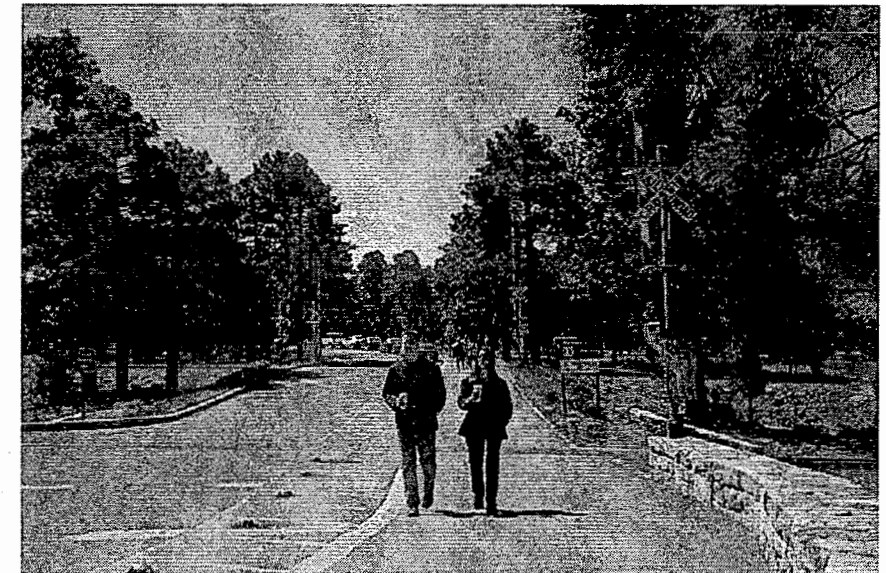
Signage in the Railroad Area includes several contemporary **wayside exhibits** at the Depot. A contemporary **railroad crossing sign** is located at the intersection of the rail tracks and Village Loop Drive along the western edge of the Railroad Area (*Photograph 126*), while another is located at the intersection of the railroad wye and Old Village Bypass Road (*Photograph 110*). **Vehicular traffic signs**, typical of those found throughout the Village, are located where Village Loop Drive intersects or borders the railroad (*Photograph 112*).

Photograph 126. Railroad crossing gate and sign, cut stone curbing along Village Loop Drive. (JMA, 2001)

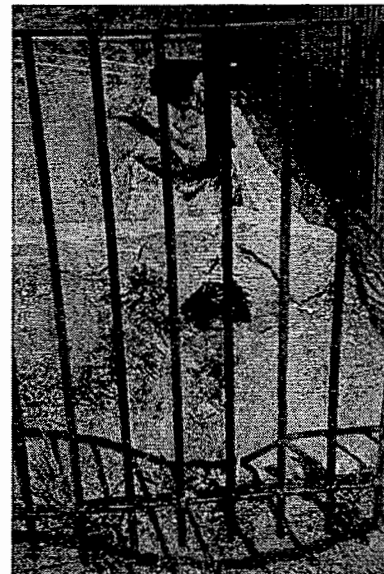
Photograph 127. Concrete-lined swale with decorative cut stone arch, viewed through iron fence at Depot. (JMA, 2001)

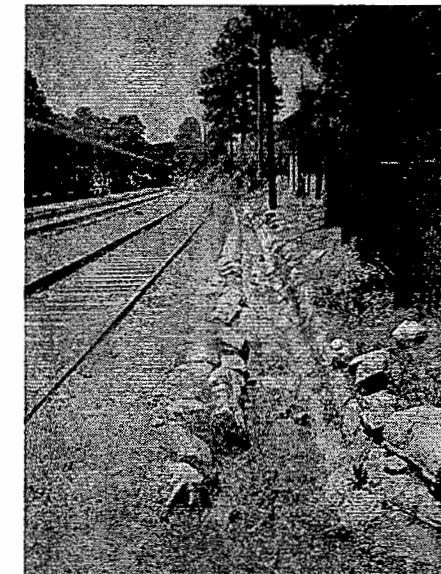
Photograph 128. Stone-lined swale and iron fence. (JMA, 2001)

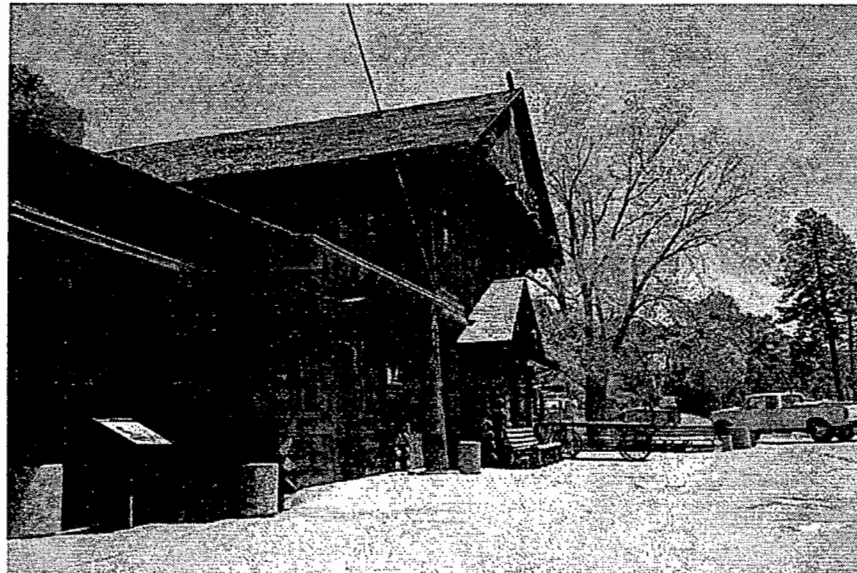
An exhibit comprised of a **historic railroad cart** is located just south of the Depot on the platform (*Photograph 129*). This exhibit includes a refurbished cart of metal with red-painted wheels and undercarriage.

Photograph 129. Depot platform features including trash receptacles, historic railroad cart, wood bench, wayside. (JMA, 2001)

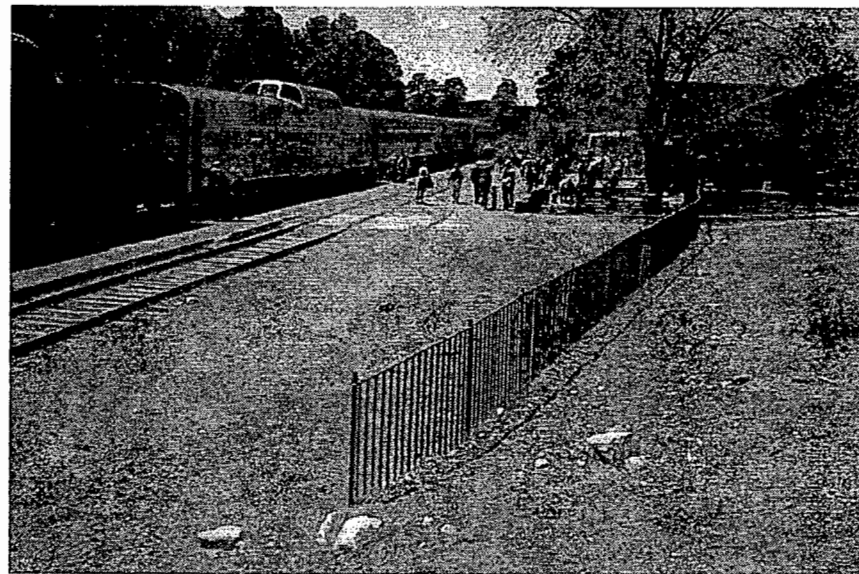
Photograph 130. Iron fence. (JMA, 2001)

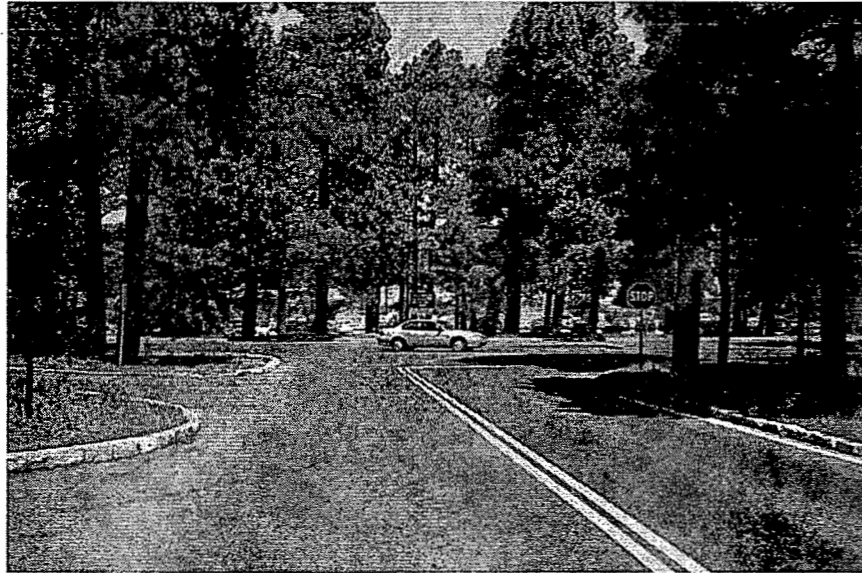
Photograph 132. Intersection of Center Road and Village Loop Drive. (JMA, 2001)

The **intersection of Center Road and Village Loop Drive** comprises a space that includes the parking lot and clearing at the Magistrate's Office (*Photograph 132*). This node was the site of the historic plaza provided in both the Waugh and Hull Master Plans. To the east of this intersection, the **Village Loop Drive corridor** is divided with a planted median, forming a park-like boulevard (*Photograph 133*). Turning south on Center Road from the intersection, the roadway enters a ravine and is wooded along the sides, creating the **Center Road corridor**. The former **Fred Harvey service station node** is comprised of a paved open space in front of the station building (*Photograph 134*). From the east, visitors enter the Village Historic District at the **intersection of Village Loop Drive and South Entrance Road** (*Photograph 135*). At this point, between the Original Superintendent's Residence and the Public Garage, is a grassy, triangular plaza in the center of the three-way intersection.

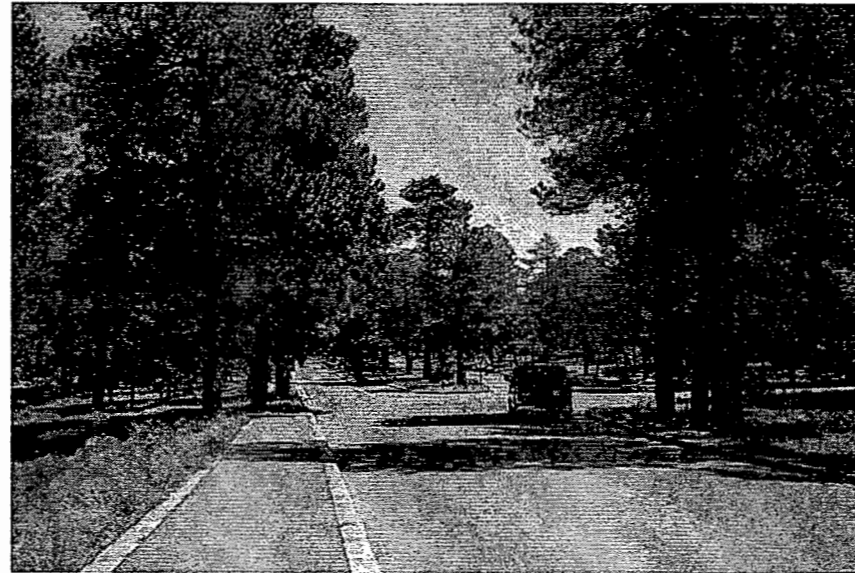
Photograph 133. Village Loop Drive corridor. Note asphalt sidewalk along left edge of road. (JMA, 2001)

Stone-edged **asphalt sidewalks** run throughout the area and constitute the main form of pedestrian circulation. These sidewalks occur along South Entrance Road's southern edge, the southern edge of Village Loop Drive (*Photograph 133*), a short section of the eastern edge of

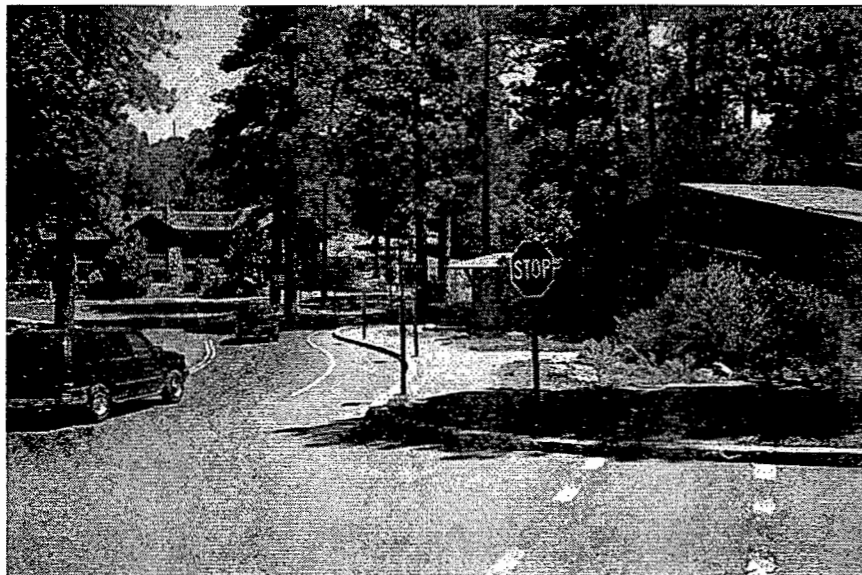
Photograph 135. Intersection of Village Loop Drive and South Entrance Road in background. (Center Road and Village Loop Drive intersection in foreground.) (JMA, 2001)

Cut stone curbing lines Village Loop Drive and Center Road (*Photograph 135*), as well as certain parking lots such as the asphalt lot north of the Magistrate's Office. Stretches of **stone edging** line gravel paths leading to the Grand Canyon Association building (*Photograph 151*) and the asphalt path leading south from Village Loop Drive. **Boulders** are used ornamentally along roads and function as traffic bollards. These are found in the medians of the divided portion of Village Loop Drive, in the parking lots at the Public Garage, and near the Magistrate's Office.

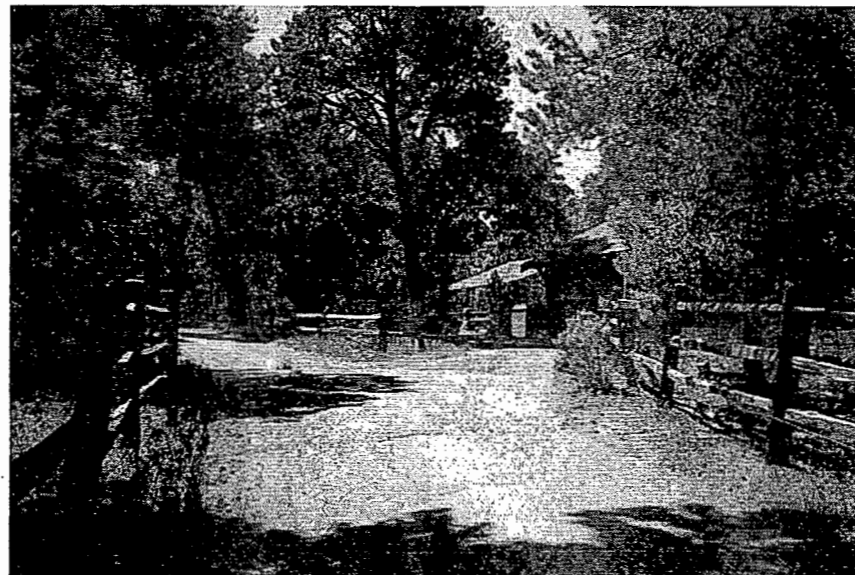
Photograph 136. Residential asphalt drive. (JMA, 2001)

The **residential asphalt loop drive** leads from the southern lane of Village Loop Drive south into the residential cluster (*Photograph 136*). A **gravel and macadam drive** leads behind, west and south, of the Magistrate's Building (*Photograph 137*).

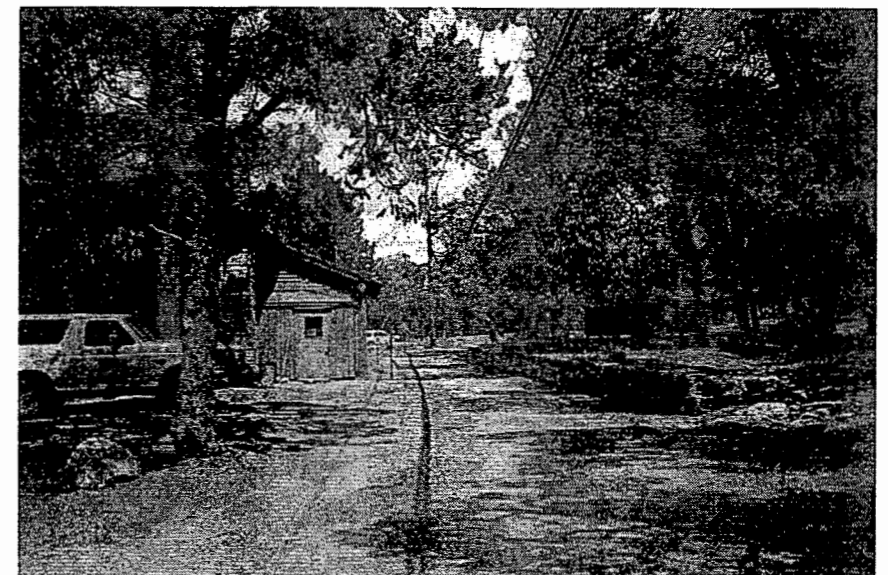
Photograph 137. Gravel and macadam drive behind Magistrate's Office, with retaining wall. (JMA, 2001)

The **Magistrate's Building** (Bldg. #SRB0166) was built in 1935 and served as a post office and ranger services office before being adaptively re-used as the local judicial magistrate's and NPS law enforcement offices (*Photograph 138*). The rectangular building has a gable roof with exposed rafter tails. The exterior walls are sided with wood clapboard interrupted by cut stone piers. Windows are four-by-four and located in long bays. The main entrance is located at the northwestern corner of the building; in a stone and board-and-batten-sided ell with gable roof. The west elevation is taken up almost completely by windows located between stone corner piers. A stone chimney rises from the roof near the entrance. A low, **stone retaining wall**, approximately eighteen inches in height, runs along the back of the Magistrate's Building and yard, retaining earth from the driveway (*Photograph 137*).

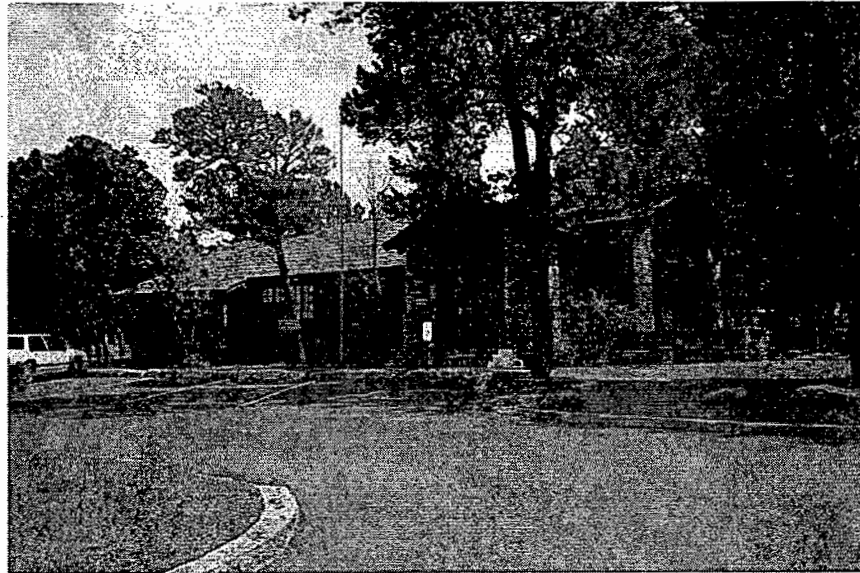
Photograph 138. Magistrate's Office with parking lot. (JMA, 2001)

Several asphalt parking lots are located throughout the area. The **largest parking lot** is located off Center Road and north of the Magistrate's Building (*Photograph 138*). The asphalt lot has angled parking stalls and low, rectangular stone curbing. This parking lot was intended to serve as a civic plaza, although parking uses took over soon after its construction.

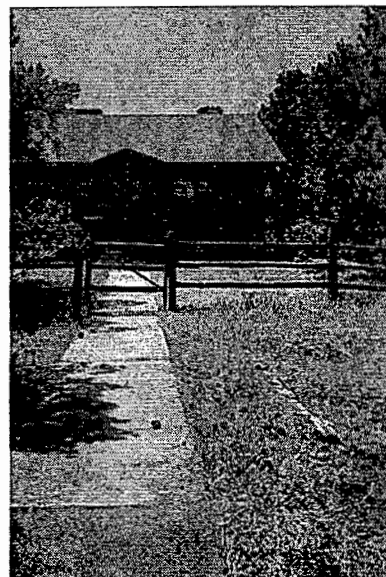
Photograph 140. Concrete sidewalk and post-and-rail fencing in front of residence. Note grasses in yard. (JMA, 2001)

Narrow **concrete sidewalks** lead to the front doors of the single family residences in the residential cluster (*Photograph 140*). The walks are two feet to three feet in width. A **gravel path**, two feet to three feet in width with stone edging, leads west from the Grand Canyon Association Building to the asphalt path south of the residential cluster. An **earthen path**, most likely a desire path worn by staff and visitors, leads from the asphalt sidewalk located at the corner of Village Loop Drive and Navajo Road, south to the Grand Canyon Association Building parking lot and turn-around (*Photograph 141*).

Vegetation in the Visitor and Community Services Area is comprised largely of ponderosa pine and pinyon-juniper-association **woodlands**. Some **grasses** exist around the residences in the area, and grass grows under the trees in areas where sunlight penetrates the canopy (*Photograph 140*). It is not known if these grasses are native or invasive.

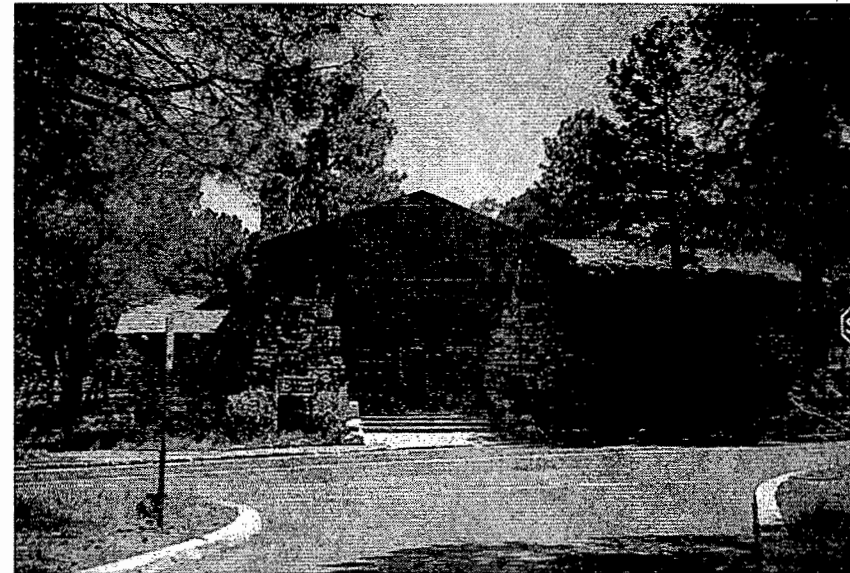
Photograph 142. Ranger Operations Building. (JMA, 2001)

The **Ranger Operations Building** (Bldg. #SRB0103) is located at the intersection of Center Road and Village Loop Drive (*Photograph 142*). Built in 1929, the building is now designated as a National Historic Landmark. According to a 2000 Historic Structure Report, the Grand Canyon Ranger Operations Building was styled after a rustic Swiss chalet. The building is a two-story stone and wood-frame structure of classic park rustic design. The first floor of the building, up to sill height, and the building's corner piers, are of coursed rubble masonry with cement mortar. The rest of the superstructure is of wood-frame construction with horizontal wood siding on the first floor and vertical board-and-batten siding on the second floor. The battered stone piers at the building's corners each support three peeled logs that define the corners. The main pavilion of the building is symmetrical and sits slightly forward of two side wings. The north wing is one story while the south wing has two stories. The roof is gabled with wood shingles and no gutters. Exaggerated eaves overhang the walls and have axe-cut brackets and outlookers. A coursed rubble masonry chimney rises through the roof on the north side of the building. A **concrete masonry unit planting bed**, approximately three feet in height and rectangular in shape, is located at the southeast corner of the building (*Photograph 143*).

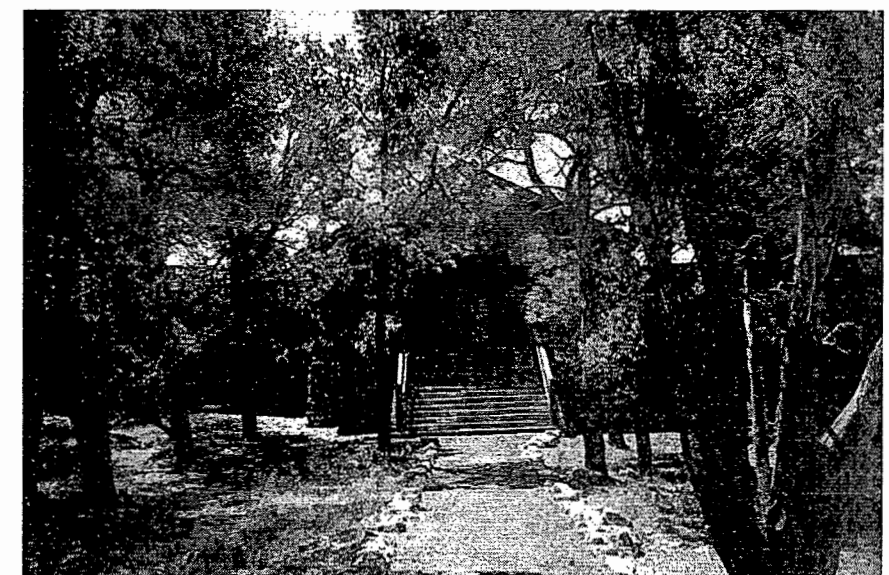
Photograph 145. Grand Canyon Association building. (JMA, 2001)

The **Grand Canyon Association building** (Bldg. #SRB0100) is sited to the east of the residential cluster (*Photograph 145*). Built in 1930, the building was originally a hospital, then a Youth Conservation Corps dormitory, and currently houses the Grand Canyon Association offices. The long, rectangular building has a large, gable-roofed entrance ell on the northern façade. A massive stone staircase leads to the entrance porch, which is supported by a stone foundation. The remainder of the building is covered in horizontal wood siding, has a gabled roof, green-painted windows, and rests on a stone foundation.

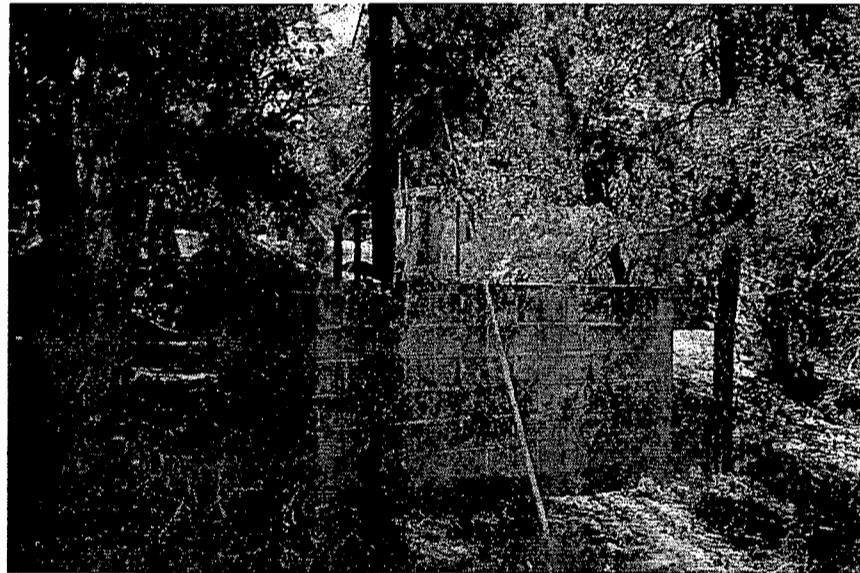
Photograph 146. Concrete masonry unit wall. (JMA, 2001)

A **concrete masonry unit wall**, approximately four feet in height, is located south and west of the Grand Canyon Association building (*Photograph 146*). A square **concrete masonry unit structure** is located near the southwestern corner of the building. It has a flat roof, rectangular windows, and a door on the east elevation. **Concrete stairs**, with a metal pipe handrail, are located near the northeast corner of the building and lead down from the parking lot (*Photograph 147*).

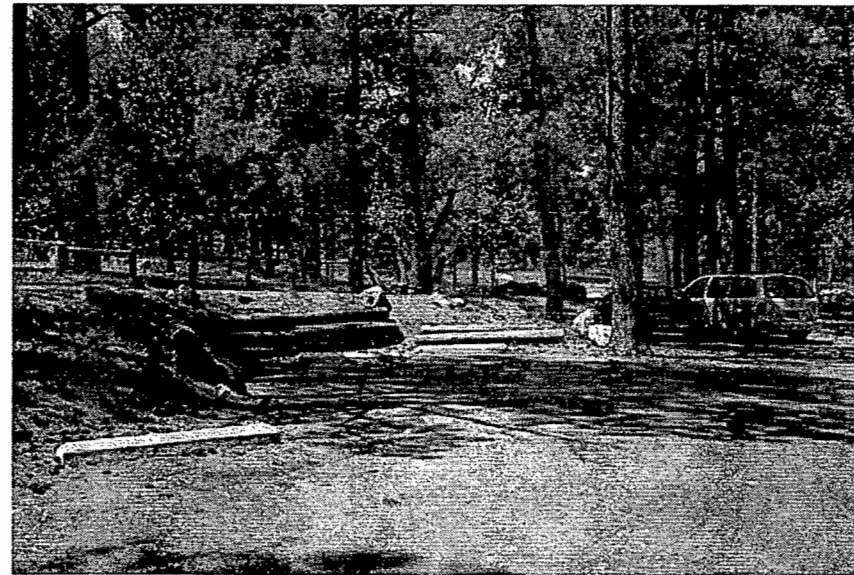
Photograph 150. Log retaining wall and wheelstops near General Office and Public Garage. (JMA, 2001)

Features associated with circulation in this character area include **wheel stops** in parking lots. These are made of concrete in the asphalt parking lots near the Grand Canyon Association Building, while wheel stops in the small parking lots adjacent to the Public Garage are of both log and concrete (*Photograph 150, 152*).

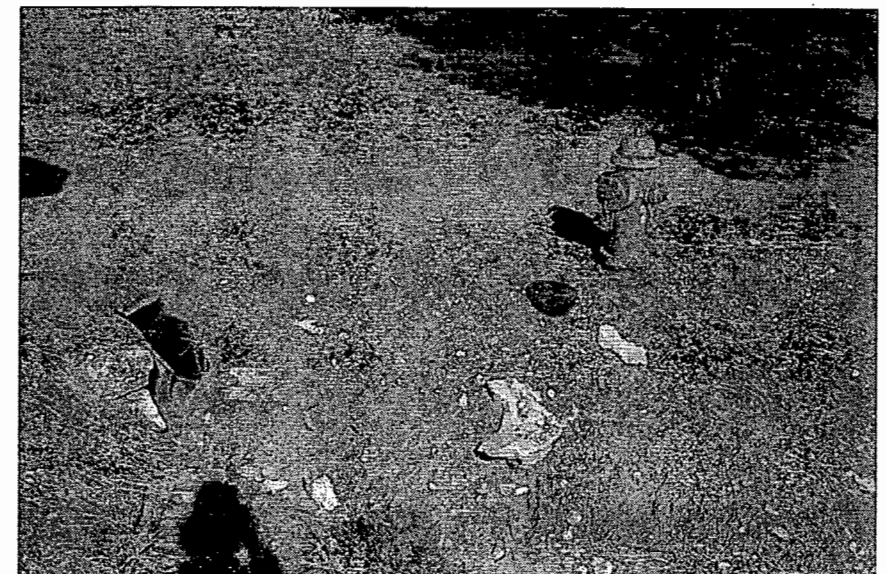
Photograph 153. Terra cotta culvert and fire hydrant. (JMA, 2001)

A **metal pipe culvert**, with flared end, directs drainage under the asphalt drive leading to the Fee Management Office. A **terra cotta culvert** is located at the corner of Boulder Street and Center Road (*Photograph 153*). There is a **concrete-lined swale** south of the Public Garage. This swale leads into a **stone/concrete drainage structure** consisting of depressed drain covered by a metal grate and surrounded by one course of mortared stone edging (*Photograph 154*).

North of the Ranger Operations Building is a cluster of small-scale features including a **pay telephone** and **trash receptacles** (*Photograph 158*). Trash receptacles found throughout the character area are primarily contemporary brown-painted cylinders with dome lids, similar to those seen elsewhere in the Village Historic District. **Wooden picnic tables** are found south of the Ranger Operations Building (*Photograph 156*). Small **fuel/propane tanks** sited near buildings, including an oil tank at the southeastern corner of the Public Garage and a propane tank adjacent to the residence at 221 Village Loop Drive. **Fire hydrants** are typical of the Village Historic District; a representative hydrant is located on the corner of Center Road and Boulder Street (*Photograph 153*).

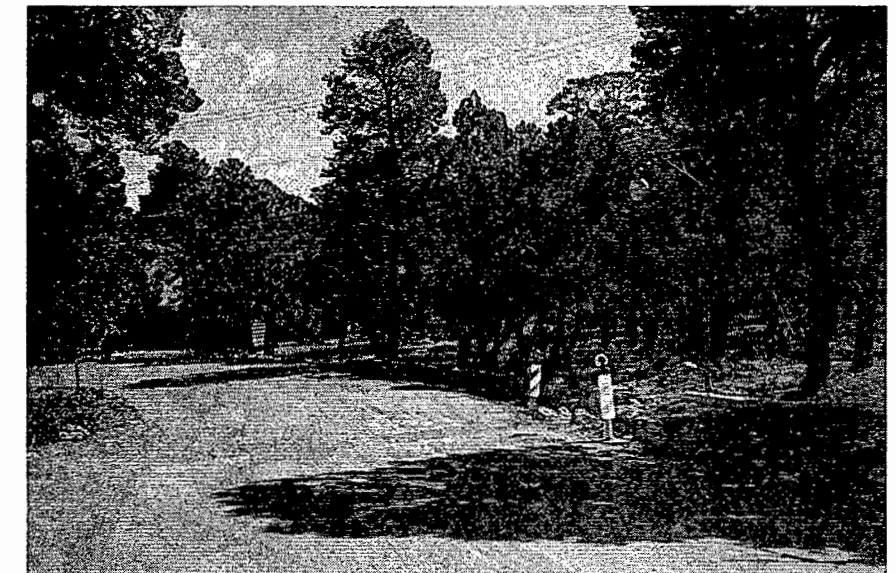
Photograph 159. Navajo Street. Note street light and stone wall on left. (JMA, 2001)

Lighting standards in the NPS Housing Area are street lamps composed of green-painted metal poles with a decorative bracket supporting an arm and acorn luminaire— similar to lighting standards found in the Rim Area. An example of this street light type is found along Navajo Street near the intersection with Tonto Street (*Photograph 159*).

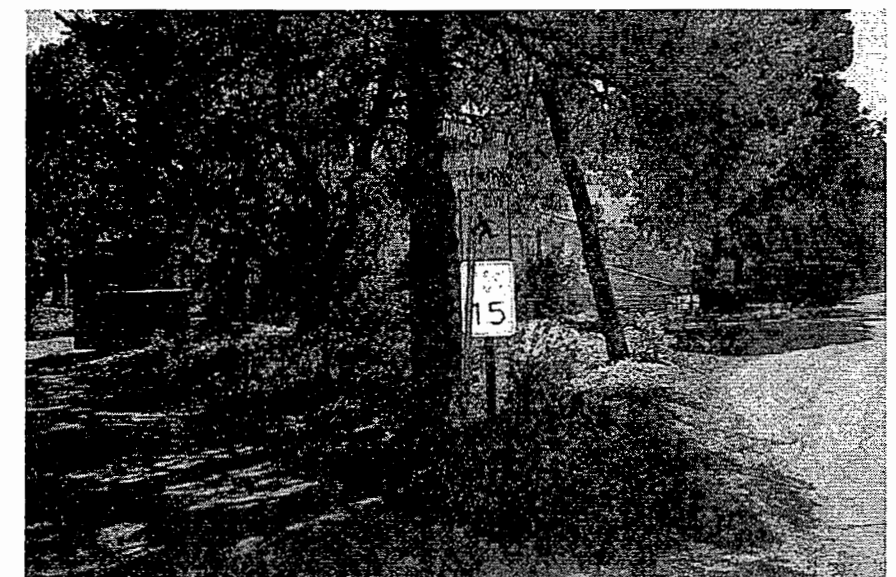
Photograph 160. Tonto Street and Juniper Hill wye intersection, with traffic signage and street sign. (JMA, 2001)

Signage is typical of the Village Historic District, including standard reflective green **street signs**, standard **vehicular traffic signs**, and **brown and white NPS signs** (*Photograph 160*).

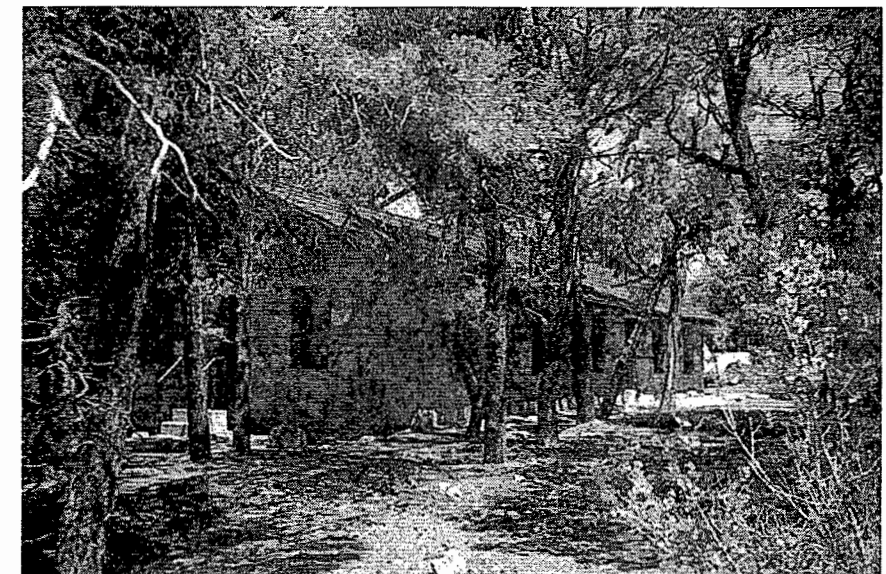
The **Fee Management Office** (Bldg. #SRB0076) was built in 1921 and is located south of the Grand Canyon Association Building and near the intersection of Tonto Street and the Grand Canyon Association Building driveway (*Photograph 164*). The long rectangular building is sheathed with unusually large stone siding set with thick mortar. The roof is gabled, having weatherboard at the gable ends. Windows are inset into the walls and are double-hung.

Photograph 164. Fee Management Office. (JMA, 2001)

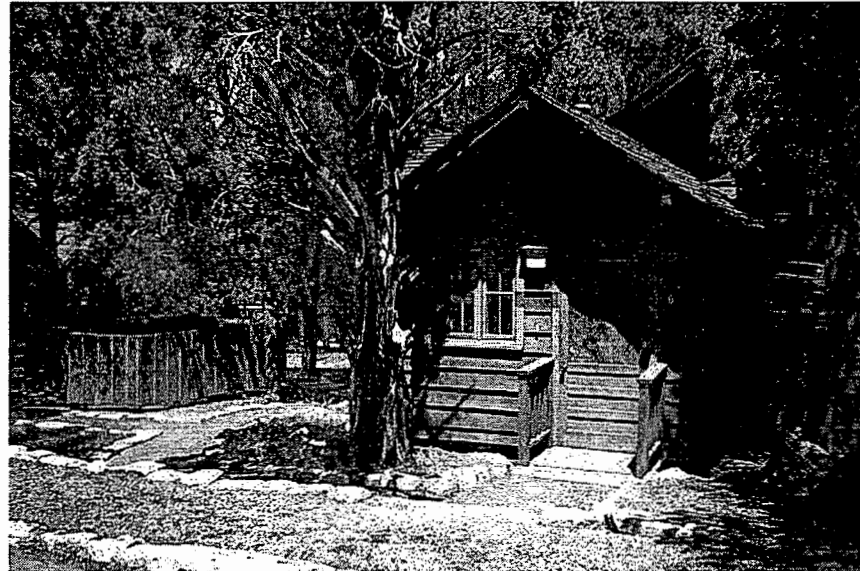
Single family residence #8 Tonto St. (Bldg. #SRQ0003) is located east of Bldg. #SRQ0002 and was built in 1923 (*Photograph 165*). The building is rectangular in shape with a smaller entrance ell on the south elevation and another ell on the west elevation. The main building and ells all have gable roofs with wood shingles. Siding is wood clapboard while windows are two-over-two double hung with narrow, rectangular lights. Door and window trim is painted green.

Photograph 165. Single family residence #8 Tonto St. (Bldg. #SRQ0003). (JMA, 2001)

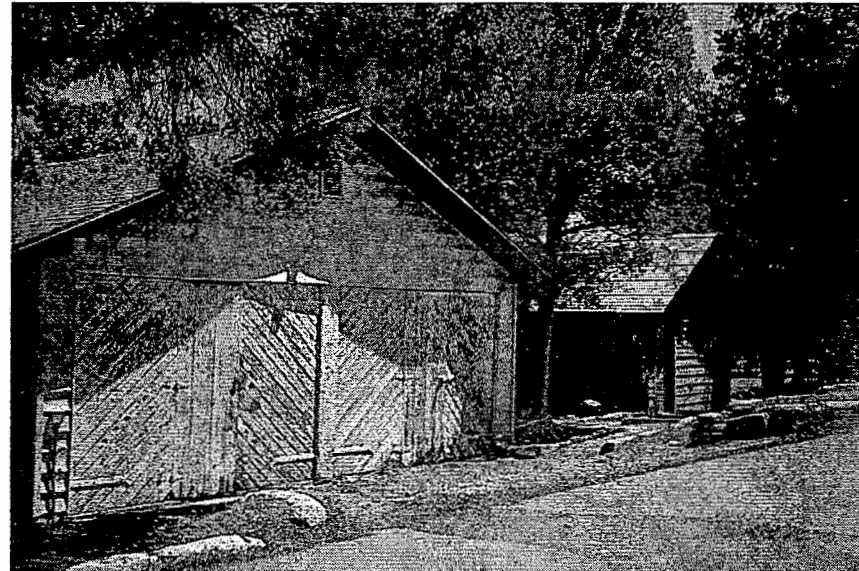
Photograph 166. Garage and shed at Bldg. #SRQ0004. (JMA, 2001)

Single family residence #10 Tonto St. (Bldg. #SRQ0004) is located on Tonto Street, east of Bldg. #SRQ0003. Built in 1924, the building shares much of the same detailing as Bldg. #SRQ0003—having a gable roof, wood clapboard siding, and green-painted door and window trim. The associated **garage and shed** (Bldg. #SRB0004A) is located to the east of Bldg. #SRQ0004 (*Photograph 166*). The building is wide and rectangular, with white clapboard siding and a gable roof covered in asphalt shingles. Two wooden, double garage doors are located on the south elevation.

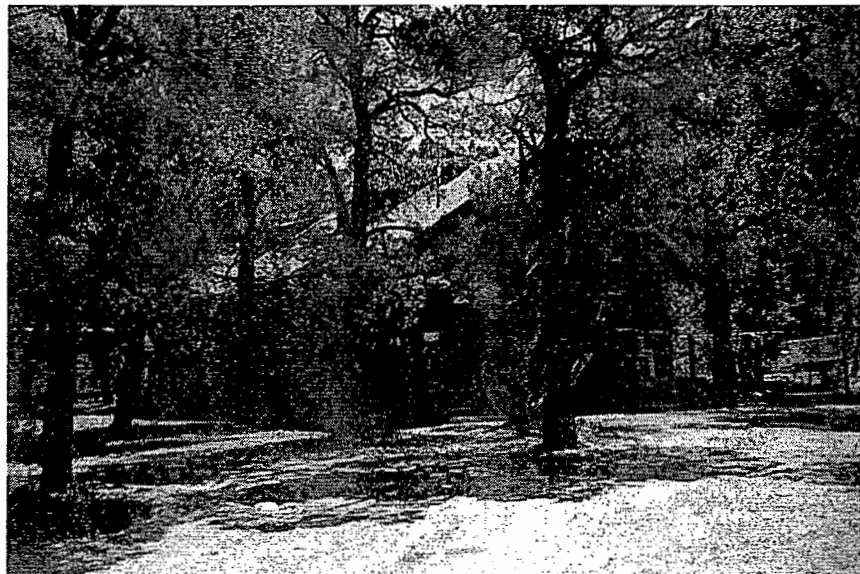
Photograph 167. Duplex #7 A/B Tonto St. (Bldg. #SRQ0006). (JMA, 2001)

Duplex #7 A/B Tonto St. (Bldg. #SRQ0006) is located on the south side of Tonto Street and across from Bldg. #SRQ0003 (*Photograph 167*). Built in 1924, the rectangular building has a gable roof with shed dormers and stone chimney, brown clapboard siding, and a stone foundation. Windows are three-by-three double hung, placed singly or in bays of three, with green-painted trim. Two entrances, one to each unit, are located on the west elevation.

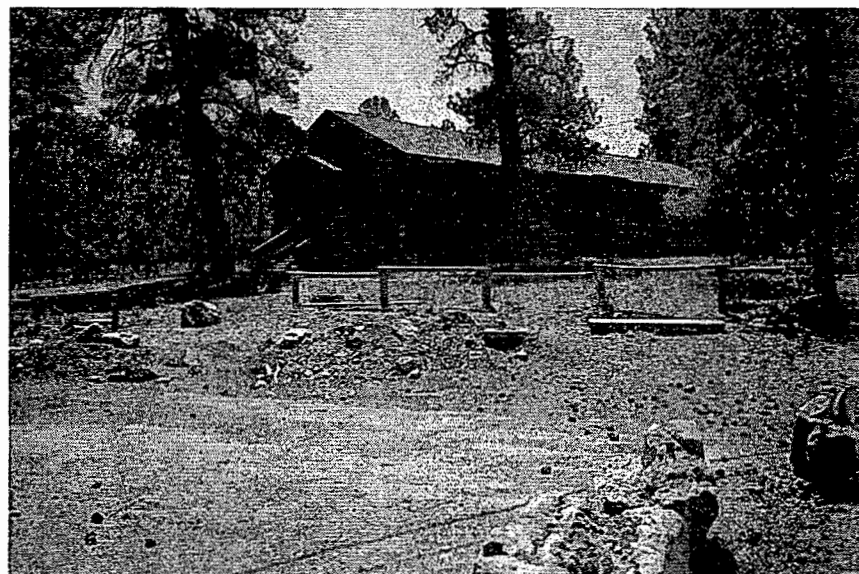
Photograph 168. WODC/Library with parking lot and log fence in foreground. (JMA, 2001)

The **WODC/Library** (Bldg. #SRB0208) is located south of the Public Garage and at the eastern end of a long driveway leading from Navajo Street (*Photograph 168*). Built in 1927, the building was originally a schoolhouse, yet currently houses local Denver Service Center offices and the community library. The long, narrow, rectangular building is of stacked log construction with a gable roof and square rafter tails beneath the eaves. The gable ends are covered with wood shingles. Windows are either two-over-two squares or rectangular in shape. The main entrance is located on the north elevation; beneath a gable-roof porch.

Post-and-rail fencing appears around certain residences and adds to the residential scale of the character area. A recently-constructed **log fence**, consisting of single-rail segments on wood posts, divides the WODC/Library building from the Public Garage and General Office (*Photograph 168*). New plantings in small garden beds in front of Bldg. #SRQ0025 are surrounded by protective **wire fencing**.

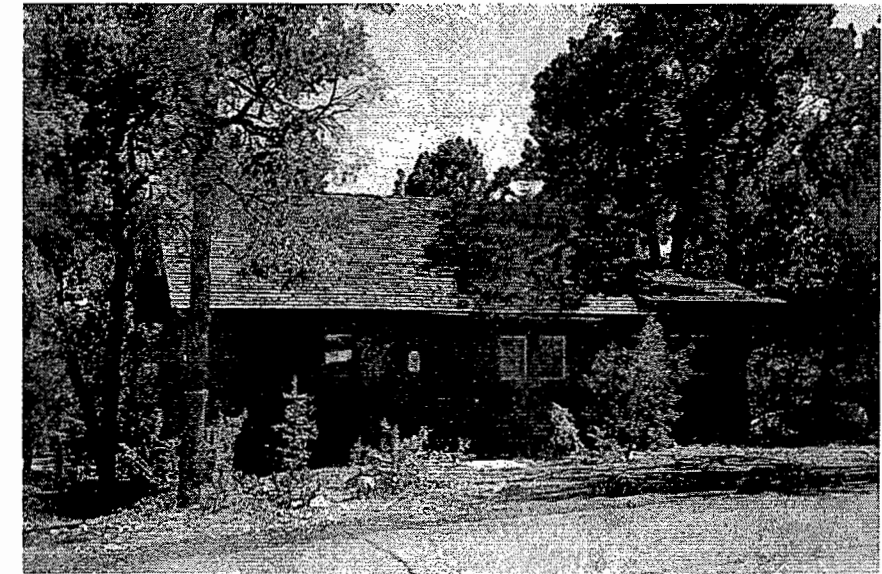
Single family residence #11 Kaibab St. (Bldg. #SRQ0011) was built in 1928 and is located on the north side of Kaibab Street, near the intersection of Kaibab and Navajo Streets (*Photograph 169*). The building is rectangular in shape and has an addition on the east elevation. Both the central roof and lower addition roof are gabled and have wood shingles and exposed rafter tails. The windows are two-over-two and exist in bays of two. The main entrance is located on the north elevation. All trim is painted green. The associated **garage and shed** (Bldg. #SRB0011A) is located east of Bldg. #SRQ0011 and is a simple wood frame structure with gable roof, exposed rafter tails, and white clapboard siding.

Photograph 169. Single family residence #11 kaibab St. (Bldg. #SRQ0011). (JMA, 2001)

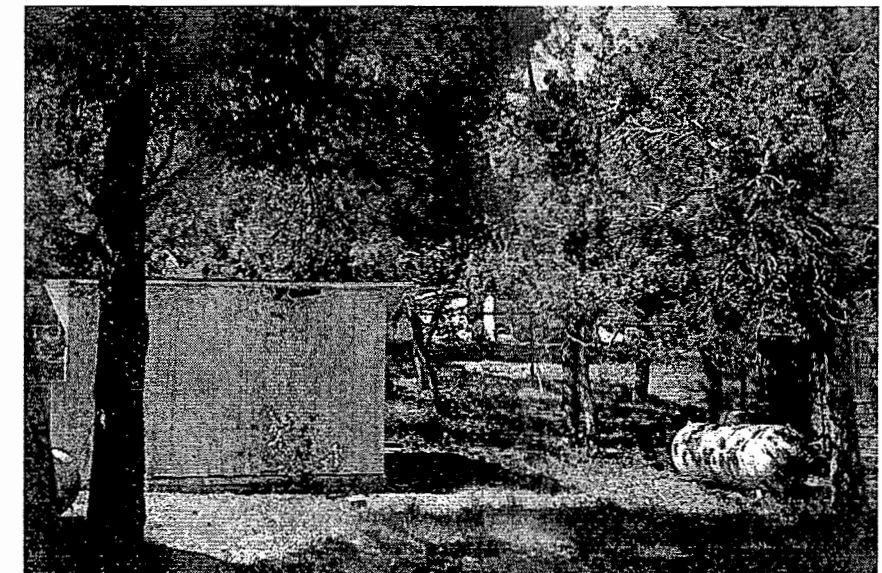
Single family residence #14 Kaibab St. (Bldg. #SRQ0014) was built in 1930 and is located on the south side of Kaibab Street, across from Bldg. #SRQ0015. The building has brown clapboard siding and windows with green trim. A small, white **storage shed** is located to the east of the residence (*Photograph 170*). The shed has a shed roof with exposed rafter tails and board-and-batten siding. It rests on a concrete slab foundation.

Photograph 170. Storage shed east of Single family residence #14 Kaibab St. (Bldg. #SRQ0014). (JMA, 2001)
