**Grand Canyon Village
National Historic Landmark District
Cultural Landscape Report**

**Grand Canyon National Park
Arizona**

January 2004

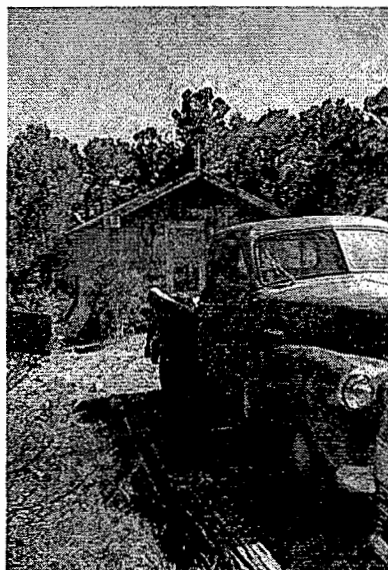
Photograph 171. Single family residence #53 Juniper Hill (Bldg. #SRQ0053), with gravel parking and wood edging. (JMA, 2001)

Single family residence #53 Juniper Hill (Bldg. #SRQ0053) was built in 1931 and is located on Juniper Hill and east of Bldg. #SRQ0051 (Photograph 171). The rectangular building has a gable roof with exposed rafter tails. The upper half of the exterior walls are clad in wide, gray, vertical board siding while the lower half has horizontal clapboard. Windows come in multiple sizes and trim colors. The main entrance is located on the south elevation.

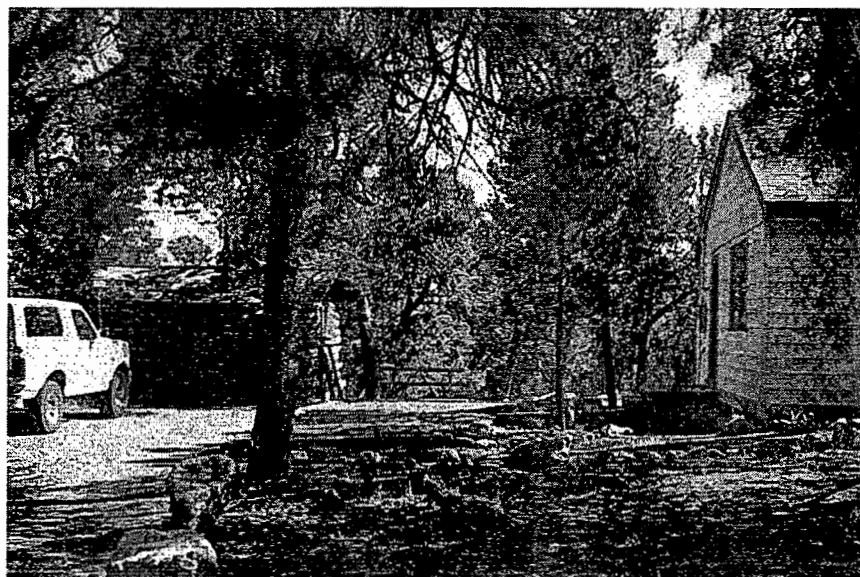
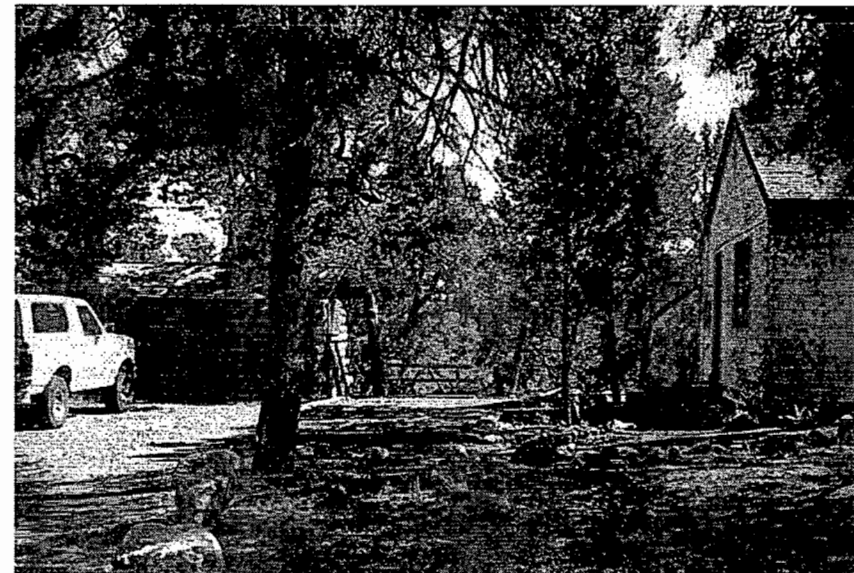
Photograph 172. Log structure between Single family residence #65 Juniper Hill (Bldg. #SRQ0066) and Single family residence #67 Juniper Hill (Bldg. #SRQ0067). (JMA, 2001)

A **log structure** is located between Bldg. #SRQ0066 and Bldg. #SRQ0067 (Photograph 173). This may be the Bldg. #66A, associated with Bldg. #SRQ0066. The small, rectangular structure has a shingled gable roof and chinked log walls. A small, square window is located on the east elevation while a wood board door is located on the south elevation.

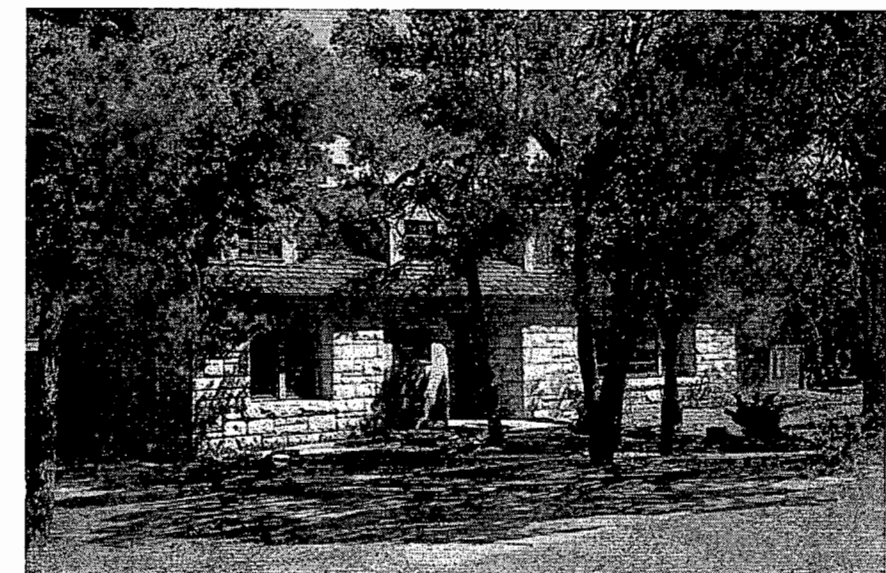
Photograph 173. Single family residence #23 Tapeats Circle (Bldg. #SRQ0023). (JMA, 2001)

Single family residence #23 Tapeats Circle (Bldg. #SRQ0023) was built in 1941 and is located on Tapeats Circle; near the intersection of Tapeats Circle and Kaibab Street (*Photograph 173*). The building has a wood-shingle gable roof with four gable-roof dormers. The exterior walls are clad in cut stone. The windows are inset into the walls and are varied in size and shape.

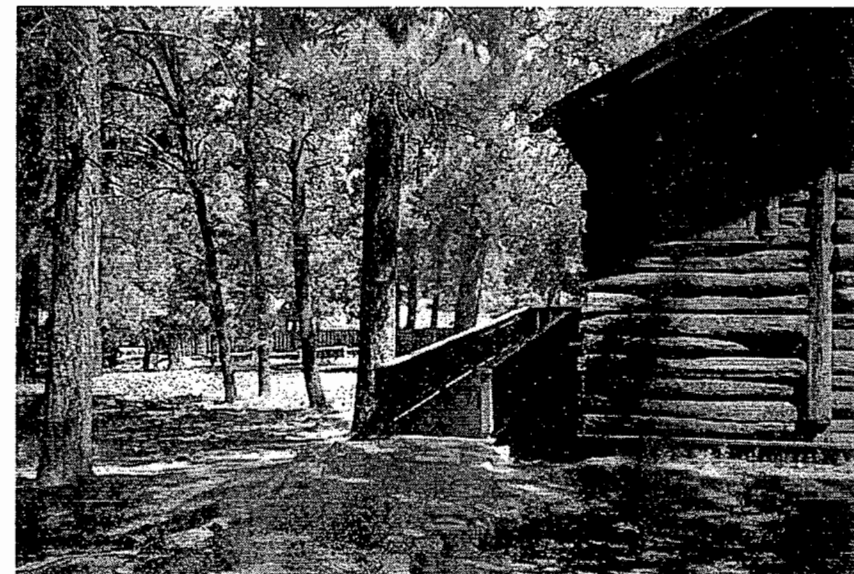
Photograph 174. Wood accessibility ramp and railing at WODC/Library. (JMA, 2001)

Small-scale features associated with circulation include an **accessibility ramp** with **wood railing** located at the entrance of the WODC/Library building (*Photograph 174*). This feature is of recent construction.

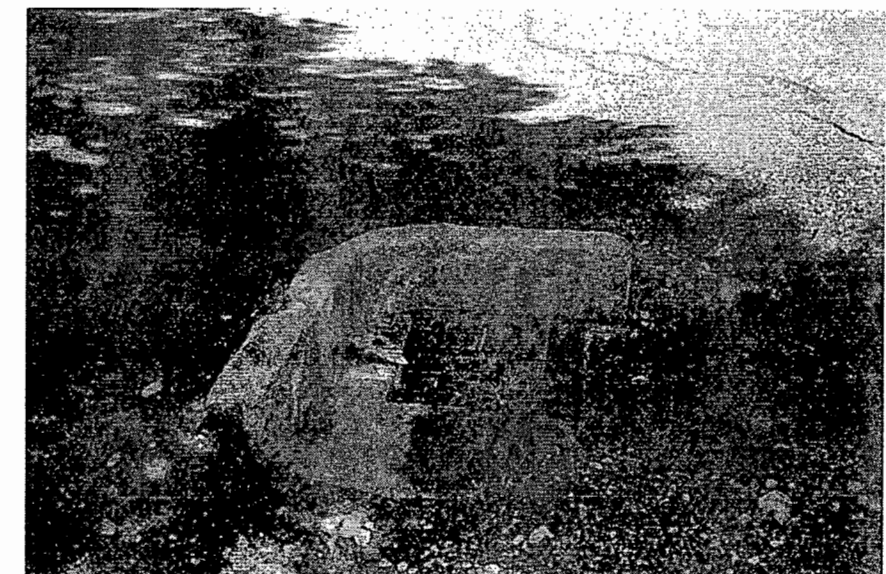
Photograph 175. Metal drainage grate with concrete curb. (JMA, 2001)

Between Bldg. #SRQ0019 and its garage is a gravel path lined with **cut stone edging** that differs from the typical Grand Canyon Village rough stone and boulder edging types due to its more formal, designed appearance (*Photograph 164*). Wooden **wheel stops** that appear to be old railroad ties are used for parking and edging in many places, such as along the side of the driveway to Bldg. #SRQ0053 (*Photograph 171*). Small-scale features associated with drainage include a **metal drainage grate** surrounded by a short concrete curb (*Photograph 175*). Small **metal pipe culverts** are found elsewhere in the character area.

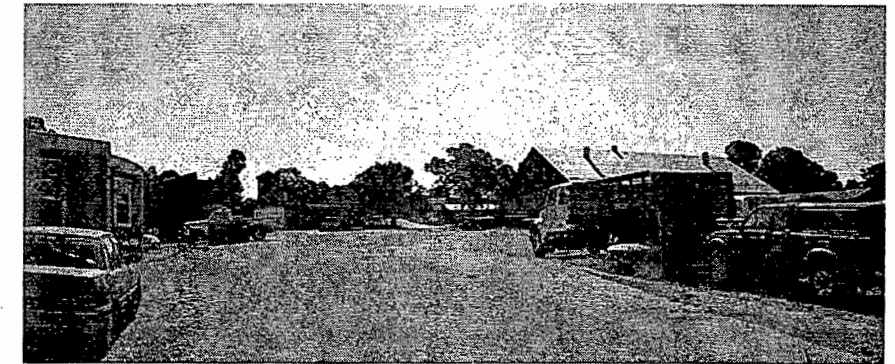
The primary space in this area is the **central work plaza** which is defined by building façades (*Photograph 177*). The open plaza is paved with asphalt and contains clusters of buildings and a vehicular drive. Woodlands define the outer edge of this space, encompassing the buildings, drive, and plaza.

Photograph 177. Central work plaza in NPS Service Area. (JMA, 2001)

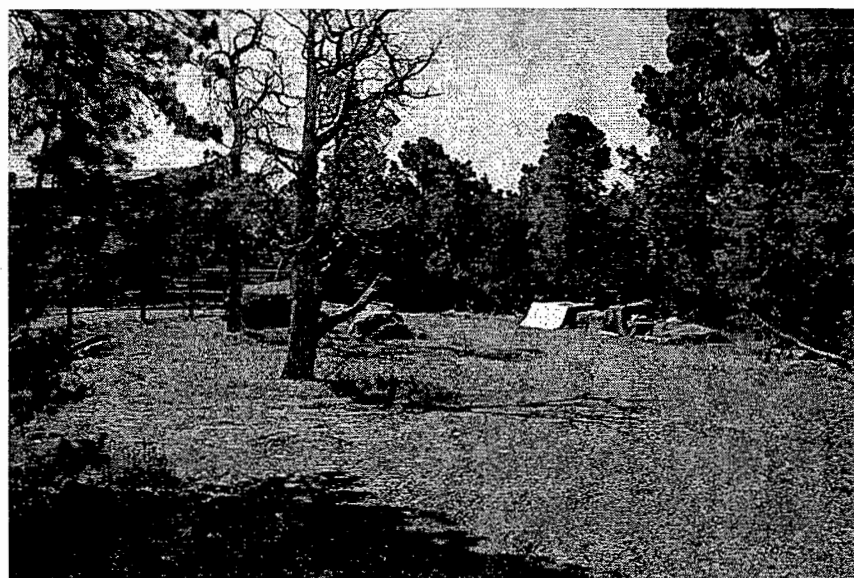
West of the Mule Barn, a narrow **gravel access drive**, consisting of dark-colored loose stone approximately twelve-to-fifteen feet in width, reaches from Sunset Drive to the Pole Hay Shed (*Photograph 179*).

Photograph 179. Gravel access drive near Mule Barn. (JMA, 2001)

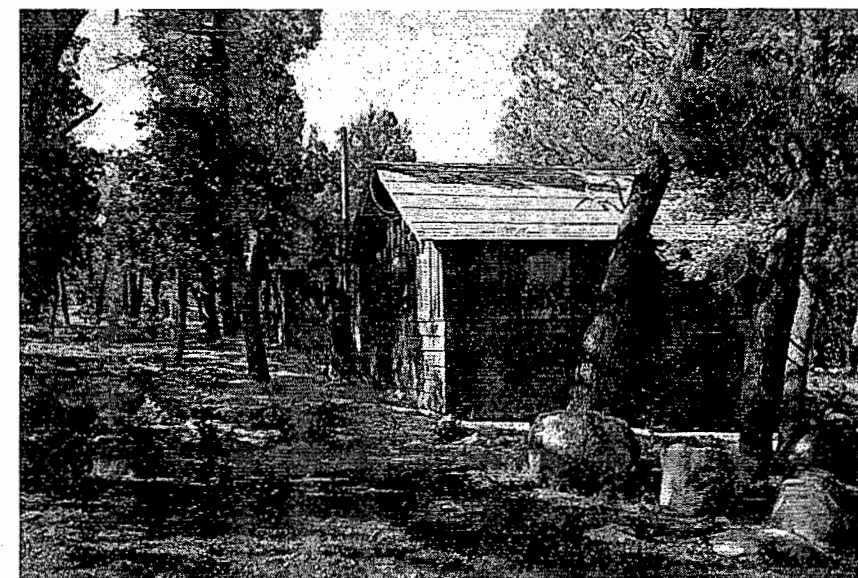
The **Labor Cabins** (Bldgs. #SRQ0061-SRQ0065) were built in 1930 and are located at the intersection of Juniper Hill and Sunset Drive (*Photograph 180*). The six cabins all share similar characteristics. All of the cabins have gable roofs. Siding is board-and-batten on the upper half of the exterior walls while the lower portions are clapboard. Windows are two-over-two with green trim. The **Labor Cabin Comfort Station** (Bldg. #SRB0060) is larger, having two rooms.

Photograph 180. Labor Cabins and Ponderosa pines. (JMA, 2001)

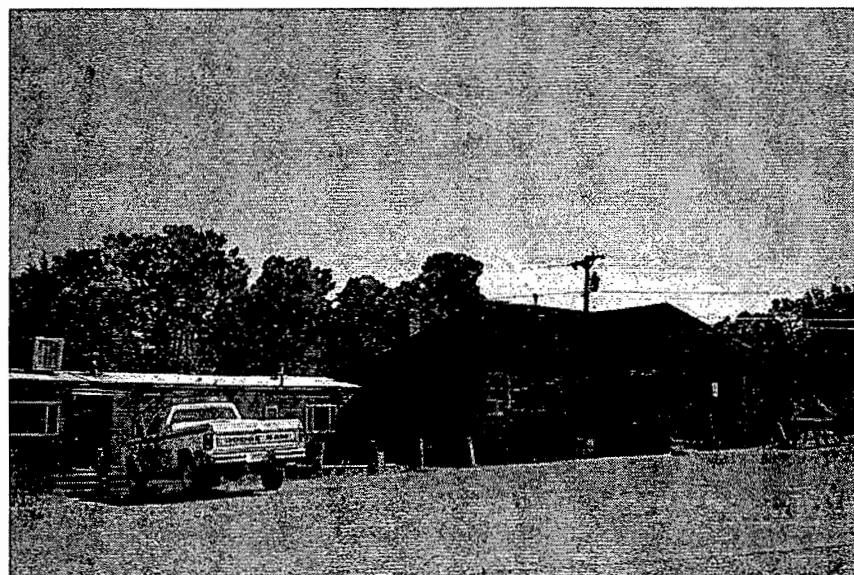
Within the second cluster, several buildings and structures are arranged around a central parking area. Three contemporary **Temporary Housing units** (Bldgs. #TH-01, TH-02, and TH-03) are located along the northeastern boundary of the character area (*Photograph 181*). These trailer-like residences are narrow and rectangular with vertical board siding and contemporary windows.

Photograph 181. Temporary Housing units on left, Boat Shop on right. Note wooden bollards. (JMA, 2001)

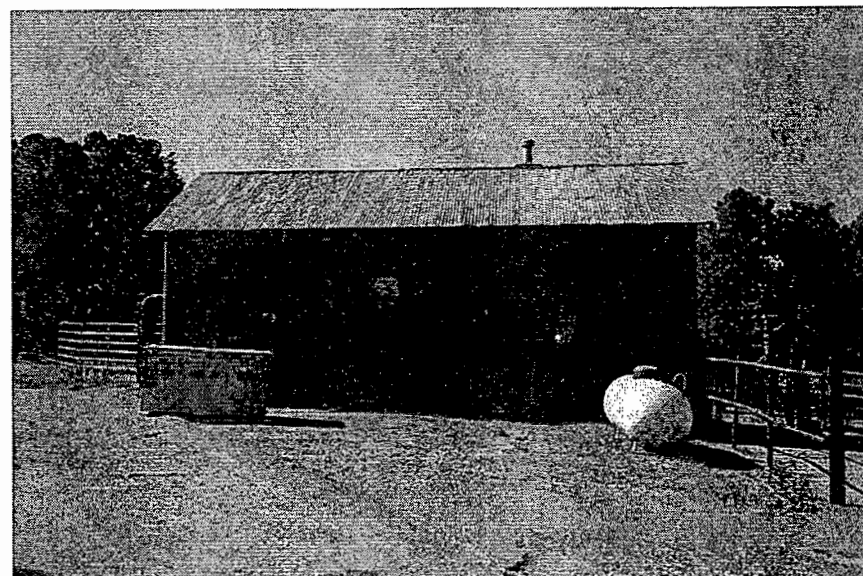
The **Paint Shop** (Bldg. #SRB0080) is located east of the Horse Barn and was built in 1930 (*Photograph 185*). The building is rectangular in shape and has a gable roof sheathed with corrugated metal. Two large vehicular bay doors, with chamfered door jambs, are located on the north elevation. A set of double doors with long, iron hinges is also located on the north elevation.

Photograph 185. Paint Shop with typical propane tank on right. (JMA, 2001)

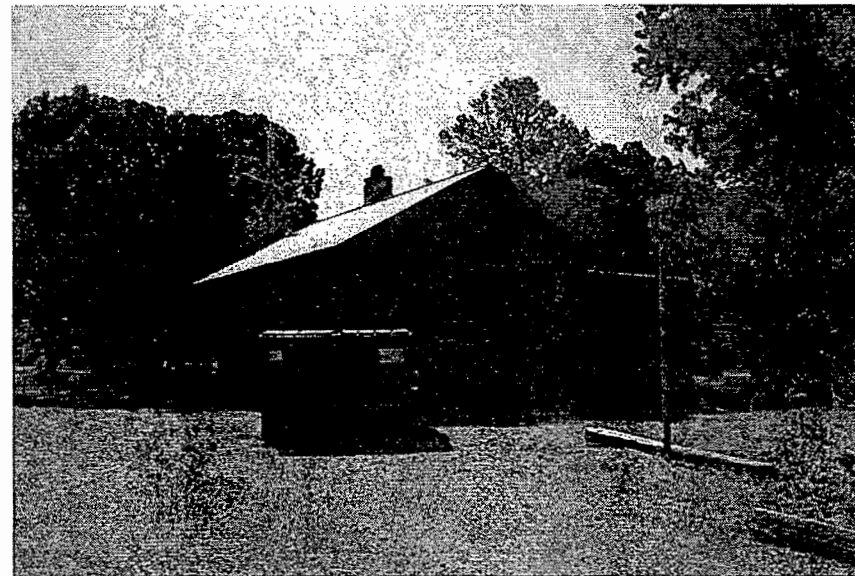
Photograph 186. Jail, with typical dumpster, wood wheel stops, and street sign in foreground. (JMA, 2001)

The **Jail** (Bldg. #SRB0087) is a two-room holding facility built in 1936 (*Photograph 186*). The Jail is a rectangular building with a gable roof and exposed rafter tails. A brick chimney rises up from the roof near the east elevation. The exterior walls are sheathed in brown wood clapboard siding. Two three-by-three windows with green trim are located on the north elevation, as is the entrance door. A shed addition is located on the south elevation.

Signage is minimal and includes standard green reflective **street signs** on poles (*Photograph 186*). An example is found on the corner of Kaibab Street and Tonto Street.

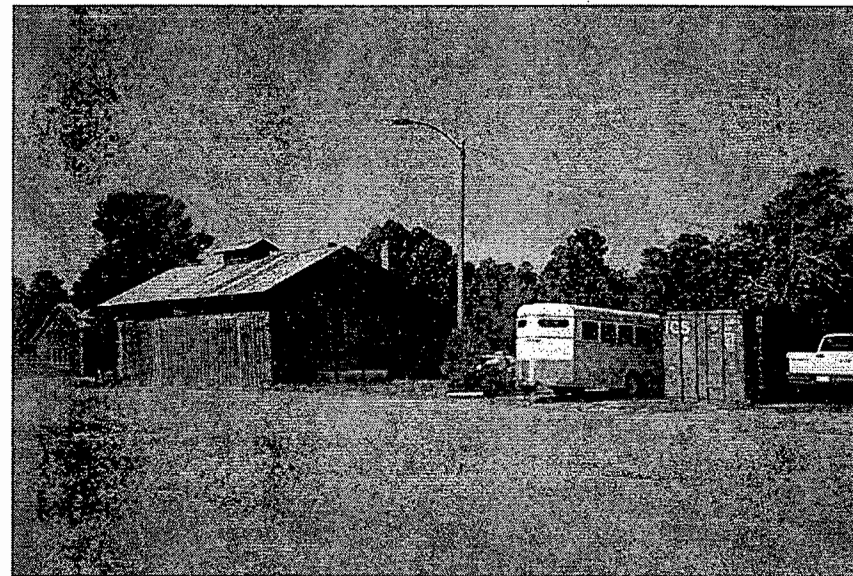
The **Blacksmith Shop** (Bldg. #SRB0075) is located on the southwestern corner of this plaza and on the north side of Sunset Drive (*Photograph 187*). The rectangular building has a gable roof with corrugated-metal sheathing and a gable-roof monitor. The walls are clad in stained board-and-batten siding. Three sets of large double doors are located on the east elevation.

Photograph 187. Blacksmith Shop, on left, with overhead light and storage container. (JMA, 2001)

Storage containers, horse trailers, and other equipment are found here—as well as scattered around the edges of the plaza (*Photograph 187*). Just west of the mule corral and pole barns, in the southeastern corner of the character area, are **materials piles**.

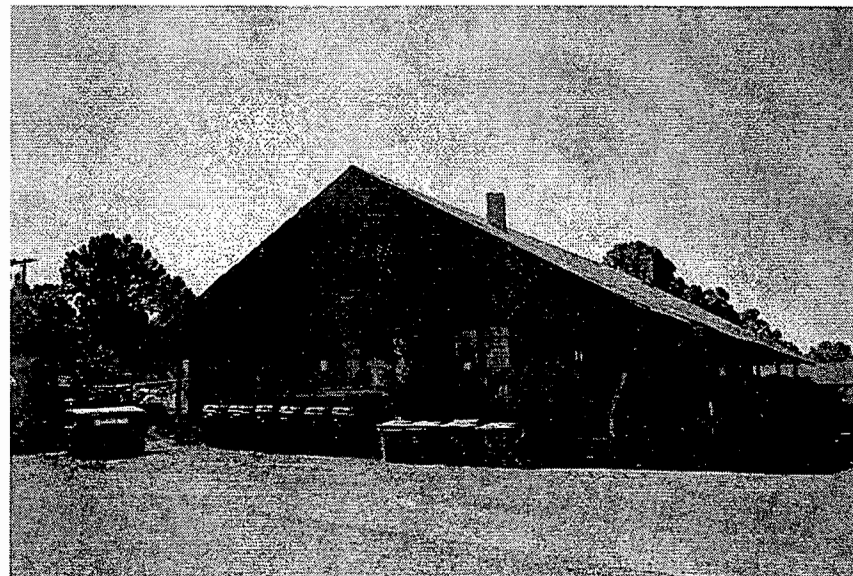
Photograph 189. 1926 Warehouse, with typical trash receptacles and dumpster. (JMA, 2001)

Other small-scale features in the NPS Service Area include **trash receptacles**, such as the plastic trash cans found on the north side of the 1926 Warehouse (*Photograph 189*); **dumpsters**, such as the one located beside the Jail (*Photograph 186*); and **fuel or propane tanks**, such as the one located near the Mule Barn and north of the Paint Shop. **Satellite dishes** are found just south of the Lumber Shed in the space enclosed by chain-link fencing (*Photograph 194*).

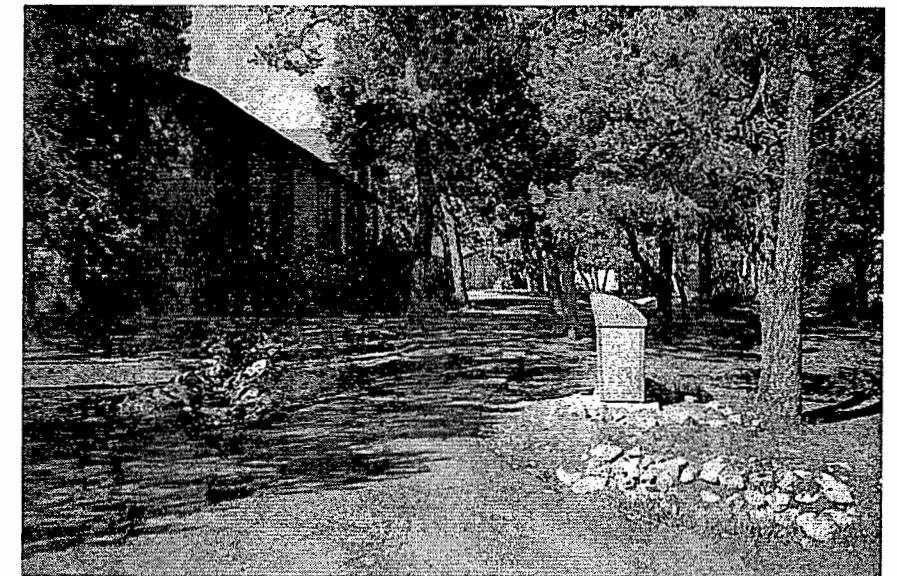
Pedestrian paths and walks form the circulation patterns in the Community School Area. A system of un-edged **asphalt paths** winds through the northern part of the area, leading to and from buildings and roads (*Photograph 221*). A five feet to six feet-wide **concrete sidewalk** leads from Boulder Street to the Middle School entrance (*Photograph 222*). The sidewalk splits into two walks that run along the front of the building.

Photograph 221. Asphalt path between school buildings, with stone-lined swale, culvert, and trash receptacle. (JMA, 2001)

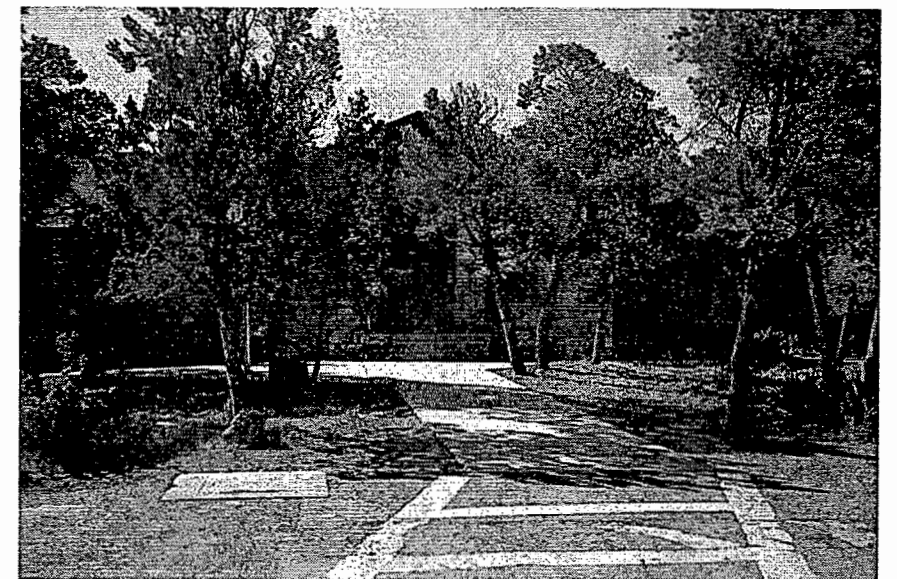
Photograph 222. Concrete sidewalk to Middle School entrance. (JMA, 2001)

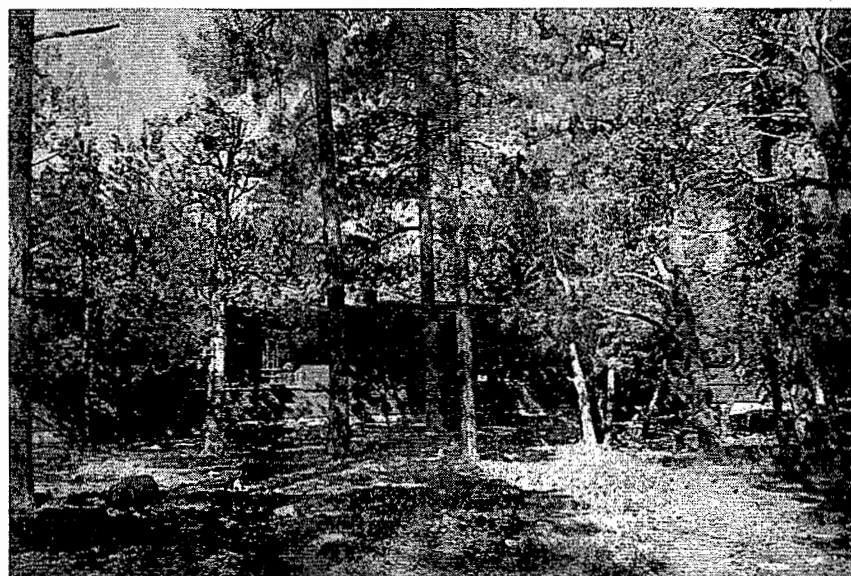
The Community School Area is shaded by **ponderosa pine trees**, which surround the school buildings and buffer them from the street (*Photograph 223*). **Ornamental plantings** of native species, such as several agaves, are planted near the stone-lined swale (*Photograph 224*). The ground cover in this area is comprised of patches of **grass**.

Photograph 223. Ponderosa pines shading school site. (JMA, 2001)

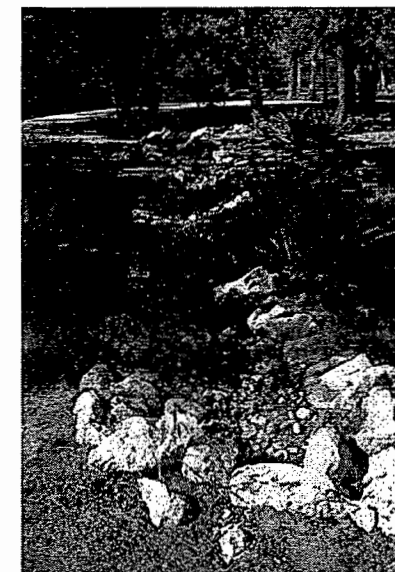
Features associated with drainage in the Community School Area include several small **stone-lined swales** that carry stormwater and roof runoff away from the buildings and into culverts beneath the asphalt paths in this area (*Photograph 224*). **Metal pipe culverts** are located near the northeast and northwest corners of the Elementary School building.

Photograph 224. Ornamental plantings along stone-lined swale with larger stone edging. (JMA, 2001)

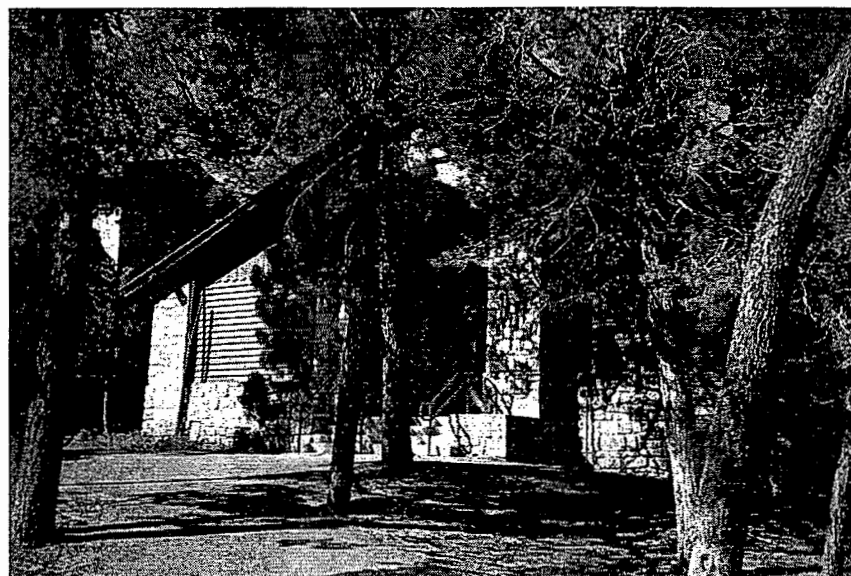
The **Grand Canyon Middle School** (Bldg. #0227) was built in 1939 and is located along Boulder Street and along the western edge of the area (*Photograph 225*). The building has a cross-gable roof. The cut-stone exterior walls are punctuated by tall, wide windows that reach almost from the roof to the ground. The main entrance is on the north façade that faces Boulder Street. The double doors are located beneath a grand cross gable with stone pilasters reaching from the concrete patio to the roofline. A stone wall wraps around the entrance steps and patio.

Photograph 225. Grand Canyon Middle School. Note pipe handrail on stair. (JMA, 2001)

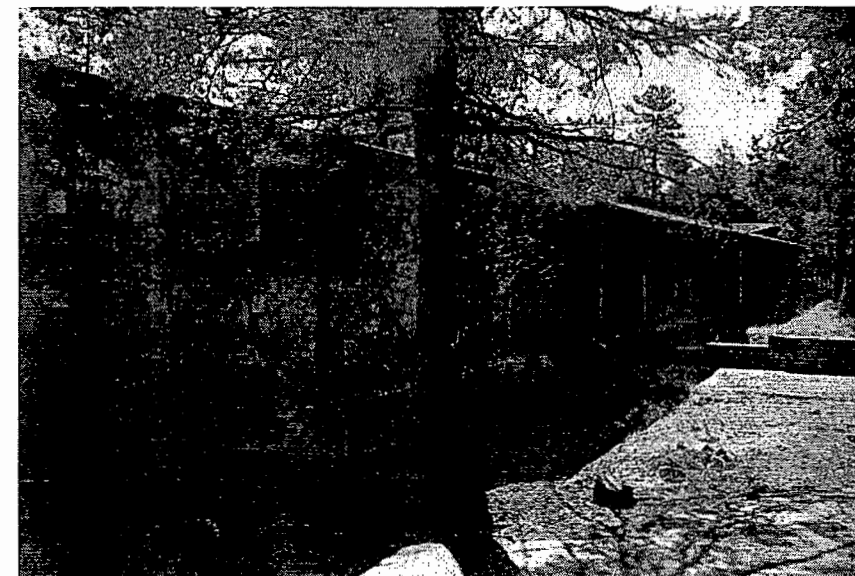
Grand Canyon Elementary School (Bldg. #323) was built in 1953 and is located east of the Middle School and near the intersection of Boulder Street and Center Road (*Photograph 226, 223*). The long rectangular building has a gable roof. The exterior walls have a variety of siding treatments. The majority of the walls are sheathed with vertical board siding on the upper two-thirds while the lower third has horizontal board siding. The west façade is clad in cut stone from roof to ground. A loggia runs along the south elevation of the building.

Brown-painted **metal railings** frame the steps to the north and east entrances at the Grand Canyon Middle School (*Photograph 226*).

Photograph 226. Grand Canyon Elementary School. (JMA, 2001)

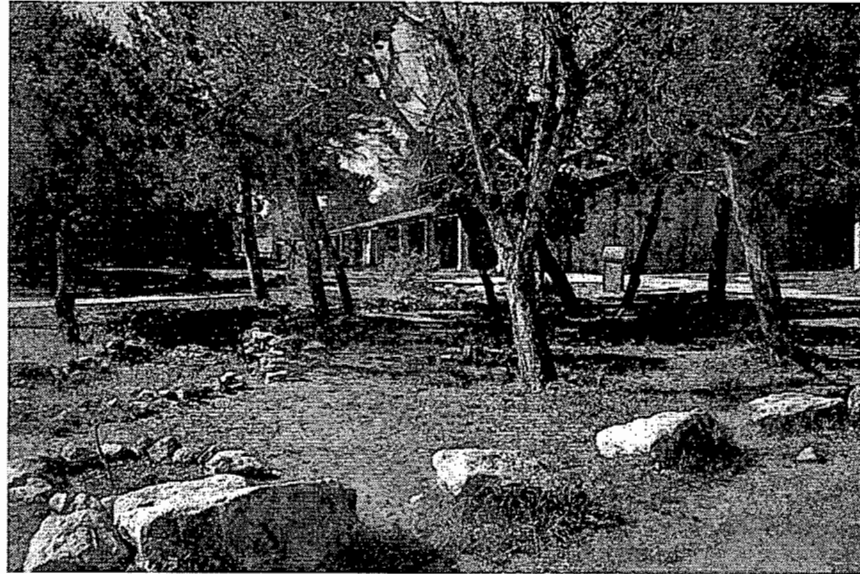
Northwest of the Grand Canyon Middle School, **boulders** line the asphalt path to the building, while smaller **stone edging** encircle planting beds and create curving forms along the lawn area near the building (*Photograph 227*).

Photograph 227. Rough stone edging. (JMA, 2001)

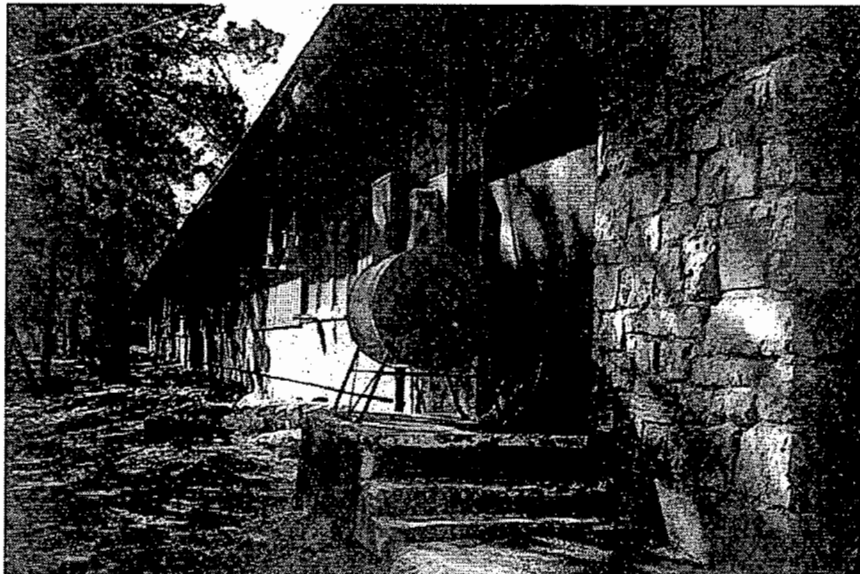
Trash receptacles in the Community School Area include brown-painted metal drums present elsewhere in the Village. There are also four-sided trash receptacles of gray-painted metal with paneling on the sides, as seen northeast of the Elementary School (*Photograph 221*). There is a contemporary plastic **compost bin** on the east side of the Elementary School (*Photograph 228*).

Photograph 228. Compost bin on east side of Elementary School. (JMA, 2001)

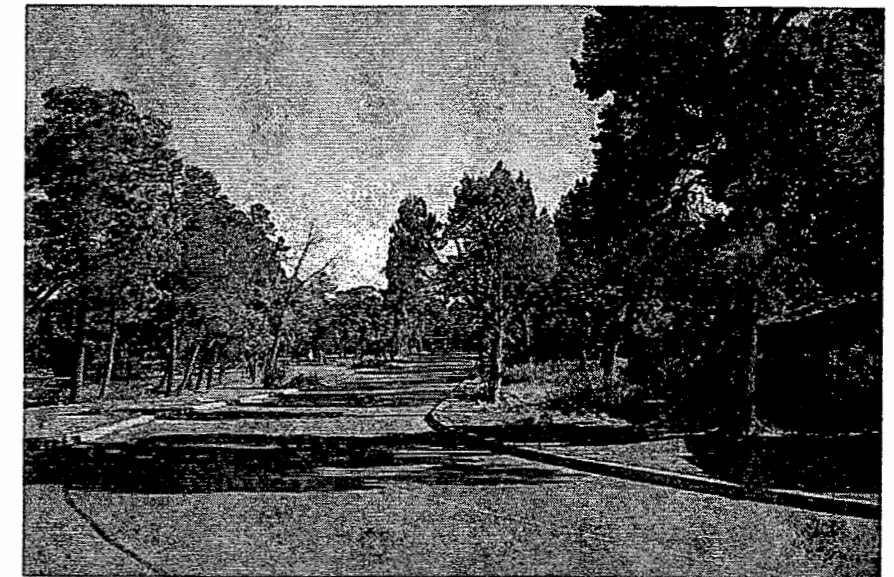
Village Loop Drive is the primary vehicular circulation route through the Cabin Area (*Photograph 229*). In this character area, Village Loop Drive is a two-way asphalt road with cut stone curb. It extends from the southeast corner of the area, near the Grand Canyon Railroad tracks, to the northern area boundary. A **concrete drop-off lane** is located in front of Maswik Lodge and is part of Village Loop Drive (*Photograph 230*). A secondary **access road** runs through the Maswik Cabin cluster (*Photograph 231*). This narrow, one-lane eroded asphalt and gravel road runs from Village Loop Drive north, through the cabins, then turns west to meet Village Loop Drive again. The road has gravel shoulders that extend to the building façades.

Photograph 229. Village Loop Drive. (JMA, 2001)

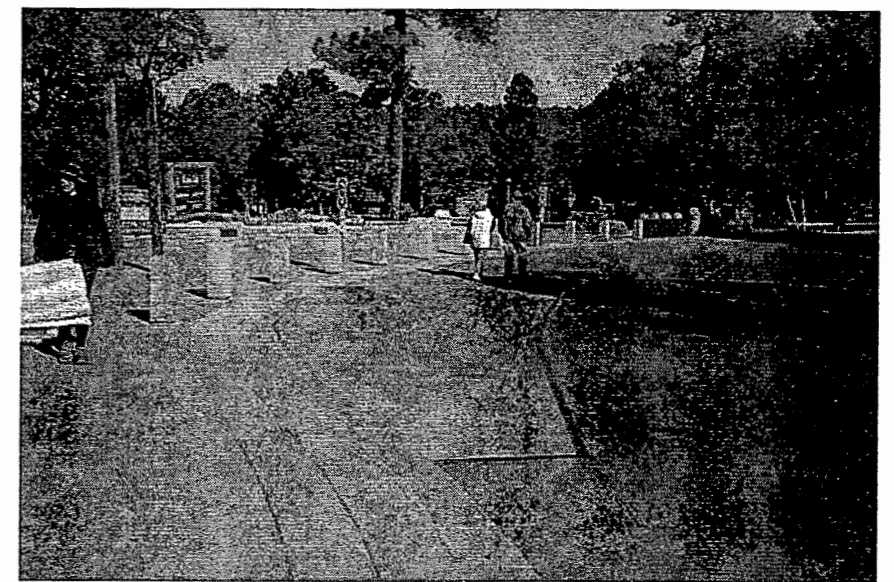
Photograph 230. Concrete drop-off lane in front of Maswik Lodge, with concrete bollards. (JMA, 2001)

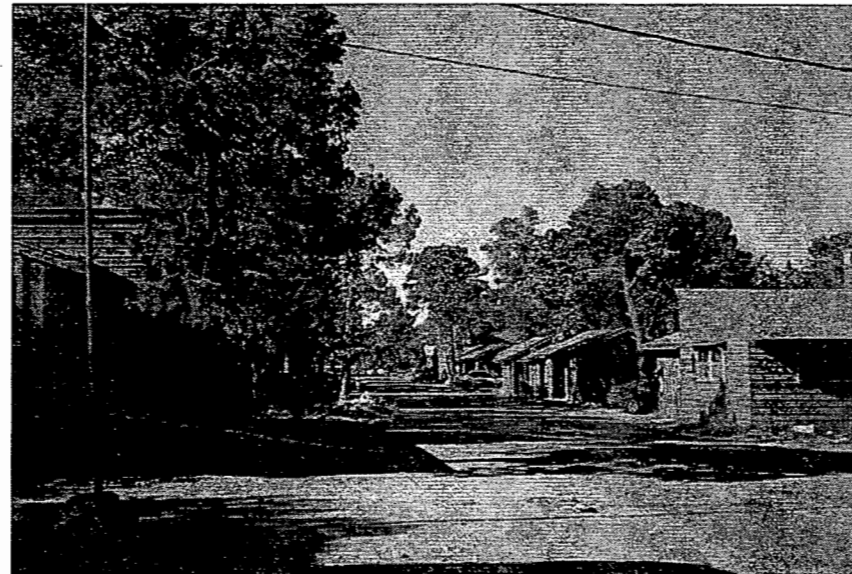
Photograph 231. Access road to cabin cluster. (JMA, 2001)

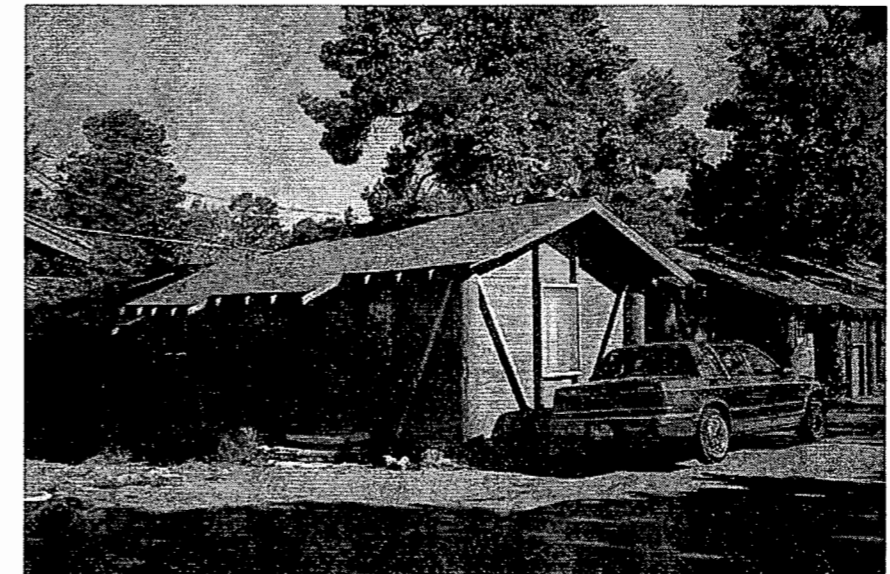
Parking is very informal and somewhat opportunistic. **Gravel parking spaces** are located in between cabins and along the road shoulders (*Photograph 232*).

Photograph 232. Gravel parking spaces among cabins. (JMA, 2001)

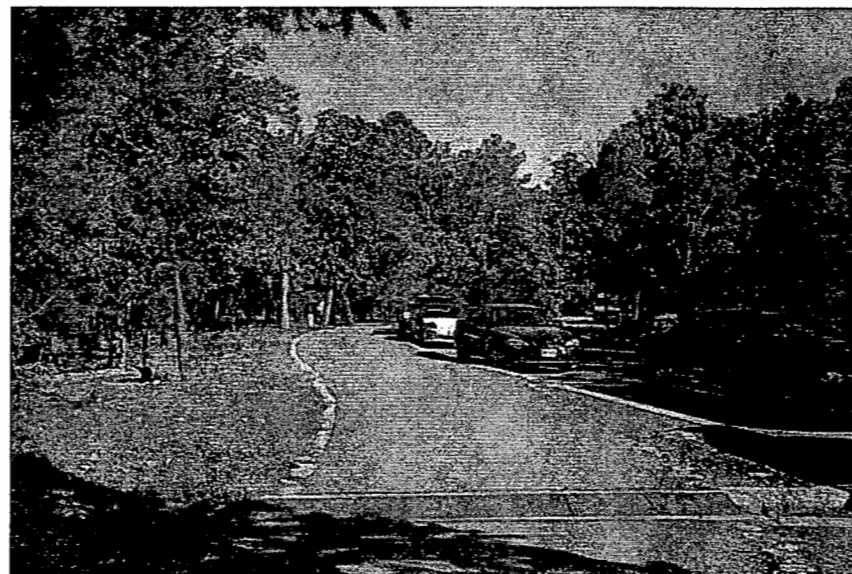
Pedestrian circulation consists of earthen paths, asphalt sidewalks, and gravel paths. An **asphalt sidewalk**, with stone edging, runs along the western edge of Village Loop Drive (*Photograph 233*). This sidewalk is similar to those that run throughout the rest of the Grand Canyon Village. An **asphalt path** extends along the southern edge of the former amphitheater space and consists of a two-to-three-foot-wide surface edged by small cut stones (*Photograph 234*). A second **asphalt path** extends from Village Loop Drive along the northern edge of the former amphitheater site. It consists of a highly deteriorated, two-to-three-foot-wide asphalt surface with cut stone edging.

Photograph 233. Asphalt sidewalk with trench drain and stone curbing along Village Loop Drive. (JMA, 2001)

Small-scale features associated with drainage include metal slabs over stone **trench-style storm drains** that cross the sidewalk just north of the cabins (*Photograph 233*). **Metal grates** cover drop inlets along the southern segment of Village Loop Drive roadway in the Camp Area.

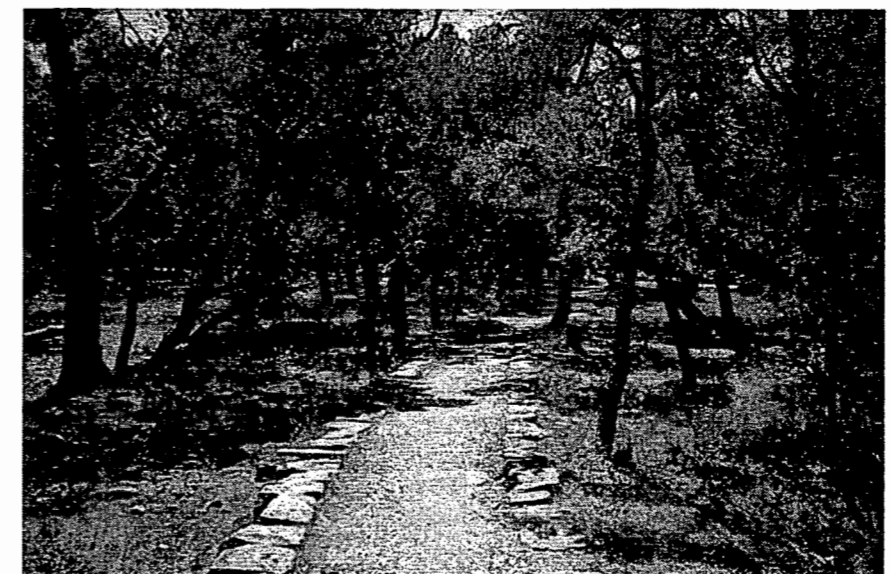
Photograph 234. Macadam path with stone edging. (JMA, 2001)

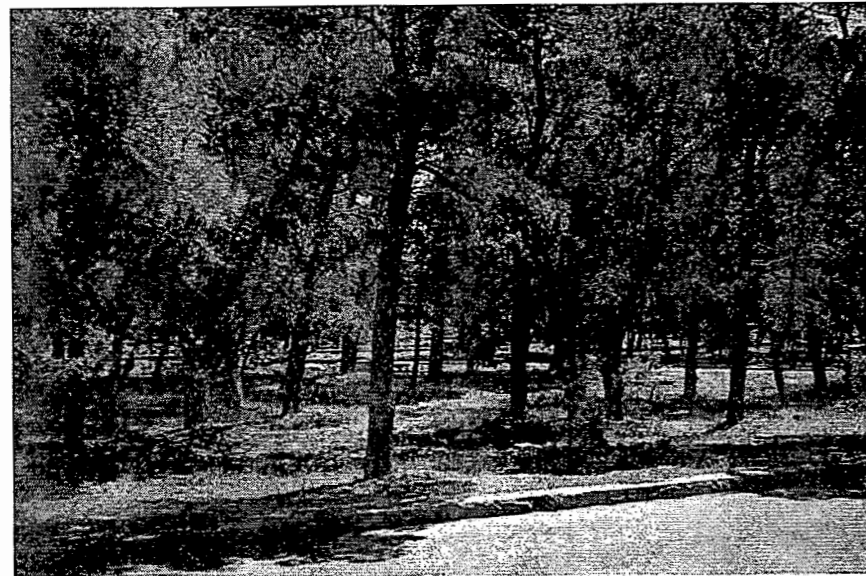
In the Camp Area, little vegetation exists aside from **stands of Ponderosa pines** and associated tree species, which function to screen the cabins from Village Loop Drive, the railroad tracks, and the Utility Area (*Photograph 235*).

Photograph 235. Ponderosa pine vegetation. (JMA, 2001)

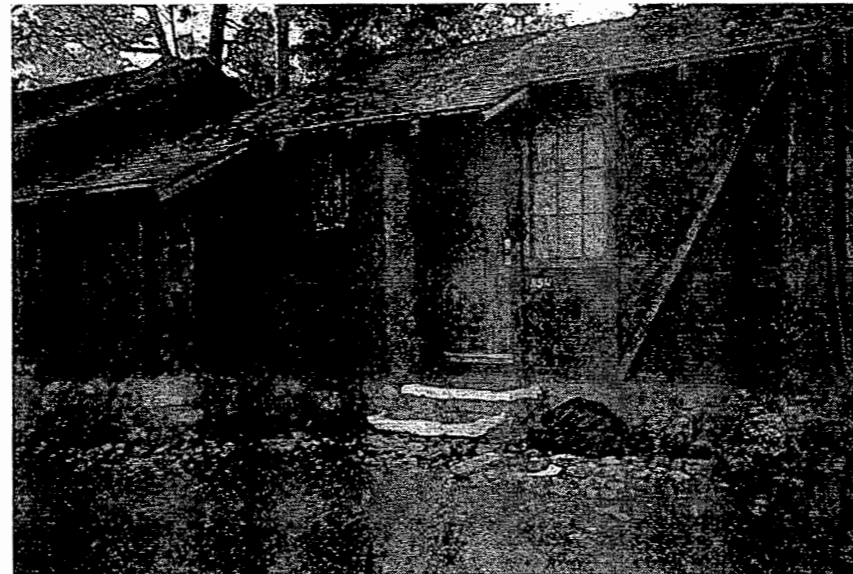
One-room **Maswik Cabins** (Bldgs. #0595-#0606) share similar architectural style and construction methods. Built in 1927, the cabins have gable roofs and exposed-framing extending between thick, round log posts. The cabins rest on stone foundations. Windows have multiple lights and green trim. Bathrooms are located in small gable-roofed additions. Stone and/or concrete steps lead to the front entrances.

Photograph 236. Maswik cabins. (JMA, 2001)

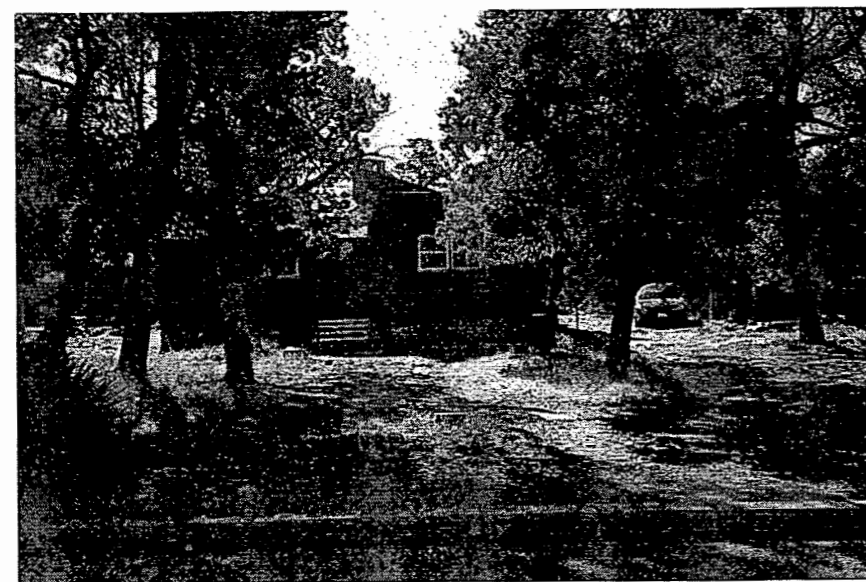
Four-room **Maswik Quad Cabins** (Bldgs. #0581-#0587) were built in 1940. All cabins share similar characteristics. Each cabin consists of four shed-roofed rooms set perpendicular to each other to form somewhat of a pin-wheel design. Each room has either board-and-batten or clapboard siding and two sets of double windows on each elevation. Windows not below an eave have a tiny shed-roof lintel. A square brick chimney rises from the center of the building (*Photograph 237*).

Photograph 237. Maswik quad cabin. (JMA, 2001)

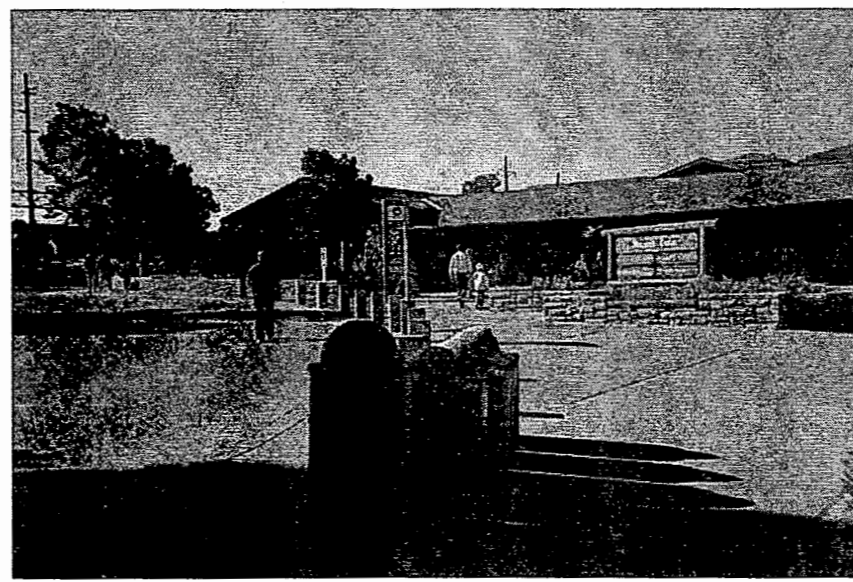
Photograph 238. Cut-stone planter wall near Maswik Lodge in background, with wood sign; trash receptacles in foreground. (JMA, 2001)

In the southwestern corner of the character area, and west of the Maswik Lodge shuttle bus drop-off, a **cut-stone planter wall** sits in the midst of a plaza and creates a planter bed and seat wall (*Photograph 238*).

In general, small-scale features in the Camp Area are typical of the Village. **Stone edging** lines the asphalt and unpaved paths in the area. Uneven **boulder** and stone edging is found along sections of the road through the cabins, although the edges of the road are generally informal here. **Cut stone curbing** is found along both sides of Village Loop Drive (*Photograph 233*). As Village Loop Drive approaches Maswik Lodge on the southern perimeter of the character area, contemporary **concrete bollards** line the road edge (*Photograph 238*).

Signage is typical of the Village at large, and includes **brown and white NPS signs**, **vehicular traffic regulation signs**. At the bus stop near Maswik Lodge are typical **bus system orientation signs**. These types of signage are described in previous sections. A large **wooden sign** identifying the adjacent Maswik Lodge is located just within the Camp Area boundary (*Photograph 238*).

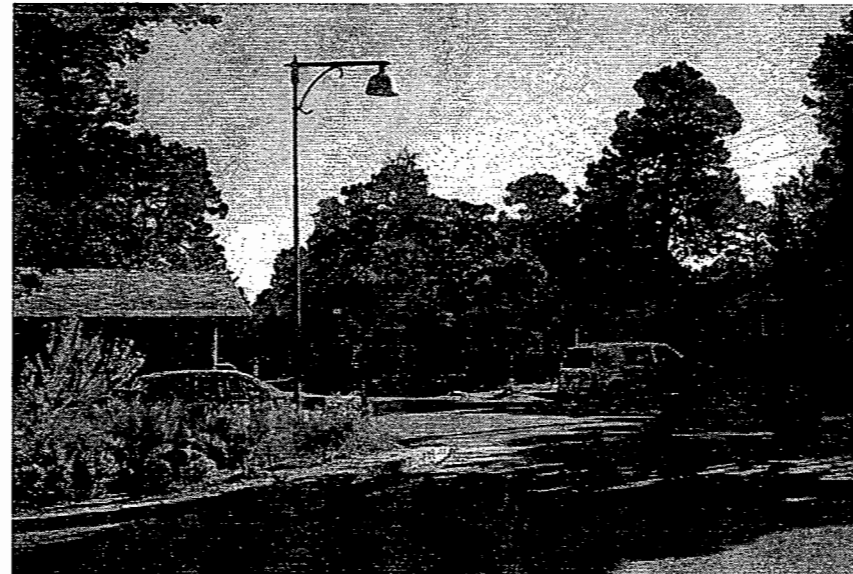
Lights in the Camp Area include **green-painted metal street lights**, similar to those located near the Bright Angel Cabins: mounted on eighteen-foot-tall poles, with a curving lamp arm and ornamented by a metal bracket with curled ends (*Photograph 239*). Other **lighting standards** the area are also of green-painted metal but shorter and without ornament, and appear to be contemporary (*Photograph 240*).

Photograph 239. Lighting at Camp Area. (JMA, 2001)

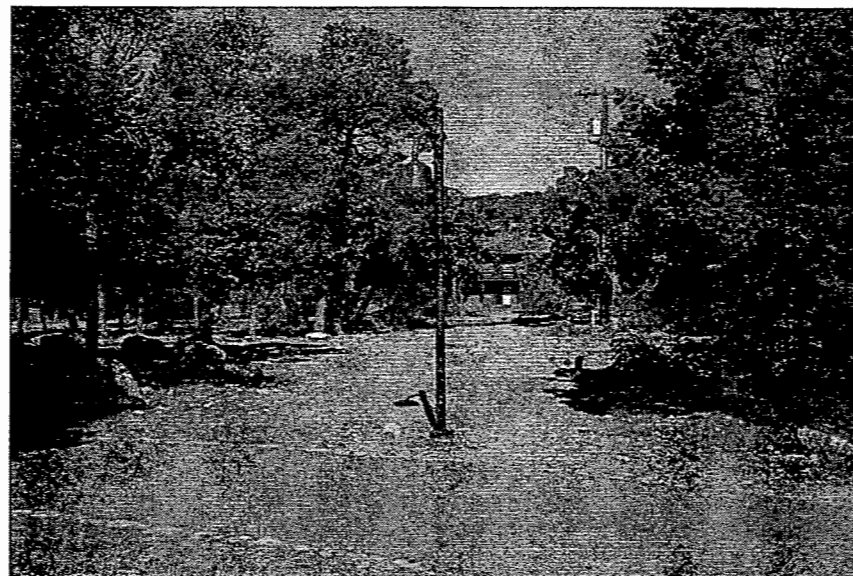
Photograph 240. Other lighting along an asphalt path. (JMA, 2001)

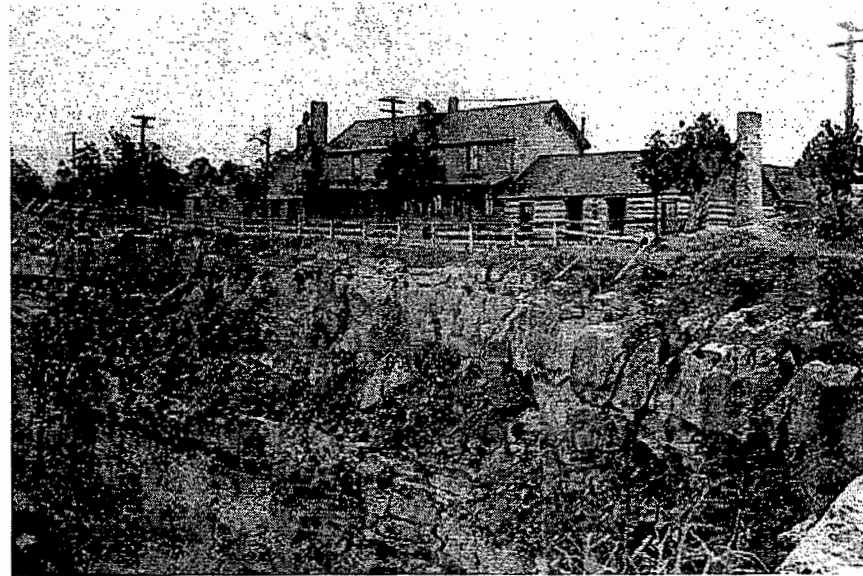
Figure 57. 1906 photo of the Bright Angel Hotel and Buckey O'Neil Cabin on the South Rim of the Grand Canyon. (Grand Canyon Museum Collection Catalog #9828).

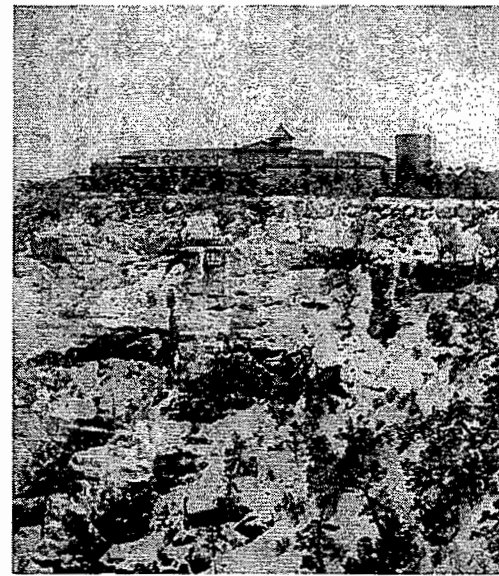
Figure 58. Circa 1910 view of El Tovar Hotel from the east. Note water tank on left side of photograph. (Grand Canyon Museum Collection Catalog #9824)

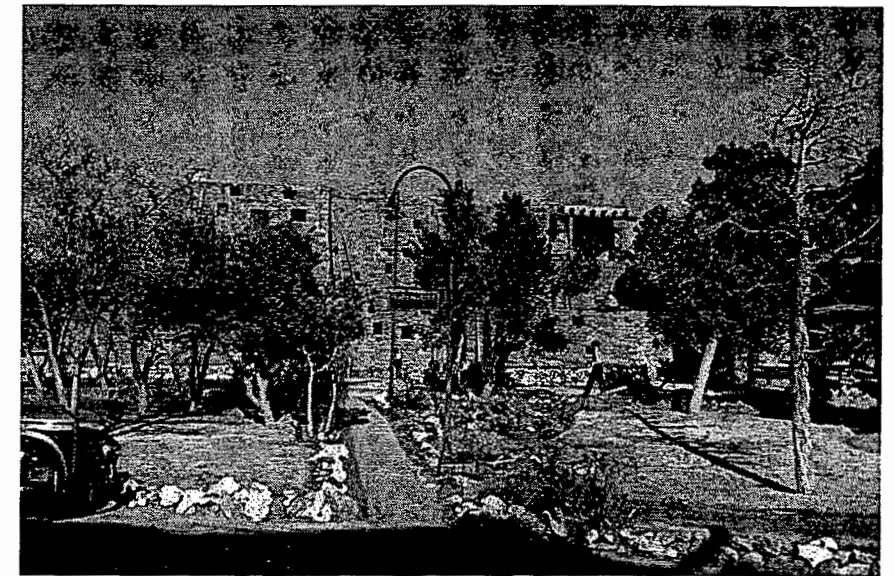
Figure 59. View of Hopi House from El Tovar Hotel, circa 1930s. Note increased amount of vegetation within the traffic island. (Grand Canyon Museum Collection Catalog #9520)

create a landscape that was highly susceptible to, and presumably required, the manipulation of vegetation for both utilitarian and aesthetic purposes. Early 19th-century photographs depict a rim landscape that was heavily cleared in places and then apparently replanted with native vegetation (*Figures 8, 10, 26, and 30 in Chapter II*). Photographs from later in the period of significance show ornamental plantings of native plants meant to both respect and enhance the natural beauty of the surrounding features (*Figure 59, in Chapter IV Comparative Photographs*).

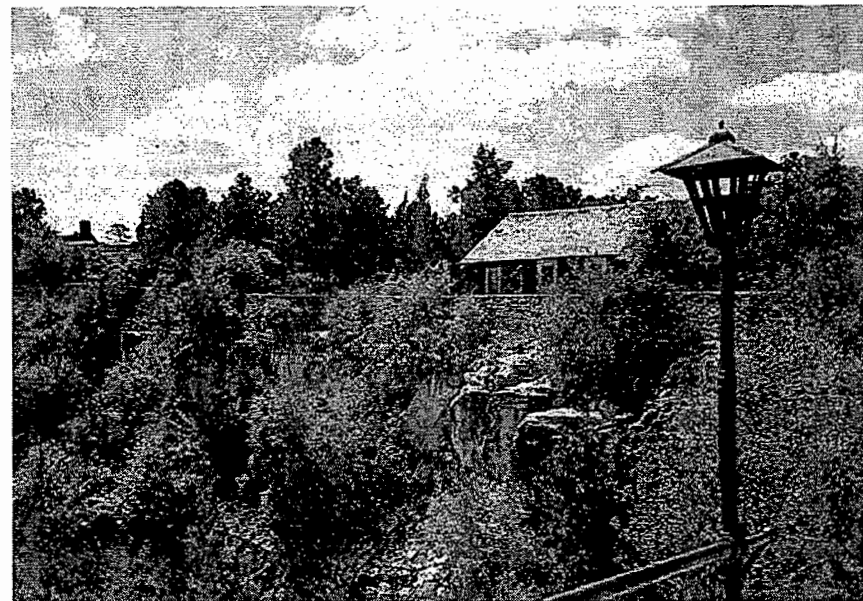
Figure 57a. 2001 view of rehabilitated Buckey O'Neill Cabin from a similar vantage point. (JMA, 2001).
