**Grand Canyon Village
National Historic Landmark District
Cultural Landscape Report**

**Grand Canyon National Park
Arizona**

January 2004

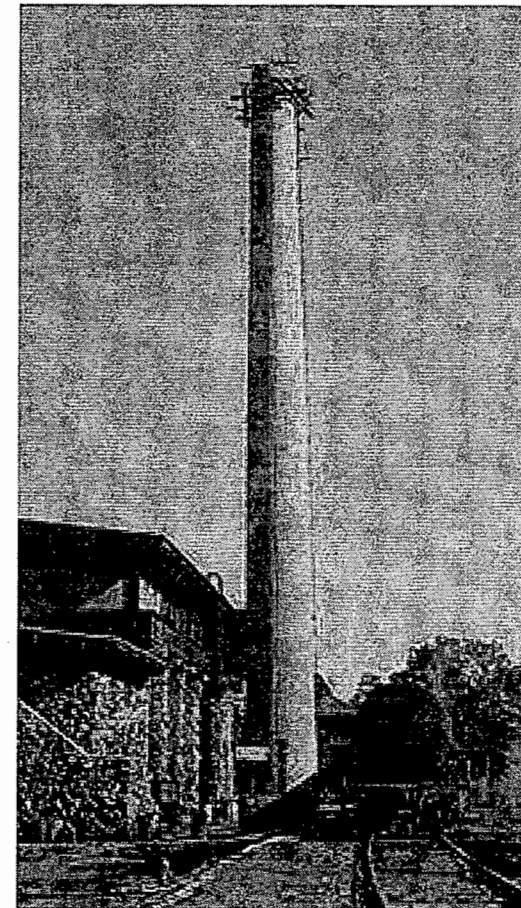
Figure 61. Power House smokestack and railroad spur in the Utility Area character area, circa 1940. (Cline Library, Local Call #NAU.PH.99.21.32).

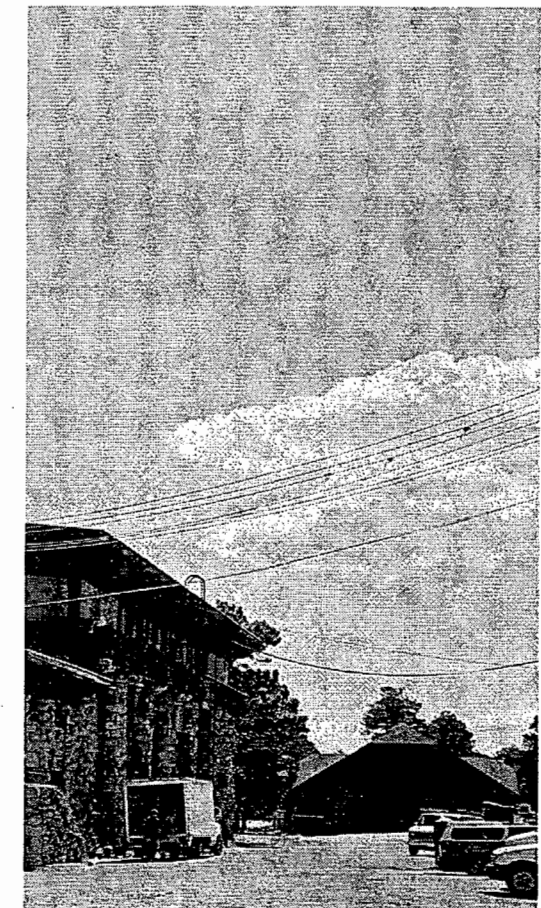
Figure 61a. Power House without smokestack or spur. (JMA, 2001).

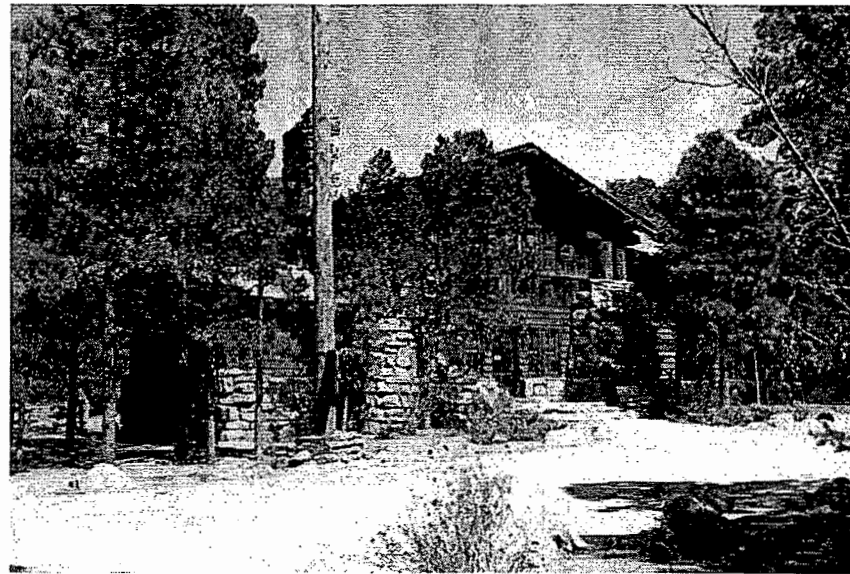
Figure 62. Ranger Operations Building, previously the park's Administration Building, circa 1935. (Grand Canyon Museum Collection Catalog #9506)

In contrast, pre-settlement vegetation south of the Bright Angel Wash was likely much more dense. The lack of views into the Grand Canyon, coupled with the planned use of these southern areas by NPS and concessionaire employees and staff, did not necessitate the removal of large amounts of vegetation to accommodate public uses. In fact, landscape architectural principles of the time, particularly Rustic design principles, advocated the retention of as much existing vegetation as possible and the desire to harmonize built features with the surrounding environment. In these locations, vegetation was more apt to be transplanted during revegetation efforts or selectively thinned to accommodate new buildings and features (*Figures 41 and 44, in Chapter II*). Ornamental vegetation appears to have been used to accentuate buildings, roads, and paths rather than used as decorative displays, particularly closer to the canyon edge (*Figure 62, in Chapter IV Comparative Photographs*).

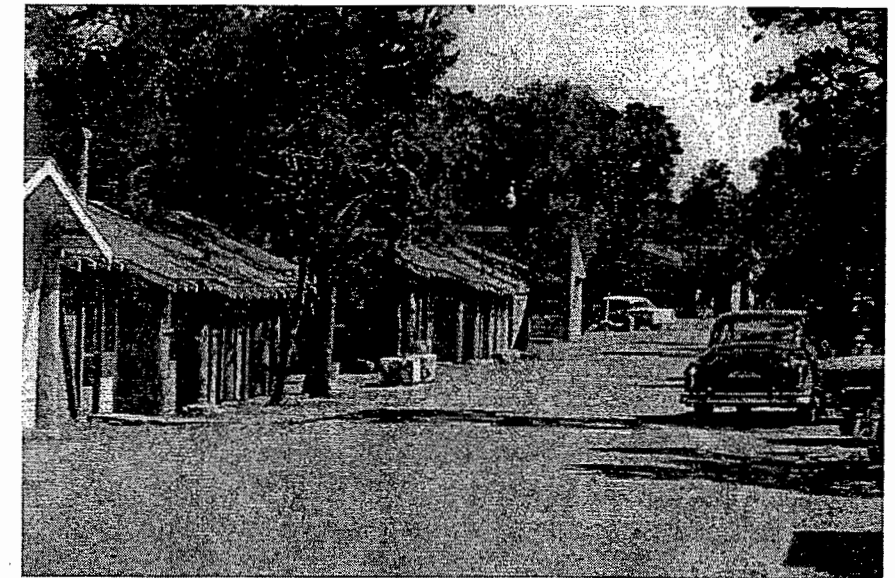
Figure 63. View of Fred Harvey Auto Camp, now the Maswik Cabins, looking north, circa 1950 (Grand Canyon Museum Collection #9966).

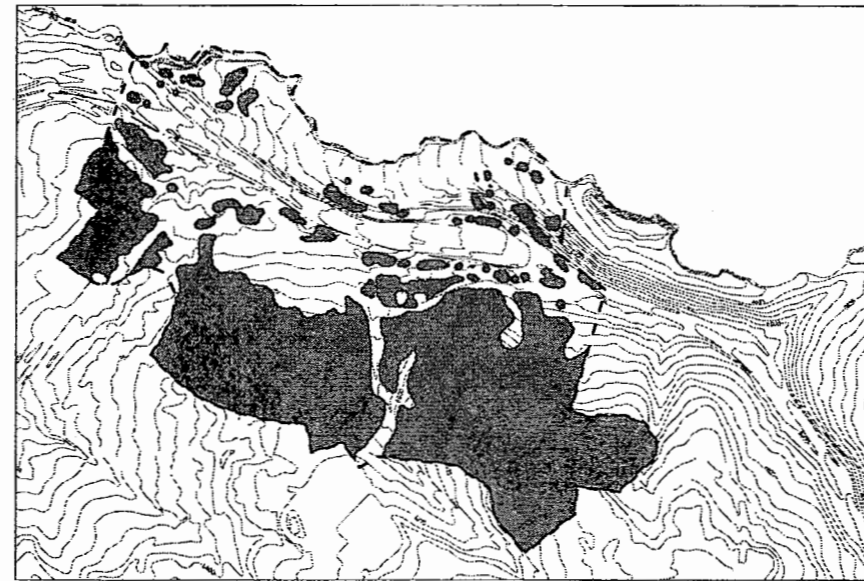
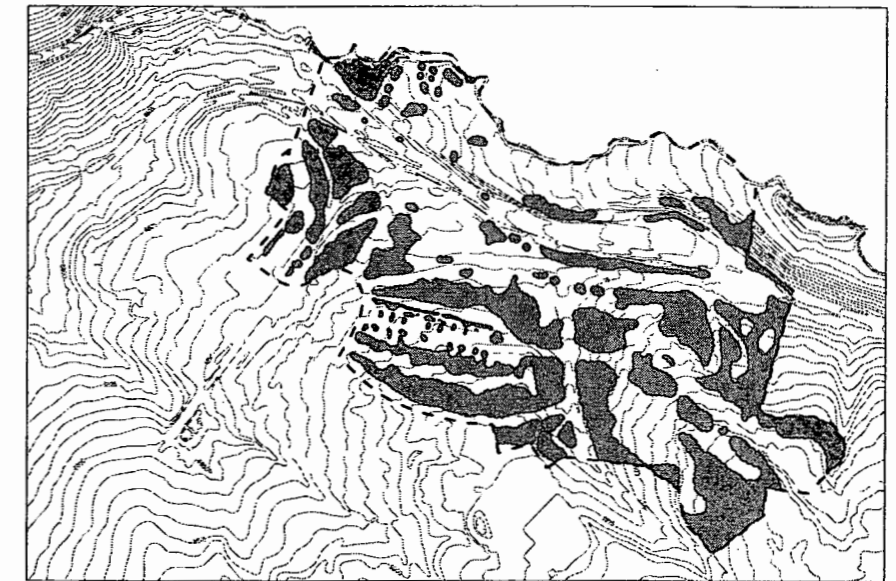
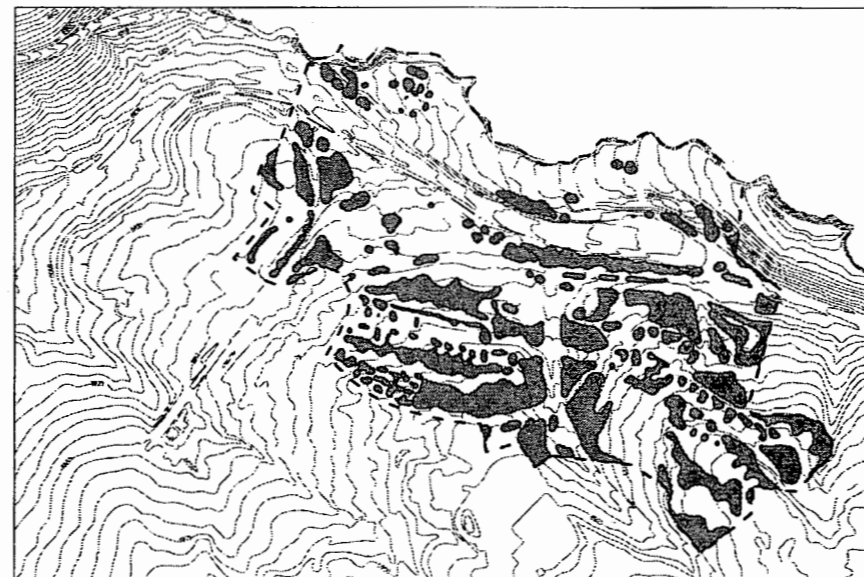
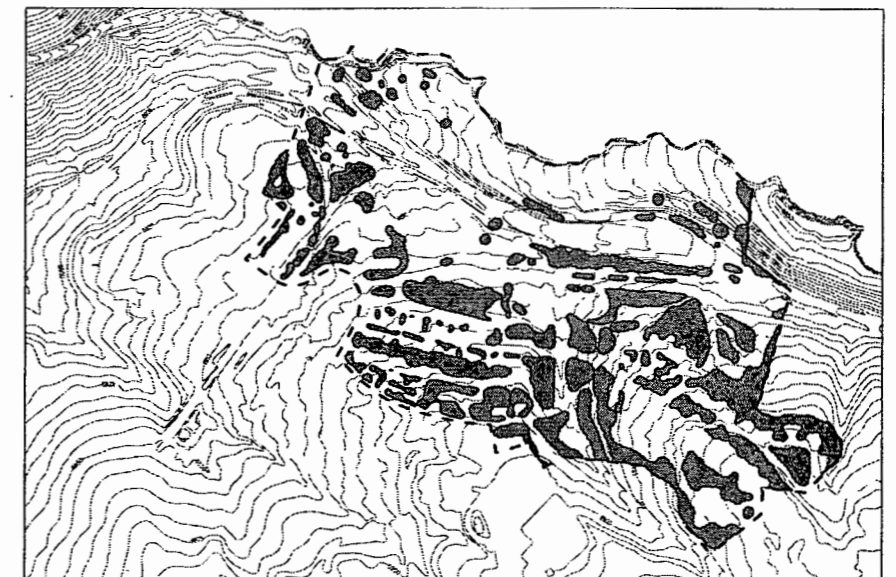
Figure 64

**Grand Canyon Village
National Historic Landmark District
Vegetative Changes 1924-2002**

This combination of human intervention and the natural response by the environment led to an ever-evolving forest character—one that was growing increasingly more dense, and possibly more diverse with the transplantation efforts of NPS and CCC vegetation crews. While the remaining forest vegetation grew denser with young trees, disturbed landscapes gained more native shrubs and groundcovers that were introduced from the surrounding region and planted around new buildings and developed areas. Meanwhile, the original pre-settlement forest was becoming increasingly fragmented as new buildings and roads were constructed (*Figures 64 and 65, located at the end of this section*).

- Retain as much existing, healthy forest vegetation as possible within the Village Historic District.
- Avoid removing vegetation patterns that remain from the period of significance. Refer to the maps portraying vegetative change over time to determine these sensitive areas (*Figures 64 and 65*). Figure 65 depicts forest vegetation that remains from 1942—the end date of the period of significance.

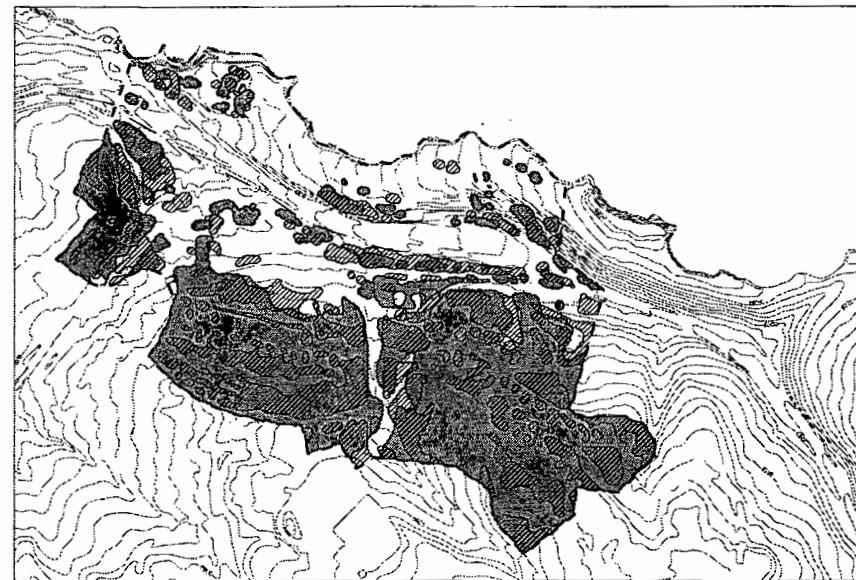
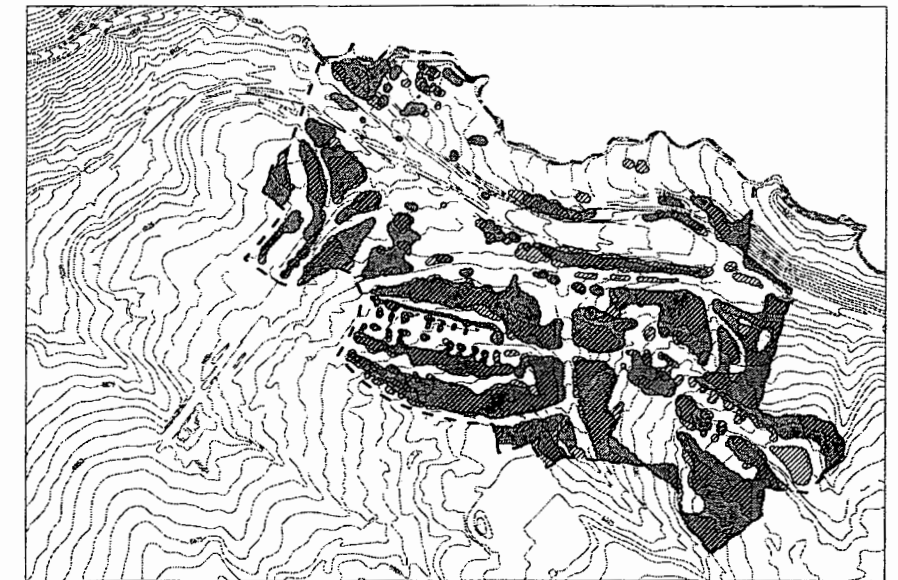
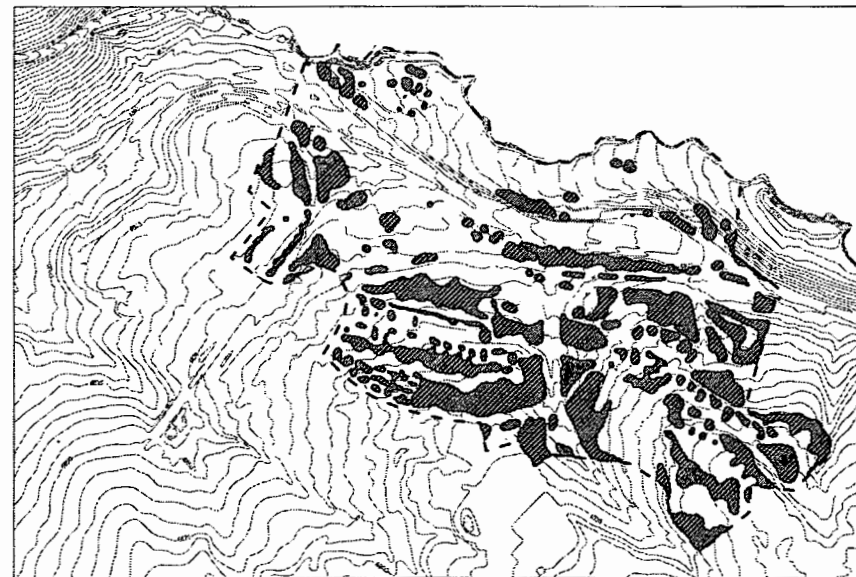
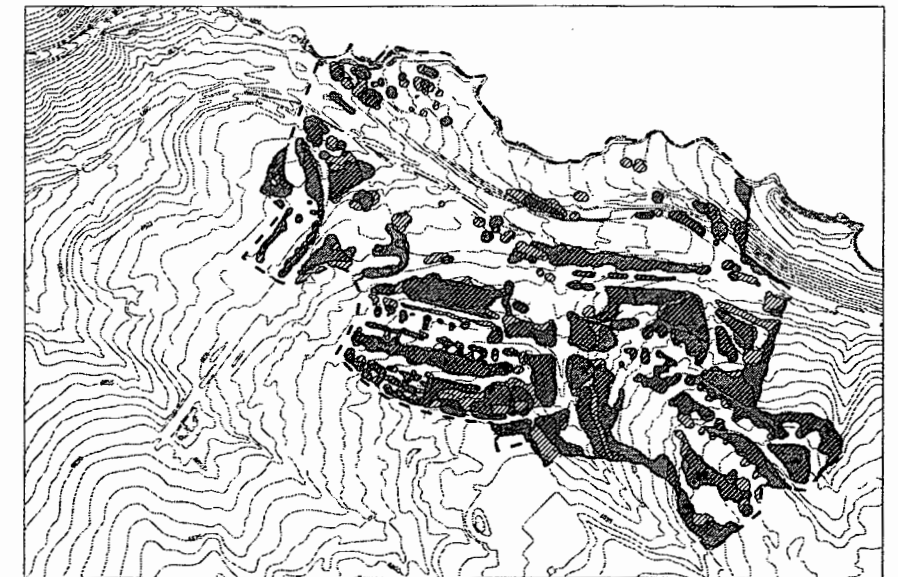
Figure 65

- Village Historic District boundary
- Existing vegetation
- ▨ Existing vegetation in 1942 (End date of the period of significance.)

**Grand Canyon Village
National Historic Landmark District
Period of Significance Comparison**

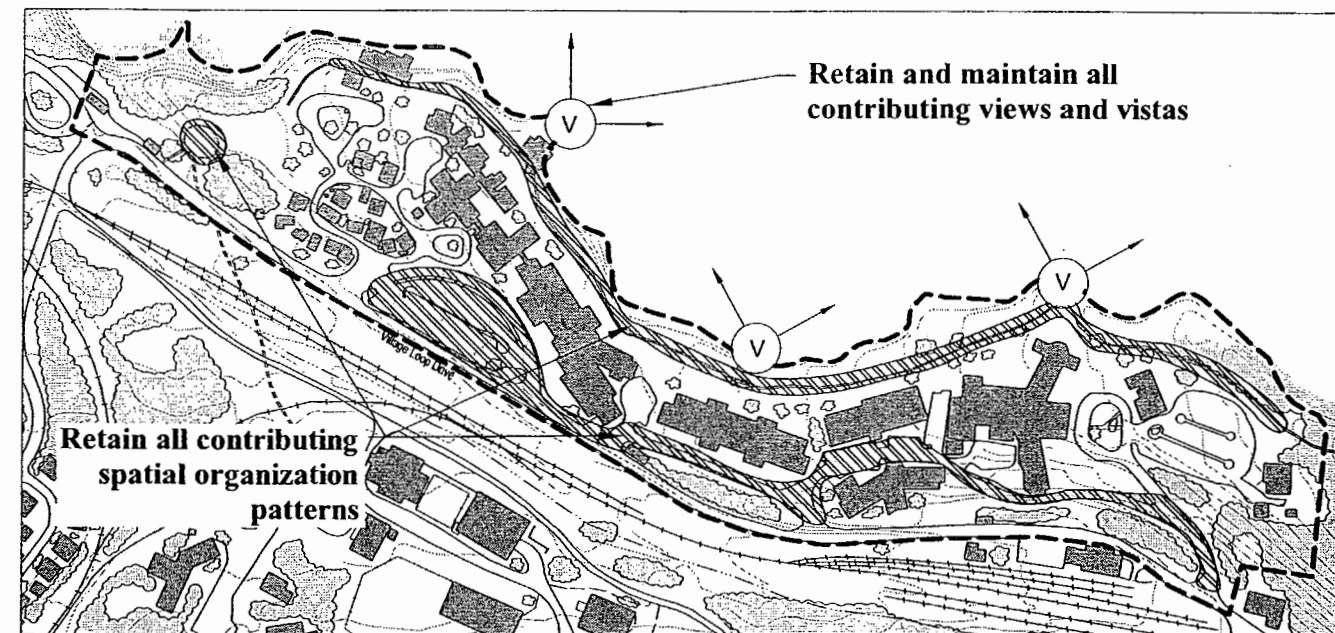
Spatial Organization, Views/Vistas

- Retain all contributing patterns of spatial organization.
- Avoid new construction or demolition that would eliminate these spaces. The removal of Kachina Lodge and Thunderbird Lodge is appropriate, according to the *Secretary of the Interior's Standards for the Treatment of Historic Properties*, however, as they are non-contributing features that were constructed in an historically open space. *Refer to the Specific Project Recommendations for Possible Removal of Kachina and Thunderbird Lodges.

- Retain and maintain all existing, contributing views and vistas. Avoid creating obstruction to these views. Perform maintenance tasks to keep the views clear, such as the removal and thinning of vegetation that obscures contributing views and viewpoints.

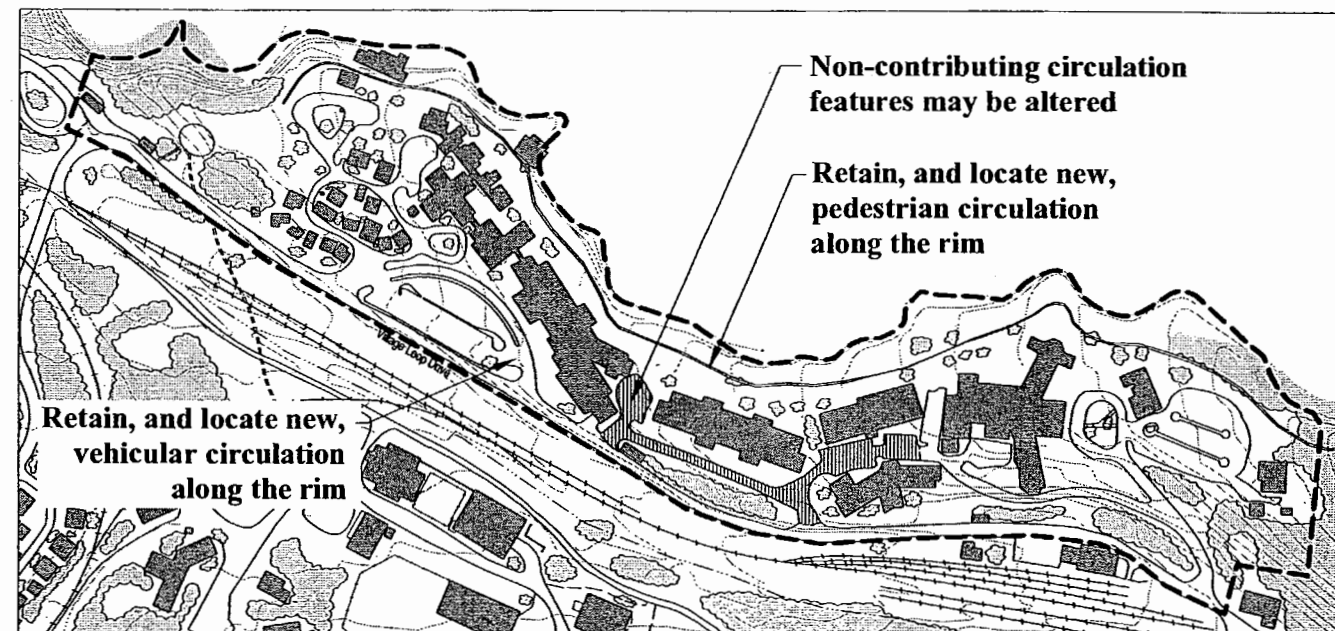
Circulation

- Repair and maintain all circulation features assessed in fair or poor condition in the Chapter III Condition Assessments. These features show clear evidence of minor and major disturbances that require corrective action.

- Minimize the establishment of desire paths, which trample vegetation, enhance erosion, and damage cultural resources, by carefully assessing the most efficient and well-traveled routes between destinations prior to the implementation of new pedestrian patterns. Upgrade desire paths by paving, edging, or the installation of signage, if the paths become heavily-used and are not considered detrimental to natural or cultural resources in the area.

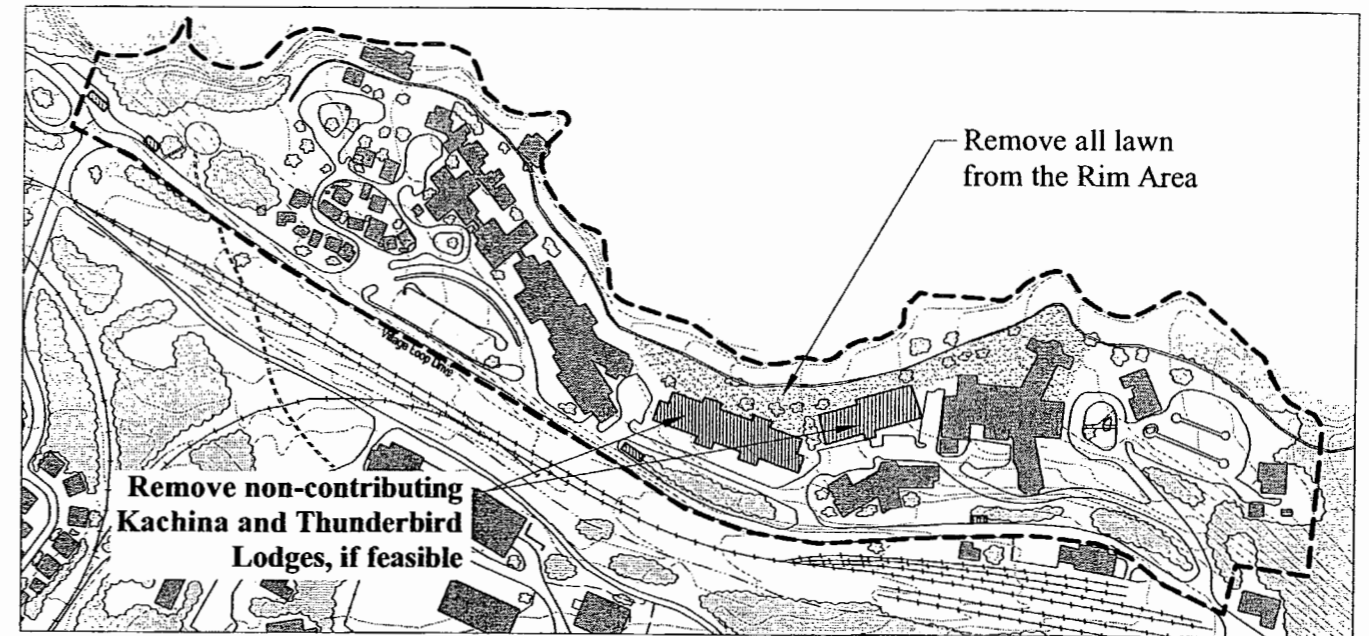
Vegetation, Buildings and Structures

- Evaluate the location, density, and role of non-native plants within the Rim Area landscape. Invasive non-native vegetation should be monitored, controlled, and removed if it threatens to displace or disrupt native vegetation or escape beyond the developed area. Non-native vegetation that is not invasive or detrimental to other natural resources, and is found to have been used or existed during the period of significance may remain, yet should be monitored carefully for possible colonization or invasive properties.

- Utilize plants that are native to the Village Historic District and South Rim region when designing and installing new plantings.
- Implement planting designs that are informal and organic in character. Avoid rigid geometry or highly-stylized designs, such as tree allees, formal gardens or planting beds, and clipped or trimmed foundation plantings.

- Retain all contributing buildings and structures. Avoid removing or relocating these features.
- Repair and maintain features identified in the Chapter III Condition Assessment as being in fair or poor condition.

- Remove Thunderbird Lodge and/or Kachina Lodge, if they are not found to be eligible for the National Register under Criterion G. * Refer to the Specific Project Recommendations for Possible Removal of Kachina and Thunderbird Lodges for further recommendations.

- Limit the construction of new buildings and structures in the Rim Area. If necessary, new features should be located within the existing clusters of development, at the eastern and western edges of the character area. They should be sited, if possible, in the location of missing buildings and structures.

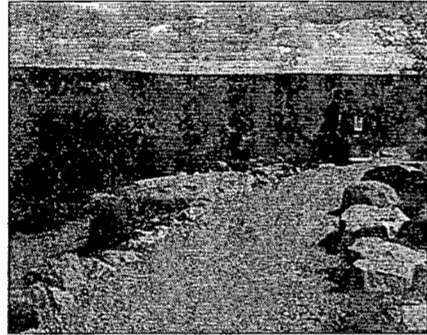
Stone edging and gravel paths

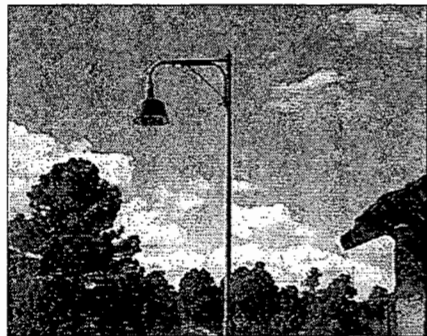
Historic lighting standard

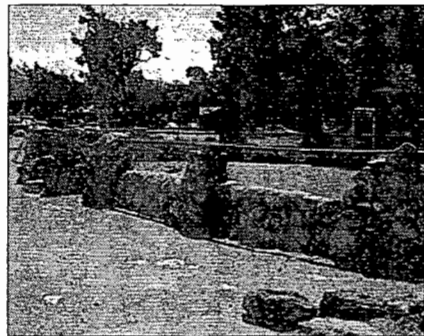
Stacked stone wall

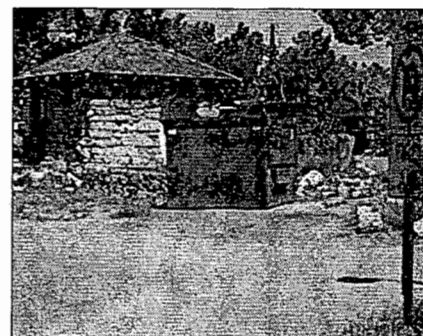
Visible dumpster

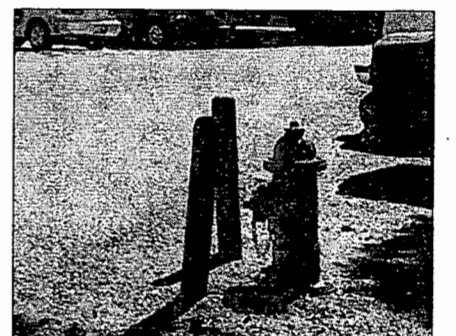
Damaged and inadequate bollards

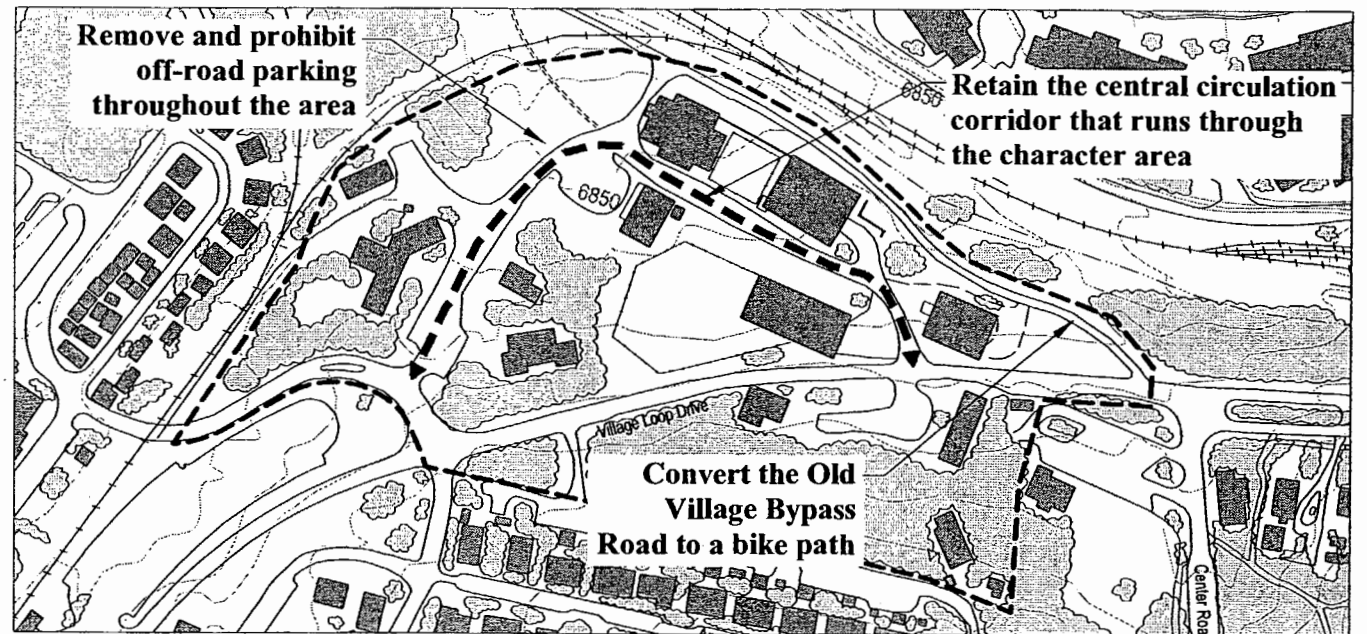
Circulation

- Retain and maintain all contributing road alignments and parking areas.
- Repair and maintain all circulation features assessed in fair or poor condition in the Chapter III Condition Assessments. These features show clear evidence of minor and major disturbances that require corrective action.

- Remove and prohibit off-road parking throughout the character area. This type of opportunistic parking damages pavement edges, compacts soil, damages vegetation, and creates an unkempt and cluttered appearance.

- Convert the Old Village Bypass Road to a bike path, or incorporate into the proposed Greenway, if it is no longer needed for vehicular circulation or will not become part of the light rail transit system, as proposed by the NPS.

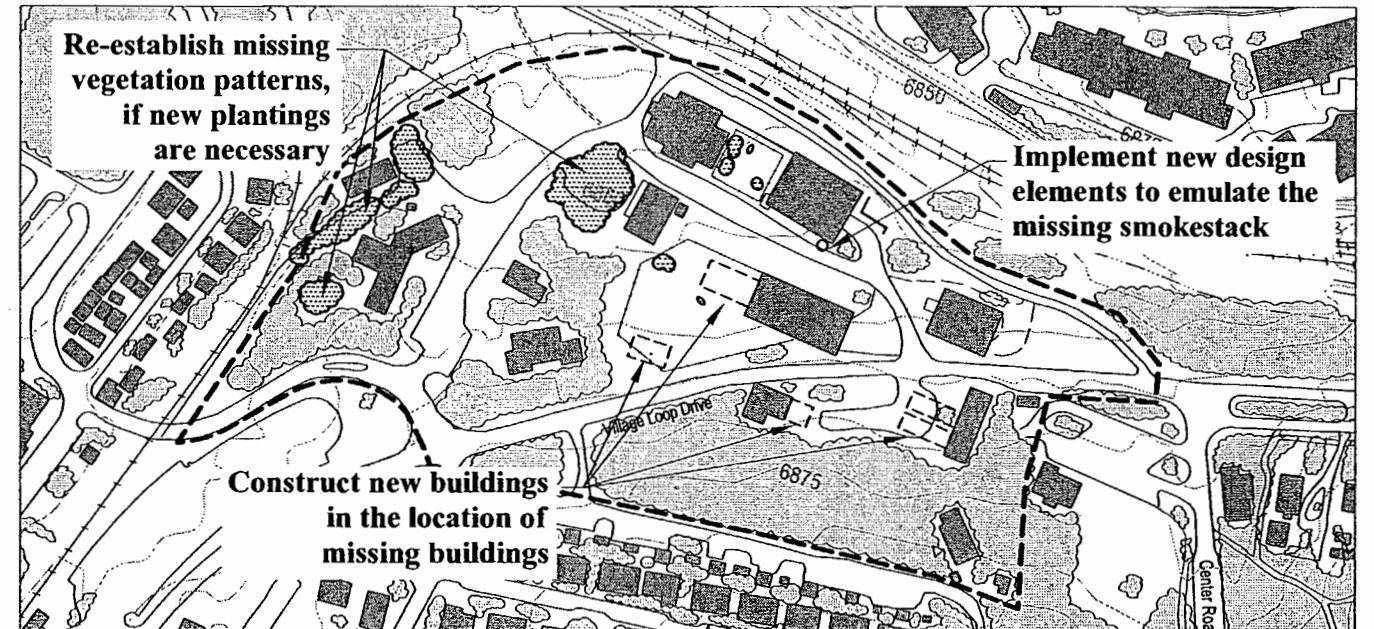
Vegetation, Buildings and Structures

- Retain and maintain, as much as possible, all existing tree cover that is non-invasive and in good condition. Particular attention should be given to retaining and maintaining contributing vegetation.

- Re-establish missing vegetation patterns associated with the period of significance, if new plantings are necessary. Refer to historic aerial photographs in Chapter II for historic vegetation patterns and the graphic at right for representative locations of missing vegetation masses.

- Design new vegetation patterns to reflect historic patterns. During the period of significance, vegetation was randomly planted about the buildings, or left in their original locations as buildings were constructed around them. New plantings should be introduced as individual trees, loose groupings of trees, and masses of trees. Avoid allees of trees, geometric patterns, or other formal planting designs.

- Repair and maintain all buildings and structures assessed in fair poor condition in the Chapter II Condition Assessment. These features show clear evidence of minor and major disturbances that require corrective action.

- Construct necessary new buildings or structures in the locations of missing historic buildings and structures. Archeological investigations may prove useful in determining the location of no-longer-extant buildings or structures.

- Consider implementing new design elements that emulate or interpret the missing Power House smokestack, removed in 1956.

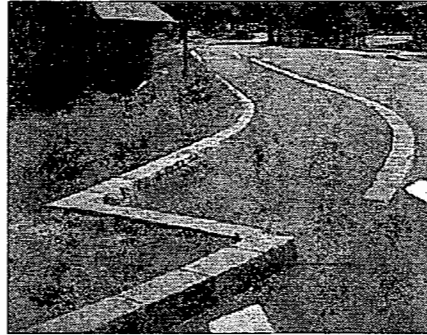
Cut stone curbing

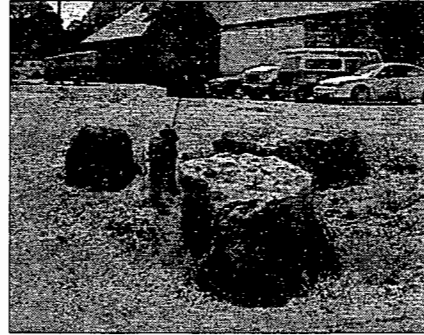
Boulder "bollard" protection

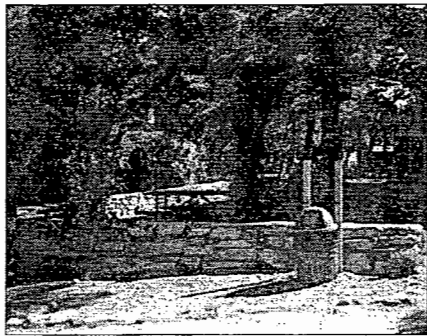
Wood railing details

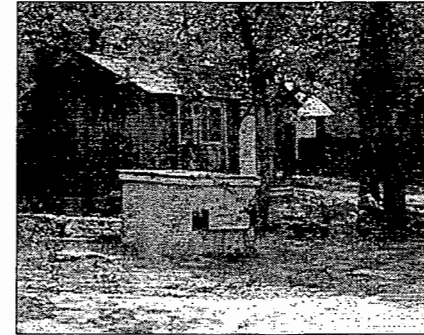
Visible material piles

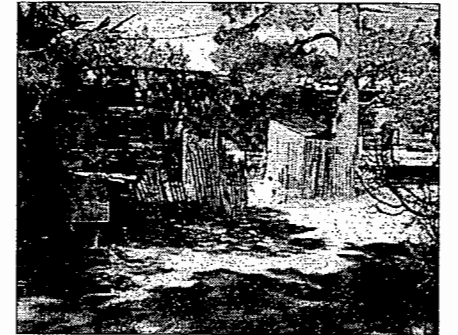
Deteriorating and visible dumpster

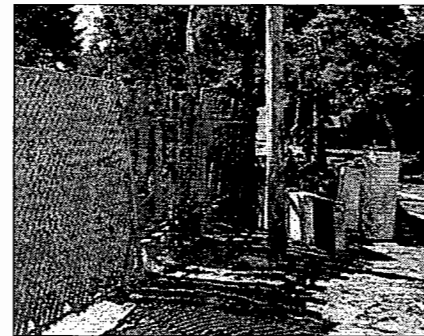
Material piles and damaged fencing

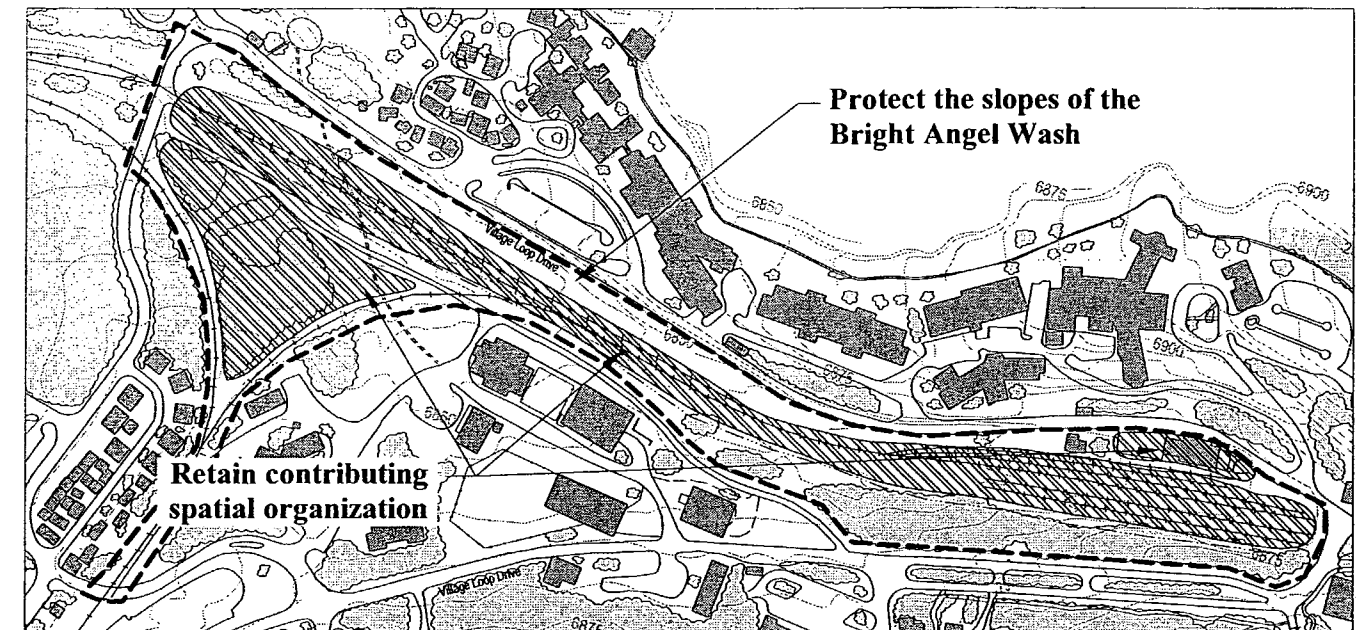
Natural Systems and Features, Spatial Organization

- Retain and maintain all contributing circulation features, particularly the railroad tracks, asphalt parking near the Railroad Depot, the asphalt path along the southern edge of the character area, and the median. Avoid removing the railroad tracks, even if rail service is suspended.
- Remove the gravel parking lot south of the tracks. This parking lot is not historic, detracts from the character of the area, and is likely detrimental to surrounding natural resources.

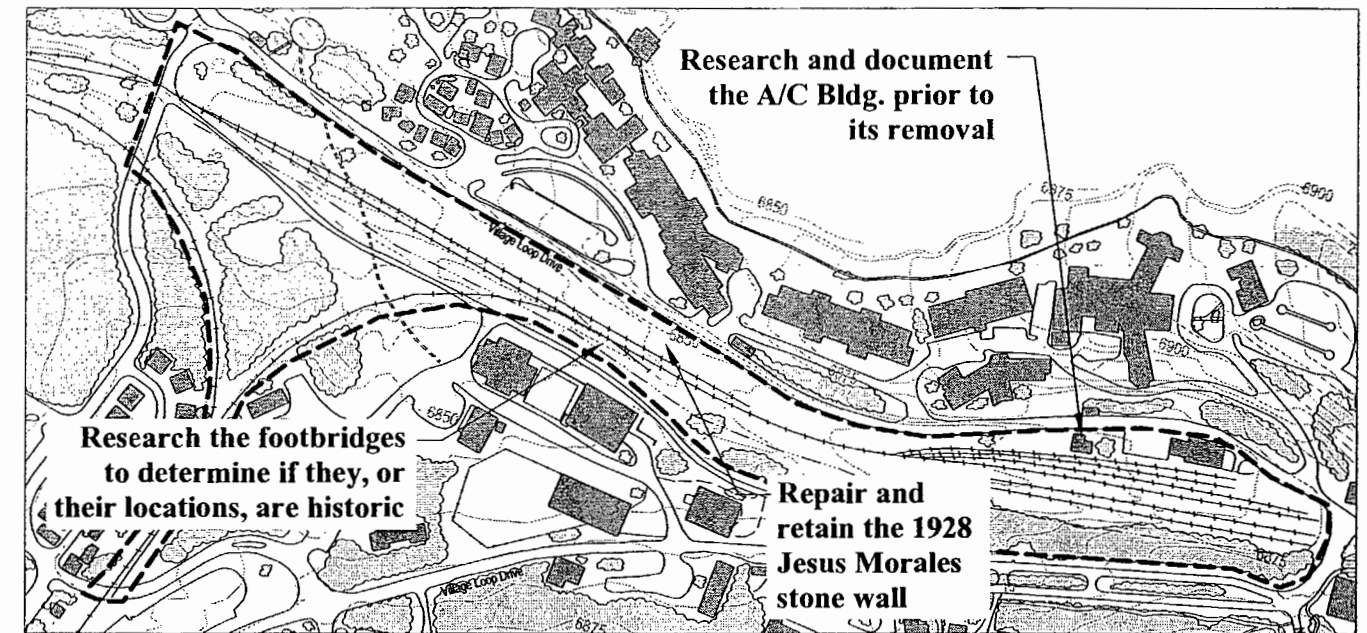
Buildings and Structures

- Retain and maintain all stone headwalls, bridges, steps, and stone-faced culverts. Avoid removing or obscuring these features.
- Research and document the Air Conditioning Building that is slated for removal.

- Research all footbridges to determine if they, or their locations, are historically significant. Remove existing bridges that are non-contributing, pose a safety hazard, or are beyond repair. If any of the bridges are found to be historic, or in an historic location, consider replacing them "in-kind" with structurally sound bridges based on accurate historic documentation. If historic bridges will be replaced, rather than repaired, the new bridge should match the old in design, color, texture, and where possible, materials. If necessary, new bridge materials for an historic bridge design may be of more contemporary and sustainable composition. However, the essential base material should remain the same (i.e. metal components should not be substituted for an historic wood bridge).

- Repair and retain the 1928 stone wall constructed by stonemason Jesus Morales.
- Avoid constructing new buildings and structures within the Bright Angel Wash, and the character area in general. If construction of new features is necessary, locate them near the Railroad Depot. Any new buildings or structures should be of minimal size and, if possible, located on the former sites of missing buildings.

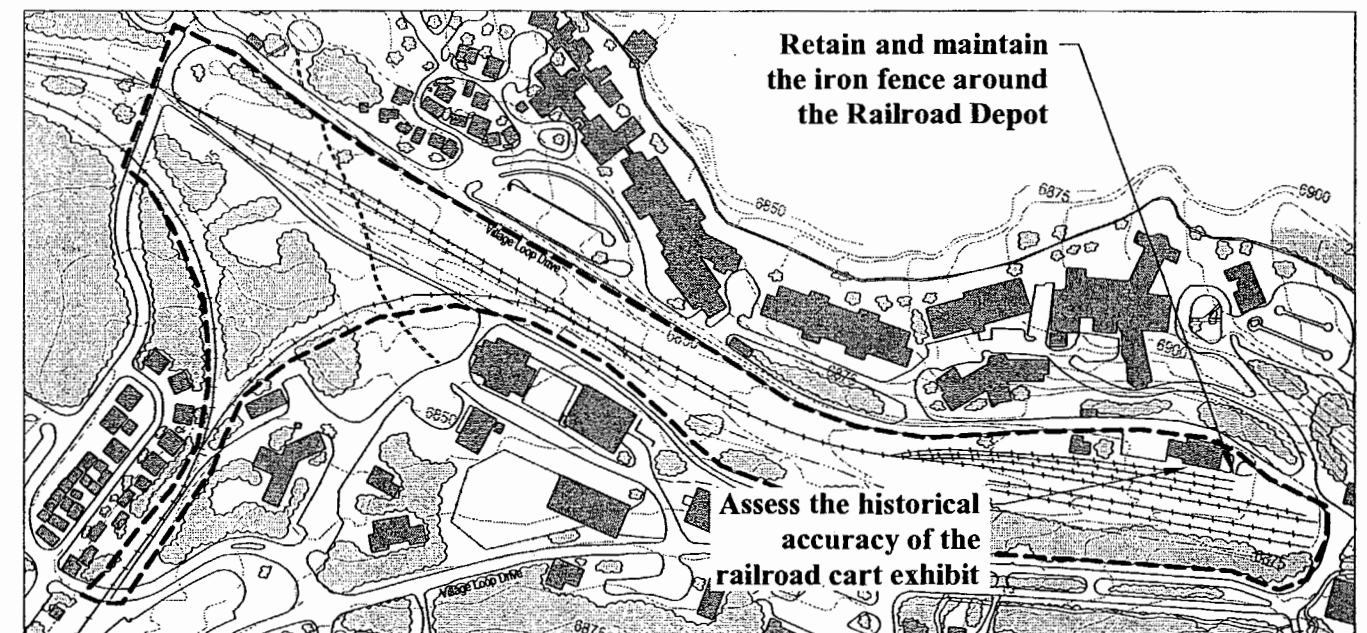
Small-scale Features

- Retain and maintain the iron fence surrounding the Depot.
- Repair and maintain all small-scale features assessed in fair or poor condition in the Chapter II Condition Assessments. These features show clear evidence of minor or major disturbances that require corrective action.
- Assess the accuracy of the railroad cart exhibit. If this cart, or the style of cart, was never used in the park, consider removing the exhibit to avoid conveying a false sense of history.

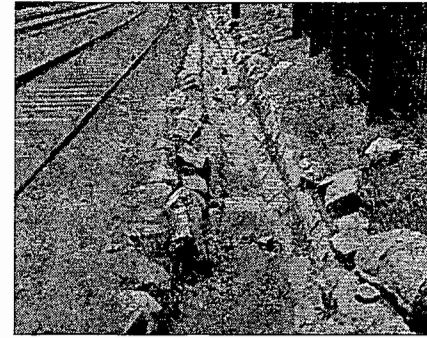
Stone wall and steps

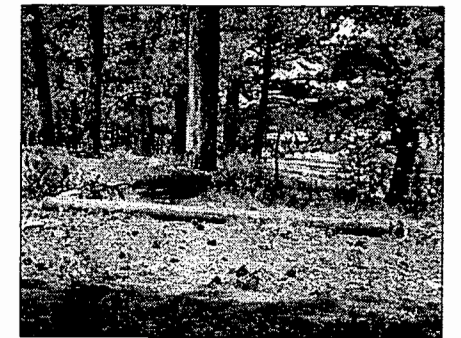
Excessive signage in historic median

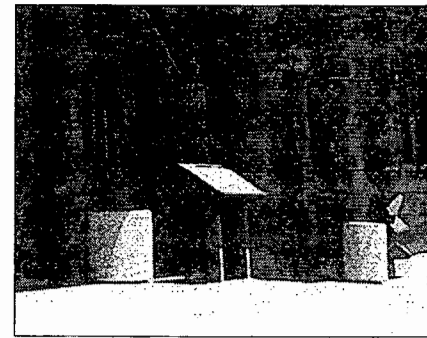
Visible construction remnants

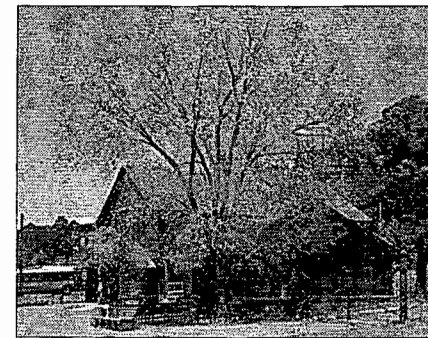
Non-native maple tree

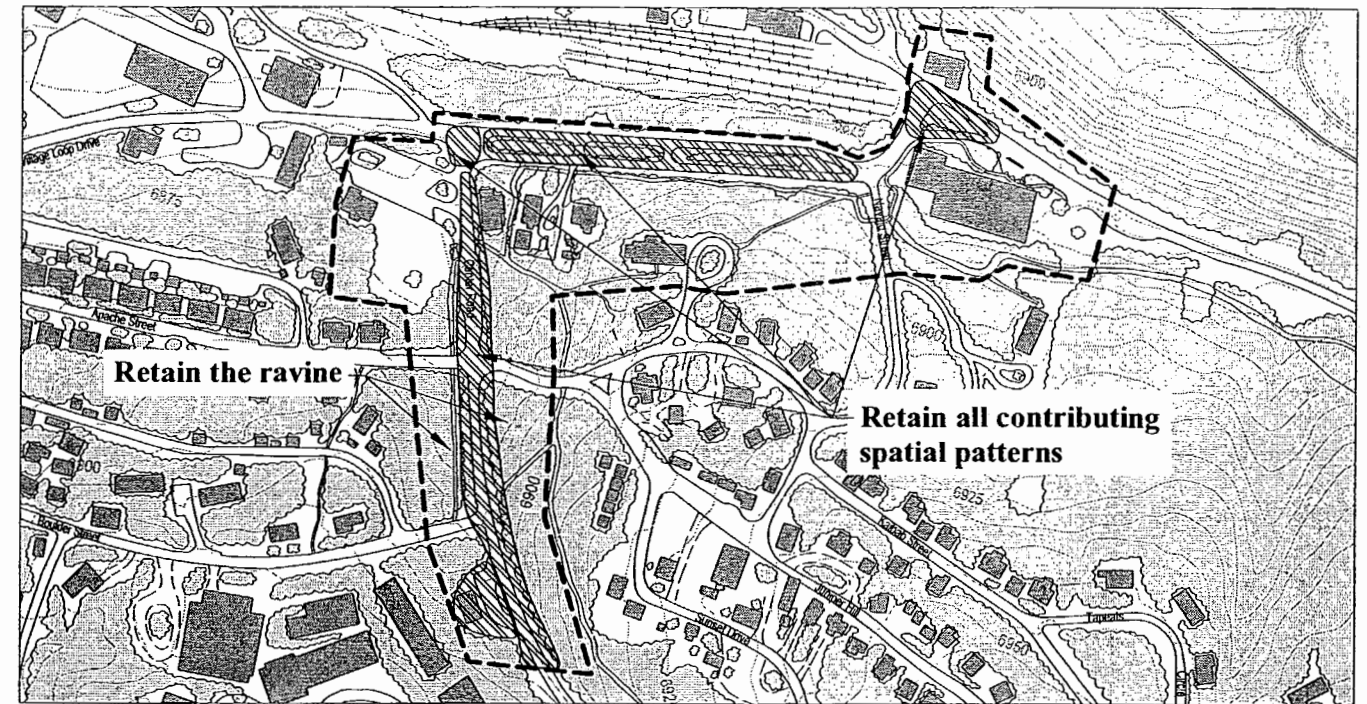
Natural Systems and Features, Spatial Organization

- Repair and maintain all parking lots, roads, drives, paths, and sidewalks to remain. Particular attention should be paid to the features assessed in fair or poor condition as described in the Chapter III Condition Assessments.

- Evaluate the underlying reasons for the presence of earthen desire paths, such as the path between the Grand Canyon Association Building and Navajo Street. Consider formalizing or paving these paths, if they are found to be well-used, to decrease erosion and prevent further damage to surrounding vegetation. Future development of pedestrian circulation should take into consideration current circulation patterns and weigh efficiency with the need to protect natural and cultural resources.

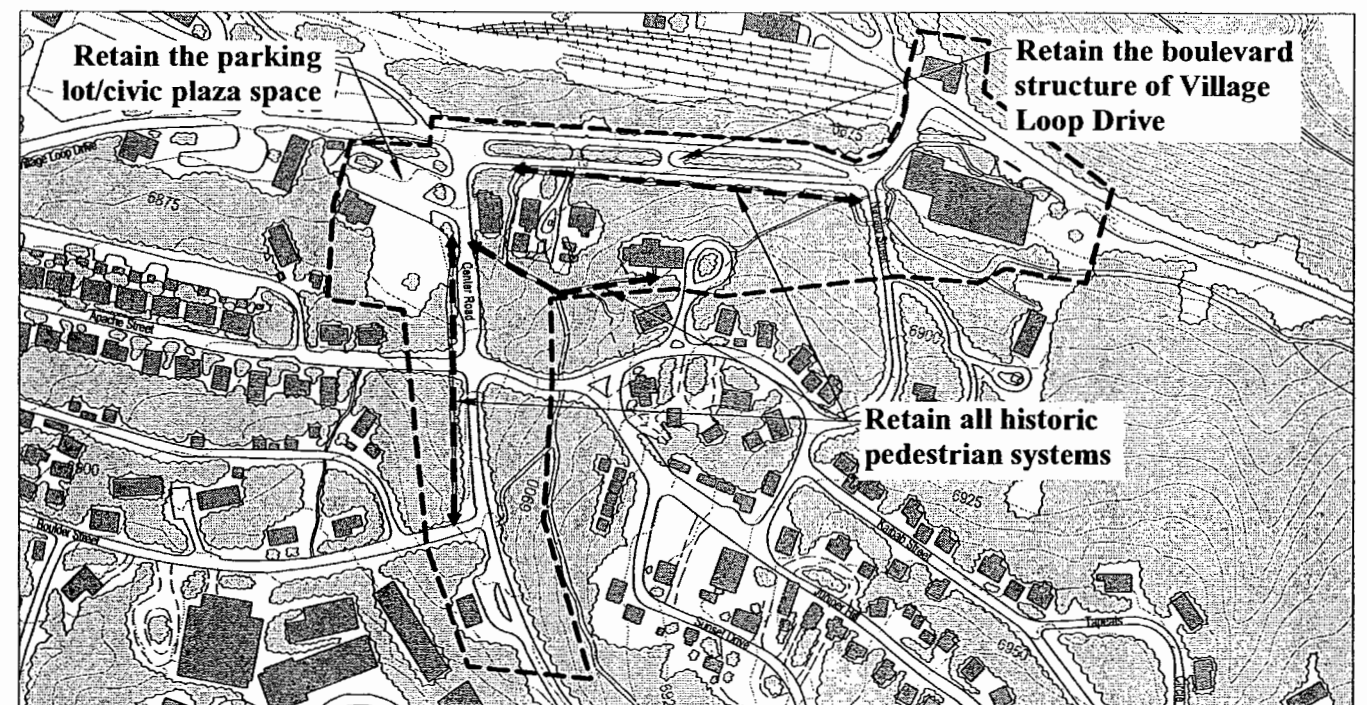
Circulation

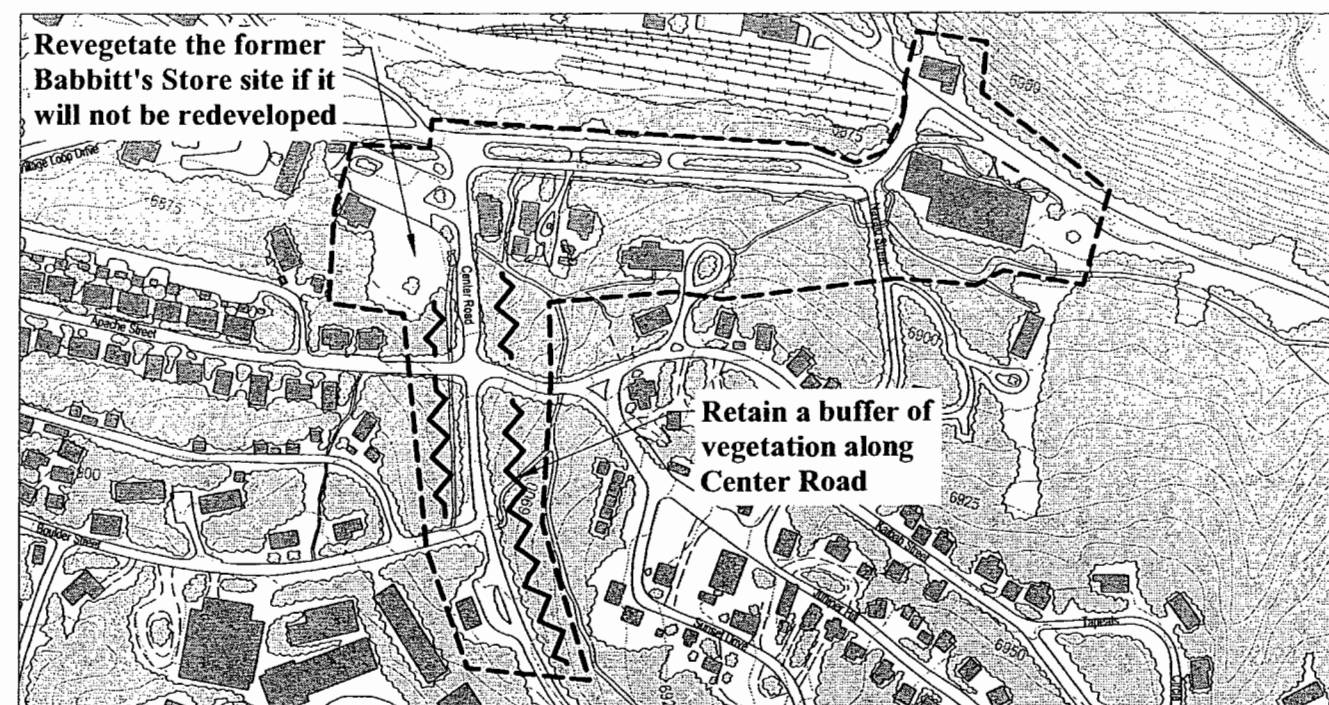
Vegetation

- Retain as much existing vegetation as possible in this character area. Historic photographs indicate this area was wooded throughout the period of significance. Remove dead and diseased vegetation, as identified in the Chapter III Condition Assessments. Assess the causes of these problems and discontinue or prohibit activities that contribute to the loss of vegetation.
- Thin vegetation along road edges, if necessary for fire prevention and suppression purposes. Maintain a buffer of vegetation along Center Road, however, in order to retain the forested character and prevent views into developed areas.
- Revegetate the former Babbitt's Store site if no new development is planned in this location.

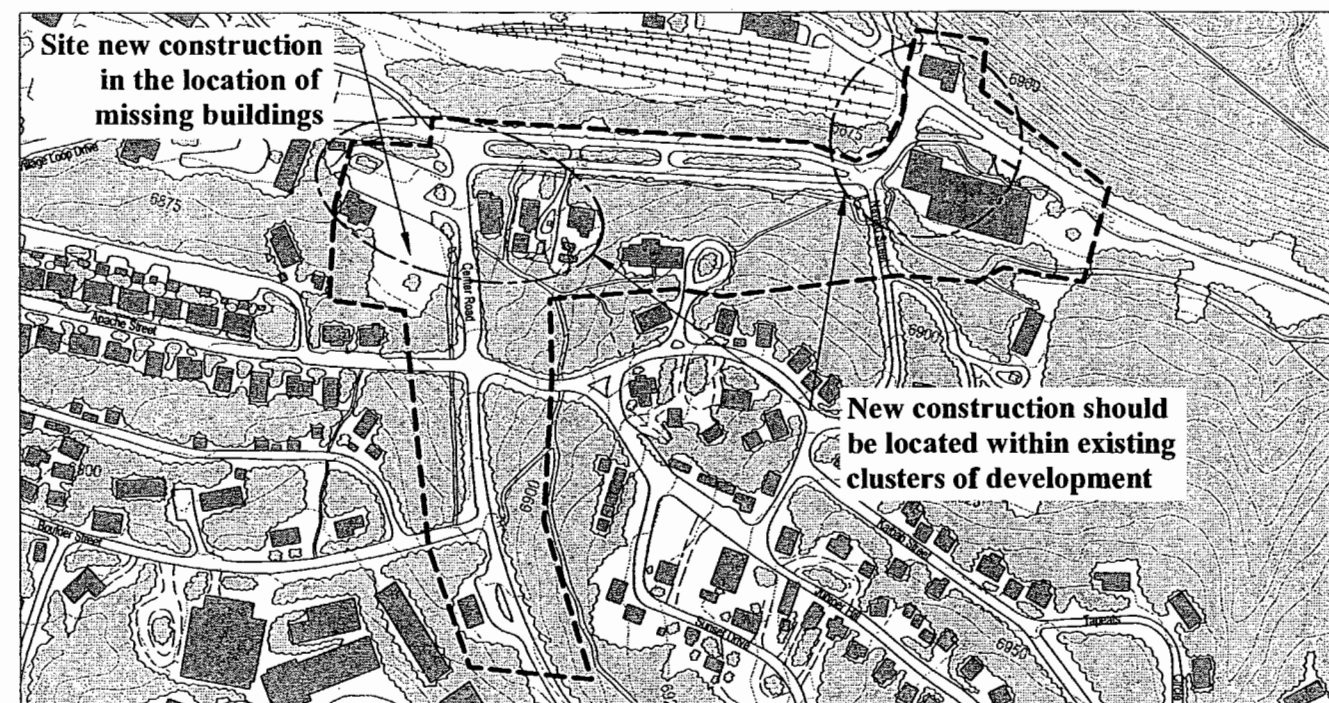
Buildings and Structures

- Retain all contributing buildings and structures.
- Limit new construction within the character area. New construction, if necessary, should be sited in the locations of missing buildings, such as Babbitt's Store. New construction may also be located within existing clusters of buildings, located around the Village Loop Drive and Center Road intersection and the Village Loop Drive and South Entrance Road intersection.

- Construct new retaining walls, planters, and structures to reflect the historic characters of the area - typically wood and stone materials, hand-built craftsmanship, and of generally NPS Rustic and Rustic Revival design. New features may be contemporary in design, or a contemporary interpretation of an historic feature, yet also must be compatible with the historic character. Compatible new features will incorporate primarily wood and stone elements. Avoid using concrete masonry units or constructing concrete walls, unless the resultant structures will be well-screened from view and no other building material may feasibly be used.

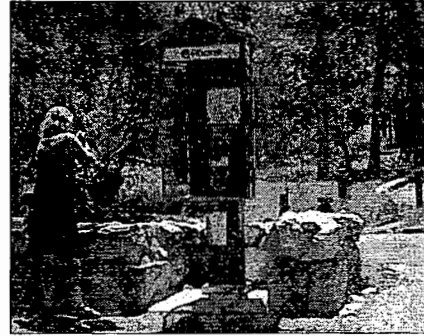
Telephone kiosk and stone wall
