**Grand Canyon Village
National Historic Landmark District
Cultural Landscape Report**

**Grand Canyon National Park
Arizona**

January 2004

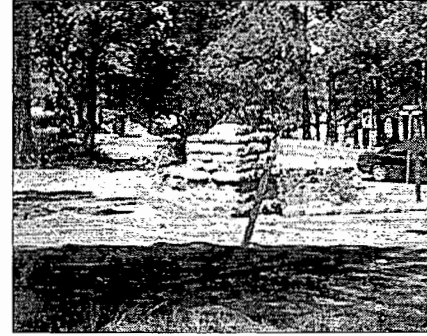
Stone pier

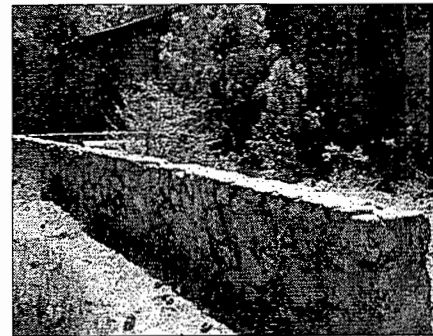
Stone wall

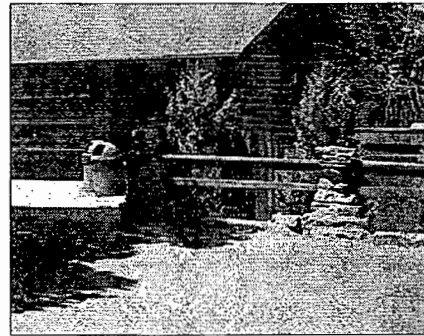
Stone and wood fence

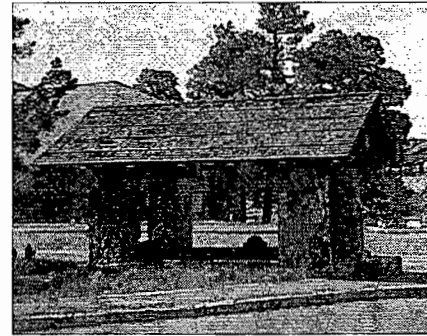
Rustic-styled bus shelter

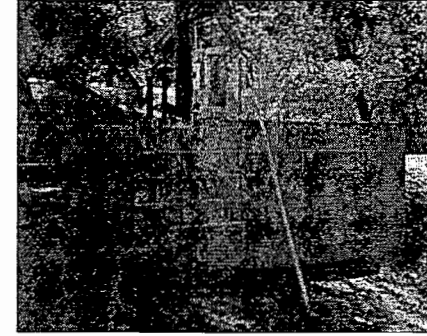
Concrete masonry unit wall

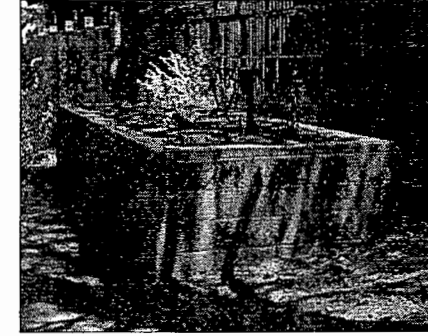
Concrete masonry unit wall

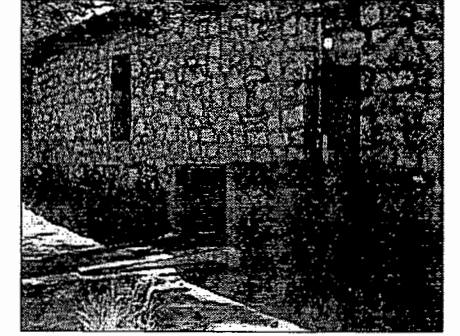
Concrete masonry unit wall

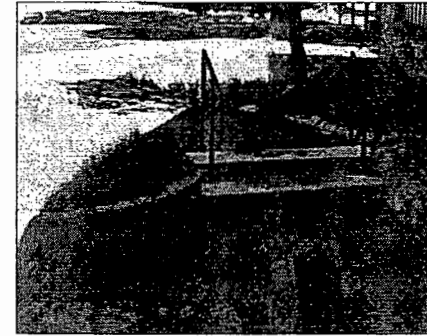
Concrete retaining wall

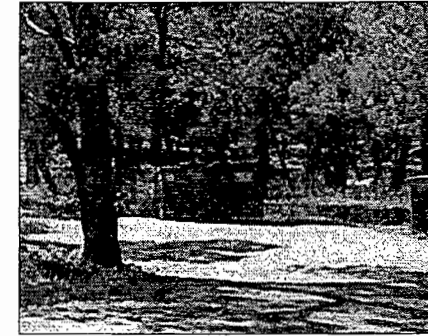
Visible dumpster

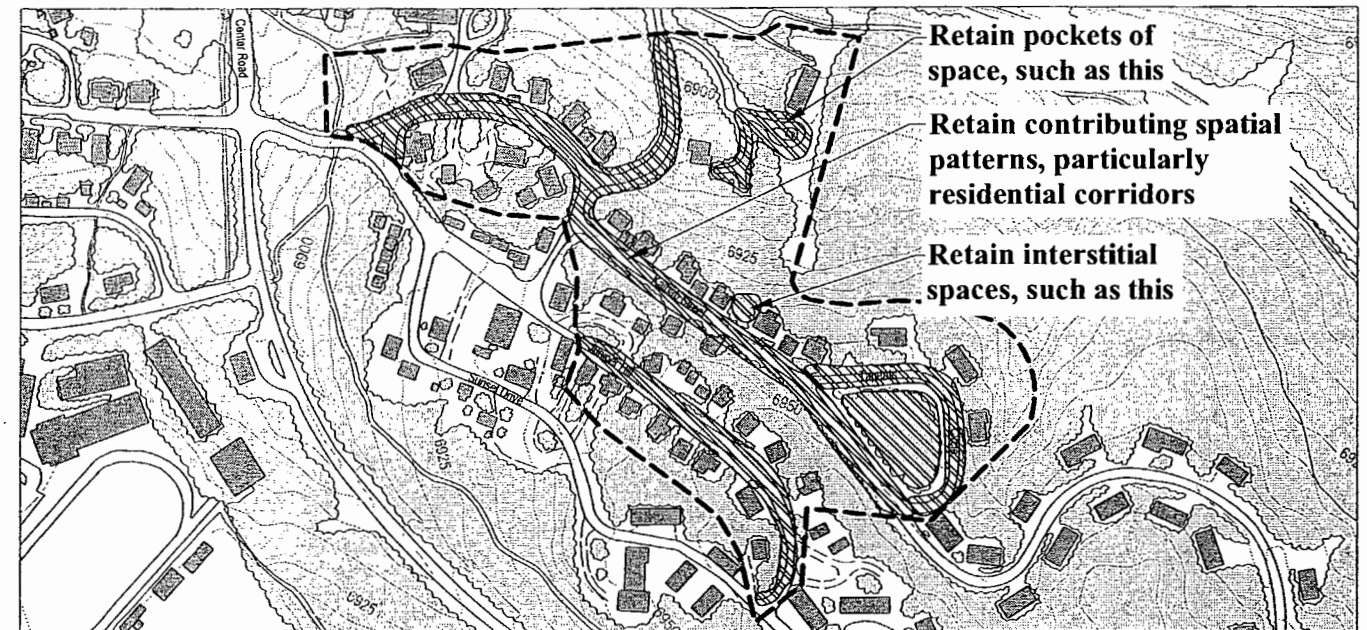
Spatial Organization

- Retain as much of the existing vegetation as possible in this character area. Historic photographs suggest that dense tree cover characterized this during the period of significance.
- Retain ornamental vegetation around the residences and within the character area that is non-invasive and does not present a threat to historic and/or native vegetation. Future research should be undertaken to determine which ornamental plantings reflect the period of significance. Consider replacing plantings found to be non-contributing with more appropriate plantings.
- Remove vegetation that is dead or exhibits signs of disease that cannot be easily treated. Replace removed vegetation in-kind with plants of similar habit and character.

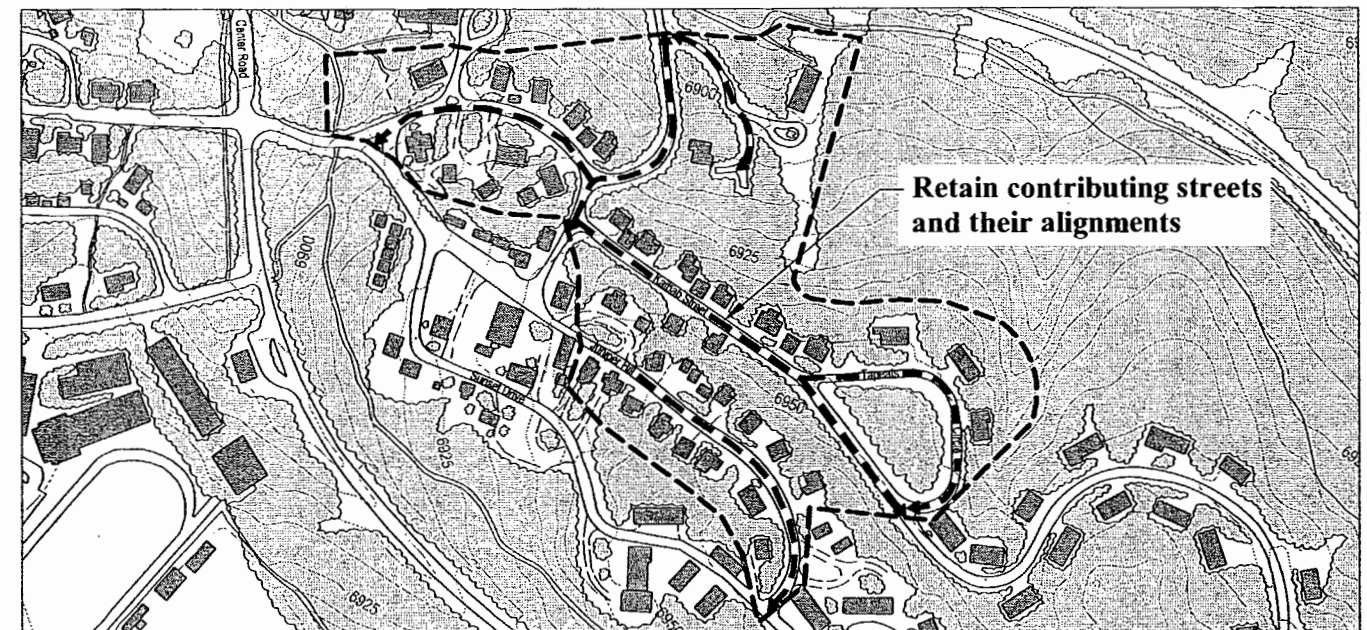
Circulation

- Retain all contributing streets. Avoid altering their alignment or width.
- Retain gravel driveways and parking areas around residences. Historic photographs suggest that gravel driveways and parking were typical of the period of significance. Consider, however, lining these features with stones or boulders to clearly define their edges and prevent damage to cultural and natural resources.
- Re-establish the historic pedestrian systems associated with the residential streetscape, if the need exists. Use historic materials, such as crushed limestone tread and stone edging, whenever feasible. Attempt to follow the historic path alignments, whenever possible.
- Repair and maintain all circulation systems assessed in fair or poor condition in the Chapter III Condition Assessments. These features show clear evidence of minor or major disturbances that require corrective action.

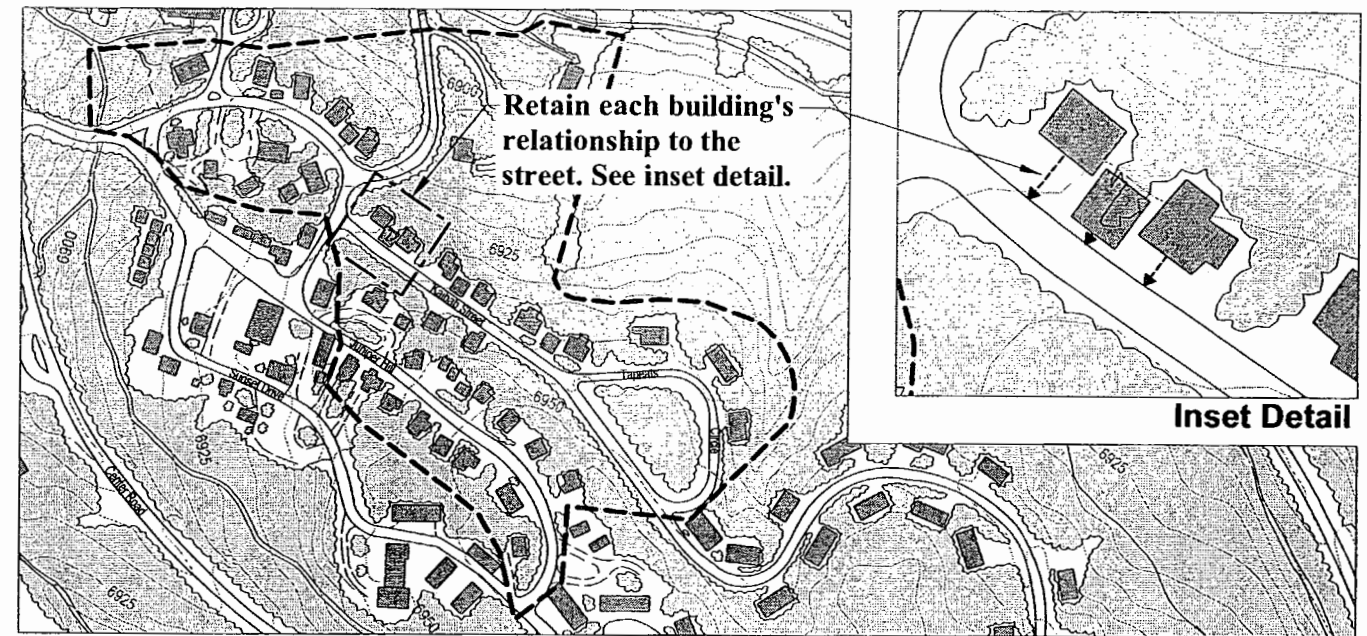
Buildings and Structures

- Retain all contributing buildings and structures, including residences, garages, and sheds. Avoid demolishing or removing these features.
- Retain each building's relationship to the street, which helps to define the character and spatial organization of the area. Avoid moving contributing buildings farther away or closer to the street edge.
- Avoid altering the exterior appearances of buildings in such a way as to detract from the historic character of the area. Aluminum siding, replacement windows, and asphalt shingle types are examples of unsuitable materials. Follow the *Secretary of the Interior's Standards for the Treatment of Historic Properties* when undertaking any alterations to buildings.
- Retain and repair all contributing stone walls within the character area.

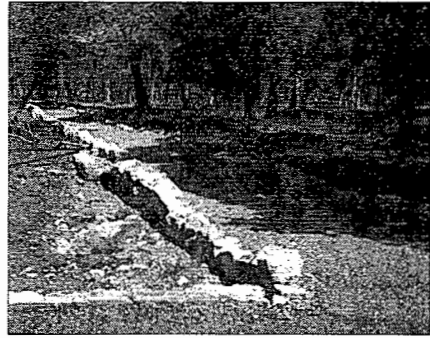
Stone edging and gravel paths

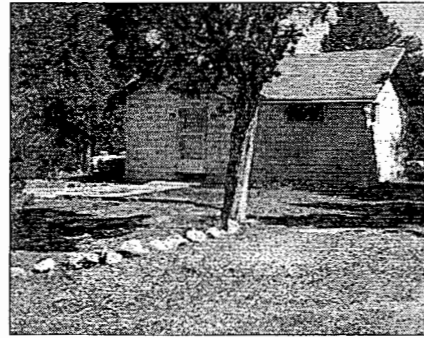
Stone-edged gravel drives

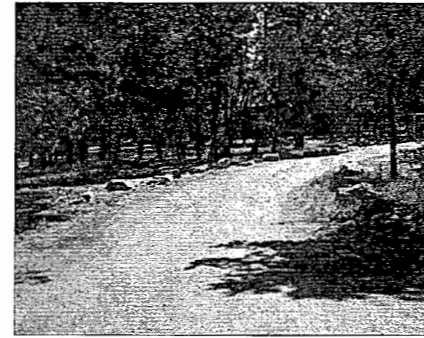
Boulder edging

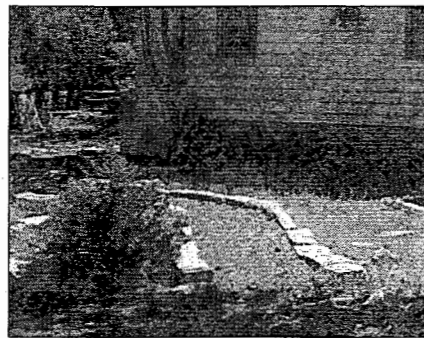
Cut stone edging

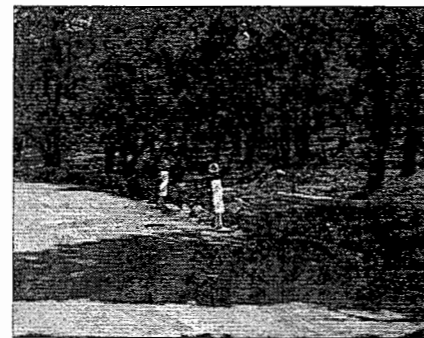
Stone retaining wall

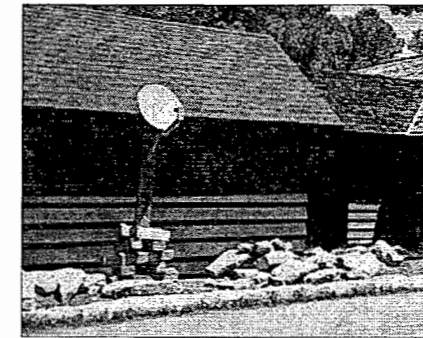
Makeshift satellite dish stand

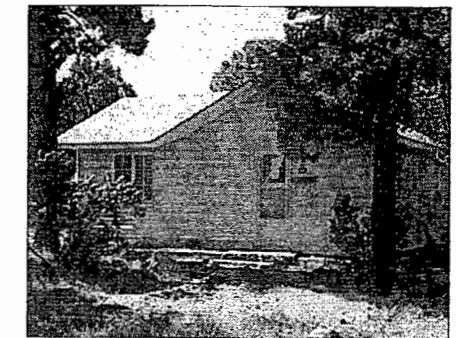
Aluminum siding

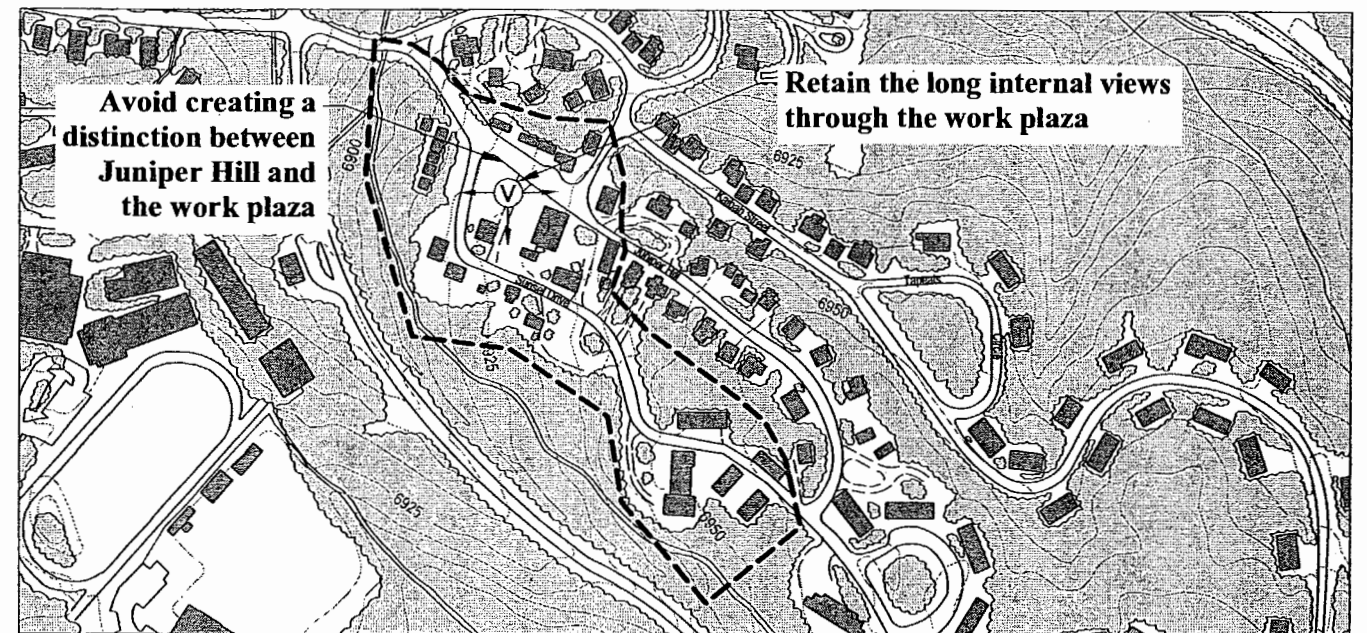
Circulation, Views and Vistas

- Avoid introducing formal pedestrian paths, such as stone-edged asphalt paths or concrete sidewalks, into the character area. No obvious pedestrian circulation, of any type, was historically located in this area.

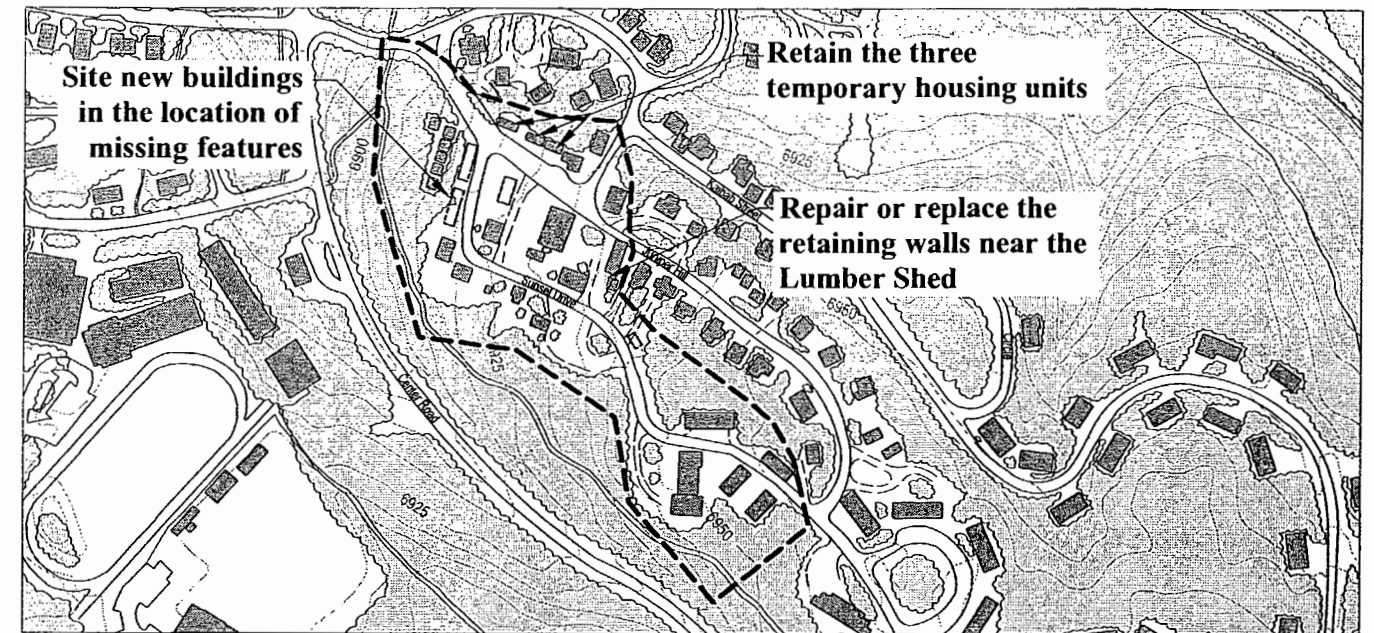
Buildings and Structures

- Repair or replace the retaining walls near the Lumber Shed. Determine whether the masonry wall is historic *prior* to undertaking any action; the contributing or non-contributing status of the wall will determine the approach to its treatment. If it is determined that the walls should be replaced, use materials found in the original wall.

- Locate new buildings and structures on the site of missing features, whenever possible. New features should reflect the informal, utilitarian character of the area and draw design concepts from existing, historic buildings and structures. Refer to the graphic at right for representative locations of missing buildings and also to Figure 36 in Chapter II for building locations in 1941.

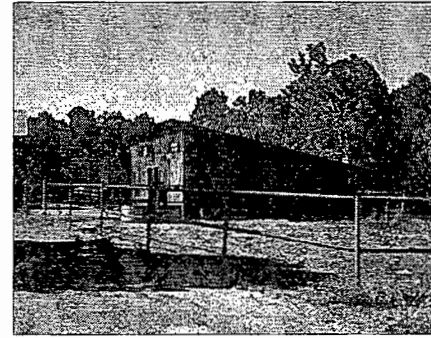
Metal corral fencing

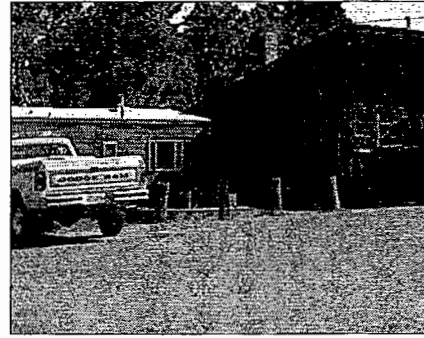
Wooden bollards

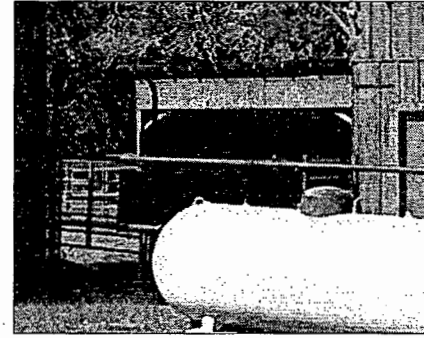
Wood shelter with rafter ends

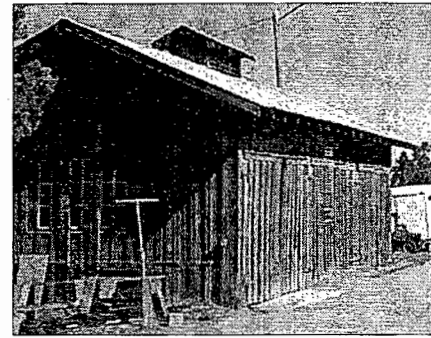
Typical wood building with metal roof

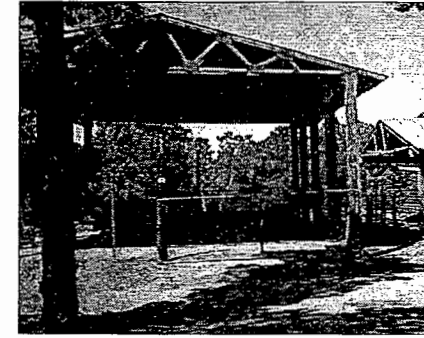
Chain-link fence around corral

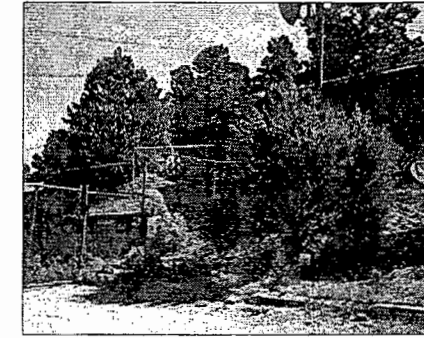
Chain-link fence and satellite dishes

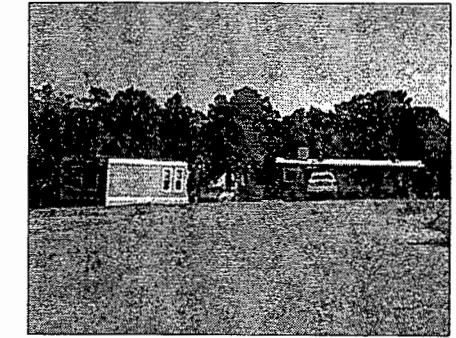
Temporary housing units

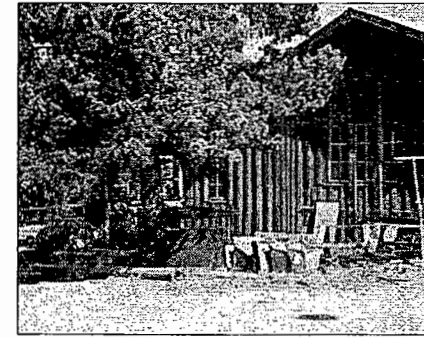
Materials stored outdoors

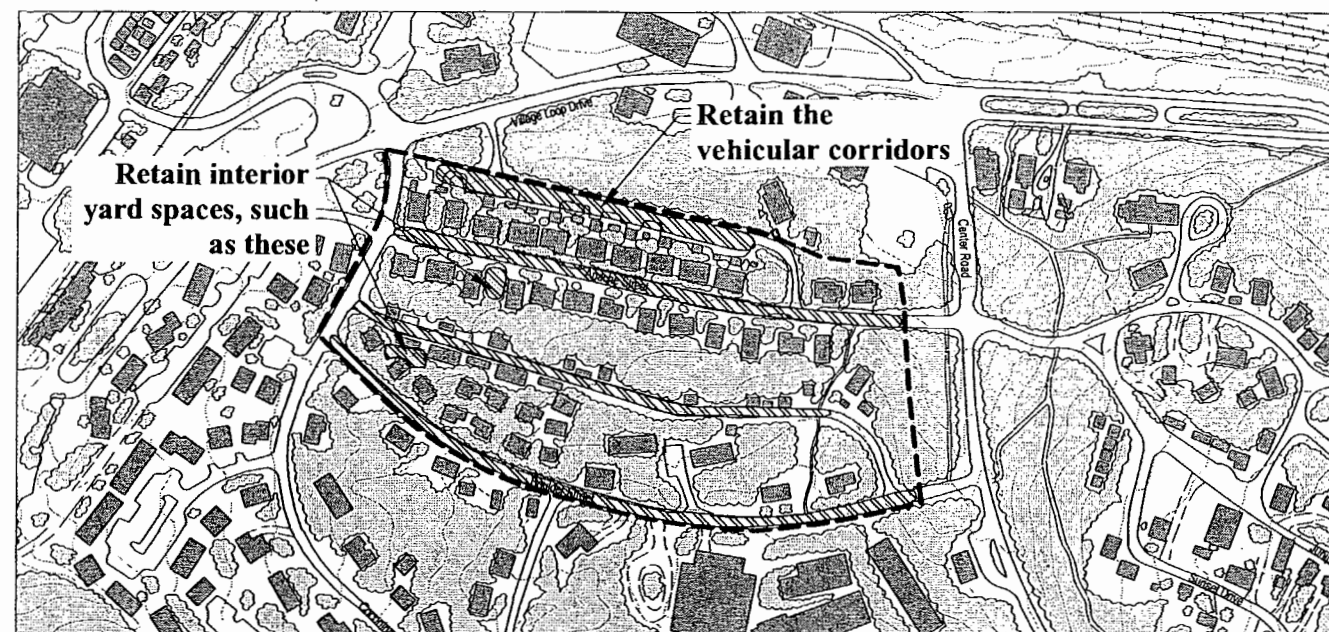
Spatial Organization, Views/Vistas

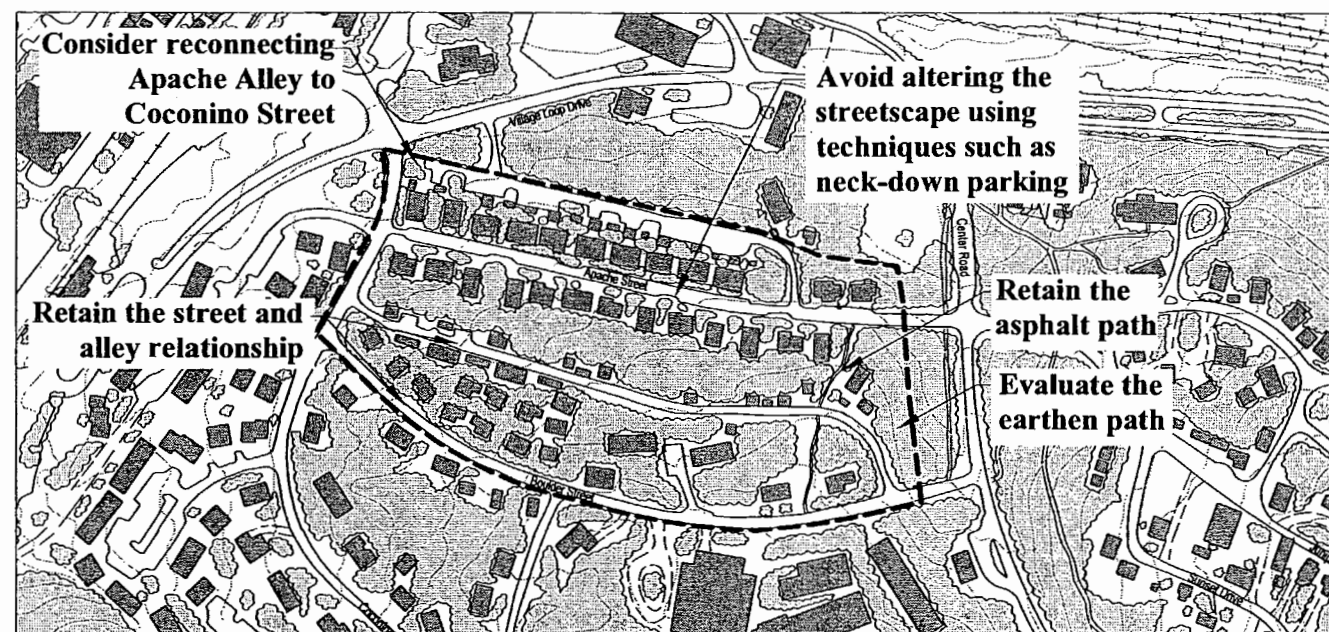
- Repair and maintain all circulation features assessed in fair or poor condition in the Chapter III Condition Assessments. These features show clear evidence of minor or major disturbances that require corrective action.

- Assess the necessity for, and the historic status of, the earthen path located in the eastern portion of the character area. Remove and revegetate the path if it is not historic and not well-traveled. However, if the path is found to be an important route for staff and employees, consider edging and/or paving the path to prevent damage to surrounding natural and cultural resources.

Circulation

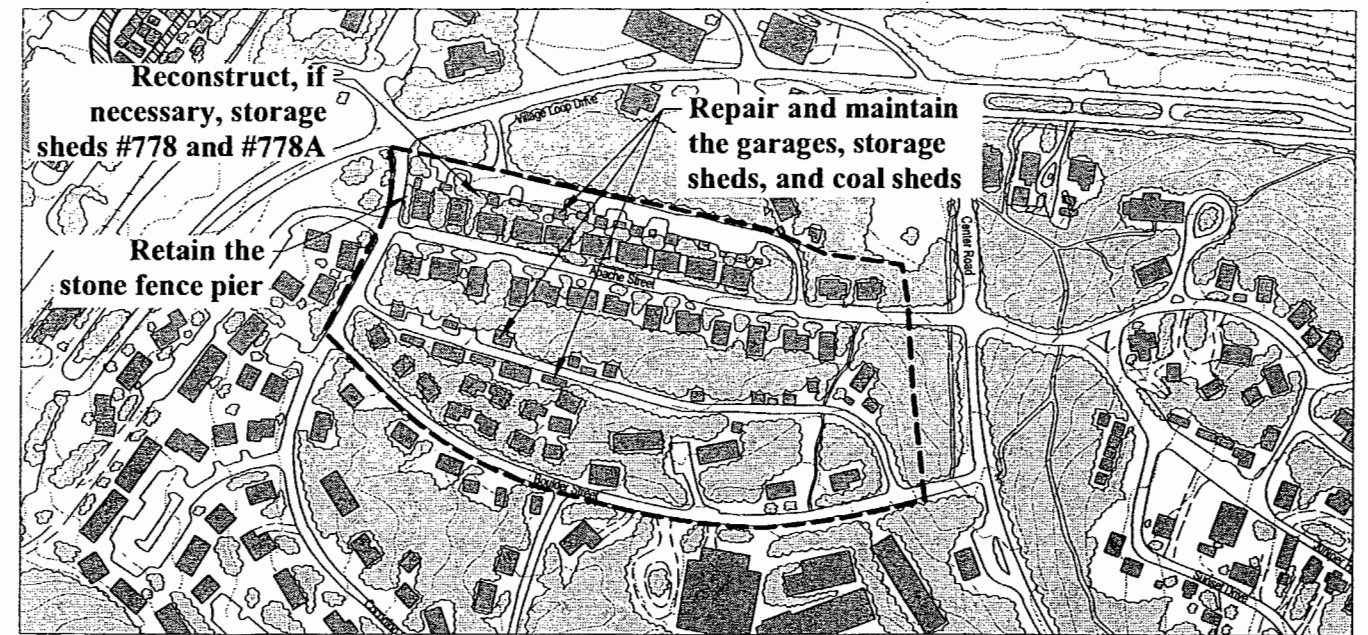
- Repair and maintain all deteriorating and damaged buildings and structures within the character area, particularly the garages, storage sheds, and coal sheds.

- Avoid removing or relocating any contributing building or structure.
- Site new construction as infill along the street corridors, in the location of missing buildings or structures, or in the southeast corner of the site. The setbacks, building style, and massing of new features should reflect the historic character of the area.

- Reconstruct, if necessary, the storage shed (Bldg. #778) and garage (Bldg. #778A), which currently exist as stone foundations. Undertake a reconstruction only if the need for storage arises and enough documentation is available to accurately reconstruct these features. If the structures will not be reconstructed, alternatives for their sites include maintaining the foundations, removing the foundations, or locating other structures in their place.

Buildings and Structures

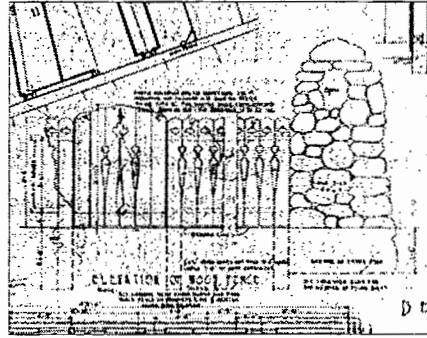
Historic wood fence and stone pier

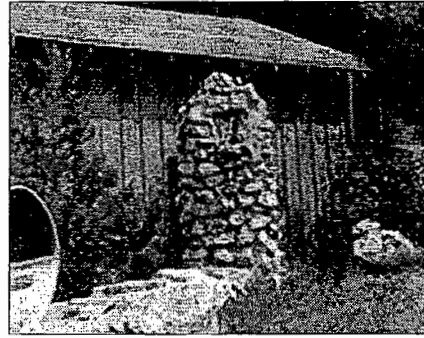
Remnant stone pier

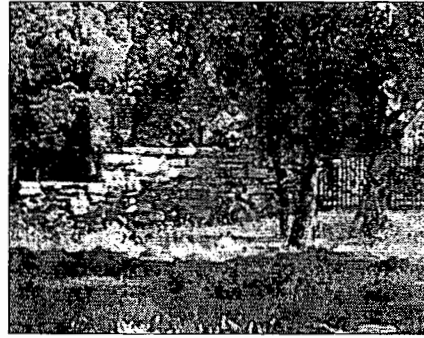
Stone wall

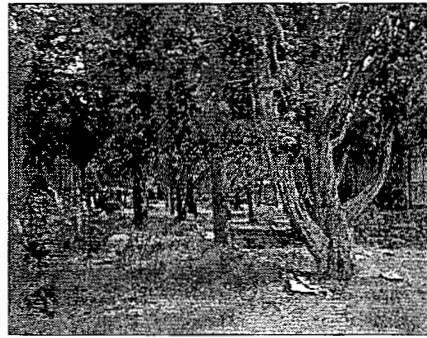
Vegetation between buildings

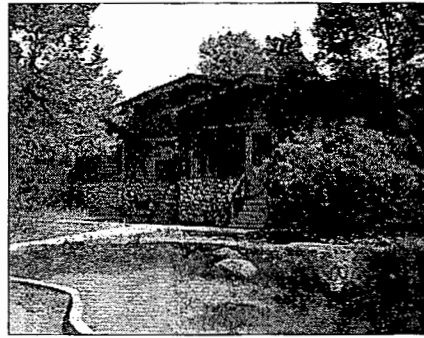
Vegetation at building corners

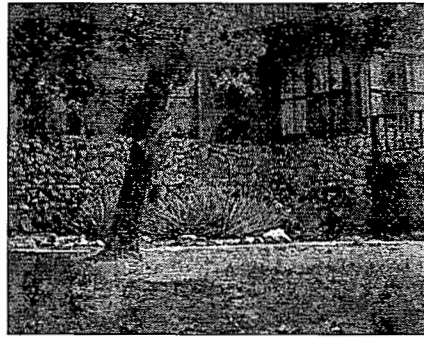
Native vegetation around building

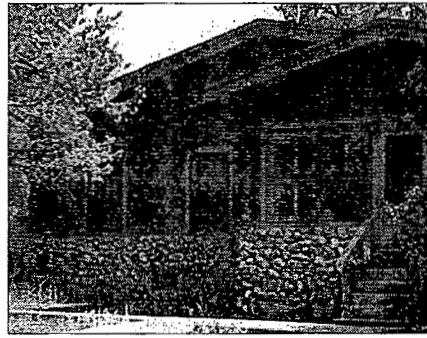
Architectural details

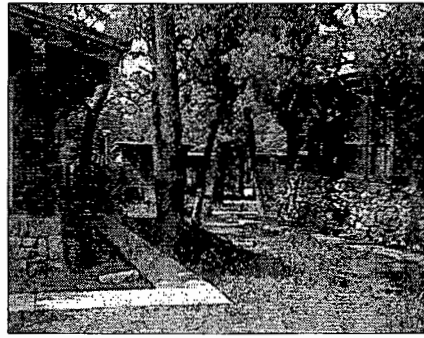
Concrete sidewalks

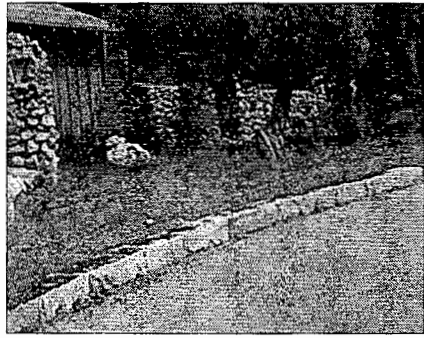
Stone curbing

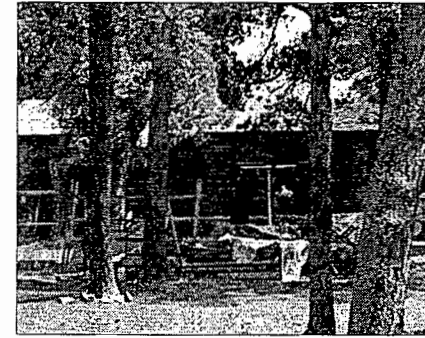
Material stored outdoors

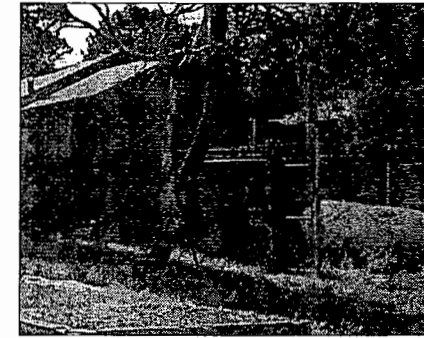
Chain-link fence

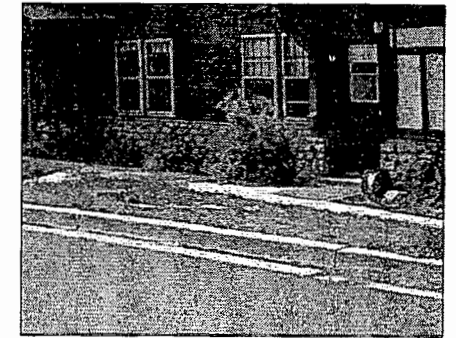
Concrete curbing

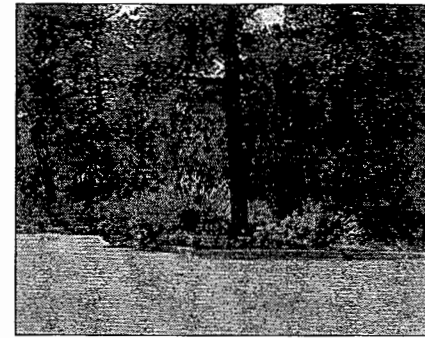
Neck-down parking

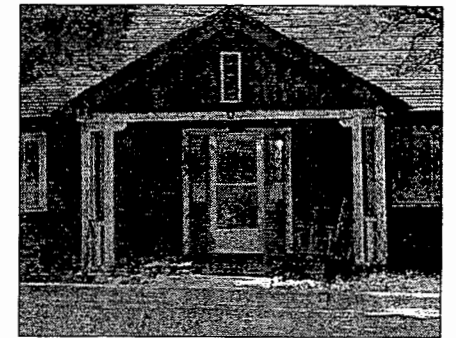
Incompatible replacement door

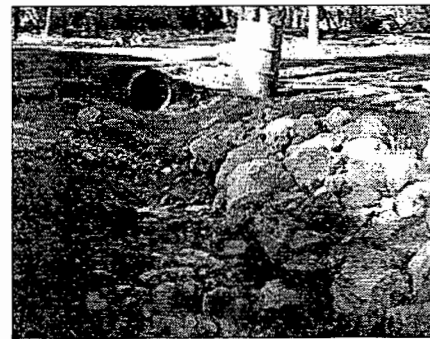
Stone riprap protection

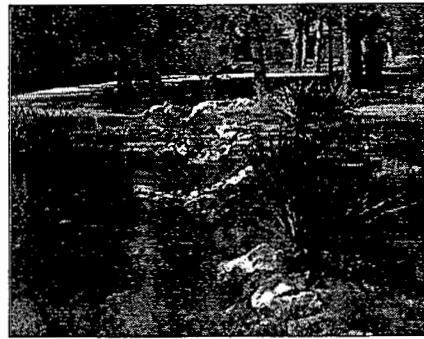
Stone/gravel swale and ornamental yucca plantings

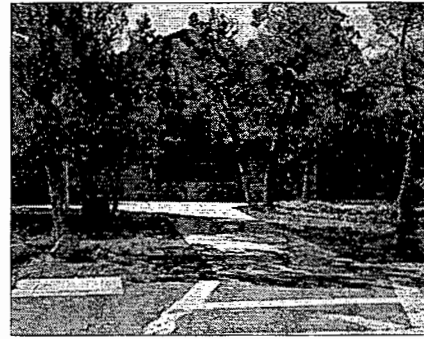
Wide walk to school entrance and ornamental tree plantings

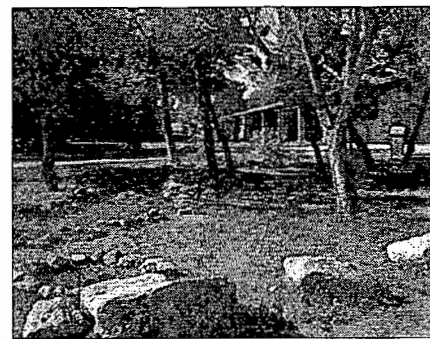
Stone and boulder edging

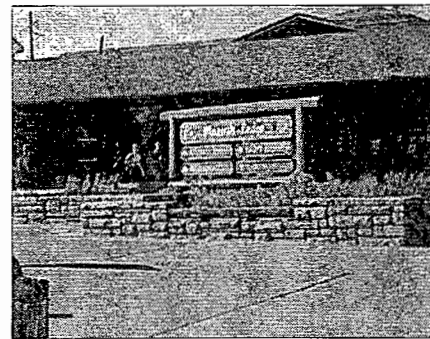
Cut stone retaining wall

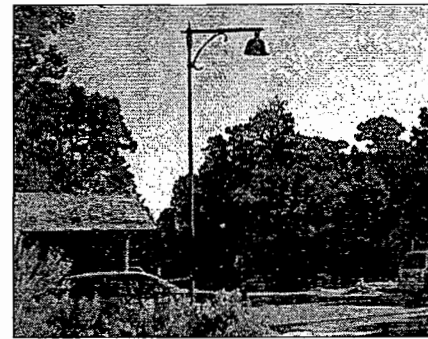
Light standard

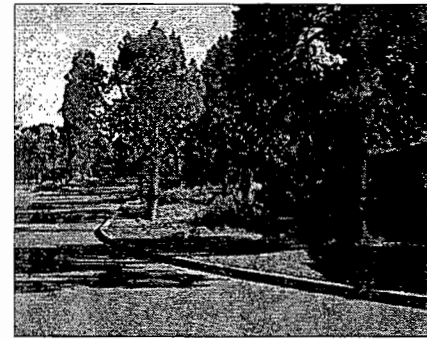
Vegetative buffer to left of cabins

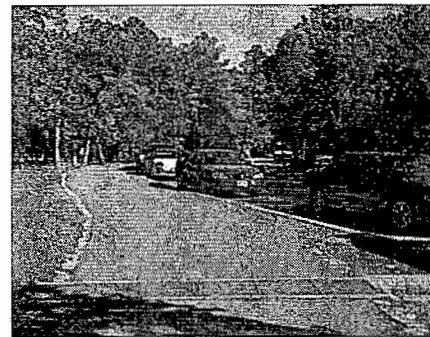
Stone edged sidewalk

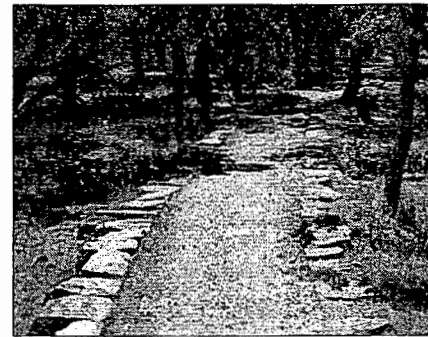
Stone edged path

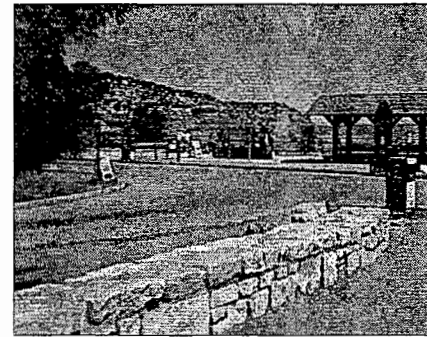
Stone wall

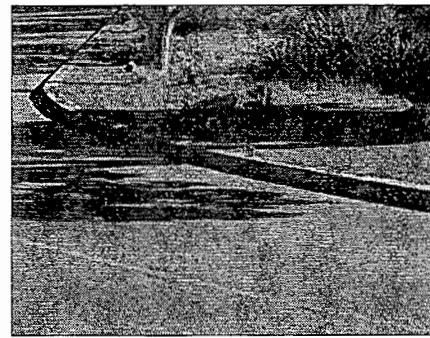
Cut stone curbing

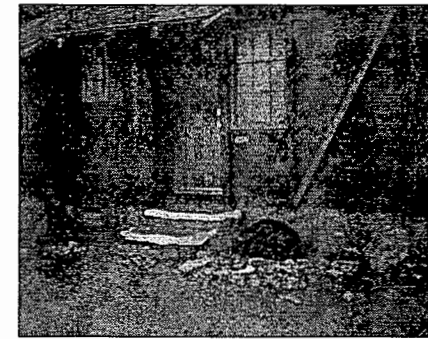
Refuse in front of cabin

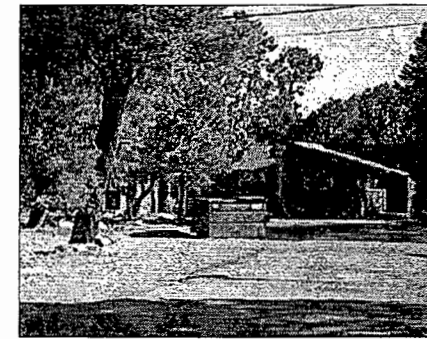
Visible dumpster

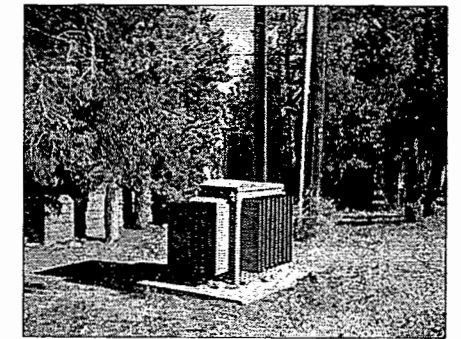
Exposed utility boxes
