# Grant-Kohrs Ranch National Historic Site

## CULTURAL LANDSCAPE REPORT

*Landscape History, Existing Conditions,  
and Analysis and Evaluation*

July 2004

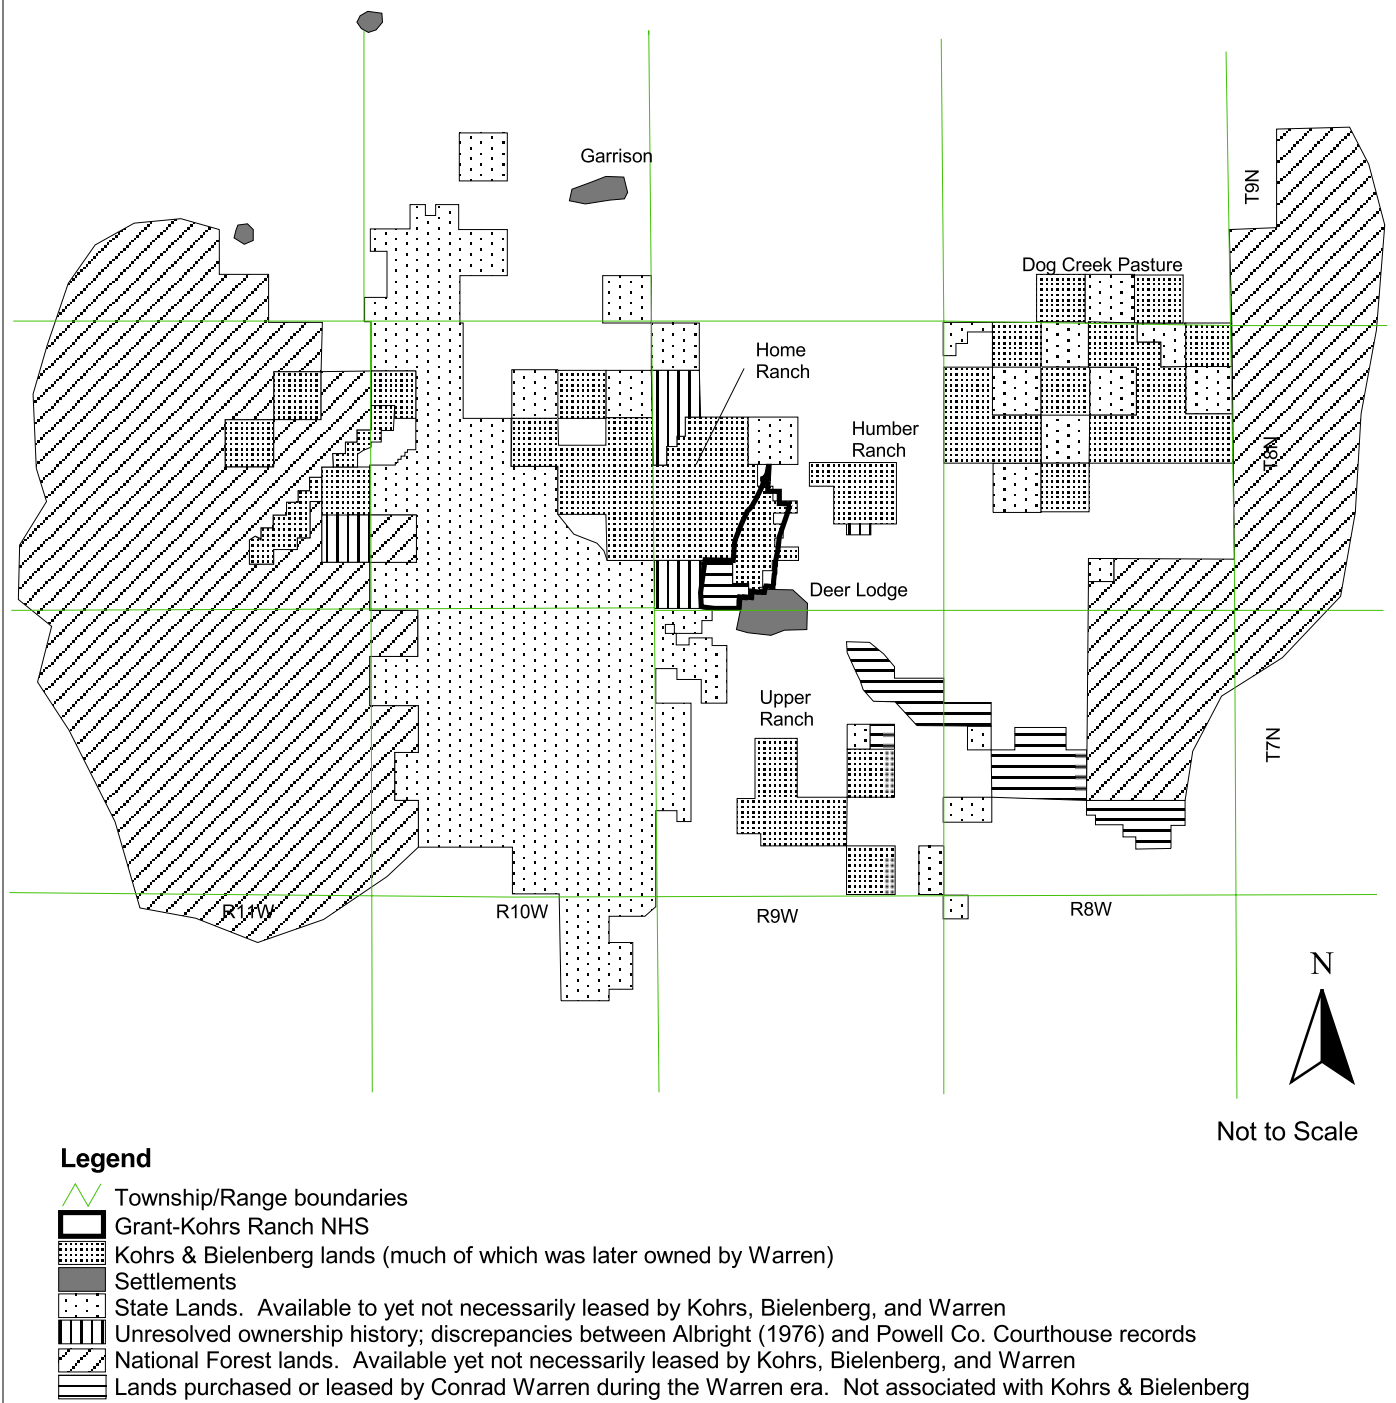
Figure 1-1: Extent of lands owned, leased or available for lease to Kohrs, Bielenberg, and Warren, 1866-1892.

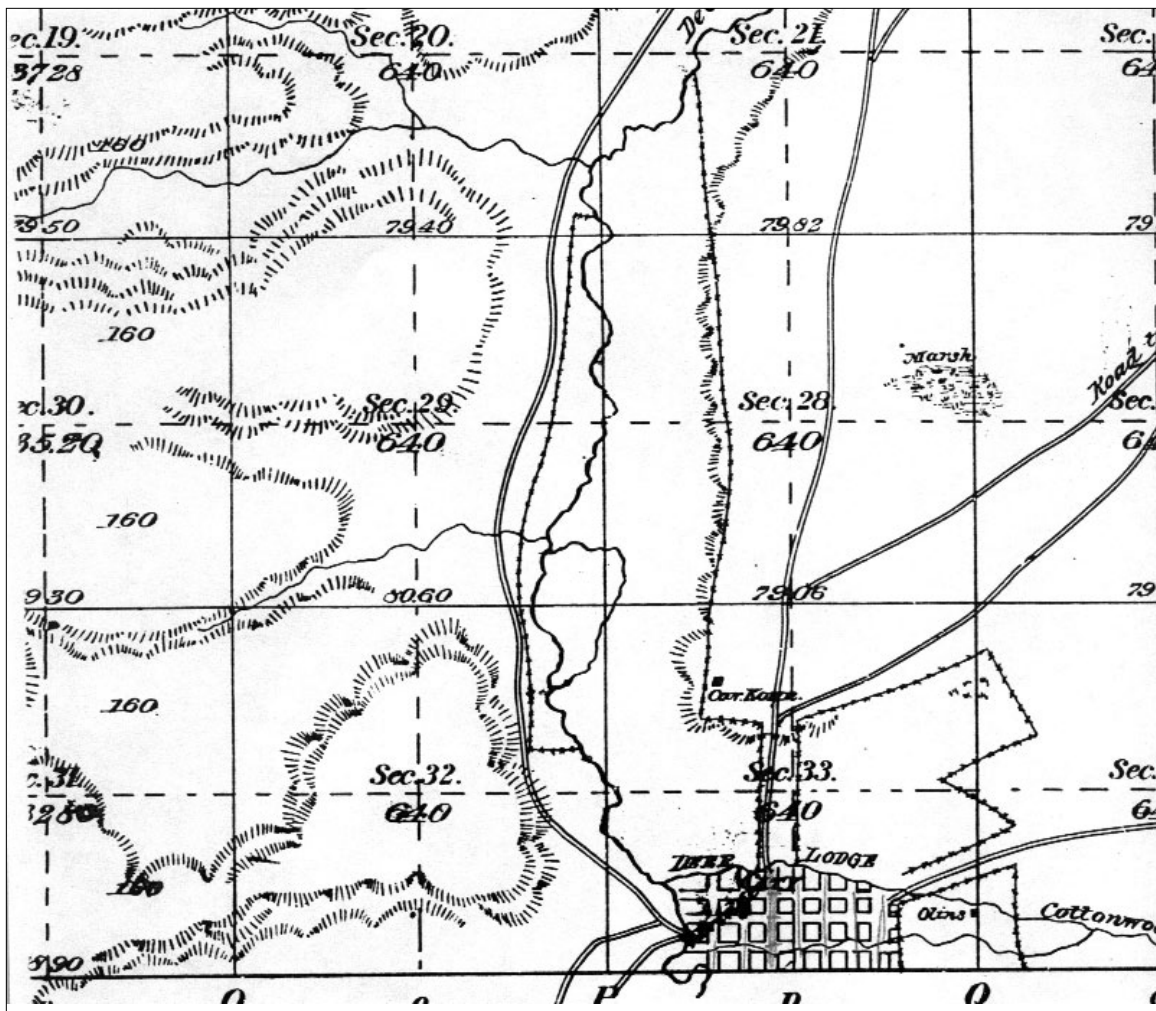
Figure 2-4: Detail of 1869 Survey T8N, R9W, showing Grant-Kohrs home ranch.

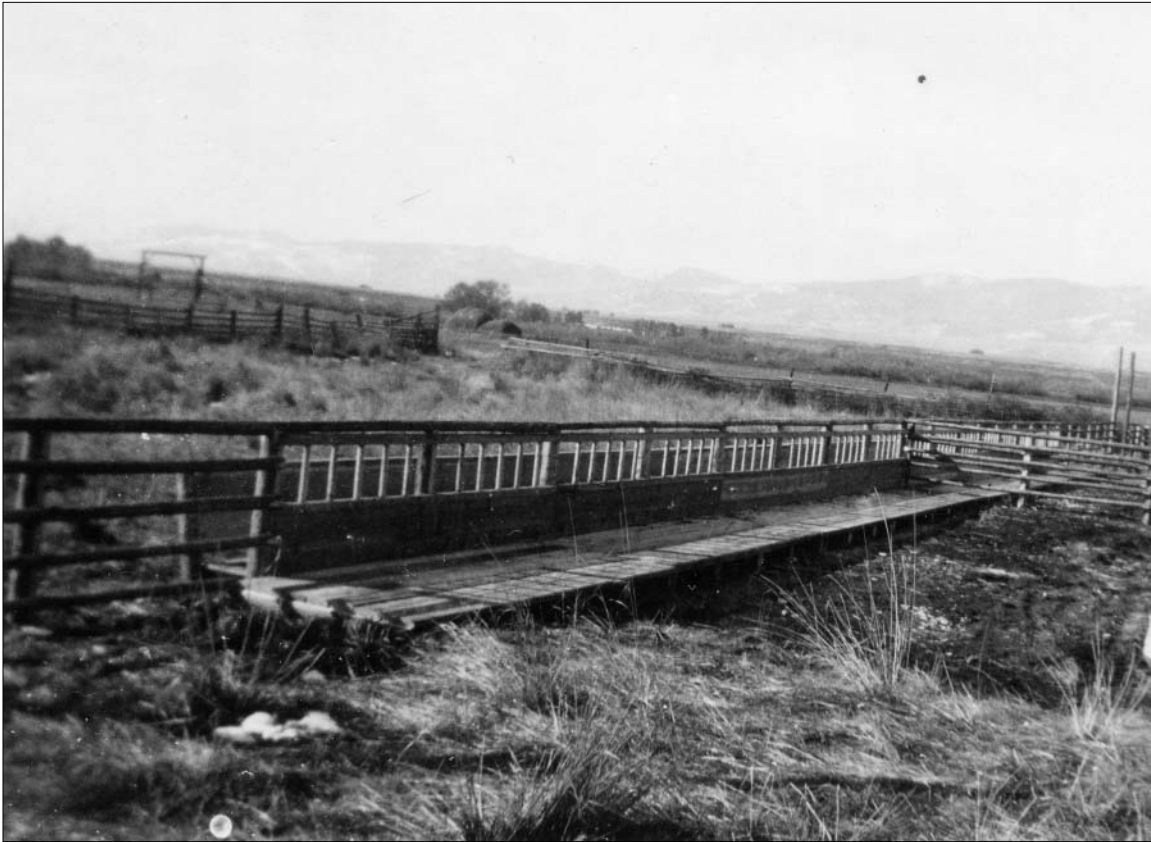
Figure 2-32: (16109B) Feed Bunk (HS-52), circa 1940.

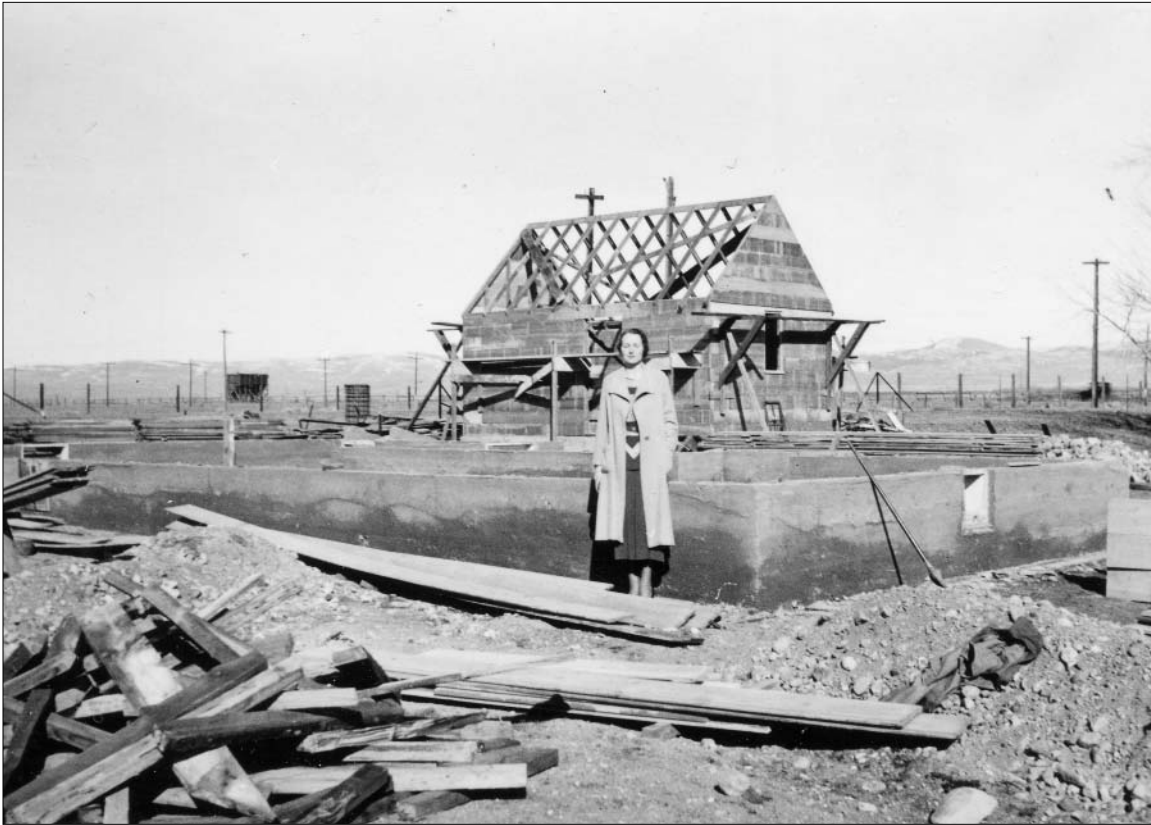
Figure 2-42: (15884-24) Nellie Warren in front of HS-58, Warren House foundation, with garage framing in background, 1934.

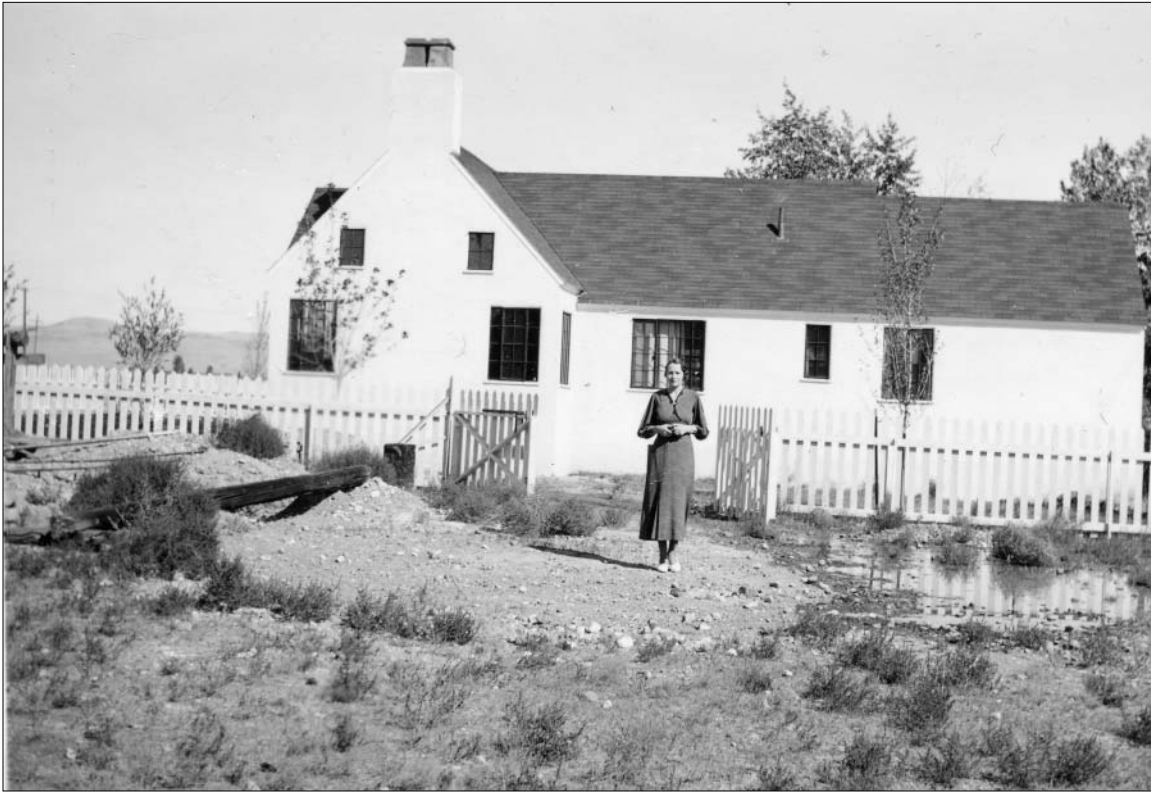
Figure 2-43: (15884-25) Construction of new Warren residence with Nellie Warren, 1934.

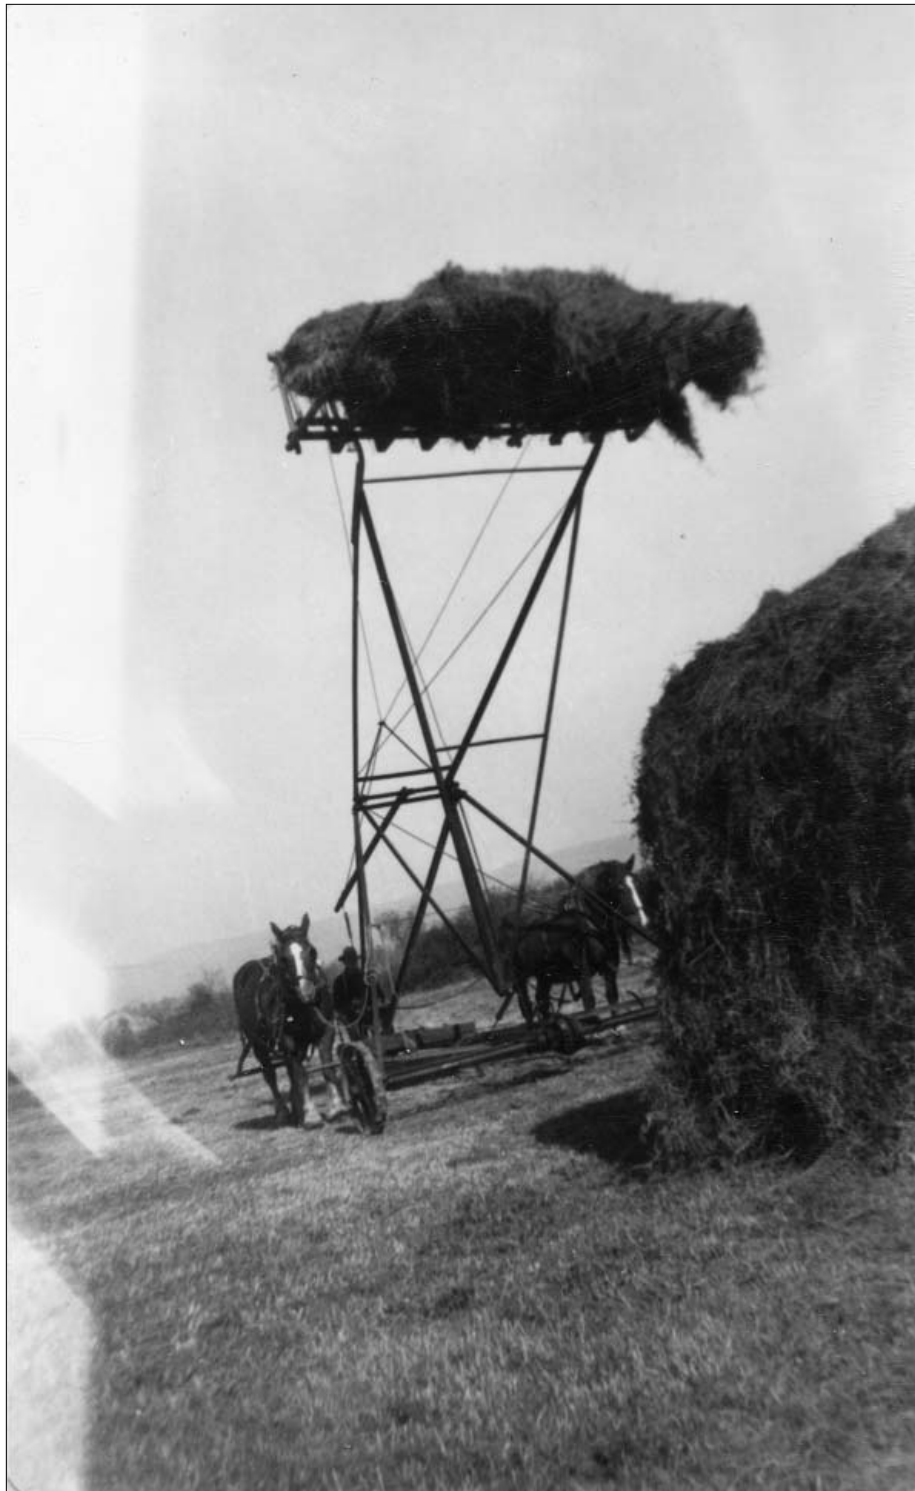
Figure 2-64: (4994HA) Jayhawk Overshot Hay Stacker, 1938.

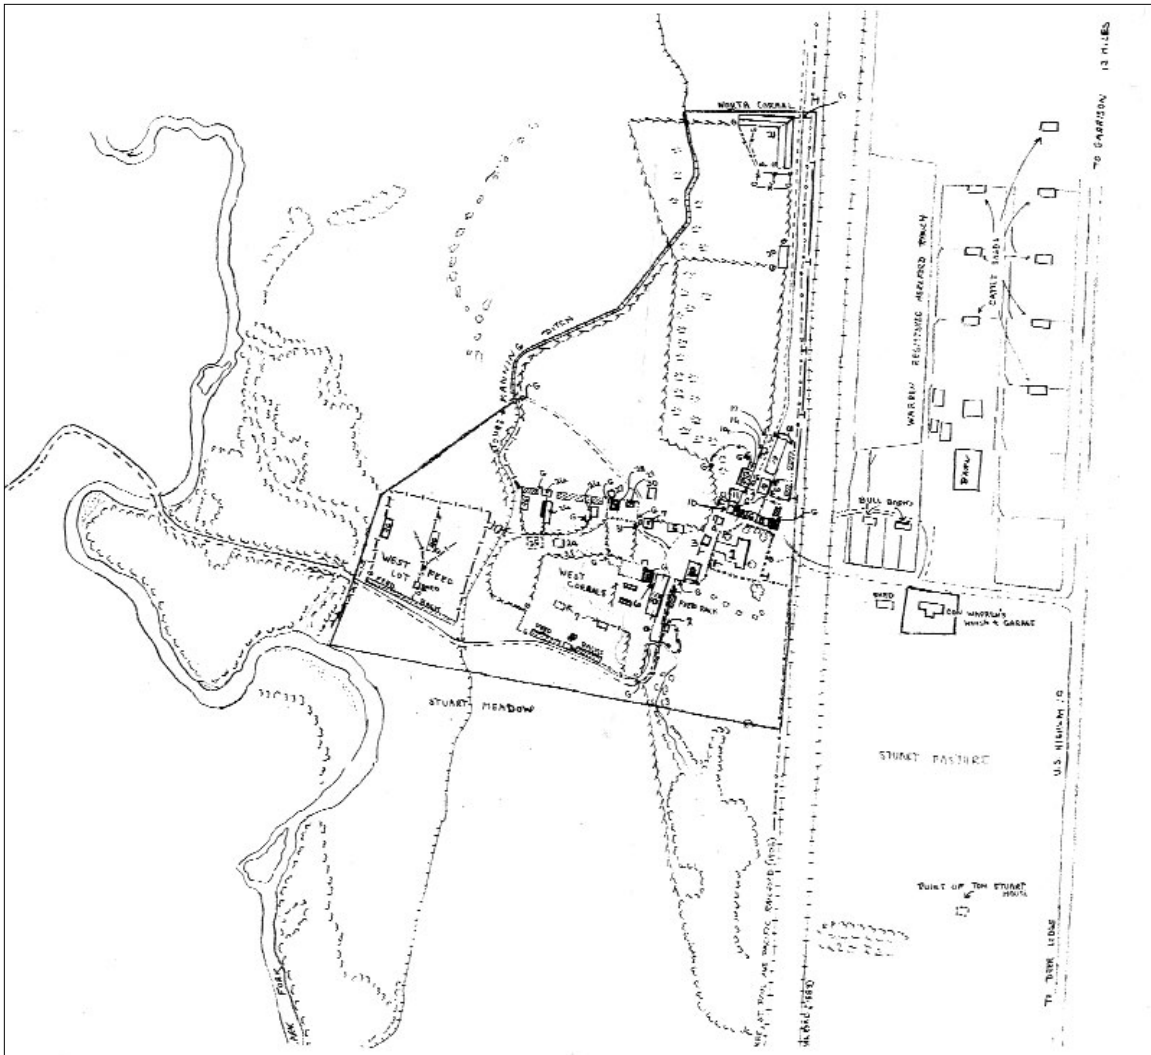
Figure 2-79: NPS Historical Base Map, 1958-1971.
