historic structure report

HERBERT HOOVER
11 CORE AREA BUILDINGS

NATIONAL HISTORIC SITE / IOWA

HISTORIC STRUCTURE REPORT
ELEVEN CORE AREA BUILDINGS
HERBERT HOOVER NATIONAL HISTORIC SITE
WEST BRANCH, CEDAR COUNTY, IOWA

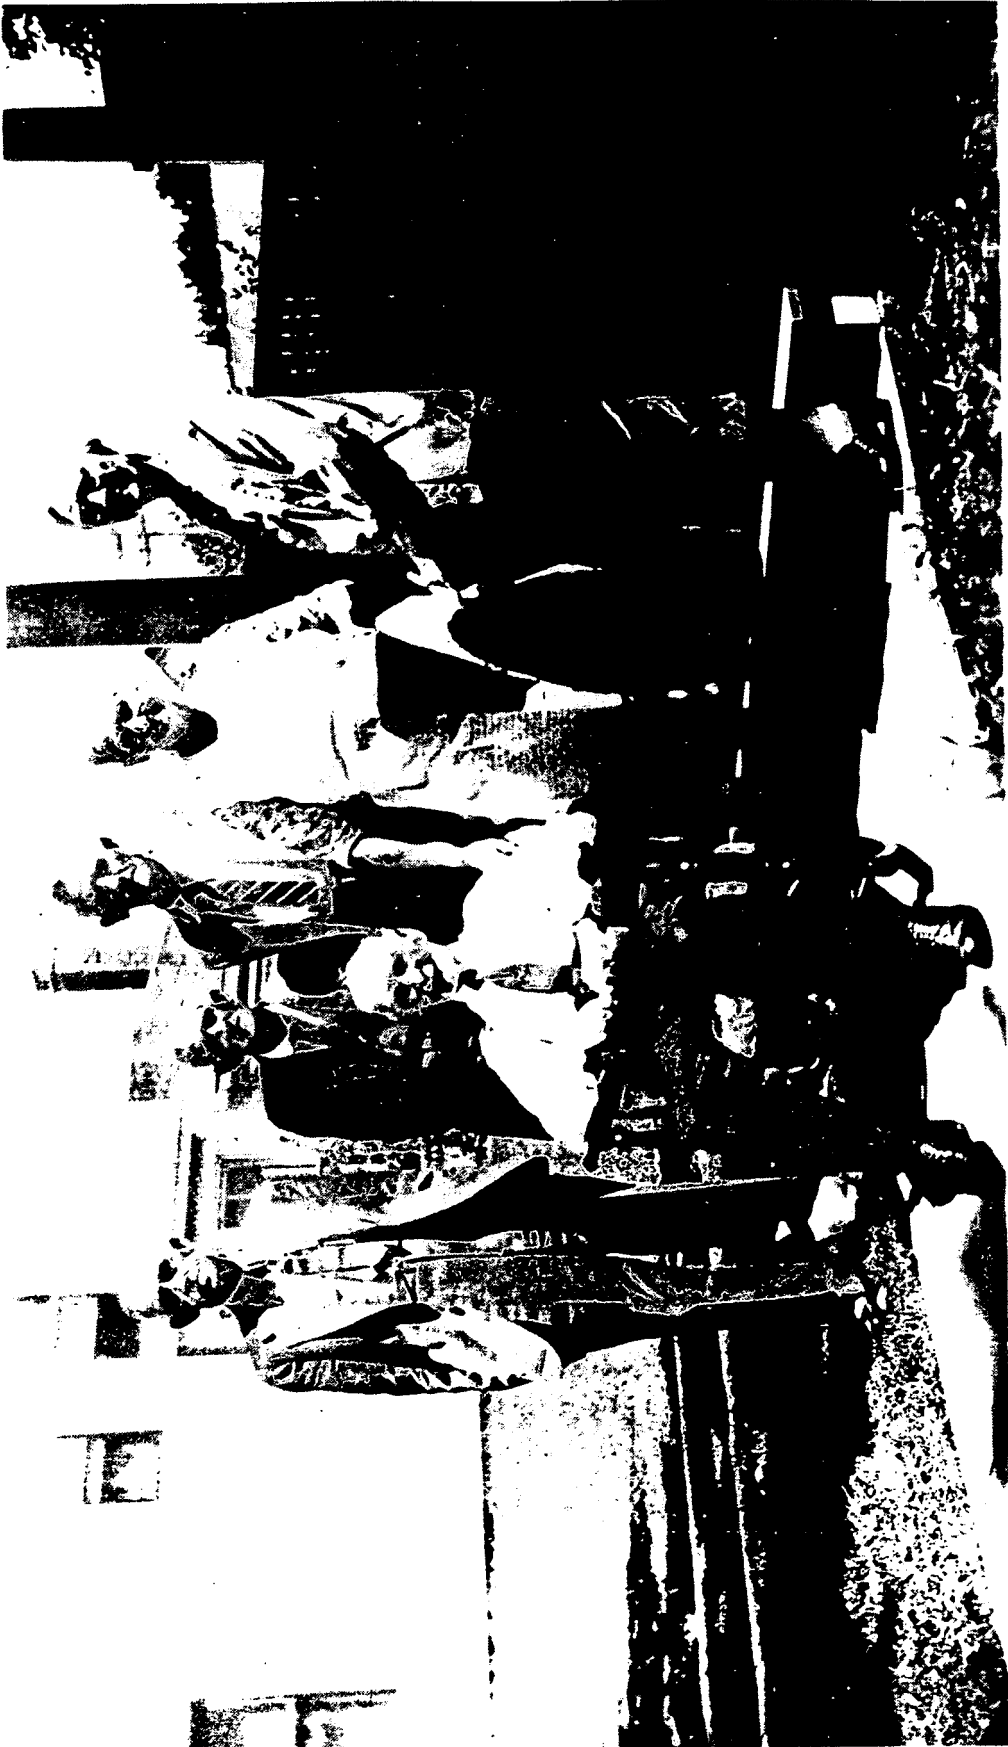
R-10, DR. L.J. LEECH HOUSE HS-5, 1932. View looking southeast, showing front porch and entrance to the house. The original photograph (postcard) is from M. Stratton's albums, located at the Hoover Presidential Library, West Branch, Iowa. E. Witmer, Wilton Junction, Iowa, also has an original photograph (postcard). A copy of the negative is at the Hoover Presidential Library, West Branch, Iowa (reference 1932-21D).

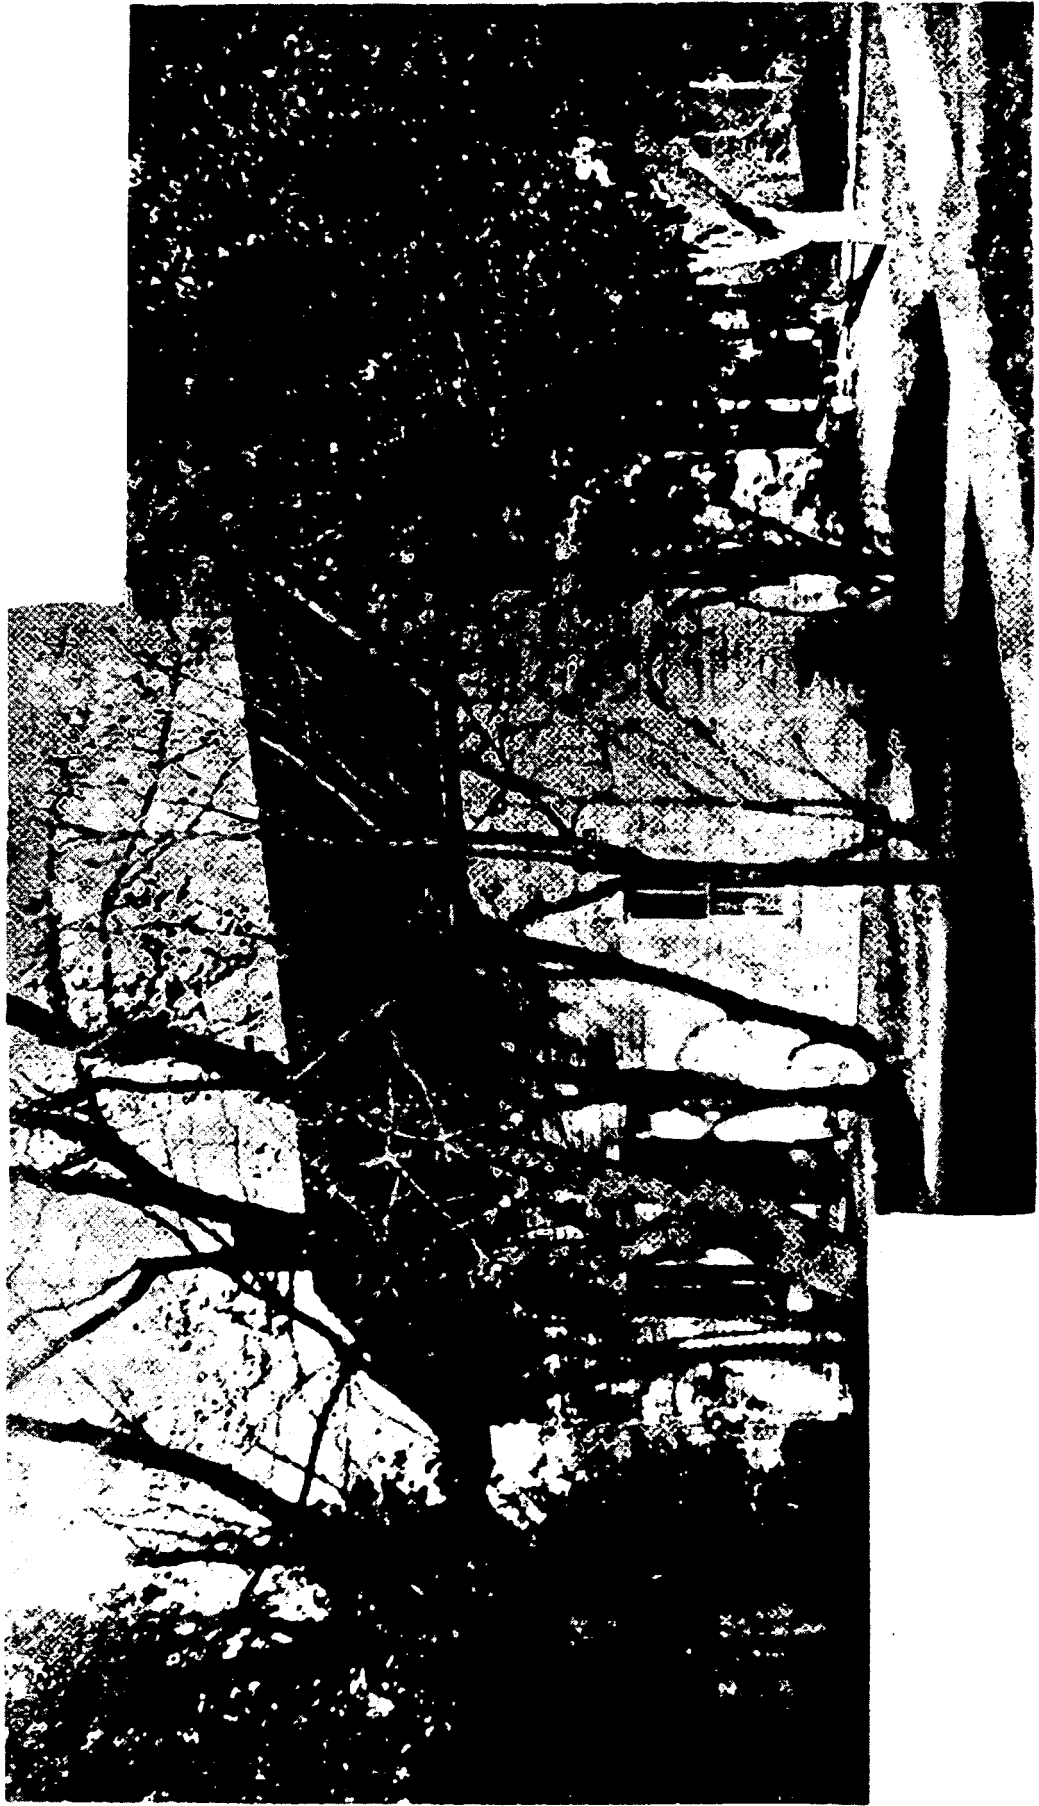
R-42, SECOND HOOVER HOUSE, ca. 1915. View looking northeast, showing a portion of the rear porch and south gable end. The original photograph is with L. Rummells, West Branch, Iowa. A copy of the negative is at the Hoover Presidential Library, West Branch, Iowa (reference 1915-69A).

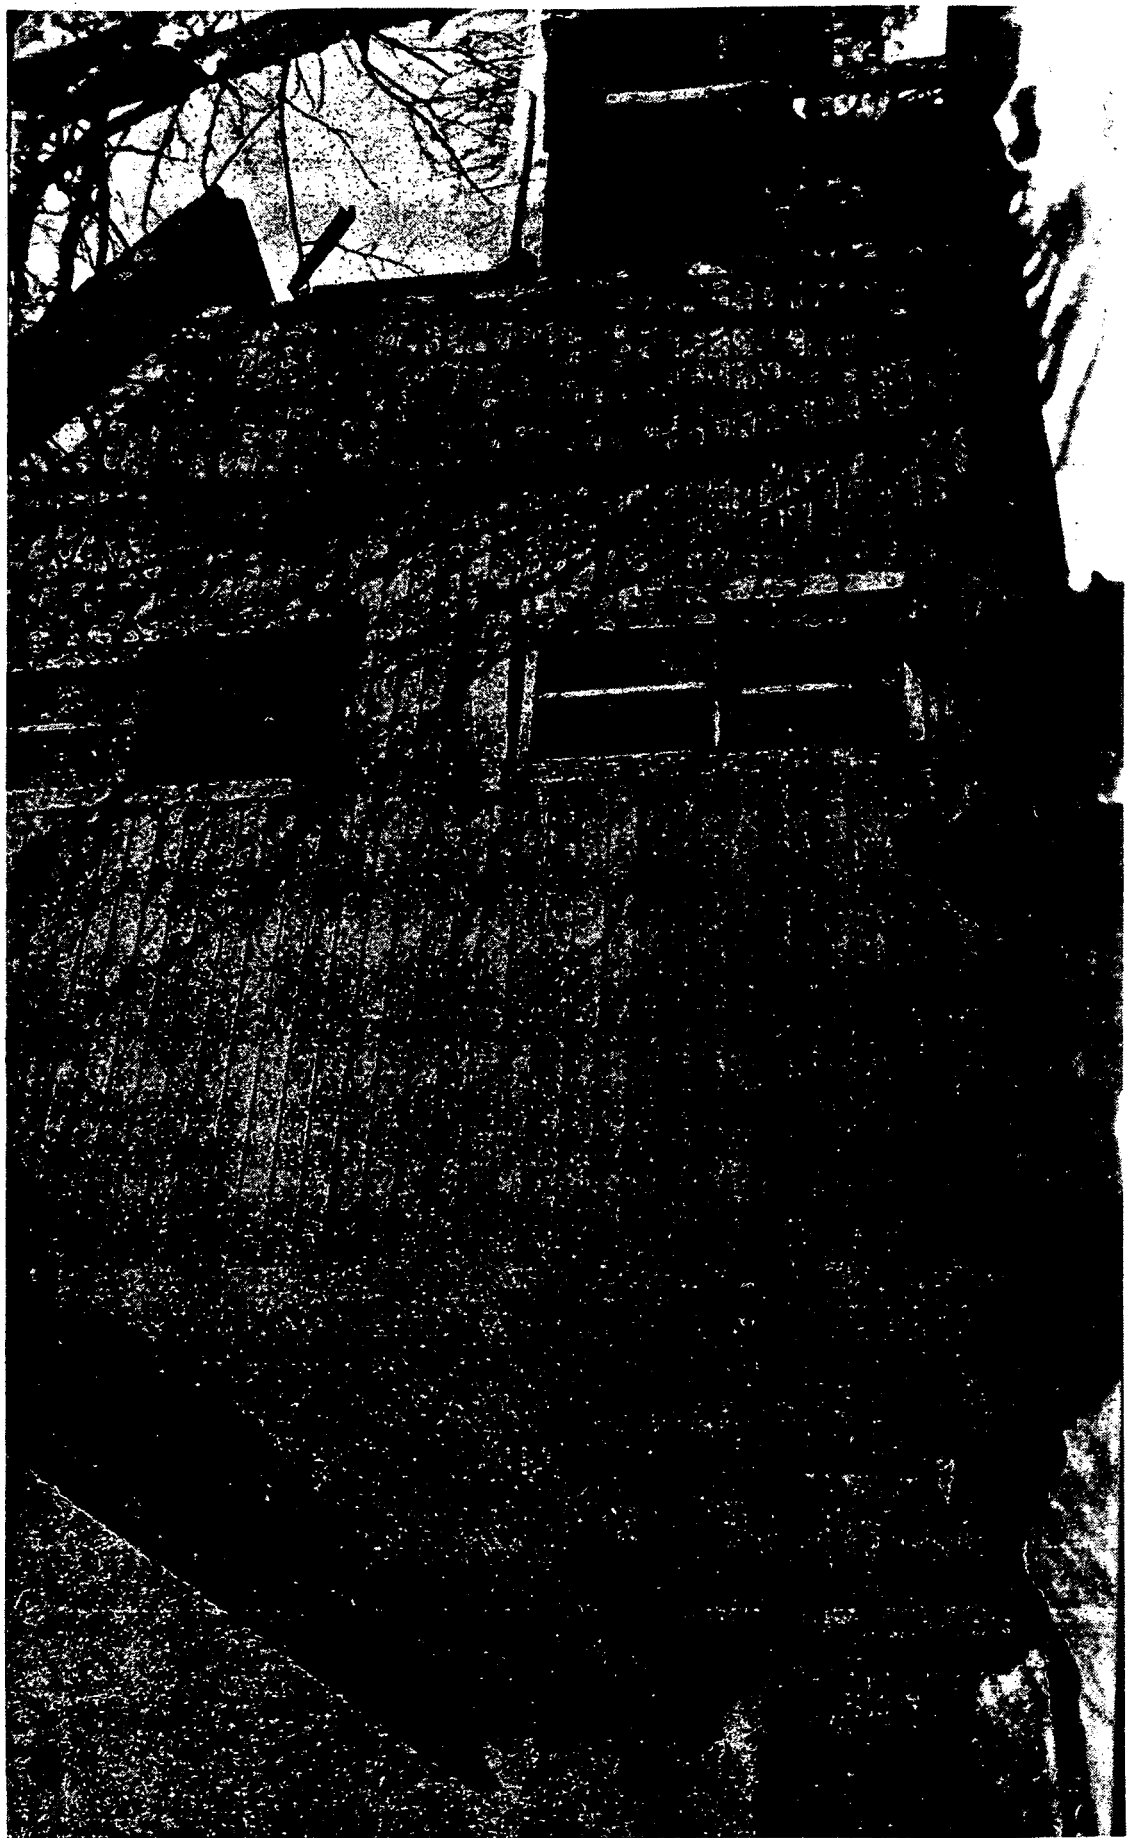
R-43, SECOND HOOVER HOUSE, ca. 1915. View looking northeast and showing the rear porch. The original photograph is with L. Rummells, West Branch, Iowa. A copy of the negative is at the Hoover Presidential Library, West Branch, Iowa (reference 1915-68A).

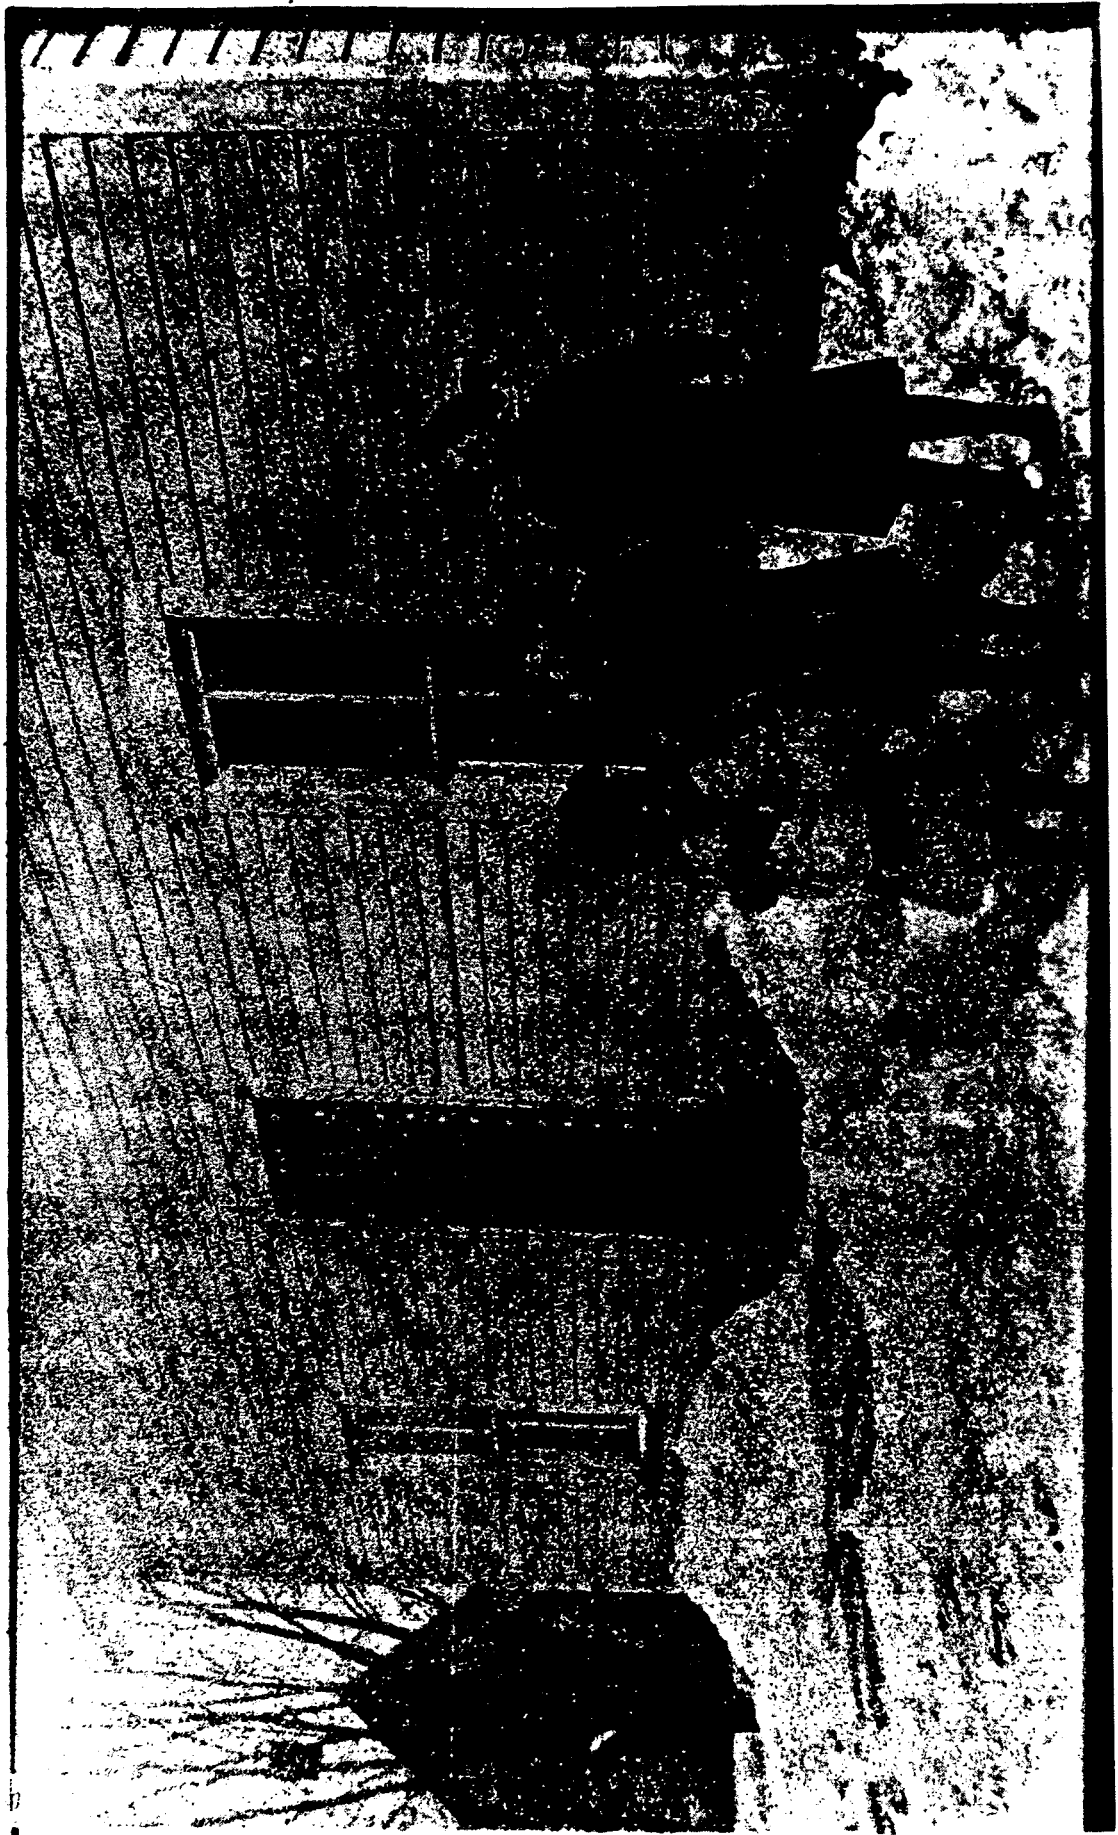
R-45, SECOND HOOVER HOUSE, ca. 1915. View looking northwest and showing the rear corner of the house. The original photograph is with L. Rummells, West Branch, Iowa. A copy of the negative is at the Hoover Presidential Library, West Branch, Iowa (reference 1915-65A).

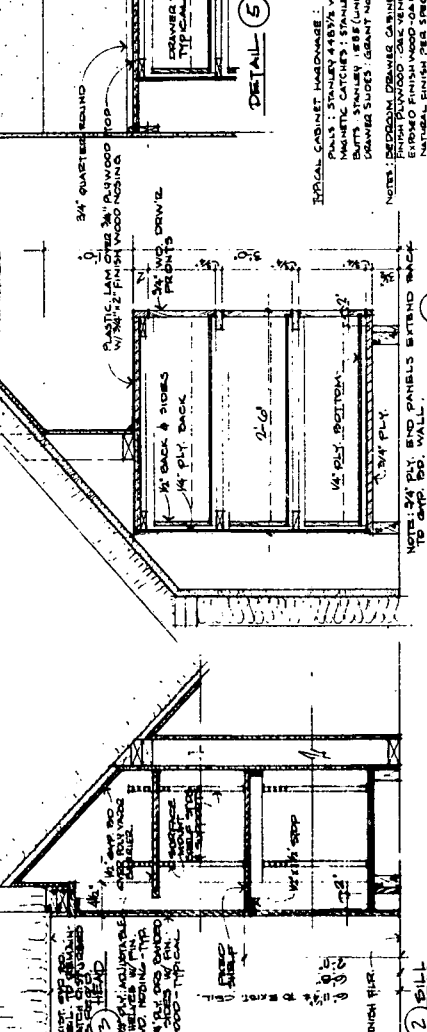
TYPICAL VERTICAL SECTION (6) BORN SHELF UNIT

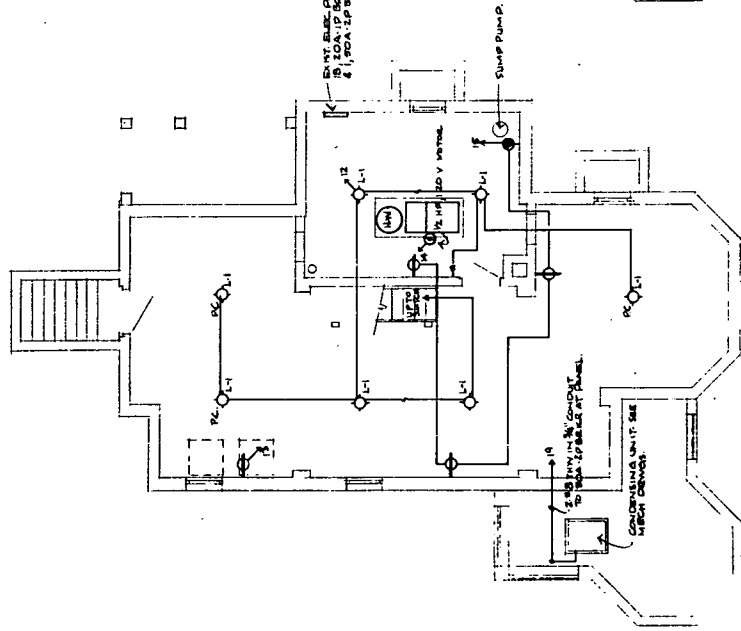
FIRST FLOOR ELECTRICAL FLOOR PLAN SCALE - 1/4"=1'-0"
 REPAIRS TO BE MADE TO EXISTING ELECTRICAL SYSTEM, CONDUIT, WIRING, ETC. BACK TO PANEL INSTALL ALL NEW WIRING SEE AS SHOWN.
 SEE DRAWING UNIT SEE ELECTRICAL CONTRACTOR FOR LOCATION OF PANEL
