Historical Documentary Report on the
BRIDGE AND WHEEL HOUSES,
Hopewell Furnace

(Buildings 10 and 8, Hopewell Village National Historic Site)

By
Russell A. Apple
Park Historian

September 28, 1956

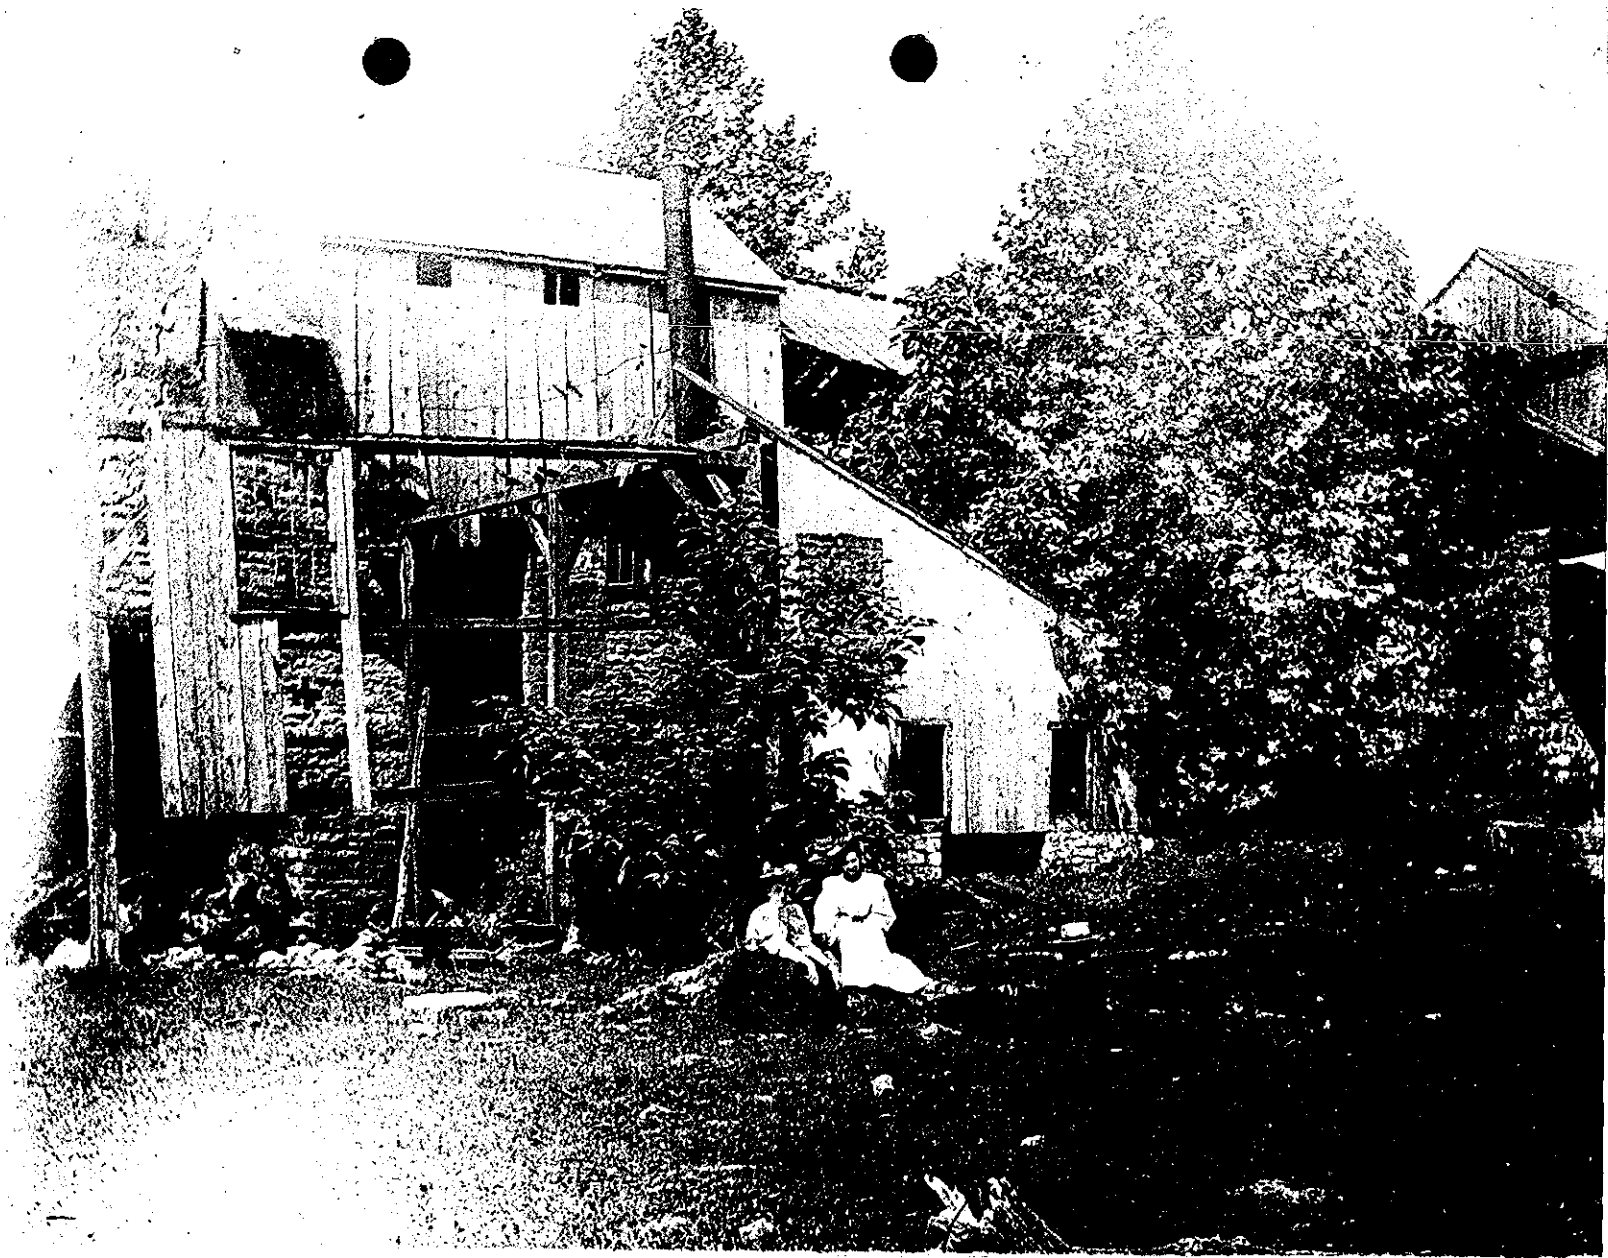
1896 Bull

Let us take the 1896 Fall Photograph 101-07 and identify the parts of the Bridge House visible. At the left and forming a small triangle up into the sky is a brick firewall.^{h1} Through an arched opening in this firewall the charges were dumped into the tunnelhead. This firewall protected the wooden Bridge House and shielded the filler. Between the Firewall and the Bridge House is a covered space. This has been termed a vestibule and protected the space between the Bridge House and the firewall.^{h2} Next comes the Bridge House. Its left, or southern end, is supported by a step in the furnace. Its right, or northern end, is supported on Wall A.^{h3} When this picture was taken, the near or east side of the Bridge House was supported on Walls E, F1 (with window) and F2 (hidden). Its far or west side was supported by a truss which extended from the furnace to Walls E and A, there being no walls on the west side. The informant on this point was

The roof of the Portico may be seen between the Bridge House and the tree which unfortunately hides the supporting posts. The roof on the far right is the southward projection of the Charcoal House, which contains a door. A small portion of the Portico roof may be seen where it attaches to the southward projection. The wall showing under the Charcoal House roof is a portion of Wall H, and the large dark area at the extreme right edge of the photograph is the Ore Roaster (Building 3h). A better view of the roaster and Wall H may be seen in the 1937 Stokes photograph 125-01. This 1936 Wall photograph 101-07 was chosen because it shows portions of all the elements of the area between the Charcoal House and the tunnelhead. Other photographs show other details of specific features.

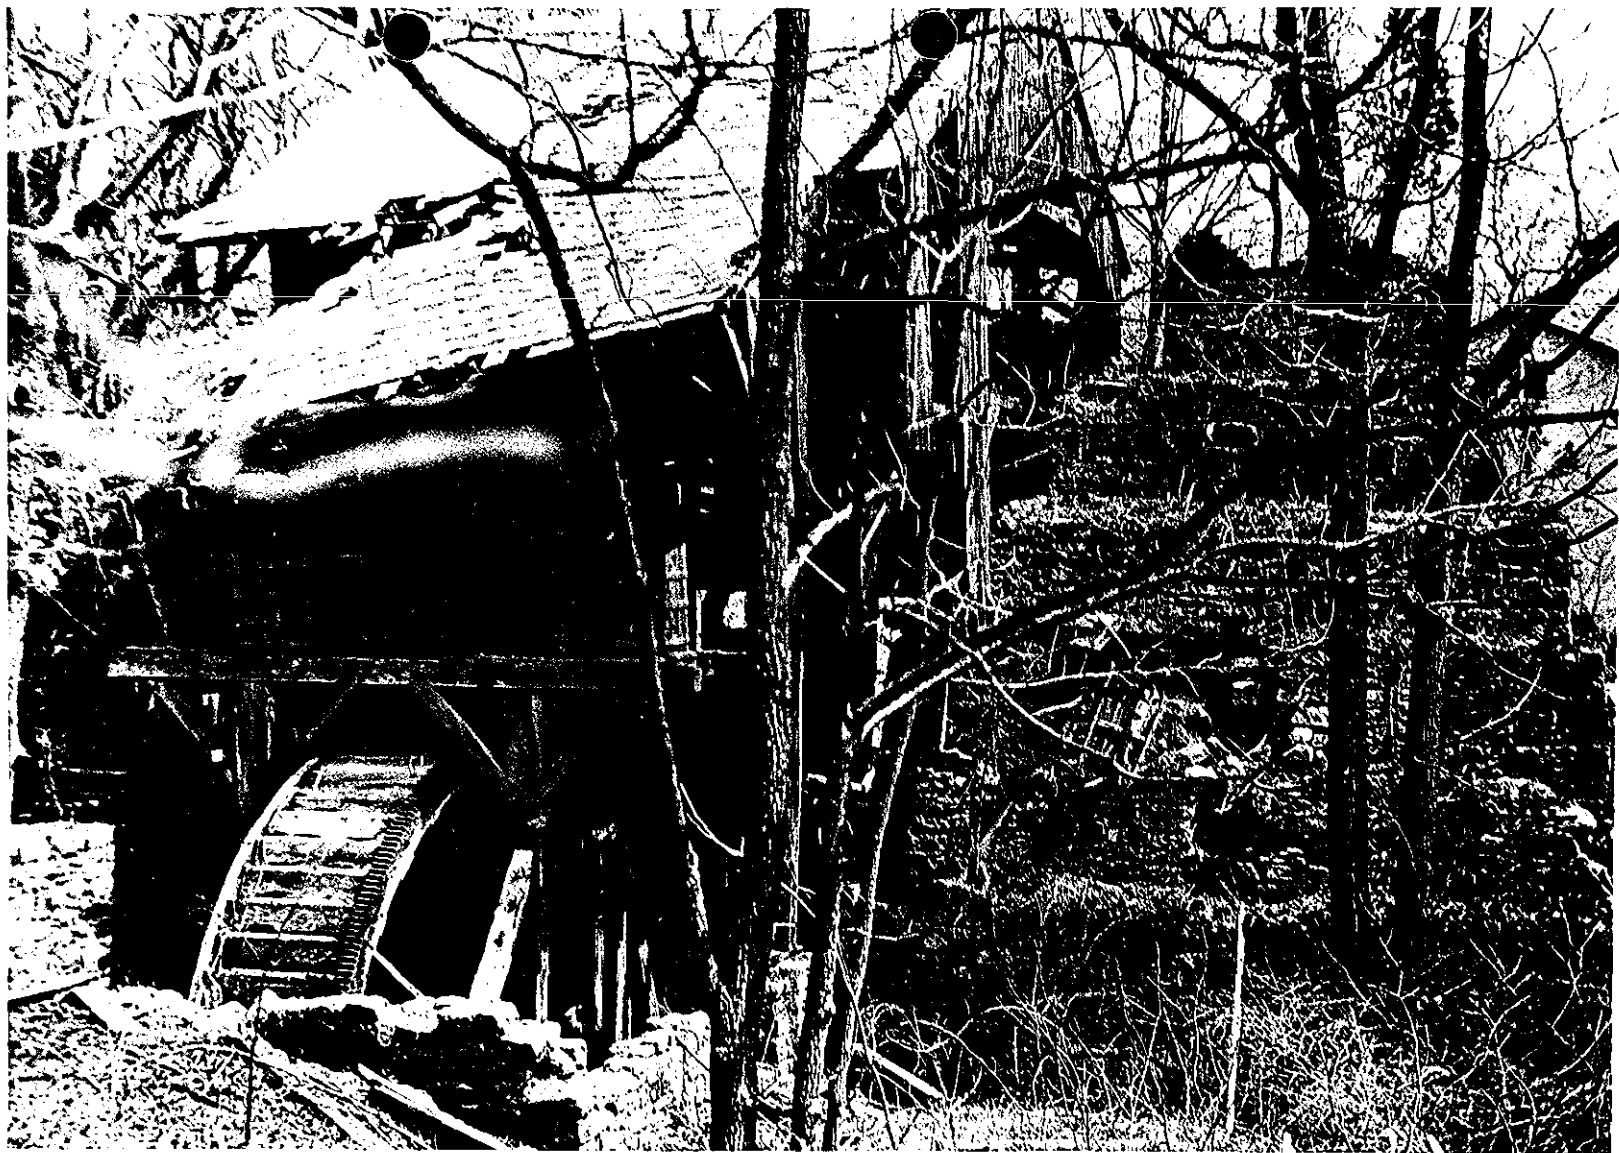
102-5 After 1920

Photographs 102-5, the 1920 Smith 22-6, and the 1920 Stauffer 125-09 show the solid ramp approach to the wooden Bridge House floor. The lower courses of wall B show in the Stauffer photograph. The upper courses were missing circa 1915, but are remembered. ⁵⁷ The ramp was composed chiefly, it is believed, of packed charcoal dust.
