TURNING THE CORNER:  
THE LANDSCAPE HISTORY OF THE ADMINISTRATION BUILDING  
HOT SPRINGS NATIONAL PARK

Laura Soullière Harrison  
Architectural Historian  
Hot Springs National Park  
January, 1990

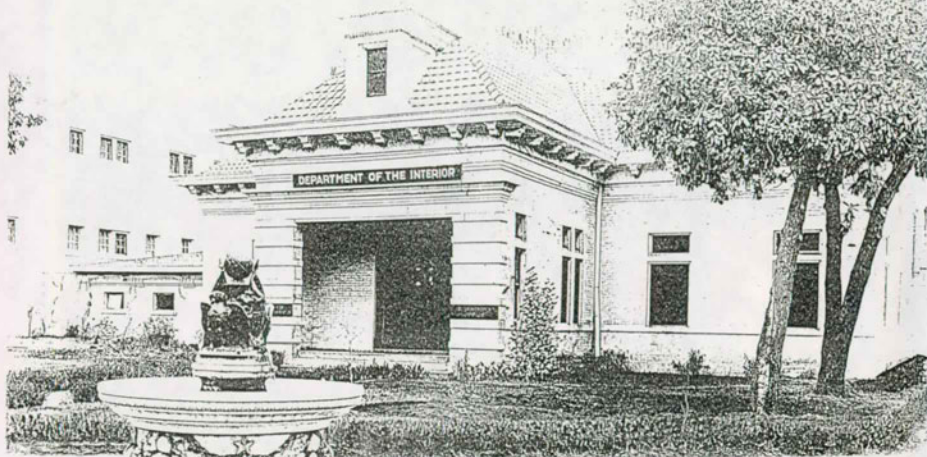
In this photograph (circa 1920), the Noble Fountain was in its original location. The Reservation's office faced Central Avenue. A paved walkway provided access to the building. A low hedge bordered the sidewalk. Two magnolias (extant in 1990) occupied the southwest corner of the building site. The magnolias grew approximately four feet from the edge of the sidewalk.

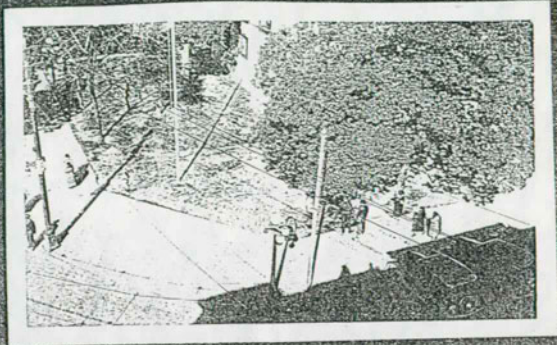
The National Park Service moved into its new Administration Building in the spring of 1936. These photographs accompanied construction completion reports. When they were taken, the landscaping work at the site had not begun. The flagpole was in place, and the grassy boundary extended partially around the base of the Noble Fountain. The scar of the former sidewalk leading from Central Avenue to the former building remained visible. The new sidewalk that provided access to the Administration Building followed the same path as the old. In other words, people had been walking down that short path to an information mode since 1898 -- the time that the Department of the Interior first began providing onsite information.

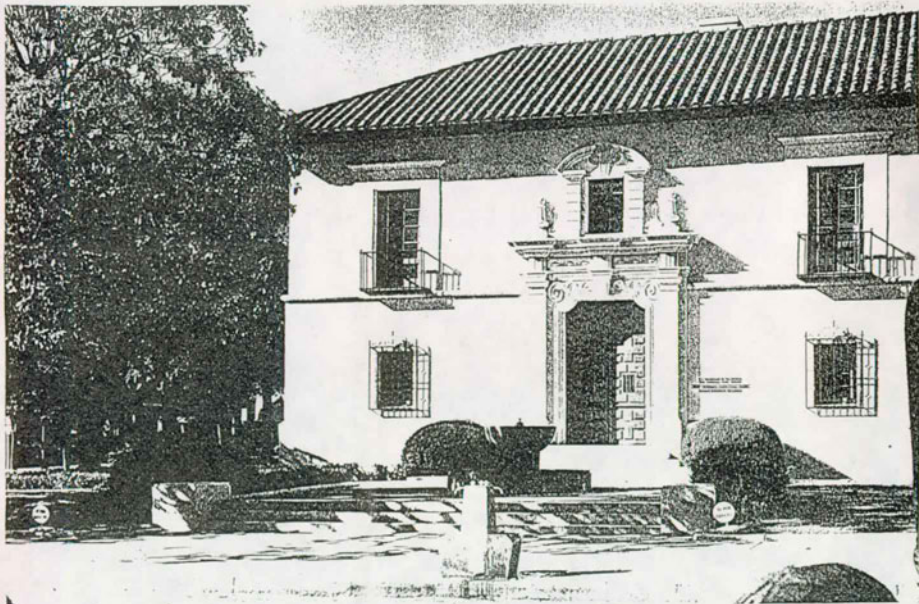
The preliminary landscaping for the site in 1936 included small boxwood hedges and larger, older boxwood shrubs. The park staff protected the smaller shrubs from summer heat by shading them.

The clarity of purpose in the landscape design was evident in 1936.  
The formal lines and strict geometry dominated the landscape.

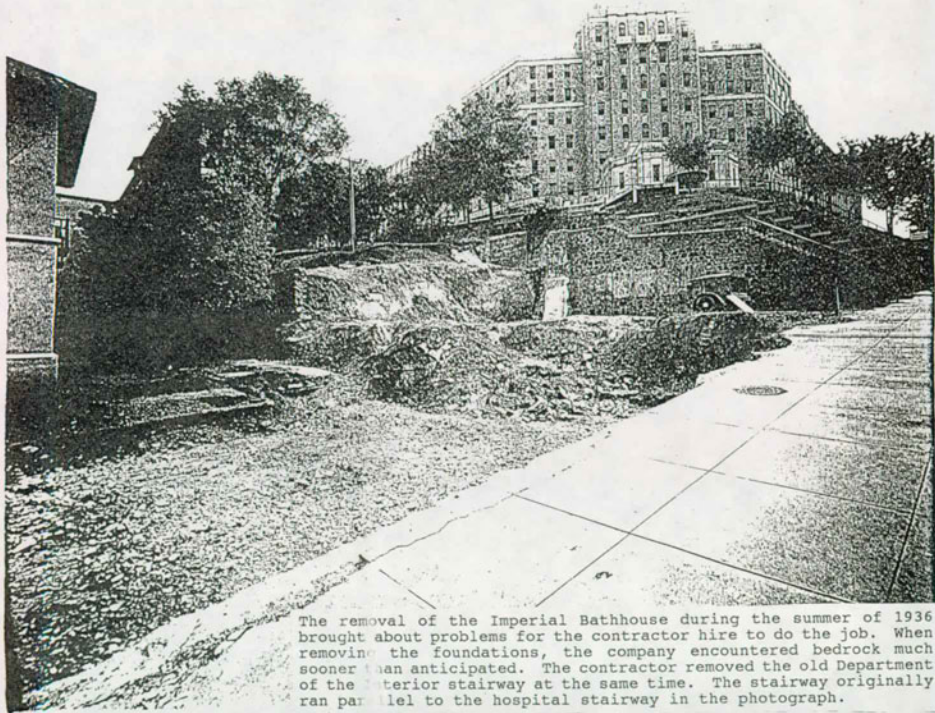
The removal of the Imperial Bathhouse during the summer of 1936 brought about problems for the contractor hire to do the job. When removing the foundations, the company encountered bedrock much sooner than anticipated. The contractor removed the old Department of the Interior stairway at the same time. The stairway originally ran parallel to the hospital stairway in the photograph.

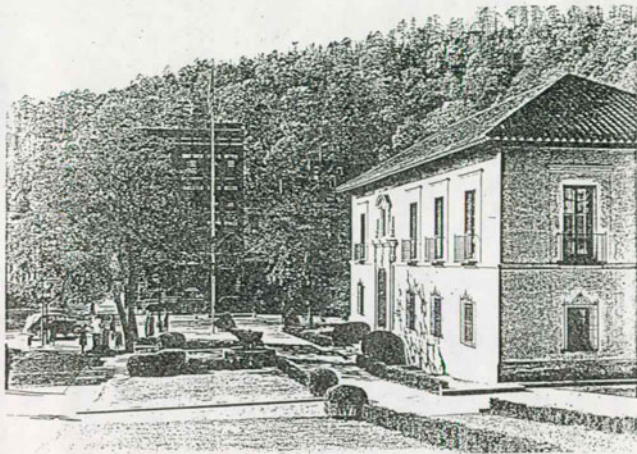
In this photograph, circa 1939, the landscaping for the temporary design solution for the south end of the Promenade was completed. The opposition of Secretary of the Interior Harold Ickes to the construction of a formal promenade delayed work on it for two decades.

The chairman of the park safety committee complained that the wooden steps at the south end of the Promenade were beginning to deteriorate. He noted: "As these were

built as a temporary structure only, it is believed that something must be done soon toward replacing them. Constant and heavy use is given these steps and it is necessary to watch them very closely to prevent conditions hazardous to visitors (File A7619, Safety Meeting Minutes, 1943-53, Sept. 18, 1946)."

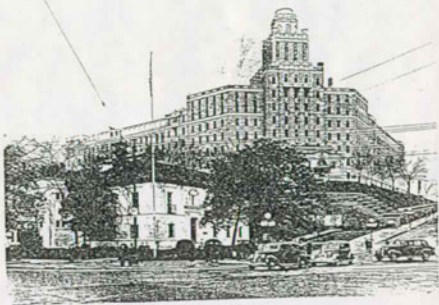
The corner of Central and Reserve looked like this in 1940. Two lights marked this south edge of the park. The Army and Navy Hospital loomed above Bathhouse Row.

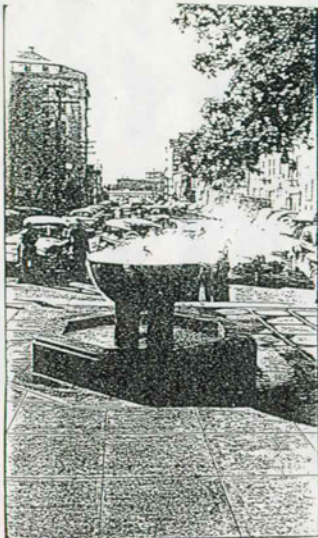
In this 1947 photograph, the length of the vista looking from the Administration Building south to the railroad station was evident. The length of this vista meant that the entrance to the Administration Building was visible for four blocks. This put increased importance on the appearance of the Administration Building and its grounds. The building was the terminal feature of this city vista. Although the plaza that the National Park Service constructed was smaller than originally proposed, it added an impressive aesthetic element to this portion of the city. The Eastman Hotel on the left and the bank of commercial blocks lining the right framed this vista.

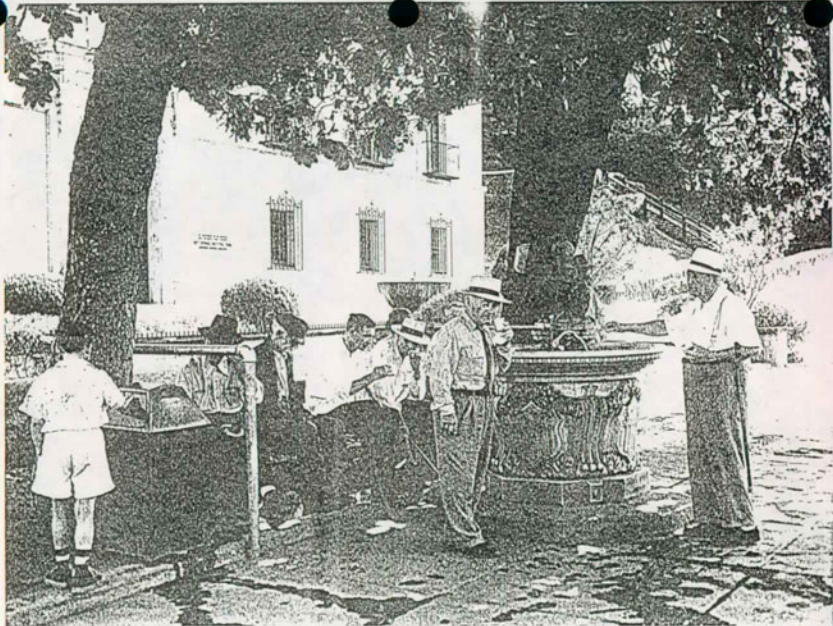
In 1952, people using the Noble Fountain often rested on the bench between the two magnolias. The pipe railing had spikes to discourage fence-sitters and to control access to the grass behind the bench. At this time no ivy had been planted.

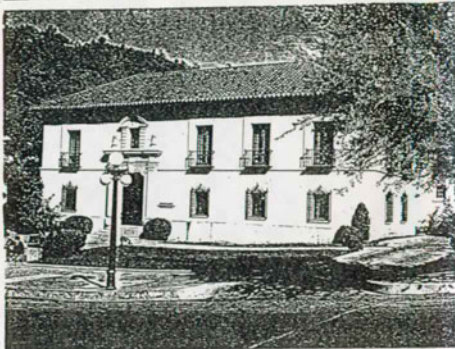
In 1952, the jug fountain (not visible in the photograph) sat at the edge of the curb. The walkways had no hedges bordering them. All of the walkways were paved. The tufa boulders were in evidence by this time. Some vegetation grew at the southeast corner of the building where none had been planted earlier.

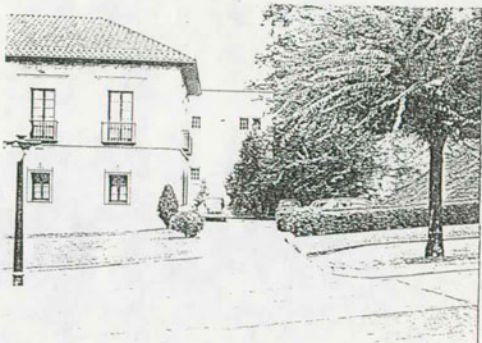
In 1952, the parking lot was quite small. The light pole adjacent to the curb was a target for cars, so the park safety committee had it moved. Vegetation between the parking lot and the Lamar Bathhouse had taken hold. The landscape design along the front elevation was simple and formal.

- 1953 The park safety committee recommended that the light pole adjacent to the jug fountain "be moved back onto the walk approximately one foot or that a guard rail be put around it. This pole is always being hit by a car and one or more of the large light globes knocked off" (File A7619, Safety Meeting Minutes, 1943-53, January 9, 1953).

- 1955 Supt. requested that the parking lot at the rear of the Admin building be enlarged (Rhodes, 236).
- 1955 Wooden steps replaced at south end of promenade (Rhodes, 237).

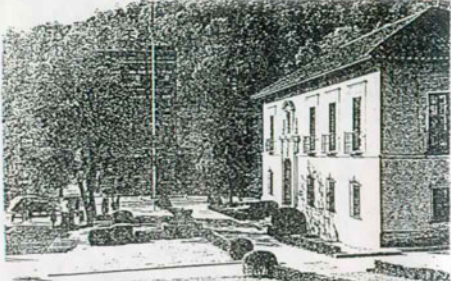
Circa 1952. By this time no change had occurred in paved and gravel walkways. Two of the walkways directly in front of the building no longer had hedges. A bench remained north of the Noble Fountain under the magnolias. The area retained a manicured appearance.

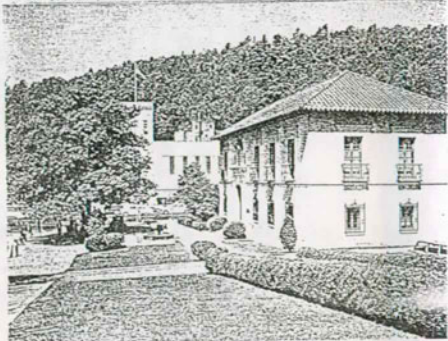
The construction of the promenade in 1957 also brought about distinct changes in the approach to landscape. The bushy shrubs and low trees that were planted started to make the landscape appear less formal.

The park staff created planting beds along the edges of the main walkway up to the building and at its foundation. Treated timbers bordered the beds (author's interview with Engineering Technician Tim Jarrell).

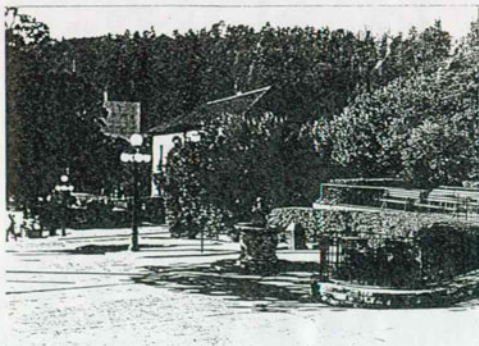
In January, 1990, the bushy vegetation overwhelmed the view of the Administration Building from the east.

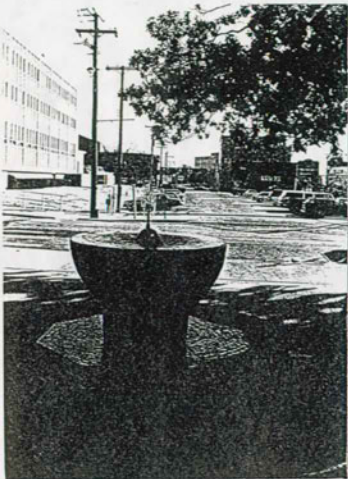
In 1990, the vista down Valley Street is not as well-framed as it had been before the demolition of the Eastman Hotel (formerly on the left) and the block of commercial buildings (formerly on the right). Nevertheless, the long axis still exists between the Administration Building and the new Arkansas Bank and Trust building.

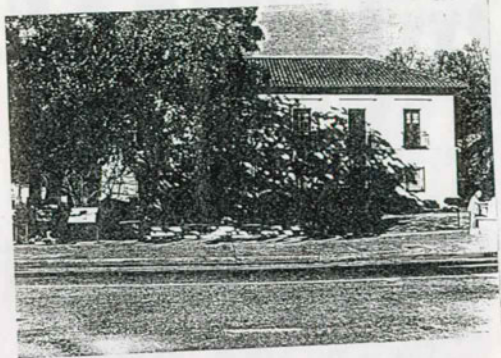
Although temporary signs clutter the site, the formal character of the building and the site remains the dominant element.
