CULTURAL LANDSCAPE REPORT

Chellberg Farm

Indiana Dunes National Lakeshore

May 2000

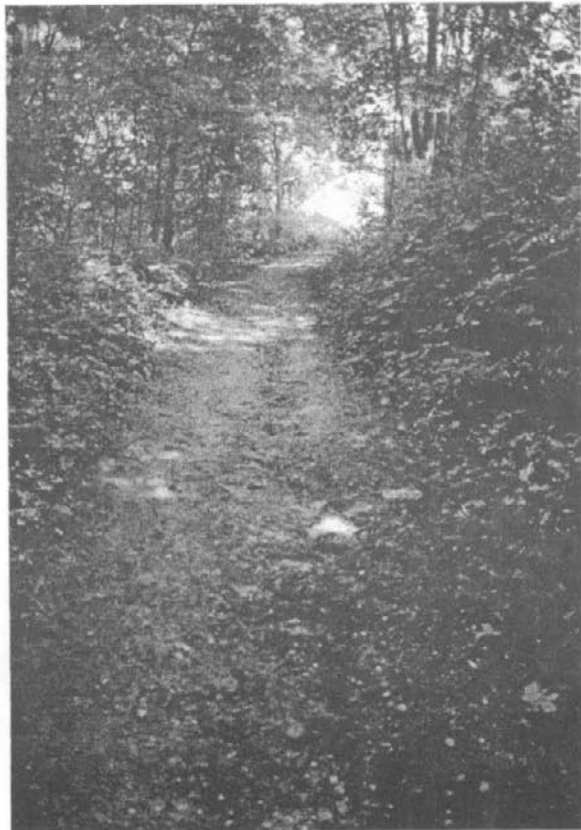
Figure III-34: Trail from bridge to farm complex, 8/11/98. Note erosion at the bottom of the picture.

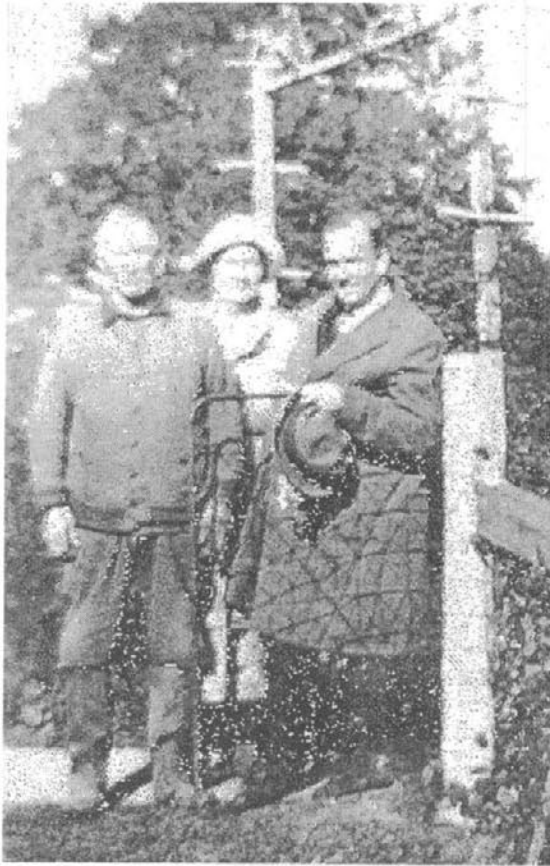
Fabricate front yard gates to match this circa 1920 photograph as closely as possible with the exception of the overhead structure. The structure was apparently very temporary (this is the only photograph in which it appears). Refer to fence elevation and fence at gate opening for information regarding the posts and fence.
