CULTURAL LANDSCAPE REPORT FOR THE MANSION GROUNDS

MARSH-BILLINGS-ROCKEFELLER NATIONAL HISTORICAL PARK

VOLUME II: EXISTING CONDITIONS & ANALYSIS

Olmsted Center for Landscape Preservation
National Park Service, Boston, Massachusetts, 2005

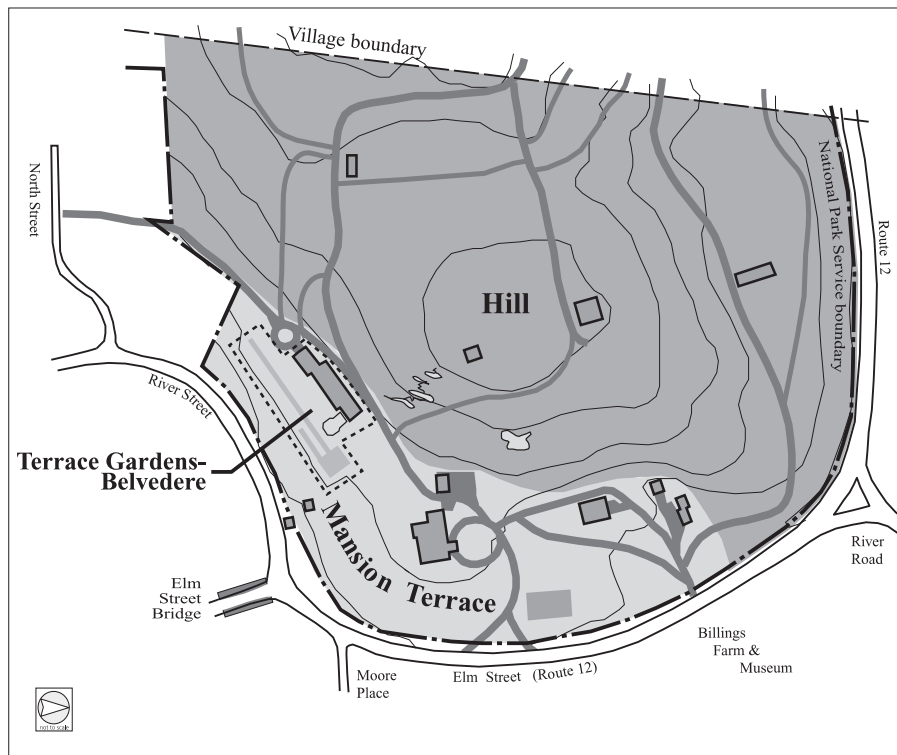
Figure 0.1: Diagram of the Mansion grounds illustrating three landscape areas used to organize the Existing Conditions & Analysis: Mansion terrace, Terrace Gardens-Belvedere, and Hill. SUNY ESF.

The description of existing conditions and analysis of the Mansion grounds is organized into three landscape areas: [Figure 0.1]

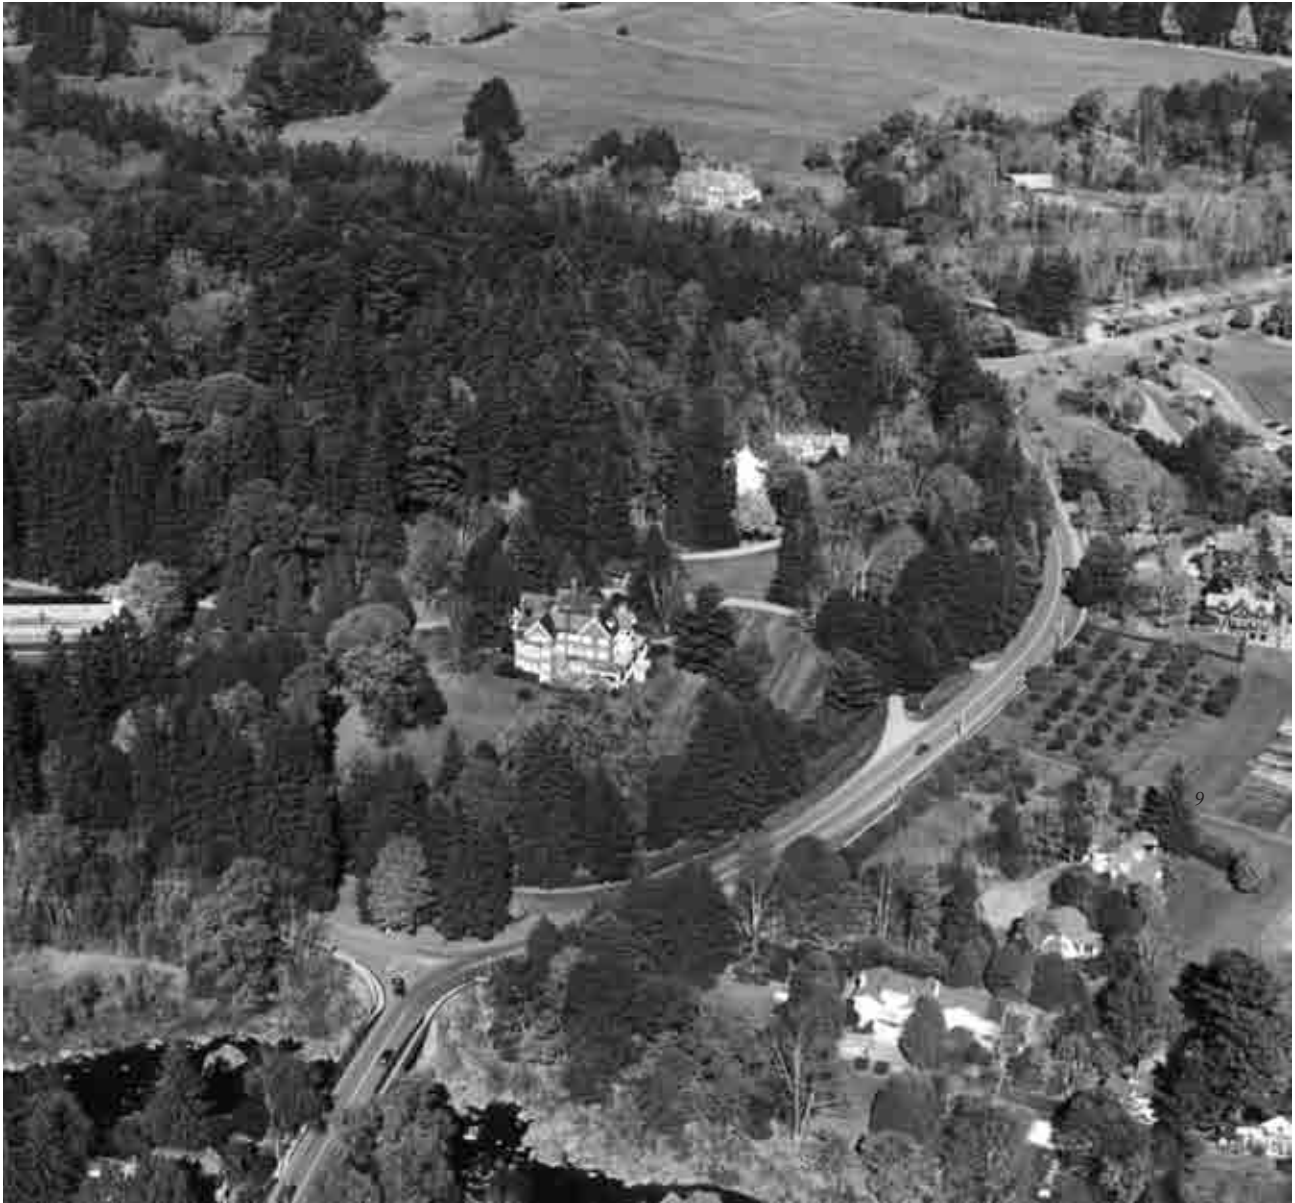
Figure 1.1: Context of the Mansion grounds, 2003. SUNY ESF.

The following sections describe properties and landscape features that adjoin the Mansion grounds and/or contribute to its historic setting. Properties are discussed according to their location on the east, south, and north sides of the Mansion grounds [Figure 1.1].

North Street is a local dead-end road that extends uphill from River Street for approximately five hundred feet along a sharply curved alignment [see Figure 1.1]. In 1858, the Town of Woodstock granted a petition to survey and open a road to be known as "North Street." In the following decade, a series of frame houses was built along the road, including one that would later serve as the residence of Frederick Billings's head gardener (3 North Street). The perimeter stone wall of the Mansion grounds borders the eastern side of North Street for about two hundred feet west from River Street. The street does not border the portion of the Mansion grounds within the National Historical Park (Sterling and Gardener's Cottage properties, historically part of the Mansion grounds, have been subdivided and are presently privately owned). North Street lies within the National Register-listed Woodstock Village Historic District, and all of the adjoining houses are contributing buildings in the district.

River Road, earlier known as the Road to Quechee and Road to Taftsville, is a two-lane local road that intersects Elm Street off the northeast corner of the Mansion grounds [see Figure 1.1]. The road is paved in asphalt across Barnard Brook (earlier known as Beaver Creek and the North Branch), to the intersection of Cloudland Road. The origin of this road is not documented, but it was part of the early route along the north side of the Ottauquechee River, possibly dating to before European settlement. The area along the road east of the Mansion grounds became known as the "Sunny Side" district beginning in the late 1880s as part of the early country-place development in Woodstock. The Billings Estate historically bordered much of the western part of River Road. Off the north side of the road east of Barnard Brook is the Richard Billings house, built in 1916–1917, now the offices of The Woodstock Foundation, Inc. Approximately a quarter mile west of Elm Street on the same side of River Road is the Charles A. Platt-designed house, built in 1906 for Laura Billings Lee, now owned by her granddaughter, Jane McDill Smith. The portion of River Road west of Barnard Brook is within the National Register-listed Woodstock Village Historic District.

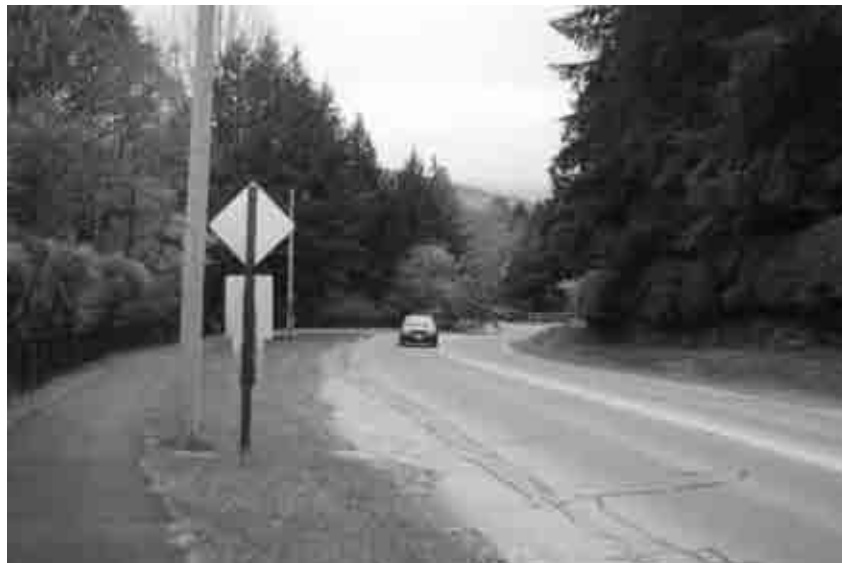
Figure 1.2: View south on Elm Street toward the Elm Street Bridge, October 2001. SUNY ESF. The Mansion grounds with the perimeter stone wall and hemlock hedge are at the right, October 2001.

Elm Street, commonly known as Route 12, is a two-lane asphalt-paved road that forms the public front of the Mansion grounds along its east and north sides. [Figures 1.1, 1.2, 1.3] Commissioned by Charles Marsh (Senior) and Jesse Williams, Elm Street was built by Oliver Williams in 1797 along with a wooden bridge across the Ottauquechee River that gave access to the Marsh Place (Mansion grounds).

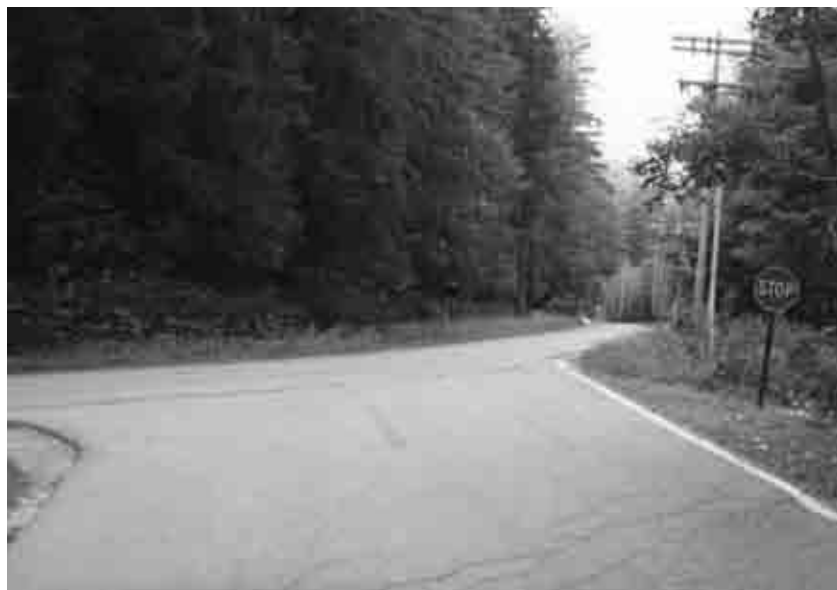
Figure 1.3: View west along Route 12 from the intersection of Elm Street (Route 12) and River Road, September 2001. SUNY ESF. The site of the Thompson Place is the wooded area at the right.

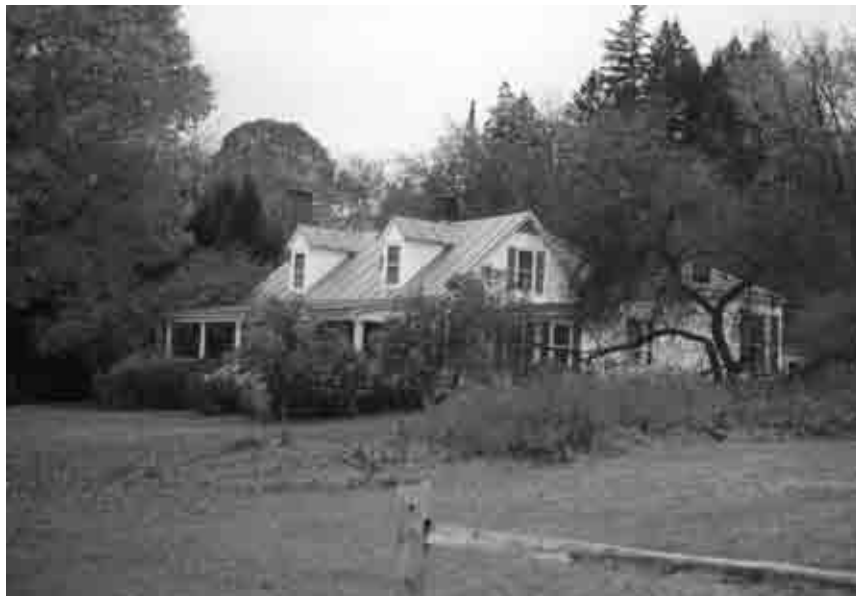
Figure 1.4: The Octagon Cottage, view southwest, October 2001. SUNY ESF. The tall Norway spruce in the background are on the Mansion grounds.

The Octagon Cottage is a privately owned, one-and-a-half story, wood-frame, side-gable residence with a connected octagonal pavilion, double-hung sash windows, and vinyl siding. [Figure 1.4] The building is purportedly the original Marsh house, built between 1789 and 1790, which was moved without its attached rear wings from the present location of the Mansion grounds tennis court by Frederick Billings in c.1869 to serve as his farm manager's residence. In 1890, a new farm manager's house was built, presently known as the 1890 Farm House at the Billings Farm & Museum. From this time through the 1940s, the Octagon Cottage was used by Elizabeth Billings as her residence

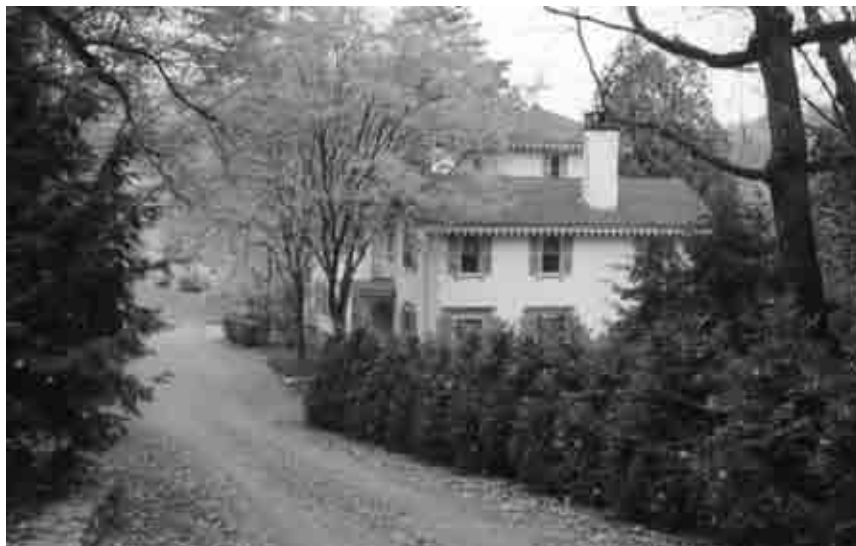
Figure 1.5: View east down Moore Place from Elm Street with Echo Acre to the right, October 2001. SUNY ESF.

floodplain meadow. Moore Place was opened around the time the property was sold by Charles Marsh (Junior) in 1861. In this year, Benjamin Mason, a noted painter, had an Italianate-style frame house built just off Elm Street on the south side of Moore Place. The Mason house is now known as “Echo Acre” and is a residence of Laurance S. Rockefeller. [Figure 1.5] Moore Place is within the National Register-listed Woodstock Village Historic District. Echo Acre is listed as a contributing building in the district (#310).

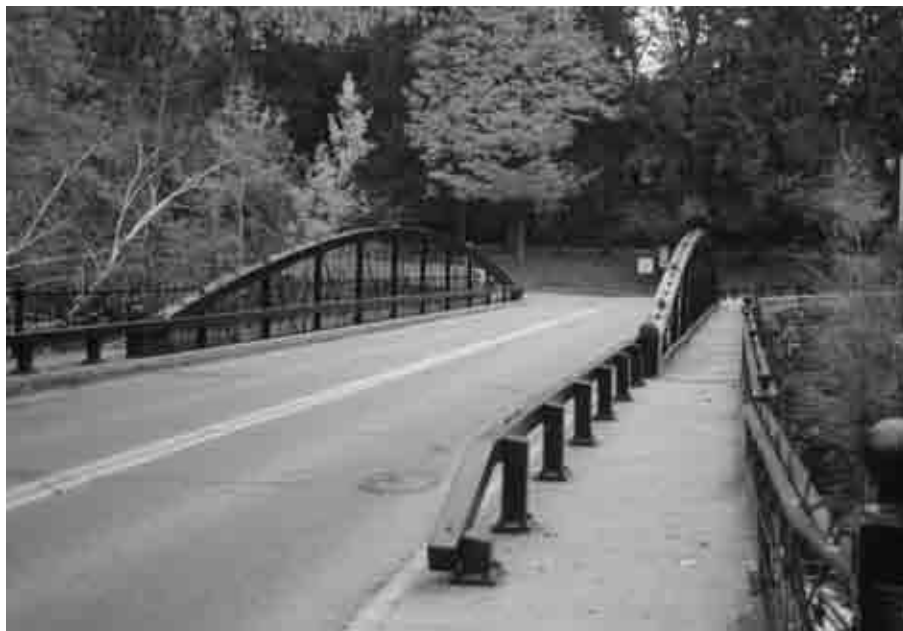
Figure 1.6: The Elm Street Bridge, view north with mature Norway spruce along the perimeter of the Mansion grounds in the background, October 2001. SUNY ESF.

The Elm Street Bridge spanning the Ottauquechee River was built as an iron bowstring truss bridge in 1869 to replace a wooden covered bridge that had been rebuilt and replaced numerous times. [Figure 1.6] Frederick Billings made a substantial financial contribution to the town to assist in the building of the bridge, which was his most direct access to the village. In 1980, following a lengthy preservation effort, the bridge was rebuilt as a 105-foot-long by 25-foot-wide welded

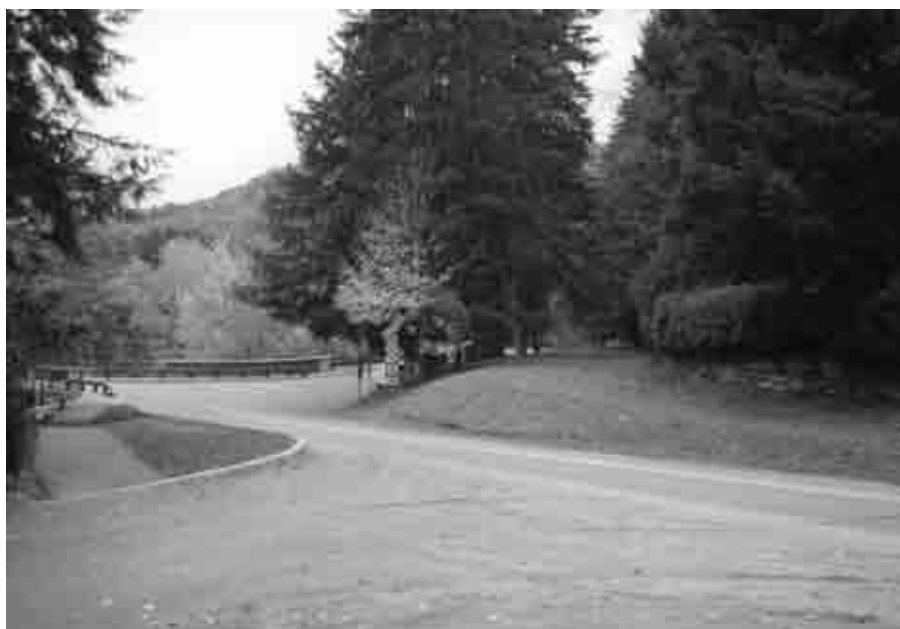
Figure 1.7: View south and west of the triangular park above the Elm Street Bridge, October 2001. SUNY ESF.

The triangular park above the Elm Street Bridge off the southeast corner of the Mansion grounds is a remnant of a triangular intersection that once existed on the steeply sloping ground between River Street and Elm Street. [Figures 1.6, 1.7] The origin of this intersection is not known, but it probably was created with the opening of the first Elm Street bridge in 1797. The park was the open ground between three road legs: River Street (about 150 feet long), Elm Street (about 175 feet long) and the connecting leg along the Mansion grounds (about 300 feet long). By the 1870s, the park was meadow, enclosed by a post-and-plank fence. In August 1882, Frederick Billings improved the triangular park with the addition of a granite post-and-chain fence, and plantings of Norway spruce,

the origin of this intersection is not known, but it probably was created with the opening of the first Elm Street bridge in 1797. The park was the open ground between three road legs: River Street (about 150 feet long), Elm Street (about 175 feet long) and the connecting leg along the Mansion grounds (about 300 feet long). By the 1870s, the park was meadow, enclosed by a post-and-plank fence. In August 1882, Frederick Billings improved the triangular park with the addition of a granite post-and-chain fence, and plantings of Norway spruce,

arborvitae, and assorted shrubs. Three gas lampposts had been added by 1887.⁷ The 300-foot long connecting road leg was probably abandoned around the time Elm Street was paved in the 1950s. The trace of this abandoned roadbed remains visible and is maintained as turf. Located in the public right-of-way and not within the National Historical Park, the park contains a dense grove of Norway spruce that forms an extension of the perimeter Norway spruce on the Mansion grounds. The triangular park is within the National Register-listed Woodstock Village Historic District.

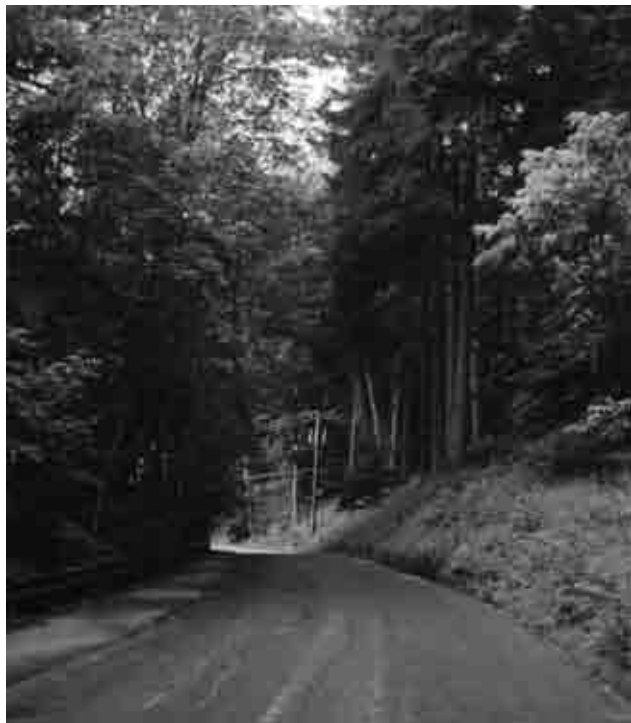
Figure 1.8 View west down River Street from the triangular park above the Elm Street Bridge, July 2002. SUNY ESF.

River Street is a two-lane asphalt-paved local road that borders the south side of the Mansion grounds, extending from the Elm Street Bridge west. [Figure 1.8] The origin of River Street is not documented, but it was probably part of the original east-west route along the north side of the

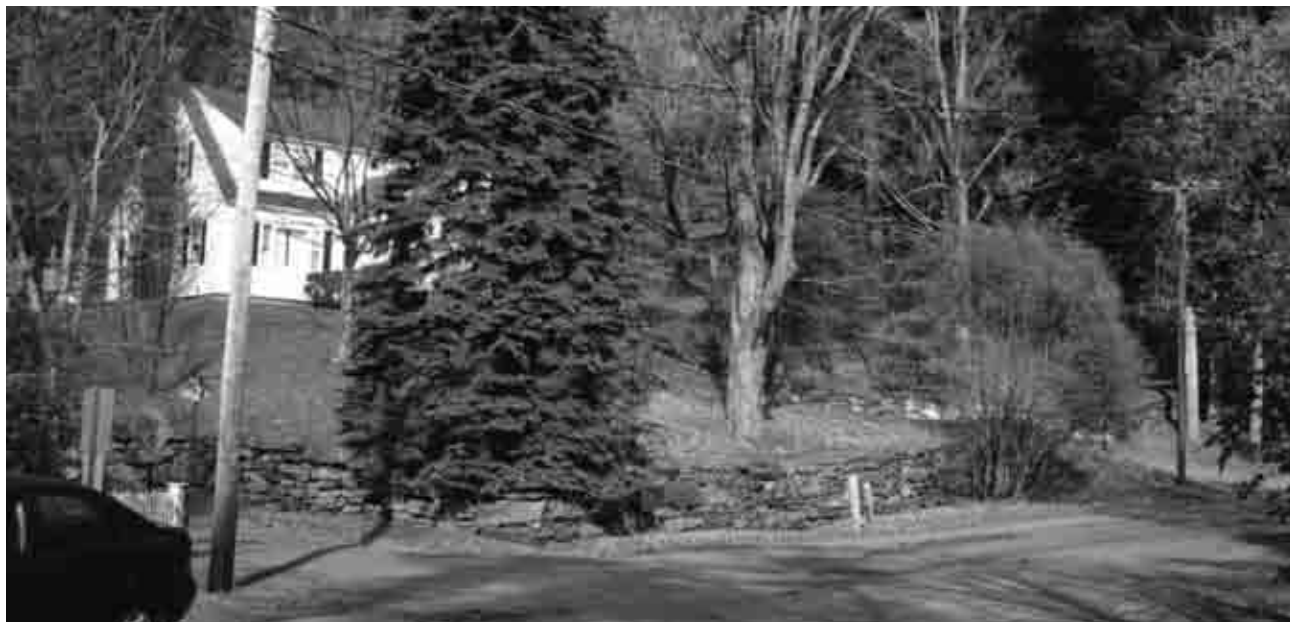
Figure 1.9: The Sterling property, view northeast across the intersection of North and River Streets, October 2001. SUNY ESF.

The Sterling Property is a 1.17-acre residential lot at the corner of North and River Streets that was subdivided from the Mansion grounds in 1951. [Figure 1.9] The lot, part of which was within Frederick Billings's 1869 purchase of the Marsh Place, contains a one-and-a-half story, 1,080 square-foot prefabricated frame house built in 1952 by a firm called "Northern Homes." The lot has two hundred feet of frontage along River Street and, at the rear, borders the service drive that extends from North Street to the Belvedere. To the west it adjoins North Street and the Gardener's Cottage property, and, to the east, the Mansion grounds. The Mansion grounds perimeter stone wall runs along the River Street frontage of the property, except where it was removed to allow for driveway access. The lot was purchased by Laurance S. Rockefeller in 1981 and is presently owned by the Woodstock Resort Corporation.⁸ Landscape features on the lot that survive from the property's earlier development as part of the Mansion grounds include the perimeter stone wall, specimen deciduous trees, and planted conifers along the perimeter. The Sterling property is within the National Register-listed Woodstock Village Historic District, in which it is identified as a

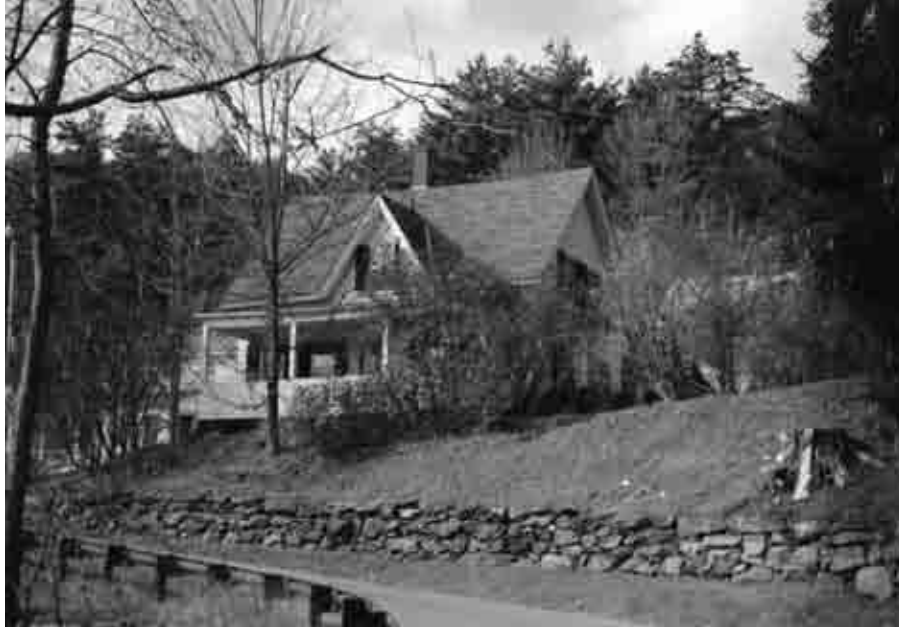
Figure 1.10: The Gardener's Cottage, view northwest with North Street and the Mansion grounds perimeter stone wall in the foreground, October 2001. SUNY ESF

The Gardener's Cottage property at 3 North Street is a 0.53-acre residential lot containing a house historically used by staff of the Billings Estate, including the head gardener. Built in c.1858 by Nathan and Arriette Claflin and acquired by Frederick Billings in 1872, the house is one-and-a-half stories with a side-gable front, full-width front porch, and a steeply-pitched front gable. [Figure 1.10] It has louvered six-over-six double-hung sash windows, shingle siding, a center chimney, asphalt roofing, and a long rear ell with a garage and loft that is banked up to the service drive to the Mansion grounds. This drive crosses the northern edge of the property along an unwritten right-

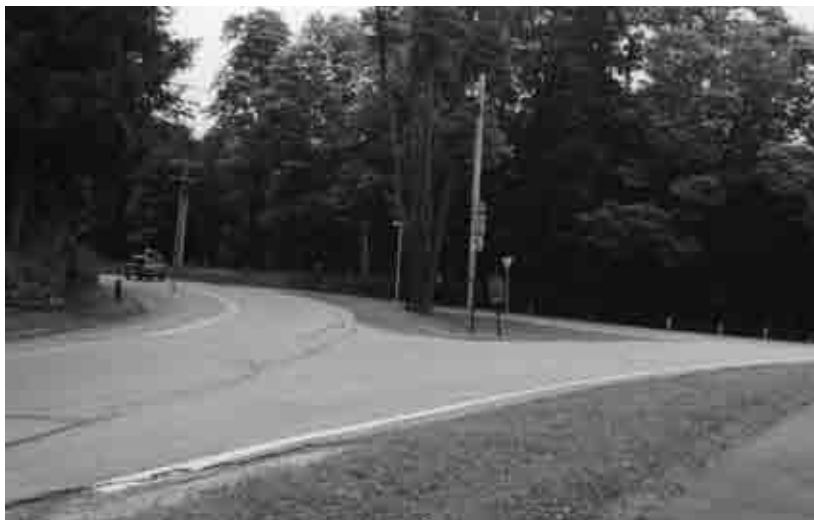
Figure 1.11: Thompson Park, view north with River Road to the right and Route 12 and the Mansion grounds perimeter stone wall to the left, July 2002. SUNY ESF.

Thompson Park is the name, no longer in use, of the triangular island formed by the three-legged intersection of River Road and Elm Street (VT-12). [Figure 1.11, see also Figure 1.1] In November 1881, when Frederick Billings was at work rebuilding the adjoining Thompson house, he was also improving what he called “Thompson Park” by enclosing it with posts, probably the granite-and-chain type he used two years later at the triangular park near the Elm Street Bridge. Billings also regraded the intersection and

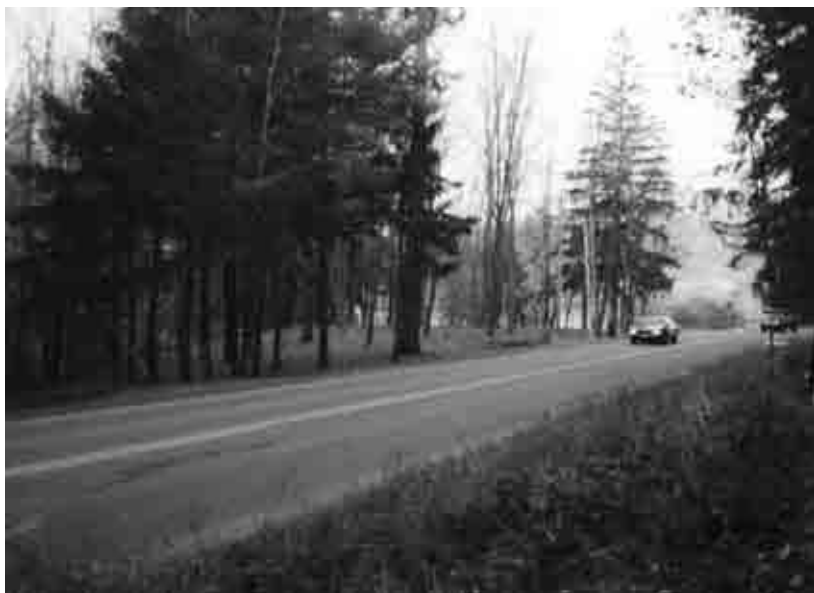
Figure 1.12: Site of the Thompson Place to the left of the passing car, view east along Route 12 with the Mansion grounds at the right, November 2000. SUNY ESF

At the northwest corner of the intersection of Route 12 and River Road is a 3.3-acre wooded lot. [Figure 1.12] This property is the house lot of a farm that belonged to the Dennison and later Thompson families. The farmhouse was built in 1801 at the corner facing south; it was subsequently rebuilt in 1881 by Frederick Billings, who had acquired

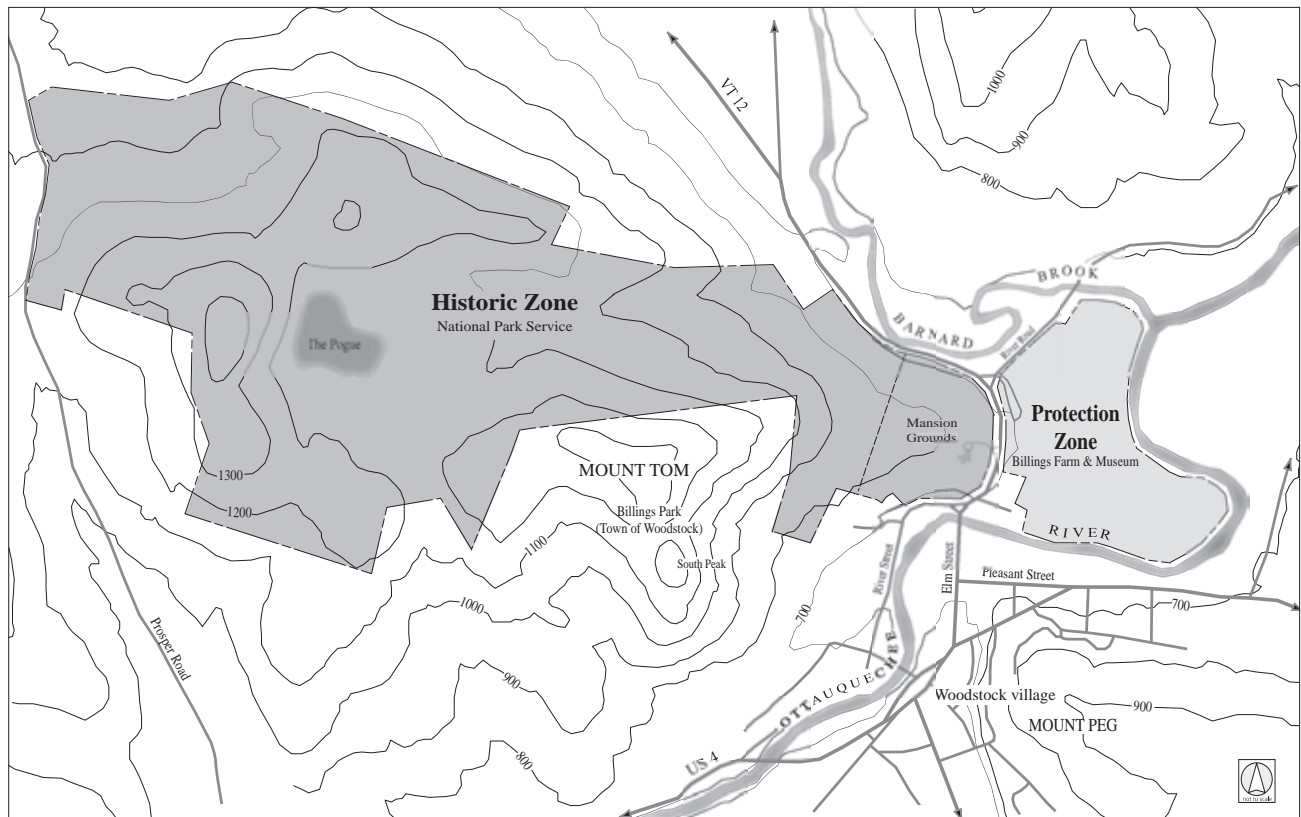
Figure 1.13: Map of Marsh-Billings-Rockefeller National Historical Park illustrating the Historic Zone (National Park Service property, including the Mansion grounds) and the Protection Zone (Billings Farm & Museum). SUNY ESF

The Historic Zone is a 555-acre parcel that extends from Elm Street at the Mansion grounds west across Mount Tom to Prosper Road. Outside the Mansion grounds, the Historic Zone consists of mature forest plantations, native woodlands, a system of carriage roads, a mountain-top pond known as the “Pogue,” and meadows. This land was documented in the

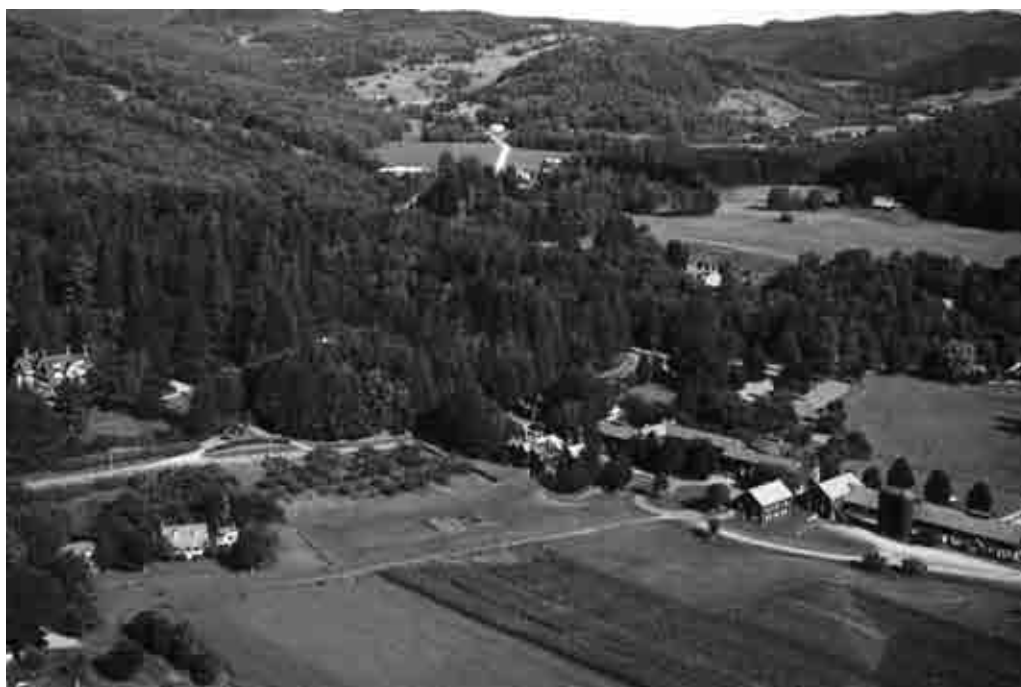
Figure 1.14: Aerial view of Billings Farm & Museum looking northwest from Mount Peg across the intervale meadow toward the Mansion grounds, c.1998. Courtesy of Billings Farm & Museum and Mayer Photographics, Rutland, Vermont.

The Protection Zone consists of eighty-eight acres that occupies much of the Ottauquechee River floodplain on the east side of Elm Street across from the Mansion grounds. [Figure 1.14] It encompasses the core of Billings Farm & Museum, which is owned and operated by The Woodstock Foundation, Inc. and was opened to the public in 1983, nine years before the establishment of the National Historical Park. The Protection Zone was part of the original Marsh Place, but the northern half was sold in 1855 to become the Windsor County Fairgrounds. In 1869, Frederick Billings purchased the portion of the property owned by Marsh, and in 1932, Billings’s heirs acquired the fairgrounds property. Billings Farm & Museum includes cultivated fields and fenced pastures, with a complex of buildings toward the northeast corner of the property, across from the tennis court and Double Cottage on the Mansion grounds. The Billings Farm & Museum buildings include the farm’s restored farm manager’s house (1890) and Herdsman’s House

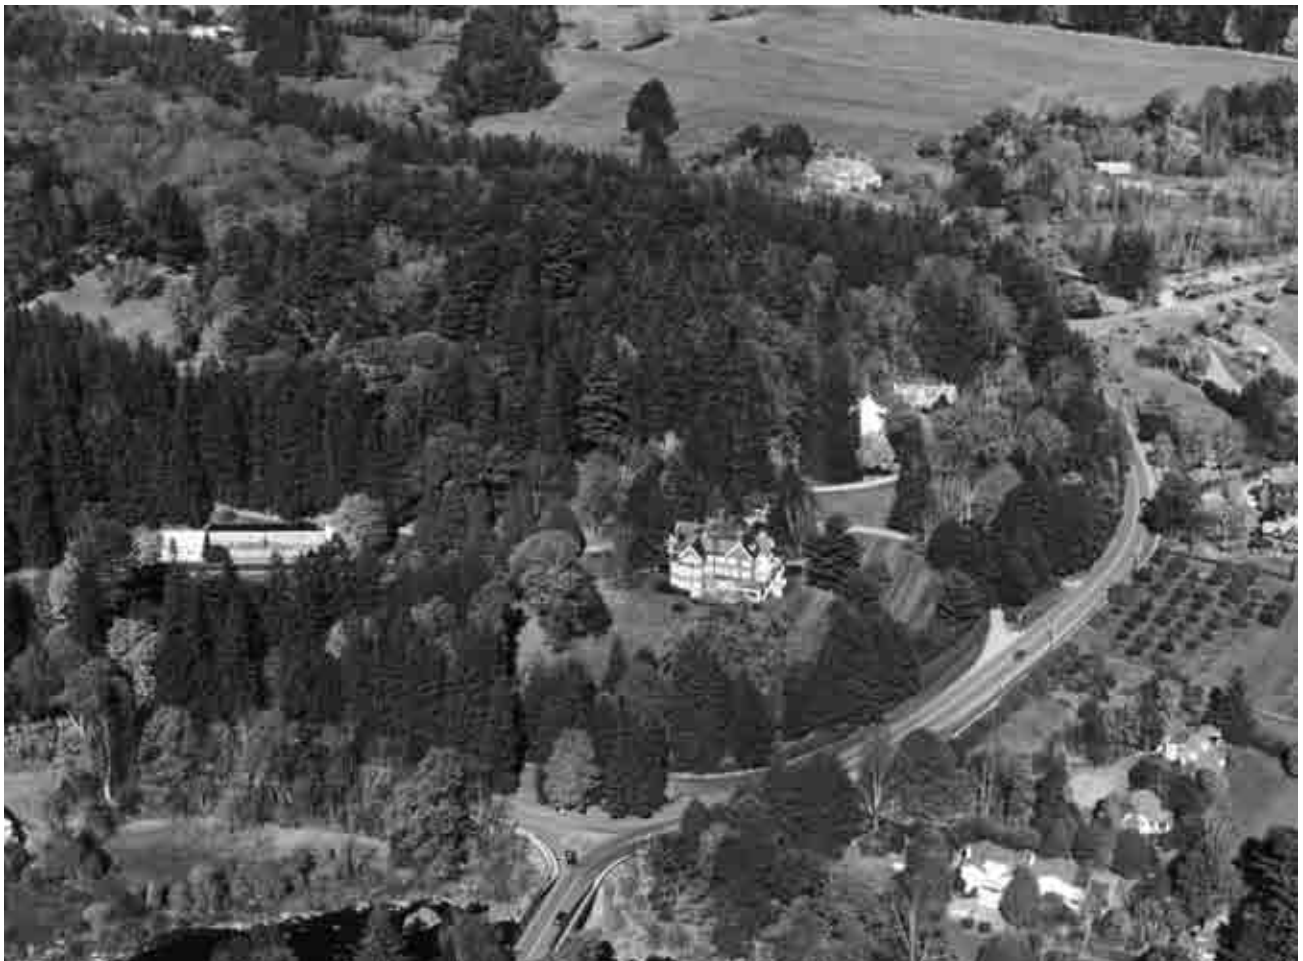
Figure 1.15: Aerial view of the Mansion grounds from the south, 1994. Copyright Aero Photo, Inc., Wareham, Massachusetts.

On the approach north across the Elm Street Bridge from Woodstock village, the Mansion grounds appear as an elevated, forested landscape punctuated by the late-nineteenth-century peaked roofs and chimneys of the Mansion. [Figure 1.15] The shady character of the landscape is accentuated by its contrast with the more densely developed village on the south side of the river, and by the broad open space of the estate's farm occupying the floodplain meadow to the east, now part of the Billings Farm & Museum. The character of the landscape owes much to Frederick Billings's pioneering reforestation program that he began in the 1870s, in which he made extensive use of the Norway spruce and other conifers not only to line the perimeter of the grounds, but also to reforest the worn-out pastures on

the hill behind the Mansion. The great height of these trees—many of which are now over 130 years old—enhances the dramatic natural topography of the landscape. The Mansion is positioned on a terrace at an average elevation of thirty feet above Elm Street, set apart from the street by a three-foot-high stone wall that borders the entire landscape. Behind the Mansion, the land ascends steeply another eighty feet before leveling out at a hilltop pasture. West of the Mansion grounds, the land continues to ascend nearly another five hundred feet to the twin peaks of Mount Tom, visible in a vista through the Terrace Gardens.

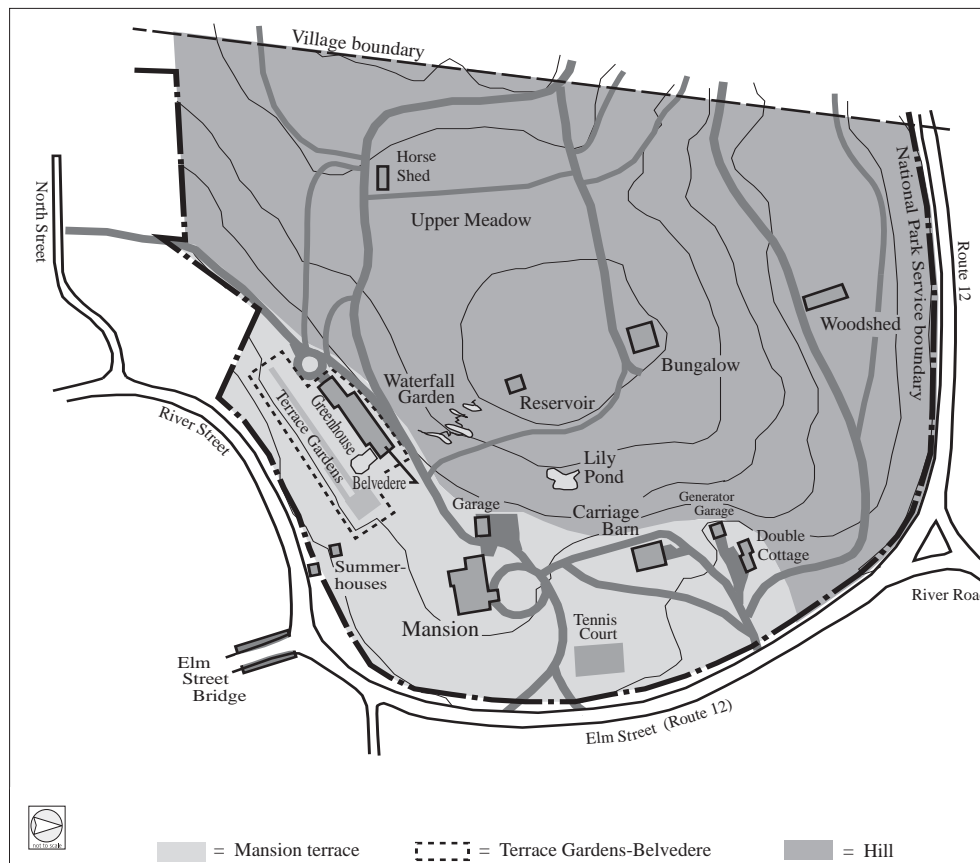
Figure 1.16: Diagram of the Mansion grounds illustrating organization and major landscape features. SUNY ESF.

The Mansion terrace occupies the lower level of the Mansion grounds adjoining Elm Street (Route 12) and River Street. [Figures 1.16, 1.17] The landscape has an idealized rural character that reflects the enduring popularity in America of the English landscape garden, characterized by sweeping lawns, informally placed specimen trees, and curving drives. Frederick Billings built this landscape based largely on a conceptual plan made in 1869 by landscape gardener Robert Morris Copeland, but gave it a distinctive character through his reforestation program. His heirs added a series of improvements that reflected Neoclassical and Arts and Crafts-inspired design characteristic of the turn of the century. This late-nineteenth-century landscape has survived in large part to the present, with an overlay of mid-twentieth-century improvements

To the rear (west) of the Mansion is a complex of buildings and gardens positioned on terraces built into the sloping ground between the south side of the hill and River Street [see Figures 1.16, 1.17]. The focal point of the complex is the Belvedere, a Swiss chalet-style building designed by Detlef Lienau in c.1872 as part of a complex that included four greenhouses built by Lord’s Horticultural Works and a bowling alley. A surviving half-span greenhouse, rebuilt in 1902 by Lord & Burnham Company, extends off the bowling alley, with the foundations of two others extending to the south. These foundations were converted into a swimming pool in 1931; between 1959 and 1962, the Rockefellers added a terrace and patio around the pool. At the same time, they commissioned the landscape designer Zenon Schreiber to add a series of rock gardens to transition the pool terrace to the adjoining lawn. At the west end of the greenhouse, the Rockefellers also added a utility building known as the Garden Workshop in c.1958 and, in c.1968, a small putting green south of the greenhouse attributed to the design of Robert Trent Jones.

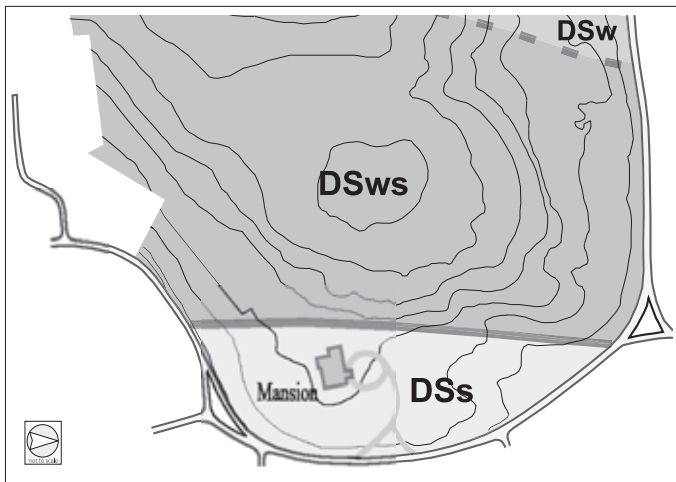
Figure 3.1: Bedrock formations in the Mansion grounds. SUNY ESF, based on P.H. Chang et al., “Geologic Map and Structure Sections of the Woodstock Quadrangle, Vermont (Montpelier: Vermont Geological Survey, c.1965). “DSs” designates Standing Pond volcanics; “DSws” and “DSw” designate two parts of the Waits River formation.

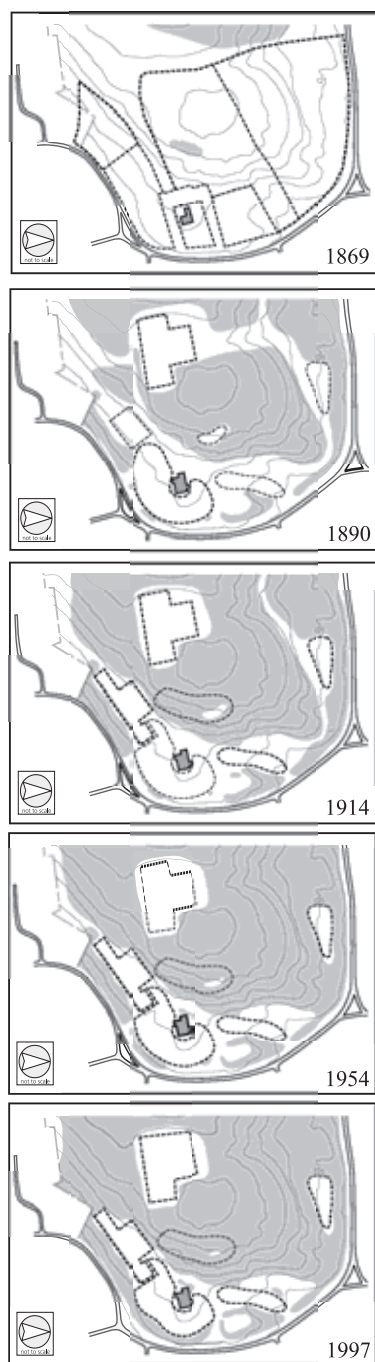
Figure 3.2: Spatial organization of the Mansion grounds at the end of the five historic eras. SUNY ESF. Dashed lines indicate primary spaces within the overall spatial organization of the open Mansion terrace and forested hill; gray shading indicates forest cover. For orientation purposes, the maps show only the Marsh house/Mansion and perimeter roads.

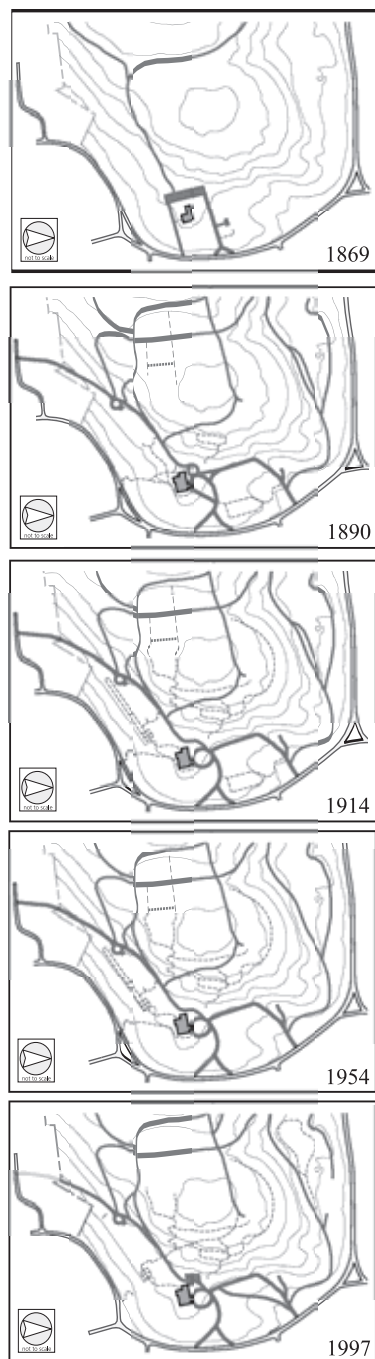
Figure 3.3: Circulation within the Mansion grounds at the end of the five historic eras. SUNY ESF. Solid lines indicate drives and roads, dashed lines indicate walks and paths. For orientation purposes, the maps show only the Marsh house/Mansion.

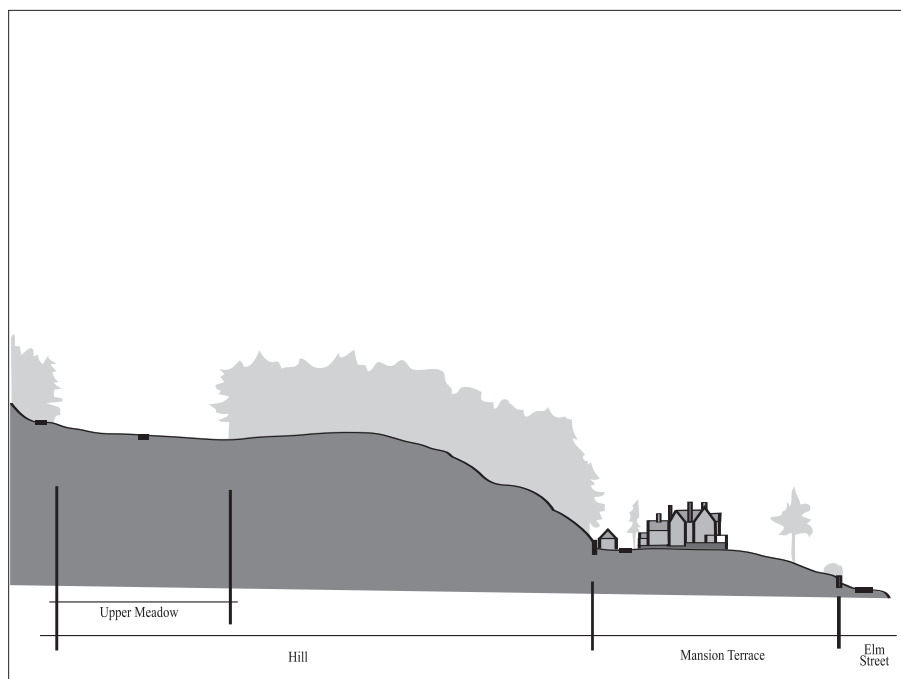
Figure 3.4: East-west cross section through Mansion grounds at the Mansion illustrating large-scale topography (landform) of the hill and Mansion terrace at the end of the historic period. SUNY ESF.

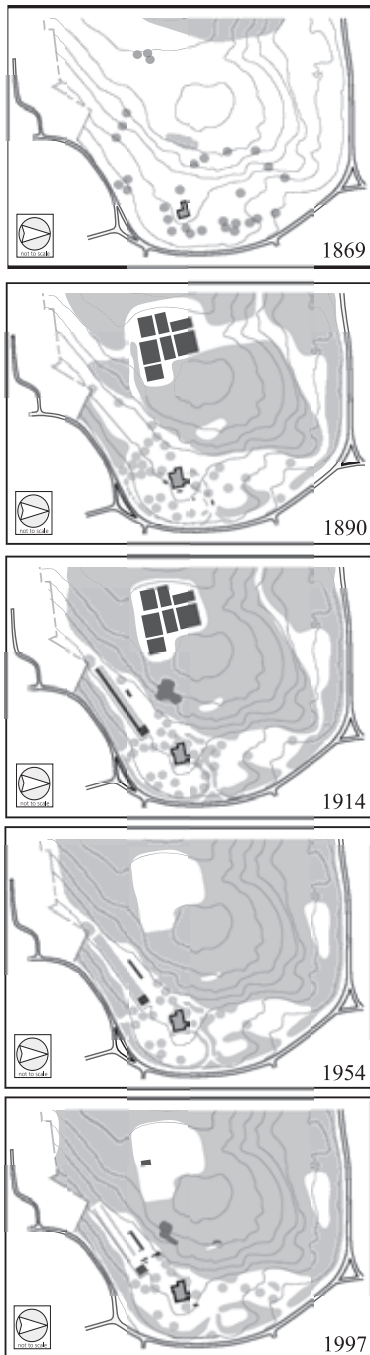
Figure 3.5: Vegetation of the Mansion grounds at the end of the five historic eras. SUNY ESF. Gray areas indicate forest plantations, specimen trees, and hedges. Black areas indicate herbaceous beds (flower, rock garden, and vegetable beds). For orientation purposes, the maps show only the Marsh house/Mansion.

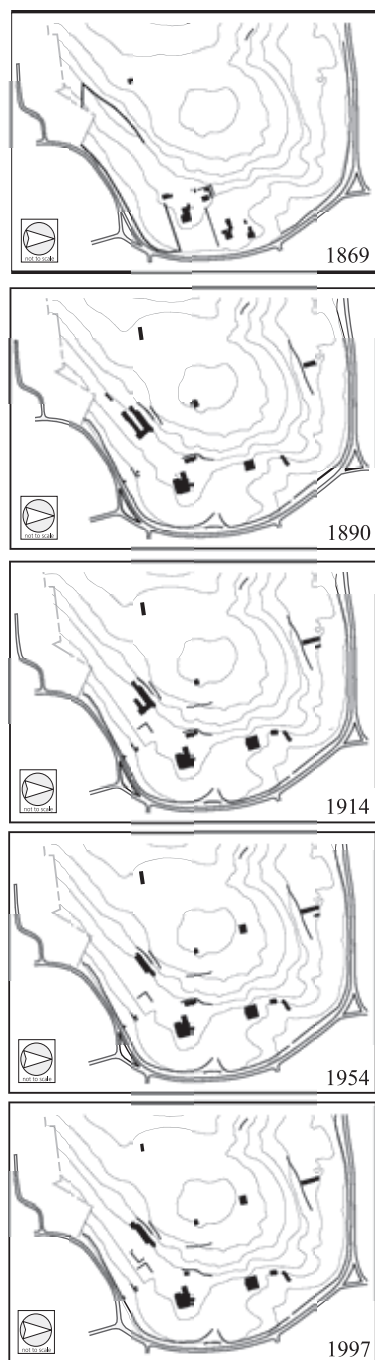
Figure 3.6: Buildings and structures on the Mansion grounds at the end of the five historic eras. SUNY ESF. Buildings are shown in black; heavy lines indicate stone walls as the major structures on the Mansion grounds. For orientation purposes, the maps show only perimeter roads.

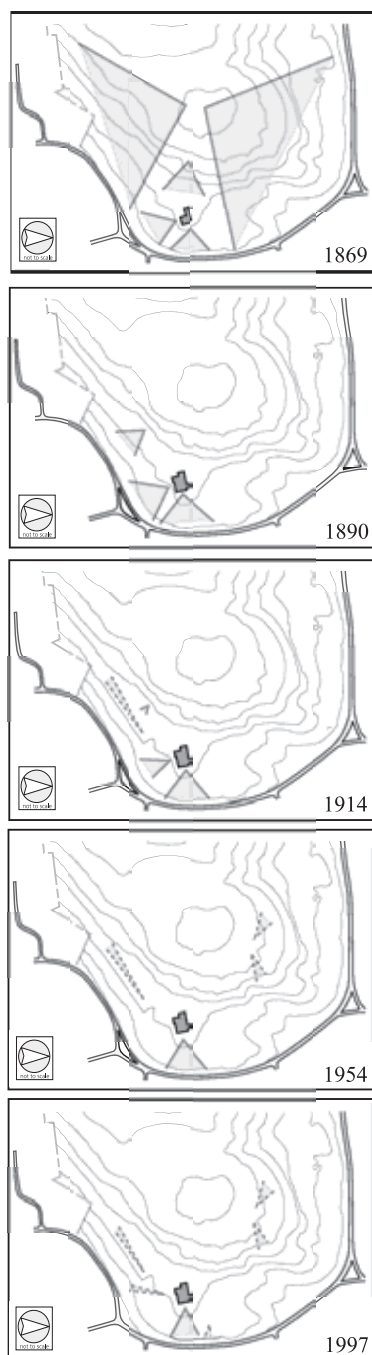
Figure 3.7: Views and vistas on the Mansion grounds at the end of the five historic eras. SUNY ESF. Views are indicated by solid lines and vistas by dashed lines. For orientation purposes, the maps show only the Marsh house/Mansion.

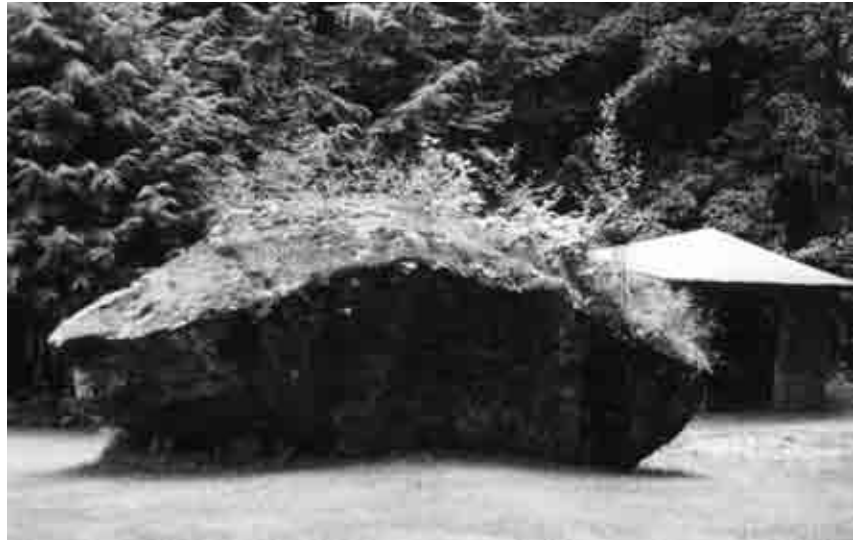
Figure 4.1 The Mansion lawn boulder, view south with the Upper Summerhouse in the background and a mature sugar maple (V-3) to the right that was removed in 2000, July 2002. SUNY ESF.

The Mansion lawn boulder is located off the northeast corner of the Upper Summerhouse. Its geologic composition has not been determined. The boulder has an irregular four-sided shape and is approximately 8' tall, 24' at its longest, and 19' at its widest; it is partly covered in lichen and moss, with a few volunteer woody plants growing on top. [Figure 4.1] A series of heavy-gauge rusted iron wires, set on iron spikes fixed in the stone, crisscross the sides and top of the boulder.

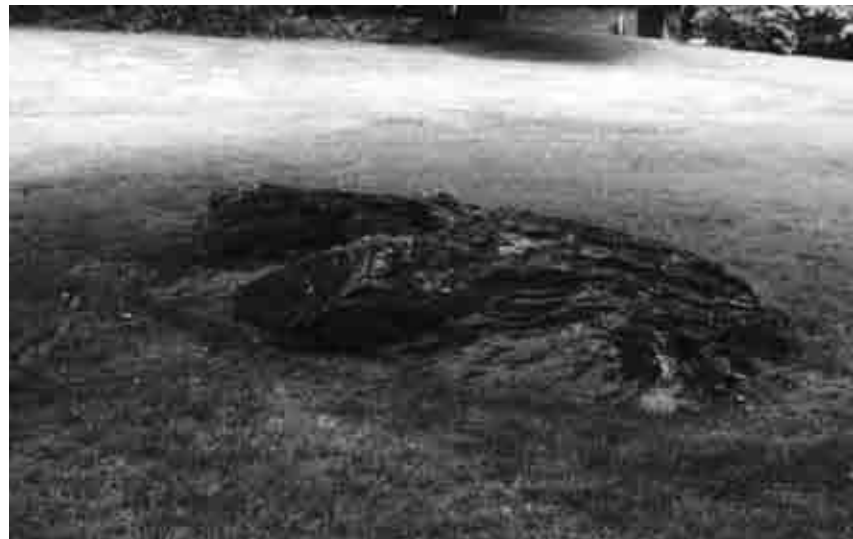
Figure 4.2: Rock outcropping in the Mansion lawn near the Mansion-Flower Garden walk, view north, August 2001. SUNY ESF.

The outcroppings on the lawn west and south of the Mansion are located on the north side of the Mansion-Flower Garden walk, along the Belvedere drive below mature arborvitae, and on Fairy Hill. They are composed of the native metamorphic bedrock of the Mansion grounds, either of the Waits River or the Standing Pond Volcanics formation. The outcropping on the Mansion-Flower Garden walk is approximately 10' long by 5' wide and is an isolated feature in the lawn. [Figure 4.2] The one along the Belvedere drive is approximately 10' long by 7' wide and is set within a rock garden along the upper pool terrace stairs; it is surrounded by constructed outcroppings. The outcropping on Fairy Hill measures 20' long by 5' wide and is largely obscured by rhododendron.
