CULTURAL LANDSCAPE REPORT FOR THE MANSION GROUNDS

MARSH-BILLINGS-ROCKEFELLER NATIONAL HISTORICAL PARK

VOLUME II: EXISTING CONDITIONS & ANALYSIS

Olmsted Center for Landscape Preservation
National Park Service, Boston, Massachusetts, 2005

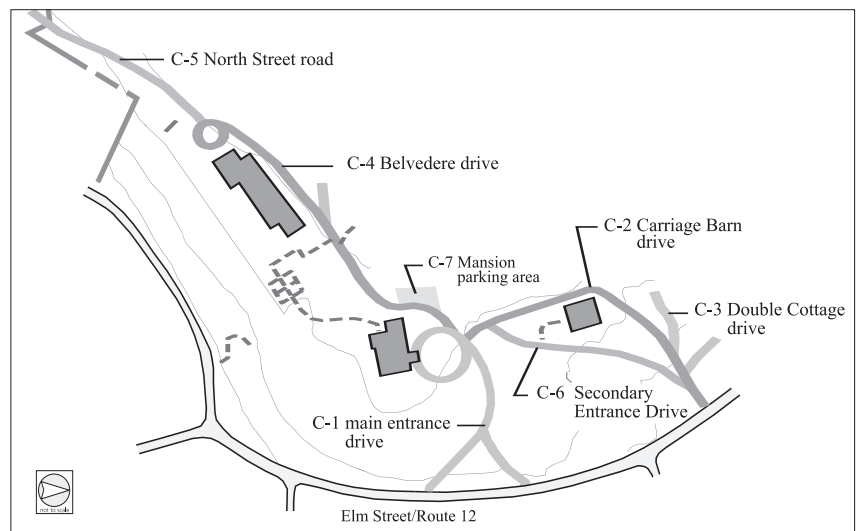
Figure 4.3: Diagram of circulation features on the Mansion Terrace. SUNY ESF. Dashed lines indicate paths, heavy lines indicate drives.

The main entrance drive begins at Elm Street where it branches into two 100’-long legs that form a triangular island. [Figure 4.3] After passing a set of stone gateposts, the drive enters the Mansion lawn, following a southward-leaning arc for 150’, and ascending a 10% slope. It then forms an 80’-diameter circle that passes beneath the Mansion’s porte cochere. The Belvedere drive and Mansion parking area intersect the west side of the circle, and the Carriage Barn drive the east side. The earthen-gravel drive measures approximately 10’ to 12’ wide and is bordered by lawn with no visible edging. [Figure 4.4] Drainage is provided by five perimeter catch basins with steel grates. The circle is annually graded with a 3/4" gray gravel obtained from Hartland, Vermont, or West Lebanon, New Hampshire, using the same specifications employed during the late Rockefeller era. The main entrance drive is no longer used as the main entrance to the Mansion grounds.

The Double Cottage drive is a short driveway that extends for 120' from the Carriage Barn drive to the Generator Garage [see Figure 4.3]. The earthen-gravel drive averages 25' in width and does not have any visible edging. [Figure 4.6] The drive is not graded on an annual basis.

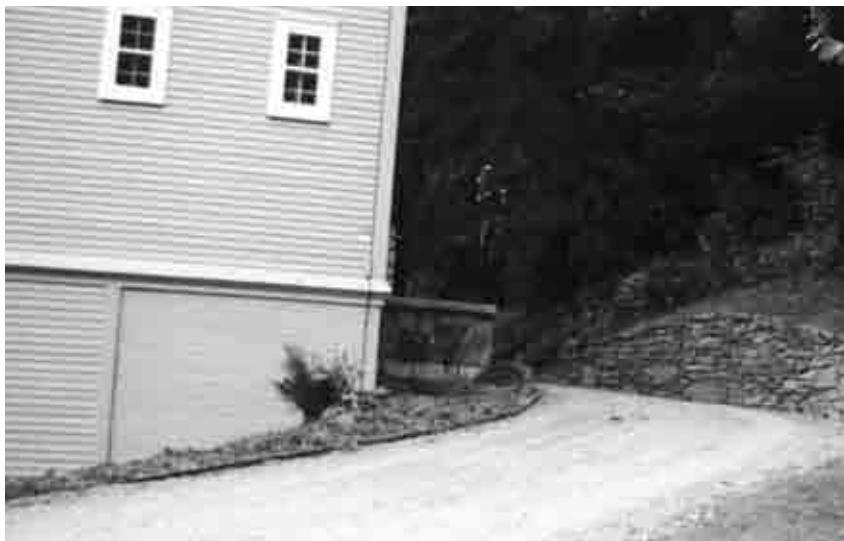
Figure 4.5: The Carriage Barn drive, view southwest at northwest corner of the Carriage Barn illustrating stone wall added in 1998–1999, September 2001. SUNY ESF.

In 1998–1999, as part of the rehabilitation of the Carriage Barn into a visitor center, the section of the drive leading to the front (south) entrance of the Carriage Barn was converted into a stone-paved walkway. At the same time, the main part of the drive was widened to 15', which required the addition of a stone retaining wall off the northwest corner of the Carriage Barn. [Figure 4.5] The Carriage Barn drive extends for approximately 600' from Elm Street on the east to the main entrance drive on the south, ascending a 12% slope from Elm Street to the Carriage Barn [see Figure 4.3]. It averages 15' wide, with a maximum width of 18' at the juncture with the main carriage road and Secondary Entrance Drive. A 25'-wide service area is at the north side of the Carriage Barn. The earthen-gravel drive has steel edging along sections rebuilt in 1978 (near Elm Street and south of the Carriage Barn) and is annually graded with a 3/4" gray gravel obtained from Hartland, Vermont, or West Lebanon, New Hampshire. The new stone retaining wall above the Carriage Barn is 50' long and 3' to 5' in height. A 2'- to 3'-high, 30'-long wall, probably original to the Carriage Barn, retains the lower slope of the drive above the pull-off to the rear entrance. The Elm Street entrance of the Carriage Barn drive serves as the main vehicular and pedestrian entrance to the Mansion grounds. The rest of the drive provides access for delivery and service vehicles to the Carriage Barn, and as pedestrian access between the Carriage Barn and Mansion.

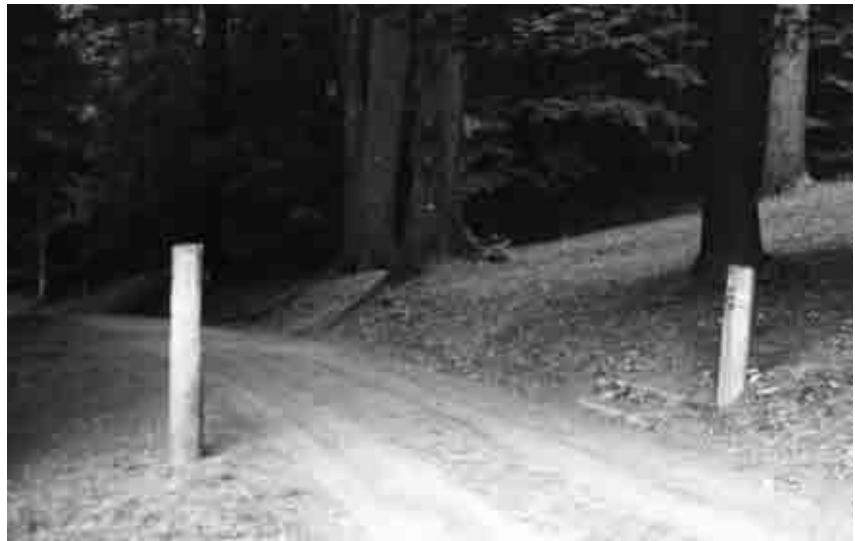
Figure 4.9: The Secondary Entrance Drive, view south from Carriage Barn drive illustrating yellowwoods (V-22) along the right side and swale lawn (V-2) to the left, October 2000. SUNY ESF.

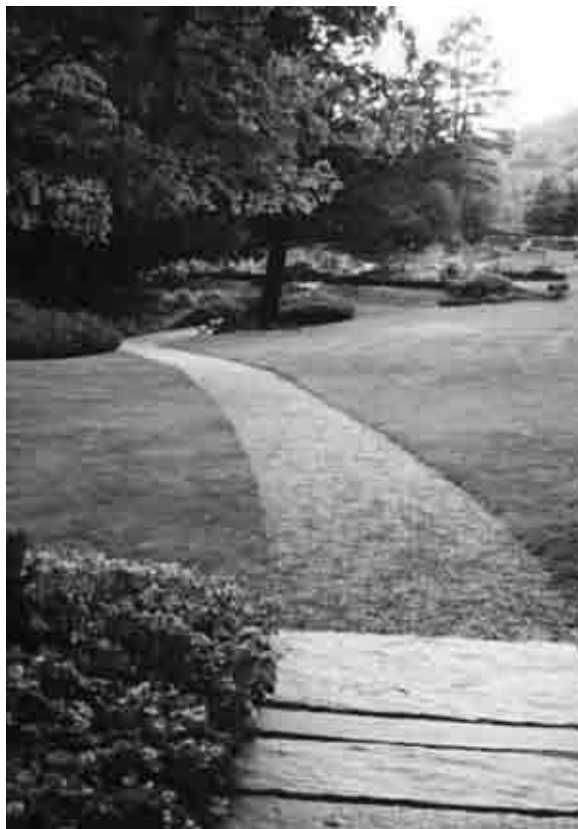
Figure 4.11: The Mansion-Flower Garden walk, view west toward Flower Garden illustrating gravel and stone surfaces, September 2001. SUNY ESF.

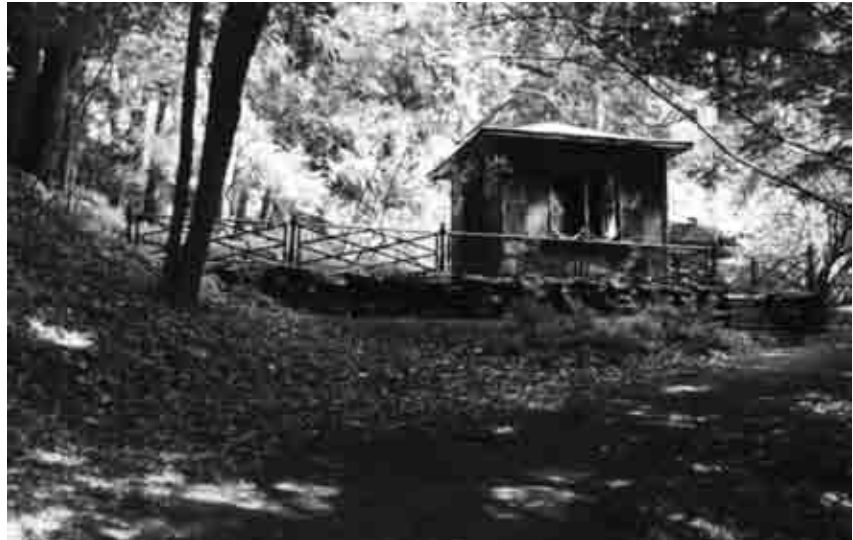
Figure 4.13: The Carriage Barn, view east of entrance and drive prior to construction of walkway, winter 1997. Olmsted Center for Landscape Preservation.

The Carriage Barn walkway did not exist during the historic period. [Figure 4.13]

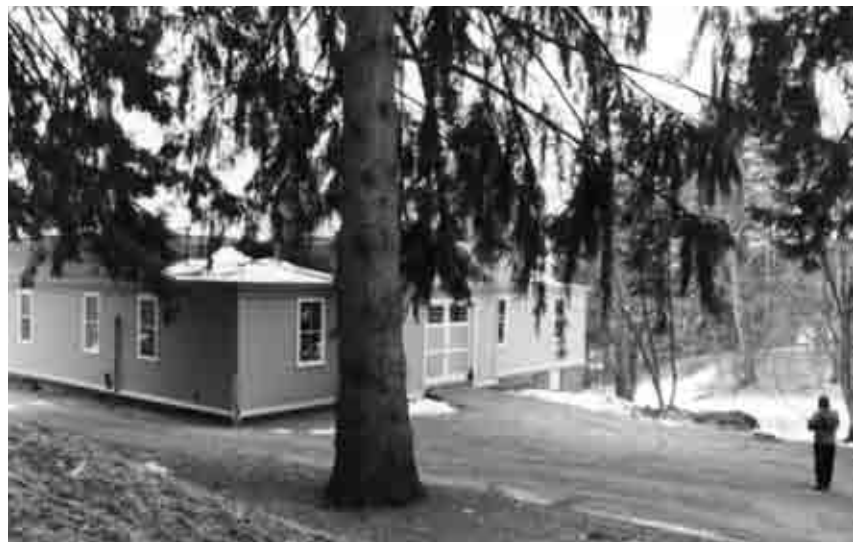
Figure 4.14: The Carriage Barn walkway, view east of stone patio and wall added in 1998–1999, with new beds (V-37) visible along building, July 2002. SUNY ESF.

Following rehabilitation of the Carriage Barn in 1998–1999, two of the Rockefeller-era terra-cotta planters were moved to either side of the visitor entrance. These are planted with flowering annuals (red geraniums in 2002) [see Figure 4.14].

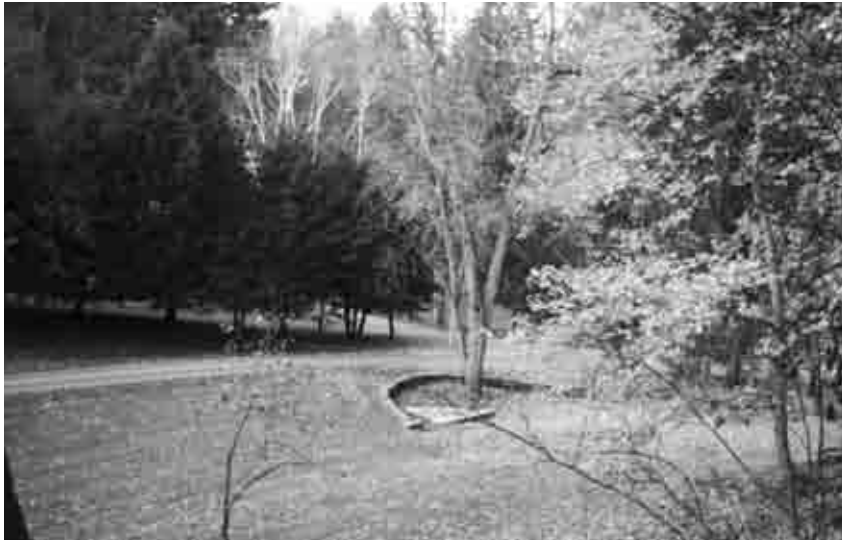
Figure 4.24: Browsed hemlock screening at intersection of Secondary Entrance Drive and Carriage Barn drive, view north from swale, September 2001. SUNY ESF. Also visible is the triangular Pogue-line valve pit (BS-13).

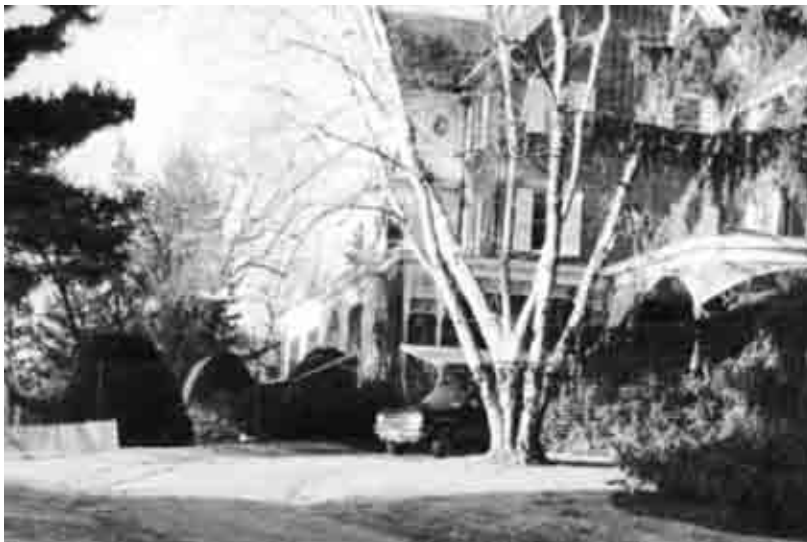
Figure 4.30: Paper birch in main entrance drive circle, April 2002. SUNY ESF.

A multi-leader specimen paper birch (*Betula papyrifera*) is located on the eastern edge of the main entrance drive circle adjoining the porte cochere and a large Norway spruce. [Figure 4.30] The tree has a 20' average canopy spread.

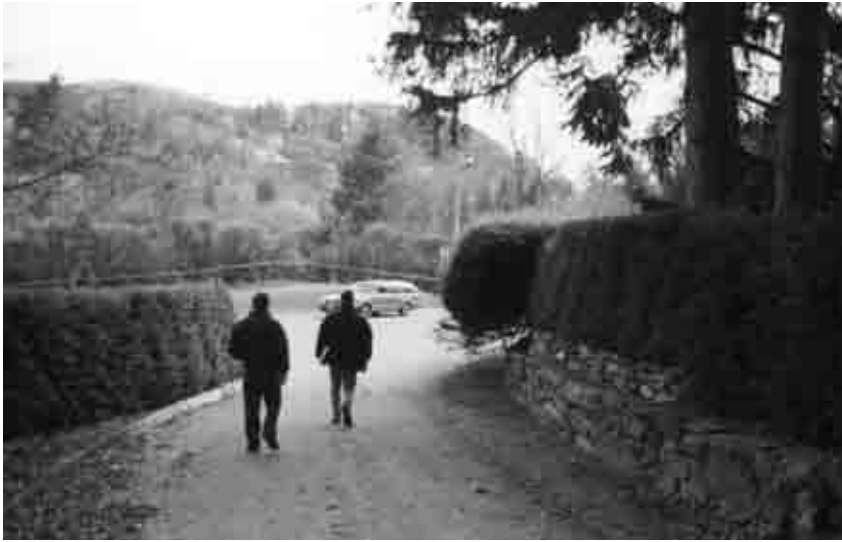
Figure 4.35: Perimeter hemlock hedge, view southeast along main entrance drive illustrating original c.1905 plant material (background) and sections replanted in 1997 (foreground), October 2000. SUNY ESF.

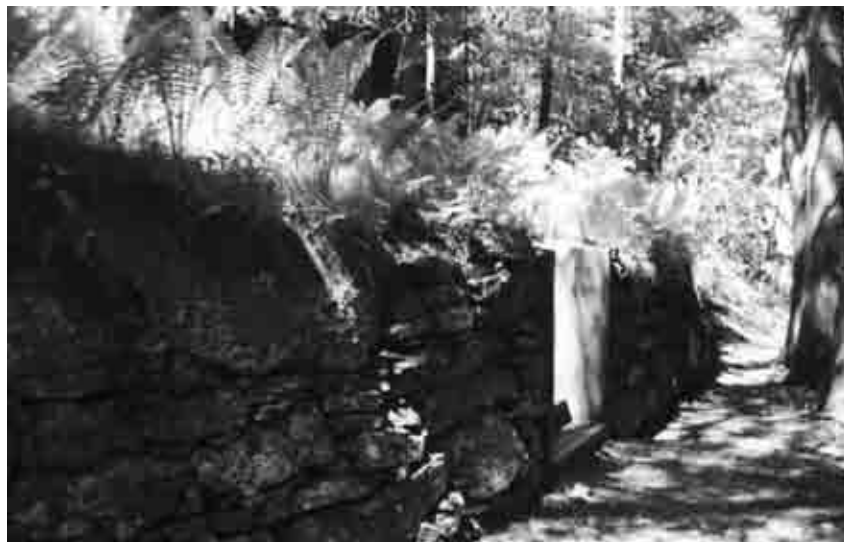
Figure 4.48: Mansion parking area stone wall, view north of section north of parking area showing break for steps leading up to the Lily Pond path, June 2001. SUNY ESF.

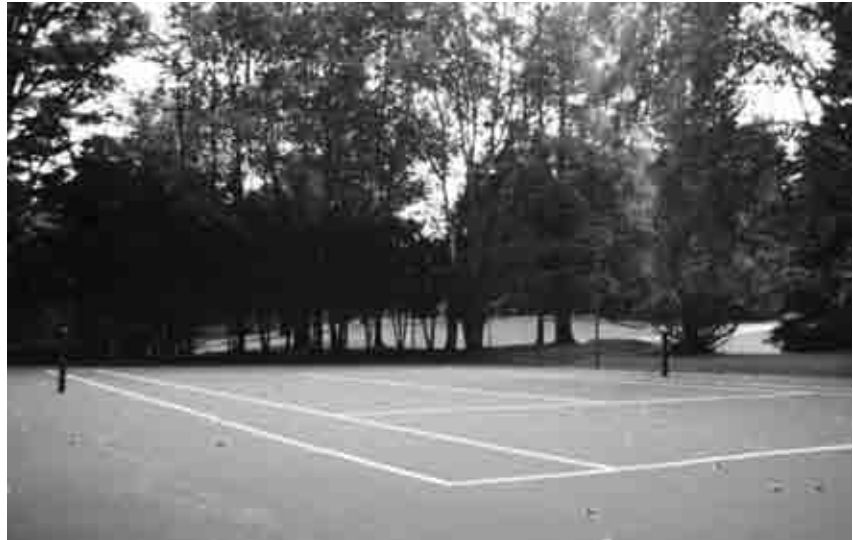
Figure 4.50: The tennis court, view south toward the Mansion with Cyclone fence (SSF-4) and tennis court grove (V-5) in the background, September 2001. SUNY ESF.

The tennis court fence is an 8'-high Cyclone-brand steel fence that is painted green [see Figure 4.50]. The fence has a 40'-long opening on the west side of the court, and ball finials on the posts.

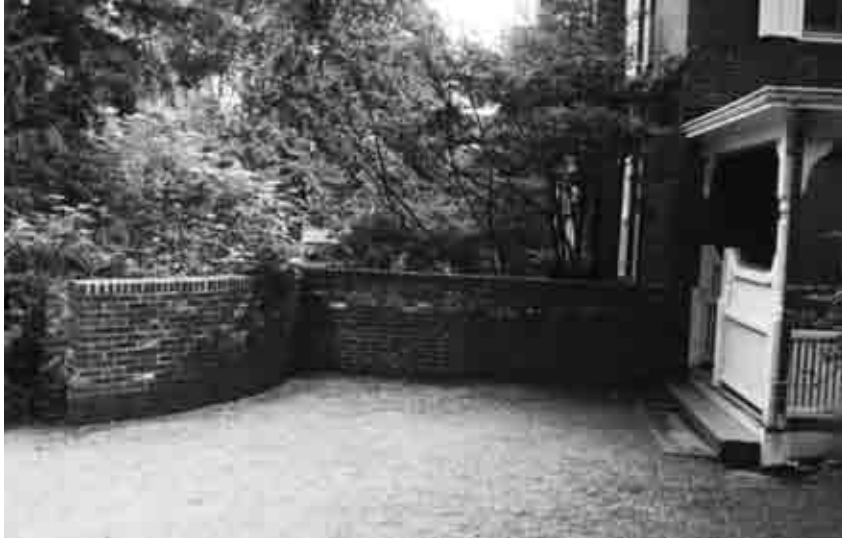
Figure 4.53: The brick retaining wall at the Mansion kitchen entrance, view east illustrating rebuilt sections and ghost of removed garbage enclosure, July 2002. SUNY ESF.

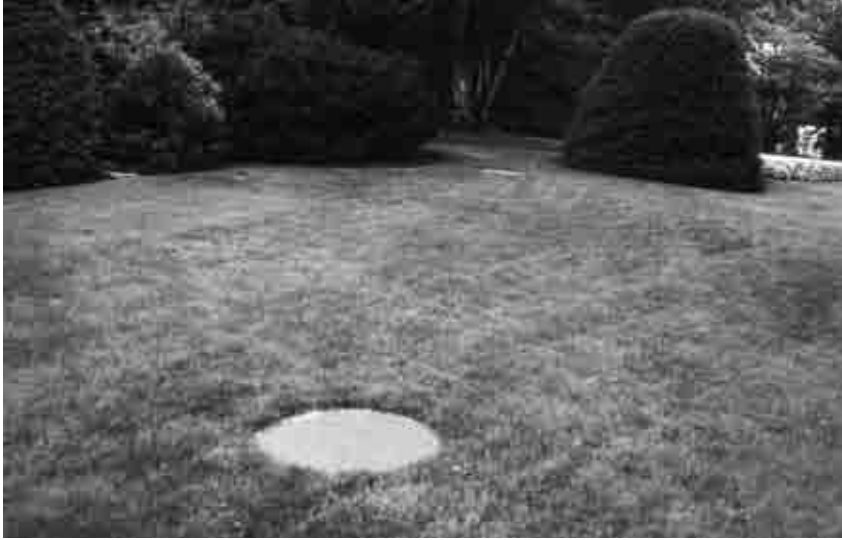
Figure 4.61: Fallout-shelter escape hatches (manholes) in the Mansion lawn, view north with the Mansion foundation shrubs at left, July 2002. SUNY ESF.

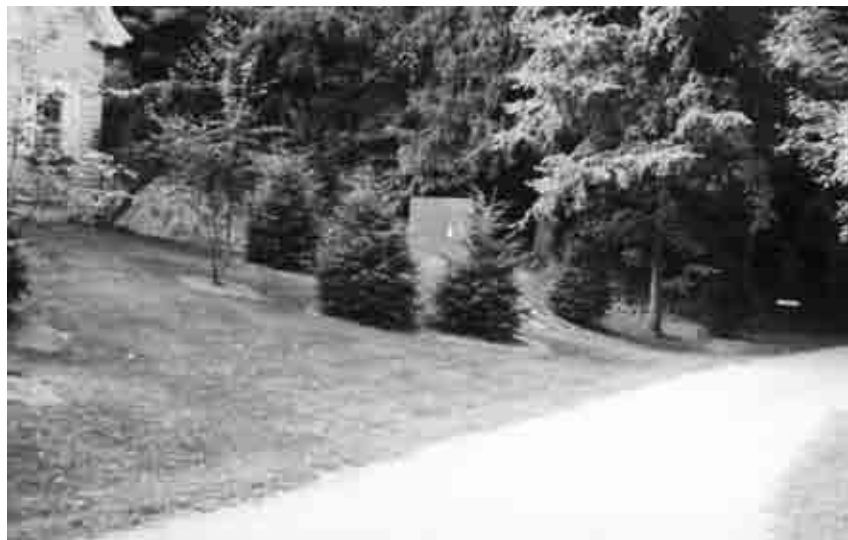
Figure 4.65: Carriage Barn remote air-conditioning unit, view northwest with the Generator Garage to the right, September 2001. SUNY ESF.

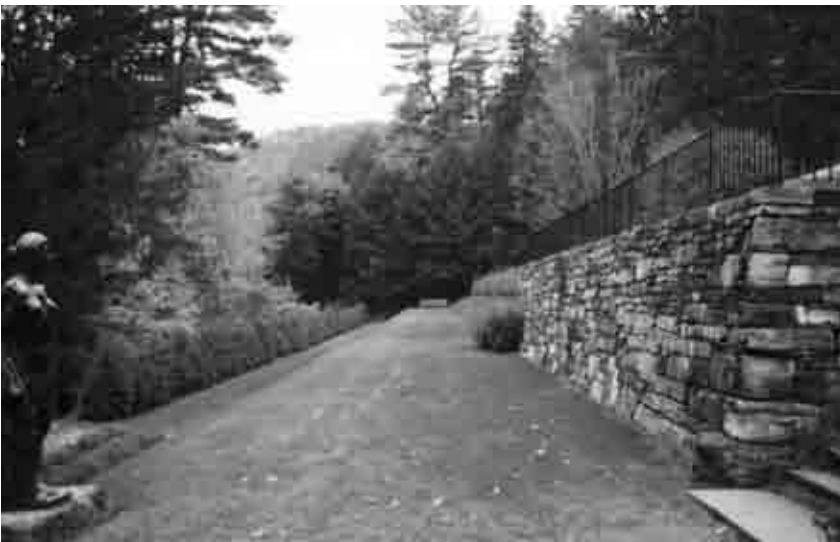
Figure 5.2: The Long Terrace, overview looking west from the main walk and Flower Garden with the pool terrace stone wall (BS-12) at the right, the hemlock grove (V-41), and double-leader white pine (V-42) in the background, October 2000. SUNY ESF.

A prominent white pine (*Pinus strobus*) with a double leader and an approximately 30'-diameter canopy is located 6' behind the Platt bench at the west end of the main walk of the Long Terrace [see Figure 5.2]. This tree is a focal point in the middle ground of the Mount Tom vista looking west across the Terrace Gardens.

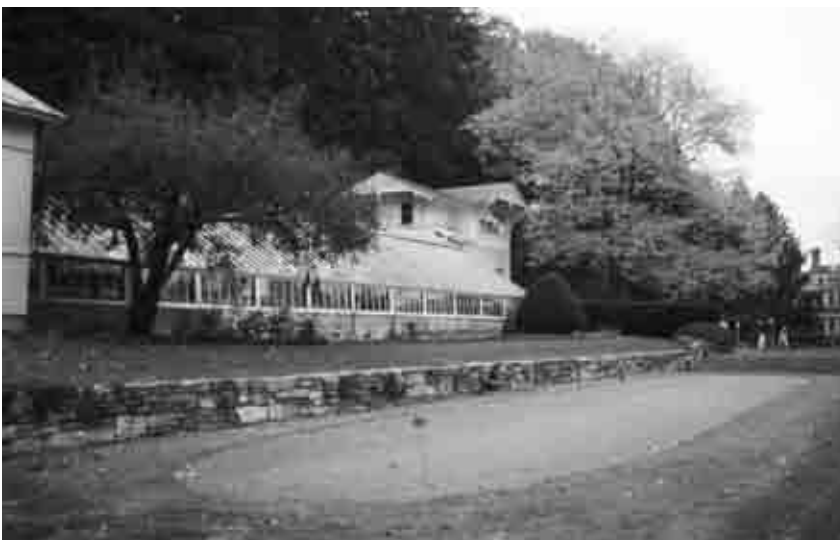
Figure 5.3: The cutting garden terrace (above stone wall BS-22), view northeast across the putting green terrace (SO-8, BS-23) with cutting garden crabapple (V-43) and greenhouse (BS-17) in the background, October 2000. SUNY ESF.

A crabapple (*Malus sp.*) with a 20'-diameter canopy is located at the west end of the cutting garden, adjacent to the Garden Workshop [see Figure 5.3]. The variety of crabapple has not been identified.

The greenhouse is a half-span or lean-to Lord & Burnham greenhouse with iron framing, lapped glass, and wood glazing bars [see Figure 5.3]. It measures 103' by 16'. This superstructure is supported by the south wall of the Bowling Alley to the north and a low brick side wall with granite posts to the south (wall remnant of original 1872–74 greenhouse). The greenhouse adjoins the Garden Workshop to the west. Presently used for storing plants during the winter, the greenhouse was restored in 2001.

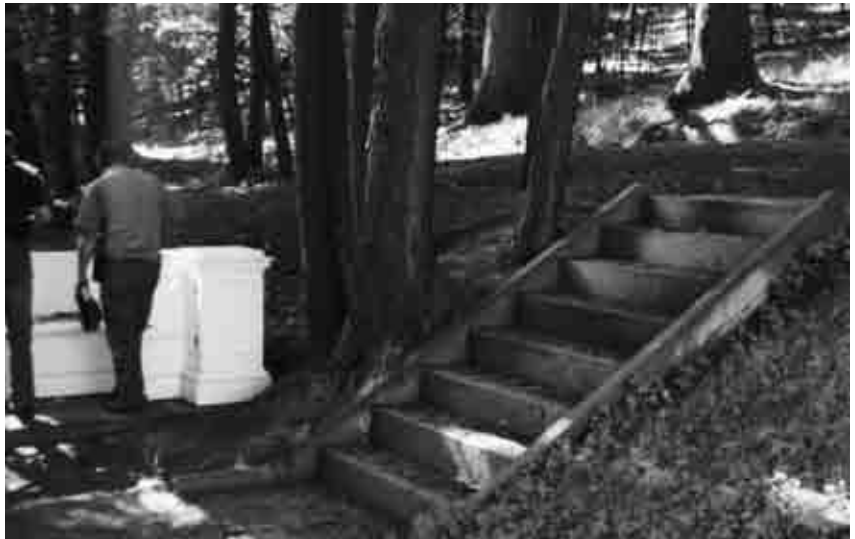
Figure 5.10: Swimming pool patio, view north with brick barbecue and Boston-ivy-covered brick wall (BS-20) in the background, adjoining the Belvedere, August 2001. SUNY ESF.

Boston ivy (*Parthenocissus tricuspidata*) covers the north patio brick wall adjoining the Belvedere, including the adjoining angled retaining wall [see Figure 5.10]. The vine is pruned to stay off the wood siding of the Belvedere and off the adjoining barbecue.

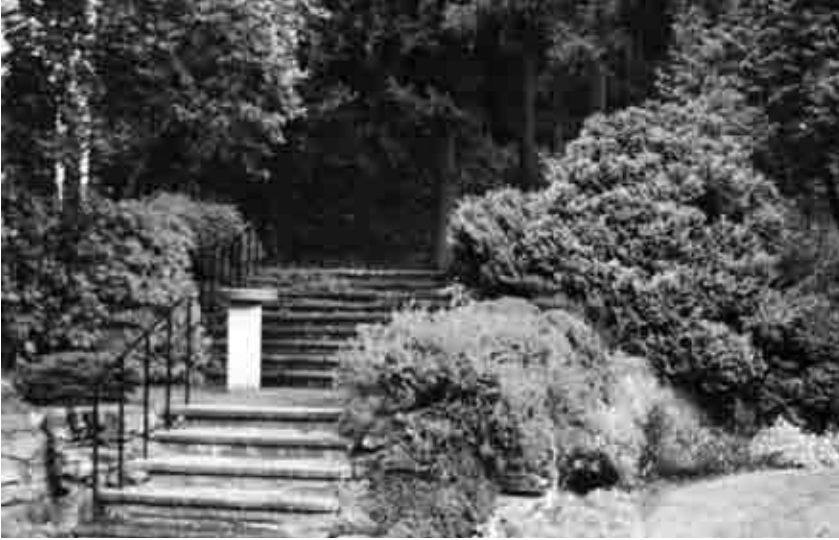
Figure 5.11: Pool terrace steps, view north of upper two flights with upper rock garden (V-58) to the right, and sundial (SSF-19) on the landing, September 2001. SUNY ESF.

[see Figure 5.11]. The rock garden at the middle set of steps, measuring approximately 40' by 8', is largely devoted to heather (*Erica sp.*), along with blue fescue (*Festuca glauca*), globe daisy (*Globulairia cordifolia*), creeping phlox (*Phlox subulata*), bird's-nest spruce (*Picea abies* "nidiformis"), and creeping sedums (*Sedum sp.*) [see Figure 5.12]. Three feet east of this garden in the lawn is a large mound of creeping juniper (*Juniperus horizontalis*), measuring approximately 18' by 8' and surrounding several rocks. The lower rock garden, measuring approximately 20' by 6', features a few small shrubs, including juniper (*Juniperus sp.*) and Alberta spruce (*Picea abies/glauca sp.*), but is dominated by an assortment of alpine and herbaceous plants and grasses, including blue German garlic (*Alium sp.*), dwarf Chinese astilbe (*Astilbe sp.*), clustered bellflower (*Campanula sp.*), creeping baby's breath (*Gypsophilia repens*), and scabiosa (*Scabiosa sp.*). Sedum grows along the stone treads [see Figure 5.13].

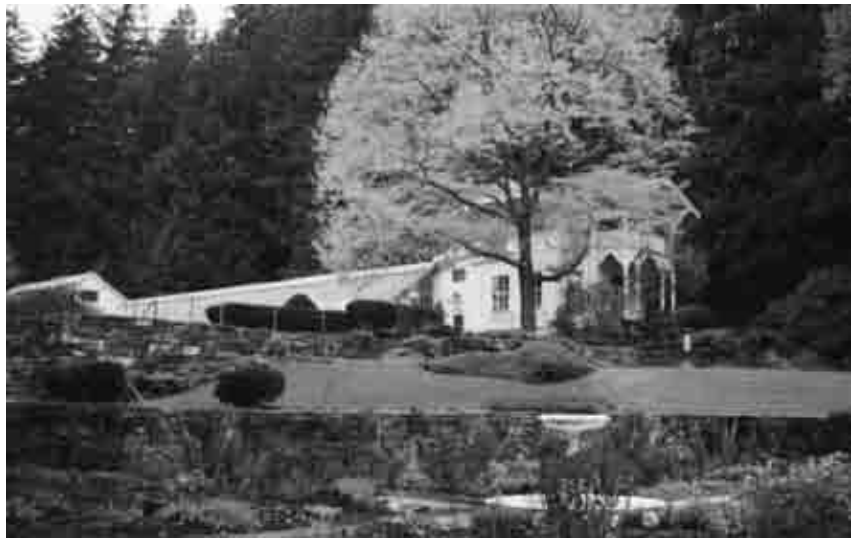
Figure 5.16: Pear tree (background) and red maple (foreground) at the Garden Workshop, view southeast with putting green in background, July 2002. SUNY ESF.

The pear tree at the west end of the putting green wall was planted in c.1975, probably when the adjoining rock garden and the rock garden at the east end of the putting green wall were planted.¹⁷ [Figure 5.16]

A red maple (*Acer rubrum*) with a 20' average canopy spread is located 12' off the southwest corner of the Garden Workshop [see Figure 5.16]. The tree suffered loss of a number of limbs in the winter of 2001.

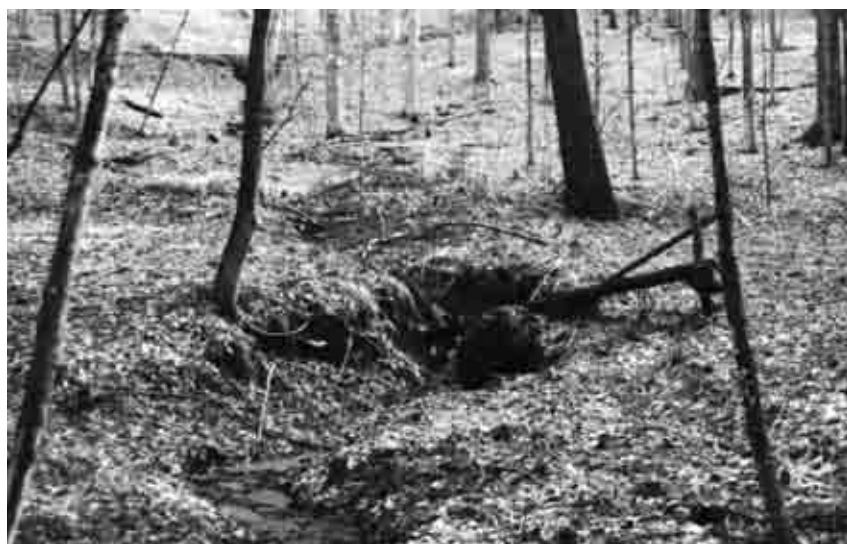
Figure 6.2: Intermittent stream on north side of hill, view south with collapsed plank bridge on Woodland garden path circuit (C-33) and main carriage road in the distance, April 2002. SUNY ESF.

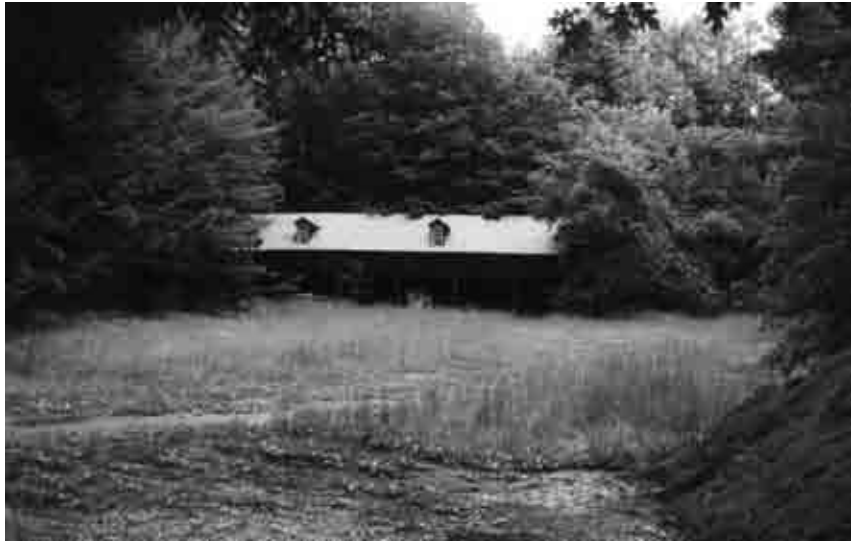
Figure 6.5: The northern portion of the Hillside Gardens space, view north across dewatered Lily Pond (CWF-2) showing a portion of the Lily Pond path (C-27), September 2001. SUNY ESF.

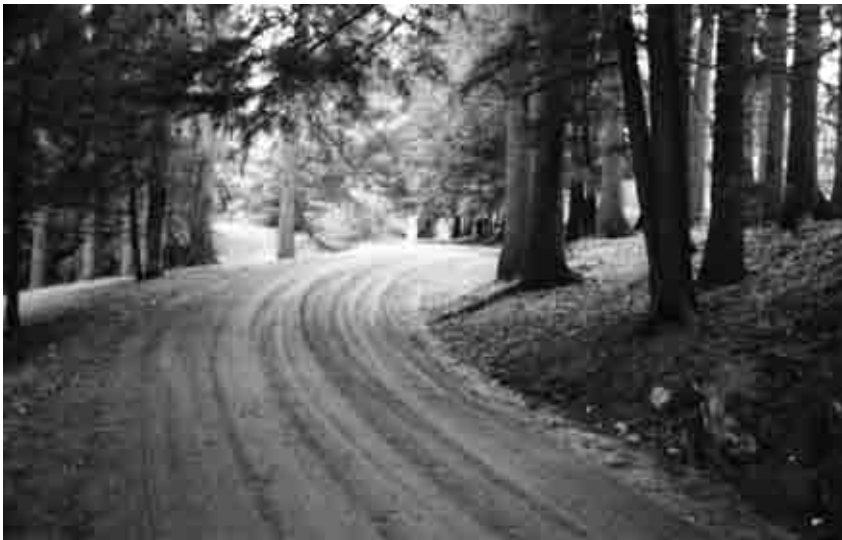
Figure 6.13: Upper Meadow road, view west toward Upper Meadow following seasonal grading, May 2001. SUNY ESF.

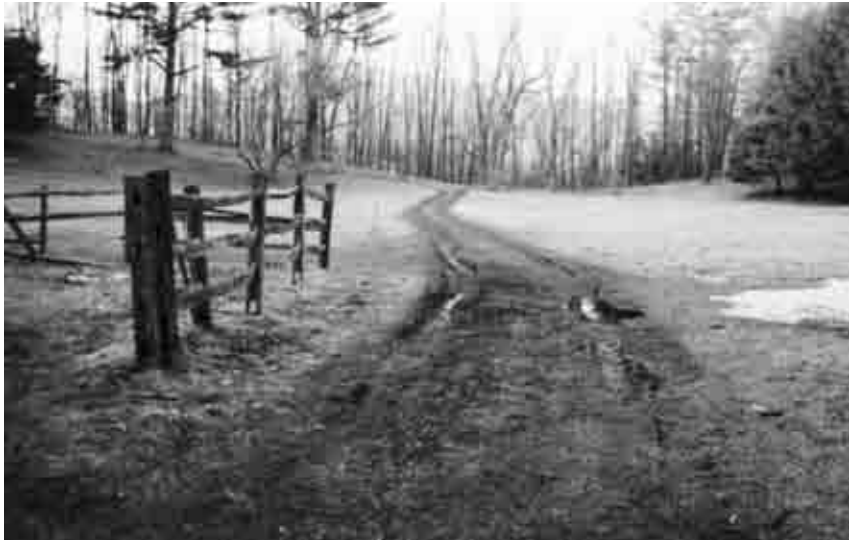
Figure 6.15: Shortcut from Garden Workshop to Upper Meadow road, view south from Upper Meadow road through hillside Norway spruce plantation, August 2001. SUNY ESF.

The shortcut road from the Garden Workshop to the Upper Meadow road is a 175'-long loop between the Belvedere drive and Upper Meadow road [see Figure 6.8]. The shortcut consists of two indistinct earthen tracks through the grass and fern-covered understory of the hillside Norway spruce plantation. [Figure 6.15] The road is not actively used or maintained.

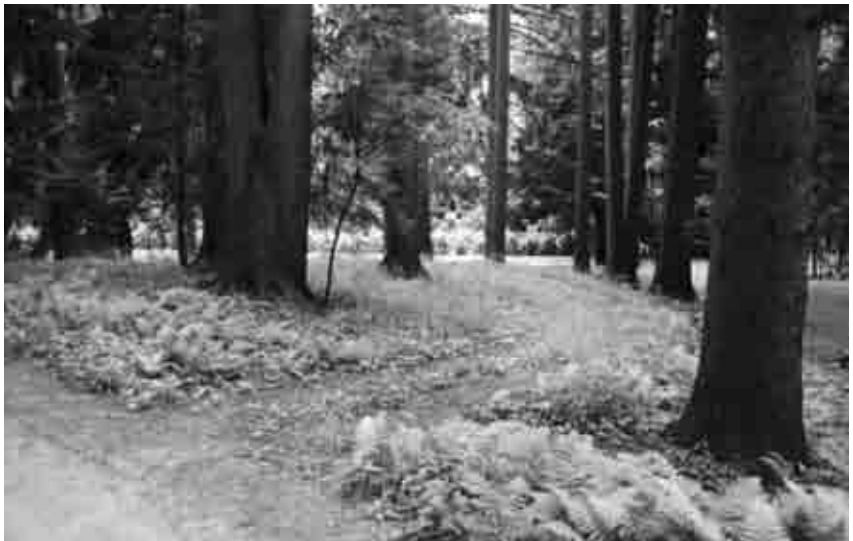
Figure 6.16: Lower Woodshed road, view west from main carriage road through Woodshed yard (SO-10), September 2001. SUNY ESF.

The lower Woodshed road begins at a “Y” intersection on the main carriage road at the east end of the Woodshed yard, and then disappears in the Woodshed yard [Figure 6.16; see also Figure 6.8]. The road becomes distinct again in the woods west of the Woodshed, where it consists of two tracks that continue in a westerly direction beyond the Mansion grounds. The spur to Route 12, located 450' northwest of the Woodshed and identifiable by a break in the perimeter stone wall, is no longer distinct. The lower Woodshed road is not actively used or maintained, except during the winter when it serves as part of the cross-country ski-trail system maintained by the Woodstock Inn & Resort.

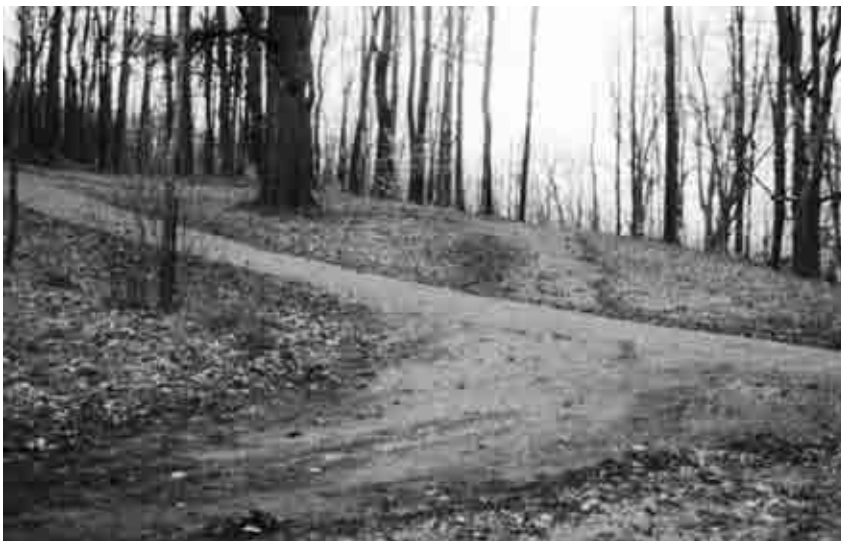
Figure 6.18: The compost road, view northwest from the Upper Meadow through-road (C-21) across the Wood Drive (C-24) toward the "Y" intersection, April 2002. SUNY ESF.

A 250'-long dead-end road connects the compost area with the Wood Drive (Bungalow road) at the Upper Meadow [see Figure 6.8]. The road branches into two legs at the Wood Drive, forming a “Y” intersection. [Figure 6.18] One leg aligns with the Upper Meadow through-road. The road appears to have been previously graded and surfaced with gravel, but has not recently been graded.

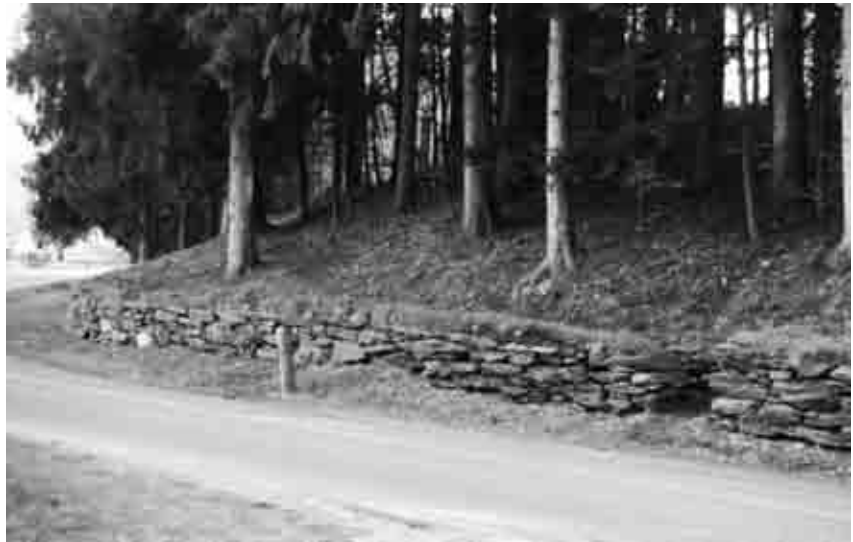
Figure 6.21: The Lily Pond path, view west of beginning of stone staircase at Mansion parking area stone wall (BS-8), September 2001. SUNY ESF.

The Lily Pond path is a 200' track that rises 40' in elevation along two switchbacks through naturalized conifer plantations [see Figure 6.19]. The path is a single earthen track and begins at a stone staircase built into the Mansion parking area stone wall (BS-8). [Figure 6.21] Beyond the staircase, there are six sets of steps built of either log or stone risers with earthen treads. The path then follows the perimeter of the Lily Pond and crosses a stone-slab bridge (BS-32) over the inlet [see Figure 6.5]. The path branches to the south over the capped swimming pool toward the Wood Drive and Waterfall Garden. To the west is the path leading up to the Lily Pond waterfall, and to the north, the arboretum path. The Lily Pond path is not open for tours or public use.

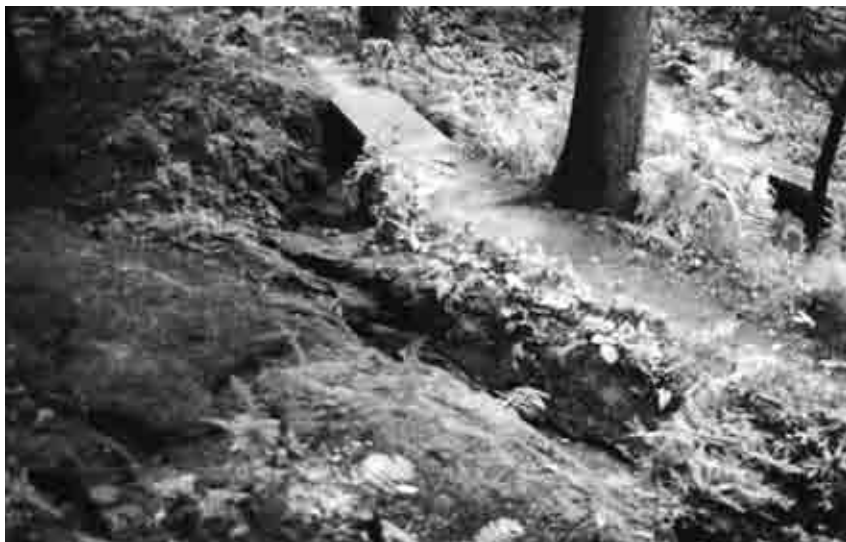
Figure 6.23: The Lily Pond waterfall path, view northeast along upper section as it crosses the waterfall gorge on a stone-slab bridge (BS-33), September 2001. SUNY ESF.

Existing Condition The Lily Pond waterfall path follows the course of the waterfall and rises 16' in elevation over a length of 80' from the Lily Pond to the Wood Drive [see Figure 6.19]. The path borders the lower limits of the rock outcropping, and crosses the waterfall gorge on a stone-slab bridge. [Figure 6.23] The path ascends a set of twelve steps consisting of stone risers and earthen treads. The path is a single earthen track without any visible surface material or edging. It is not open for tours or public use.

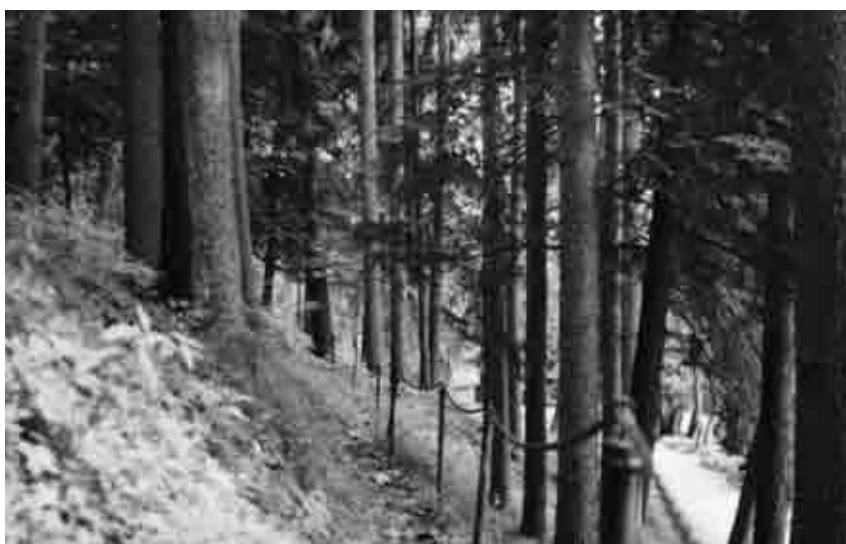
A railing extends along the down-slope side of the upper hillside path for approximately 180'. The railing is constructed of standard black-painted galvanized chain strung between pipe posts with eye-hook caps [see Figure 6.24].

Figure 6.24: Upper hillside path, view east along section through Norway spruce plantation west of Waterfall Garden showing chain railing (SSF-37), September 2001. SUNY ESF.

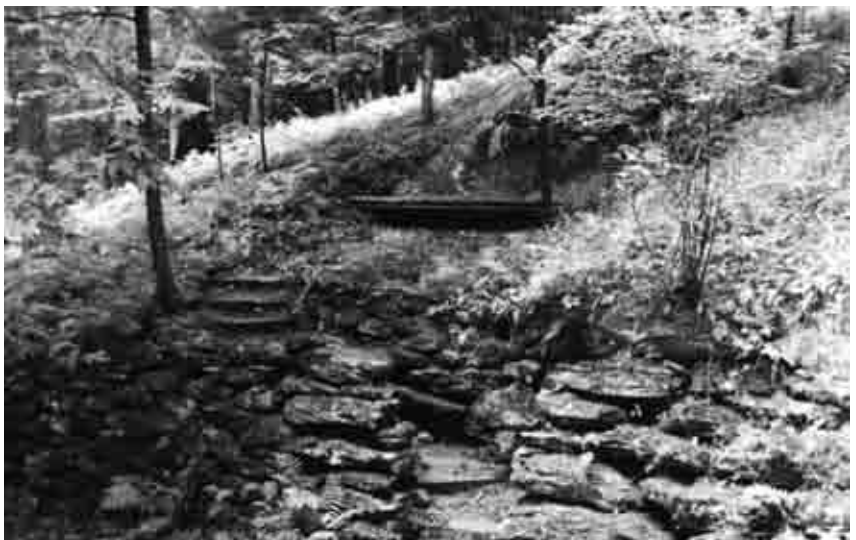
The stone ledge bench is located at the top of the rustic steps leading from the Wood Drive [see Figure 6.27]. It is 17' long, with a 4'-high ledge back and an 18"-deep seat. The seat is cut stone with a rounded nosing, and is cantilevered out from the ledge and supported in part by a diagonal slab leg.

Figure 6.27: Wood Drive stone stairway, view west from Wood Drive with stone ledge bench (SSF-29) in the background, August 2001. SUNY ESF.

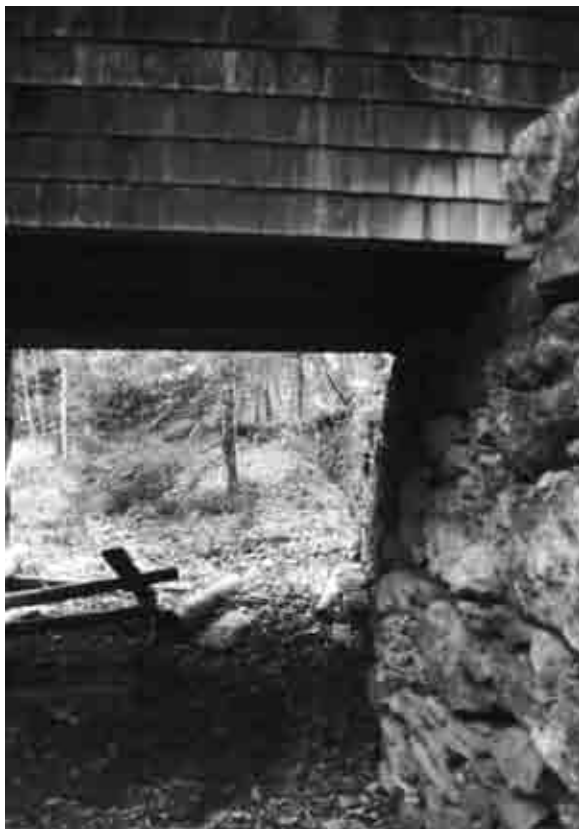
Figure 6.44: Woodshed yard retaining wall, view east beneath the Woodshed along Woodshed access road trace (A5-1), October 2000. SUNY ESF.

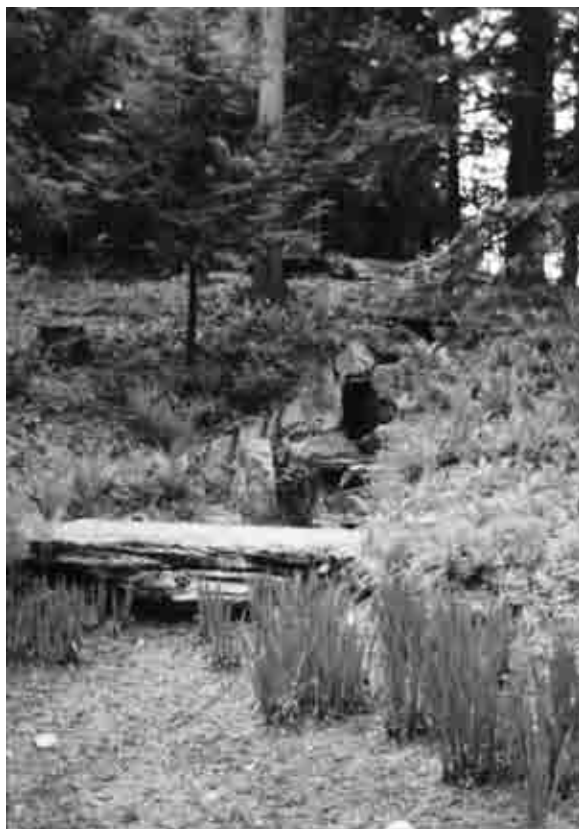
Figure 6.45: The Lily Pond waterfall lower bridge, view west across dewatered pond with stone-lined waterfall (CWF-4) in background, June 2001. SUNY ESF.

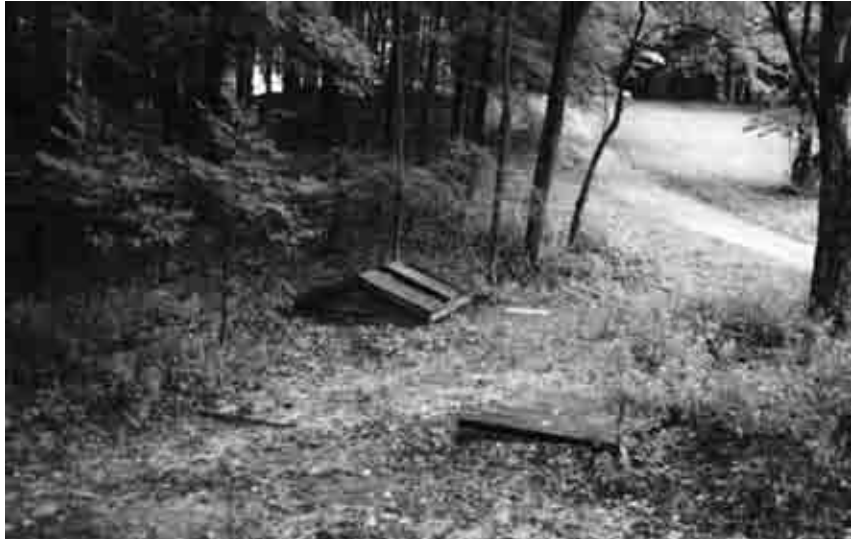
A dry-laid rubble stone retaining wall borders the west side of the Wood Drive between the Waterfall Garden and the Lily Pond. The wall is 130' long and is upwards of 4' high. [Figure 6.47] The stones are covered in moss and lichen, and are overgrown by ferns and other woodland plants.

Figure 6.47: Wood Drive stone wall, view south through the Hillside Gardens space (SO-11), July 2002. SUNY ESF.

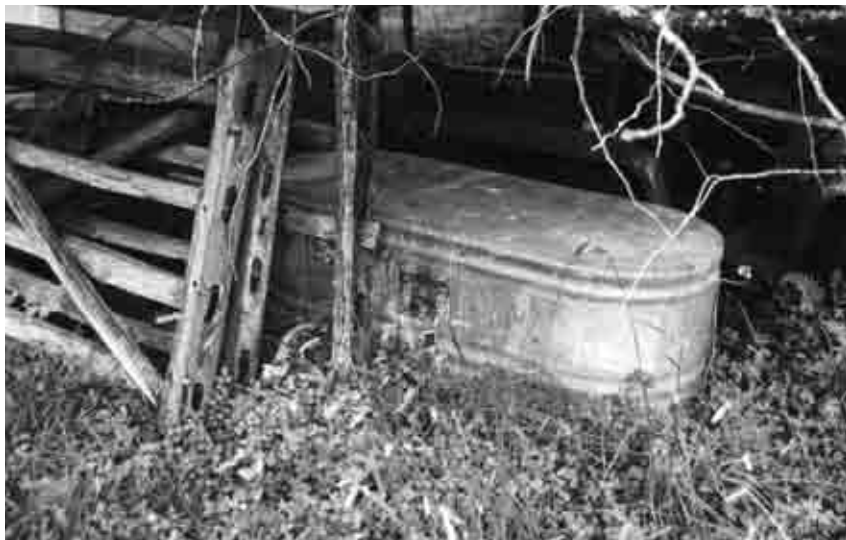
A galvanized steel horse trough is located in the Upper Meadow corral, presently located upside-down under an arborvitae. [Figure 6.55] The oval trough was manufactured by the Hudson company and measures 2' high, 6' long and 2.5' wide. A worn painted label is located on the side of the trough.

Figure 6.55: Upper Meadow corral horse trough, view southwest, July 2002. SUNY ESF.

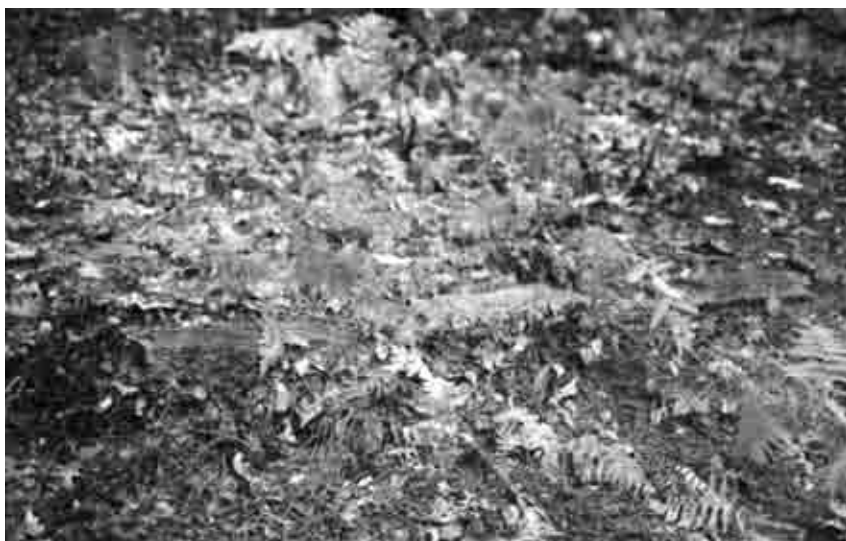
Three rectangular granite monuments are located along the west side of the upper hillside path, 120' north of the Waterfall Garden and 40' east of the Reservoir. The monuments are flush-set, unpolished gray granite without any marking, each approximately 1' by 3'. [Figure 6.56] They are set in a line and are inconspicuous in the wooded landscape.

Figure 6.56: Rockefeller pet cemetery monuments, view west from upper hillside path, September 2001. SUNY ESF.

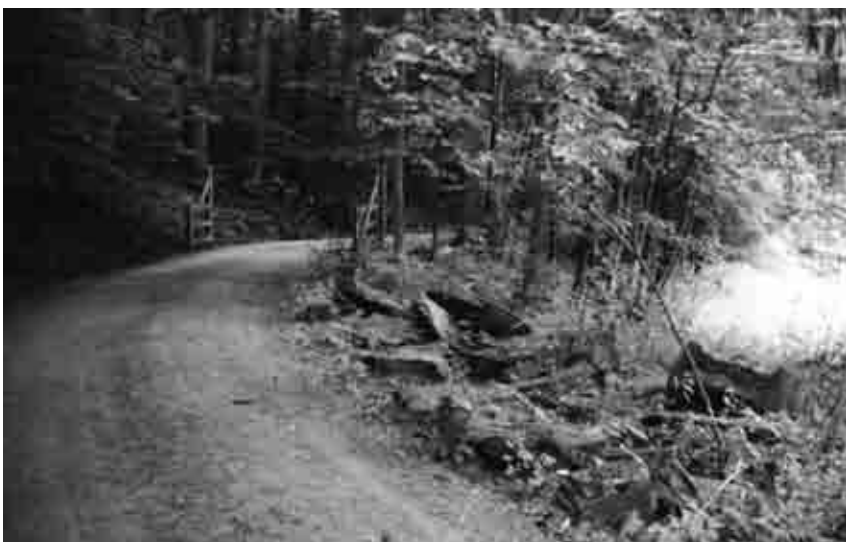
A gate is located on the Upper Meadow road approximately 100' west of the Horse Shed. The 16'-wide gate is built of unfinished dimensional lumber, and consists of two, three-plank gates hung off 6'-high posts. [Figure 6.57] Each gate is 41" high and has a diagonal brace.

A 75'-long, low pile of stone debris is located on the east side of the Upper Meadow road between the Horse Shed and Upper Meadow road gate [see Figure 6.57]. Included in this pile is a stone staircase, which may have been removed from the Long Terrace.

Figure 6.57: Upper Meadow road gate, view northwest with southern end of stone cutting debris (AS-2) in the foreground, September 2001. SUNY ESF.

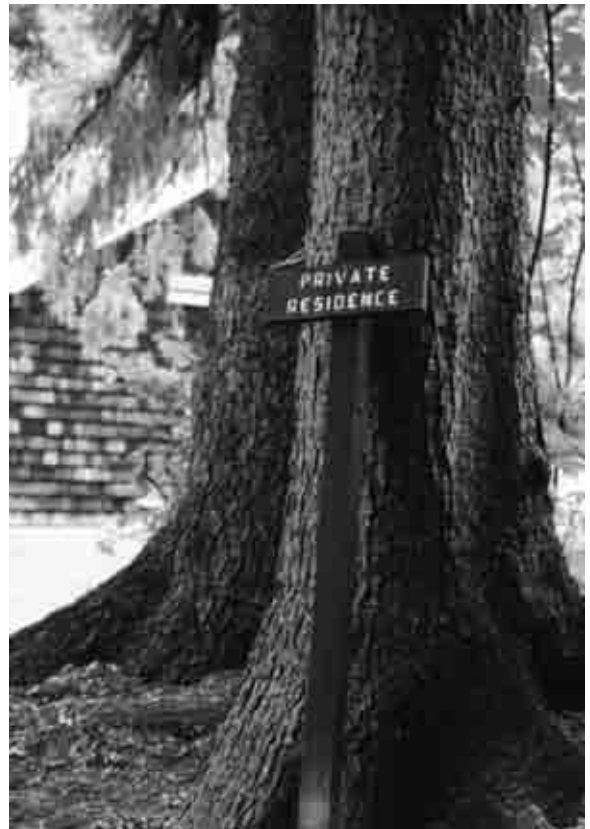
In c.1998, the “Private Residence” sign was taken out of the ground and is presently in storage, but the directional signs to River Street and Billings Park remain mounted on trees. [Figure 6.58] These signs have brown-painted rectangular boards with inscribed white-painted upper case letters. The “Private Residence” sign is mounted on an approximately 4'-tall square wood post. There may have been similar signs elsewhere on the hill, but no other presently exists.

Figure 6.58: Rockefeller-era directional and privacy signs, view west of "Private Residence" sign along Upper Meadow road, September 2001. SUNY ESF.

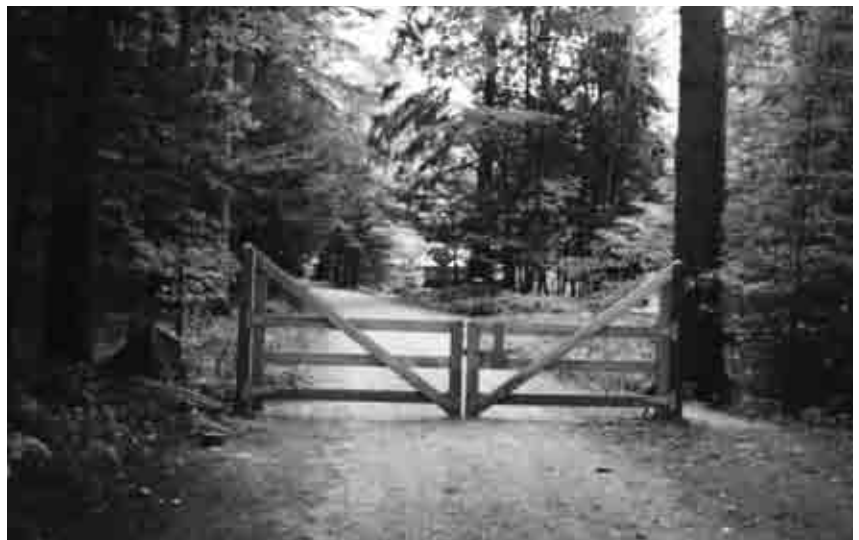
In 1998, a new gate was constructed on the main carriage road, 30' east of its intersection with the lower Woodshed road. It is 16' wide and consists of paired, dimensional-lumber, three-plank 41"-high gates with diagonal braces that are hung off 6'-high posts. This gate was built by Peter Glover and was modeled after the gate on the Upper Meadow road near the Horse Shed.⁵⁷ [Figure 6.59] In addition to this gate, there are old eye hooks in the perimeter stone wall to either side of the Carriage Barn drive, indicating that a chain was strung across at one time to close off the road.

Figure 6.59: Main carriage road gate, view west with the Woodshed in the distance, September 2001. SUNY ESF.

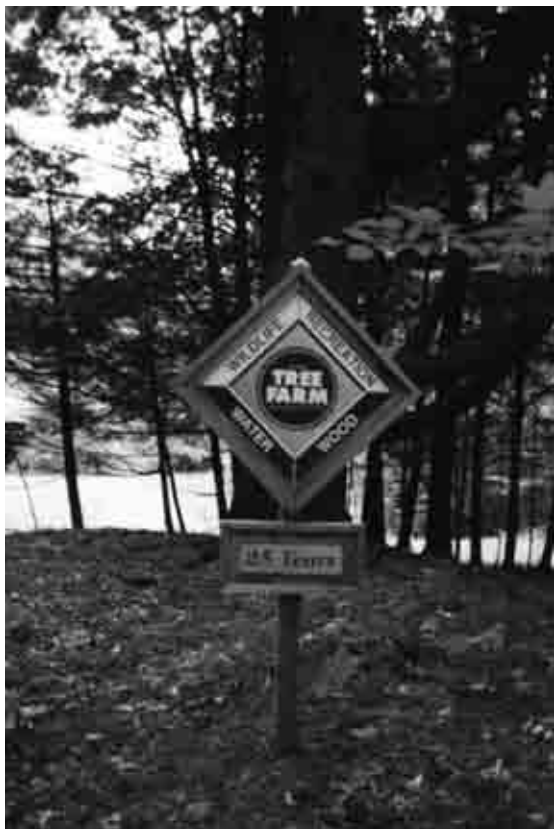
In 1999, an official American Tree Farm System sign was installed on the north side of the main carriage road at the intersection with the lower Woodshed road. This sign is 7' high and consists of a 42"-wide, diamond-shaped metal sign with a wood frame mounted on a wood post. [Figure 6.60] A secondary sign is located below the main sign noting that Billings Farm/Mount Tom forest has been in the system for twenty-five years (as of 1981).

Figure 6.60: Tree Farm sign, view west with Woodshed yard in background, September 2001. SUNY ESF.
