CULTURAL LANDSCAPE REPORT FOR THE MANSION GROUNDS

MARSH-BILLINGS-ROCKEFELLER NATIONAL HISTORICAL PARK

VOLUME II: EXISTING CONDITIONS & ANALYSIS

Olmsted Center for Landscape Preservation
National Park Service, Boston, Massachusetts, 2005

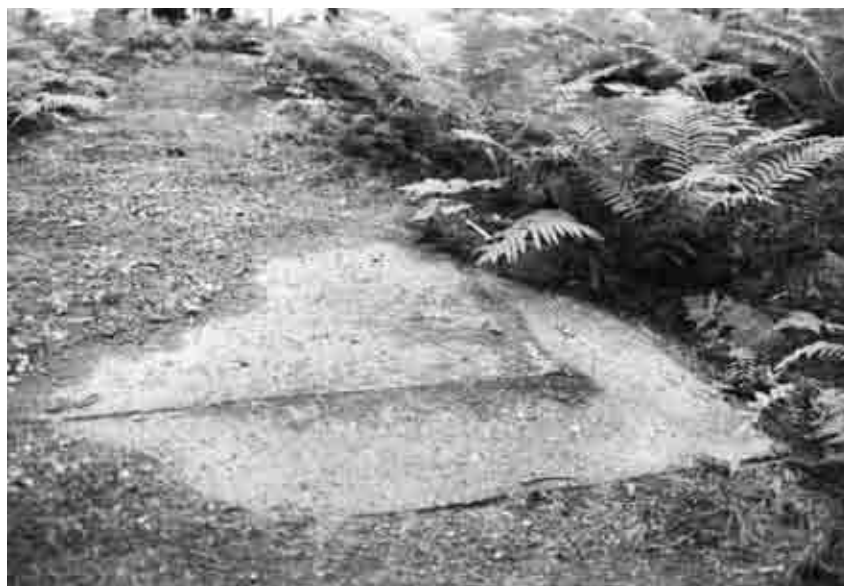
Figure 6.61: Remnants of hillside swimming pool, view south of above-grade corner near the Lily Pond, July 2002. SUNY ESF.
