CULTURAL LANDSCAPE REPORT: BIRTH-HOME BLOCK

**MARTIN LUTHER KING, JR.
NATIONAL HISTORIC SITE
CULTURAL LANDSCAPE REPORT: BIRTH-HOME BLOCK**

May 1995

**Lucy A. Lawliss
Regional Historical Landscape Architect**

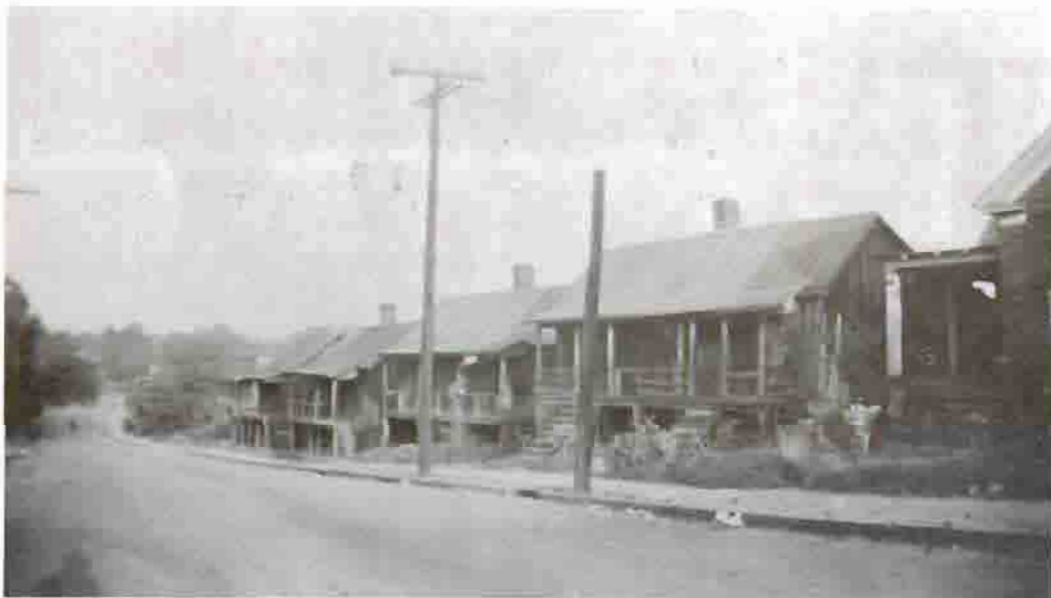
An important feature noted in the AHA photographs was the standard use of roll roofing on residential structures (figure 3). Not only was this an inexpensive way to

Fig. 3. Street of duplexes all with roll roofing, 1940, AHA Collection, Atlanta Historical Society.

repair one's roof, but the material was sold as a fire-retardant measure. Several of the houses that have not been rehabilitated in the Birth-Home Block still have some or all of this roll roofing intact. Others that have been rehabilitated were documented with roll roofing in the layers of roofing, but it was not replaced in the rehabilitation process.

shotguns did what they could to make their homes attractive and comfortable.⁵⁸ Drawing on African-American landscape traditions, many of these shotgun residents used pots or containers of plants, preferably colorful flowering varieties, which made plants easily transportable when the tenants relocated.⁵⁹ Having a history of transience, less well-to-do African Americans knew of ways to keep beauty and color at their homeplaces despite their economic circumstances (see figure 3 for examples of ornamental plantings at duplexes, 1940).

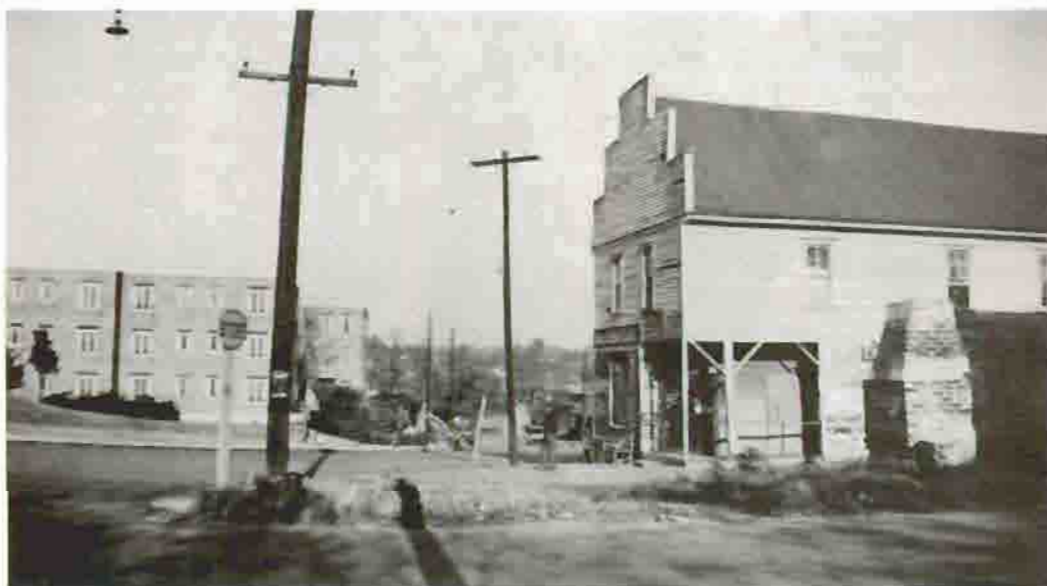
photographic collection in similar neighborhoods.⁴⁰ The oral histories provide some descriptions of the street light locations during the study period. The lighting was described as very dim, and the lights were sparsely set along the street. It is believed that at a minimum, one street light was located at the corner of Auburn Avenue and Hogue Street and another at the corner of Auburn Avenue and Howell Street.⁴¹ This is substantiated by the infrequent spacing of the lighting fixtures noted in the AHA photographs (figure 6).

Fig. 6. Neighborhood photographs that include typical light fixtures. Note that only one lamp appears in either photograph although many poles are seen in the distance. Note also fence, porch with planter box, and miscellaneous street furnishings, c. 1940. AHA Collection, Atlanta Historical Society.

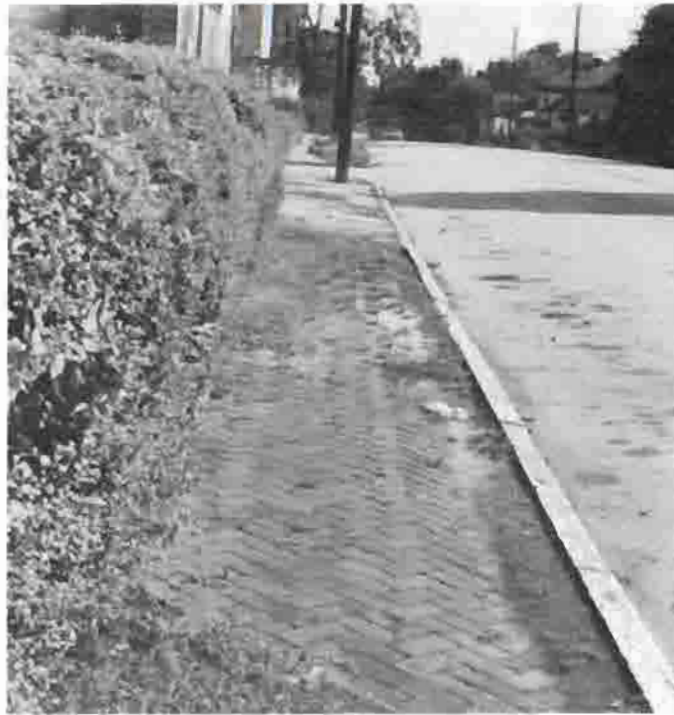
The other historic sidewalk material is brick. One original section of brick sidewalk with granite curb, although in poor condition, is extant along the west side of Howell Street from Auburn Avenue north to mid-block (figure 7). The other brick sidewalks

Fig. 7. Existing brick sidewalk on the northwest intersection of Auburn Avenue and Howell Street.

along the east and south sides of the triangle, although in their historic location, were reset and supplemented with new brick in the early 1980s as part of the rehabilitation work on the triangle. The radiating brick pattern on the corner is entirely of new brick and constitutes a nonhistoric detail. The historic brick sidewalk along the west side of Howell Street, south of Auburn Avenue, was replaced with concrete (date unknown) and is in very poor condition.

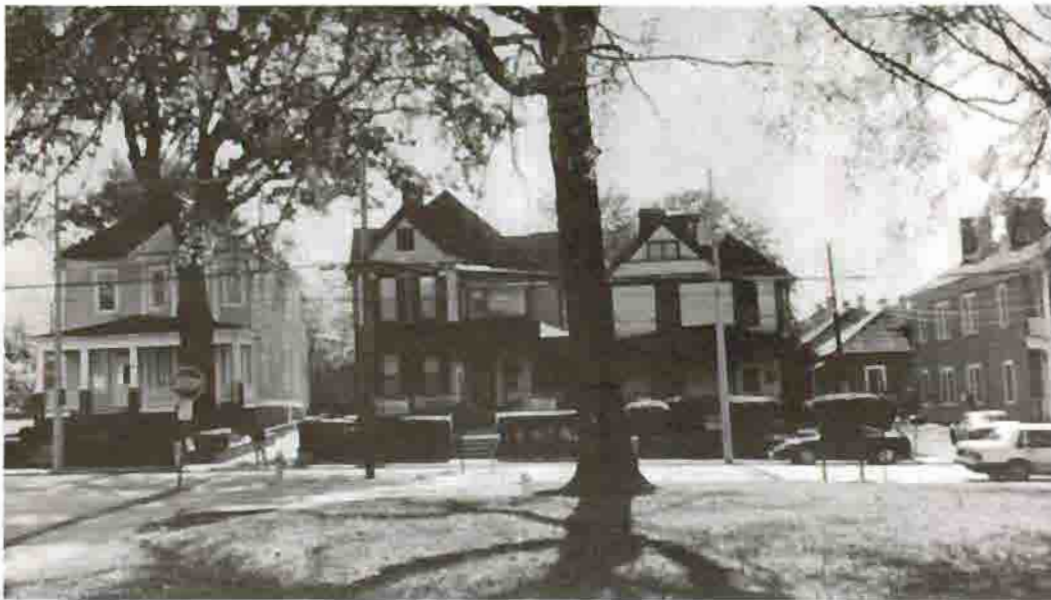
The existing street lights are supplied by Georgia Power and are the aluminum "cobra-head" design, mounted approximately twenty feet above ground on every power pole. Most of the power poles are treated-wood poles. The exceptions are five high-voltage concrete poles on the south side of Auburn Avenue which begin at the corner of Boulevard and move east into the Birth-Home Block (figure 8). All the power poles are

Fig. 8. Concrete power poles along the southwest side of Auburn Avenue. Birth Home is second from left. Note contrast with wood poles along the north side of Auburn Avenue.

irregularly spaced from 200 to 360 feet apart with three or four pole locations per block. City standards for these lights are high pressure sodium bulbs. This type of light emits a yellowish glow.

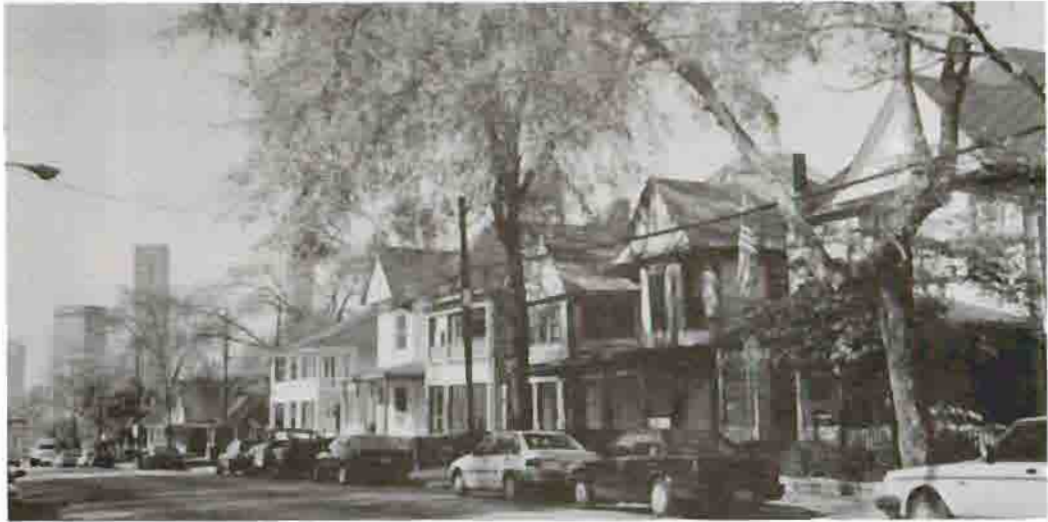
The front yard and, most especially, the front porch were the key outdoor social spaces of the Birth-Home Block. Without exception, all of the residences present during the historic period had a front porch and a front walk that connected the porch (dwelling) to the street (figure 9). The porch functioned as an extension of the parlor in good weather and was fully furnished with chairs, swings, and gliders. Families regularly communicated from porch to porch because of the proximity of houses. Different households could socialize with neighbors without leaving their yards, and conversations between adjoining neighbors and those across the street were quite common especially on long summer evenings and on Sunday afternoons. Children also participated in these social gatherings by sitting on the porch railings, or playing on the porch, or in the front yard.⁴⁷

The front walk, which was centered on the front door, ran perpendicular from the sidewalk to a set of steps, raising the front porch above the yard level. The materials of these walkways varied; however, concrete with a rolled curb edge was most commonly used at the c. 1900 dwellings. Some of these early walkways exhibited an interesting detail--as the walkway reached the porch it became integrated into a walk/gutter feature

Fig. 9. View looking west along the north side of Auburn Avenue, 1995.

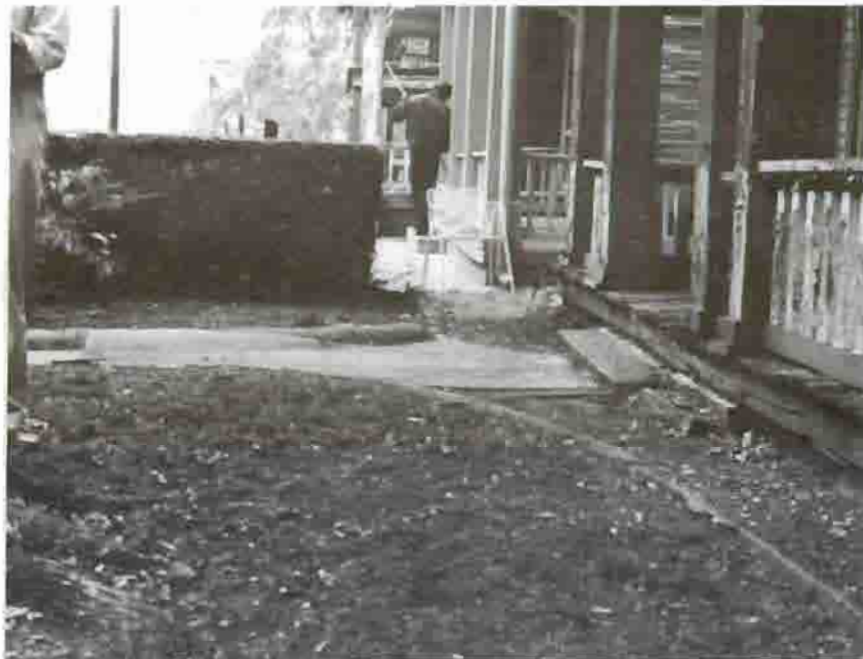
Fig. 10. Historic walk and gutter at 518 Auburn Avenue, 1995.

that ran along the face of the porch, in both directions, to the side yard (figure 10). Frequently shrubbery and/or flowers were planted beside the front walkways.⁴⁸

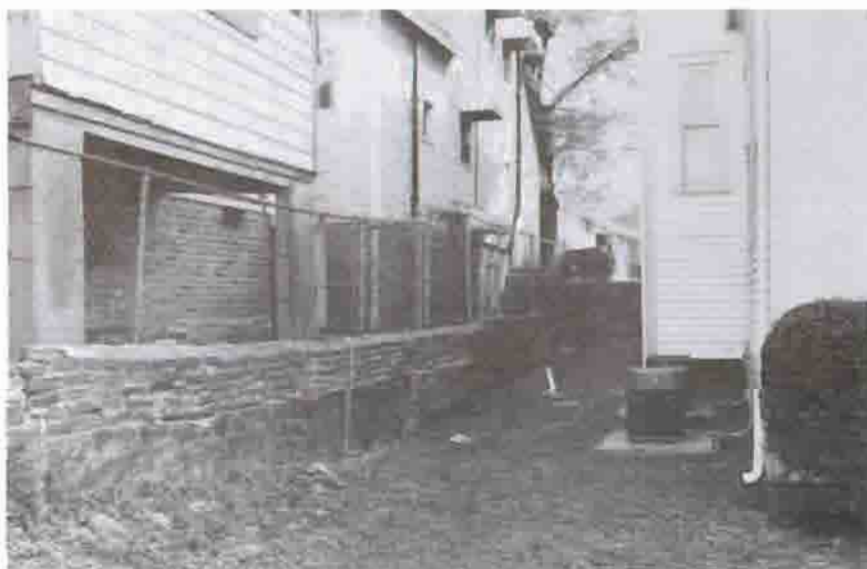
Side yards, in general, were very narrow and, therefore, unusable spaces except for circulation from front to back yards. This is particularly true on the north side of the Birth-Home Block where only a ten-foot space separated the structures. In addition, several of the side yards on the east end of the block had masonry (concrete or brick atop a stone base) retaining walls, often with integrated steps, that ran between front corners of adjacent structures in order to keep the front yard level with Auburn Avenue (figure 11). By absorbing the drop in elevation from Auburn Avenue to Old Wheat Street, the

Fig. 11. Typical existing sideyard along the north side of Auburn Avenue. Note wall and steps in background (front corners of 530 and 526 Auburn Avenue), 1994.

wall allowed the front and back yards to be flat. Often the same materials were used to construct freestanding wall foundations for fencing along rear side-yard property lines. All sources concur that side property lines were delineated with fencing both to define property and to provide privacy. Walkways and/or stairs were generally located in this narrow space between houses, especially secondary, fire-escape stairways associated with the multi-unit structures. Because of its narrowness and the shade cast by adjacent buildings, limited planting, if any, occurred in the side yard.

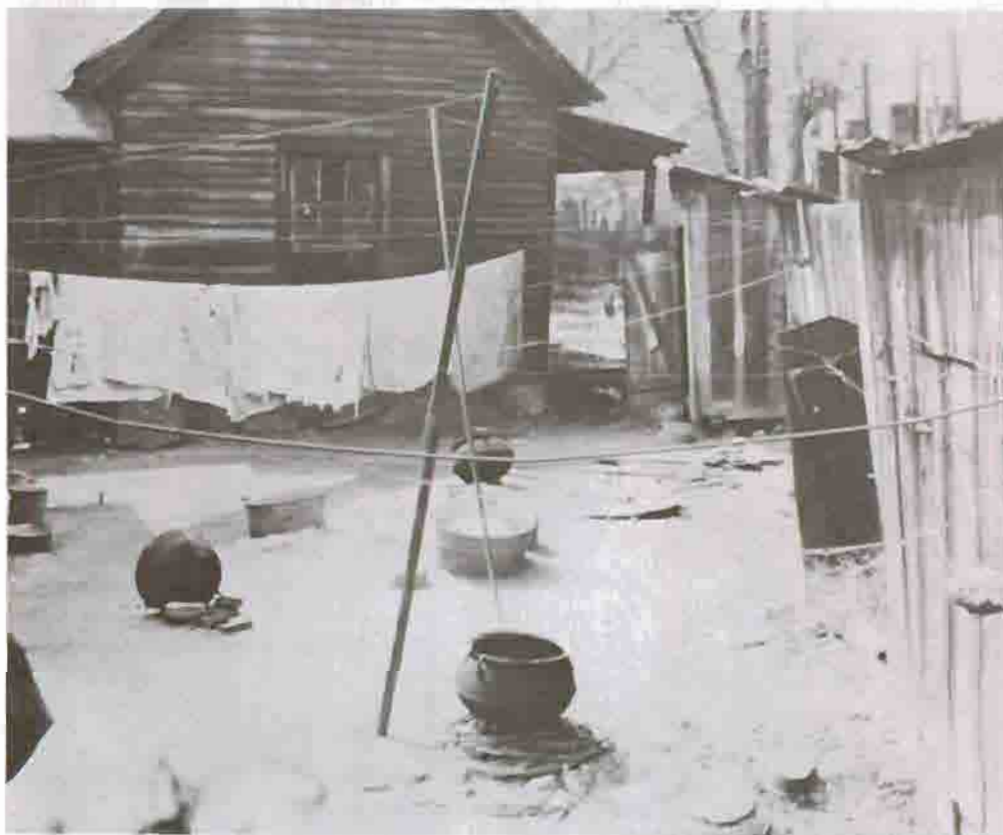
Fig. 13. Back yard of home near Atlanta University, c. 1940. AU Collection, Atlanta Historical Society.

Although typical in the AHA photographs, outdoor privies have not been documented as a back yard feature in the Birth-Home Block. Indoor plumbing seems to have been standard by the 1930s along Auburn Avenue.

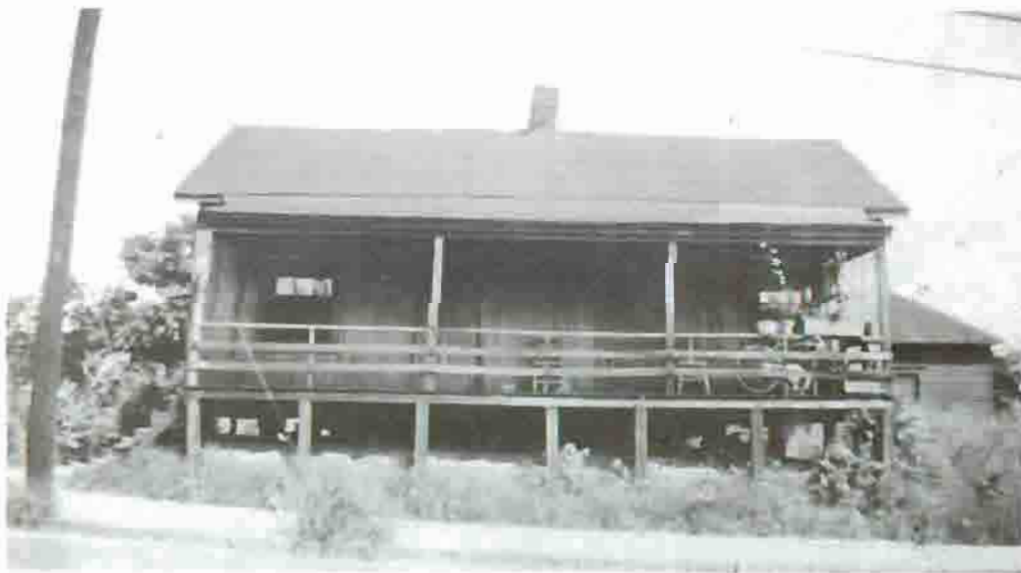
In addition to plantings in the ground, it was typical to find individual and small groups of plants that were set in boxes or pots. These containers were placed on the railings of the porch and on the steps, as well as in the yard (figure 15).⁵⁵ This appears

Fig. 15. Porch with planter boxes and pots, 1940. AHA Collection, Atlanta Historical Society.

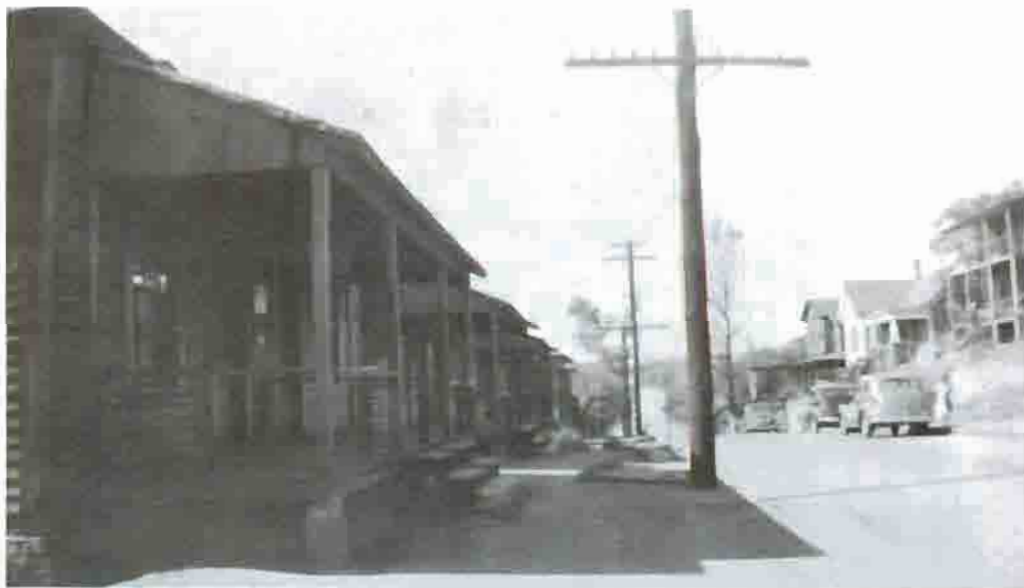
Fig. 17. Swept yards at double shotguns, 1940. AHA Collection, Atlanta Historical Society.

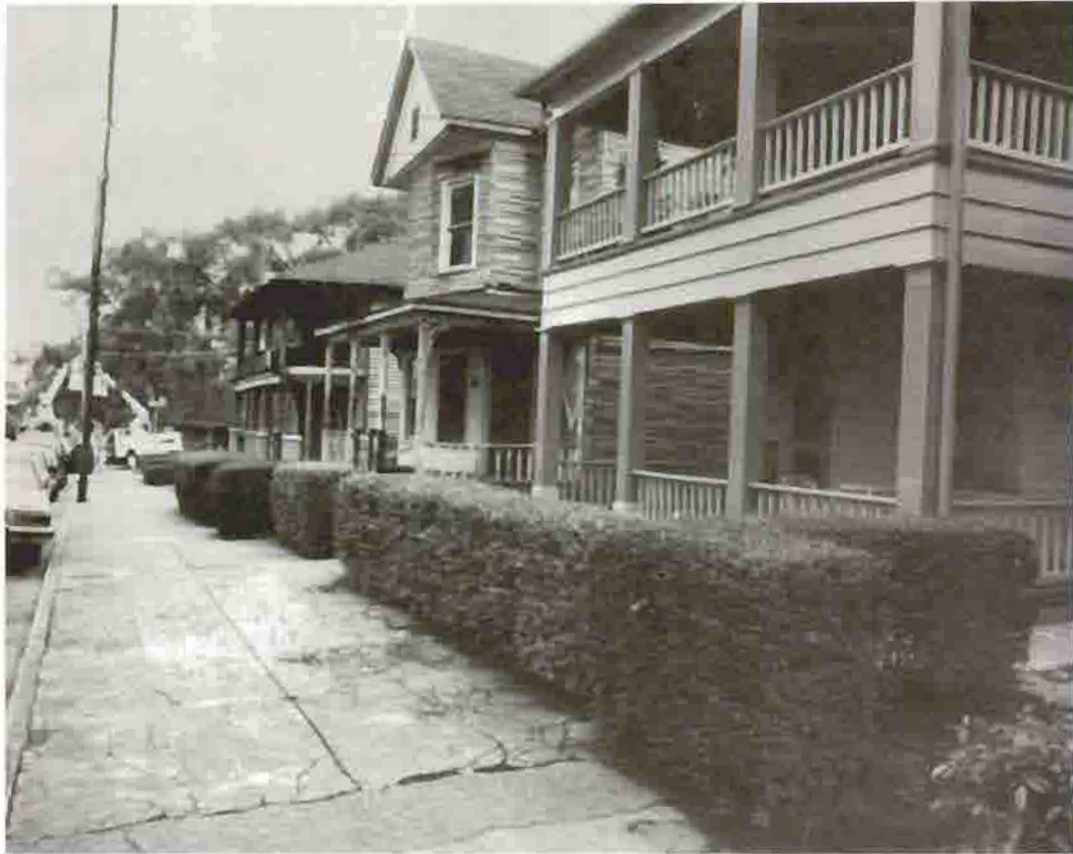
The front yard includes the front walk, the ornamental enclosure (fences, walls, and/or hedges), and the front porch with its associated furniture and potted plants. These elements are consistently identified in the memories of past residents, as well as being extant features in most of the yards. Every house in the Birth-Home Block, including the double shotguns, still has a front porch (figure 18). Even the historic apartment buildings have front porches on both the first and second floors. Although most of the period porch furniture has been lost, hardware associated with porch swings still exists in some cases and is noted on the site plans where found. Any future architectural assessments should be careful to note hardware features, including original mailboxes, doorbells, etc., in surveys to assure their protection during renovation.

Fig. 18. Existing hedges and front porches along north side of Auburn Avenue, 1994.

While front walks and front porches are consistent elements throughout the Birth-Home Block, the front yard--the distance from sidewalk edge to the face of the porch--varies on the north and south sides of Auburn Avenue. On the north side there is a consistent shallow front yard of approximately seven feet. These yards are flat and at grade with the sidewalk.

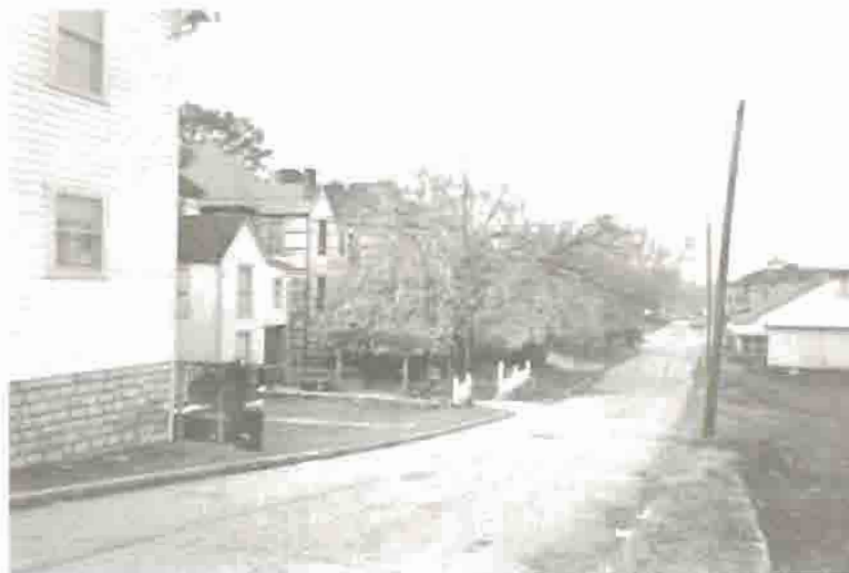
Residences along the north side of Auburn Avenue have back yards that run into Old Wheat Street. Fence and wall remnants define a consistent setback of five feet from the granite curb on Old Wheat Street where a fence ran (figure 19). Curb cuts are another important feature along Old Wheat Street. A depressed granite curb provided access to the back yards that otherwise was not available from the Auburn Avenue (front-yard) side because of the narrowness of the side yards, as well as the retaining walls that ran perpendicular between houses. The historic curb breaks do not always correspond to current driveway locations. These discrepancies are noted on the site plans where found.

Fig. 19. Existing rear property lines and unpaved rights-of-way along Old Wheat Street defined by granite curb and remnant walls and fences, 1994.

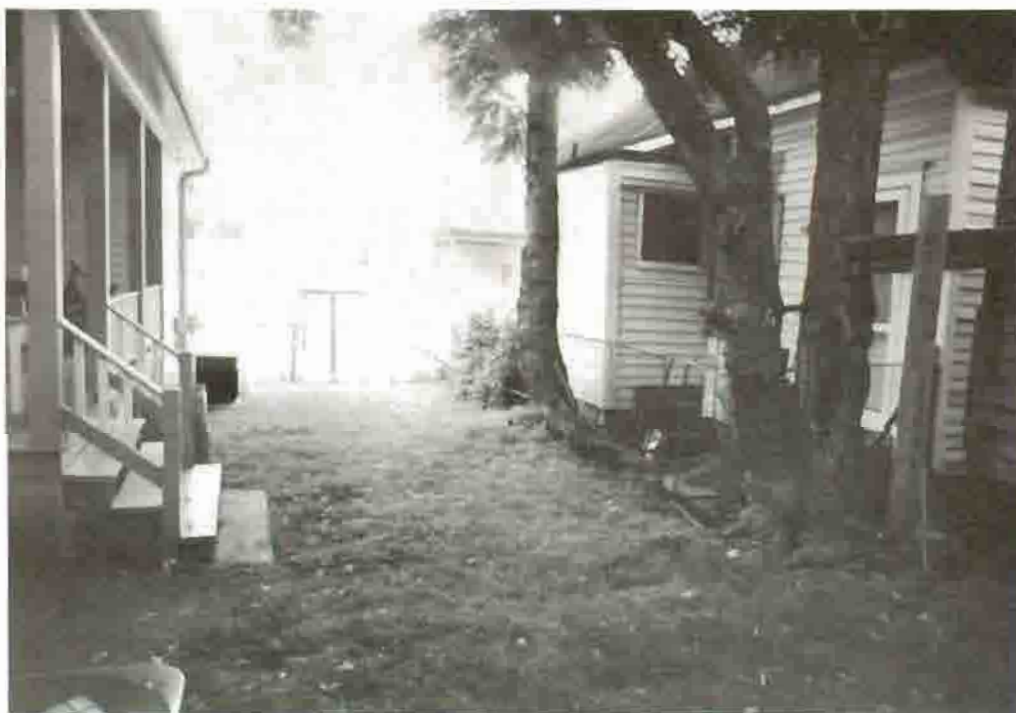
Fig. 20. Existing rear property line of a double shotgun defined by ailanthus trees and remnant fence.

There is a limited amount, as well as a limited variety, of existing plant material. The few large shade trees (oaks, Chinese elms, or pecans) are, for the most part, located in the front yards. More detail on species and locations will be handled on an individual yard basis. Exotic trees, such as Chinese tree-of-heaven (*Ailanthus altissima*) and paper mulberry (*Brousonetia papyrifera*), are typically trees now found in back yards. These weedy species are fast growing and reseed easily. More than likely, they have escaped into neglected back-yard areas as opposed to having been planted by owners for shade or ornamental purposes. This is also evidenced by the fact that these trees are most often found along the property lines and low use areas and not in the middle of the back yards (figure 20).

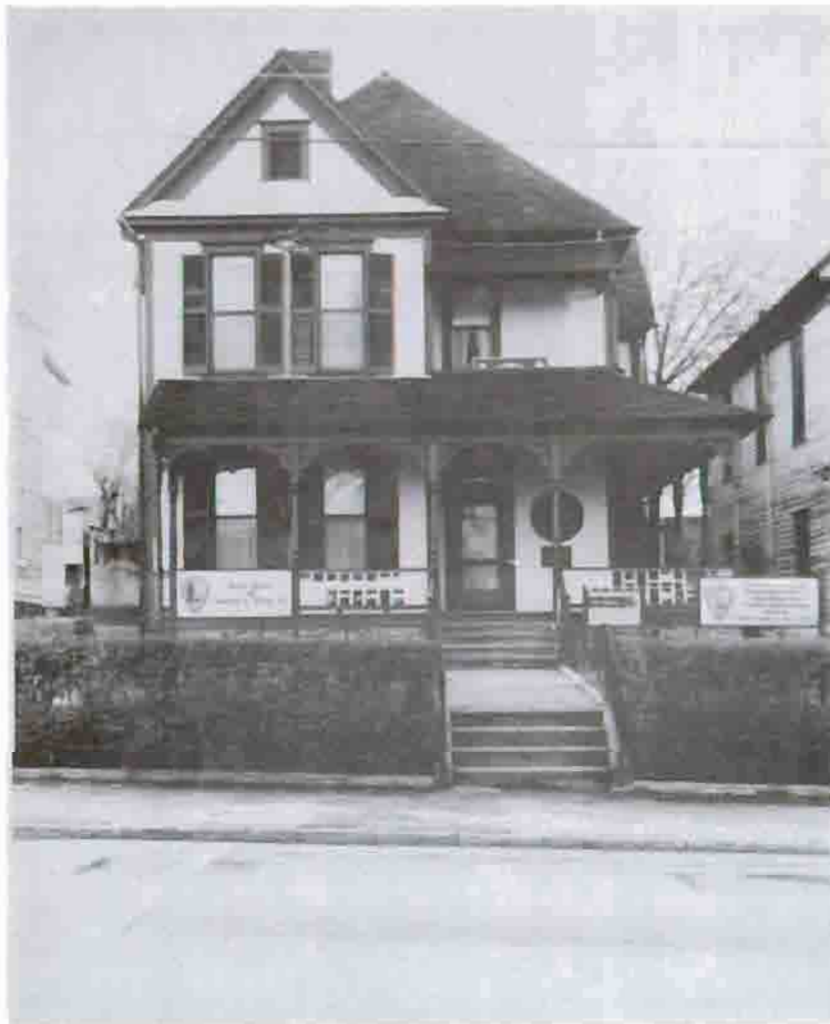
Fig. 21. 501 Auburn Avenue, the Birth Home, 1994.

The Birth Home is a c. 1895, two-story wood house with Queen-Anne-style detailing (figure 21). The original owner was a widow, Mrs. Nancy J. Holbrook, who lived in the house until 1907.¹ There were two other occupants of the house prior to Reverend A. D.

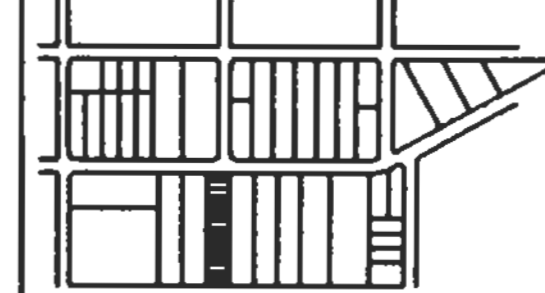
SITE MAP

NATIONAL PARK SERVICE
 SOUTHEAST REGION - OFFICE OF CULTURAL RESOURCES
CULTURAL LANDSCAPE REPORT
 MARTIN LUTHER KING, JR., NHS
 ATLANTA, GEORGIA
BIRTH-HOME BLOCK
501 Auburn Avenue
 HISTORIC and EXISTING CONDITIONS
 DRAWN BY: L. Lowliss and B. Morris DRAWING NO.
 DATE: April 1995 489-80017-1

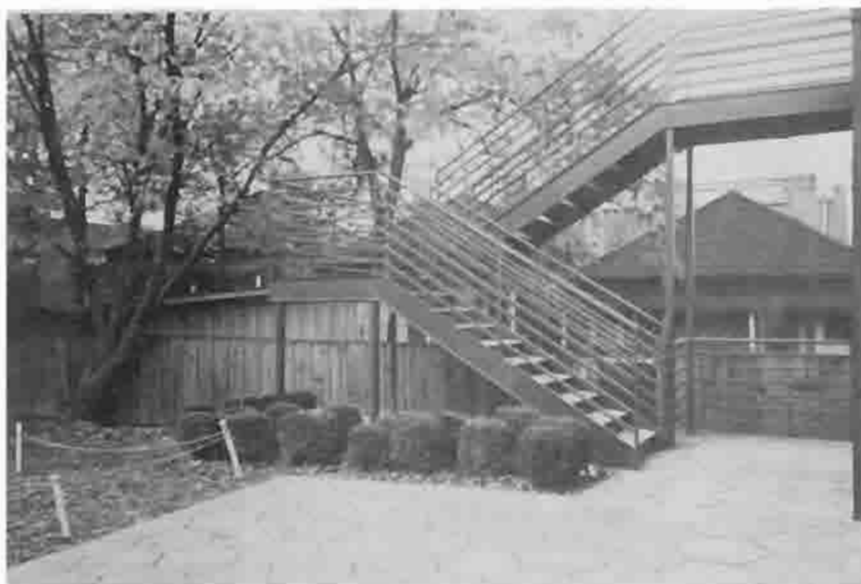
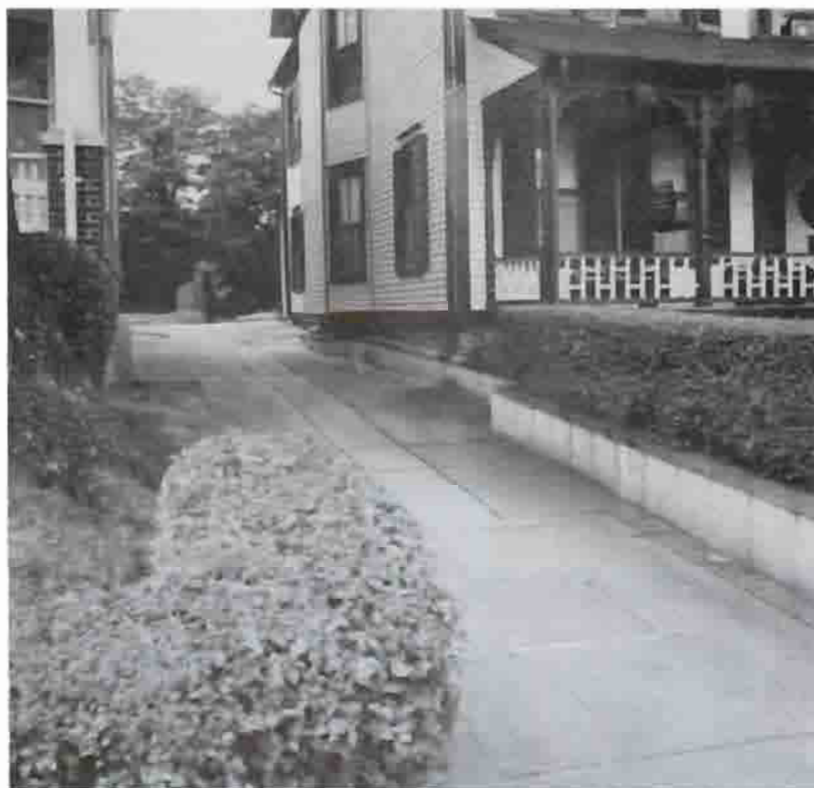
Fig. 23. Rear fire escape stairway, patio and edge of garden (top) and new concrete driveway between 501 and 503 Auburn Avenue (bottom), 1995.

Most of the NPS changes to the landscape have been made to accommodate visitors to the Birth Home and to satisfy fire and access codes. Examples of these types of changes include the two-story exterior stairs/fire escape in the back yard and the concrete driveway that fills the side yard between the Birth Home and 503 Auburn Avenue (figure 23).

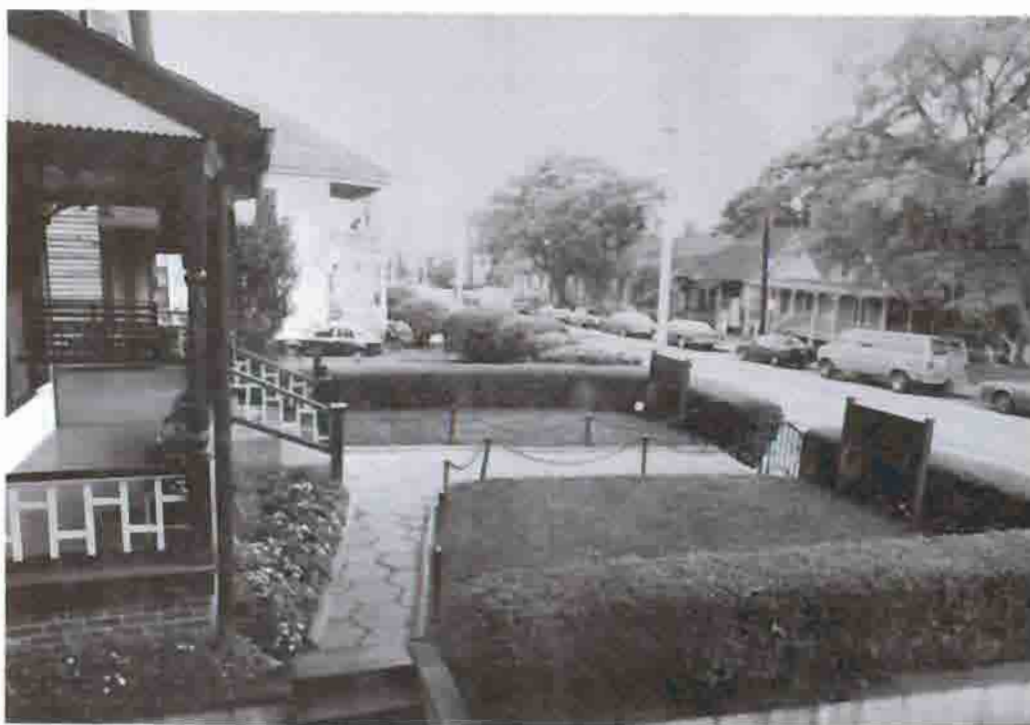
Fig. 24. Existing front yard of the Birth Home, 1995.

In the front yard, changes to the landscape include sodding the existing grass area and edging the lawn area with a low (twelve-inch-tall) post-and-chain detail to discourage people from walking on the grass (figure 24). The foundation shrubs were removed (varieties at the time of removal are unknown), and in their place, flower beds are maintained seasonally (red and white begonias were planted at the time of this survey). The porch furniture (wood rockers and swing) and plant boxes have been restored.

To accommodate circulation, a secondary path from the front stoop to the driveway was added by NPS. This path was constructed of octagonal concrete pavers to match the front walk and sidewalk in front of the Birth Home.

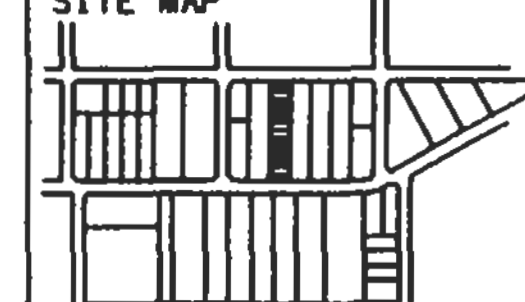
SITE MAP

BIRTH-HOME BLOCK
514 Auburn Avenue
HISTORIC and EXISTING CONDITIONS

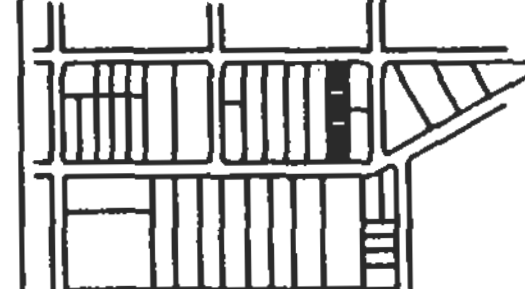
SITE MAP

BIRTH-HOME BLOCK
526 Auburn Avenue
 HISTORIC and EXISTING CONDITIONS

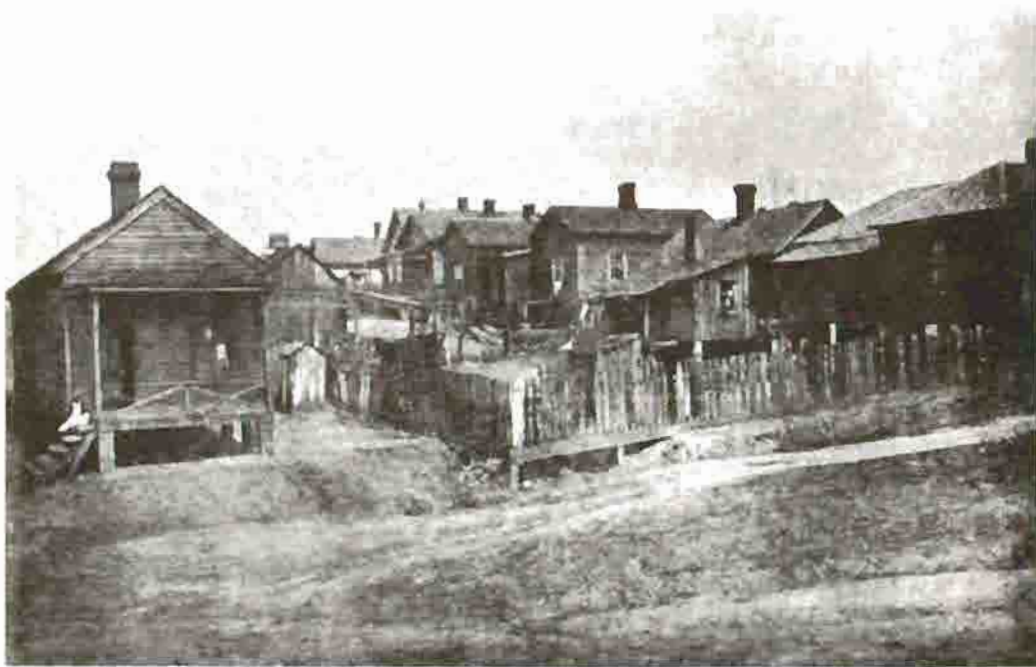
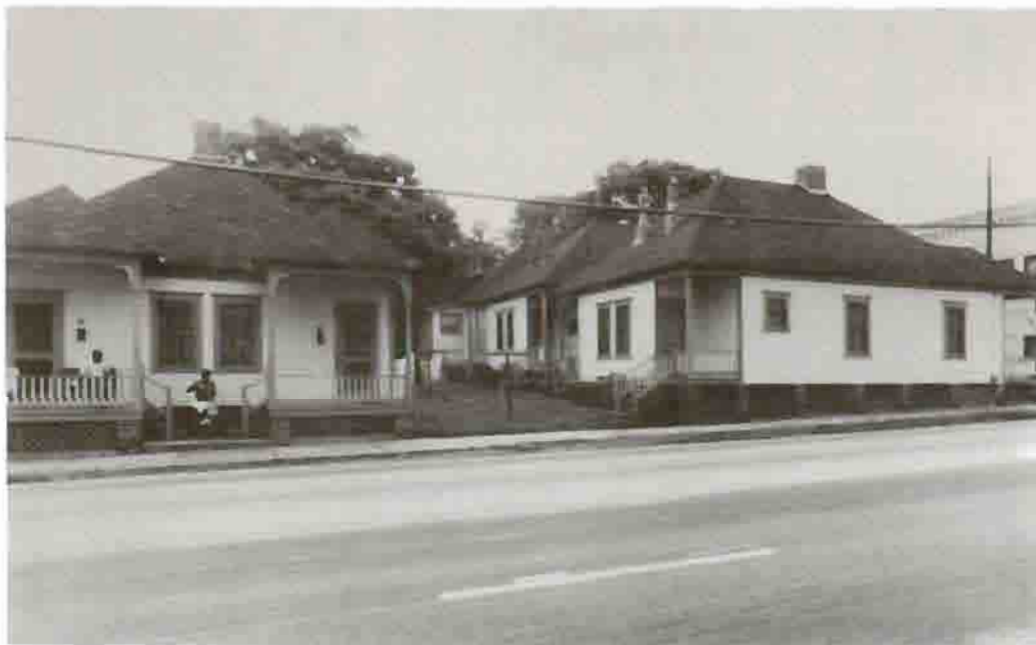
Fig.s 33 & 34. (top) Historic setting of shotguns from *The Negro American Family* in contrast to the (bottom) existing conditions of the double shotguns at Boulevard and Auburn Avenue, 1995.

Three rehabilitated double shotguns--480-488 Auburn Avenue--have been interiorly reconfigured into single-family dwellings. In the process the historic double front porches were joined into single units by the addition of a connecting piece of porch.

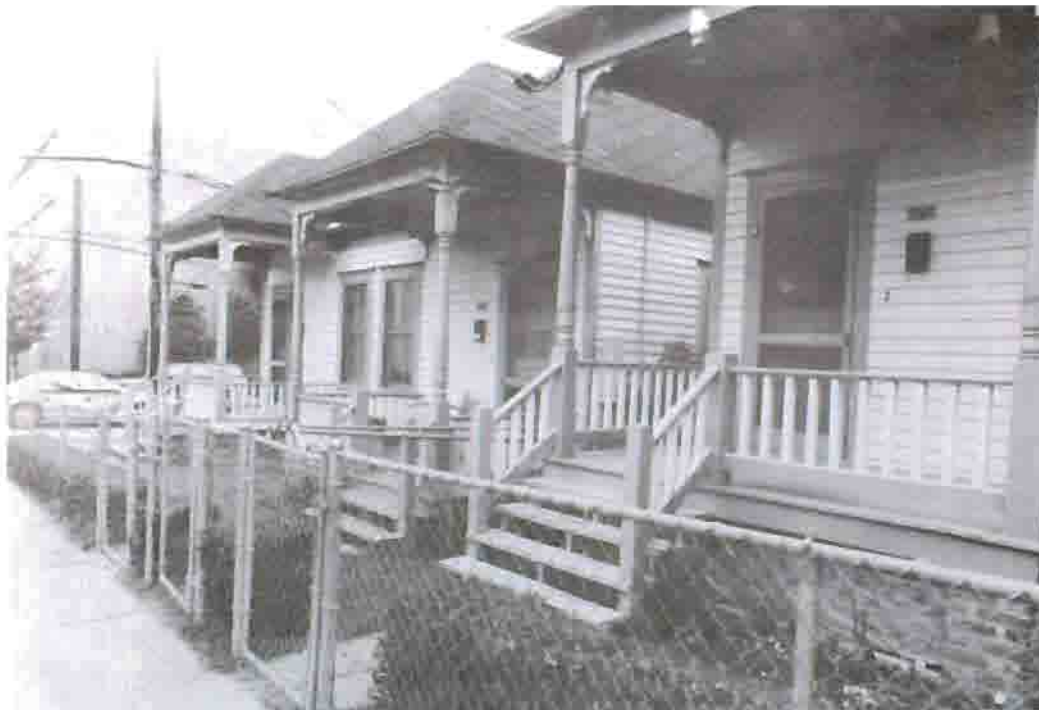
Fig. 35. Existing condition of double shotguns at intersection of Boulevard and Auburn Avenue, 1995.

Because the NPS policy is to restore the shotguns to residential use, there has been an effort to upgrade the interiors and landscape to contemporary residential standards. This policy has resulted in many changes because in current thinking the historic size and condition of this house type is considered substandard. Therefore, many nonhistoric features have been added such as a four-foot chain link fence around the perimeter of the three corner properties, sodded lawn areas, and foundation and ornamental plantings (figure 35).

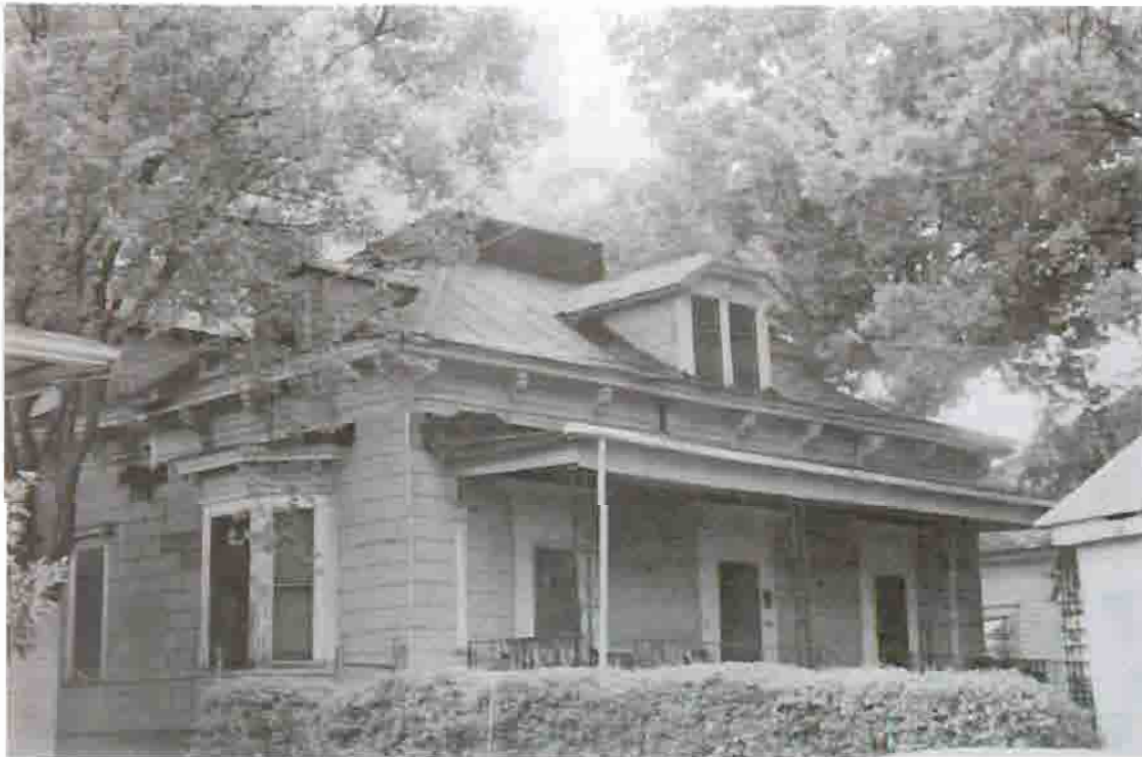
Fig. 38. 521 Auburn Avenue, the Calhoun Home, 1995.

The Calhoun Home is an Italianate style structure and is the oldest dwelling remaining on the Birth-Home Block (figure 38). It was purchased and occupied by Moses and Polly Mae Calhoun in 1913, who remained in this house until their deaths.¹⁷ Mrs. Calhoun's sister, Ida McKennon, came to live with the Calhouns in the 1940s and continues to reside there today. Mrs. McKennon provided information about the historic landscape of this property in an informal interview conducted on her front porch on December 12, 1991 (figure 39).

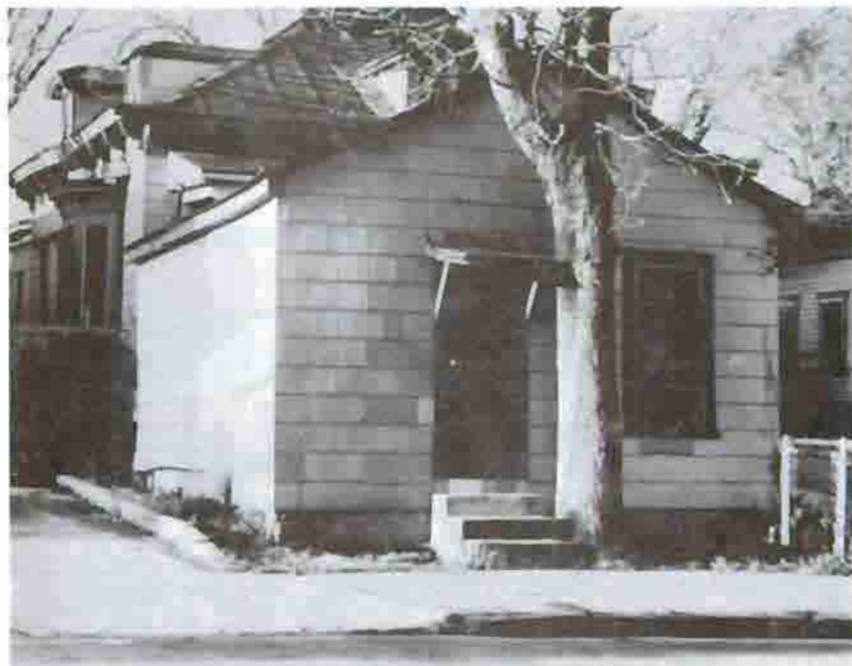
Fig. 40. "Store" at 521 1/2 Auburn Avenue, 1995.

The Calhoun home was originally constructed as a single-family dwelling. However, consistent with changing socioeconomic patterns in the study area, it was converted to three apartments in 1931. The Calhouns lived on the premises and rented the other two apartments to a variety of tenants. In addition to the house, there was a small outbuilding sitting next to the sidewalk, where Mr. Calhoun operated a small neighborhood restaurant and store (figure 40).¹⁸ This structure was converted into a living space in 1936.

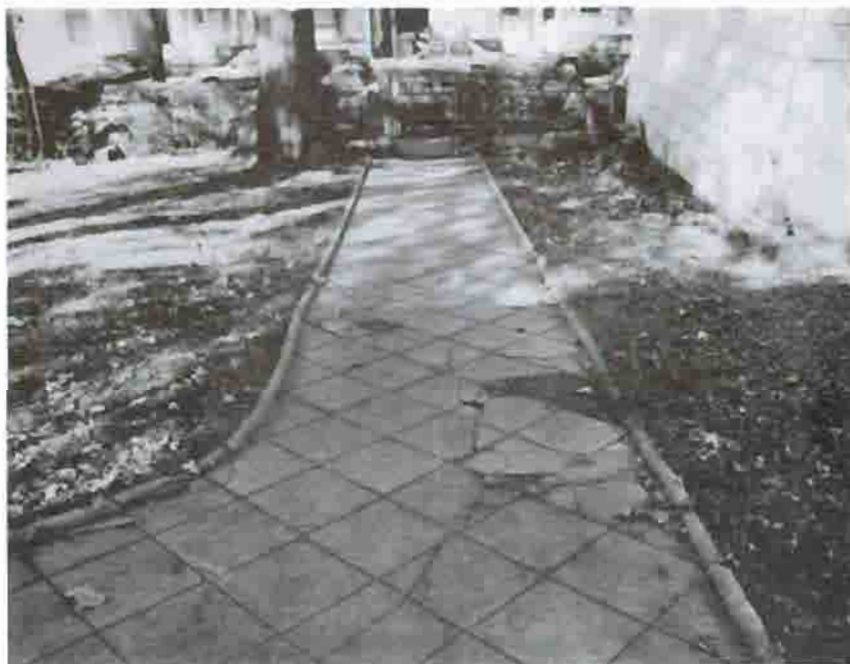
Fig. 41. Front walk at 521 Auburn Avenue, 1995.

The historic landscape that Mrs. McKennon described was quite different than that of the other single-family dwellings. The space in the front yard was significantly larger and allowed the owners many more options as to how the space would be used. Because the Calhouns were farmers whose roots were in rural south Georgia, they chose to use the space for a large vegetable garden. Mrs. McKennon recalled that the entire west side of the front yard was taken up by a garden in which the Calhouns grew collard greens, cabbage, turnips, and onions. There was also a smaller garden on the east side of the yard where similar varieties of vegetables were grown. The entire front yard was fenced from the street and adjacent properties with rolled wire on wood supports.¹⁹ Mrs. McKennon recalled that there were hydrangeas and other bushes along the foundation of the house. Perennials, especially sunflowers, were planted in front of the shrubs to add variety and color to the yard. Plum trees were planted along the east side-yard fence, and a large oak tree was located on this same side (figure 41).

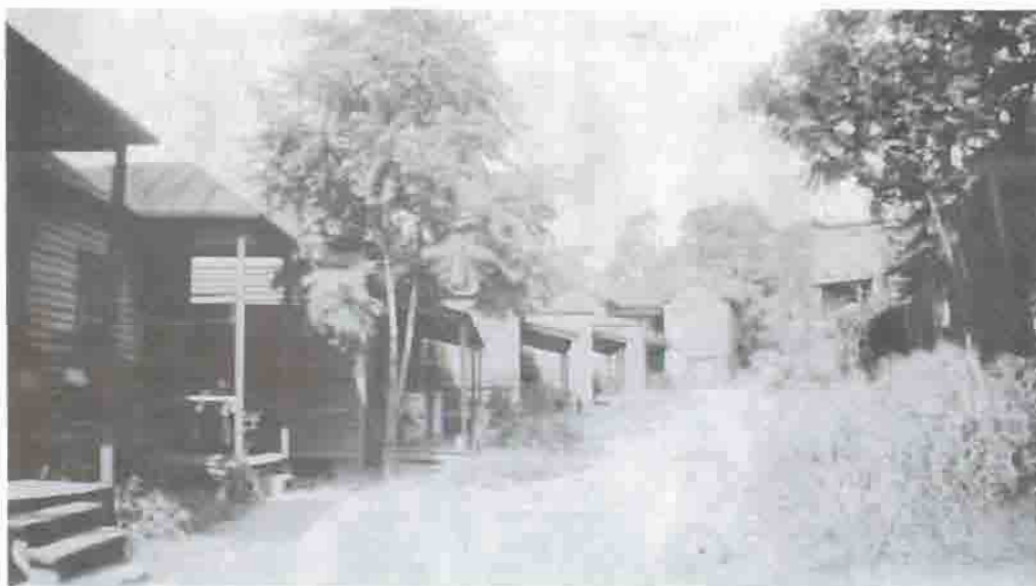
Fig. 45. Photograph of an Atlanta alley, 1940. AHA Collection, Atlanta Historical Society.

In a minimum amount of space—five feet between structures, a ten-foot deep backyard split by a fence to define each unit's space, and the dirt alley as the front yard—there was little landscape available for tenants to manipulate. While nothing has been found to document the historic condition of this alley, the AHA photographs show other alleys in 1940 to be poorly maintained with hard-packed dirt surfaces, open-backed wood steps, porch railings with no vertical supports, overgrown grass, and weedy trees growing up in corners and along property lines (figure 45). Decoration of the outdoor living space would have been limited to some potted plants on the porches.

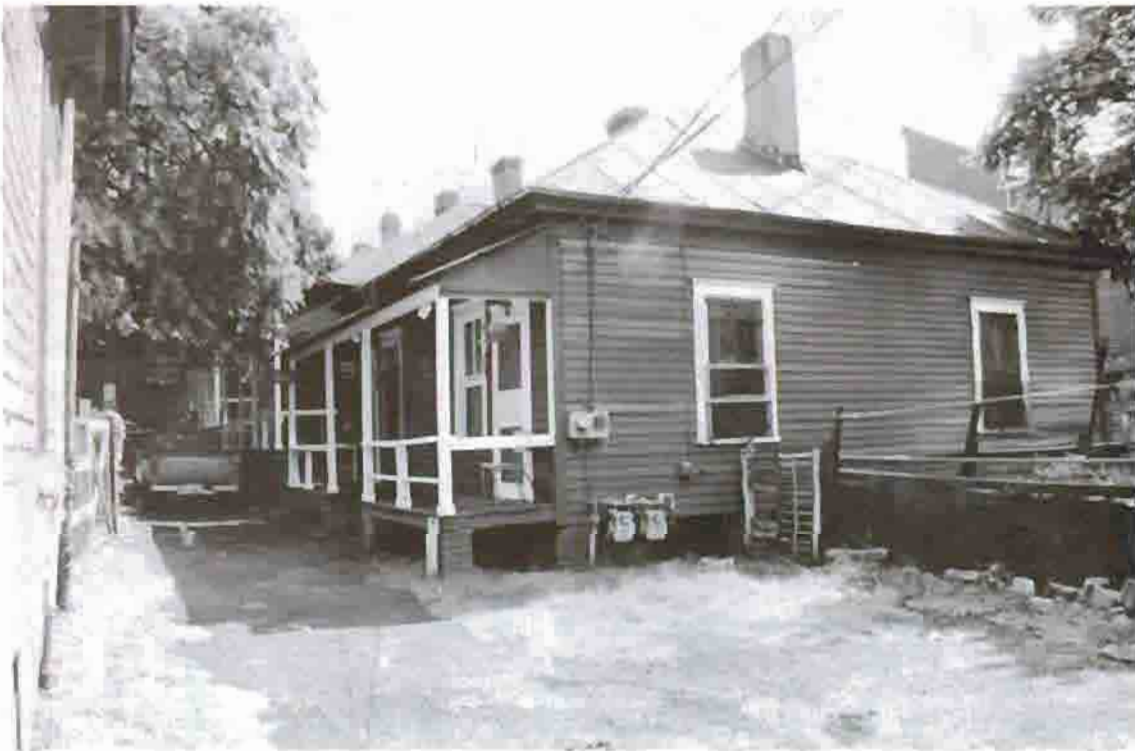
Fig. 47. 493 A, B, & C Auburn Avenue--alley of double shotguns, 1995.

The shallow back yards seem even smaller because of the nonhistoric retaining wall and school building (Our Lady of Lourdes School on Boulevard) that now defines the rear (west) property line. Chain-link fence gates, set between the front corners of the shotguns, prevent access to the back yards (figure 46).

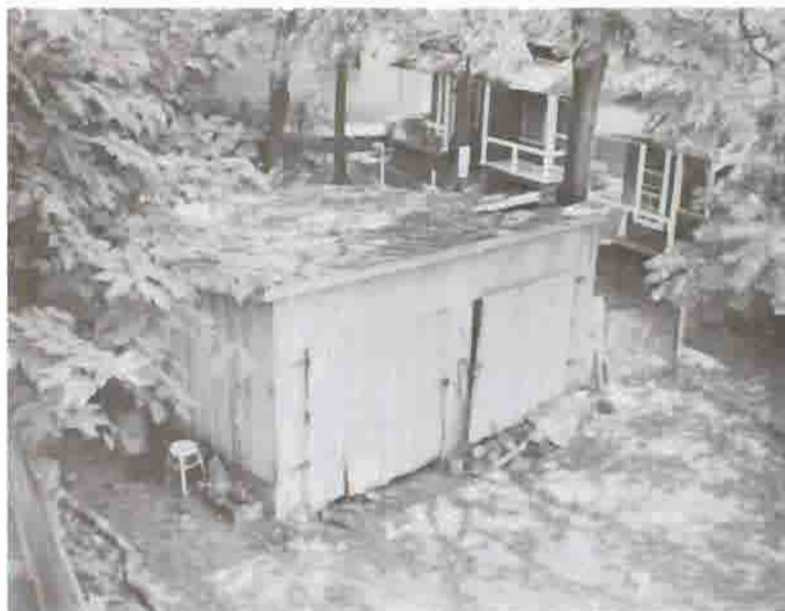
Fig. 50. Shed behind 497 Auburn Avenue, 1995.

The back yard was fenced in except for a break at the southwest corner of the house where an opening (approximately ten to twelve feet wide) allowed vehicle access to a shed/garage that was placed mid-back yard. The shed was skewed off perpendicular approximately thirty degrees in order to accommodate automobile maneuverability from the awkward corner entrance (figure 50).
