CULTURAL LANDSCAPE REPORT: BIRTH-HOME BLOCK

**MARTIN LUTHER KING, JR.
NATIONAL HISTORIC SITE
CULTURAL LANDSCAPE REPORT: BIRTH-HOME BLOCK**

May 1995

**Lucy A. Lawliss
Regional Historical Landscape Architect**

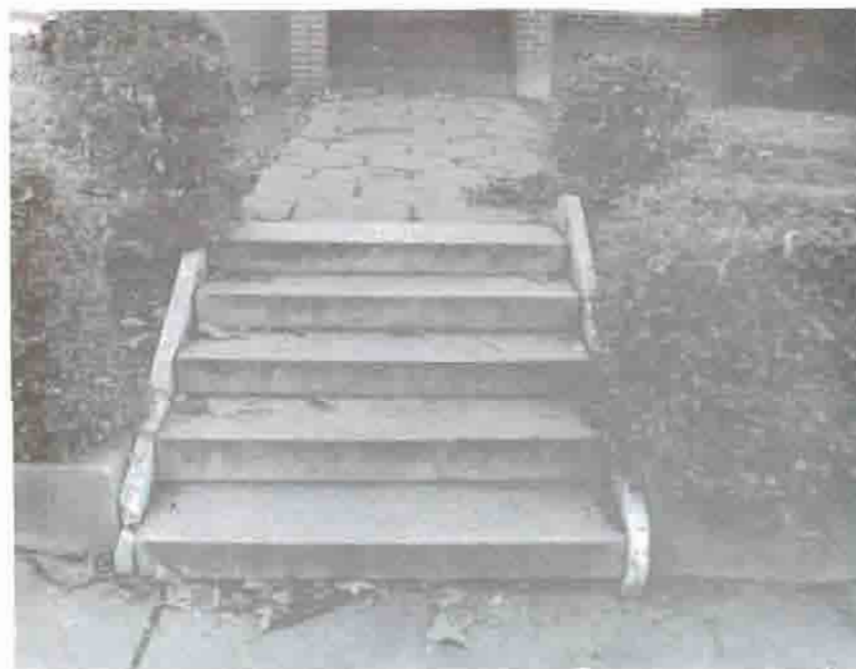
Fig. 51. Detail of front steps at 503 Auburn Avenue, 1995.

A low wall lifted the front yard approximately two feet above the sidewalk grade, and a hedge ran along the top of the wall and down the front-yard property lines. Centered along the front wall were five rough-faced granite steps with a two-inch-thick white marble edging at each end of the steps (figure 51). A front walk ran from the top of the steps to the porch steps, and both walk and stairs were centered on the front door. The distinguishing feature in the front yard was the large red oak just off the west end of the porch near the property line.

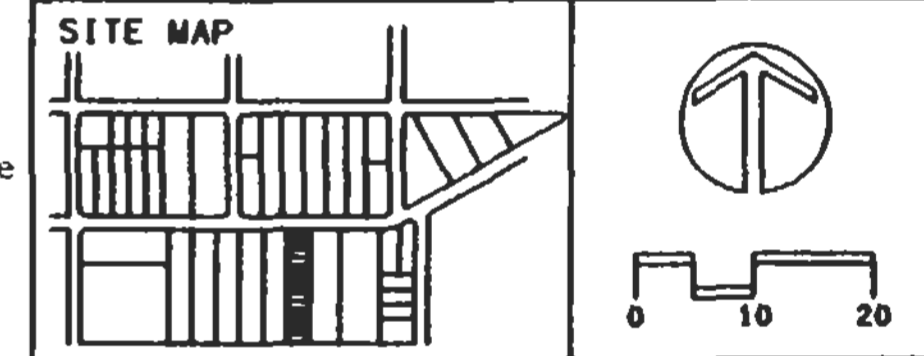
BIRTH-HOME BLOCK
515 Auburn Avenue
 HISTORIC and EXISTING CONDITIONS

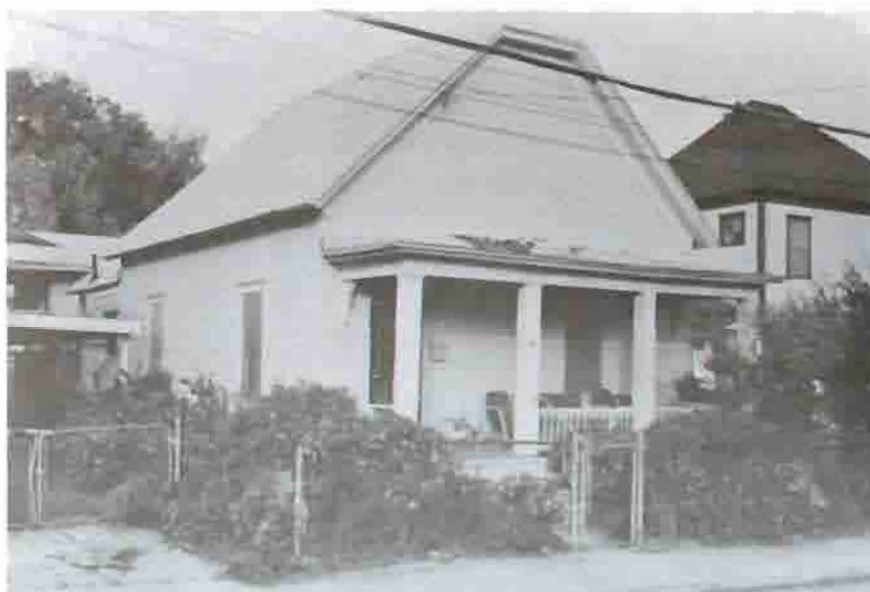
Fig. 60. 28 Howell Street, 1995.

Four of the five houses and yards are extant. 28 Howell Street is included in the report because it forms an important edge to the Birth-Home Block and because the yard is noteworthy, it should be recognized as a contributing landscape (figure 60). Not only

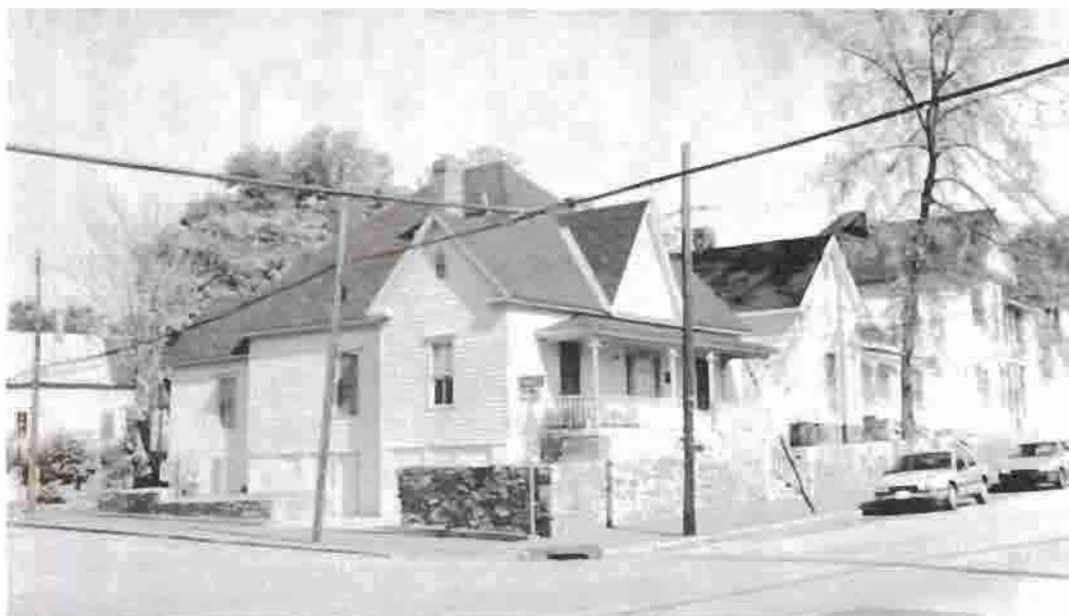
Fig. 65. The triangle--the intersection of Auburn Avenue, Howell and Old Wheat Streets, 1995.

The brick flat-iron commercial building at 554-558 Auburn Avenue was removed in the 1970s. Today, grass covers the site. The three extant wood buildings were all rehabilitated prior to the Park obtaining them. In that process the top third of the wall around the site was rebuilt, and steps leading up to the buildings were widened and formed from concrete (figure 65). Nonhistoric foundation plants were placed across the fronts of the three buildings. One sixteen-inch-diameter tree (species unknown--go see assumed to be historic) remains in west front yard of 546 Auburn Avenue.

Along the Howell Street side of 540 Auburn Avenue (east side), the curb was broken and a driveway was constructed at the Howell Street level. A tree-of-heaven exists on the rear west corner of 540 Auburn Avenue. The rest of the site is grassed (figures 62-64).

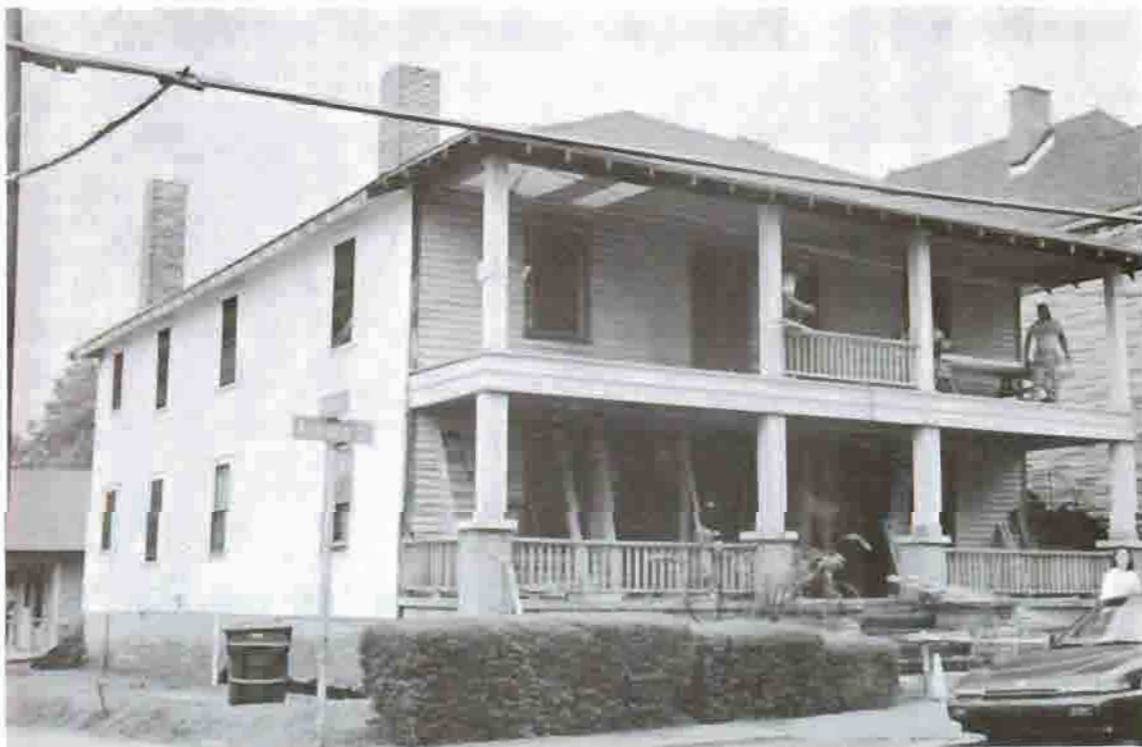
Fig. 71. 506 Auburn Avenue, 1995.

This two-story, four-unit apartment building was constructed in 1933 on the site of an earlier residence. At about this same time the back quarter of the lot was subdivided, and a duplex was developed directly behind the apartment building (53 Hogue Street) (Figure 71). The apartment building had a two-story front porch and a small front yard like the other residences on the north side of Auburn Avenue. It had a centered front walk. The Cadastral survey and aerial photograph both document a hedge planted along the front property line (figure 72).

The existing landscape of 506 Auburn Avenue is limited to a concrete front walk (not historic), a shrub rose growing along the front edge of the porch, just west of the porch steps, and the remains of a privet hedge along the sidewalk. The narrow side and rear yards are grassed (figure 72).

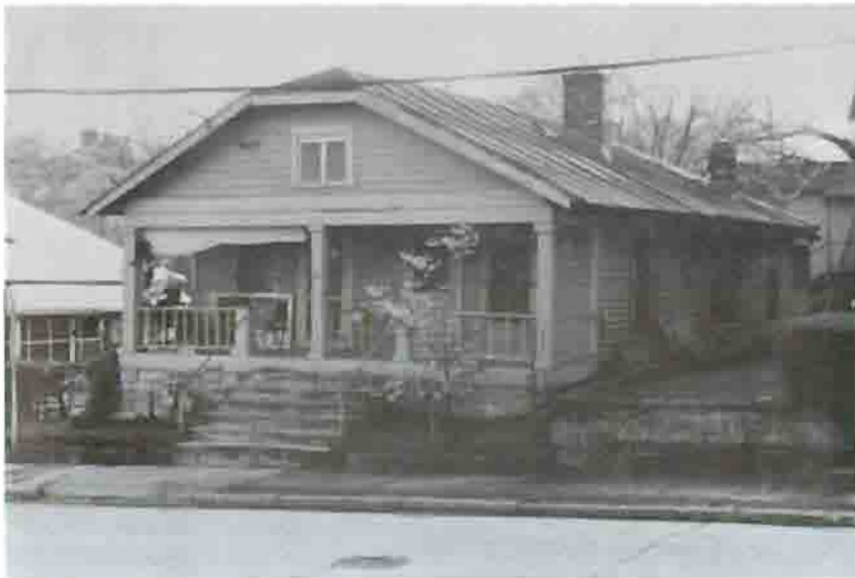
Fig. 73. 53 Hogue Street, 1995.

This duplex was developed on the back half of the lot of 506 Auburn Avenue c. 1930. It had a tiny front yard, approximately six feet deep, determined by the five steps required to reach the front porch from the sidewalk (figure 73). There was an equally narrow back yard, and according to the Cadastral survey, a fence separated it from the backyard of 510 Auburn Avenue. A low retaining wall defined a two-foot-wide side yard that was twelve to eighteen inches below the back yard of 506 Auburn Avenue. The side yard along Old Wheat Street was the unpaved setback from the street and according to the Cadastral survey there was a fence that ran the length of the property on this north side (figure 74).

The landscape of 53 Hogue Street retains much of its integrity. The front yard is still limited to the tiny patch of ground either side of the entry steps. The yard is enclosed by a rolled wire fence (one of the last examples of this once popular fence types in the Birth-Home Block). A narrow planting strip exists as the side yard along Old Wheat Street. This strip along Old Wheat Street is edged with a rubble wall and it appears to be a continuation of the wall along the rear setback line of 510 Auburn Avenue and, therefore, assumed to date to a period before the construction of 53 Hogue Street, c. 1930, when all this lot was the back yard of 506 Auburn Avenue (figure 72).

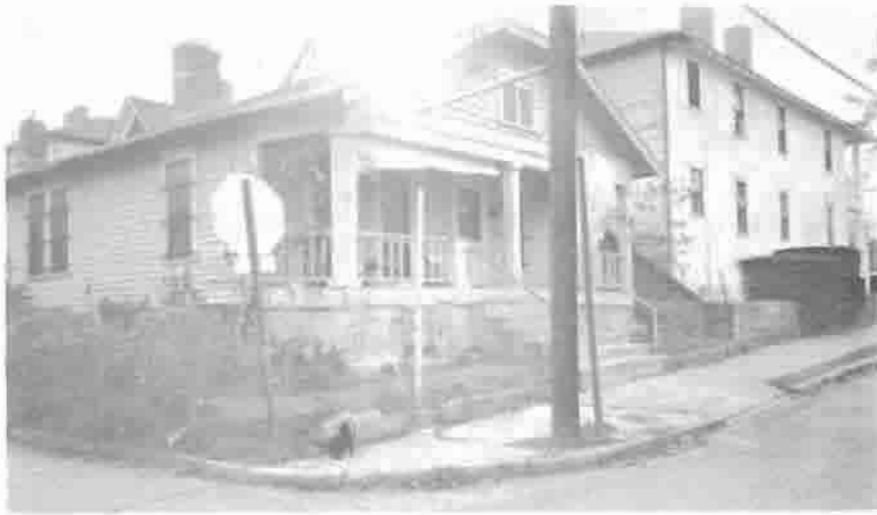
53 Hogue Street. Note rolled wire fence across front yard.

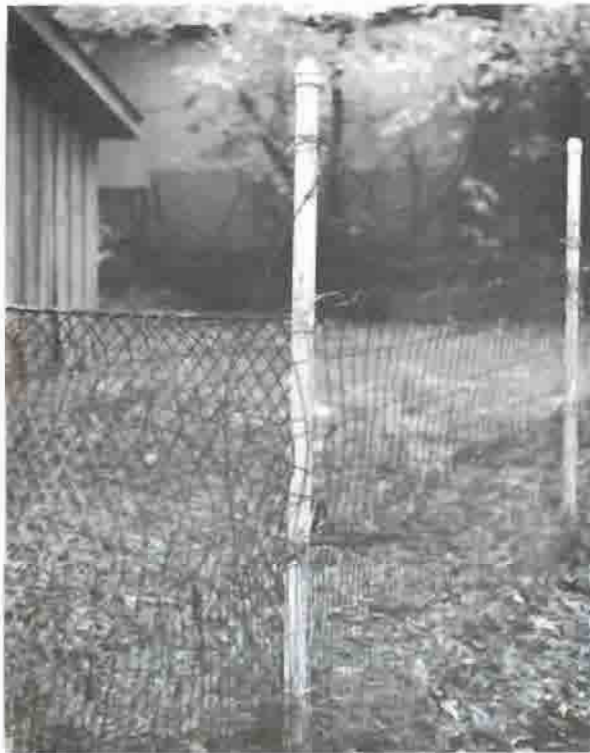
Rolled wire fence at 497 Auburn Avenue.
