TECHNICAL REPORT NUMBER 7

# The Trump-Lilly Farm:

Historic Structures & Cultural Landscape Report

TRUMP-LILLY FARM  
HISTORIC STRUCTURES  
AND CULTURAL LANDSCAPE REPORT

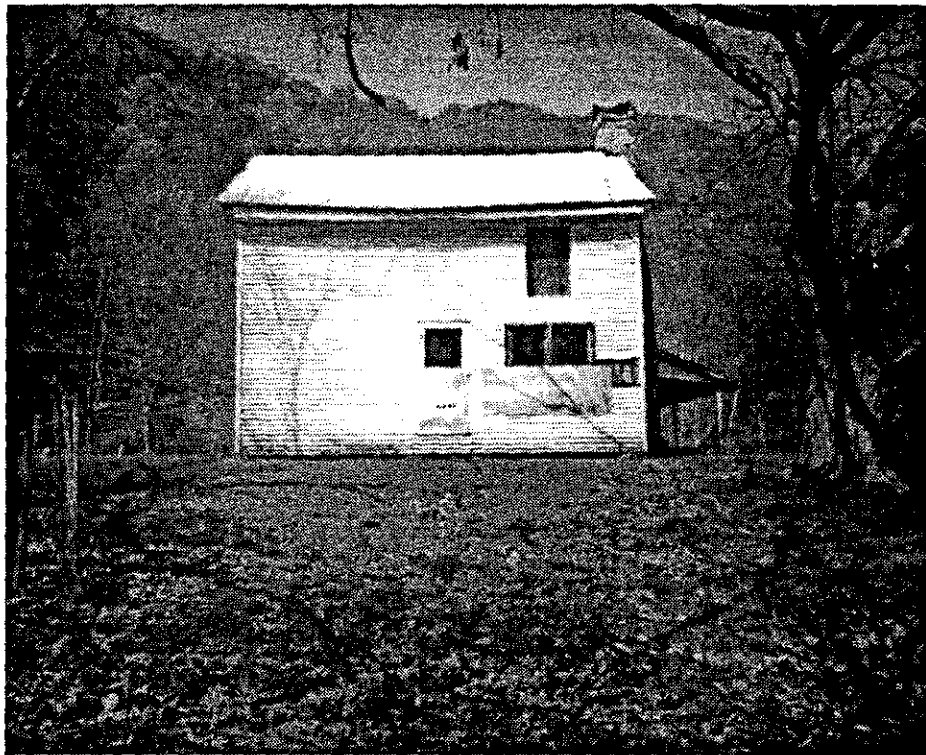
Fig. 1. Farmhouse, east elevation. (IHTIA)

The east front of the structure is pierced twice on the first floor and once on the second. The first floor has a doorway approximately in the center of the wall and a pair of double-hung windows just north of the doorway. The second floor is pierced only once on the east by a single double-hung window, which has been removed from its framing but whose parts remain in the structure. The first floor door is glazed. A single glass panel is found in the uppermost position with three wooden panels below. The pair of double-hung windows is divided by a mullion and composed of two sashes, each sash being divided vertically by a single muntin.

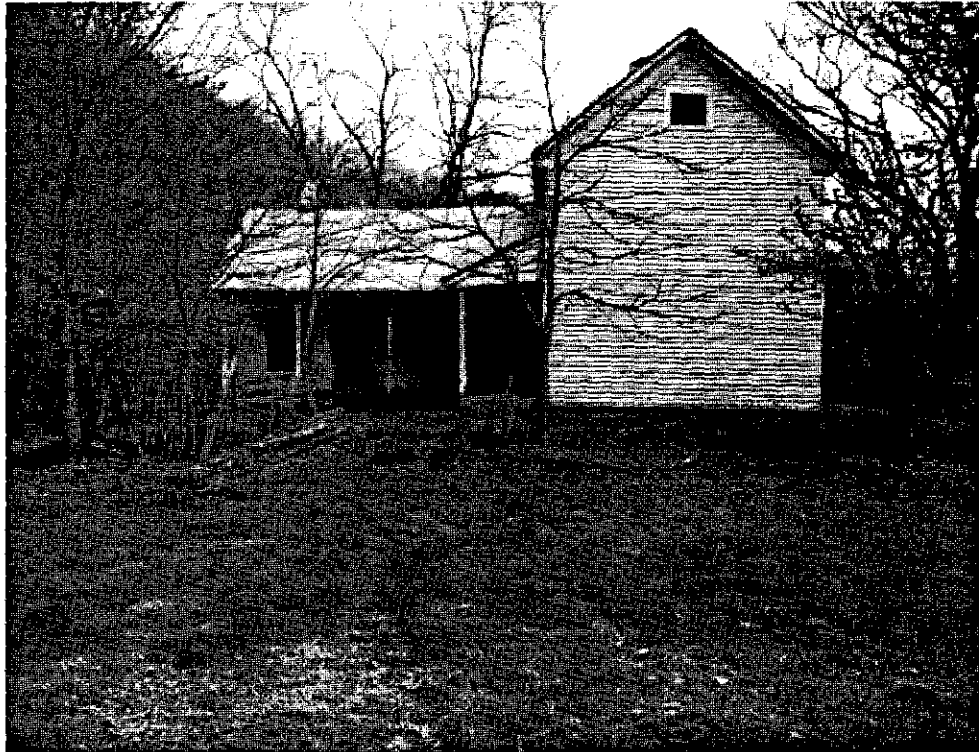
Fig. 2. Farmhouse, south elevation. (IHTIA)

The south wall of the kitchen wing, which is clad in horizontally applied flush poplar siding is broken twice by windows and once by a door. From east to west one finds a pair of double-hung windows lighting the dining room, a door opening into the kitchen area and a single double-hung window lighting the kitchen. All three windows in this wall are of the same double-sash, two-tier, three-rank, six-light design as other examples in the structure. The door is of the same design as other exterior doors in the structure, three panels below a large single light. The L-shaped covered porch which is founded on log members is attached to this

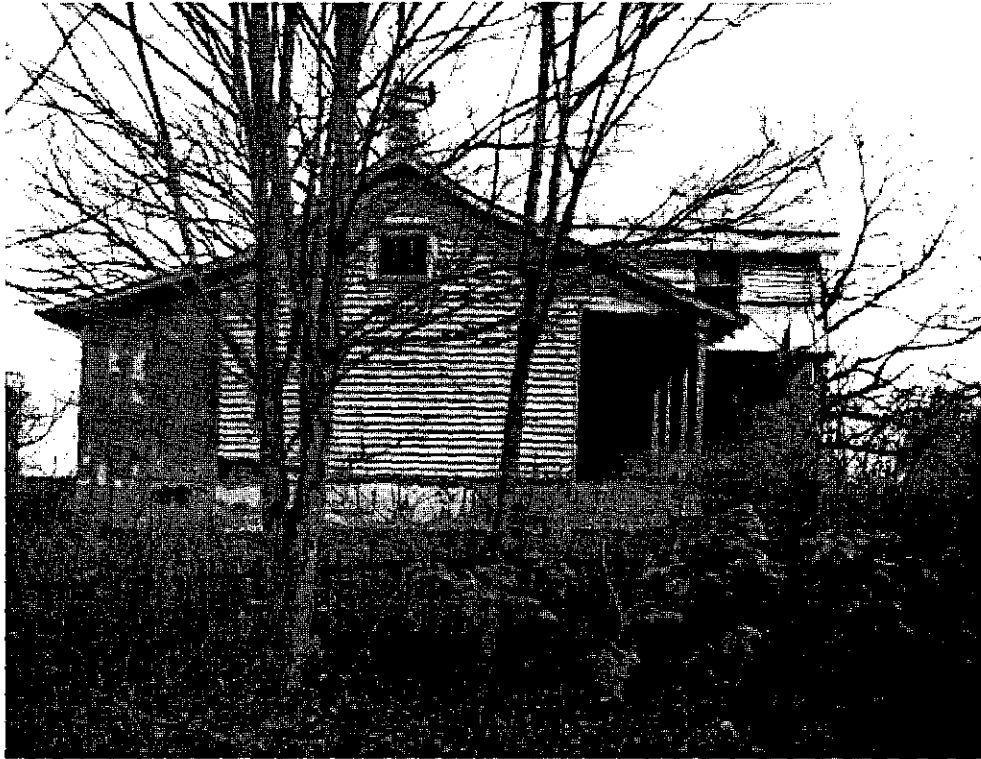
Fig. 3. Farmhouse, west elevation. (IHTIA)

A portion of the west wall of the main body of the house remains exposed, and with the south wall of the kitchen wing creates an L. This portion of the house is peculiar in that it is clad in vertically applied tongue and groove siding. The visible first floor wall is interrupted by both a door and a window. This door is located approximately opposite of and of the same design as that found in the east front, that is, one large glass panel over three smaller wooden panels. The double-hung six-over-six window is made up of two sashes divided into two tiers and three ranks. Both openings in this wall are south of the center line of the wall.

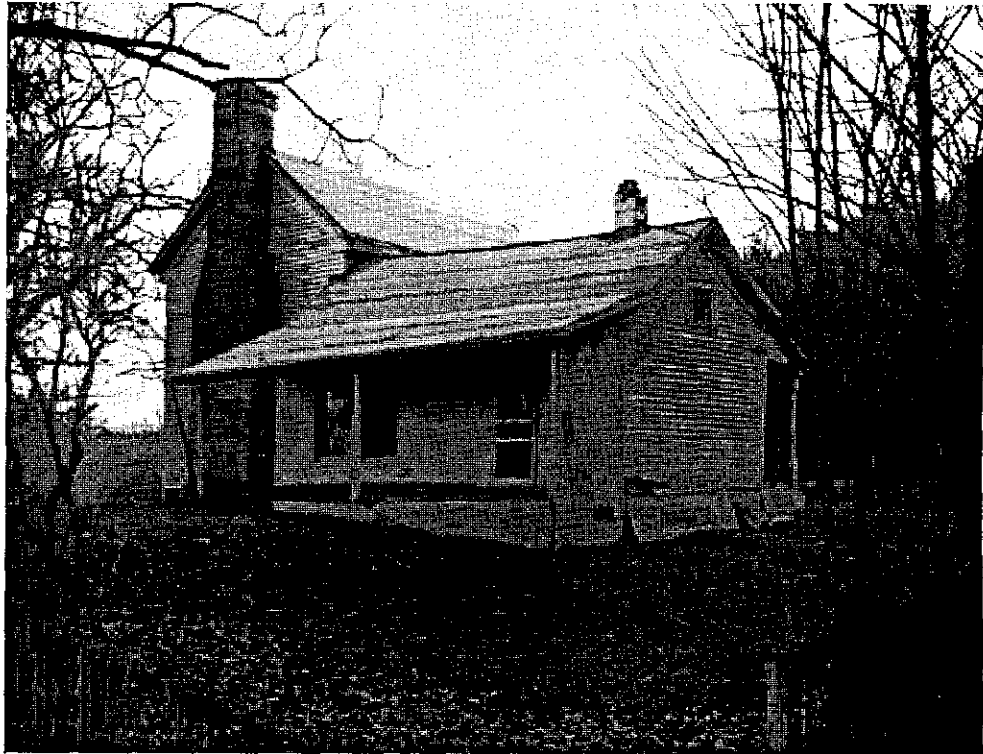
Fig. 4. Farmhouse, north and west elevations. (IHTIA)

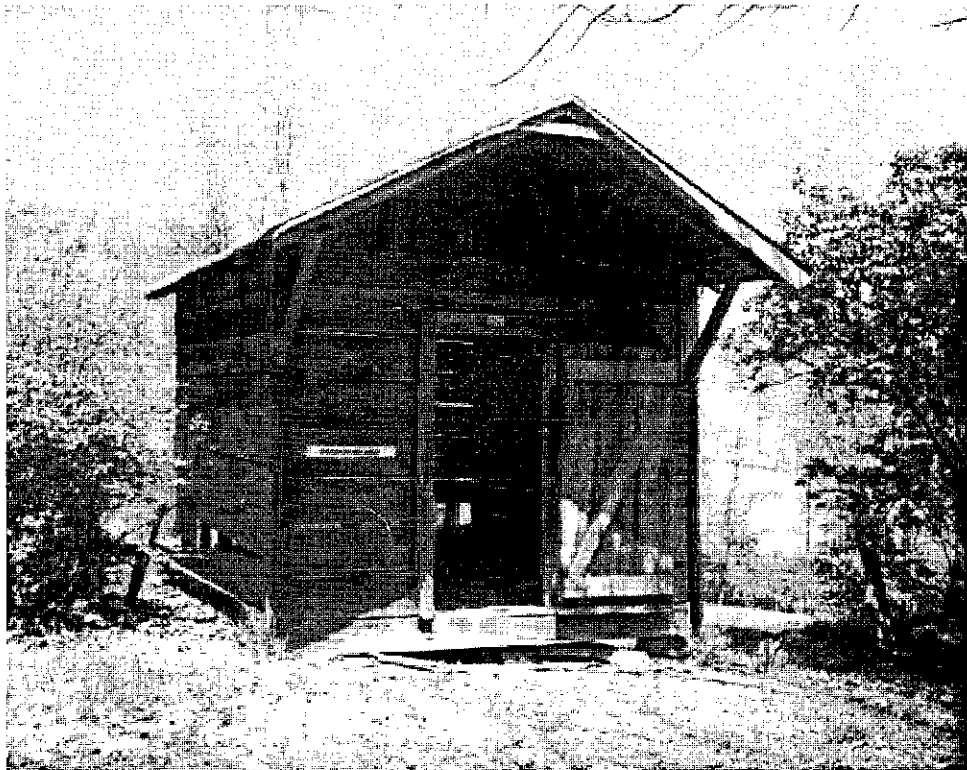
Fig. 18. Meat Shed, south elevation. (IHTIA)

The meat shed is a 13' 1" x 10' 3" frame structure constructed of rough cut lumber on a stone foundation. The framing system is of typical platform style. The exterior siding is composed for the most part of 9" chestnut boards applied horizontally. The east wall of the structure carries an additional layer of beveled clapboard poplar siding which is somewhat deteriorated. The south wall of the structure contains the door which is constructed of the same type members as the siding. The gable plate is covered with various sized boards, battens are absent. The structure's front gabled roof lies on a north-south axis and is constructed of rough cut 2'x 4" rafters and joists. The front gable eave is extended some three feet over the south front of the structure creating a sheltered entrance.

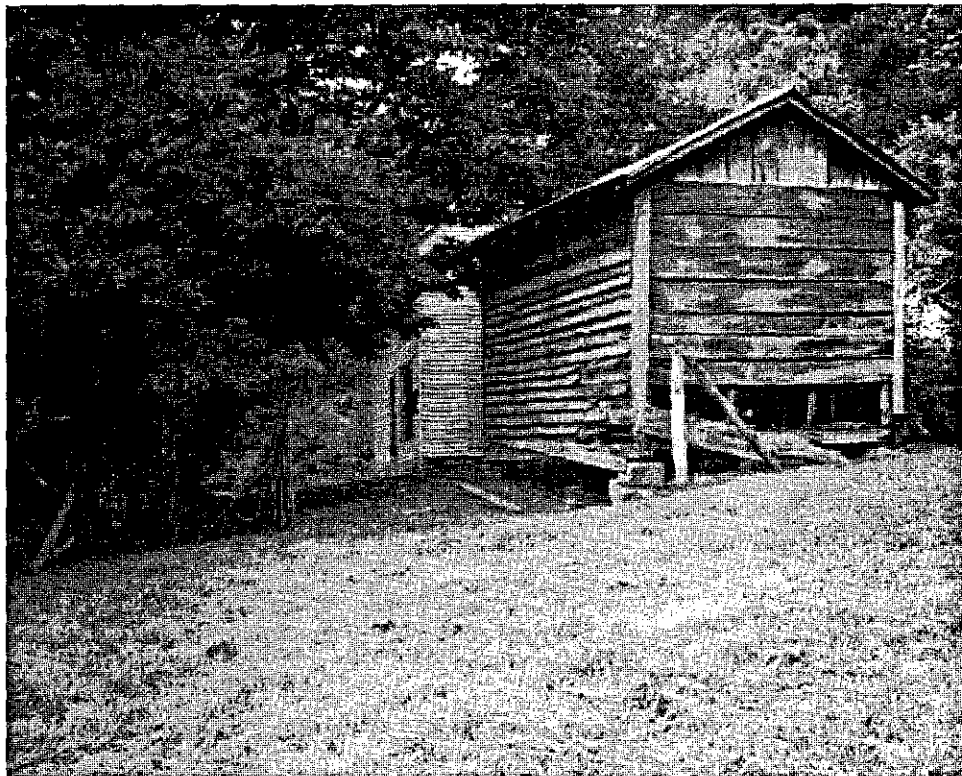
Fig. 19. Meat Shed, northeast corner. (IHTIA)

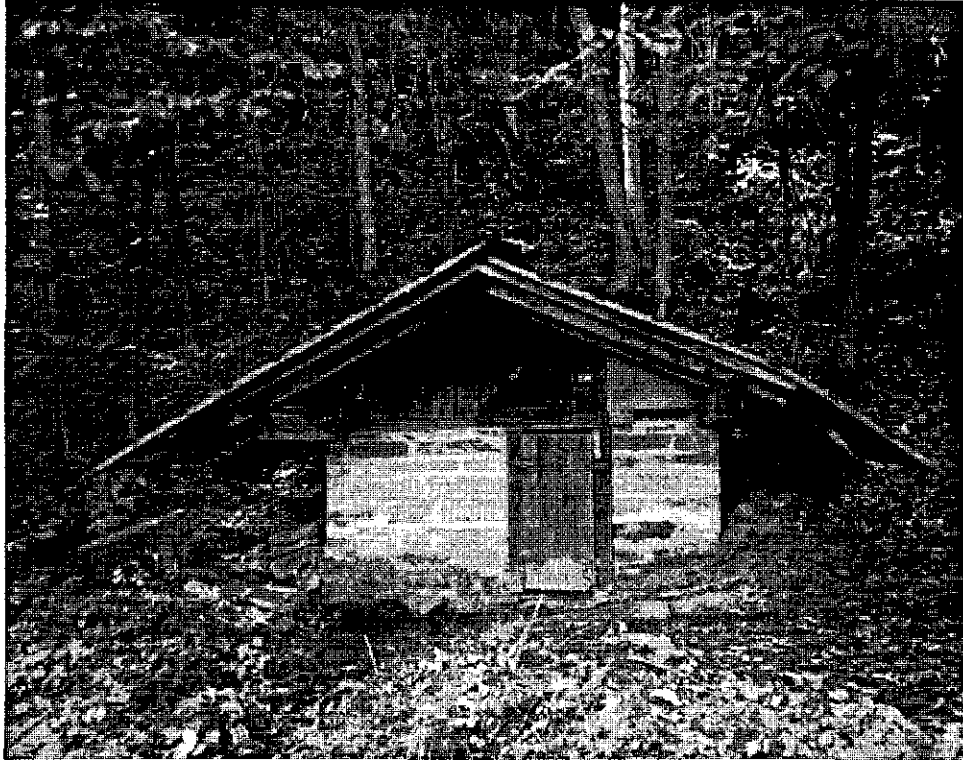
Fig. 20. Springhouse, east elevation. (IHTIA)

The springhouse roof is similar in configuration to that of the meat shed in that the roof's truss system rests on massive hewn chestnut plates which rest on the stone walls and extend some five feet from the east, gable wall. This system creates an extended roof which shelters the doorway as well as a portion of the small pool which collects directly outside the springhouse. A screened opening in the east gable plate above the door vents the interior. The roof itself is absent of joists or ridge board and its 2" x 6" rafters rest directly on the timber plates. The roof is currently protected by large sheets of aluminum scavenged from roadside billboards.

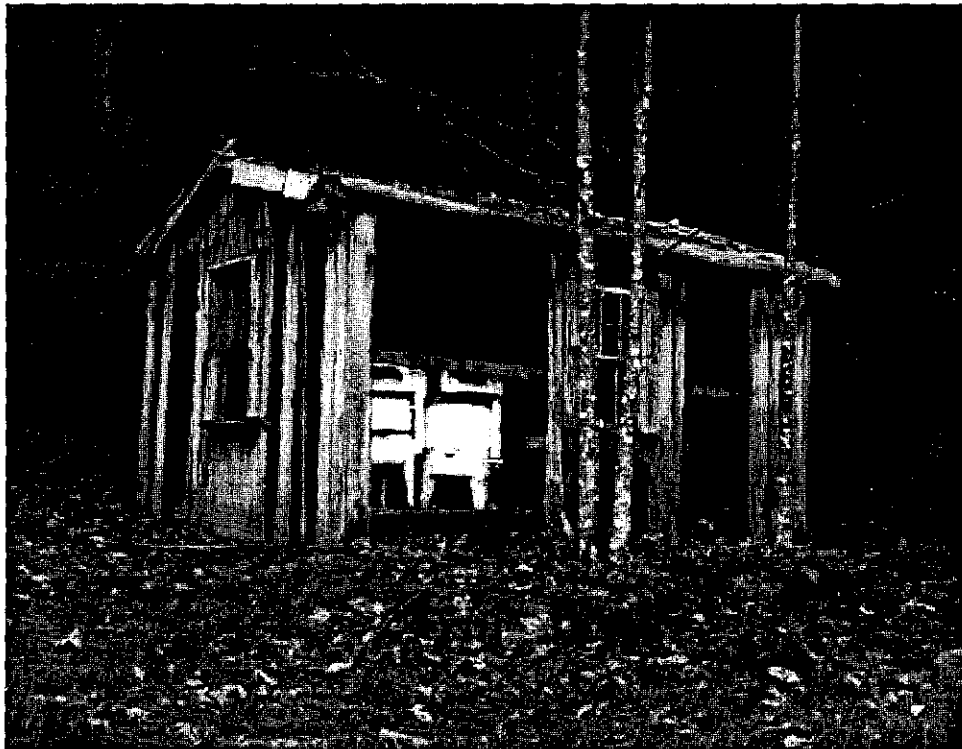
Fig. 25. Washhouse, east elevation, after August 1993. (IHTIA)

After the 1940s electrification of the farm, the washhouse was constructed. It provided a sheltered location near the house and the springhouse for family washing. The washhouse was seriously damaged in August 1992 when vandals removed much of the original siding of the structure.

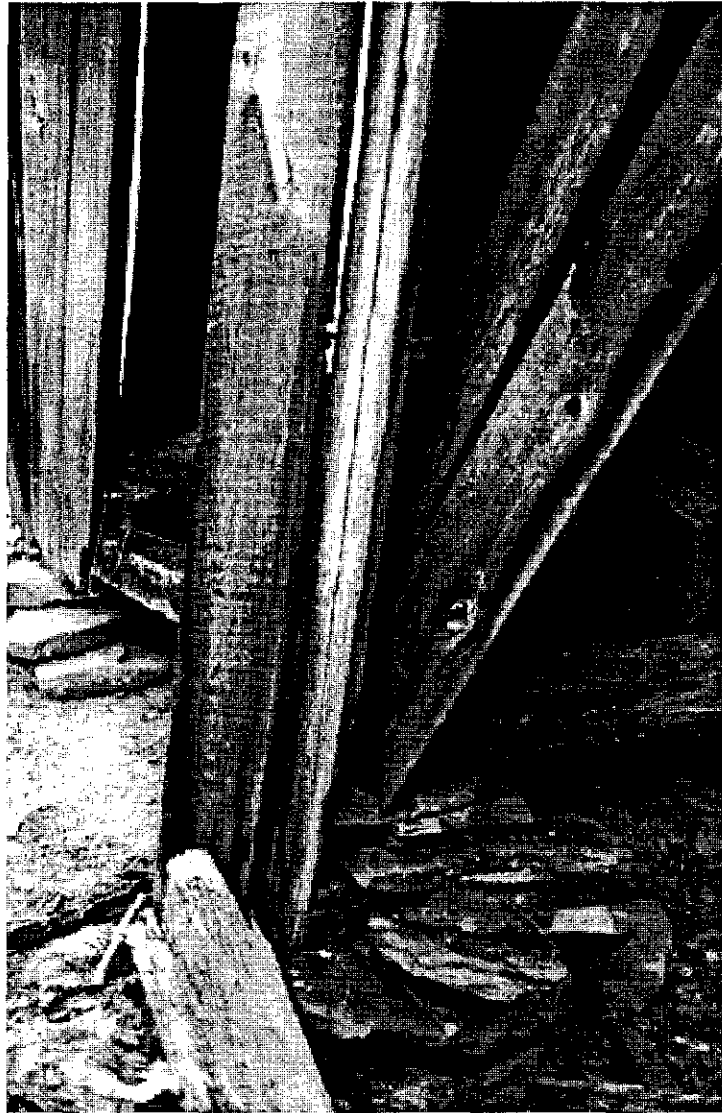
Fig. 31. Outhouse, northeast corner, note foundation stones and deteriorated condition. (IHTIA)

The outhouse was relatively well leveled by its stone foundation piers on this sloping grade. No evidence of a pit beneath the structure is evident. Currently the structure lists noticeably to the east and portions of the rear and east walls are absent.

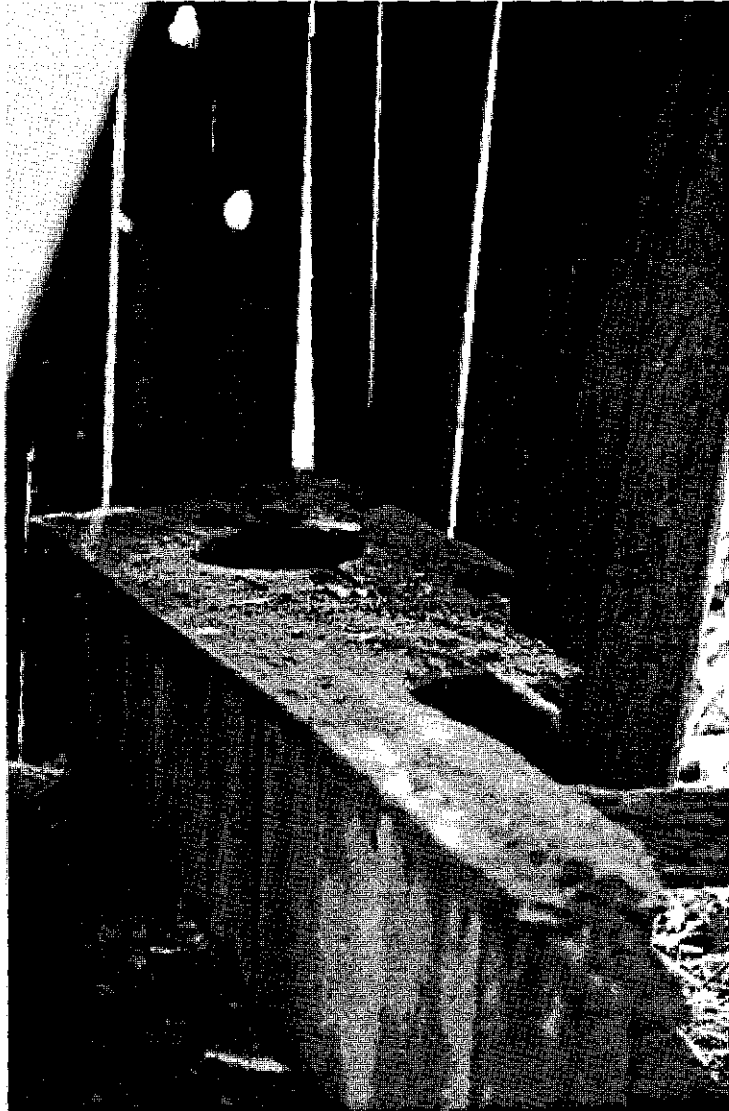
Fig. 32. Outhouse, interior, northwest corner, note seat along north wall. (IHTIA)

The interior of the structure consists of a two-seat bench positioned along the full length of the north wall. The 1' 10" deep bench is constructed of two 6' 10" boards and is pierced by two circular holes approximately 11" in diameter. The east end of the bench is badly deteriorated. The flooring is composed of the same type boards as the exterior siding.

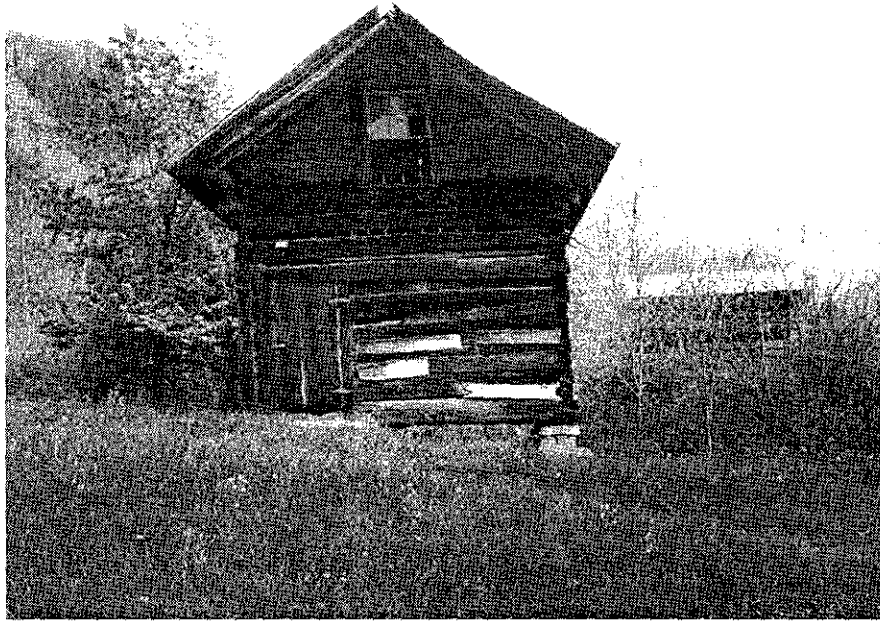
Fig. 33. Granary, south elevation, note barn in rear. (IHTIA)

Entrance to the structure is gained through a doorway cut into the south wall. The ledged and braced door is composed of three vertical boards. The entrance is sheltered by the eave overhang described earlier. Other exterior walls are characterized by the addition of horizontal boards in areas where large openings are created by the failure of wall logs to abut tightly.

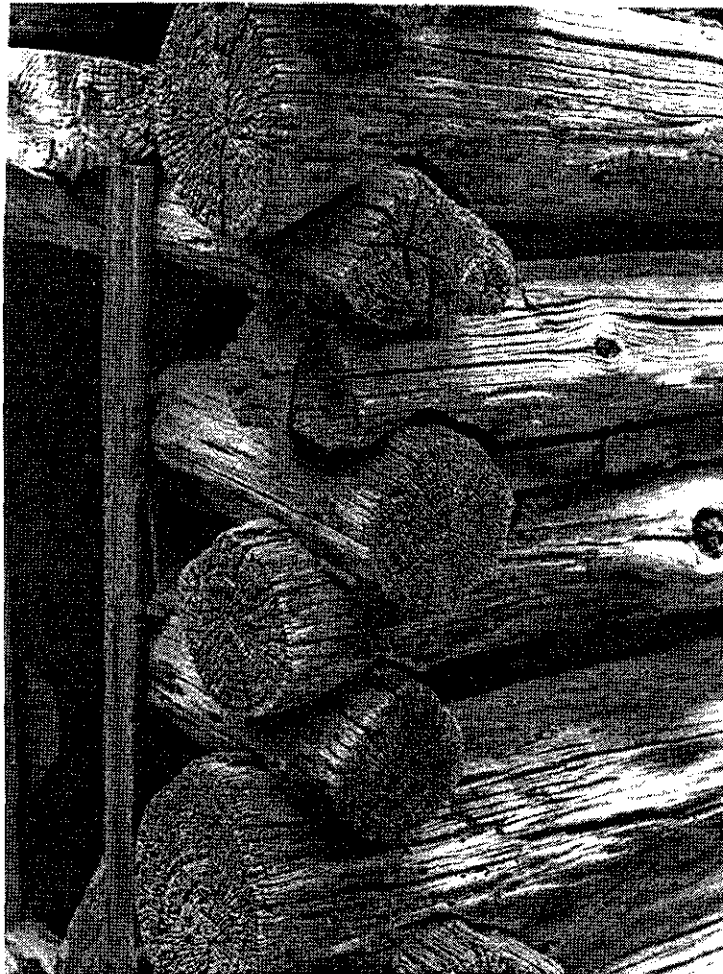
Fig. 45. Stable, northwest corner, detail, saddle notches. (IHTIA)

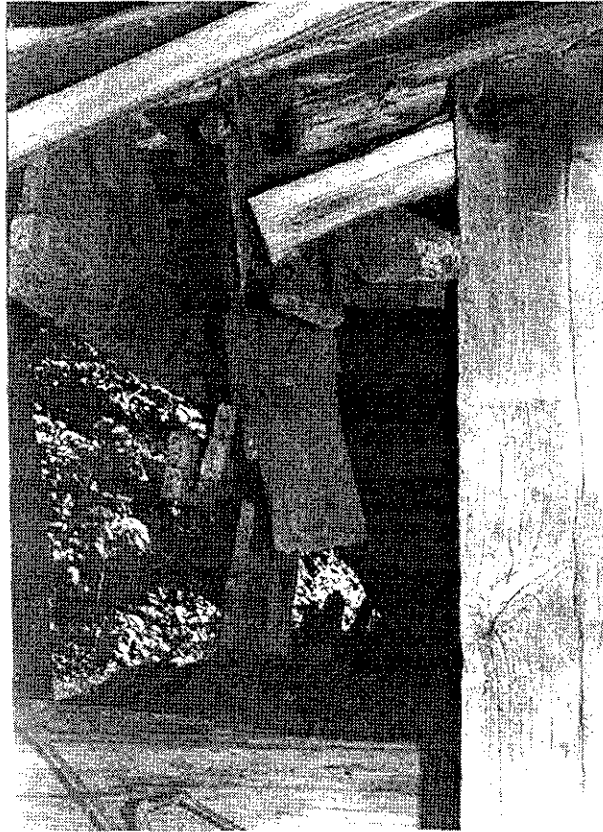
Fig. 46. Stable, northeast corner, side shed, note deteriorated condition. (IHTIA)

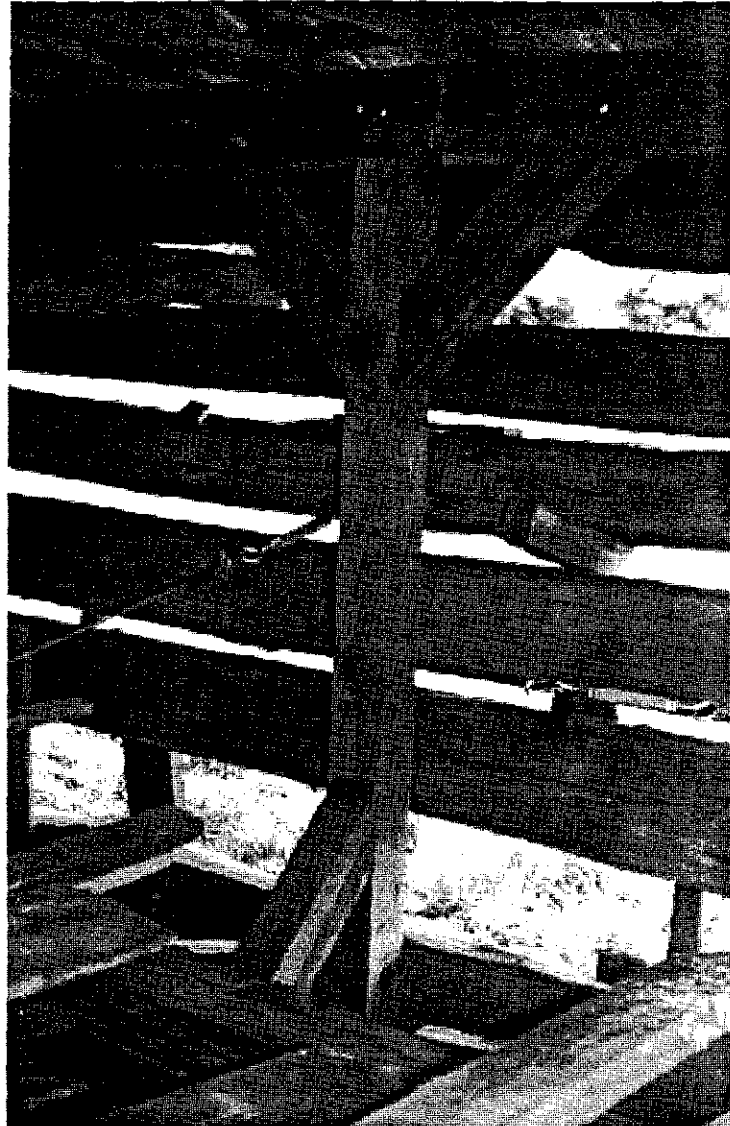
Fig. 53. Barn, interior, north wall, stabilization support. (IHTIA)

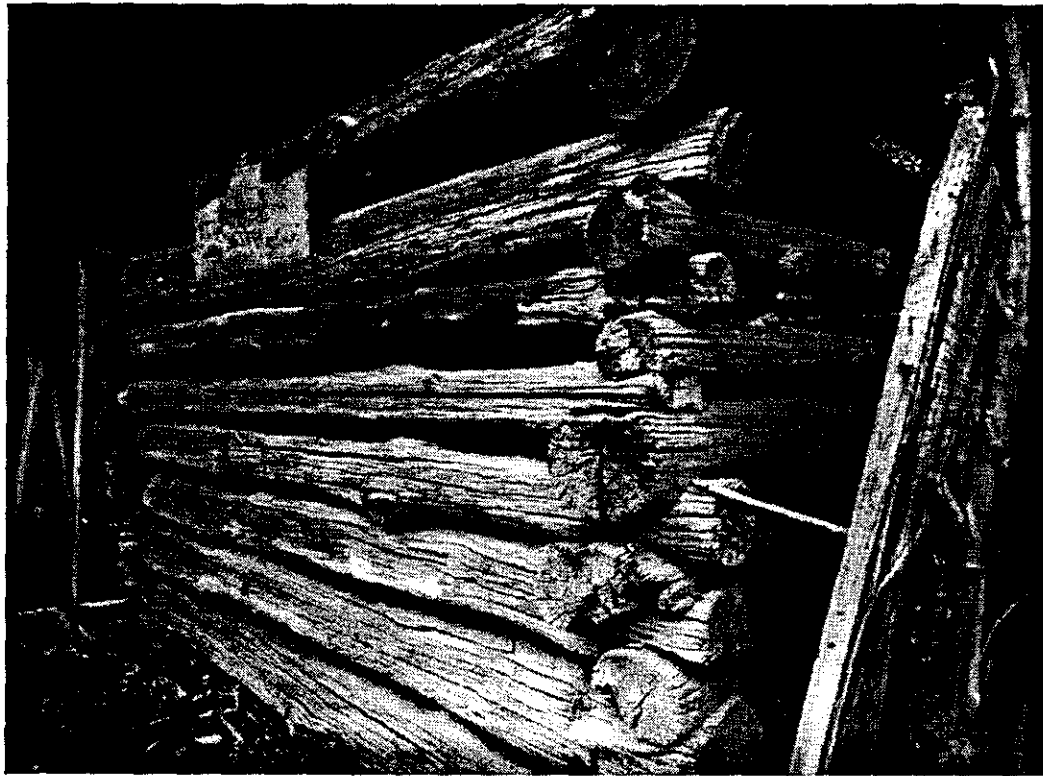
Fig. 58. Hay barn, southeast corner, note flat and saddle type notches. (IHTIA)

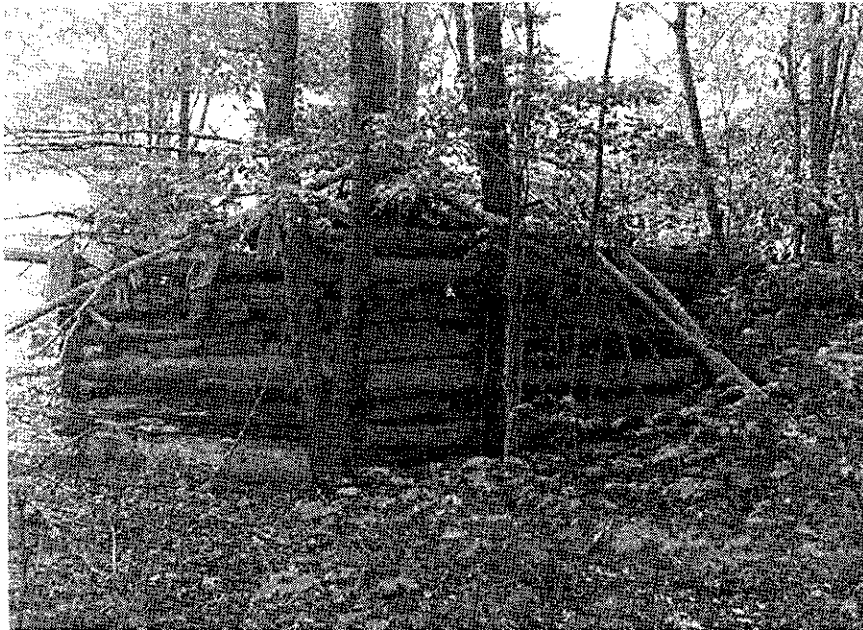
Fig. 59. Outlying Barn, view southeast. (IHTIA)

The structure is composed of unhewn log members of irregular size. Both saddle and square (flat) notches are used in this unsophisticated construction. A doorway approximately 3' high is cut into the center of the west wall between the first and fourth logs. Interlog spaces have been chinked with a variety of sized and shaped wooden pieces.

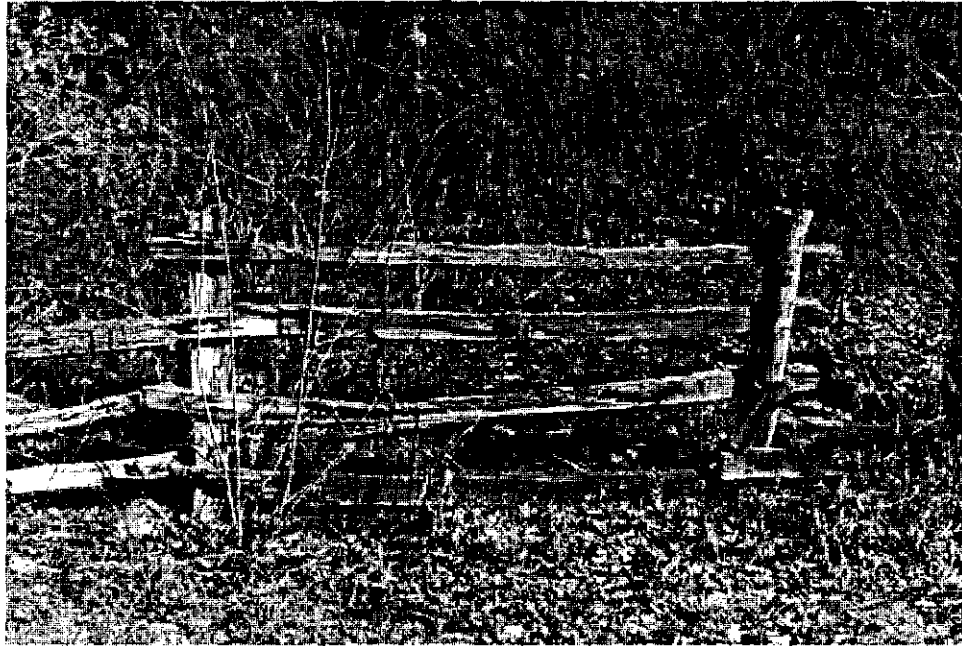
Fig. 68. Typical post and rail fence. This section found between barn and hay barn fields. (IHTIA)

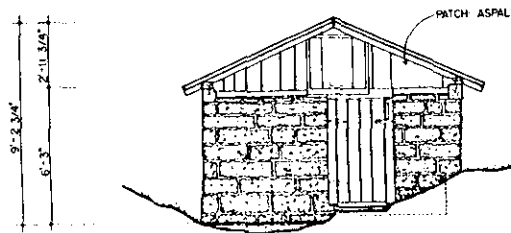
EAST ELEVATION

NOTE: PROTECTIVE METAL ROOF IS NOT ILLUSTRATED IN ORDER TO SHOW EARLIER, DETERIORATED WOODEN ROOF BENEATH

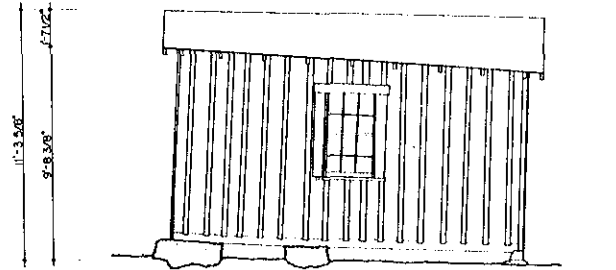
FOUNDATION HAS SUNK INTO SOFT EARTH AND MISALIGNED THE STRUCTURE  
BATTENS OCCUR ONLY ON EAST ELEVATION

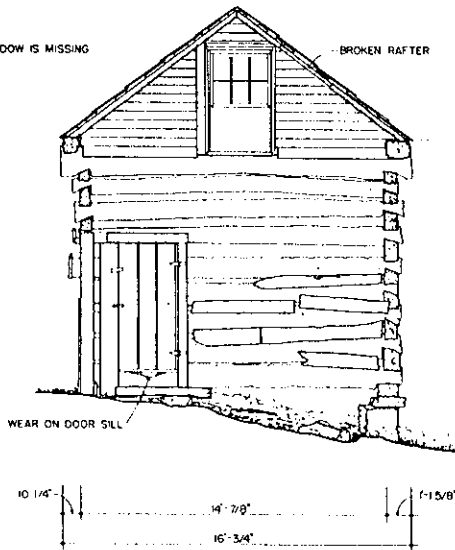
SOUTH ELEVATION

NOTE: PROTECTIVE METAL ROOF IS NOT ILLUSTRATED IN ORDER TO SHOW EARLIER SHINGLE ROOF BENEATH

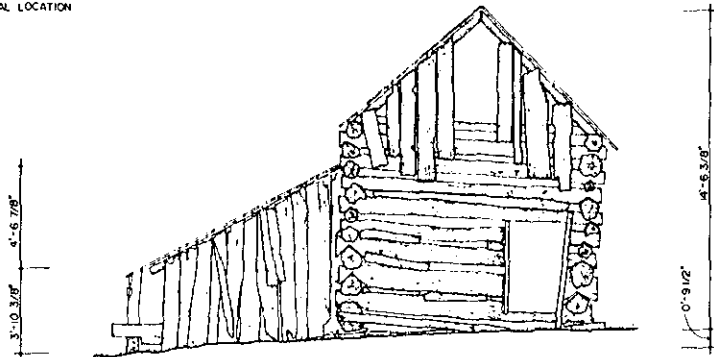
NORTH ELEVATION

NOTE: PROTECTIVE METAL ROOF IS NOT ILLUSTRATED IN ORDER TO SHOW EARLIER, DETERIORATED WOODEN ROOF BENEATH
