PADRE ISLAND NATIONAL SEASHORE

NOVILLO LINE CAMP HISTORIC STRUCTURES REPORT

U. S. National Park Service
Southwest Cultural Resources Center
Santa Fe, New Mexico

October 1979

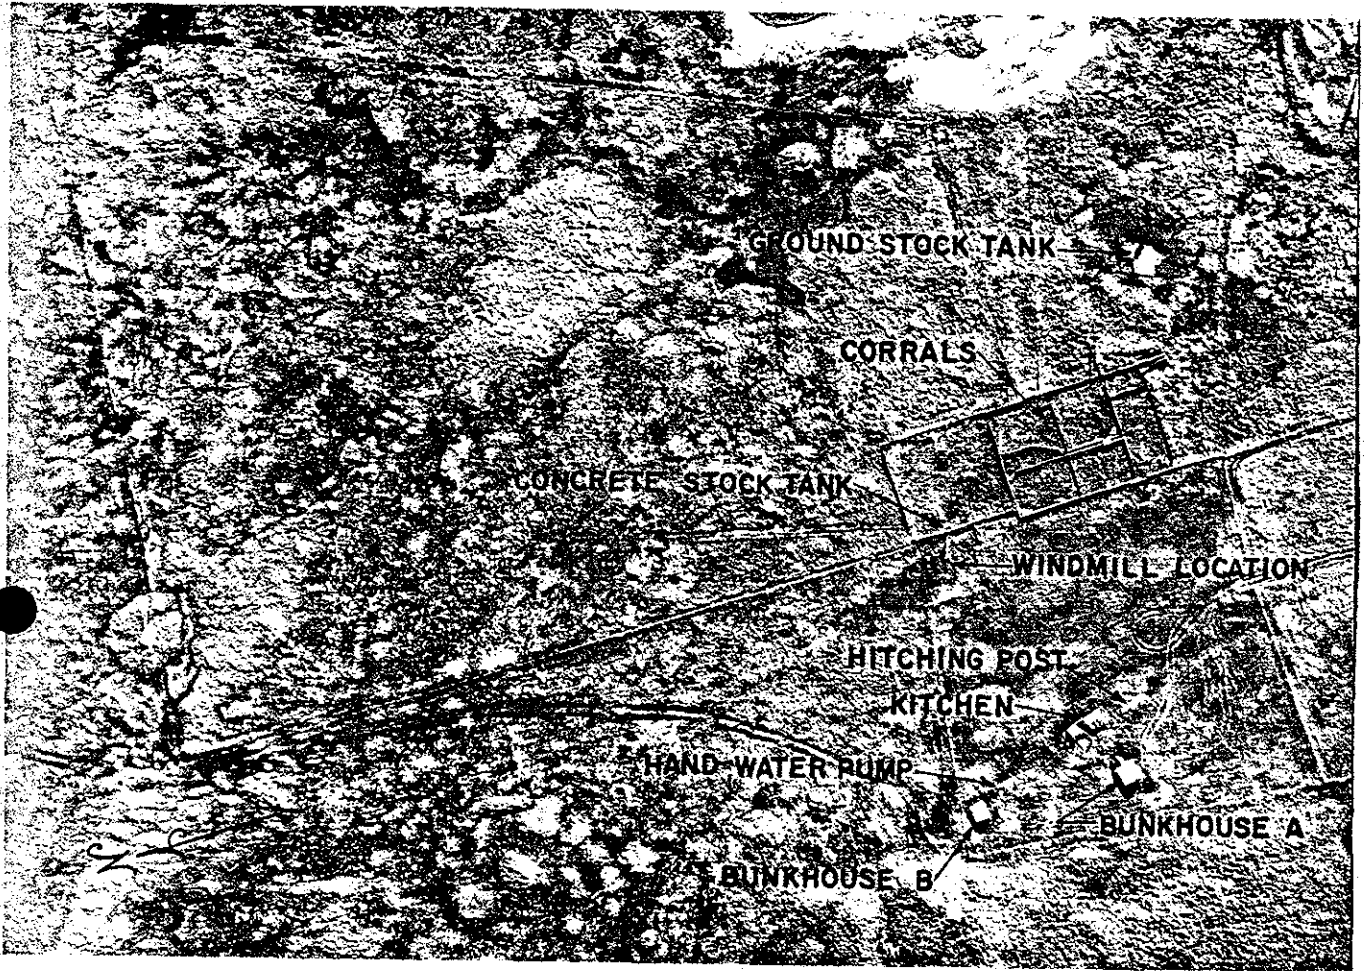
Aerial photograph of the Novillo Line Camp, taken
October, 1979.

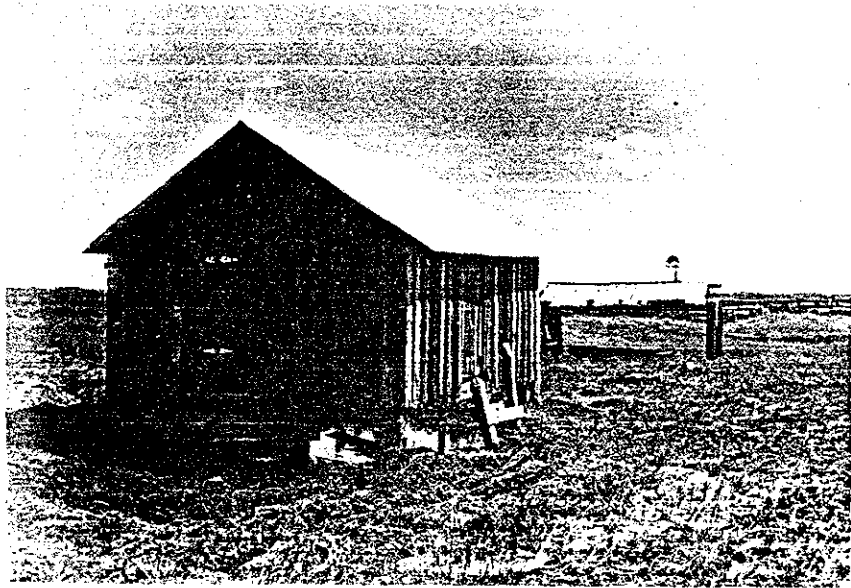
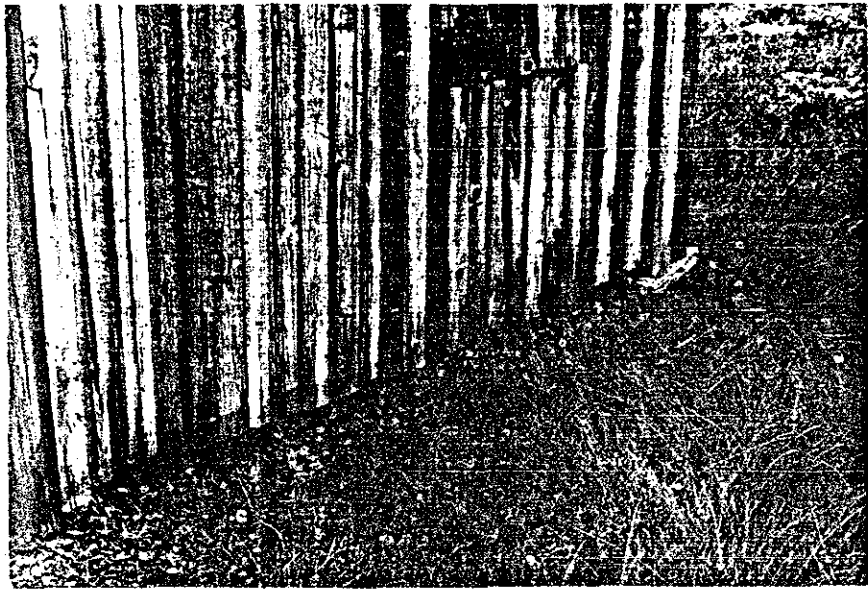
PLATE 11

BUNKHOUSE A

Corrosion to metal hinges causes deterioration to adjacent wood.

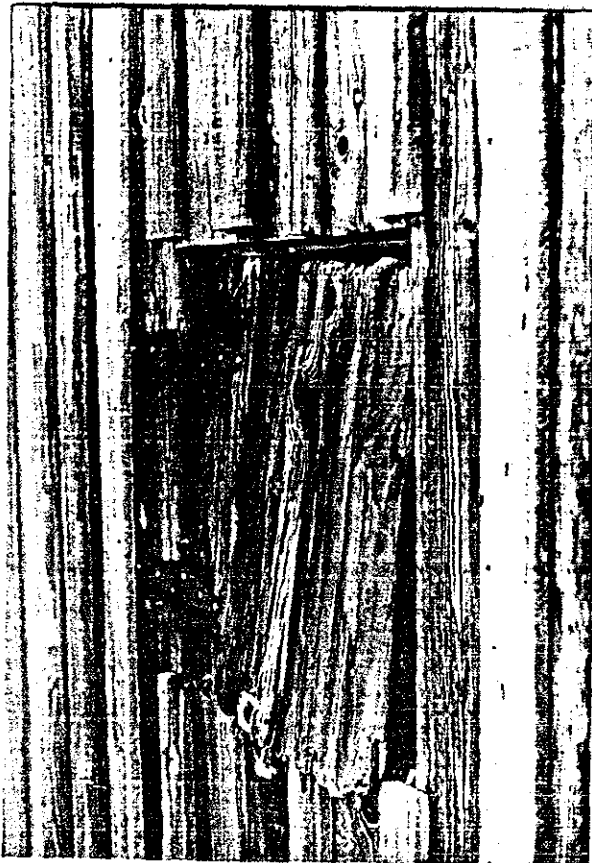
PLATE 13

BUNKHOUSE B

Corrugated metal roofing (c.1970) is providing limited protection to the original split cedar shingle roofing.

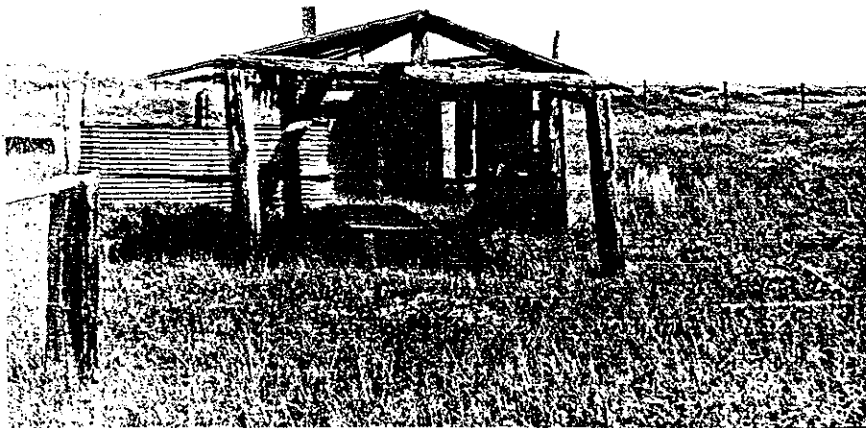
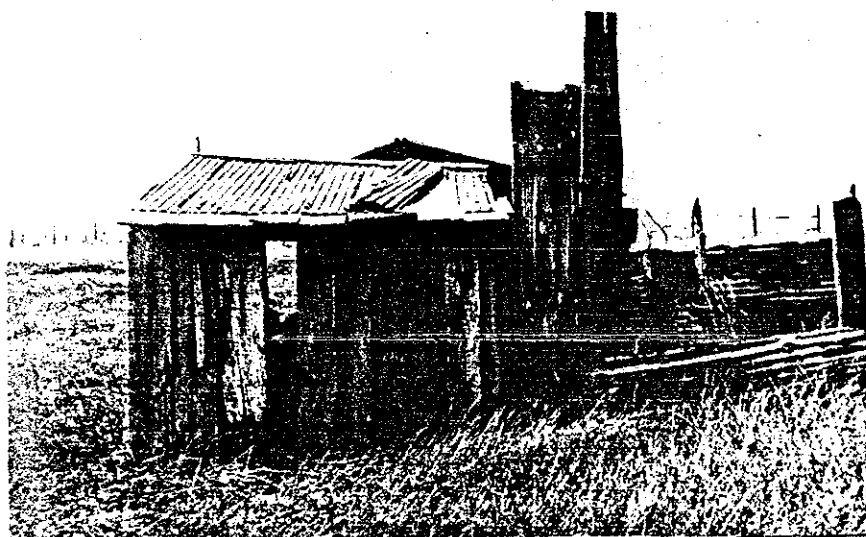
PLATE 16

KITCHEN

West elevation, south end. Note the windmill stand lying on the ground, away from its original location.

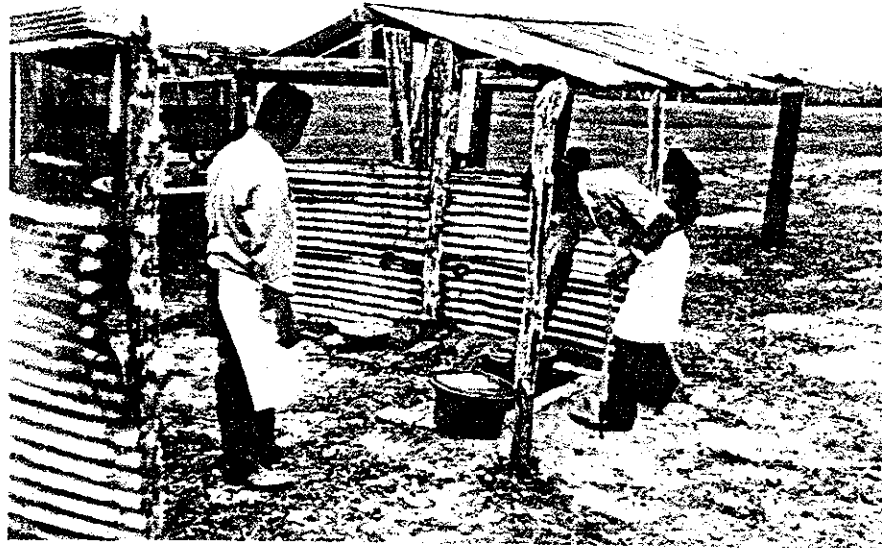
PLATE 22

KITCHEN

Severe wood deterioration of windbreak portion of
kitchen structure.

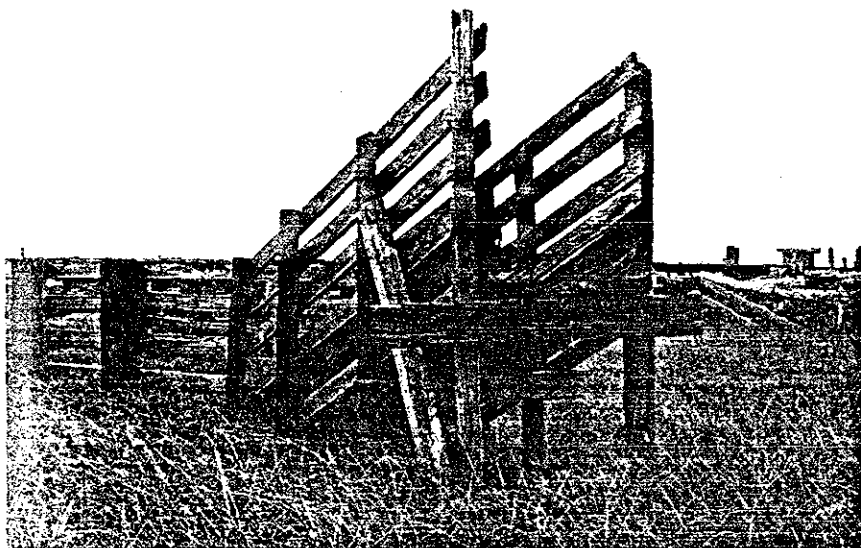
PLATE 27

CORRAL

WOOD ROT

This degree of deterioration is not unusual in the corral area. Note the algal growth at the upper left, due to the proximity of a marine environment.

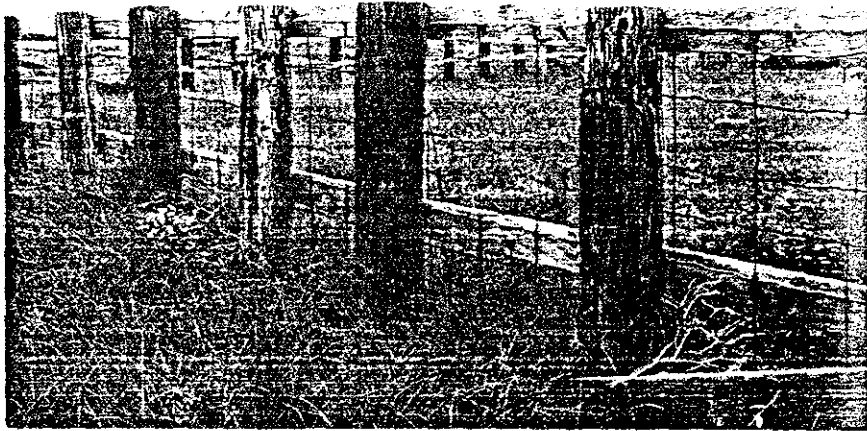
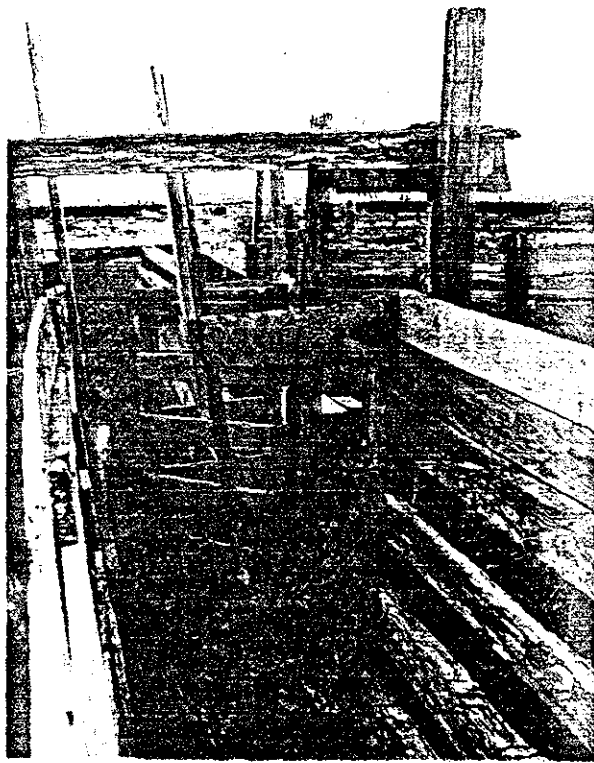
PLATE 33 CORRAL GATE 1979

This particular gate is hinged in the manner first used on Padre as a simplistic solution to hanging a gate -- namely, the use of a pentil.

This strap-hinged gate was modified at an unknown date from the previous use of a pentil.
