# historic structure report

## THEODORE ROOSEVELT

CCC STRUCTURES / PEACEFUL VALLEY RANCH /  
MALTESE CROSS CABIN / ELKHORN RANCH

NATIONAL PARK / NORTH DAKOTA

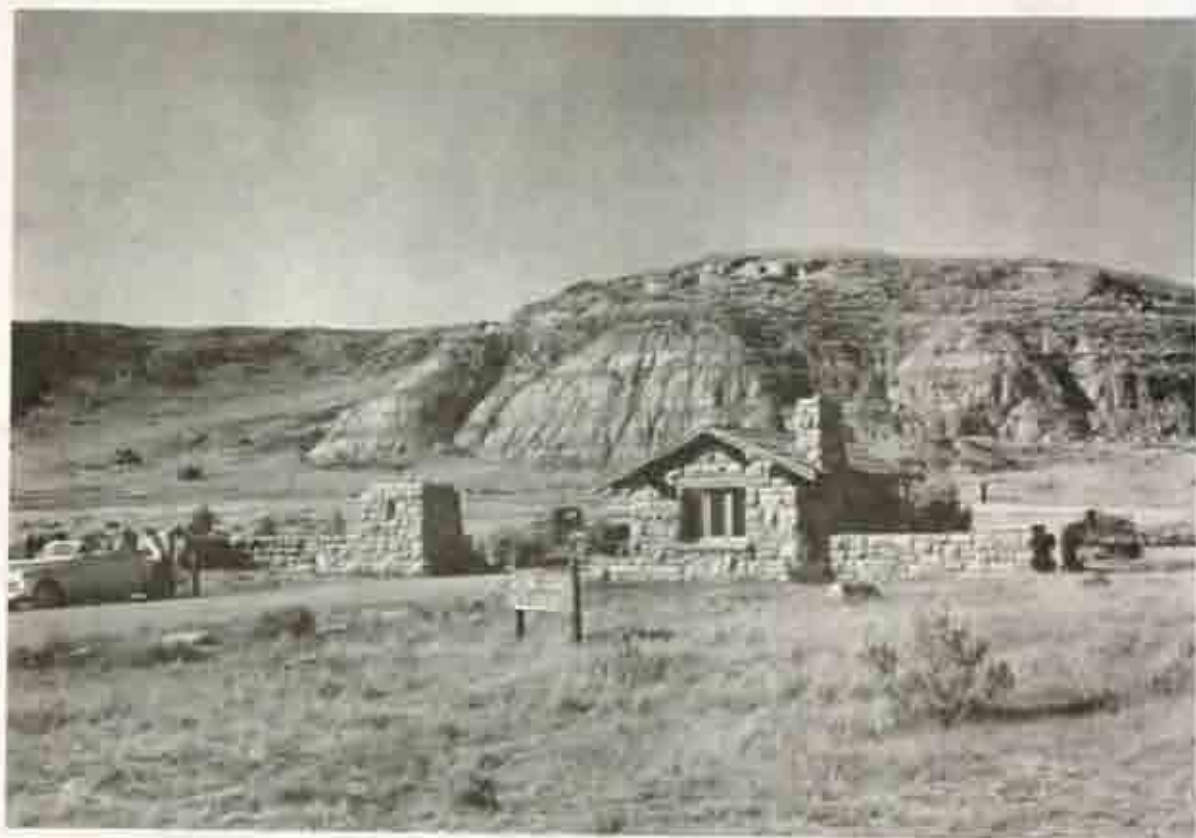
Illus 1. East entrance, showing privy on left, check station on right (photograph from park files, taken June 4, 1949)

iron sculpture and iron lettering on the pylon, these structures were constructed by the CCC. The entrance station was completed in 1938 (illustrations 1, 2, 3). In 1968, after a stretch of Interstate 94 was finished, the east entrance was closed and abandoned, and the pylon with its ironwork was moved to the Painted Canyon overlook, where it stands today (illustration 4).

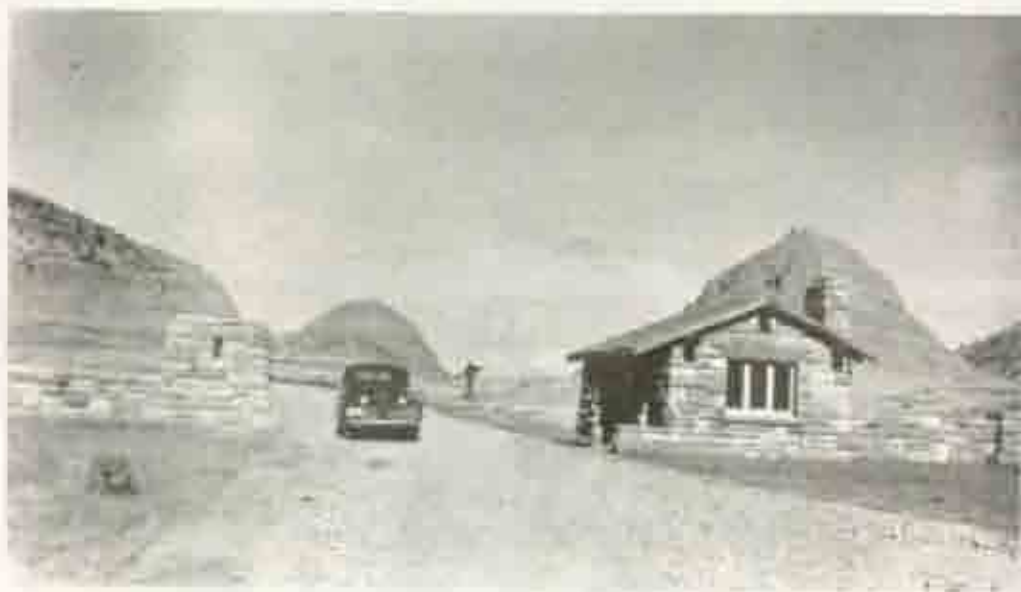
Illus 2. East entrance, showing privy on left, check station on right (photograph from park files, taken September 28, 1939)

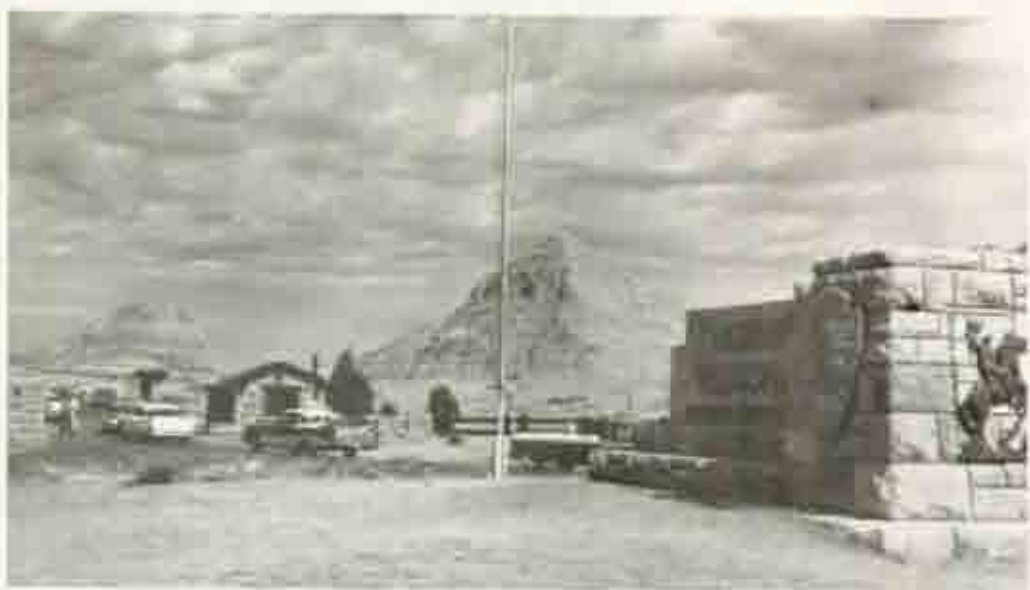
Illus 3. Pylon at east entrance (photograph from park files, taken September 12, 1959)

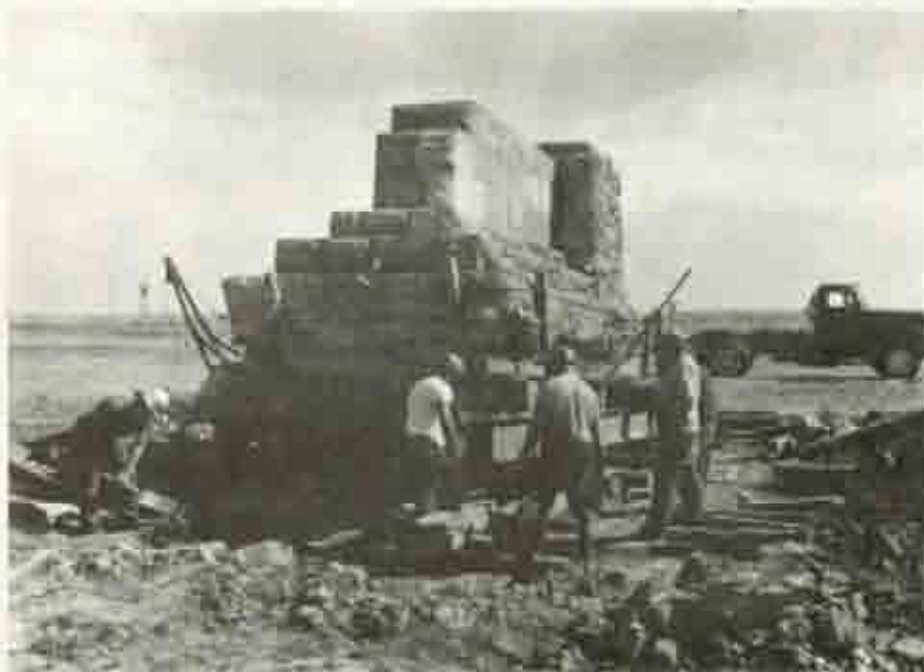
Illus. 4. Pylon being moved from east entrance to Painted Canyon overlook (photograph from park files, taken August 1968)

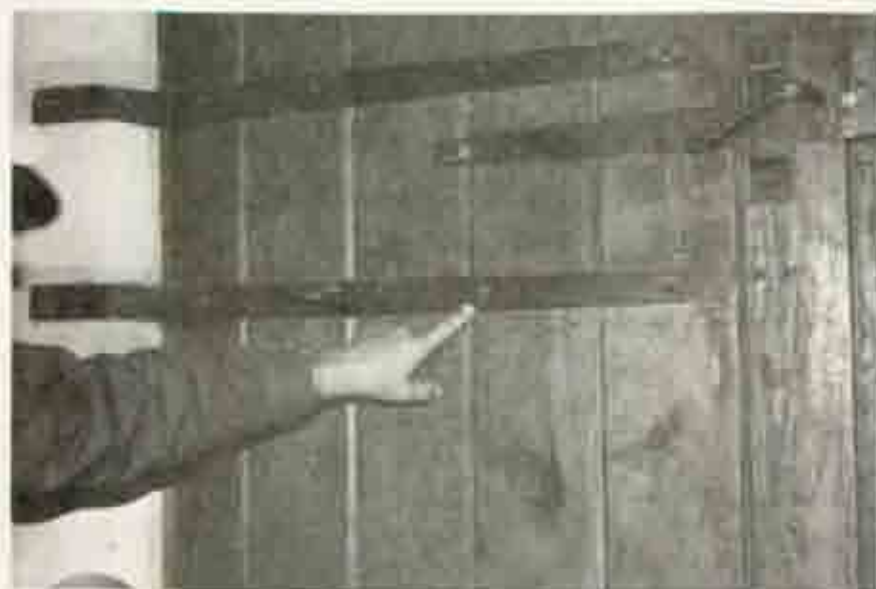
Illus 5. Ranch brands on iron strips, door in east entrance check station (photograph by author, taken October 1977)

One of the most distinctive features of this structure is the iron that appears on the interior and on the door. This iron was hand forged by Einar R. Olstad, a blacksmith and rancher who at one time lived in Medora and worked for the WPA. Olstad did much of the ironwork in the park and was responsible for the exquisite iron sculpture. The horizontal iron strips that reinforce the doors contain incised figures of both the Maltese Cross Ranch and Elkhorn Ranch brands where bolts are found. Olstad's name is incised on an iron bar of the main door (illustration 5).

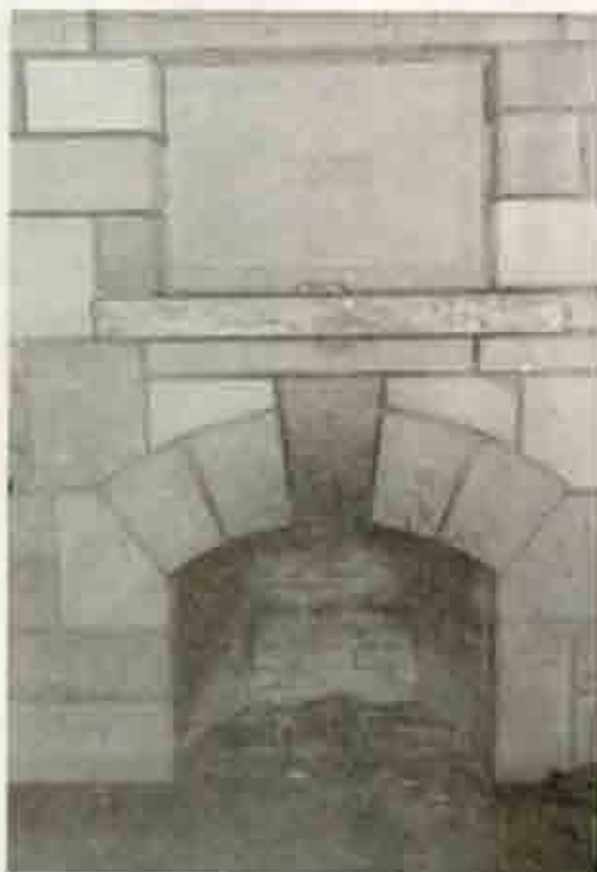
Illus 6. Fireplace in east entrance check station (photograph by author, taken October 1977)

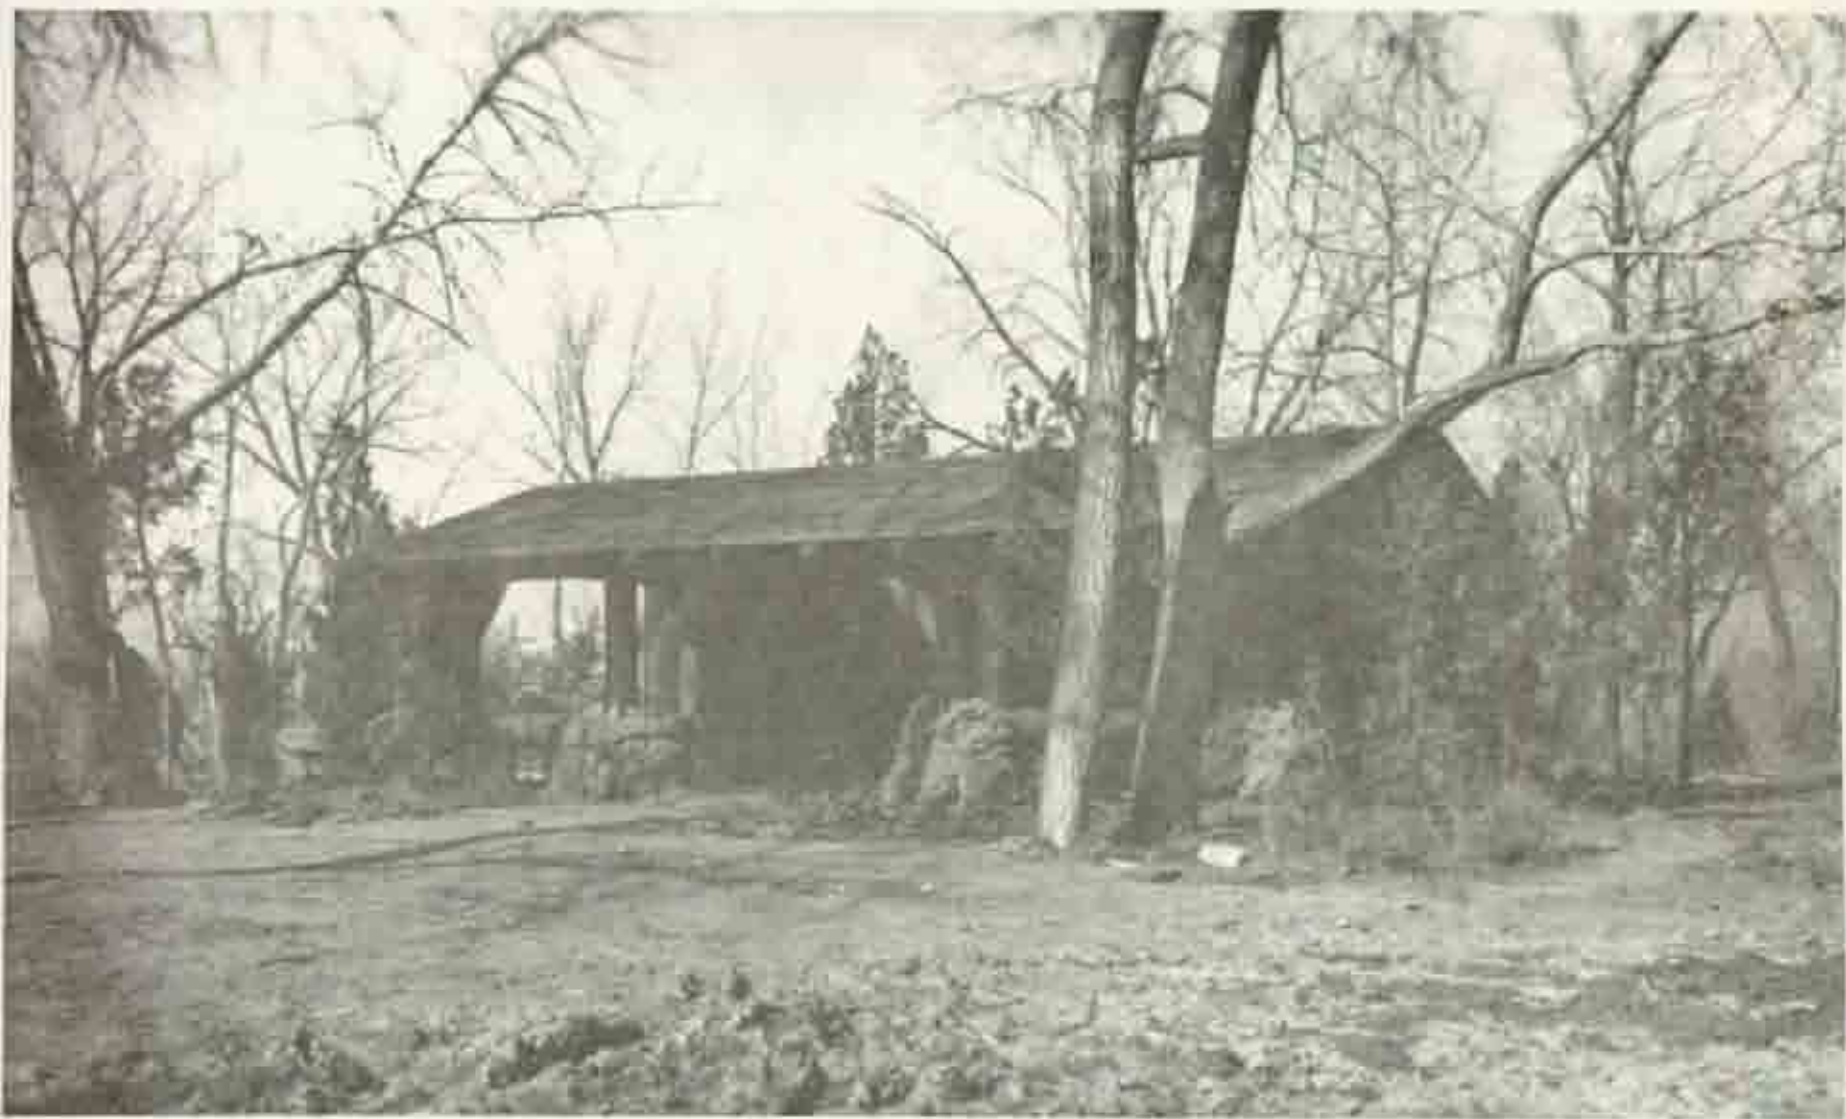
illus 7. Large shelter at Squaw Creek campground, soon after construction (photograph from National Archives, taken ca. 1938)

The two picnic shelters at the Squaw Creek campground are permanent structures of sandstone, volcanic rock, and heavy logs. They were designed in 1938 by Mr. Weingarten of the National Park Service regional office in Omaha, Nebraska. One shelter, the larger of the two, is located to the right upon entering the campground (illustration 7). It has an open, rectangular-shaped front chamber joined in a T formation with a smaller enclosed rear chamber. The low gabled roof consists of pine shingles, and the floor is made of flagstone. The structure rests on a volcanic-stone foundation. The most prominent feature of the shelter is the large chimney stack, which consists of uncoursed rubble scoria. Two identical fireplaces lie back to back, one in the front and one in the rear chamber. The fireplaces are semicircular with white brick interiors. Large sandstones flank the fireplaces, and the rest of the wall consists of vertical planks. The other three sides of the front chamber are open, with uncoursed rubble scoria piers forming small benches at the corners, and log posts and beams supporting the roof (illustrations 8, 9, 10, 11, 12, 13). The smaller rear chamber is enclosed on three sides with vertical board walls on 2-foot foundations.

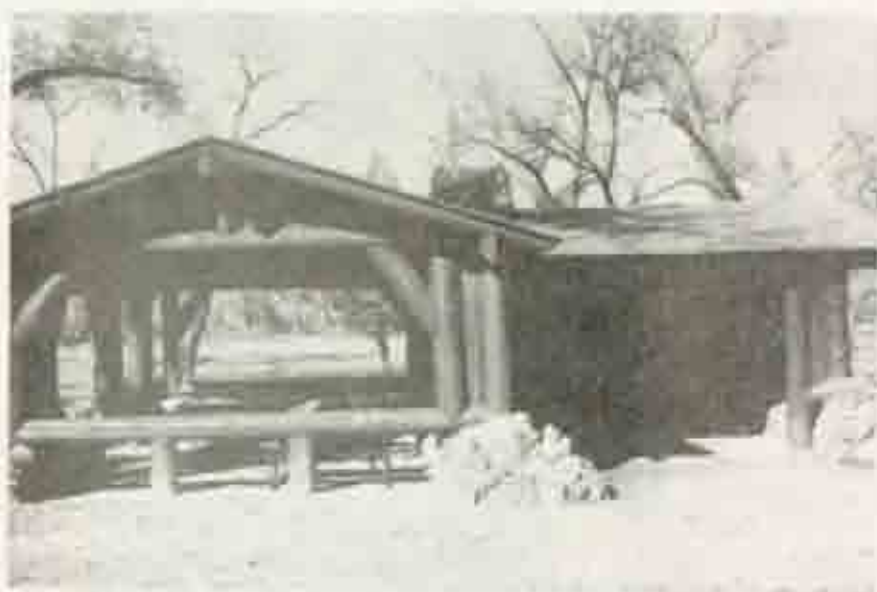
Illus 8. Large shelter at Squaw Creek campground (photograph by author, taken October 1977)

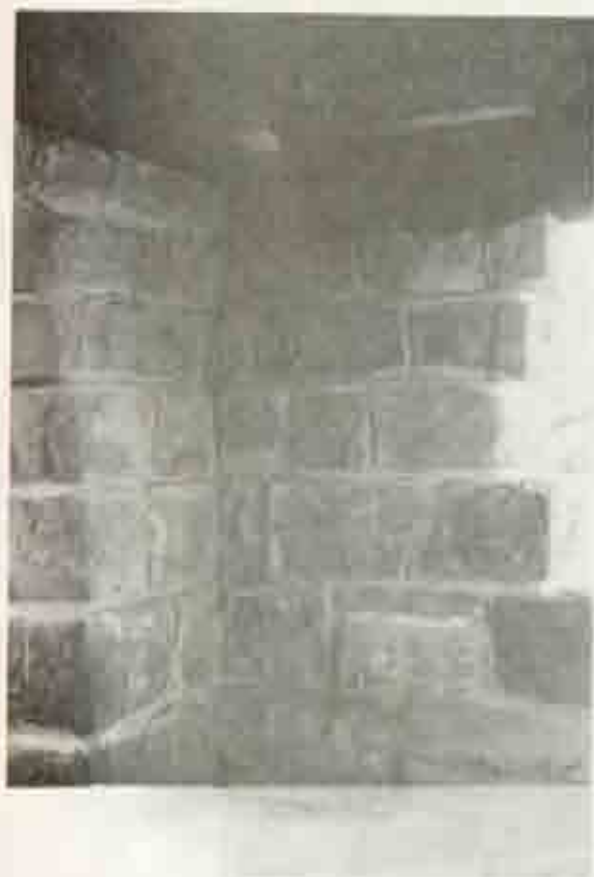
Illus 9. Details of construction, large shelter at Squaw Creek campground (photograph by author, taken October 1977)

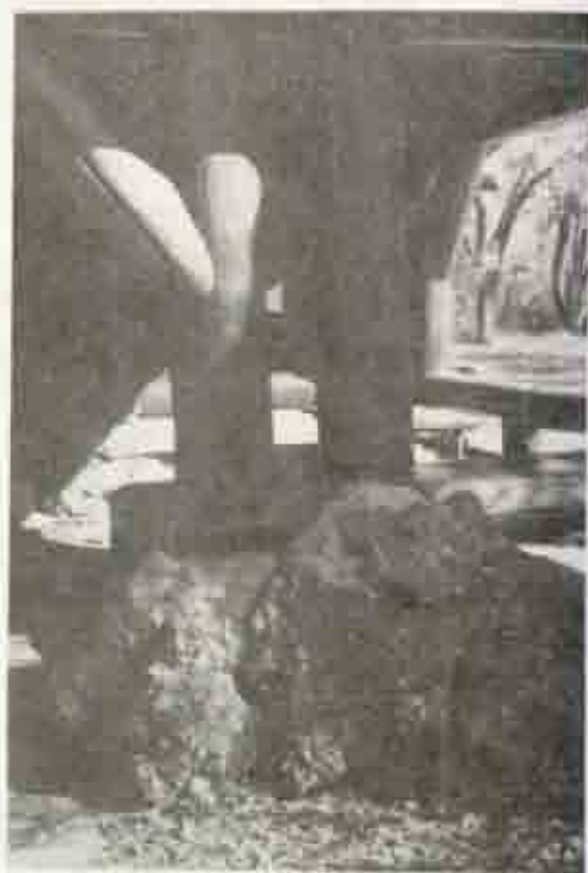
Illus 10. Details of construction, large shelter at Squaw Creek campground (photograph by author, taken October 1977)

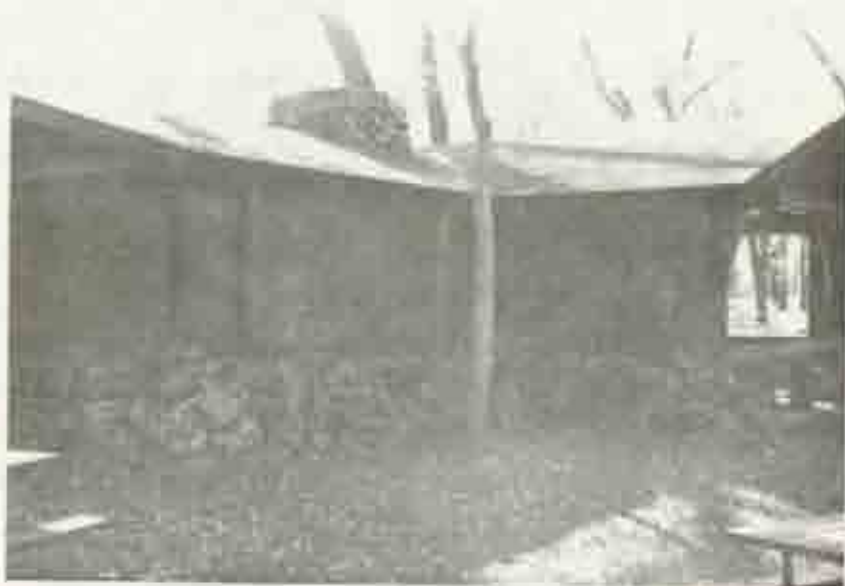
Illus 12. Details of ceiling, large shelter at Squaw Creek campground (photograph by author, taken October 1977)

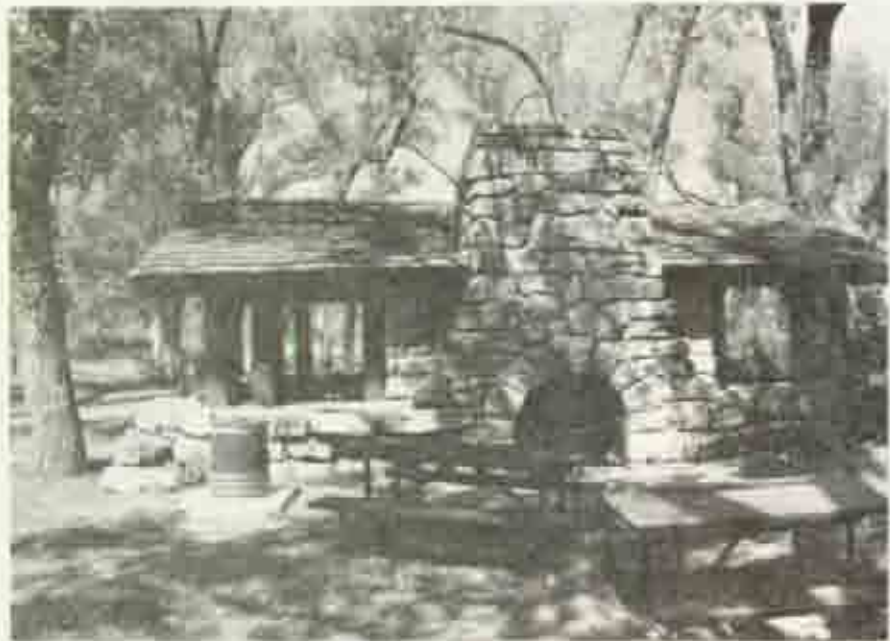
Illus 14. Small shelter at Squaw Creek campground  
(photograph by author, taken October 1977)

shelter also differs to some extent from the larger one in the materials used. The fireplaces in the smaller shelter are composed of sandstone in their entirety, unlike the fireplaces in the large shelter which consist of sandstone and scoria (like the other fireplaces they are lined with white brick). While the stone that acts as a foundation for the smaller structure is a volcanic stone, it differs from the volcanic stone employed in the large shelter in that it is smoother and less irregular. It gives the appearance of having been cut (illustrations 14, 15).

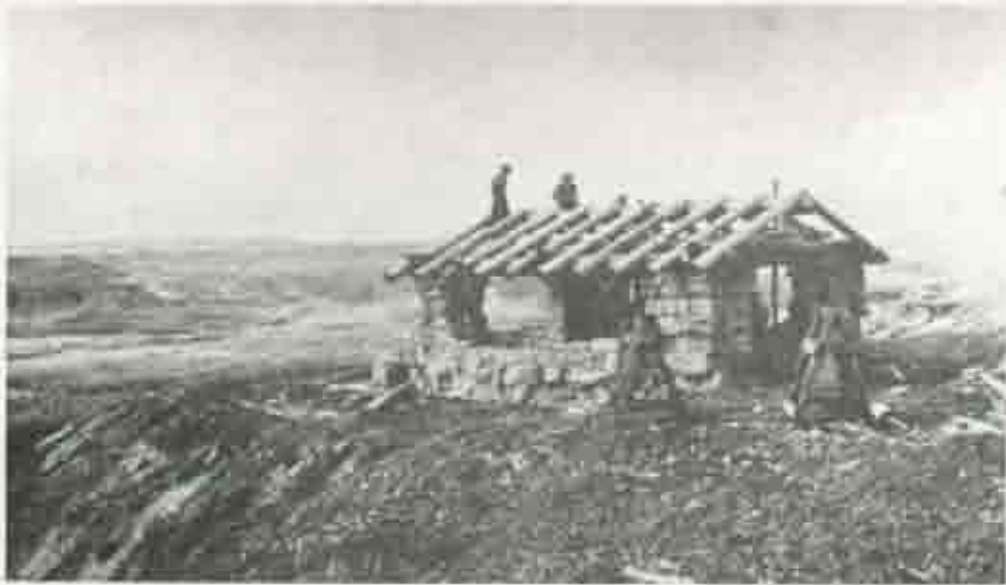
Illus 16. Shelter at Little Missouri River overlook, under construction (photograph from park files, taken ca. 1937)

Photographs taken in 1937 depict this shelter when it was being constructed (illustrations 16, 17). It was probably designed by the National Park Service regional office in Omaha.

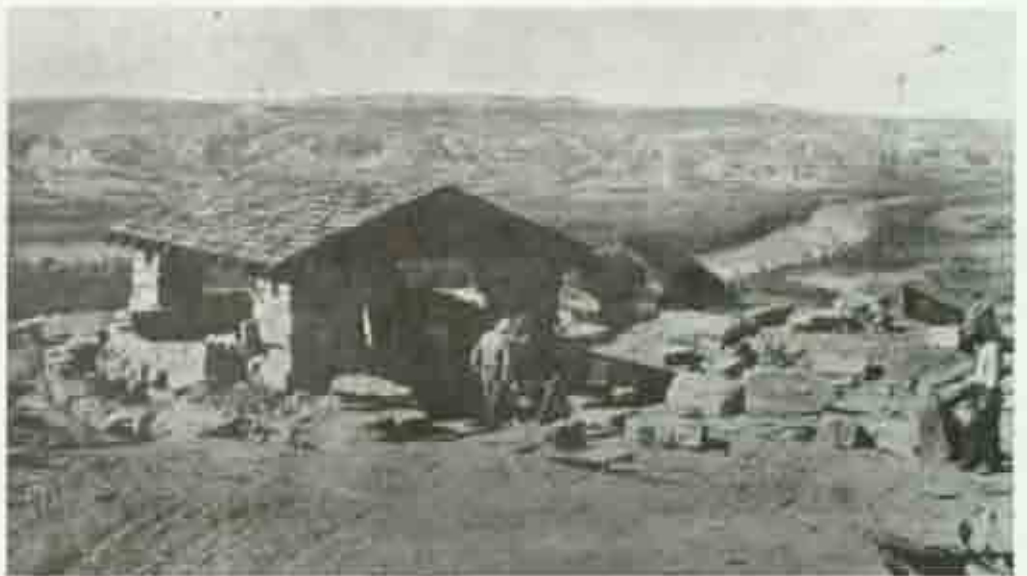
Illus 17. Shelter at Little Missouri River overlook, under construction (photograph from park files, taken ca. 1937)

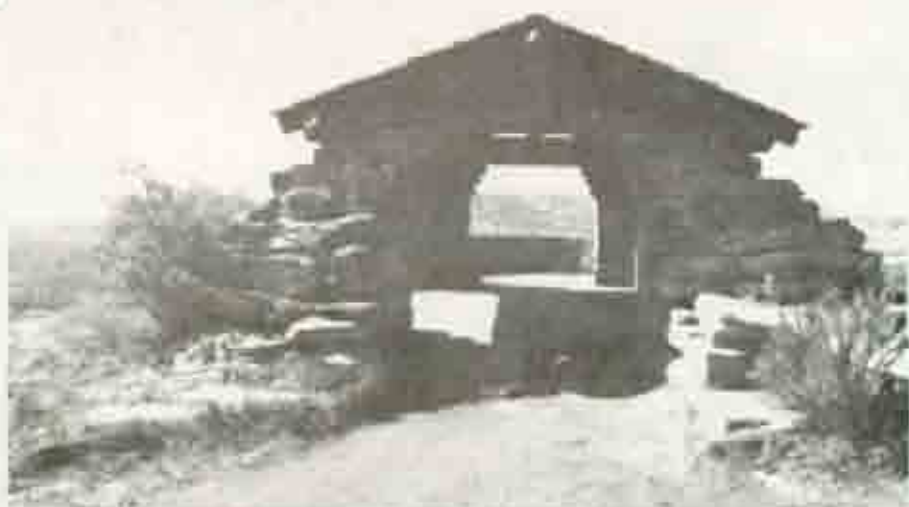
Illus 19. Shelter at Little Missouri River overlook (photograph by author, taken July 1977)

The rectangular structure has semicircular terraces extending on three sides. One terrace overlooks the Little Missouri River, providing a spectacular view. The roof, which is low pitched, consists of wood shingles, and the floor is made of flagstone. In recent years, the wooden members have been stained and the roof has been resingled. Enclosure walls are of four-coursed squared rubble stone, and piers of the same material are battered to meet the log wall plate that supports the gabled roof. The inner lining of the structure as well as the main support of the roof are made of sandstone, whereas the stone on the exterior is a volcanic rock or rubble. The terrace overlooking the river is also made of sandstone, but its exterior is a volcanic stone. The sandstone is cut much more evenly than the volcanic stone (illustrations 18, 19, 20).

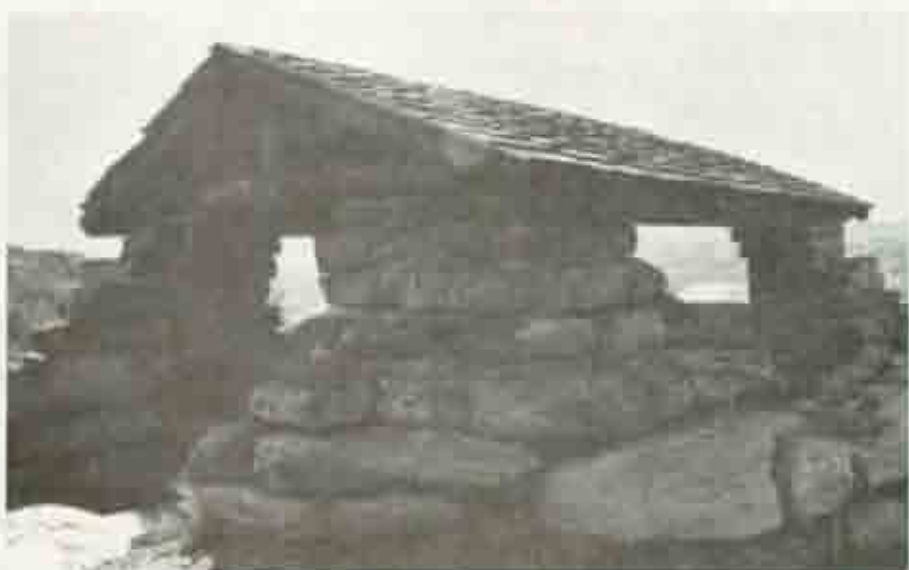
Illus 20. Shelter at Little Missouri River overlook (photograph by author, taken July 1977)

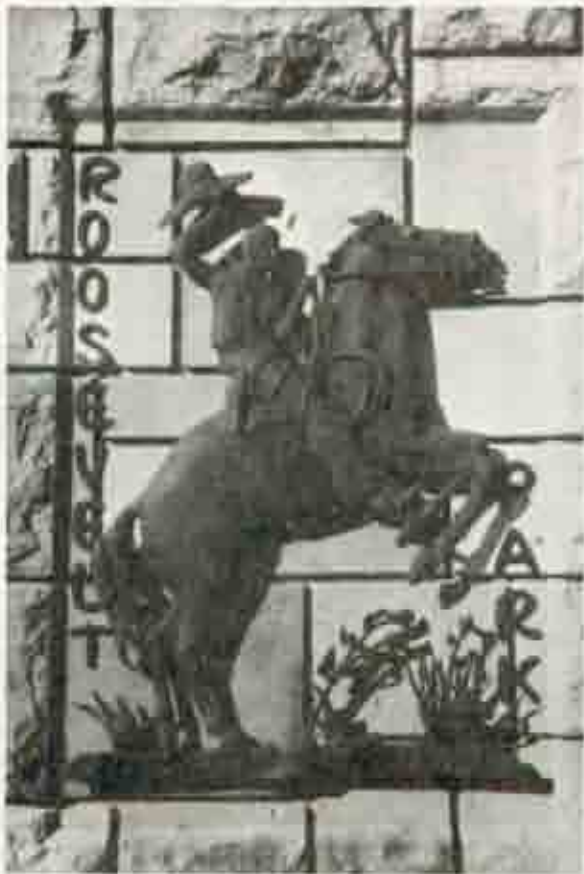
Illus 21. Iron sculpture on pylon at Painted Canyon overlook (photograph by author, taken October 1977)

Like other ironwork in the two main areas of the park, this sculpture was cast by the local blacksmith Einar H. Olstad under the emergency relief programs. Its dimensions are 47 inches high by 34 inches wide measured at its widest point. The bottom right corner has inscribed "H. Olstad." The first initial E (for Einar) either was never placed there or has been obliterated by age. At the extreme lower right corner is inscribed "254." It is not known what this number stands for. There are also faint inscriptions of what appear to be two other names. Next to these names are roughly inscribed "Proj. Mgr." (Project Manager) and "Don" followed by an illegible word.

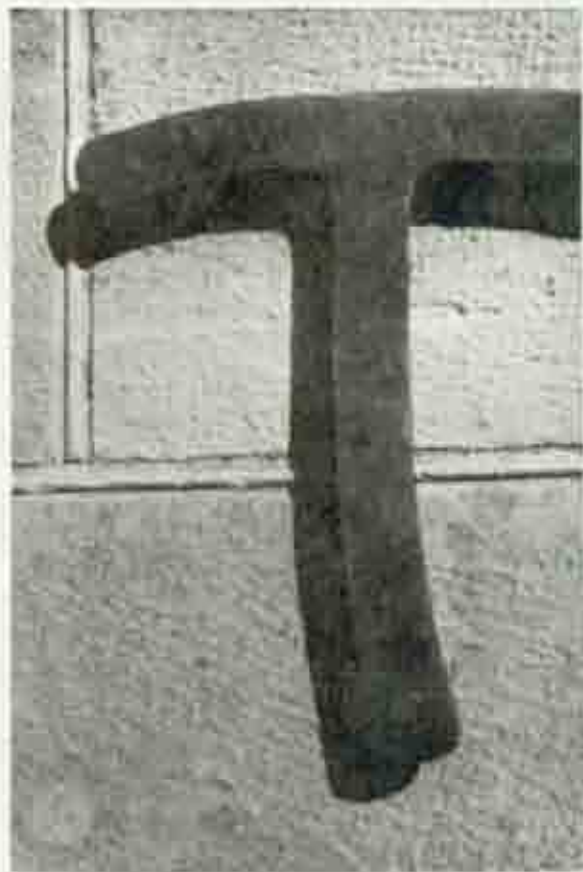
Illus 22. Inscription on letter "T", pylon at Painted Canyon overlook (photograph by author, taken October 1977)

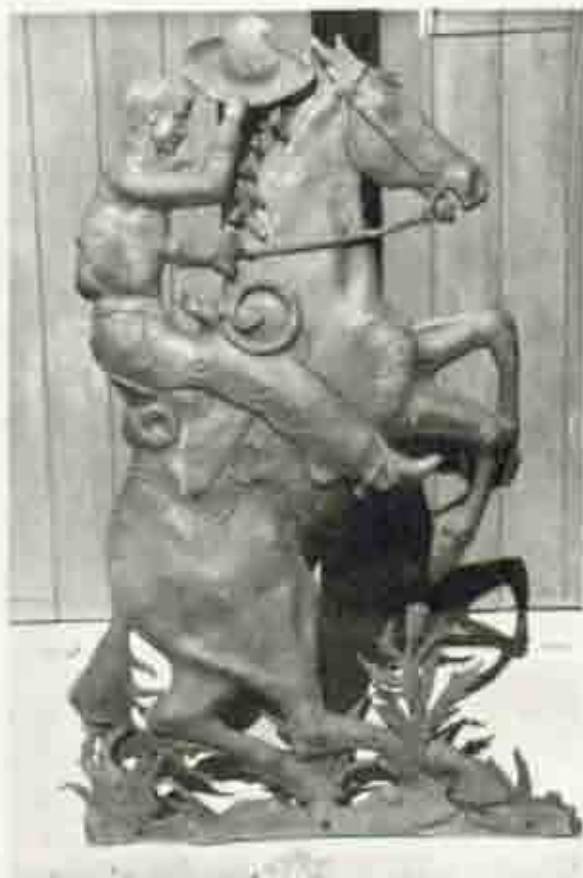
illus 23: Iron sculpture at Cottonwood campground  
(photograph by author, taken October 1977)

. The Elkhorn Ranch brand is also incised on the horse just below the neck and above the horse's right front leg. The cowboy faces to the right.

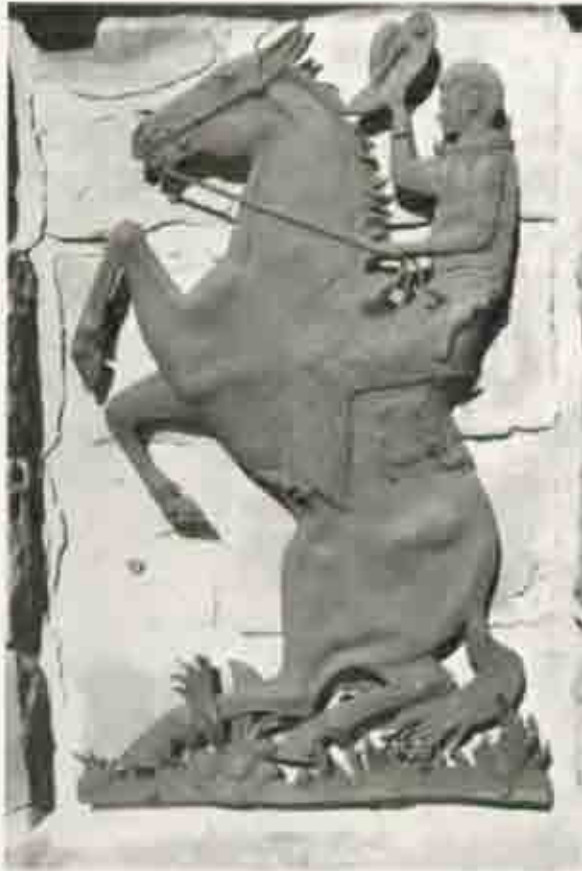
Illus 24. Iron sculpture at North Unit entrance  
(photograph by author, taken October 1977)

The third sculpture, which hangs on the pylon at the North Unit entrance station, depicts a cowboy on horseback, also said to represent Will Rogers (illustration 24). Unlike the sculpture at the Cottonwood campground, this cowboy faces left. What is unusual about this sculpture is the fact that no names appear on it; the only engraving is the Maltese Cross Ranch brand, which appears on

the horse's rump. However, even though there is no name on this sculpture, there is enough similarity in style to believe that it was also made by Olstad. Why he did not inscribe his name upon it remains a mystery. This sculpture measures about 46 inches high by 28 inches wide at the base. When the pylon was moved to the present location in 1961, the sculpture was removed and replaced in its original position.

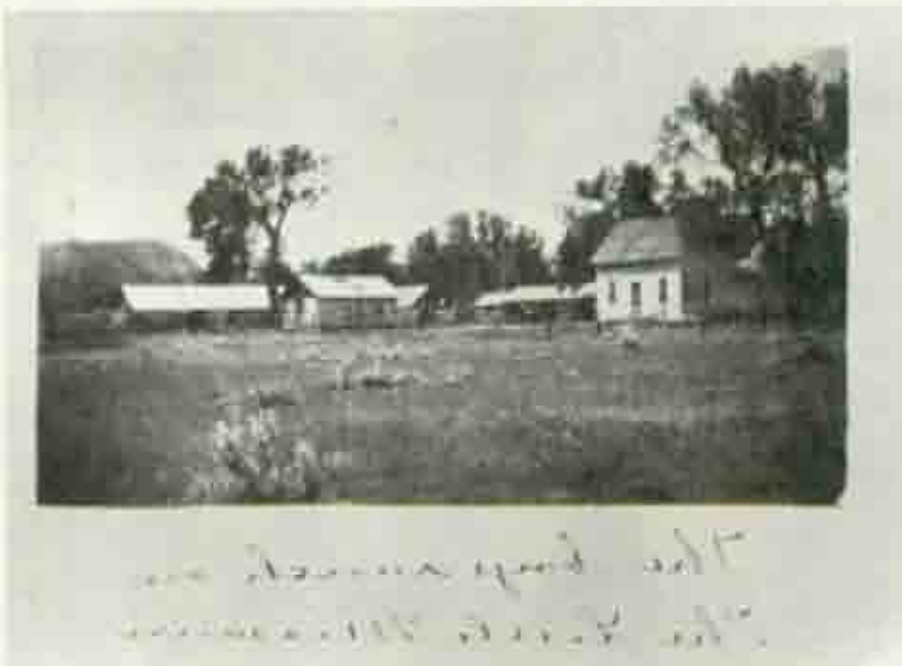
Illus 25. Peaceful Valley Ranch. Original two-story house with first addition is at the right; however, this is a reverse print--house should be at left (photograph from park files, taken ca. 1904)

The ranch house is the oldest and most significant structure at Peaceful Valley. According to Mrs. Chris Rasmussen, a former resident of the ranch whose husband worked for Lamb, the main portion of the ranch house was originally built about 1885-87, while Lamb was the proprietor. This is the two-story frame section (illustration 25). The lower story consisted of two rooms, one of which was a kitchen. The upper story was an attic that was

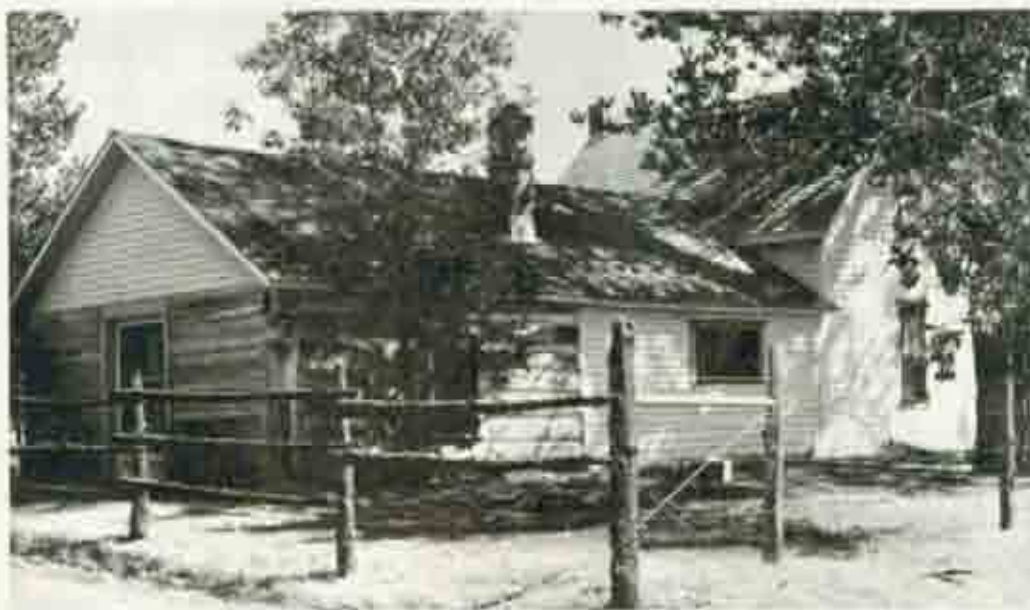
Illus 26. Peaceful Valley ranch house. View shows two additions at rear of house (photograph from park files, taken ca. 1959)

In 1947 the house was remodeled, but the floor plan did not change appreciably. What prompted this remodeling was a flood that caused considerable damage to the house. After the flood, the partial basement, which had consisted of a combination of earth, brick, plank, and cement walls, was enlarged into a full basement with new beams, and a cement foundation was installed under the main portion of the house. New cross members in the floors of the main house were also installed. The floors in the living room and utility room were replaced, the closet in the living room was converted to a stairway to the attic bedroom, and the bathroom was remodeled. Finally, the main chimney was replaced by a new brick chimney on the outside of the house.<sup>11</sup>

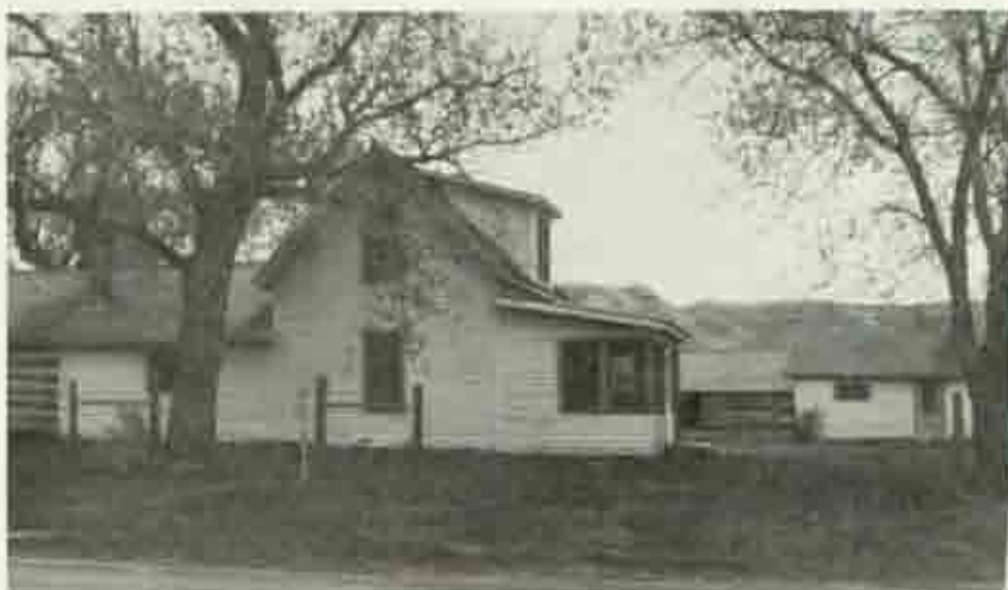
Illus 27. Peaceful Valley ranch house. View shows porch addition and dormer window (photograph from park files, taken ca. 1959)

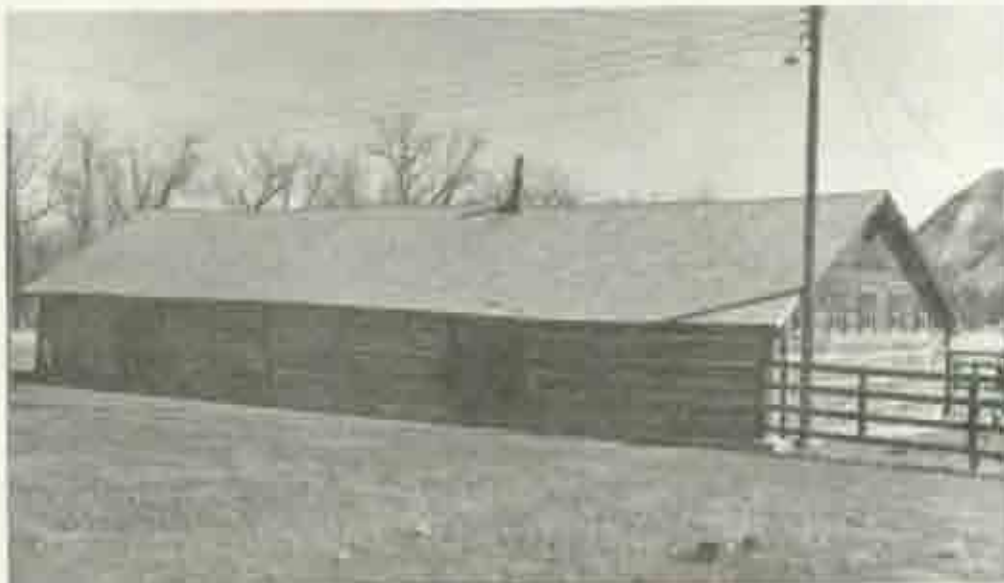
Illus 28. Front view of barn, Peaceful Valley Ranch (photograph from park files, taken 1967)

The barn, which has a long rectangular plan, runs north and south for approximately 200 feet east of the ranch house. It is a more permanent type of structure than that usually found on most ranches of the area.<sup>13</sup> Construction consists of double saddle-notched logs with 6-by-6-inch horizontal timber walls, 2-by-2-inch roof joists, and 1-inch decking. The upper gable walls are clapboard, and the barn has a medium-pitched shingled roof.

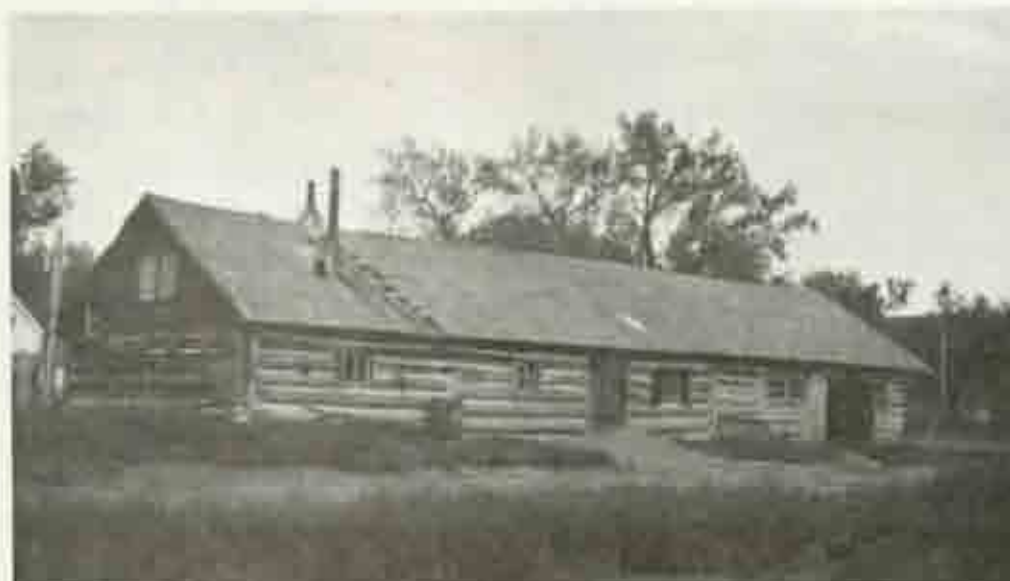
Illus 29. Rear view of barn, Peaceful Valley Ranch (photograph from park files, taken 1947)

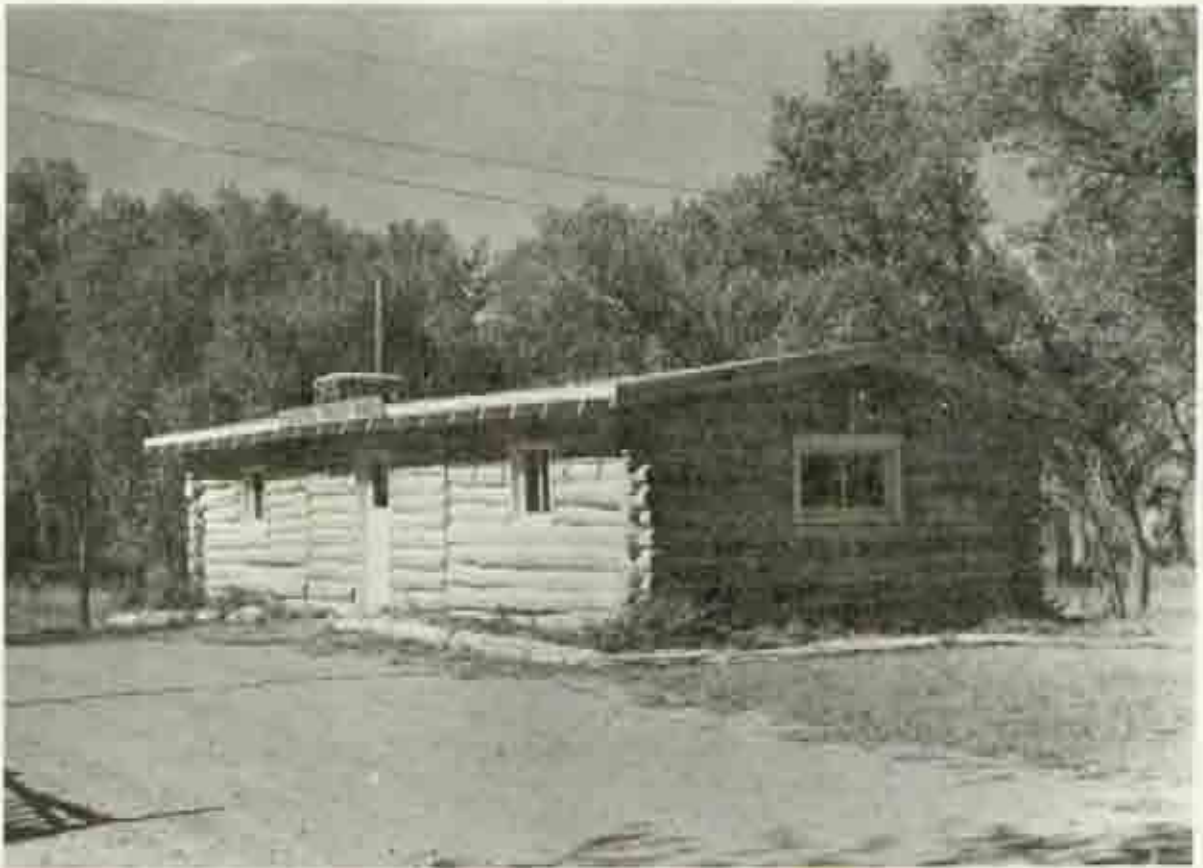
Illus 30. Bunkhouse at Peaceful Valley Ranch (photograph from park files, taken 1947)

Aside from the extension that was added at the rear, the exterior remains essentially as it was when the bunkhouse was first built. However, the interior, as we have seen, has undergone extensive changes.

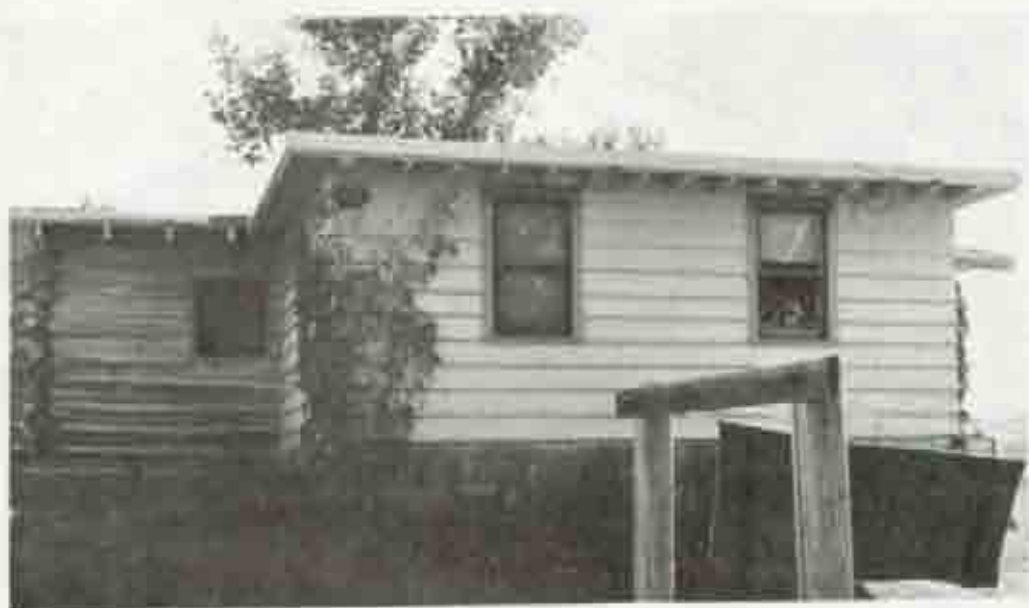
Illus 31. Rear addition to bunkhouse at Peaceful Valley Ranch  
(photograph from park files, taken ca. 1950)

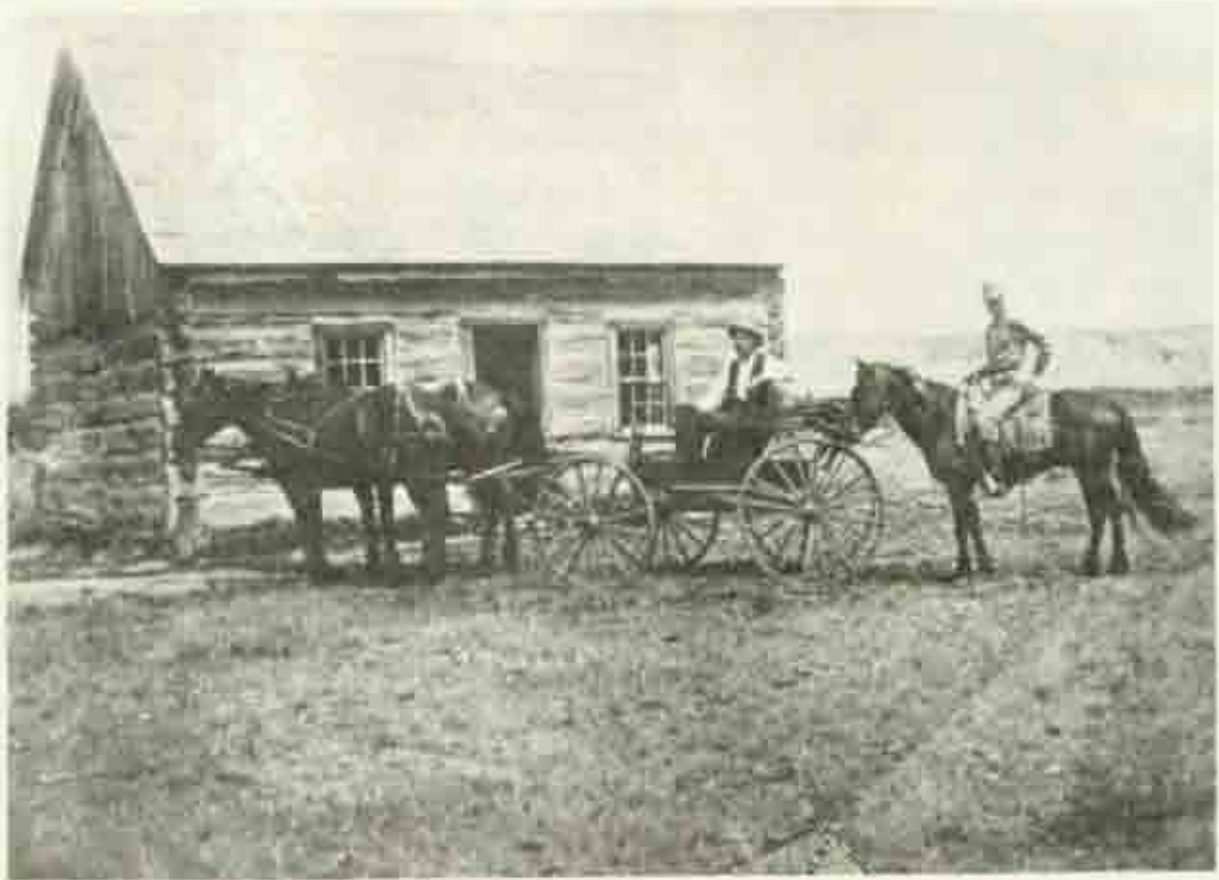
Illus 32. Maltese Cross cabin (photograph from Harvard University Library, taken ca. 1886)

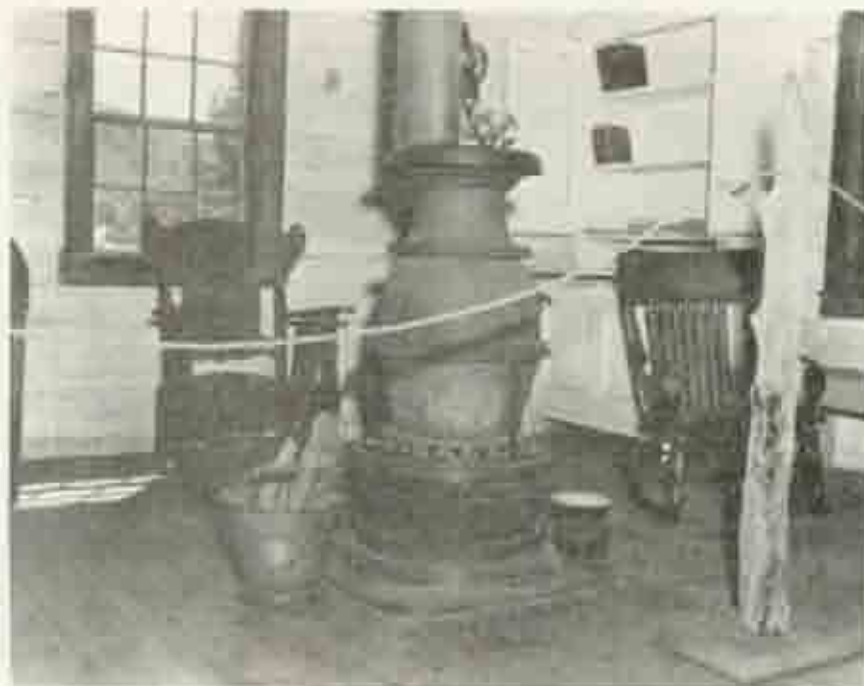
Illus 33. Restored living quarters in the Maltese Cross cabin (photograph from park files, taken ca. 1967)

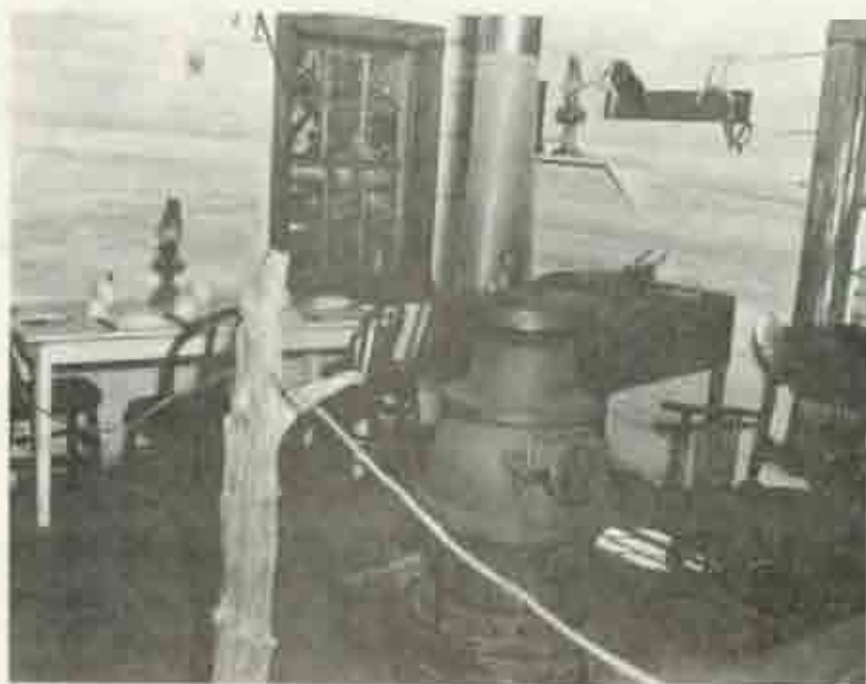
Illus 34. Restored living quarters in the Maltese Cross cabin (photograph from park files, taken ca. 1967)
