# historic structure report

## THEODORE ROOSEVELT

CCC STRUCTURES / PEACEFUL VALLEY RANCH /  
MALTESE CROSS CABIN / ELKHORN RANCH

NATIONAL PARK / NORTH DAKOTA

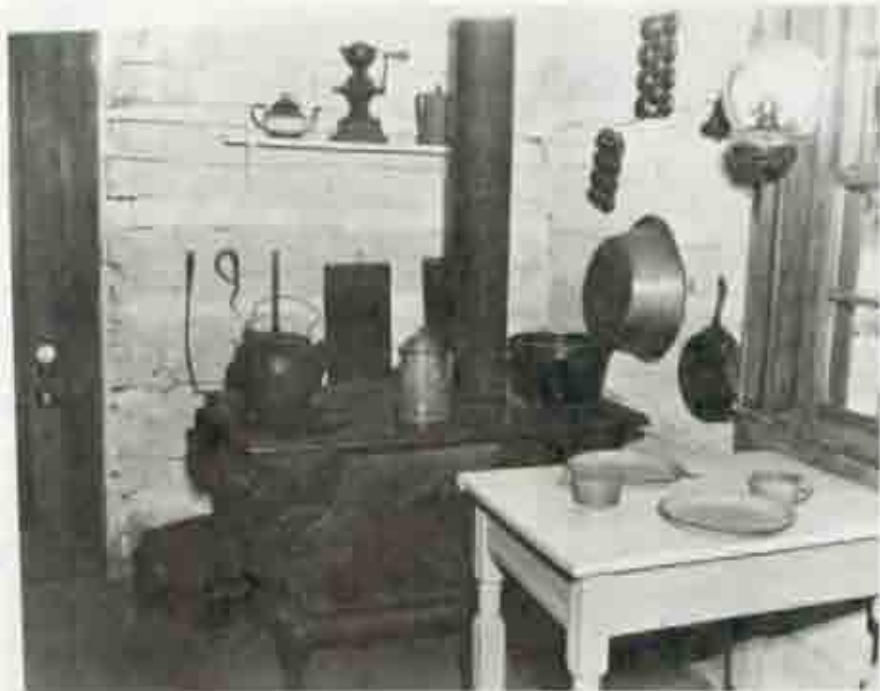
Illus 35. Restored kitchen in the Maltese Cross cabin (photograph from park files, taken ca. 1967)

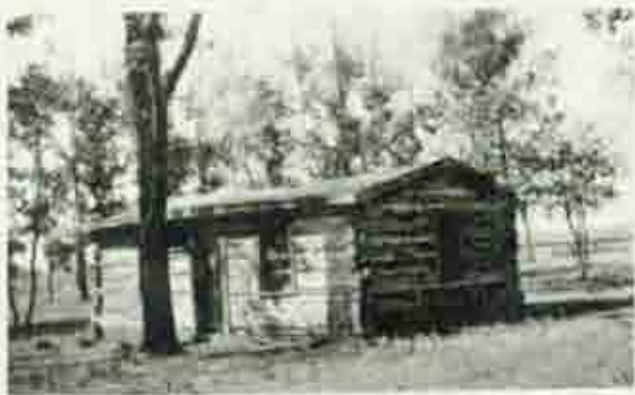
Illus 36. Maltese Cross cabin at Bismark, N.D.  
(photograph from park files, taken ca. 1919)

In the 1920s the Daughters of the American Revolution took steps long needed to preserve and restore the cabin, which had by then deteriorated considerably. Much of the deterioration was due to the number of times it had been dismantled and shipped to various places. The sod roof was replaced by cedar shingles, although the low-pitched style remained. A concrete foundation was layed and a general preservative treatment was given to the cabin.<sup>9</sup>

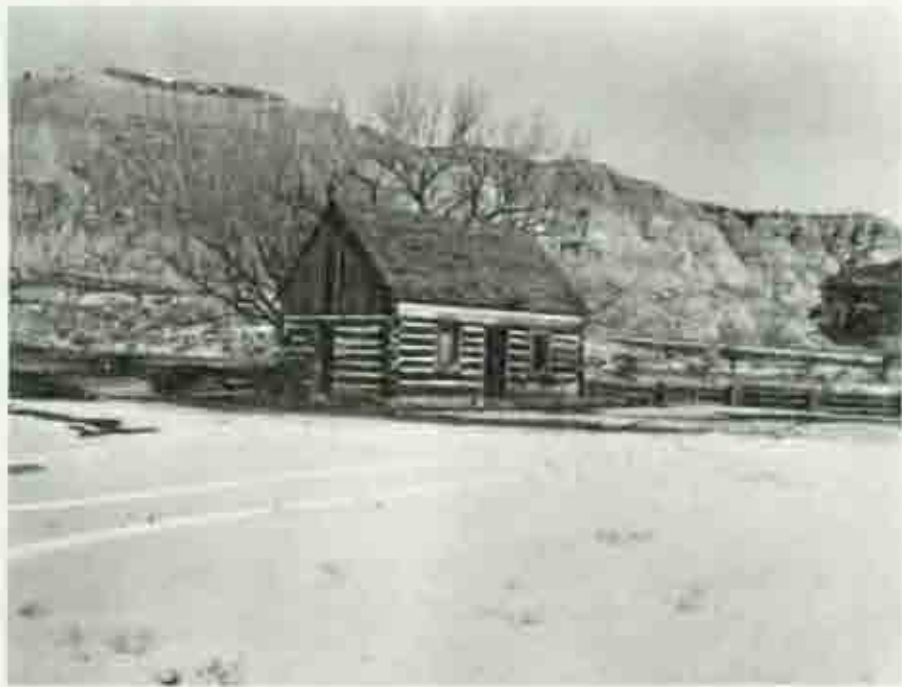
Illus 37. Restored Maltese Cross cabin (photograph from park files, taken ca. 1960)

had when Roosevelt had lived in it (illustration 37). The cabin attained essentially the same appearance as the cabin portrayed in Roosevelt's photograph. The following instructions are a verbatim account of the specifications generally followed by the park in restoring the cabin:
