# WILLIAM HOWARD TAFT NATIONAL HISTORIC SITE

## CULTURAL LANDSCAPE REPORT

CULTURAL LANDSCAPE REPORT  
**WILLIAM HOWARD TAFT  
NATIONAL HISTORIC SITE**  
CINCINNATI, OHIO

**SCRUGGS AND HAMMOND, INC.**  
LANDSCAPE ARCHITECTS  
COLUMBUS, OHIO

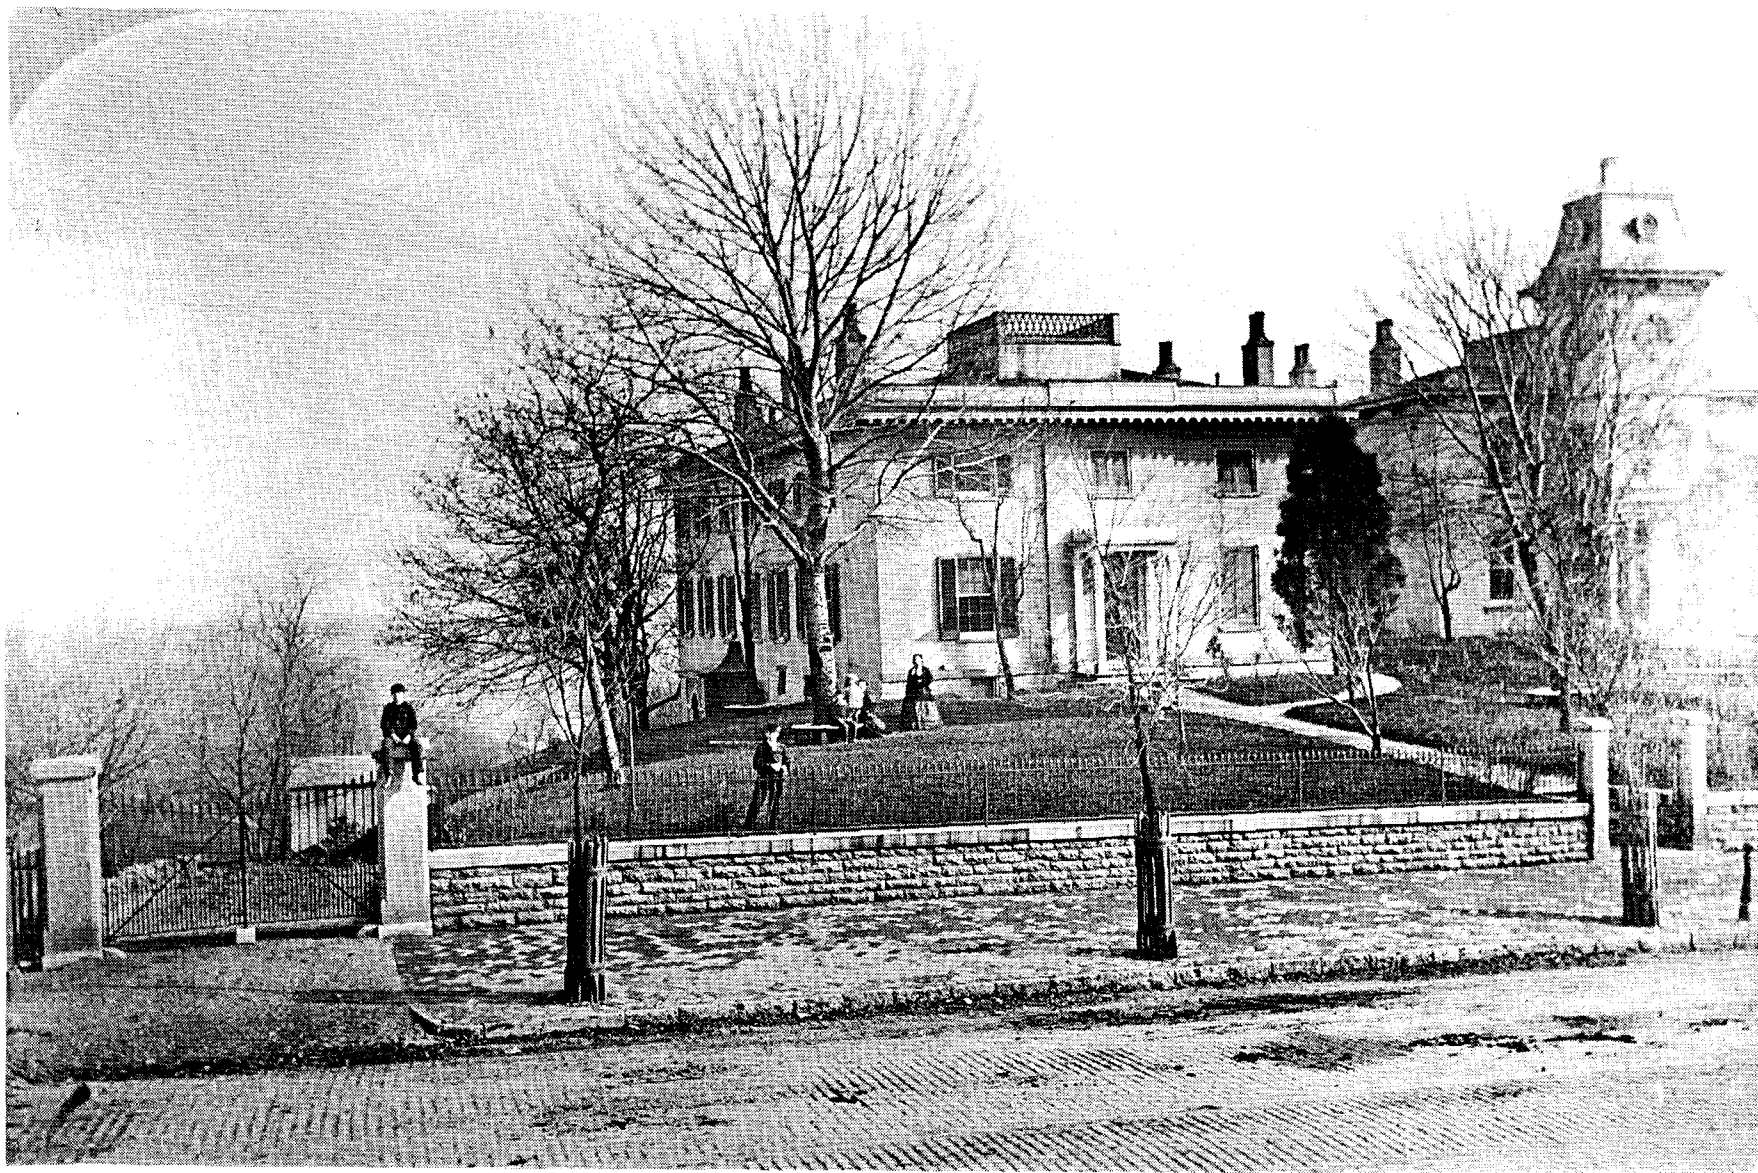
FIGURE A.1: A c.1868 view of the house from Auburn Avenue. This image demonstrates that grade for the front portion of the house has been fairly stable. A low berm, running north and south behind the seated figures has been removed. Source: Collection of the William Howard Taft National Historic Site.

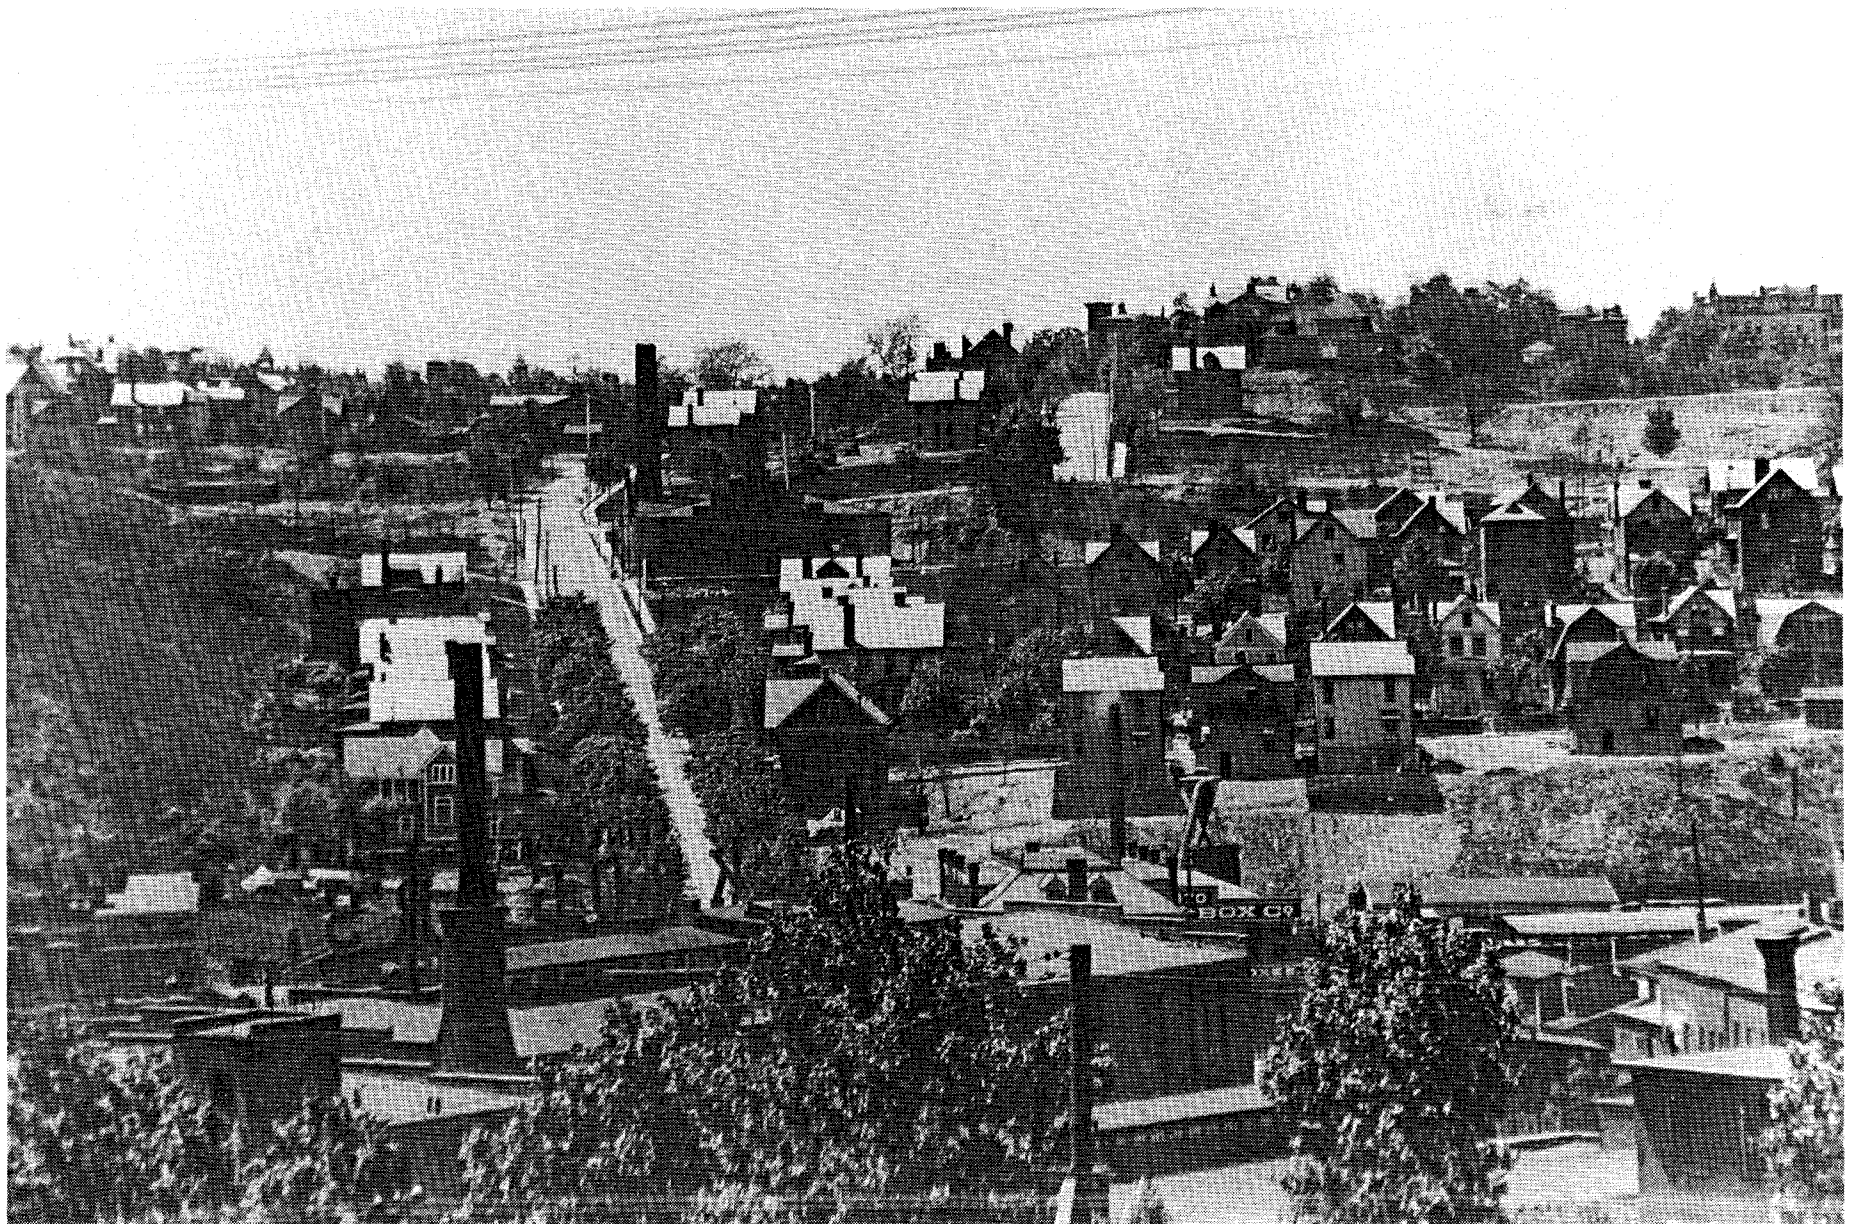
FIGURE A.4

A c. 1892 view, looking west up into the back yards of the houses on Auburn Avenue. Bodman Street is at left center and the massive fill used to extend Young Street can be seen in the upper right. Source: Cincinnati Historical Society.

A line drawing made from an enlargement of the historic photograph, Figure A.4. showing the height of fill at the extension of Young Street, from the east looking toward the rear of the Taft property. (Drawn by: The Westerly Group, Inc.) Source: Cincinnati Historical Society.

An historic photograph of the Taft site (Figure A.4) is interesting because it was taken not only to display the beauty of so many of the Victorian facades, but rather the back yards of houses along the east side of Auburn Avenue. The Taft house, the apartment house to the north, the Burkhardt house and downslope ancillary structures can clearly be seen. Because of their limited dimension, very few photographs are able to adequately demonstrate changes in grade. This photograph, by contrast, does just that. But perhaps the most revealing aspect of this image is the amount of fill that is evident in the extension of Young Street from Bodman to Southern. (See Illustration, previous page). A profile map (Figure B. 10) attempts to compare original, historic grade to that of several subsequent eras. The amount of manipulation is quite apparent.

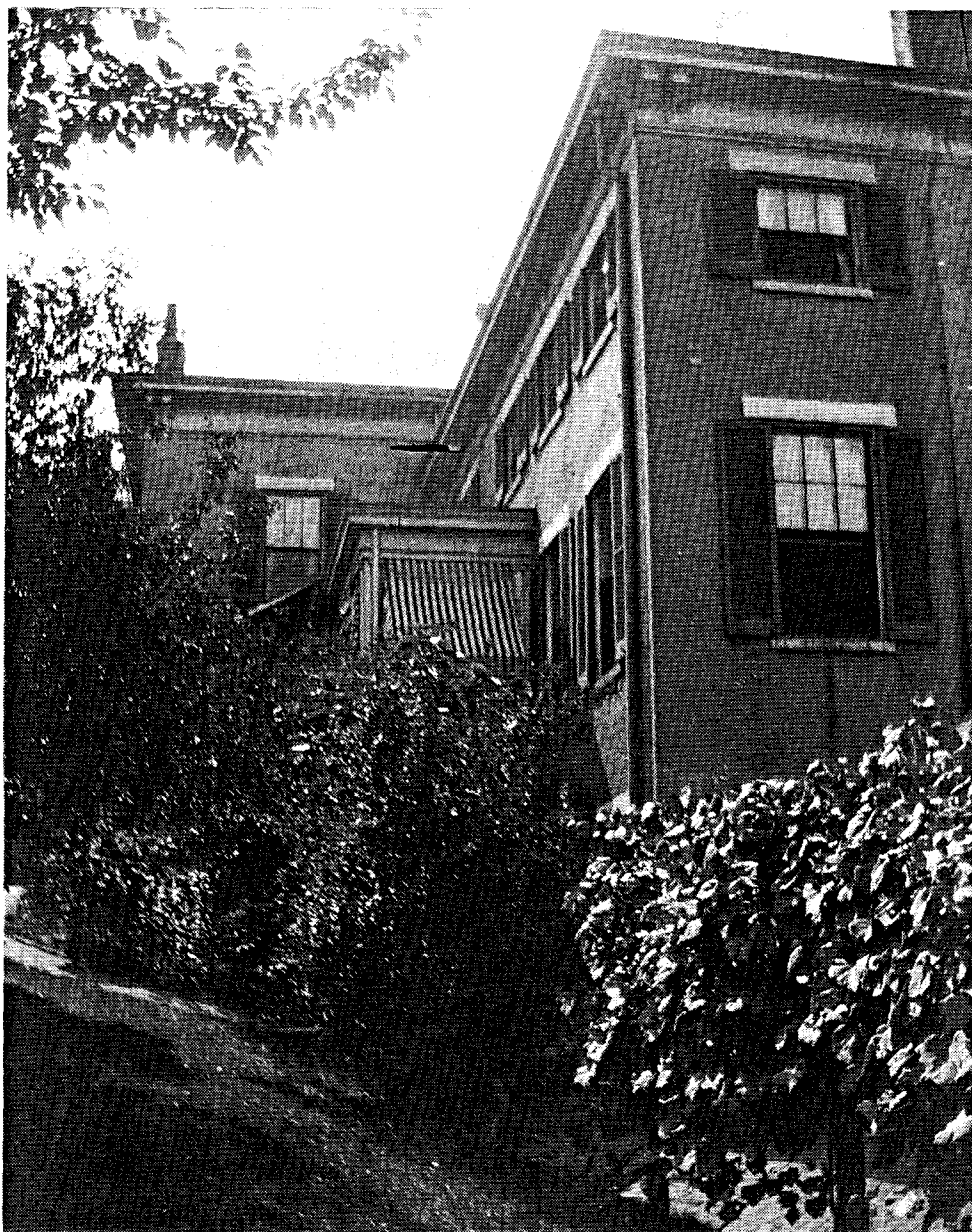
FIGURE A.5: A c. 1910 view of the southeast corner of the house, showing a healthy grape vine, its arbor and a brick path which allegedly led to the privy shown at right. A 1991 view of the scene shown at left. Source: Cincinnati Historical Society (right); The Westerly Group, Inc. (left).

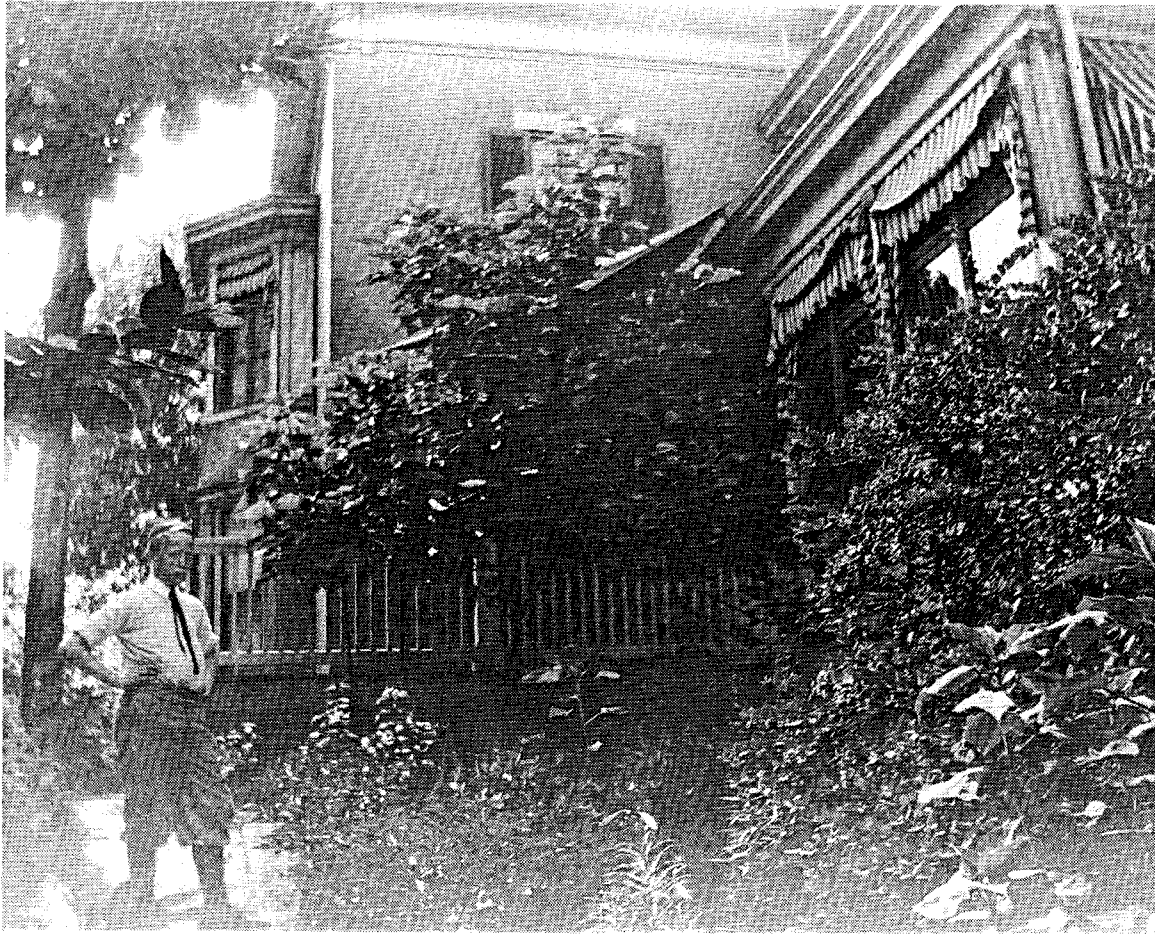
FIGURE A.7: A possible c. 1920 view of fruit trees situated on the north lawn of the house, similar to where the replacements are located today. Source: Cincinnati Historical Society.

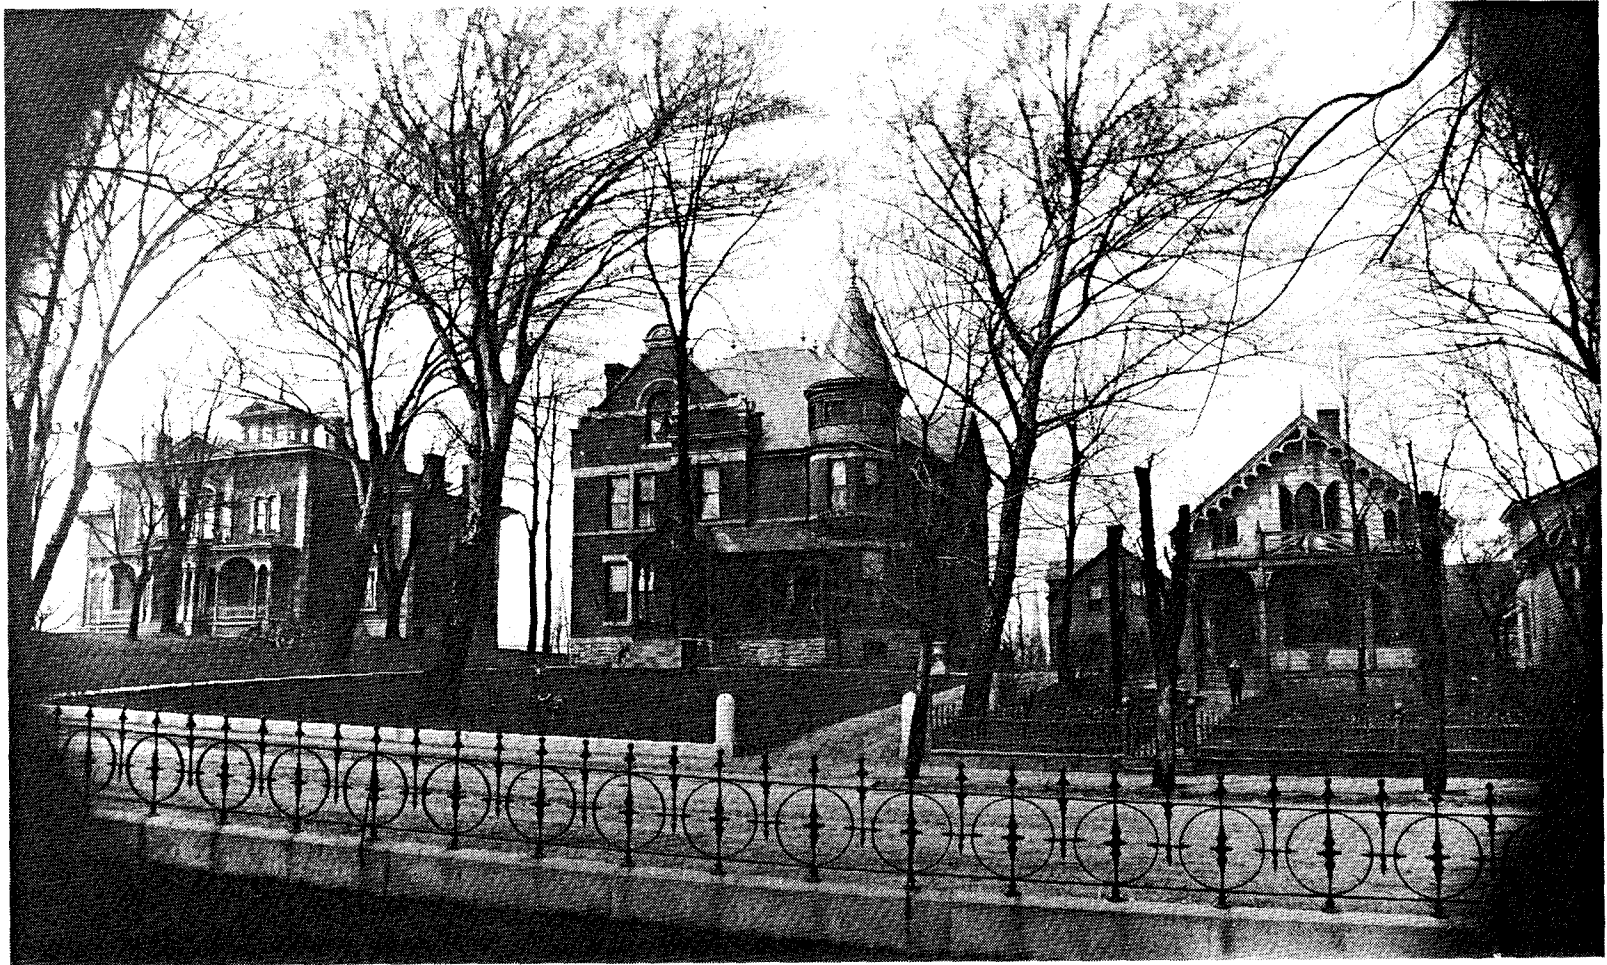
FIGURE A.15: A c. 1900 Mount Auburn street scene. Note the diversity of decorative iron fencing, limestone pillars, overhanging tree canopy and the presence of the street railway - all typical elements of the neighborhood ambiance during the years when the Taft family was in residence on Auburn Avenue. Source: Cincinnati Historical Society.

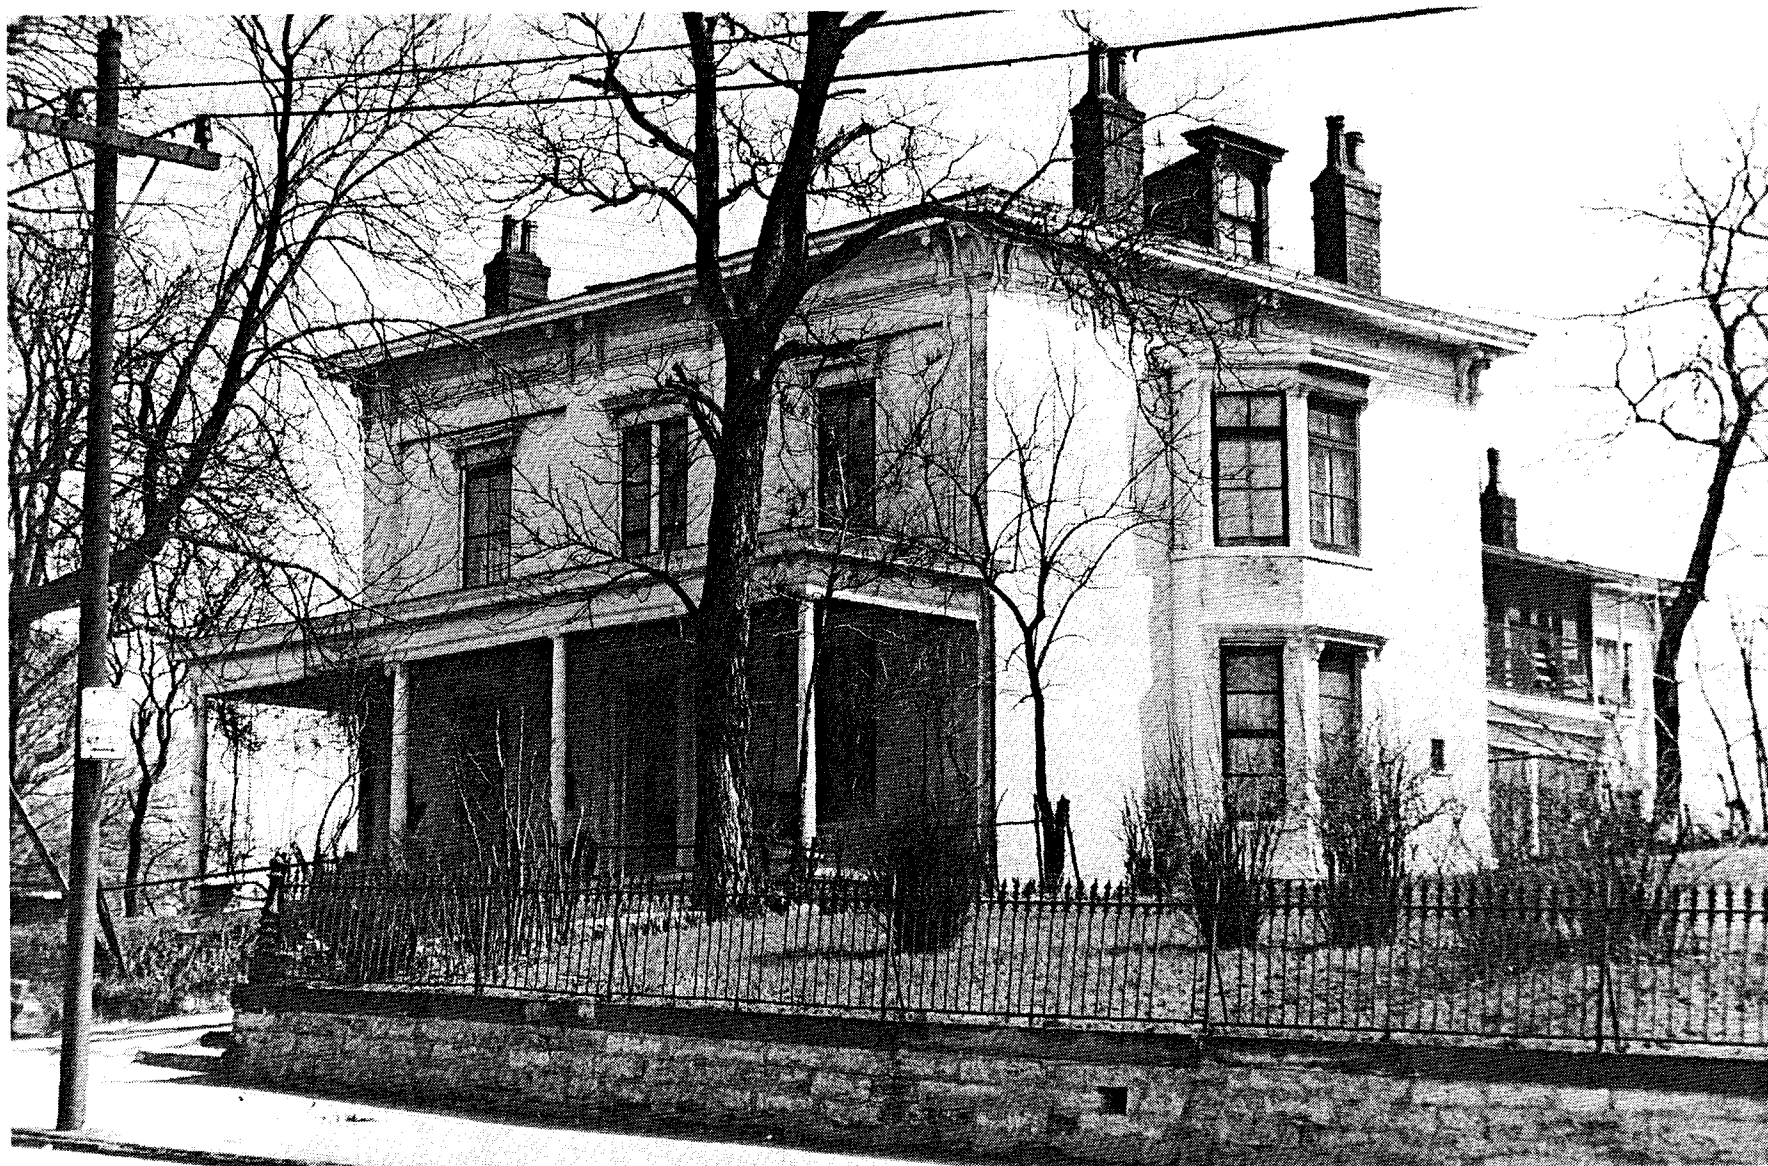
FIGURE A.17: A 1958-63 view of the new Detention Center driveway, the petrifications, complete with pottery and cast iron and an oblique view of the apartment house on the Cross Lot. Source: The Cincinnati Enquirer.

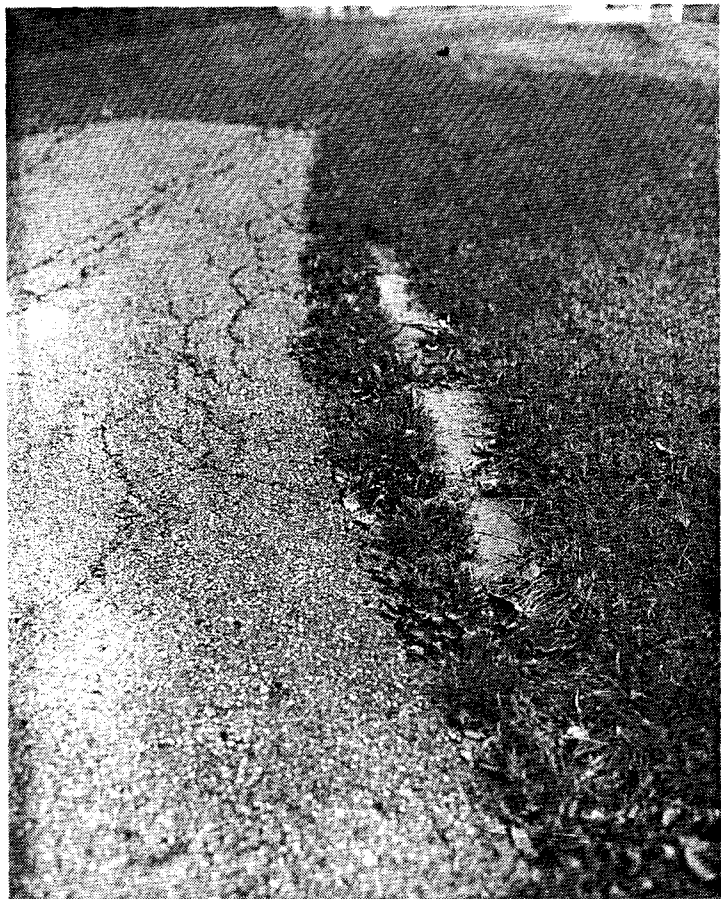
FIGURE A.18: A c.1955-60 view, looking at the southeast corner of the house, of a masonry curb, or possibly the top of a retaining wall shown at right. A 1991 view of this feature, of unknown origin, can be seen in the south drive today, shown at left. Sources: William Howard Taft National Historic Site Archives (right); The Westerly Group, Inc. (left).

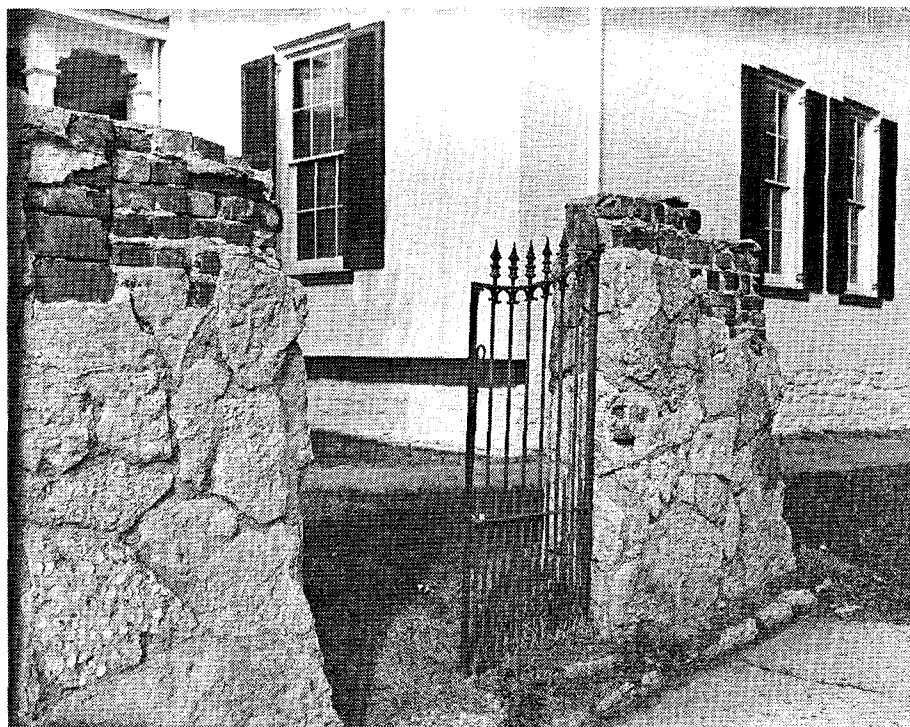
FIGURE A.20: A 1991 view (looking toward the southwest corner of the Taft house) through stone and brick features, desecrations which were placed on the site after 1946. Source: The Westerly Group, Inc..

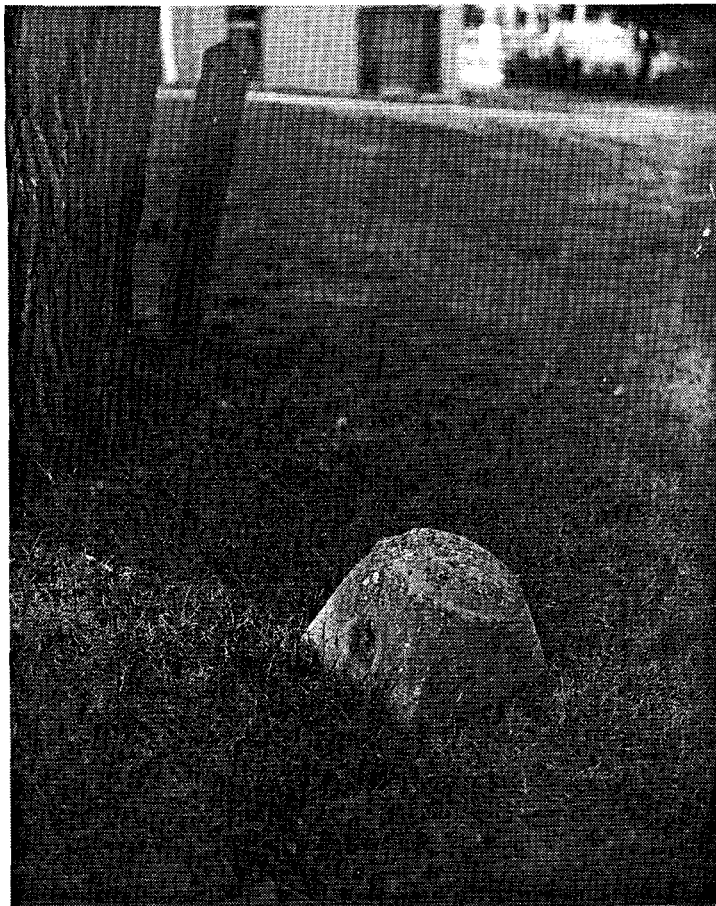
FIGURE A.21: A 1991 view of two features at the rear of the property, a wood hitching post and a concrete horse hobble shown at left and sandstone steps let into a masonry wall, foundations from the demolished apartment house which once occupied the Cross Lot shown at right. Source: The Westerly Group, Inc..

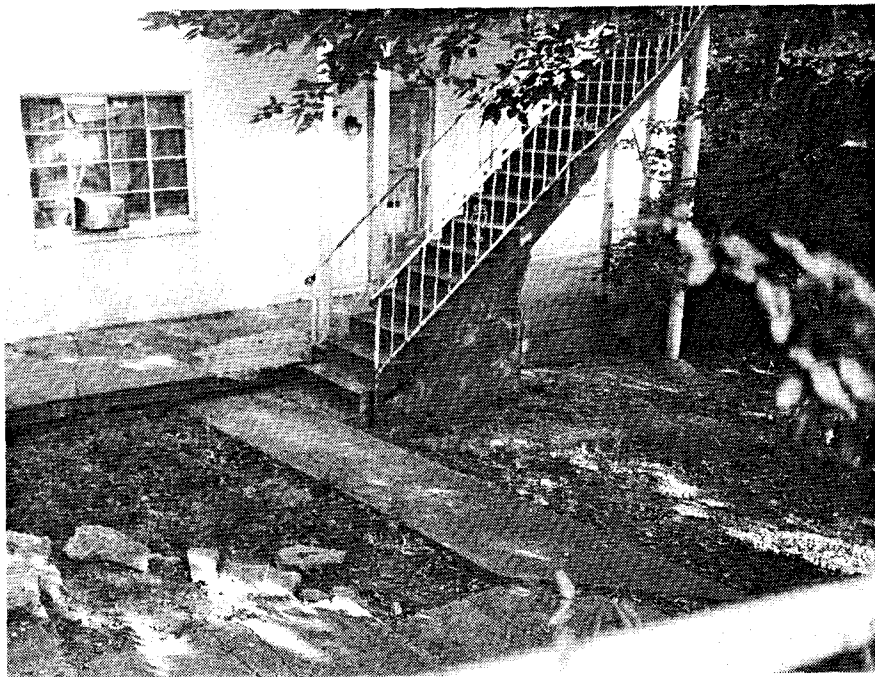
FIGURE A.22: A 1991 view of the side yard of number 219 Southern Avenue, showing portions of what might have been historic grade (fieldstone area off the walk at the foot of the staircase). This low point can be seen below our center line profile on the excerpted drawing at right. Source: The Westerly Group, Inc..

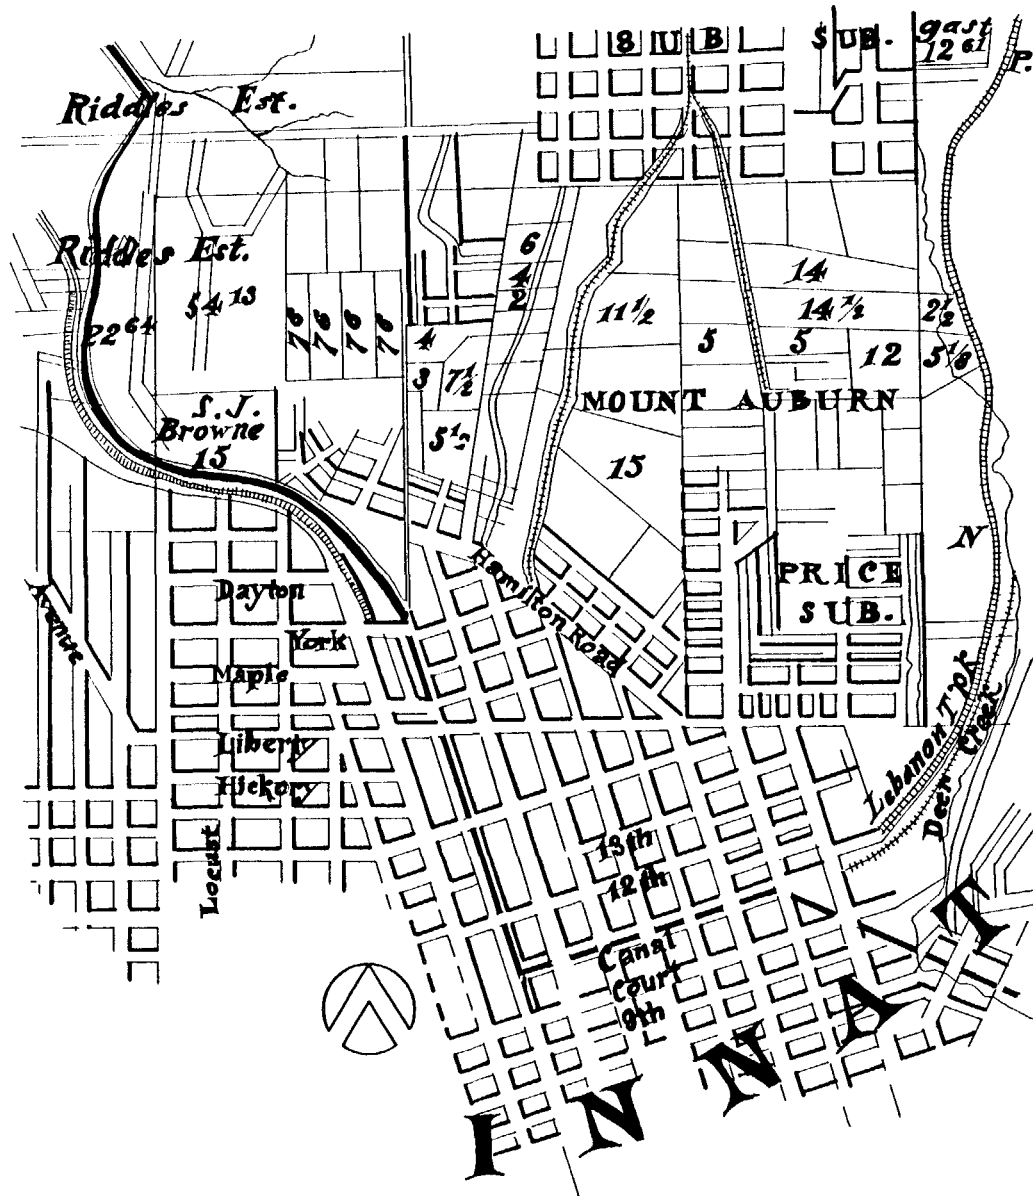
FIGURE B.4: The 1869 Titus Atlas for Mount Auburn shows the property in its entirety prior to the extension of Young Street to the north. The streetcar lines on Auburn Avenue are clearly shown. Source: Cincinnati Historical Society.
