Improving Watershed Health at John Muir National Historic Site

The Question: What are the factors contributing to exacerbated erosion and flooding within the Mt. Wanda-Strentzel Canyon watershed? What are the possible remedies?

John Muir National Historic site has recently completed a study to address erosion and flooding concerns in Strentzel Canyon. This briefing summarizes the issues and highlights some of the possible actions to improve watershed health.

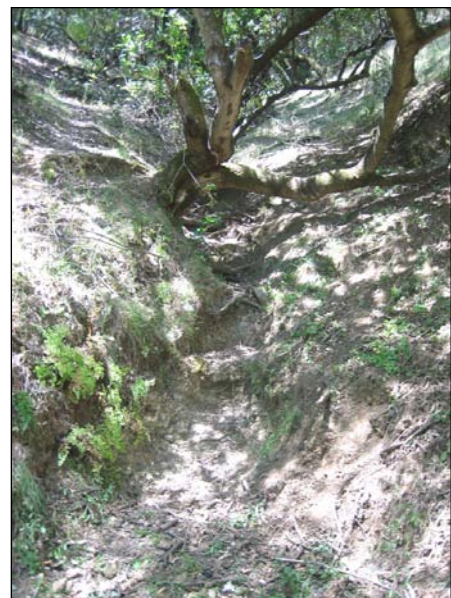
The network of ephemeral streams on Mt. Wanda carries eroded hillside sediment to the mouth of Strentzel Canyon, and Alhambra Creek.

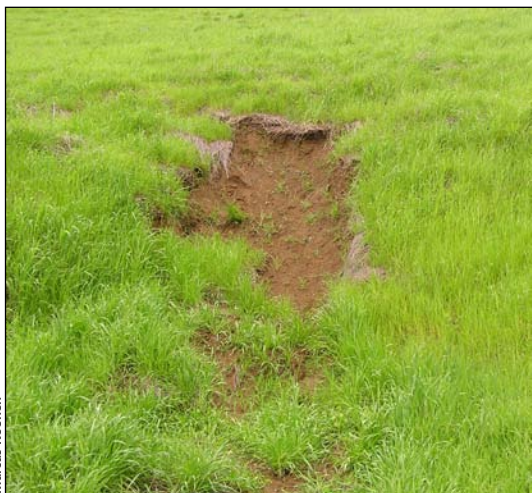
The shallow roots of non-native grasses accelerate erosion on Mt. Wanda. Dynamic creek channel erosion in the watershed and related downstream flooding prompted John Muir National Historic Site to begin a study that would determine the cause.

During the mid-1800s, the combination of the grazing pressure, disturbance by agriculture and drought forced a significant change in vegetation. Shallow-rooted exotic grasses replaced deep-rooted native bunch grasses. This shift in vegetation composition likely contributes to erosion seen today along ephemeral creeks in the watershed. The shallow roots of exotic grasses do not hold soil as tightly or hold as much water in the soil as the deeper roots of native grasses. The resulting increase in soil moisture allows precipitation to run more rapidly downslope, eroding the stream banks into deeply incised gullies.

The worst gullying is found on the north and east slopes. In some areas soil has eroded underground into small pipes that conduct water 0.3 to 1 meters below the soil surface. These can enlarge into tunnels or collapse to form a gully. Gullies are telltale signs of the hillside erosion and increased runoff that alter water quality, flooding intensity, vegetation dynamics and aquatic habitat.

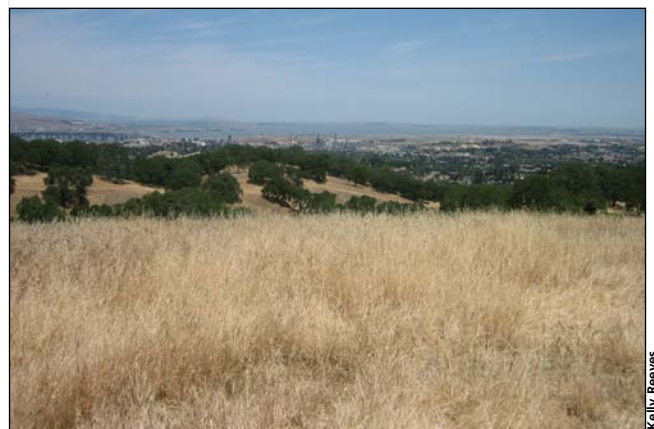
By the time John Muir strolled on Mt. Wanda, non-native grasses had replaced the native grasses. The vegetation shift likely contributes to the accelerated hillside and stream channel erosion seen today.
