# Managing Park Rangeland to Improve the Health of the Tomales Bay Watershed

**Importance:** *Ten thousand acres of park rangeland at Point Reyes National Seashore (PRNS) and Golden Gate National Recreation Area (GGNRA) are within the Tomales Bay watershed. The non-point source pollution from these rangelands contributes to the compromised health of this important watershed.*

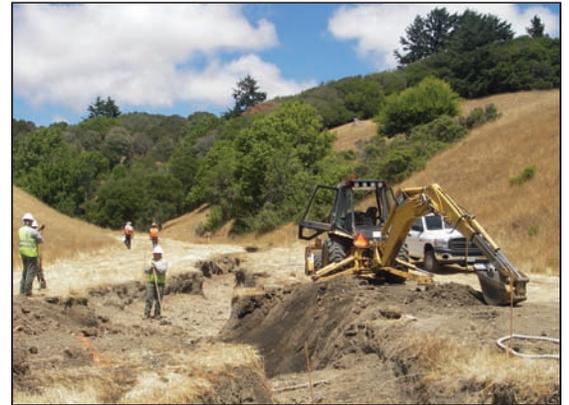
To stem the infusion of sediment and pollutants into the watershed, crews repaired and filled in the Truttman Ranch Headcut.

The project also aimed to repair erosion features such as headcuts. These gashes in the ground form where there is a sharp break in slope gradient in a drainage or at the top of a gully. As water flows over the cut face, it continues to erode. Consequently, the gully creeps upslope, losing more soil into the watershed. Because this process is accelerated by the movement of livestock through the area, preventing animal access was a first step in addressing the problem. To repair the headcut, staff constructed barriers—called willow walls—made of tightly woven, freshly cut willow branches that trap sediment flowing downhill, dissipate the erosive energy of concentrated water flow, and halt the upward march of the headcut. These bioengineered partitions eventually take root and spawn willow saplings, stabilizing what was once a non-point source pollution hotspot.

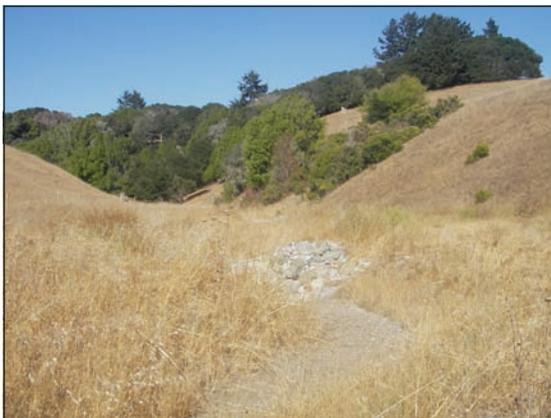
The rehabilitated area (shown in 2008) is less likely to serve as a highway for pollutants.
