# Prehistoric Rock Alignments for Water Manipulation in Saguaro National Park

# Saguaro National Park

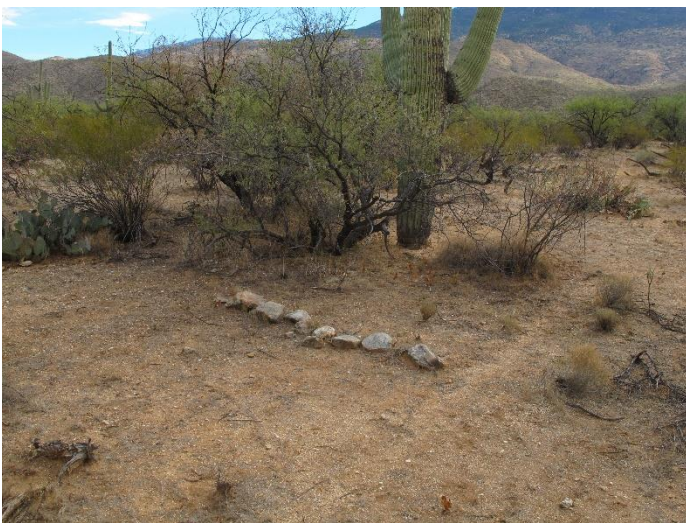
**Figure 1. Rock alignment at site 83A-165. Further testing is needed to determine whether or not this was used as a terrace.**

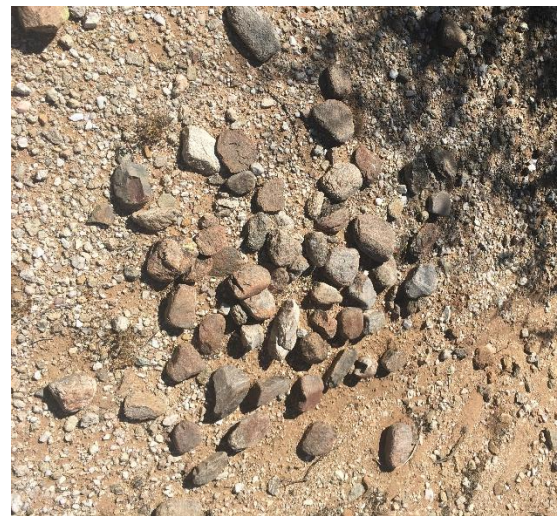
**Figure 2. Rock Pile located next to a drainage at site 83A-165. May have been used as a roasting pit or for agave cultivation.**

**Rock Fields/Piles** This category is broader than terraces, and encompasses several types of rock alignments. Rock piles can vary greatly in size and can be used for many different purposes. One of the most common uses for high elevation rock piles were for the cultivation of agave. Fire cracked rock is present in some of these rock piles, indicating that they may have been used as roasting pits. Rock fields, collections of rocks in a grid like pattern, were used to hold sediment and had better temperature regulation than soil fields, which was especially important for protecting crops from freezes at higher elevations.
