San Juan Island National Historical Park

Blockhouse Rehabilitation Underway at English Camp

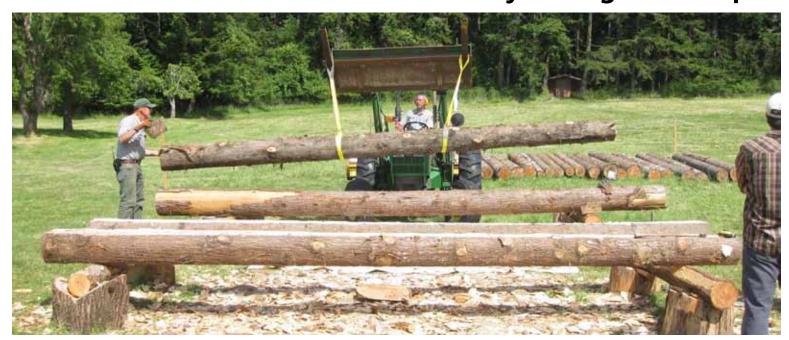
San Juan National Historical Park's blockhouse restoration project crew chief David Harsh guides maintenance worker Todd Narum in setting a log onto a platform that serves as workplace to shave and prepare logs for fitting the new lower structure.

Maintenance crews will use modern tools such as chain saws and vintage hand tools such as broad axes and adze planes to notch and assemble the logs, which were shipped last year from Oregon. The new structure will be assembled at the north end of the English Camp parade ground, said Ken Arzarian, park maintenance foreman.

The logs will then be coded and the structure disassembled. The upper story will be raised and supported by jacks and cribbing while the current lower story is removed log by log.

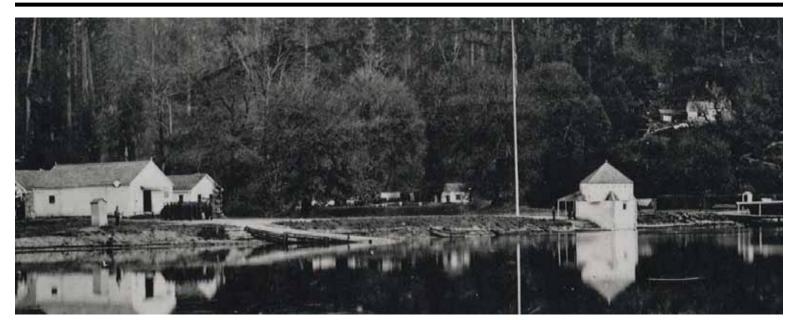
The blockhouse at far right was primarily used as a guardhouse throughout the joint occupation of San Juan Island.

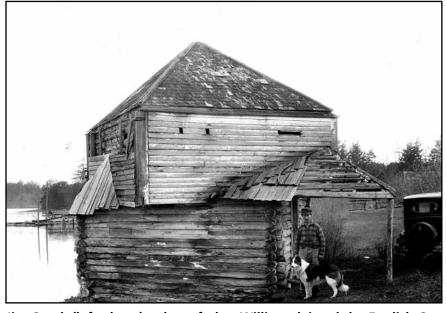
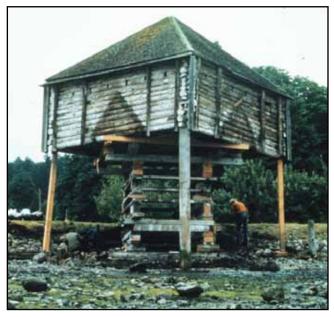
Jim Crook (left photo), whose father William claimed the English Camp site under the Homestead Act of 1862, made temporary repairs to the blockhouse until his death in 1967. He never had the heart to tear it down. The only original logs left in the structure today compose the entire upper story behind the plank siding. Some can be seen exposed in this photo. National Park Service crews (at right) preserved the original upper story while replacing the lower logs.

The upper-story logs (hidden by siding) of the English Camp structure are authentic, but because of tidal action, the log base was replaced wholly in 1970 and partially (the bottom 10 logs) in 1995. The lower story has significantly deteriorated since then.
